## Appendix - Phase 1 Fish Passage Assessment Data and Photos

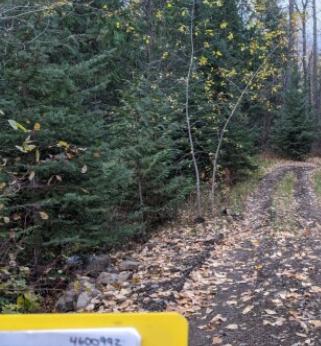
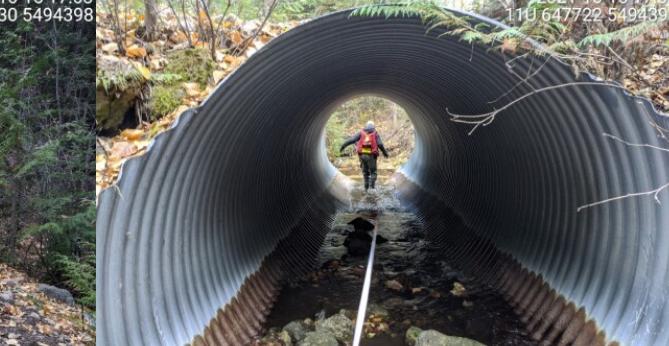
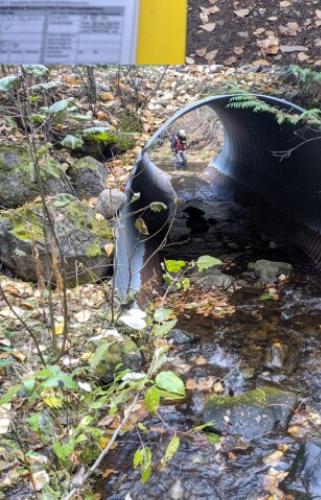
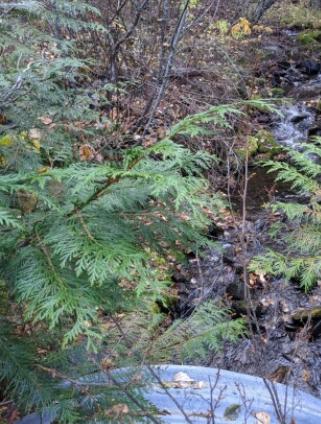
Location and Stream Data	Crossing Characteristics
Photos: PSCIS ID 197866. From top left clockwise: Road/Site Card, Barrel, Outlet, Downstream, Upstream, Inlet.

Comments: Embedded for approximately 8m from the inlet. Small water supply dam located upstream of culvert ~45m. Structure is ~1m high. 17:00

Location and Stream Data		CROSSING CHARACTERISTICS	
Date	2021-10-15	Crossing Sub Type	Round Culvert
PSCIS ID	197866	Diameter (m)	2.3
External ID	4600992	Length (m)	13
Crew	AI BK	Embedded	No
UTM Zone	11	Depth Embedded (m)	—
Easting	647734	Resemble Channel	No
Northing	5494404	Backwatered	No
Stream	Hosmer Creek	Percent Backwatered	—
Road	Unnamed	Fill Depth (m)	0.5
Road Tenure	Resource	Outlet Drop (m)	0.25
Channel Width (m)	4.1	Outlet Pool Depth (m)	0.57
Stream Slope (%)	11	Inlet Drop	No
Beaver Activity	No	Slope (%)	2
Habitat Value	High	Valley Fill	Deep Fill
Final score	26	Barrier Result	Barrier
Fix type	Replace with New Open Bottom Structure	Fix Span / Diameter	12

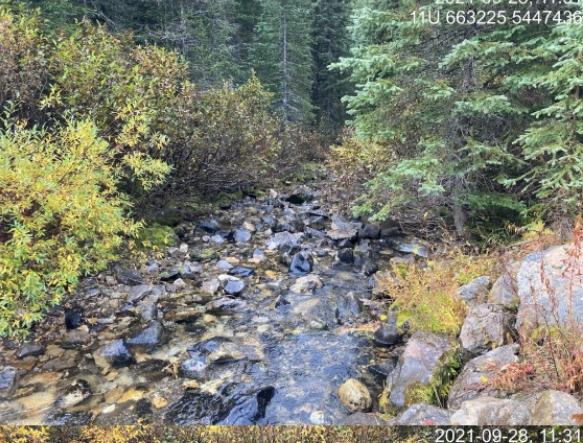
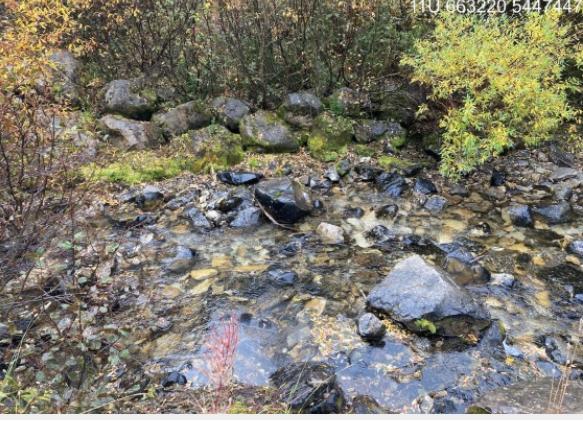
Comments: Inactive road. Thick alders. Walked in from Cabin FSR. 11:28

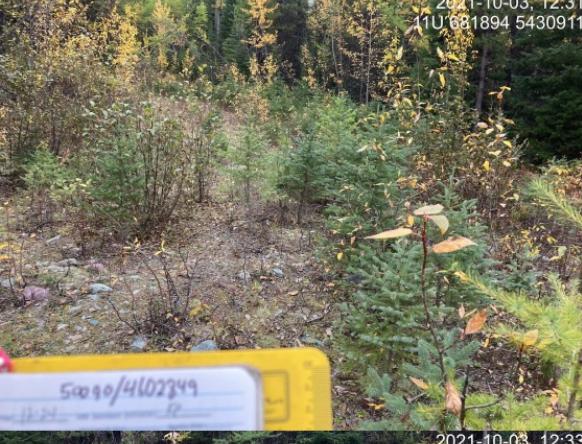
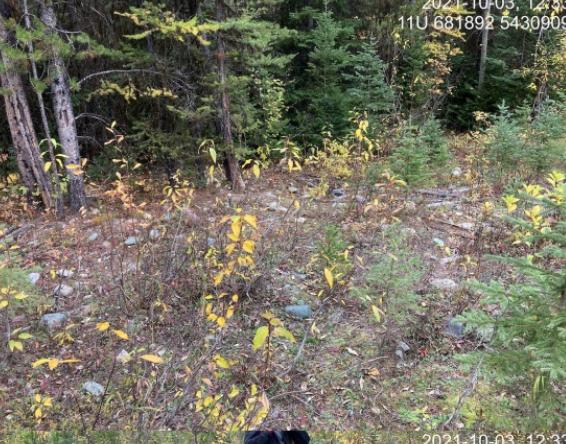
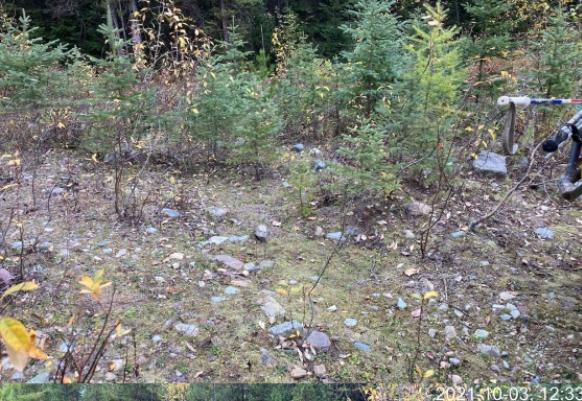
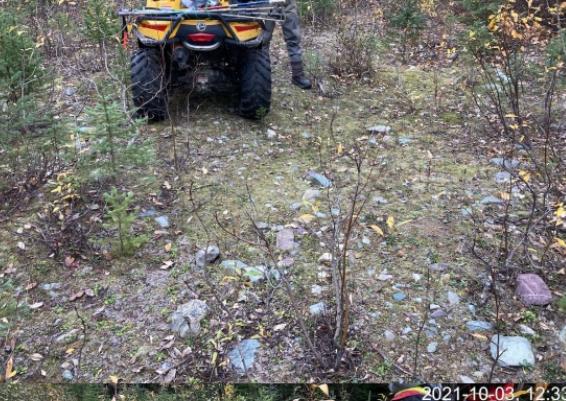
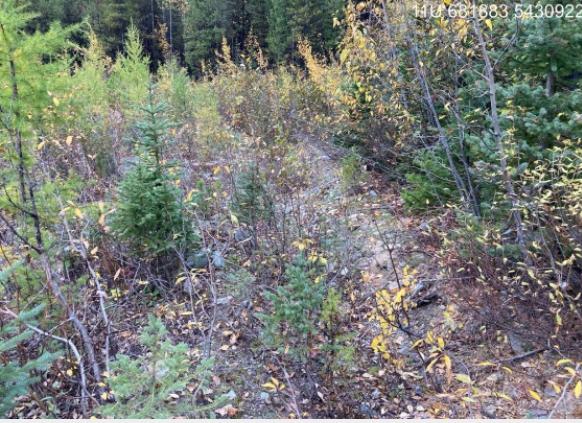
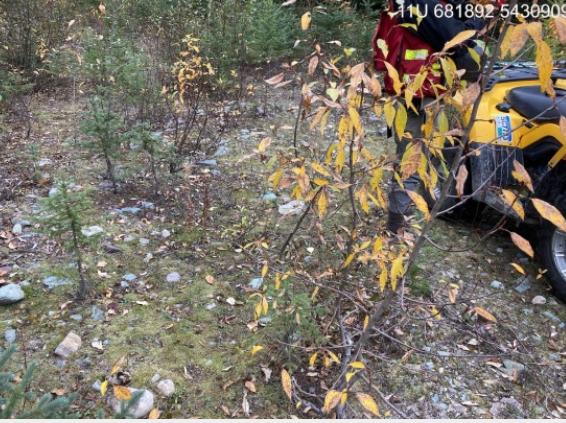
Location and Stream Data	•	Crossing Characteristics	-
Photos: PSCIS ID 197868. From top left clockwise: Road/Site Card, Barrel, Outlet, Downstream, Upstream, Inlet.

Comments: Inactive road. Site was assessed because of good flows upstream at PSCIS crossing 50092 and documentation of culvert at 50090. However, no culvert or evidence of stream channel located in area. 12:24
