Elk River Watershed Group Fish Passage Restoration Planning 2021

**Prepared for
Nupqua Resource Limited Partnership**

**Prepared by
Al Irvine, B.Sc., R.P.Bio.
New Graph Environment Ltd.**

**Version 1.0.0
2022-03-22**

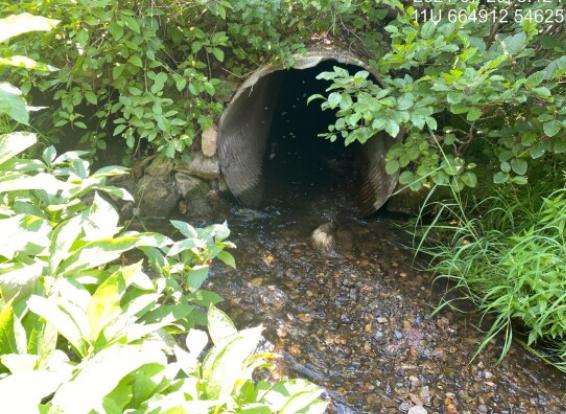
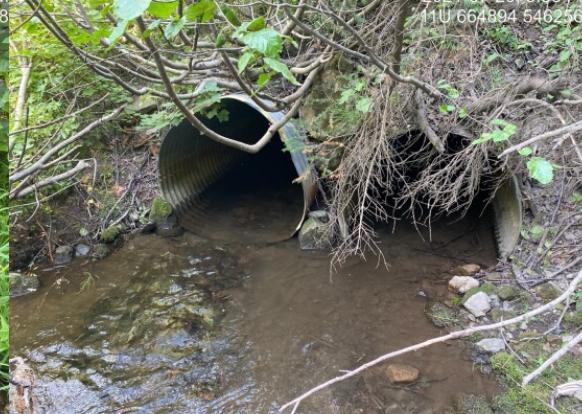
Location and Stream Data	• Crossing Characteristics	-
<p>Comments: Two pipes (1m each) but one blocked with debris. Because height of outlets equivalent widths were added together for input to stream width ratio. Large beaver dams upstream between culvert and Lodgepole Lake. 15:37</p>
