DRAFT - Elk River Watershed Group Fish Passage Restoration Planning 2021

**Prepared for
Nupqua Limited Partnership**

**Prepared by
Al Irvine, B.Sc., R.P.Bio.
New Graph Environment Ltd.**

**Version 0.1.2 - DRAFT
2022-03-12**

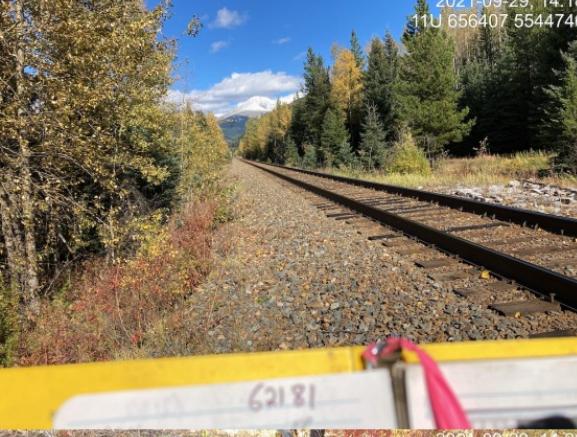
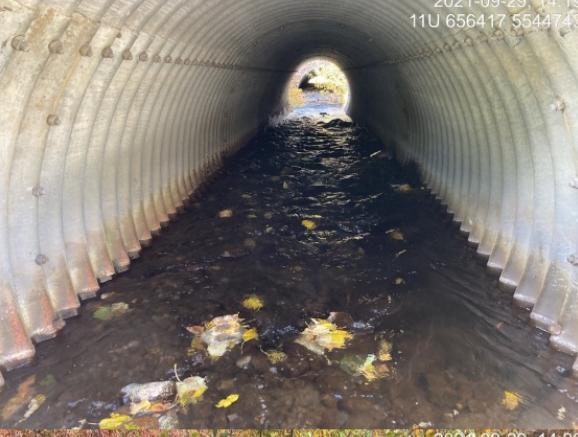
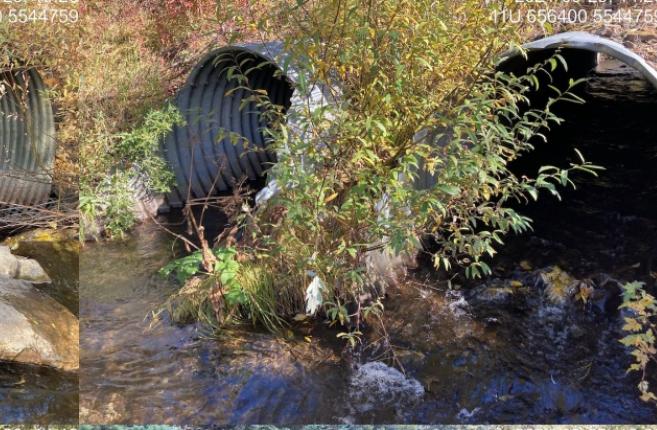
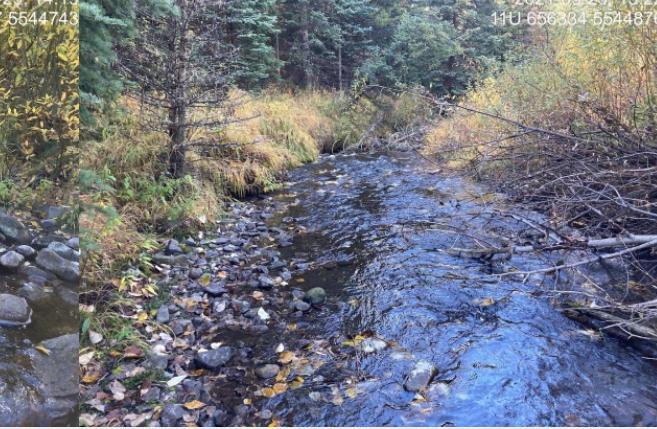
Location and Stream Data	• Crossing Characteristics
Comments: Two pipes (1.8m x 1.8m). Left pipe was measured. Right pipe gradient ~3%. Right pipe partially embedded.

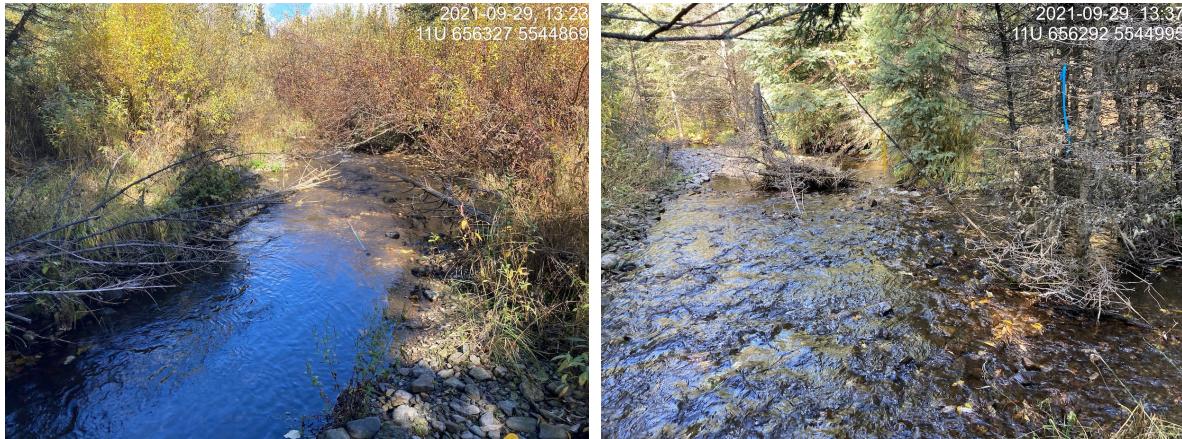
The stream was surveyed downstream from 62182 for 500m (Figure [5.4](#)). Overall, total cover amount was rated as abundant with undercut banks dominant. Cover was also present as deep pools and overhanging vegetation (Table [5.9](#)). The average channel width was 3.9m, the average wetted width was 3.1m and the average gradient was 2%. The dominant substrate was cobbles with gravels subdominant. During the downstream survey the stream was observed to be quite open with all riparian vegetation comprised as shrub before transitioning into mature mixed forest. Pools and undercut banks were noted with their frequency increasing further downstream. The stream was noted as very braided at times and had appeared to have shifted into a new channel, indicated by fine substrate, mid stream standing and dead conifers and no major channel development (ie. wetted channel was equivalent to channel width in these areas). Substrate was noted well outside the normal high water mark suggesting high flows and channel movement. Sharp bends in the stream resulted in deep pools and undercut banks. A climate and hydrometric station was observed downstream of the highway in first few hundred meters. Habitat value was rated as high.

Figure 5.4: Left: Typical habitat downstream of PSCIS crossing 62182. Right: Typical habitat downstream of PSCIS crossing 62182.

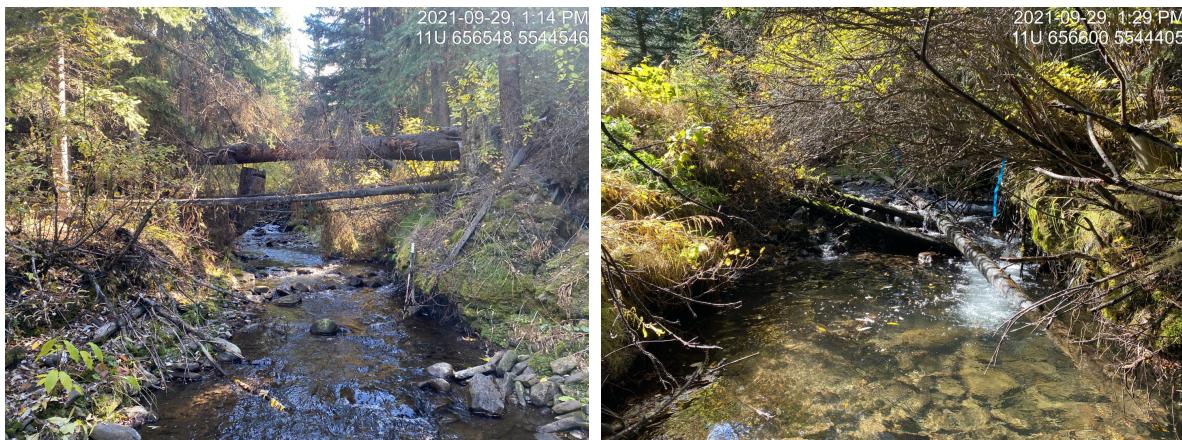
Figure 5.5: Left: Typical habitat upstream of PSCIS crossing 62181. Right: Typical habitat upstream of PSCIS crossing 62181.

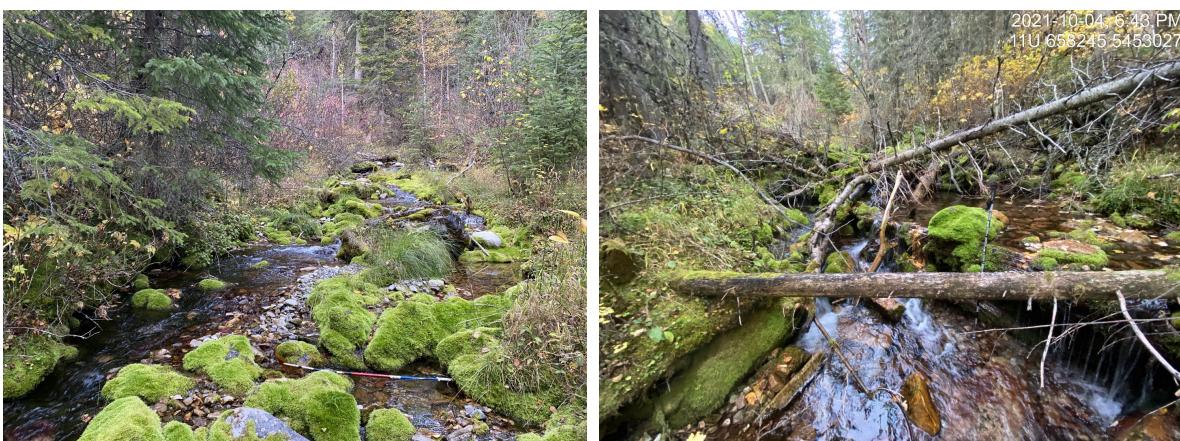
Figure 5.18: Left: Habitat upstream of PSCIS crossing 197844. Right: Habitat upstream of PSCIS crossing 197844.
