Effectiveness Monitoring for Cross Creek, Bittner Creek and Five Mile Creek - 2022

**Prepared for
Ministry of Transportation and Infrastructure**

**Prepared by
Al Irvine, B.Sc., R.P.Bio.
New Graph Environment Ltd.**

**Version 0.0.1 DRAFT
2023-05-03**

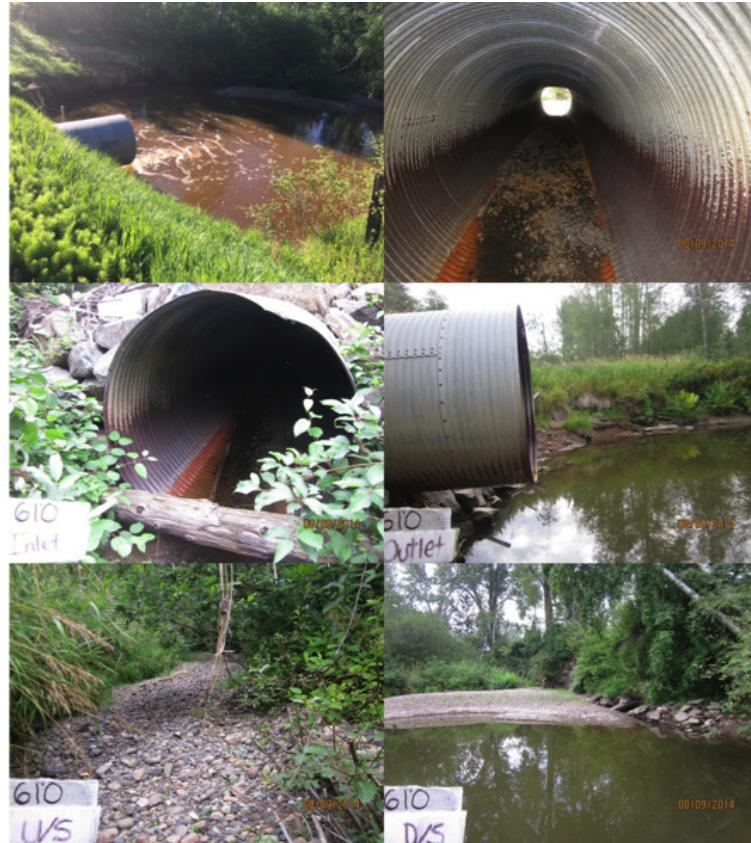
Before remediation, the Bittner Creek culvert at PSCIS crossing 196200 was documented as a 1.9m wide round culvert of 20m in length, having an outlet drop of 0.7m and a culvert slope of 1% (MoE 2023c). The crossing ranked as a barrier to upstream migration according to the provincial protocol (MoE 2011b) . Photos taken in 2014 - before the remediation was completed are included as Figure [4.3](#).

Figure 4.3: Photos of culverts on Cross Creek taken in August 2014 before remediation of site.

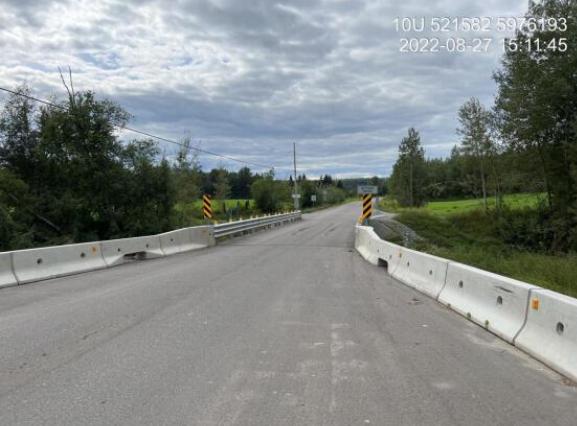
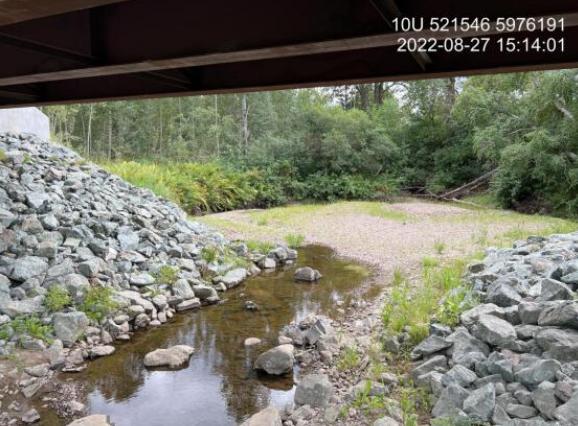
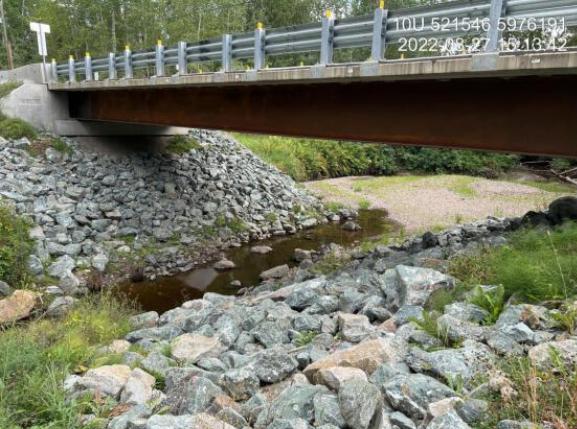
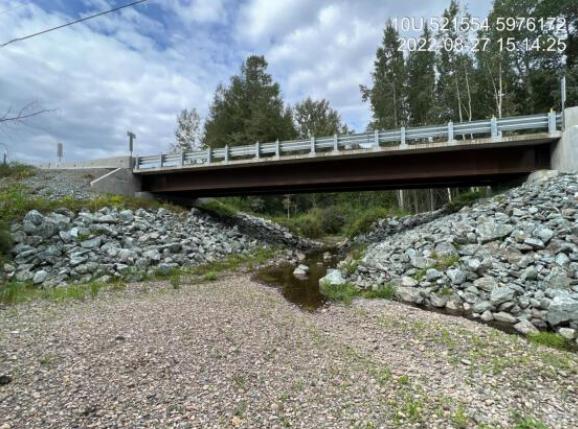
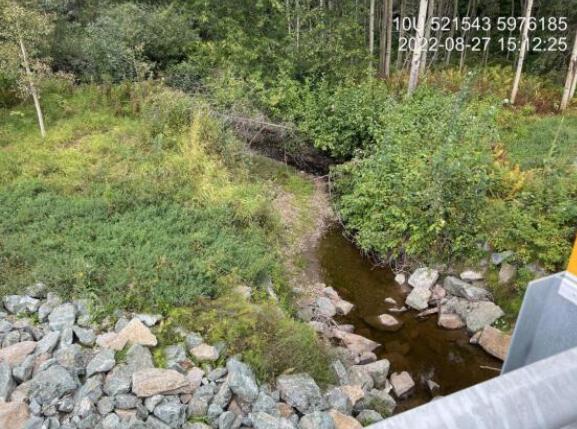
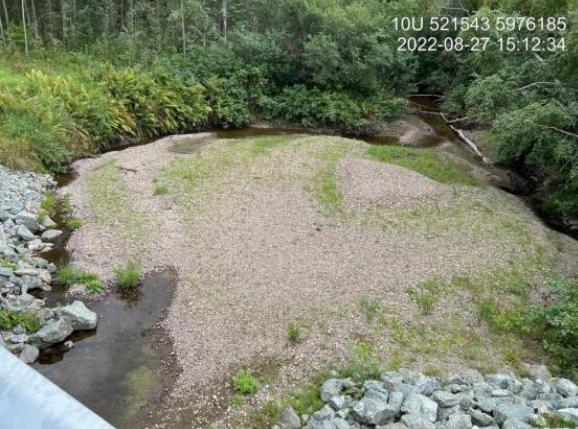
Location and Stream Data	•	Crossing Characteristics	-
Comments: Effectiveness monitoring for MoTi. Adjacent landowner mentioned that in 30 years he has not seen salmon come to spawn and also indicated that the stream dewatered annually.			
Photos: From top left clockwise: Road/Site Card, Barrel, Outlet, Downstream, Upstream, Inlet.

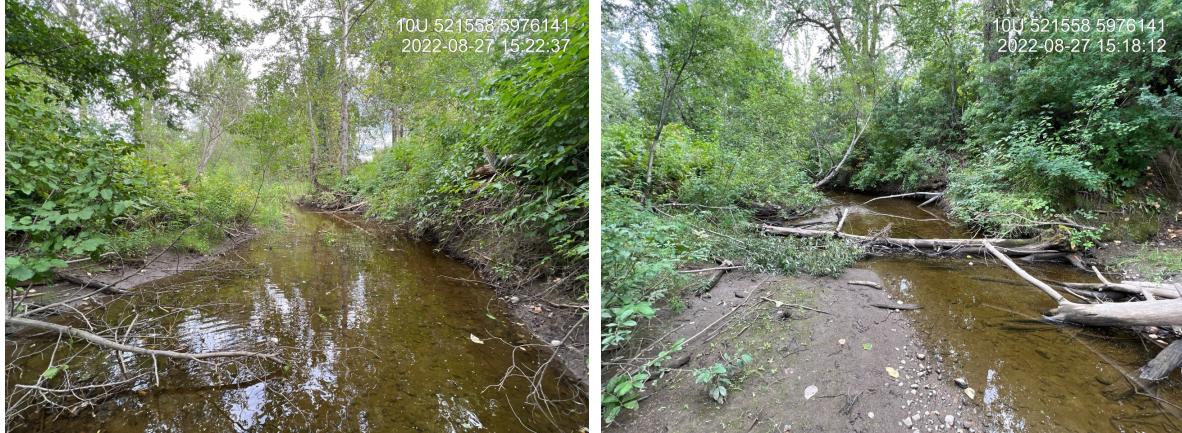
Downstream of the bridge, the stream was surveyed for 100m. `rfpr_my_habitat_paragraph('ds')` The portion of creek immediately downstream of the bridge (20m) was lacking meaningful riparian vegetation due to a lack of shrub/tree installation into riprap areas during construction and the very wide channel width in this location. (due to infilling of historic large outlet pool).

Figure 4.4: Left: Habitat downstream of PSCIS crossing 196200, on Bittner Creek. Right: Habitat downstream of PSCIS crossing 196200, on Bittner Creek

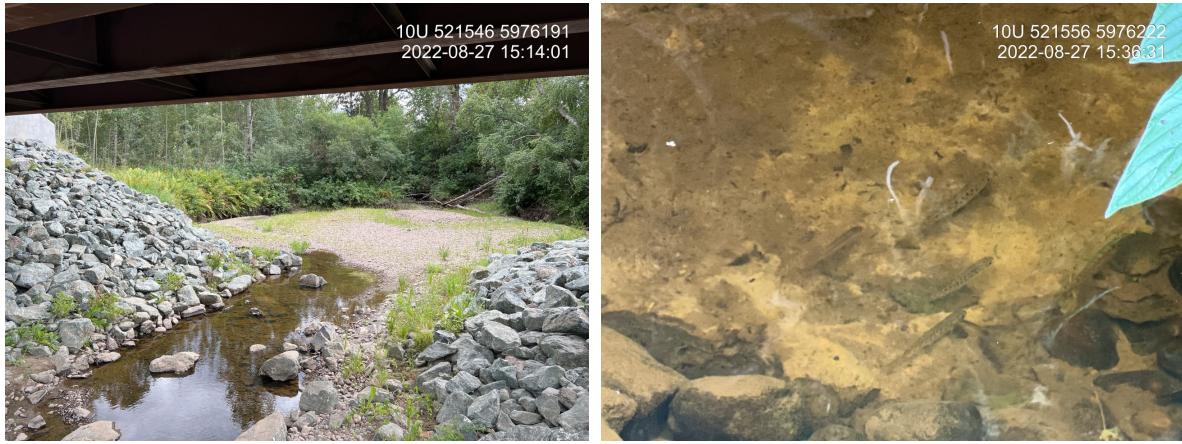
Although DWB Consulting Services Ltd. (2019) noted that installation of a rock weir on the upstream end of the historic culvert outlet pool was planned to maintain this habitat feature, it is unclear if this occurred. Regardless, sediments have infilled the historic outlet pool and this area does not likely provide high or even moderate value habitat.

Figure 4.5: Left: Downstream view of location of historic outlet pool on Bittner Creek below Foreman Road which has filled with gravels due to culvert removal. Right: Salmonid parr observed upstream of bridge on Bittner Creek.

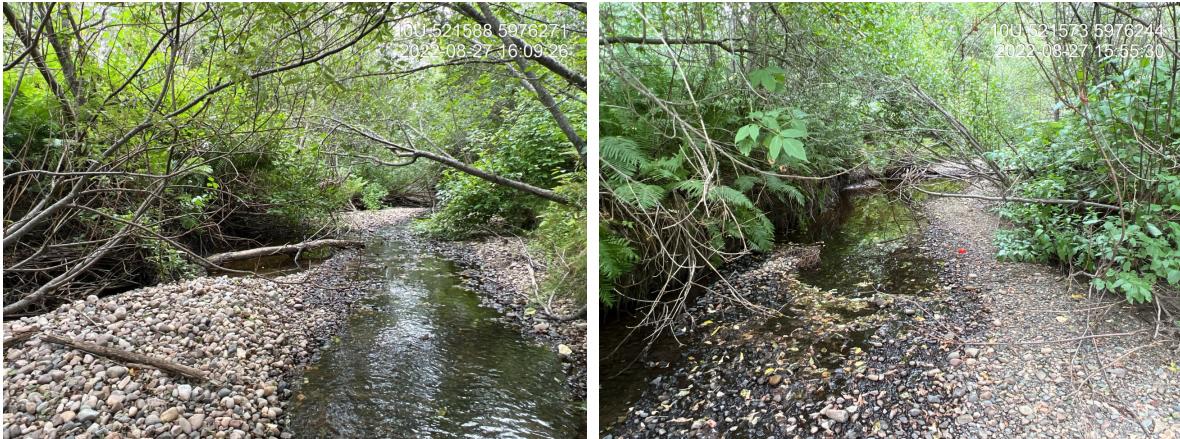
Flows in Bittner Creek were low at the time of assessment and the adjacent landowner reports seasonal dewatering of the stream. Nevertheless, numerous parr were observed within isolated pools upstream of the newly installed bridge and residual pools within intermittent systems can provide valuable habitat for juvenile salmon encouraging high growth rates and subsequent increased rates of overwinter survival (Ebersole et al. 2006; Wigington Jr et al. 2006; Maslin and McKinney 1998). We recommend fish sampling to determine use of Bittner Creek habitats by chinook salmon for both spawning and rearing. As the site is located within Prince George city boundaries, potential collaborations could include programs involving University of Northern BC and local First Nations to understand not only fish health and movement but also overall watershed health including flow patterns and water temperatures. To encourage year round flows, in collaboration with local landowners/stewardship groups/First Nations, wetland area in the agricultural area to the north of the bridge (connected to first upstream tributary) should be assessed to determine if water storage could be increased by actions such as promoting beaver activity and infilling of historic drainage structures. The rail crossing located on the CN line

Figure 4.6: Left: Typical habitat upstream of Foreman Road bridge on Bittner Creek. Right: Typical habitat upstream of Foreman Road bridge on Bittner Creek.

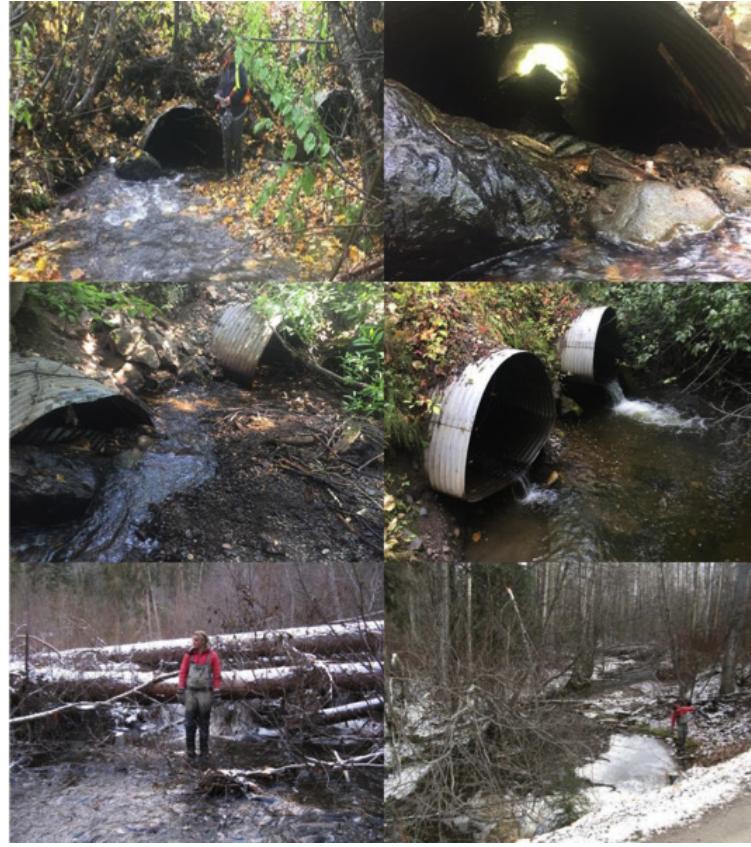
Before remediation, the Cross Creek culverts at PSCIS crossing 198283 were documented as 1.8m wide ovals culverts of 12.4m in length, having an outlet drop of 0.45m and a culvert slope of 2% (MoE 2023c). The crossing ranked as a barrier to upstream migration according to the provincial protocol (MoE 2011b). Photos taken in 2017 - before the remediation was completed are included as Figure [4.7](#). In 2022, the site was reassessed. As PSCIS crossing 198283 was a newly installed open bottomed structure it ranked as a passable to upstream fish passage according to the provincial protocol (Table [4.7](#)).

Figure 4.7: Photos of culverts on Cross Creek taken in November 2017 before remediation of site.

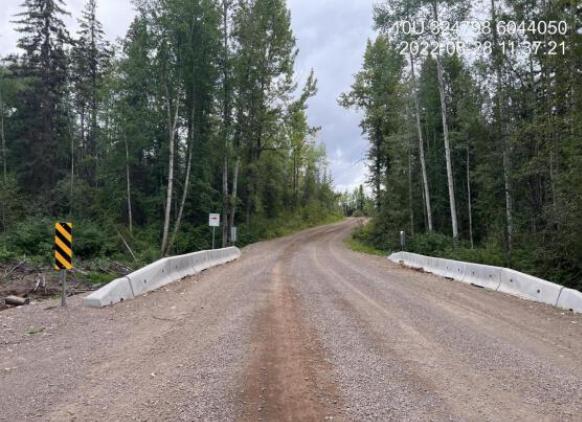
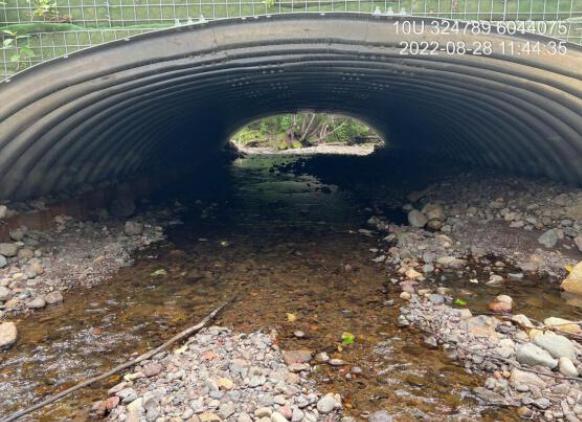
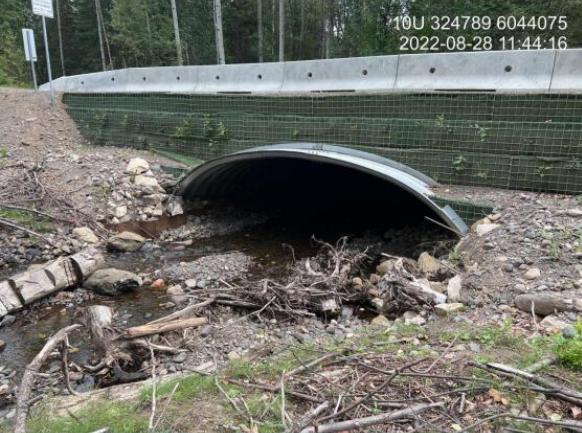
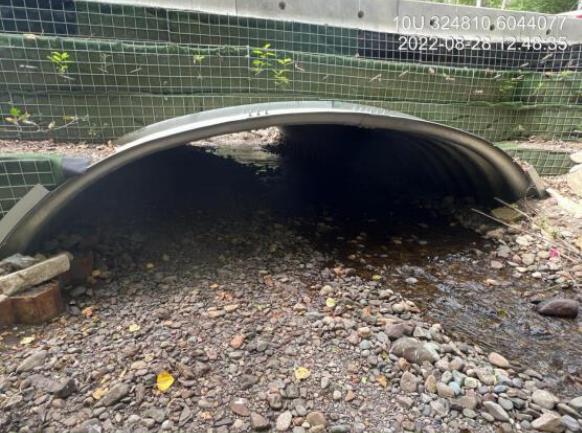
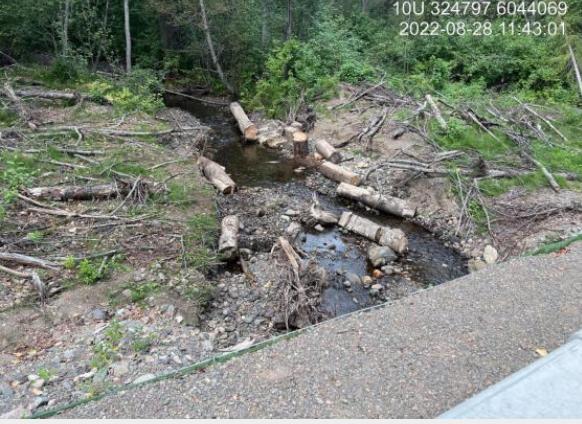
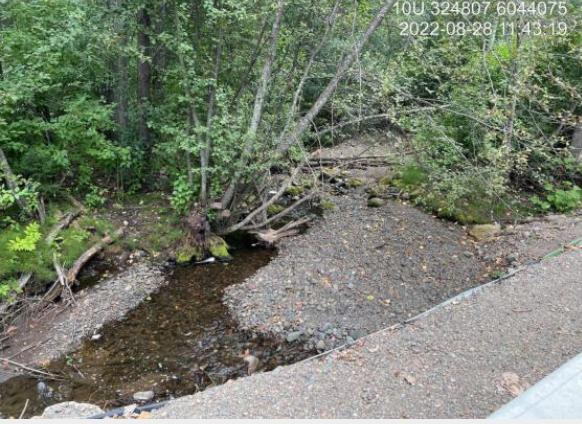
Location and Stream Data	.	Crossing Characteristics	-
Fix type	-	Fix Span / Diameter	-
Comments: Effectiveness monitoring for MoTi. Channel has filled in nicely since last year. Numerous sockeye holding upstream and downstream of the crossing. Multiple large dead spawn out sockeye present. Live cuttings installed within riparian area appear to be growing however year two and three will be better indicators of success for revegetation.			
Photos: From top left clockwise: Road/Site Card, Barrel, Outlet, Downstream, Upstream, Inlet.

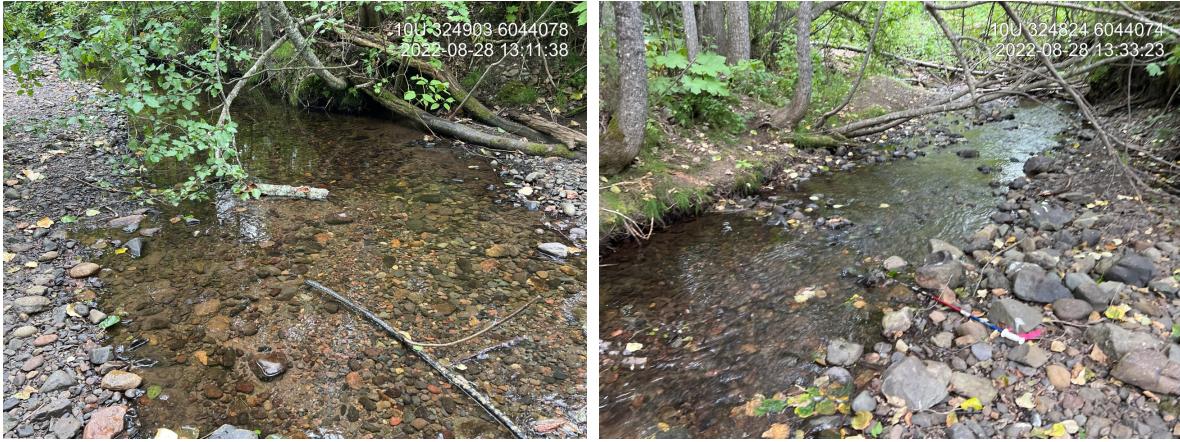
Figure 4.8: Left: Typical habitat downstream of PSCIS crossing 198283 in Cross Creek showing high value spawning gravels. Right: Typical habitat downstream of PSCIS crossing 198283 in Cross Creek.

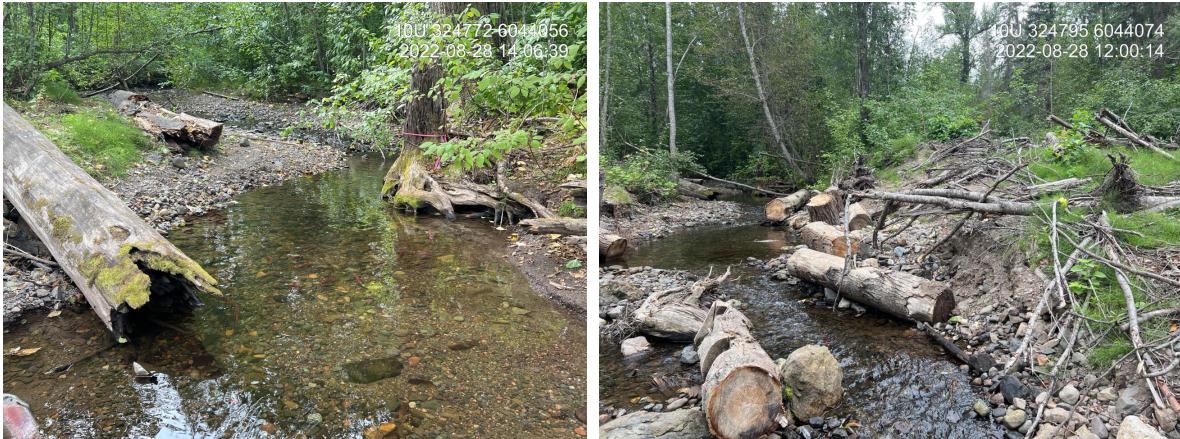
Figure 4.9: Left: Habitat upstream of PSCIS crossing 198283 in Cross Creek. Right: Habitat immediately upstream of PSCIS crossing 198283 in Cross Creek.

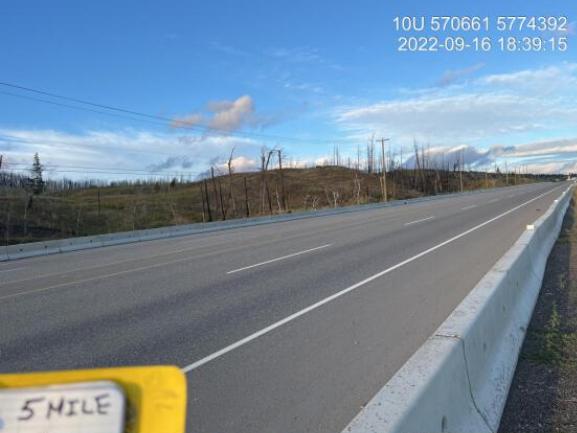
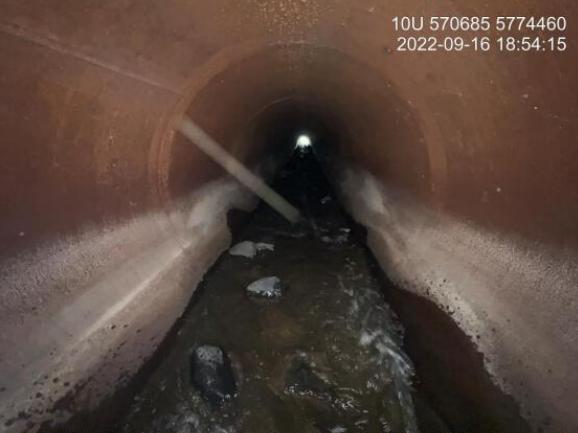
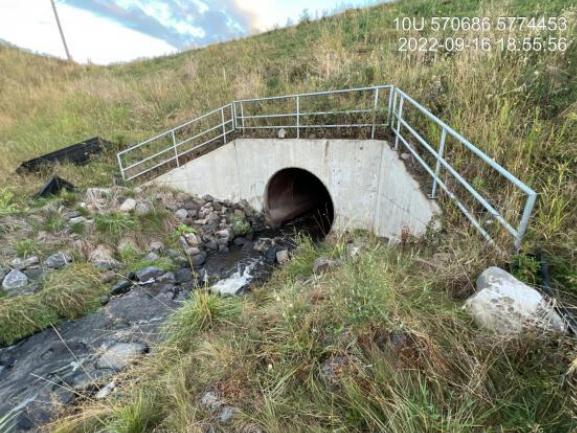
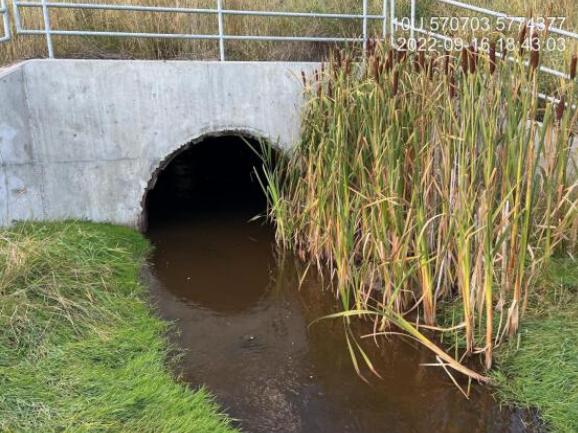
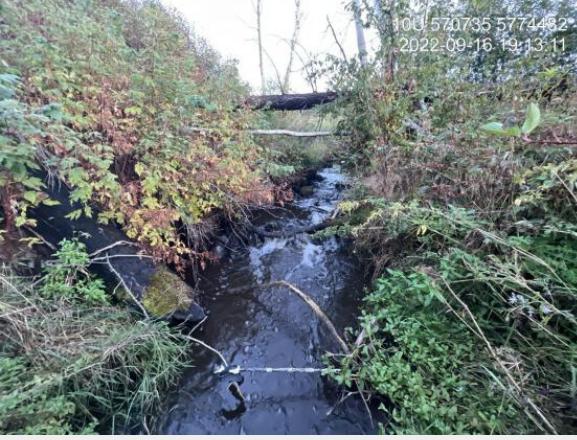
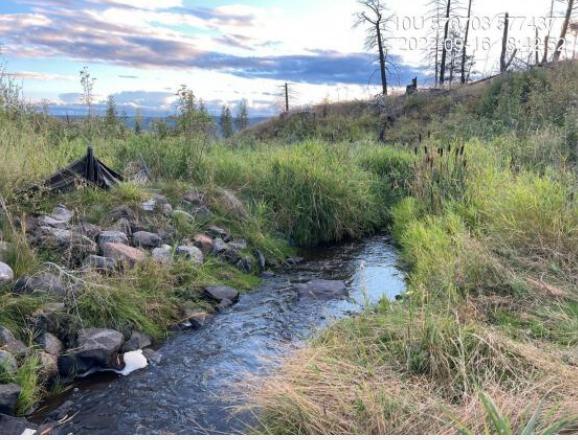
The highway crossing on Five Mile Creek was assessed on September 16, 2022. PSCIS crossing 198400 was embedded 80cm at the outlet of the culvert with no embeddedness at the inlet. Due to the length of the 2.25m diameter round pipe (55m), a lack of embeddedness and culvert slope (3%) the structure ranked as a barrier to upstream fish passage according to the provincial protocol (Table [4.7](#)).

Location and Stream Data	•	Crossing Characteristics	-
Comments: MoTi effectiveness monitoring site. Culvert has been replaced with horizontally drilled pipe. Outlet of the culvert is embedded 80 cm. It is only the top 2 1/2 m of pipe that is not fully embedded with natural substrate. Although this culvert may score as a barrier with the Provincial metric conditions within the pipe are very similar to those upstream within the natural step-pool channel.			
Photos: From top left clockwise: Road/Site Card, Barrel, Outlet, Downstream, Upstream, Inlet.

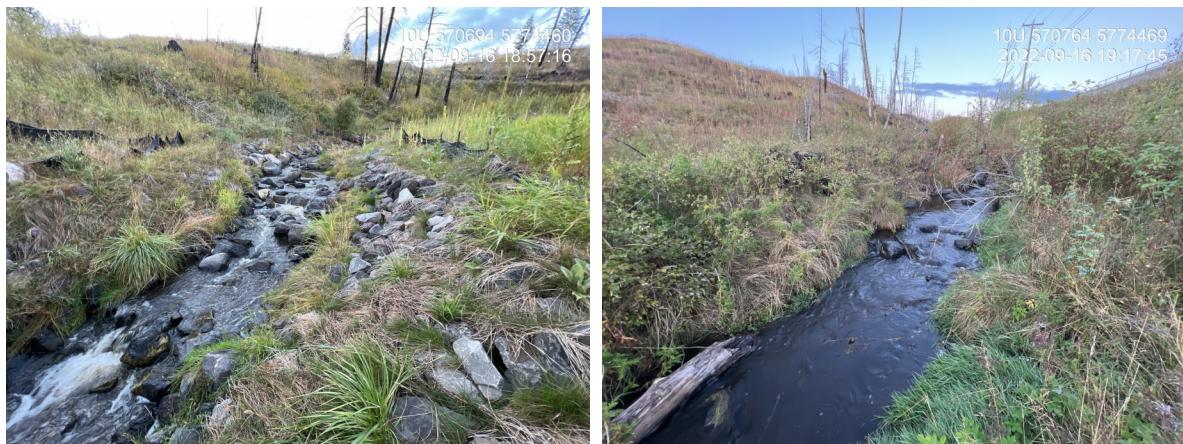
Figure 4.12: Left: Habitat within construction footprint upstream of PSCIS crossing 198400 in Five Mile Creek. Right: Habitat upstream of construction footprint adjacent to crossing 198400 in Five Mile Creek.

Replacement of crossing structures for small streams on large highways can be extremely expensive, requiring significant resources and time to complete. Although not ideal for facilitating upstream fish migration, horizontal drilling of pipes (versus the installation of open bottom structures) can help reduce costs related to construction and proper embedding of these pipes with substrate similar to that found in adjacent natural reaches can provide conditions suitable for upstream fish migration. Although the highway crossing ranked as a barrier to upstream migration, embedding the pipe for its full length would result in a ranking of “potential” barrier and likely provide channel roughness conditions suitable for all life stages of rainbow trout to migrate upstream. For this reason we recommend the addition of large cobble and boulder substrate at the upstream end of the pipe. We also recommend that silt fencing installed for erosion and sediment control during construction be removed at the same time.
