Effectiveness Monitoring for Cross Creek, Bittner Creek and Five Mile Creek - 2022

**Prepared for
Ministry of Transportation and Infrastructure**

**Prepared by
Al Irvine, B.Sc., R.P.Bio.
New Graph Environment Ltd.**

**Version 0.0.2 DRAFT
2024-07-11**

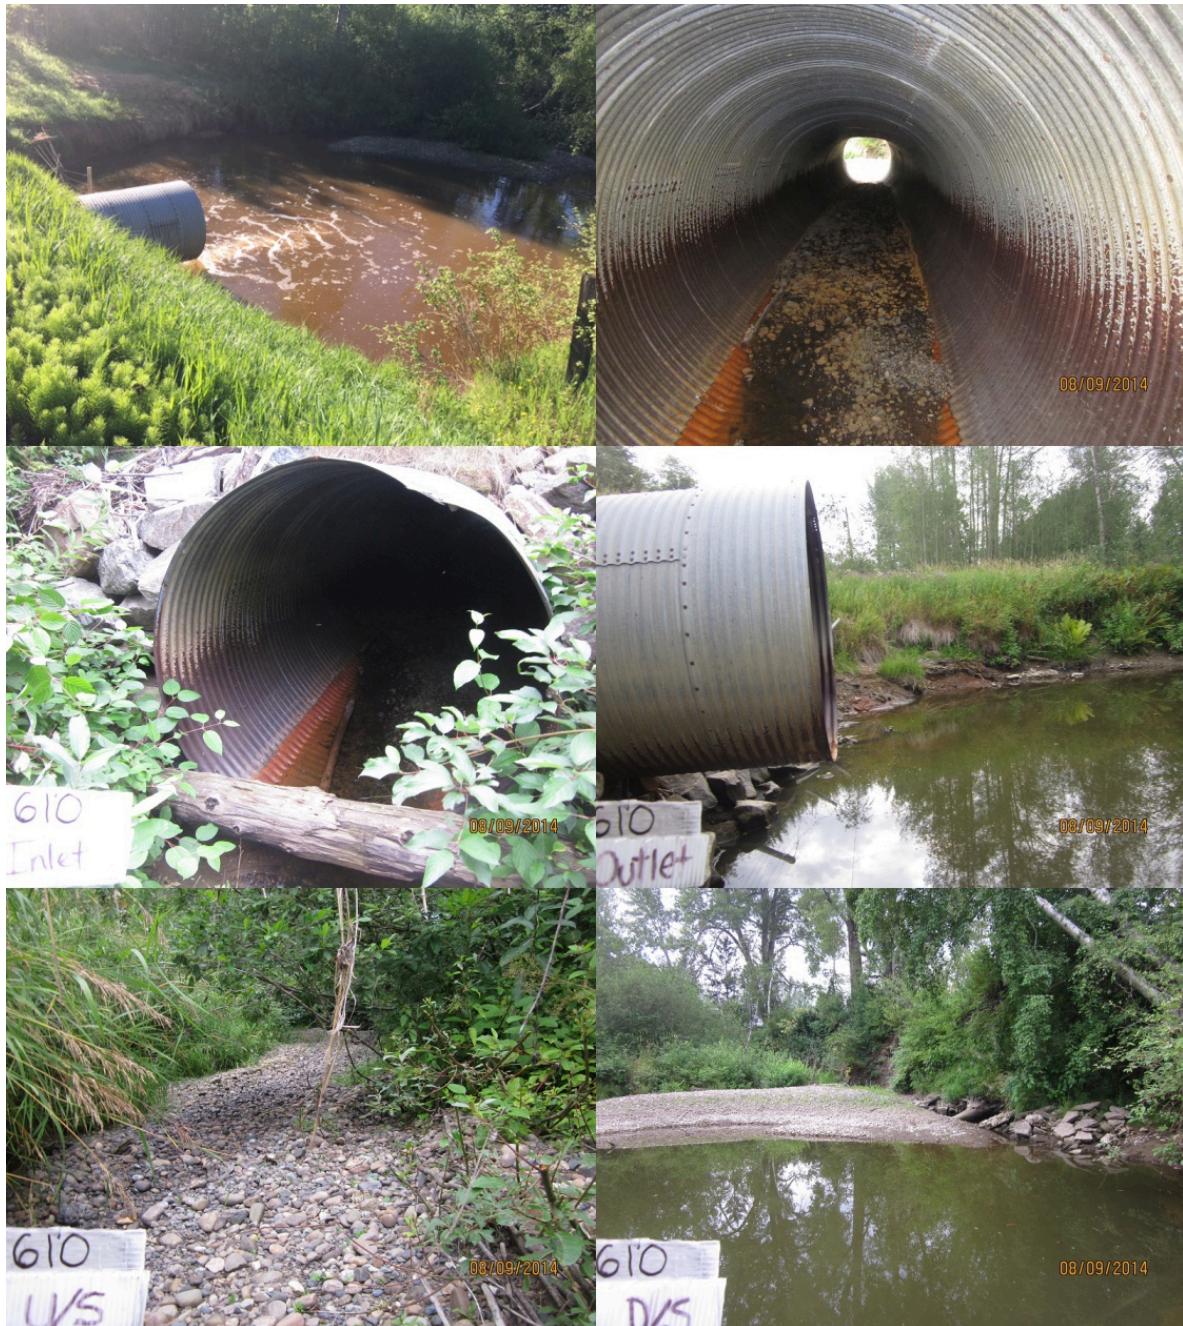
Before remediation, the Bittner Creek culvert at PSCIS crossing 196200 was documented as a 1.9m wide round culvert of 20m in length, having an outlet drop of 0.7m and a culvert slope of 1% (MoE 2023c). The crossing ranked as a barrier to upstream migration according to the provincial protocol (MoE 2011b) . Photos taken in 2014 - before the remediation was completed are included as Figure 4.3.

Figure 4.3: Photos of culverts on Cross Creek taken in August 2014 before remediation of site.

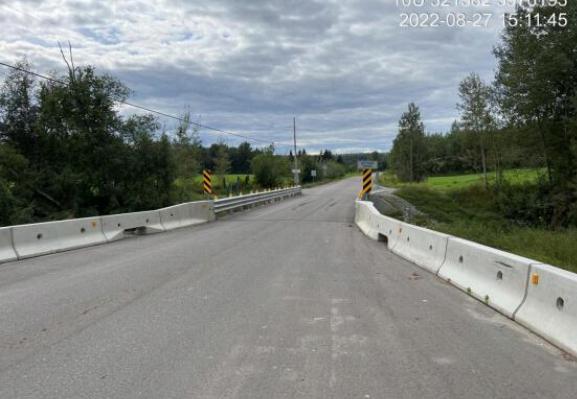
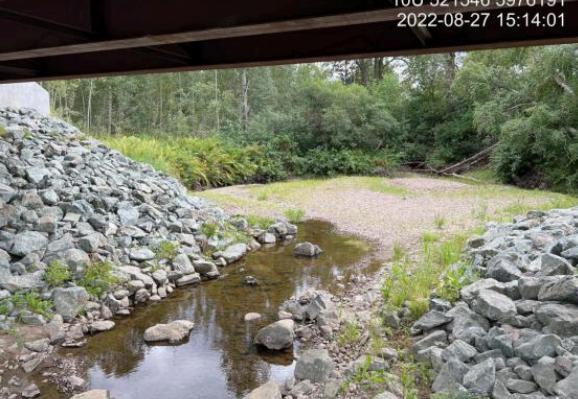
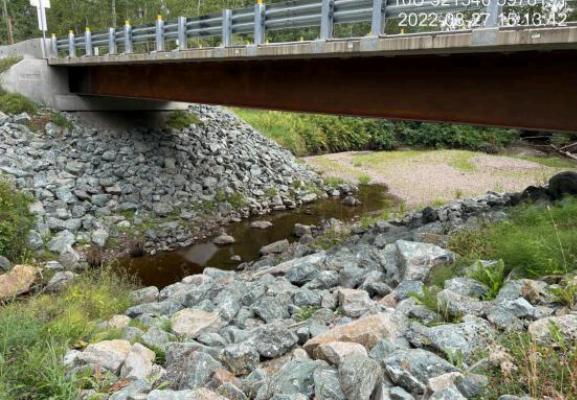
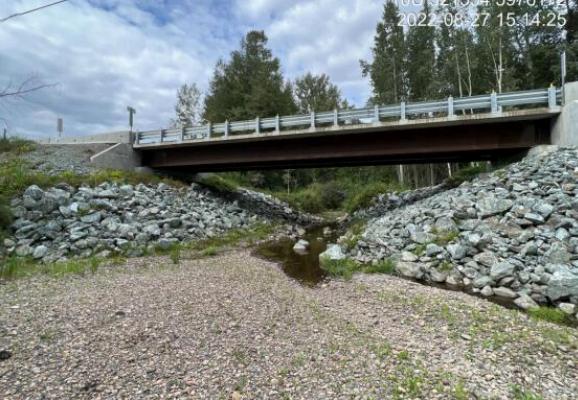
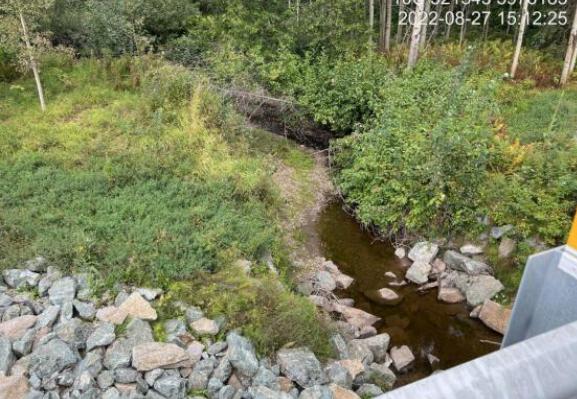
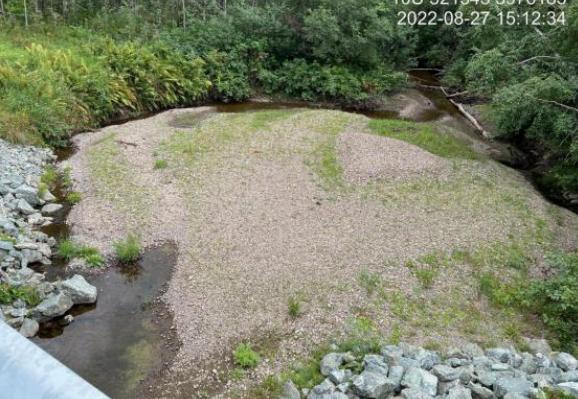
Location and Stream Data	•	Crossing Characteristics	-
Comments: Effectiveness monitoring for MoTi. Adjacent landowner mentioned that in 30 years he has not seen salmon come to spawn and also indicated that the stream dewatered annually.			
Photos: From top left clockwise: Road/Site Card, Barrel, Outlet, Downstream, Upstream, Inlet.

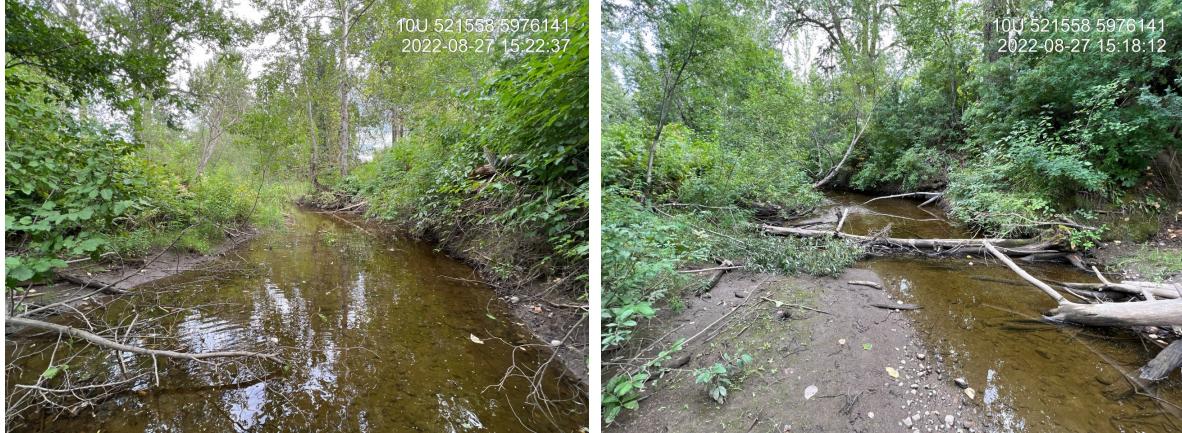
Downstream of the bridge, the stream was surveyed for 100m. rfpr_my_habitat_paragraph('ds')` The portion of creek immediately downstream of the bridge (20m) was lacking meaningful riparian vegetation due to a lack of shrub/tree installation into riprap areas during construction and the very wide channel width in this location. (due to infilling of historic large outlet pool).

Figure 4.4: Left: Habitat downstream of PSCIS crossing 196200, on Bittner Creek. Right: Habitat downstream of PSCIS crossing 196200, on Bittner Creek

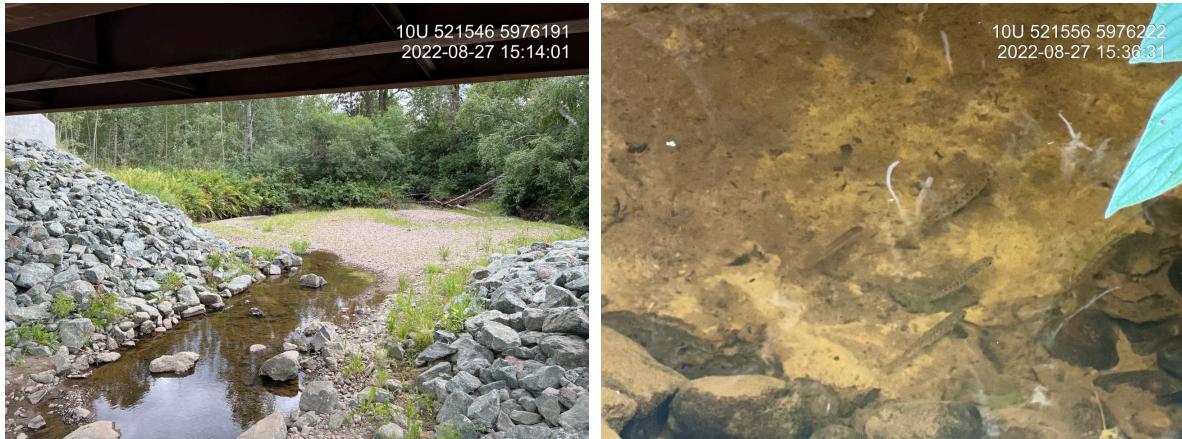
Although DWB Consulting Services Ltd. (2019) noted that installation of a rock weir on the upstream end of the historic culvert outlet pool was planned to maintain this habitat feature, it is unclear if this occurred. Regardless, sediments have infilled the historic outlet pool and this area does not likely provide high or even moderate value habitat.

Figure 4.5: Left: Downstream view of location of historic outlet pool on Bittner Creek below Foreman Road which has filled with gravels due to culvert removal. Right: Salmonid parr observed upstream of bridge on Bittner Creek.

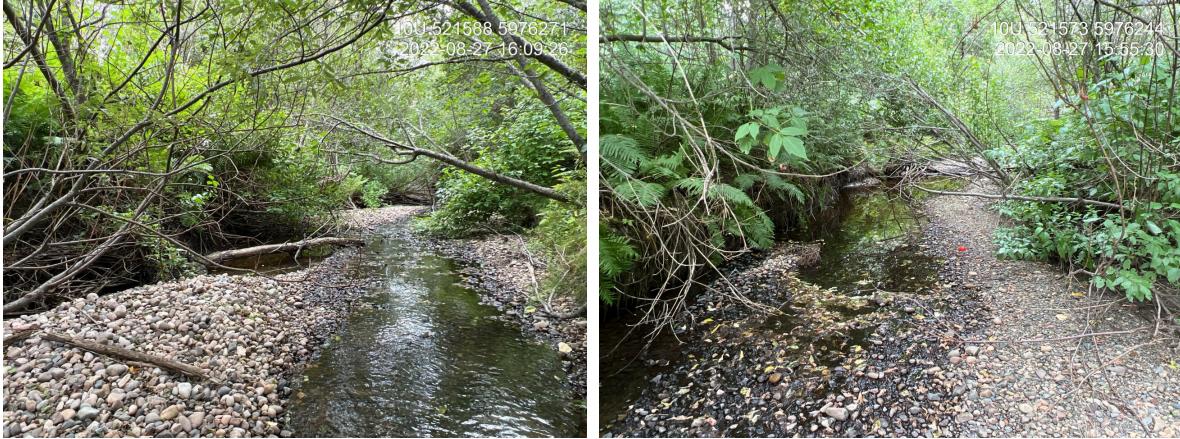
Figure 4.6: Left: Typical habitat upstream of Foreman Road bridge on Bittner Creek. Right: Typical habitat upstream of Foreman Road bridge on Bittner Creek.

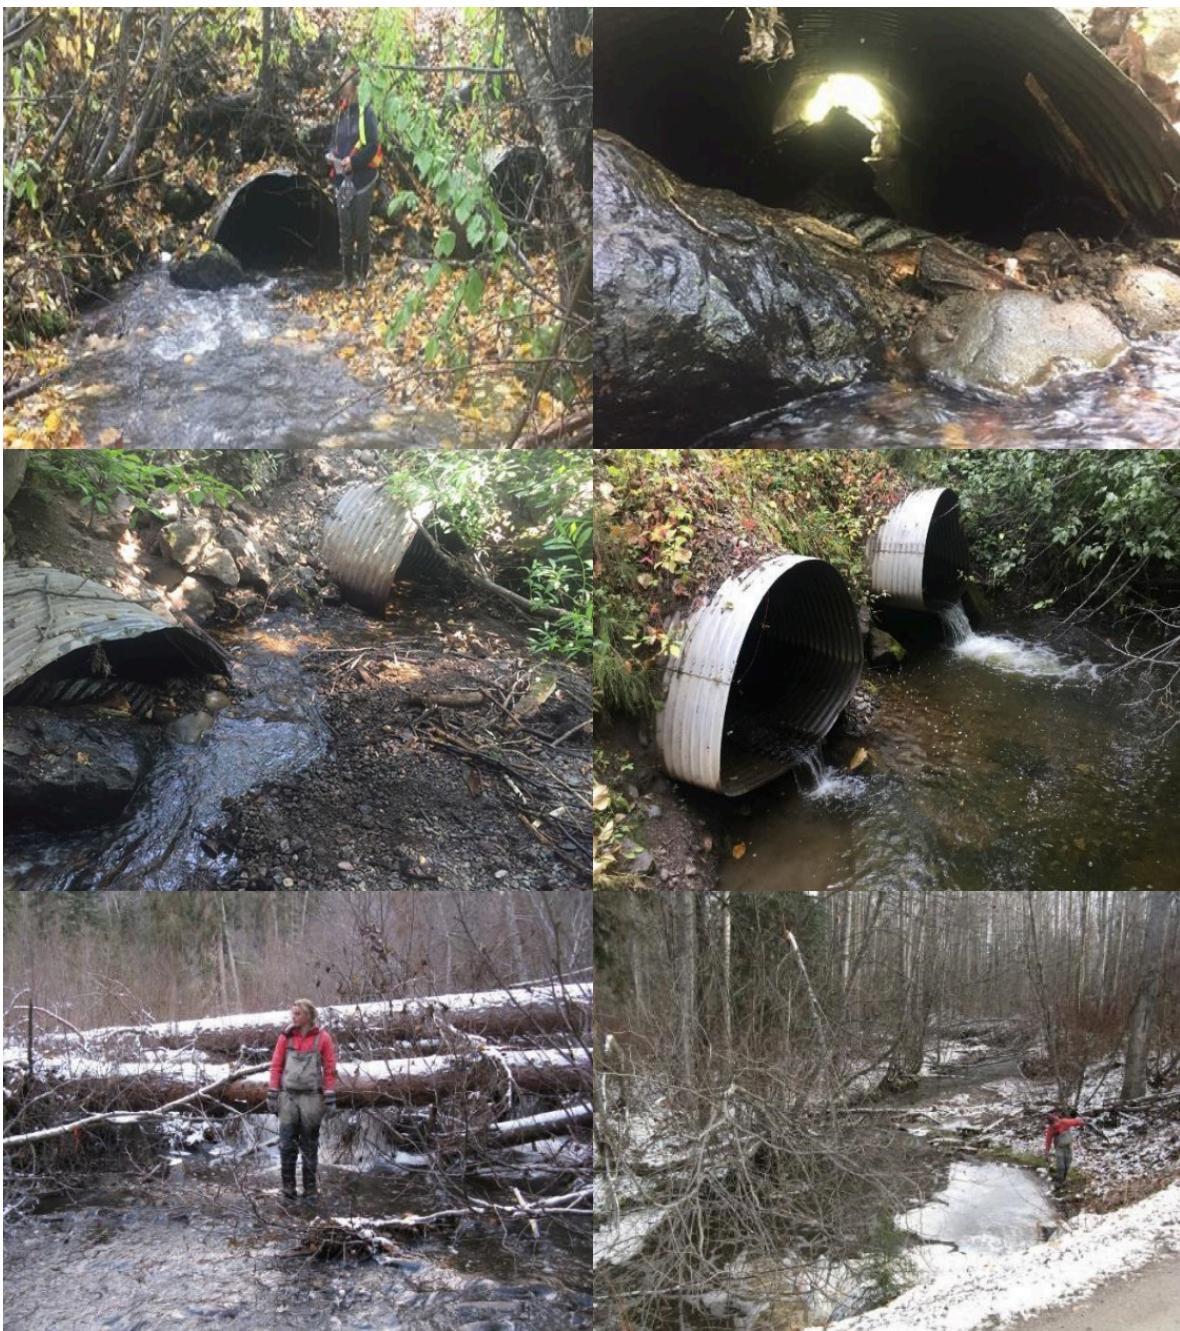
Before remediation, the Cross Creek culverts at PSCIS crossing 198283 were documented as 1.8m wide ovals culverts of 12.4m in length, having an outlet drop of 0.45m and a culvert slope of 2% (MoE 2023c). The crossing ranked as a barrier to upstream migration according to the provincial protocol (MoE 2011b). Photos taken in 2017 - before the remediation was completed are included as Figure [4.7](#). In 2022, the site was reassessed. As PSCIS crossing 198283 was a newly installed open bottomed structure it ranked as a passable to upstream fish passage according to the provincial protocol (Table [4.7](#)).

Figure 4.7: Photos of culverts on Cross Creek taken in November 2017 before remediation of site.

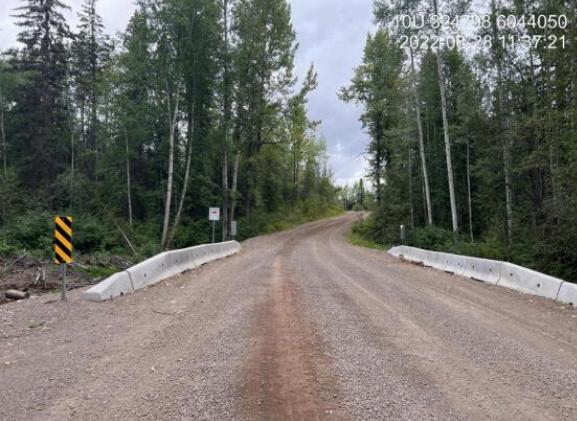
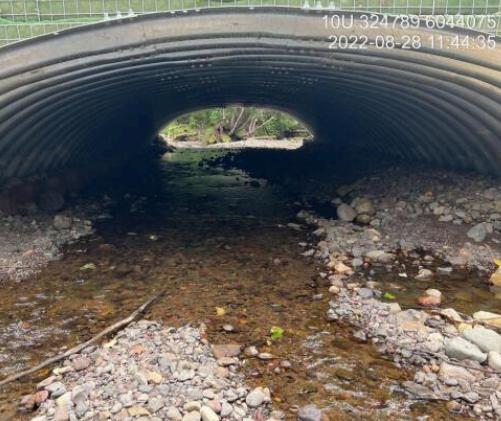
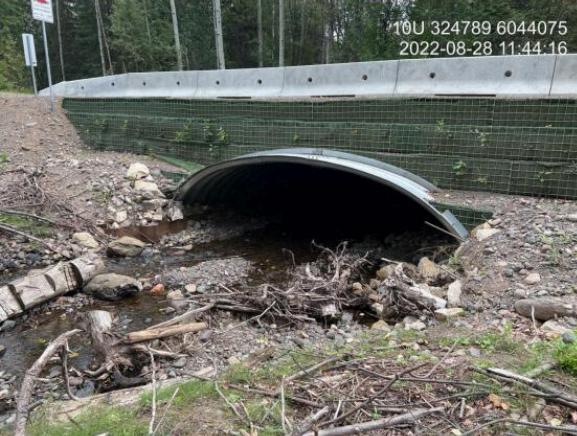
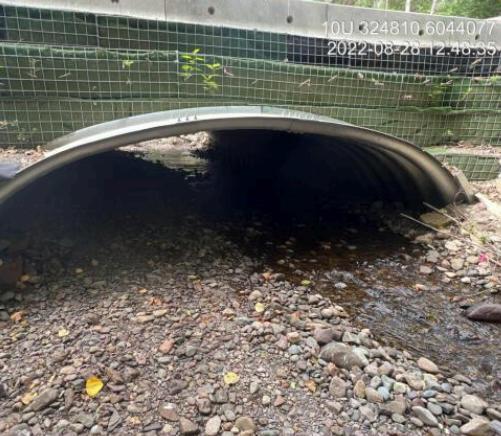
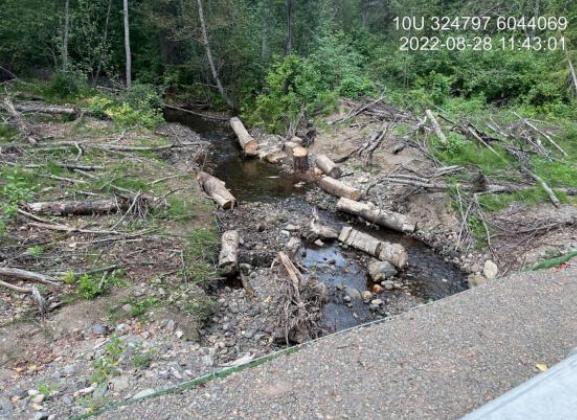
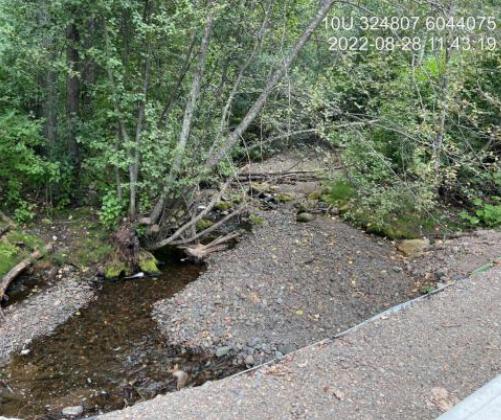
Location and Stream Data	•	Crossing Characteristics	-
<p>Comments: Effectiveness monitoring for MoTi. Channel has filled in nicely since last year. Numerous sockeye holding upstream and downstream of the crossing. Multiple large dead spawn out sockeye present. Live cuttings installed within riparian area appear to be growing however year two and three will be better indicators of success for revegetation.</p>			
<p>Photos: From top left clockwise: Road/Site Card, Barrel, Outlet, Downstream, Upstream, Inlet.</p>

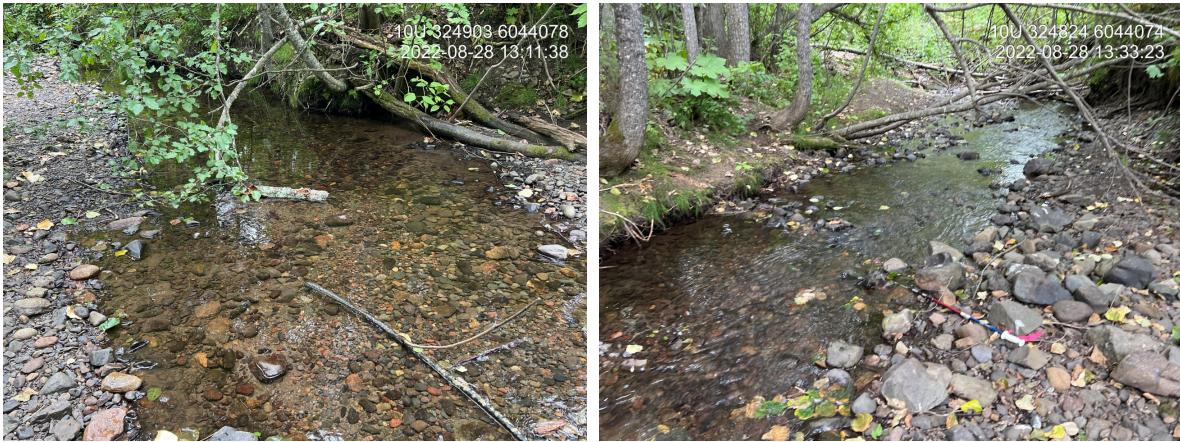
Figure 4.8: Left: Typical habitat downstream of PSCIS crossing 198283 in Cross Creek showing high value spawning gravels. Right: Typical habitat downstream of PSCIS crossing 198283 in Cross Creek.

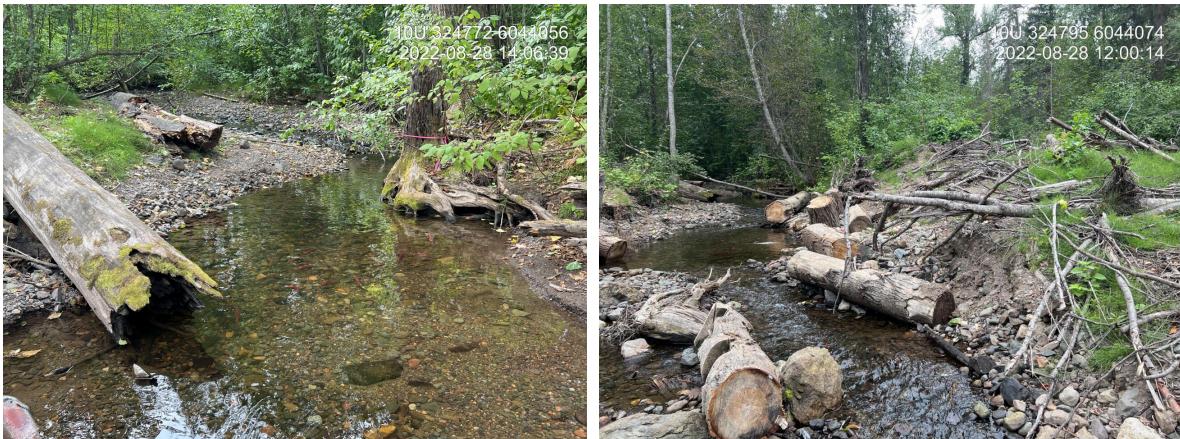
Figure 4.9: Left: Habitat upstream of PSCIS crossing 198283 in Cross Creek. Right: Habitat immediately upstream of PSCIS crossing 198283 in Cross Creek.

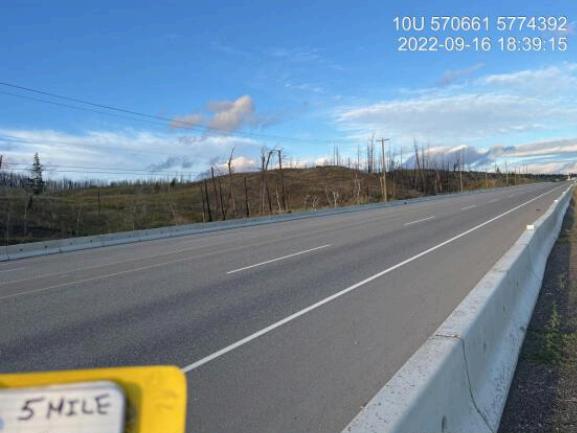
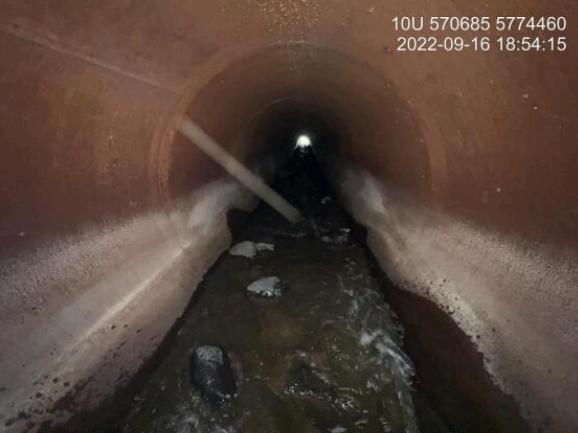
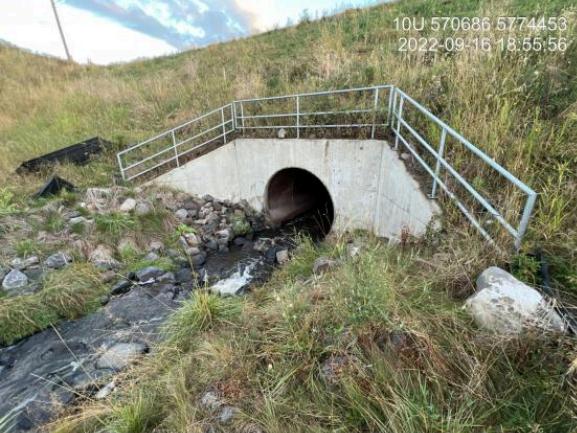
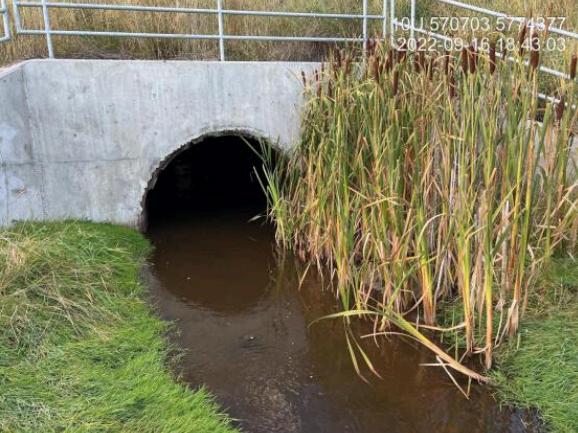
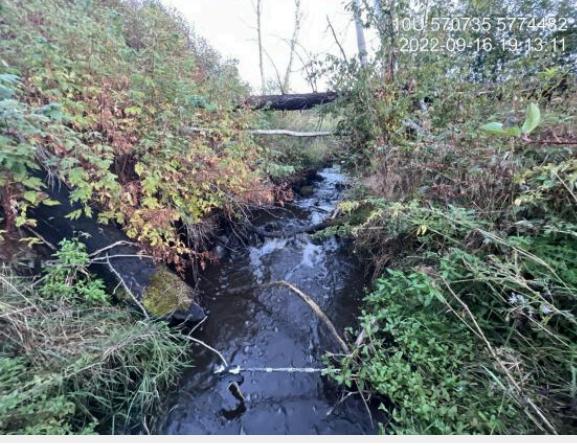
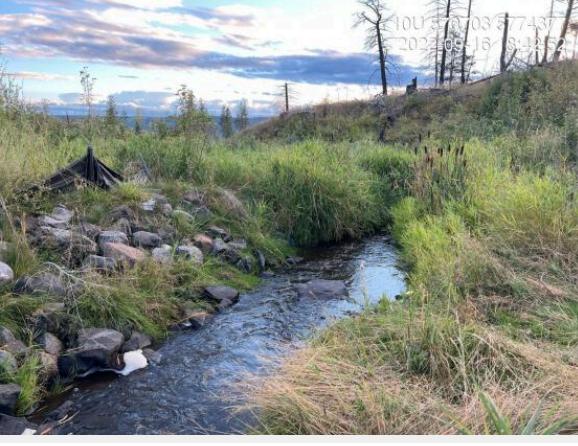
Location and Stream Data	•	Crossing Characteristics	-
<p>Comments: MoTi effectiveness monitoring site. Culvert has been replaced with horizontally drilled pipe. Outlet of the culvert is embedded 80 cm. It is only the top 2 1/2 m of pipe that is not fully embedded with natural substrate. Although this culvert may score as a barrier with the Provincial metric conditions within the pipe are very similar to those upstream within the natural step-pool channel.</p>			
<p>Photos: From top left clockwise: Road/Site Card, Barrel, Outlet, Downstream, Upstream, Inlet.</p>

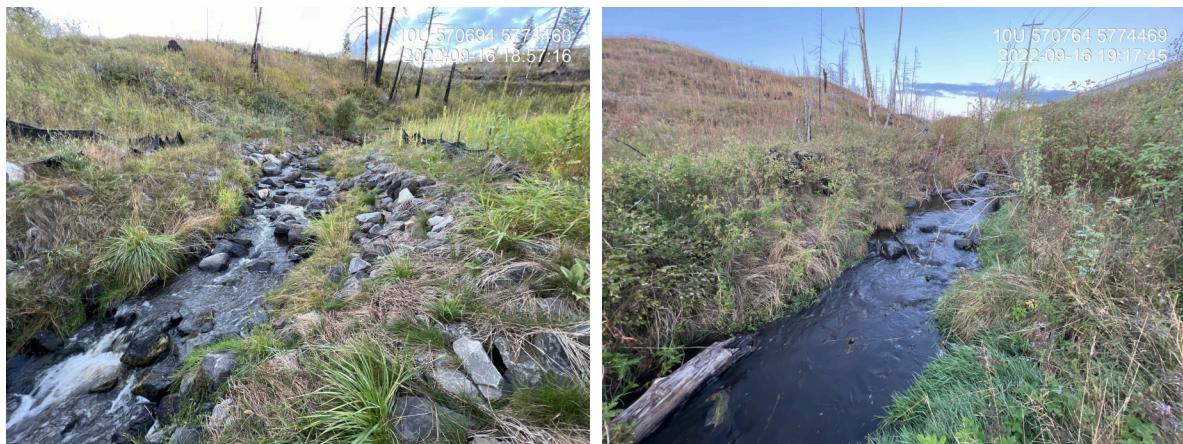
Figure 4.12: Left: Habitat within construction footprint upstream of PSCIS crossing 198400 in Five Mile Creek. Right: Habitat upstream of construction footprint adjacent to crossing 198400 in Five Mile Creek.

Replacement of crossing structures for small streams on large highways can be extremely expensive, requiring significant resources and time to complete. Although not ideal for facilitating upstream fish migration, horizontal drilling of pipes (versus the installation of open bottom structures) can help reduce costs related to construction and proper embedding of these pipes with substrate similar to that found in adjacent natural reaches can provide conditions suitable for upstream fish migration. Although the highway crossing ranked as a barrier to upstream migration, embedding the pipe for its full length would result in a ranking of “potential” barrier and likely provide channel roughness conditions suitable for all life stages of rainbow trout to migrate upstream. For this reason we recommend the addition of large cobble and boulder substrate at the upstream end of the pipe. We also recommend that silt fencing installed for erosion and sediment control during construction be removed at the same time.
