Restoring Fish Passage in the Peace Region - 2022 - PEA-F23-F- 3761-DCA

**Prepared for
Fish and Wildlife Compensation Program
and
Fish Passage Technical Working Group**

**Prepared by
Al Irvine, B.Sc., R.P.Bio. and Mateo Winterscheidt, B.Sc.
New Graph Environment Ltd.
on behalf of
Society for Ecosystem Restoration in Northern BC**

Version 0.0.1 2023-07-13

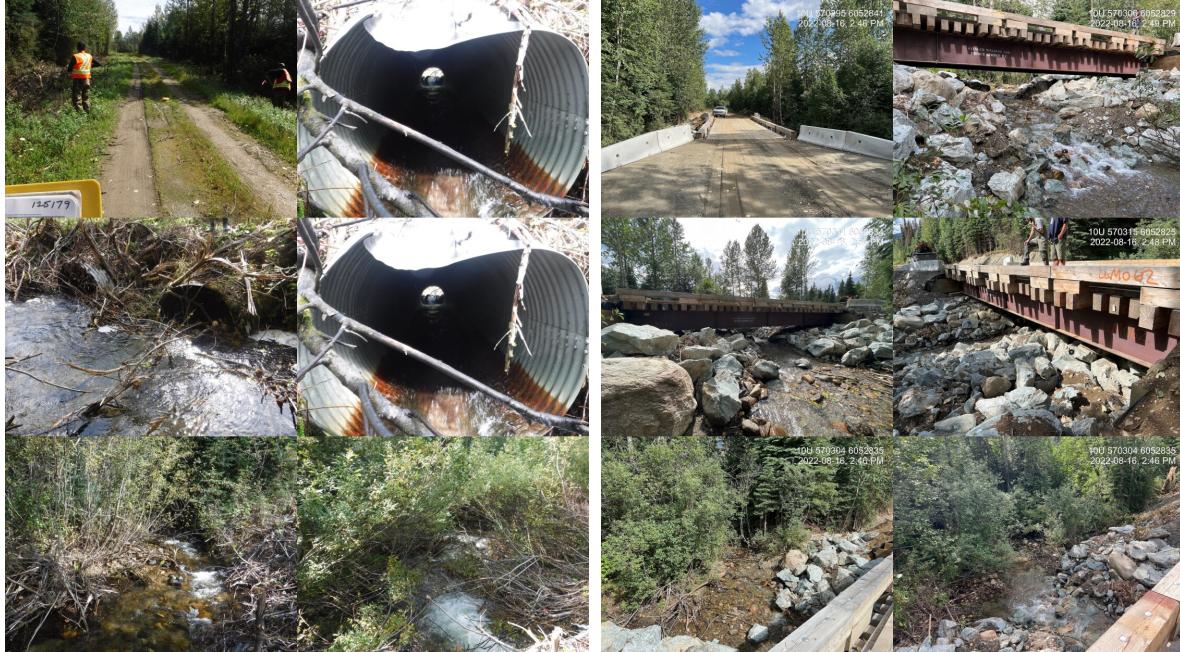
assessment conducted in 2019 versus the completed bridge construction in 2022 are presented in Figure 3.11. Overall the cost of the site was reported by Sinclair as \$190,000 which is considerably lower than recent costs estimates elsewhere in the watershed due to recent inflation. Remediation details including as-built drawings have been loaded to the PSCIS data portal for upload to the province.

Figure 3.1: Left: Photos of crossing 125179 in 2019. Right: Photos of crossing 125179 in 2022.

It is recommended that future monitoring be conducted at this location to track the stream morphological changes and provide insight into fish migration within the system. Electrofishing with tagging of target species is recommended along with photo documentation of stream morphology near the bridge. Fish sampling in the adjacent similar sized stream ([PSCIS crossing 125180](#)) containing culverts ranked as barriers would provide reference site data for comparison.

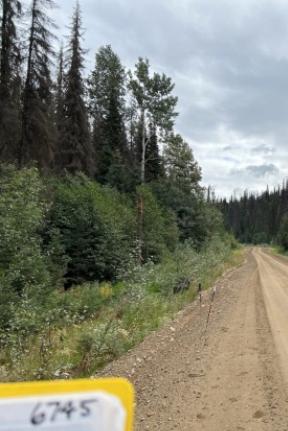
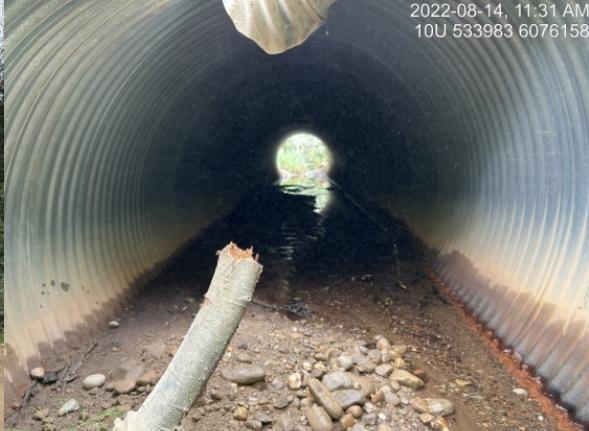
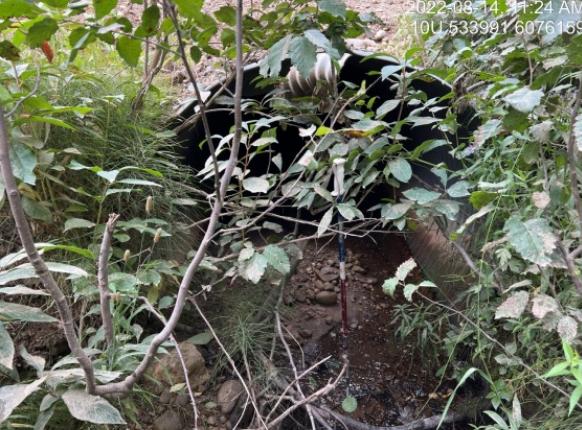
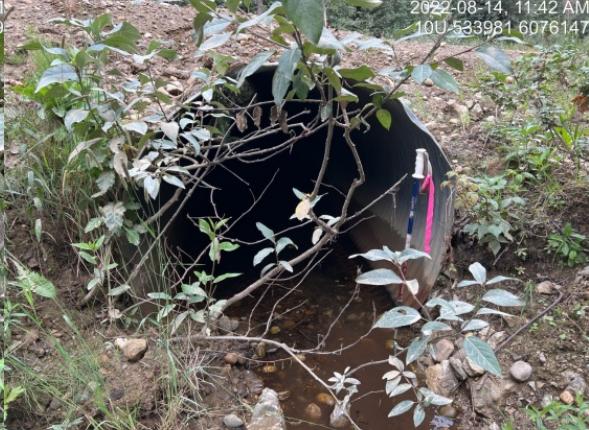
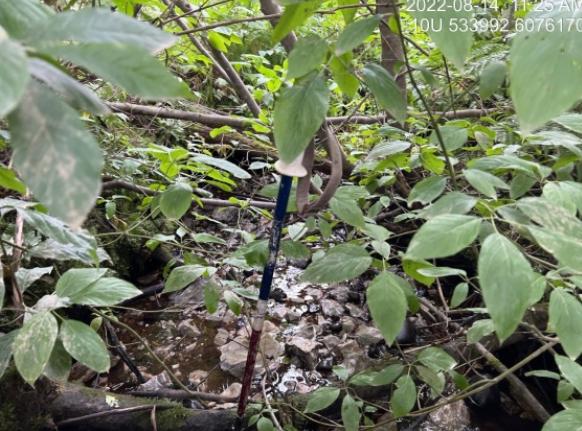
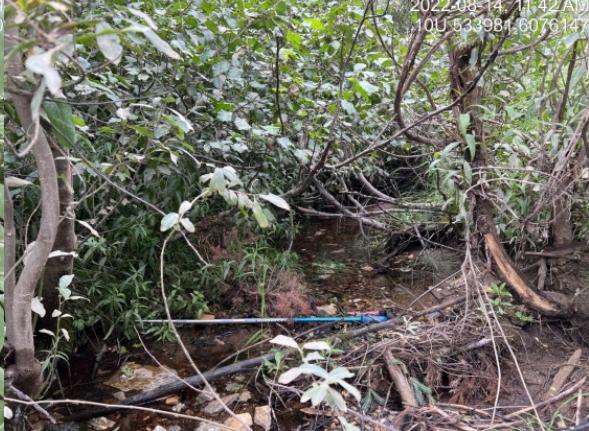
Location and Stream Data	•	Crossing Characteristics	-
Comments: Damaged near outlet. Small stream but flowing. Middle of pipe filled with fines. 11:18			
Photos: From top left clockwise: Road/Site Card, Barrel, Outlet, Downstream, Upstream, Inlet

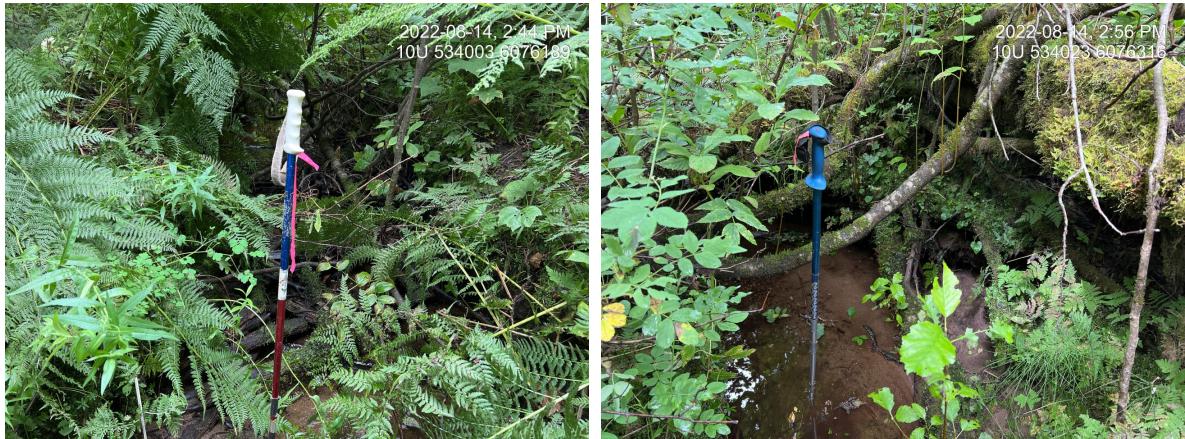
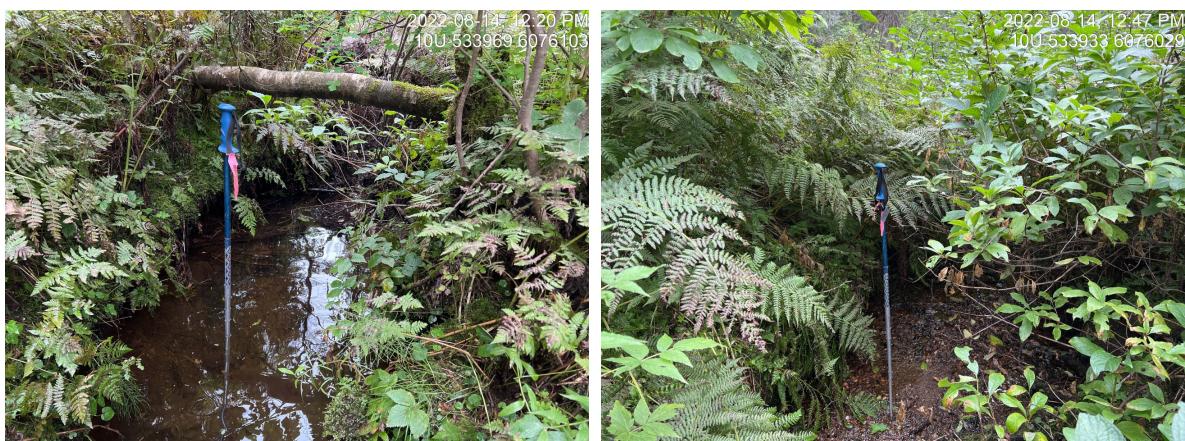
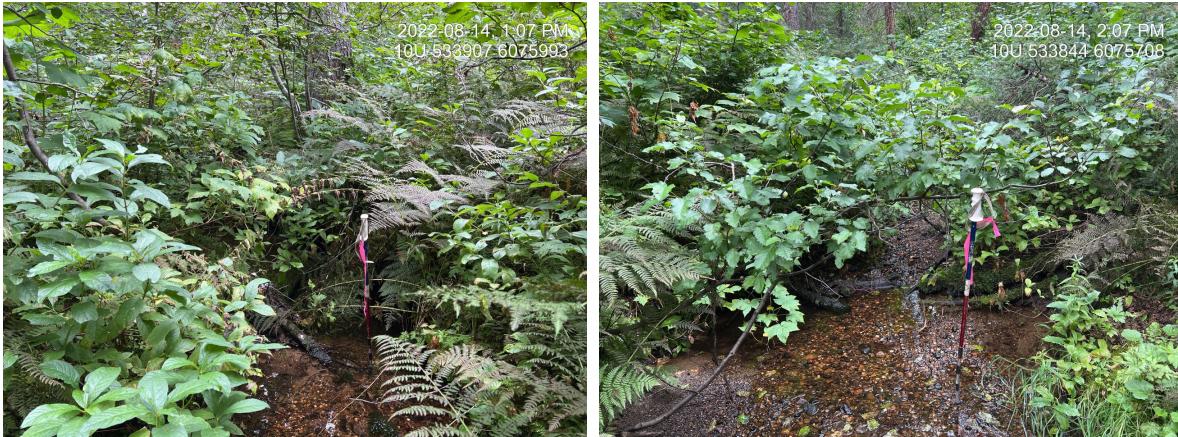
Modelling indicates there is 1.2km of habitat upstream of crossing 6745 suitable for bull trout rearing with areas surveyed rated as medium value for rearing and spawning. Crossing 6745 was ranked as a low priority for proceeding to design for replacement. The culvert is considered a potential barrier and could be considered a fish passage issue. Further information is required to make an informed decision. There were abundant gravels present upstream of the crossing, but no fish were spotted. Due to the lack of historic fisheries information upstream, fish sampling is recommended to determine if fish are utilising this tributary as a spawning and rearing location.

Figure 3.2: Left: Typical habitat downstream of PSCIS crossing 6745. Right: Typical habitat downstream of PSCIS crossing 6745.

Figure 3.3: Left: Typical habitat upstream of PSCIS crossing 6745. Right: Typical habitat upstream of PSCIS crossing 6745.

Figure 3.4: Left: Typical habitat upstream of PSCIS crossing 6745. Right: Typical habitat upstream of PSCIS crossing 6745.

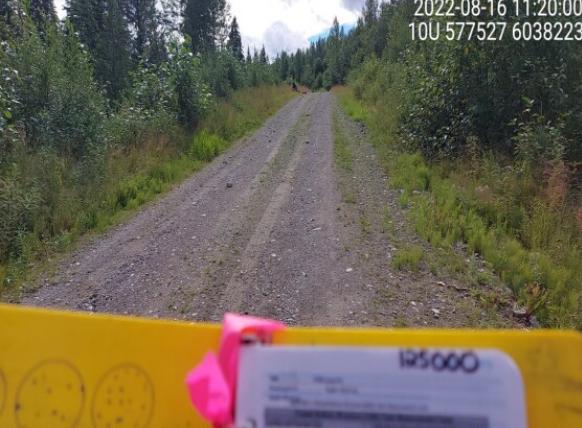
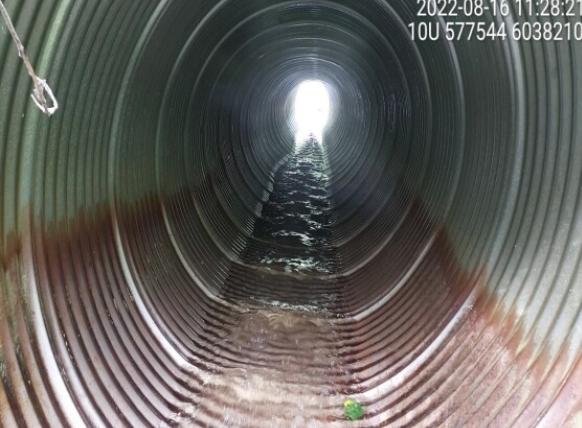
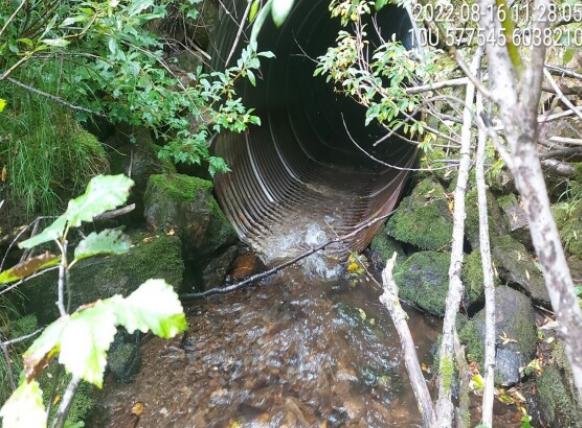
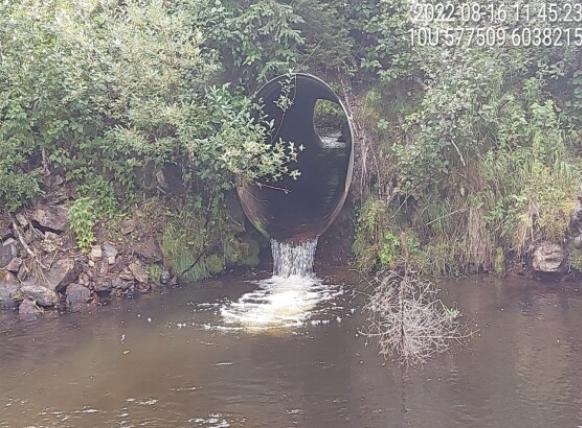
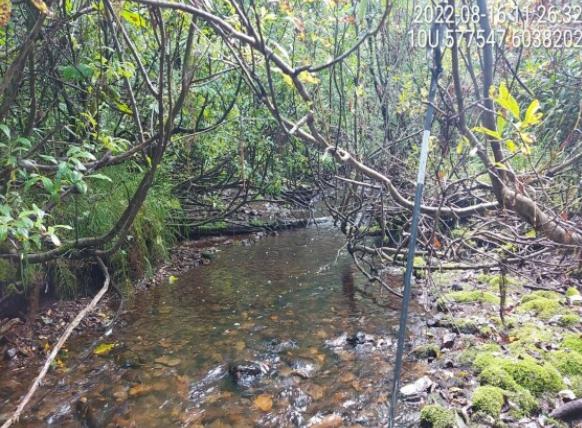
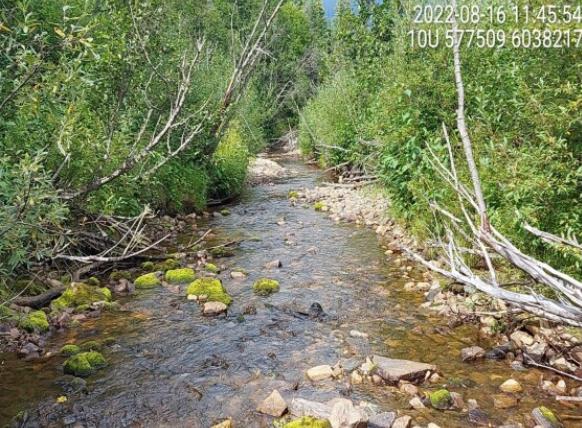
Location and Stream Data	•	Crossing Characteristics	-
Comments: Habitat survey done with drone. 11:15:00 AM			
Photos: From top left clockwise: Road/Site Card, Barrel, Outlet, Downstream, Upstream, Inlet.

Although - at the time of reporting - plans for replacement of this site have been delayed, removal of the crossing or replacement is still recommended for the future. Additionally, re-assessment of the site in the 2023 and/or 2024 could provide valuable information regarding fish health and migration at the site.

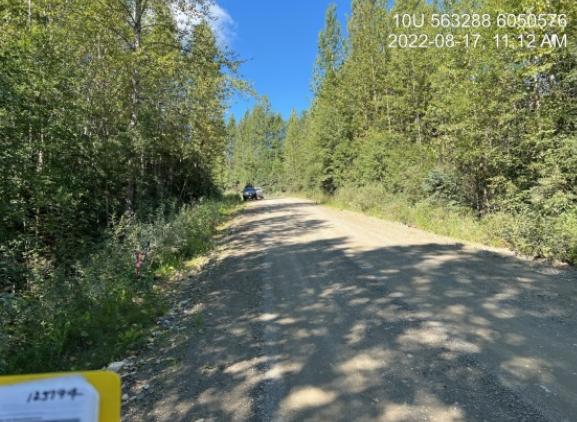
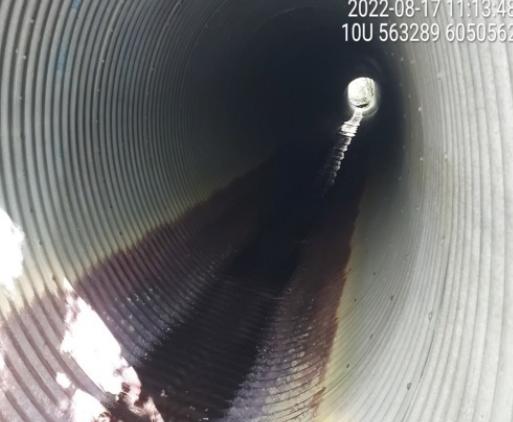
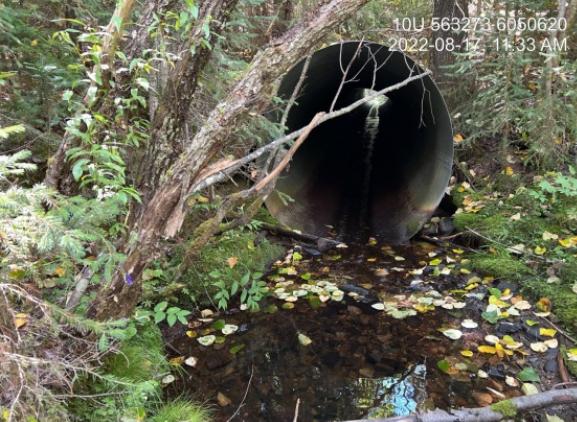
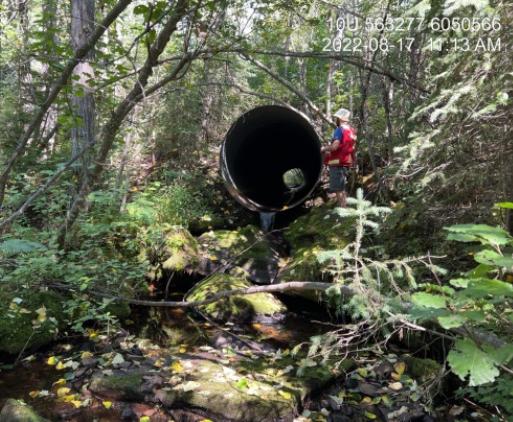
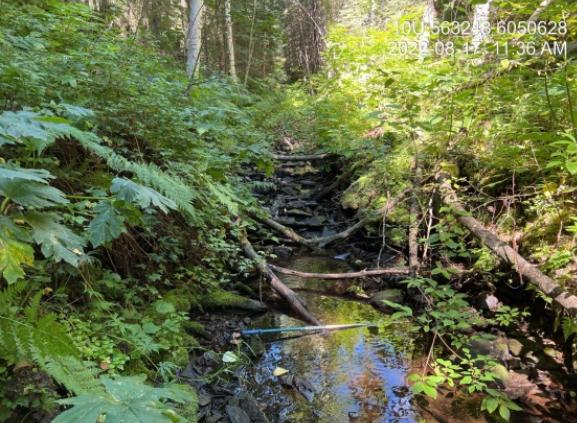
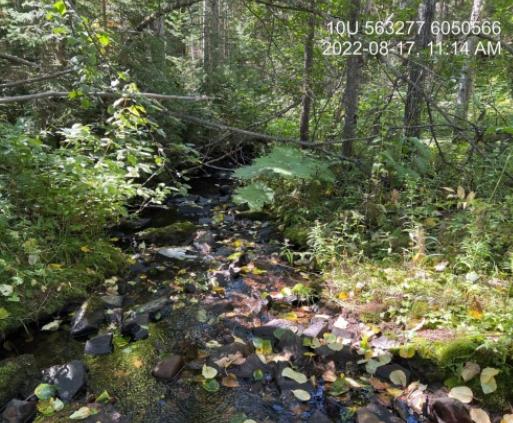
Location and Stream Data	•	Crossing Characteristics	-
Comments: Very narrow cascade at outlet, big outlet drop. Good size pools downstream. Upstream has evenly distributed shale. Lots of functional woody debris. 11:09			
Photos: From top left clockwise: Road/Site Card, Barrel, Outlet, Downstream, Upstream, Inlet.

Replacement of PSCIS crossing 125194 with a bridge (13m span) is recommended. The cost of the work was estimated at \$325,000 for a cost benefit of 6153.8 linear m/\$1000 and 7384.6 m²/\$1000.

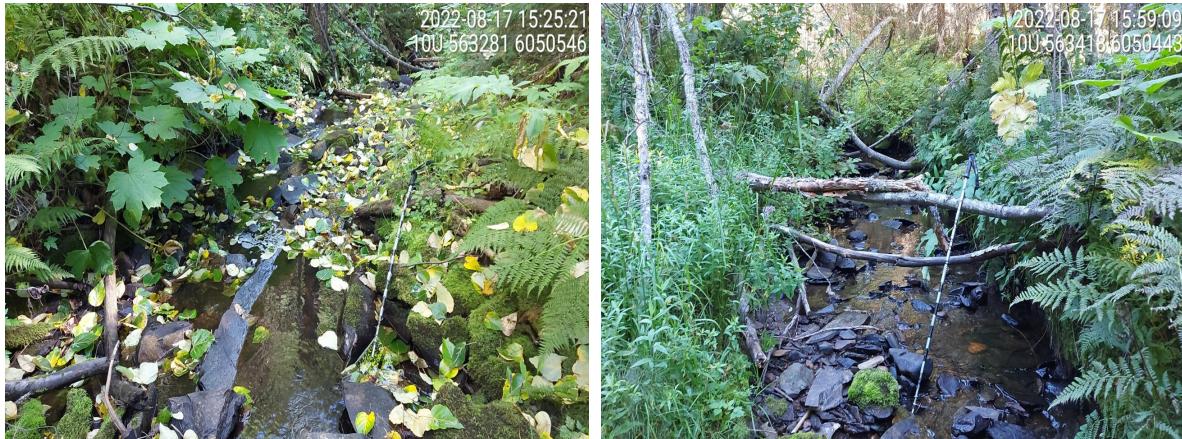
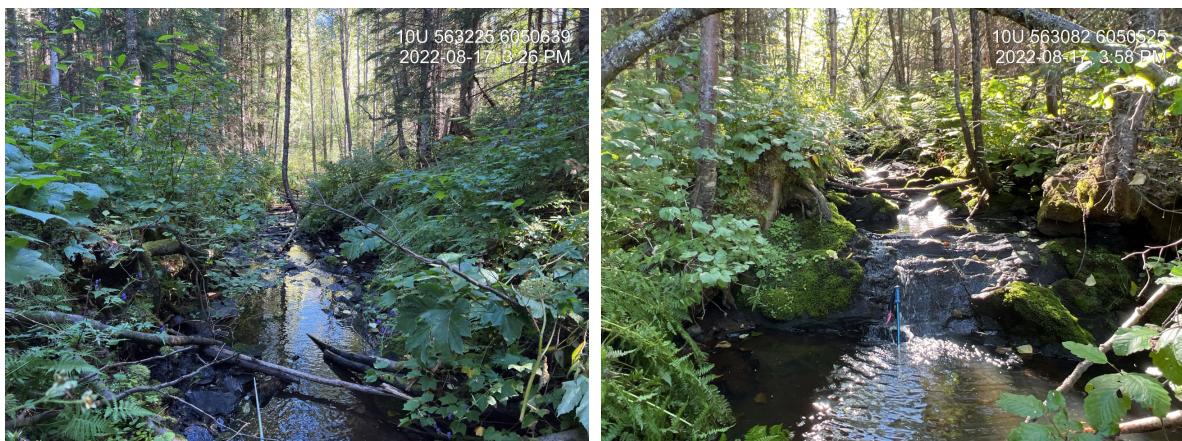
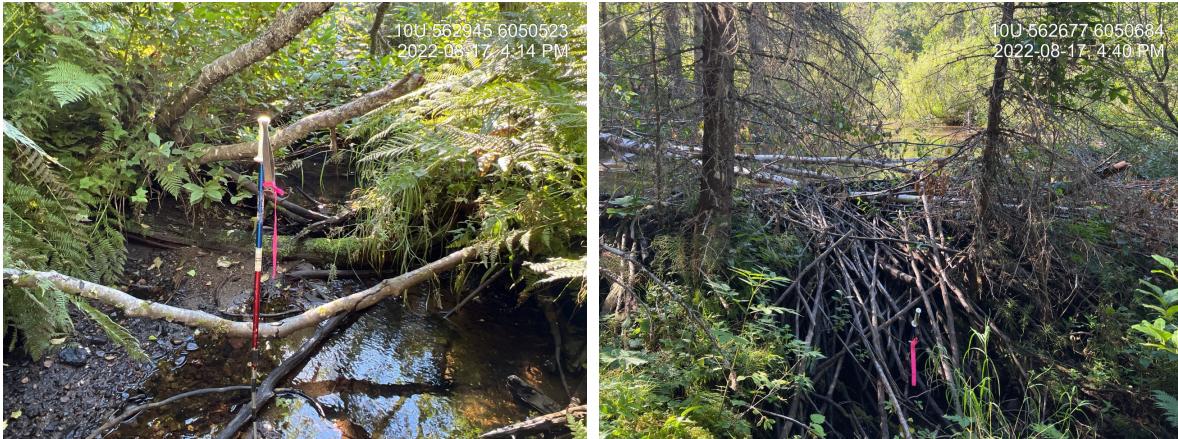
Crossing 125194 was ranked as a low priority for proceeding to design for replacement. Modelling indicates 2km of habitat upstream of crossing 125194 suitable for bull trout rearing with areas surveyed rated as medium value for rearing and spawning. However, there is a beaver dam 1.6m in height located approximately 800m upstream of this crossing. This would likely block the upstream migration of all fish species and life stages. In order to open up habitat in this system, it is recommended that beaver management methods be pursued at this location.

Figure 3.7: Left: Typical habitat downstream of PSCIS crossing 125194. Right: Example of typical stream substrate downstream of PSCIS crossing 125194.

Figure 3.8: Left: Typical habitat upstream of PSCIS crossing 125194. Right: Small rock step approximately 0.6m in height, upstream of PSCIS crossing 125194.

Figure 3.9: Left: Typical habitat upstream of PSCIS crossing 125194. Right: Beaver dam 1.6m high at modelled crossing 16601526, upstream of PSCIS crossing 125194.

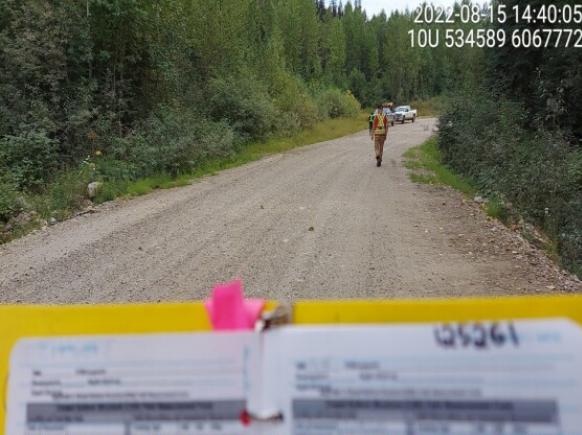
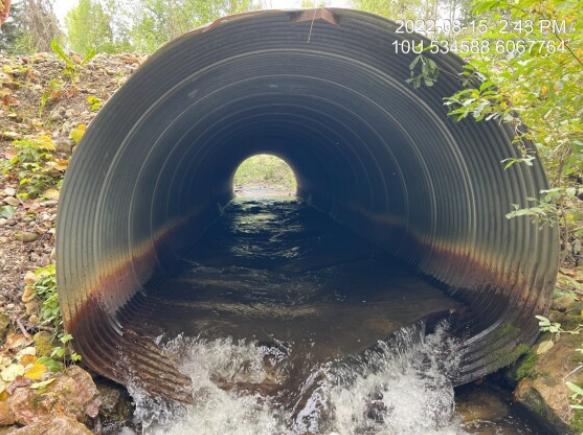
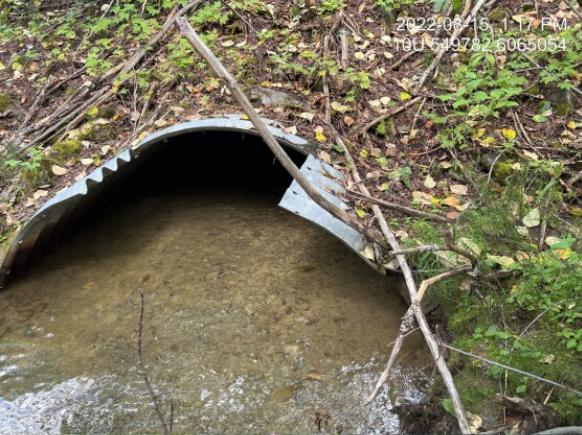
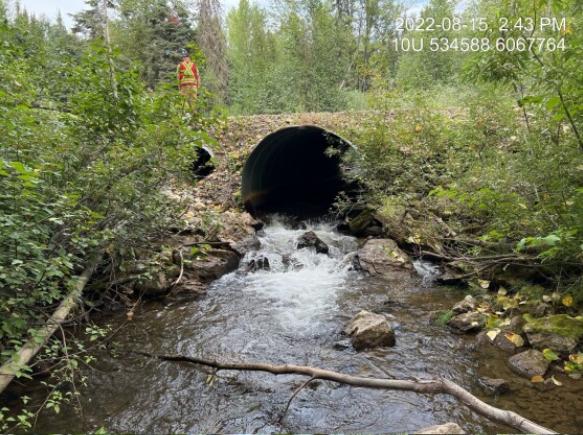
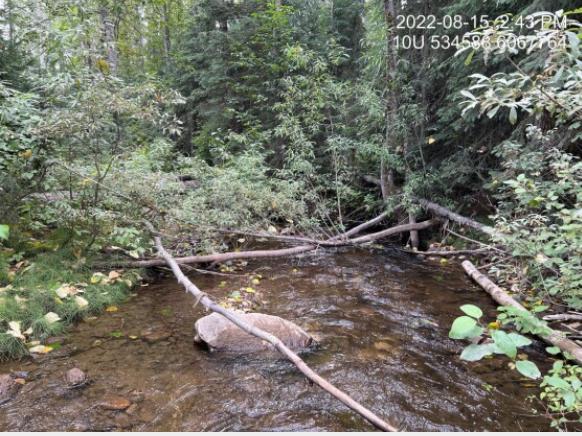
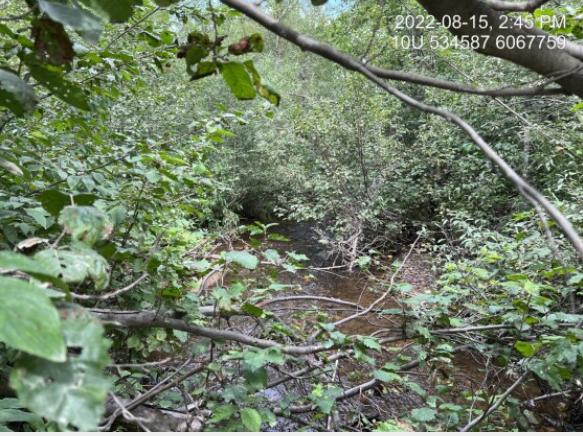
Location and Stream Data	Crossing Characteristics
Comments: Culvert has baffles in it but has significant riprap at the outlet that creates cascade approximately 0.5 m high. 14:36	
Photos: From top left clockwise: Road/Site Card, Barrel, Outlet, Downstream, Upstream, Inlet.

Replacement of PSCIS crossing 125261 with a bridge (10m span) is recommended. The cost of the work was estimated at \$250,000 for a cost benefit of 57560 linear m/\$1000 and 146778 m²/\$1000.

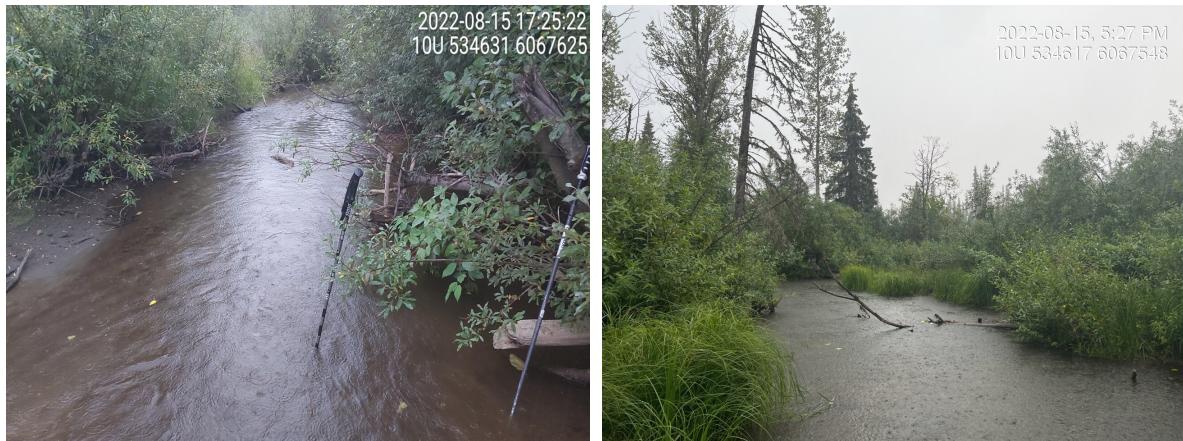
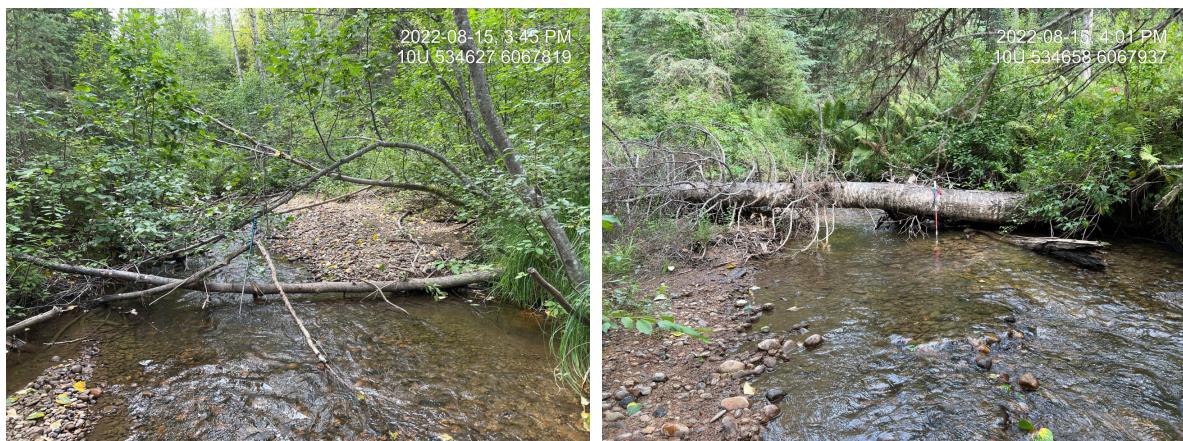
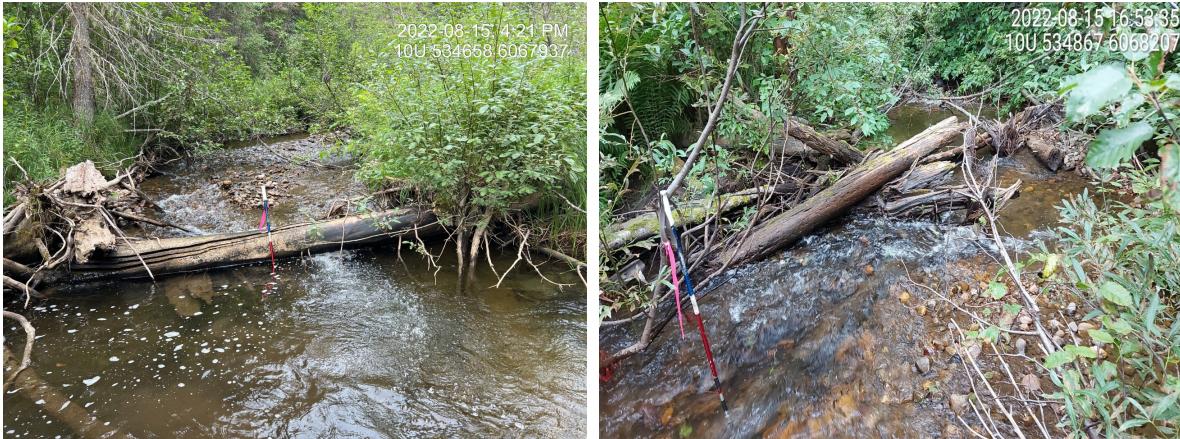
The stream was surveyed downstream from crossing 125261 for 150m (Figure [3.10](#)). The average channel width was 5.6m, the average wetted width was 4.1m, and the average gradient was 1%. Total cover amount was rated as moderate with deep pools dominant. Cover was also present as small woody debris, overhanging vegetation, and instream vegetation. The dominant substrate was gravels with fines sub-dominant. Extensive gravels were found in the first 150 m surveyed downstream. The habitat then transitions to a wetland type, with depths of up to 1m on the floodplain. The habitat was rated as high value for salmonid rearing and spawning.

The stream was surveyed upstream from crossing 125261 for 700m (Figure [3.11](#)). Total cover amount was rated as moderate with deep pools dominant. Cover was also present as small woody debris, large woody debris, undercut banks, and overhanging vegetation. The dominant substrate was gravels with cobbles sub-dominant. The average channel width was 6.2m, the average wetted width was 2.4m, and the average gradient was 2.3%. This is a large stream with abundant gravel suitable for spawning and deep pools for overwintering. Numerous fish were observed, the habitat was stable with large woody debris found throughout, and there were abundant undercut banks. At the end of the survey, a stream crossing was listed in the PSCIS database (ID 198321). Upon investigation, it was concluded that this crossing was deactivated (Figure [3.13](#)). Overall, the habitat surveyed upstream of crossing 125261 was rated as high value as an important migration corridor containing habitat suitable for spawning with moderate rearing potential.

Figure 3.10: Left: Habitat downstream of PSCIS crossing 125261. Right: Transition to wetland type habitat, downstream of PSCIS crossing 125261.

Figure 3.11: Left: Habitat upstream of PSCIS crossing 125261. Right: Habitat upstream of PSCIS crossing 125261.

Figure 3.12: Left: Deep pool and functional woody debris upstream of PSCIS crossing 125261. Right: Habitat upstream of PSCIS crossing 125261.

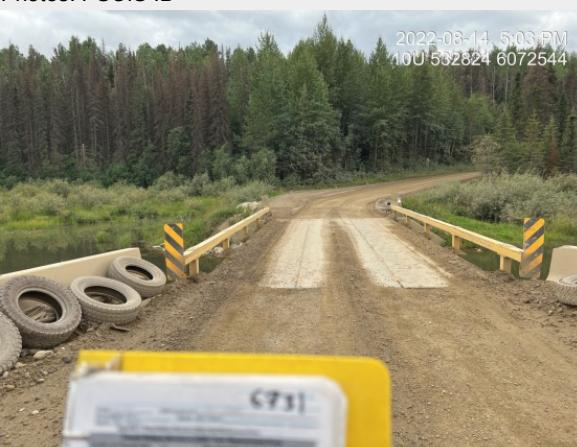
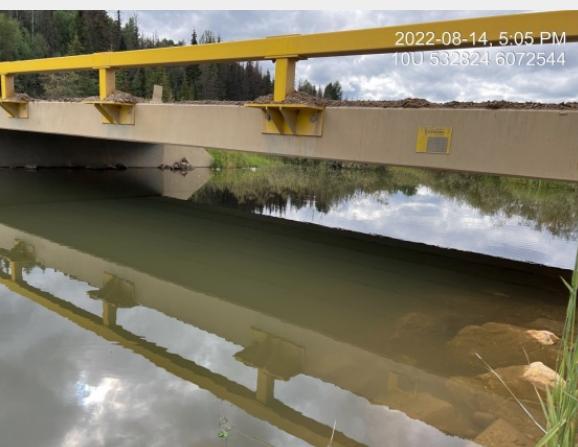
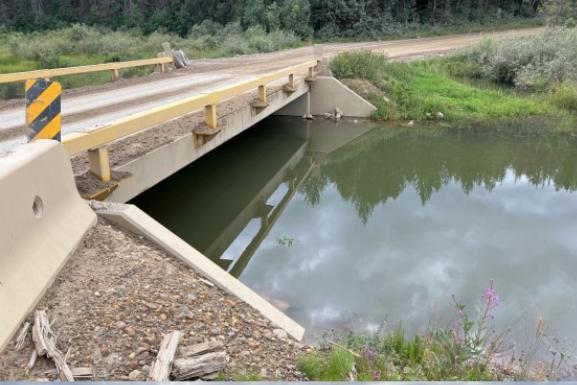
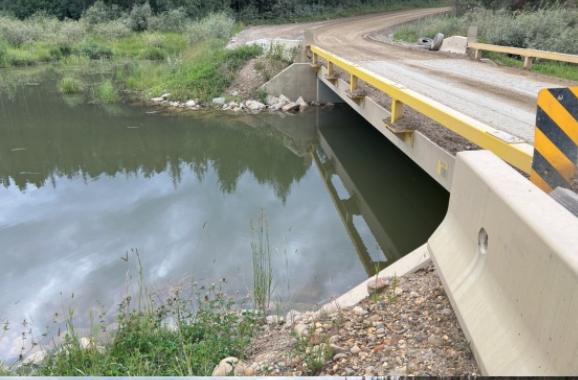
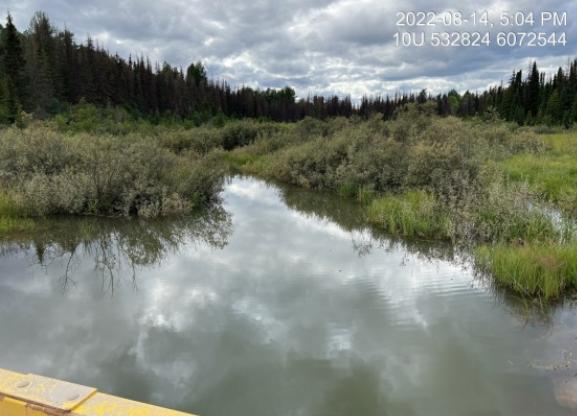
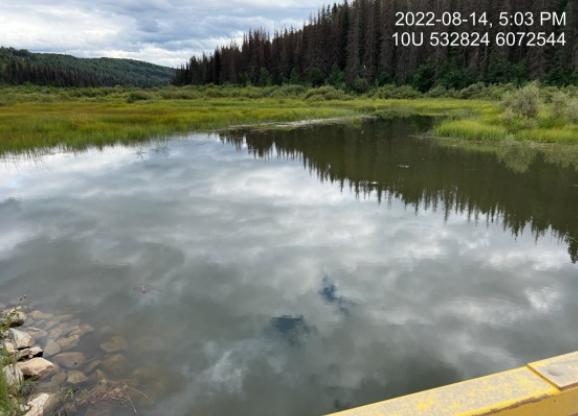
. From top left clockwise: Road/Site Card, Barrel, Outlet, Downstream, Upstream, Inlet.6731

Location and Stream Data	•	Crossing Characteristics	-
Comments: Bridge was recently installed since 2019. 16:57			
Photos: PSCIS ID

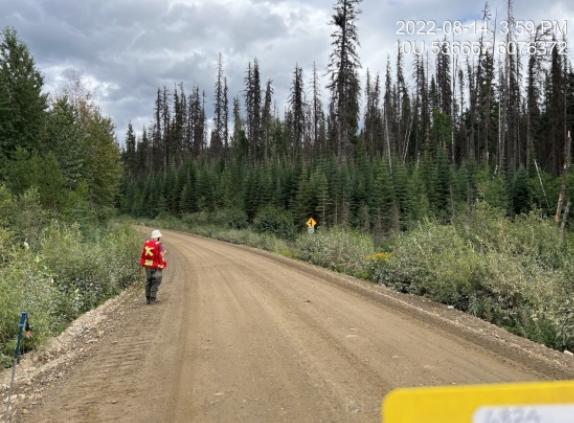
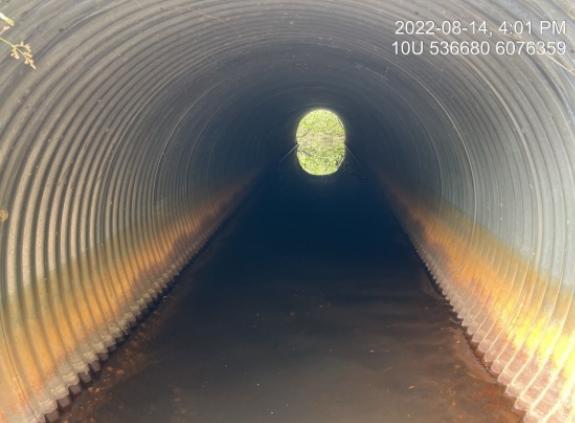
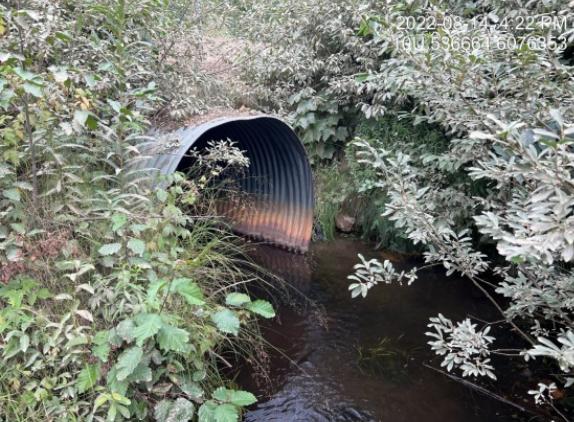
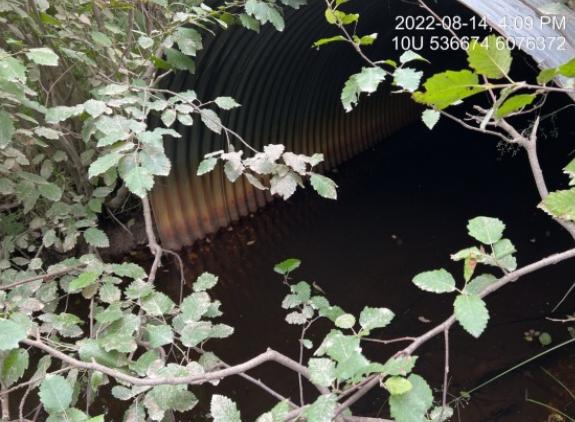
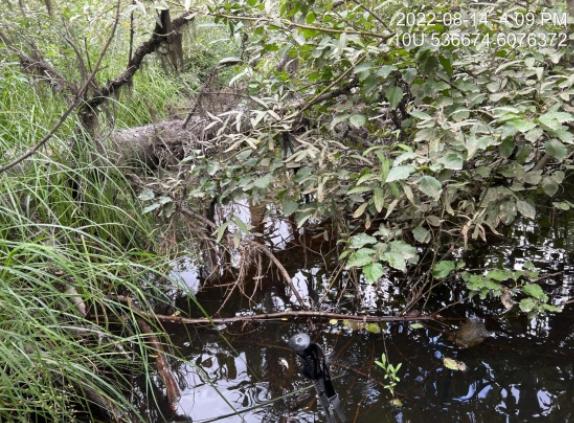
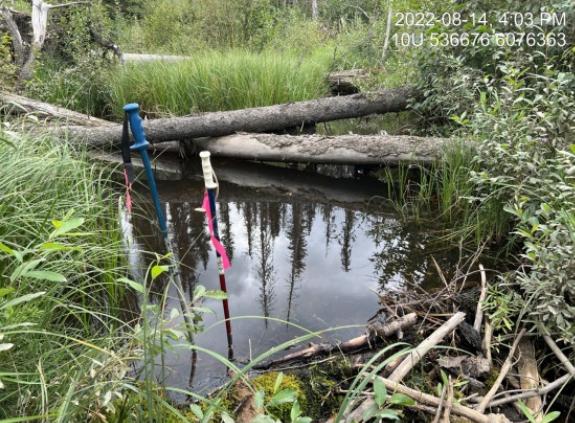
. From top left clockwise: Road/Site Card, Barrel, Outlet, Downstream, Upstream, Inlet.6824

Location and Stream Data		Crossing Characteristics	
Date	2022-08-14	Crossing Sub Type	Round Culvert
PSCIS ID	6824	Diameter (m)	1.6
External ID	–	Length (m)	14
Crew	MW AI	Embedded	No
UTM Zone	10	Depth Embedded (m)	–
Easting	536665	Resemble Channel	No
Northing	6076345	Backwatered	Yes
Stream	Tributary to Anzac River	Percent Backwatered	100
Road	Chuchinka-Crocker FSR	Fill Depth (m)	1.2
Road Tenure	Resource Demographic	Outlet Drop (m)	0
Channel Width (m)	3	Outlet Pool Depth (m)	0.6
Stream Slope (%)	0.5	Inlet Drop	No
Beaver Activity	Yes	Slope (%)	1.5
Habitat Value	Medium	Valley Fill	Deep Fill
Final score	21	Barrier Result	Barrier
Fix type	Replace with New Open Bottom Structure	Fix Span / Diameter	10

Location and Stream Data	•	Crossing Characteristics
Comments: Channel with gradient estimated. Culvert is fully backwatered due to beaver dams at this time and passable but might be a good idea to assess flow velocities in the spring at higher flows. Habitat confirmation could be conducted to get an idea of fish values and habitat values to inform if are an issue. 15:54		
Photos: PSCIS ID

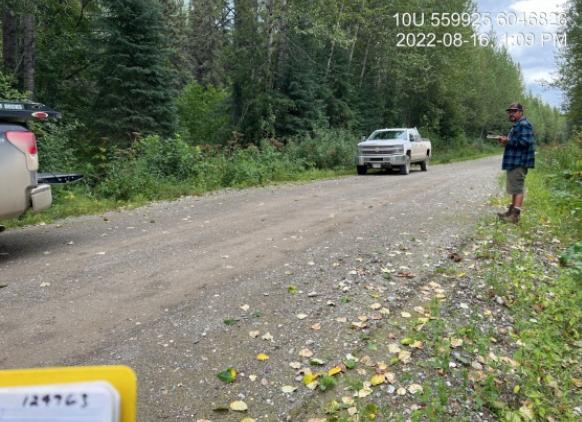
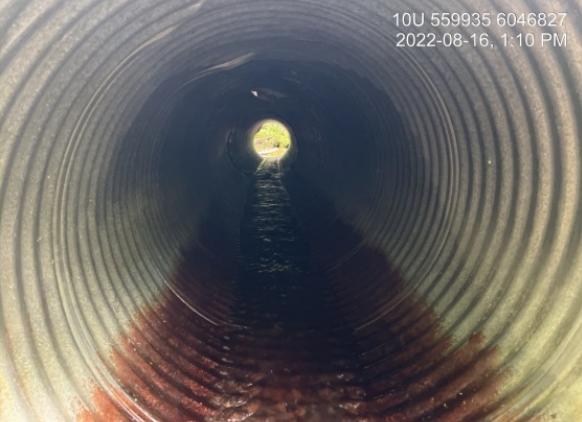
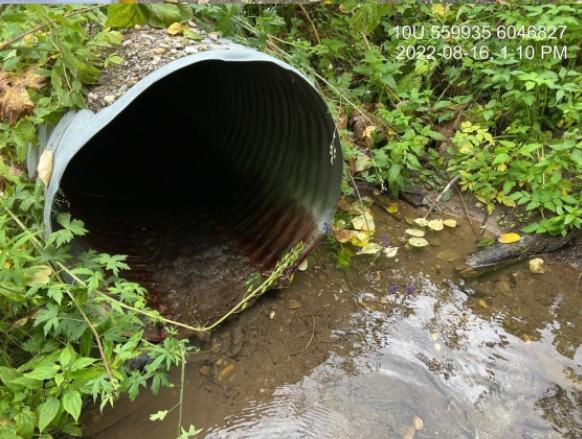
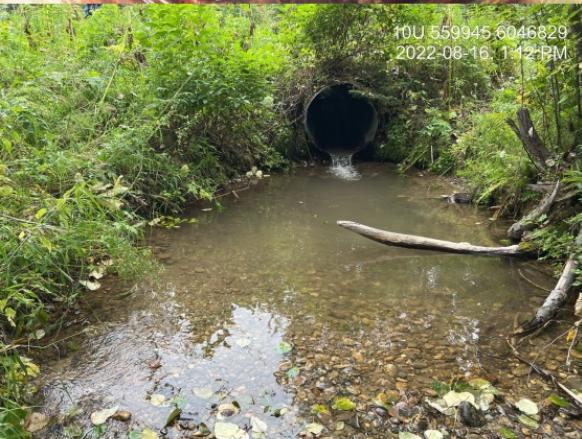
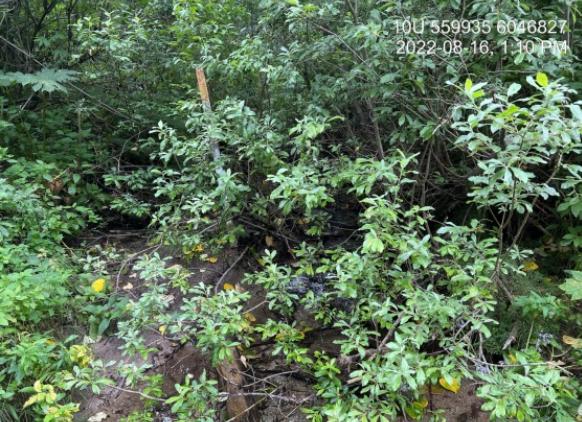
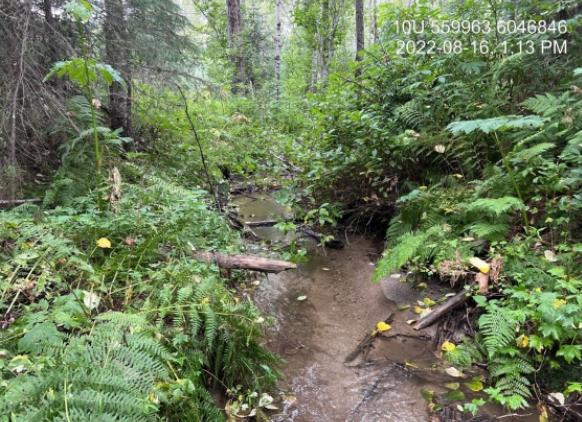
. From top left clockwise: Road/Site Card, Barrel, Outlet, Downstream, Upstream, Inlet.124963

Location and Stream Data		Crossing Characteristics	
Date	2022-08-16	Crossing Sub Type	Round Culvert
PSCIS ID	124963	Diameter (m)	1
External ID	–	Length (m)	12
Crew	AI MW	Embedded	No
UTM Zone	10	Depth Embedded (m)	–
Easting	559940	Resemble Channel	No
Northing	6046827	Backwatered	No
Stream	Tributary to Parsnip River	Percent Backwatered	–
Road	Chuchinka-Arctic FSR	Fill Depth (m)	0.5
Road Tenure	Resource Demographic	Outlet Drop (m)	0.2
Channel Width (m)	2.7	Outlet Pool Depth (m)	0.6
Stream Slope (%)	1.5	Inlet Drop	No
Beaver Activity	No	Slope (%)	3
Habitat Value	Medium	Valley Fill	Deep Fill
Final score	31	Barrier Result	Barrier
Fix type	Replace with New Open Bottom Structure	Fix Span / Diameter	10

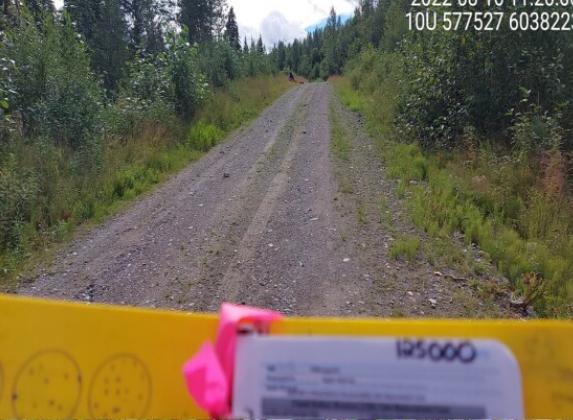
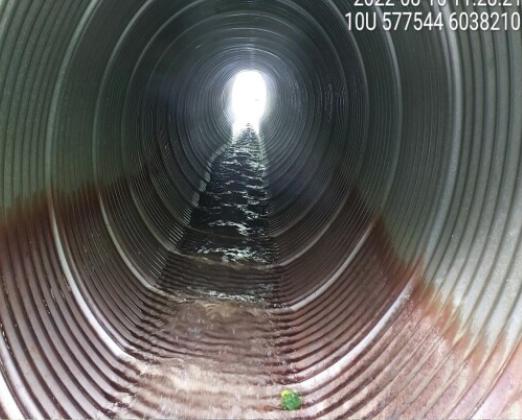
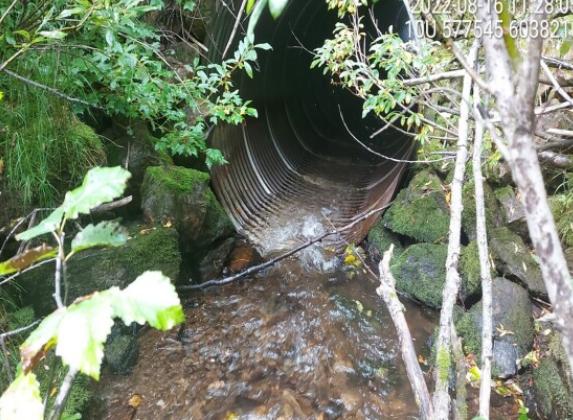
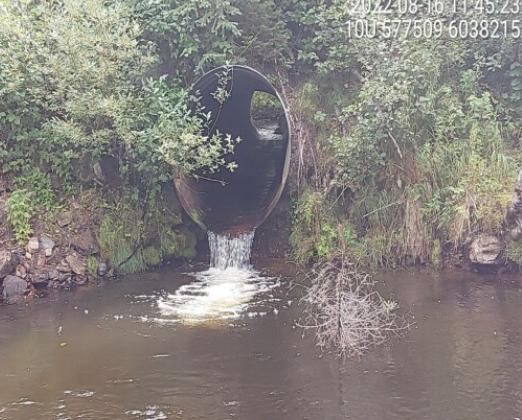
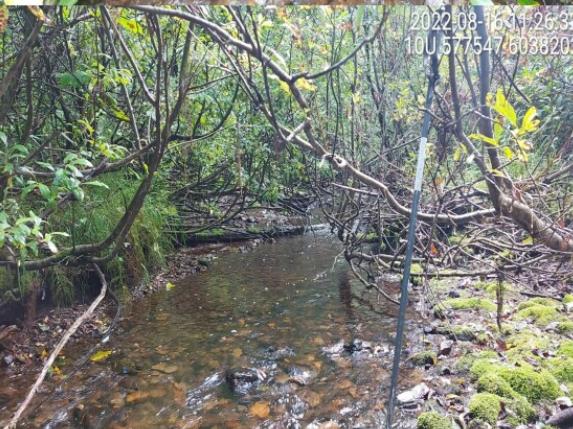
Location and Stream Data		Crossing Characteristics	
Date	2022-08-15	Crossing Sub Type	Round Culvert
PSCIS ID	125000	Diameter (m)	1.5
External ID	–	Length (m)	18
Crew	MW AI	Embedded	No
UTM Zone	10	Depth Embedded (m)	–
Easting	577540	Resemble Channel	No
Northing	6038199	Backwatered	No
Stream	Tributary to Parsnip River	Percent Backwatered	–
Road	Chuchinka-Arctic FSR	Fill Depth (m)	2.5
Road Tenure	Resource Demographic	Outlet Drop (m)	0.6
Channel Width (m)	4.52	Outlet Pool Depth (m)	2
Stream Slope (%)	1.5	Inlet Drop	No
Beaver Activity	No	Slope (%)	2
Habitat Value	Medium	Valley Fill	Deep Fill
Final score	34	Barrier Result	Barrier
Fix type	Replace with New Open Bottom Structure	Fix Span / Diameter	10

Location and Stream Data	•	Crossing Characteristics	-
Comments: Habitat survey done with drone. 11:15:00 AM			
Photos: PSCIS ID

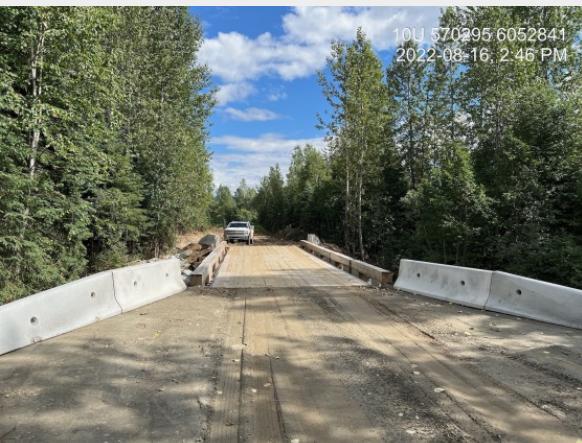
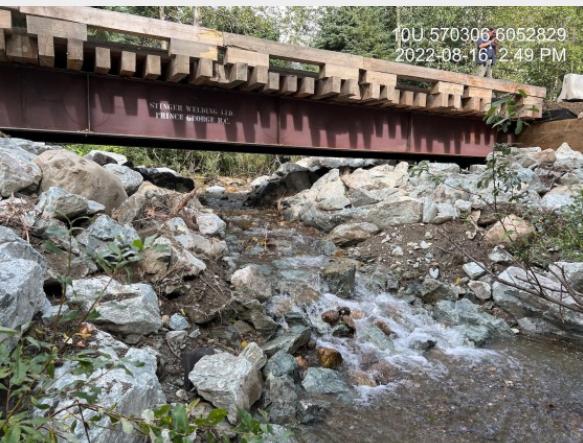
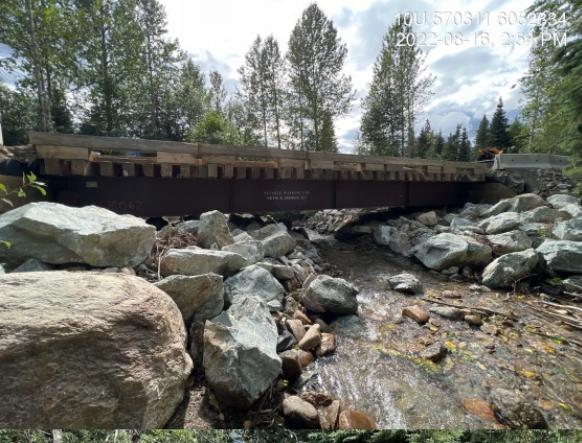
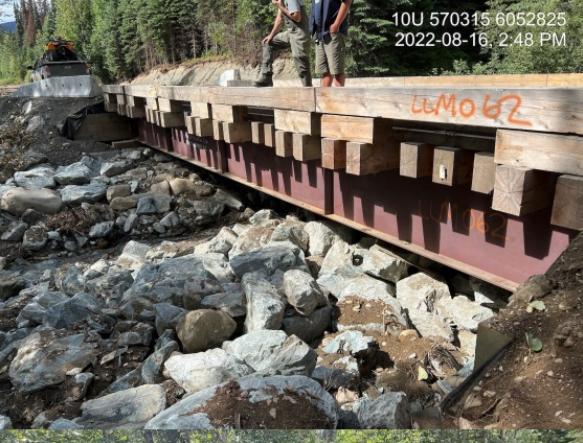
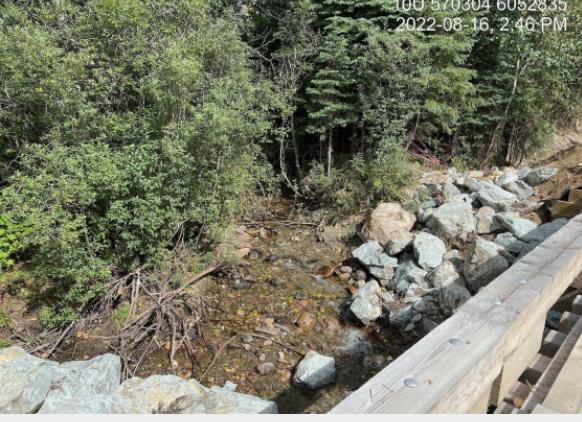
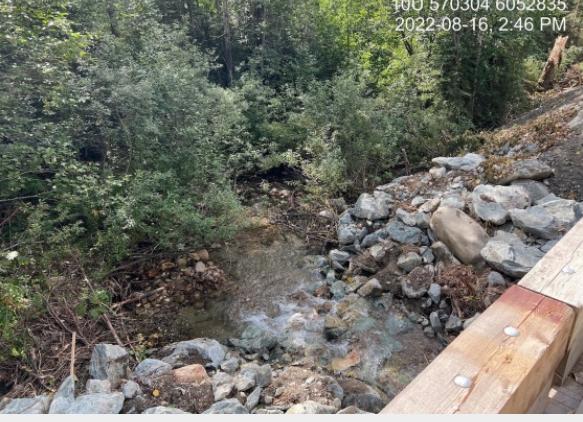
Location and Stream Data	•	Crossing Characteristics	-		
Comments: Riprap is 6.7m wide on east and 4.7m wide on west. Riprap cascade downstream of structure ~5m.					
Photos: PSCIS ID

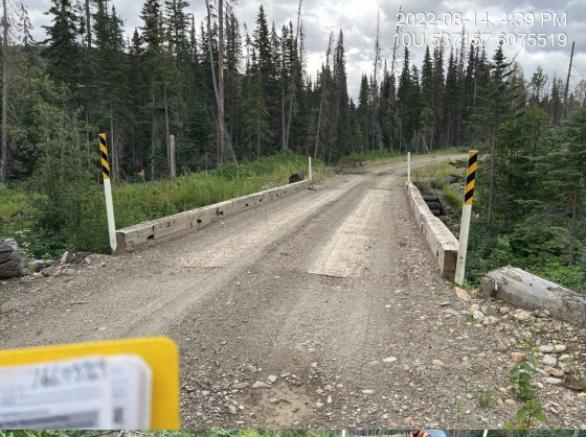
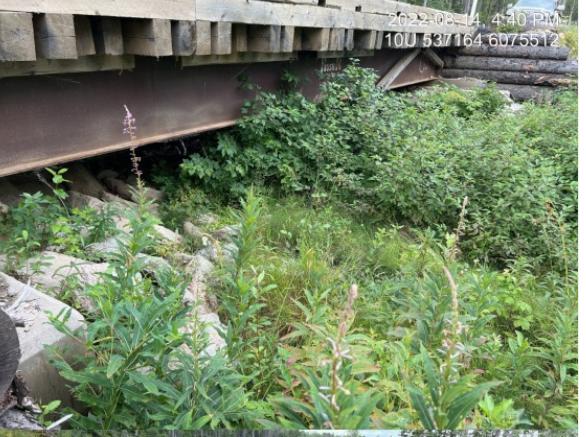
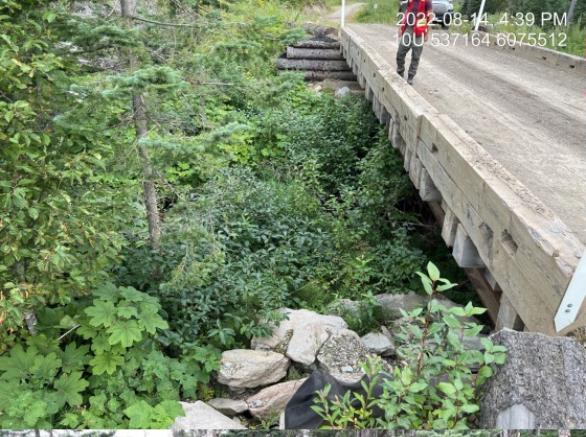
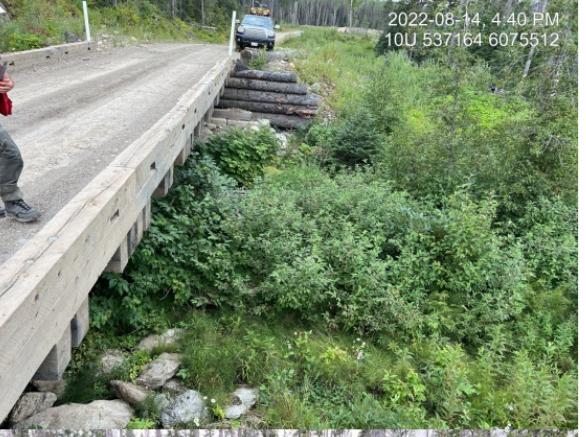
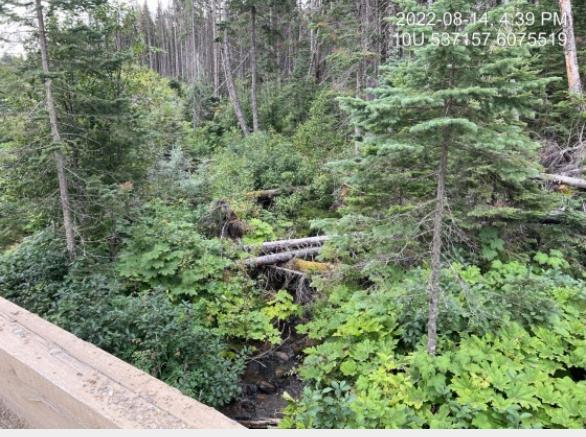
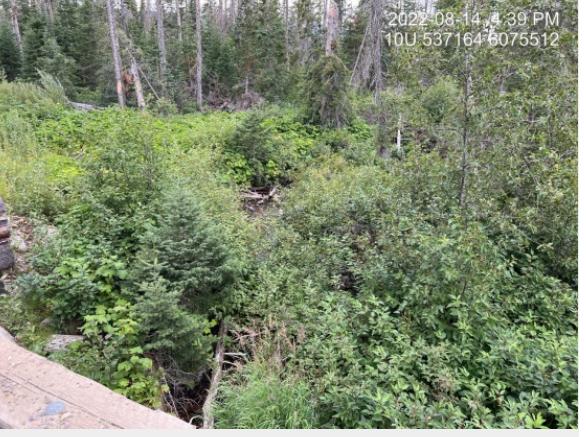
Location and Stream Data	•	Crossing Characteristics	-
Comments: Bridge, overgrown vegetation at inlet and outlet. 16:35:00			
Photos: PSCIS ID
