Restoring Fish Passage in the Peace Region - 2022 - PEA-F23-F- 3761-DCA

**Prepared for
Fish and Wildlife Compensation Program
and
Fish Passage Technical Working Group**

**Prepared by
Al Irvine, B.Sc., R.P.Bio. and Mateo Winterscheidt, B.Sc.
New Graph Environment Ltd.
on behalf of
Society for Ecosystem Restoration in Northern BC**

Version 0.0.1 2023-07-13

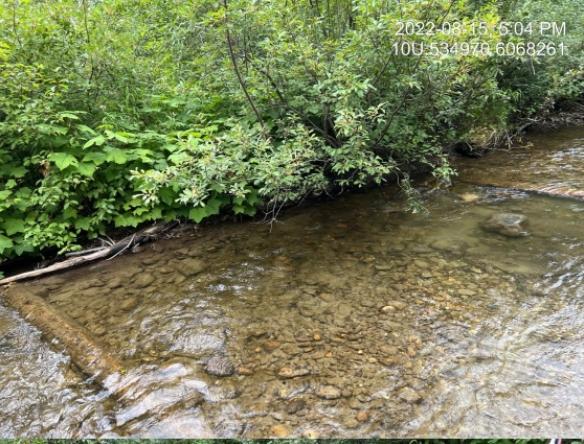
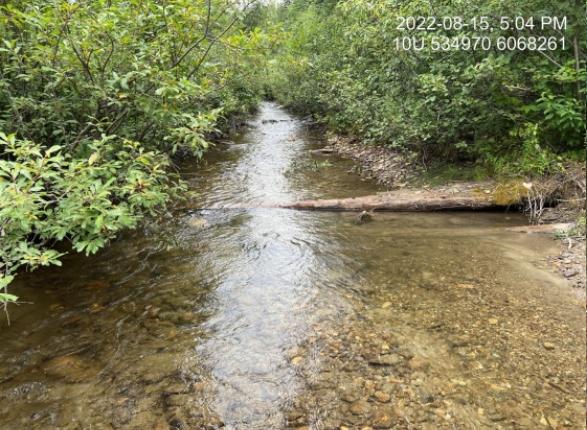
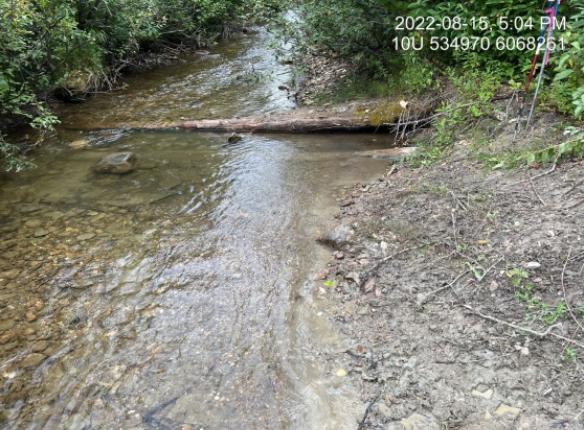
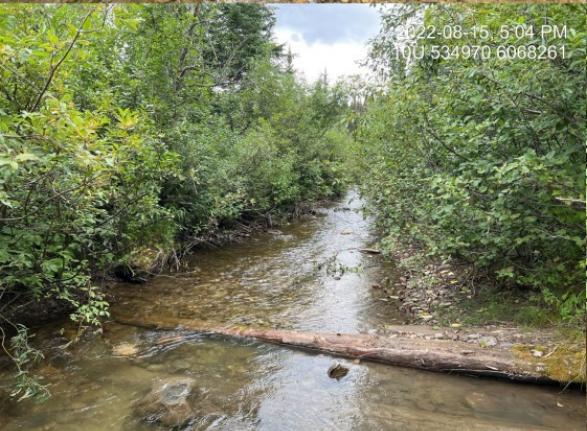
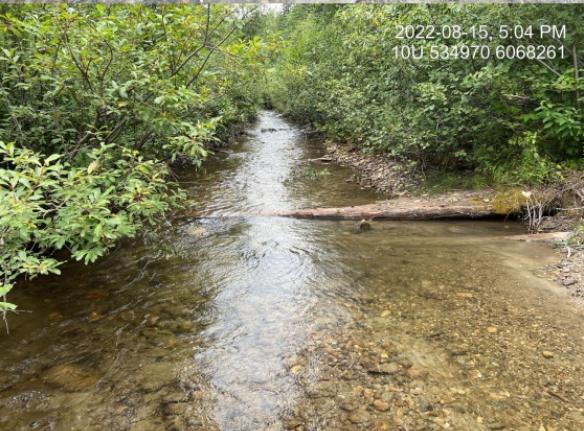
. From top left clockwise: Road/Site Card, Barrel, Outlet, Downstream, Upstream, Inlet.16601271

Location and Stream Data	•	Crossing Characteristics	-
Comments: No ford or crossing. This appears to be the end of the accessible remnants of this rough ATV road. 17:06			
Photos: PSCIS ID

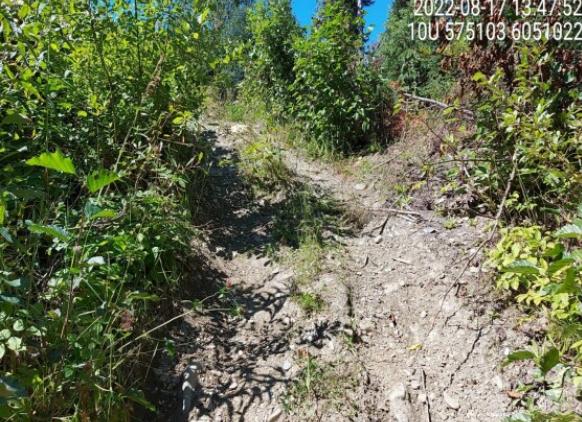
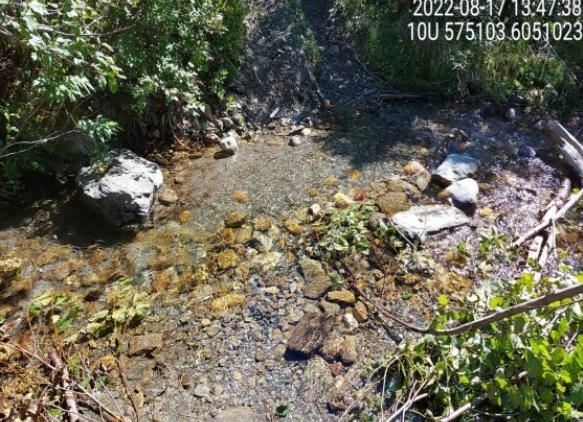
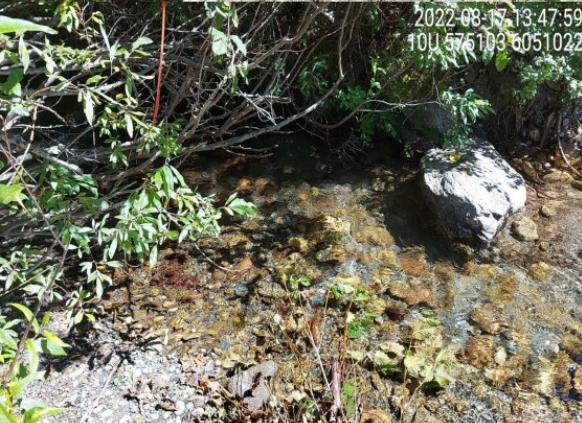
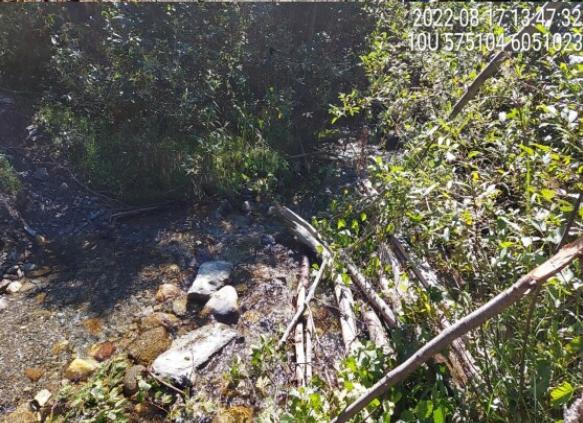
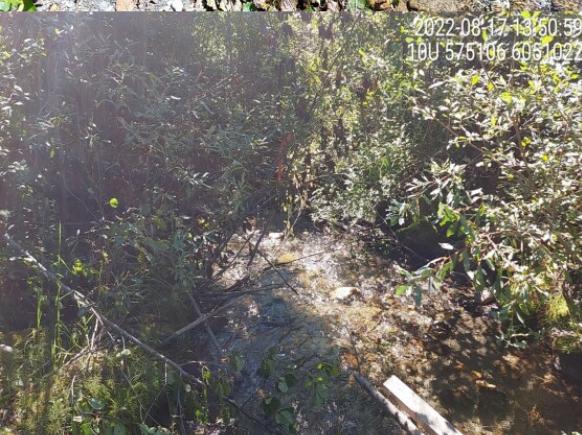
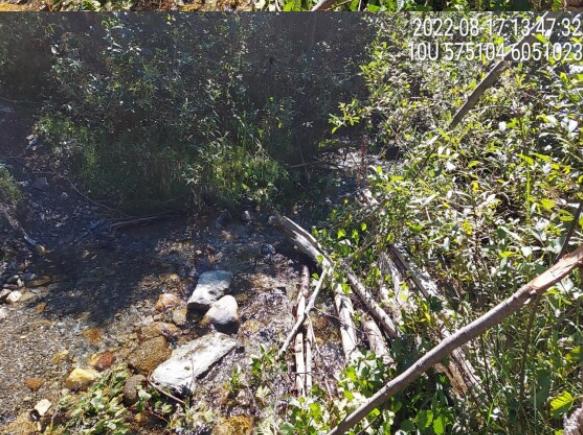
. From top left clockwise: Road/Site Card, Barrel, Outlet, Downstream, Upstream, Inlet.2022081750

Location and Stream Data		Crossing Characteristics –	
Date	2022-08-17	Crossing Sub Type	Ford
PSCIS ID	198322	Diameter (m)	–
External ID	2022081750	Length (m)	–
Crew	MW AI	Embedded	–
UTM Zone	10	Depth Embedded (m)	–
Easting	575104	Resemble Channel	–
Northing	6051021	Backwatered	–
Stream	tributary to Missinka River	Percent Backwatered	–
Road	Chuchinka-missinka FSR	Fill Depth (m)	–
Road Tenure	Unclassified	Outlet Drop (m)	–
Channel Width (m)	–	Outlet Pool Depth (m)	–
Stream Slope (%)	–	Inlet Drop	–
Beaver Activity	Yes	Slope (%)	–
Habitat Value	–	Valley Fill	–
Final score	0	Barrier Result	Unknown
Fix type	–	Fix Span / Diameter	–

Location and Stream Data	•	Crossing Characteristics	-
Comments: Located at a quad trail. 13:53			
Photos: PSCIS ID
