**Restoring Fish Passage in the Peace Region - 2022 - PEA-F23-F-
3761-DCA**

Prepared for
Fish and Wildlife Compensation Program
and
Fish Passage Technical Working Group

Prepared by
Al Irvine, B.Sc., R.P.Bio. and Mateo Winterscheidt, B.Sc.
New Graph Environment Ltd.
on behalf of
Society for Ecosystem Restoration in Northern BC

Version 0.0.1 2023-07-13

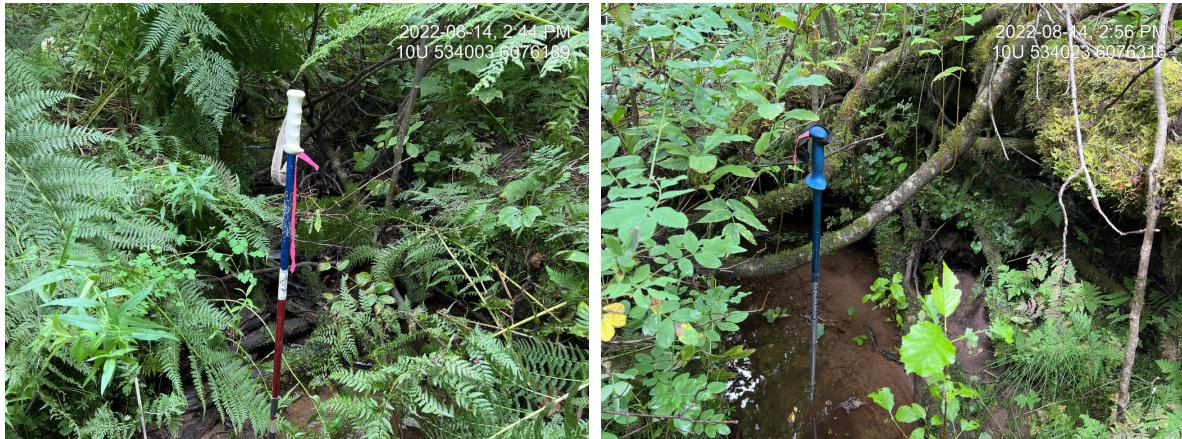
Figure 3.2: Left: Typical habitat downstream of PSCIS crossing 6745. Right: Typical habitat downstream of PSCIS crossing 6745.

The stream was surveyed downstream from crossing 6745 for 200m (Figure [3.2](#)). Total cover amount was rated as abundant with undercut banks dominant. Cover was also present as small woody debris, large woody debris, and overhanging vegetation. The average channel width was 1.2m, the average wetted width was 1m, and the average gradient was 0.5%. The dominant substrate was gravels with fines sub-dominant. There were abundant undercut banks suitable for juvenile rearing. The stream channel is smaller and narrower than upstream. There were small gravels suitable for smaller fish. The habitat was rated as medium value for salmonid rearing and spawning due to low flow volumes and a lack of deep pools.

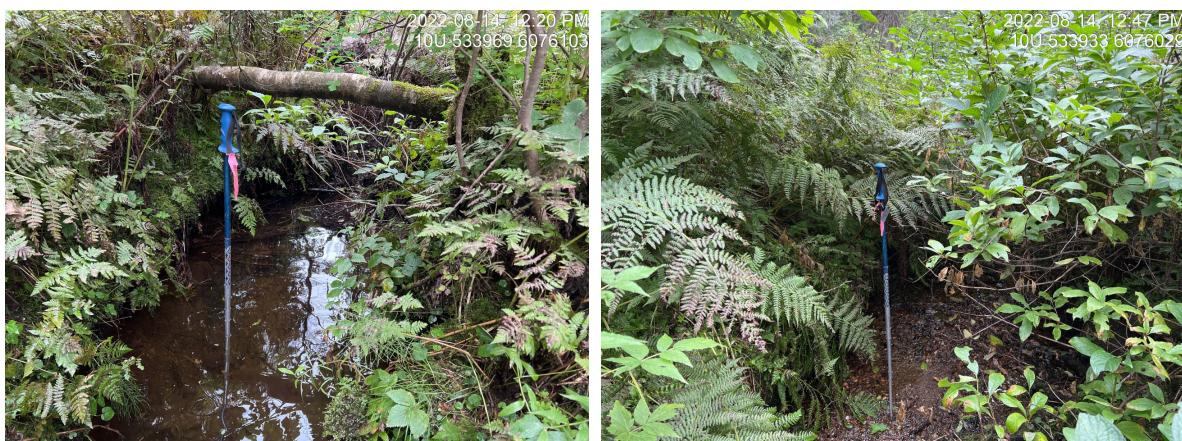
Figure 3.3: Left: Typical habitat upstream of PSCIS crossing 6745. Right: Typical habitat upstream of PSCIS crossing 6745.

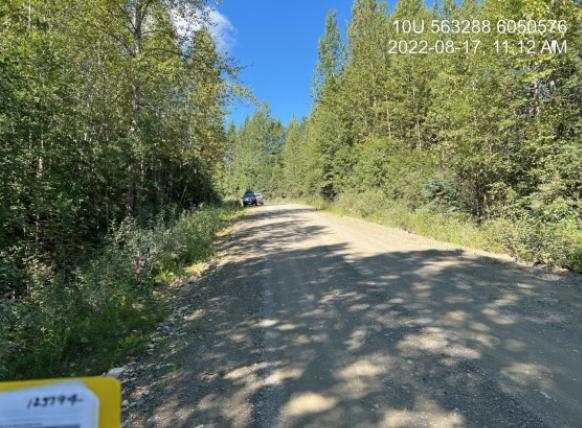
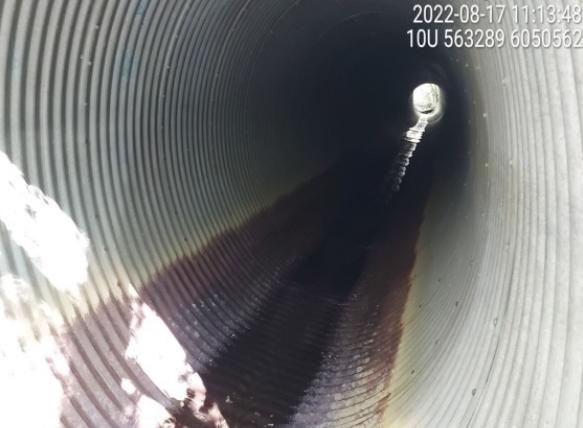
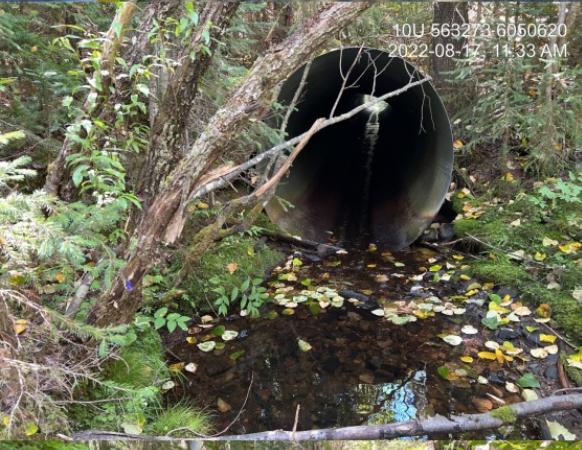
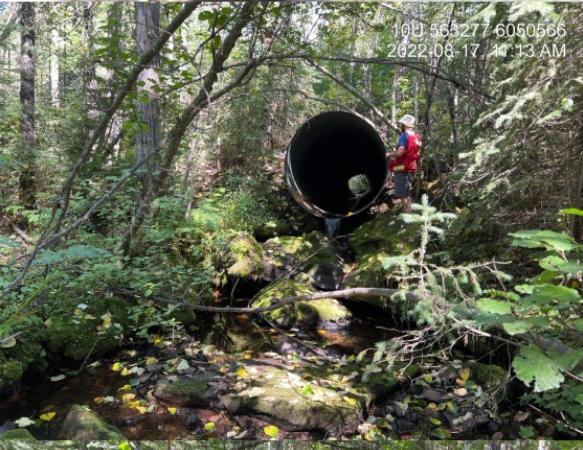
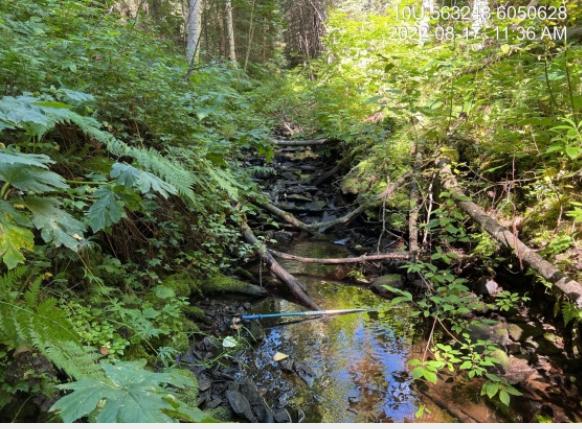
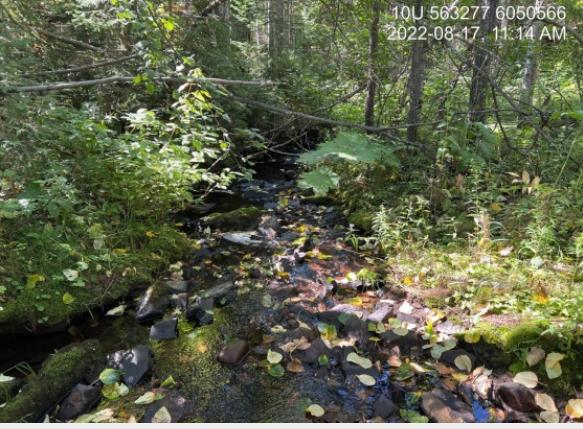
| Location and Stream Data | • | Crossing Characteristics | - |
|---|---|--|---|
| Photos: From top left clockwise: Road/Site Card, Barrel, Outlet, Downstream, Upstream, Inlet. | | | |

| Location and Stream Data | • | Crossing Characteristics | - |
|---|---|--|---|
| Comments: Very narrow cascade at outlet, big outlet drop. Good size pools downstream. Upstream has evenly distributed shale. Lots of functional woody debris. 11:09 | | | |

Replacement of PSCIS crossing 125194 with a bridge (13m span) is recommended. The cost of the work was estimated at \$325,000 for a cost benefit of 6153.8 linear m/\$1000 and 7384.6 m²/\$1000.

Crossing 125194 was ranked as a low priority for proceeding to design for replacement. Modelling indicates 2km of habitat upstream of crossing 125194 suitable for bull trout rearing with areas surveyed rated as medium value for rearing and spawning. However, there is a beaver dam 1.6m in height located approximately 800m upstream of this crossing. This would likely block the upstream migration of all fish species and life stages. In order to open up habitat in this system, it is recommended that beaver management methods be pursued at this location.

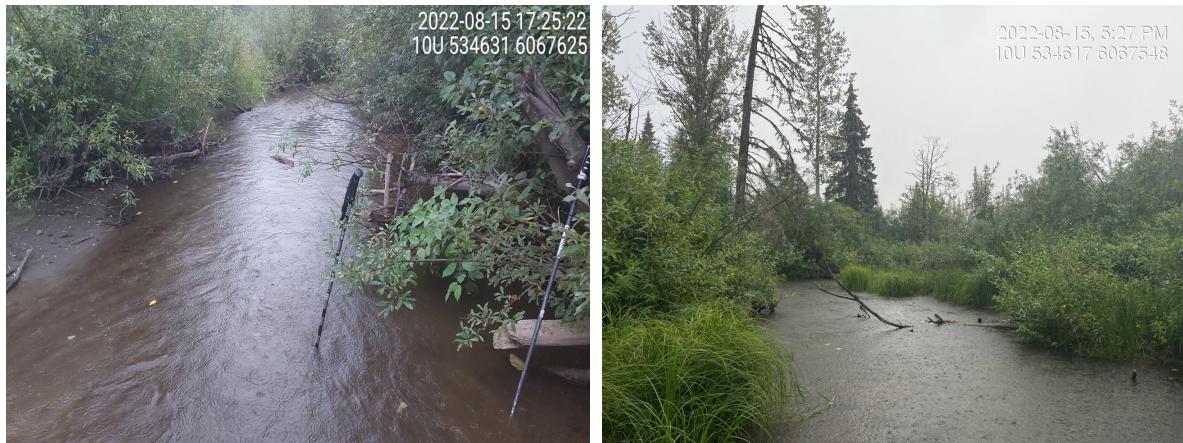
Figure 3.10: Left: Habitat downstream of PSCIS crossing 125261. Right: Transition to wetland type habitat, downstream of PSCIS crossing 125261.

The stream was surveyed downstream from crossing 125261 for 150m (Figure [3.10](#)). Total cover amount was rated as moderate with deep pools dominant. Cover was also present as small woody debris, overhanging vegetation, and instream vegetation. The average channel width was 5.6m, the average wetted width was 4.1m, and the average gradient was 1%. The dominant substrate was gravels with fines sub-dominant. Extensive gravels were found in the first 150 m surveyed downstream. The habitat then transitions to a wetland type, with depths of up to 1m on the floodplain. The habitat was rated as high value for salmonid rearing and spawning.

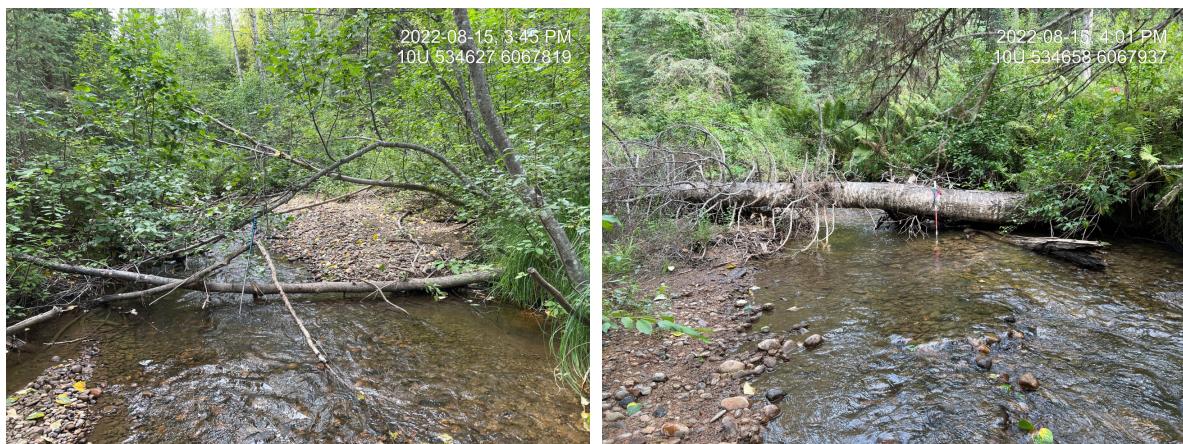
Figure 3.11: Left: Habitat upstream of PSCIS crossing 125261. Right: Habitat upstream of PSCIS crossing 125261.

The stream was surveyed upstream from crossing 125261 for 700m (Figure [3.11](#)). The dominant substrate was gravels with cobbles sub-dominant. The average channel width was 6.2m, the average wetted width was 2.4m, and the average gradient was 2.3%. Total cover amount was rated as moderate with deep pools dominant. Cover was also present as small woody debris, large woody debris, undercut banks, and overhanging vegetation. This is a large stream with abundant gravel suitable for spawning and deep pools for overwintering. Numerous fish were observed, the habitat was stable with large woody debris found throughout, and there were abundant undercut banks. At the end of the survey, a stream crossing was listed in the PSCIS database (ID 198321). Upon investigation, it was concluded that this crossing was deactivated (Figure [3.13](#)). Overall, the habitat surveyed upstream of crossing 125261 was rated as high value as an important migration corridor containing habitat suitable for spawning with moderate rearing potential.

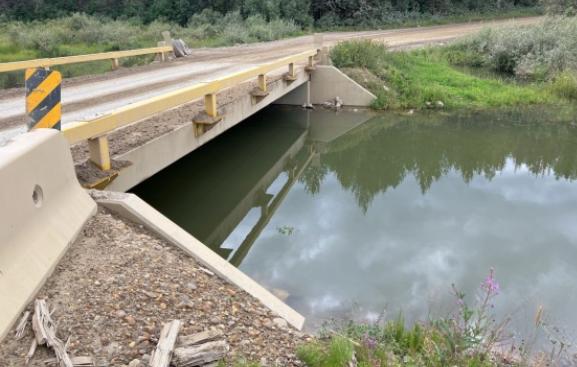
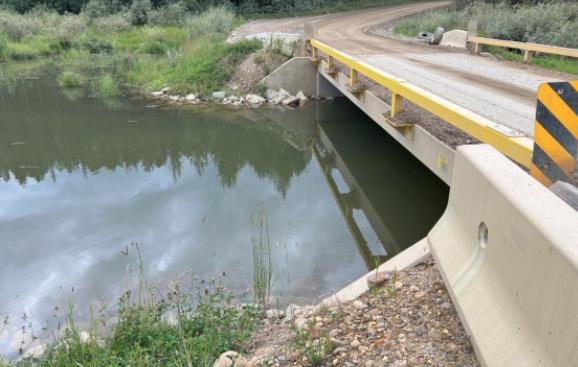
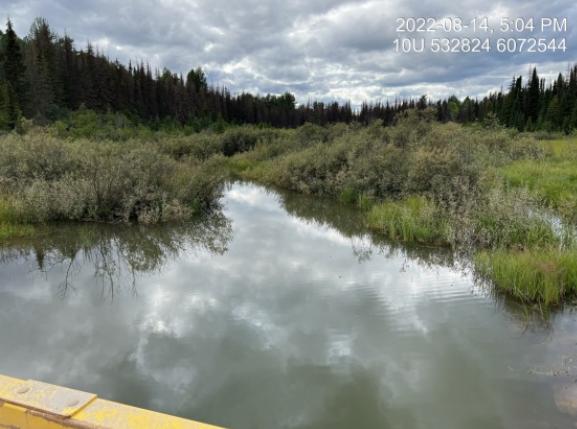
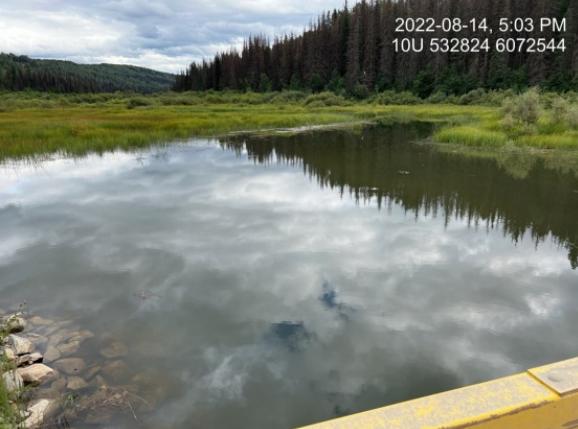
| Location and Stream Data | • | Crossing Characteristics | - |
|---|---|--|---|
| . From top left clockwise: Road/Site Card, Barrel, Outlet, Downstream, Upstream, Inlet.6731 | | | |

| id | stream_name | habitat_value | outlet_drop | bt_spawning_km | bt_rearing_km | utm_easting | utm_northing | assessment_comment |
|--|---|---|---|---|---|---|---|--|
| 6731 | UNN trib of Anzac R. | — | 0.20 | 0.11 | 6.90 | 532823 | 6072543 | Failed - drop is too high - Beaver blockage in culvert - water flowing over the road |

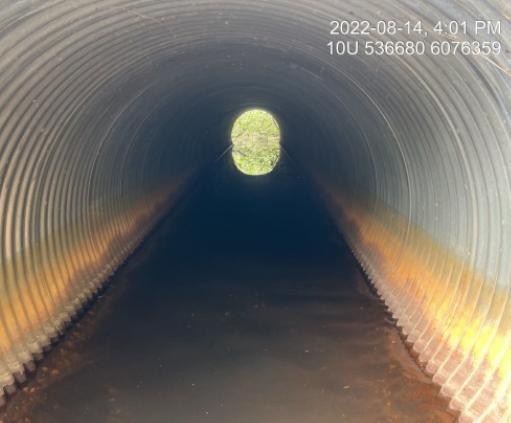
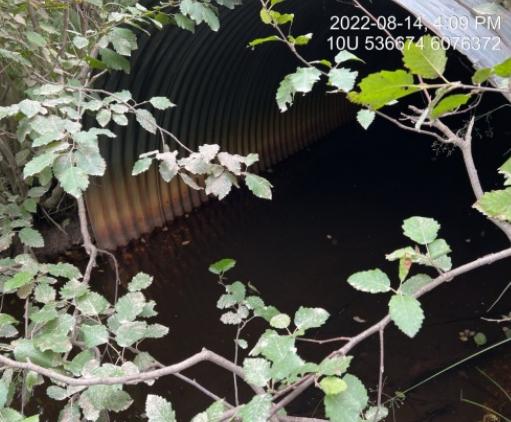
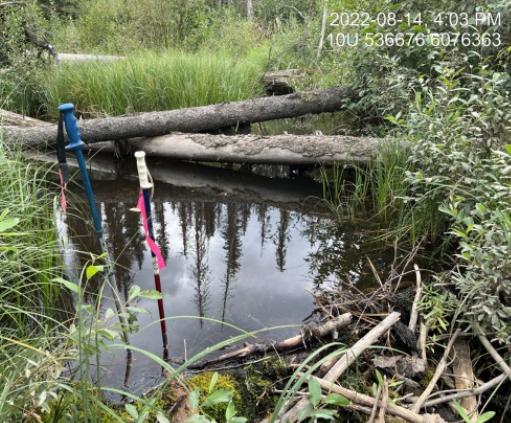
. From top left clockwise: Road/Site Card, Barrel, Outlet, Downstream, Upstream, Inlet.6824

| id | stream_name | habitat_value | outlet_drop | bt_spawning_km | bt_rearing_km | utm_easting | utm_northing | assessment_comment |
|--|---|---|---|---|---|---|---|--|
| 6824 | — | — | 0.00 | 0.31 | 1.45 | 536665 | 6076345 | Fail due to stream constriction, slope, embedment -- downstream has lots of blockages (trees down) upstream very thick/ deep silt/muck |

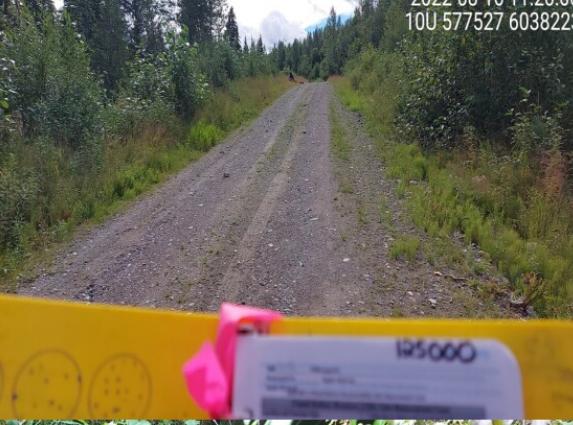
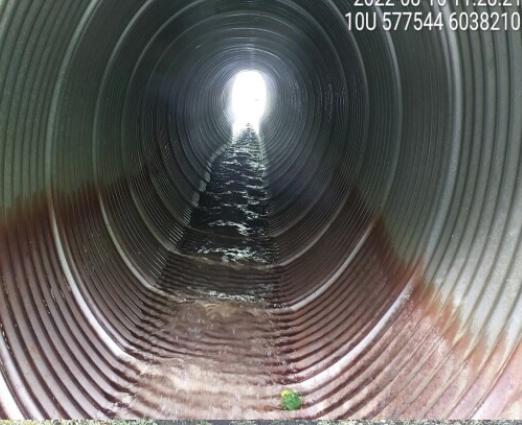
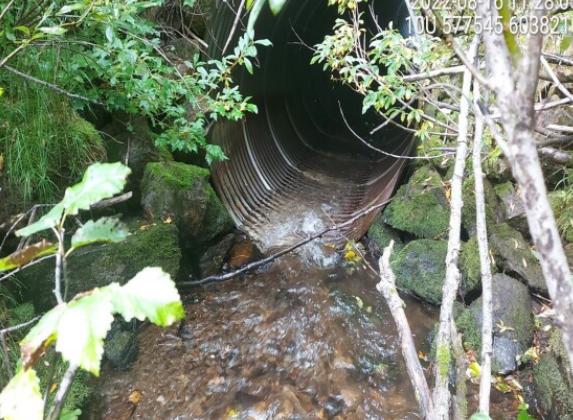
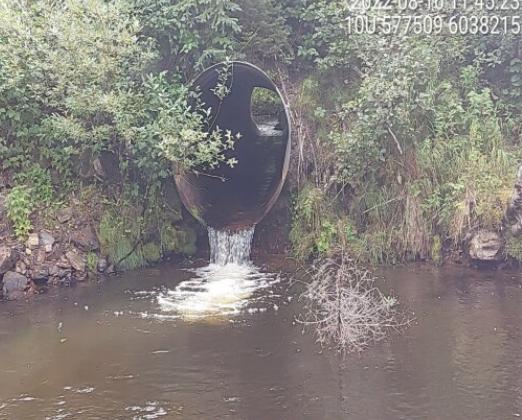
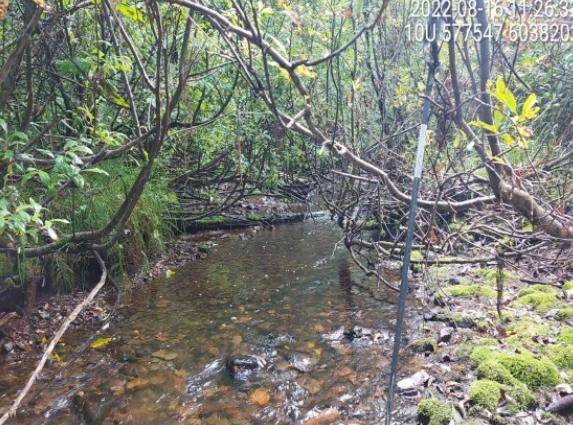
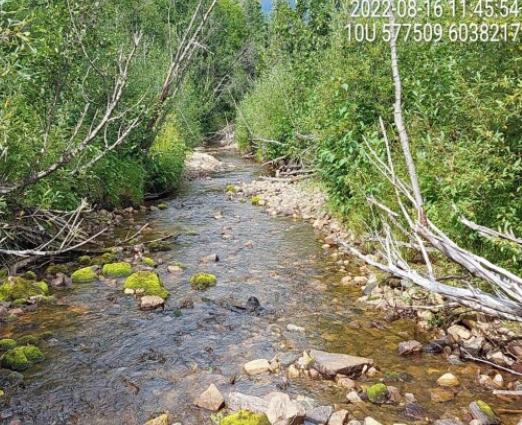
| Location and Stream Data | • | Crossing Characteristics | - |
|---|---|--|---|
| <p>. From top left clockwise: Road/Site Card, Barrel, Outlet, Downstream, Upstream, Inlet.125000</p> | | | |

| Location and Stream Data | • | Crossing Characteristics | - |
|---|---|--|---|
| Comments: Habitat survey done with drone. 11:15:00 AM | | | |

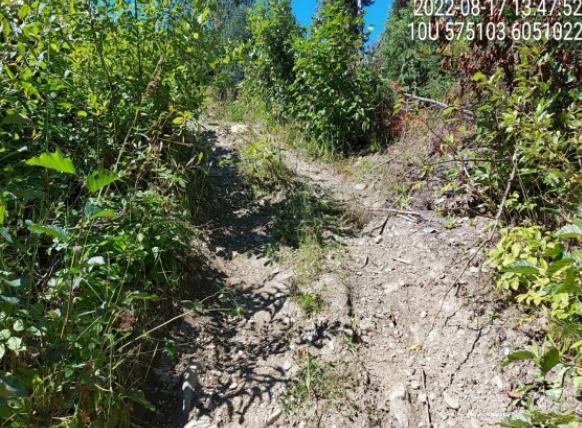
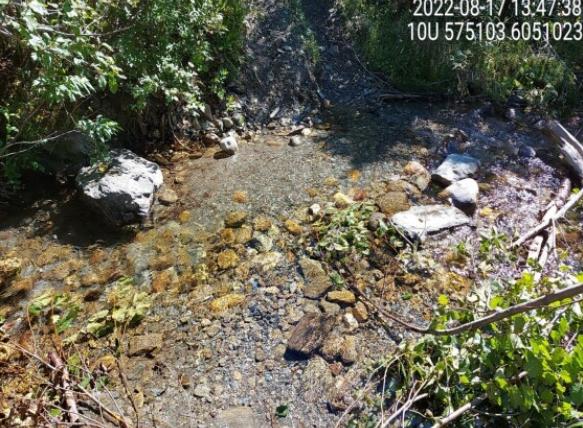
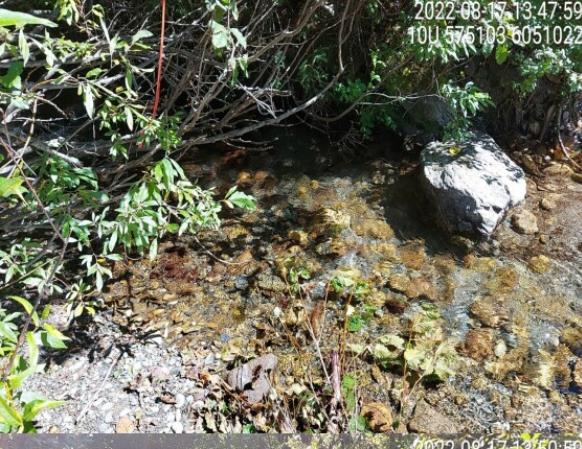
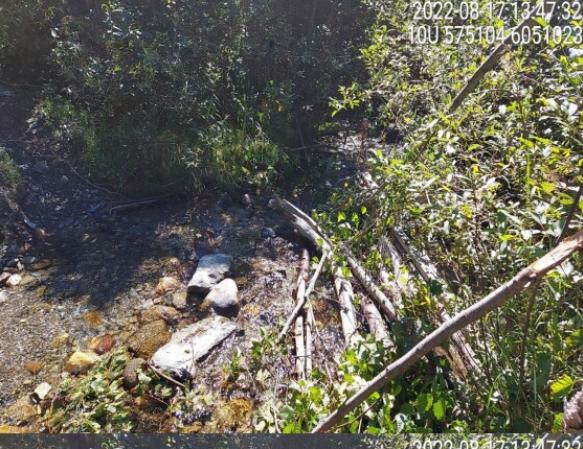
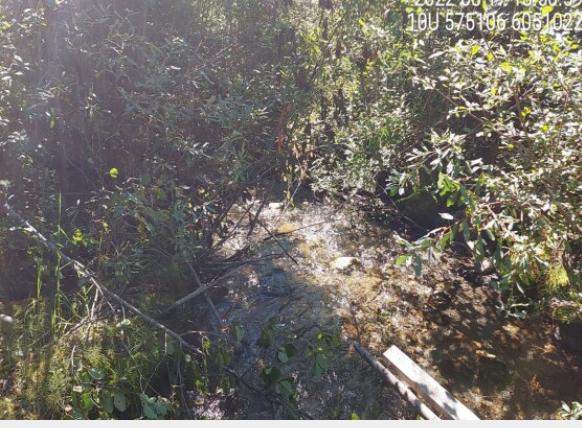
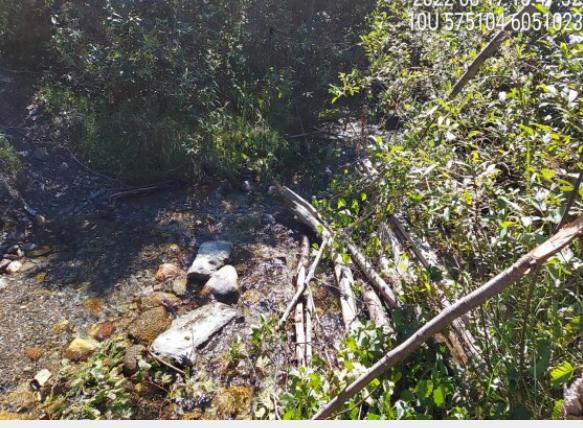
| Location and Stream Data | • | Crossing Characteristics | - |
|---|---|--|---|
| Photos: PSCIS ID | | | |

| Location and Stream Data | • | Crossing Characteristics | - |
|---|---|--|---|
| Comments: Located at a quad trail. 13:53 | | | |

. From top left clockwise: Road/Site Card, Barrel, Outlet, Downstream, Upstream, Inlet.2022081750
