SOCIETY FOR ECOSYSTEM RESTORATION
IN NORTHERN BRITISH COLUMBIA

Restoring Fish Passage in the Peace Region - 2022 - PEA-F23-F- 3761-DCA

Prepared for
Fish and Wildlife Compensation Program
and
Fish Passage Technical Working Group

Version 0.1.1 2023-07-17

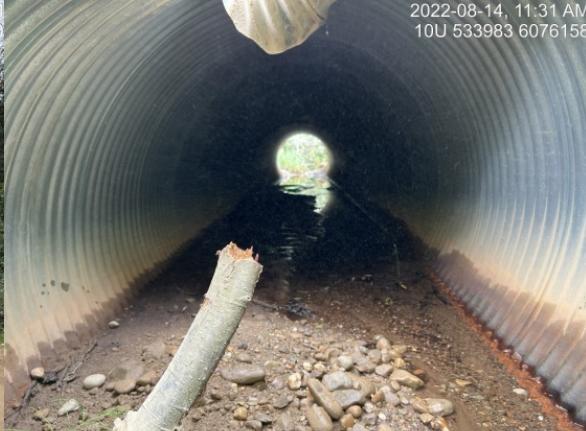
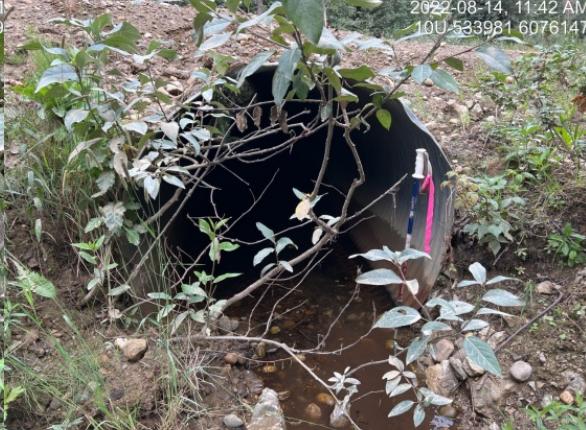
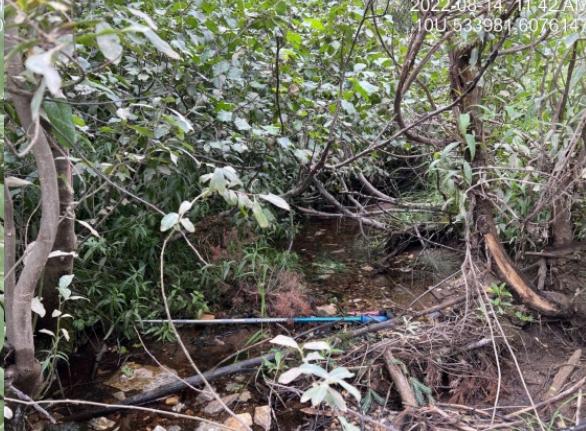
Location and Stream Data	•	Crossing Characteristics	-
Comments: Damaged near outlet. Small stream but flowing. Middle of pipe filled with fines. 11:18			
Photos: From top left clockwise: Road/Site Card, Barrel, Outlet, Downstream, Upstream, Inlet

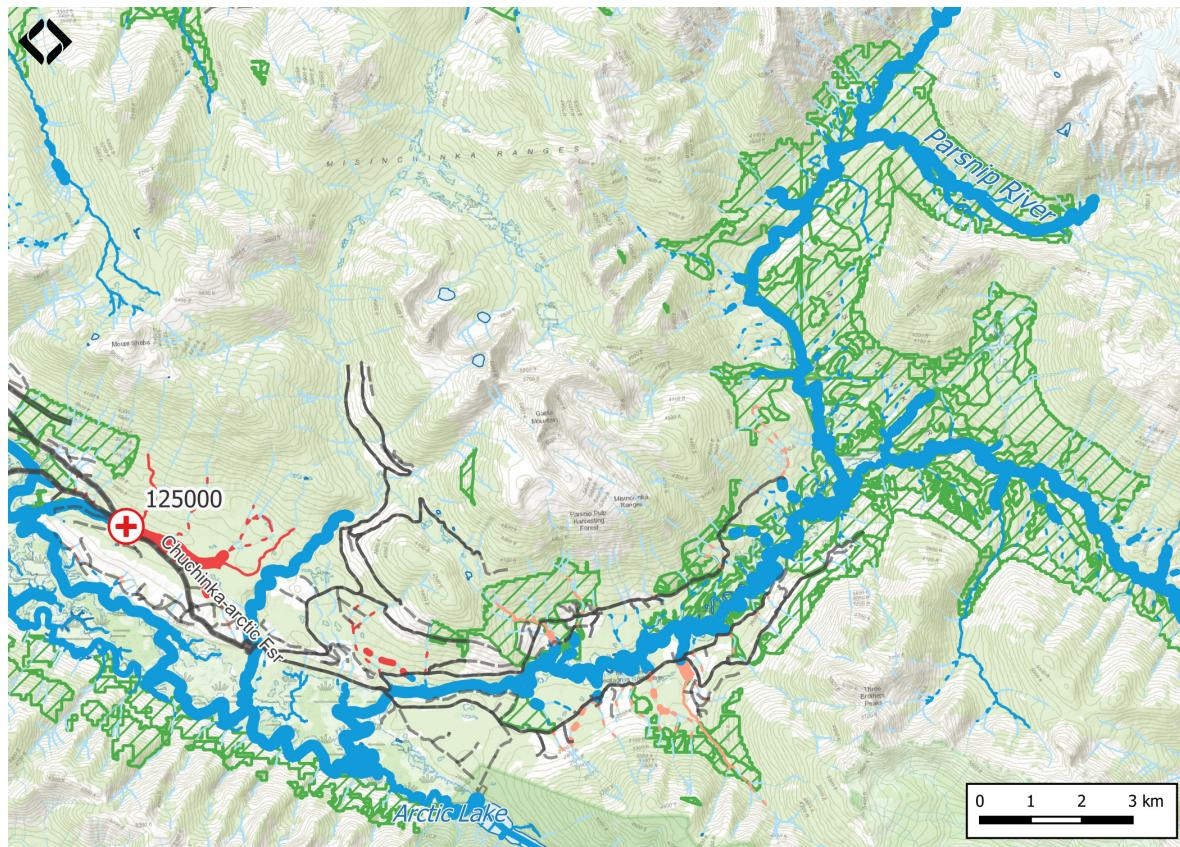
Plans were in place for remediation of the site in 2022/2023 and 2023/24 with funding support from FWCP however in the spring of 2023 Sinclair indicated that updates to the road no longer made sense as most plans for logging beyond the stream were on hold due to old growth referrals (Figure [3.4](#)). The British Columbia government has asked licensees to defer harvest of these areas until “partners develop a new approach for old growth forest management” (Ministry of Forests n.d.).

Figure 3.4: Map showing old growth management areas (green hashed polygons) beyond crossing 125000 accessed by the Chuckinka-Arctic FSR

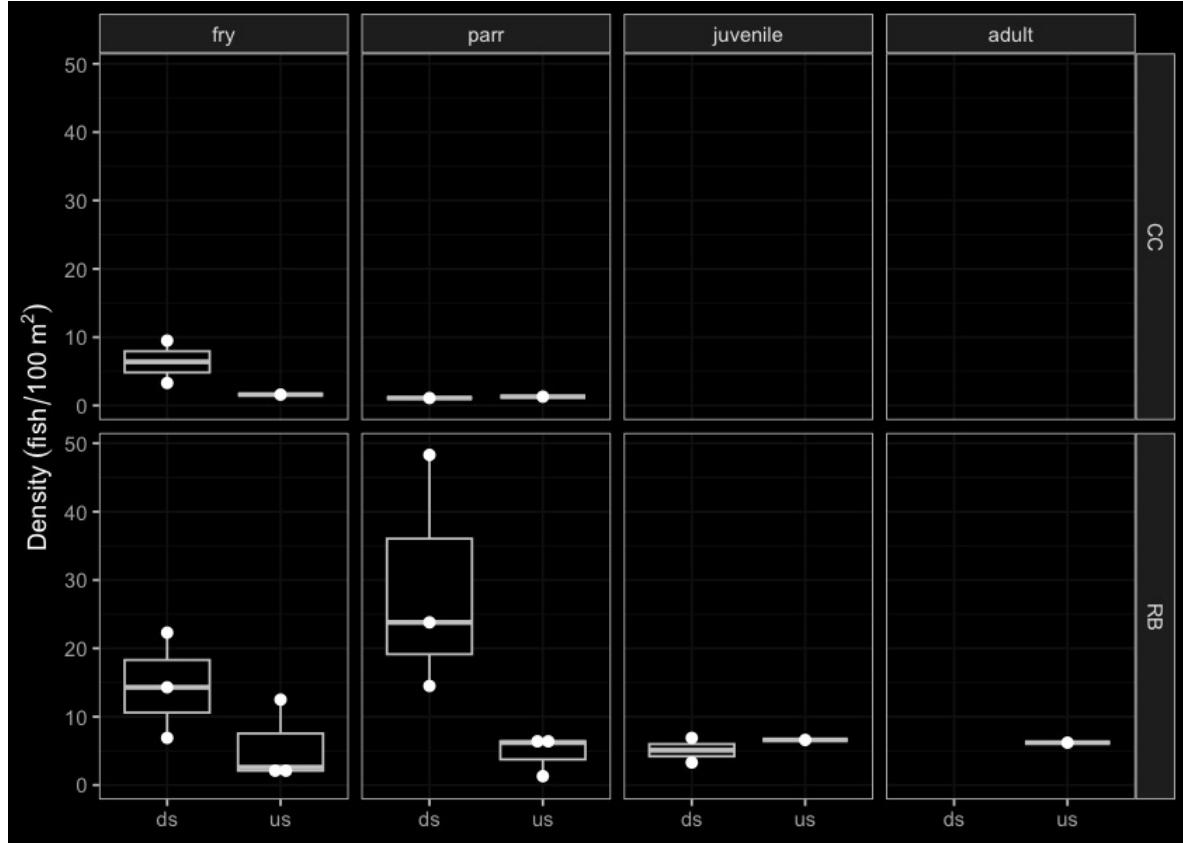
This site was reassessed in 2022, with drone survey and fish sampling conducted. At the time of survey the crossing was un-embedded, non-backwatered and ranked as a barrier to upstream fish passage. The culvert was undersized - evidenced by the large outlet drop of 0.6m and outlet pool depth of 2m (MoE 2011) (Table 3.5).

Figure 3.5: Densities of fish (fish/100m²) captured upstream of PSCIS crossing 125000.

Although at the time of reporting plans for replacement of this site had been delayed, future removal (or replacement) of the crossing is still recommended. Preliminary cost estimates for the work were estimated at /\$350,000 to /\$400,000. Additionally, re-assessment of the site with electrofishing in the 2023 and/or 2024 will provide valuable information regarding fish health and migration at the site.

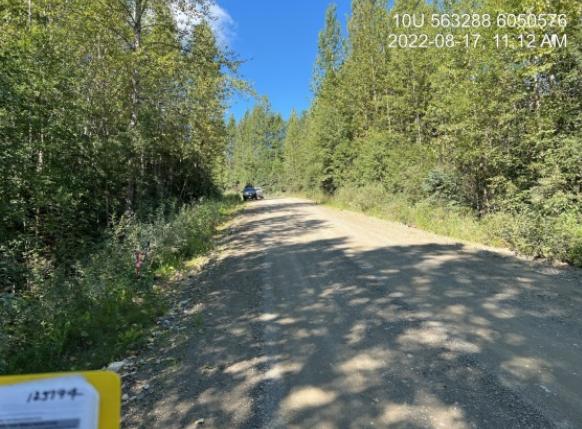
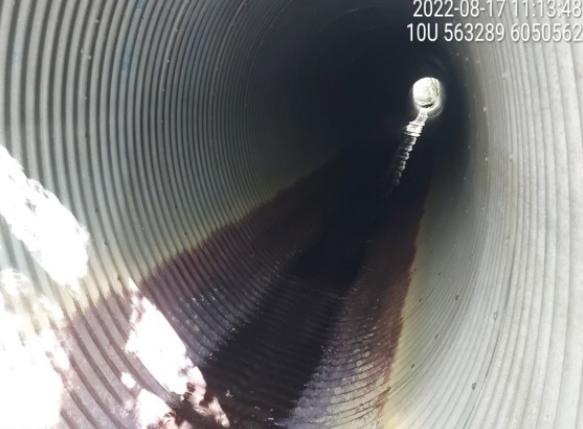
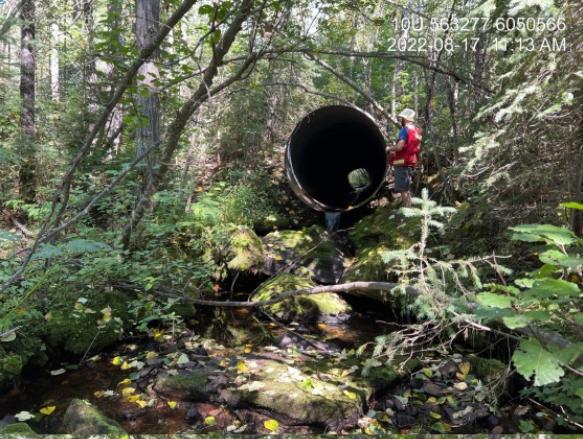
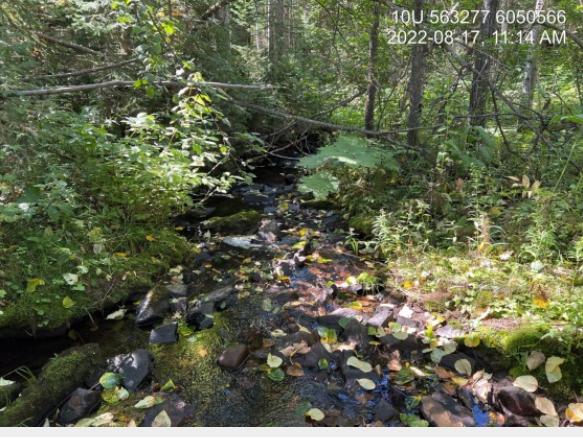
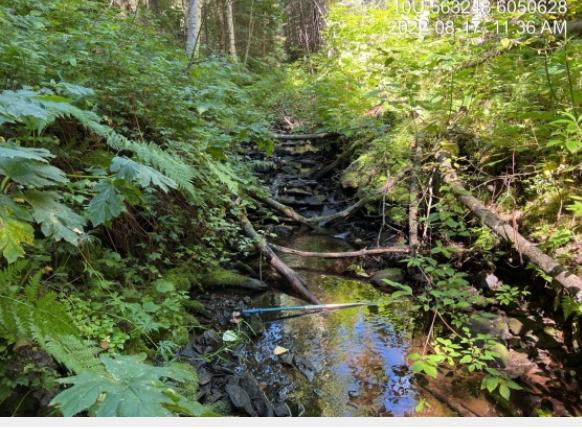
Location and Stream Data	•	Crossing Characteristics	-
Comments: Very narrow cascade at outlet, big outlet drop. Good size pools downstream. Upstream has evenly distributed shale. Lots of functional woody debris. 11:09			
Photos: From top left clockwise: Road/Site Card, Barrel, Outlet, Downstream, Upstream, Inlet.	•		-

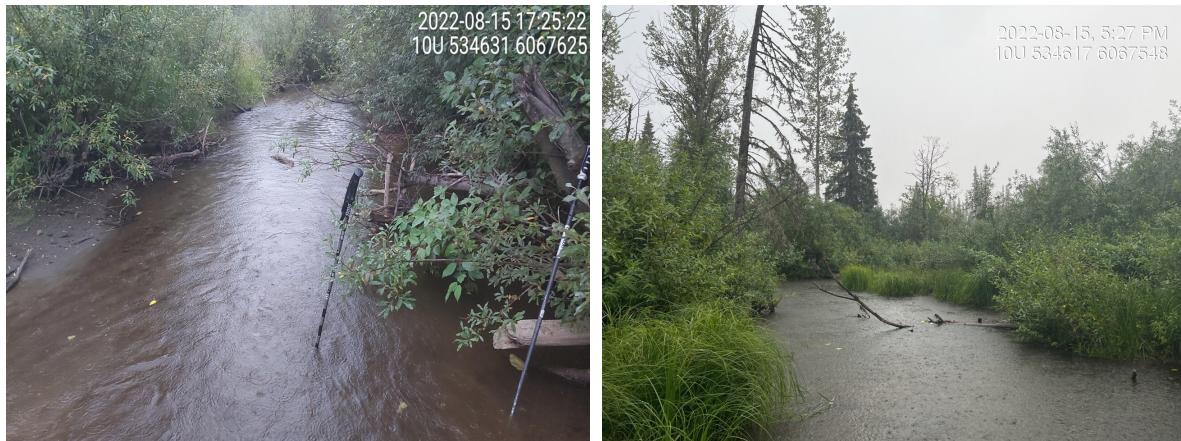
The stream was surveyed downstream from crossing 125261 for 250m (Figure 3.9). The dominant substrate was gravels with fines sub-dominant. Total cover amount was rated as moderate with deep pools dominant. Cover was also present as small woody debris, overhanging vegetation, and instream vegetation. The average channel width was 5.6m, the average wetted width was 4.1m, and the average gradient was 1%. Extensive gravels were found in the first 150 m surveyed downstream. The habitat then transitioned to beaver influenced wetland, with depths of up to 1m and deep laminar flow. The habitat was rated as high value for salmonid rearing and spawning.

Figure 3.9: Left: Habitat downstream of PSCIS crossing 125261. Right: Transition to wetland type habitat, downstream of PSCIS crossing 125261.

Replacement of PSCIS crossing 125261 with a bridge (15m span) is recommended. The cost of the work was estimated at \$375,000 for a cost benefit of 38373.3 linear m/\$1000 and 97852 m²/\$1000.

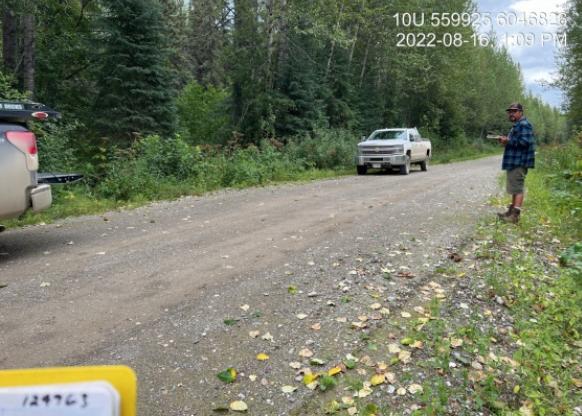
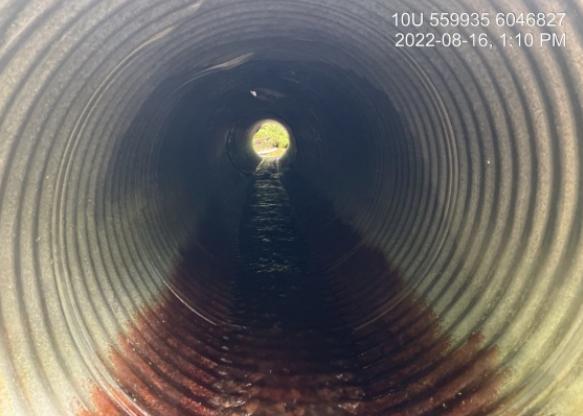
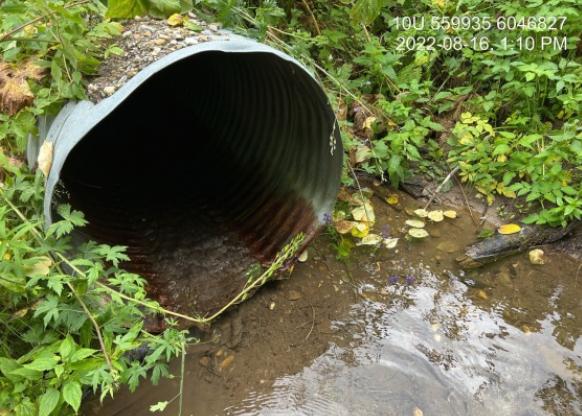
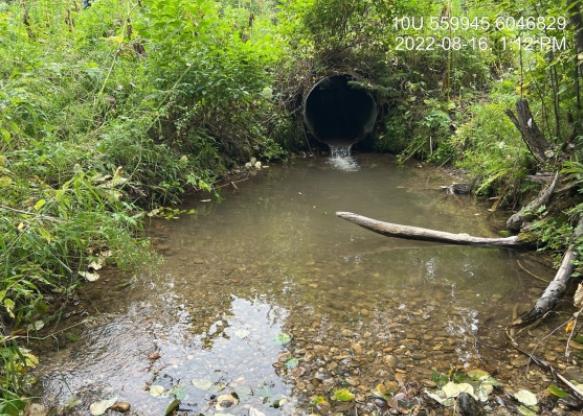
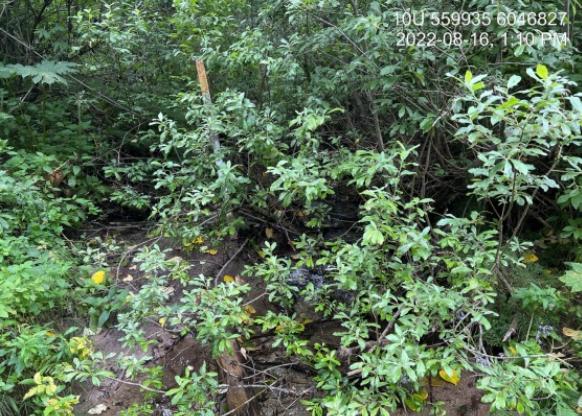
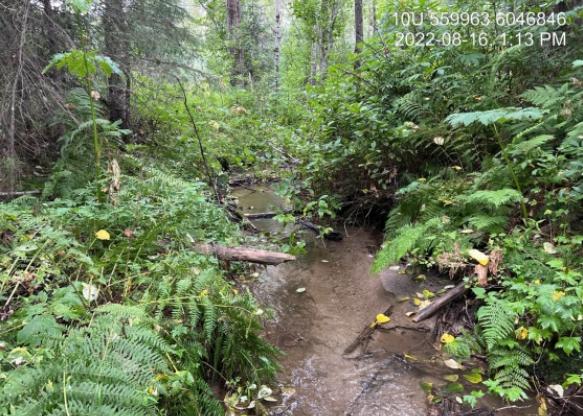
Location and Stream Data		Crossing Characteristics	
Date	2022-08-16	Crossing Sub Type	Round Culvert
PSCIS ID	124963	Diameter (m)	1
External ID	–	Length (m)	12
Crew	AI MW	Embedded	No
UTM Zone	10	Depth Embedded (m)	–
Easting	559940	Resemble Channel	No
Northing	6046827	Backwatered	No
Stream	Tributary to Parsnip River	Percent Backwatered	–
Road	Chuchinka-Arctic FSR	Fill Depth (m)	0.5
Road Tenure	Resource Demographic	Outlet Drop (m)	0.2
Channel Width (m)	2.7	Outlet Pool Depth (m)	0.6
Stream Slope (%)	1.5	Inlet Drop	No
Beaver Activity	No	Slope (%)	3
Habitat Value	Medium	Valley Fill	Deep Fill
Final score	31	Barrier Result	Barrier
Fix type	Replace with New Open Bottom Structure	Fix Span / Diameter	15

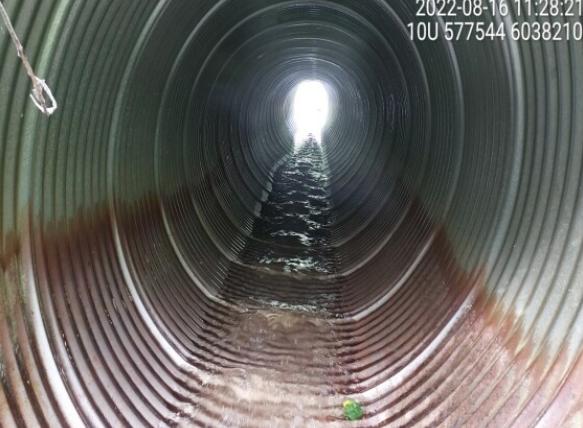
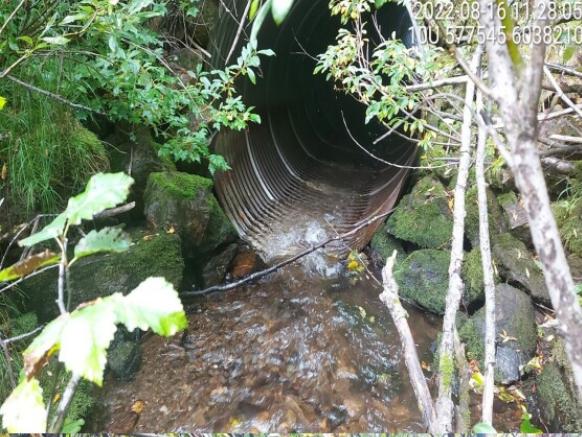
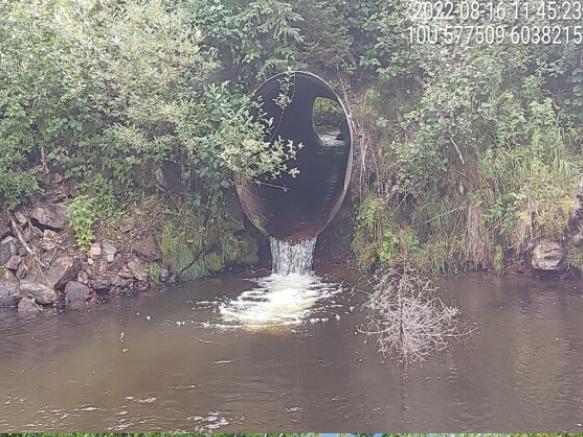
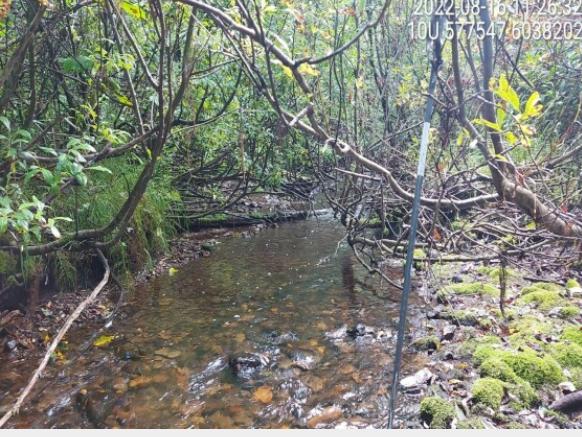
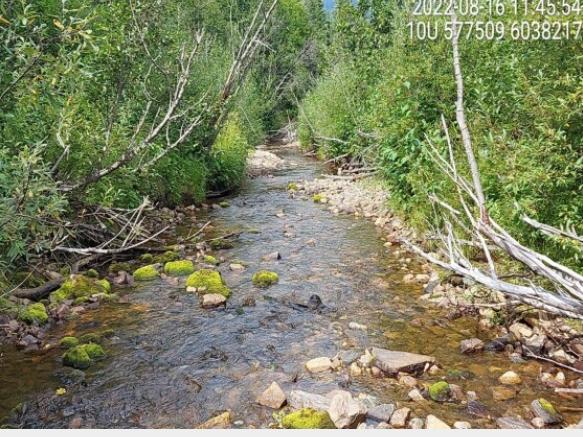
. From top left clockwise: Road/Site Card, Barrel, Outlet, Downstream, Upstream, Inlet.125000

Location and Stream Data		Crossing Characteristics	
Date	2022-08-15	Crossing Sub Type	Round Culvert
PSCIS ID	125000	Diameter (m)	1.5
External ID	–	Length (m)	18
Crew	MW AI	Embedded	No
UTM Zone	10	Depth Embedded (m)	–
Easting	577540	Resemble Channel	No
Northing	6038199	Backwatered	No
Stream	Tributary to Parsnip River	Percent Backwatered	–
Road	Chuchinka-Arctic FSR	Fill Depth (m)	2.5
Road Tenure	Resource Demographic	Outlet Drop (m)	0.6
Channel Width (m)	4.52	Outlet Pool Depth (m)	2
Stream Slope (%)	1.5	Inlet Drop	No
Beaver Activity	No	Slope (%)	2
Habitat Value	Medium	Valley Fill	Deep Fill
Final score	34	Barrier Result	Barrier
Fix type	Replace with New Open Bottom Structure	Fix Span / Diameter	15

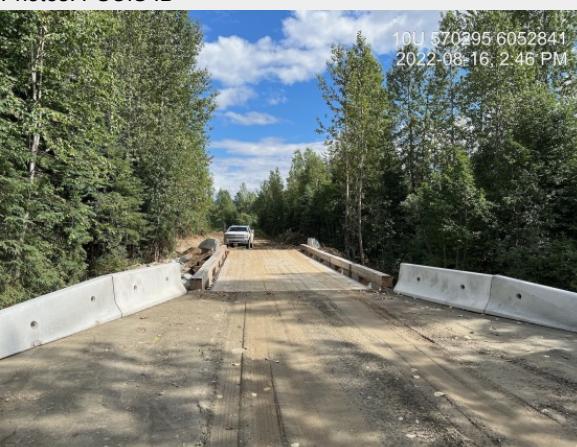
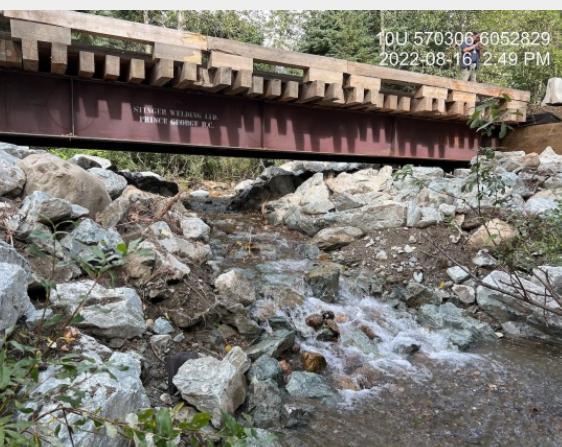
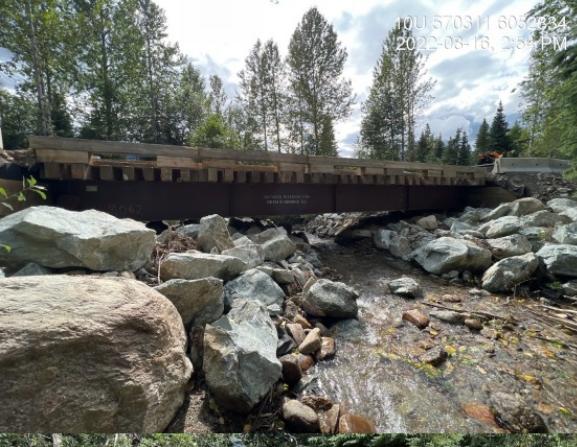
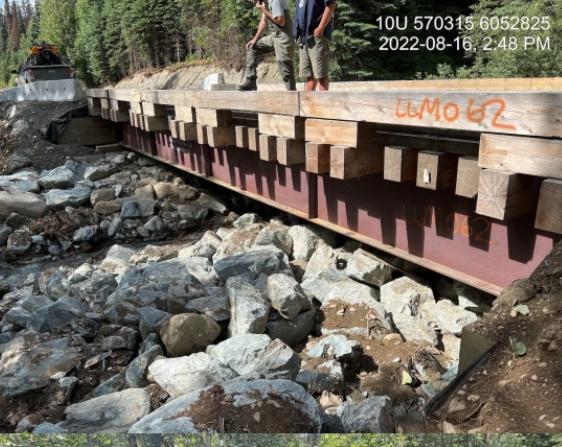
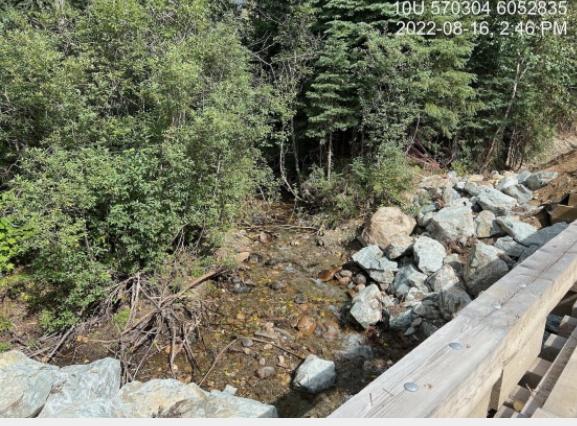
Location and Stream Data	•	Crossing Characteristics	-
Comments: Riprap is 6.7m wide on east and 4.7m wide on west. Riprap cascade downstream of structure ~5m.			
Photos: PSCIS ID

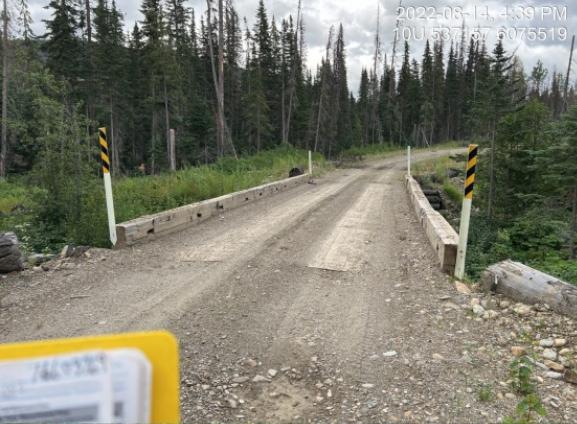
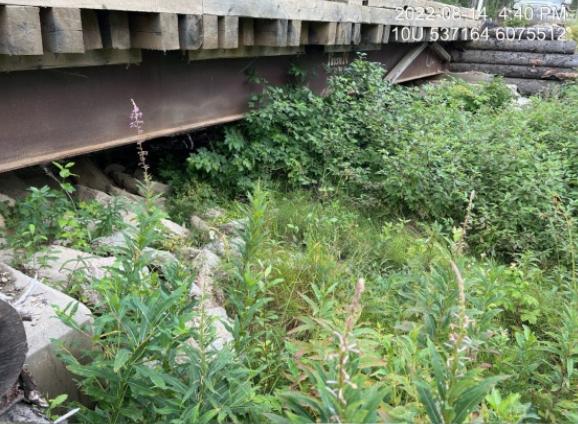
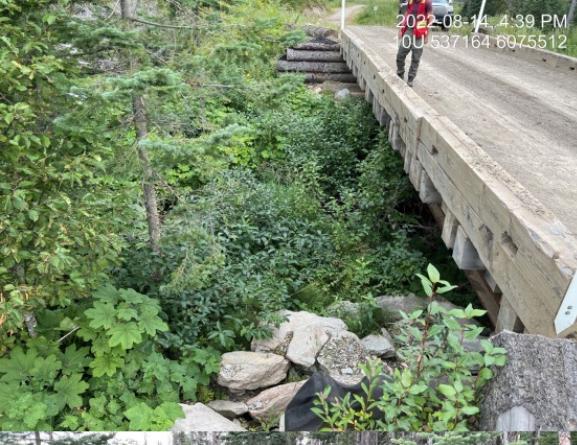
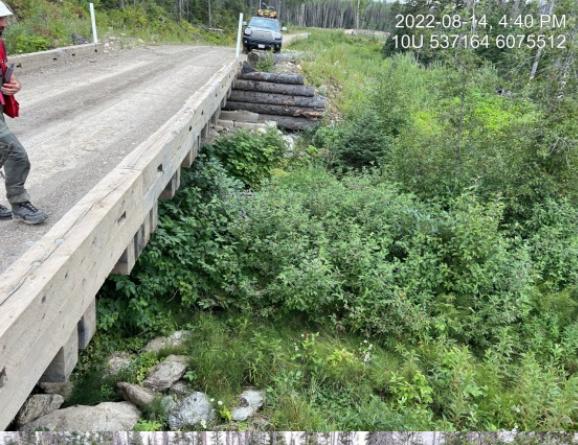
Location and Stream Data	• Crossing Characteristics
Comments: Bridge, overgrown vegetation at inlet and outlet. 16:35:00	
Photos: PSCIS ID

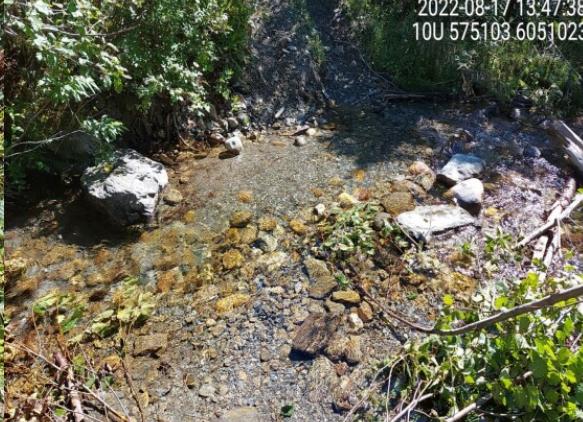
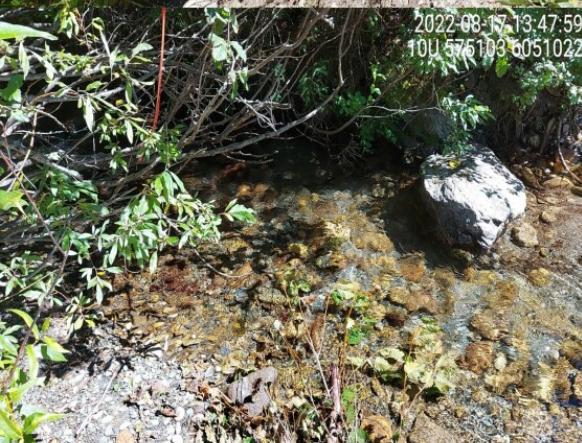
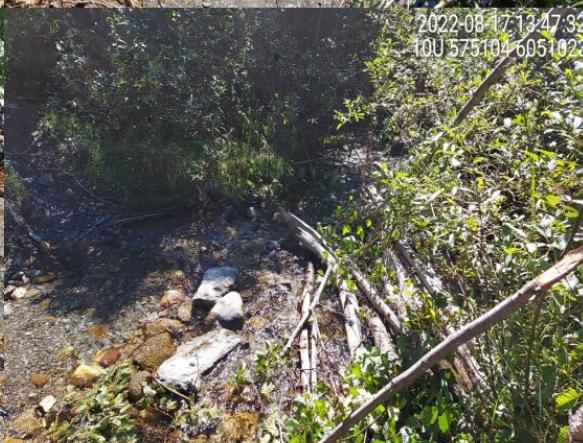
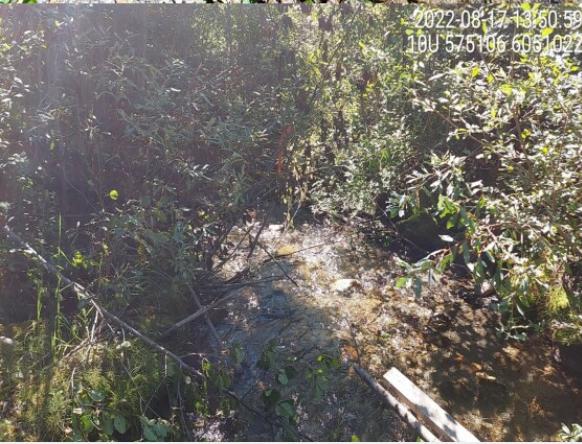
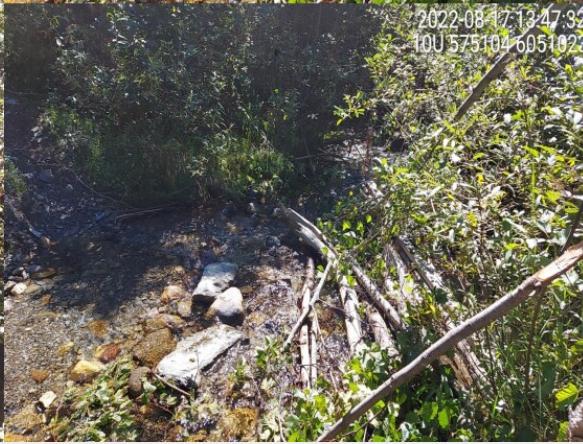
. From top left clockwise: Road/Site Card, Barrel, Outlet, Downstream, Upstream, Inlet.2022081750

Location and Stream Data	•	Crossing Characteristics	-
Comments: Located at a quad trail. 13:53			
Photos: PSCIS ID
