SOCIETY FOR ECOSYSTEM RESTORATION
IN NORTHERN BRITISH COLUMBIA

Restoring Fish Passage in the Peace Region - 2022 - PEA-F23-F- 3761-DCA

Prepared for
Fish and Wildlife Compensation Program
and
Fish Passage Technical Working Group

Version 0.1.1 2023-07-17

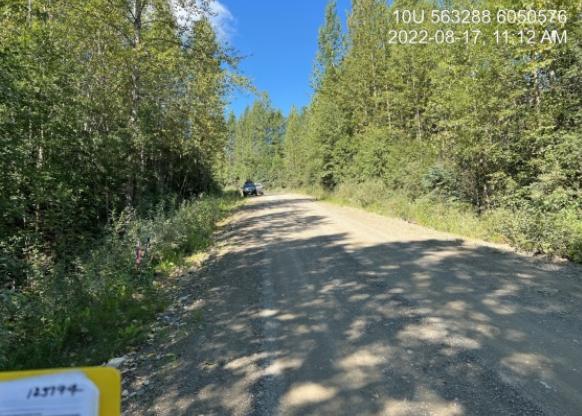
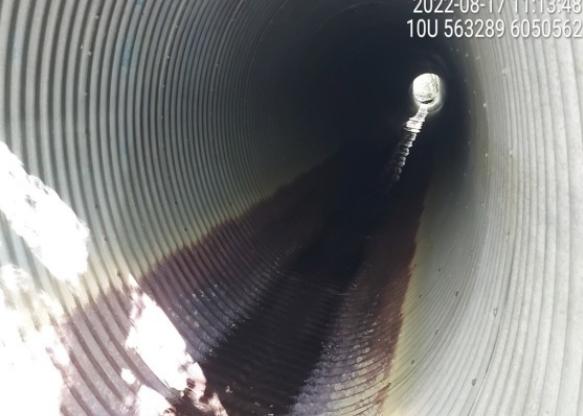
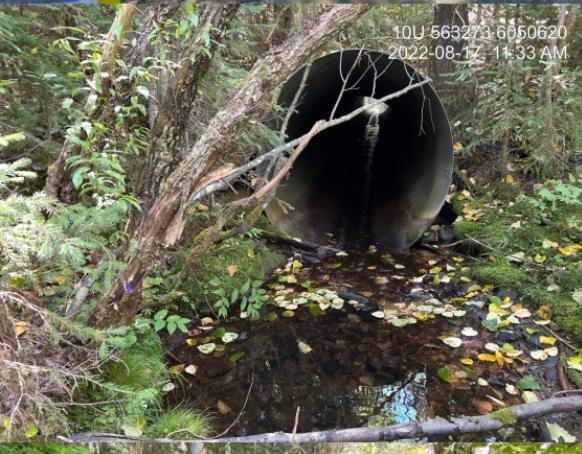
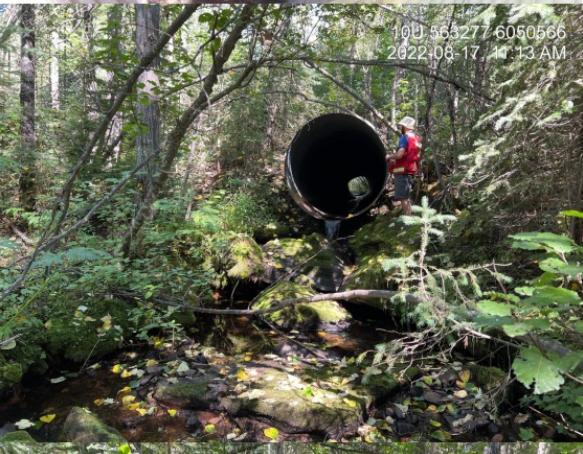
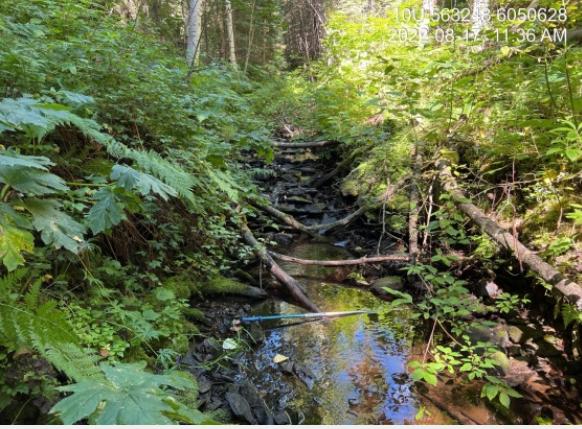
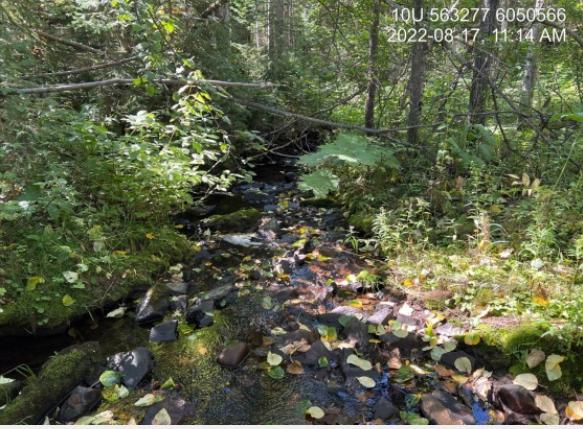
Location and Stream Data	•	Crossing Characteristics	-
Comments: Very narrow cascade at outlet, big outlet drop. Good size pools downstream. Upstream has evenly distributed shale. Lots of functional woody debris. 11:09			
Photos: From top left clockwise: Road/Site Card, Barrel, Outlet, Downstream, Upstream, Inlet.

Replacement of PSCIS crossing 125194 with a bridge (15m span) is recommended. The cost of the work was estimated at \$375,000 for a cost benefit of 5333.3 linear m/\$1000 and 6400 m²/\$1000.

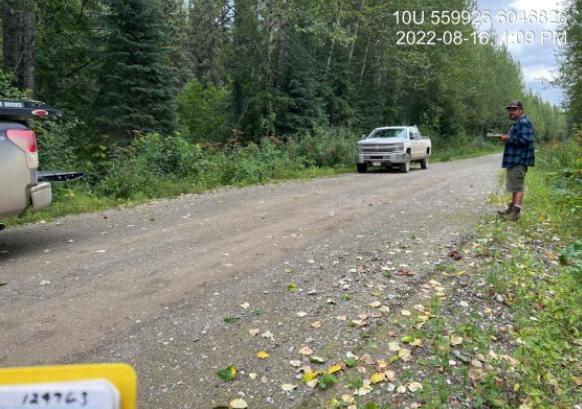
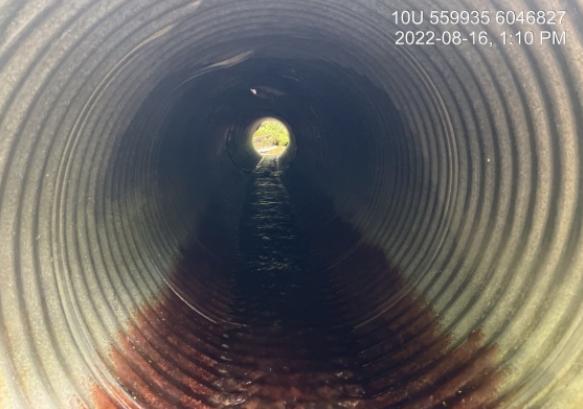
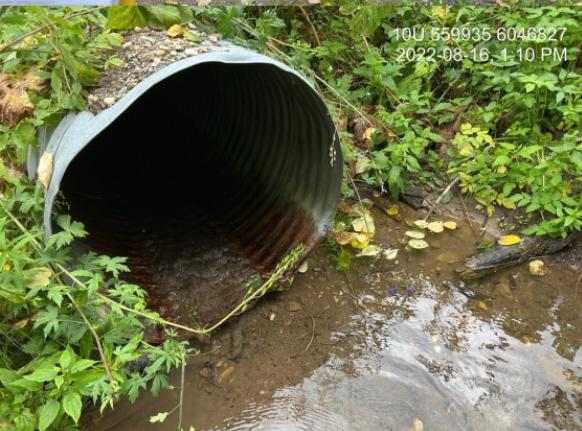
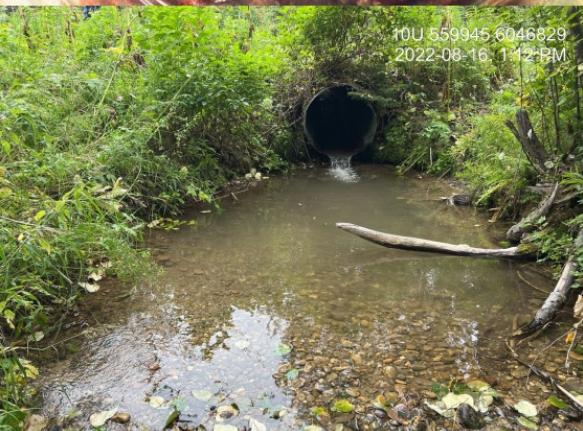
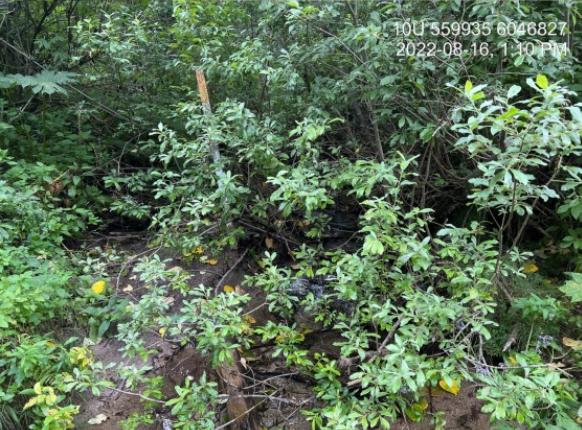
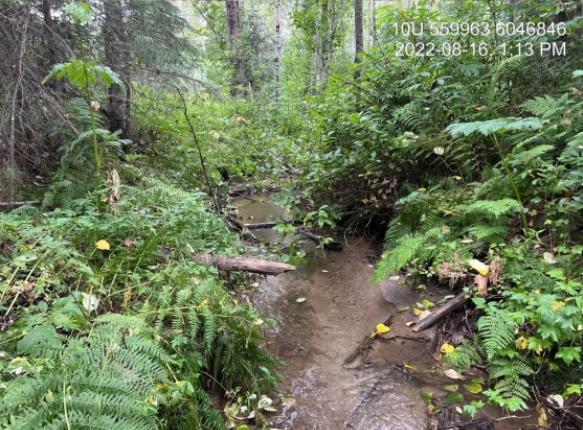
Location and Stream Data		Crossing Characteristics	
Date	2022-08-16	Crossing Sub Type	Round Culvert
PSCIS ID	124963	Diameter (m)	1
External ID	–	Length (m)	12
Crew	AI MW	Embedded	No
UTM Zone	10	Depth Embedded (m)	–
Easting	559940	Resemble Channel	No
Northing	6046827	Backwatered	No
Stream	Tributary to Parsnip River	Percent Backwatered	–
Road	Chuchinka-Arctic FSR	Fill Depth (m)	0.5
Road Tenure	Resource Demographic	Outlet Drop (m)	0.2
Channel Width (m)	2.7	Outlet Pool Depth (m)	0.6
Stream Slope (%)	1.5	Inlet Drop	No
Beaver Activity	No	Slope (%)	3
Habitat Value	Medium	Valley Fill	Deep Fill
Final score	31	Barrier Result	Barrier
Fix type	Replace with New Open Bottom Structure	Fix Span / Diameter	15

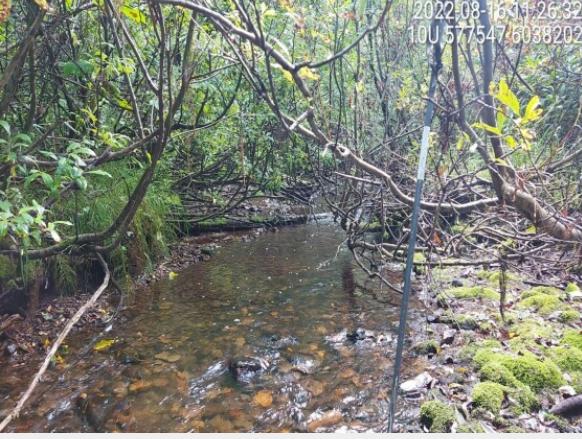
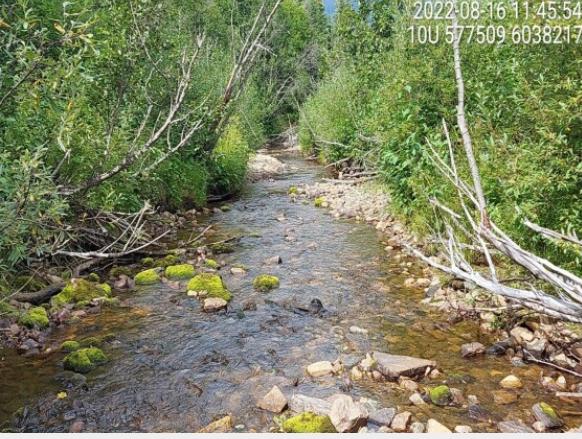
. From top left clockwise: Road/Site Card, Barrel, Outlet, Downstream, Upstream, Inlet.125000

Location and Stream Data		Crossing Characteristics	
Date	2022-08-15	Crossing Sub Type	Round Culvert
PSCIS ID	125000	Diameter (m)	1.5
External ID	–	Length (m)	18
Crew	MW AI	Embedded	No
UTM Zone	10	Depth Embedded (m)	–
Easting	577540	Resemble Channel	No
Northing	6038199	Backwatered	No
Stream	Tributary to Parsnip River	Percent Backwatered	–
Road	Chuchinka-Arctic FSR	Fill Depth (m)	2.5
Road Tenure	Resource Demographic	Outlet Drop (m)	0.6
Channel Width (m)	4.52	Outlet Pool Depth (m)	2
Stream Slope (%)	1.5	Inlet Drop	No
Beaver Activity	No	Slope (%)	2
Habitat Value	Medium	Valley Fill	Deep Fill
Final score	34	Barrier Result	Barrier
Fix type	Replace with New Open Bottom Structure	Fix Span / Diameter	15

Location and Stream Data	•	Crossing Characteristics	-
Comments: Habitat survey done with drone. 11:15:00 AM			
Photos: PSCIS ID

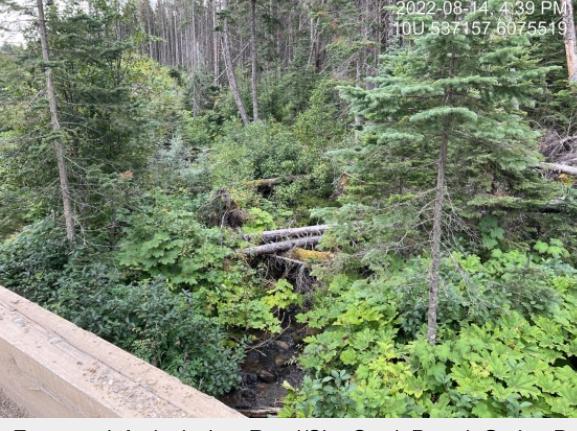
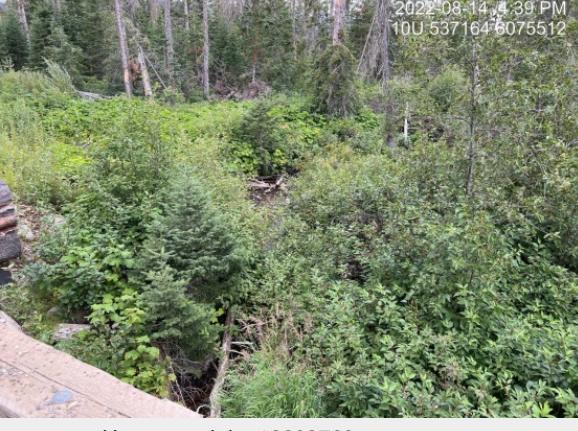
. From top left clockwise: Road/Site Card, Barrel, Outlet, Downstream, Upstream, Inlet.16603769

Location and Stream Data	• Crossing Characteristics
Comments: Bridge, overgrown vegetation at inlet and outlet. 16:35:00	
Photos: PSCIS ID
