SOCIETY FOR ECOSYSTEM RESTORATION
IN NORTHERN BRITISH COLUMBIA

Restoring Fish Passage in the Peace Region - 2022 - PEA-F23-F- 3761-DCA

Prepared for
Fish and Wildlife Compensation Program
and
Fish Passage Technical Working Group

Version 0.0.1 2023-07-15

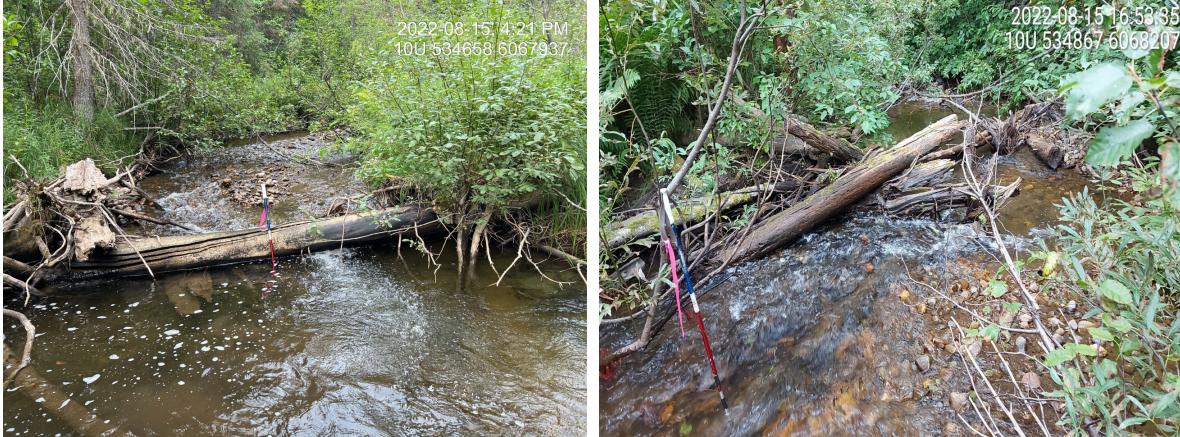
Figure 3.11: Left: Deep pool and functional woody debris upstream of PSCIS crossing 125261. Right: Habitat upstream of PSCIS crossing 125261.

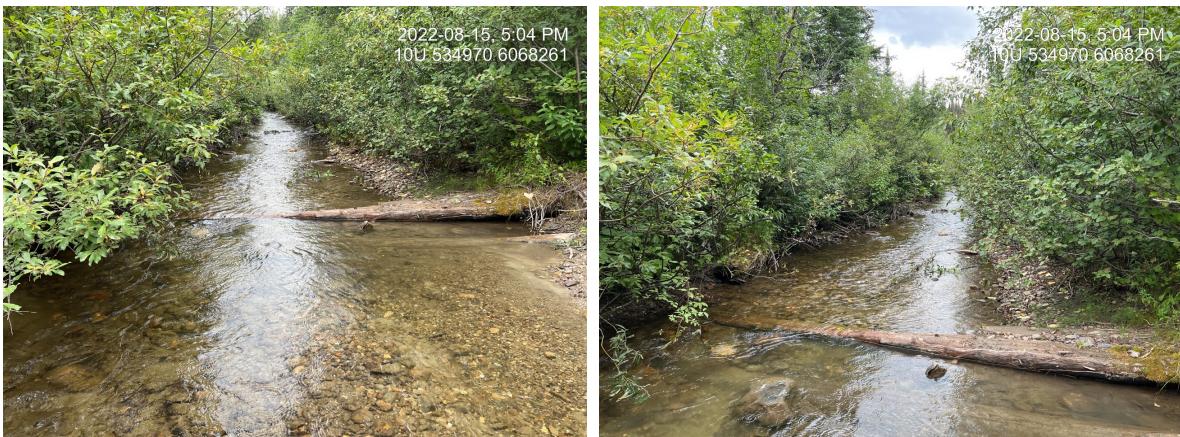
Figure 3.12: Left: Downstream view at end of survey, at location of PSCIS crossing 198321. Right: Upstream view at end of survey, at location of PSCIS crossing 198321.

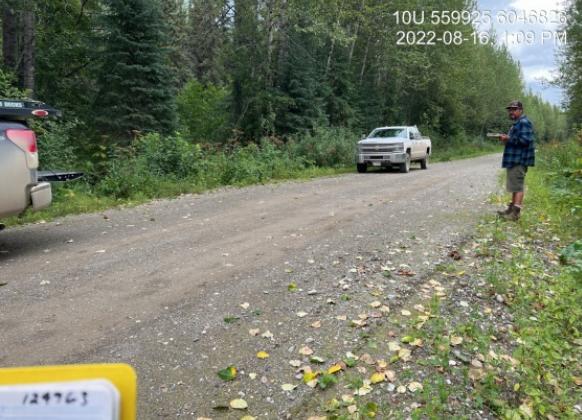
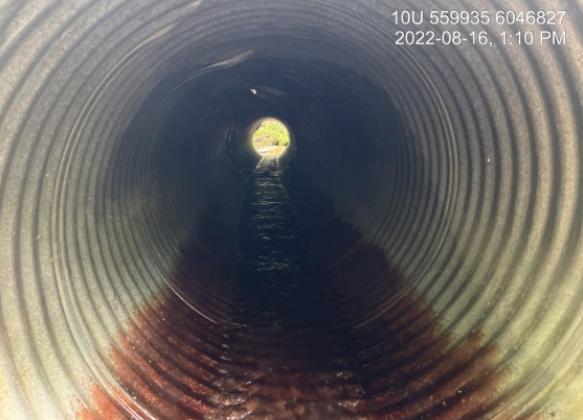
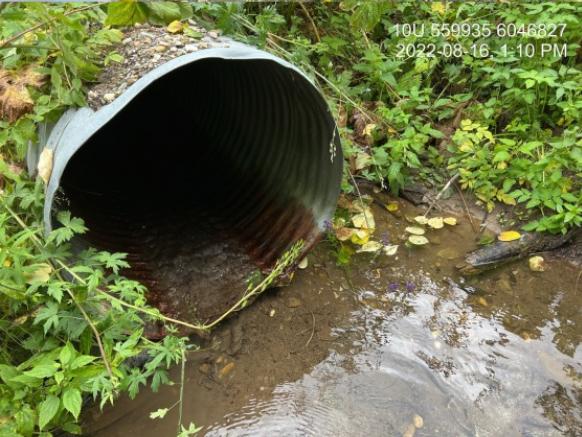
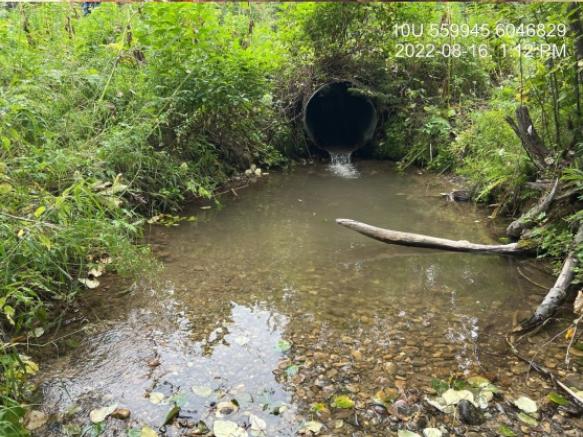
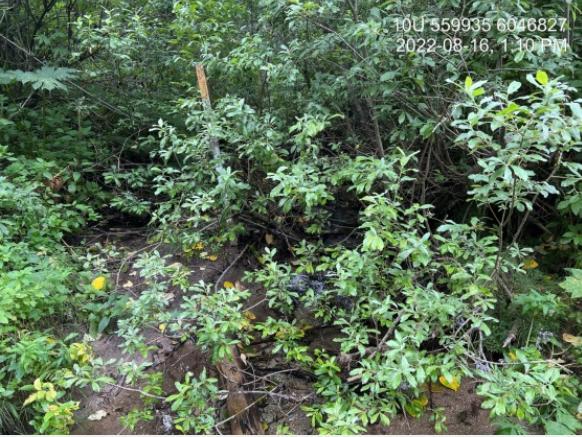
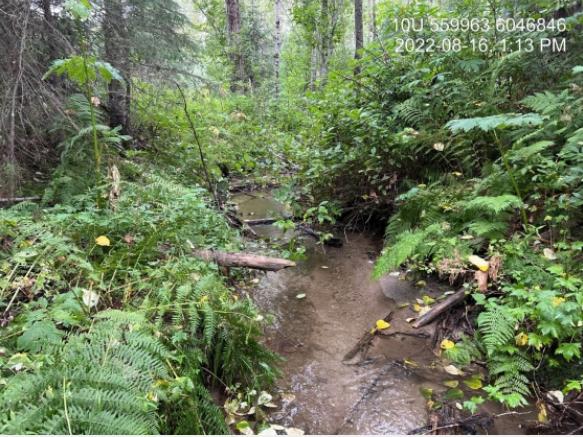
. From top left clockwise: Road/Site Card, Barrel, Outlet, Downstream, Upstream, Inlet.124963

Location and Stream Data		Crossing Characteristics	
Date	2022-08-16	Crossing Sub Type	Round Culvert
PSCIS ID	124963	Diameter (m)	1
External ID	–	Length (m)	12
Crew	AI MW	Embedded	No
UTM Zone	10	Depth Embedded (m)	–
Easting	559940	Resemble Channel	No
Northing	6046827	Backwatered	No
Stream	Tributary to Parsnip River	Percent Backwatered	–
Road	Chuchinka-Arctic FSR	Fill Depth (m)	0.5
Road Tenure	Resource Demographic	Outlet Drop (m)	0.2
Channel Width (m)	2.7	Outlet Pool Depth (m)	0.6
Stream Slope (%)	1.5	Inlet Drop	No
Beaver Activity	No	Slope (%)	3
Habitat Value	Medium	Valley Fill	Deep Fill
Final score	31	Barrier Result	Barrier
Fix type	Replace with New Open Bottom Structure	Fix Span / Diameter	15

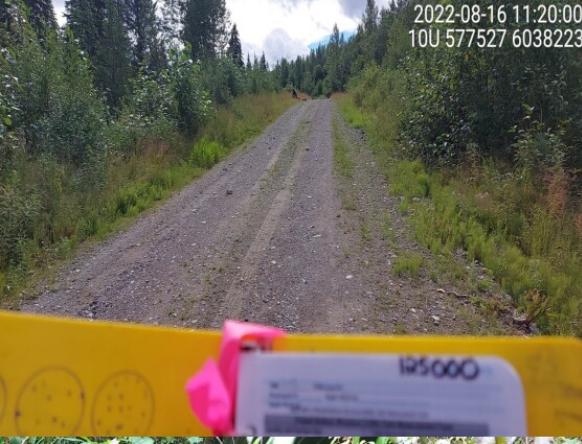
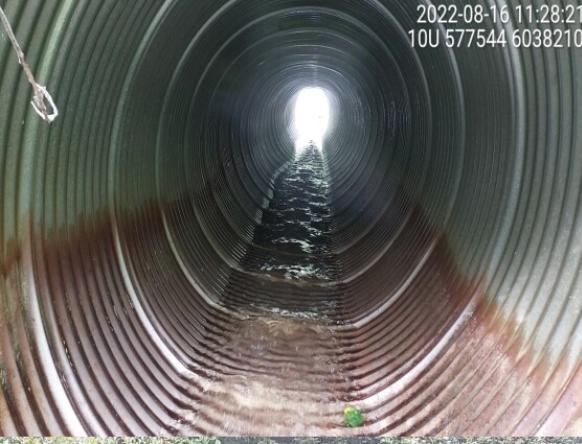
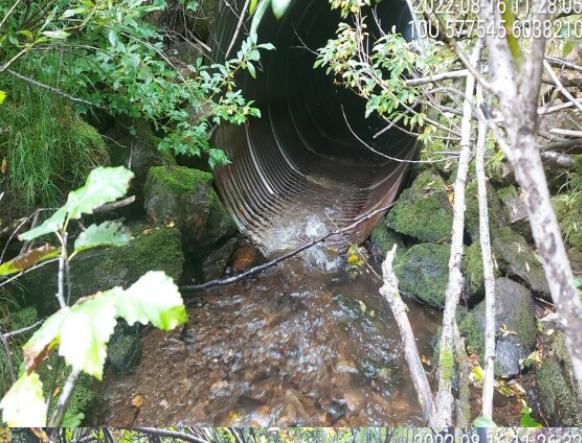
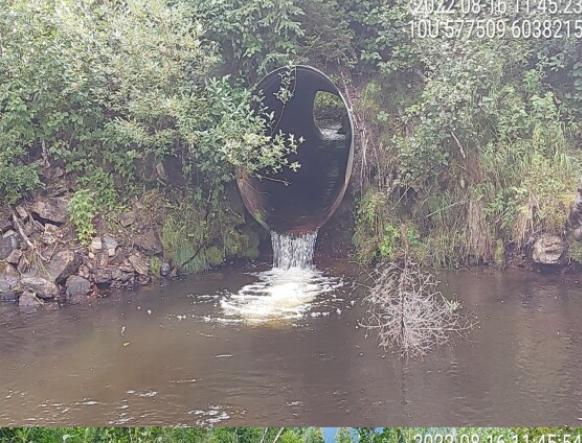
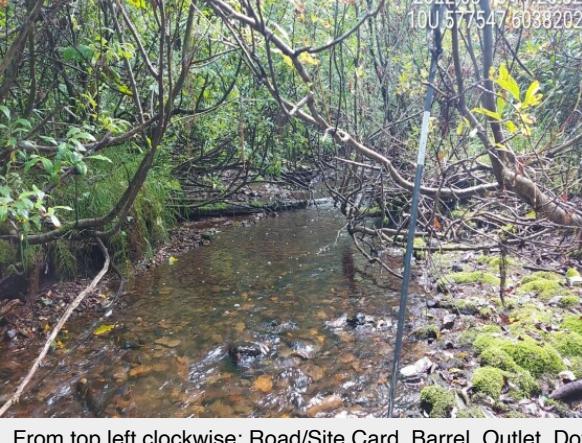
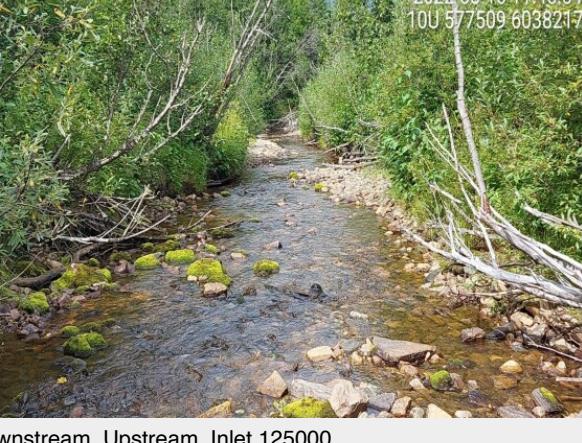
2022-08-16 11:45:54 10U 577509 6038217
. From top left clockwise: Road/Site Card, Barrel, Outlet, Downstream, Upstream, Inlet.125000

Location and Stream Data		Crossing Characteristics	
Date	2022-08-15	Crossing Sub Type	Round Culvert
PSCIS ID	125000	Diameter (m)	1.5
External ID	–	Length (m)	18
Crew	MW AI	Embedded	No
UTM Zone	10	Depth Embedded (m)	–
Easting	577540	Resemble Channel	No
Northing	6038199	Backwatered	No
Stream	Tributary to Parsnip River	Percent Backwatered	–
Road	Chuchinka-Arctic FSR	Fill Depth (m)	2.5
Road Tenure	Resource Demographic	Outlet Drop (m)	0.6
Channel Width (m)	4.52	Outlet Pool Depth (m)	2
Stream Slope (%)	1.5	Inlet Drop	No
Beaver Activity	No	Slope (%)	2
Habitat Value	Medium	Valley Fill	Deep Fill
Final score	34	Barrier Result	Barrier
Fix type	Replace with New Open Bottom Structure	Fix Span / Diameter	15

Location and Stream Data	.	Crossing Characteristics	-
Comments: Habitat survey done with drone. 11:15:00 AM			
Photos: PSCIS ID

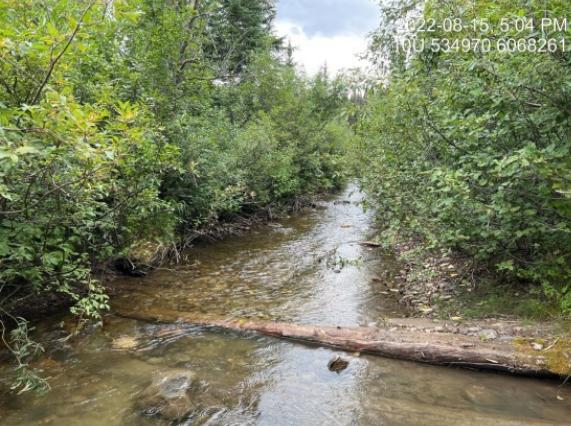
A photograph showing an inlet or side channel of the stream flowing into the main channel. A fallen log is visible in the water.

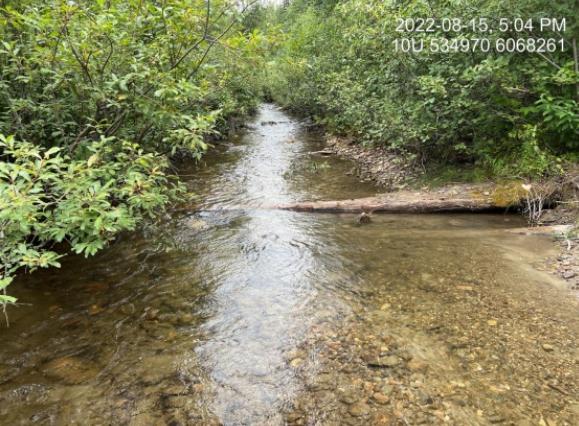
A photograph showing the outlet of the stream where it flows into a larger body of water. The water is slightly turbulent at the outlet point.
