Appendix - Phase 1 Fish Passage Assessment Data and Photos

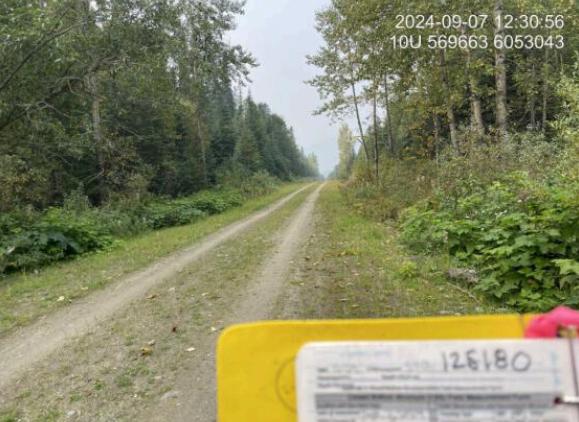
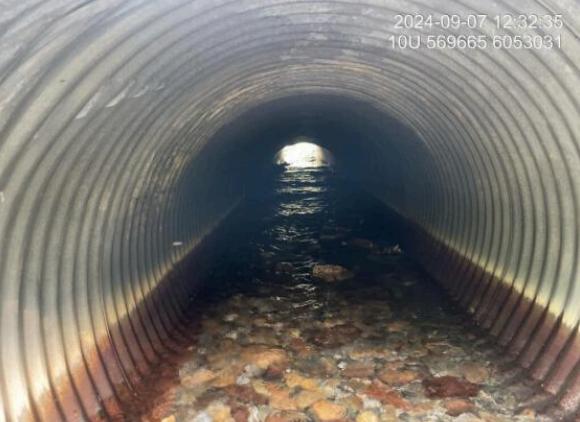
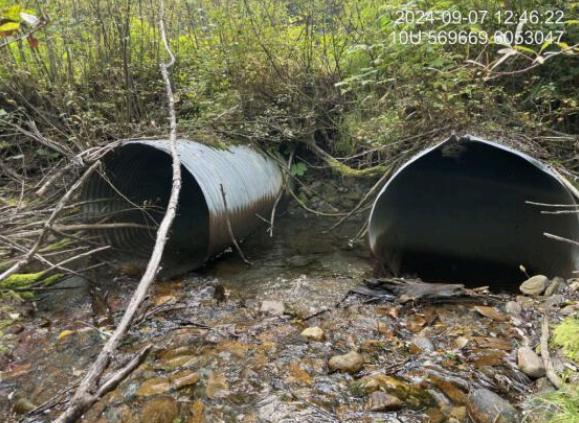
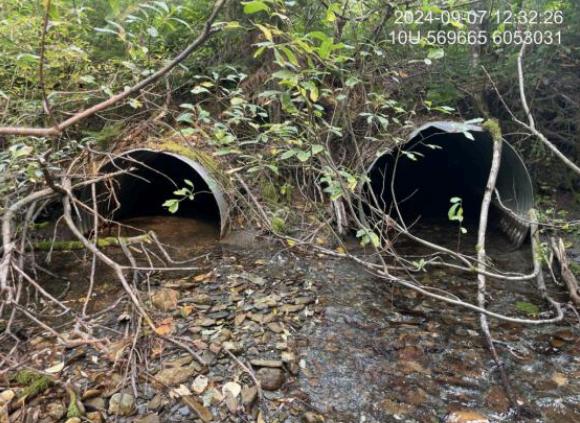
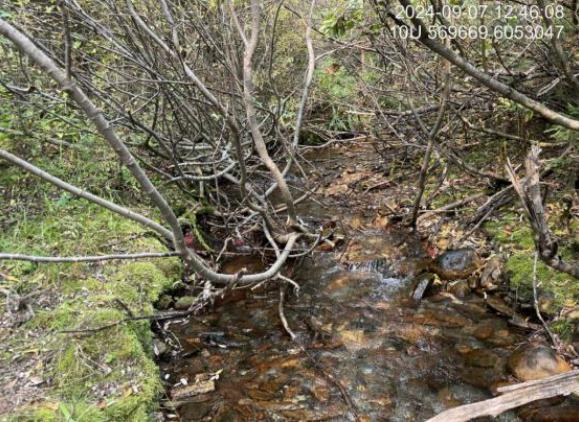
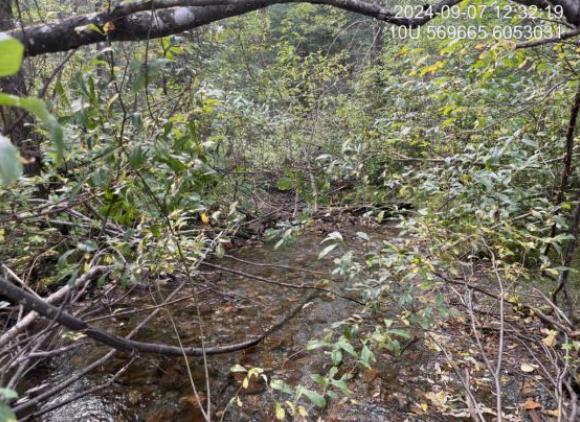
Photos: PSCIS ID 125180. From top left clockwise: Road/Site Card, Barrel, Outlet, Downstream, Upstream, Inlet.

Location and Stream Data	.	Crossing Characteristics	-
Date	2024-09-07	Crossing Sub Type	Round Culvert
PSCIS ID	125180	Diameter (m)	2.4
External ID	-	Length (m)	16
Crew	LS AI	Embedded	Yes
UTM Zone	10	Depth Embedded (m)	0.2
Easting	569665	Resemble Channel	Yes
Northing	6053047	Backwatered	No
Stream	Tributary to Missinka River	Percent Backwatered	-
Road	Chuchinka-Missinka FSR	Fill Depth (m)	1
Road Tenure	Winton R01821 51A	Outlet Drop (m)	0
Channel Width (m)	4.1	Outlet Pool Depth (m)	0
Stream Slope (%)	4	Inlet Drop	Yes
Beaver Activity	No	Slope (%)	2
Habitat Value	Medium	Valley Fill	Deep Fill
Final score	19	Barrier Result	Potential
Fix type	Replace with New Open Bottom Structure	Fix Span / Diameter	15
Comments: Two pipes each at 1.2m in diameter, with one showing an inlet drop. Both pipes are embedded, except for 1 m at the inlet of one pipe, allowing them to function as embedded culverts, resulting in a low priority for replacement. The habitat is high quality, featuring deep pools and gravels. Rainbow trout ranging from 40-140 mm were captured during sampling.. 12:26:48

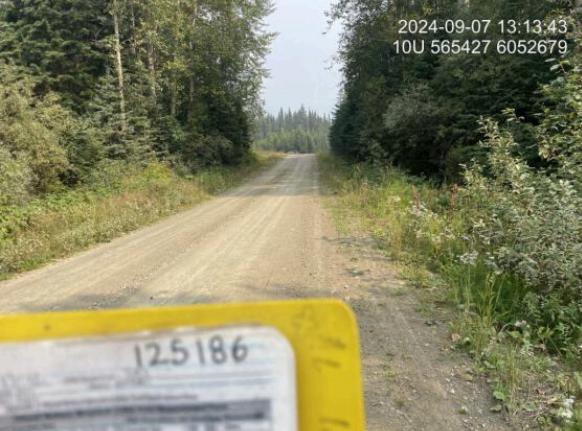
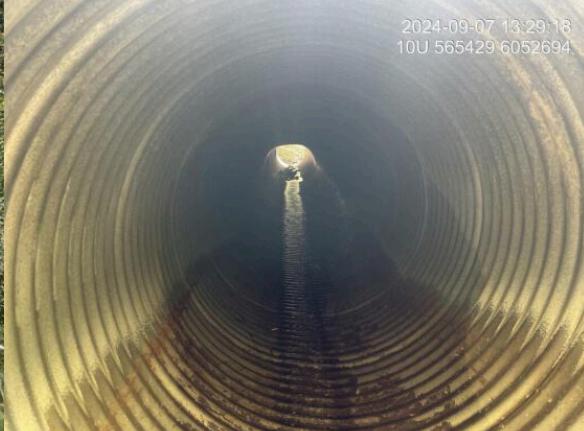
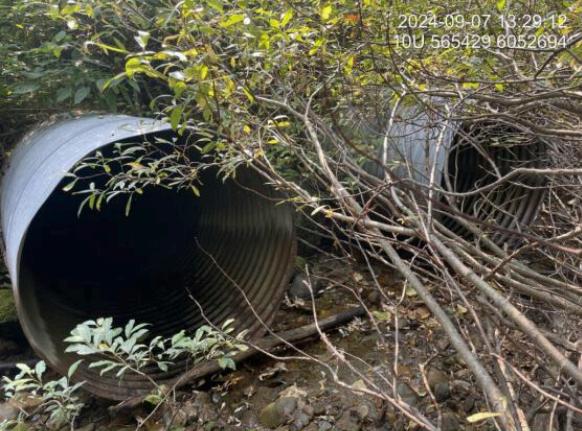
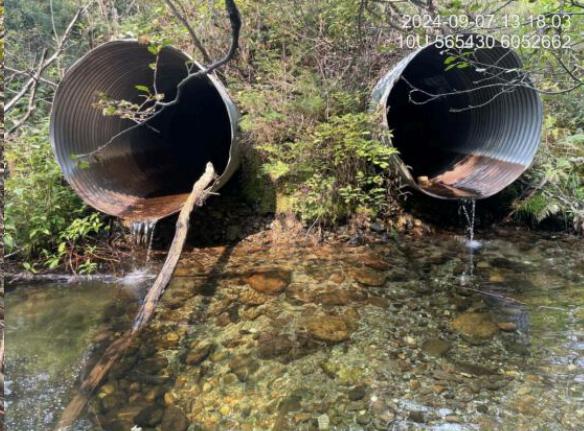
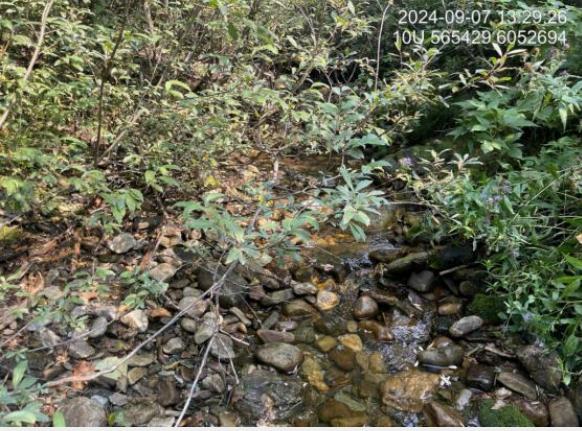
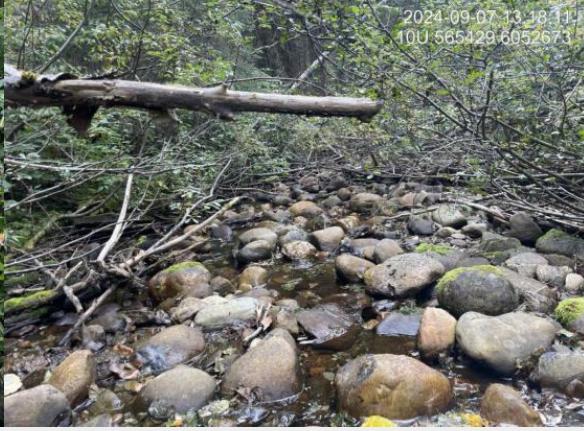
Photos: PSCIS ID 125186. From top left clockwise: Road/Site Card, Barrel, Outlet, Downstream, Upstream, Inlet.

Location and Stream Data		Crossing Characteristics	
Date	2024-09-07	Crossing Sub Type	Round Culvert
PSCIS ID	125186	Diameter (m)	2.4
External ID	–	Length (m)	18
Crew	LS AI	Embedded	No
UTM Zone	10	Depth Embedded (m)	–
Easting	565424	Resemble Channel	No
Northing	6052679	Backwatered	No
Stream	Tributary to Missinka River	Percent Backwatered	–
Road	Chuchinka-Missinka FSR	Fill Depth (m)	1.5
Road Tenure	Winton R01821 51A	Outlet Drop (m)	0.34
Channel Width (m)	2.8	Outlet Pool Depth (m)	0.85
Stream Slope (%)	5	Inlet Drop	No
Beaver Activity	No	Slope (%)	4
Habitat Value	Medium	Valley Fill	Deep Fill
Final score	36	Barrier Result	Barrier
Fix type	Replace with New Open Bottom Structure	Fix Span / Diameter	15

Comments: Two 1.2 m diameter pipes are present, with a significant outlet drop and a deep outlet pool. The habitat was good and consisted of cobbles, boulders, and woody debris, providing complexity and cover for fish. The stream flows into the inlet from the east but goes subsurface approximately 10 m upstream, with occasional small, shallow pools. The well-defined stream channel suggests it often carries higher flows. A wetland area to the east of the inlet likely contributes flow to the stream. An ~8 m wide area directly in front of the inlet was dry at the time of assessment but showed evidence of flowing water during higher flows.. 13:14:10

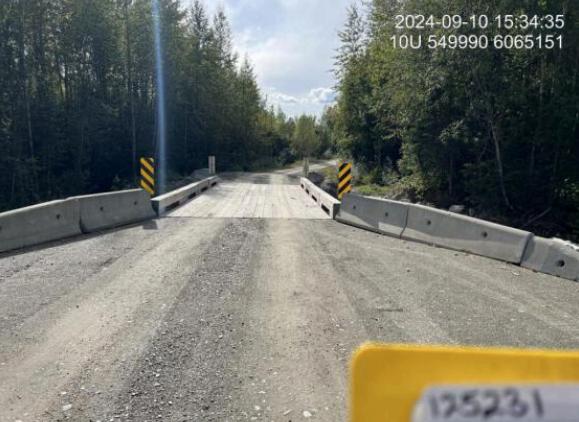
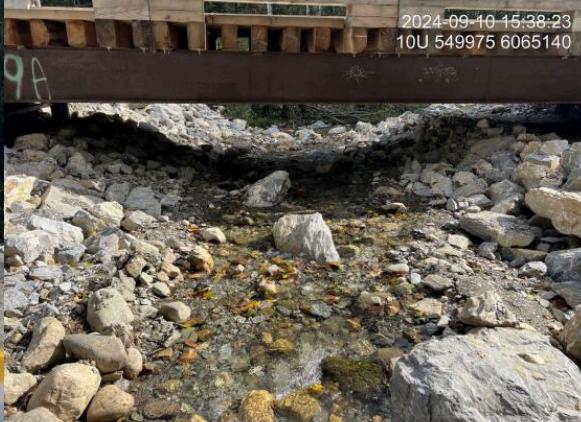
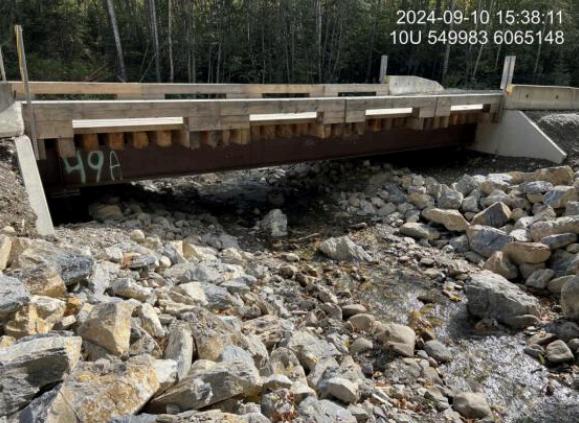
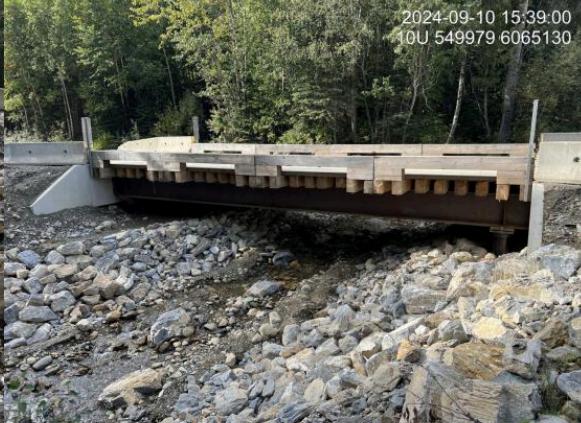
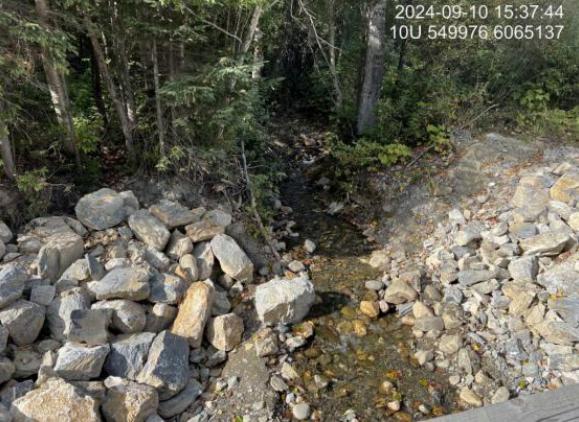
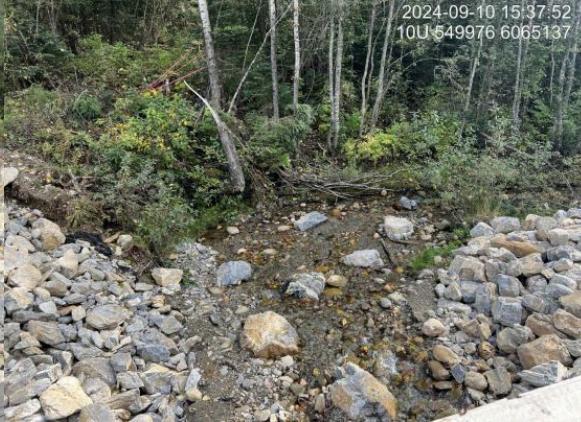
Photos: PSCIS ID 125231. From top left clockwise: Road/Site Card, Barrel, Outlet, Downstream, Upstream, Inlet.

Location and Stream Data		•	Crossing Characteristics	-
Date	2024-09-10		Crossing Sub Type	Bridge
PSCIS ID	125231		Diameter (m)	12.2
External ID	-		Length (m)	5
Crew	AI LS		Embedded	-
UTM Zone	10		Depth Embedded (m)	-
Easting	549973		Resemble Channel	-
Northing	6065136		Backwatered	-
Stream	Tributary to Table River		Percent Backwatered	-
Road	Chuchinka-Table FSR		Fill Depth (m)	-
Road Tenure	Canfor R09333 UZ6_16		Outlet Drop (m)	-
Channel Width (m)	-		Outlet Pool Depth (m)	-
Stream Slope (%)	-		Inlet Drop	-
Beaver Activity	No		Slope (%)	-
Habitat Value	-		Valley Fill	-
Final score	0		Barrier Result	Passable
Fix type	-		Fix Span / Diameter	-
Comments: Culvert replaced with Bridge by Canfor in the summer of 2024 with environmental oversight and engineering from DWB. Very nicely designed structure that fits the stream channel well. Minimal rock placement within areas likely to be within the natural channel with not constricting the channel. It is recommended that future projects incorporate vegetated riprap and reinstall the vegetation removed from the construction footprint within the same area.. 15:35:51

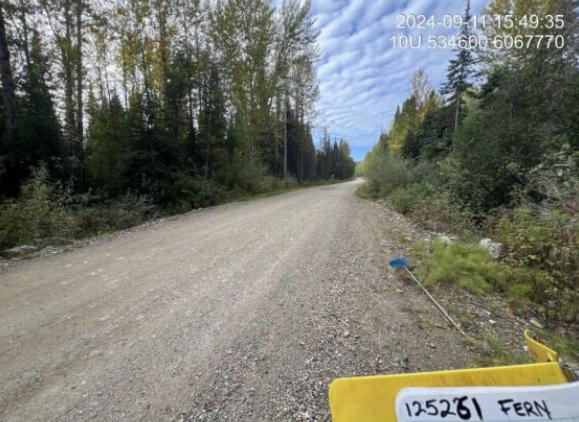
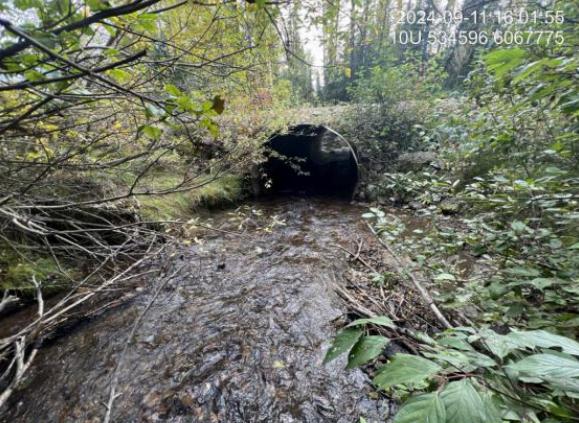
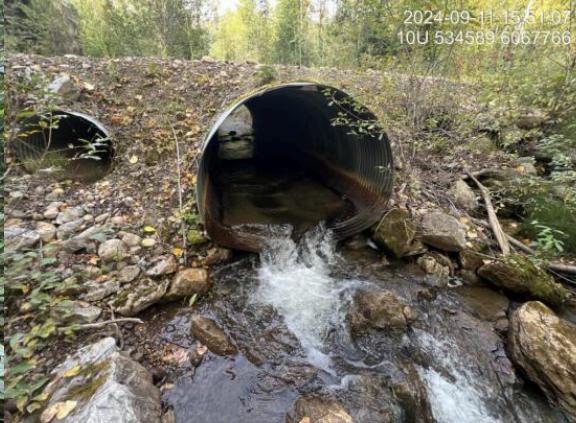
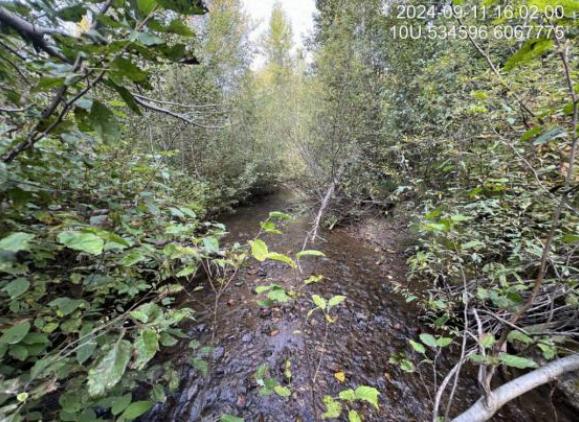
Photos: PSCIS ID 125261. From top left clockwise: Road/Site Card, Barrel, Outlet, Downstream, Upstream, Inlet.

Location and Stream Data		Crossing Characteristics	
Date	2024-09-11	Crossing Sub Type	Round Culvert
PSCIS ID	125261	Diameter (m)	2.15
External ID	–	Length (m)	12
Crew	AI	Embedded	No
UTM Zone	10	Depth Embedded (m)	–
Easting	534595	Resemble Channel	No
Northing	6067775	Backwatered	No
Stream	Fern Creek	Percent Backwatered	–
Road	Chuchinka-Table FSR	Fill Depth (m)	0.5
Road Tenure	MoF	Outlet Drop (m)	0.23
Channel Width (m)	5	Outlet Pool Depth (m)	0.15
Stream Slope (%)	1.5	Inlet Drop	No
Beaver Activity	Yes	Slope (%)	2
Habitat Value	High	Valley Fill	Deep Fill
Final score	26	Barrier Result	Barrier
Fix type	Replace with New Open Bottom Structure	Fix Span / Diameter	15
Comments: Reassessed as part of a baseline assessment before hopeful future replacement. Fish sampling was conducted in a 75-meter stretch downstream and a 50-meter stretch upstream of the culvert, and fish 60 mm or greater were tagged with PIT tags. There are baffles made of metal in the culvert and ~æ of the pipe is embedded with streambed material. The outlet of the pipe sits on a large pile of rip rap creating a 30 cm cascade that occurs approximately a meter after the outlet of the pipe. There are two overflow pipes each at 0.9 m in diameter.. . 15:58:48

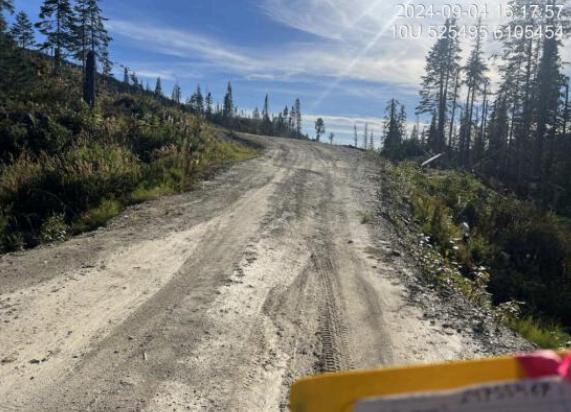
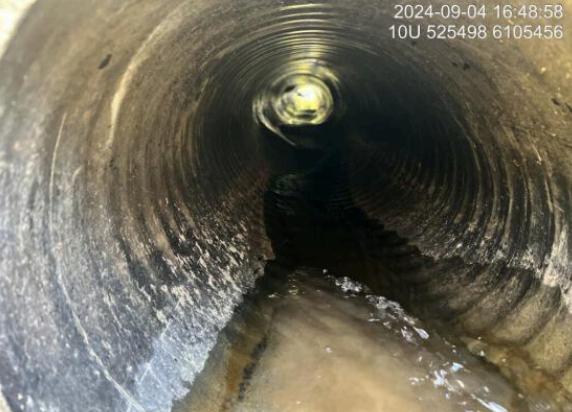
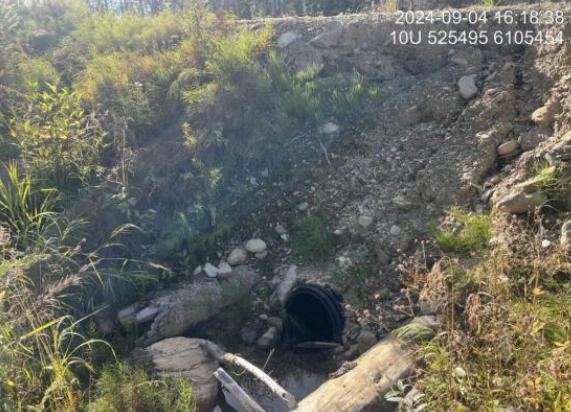
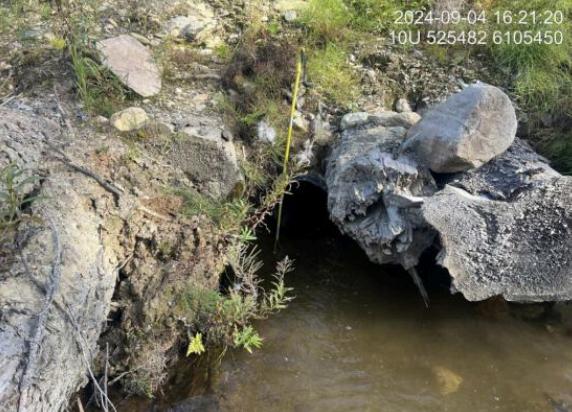
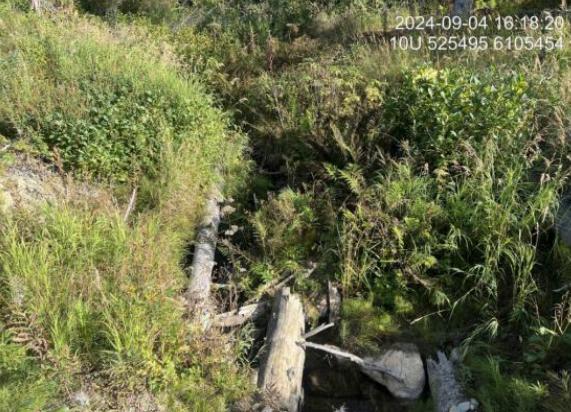
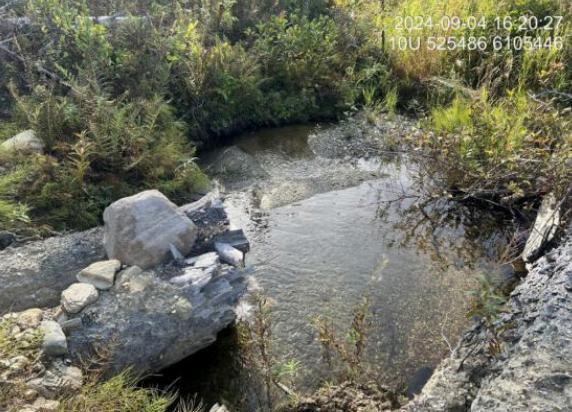
Photos: PSCIS ID 24755467. From top left clockwise: Road/Site Card, Barrel, Outlet, Downstream, Upstream, Inlet.

Location and Stream Data	.	Crossing Characteristics	-
Date	2024-09-04	Crossing Sub Type	Round Culvert
PSCIS ID	199662	Diameter (m)	0.45
External ID	24755467	Length (m)	12
Crew	AI	Embedded	No
UTM Zone	10	Depth Embedded (m)	-
Easting	525498	Resemble Channel	No
Northing	6105456	Backwatered	No
Stream	Tributary to Colbourne Creek	Percent Backwatered	-
Road	Chuchinka-Colbourne FSR	Fill Depth (m)	1.8
Road Tenure	MoF	Outlet Drop (m)	0
Channel Width (m)	1	Outlet Pool Depth (m)	0.2
Stream Slope (%)	4	Inlet Drop	No
Beaver Activity	No	Slope (%)	4
Habitat Value	Low	Valley Fill	Deep Fill
Final score	26	Barrier Result	Barrier
Fix type	Replace Structure with Streambed Simulation CBS	Fix Span / Diameter	3

Comments: Small stream system with low habitat value. Limited flow volume and minimal channel structure, with sparse instream features such as large woody debris, pools, or gravels. Riparian vegetation consists of grasses, ferns, and small shrubs, providing minimal shading and bank stability. Slope estimated visually. . 16:12:04

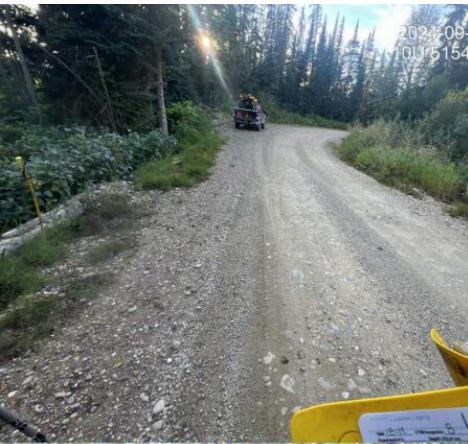
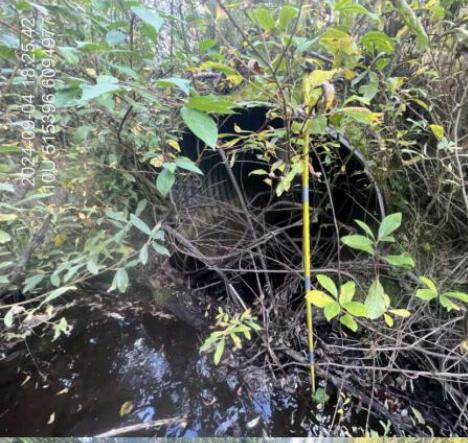
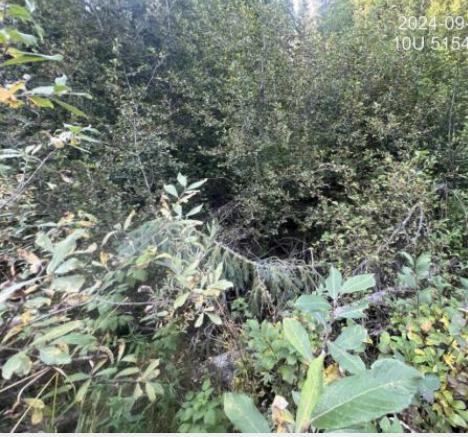
Photos: PSCIS ID 16602610. From top left clockwise: Road/Site Card, Barrel, Outlet, Downstream, Upstream, Inlet.

Location and Stream Data		Crossing Characteristics	
Date	2024-09-04	Crossing Sub Type	Round Culvert
PSCIS ID	199663	Diameter (m)	1.2
External ID	16602610	Length (m)	13
Crew	AI LS	Embedded	No
UTM Zone	10	Depth Embedded (m)	–
Easting	515397	Resemble Channel	No
Northing	6094977	Backwatered	No
Stream	Tributary to Colbourne Creek	Percent Backwatered	–
Road	CHCO 11000 FSR	Fill Depth (m)	0.5
Road Tenure	BCTS	Outlet Drop (m)	0.6
Channel Width (m)	2.5	Outlet Pool Depth (m)	0.4
Stream Slope (%)	1	Inlet Drop	No
Beaver Activity	Yes	Slope (%)	3
Habitat Value	Medium	Valley Fill	Deep Fill
Final score	36	Barrier Result	Barrier
Fix type	Replace with New Open Bottom Structure	Fix Span / Diameter	15

Comments: The system has good flow and a significant outlet drop. Upstream substrate consists primarily of fine materials, likely indicating limited habitat complexity for fish.. 18:21:40

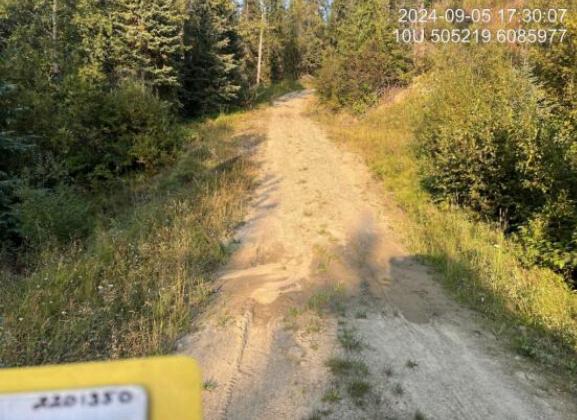
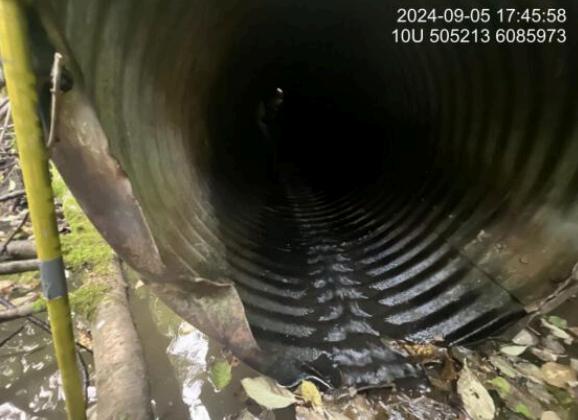
Photos: PSCIS ID 2201350. From top left clockwise: Road/Site Card, Barrel, Outlet, Downstream, Upstream, Inlet.

Location and Stream Data		Crossing Characteristics	
Date	2024-09-05	Crossing Sub Type	Round Culvert
PSCIS ID	199664	Diameter (m)	0.95
External ID	2201350	Length (m)	33
Crew	AI	Embedded	No
UTM Zone	10	Depth Embedded (m)	–
Easting	505221	Resemble Channel	No
Northing	6085999	Backwatered	Yes
Stream	Tributary to McLeod Lake	Percent Backwatered	30
Road	Unnamed	Fill Depth (m)	4.5
Road Tenure	Canfor R02916 Q	Outlet Drop (m)	0
Channel Width (m)	2.3	Outlet Pool Depth (m)	0.55
Stream Slope (%)	1	Inlet Drop	No
Beaver Activity	No	Slope (%)	10
Habitat Value	Medium	Valley Fill	Deep Fill
Final score	32	Barrier Result	Barrier
Fix type	Replace with New Open Bottom Structure	Fix Span / Diameter	19.5

Comments: A low-gradient, low-energy system with moderate flow. Fish were observed downstream near the highway crossing. The culvert was deteriorating and was poorly installed, causing significant upstream water backup. Medium value habitat due to dense riparian vegetation, including shrubs and ferns. NULL. 17:35:22

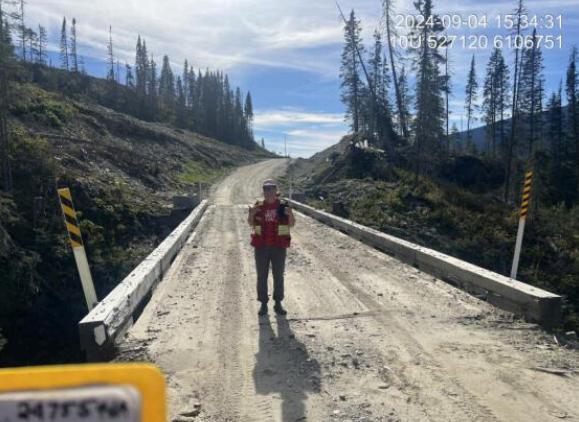
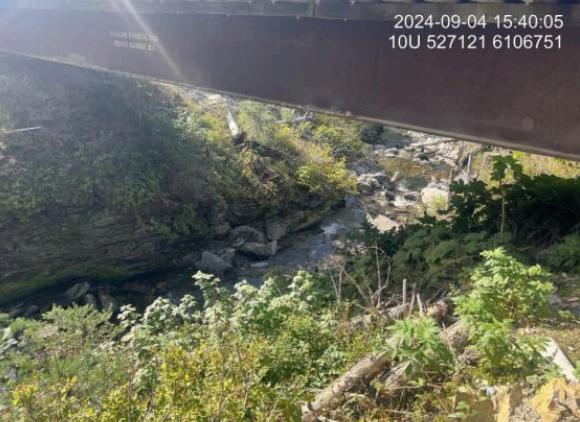
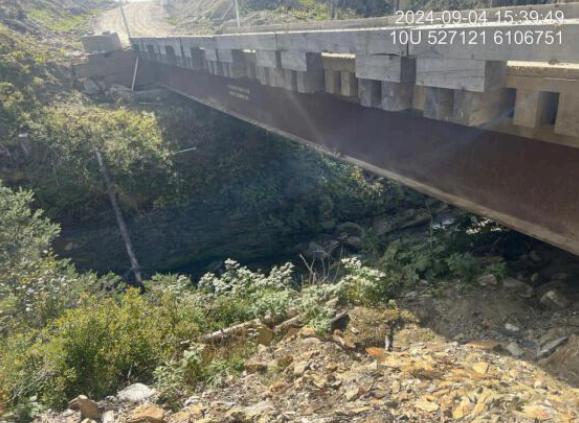
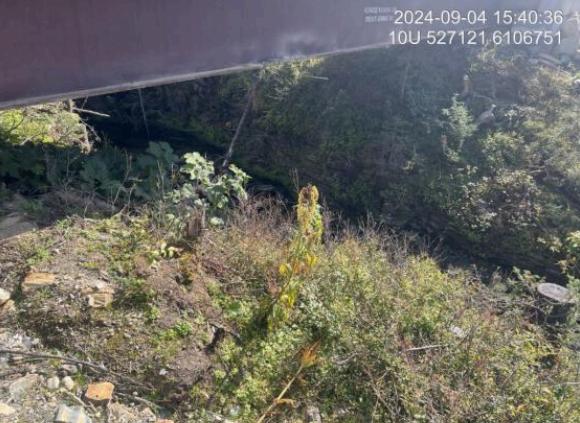
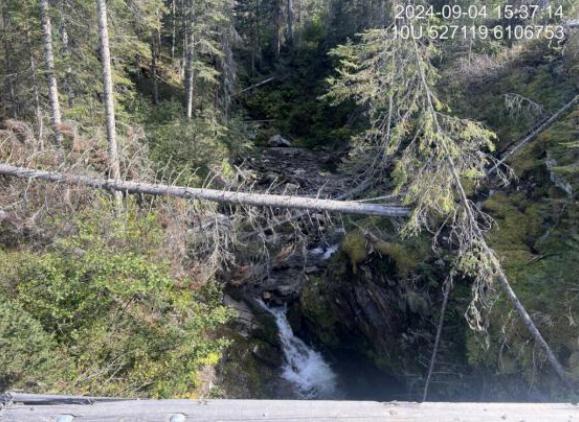
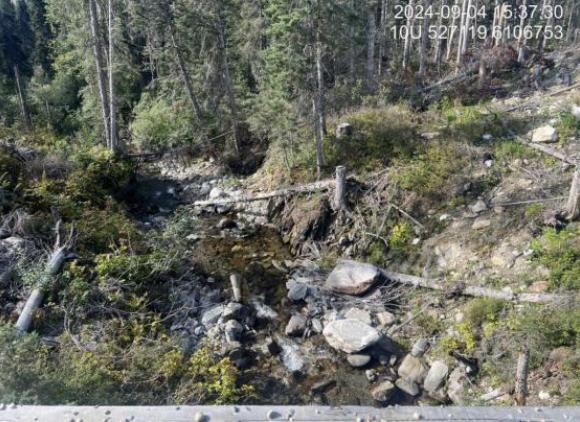
Location and Stream Data		.	Crossing Characteristics	–
Date	2024-09-04		Crossing Sub Type	Bridge
PSCIS ID	199665		Diameter (m)	22.5
External ID	24755464		Length (m)	5
Crew	AI LS		Embedded	–
UTM Zone	10		Depth Embedded (m)	–
Easting	527121		Resemble Channel	–
Northing	6106753		Backwatered	–
Stream	Tributary to Colbourne Creek		Percent Backwatered	–
Road	Chuchinka-Colbourne FSR		Fill Depth (m)	–
Road Tenure	MoF		Outlet Drop (m)	–
Channel Width (m)	–		Outlet Pool Depth (m)	–
Stream Slope (%)	–		Inlet Drop	–
Beaver Activity	No		Slope (%)	–
Habitat Value	–		Valley Fill	–
Final score	0		Barrier Result	Passable
Fix type	–		Fix Span / Diameter	–
Comments: New bridge in 2024. Small cascades upstream.. 15:27:12				
Photos: PSCIS ID 24755464. From top left clockwise: Road/Site Card, Barrel, Outlet, Downstream, Upstream, Inlet.

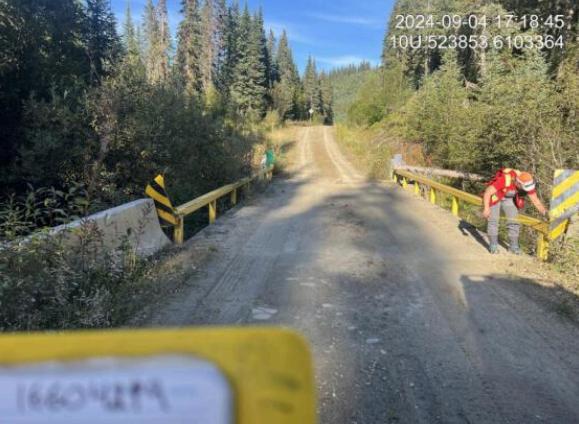
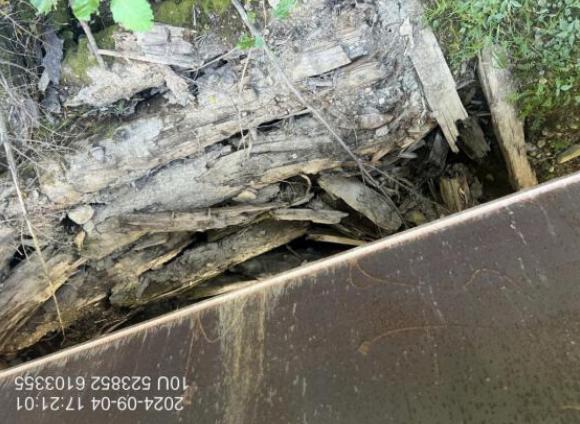
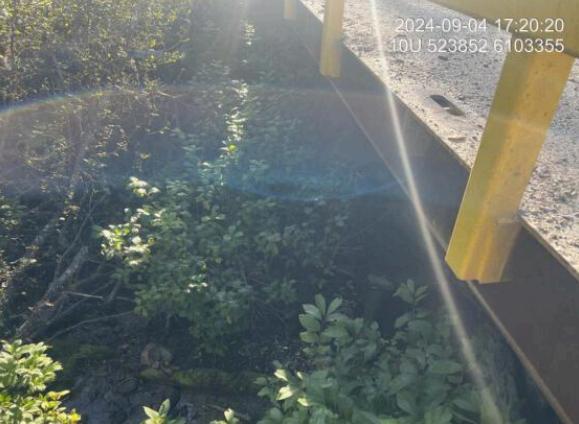
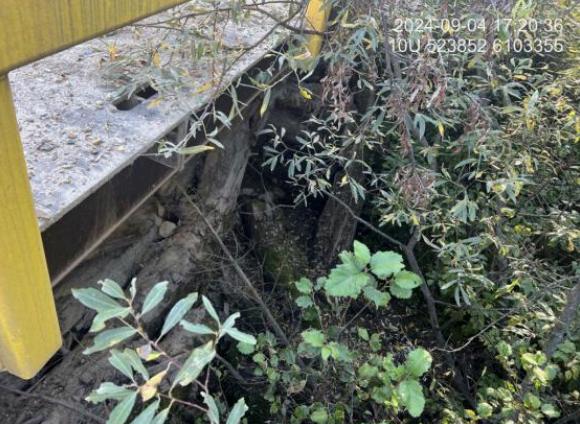
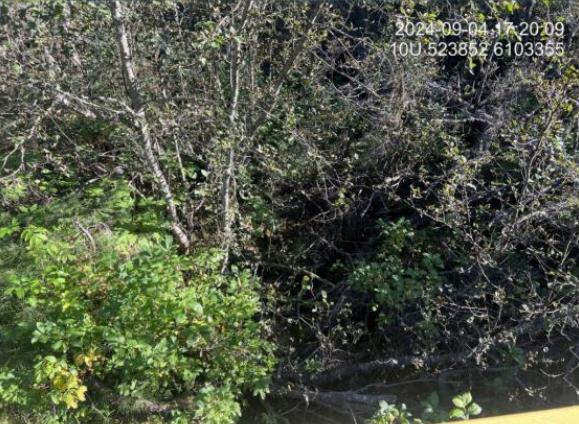
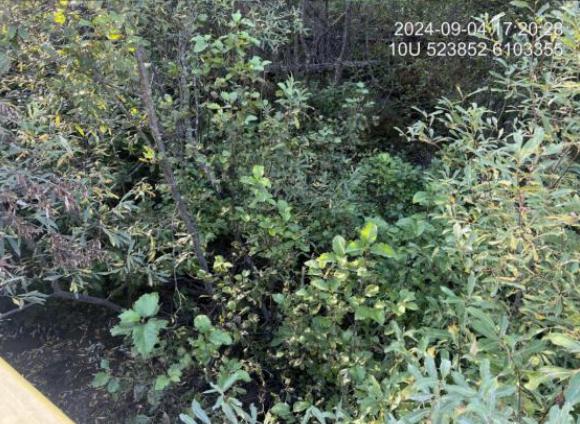
Location and Stream Data		.	Crossing Characteristics	–
Date	2024-09-04		Crossing Sub Type	Bridge
PSCIS ID	199666		Diameter (m)	12
External ID	16604219		Length (m)	5
Crew	AI LS		Embedded	–
UTM Zone	10		Depth Embedded (m)	–
Easting	523853		Resemble Channel	–
Northing	6103364		Backwatered	–
Stream	Tributary to Colbourne Creek		Percent Backwatered	–
Road	Chuchinka-Colbourne FSR		Fill Depth (m)	–
Road Tenure	MoF		Outlet Drop (m)	–
Channel Width (m)	–		Outlet Pool Depth (m)	–
Stream Slope (%)	–		Inlet Drop	–
Beaver Activity	No		Slope (%)	–
Habitat Value	–		Valley Fill	–
Final score	0		Barrier Result	Passable
Fix type	–		Fix Span / Diameter	–
Comments: New bridge in 2024.. 17:17:22				
Photos: PSCIS ID 16604219. From top left clockwise: Road/Site Card, Barrel, Outlet, Downstream, Upstream, Inlet.

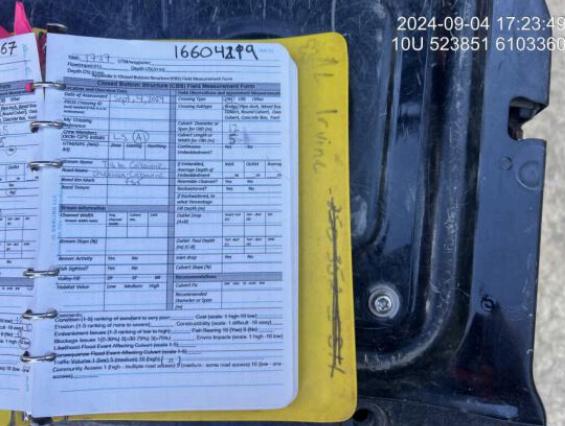
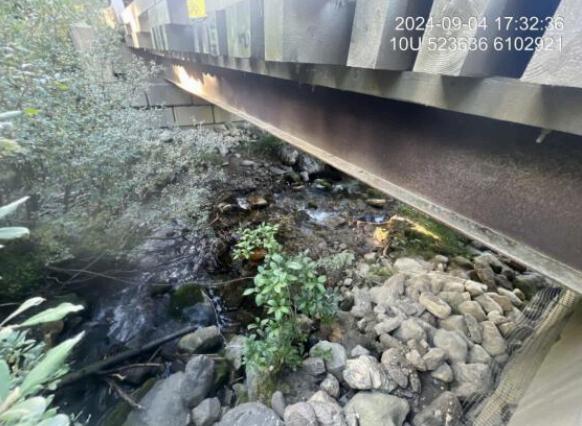
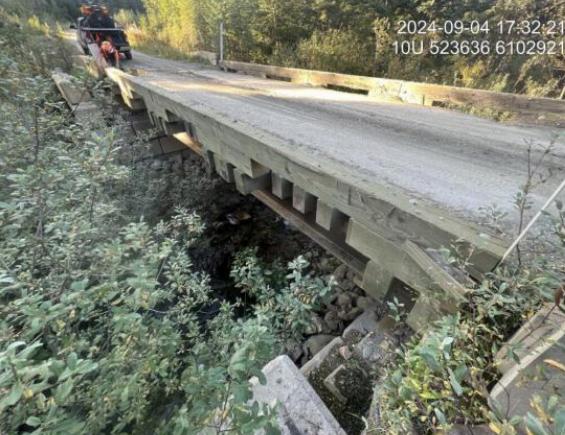
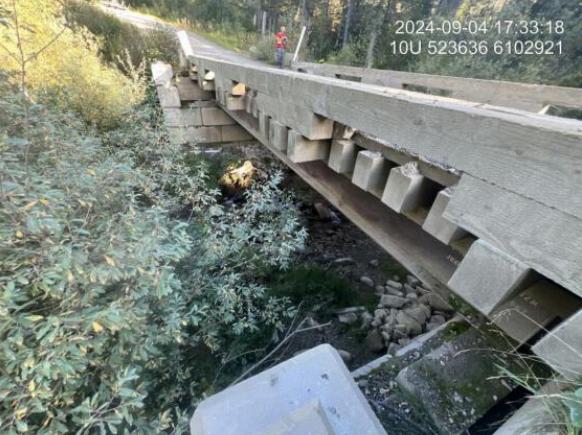
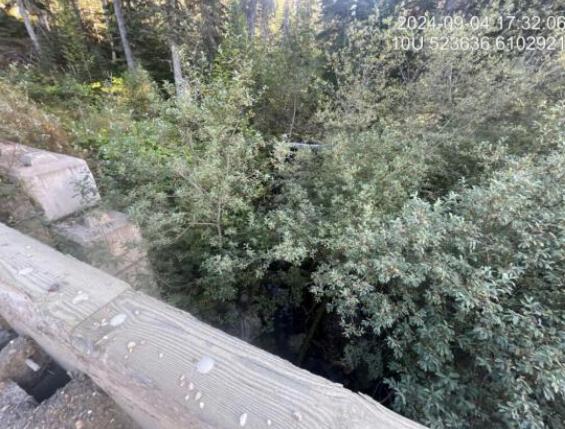
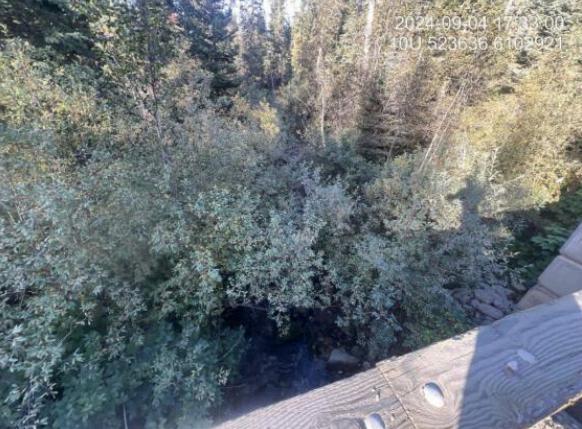
Location and Stream Data		.	Crossing Characteristics	–
Date	2024-09-04		Crossing Sub Type	Bridge
PSCIS ID	199667		Diameter (m)	12
External ID	16602775		Length (m)	5
Crew	AI LS		Embedded	–
UTM Zone	10		Depth Embedded (m)	–
Easting	523637		Resemble Channel	–
Northing	6102924		Backwatered	–
Stream	Tributary to Colbourne Creek		Percent Backwatered	–
Road	Chuchinka-Colbourne FSR		Fill Depth (m)	–
Road Tenure	MoF		Outlet Drop (m)	–
Channel Width (m)	–		Outlet Pool Depth (m)	–
Stream Slope (%)	–		Inlet Drop	–
Beaver Activity	No		Slope (%)	–
Habitat Value	–		Valley Fill	–
Final score	0		Barrier Result	Passable
Fix type	–		Fix Span / Diameter	–
Comments: New bridge in 2024. This is a large stream. . 17:30:20				
Photos: PSCIS ID 16602775. From top left clockwise: Road/Site Card, Barrel, Outlet, Downstream, Upstream, Inlet.

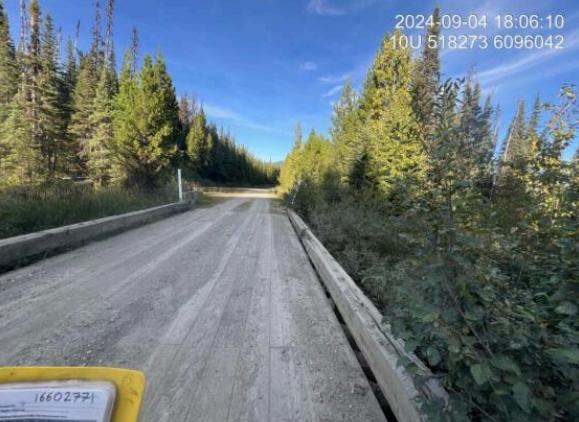
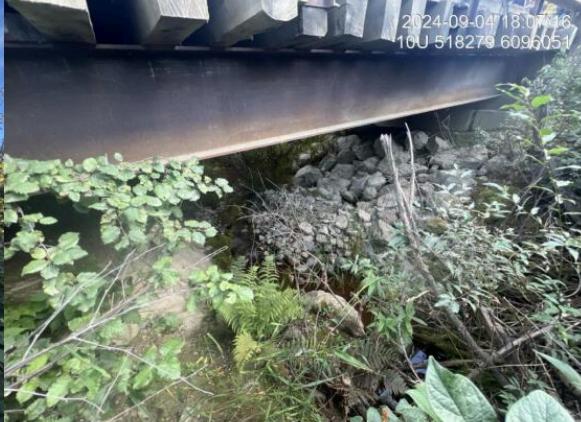
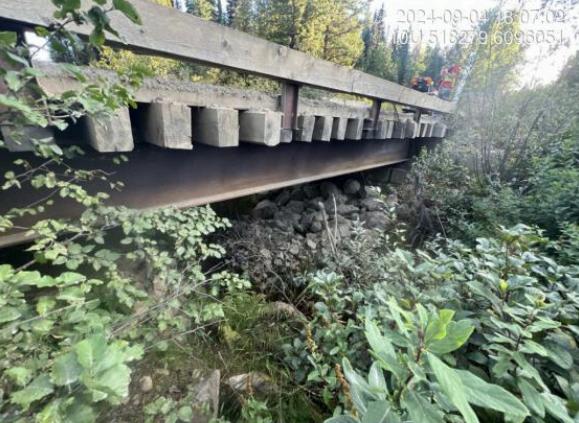
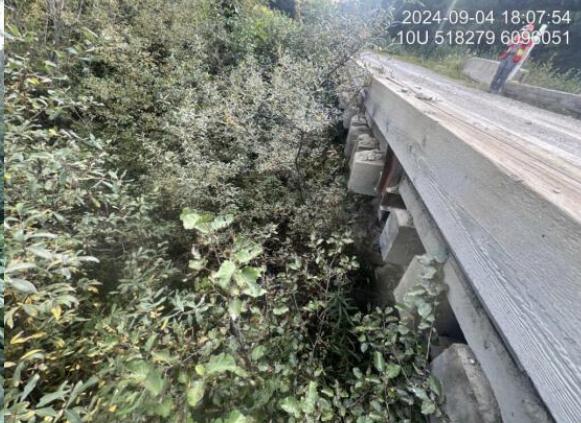
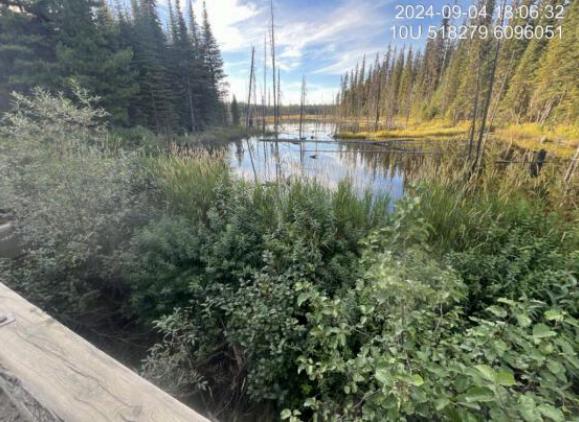
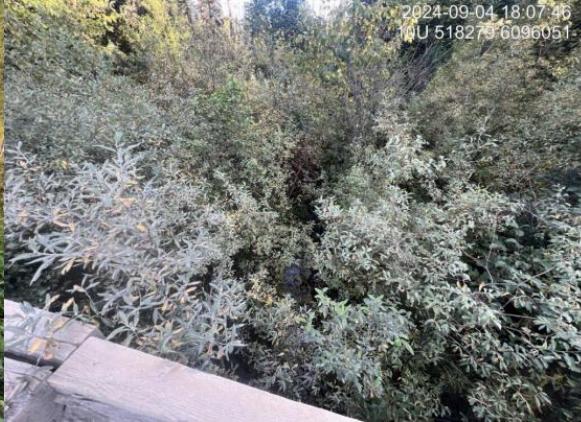
Location and Stream Data		.	Crossing Characteristics	–
Date	2024-09-04		Crossing Sub Type	Bridge
PSCIS ID	199668		Diameter (m)	12
External ID	16602771		Length (m)	5
Crew	AI LS		Embedded	–
UTM Zone	10		Depth Embedded (m)	–
Easting	518282		Resemble Channel	–
Northing	6096051		Backwatered	–
Stream	Tributary to Colbourne Creek		Percent Backwatered	–
Road	Chuchinka-Colbourne FSR		Fill Depth (m)	–
Road Tenure	MoF		Outlet Drop (m)	–
Channel Width (m)	–		Outlet Pool Depth (m)	–
Stream Slope (%)	–		Inlet Drop	–
Beaver Activity	No		Slope (%)	–
Habitat Value	–		Valley Fill	–
Final score	0		Barrier Result	Passable
Fix type	–		Fix Span / Diameter	–
Comments:				
A 3 m high beaver dam is located just upstream of the road, with a large wetland area upstream.. 18:03:41				
Photos: PSCIS ID 16602771. From top left clockwise: Road/Site Card, Barrel, Outlet, Downstream, Upstream, Inlet.

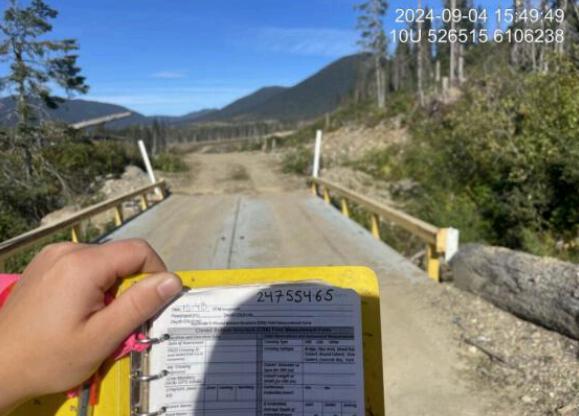
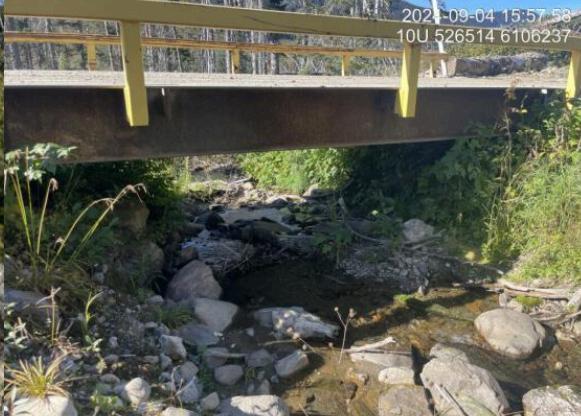
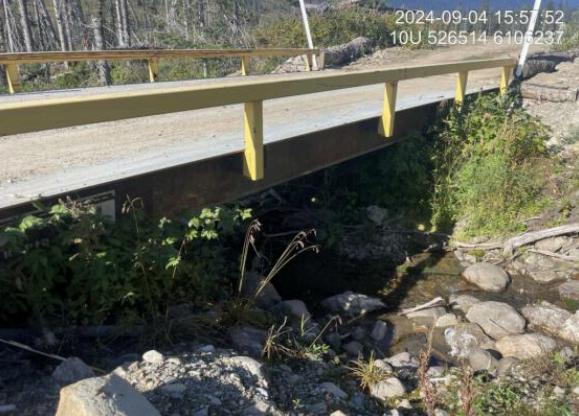
Location and Stream Data		.	Crossing Characteristics	–
Date	2024-09-04		Crossing Sub Type	Bridge
PSCIS ID	199669		Diameter (m)	9.2
External ID	24755465		Length (m)	4
Crew	LS AI		Embedded	–
UTM Zone	10		Depth Embedded (m)	–
Easting	526514		Resemble Channel	–
Northing	6106241		Backwatered	–
Stream	Tributary to Colbourne Creek		Percent Backwatered	–
Road	Chuchinka-Colbourne FSR		Fill Depth (m)	–
Road Tenure	BCTS		Outlet Drop (m)	–
Channel Width (m)	–		Outlet Pool Depth (m)	–
Stream Slope (%)	–		Inlet Drop	–
Beaver Activity	No		Slope (%)	–
Habitat Value	–		Valley Fill	–
Final score	0		Barrier Result	Passable
Fix type	–		Fix Span / Diameter	–
Comments: New bridge in 2024. 15:52:56				
Photos: PSCIS ID 24755465. From top left clockwise: Road/Site Card, Barrel, Outlet, Downstream, Upstream, Inlet.

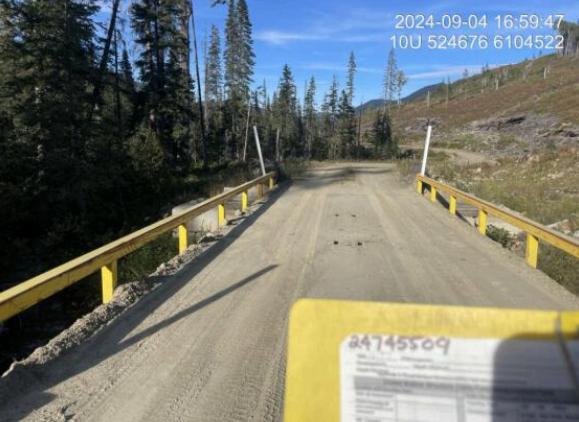
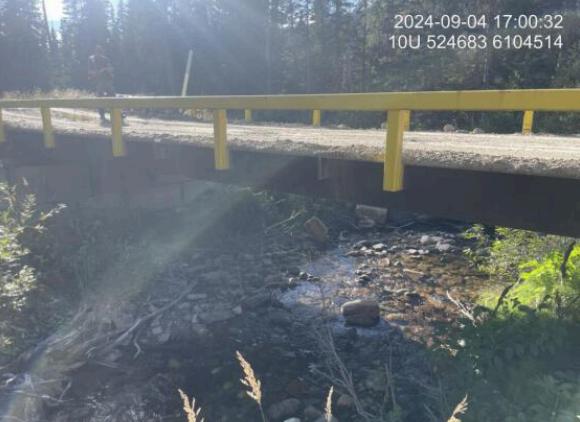
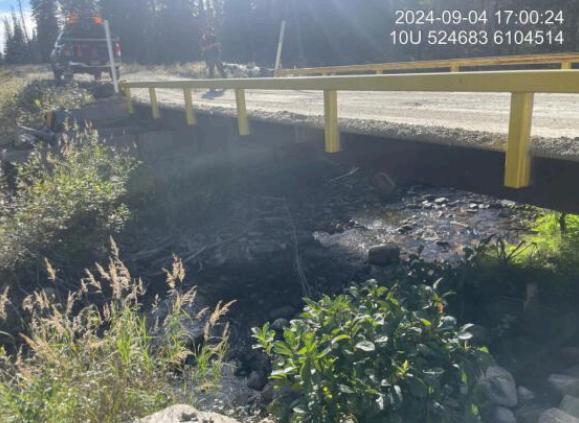
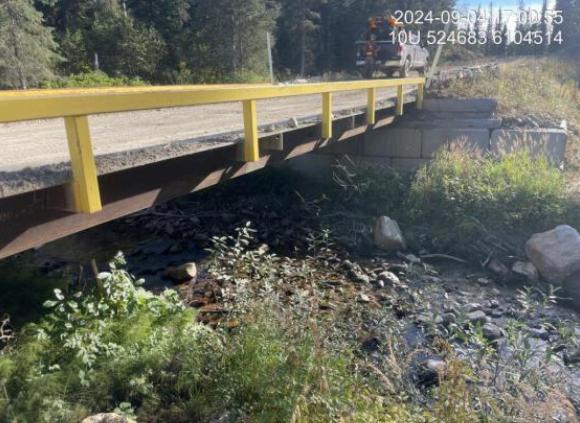
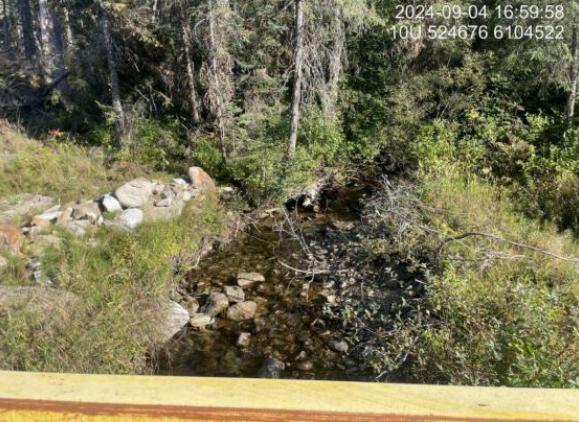
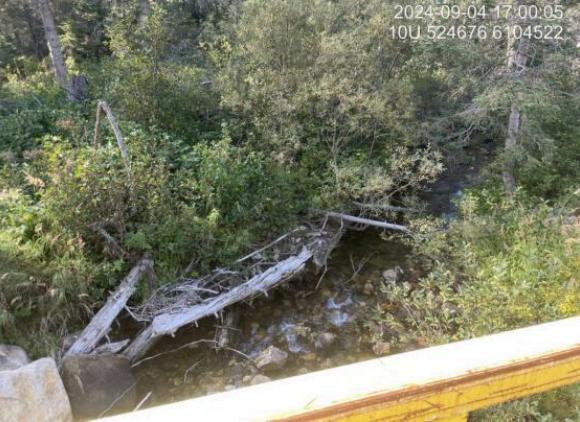
Location and Stream Data		.	Crossing Characteristics	–
Date	2024-09-04		Crossing Sub Type	Bridge
PSCIS ID	199670		Diameter (m)	12.2
External ID	24745509		Length (m)	5
Crew	LS AI		Embedded	–
UTM Zone	10		Depth Embedded (m)	–
Easting	524680		Resemble Channel	–
Northing	6104513		Backwatered	–
Stream	Tributary to Colbourne Creek		Percent Backwatered	–
Road	Chuchinka-Colbourne FSR		Fill Depth (m)	–
Road Tenure	MoF		Outlet Drop (m)	–
Channel Width (m)	–		Outlet Pool Depth (m)	–
Stream Slope (%)	–		Inlet Drop	–
Beaver Activity	No		Slope (%)	–
Habitat Value	–		Valley Fill	–
Final score	0		Barrier Result	Passable
Fix type	–		Fix Span / Diameter	–
Comments: New bridge in 2024. 16:57:19				
Photos: PSCIS ID 24745509. From top left clockwise: Road/Site Card, Barrel, Outlet, Downstream, Upstream, Inlet.

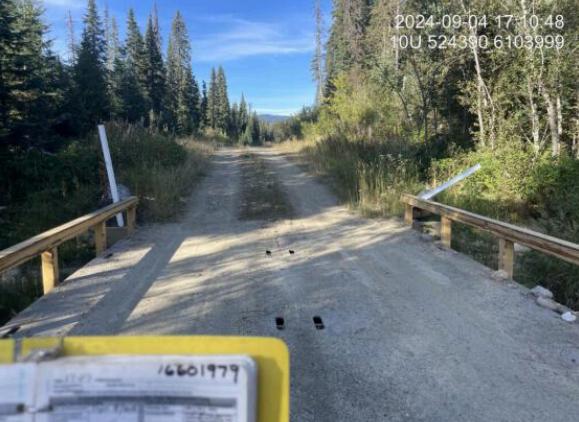
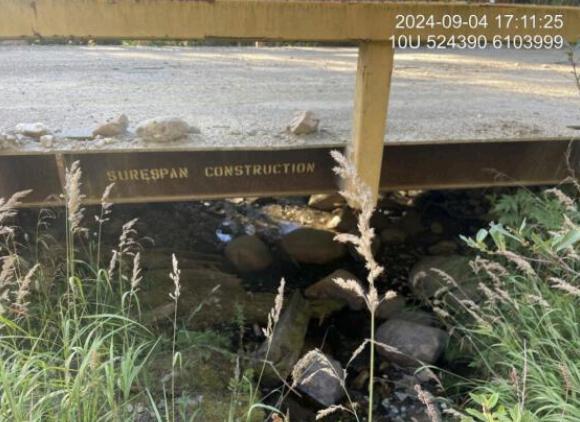
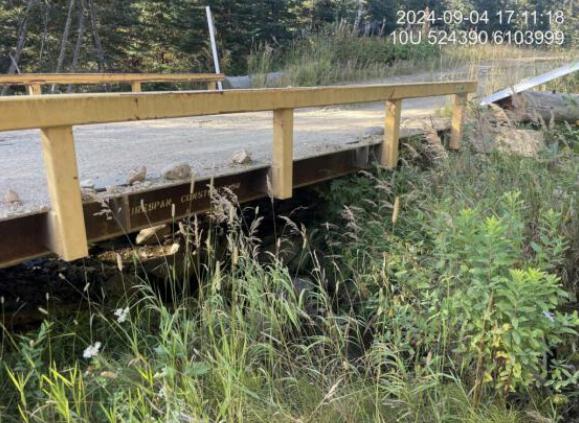
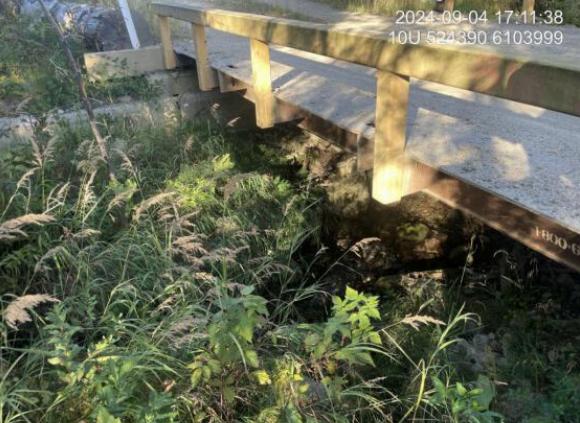
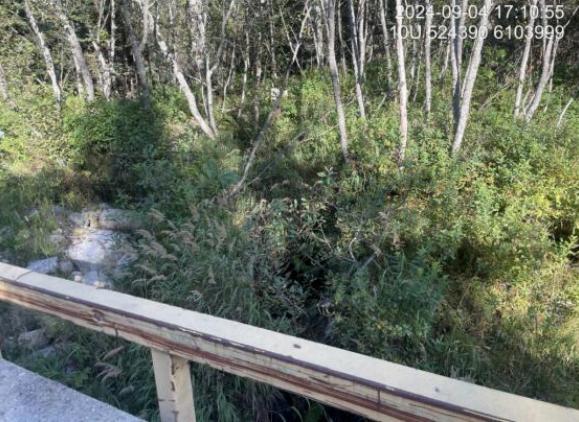
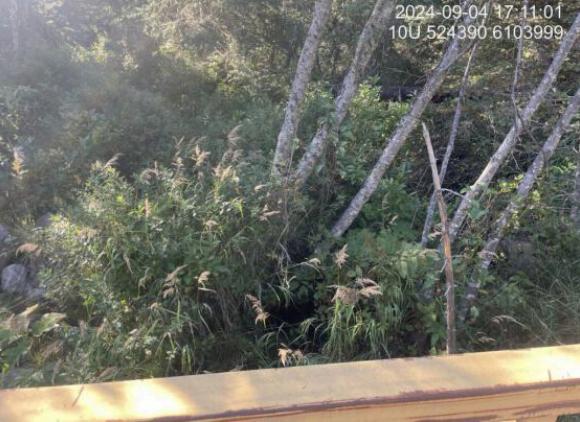
Location and Stream Data		.	Crossing Characteristics	–
Date	2024-09-04		Crossing Sub Type	Bridge
PSCIS ID	199671		Diameter (m)	6.1
External ID	16601979		Length (m)	4
Crew	LS AI		Embedded	–
UTM Zone	10		Depth Embedded (m)	–
Easting	524391		Resemble Channel	–
Northing	6104000		Backwatered	–
Stream	Tributary to Colbourne Creek		Percent Backwatered	–
Road	Chuchinka-Colbourne FSR		Fill Depth (m)	–
Road Tenure	MoF		Outlet Drop (m)	–
Channel Width (m)	–		Outlet Pool Depth (m)	–
Stream Slope (%)	–		Inlet Drop	–
Beaver Activity	No		Slope (%)	–
Habitat Value	–		Valley Fill	–
Final score	0		Barrier Result	Passable
Fix type	–		Fix Span / Diameter	–
Comments: New bridge in 2024. 17:07:54				
Photos: PSCIS ID 16601979. From top left clockwise: Road/Site Card, Barrel, Outlet, Downstream, Upstream, Inlet.
