Appendix - Phase 1 Fish Passage Assessment Data and Photos

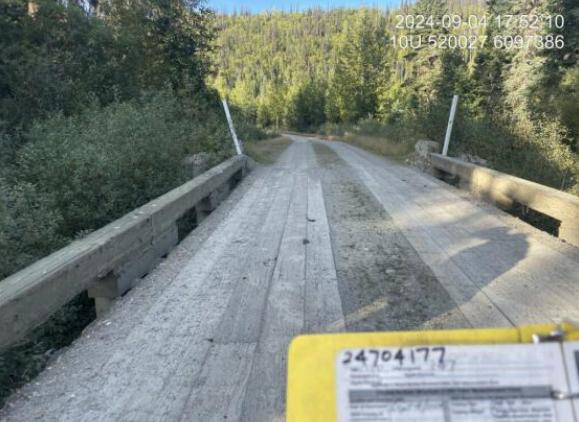
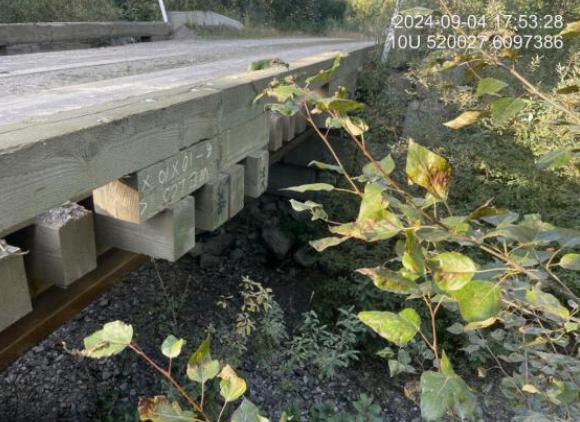
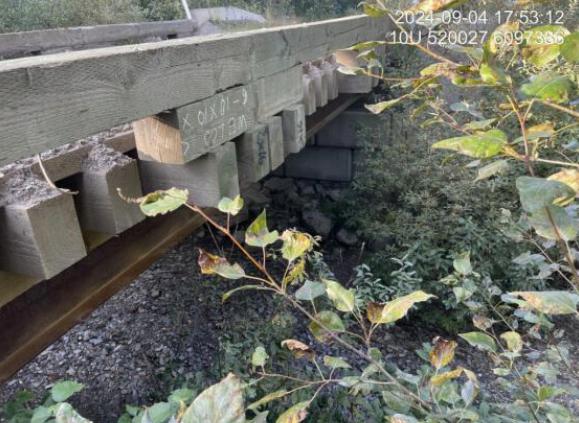
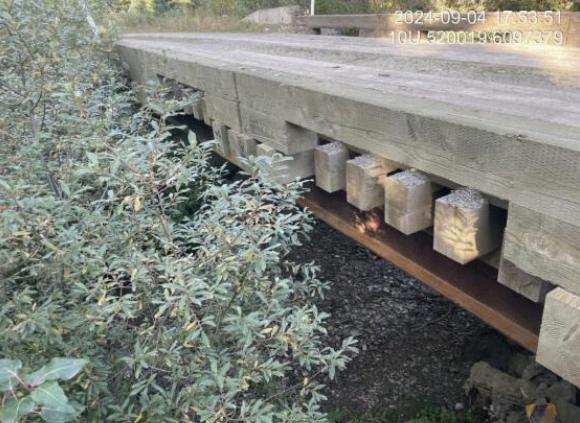
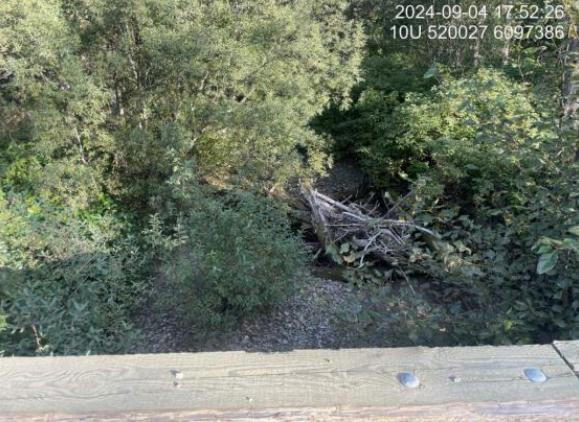
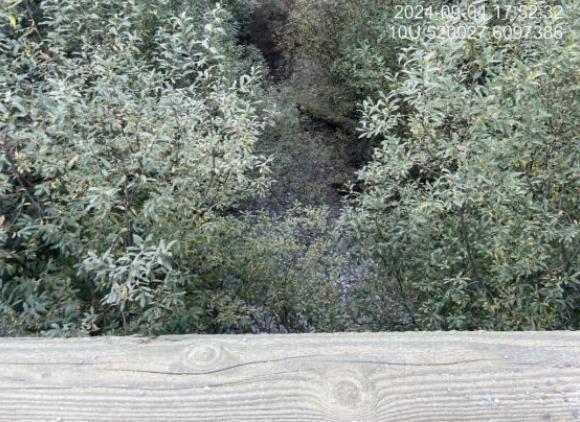
Location and Stream Data		.	Crossing Characteristics	–
Date	2024-09-04		Crossing Sub Type	Bridge
PSCIS ID	199672		Diameter (m)	10
External ID	24704177		Length (m)	5
Crew	LS AI		Embedded	–
UTM Zone	10		Depth Embedded (m)	–
Easting	520025		Resemble Channel	–
Northing	6097384		Backwatered	–
Stream	Tributary to Colbourne Creek		Percent Backwatered	–
Road	Chuchinka-Colbourne FSR		Fill Depth (m)	–
Road Tenure	MoF		Outlet Drop (m)	–
Channel Width (m)	–		Outlet Pool Depth (m)	–
Stream Slope (%)	–		Inlet Drop	–
Beaver Activity	No		Slope (%)	–
Habitat Value	–		Valley Fill	–
Final score	0		Barrier Result	Passable
Fix type	–		Fix Span / Diameter	–
Comments: Bridge. Stream was dry at time of assessment. 17:50:42				
Photos: PSCIS ID 24704177. From top left clockwise: Road/Site Card, Barrel, Outlet, Downstream, Upstream, Inlet.
