## Appendix - Phase 1 Fish Passage Assessment Data and Photos

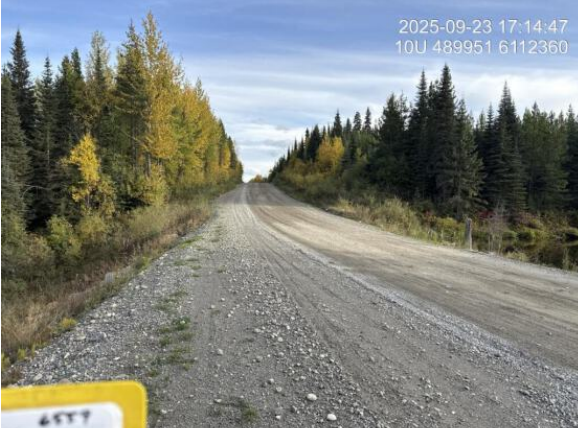
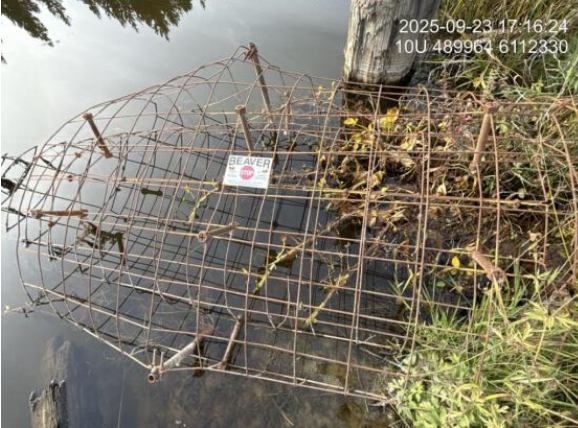
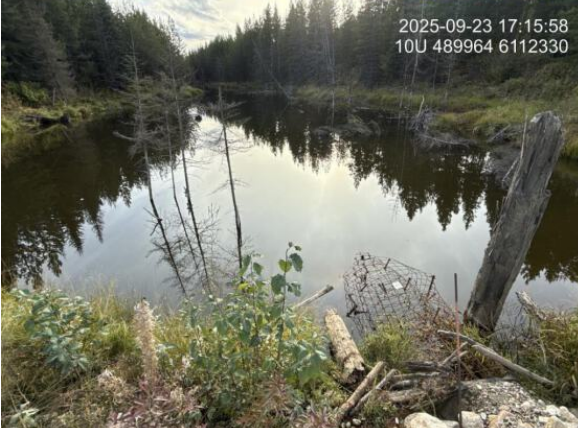
| Location and Stream Data | . | Crossing Characteristics | – |
|---|---|---|---|
| Photos: PSCIS ID 6559. From top left clockwise: Road/Site Card, Barrel, Outlet, Downstream, Upstream, Inlet. | | | |

| Location and Stream Data | . | Crossing Characteristics | – |
|---|---|---|---|
| Final score | 36 | Barrier Result | Barrier |
| Comments: Wetland upstream. Stream was not flowing at time of assessment. Small channel downstream. Beaver grate devices on inlet and outlet | | | |

| Location and Stream Data | . | Crossing Characteristics | – |
|---|---|---|---|
| Fix type | Replace Structure with Streambed Simulation CBS | Fix Span / Diameter | 3 |

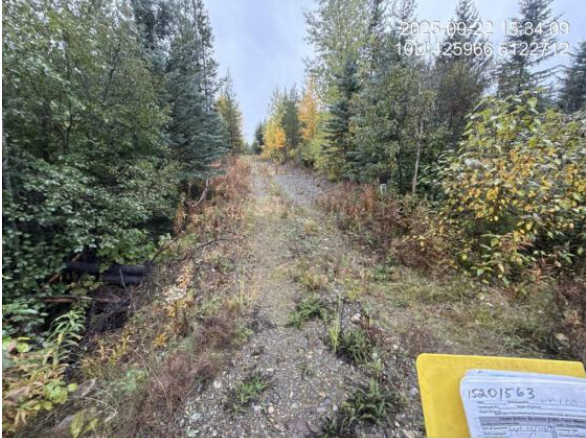
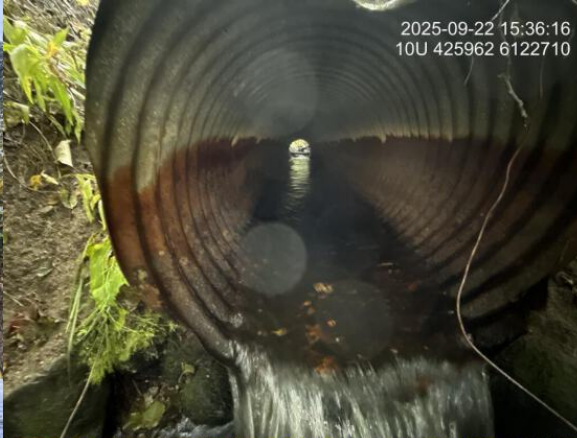
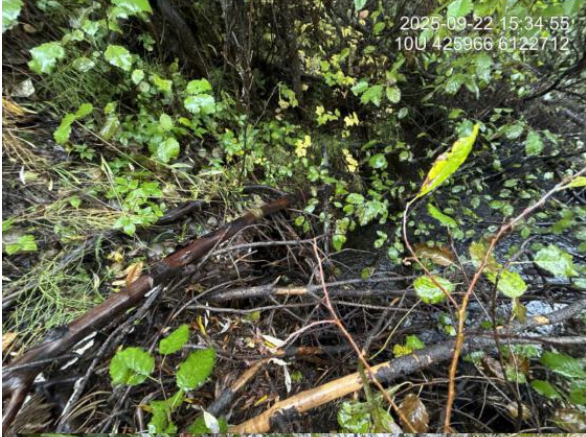
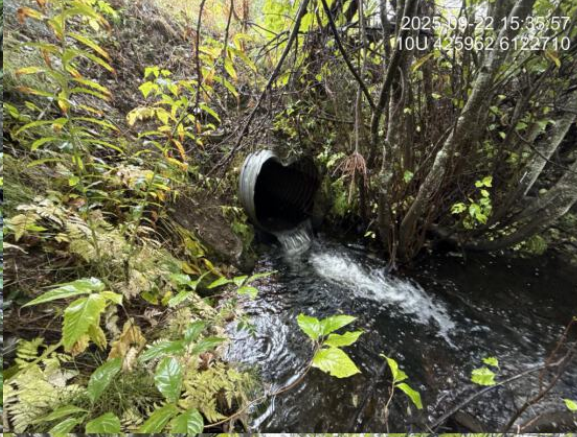
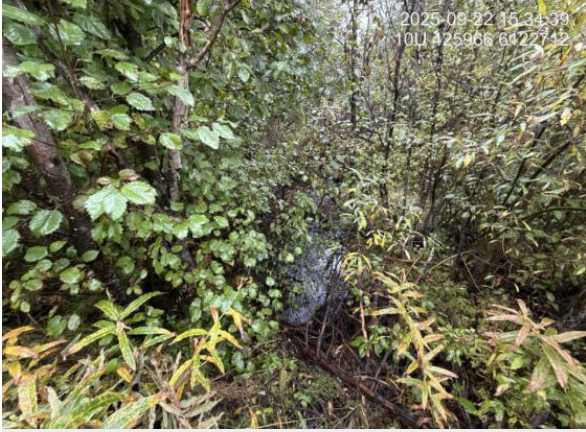
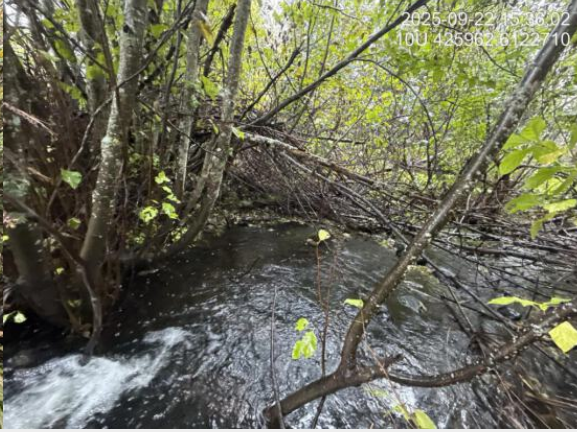
| Location and Stream Data | • | Crossing Characteristics | – |
|---|---|---|---|
| Final score | 29 | Barrier Result | Barrier |
| Comments: High-quality stream with abundant gravels and cover, directly connected to the Nation River. Bull trout noted near the confluence. eDNA samples collected upstream and downstream of the crossing. This crossing is located on a road identified by BCTS as a candidate for potential deactivation. | | | |

| Location and Stream Data | • | Crossing Characteristics | – |
|---|---|---|---|
| Fix type | Replace with New Open Bottom Structure | Fix Span / Diameter | 15 |

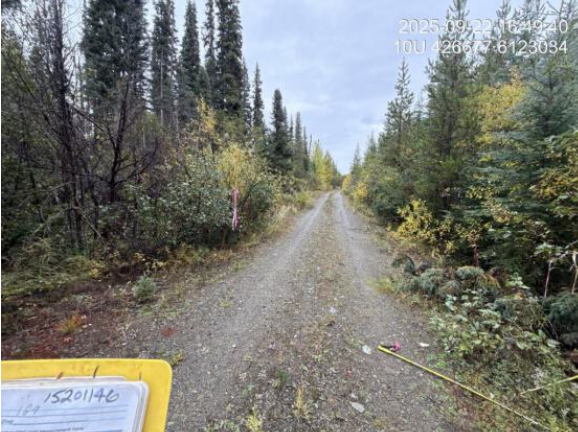
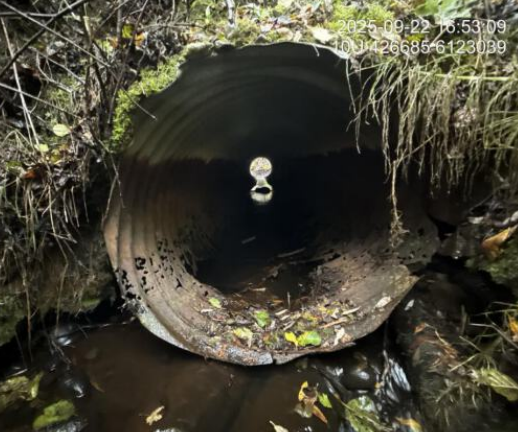
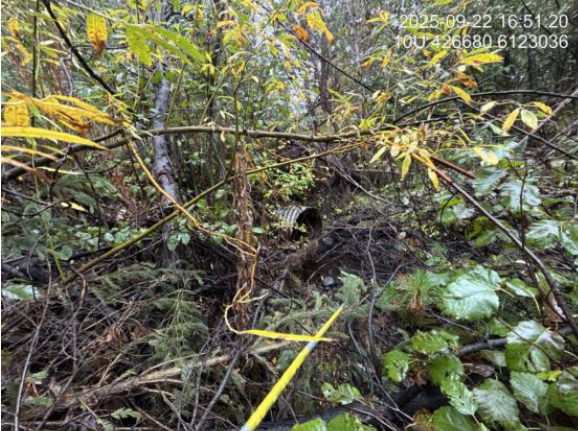
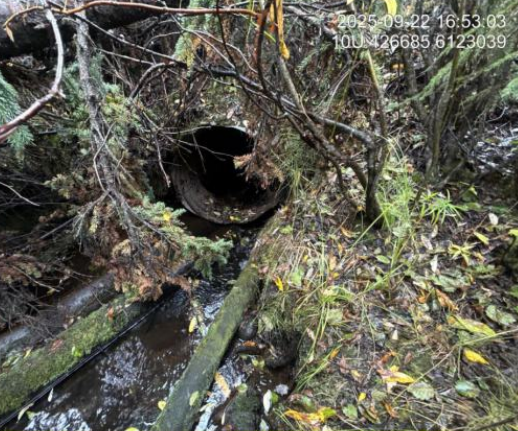
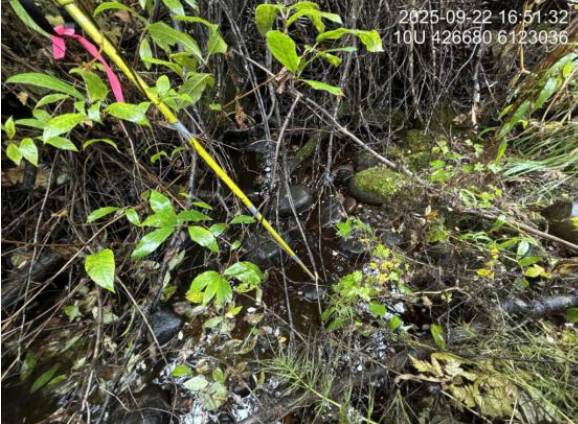
Photos: PSCIS ID 203598. From top left clockwise: Road/Site Card, Barrel, Outlet, Downstream, Upstream, Inlet.

| Location and Stream Data | . | Crossing Characteristics | – |
|---|---|---|---|
| Final score | 26 | Barrier Result | Barrier |

Comments: Small stream with short channel length before entering a large wetland area. Pockets of small gravel were present throughout. This crossing is located on a road identified by BCTS as a candidate for potential deactivation.

| Location and Stream Data | . | Crossing Characteristics | – |
|---|---|---|---|
| Fix type | Replace Structure with Streambed Simulation CBS | Fix Span / Diameter | 3 |

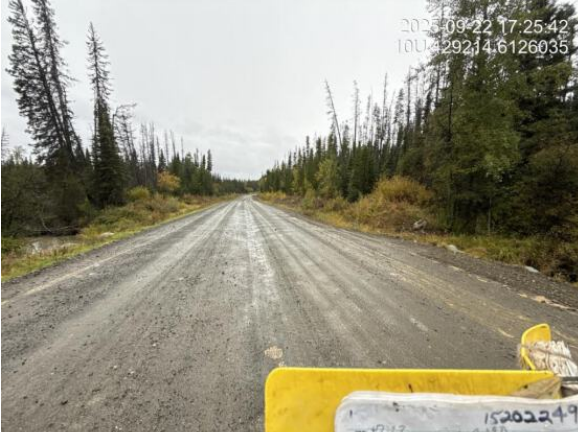
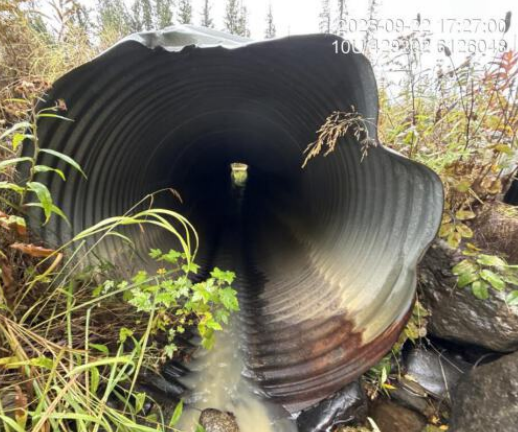
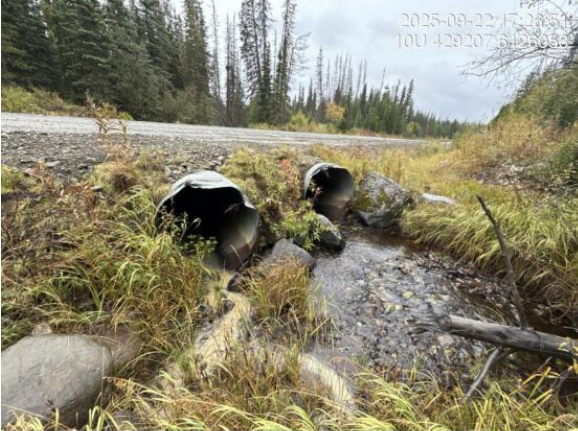
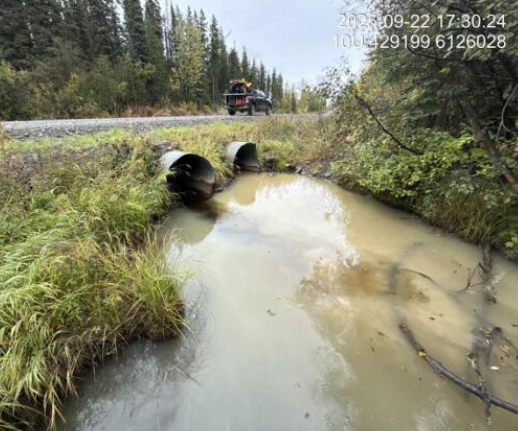
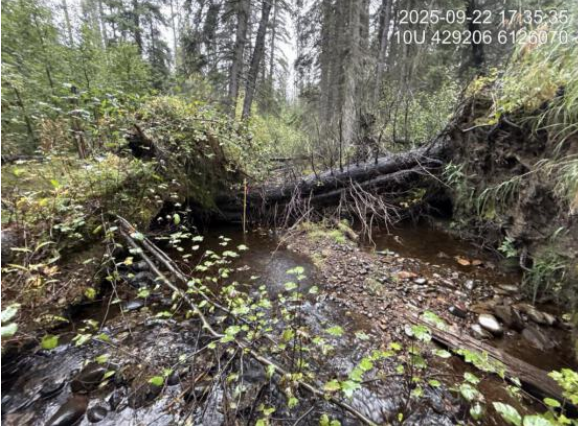
| Location and Stream Data | • | Crossing Characteristics | – |
|---|---|---|---|
| Photos: PSCIS ID 203599. From top left clockwise: Road/Site Card, Barrel, Outlet, Downstream, Upstream, Inlet. | | | |

| Location and Stream Data | • | Crossing Characteristics | – |
|---|---|---|---|
| Final score | 24 | Barrier Result | Barrier |
| Comments: Wetland type habitat downstream with good habitat upstream with pockets of gravel and a wide channel. Culverts beginning to sag in the middle. No outlet drop. | | | |

| Location and Stream Data | • | Crossing Characteristics | – |
|---|---|---|---|
| Fix type | Replace with New Open Bottom Structure | Fix Span / Diameter | 15 |

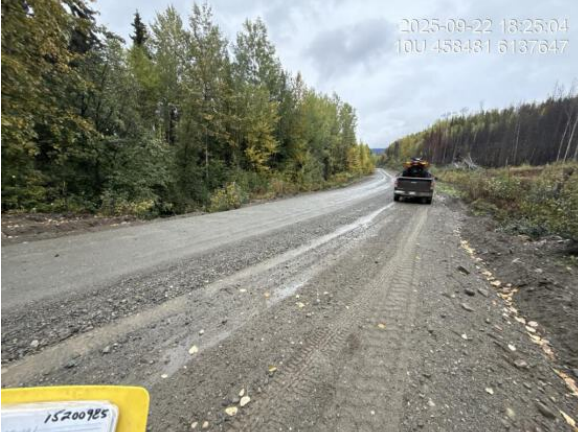
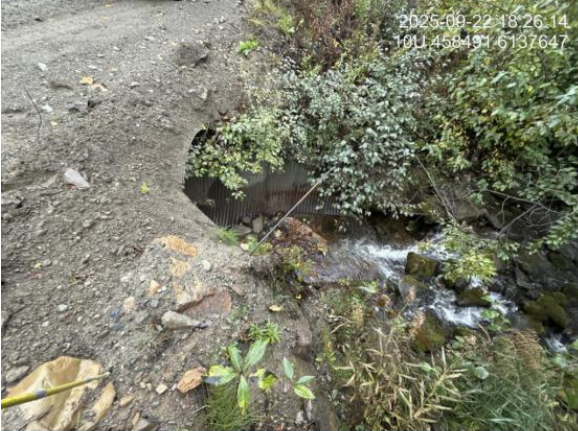
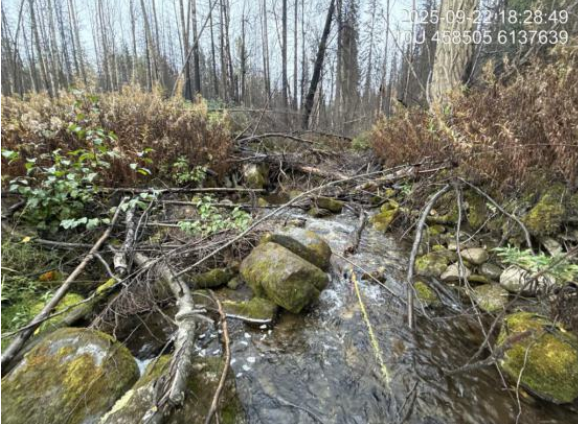
| Location and Stream Data | • | Crossing Characteristics | – |
|---|---|---|---|
| Photos: PSCIS ID 203600. From top left clockwise: Road/Site Card, Barrel, Outlet, Downstream, Upstream, Inlet. | | | |

| Location and Stream Data | • | Crossing Characteristics | – |
|---|---|---|---|
| Final score | 34 | Barrier Result | Barrier |
| Comments: Large stream with abundant woody debris, pools, and gravels upstream. Outlet dropped minimally onto a boulder. | | | |

| Location and Stream Data | • | Crossing Characteristics | – |
|---|---|---|---|
| Fix type | Replace with New Open Bottom Structure | Fix Span / Diameter | 15 |

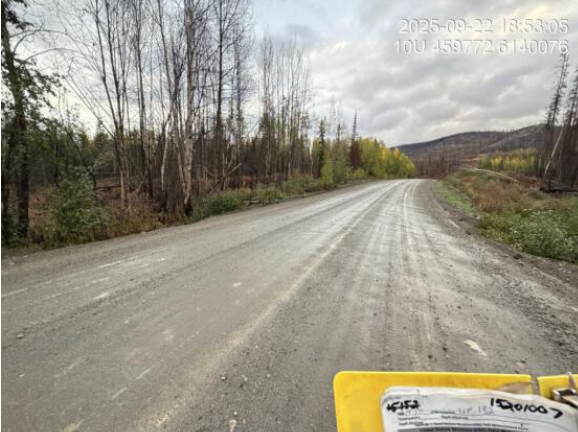
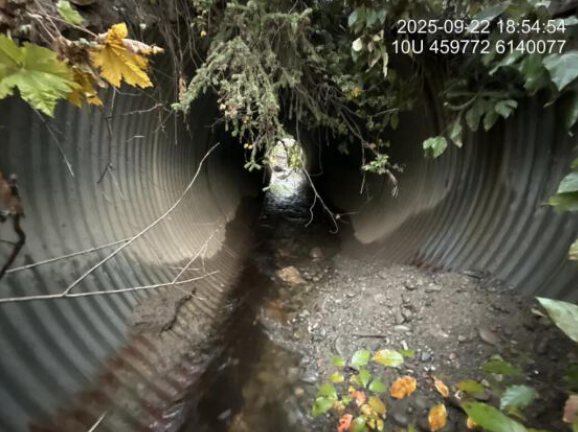
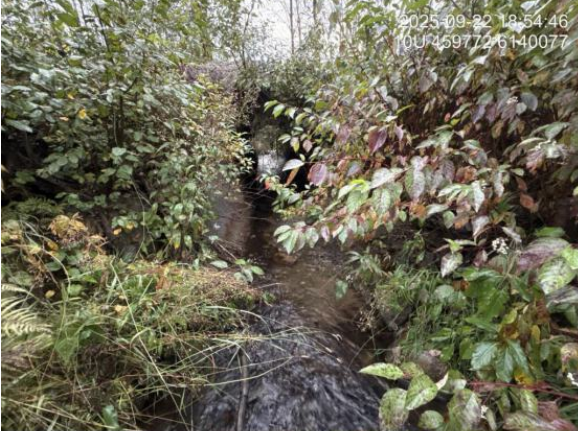
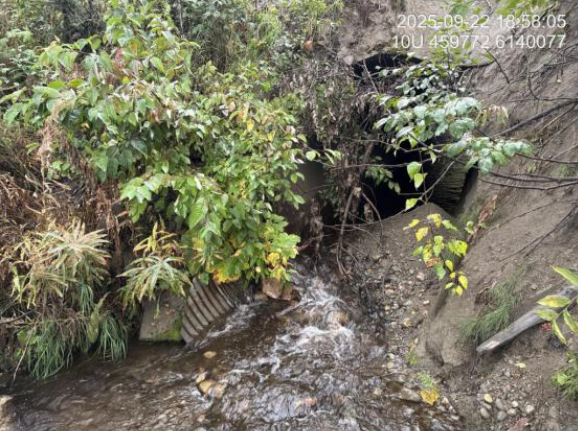
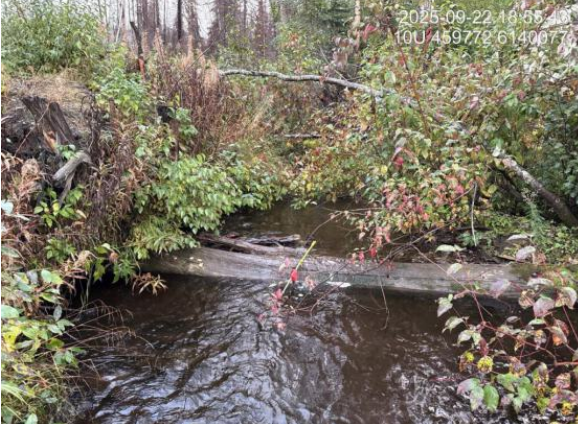
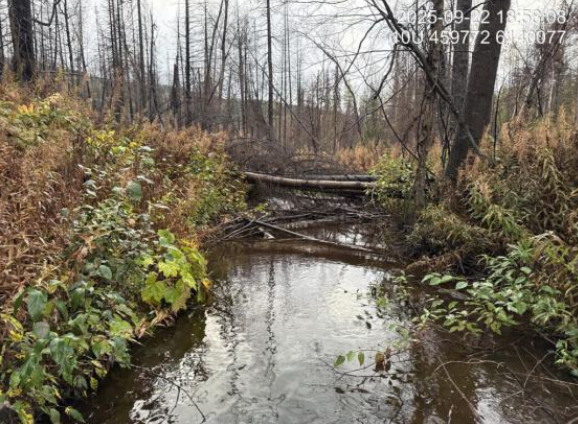
| Location and Stream Data | • | Crossing Characteristics | – |
|---|---|---|---|
| Photos: PSCIS ID 203601. From top left clockwise: Road/Site Card, Barrel, Outlet, Downstream, Upstream, Inlet. | | | |

| Location and Stream Data | • | Crossing Characteristics | – |
|---|---|---|---|
| Final score | 24 | Barrier Result | Barrier |
| Comments: Large stream with pools and gravels present upstream. Significant amounts of road fill had been graded into the channel. | | | |

| Location and Stream Data | • | Crossing Characteristics | – |
|---|---|---|---|
| Fix type | Replace with New Open Bottom Structure | Fix Span / Diameter | 15 |

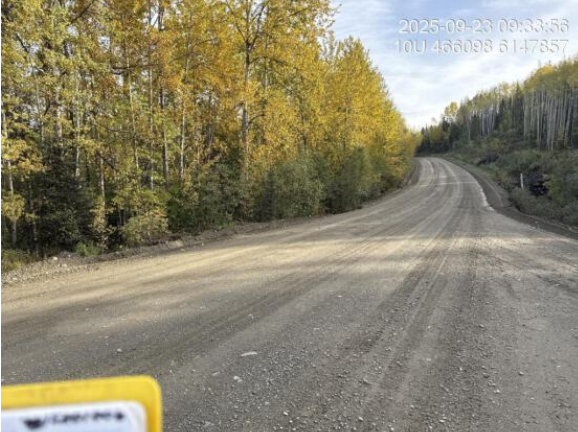
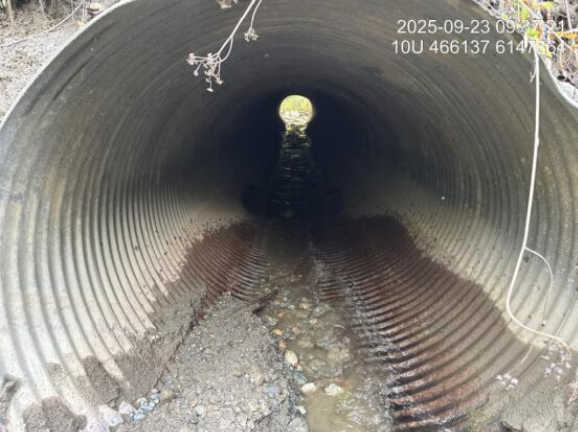
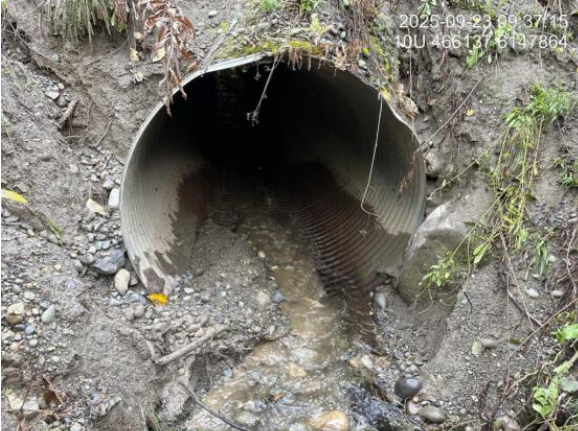
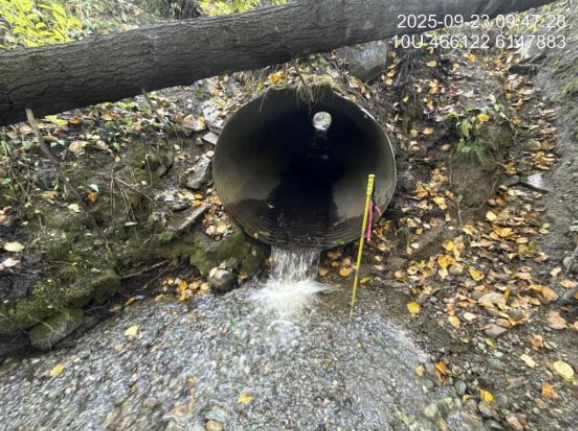
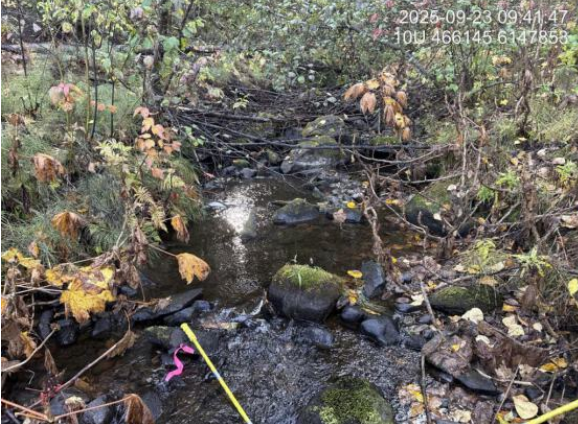
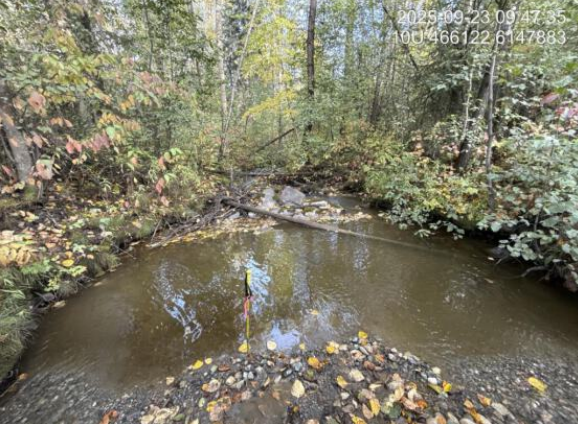
| Location and Stream Data | • | Crossing Characteristics | – |
|---|---|---|---|
| Final score | 34 | Barrier Result | Barrier |
| Comments: Large, low gradient, high value system. Significant amounts of road fill is eroding from the road prism into the stream on both sides of the FSR. Habitat confirmation and electrofishing or EDNA sampling is recommended. | | | |

| Location and Stream Data | • | Crossing Characteristics | – |
|---|---|---|---|
| Fix type | Replace with New Open Bottom Structure | Fix Span / Diameter | 16.5 |

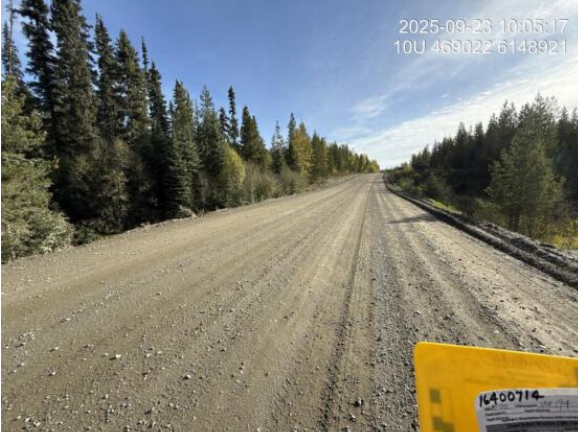
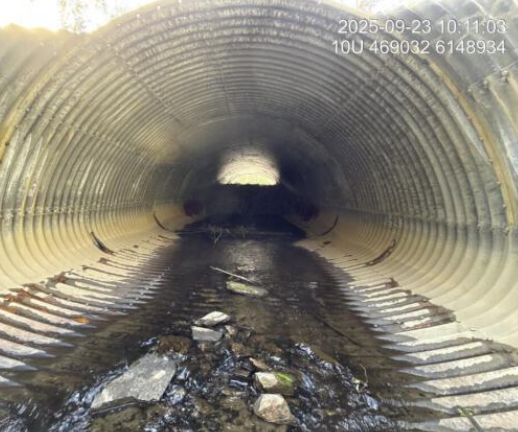
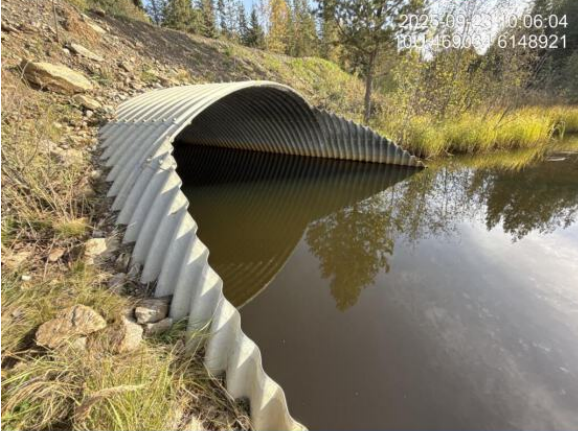
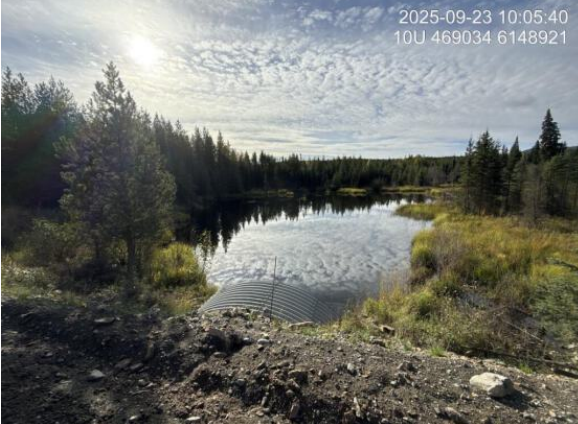
| Location and Stream Data | • | Crossing Characteristics | – |
|---|---|---|---|
| Final score | 24 | Barrier Result | Barrier |
| Comments: Very large stream with 2.5m high beaver dam located in the middle of the culvert backing up a massive wetland upstream. First passage is definitely hindered by the beaver dam however, the wetland it creates provides likely stable hydrology for the downstream system. | | | |

| Location and Stream Data | • | Crossing Characteristics | – |
|---|---|---|---|
| Fix type | Replace with New Open Bottom Structure | Fix Span / Diameter | 15 |

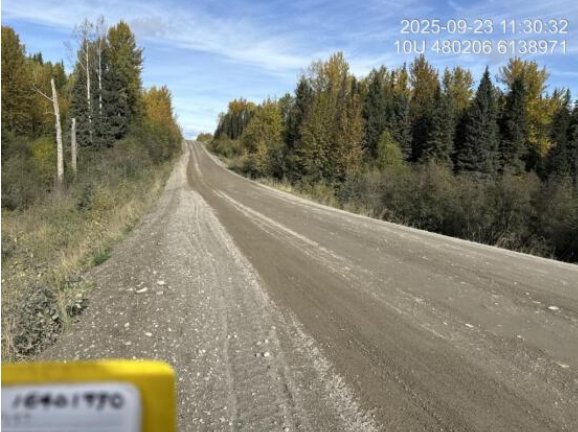
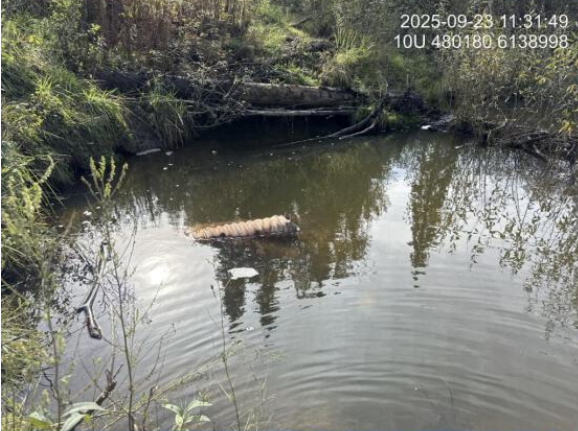
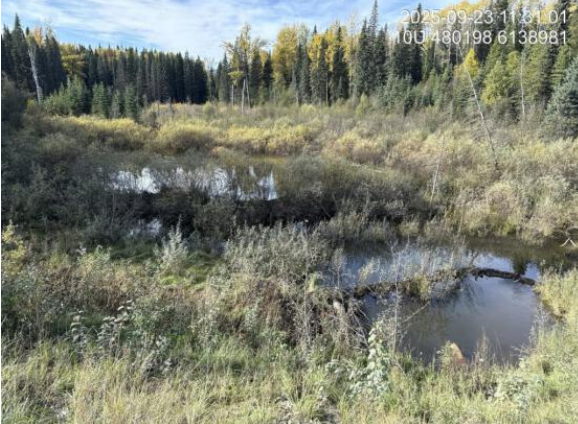
Photos: PSCIS ID 203604. From top left clockwise: Road/Site Card, Barrel, Outlet, Downstream, Upstream, Inlet.

| Location and Stream Data | • | Crossing Characteristics | – |
|---|---|---|---|
| Final score | 32 | Barrier Result | Barrier |

Comments: Very large system with extremely undersized pipe that is submerged at the inlet with obvious beaver activity within the pipe itself. Upstream is a huge wetland, beaver-influenced area. Culvert slope estimated as the outlet pool is extremely deep.

| Location and Stream Data | • | Crossing Characteristics | – |
|---|---|---|---|
| Fix type | Replace with New Open Bottom Structure | Fix Span / Diameter | 27 |

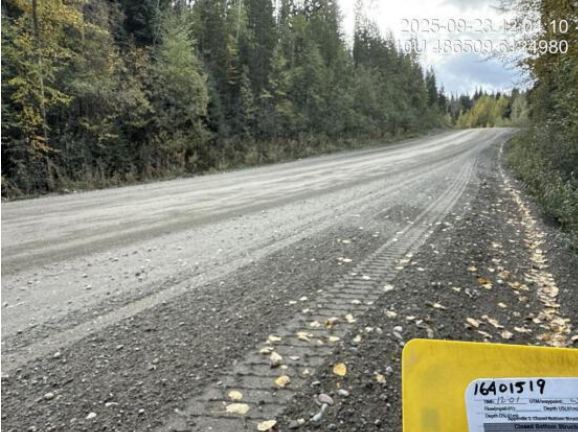
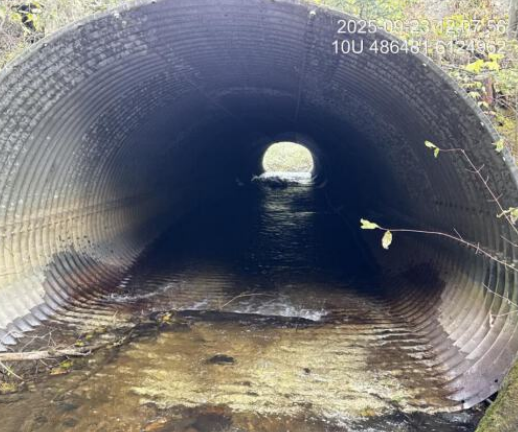
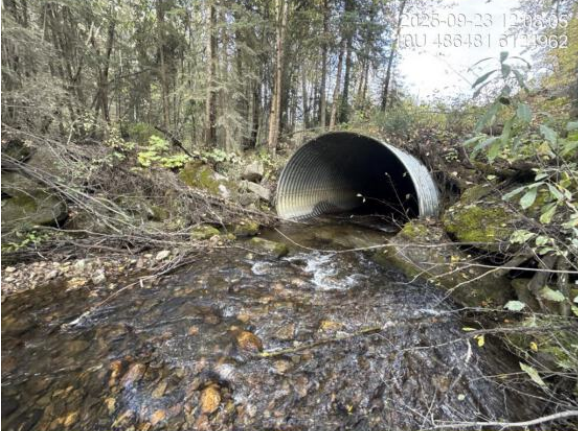
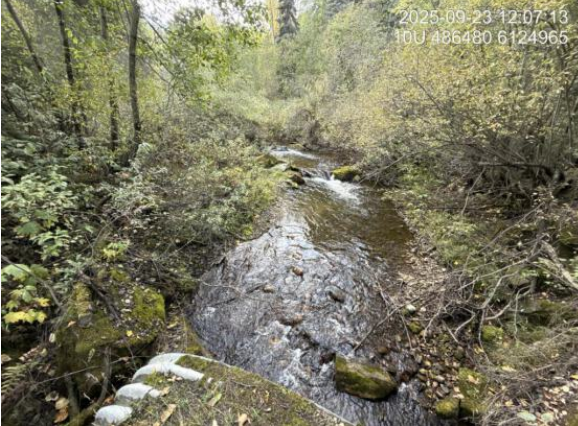
| Location and Stream Data | • | Crossing Characteristics | – |
|---|---|---|---|
| Photos: PSCIS ID 203605. From top left clockwise: Road/Site Card, Barrel, Outlet, Downstream, Upstream, Inlet. | | | |

| Location and Stream Data | • | Crossing Characteristics | – |
|---|---|---|---|
| Final score | 37 | Barrier Result | Barrier |
| Comments: High value habitat on very large system with pipe that has large outlet drop near 1m. Habitat confirmation and eDNA sampling conducted upstream and downstream of the crossing. | | | |

| Location and Stream Data | • | Crossing Characteristics | – |
|---|---|---|---|
| Fix type | Replace with New Open Bottom Structure | Fix Span / Diameter | 15 |

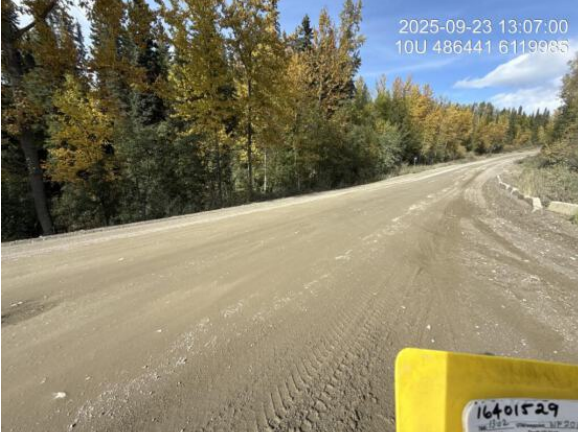
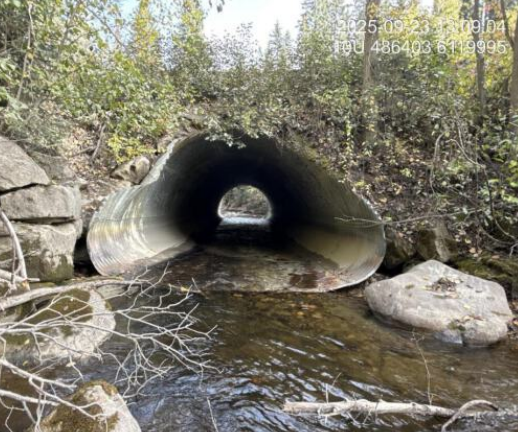
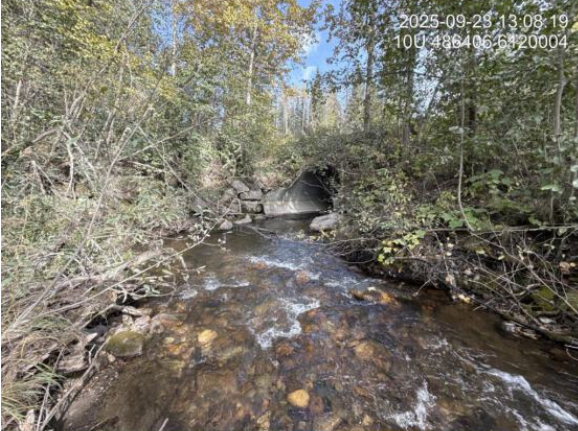
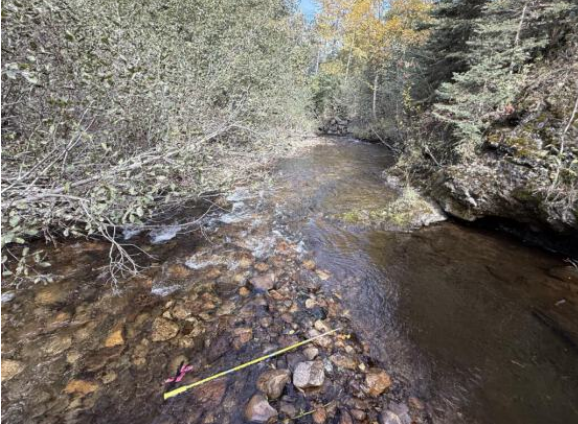
| Location and Stream Data | • | Crossing Characteristics | – |
|---|---|---|---|
| Photos: PSCIS ID 203606. From top left clockwise: Road/Site Card, Barrel, Outlet, Downstream, Upstream, Inlet. | | | |

| Location and Stream Data | • | Crossing Characteristics | – |
|---|---|---|---|
| Final score | 32 | Barrier Result | Barrier |
| Comments: Huge stream with abundant gravels and low gradient complex habitat upstream. Smaller outlet drop however pipe is somewhat undersized for the watershed. | | | |

| Location and Stream Data | • | Crossing Characteristics | – |
|---|---|---|---|
| Fix type | Replace with New Open Bottom Structure | Fix Span / Diameter | 15 |
