## **Skeena Watershed Fish Passage Restoration Planning 2022**

Prepared for  
Habitat Conservation Trust Foundation - CAT23-6-288  
BC Fish Passage Remediation Program  
Ministry of Transportation and Infrastructure

Prepared by  
Al Irvine, B.Sc., R.P.Bio. and Mateo Wintersheidt, B.Sc.  
New Graph Environment Ltd.  
on behalf of  
Society for Ecosystem Restoration in Northern British Columbia

Version 0.1.2 2024-06-25

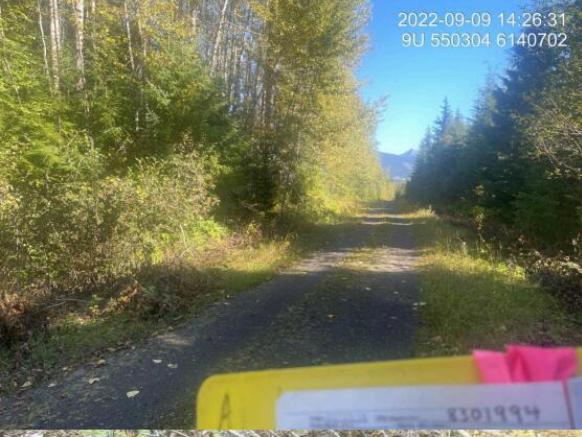
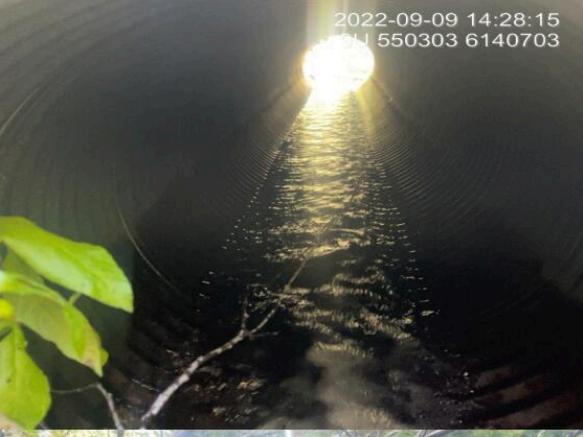
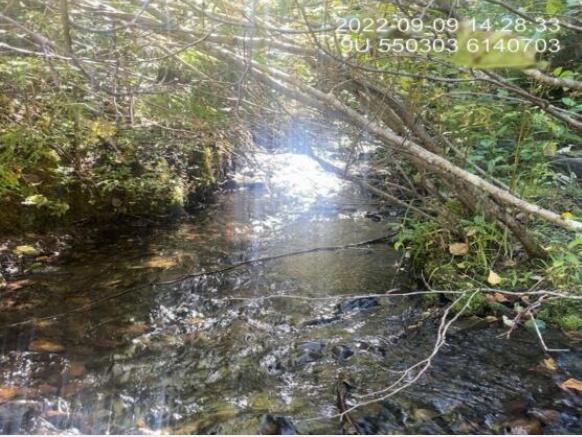
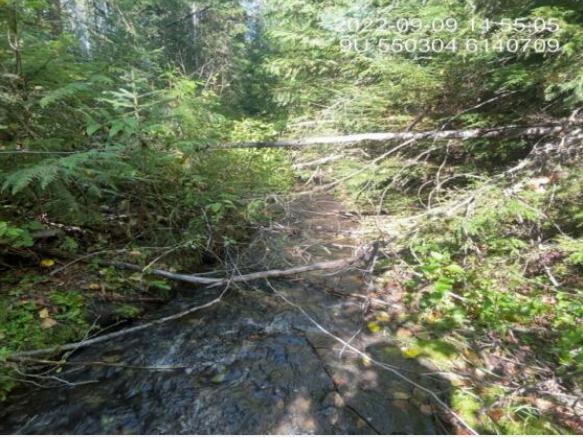
Location and Stream Data	•	Crossing Characteristics	-
Comments: Two culverts side by side (0.85m each). 14:23			
Photos: From top left clockwise: Road/Site Card, Barrel, Outlet, Downstream, Upstream, Inlet.

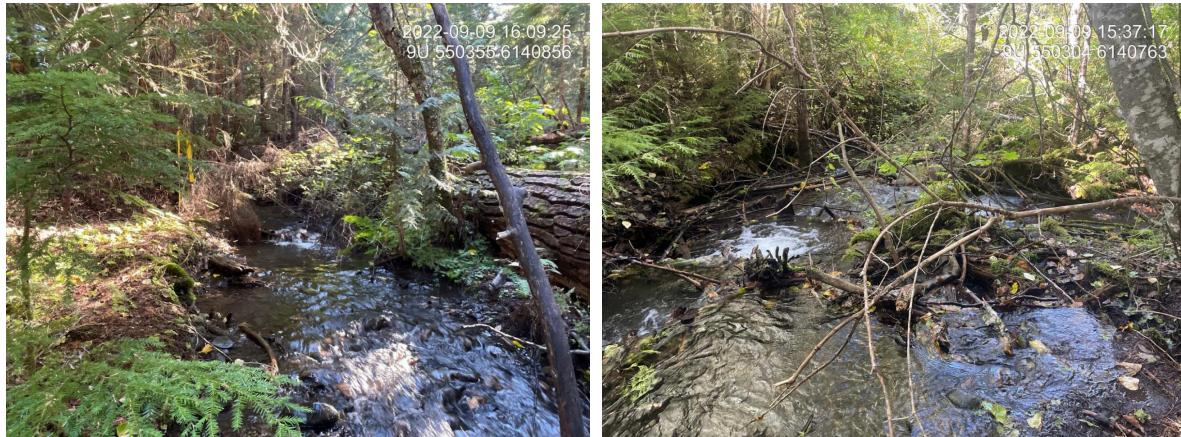
The stream was surveyed downstream from crossing 198236 for 200m (Figure 5.27). The dominant substrate was cobbles with gravels sub-dominant. Total cover amount was rated as moderate with

Figure 5.27: Left: Typical habitat downstream of PSCIS crossing 198236. Right: Typical habitat downstream of PSCIS crossing 198236.

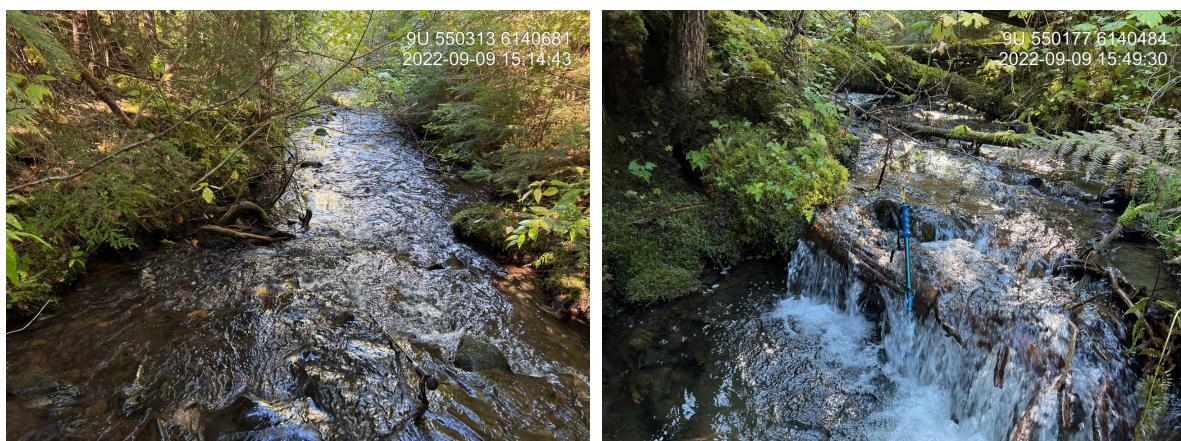
The stream was surveyed upstream from crossing 198236 for 500m (Figure [5.28](#)). The average channel width was 3m, the average wetted width was 2.6m, and the average gradient was 5.8%. The dominant substrate was gravels with cobbles sub-dominant. Total cover amount was rated as moderate with undercut banks dominant. Cover was also present as small woody debris, large woody debris, deep pools, and overhanging vegetation. There were abundant gravels noted as suitable for resident and anadromous salmonid spawning. There were frequent deep pools due to large woody debris in the canyon that was not logged. Overall, the habitat was rated as high value.

Figure 5.28: Left: Typical habitat upstream of PSCIS crossing 198236. Right: Typical habitat upstream of PSCIS crossing 198236.

Should restoration/maintenance activities proceed, replacement of PSCIS crossing 198236 with a bridge (15m span) is recommended. The cost of the work is estimated at \$450,000 for a cost benefit of 5.3 linear m/\$1000 and 6.1 m<sup>2</sup>/\$1000.

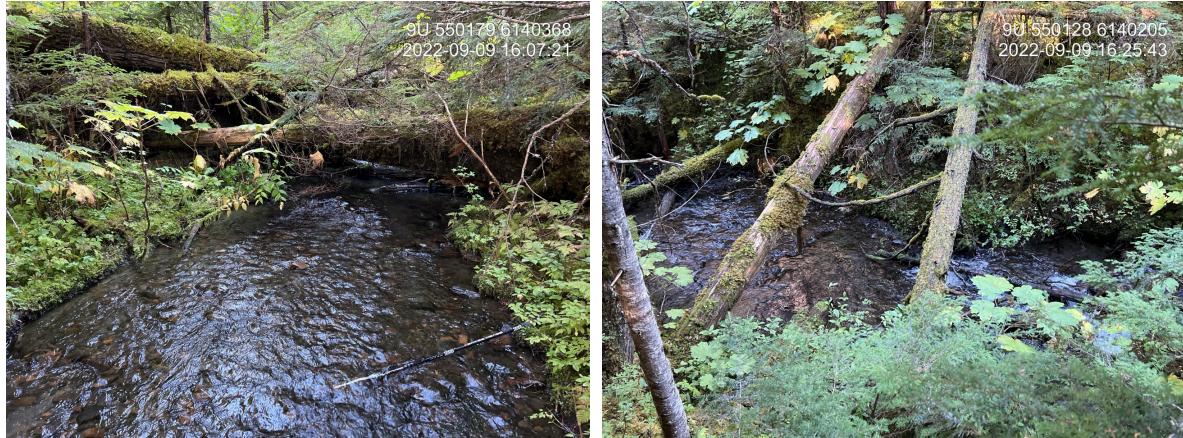
Figure 5.29: Left: Typical habitat upstream of PSCIS crossing 198236. Right: Typical habitat upstream of PSCIS crossing 198236.

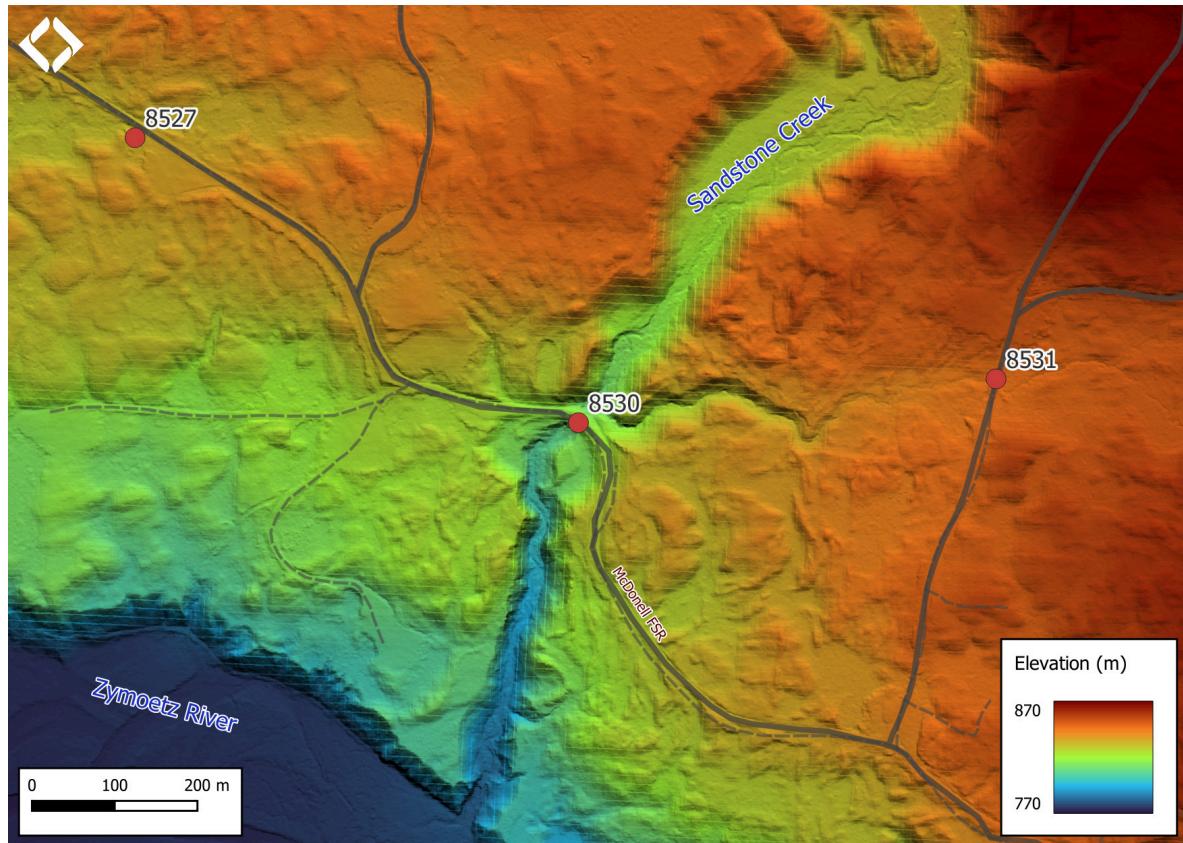
Figure 5.30: Lidar generated digital elevation model of Sandstone Creek at McDonell FSR (using elevation data from 2018).

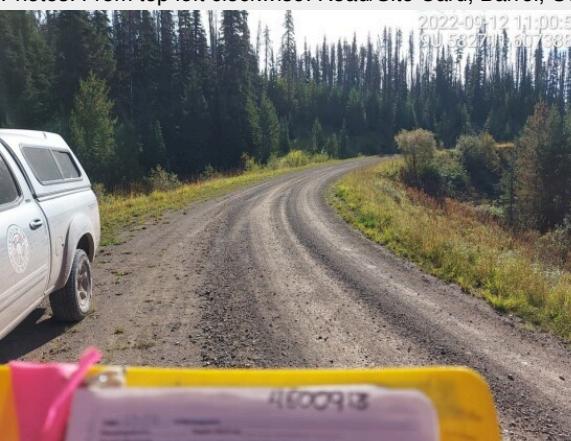
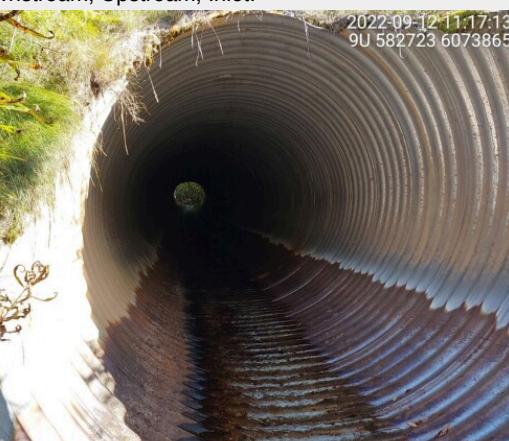
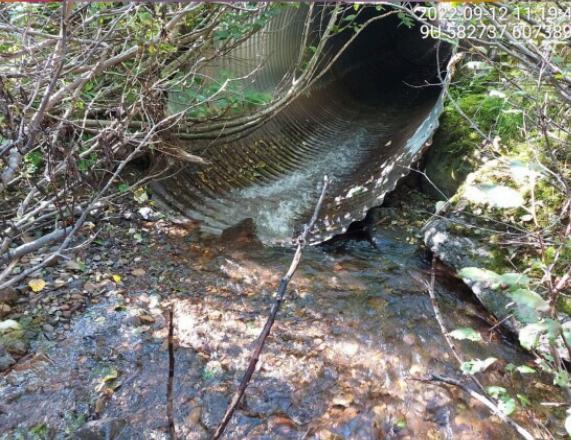
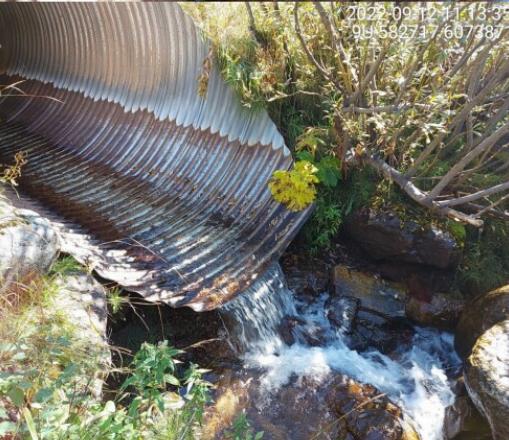
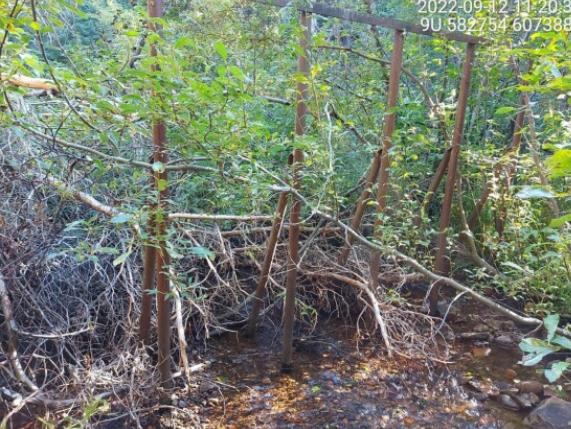
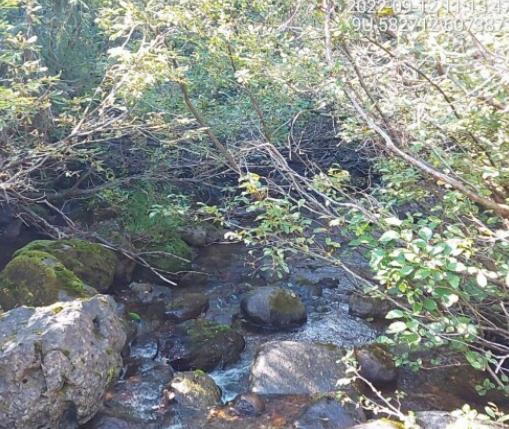
Location and Stream Data	•	Crossing Characteristics	-
Comments: Channel is steeper downstream of culvert. Very deep fill with a small outlet drop. 10:59			
Photos: From top left clockwise: Road/Site Card, Barrel, Outlet, Downstream, Upstream, Inlet.

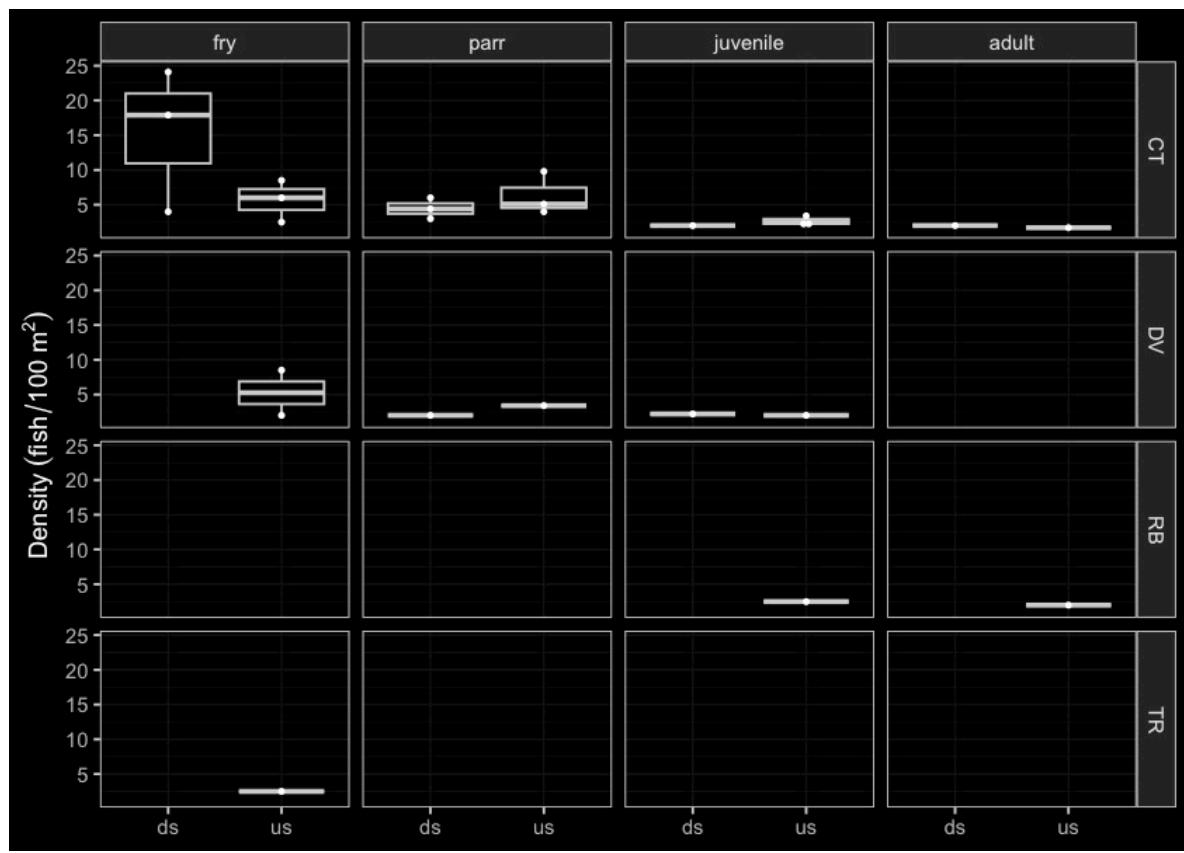
Figure 5.31: Densities of fish (fish/100m<sup>2</sup>) captured upstream of PSCIS crossing 8530.

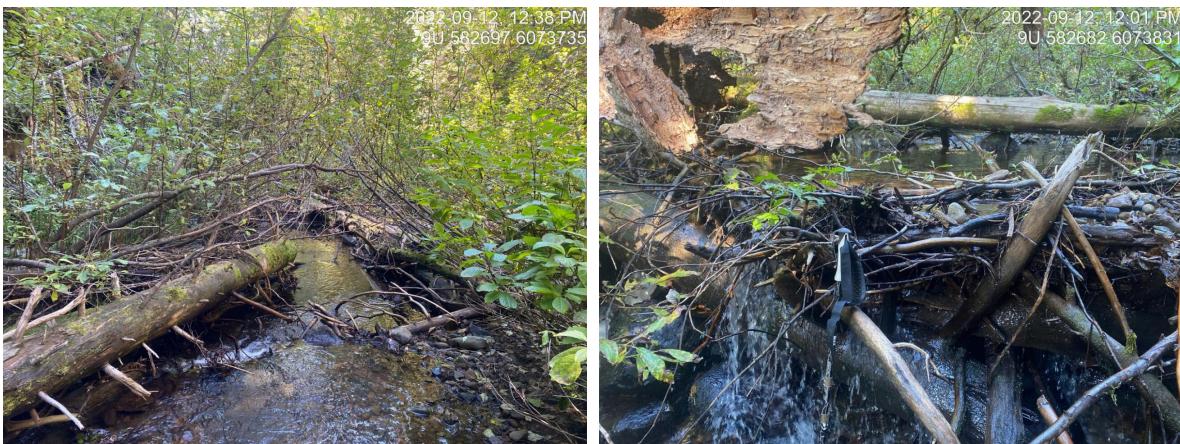
The stream was surveyed downstream from crossing 8530 for 275m (Figure 5.32). The average channel width was 4m, the average wetted width was 3.2m, and the average gradient was

Figure 5.32: Left: Typical habitat downstream of PSCIS crossing 8530. Right: Large woody debris jam downstream of PSCIS crossing 8530.

Should restoration/maintenance activities proceed, replacement of PSCIS crossing 8530 with a bridge (15m span) is recommended. The cost of the work is estimated at \$450,000 for a cost benefit of 12.7 linear m/\$1000 and 21.5 m<sup>2</sup>/\$1000.

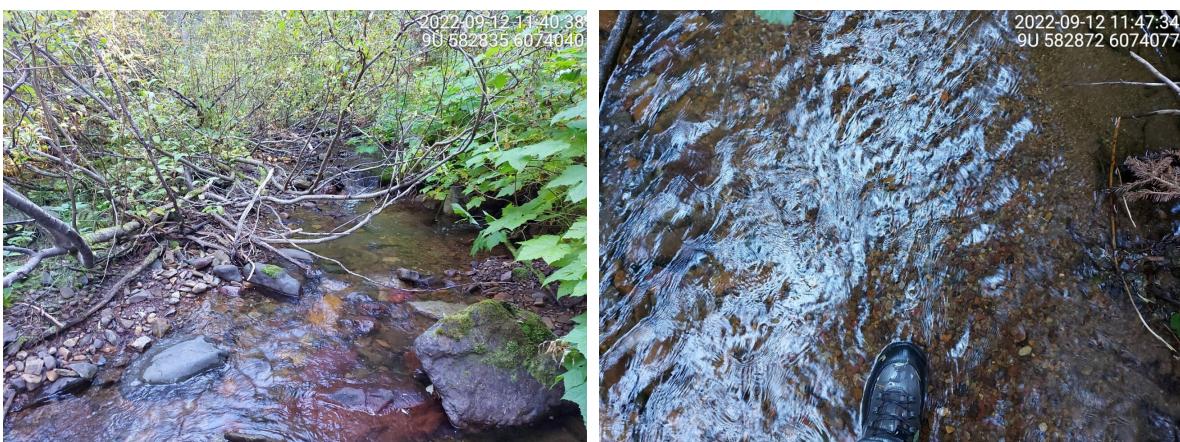
Figure 5.33: Left: Typical habitat upstream of PSCIS crossing 8530. Right: Area with suitable spawning gravels, upstream of PSCIS crossing 8530.

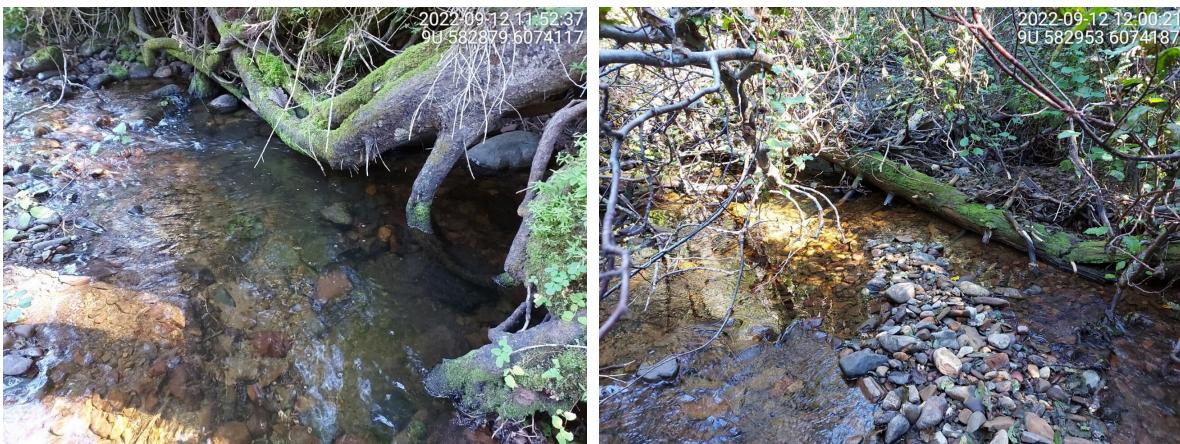
Figure 5.34: Left: Typical habitat upstream of PSCIS crossing 8530. Right: Typical habitat upstream of PSCIS crossing 8530.

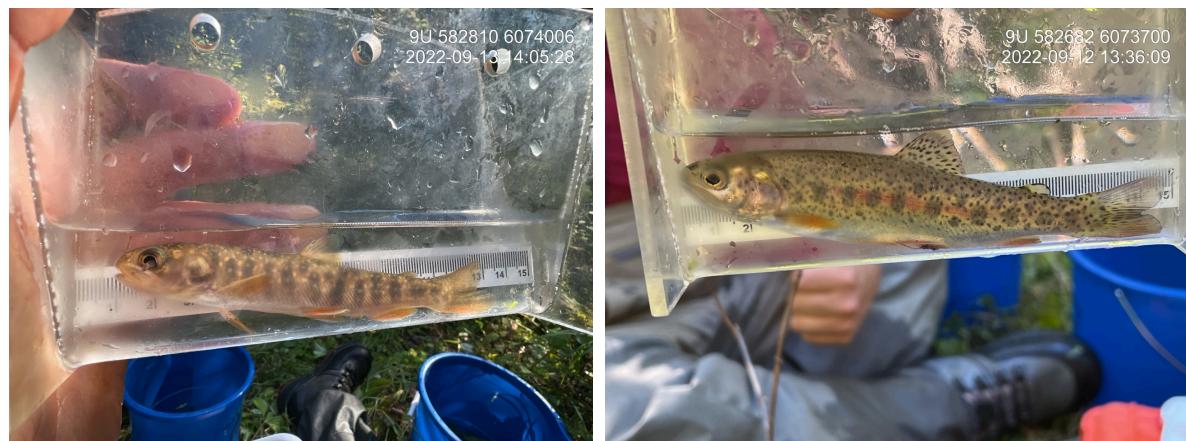
Figure 5.35: Left: Dolly Varden captured upstream of PSCIS crossing 8530. Right: Cutthroat trout captured downstream of PSCIS crossing 8530.
