Skeena Watershed Fish Passage Restoration Planning 2022

Prepared for
Habitat Conservation Trust Foundation - CAT23-6-288
BC Fish Passage Remediation Program
Ministry of Transportation and Infrastructure

Prepared by
Al Irvine, B.Sc., R.P.Bio. and Mateo Wintersheidt, B.Sc.
New Graph Environment Ltd.
on behalf of
Society for Ecosystem Restoration in Northern British Columbia

Version 0.1.0 2023-07-19

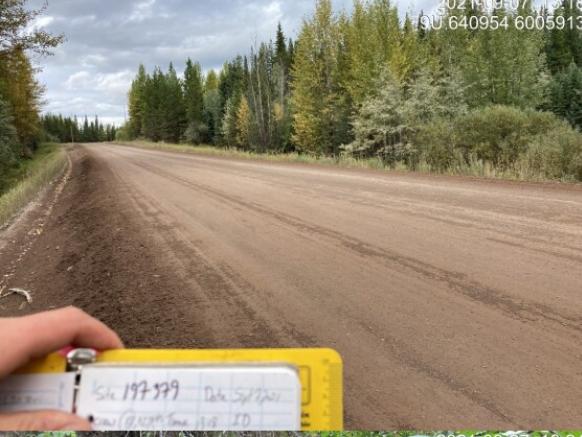
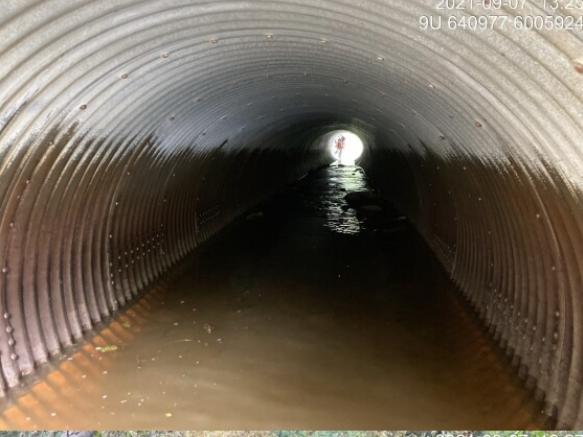
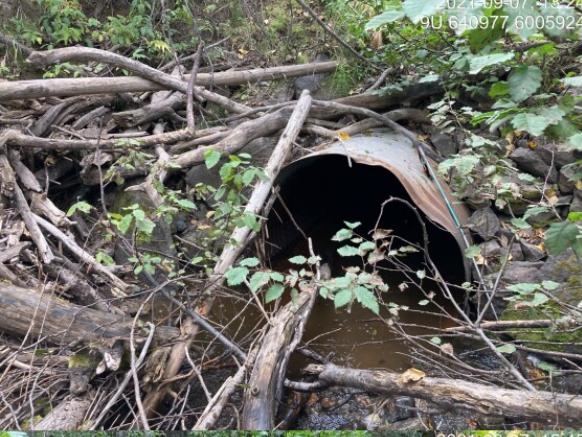
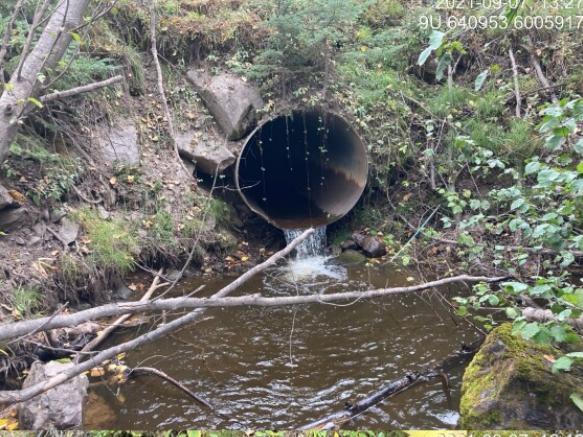
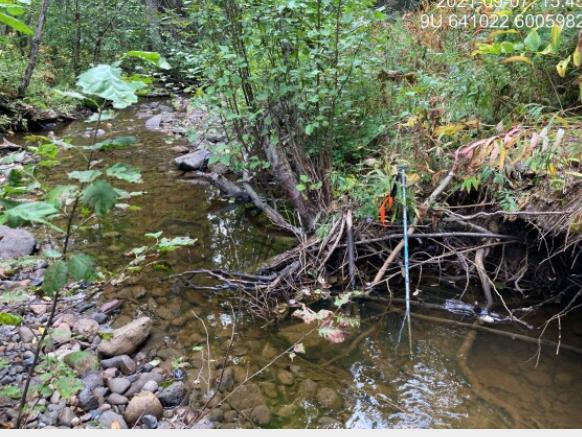
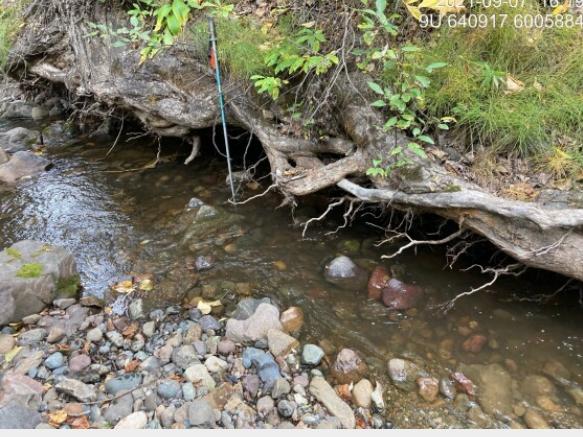
Location and Stream Data	•	Crossing Characteristics	-
Comments: Two thirds of culvert on upstream side has baffles. Fish sampling and PIT tagging conducted. Design underway by MoF. 13:18			
Photos: From top left clockwise: Road/Site Card, Barrel, Outlet, Downstream, Upstream, Inlet.

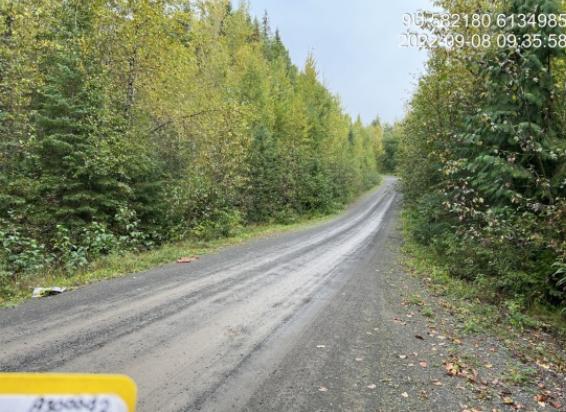
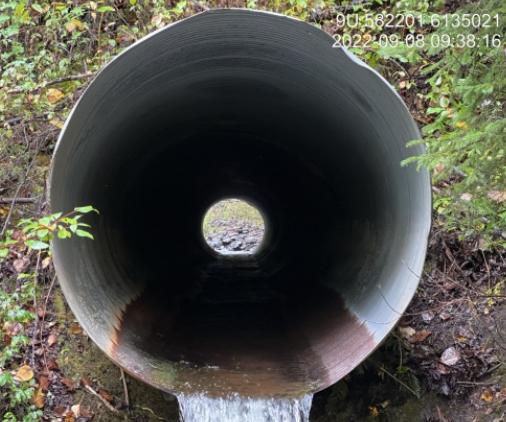
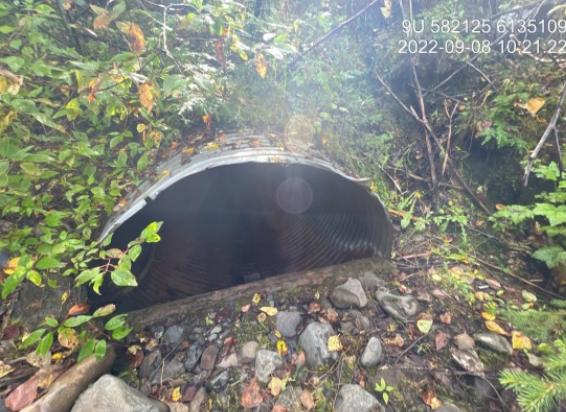
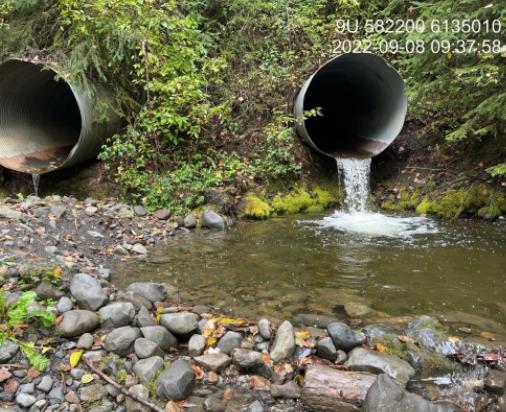
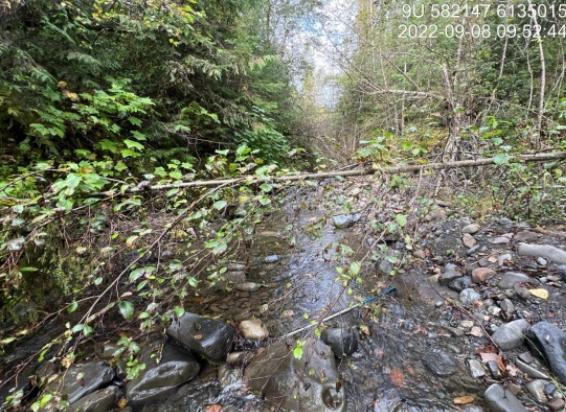
Location and Stream Data	•	Crossing Characteristics
Comments: .75-.90 m lock block step located approximately 30 m down stream of culvert. Double pipe however right pipe is not functioning and is 50% blocked at the outlet. Both pipes are of same diameter (1.85m). 9:32		
Photos: From top left clockwise: Road/Site Card, Barrel, Outlet, Downstream, Upstream, Inlet.

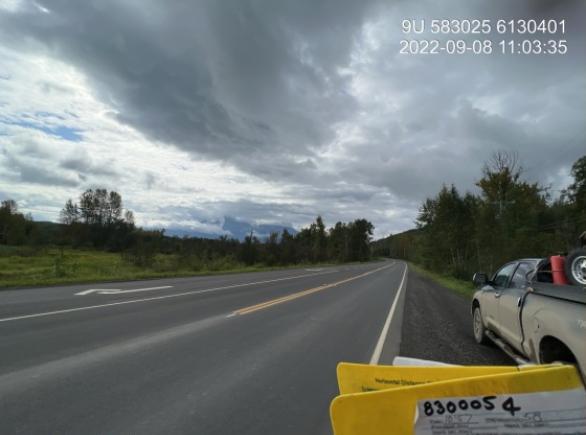
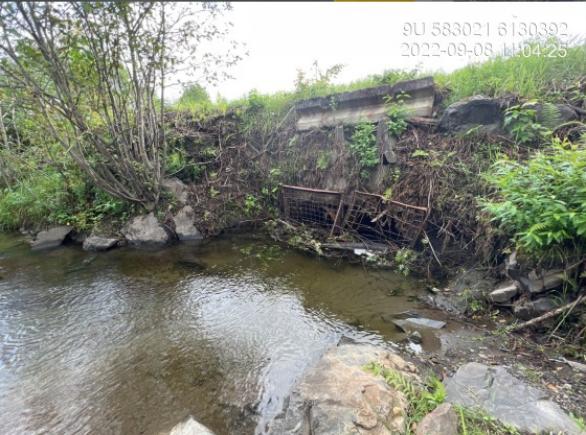
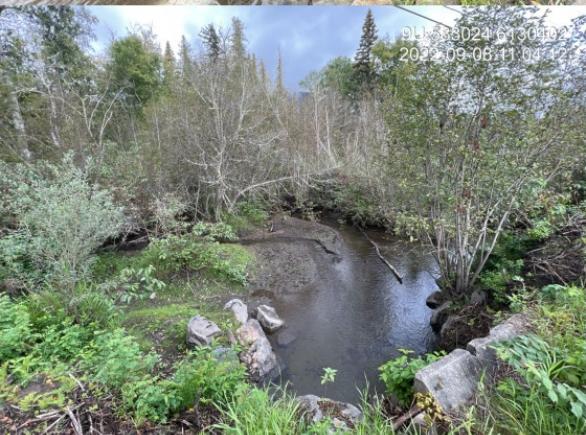
Location and Stream Data	•	Crossing Characteristics	-
Comments: Culvert appears very old and near end of life. Nice gravels upstream. Flow is moving between the two 1 m pipes. Trash rack on inlet could be barrier to adult coho migrating upstream. 10:57			
Photos: From top left clockwise: Road/Site Card, Barrel, Outlet, Downstream, Upstream, Inlet.

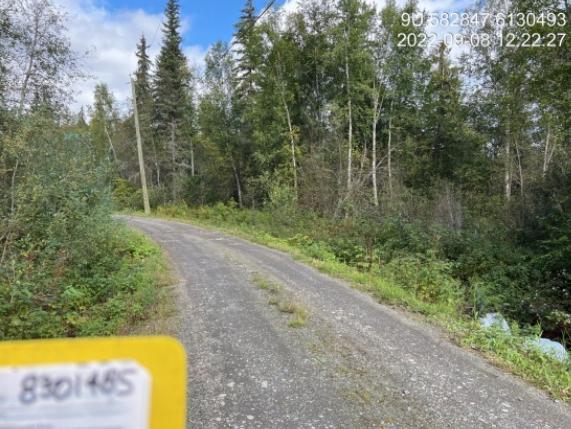
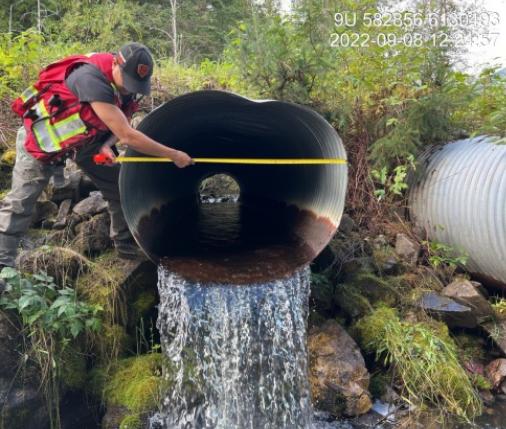
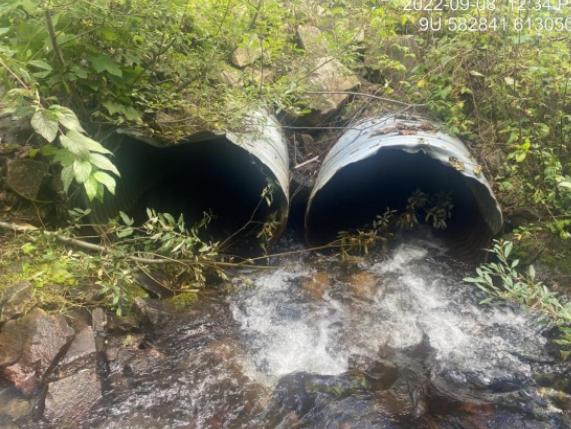
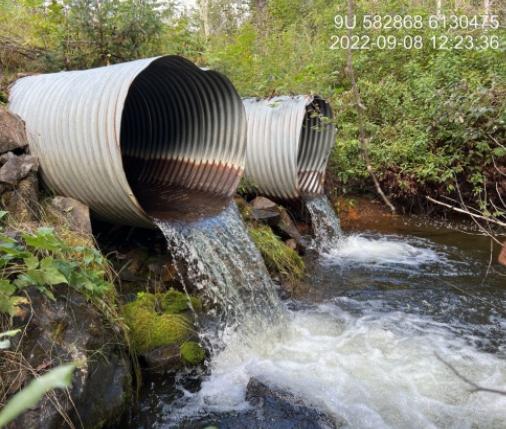
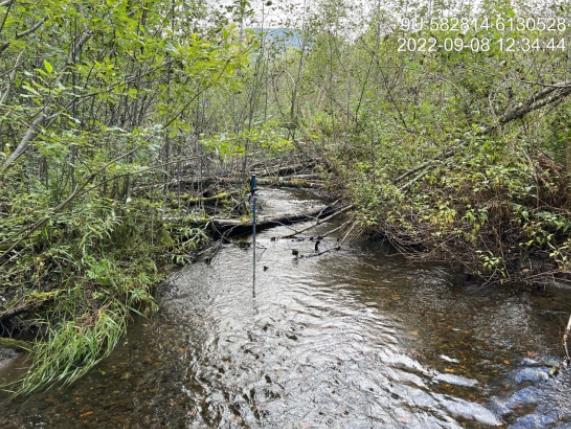
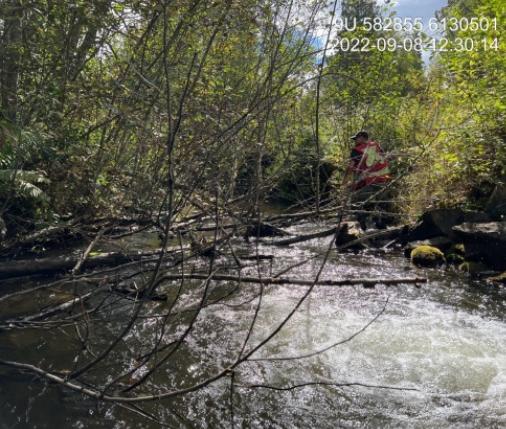
Location and Stream Data	•	Crossing Characteristics	-
<p>Comments: Francis (chief) indicated this is historic coho harvest site for Glen Vowell community and historic coho spawning stream. 2 1.25m culverts side by side. Trash rack has been removed from inlet. Inlet has significant amount of debris. Extensive gravels present suitable for CO spawning upstream and downstream. Good flow and large stream. On road to water treatment plant. 12:20</p>			
<p>Photos: From top left clockwise: Road/Site Card, Barrel, Outlet, Downstream, Upstream, Inlet.</p>

Although replacement of PSCIS crossing 198217 with a bridge (15m span with a cost estimated at \$300,000) is tentatively recommended, conditions within the greater watershed should be assessed more comprehensively first to determine how the channel alignment and wetland configuration/capacity (between Water Tower Road and the Skeena River) have been impacted by the installation of roads and Sik-E-Dakh community infrastructure as alternative options may provide greater restoration actions.

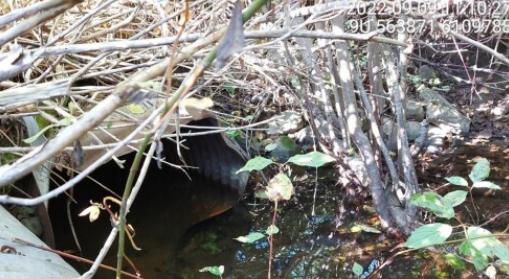
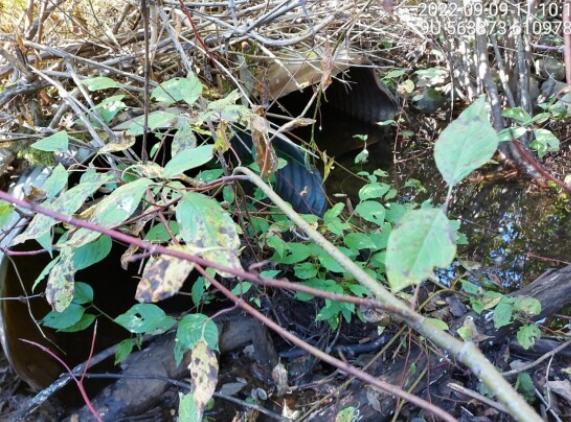
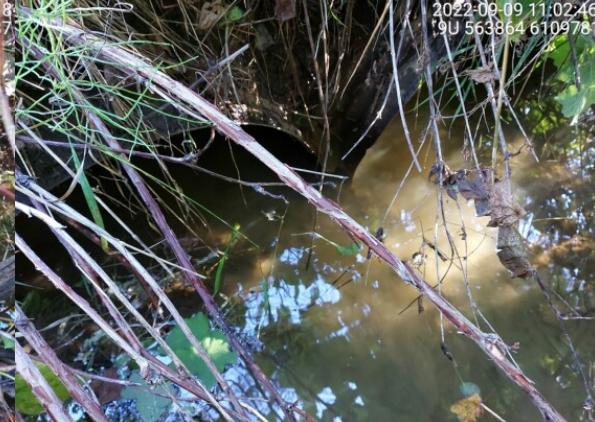
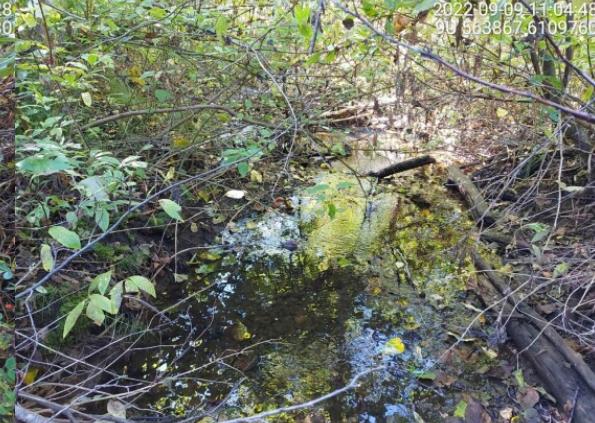
Location and Stream Data	•	Crossing Characteristics	-
Comments: Two culverts, both embedded with no drop. Fish spotted in culvert(up to 20 cm in length) and downstream. Erosion near culvert. 10:50			
Photos: From top left clockwise: Road/Site Card, Barrel, Outlet, Downstream, Upstream, Inlet.

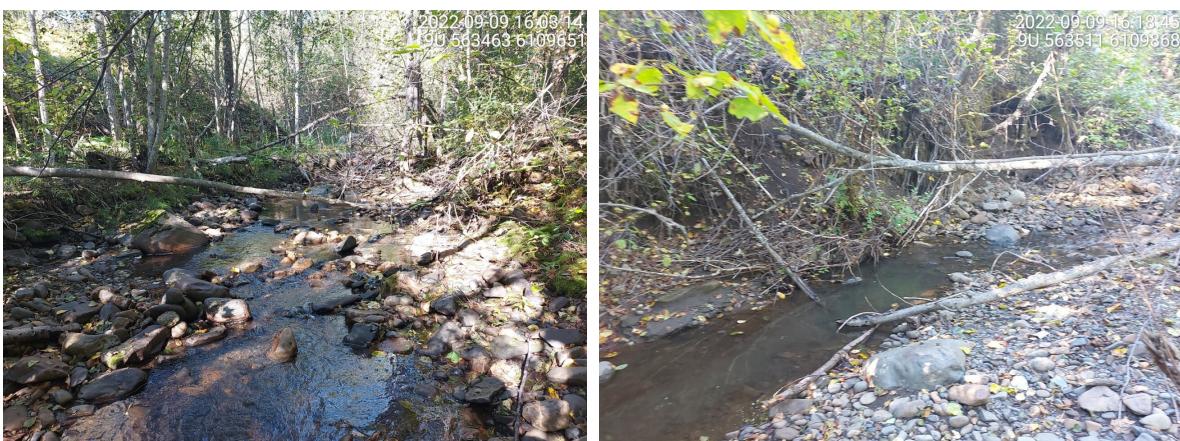
Figure 5.14: Left: Typical habitat upstream of PSCIS crossing 198220. Right: Typical habitat upstream of PSCIS crossing 198220.

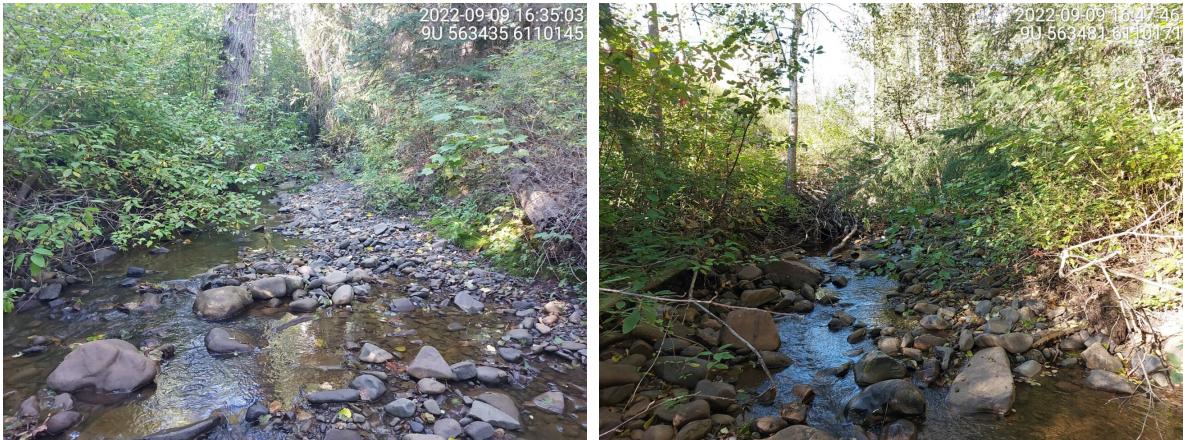
Figure 5.15: Left: Typical habitat upstream of PSCIS crossing 198220. Right: Typical habitat upstream of PSCIS crossing 198220.

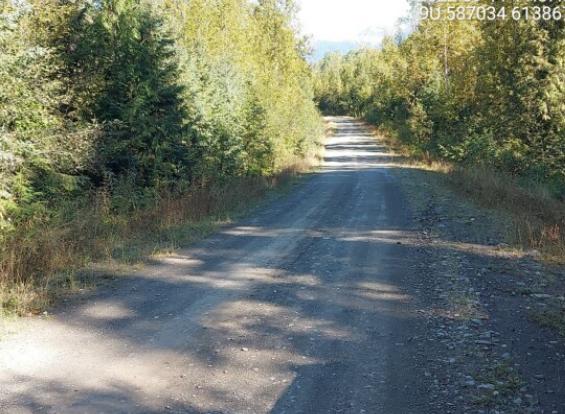
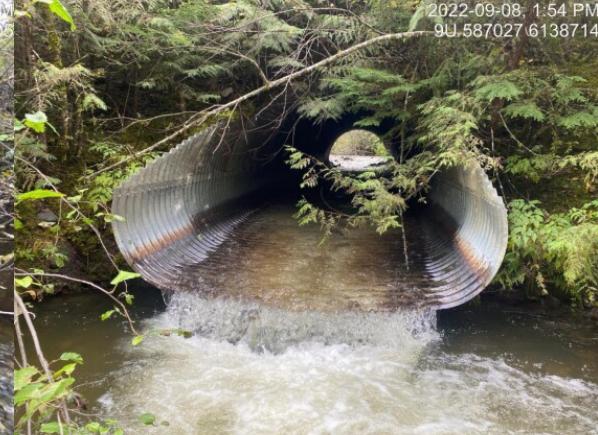
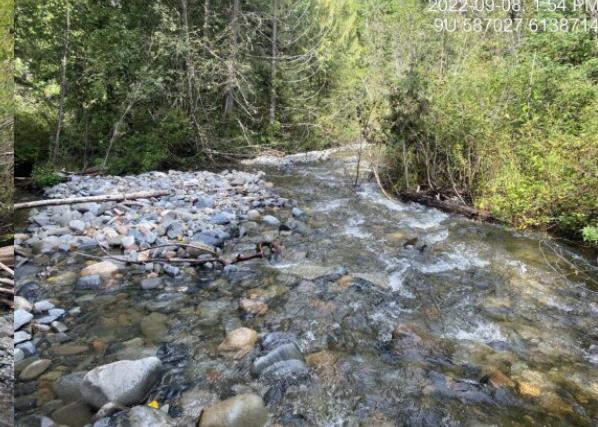
Location and Stream Data	•	Crossing Characteristics	-
Comments: Structure was replaced in 1985. Concrete wing walls on inlet. Structure is in decent shape. 13:39			
Photos: From top left clockwise: Road/Site Card, Barrel, Outlet, Downstream, Upstream, Inlet.

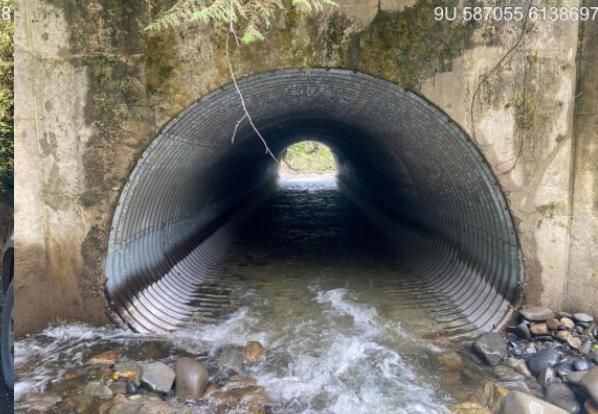
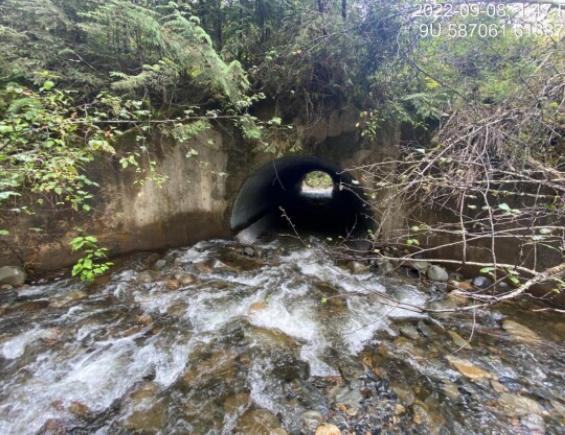
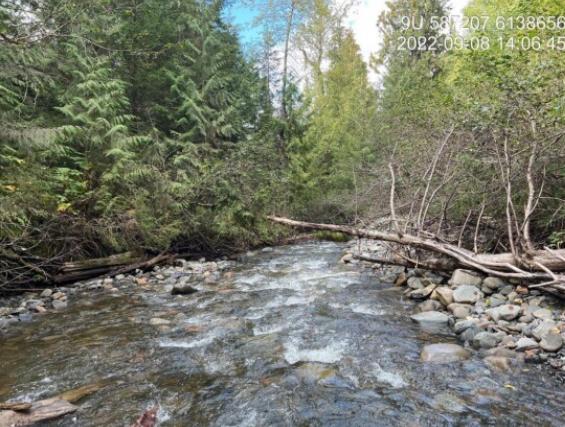
At the time of the survey, PSCIS crossing 198222 was un-embedded, non-backwatered and ranked as a barrier to upstream fish passage according to the provincial protocol (MoE 2011b) (Table 5.30). This crossing was replaced in 1985. Water temperature was 9.7°C, pH was 8.2 and conductivity was 75uS/cm.

Should restoration/maintenance activities proceed, replacement of PSCIS crossing 198222 with a bridge (15m span) is recommended. The cost of the work is estimated at \$375,000 for a cost benefit of 10453.3 linear m/\$1000 and 42858.7 m²/\$1000.

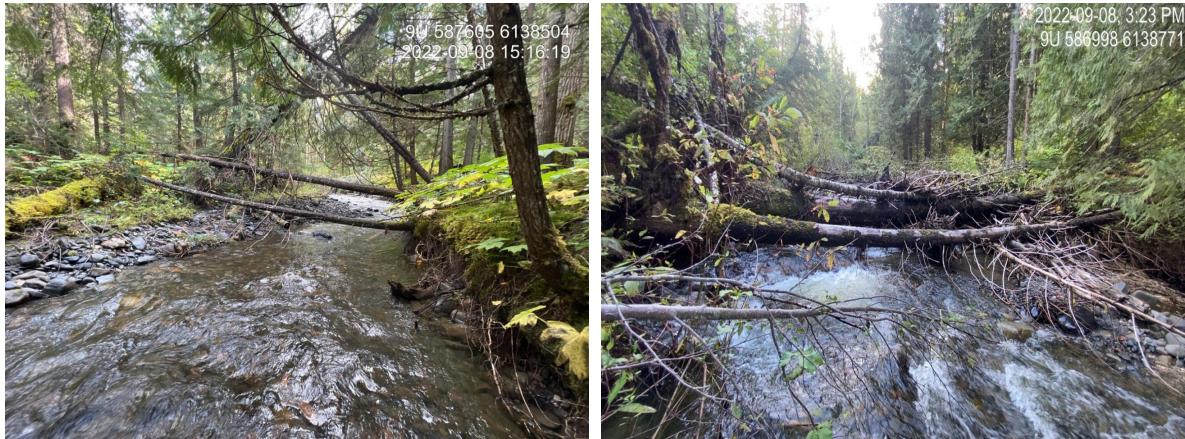
The stream was surveyed downstream from crossing 198222 for 150m (Figure 5.17). The average channel width was 8.1m, the average wetted width was 5.4m, and the average gradient was

Figure 5.17: Left: Typical habitat downstream of PSCIS crossing 198222. Right: Typical habitat downstream of PSCIS crossing 198222.

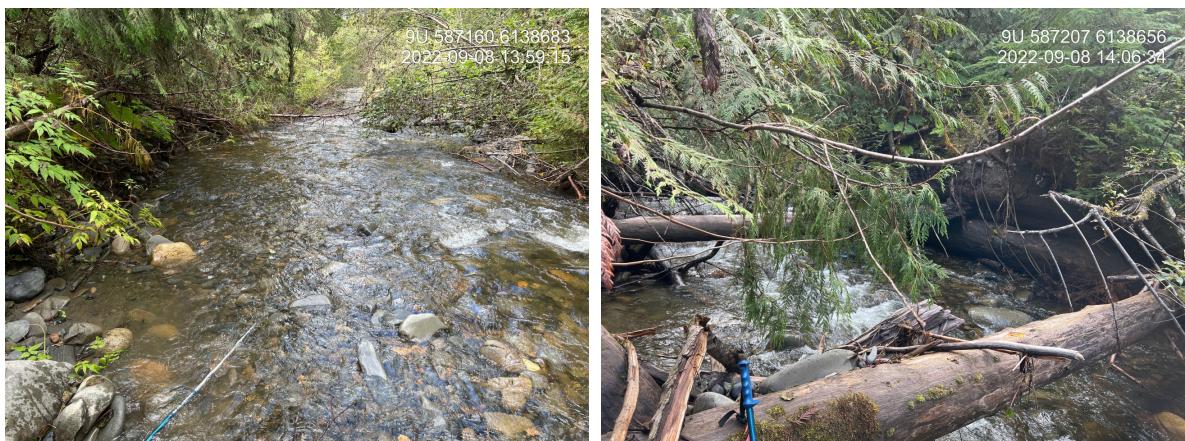
Figure 5.18: Left: Typical habitat upstream of PSCIS crossing 198222. Right: Collapsed bridge upstream of PSCIS crossing 198222.

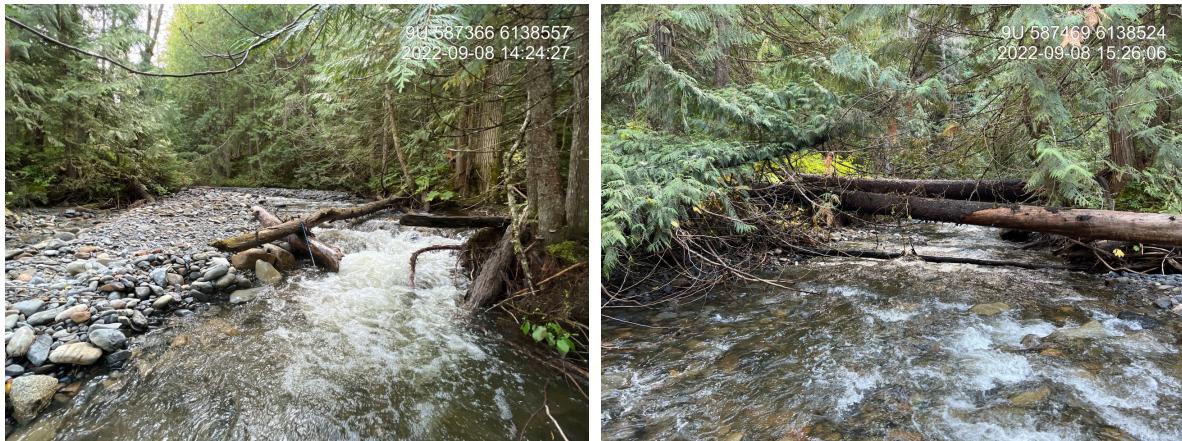
Figure 5.19: Left: Typical habitat upstream of PSCIS crossing 198222. Right: Typical habitat upstream of PSCIS crossing 198222.

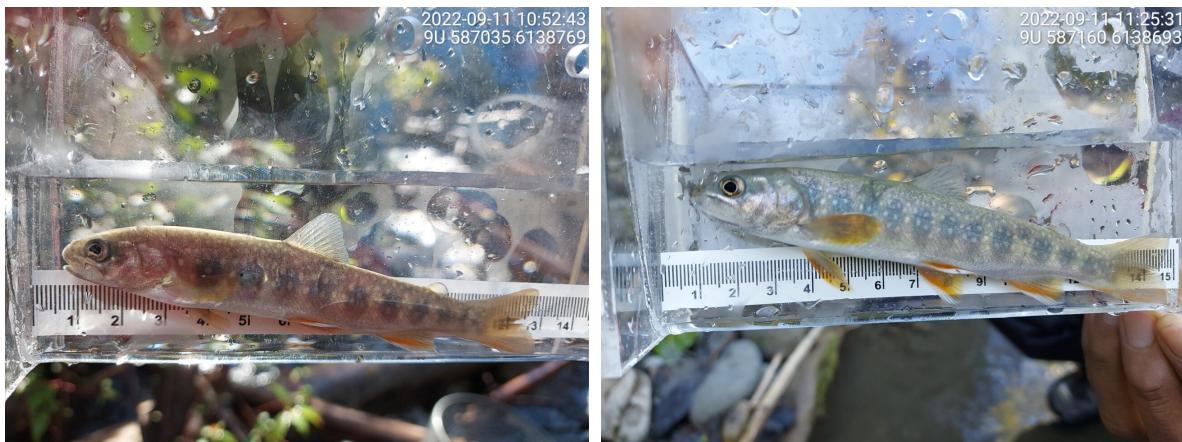
To assess potential impacts of the culvert on fisheries values in the stream, minnowtrapping was conducted upstream and downstream of the crossing. Two traps were set downstream of the crossing and two were set upstream; traps were left overnight. 1 dolly varden was captured upstream and 6 dolly varden were captured downstream (Figure 5.20).

Figure 5.20: Left: Dolly Varden captured downstream of PSCIS crossing 198222. Right: Dolly Varden captured upstream of PSCIS crossing 198222.

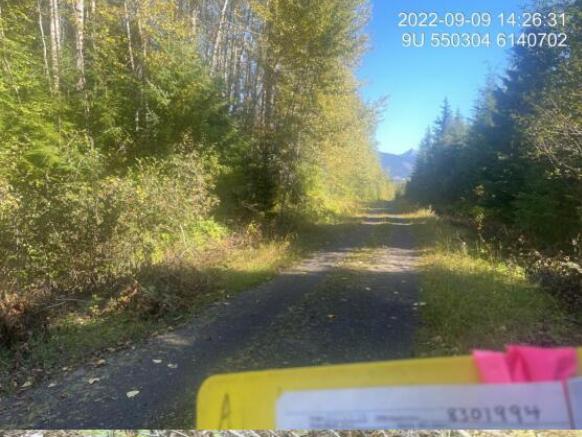
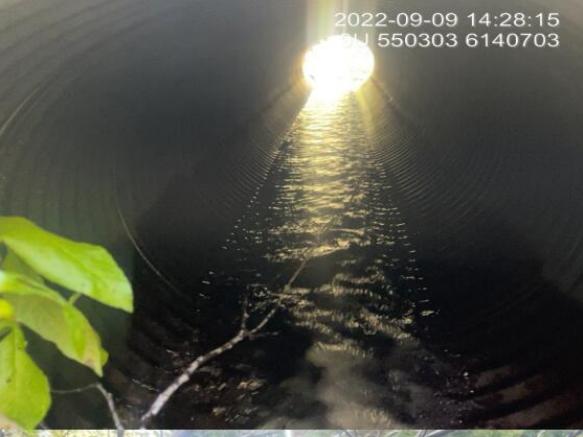
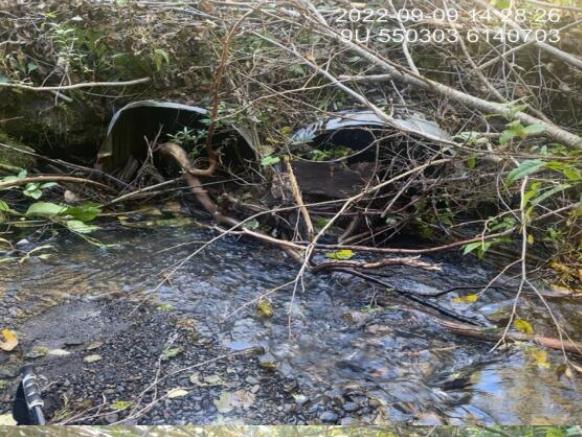
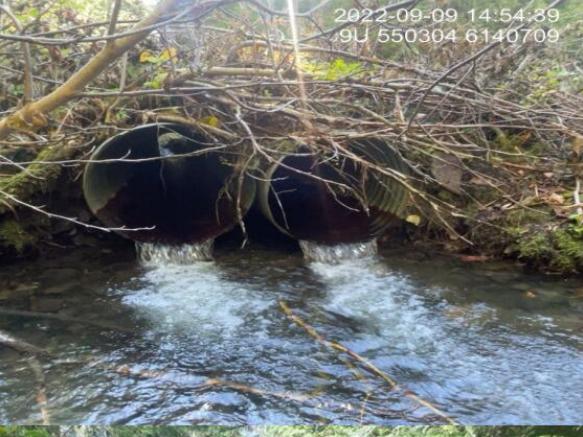
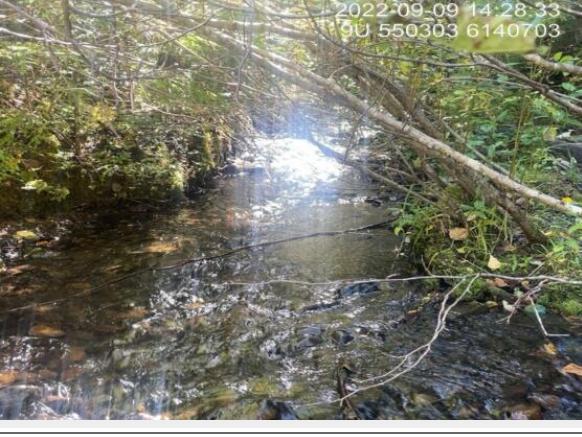
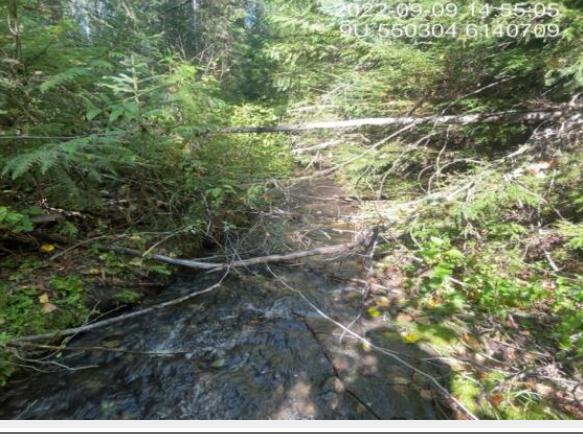
Location and Stream Data		Crossing Characteristics –	
Date	2022-09-09	Crossing Sub Type	Round Culvert
PSCIS ID	198236	Diameter (m)	1.7
External ID	–	Length (m)	10
Crew	AI JO	Embedded	No
UTM Zone	9	Depth Embedded (m)	–
Easting	550300	Resemble Channel	No
Northing	6140708	Backwatered	No
Stream	Tributary to Kitwanga River	Percent Backwatered	–
Road	Kitwancool Branch 2 FSR	Fill Depth (m)	0.45
Road Tenure	MoF 8687	Outlet Drop (m)	0.24
Channel Width (m)	2.3	Outlet Pool Depth (m)	0.22
Stream Slope (%)	1	Inlet Drop	Yes
Beaver Activity	Yes	Slope (%)	2
Habitat Value	Medium	Valley Fill	Deep Fill
Final score	26	Barrier Result	Barrier
Fix type	Replace with New Open Bottom Structure	Fix Span / Diameter	15

Location and Stream Data	•	Crossing Characteristics	-
Comments: Two culverts side by side (0.85m each). 14:23			
Photos: From top left clockwise: Road/Site Card, Barrel, Outlet, Downstream, Upstream, Inlet.

Should restoration/maintenance activities proceed, replacement of PSCIS crossing 198236 with a bridge (15m span) is recommended. The cost of the work is estimated at \$375,000 for a cost benefit of 0 linear m/\$1000 and 0 m²/\$1000.

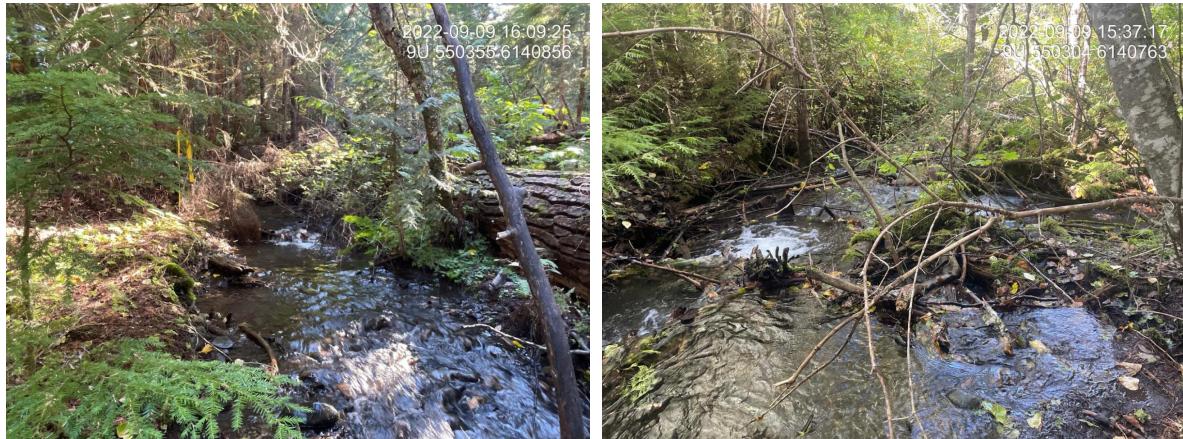
The stream was surveyed downstream from crossing 198236 for 200m (Figure 5.24). Total cover amount was rated as moderate with overhanging vegetation dominant. Cover was also present as

Figure 5.24: Left: Typical habitat downstream of PSCIS crossing 198236. Right: Typical habitat downstream of PSCIS crossing 198236.

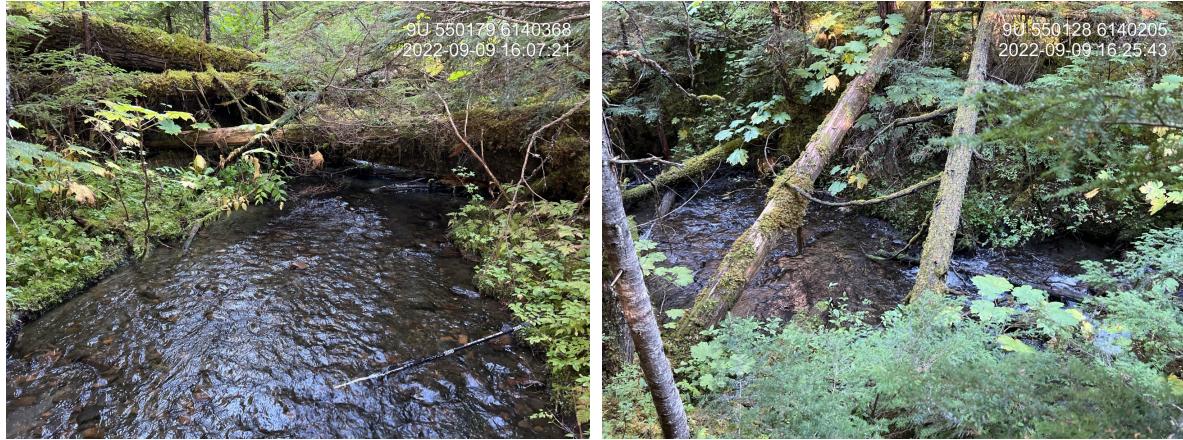
Figure 5.26: Left: Typical habitat upstream of PSCIS crossing 198236. Right: Typical habitat upstream of PSCIS crossing 198236.

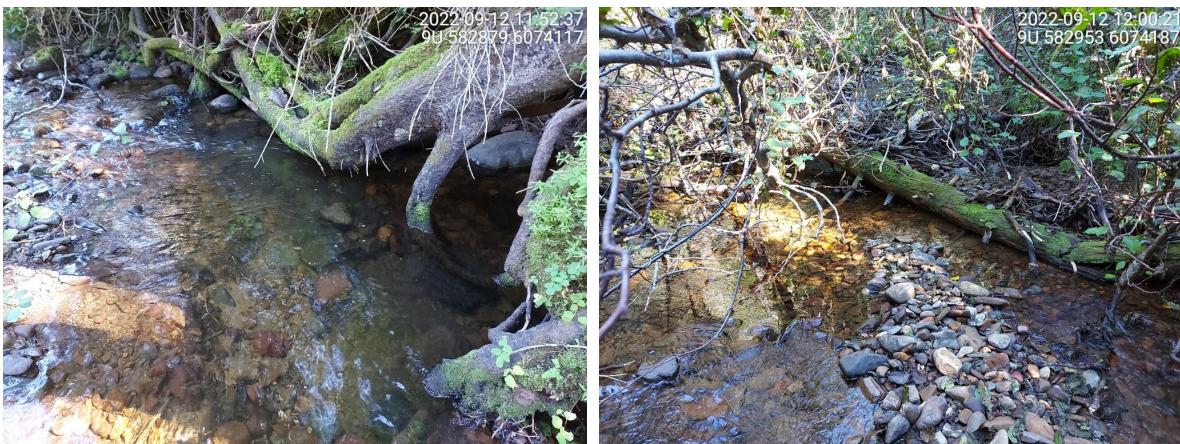
Figure 5.31: Left: Typical habitat upstream of PSCIS crossing 8530. Right: Typical habitat upstream of PSCIS crossing 8530.
