Skeena Watershed Fish Passage Restoration Planning 2022

Prepared for
Habitat Conservation Trust Foundation - CAT23-6-288
BC Fish Passage Remediation Program
Ministry of Transportation and Infrastructure

Prepared by
Al Irvine, B.Sc., R.P.Bio. and Mateo Wintersheidt, B.Sc.
New Graph Environment Ltd.
on behalf of
Society for Ecosystem Restoration in Northern British Columbia

Version 0.0.1 2023-05-25

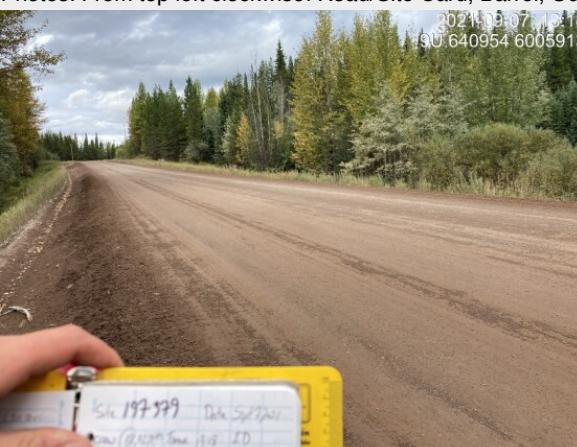
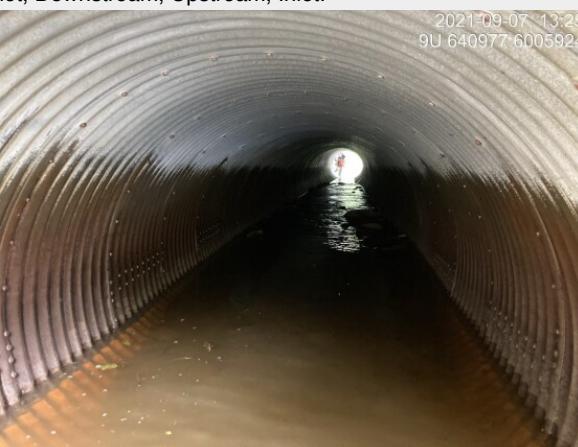
Location and Stream Data		Crossing Characteristics –	
Stream	Tributary to Owen Creek	Percent Backwatered	–
Road	Morice-Owen FSR	Fill Depth (m)	5
Road Tenure	FLNR DND 9947	Outlet Drop (m)	0.47
Channel Width (m)	6.4	Outlet Pool Depth (m)	0.9
Stream Slope (%)	4.8	Inlet Drop	No
Beaver Activity	No	Slope (%)	1.5
Habitat Value	High	Valley Fill	Deep Fill
Final score	34	Barrier Result	Barrier
Fix type	Replace with New Open Bottom Structure	Fix Span / Diameter	16

Location and Stream Data	•	Crossing Characteristics	-
Comments: 2/3 upstream culvert has baffles. 13:18			
Photos: From top left clockwise: Road/Site Card, Barrel, Outlet, Downstream, Upstream, Inlet.

There was 0.8km of habitat upstream of the culvert between the Morice-Owen FSR and the 8m high waterfall with habitat rated as high value for coho, steelhead and resident rainbow/cutthroat rearing and spawning. Crossing 197379 was ranked as a high priority for proceeding to design for replacement. Of note, at the time of reporting, due to our prioritization work, a design for a replacement structure to more effectively facilitate upstream migration for all fish life stages and species was being developed by Mark Dewit from the Ministry of Forests. In addition to replacement of the culvert with a bridge, recommendations going forward include:

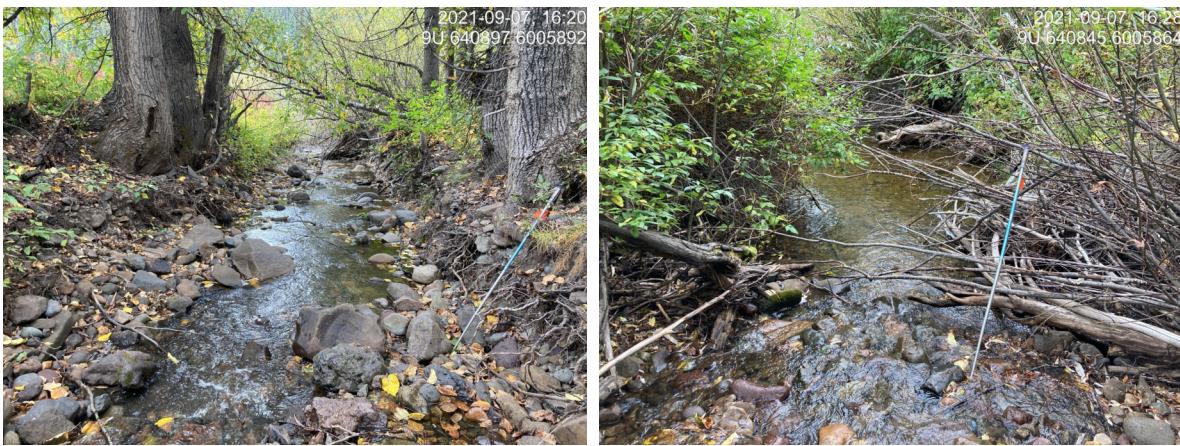
The stream was surveyed downstream from crossing 197379 for 190m (Figure 5.2). The dominant substrate was cobbles with gravels sub-dominant. The average channel width was 4.3m, the

Figure 5.2: Left: Typical habitat downstream of PSCIS crossing 197379. Right: Typical habitat downstream of PSCIS crossing 197379.

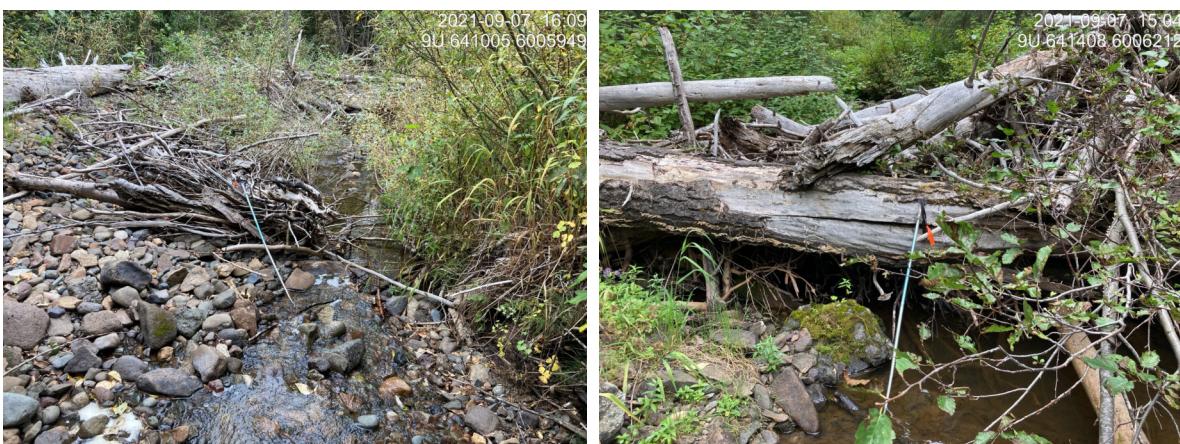
The stream was surveyed for 800m in a downstream direction to the culvert from the location of an approximately 8m high waterfall (Figure [5.3](#)). Total cover amount was rated as moderate with undercut banks dominant. Cover was also present as small woody debris, large woody debris, deep pools, and overhanging vegetation. The average channel width was 6.4m, the average wetted width was 3.1m, and the average gradient was 4.8%. The dominant substrate was cobbles with gravels sub-dominant. Near the falls, bedrock dominated the stream substrate and the gradient was noted as 7%. The mixed deciduous and coniferous forest riparian was noted as healthy. Pockets of gravel suitable for coho, steelhead and resident rainbow trout/cutthroat trout were observed. Overall, the habitat upstream of the FSR was rated as high value, containing habitat suitable for rearing and spawning of both anadromous as well as resident fish species. Of note, when the site was revisited in 2022 the stream was primarily dewatered with numerous fish concentrated within isolated pools.

Figure 5.3: Left: Typical habitat upstream of PSCIS crossing 197379. Right: Large woody debris jam upstream of PSCIS crossing 197379.

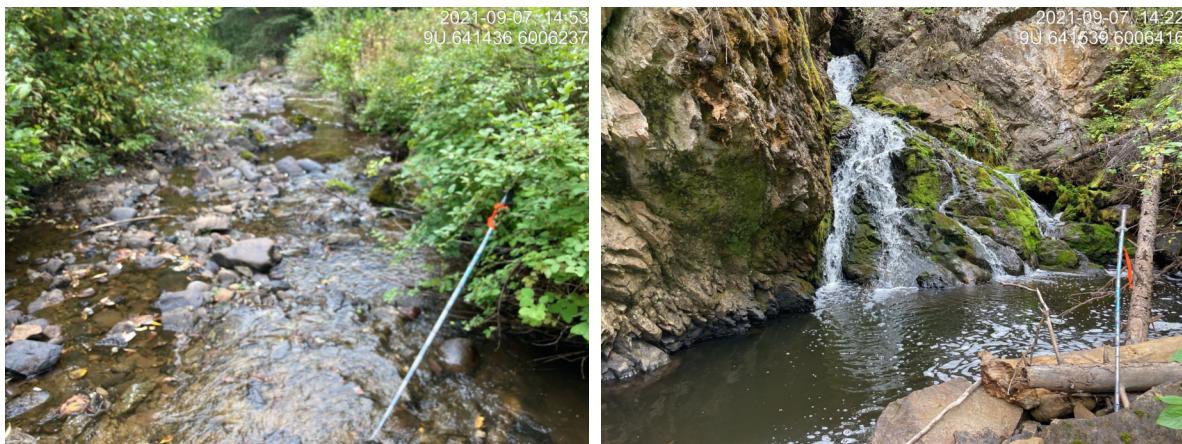
Figure 5.4: Left: Typical habitat upstream of PSCIS crossing 197379. Right: Waterfall upstream of PSCIS crossing 197379.

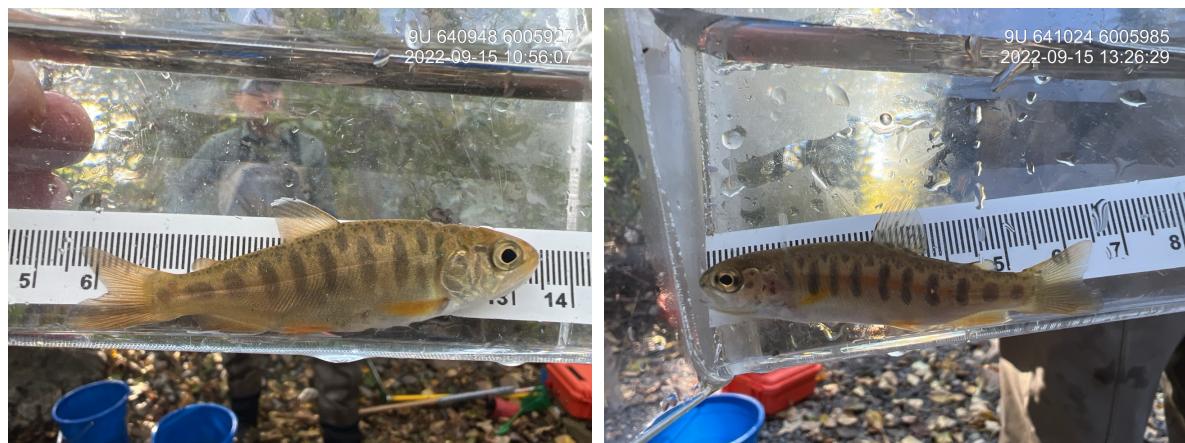
Figure 5.5: Left: Coho trout captured downstream of PSCIS crossing 197379. Right: Cutthroat trout captured upstream of PSCIS crossing 197379.

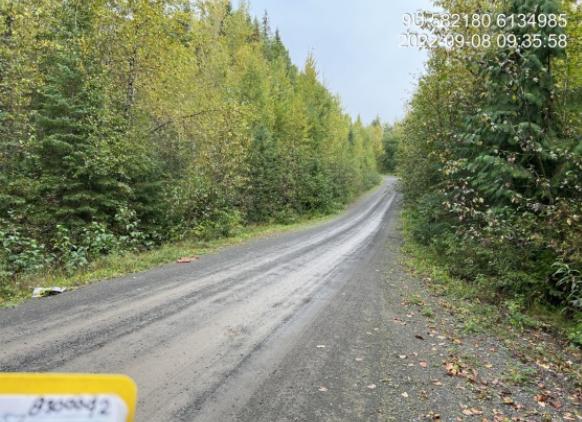
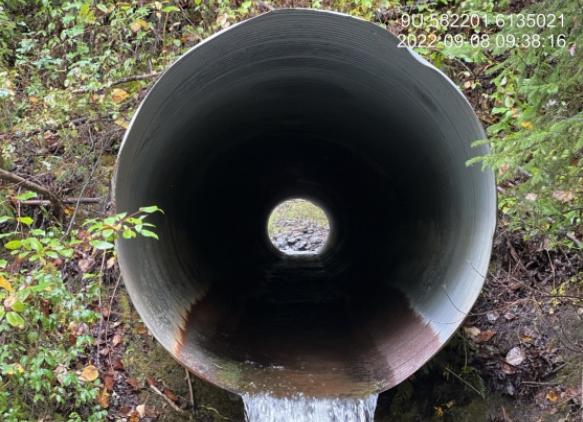
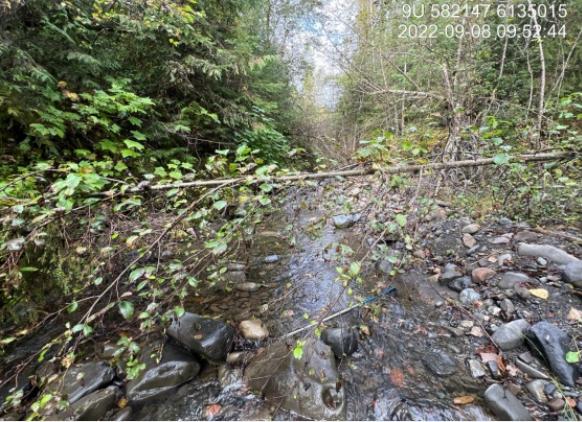
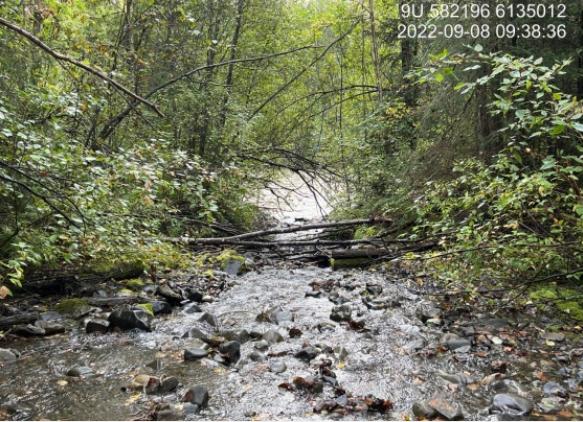
Location and Stream Data	•	Crossing Characteristics	-
Comments: .75-.90 m lock block step approximately 30 m down stream of culvert. Double pipe however right pipe is not functioning and is 50% blocked at the outlet. Both pipes are of similar diameter. Combined diameter of 3.7m. 9:32			
Photos: From top left clockwise: Road/Site Card, Barrel, Outlet, Downstream, Upstream, Inlet.

Should restoration/maintenance activities proceed, replacement of PSCIS crossing 198215 with a bridge (17.5m span) is recommended. The cost of the work is estimated at \$1,750,000 for a cost benefit of 0 linear m/\$1000 and 0 m²/\$1000.

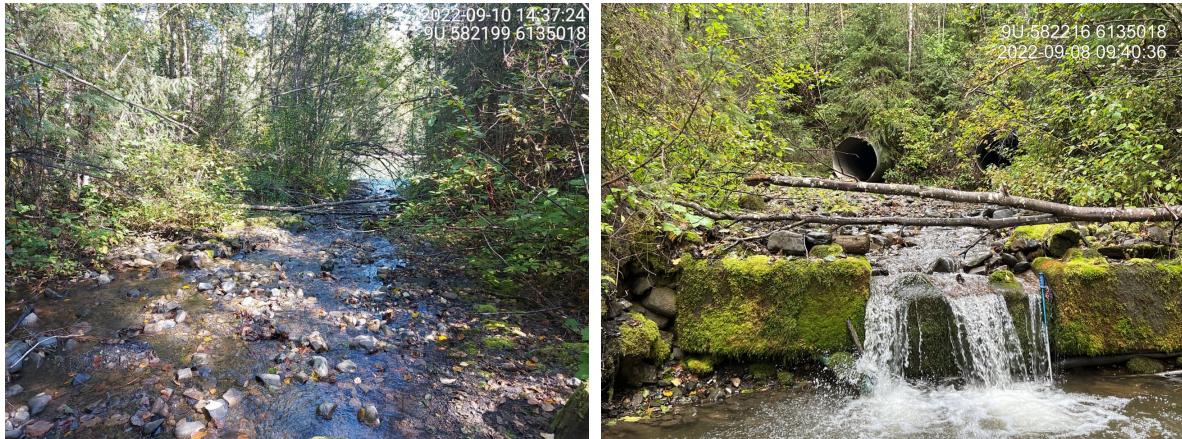
The stream was surveyed downstream from crossing 198215 for 60m to the confluence with the Kispiox River (Figure [5.6](#)). Total cover amount was rated as trace with boulders dominant. Cover was also present as large woody debris and overhanging vegetation. The average channel width was 5.3m, the average wetted width was 2.1m, and the average gradient was 11%. The dominant substrate was cobbles with gravels sub-dominant. This stretch of stream was steep but had good habitat. There was one lock block step approximately 30m downstream of the culvert that was approximately 1m in height that could block upstream migration for non adult fish species (Figure [??](#)). This was likely put in this location in the past to act as a backwatering structure and attempt to minimize the culvert outlet drop to facilitate upstream fish passage. The habitat was rated as medium value for salmonid rearing and spawning.

Figure 5.6: Left: Typical habitat downstream of PSCIS crossing 198215. Right: Lock block step downstream of PSCIS crossing 198215.

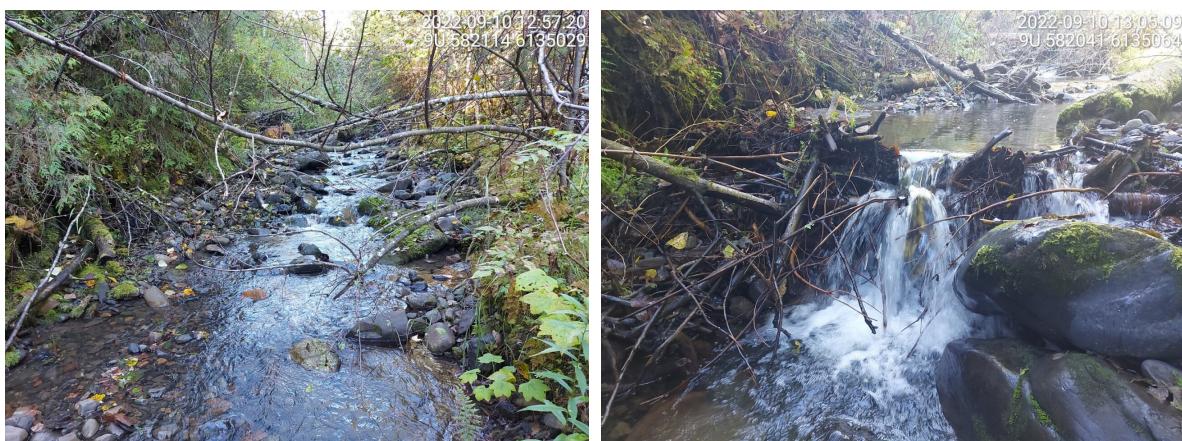
Figure 5.7: Left: Typical habitat upstream of PSCIS crossing 198215. Right: Typical habitat upstream of PSCIS crossing 198215.

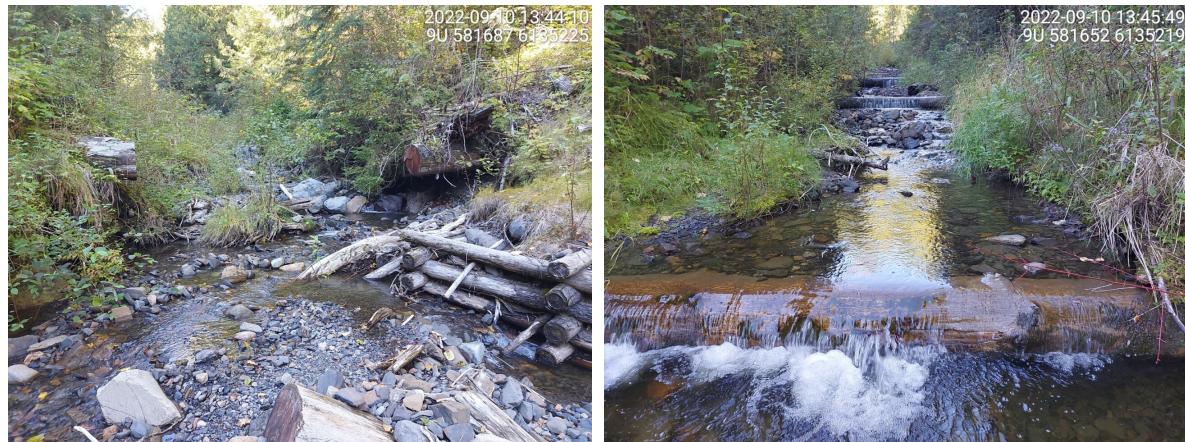
Figure 5.8: Left: Location of old historic dam, upstream of PSCIS crossing 198215. Right: Typical habitat upstream of PSCIS crossing 198215.

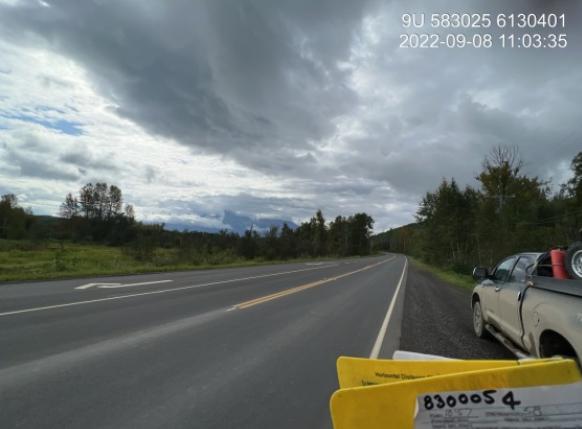
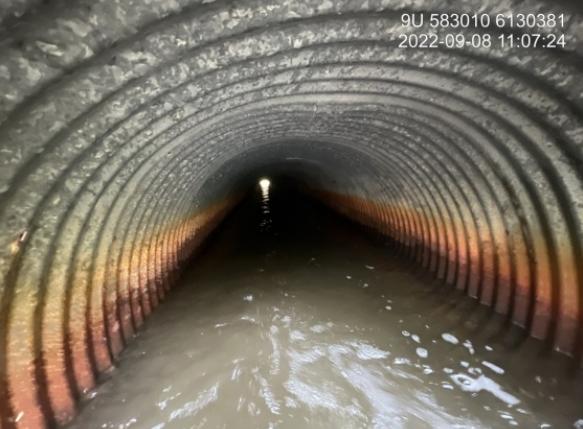
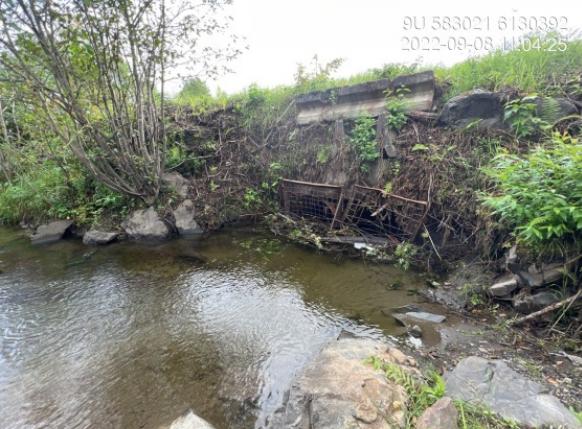
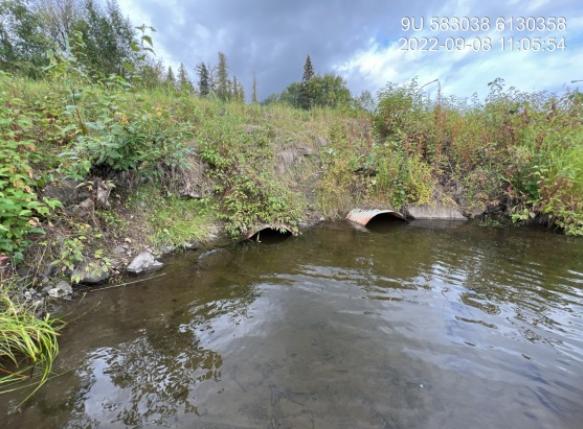
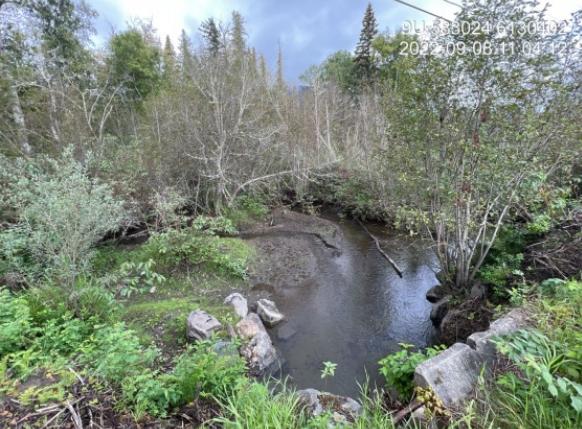
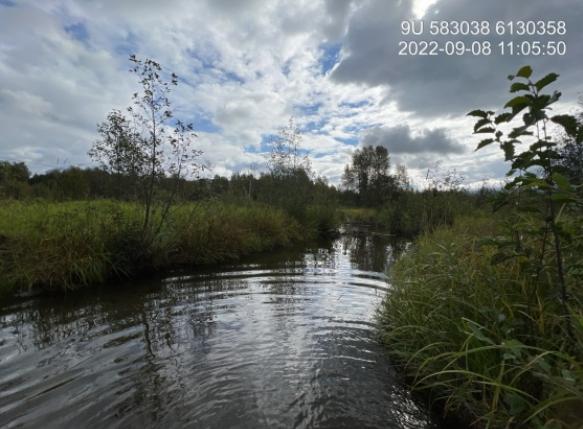
Location and Stream Data	•	Crossing Characteristics	-
Comments: Culvert appears very old and near end of life. Nice gravels upstream. Flow is moving between the two 1 m pipes. Trash rack on inlet would be barrier to coho moving up to spawn. 10:57			
Photos: From top left clockwise: Road/Site Card, Barrel, Outlet, Downstream, Upstream, Inlet.

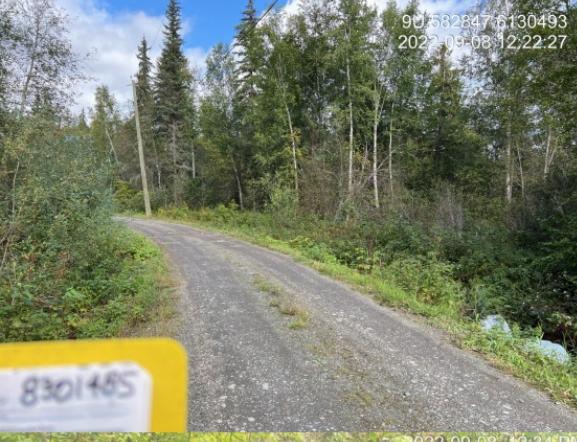
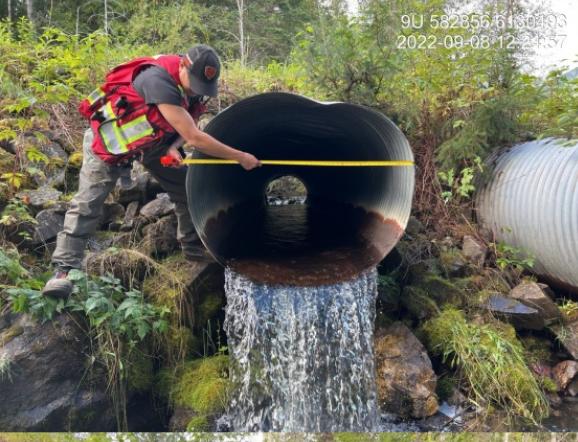
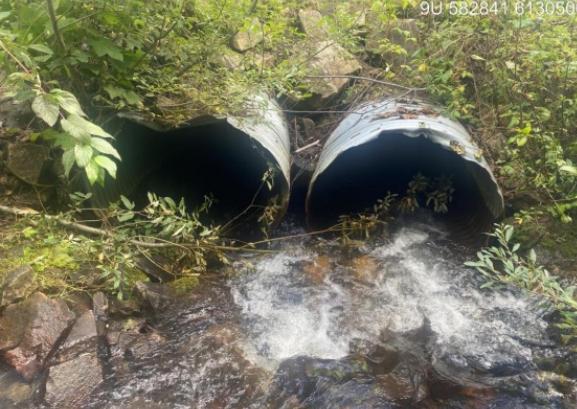
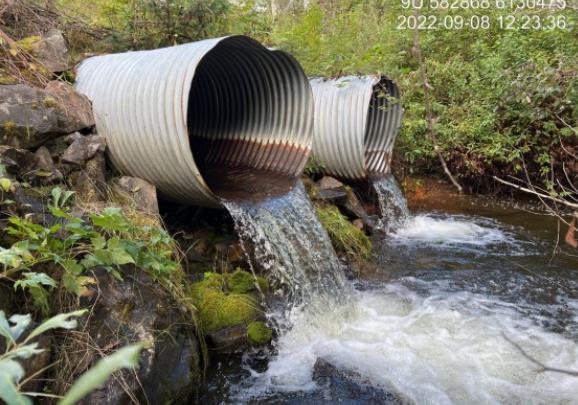
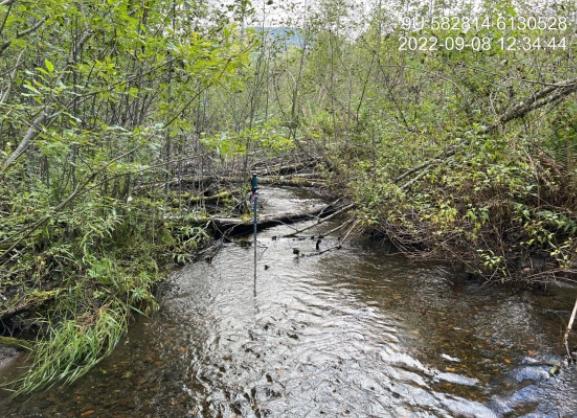
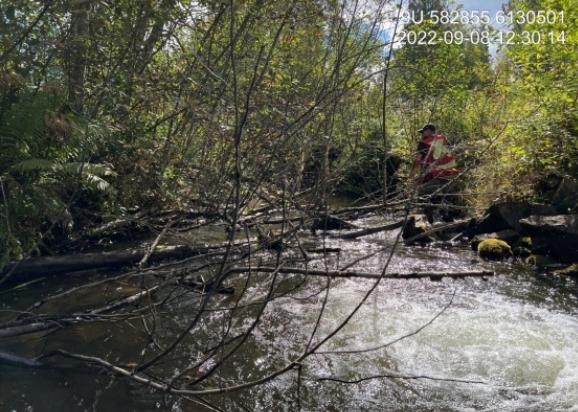
Location and Stream Data	•	Crossing Characteristics	-
<p>Comments: Francis(chief) indicated this is historic CO harvest and spawning stream. 2 active culverts side by side. Trash rack has been removed from inlet. Inlet has significant amount of debris. Extensive gravels present suitable for CO spawning. Good flow and large stream. On road to water treatment plant. 12:20</p>			
<p>Photos: From top left clockwise: Road/Site Card, Barrel, Outlet, Downstream, Upstream, Inlet.</p>

Although replacement of PSCIS crossing 198217 with a bridge (10m span with a cost estimated at \$300,000) is tentatively recommended, conditions within the greater watershed should be assessed more comprehensively first to determine how the channel alignment and wetland configuration/capacity (between Water Tower Road and the Skeena River) have been impacted by the installation of roads and Sik-E-Dakh community infrastructure as alternative options may provide greater restoration actions.

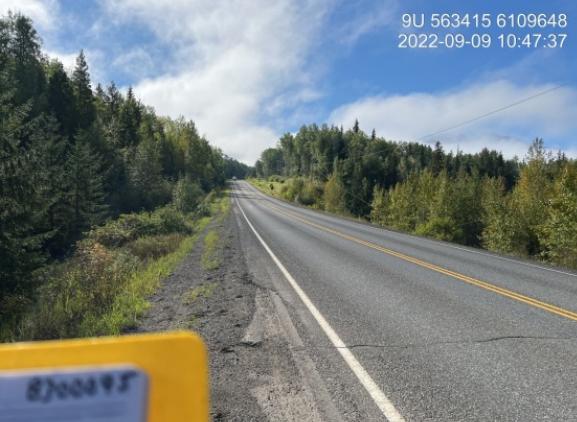
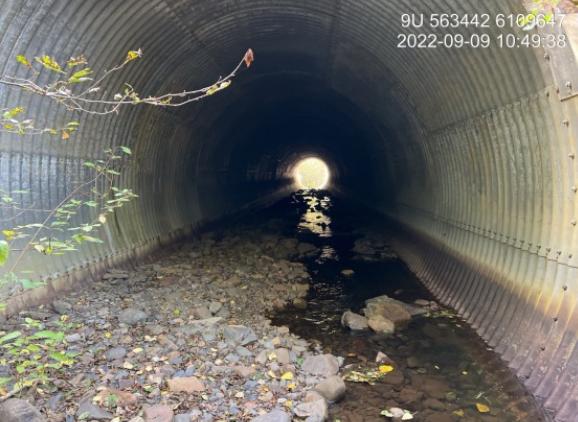
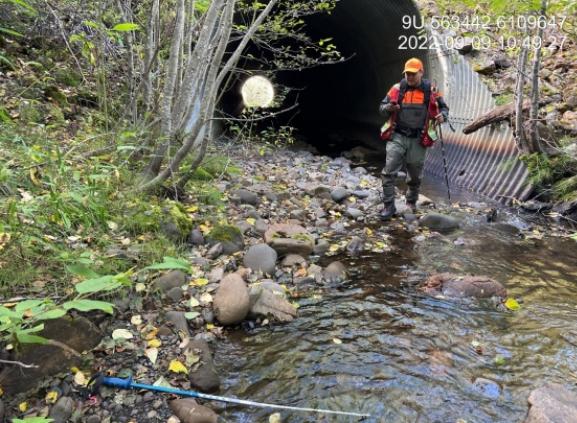
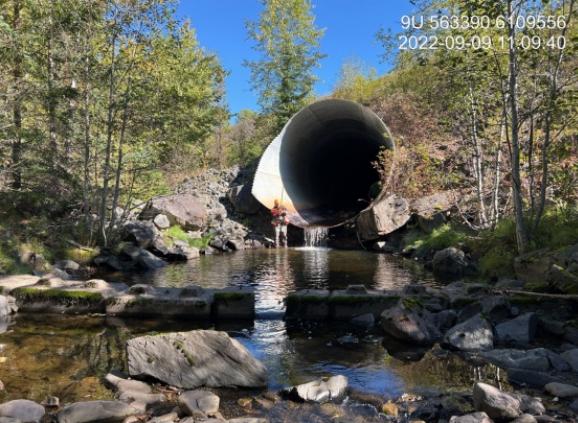
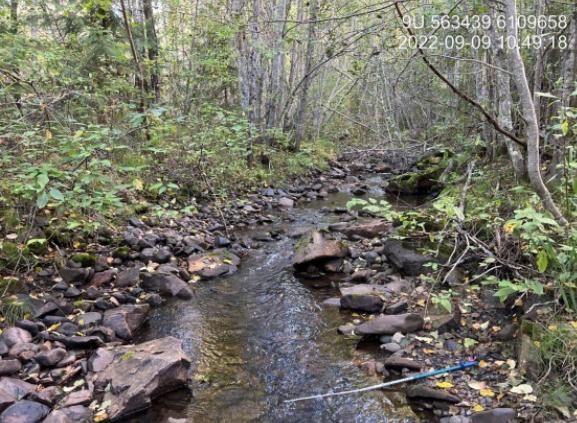
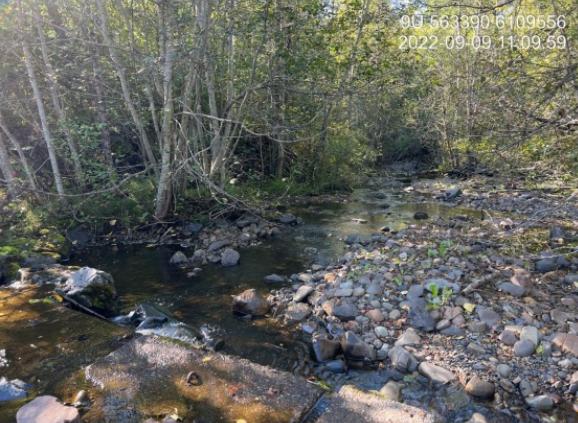
Location and Stream Data	•	Crossing Characteristics	-
Comments: Historic backwatering with 6 downstream lock block weirs. SFC has assessed site in past. Very large system, pipe embedded until last 10m. Large outlet drop. Lots of algae. 10:46			
Photos: From top left clockwise: Road/Site Card, Barrel, Outlet, Downstream, Upstream, Inlet.

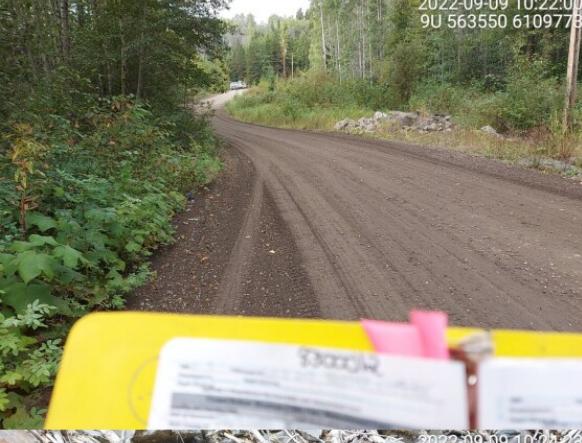
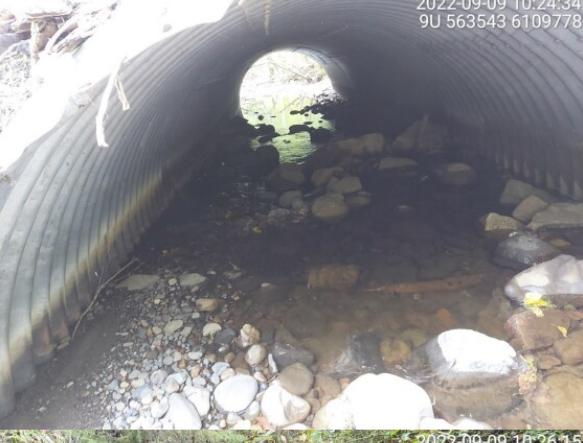
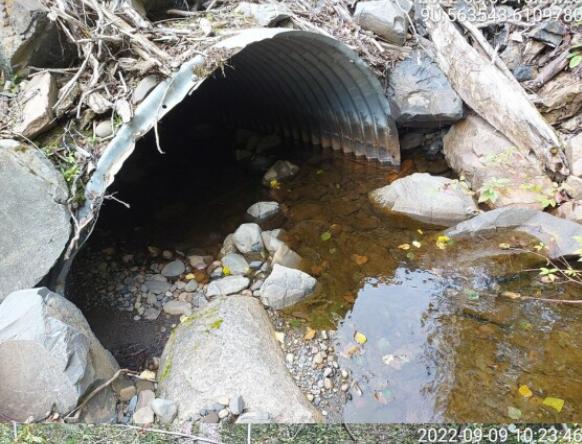
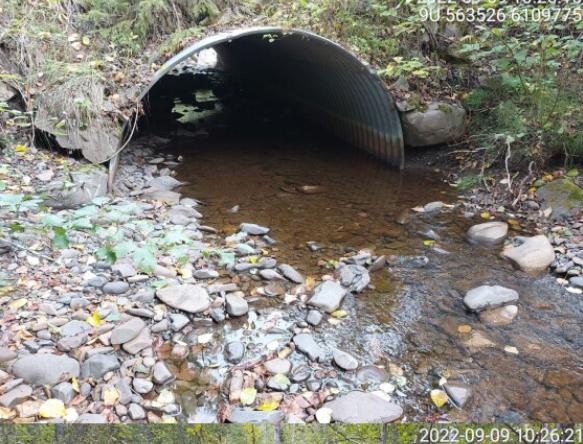
Location and Stream Data	•	Crossing Characteristics	-
Comments: Embedded with no outlet drop. Very wide channel with gravels and cobbles. 10:18			
Photos: From top left clockwise: Road/Site Card, Barrel, Outlet, Downstream, Upstream, Inlet.

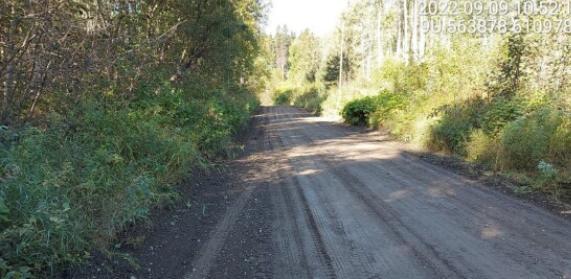
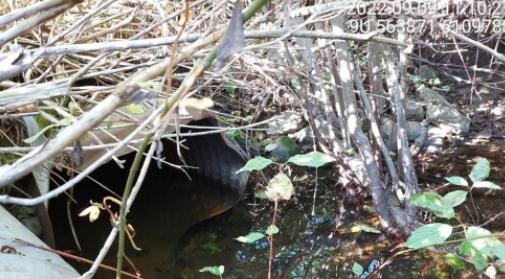
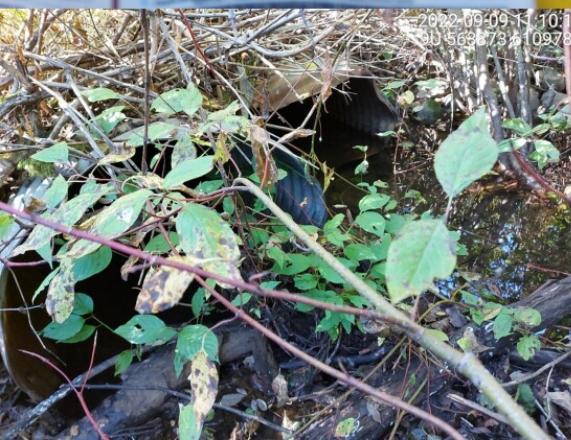
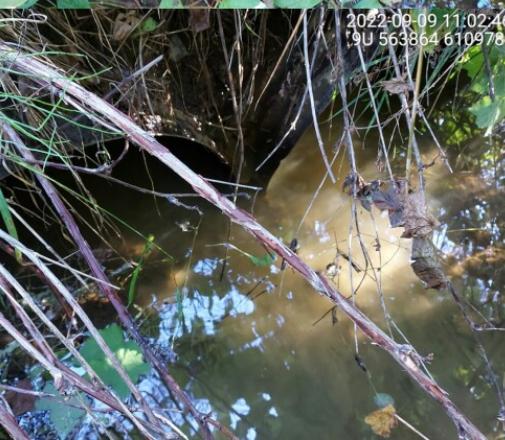
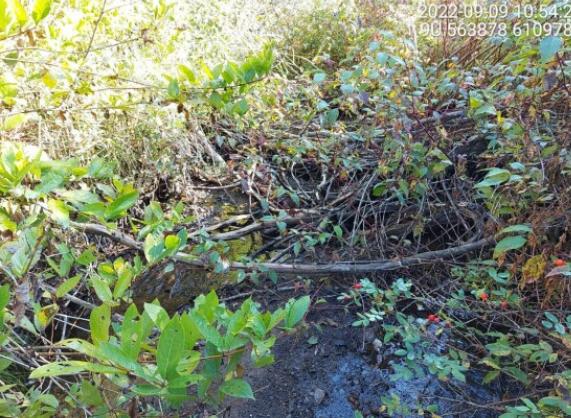
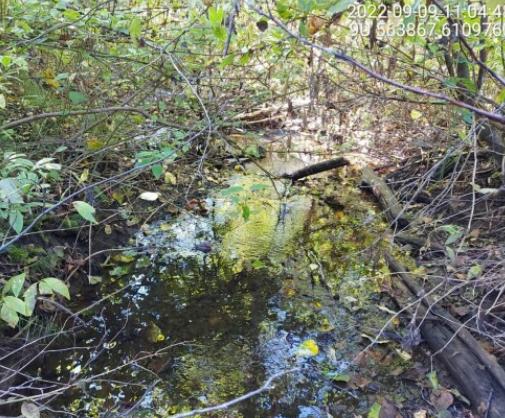
Location and Stream Data	•	Crossing Characteristics
Comments: Two culverts, both embedded with no drop. Fish spotted in culvert(up to 20 cm in length) and downstream. Erosion near culvert. 10:50		
Photos: From top left clockwise: Road/Site Card, Barrel, Outlet, Downstream, Upstream, Inlet.

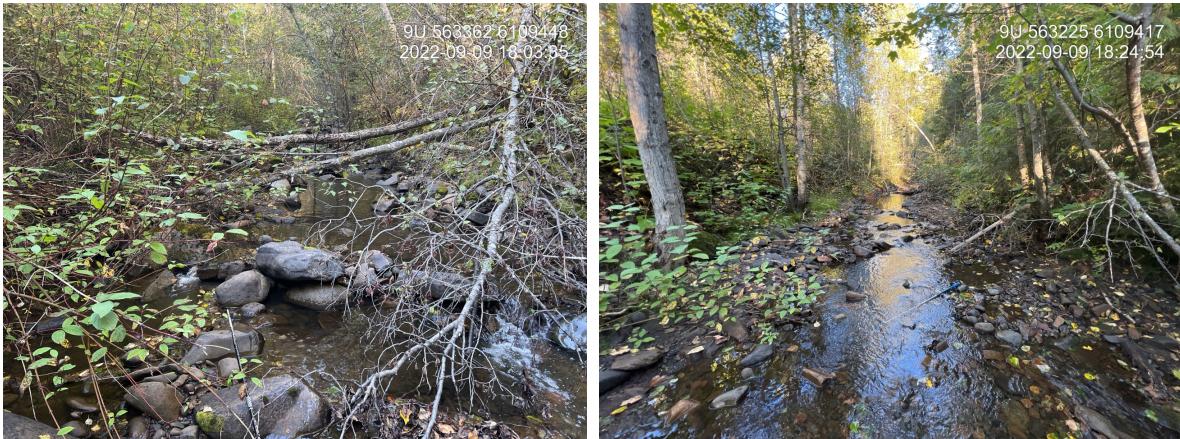
The stream was surveyed downstream from crossing 198220 for 400m (Figure [5.13](#)). The average channel width was 5.4m, the average wetted width was 3.2m, and the average gradient was 3%. The dominant substrate was gravels with cobbles sub-dominant. Total cover amount was rated as moderate with boulders dominant. Cover was also present as small woody debris, undercut banks, and overhanging vegetation. There was boulder cover and gravels throughout the survey but very few pools. The habitat was rated as high value for salmonid rearing and spawning.

Figure 5.13: Left: Typical habitat downstream of PSCIS crossing 198220. Right: Typical habitat downstream of PSCIS crossing 198220.

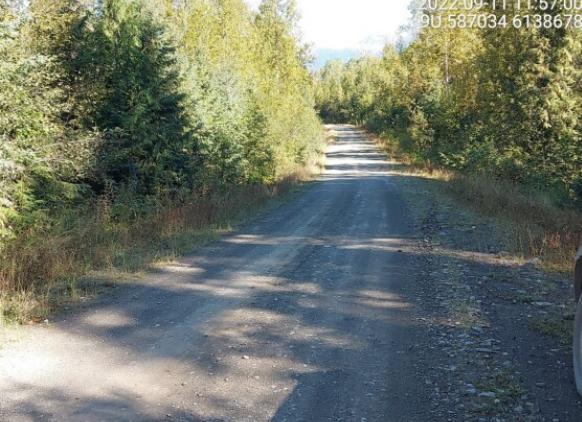
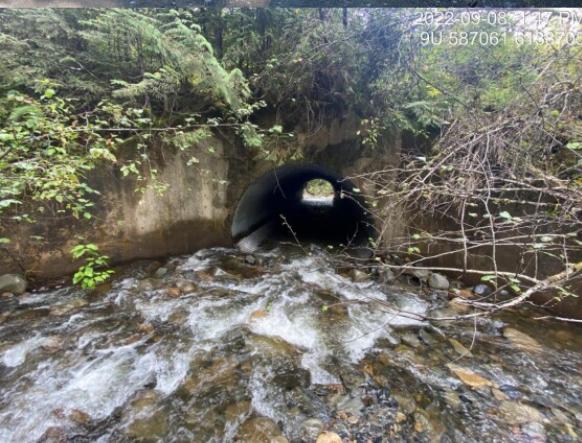
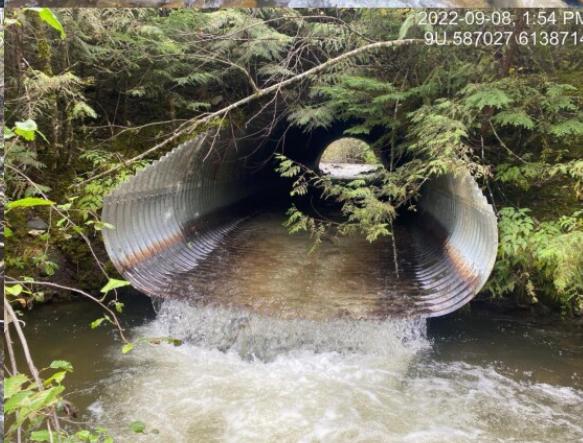
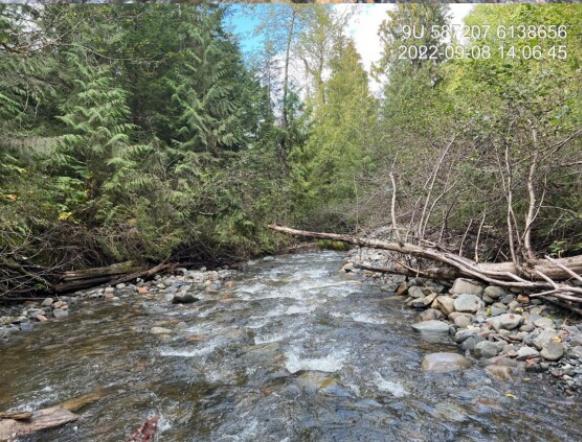
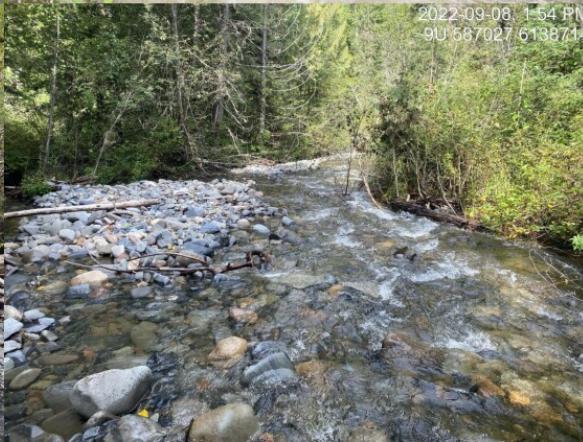
This crossing was replaced in 1985. Water temperature was 9.7°C, pH was 8.2 and conductivity was 75uS/cm.

Location and Stream Data	•	Crossing Characteristics	-
Comments: Structure was replaced in 1985. Concrete wing walls on inlet. Structure in decent shape. 13:39			
Photos: From top left clockwise: Road/Site Card, Barrel, Outlet, Downstream, Upstream, Inlet.

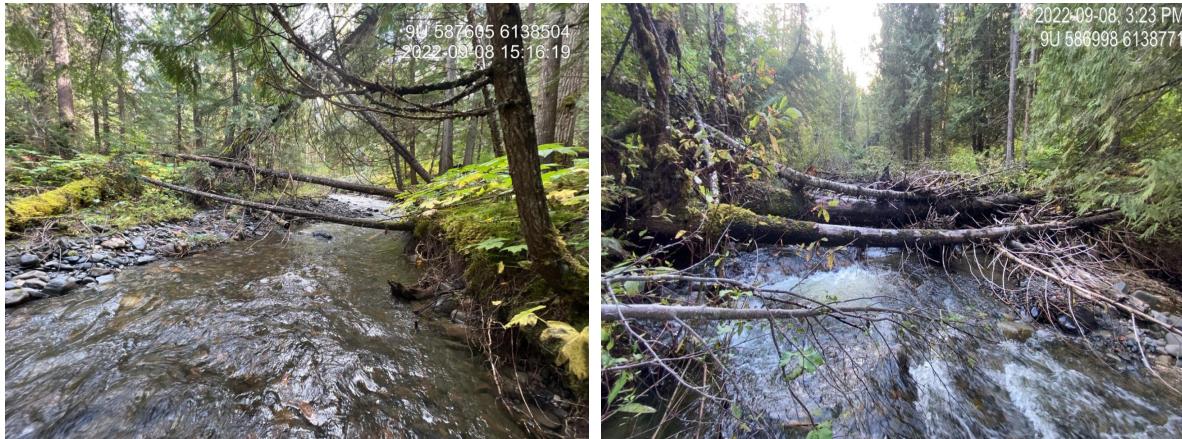
The stream was surveyed downstream from crossing 198222 for 150m (Figure 5.17). Total cover amount was rated as trace with boulders dominant. Cover was also present as undercut banks. The

Figure 5.17: Left: Typical habitat downstream of PSCIS crossing 198222. Right: Typical habitat downstream of PSCIS crossing 198222.

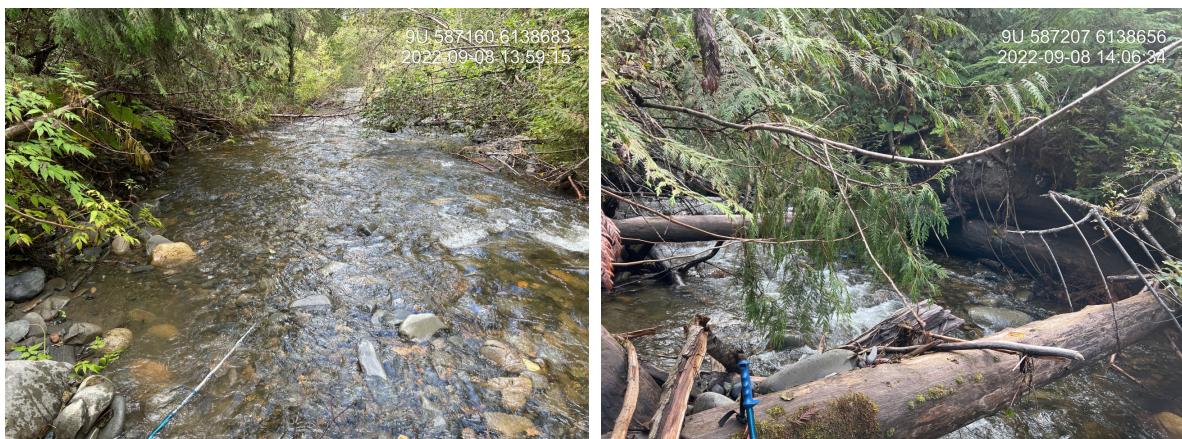
Figure 5.18: Left: Typical habitat upstream of PSCIS crossing 198222. Right: Collapsed bridge upstream of PSCIS crossing 198222.

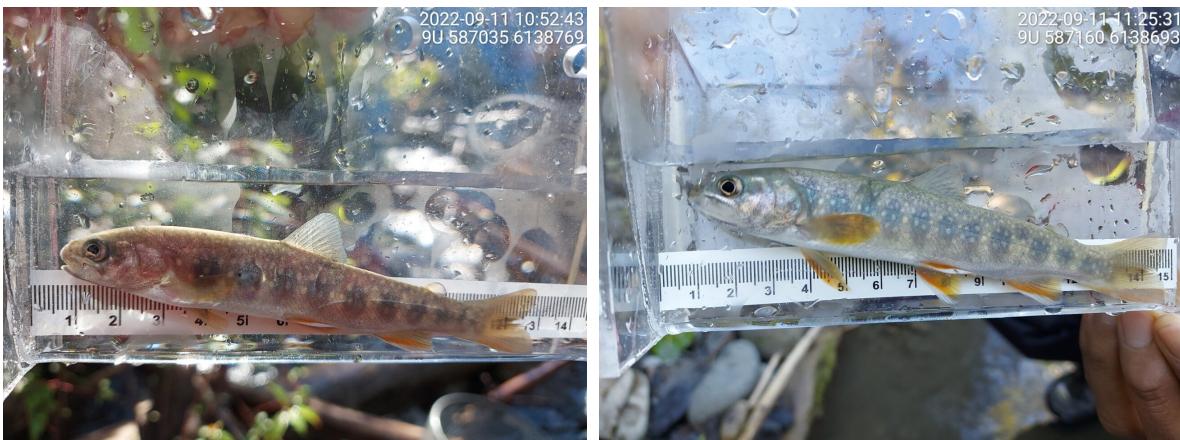
To assess potential impacts of the culvert on fisheries values in the stream, minnowtrapping was conducted upstream and downstream of the crossing. Two traps were set downstream of the crossing and two were set upstream; traps were left overnight. 1 dolly varden was captured upstream and 6 dolly varden were captured downstream (Figure 5.20).

Figure 5.20: Left: Dolly Varden captured downstream of PSCIS crossing 198222. Right: Dolly Varden captured upstream of PSCIS crossing 198222.

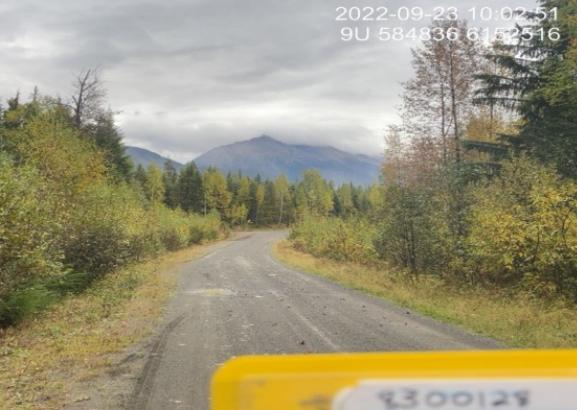
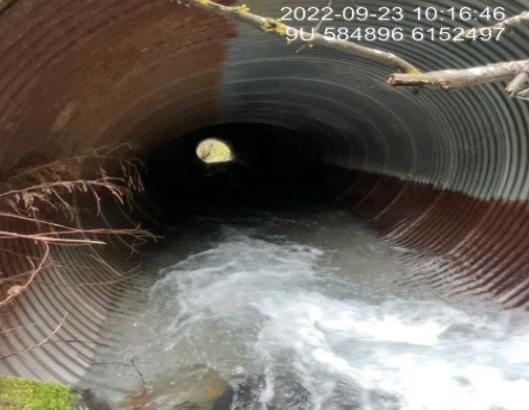
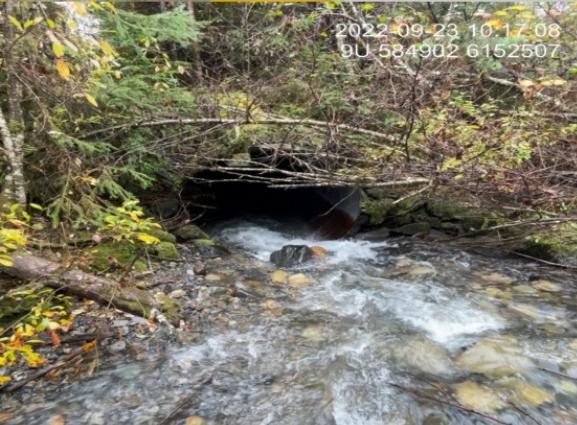
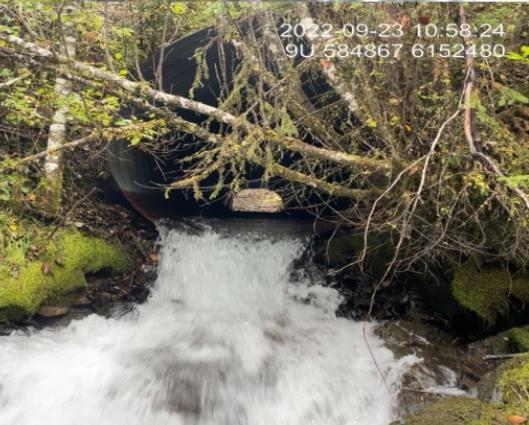
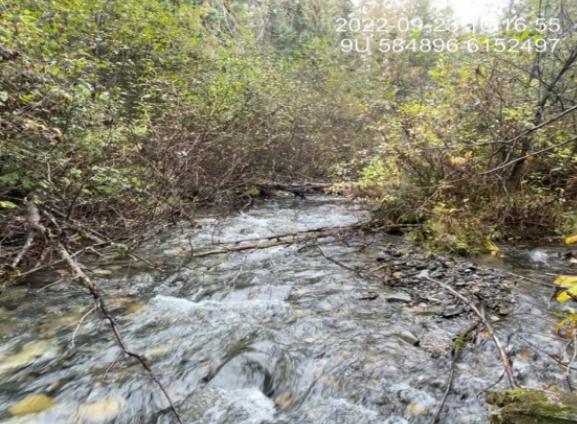
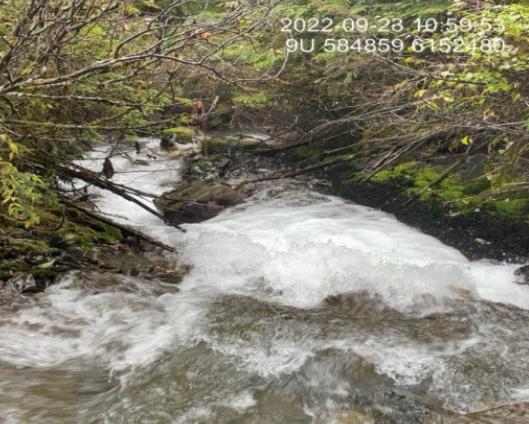
Location and Stream Data	•	Crossing Characteristics	-
Comments: Culvert is separating 10 meters in from upstream, top of culvert slumping in. 10:06			
Photos: From top left clockwise: Road/Site Card, Barrel, Outlet, Downstream, Upstream, Inlet.

Should restoration/maintenance activities proceed, replacement of PSCIS crossing 198225 with a bridge (13m span) is recommended. The cost of the work is estimated at \$NA for a cost benefit of NA linear m/\$1000 and NA m²/\$1000.

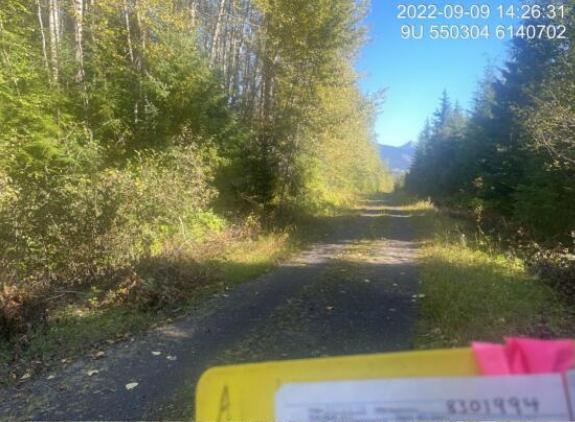
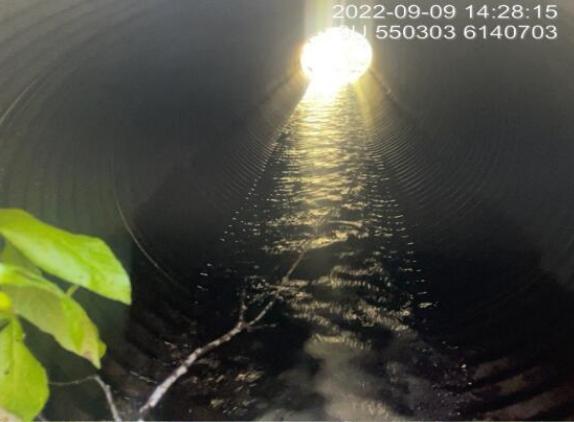
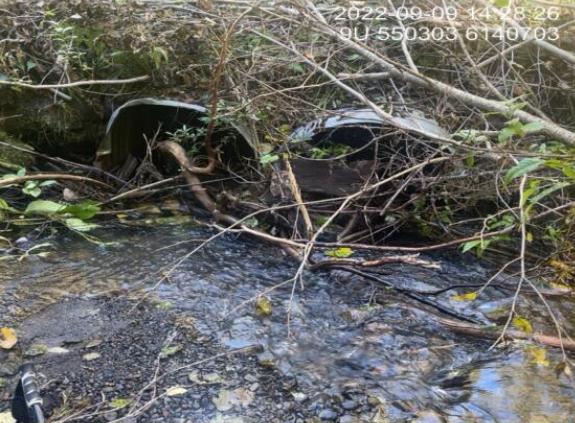
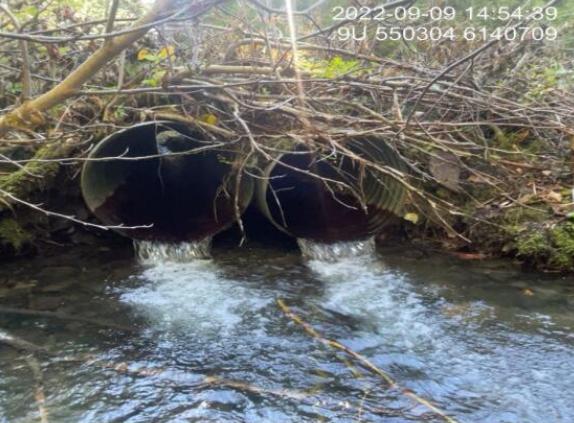
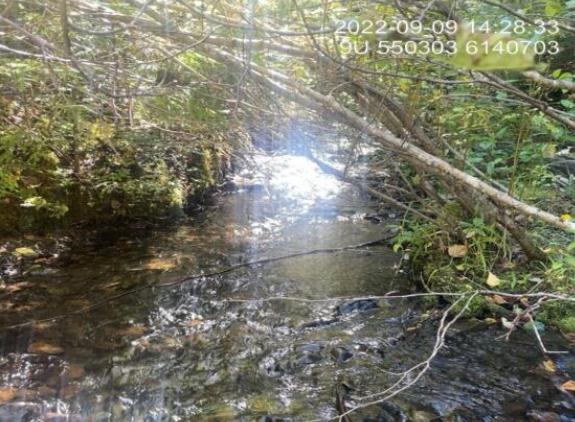
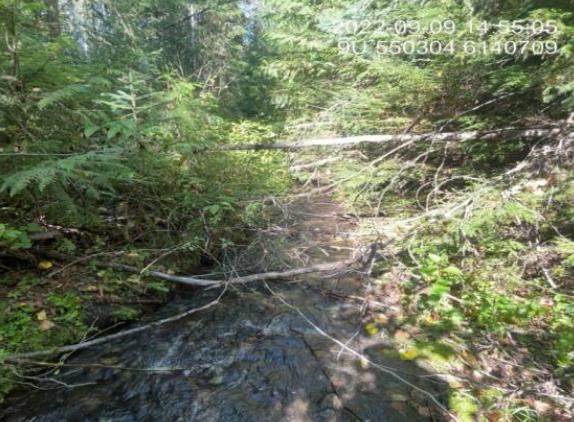
Location and Stream Data		Crossing Characteristics –	
Date	2022-09-09	Crossing Sub Type	Round Culvert
PSCIS ID	198236	Diameter (m)	0.85
External ID	–	Length (m)	10
Crew	AI JO	Embedded	No
UTM Zone	9	Depth Embedded (m)	–
Easting	550300	Resemble Channel	No
Northing	6140708	Backwatered	No
Stream	Tributary to Kitwanga River	Percent Backwatered	–
Road	Kitwancool Branch 2 FSR	Fill Depth (m)	0.45
Road Tenure	MoF 8687	Outlet Drop (m)	0.24
Channel Width (m)	2.3	Outlet Pool Depth (m)	0.22
Stream Slope (%)	1	Inlet Drop	Yes
Beaver Activity	Yes	Slope (%)	2
Habitat Value	Medium	Valley Fill	Deep Fill
Final score	26	Barrier Result	Barrier
Fix type	Replace with New Open Bottom Structure	Fix Span / Diameter	10

Location and Stream Data	•	Crossing Characteristics	-
Comments: 2 culverts side by side. 14:23			
Photos: From top left clockwise: Road/Site Card, Barrel, Outlet, Downstream, Upstream, Inlet.

Should restoration/maintenance activities proceed, replacement of PSCIS crossing 198236 with a bridge (10m span) is recommended. The cost of the work is estimated at \$250,000 for a cost benefit of 0 linear m/\$1000 and 0 m²/\$1000.

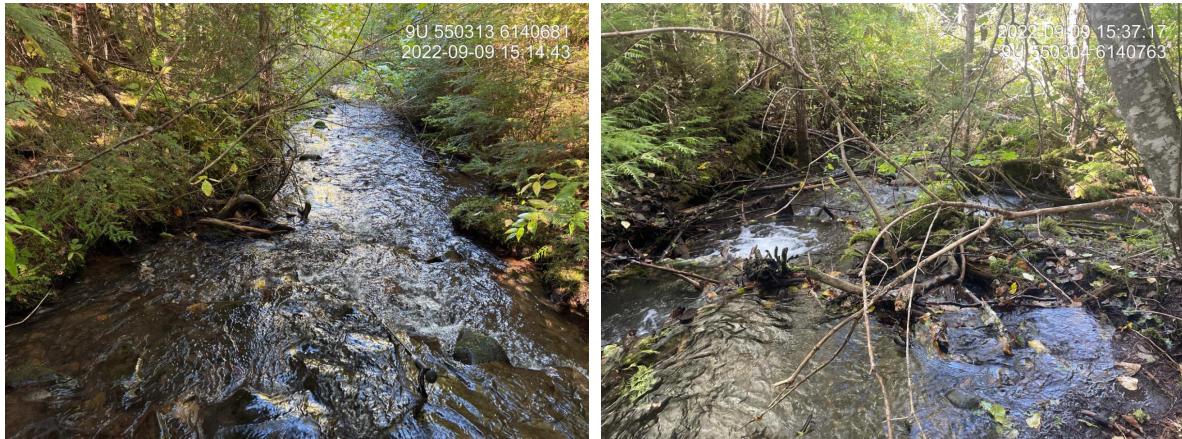
Figure 5.24: Left: Typical habitat downstream of PSCIS crossing 198236. Right: Typical habitat downstream of PSCIS crossing 198236.

The stream was surveyed downstream from crossing 198236 for 200m (Figure 5.24). The average channel width was 3.8m, the average wetted width was 2.3m, and the average gradient was

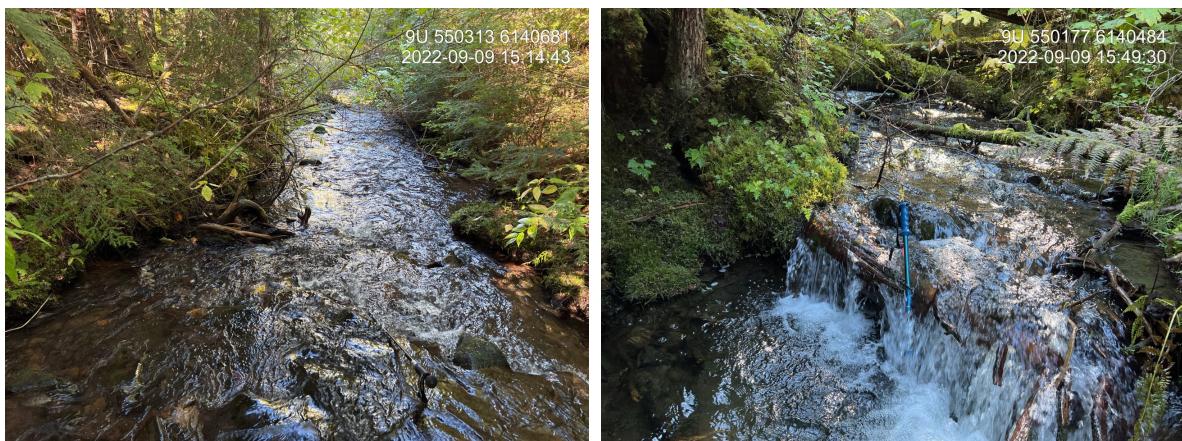
Figure 5.25: Left: Typical habitat upstream of PSCIS crossing 198236. Right: Typical habitat upstream of PSCIS crossing 198236.

The stream was surveyed upstream from crossing 198236 for 500m (Figure 5.25). The average channel width was 3m, the average wetted width was 2.6m, and the average gradient was 5.8%.The dominant substrate was gravels with cobbles sub-dominant.Total cover amount was rated as moderate with undercut banks dominant. Cover was also present as small woody debris, large woody debris, deep pools, and overhanging vegetation. There were abundant gravels suitable for resident and anadromous salmonid spawning. There were frequent deep pools due to large woody debris in the canyon that was not logged. Overall, the habitat was rated as high value.
