Skeena Watershed Fish Passage Restoration Planning 2022

Prepared for
Habitat Conservation Trust Foundation - CAT23-6-288
BC Fish Passage Remediation Program
Ministry of Transportation and Infrastructure

Prepared by
Al Irvine, B.Sc., R.P.Bio. and Mateo Wintersheidt, B.Sc.
New Graph Environment Ltd.
on behalf of
Society for Ecosystem Restoration in Northern British Columbia

Version 0.0.1 2023-05-25

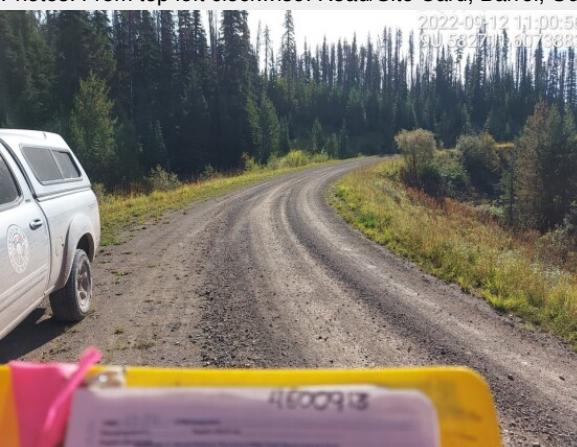
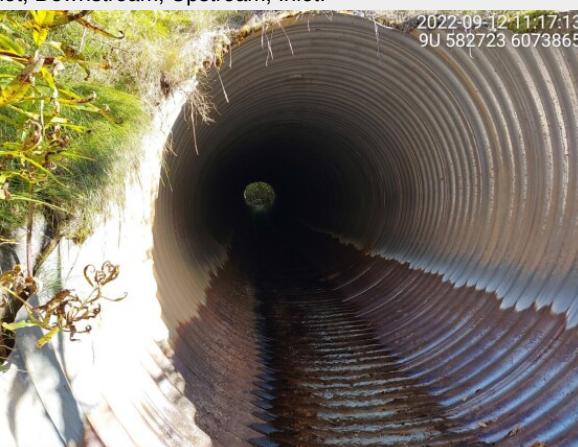
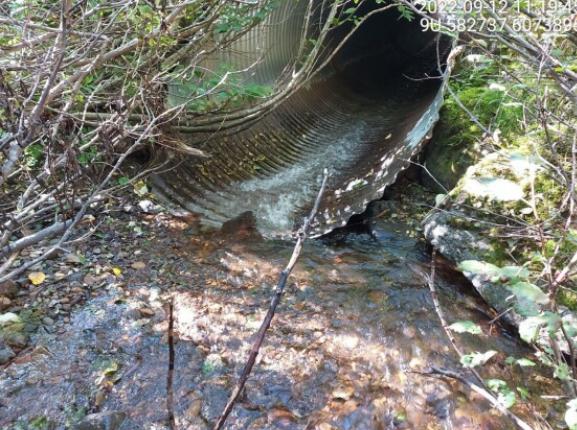
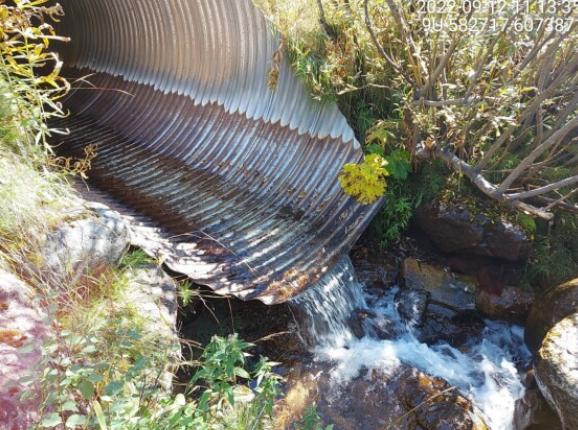
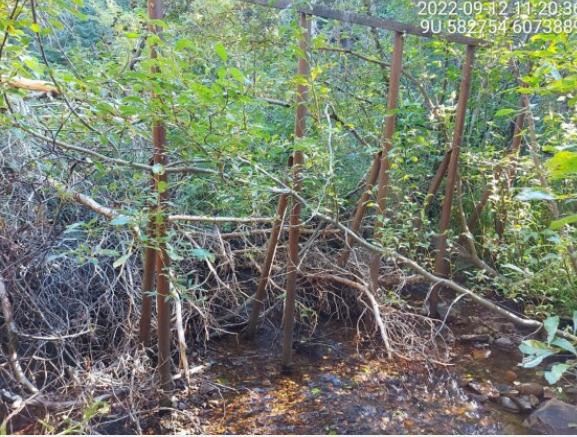
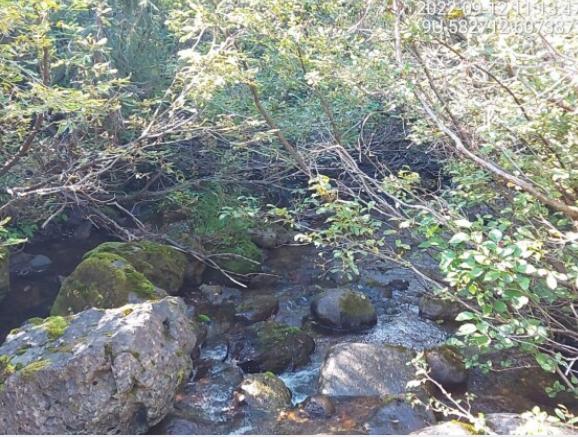
Location and Stream Data	•	Crossing Characteristics	-
Comments: Channel is steeper downstream of culvert. Very deep fill with a small outlet drop. 10:59			
Photos: From top left clockwise: Road/Site Card, Barrel, Outlet, Downstream, Upstream, Inlet.

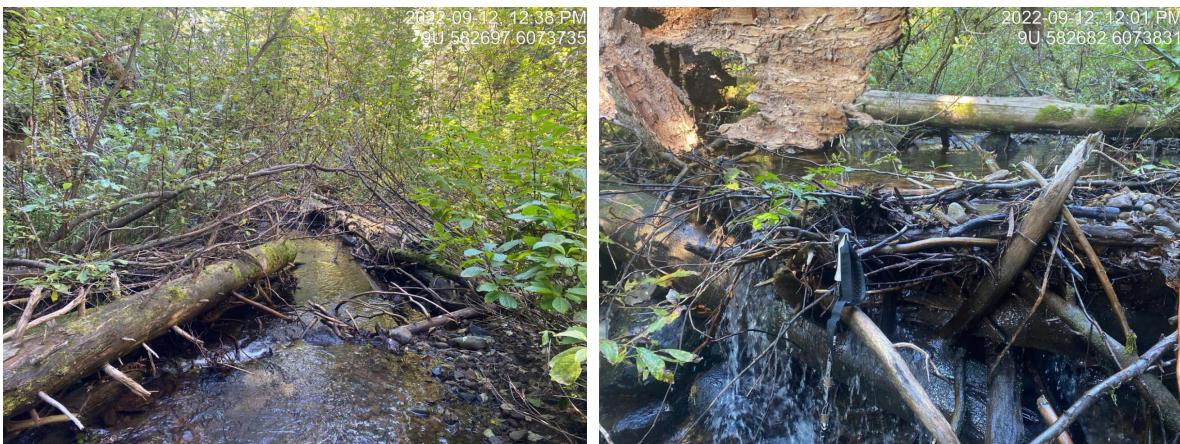
Figure 5.29: Left: Typical habitat downstream of PSCIS crossing 8530. Right: Large woody debris jam downstream of PSCIS crossing 8530.

The stream was surveyed downstream from crossing 8530 for 275m (Figure 5.29). Total cover amount was rated as abundant with boulders dominant. Cover was also present as small woody
