## **Skeena Watershed Fish Passage Restoration Planning 2022**

Prepared for  
Habitat Conservation Trust Foundation - CAT23-6-288  
BC Fish Passage Remediation Program  
Ministry of Transportation and Infrastructure

Prepared by  
Al Irvine, B.Sc., R.P.Bio. and Mateo Wintersheidt, B.Sc.  
New Graph Environment Ltd.  
on behalf of  
Society for Ecosystem Restoration in Northern British Columbia

Version 0.0.1 2023-04-14

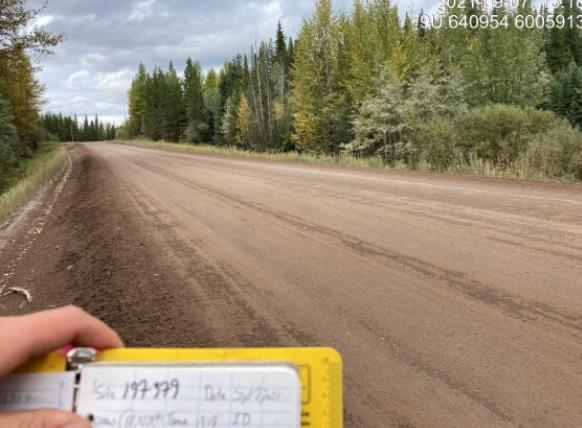
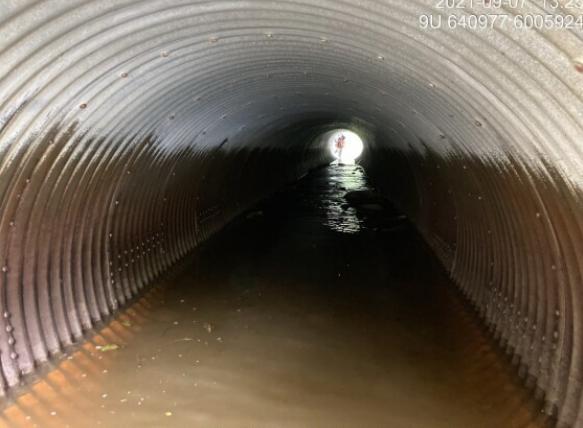
Location and Stream Data		Crossing Characteristics –	
Stream	Tributary to Owen Creek	Percent Backwatered	–
Road	Morice-Owen FSR	Fill Depth (m)	5
Road Tenure	FLNR DND 9947	Outlet Drop (m)	0.47
Channel Width (m)	6.4	Outlet Pool Depth (m)	0.9
Stream Slope (%)	4.8	Inlet Drop	No
Beaver Activity	No	Slope (%)	1.5
Habitat Value	High	Valley Fill	Deep Fill
Final score	34	Barrier Result	Barrier
Fix type	Replace with New Open Bottom Structure	Fix Span / Diameter	16

Location and Stream Data	•	Crossing Characteristics	-
Comments: 2/3 upstream culvert has baffles. 13:18			
Photos: From top left clockwise: Road/Site Card, Barrel, Outlet, Downstream, Upstream, Inlet.

There was 0.8km of habitat upstream of the culvert between the Morice-Owen FSR and the 8m high waterfall with habitat rated as high value for coho, steelhead and resident rainbow/cutthroat rearing and spawning. Crossing 197379 was ranked as a high priority for proceeding to design for replacement. Of note, at the time of reporting, due to our prioritization work, a design for a replacement structure to more effectively facilitate upstream migration for all fish life stages and species was being developed by Mark Dewit from the Ministry of Forests. In addition to replacement of the culvert with a bridge, recommendations going forward include:

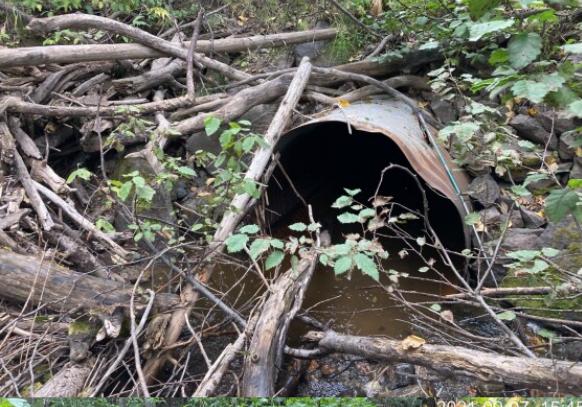
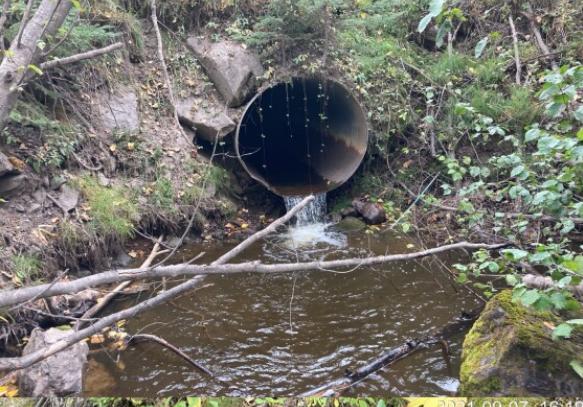
A black corrugated metal culvert pipe lying horizontally on the ground, partially buried in fallen logs and branches. Water is visible inside the pipe.	2021-09-07 13:24 9U 640977 6005924

A black corrugated metal culvert pipe protruding from the side of a stream bank. Water is flowing out of the pipe into the stream. The surrounding area is dense with green vegetation.	2021-09-07 13:27 9U 640953 6005917

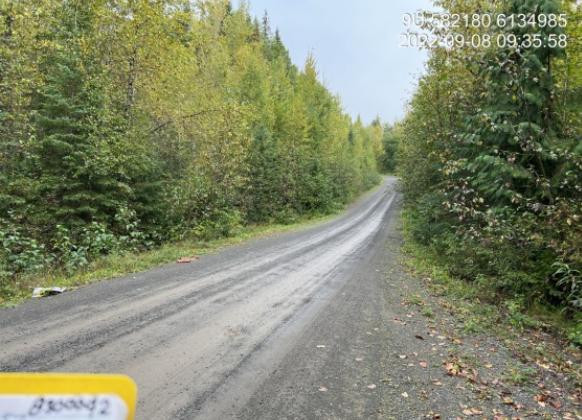
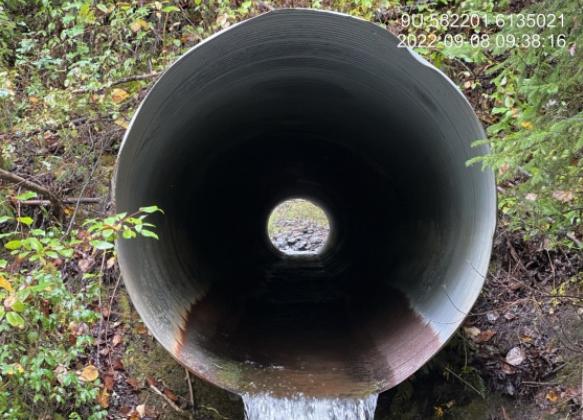
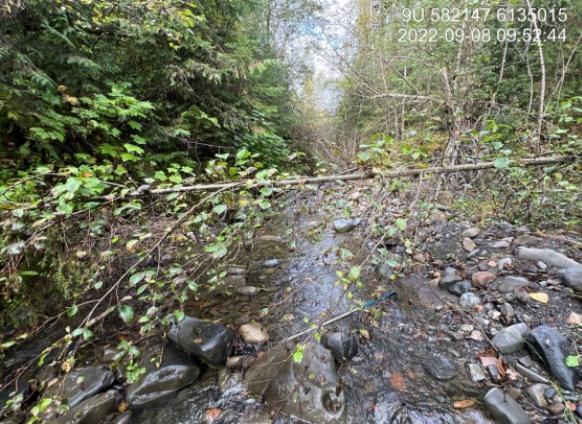
Location and Stream Data	•	Crossing Characteristics	-
Comments: .75-.90 m lock block step approximately 30 m down stream of culvert. Double pipe however right pipe is not functioning and is 50% blocked at the outlet. Both pipes are of similar diameter. Combined diameter of 3.7m. 9:32			
Photos: From top left clockwise: Road/Site Card, Barrel, Outlet, Downstream, Upstream, Inlet.

Should restoration/maintenance activities proceed, replacement of PSCIS crossing 198215 with a bridge (17.5m span) is recommended. The cost of the work is estimated at \$1,750,000 for a cost benefit of 0 linear m/\$1000 and 0 m<sup>2</sup>/\$1000.

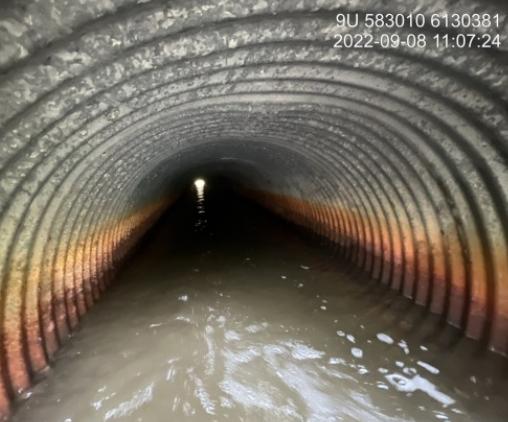
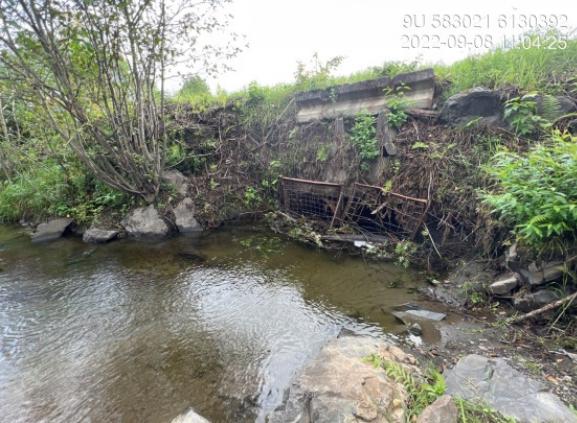
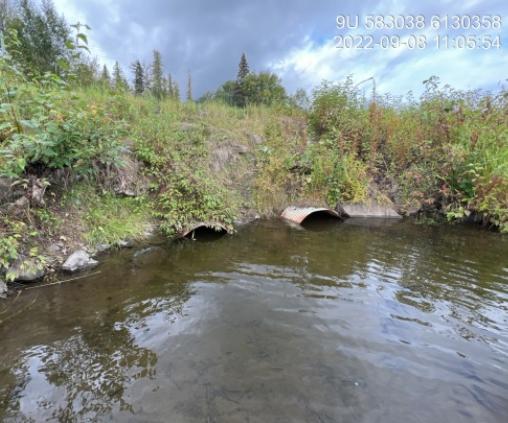
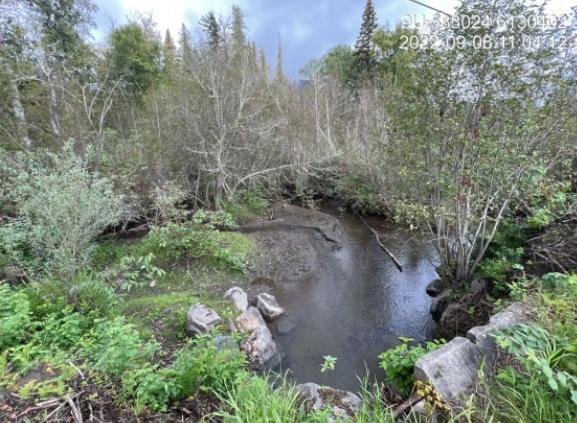
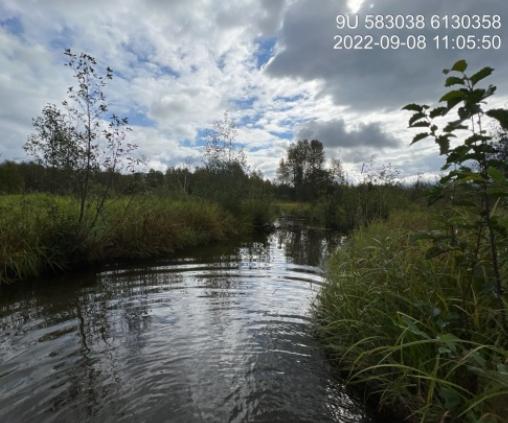
Location and Stream Data	•	Crossing Characteristics	-
Comments: Culvert appears very old and near end of life. Nice gravels upstream. Flow is moving between the two 1 m pipes. Trash rack on inlet would be barrier to coho moving up to spawn. 10:57			
Photos: From top left clockwise: Road/Site Card, Barrel, Outlet, Downstream, Upstream, Inlet.

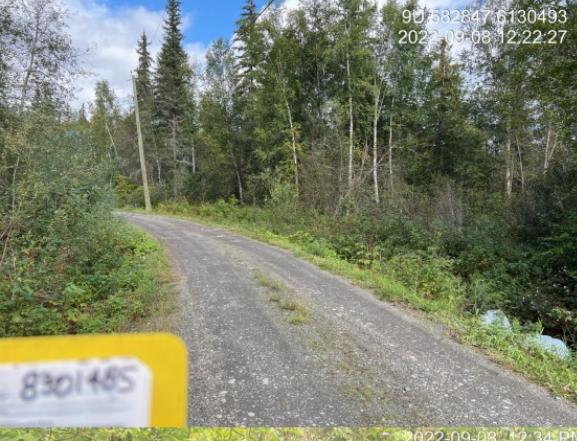
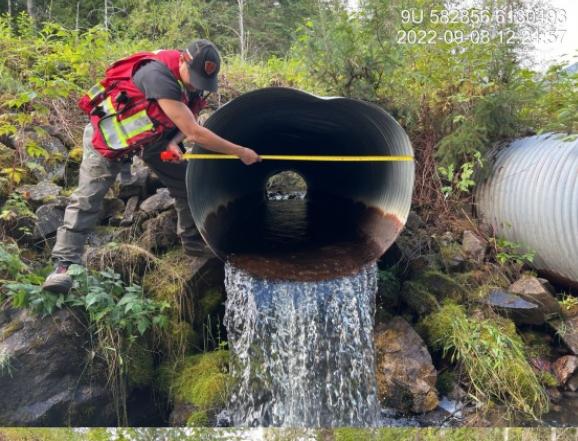
Location and Stream Data	•	Crossing Characteristics	-
<p>Comments: Francis(chief) indicated this is historic CO harvest and spawning stream. 2 active culverts side by side. Trash rack has been removed from inlet. Inlet has significant amount of debris. Extensive gravels present suitable for CO spawning. Good flow and large stream. On road to water treatment plant. 12:20</p>			
<p>Photos: From top left clockwise: Road/Site Card, Barrel, Outlet, Downstream, Upstream, Inlet.</p>

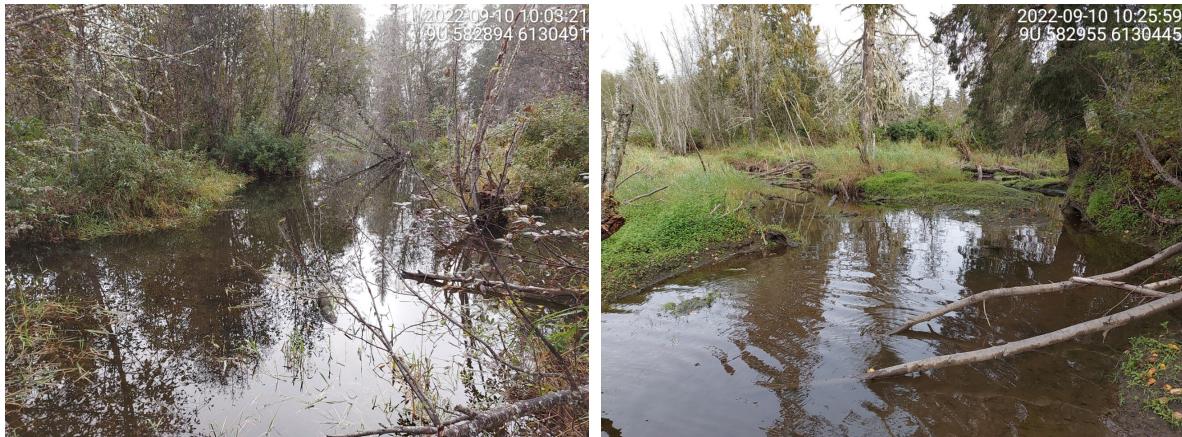
Figure 5.9: Left: Typical habitat downstream of PSCIS crossing 198217. Right: Typical habitat downstream of PSCIS crossing 198217.

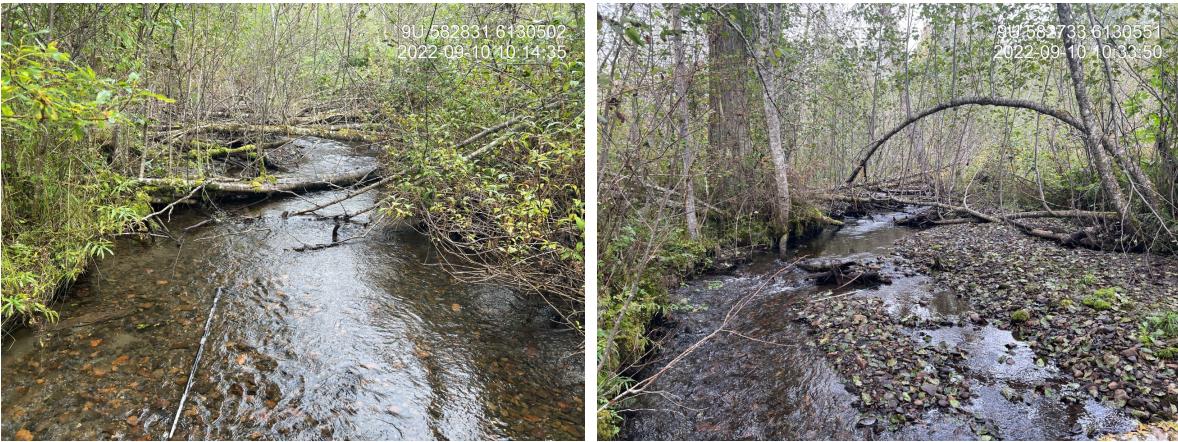
Figure 5.10: Left: Typical habitat upstream of PSCIS crossing 198217. Right: Typical habitat upstream of PSCIS crossing 198217.

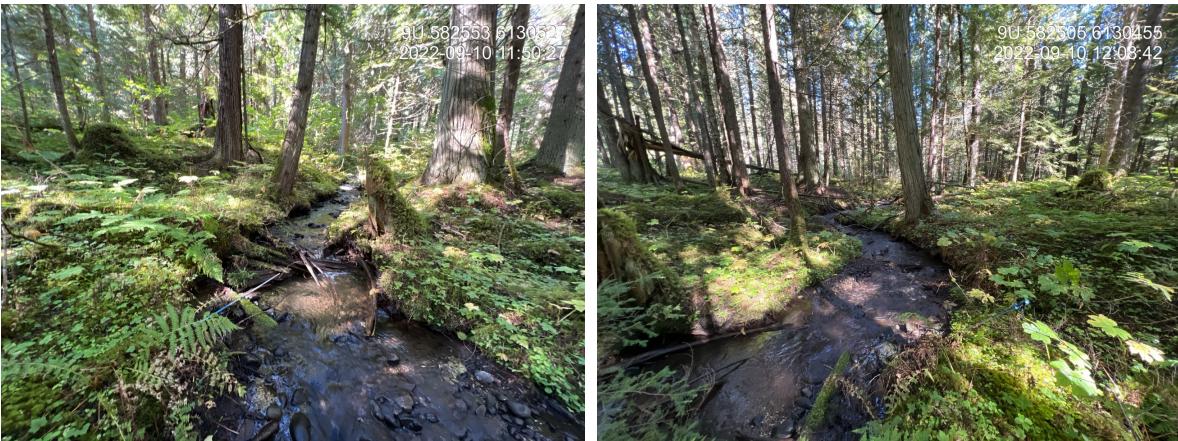
Figure 5.11: Left: Typical habitat upstream of PSCIS crossing 198217. Right: Typical habitat upstream of PSCIS crossing 198217.

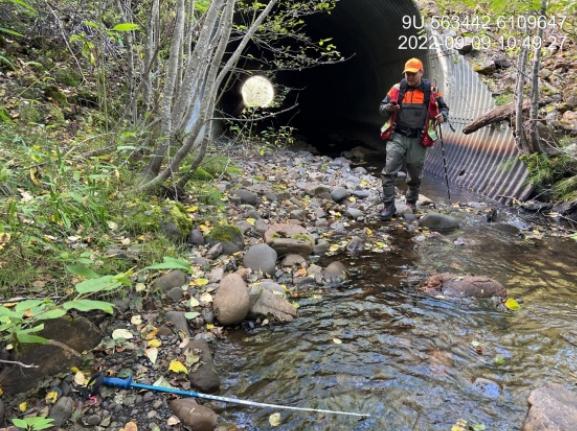
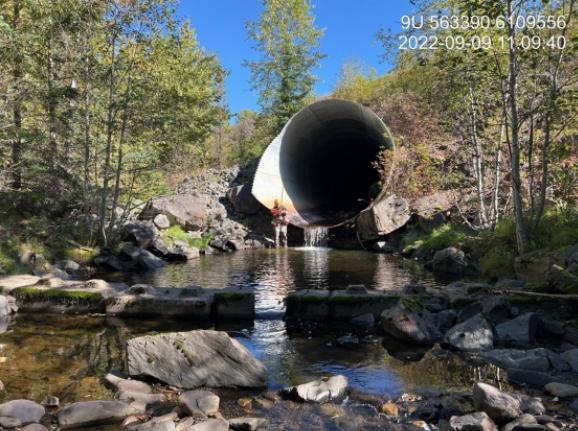
Location and Stream Data	•	Crossing Characteristics	-
Comments: Historic backwatering with 6 downstream lock block weirs. SFC has assessed site in past. Very large system, pipe embedded until last 10m. Large outlet drop. Lots of algae. 10:46			
Photos: From top left clockwise: Road/Site Card, Barrel, Outlet, Downstream, Upstream, Inlet.

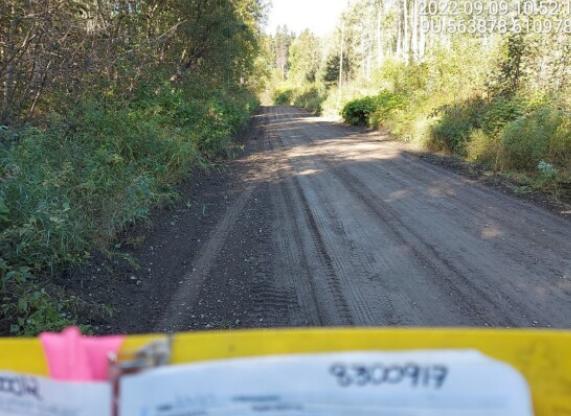
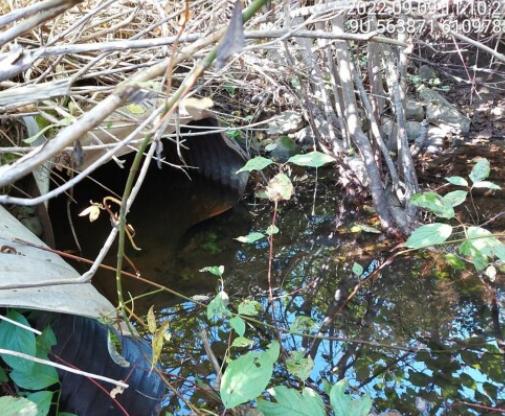
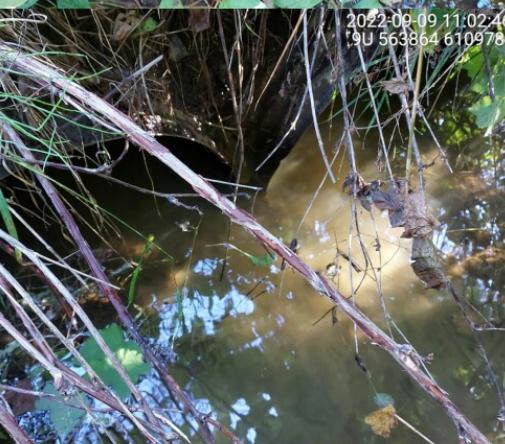
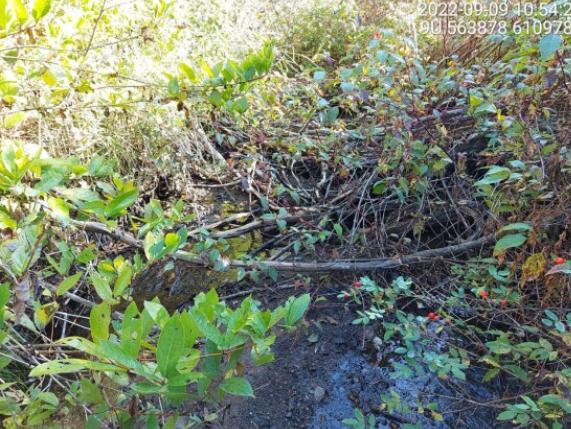
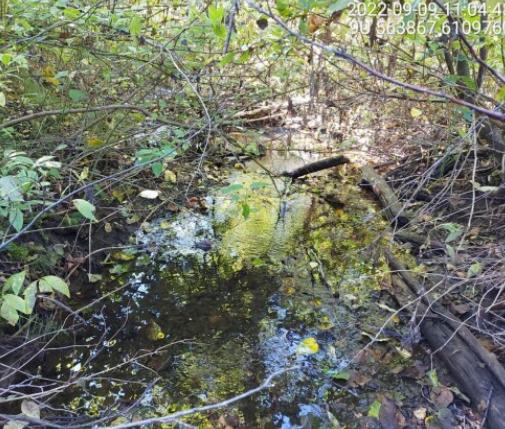
Location and Stream Data	•	Crossing Characteristics
Comments: Two culverts, both embedded with no drop. Fish spotted in culvert(up to 20 cm in length) and downstream. Erosion near culvert. 10:50		
Photos: From top left clockwise: Road/Site Card, Barrel, Outlet, Downstream, Upstream, Inlet.

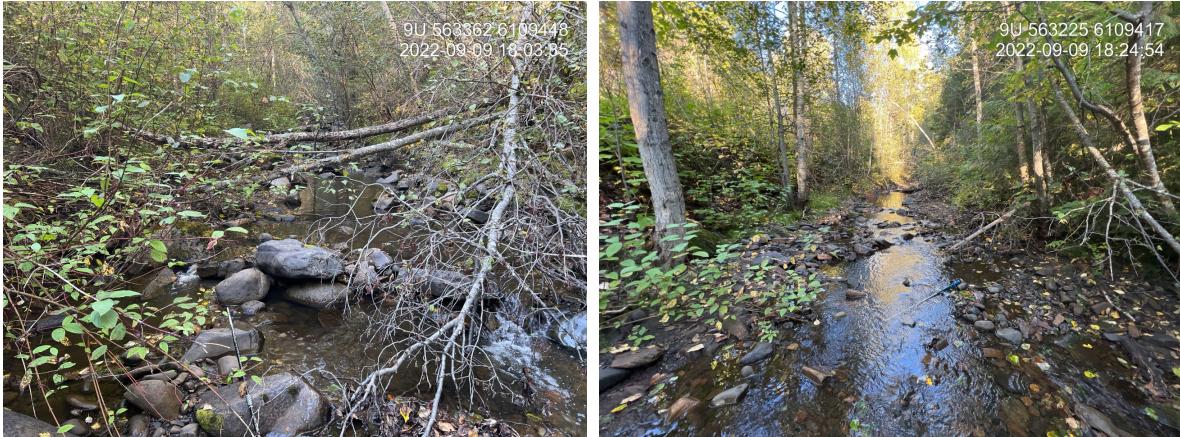
The stream was surveyed downstream from crossing 198220 for 400m (Figure [5.12](#)). The average channel width was 5.4m, the average wetted width was 3.2m, and the average gradient was 3%. Total cover amount was rated as moderate with boulders dominant. Cover was also present as small woody debris, undercut banks, and overhanging vegetation. The dominant substrate was gravels with cobbles sub-dominant. There was boulder cover and gravels throughout the survey but very few pools. The habitat was rated as high value for salmonid rearing and spawning.

Figure 5.12: Left: Typical habitat downstream of PSCIS crossing 198220. Right: Typical habitat downstream of PSCIS crossing 198220.

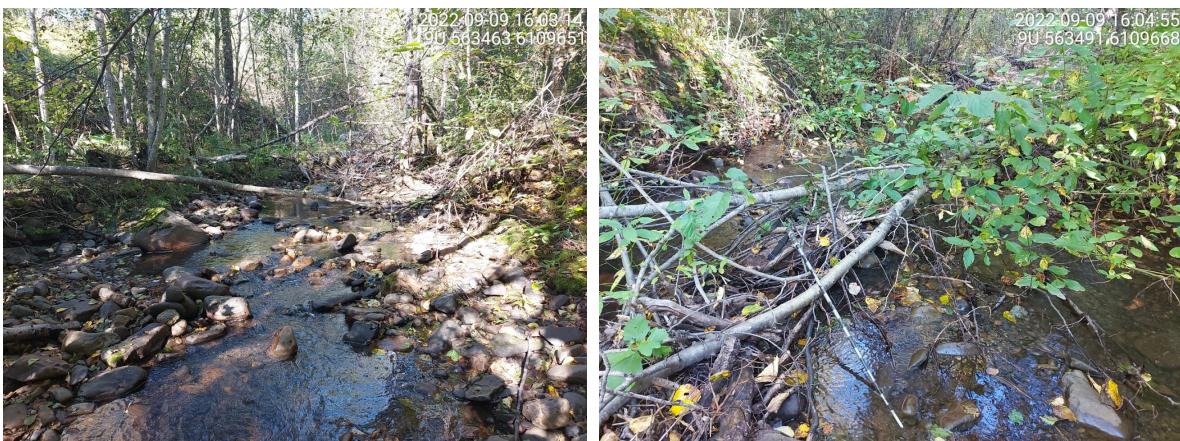
Figure 5.13: Left: Typical habitat upstream of PSCIS crossing 198220. Right: Typical habitat upstream of PSCIS crossing 198220.

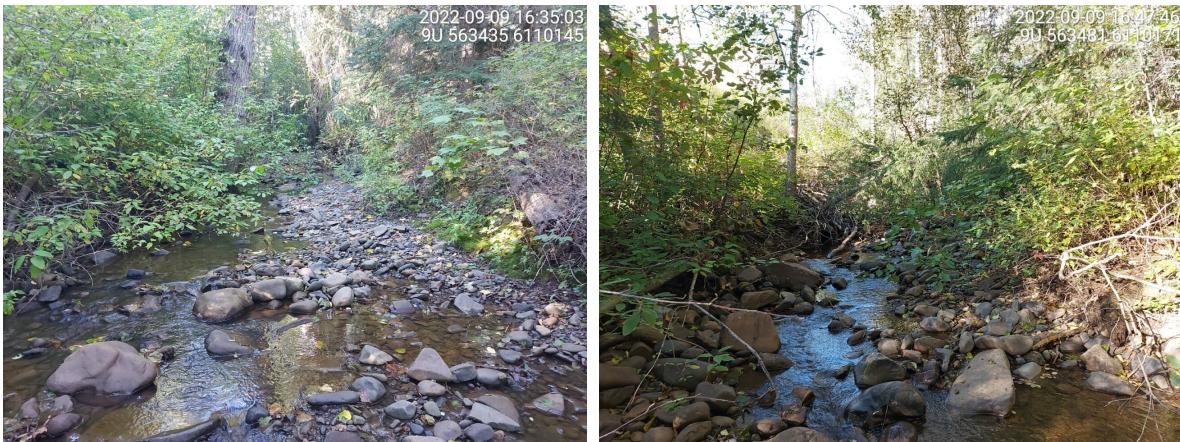
Figure 5.14: Left: Typical habitat upstream of PSCIS crossing 198220. Right: Typical habitat upstream of PSCIS crossing 198220.

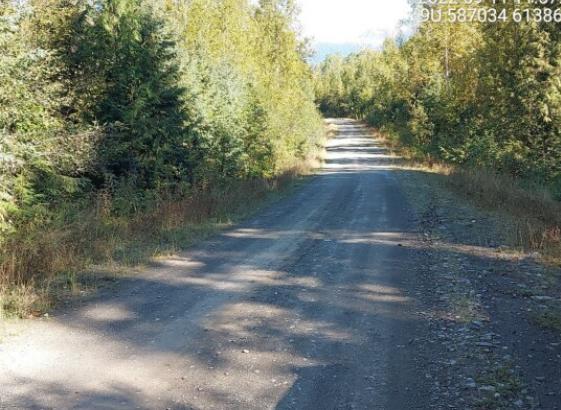
Location and Stream Data	•	Crossing Characteristics	-
Comments: Structure was replaced in 1985. Concrete wing walls on inlet. Structure in decent shape. 13:39			
Photos: From top left clockwise: Road/Site Card, Barrel, Outlet, Downstream, Upstream, Inlet.

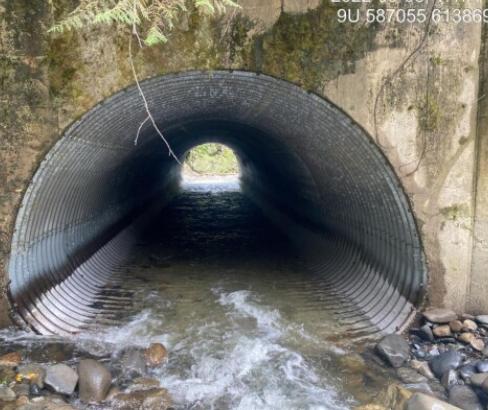
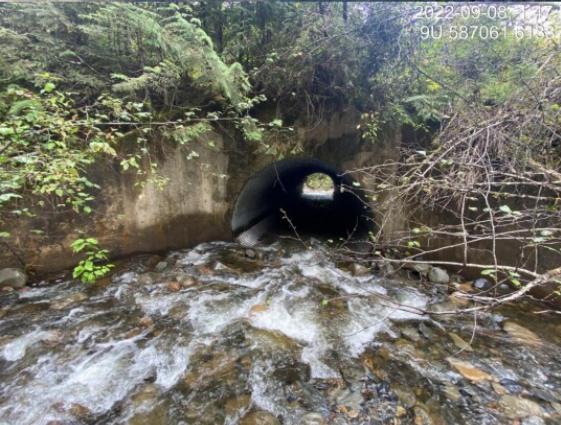
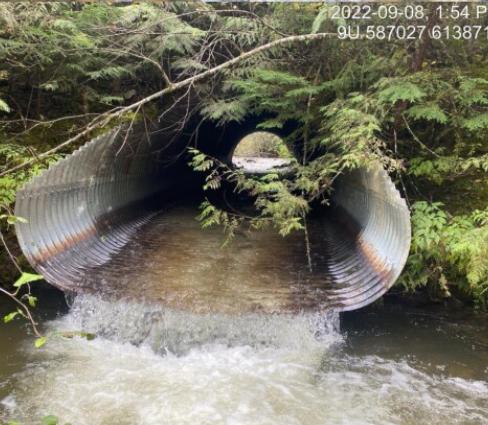
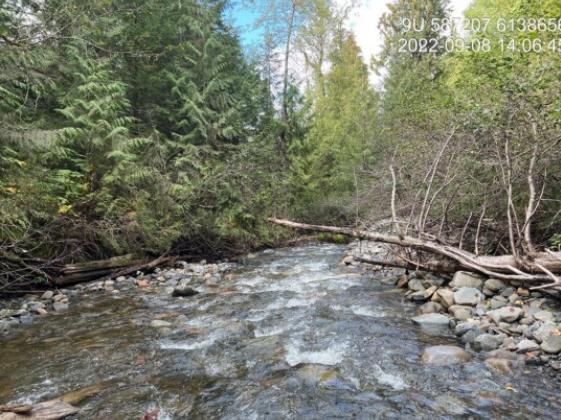
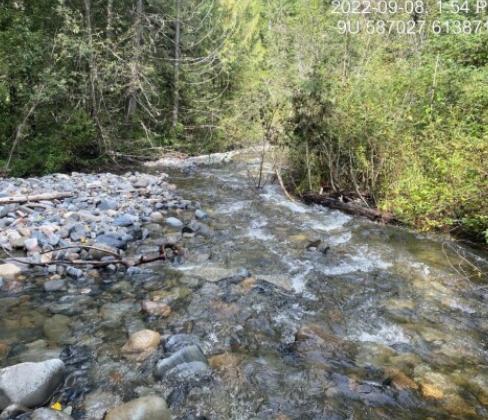
At the time of the survey, PSCIS crossing 198222 was un-embedded, non-backwatered and ranked as a barrier to upstream fish passage according to the provincial protocol (MoE 2011b) (Table [5.24](#)). This crossing was replaced in 1985. Water temperature was 9.7°C, pH was 8.2 and conductivity was 75uS/cm.

Should restoration/maintenance activities proceed, replacement of PSCIS crossing 198222 with a bridge (13m span) is recommended. The cost of the work is estimated at \$325,000 for a cost benefit of 12061.5 linear m/\$1000 and 49452.3 m<sup>2</sup>/\$1000.

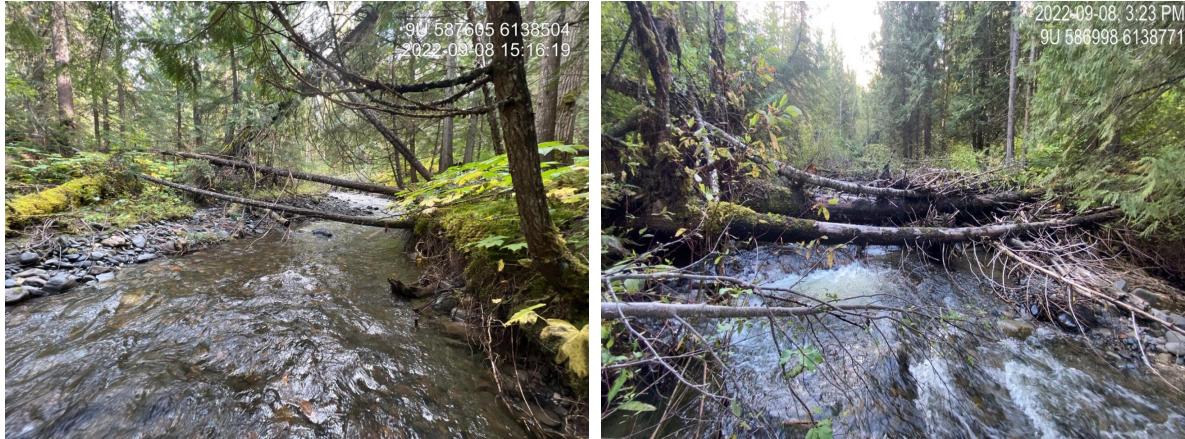
Figure 5.15: Left: Typical habitat downstream of PSCIS crossing 198222. Right: Typical habitat downstream of PSCIS crossing 198222.

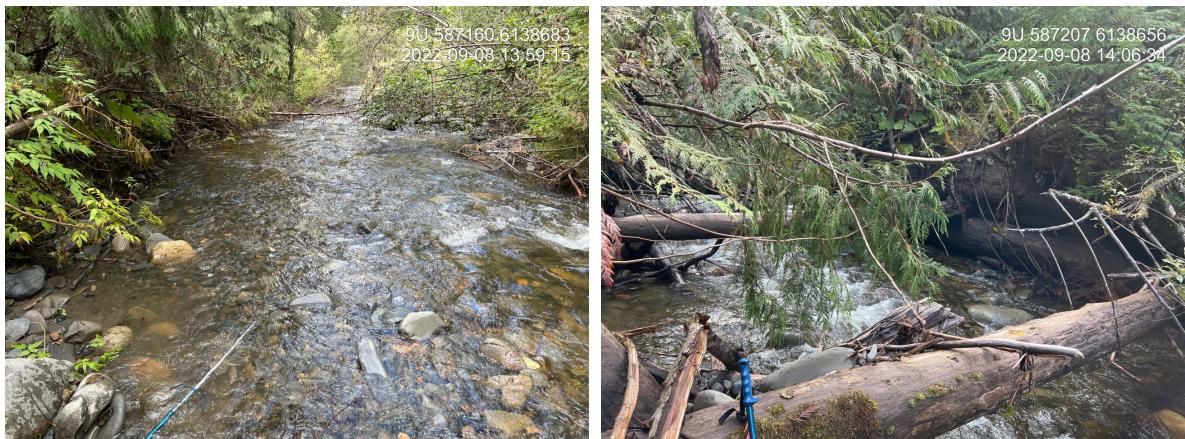
Figure 5.16: Left: Typical habitat upstream of PSCIS crossing 198222. Right: Collapsed bridge upstream of PSCIS crossing 198222.

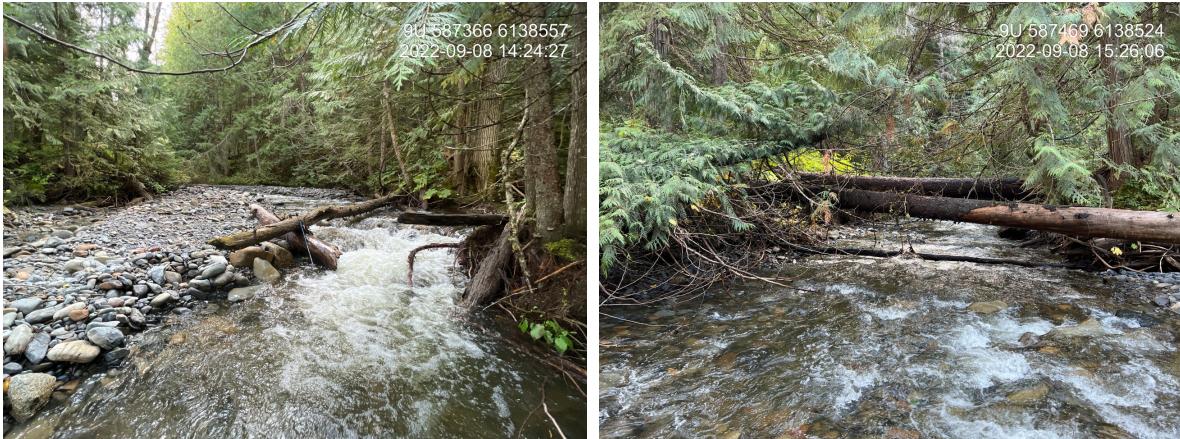
Figure 5.17: Left: Typical habitat upstream of PSCIS crossing 198222. Right: Typical habitat upstream of PSCIS crossing 198222.

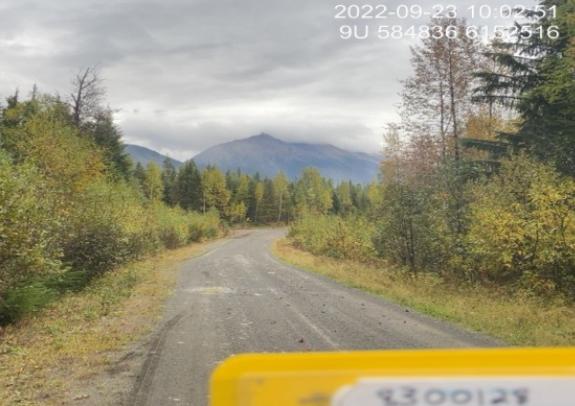
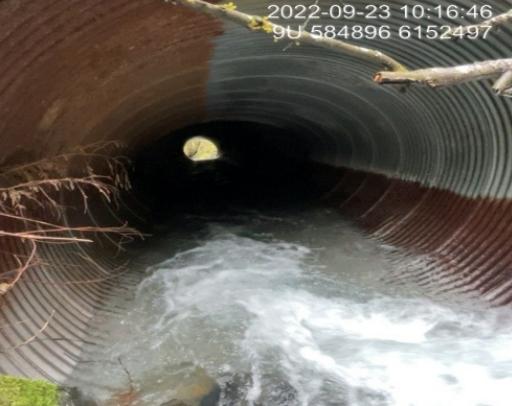
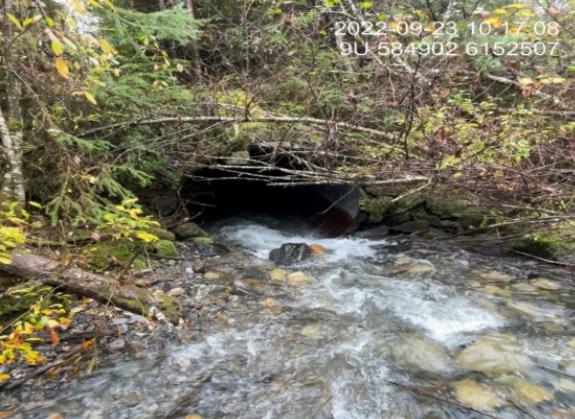
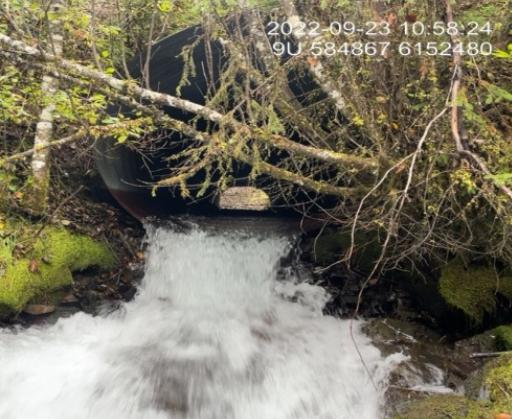
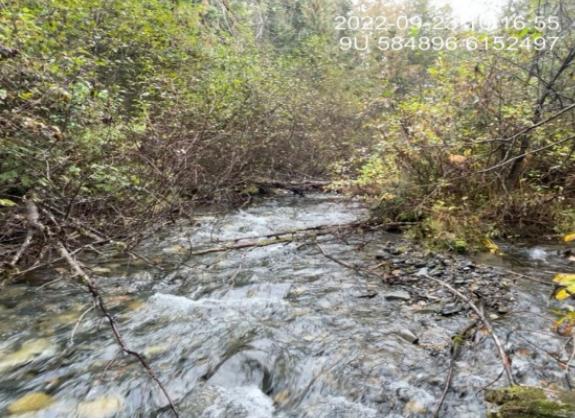
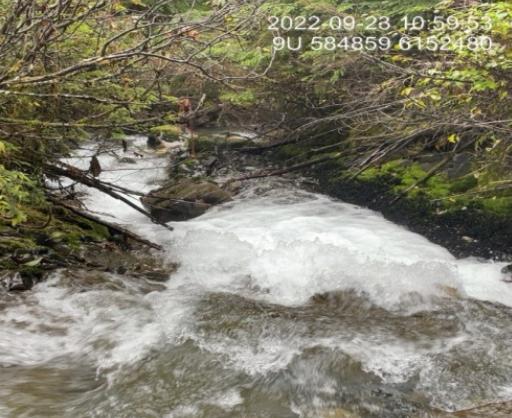
Location and Stream Data	•	Crossing Characteristics	-
Comments: Culvert is separating 10 meters in from upstream, top of culvert slumping in. 10:06			
Photos: From top left clockwise: Road/Site Card, Barrel, Outlet, Downstream, Upstream, Inlet.

Should restoration/maintenance activities proceed, replacement of PSCIS crossing 198225 with a bridge (13m span) is recommended. The cost of the work is estimated at \$NA for a cost benefit of NA linear m/\$1000 and NA m<sup>2</sup>/\$1000.

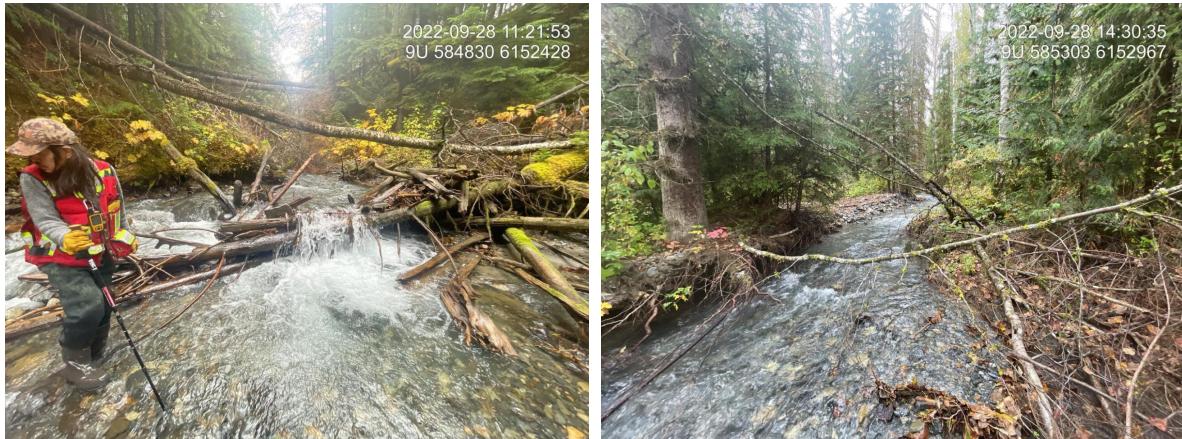
Figure 5.18: Left: Typical habitat downstream of PSCIS crossing 198225. Right: Typical habitat downstream of PSCIS crossing 198225.

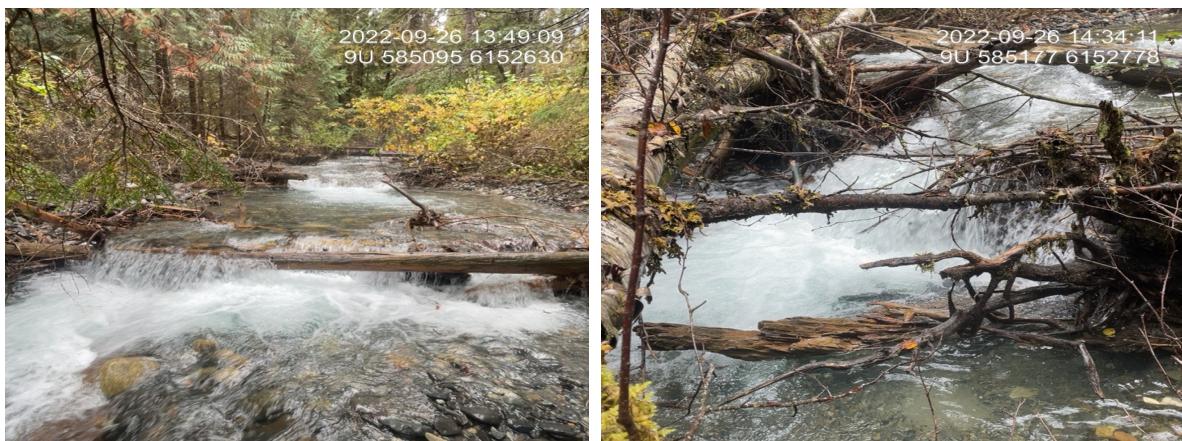
The stream was surveyed upstream from crossing 198225 for 500m (Figure 5.19). Total cover amount was rated as abundant with large woody debris dominant. Cover was also present as small woody debris. The dominant substrate was cobbles with gravels sub-dominant. The average channel width was 12.2m, the average wetted width was 5.5m, and the average gradient was 4.4%. This stream has the potential to be fish bearing but the gradient is steep. The bank full depth is very high, with a measured average of 0.8m. There was an abundance of large woody debris that provided functionality to the stream habitat by diverting flow and providing cover. The habitat was rated as medium value as an important migration corridor containing suitable rearing habitat.

Figure 5.19: Left: Typical habitat upstream of PSCIS crossing 198225. Right: Typical habitat upstream of PSCIS crossing 198225.

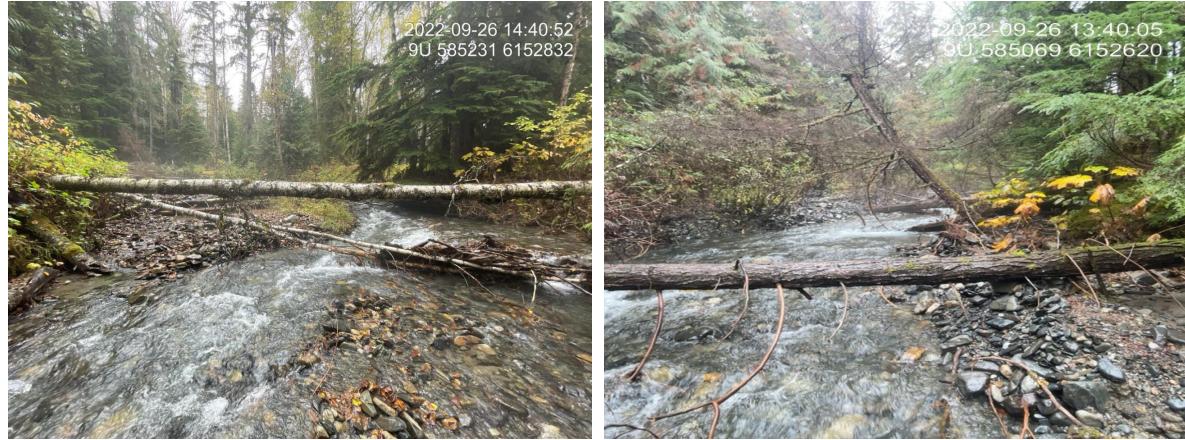
Figure 5.20: Left: Typical habitat upstream of PSCIS crossing 198225. Right: Typical habitat upstream of PSCIS crossing 198225.

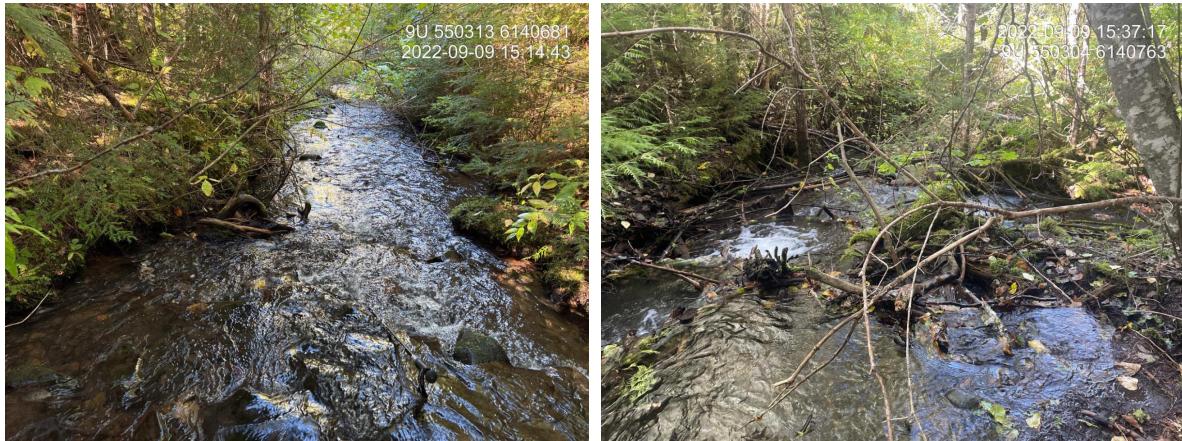
The stream was surveyed downstream from crossing 198236 for 200m (Figure 5.21). The dominant substrate was cobbles with gravels sub-dominant. Total cover amount was rated as moderate with

Figure 5.21: Left: Typical habitat downstream of PSCIS crossing 198236. Right: Typical habitat downstream of PSCIS crossing 198236.

Should restoration/maintenance activities proceed, replacement of PSCIS crossing 198236 with a bridge (10m span) is recommended. The cost of the work is estimated at \$250,000 for a cost benefit of 0 linear m/\$1000 and 0 m<sup>2</sup>/\$1000.

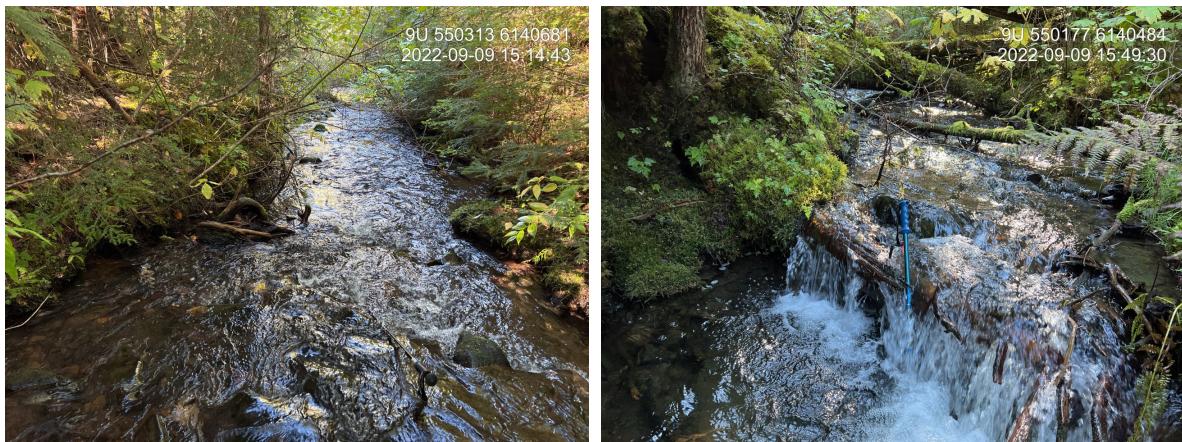
The stream was surveyed upstream from crossing 198236 for 500m (Figure 5.22). The average channel width was 3m, the average wetted width was 2.6m, and the average gradient was 5.8%. Total cover amount was rated as moderate with undercut banks dominant. Cover was also present as small woody debris, large woody debris, deep pools, and overhanging vegetation. The dominant substrate was gravels with cobbles sub-dominant. There were abundant gravels suitable for resident and anadromous salmonid spawning. There were frequent deep pools due to large woody debris in the canyon that was not logged. Overall, the habitat was rated as high value.

Figure 5.22: Left: Typical habitat upstream of PSCIS crossing 198236. Right: Typical habitat upstream of PSCIS crossing 198236.

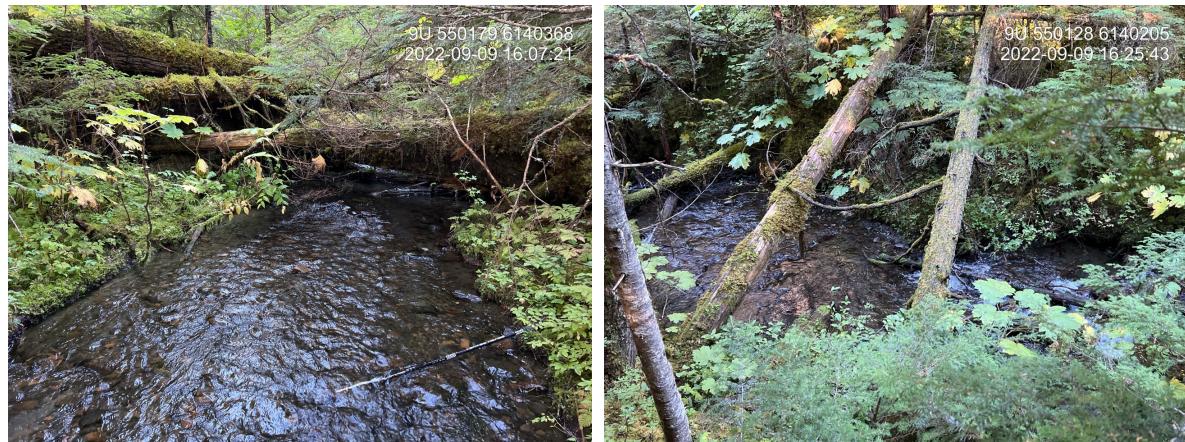
Figure 5.23: Left: Typical habitat upstream of PSCIS crossing 198236. Right: Typical habitat upstream of PSCIS crossing 198236.

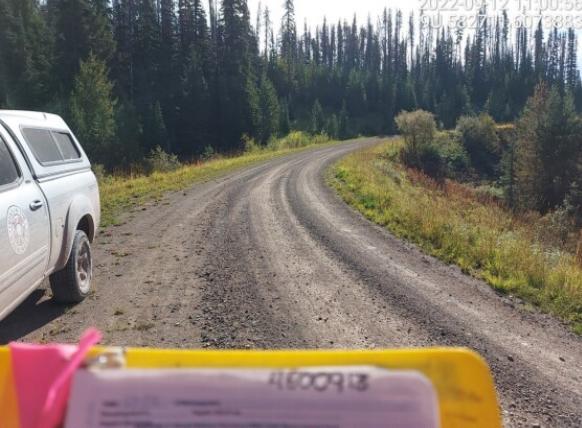
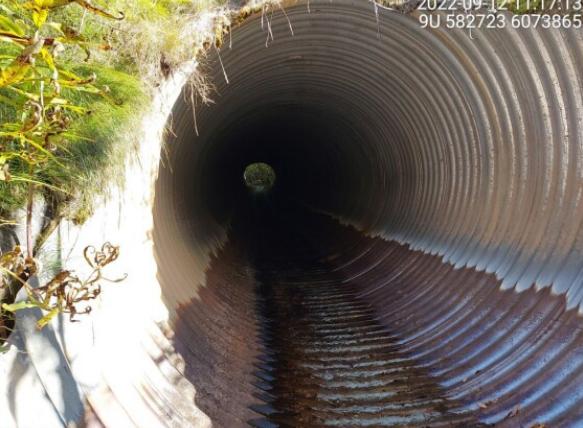
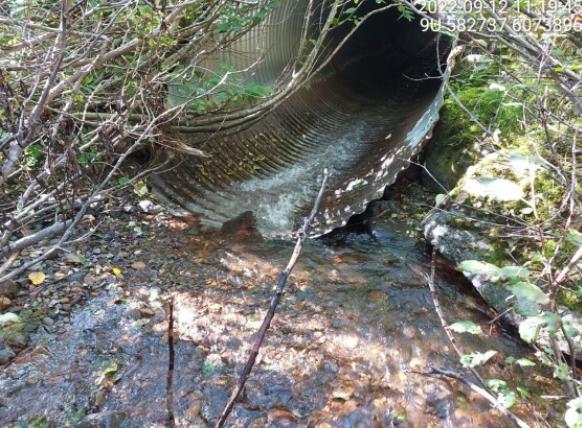
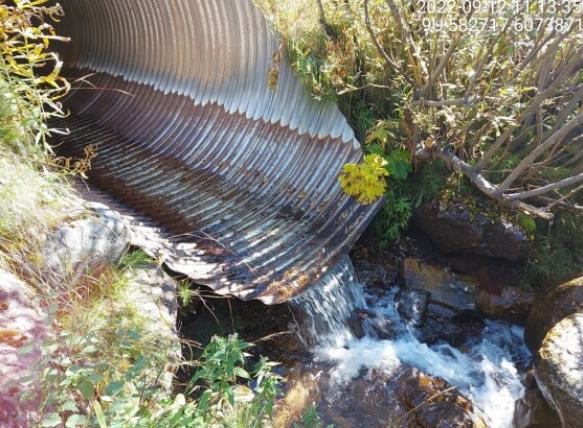
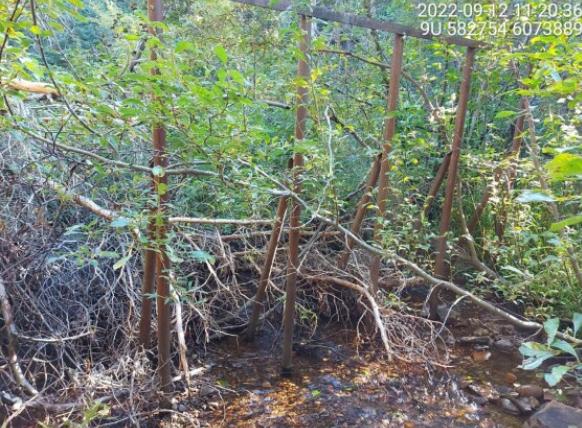
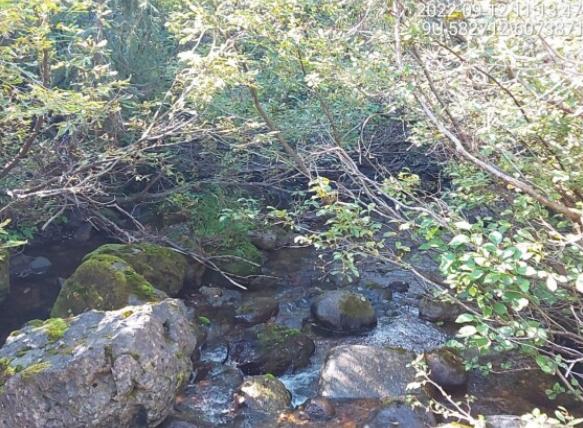
Location and Stream Data	•	Crossing Characteristics	-
Comments: Channel is steeper downstream of culvert. Very deep fill with a small outlet drop. 10:59			
Photos: From top left clockwise: Road/Site Card, Barrel, Outlet, Downstream, Upstream, Inlet.

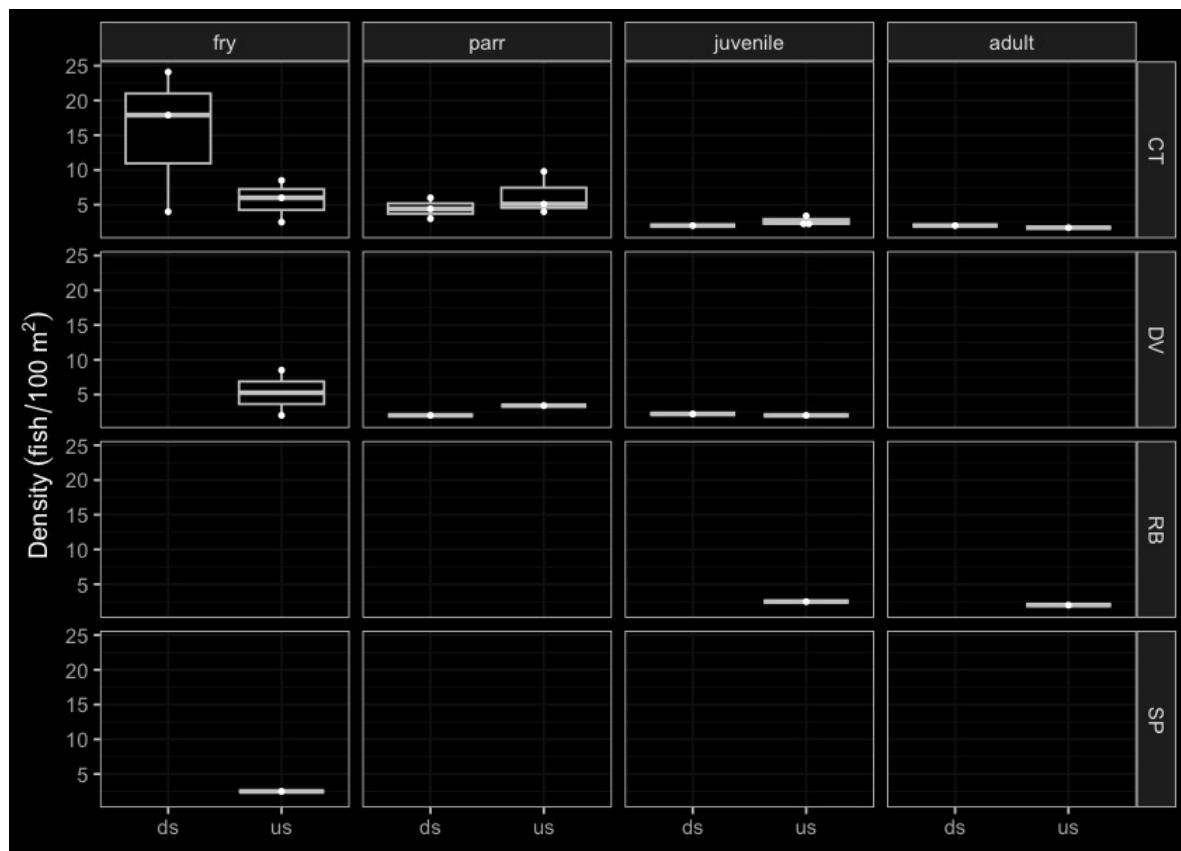
Figure 5.24: Densities of fish (fish/100m<sup>2</sup>) captured upstream of PSCIS crossing 8530.

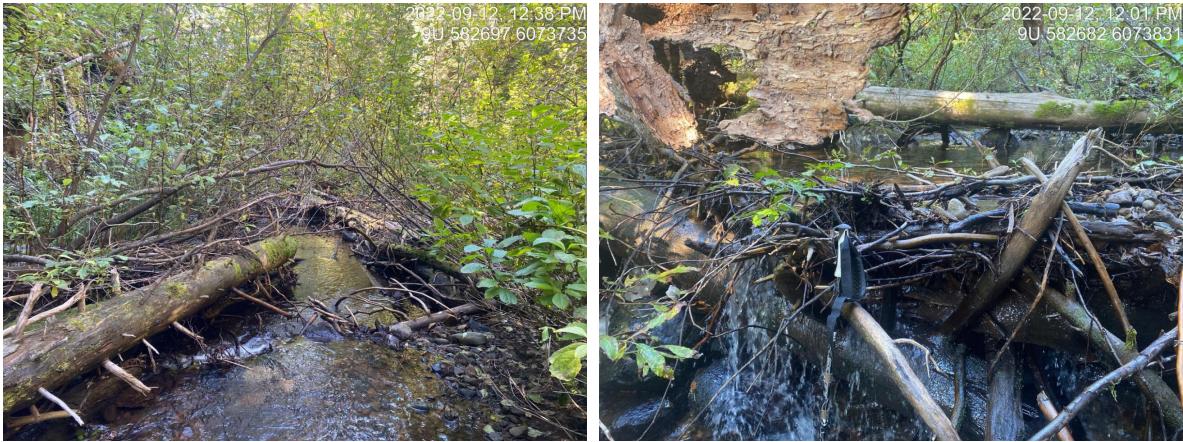
Figure 5.25: Left: Typical habitat downstream of PSCIS crossing 8530. Right: Large woody debris jam downstream of PSCIS crossing 8530.

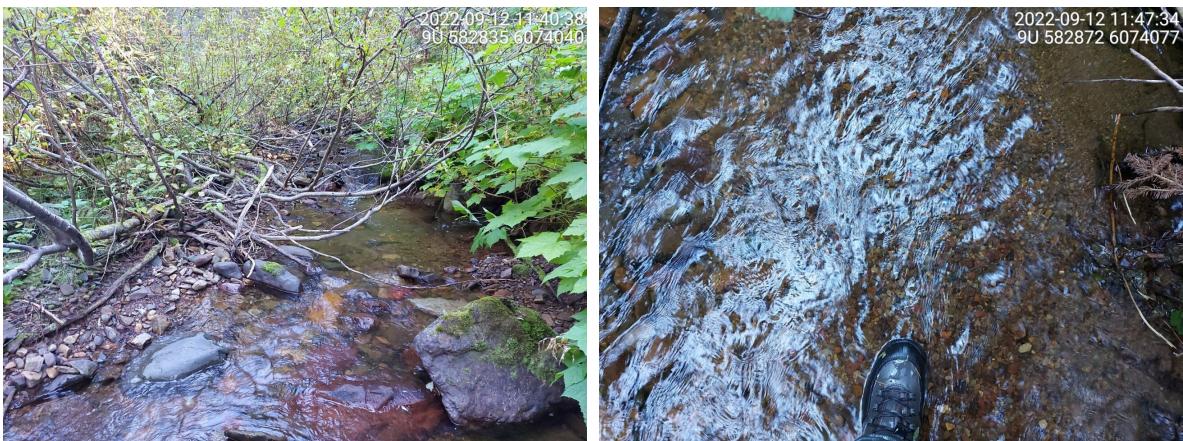
Figure 5.26: Left: Typical habitat upstream of PSCIS crossing 8530. Right: Area with suitable spawning gravels, upstream of PSCIS crossing 8530.

Should restoration/maintenance activities proceed, replacement of PSCIS crossing 8530 with a bridge (10m span) is recommended. The cost of the work is estimated at \$250,000 for a cost benefit of 0 linear m/\$1000 and 0 m<sup>2</sup>/\$1000.

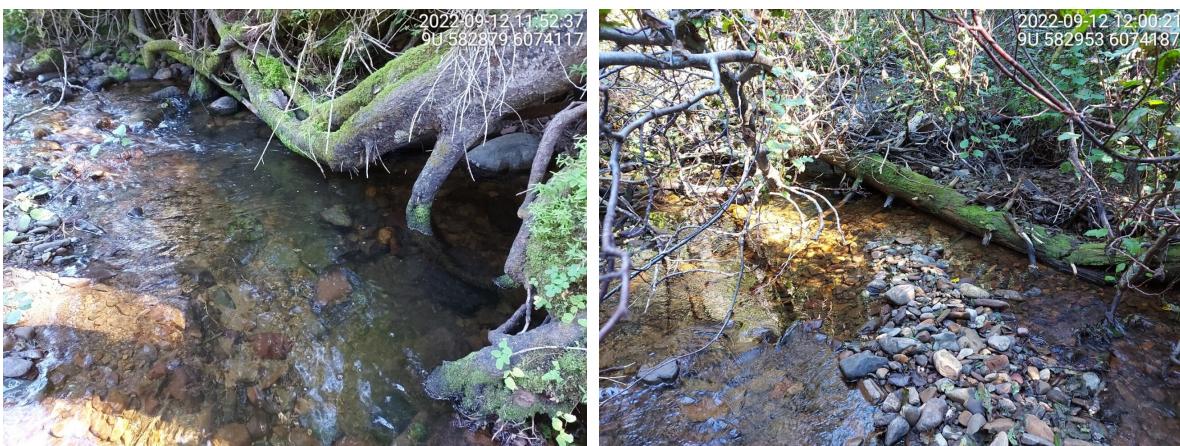
Figure 5.27: Left: Typical habitat upstream of PSCIS crossing 8530. Right: Typical habitat upstream of PSCIS crossing 8530.
