Appendix - Phase 1 Fish Passage Assessment Data and Photos

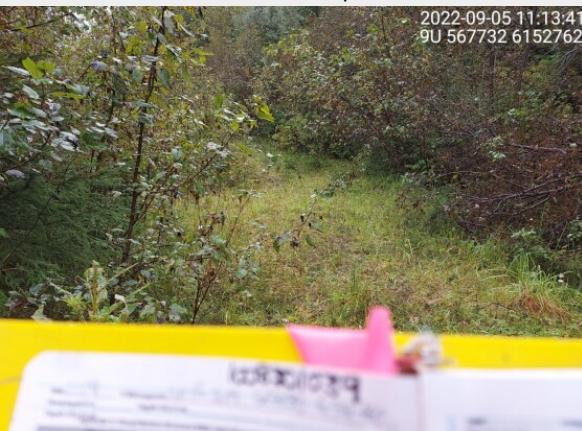
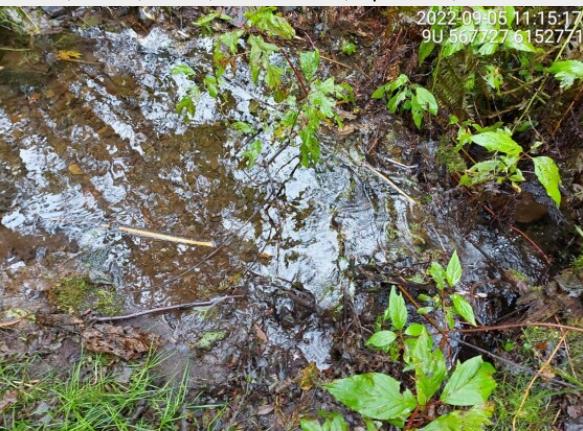
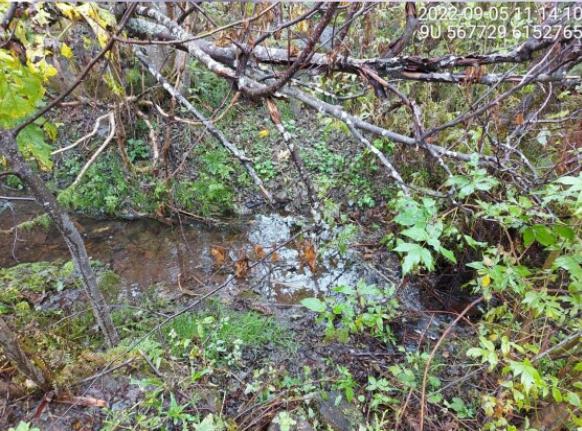
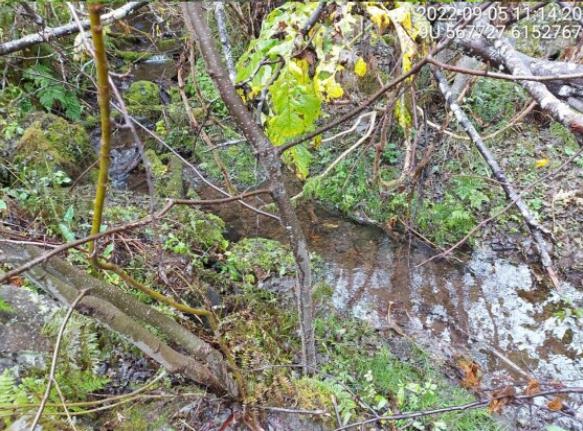
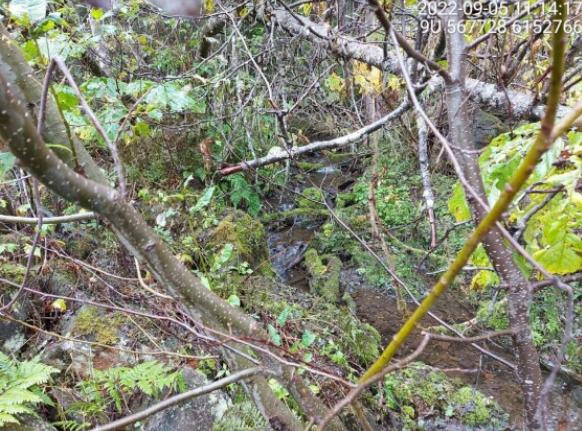
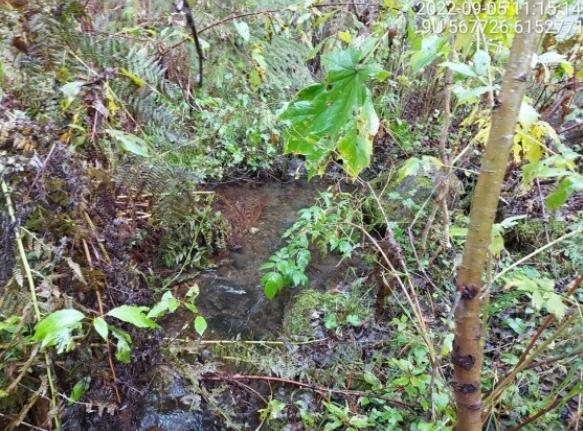
Location and Stream Data	•	Crossing Characteristics	-
Comments: Small stream, good habitat with fines and gravelly, and lots of cover and healthy riparian vegetation. 11:09			
Photos: PSCIS ID 198180. From top left clockwise: Road/Site Card, Barrel, Outlet, Downstream, Upstream, Inlet.

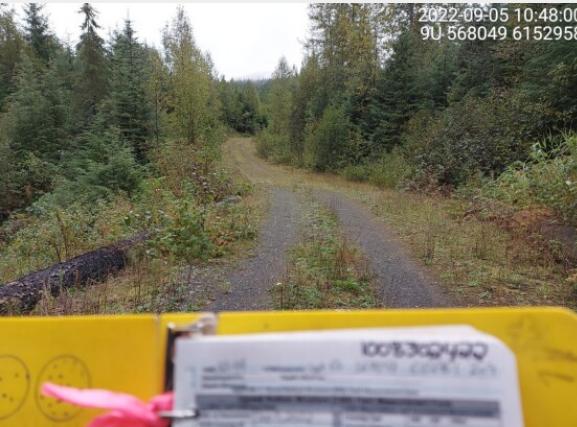
Location and Stream Data	•	Crossing Characteristics	-
Comments: Wetland habitat on both sides, grassy and shrubs. Upstream has small cascade (0.5-1m high) draining into inlet pool. Bridge is in ok condition. 10:44			
Photos: PSCIS ID 198181. From top left clockwise: Road/Site Card, Barrel, Outlet, Downstream, Upstream, Inlet.

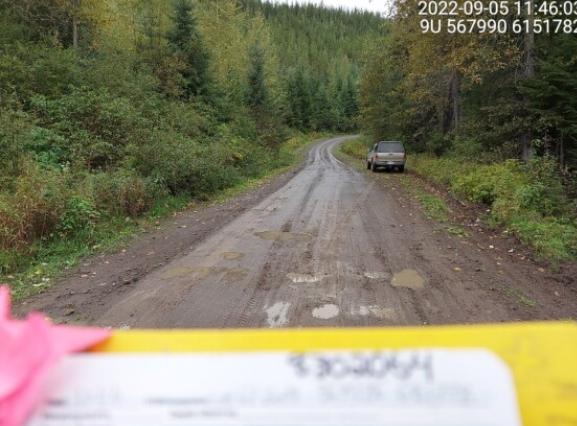
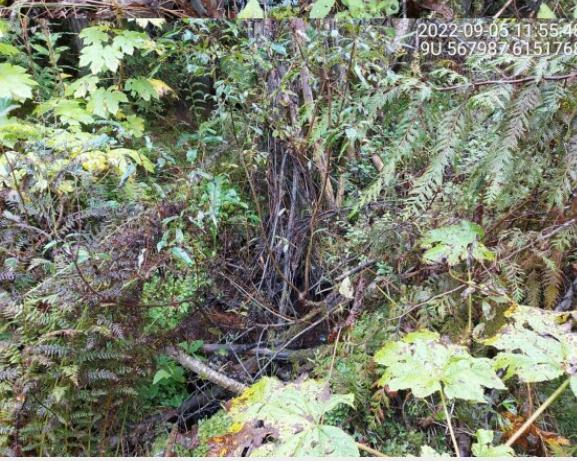
Location and Stream Data	•	Crossing Characteristics	-
Comments: Good habitat with large amounts of cover (LWD and overhanging veg). Culvert is rusted and a little warped but in good condition, no outlet drop. 11:44			
Photos: PSCIS ID 198182. From top left clockwise: Road/Site Card, Barrel, Outlet, Downstream, Upstream, Inlet.

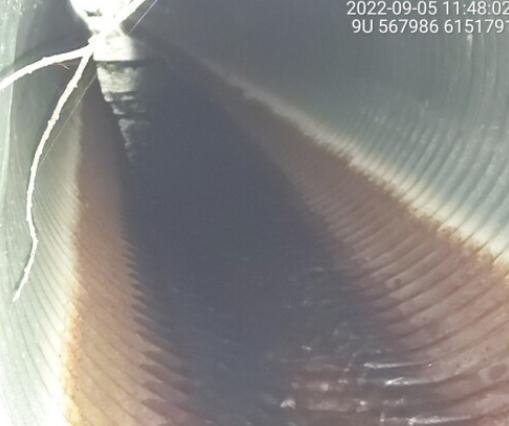
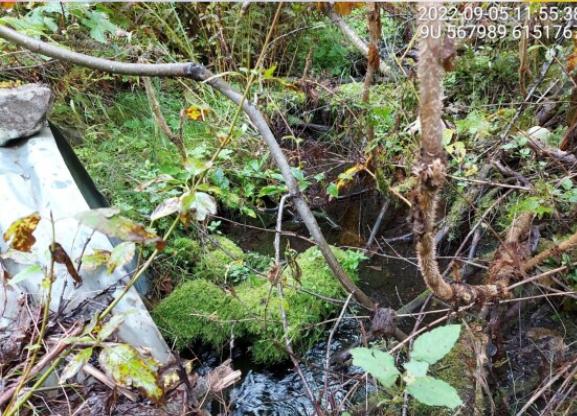
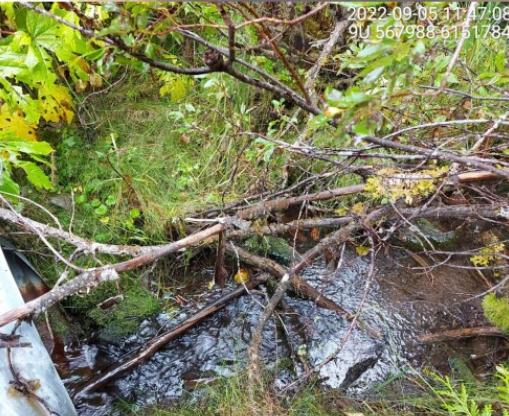
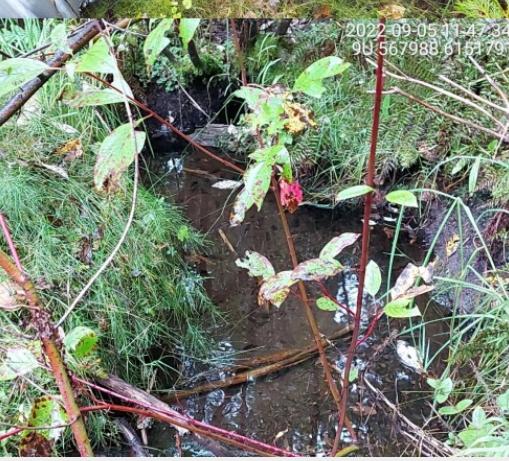
Location and Stream Data		Crossing Characteristics	
Date	2022-09-05	Crossing Sub Type	Round Culvert
PSCIS ID	198182	Diameter (m)	0.9
External ID	8302064	Length (m)	12
Crew	MW	Embedded	No
UTM Zone	9	Depth Embedded (m)	–
Easting	567986	Resemble Channel	No
Northing	6151778	Backwatered	No
Stream	Tributary to Kispiox River	Percent Backwatered	–
Road	Helen Lake Rd	Fill Depth (m)	1.5
Road Tenure	BCTS 8243	Outlet Drop (m)	0
Channel Width (m)	1.4	Outlet Pool Depth (m)	0.1
Stream Slope (%)	1.5	Inlet Drop	No
Beaver Activity	No	Slope (%)	1
Habitat Value	Medium	Valley Fill	Deep Fill
Final score	21	Barrier Result	Barrier
Fix type	Replace Structure with Streambed Simulation CBS	Fix Span / Diameter	3

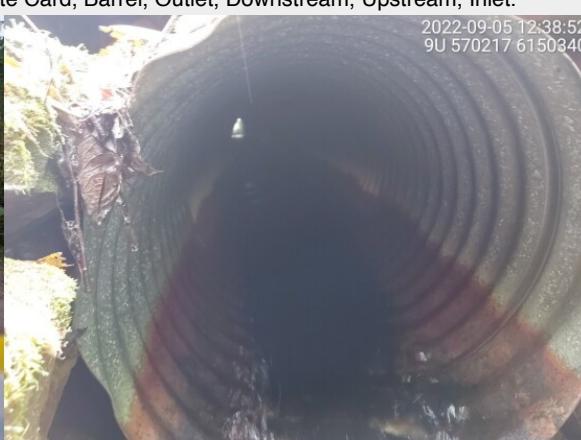
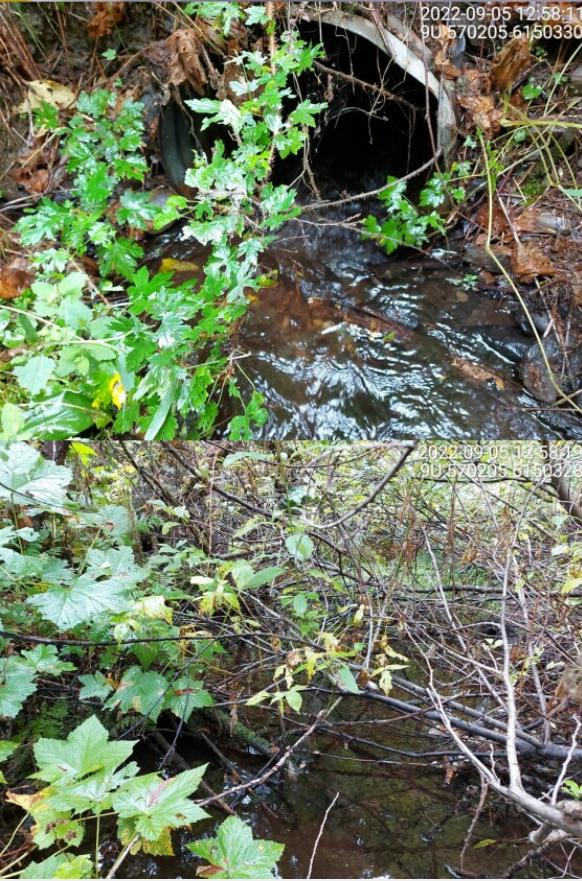
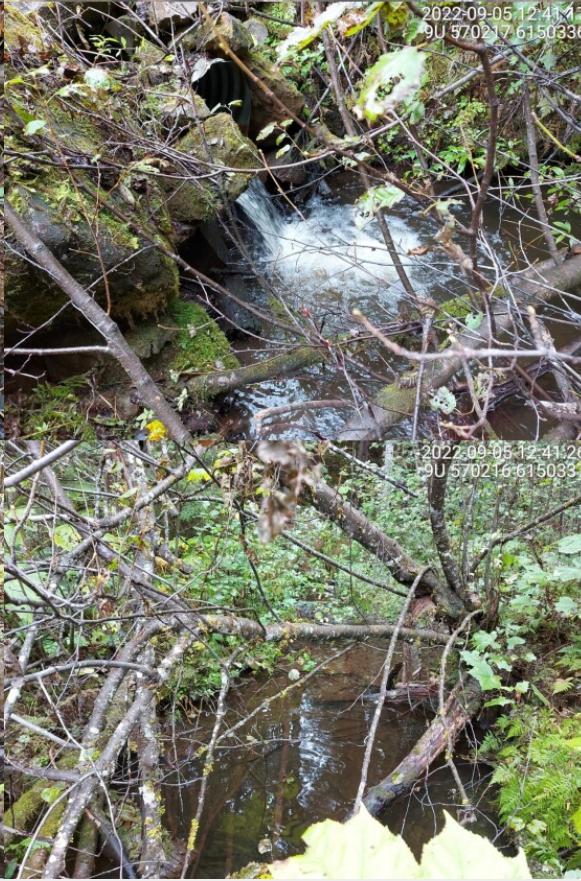
Location and Stream Data	•	Crossing Characteristics	-
Comments: Big outlet drop with deep outlet pool. Some rusting in culvert and it's bent slightly in the middle. 12:22			
Photos: PSCIS ID 198183. From top left clockwise: Road/Site Card, Barrel, Outlet, Downstream, Upstream, Inlet.

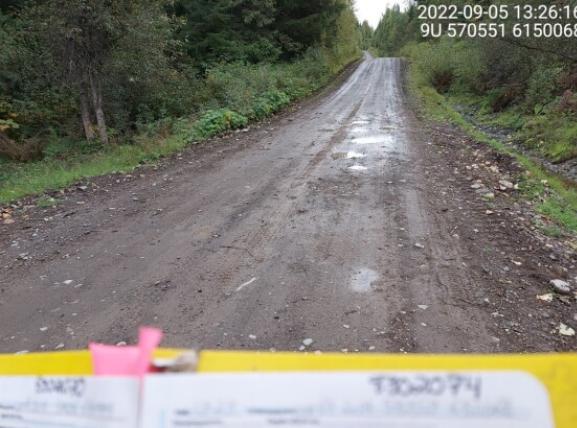
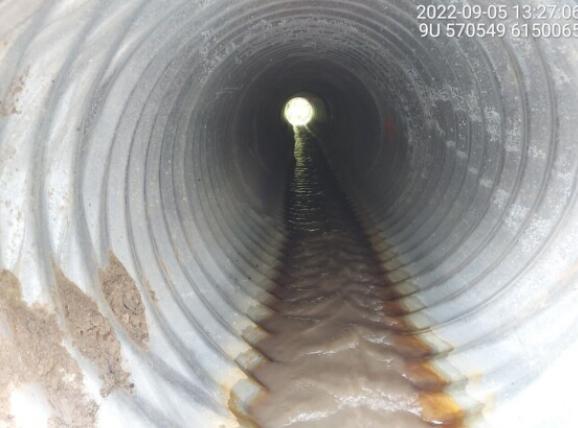
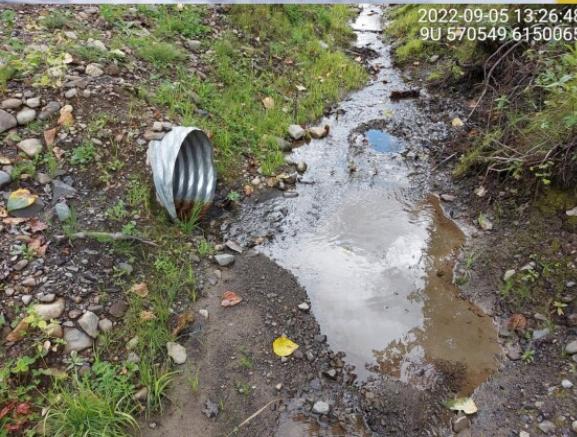
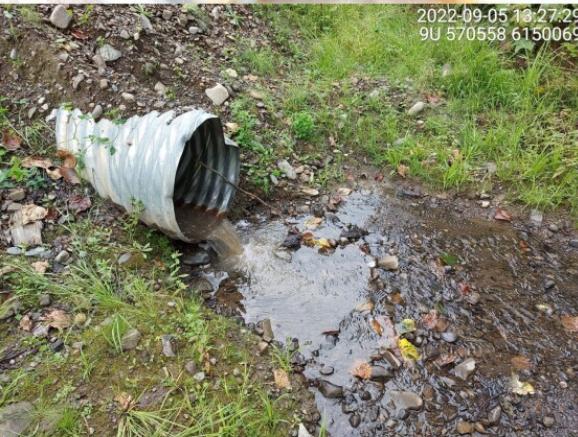
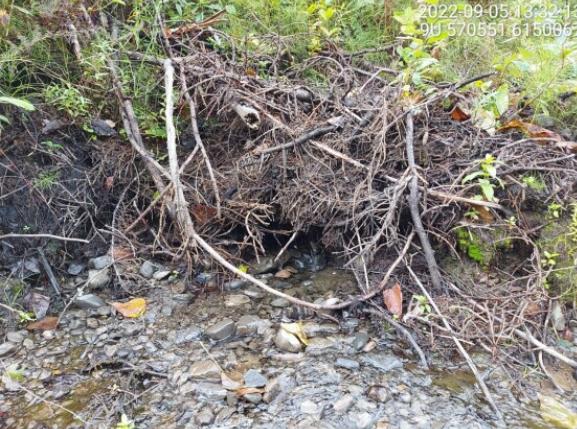
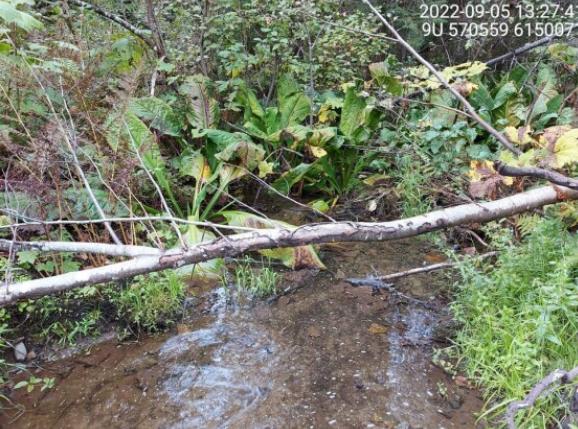
Location and Stream Data		Crossing Characteristics	
Date	2022-09-05	Crossing Sub Type	Round Culvert
PSCIS ID	198184	Diameter (m)	0.6
External ID	8302074	Length (m)	8
Crew	MW	Embedded	No
UTM Zone	9	Depth Embedded (m)	–
Easting	570565.8	Resemble Channel	No
Northing	6150060	Backwatered	No
Stream	Tributary to Kispiox River	Percent Backwatered	–
Road	Helen Lake Rd	Fill Depth (m)	0.7
Road Tenure	BCTS 8243	Outlet Drop (m)	0.2
Channel Width (m)	1.1	Outlet Pool Depth (m)	0.1
Stream Slope (%)	1	Inlet Drop	No
Beaver Activity	No	Slope (%)	0.5
Habitat Value	Low	Valley Fill	Deep Fill
Final score	21	Barrier Result	Barrier
Fix type	Replace Structure with Streambed Simulation CBS	Fix Span / Diameter	3

Location and Stream Data	•	Crossing Characteristics	-
Comments: Very little flow, shallow stream around culvert. Large amounts of woody debris blocking stream near inlet. Lots of cover around stream. 13:23			
Photos: PSCIS ID 198184. From top left clockwise: Road/Site Card, Barrel, Outlet, Downstream, Upstream, Inlet.

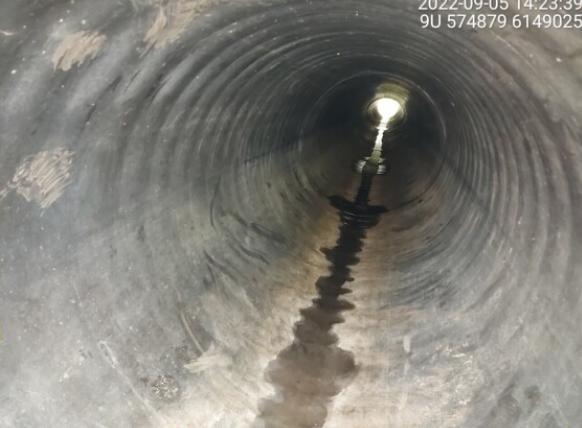
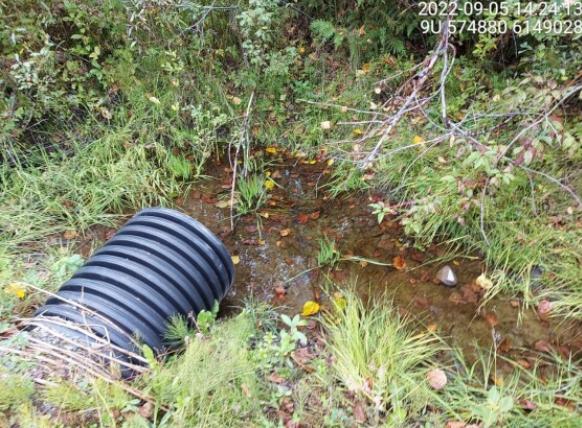
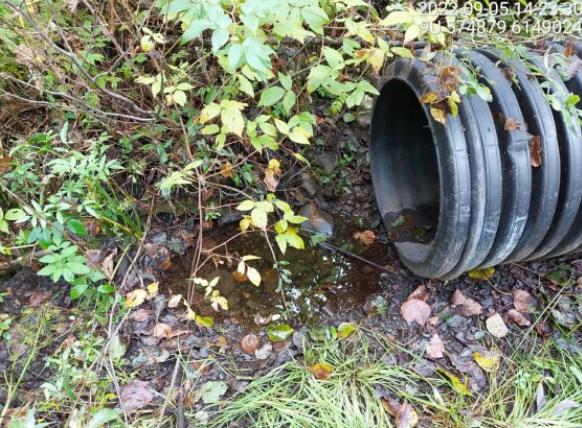
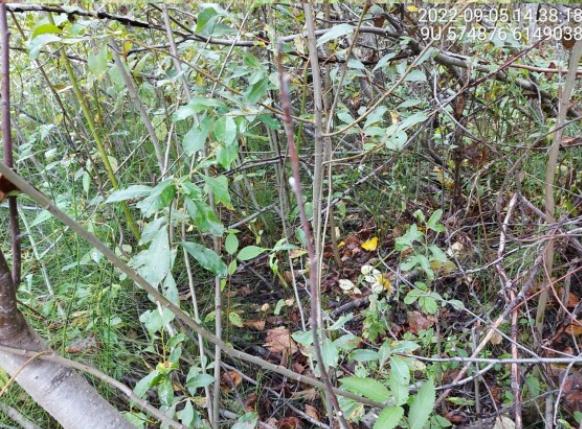
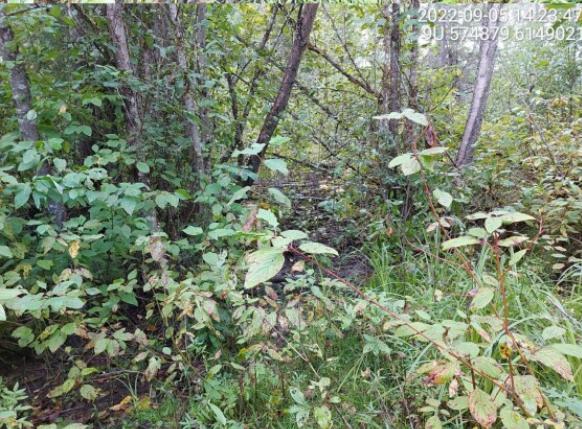
Location and Stream Data		Crossing Characteristics	
Date	2022-09-05	Crossing Sub Type	Round Culvert
PSCIS ID	198185	Diameter (m)	0.7
External ID	8300115	Length (m)	11
Crew	MW	Embedded	No
UTM Zone	9	Depth Embedded (m)	–
Easting	574866.3	Resemble Channel	No
Northing	6149021	Backwatered	No
Stream	Trib to McCully Creek	Percent Backwatered	–
Road	Helen Lake Rd	Fill Depth (m)	0.3
Road Tenure	MoTi Local	Outlet Drop (m)	0
Channel Width (m)	1.3	Outlet Pool Depth (m)	0
Stream Slope (%)	1	Inlet Drop	No
Beaver Activity	No	Slope (%)	2
Habitat Value	Low	Valley Fill	Deep Fill
Final score	21	Barrier Result	Barrier
Fix type	Replace Structure with Streambed Simulation CBS	Fix Span / Diameter	3

Location and Stream Data	•	Crossing Characteristics	-
Comments: Culvert is black and plastic. 14:16			
Photos: PSCIS ID 198185. From top left clockwise: Road/Site Card, Barrel, Outlet, Downstream, Upstream, Inlet.

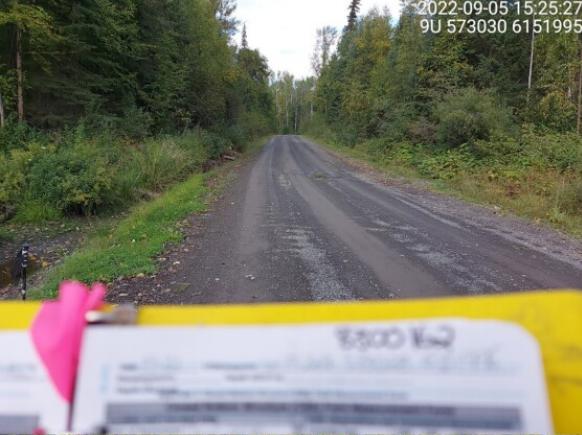
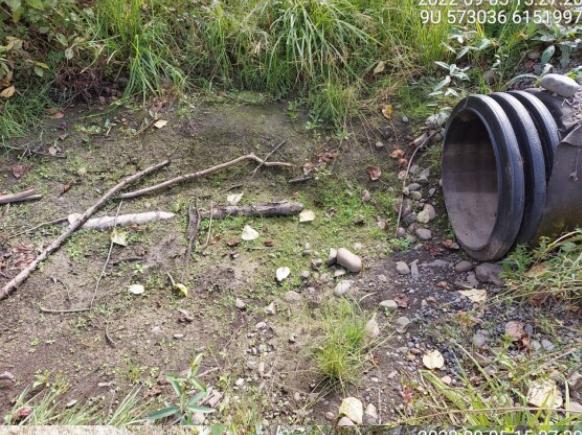
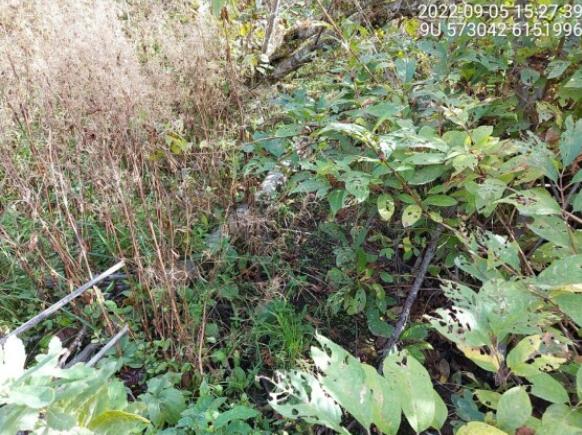
Location and Stream Data	•	Crossing Characteristics	-
Comments: Drains Pentz Lake, mostly dewatered. Dawson may have replaced this crossing in fall of 2022 (pers comm Greg Black - project manager Dawson Road Maintenance). 15:22			
Photos: PSCIS ID 198186. From top left clockwise: Road/Site Card, Barrel, Outlet, Downstream, Upstream, Inlet.

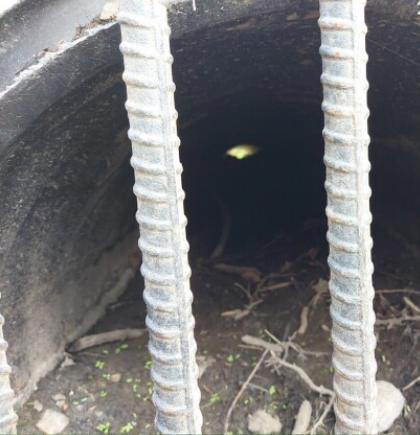
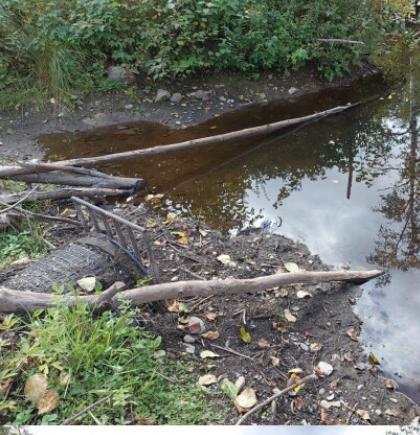
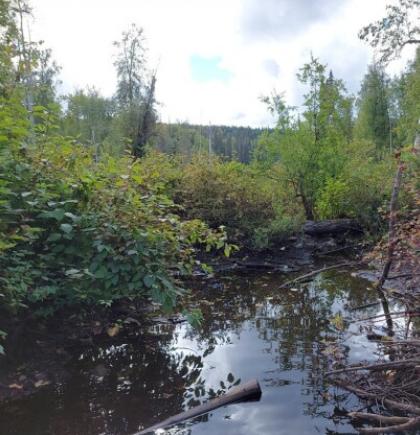
Location and Stream Data		Crossing Characteristics	
Date	2022-09-05	Crossing Sub Type	Round Culvert
PSCIS ID	198186	Diameter (m)	0.7
External ID	8300162	Length (m)	8
Crew	MW	Embedded	No
UTM Zone	9	Depth Embedded (m)	–
Easting	573033.2	Resemble Channel	No
Northing	6151997	Backwatered	No
Stream	Tributary to Kispiox River	Percent Backwatered	–
Road	Poplar Park Rd	Fill Depth (m)	0.5
Road Tenure	MoTi Local	Outlet Drop (m)	0
Channel Width (m)	1.2	Outlet Pool Depth (m)	0
Stream Slope (%)	1	Inlet Drop	No
Beaver Activity	No	Slope (%)	0
Habitat Value	Low	Valley Fill	Deep Fill
Final score	16	Barrier Result	Potential
Fix type	Replace Structure with Streambed Simulation CBS	Fix Span / Diameter	3

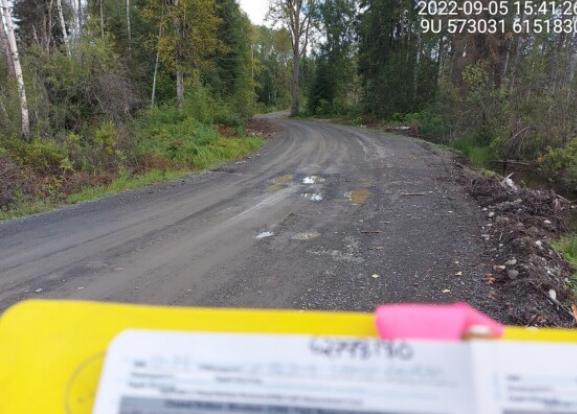
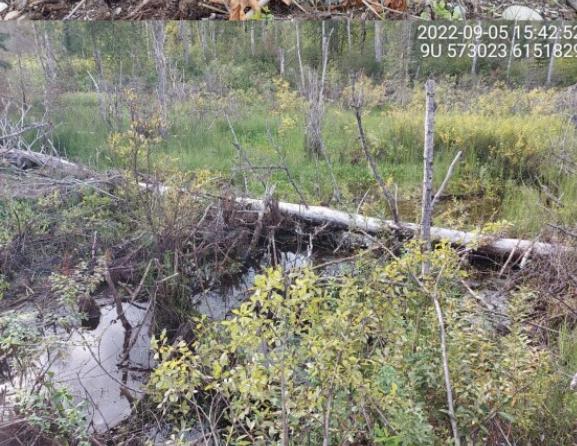
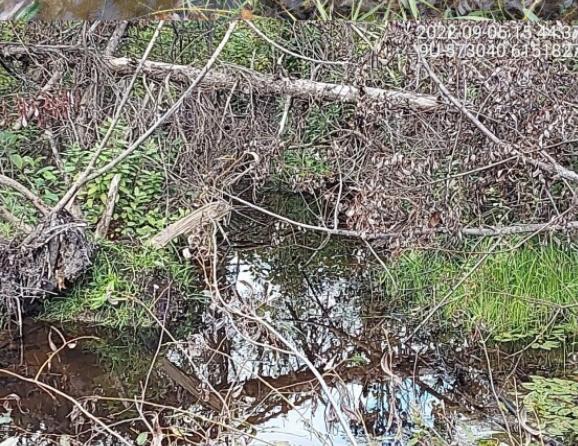
Location and Stream Data	•	Crossing Characteristics	-
Comments: Drains Pentz Lake. Not a modelled crossing. Some backwater, not a lot of flow. Dawson may have replaced this crossing in fall of 2022 (pers comm Greg Black - project manager Dawson Road Maintenance). 15:39			
Photos: PSCIS ID 198187. From top left clockwise: Road/Site Card, Barrel, Outlet, Downstream, Upstream, Inlet.

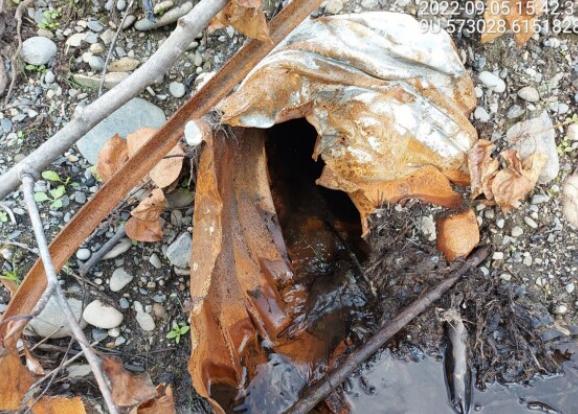
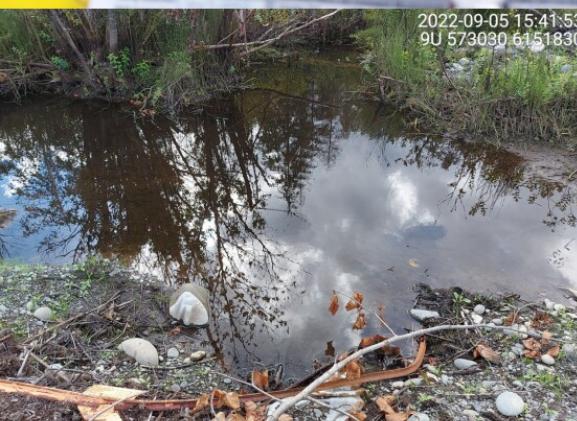
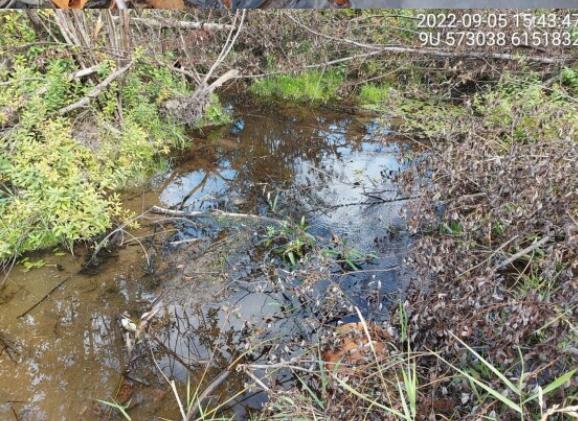
Location and Stream Data		Crossing Characteristics –	
Date	2022-09-05	Crossing Sub Type	Round Culvert
PSCIS ID	198187	Diameter (m)	0.4
External ID	2798180	Length (m)	9
Crew	MW	Embedded	No
UTM Zone	9	Depth Embedded (m)	–
Easting	573036	Resemble Channel	No
Northing	6151831	Backwatered	Yes
Stream	Tributary to Kispiox River	Percent Backwatered	50
Road	Poplar Park Rd	Fill Depth (m)	0.3
Road Tenure	MoTi Local	Outlet Drop (m)	0
Channel Width (m)	2.1	Outlet Pool Depth (m)	0
Stream Slope (%)	1	Inlet Drop	No
Beaver Activity	No	Slope (%)	1
Habitat Value	Low	Valley Fill	Deep Fill
Final score	21	Barrier Result	Barrier
Fix type	Replace with New Open Bottom Structure	Fix Span / Diameter	10

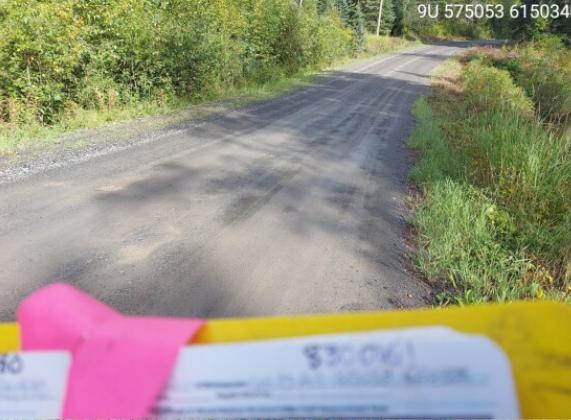
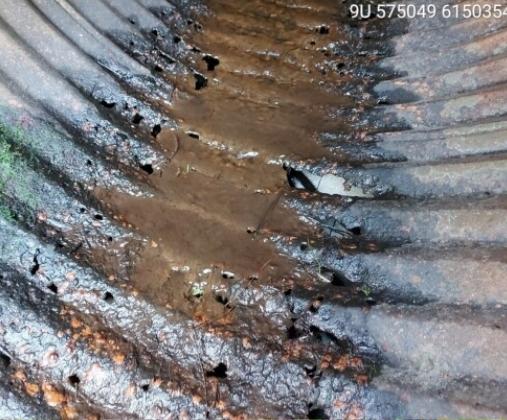
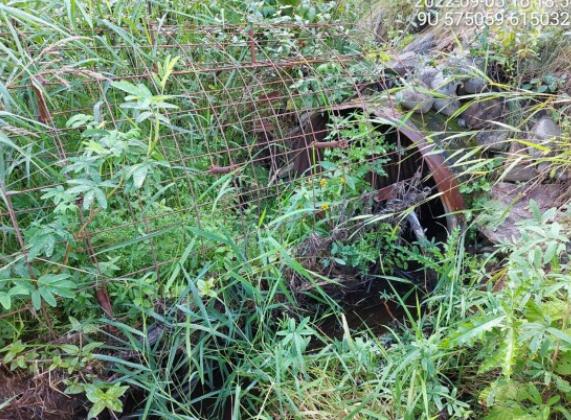
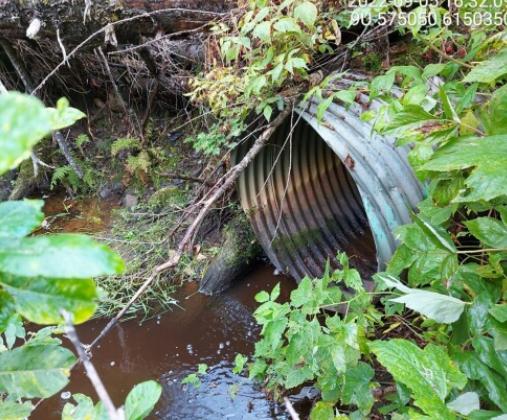
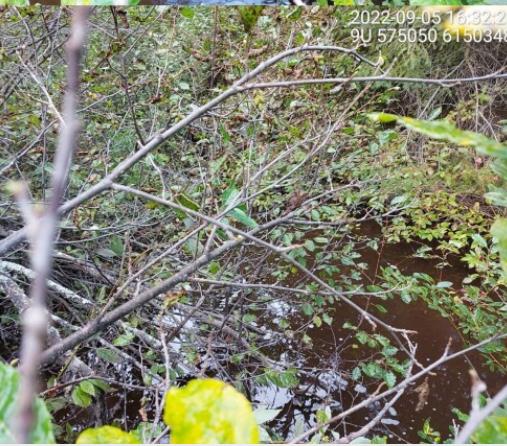
Location and Stream Data		Crossing Characteristics –	
Date	2022-09-05	Crossing Sub Type	Round Culvert
PSCIS ID	198188	Diameter (m)	1.1
External ID	8300161	Length (m)	11
Crew	MW	Embedded	No
UTM Zone	9	Depth Embedded (m)	–
Easting	575069.5	Resemble Channel	No
Northing	6150345	Backwatered	No
Stream	Tributary to Kispiox River	Percent Backwatered	–
Road	Poplar Park Rd	Fill Depth (m)	2.5
Road Tenure	MoTi Local	Outlet Drop (m)	0.2
Channel Width (m)	2.3	Outlet Pool Depth (m)	0.2
Stream Slope (%)	1.5	Inlet Drop	Yes
Beaver Activity	Yes	Slope (%)	2
Habitat Value	Low	Valley Fill	Deep Fill
Final score	26	Barrier Result	Barrier
Fix type	Replace with New Open Bottom Structure	Fix Span / Diameter	10

Location and Stream Data	•	Crossing Characteristics	-
Comments: Big beaver dam right near inlet (about 2m in height). 16:12			
Photos: PSCIS ID 198188. From top left clockwise: Road/Site Card, Barrel, Outlet, Downstream, Upstream, Inlet.

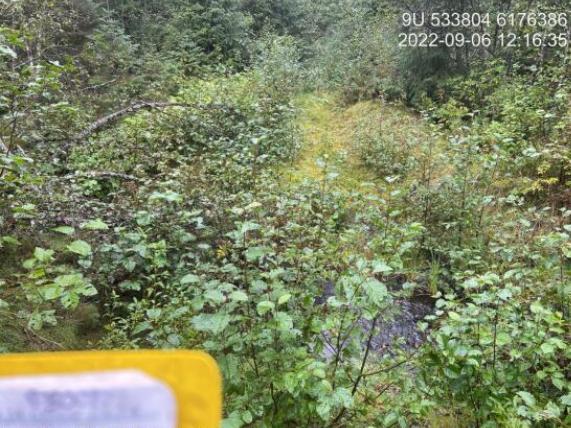
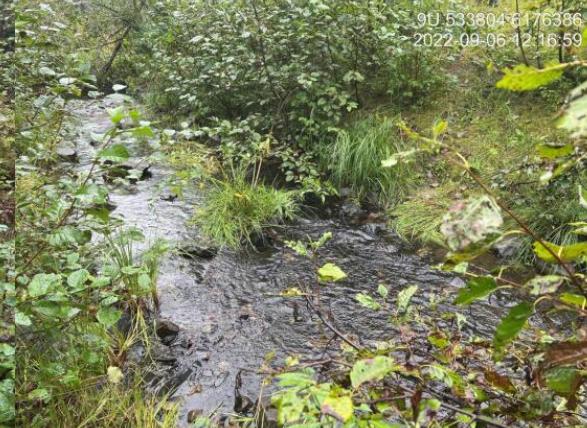
Location and Stream Data	•	Crossing Characteristics	-
Comments: Road has been deactivated with crossing pulled. Lots of flow. 12:04			
Photos: PSCIS ID 198189. From top left clockwise: Road/Site Card, Barrel, Outlet, Downstream, Upstream, Inlet.

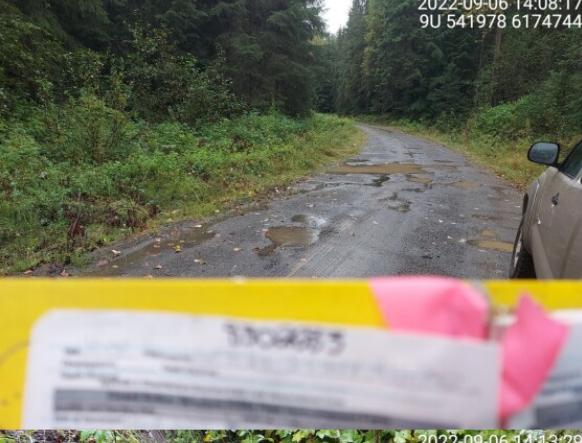
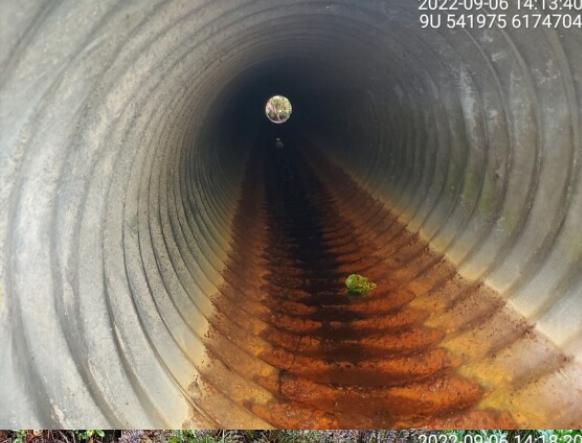
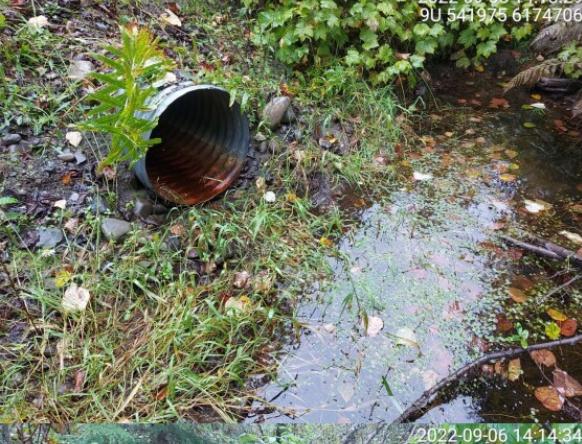
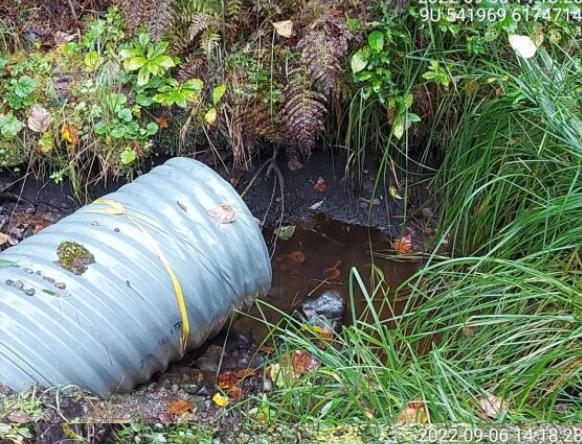
Location and Stream Data	•	Crossing Characteristics	-
Comments: Stream is dewatered. Some rain water in pools. 14:05			
Photos: PSCIS ID 198190. From top left clockwise: Road/Site Card, Barrel, Outlet, Downstream, Upstream, Inlet.

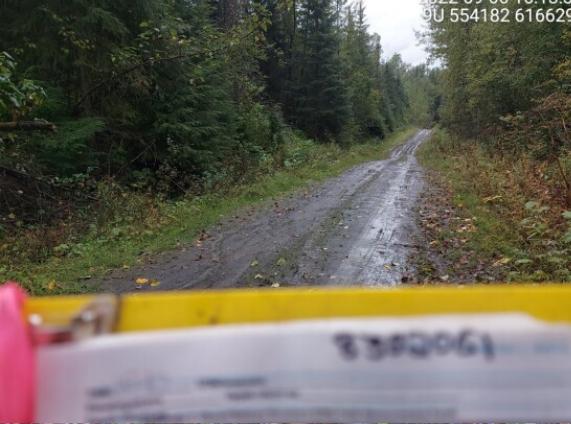
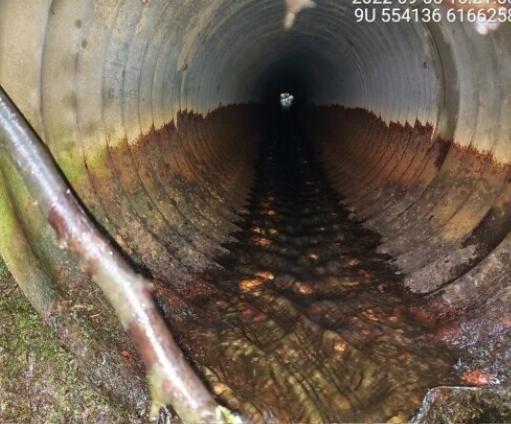
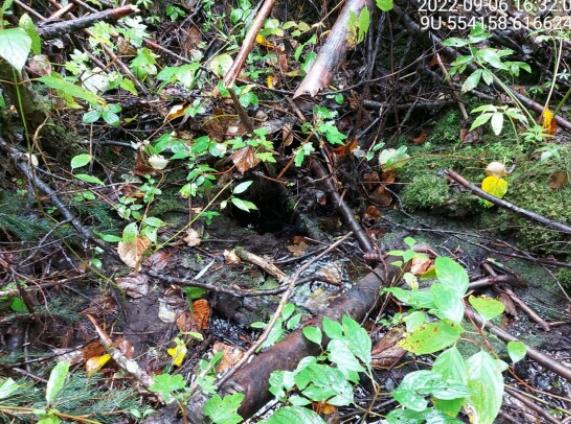
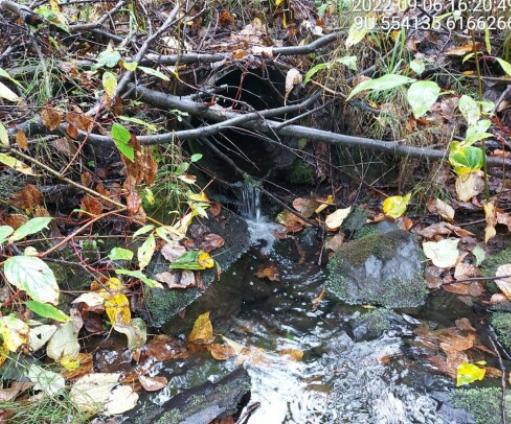
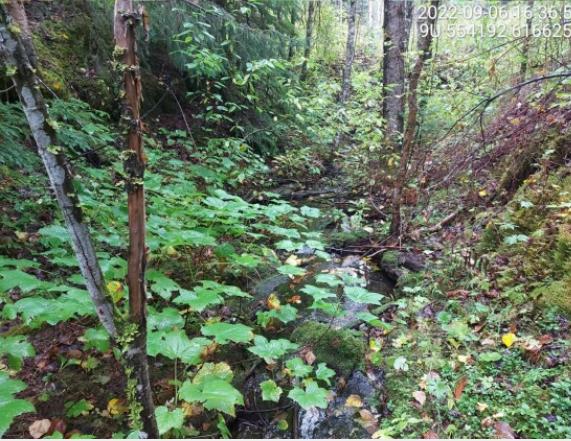
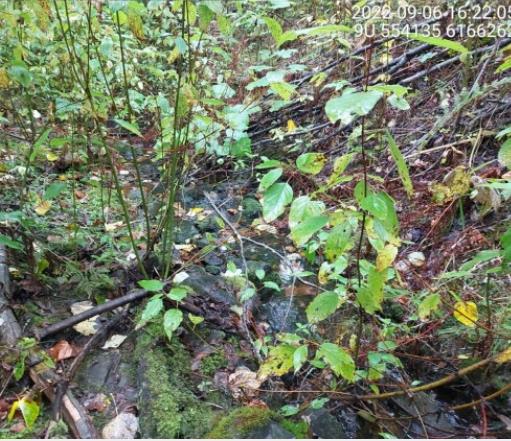
Location and Stream Data	•	Crossing Characteristics	-
Comments: Small cascade approx 50m upstream, could be barrier for smaller fish. 16:10			
Photos: PSCIS ID 198191. From top left clockwise: Road/Site Card, Barrel, Outlet, Downstream, Upstream, Inlet.

Location and Stream Data		Crossing Characteristics	
Date	2022-09-06	Crossing Sub Type	Round Culvert
PSCIS ID	198191	Diameter (m)	0.5
External ID	8302061	Length (m)	13
Crew	MW	Embedded	No
UTM Zone	9	Depth Embedded (m)	–
Easting	554147.8	Resemble Channel	No
Northing	6166257	Backwatered	No
Stream	Tributary to Kispiox River	Percent Backwatered	–
Road	Corral Main	Fill Depth (m)	3
Road Tenure	Gitxsan Forest R02415	Outlet Drop (m)	0.2
Channel Width (m)	1.5	Outlet Pool Depth (m)	0.15
Stream Slope (%)	4	Inlet Drop	Yes
Beaver Activity	No	Slope (%)	3
Habitat Value	Medium	Valley Fill	Deep Fill
Final score	31	Barrier Result	Barrier
Fix type	Replace Structure with Streambed Simulation CBS	Fix Span / Diameter	3

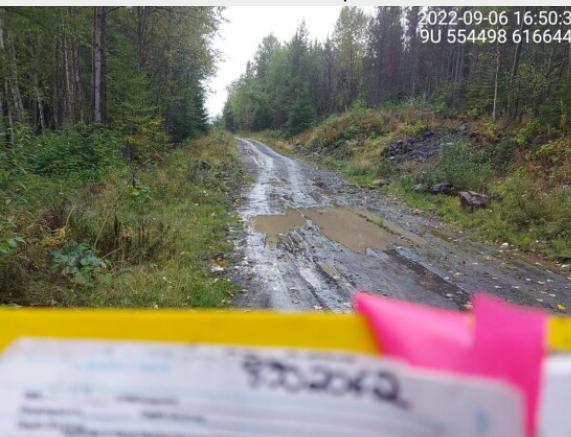
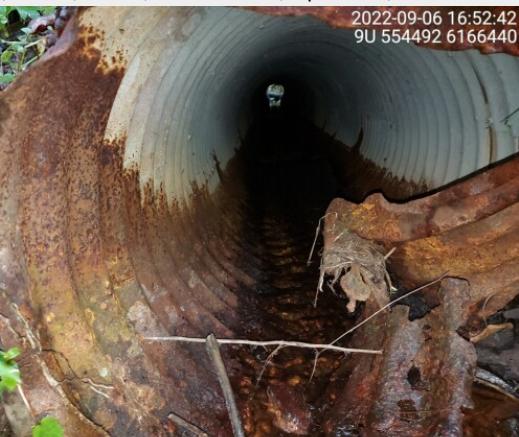
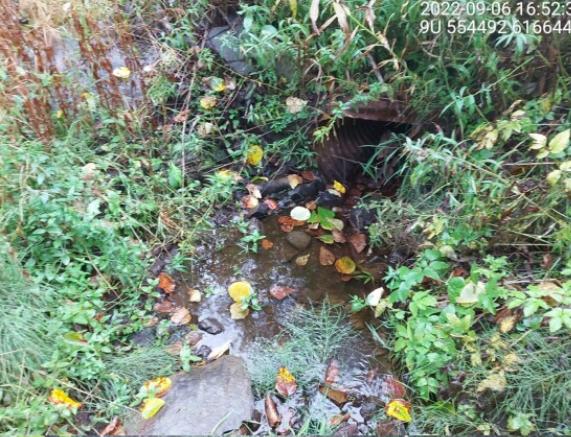
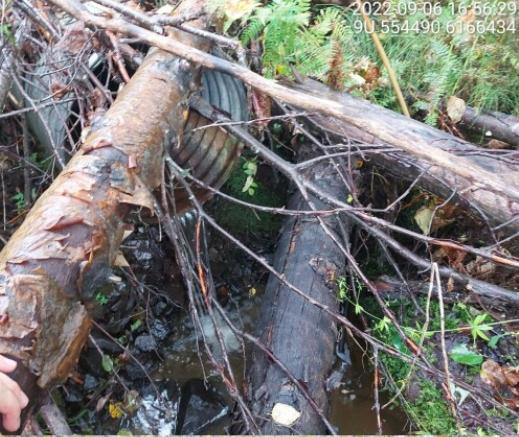
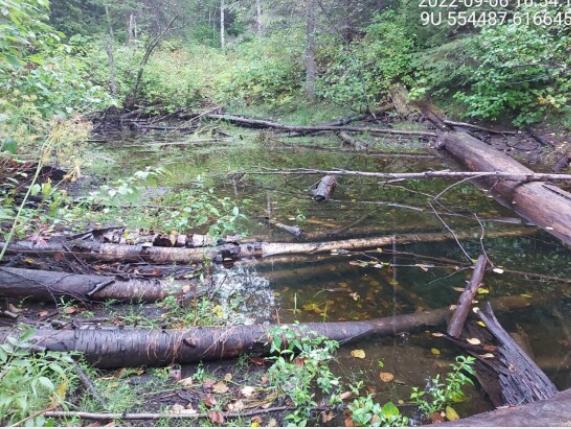
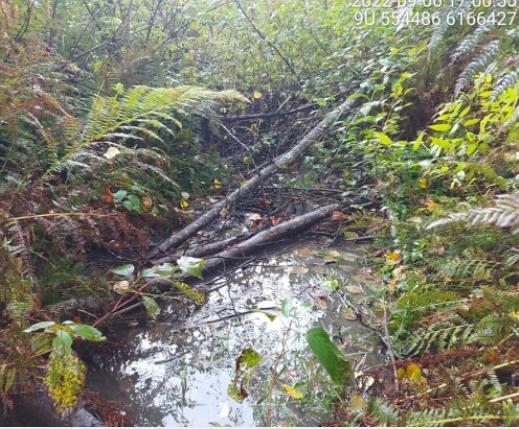
Location and Stream Data	•	Crossing Characteristics	-
Comments: Big beaver dam upstream of culvert with big pond. Huge outlet drop. 16:49			
Photos: PSCIS ID 198192. From top left clockwise: Road/Site Card, Barrel, Outlet, Downstream, Upstream, Inlet.

Location and Stream Data		Crossing Characteristics	
Date	2022-09-06	Crossing Sub Type	Round Culvert
PSCIS ID	198192	Diameter (m)	0.6
External ID	8302062	Length (m)	12
Crew	MW	Embedded	No
UTM Zone	9	Depth Embedded (m)	–
Easting	554493.4	Resemble Channel	No
Northing	6166450	Backwatered	No
Stream	Tributary to Kispiox River	Percent Backwatered	–
Road	Corral Main	Fill Depth (m)	1
Road Tenure	Gitxsan Forest R02415	Outlet Drop (m)	0.6
Channel Width (m)	1.9	Outlet Pool Depth (m)	0.3
Stream Slope (%)	2	Inlet Drop	No
Beaver Activity	Yes	Slope (%)	3
Habitat Value	Low	Valley Fill	Deep Fill
Final score	36	Barrier Result	Barrier
Fix type	Replace Structure with Streambed Simulation CBS	Fix Span / Diameter	3

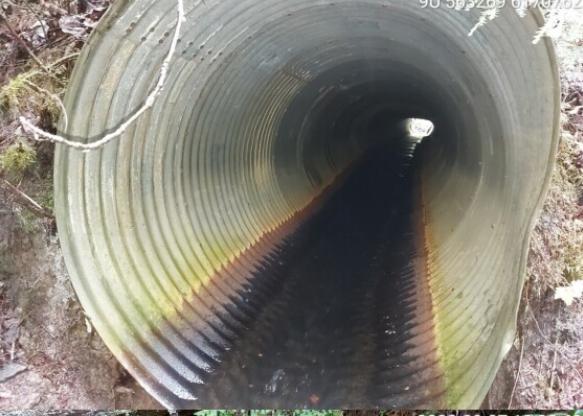
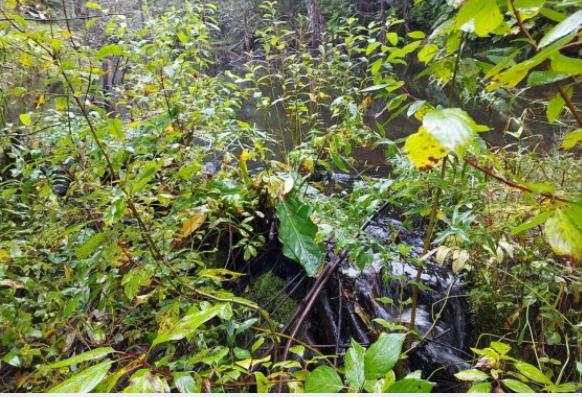
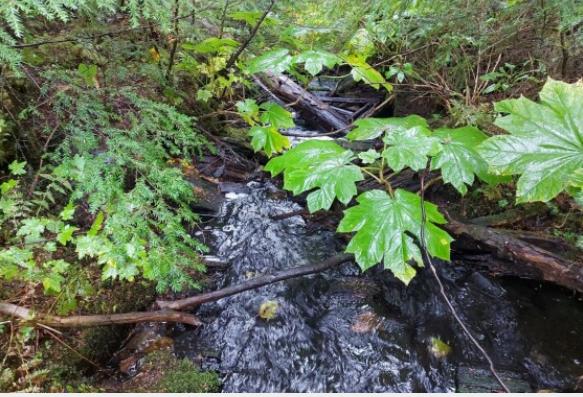
Location and Stream Data	•	Crossing Characteristics	-
Comments: Signs of beaver activity just upstream of inlet. Big pond above dam. Very steep downstream of outlet, long cascade. 12:14			
Photos: PSCIS ID 198193. From top left clockwise: Road/Site Card, Barrel, Outlet, Downstream, Upstream, Inlet.

Location and Stream Data		Crossing Characteristics	
Date	2022-09-07	Crossing Sub Type	Round Culvert
PSCIS ID	198193	Diameter (m)	1.2
External ID	8301747	Length (m)	13
Crew	MW	Embedded	No
UTM Zone	9	Depth Embedded (m)	–
Easting	563272.9	Resemble Channel	No
Northing	6170770	Backwatered	No
Stream	Tributary to Cullon Creek	Percent Backwatered	–
Road	Kuldo FSR	Fill Depth (m)	5
Road Tenure	MoF 7871	Outlet Drop (m)	0.7
Channel Width (m)	1.8	Outlet Pool Depth (m)	0.6
Stream Slope (%)	20	Inlet Drop	No
Beaver Activity	Yes	Slope (%)	3
Habitat Value	Low	Valley Fill	Deep Fill
Final score	36	Barrier Result	Barrier
Fix type	Replace Structure with Streambed Simulation CBS	Fix Span / Diameter	3

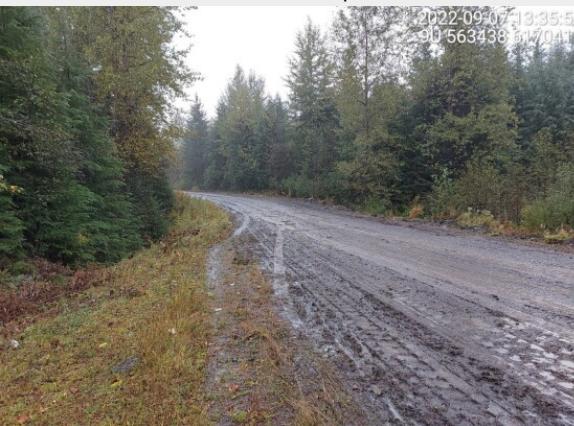
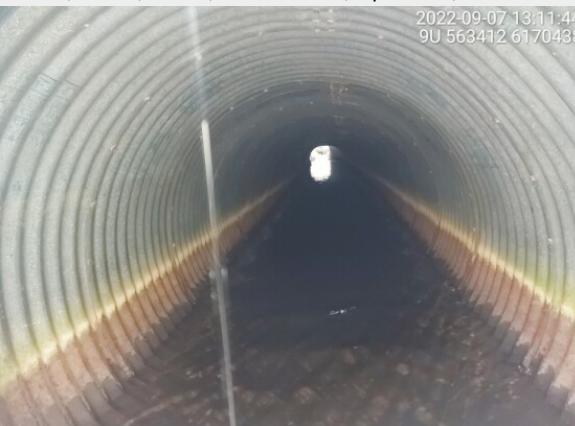
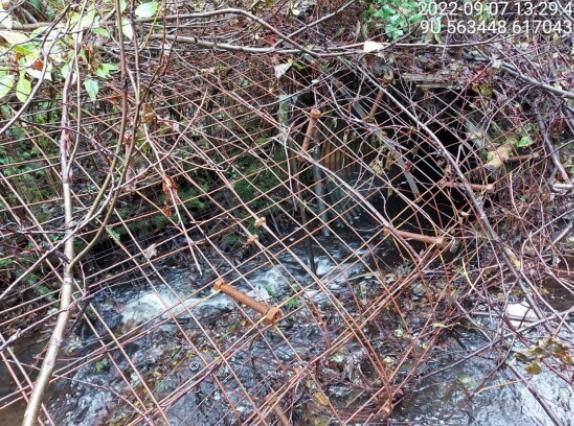
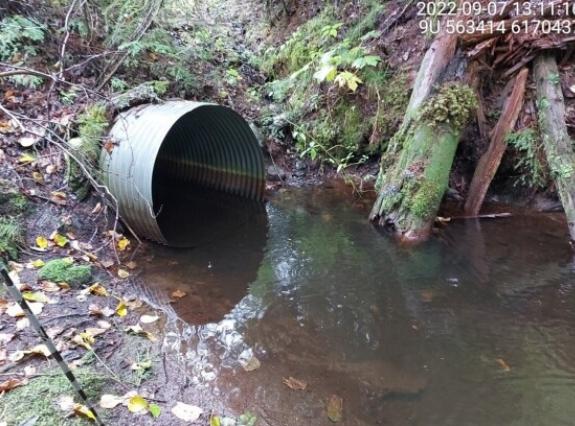
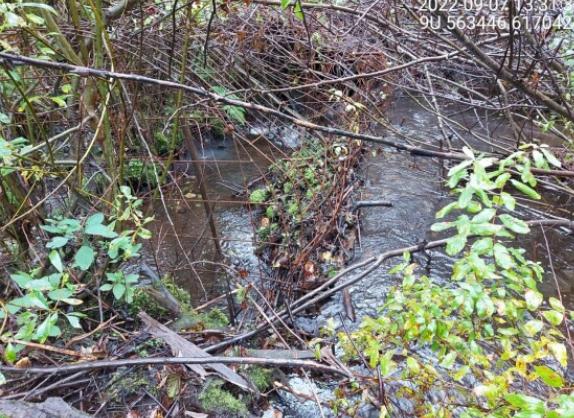
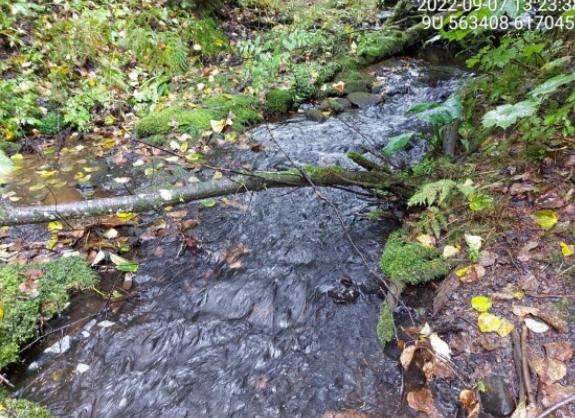
Location and Stream Data	•	Crossing Characteristics	-
Comments: Big beaver guard on inlet. Blocking some of stream access from upstream. 13:02			
Photos: PSCIS ID 198194. From top left clockwise: Road/Site Card, Barrel, Outlet, Downstream, Upstream, Inlet.

Location and Stream Data		Crossing Characteristics	
Date	2022-09-07	Crossing Sub Type	Round Culvert
PSCIS ID	198194	Diameter (m)	1.2
External ID	8301750	Length (m)	14
Crew	MW	Embedded	No
UTM Zone	9	Depth Embedded (m)	–
Easting	563429.4	Resemble Channel	No
Northing	6170437	Backwatered	No
Stream	Tributary to Cullon Creek	Percent Backwatered	–
Road	Kuldo FSR	Fill Depth (m)	2.5
Road Tenure	MoF 7871	Outlet Drop (m)	0
Channel Width (m)	1.9	Outlet Pool Depth (m)	0.6
Stream Slope (%)	2.5	Inlet Drop	Yes
Beaver Activity	No	Slope (%)	1
Habitat Value	Medium	Valley Fill	Deep Fill
Final score	21	Barrier Result	Barrier
Fix type	Replace Structure with Streambed Simulation CBS	Fix Span / Diameter	3

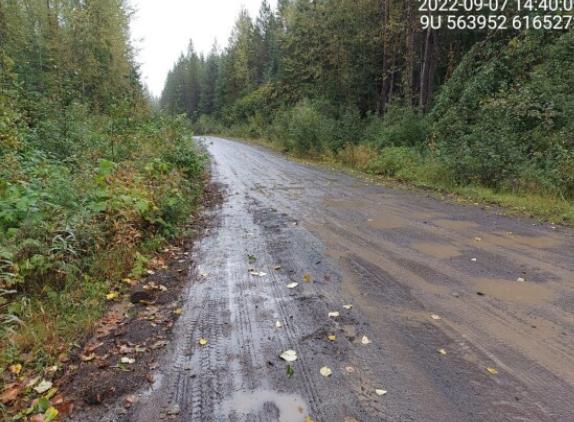
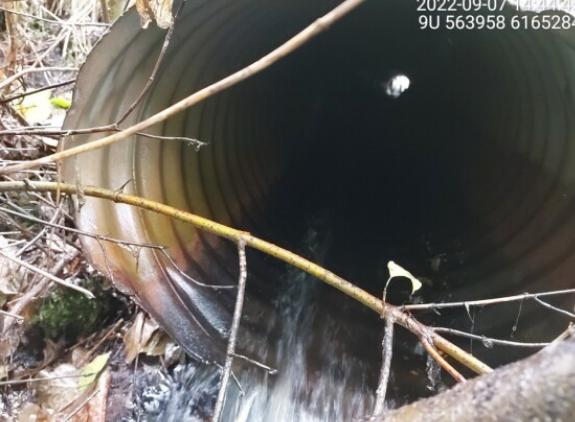
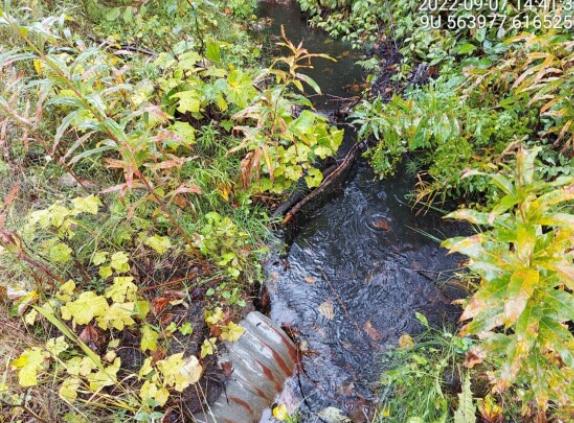
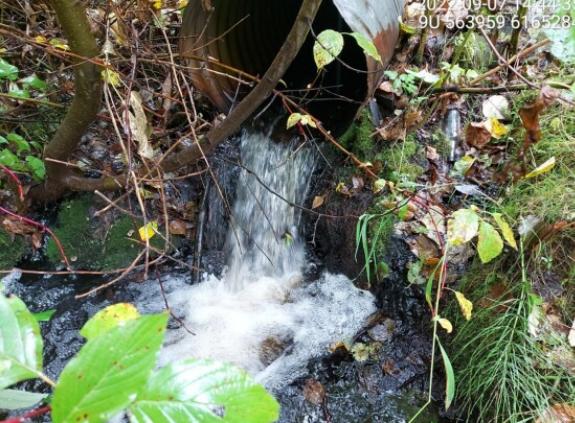
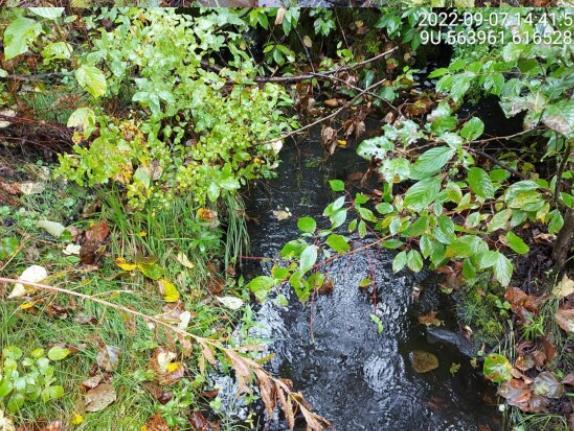
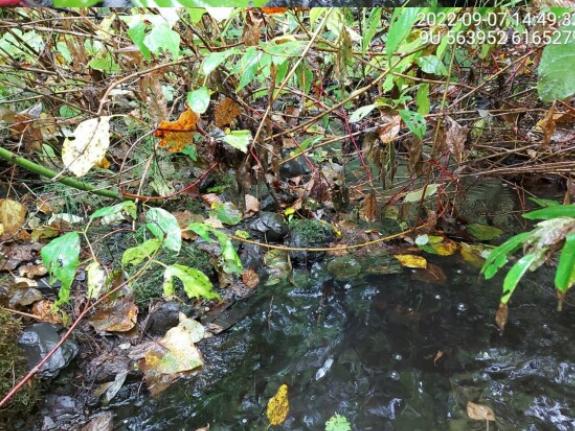
Location and Stream Data	•	Crossing Characteristics	-
Comments: Waterfall directly downstream of outlet (2m in height). And short cascade upstream of inlet (approx 1m in height). 14:36			
Photos: PSCIS ID 198195. From top left clockwise: Road/Site Card, Barrel, Outlet, Downstream, Upstream, Inlet.

Location and Stream Data		Crossing Characteristics	
Date	2022-09-07	Crossing Sub Type	Round Culvert
PSCIS ID	198195	Diameter (m)	0.65
External ID	8301761	Length (m)	10
Crew	MW	Embedded	No
UTM Zone	9	Depth Embedded (m)	–
Easting	563960.5	Resemble Channel	No
Northing	6165291	Backwatered	No
Stream	Tributary to Cullon Creek	Percent Backwatered	–
Road	Kuldo FSR	Fill Depth (m)	0.5
Road Tenure	MoF 7871	Outlet Drop (m)	0.6
Channel Width (m)	1.5	Outlet Pool Depth (m)	0.2
Stream Slope (%)	10	Inlet Drop	Yes
Beaver Activity	No	Slope (%)	4
Habitat Value	Low	Valley Fill	Deep Fill
Final score	36	Barrier Result	Barrier
Fix type	Replace Structure with Streambed Simulation CBS	Fix Span / Diameter	3
