Appendix - Phase 1 Fish Passage Assessment Data and Photos

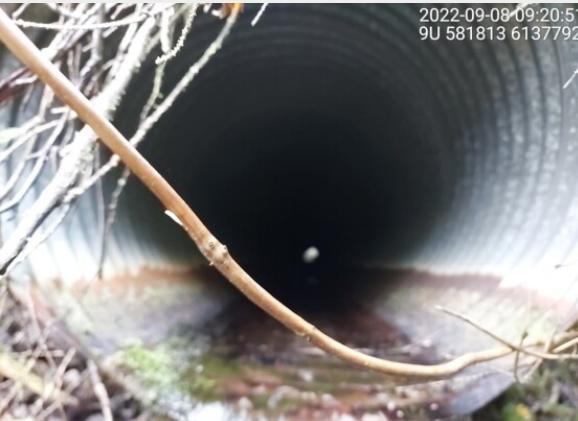
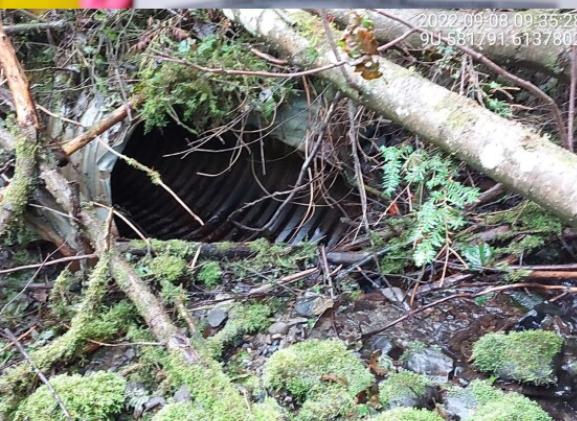
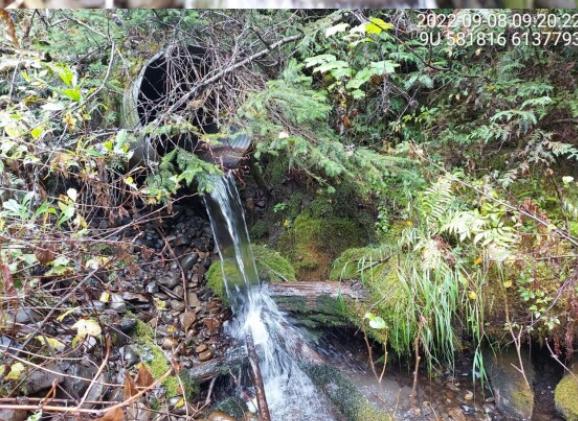
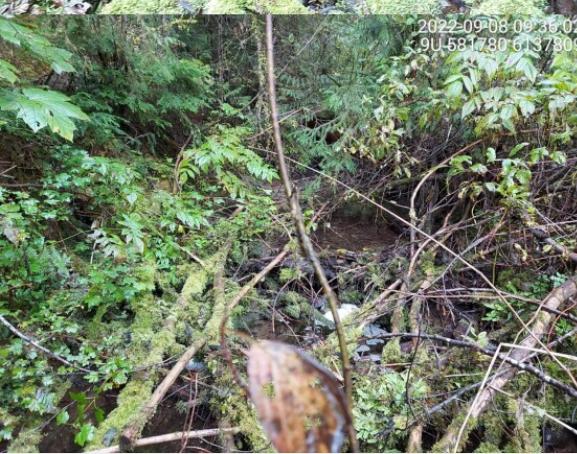
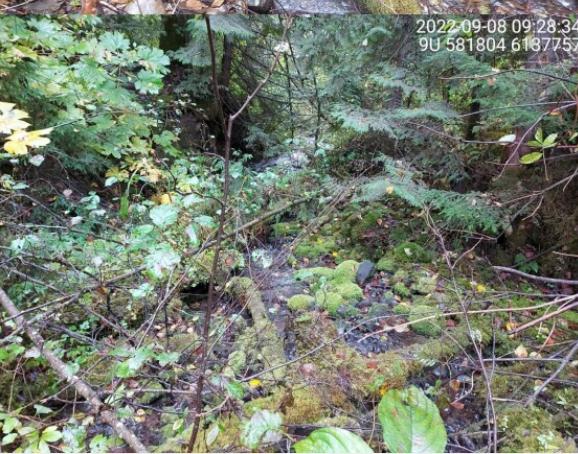
Location and Stream Data	•	Crossing Characteristics	-
Comments: Very high outlet drop and steep stream downstream. But good habitat upstream with some fines and gravels and lots of cover. 9:13			
Photos: PSCIS ID 198196. From top left clockwise: Road/Site Card, Barrel, Outlet, Downstream, Upstream, Inlet.

Location and Stream Data		Crossing Characteristics –	
Date	2022-09-08	Crossing Sub Type	Round Culvert
PSCIS ID	198196	Diameter (m)	0.9
External ID	8300186	Length (m)	21
Crew	MW	Embedded	No
UTM Zone	9	Depth Embedded (m)	–
Easting	581810.5	Resemble Channel	No
Northing	6137778	Backwatered	No
Stream	Tributary to Kispiox River	Percent Backwatered	–
Road	Kispiox Westside Rd	Fill Depth (m)	1.5
Road Tenure	MoTi Local	Outlet Drop (m)	1.6
Channel Width (m)	2.4	Outlet Pool Depth (m)	0.1
Stream Slope (%)	12	Inlet Drop	Yes
Beaver Activity	No	Slope (%)	3.5
Habitat Value	Low	Valley Fill	Deep Fill
Final score	39	Barrier Result	Barrier
Fix type	Replace with New Open Bottom Structure	Fix Span / Diameter	10

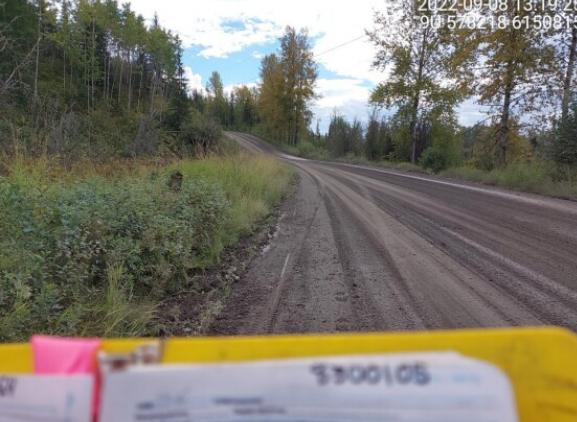
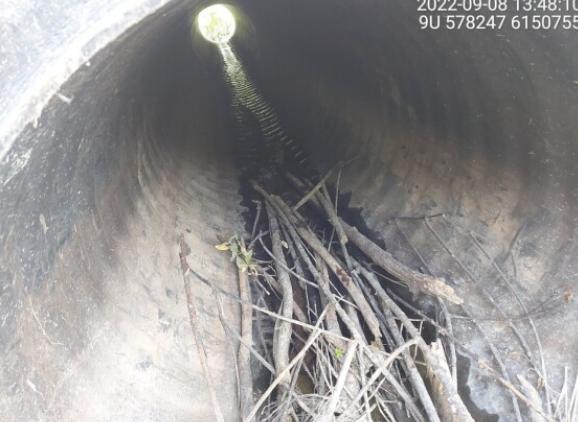
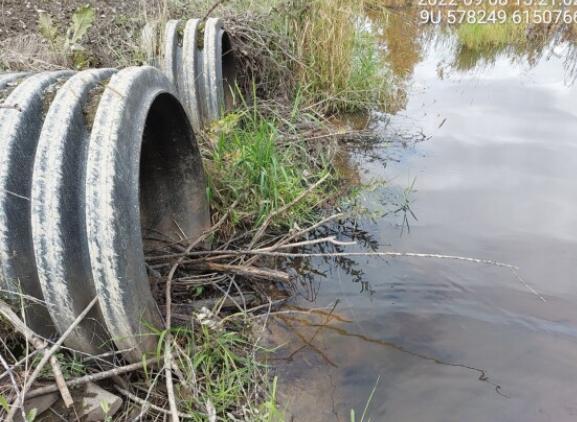
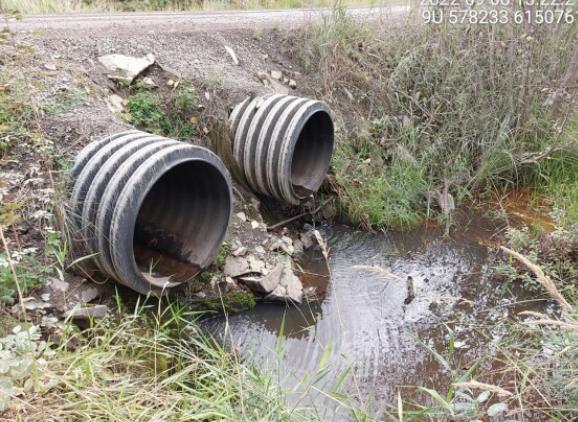
Location and Stream Data	•	Crossing Characteristics	-
Comments: Two plastic culverts, very low flow in both. Open wetland and shrub habitat u/s and d/s. Big floodplain u/s. 13:16			
Photos: PSCIS ID 198197. From top left clockwise: Road/Site Card, Barrel, Outlet, Downstream, Upstream, Inlet.

Location and Stream Data		Crossing Characteristics	
Date	2022-09-08	Crossing Sub Type	Round Culvert
PSCIS ID	198197	Diameter (m)	0.9
External ID	8300105	Length (m)	8
Crew	MW	Embedded	No
UTM Zone	9	Depth Embedded (m)	–
Easting	578249.7	Resemble Channel	No
Northing	6150754	Backwatered	No
Stream	Tributary to Kispiox River	Percent Backwatered	–
Road	Kispiox Valley Rd	Fill Depth (m)	0.3
Road Tenure	MoTi Local	Outlet Drop (m)	0.6
Channel Width (m)	1.8	Outlet Pool Depth (m)	0.4
Stream Slope (%)	2	Inlet Drop	No
Beaver Activity	No	Slope (%)	1
Habitat Value	Low	Valley Fill	Deep Fill
Final score	31	Barrier Result	Barrier
Fix type	Replace Structure with Streambed Simulation CBS	Fix Span / Diameter	3

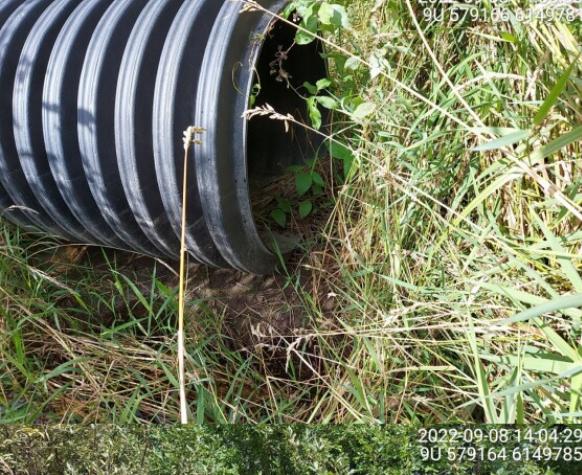
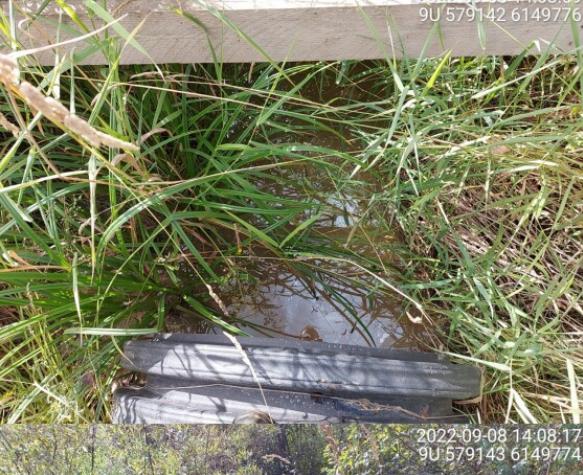
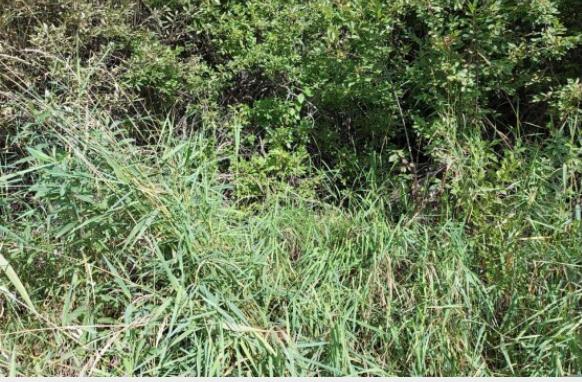
Location and Stream Data	•	Crossing Characteristics	-
Comments: Plastic culvert. Backwatered with some water near the inlet and outlet but none in culvert. Large tributary to the Kispiox with major connectivity issue. No fisheries information but should be fish bearing and if not it would be due to the culvert. Dam points located 600 m upstream of crossing. 13:59			
Photos: PSCIS ID 198198. From top left clockwise: Road/Site Card, Barrel, Outlet, Downstream, Upstream, Inlet.

Location and Stream Data		Crossing Characteristics	
Date	2022-09-08	Crossing Sub Type	Round Culvert
PSCIS ID	198198	Diameter (m)	0.8
External ID	8300104	Length (m)	15
Crew	MW	Embedded	No
UTM Zone	9	Depth Embedded (m)	–
Easting	579148.5	Resemble Channel	No
Northing	6149784	Backwatered	Yes
Stream	Tributary to Kispiox River	Percent Backwatered	100
Road	Kispiox Valley Rd	Fill Depth (m)	2
Road Tenure	MoTi Local	Outlet Drop (m)	0
Channel Width (m)	1.2	Outlet Pool Depth (m)	0.2
Stream Slope (%)	1	Inlet Drop	No
Beaver Activity	No	Slope (%)	0.5
Habitat Value	Low	Valley Fill	Deep Fill
Final score	19	Barrier Result	Potential
Fix type	Replace Structure with Streambed Simulation CBS	Fix Span / Diameter	3

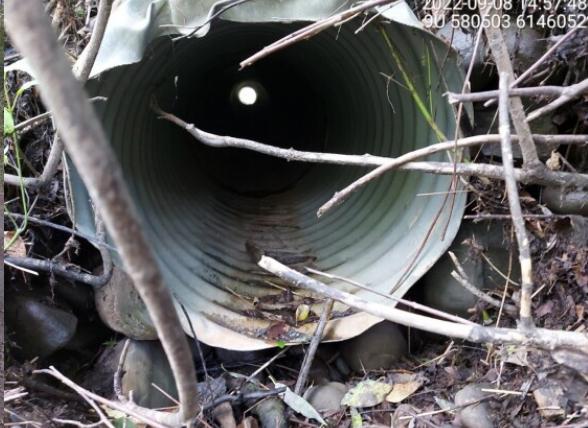
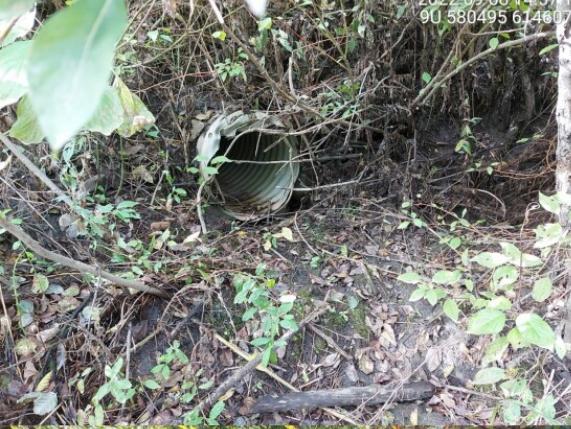
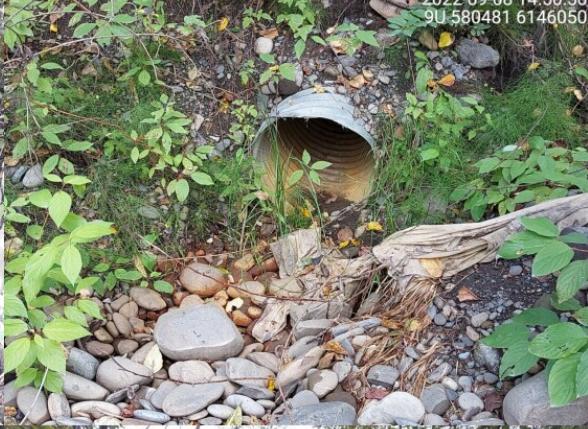
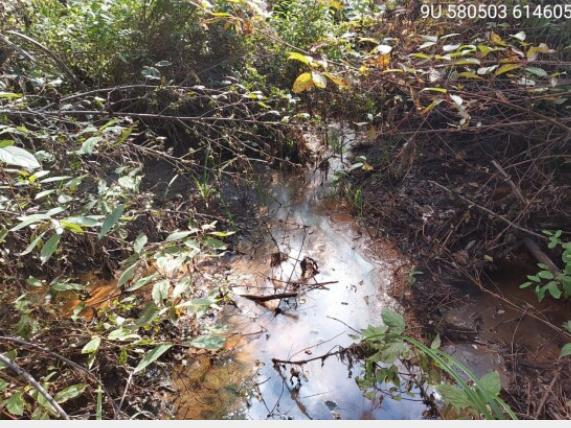
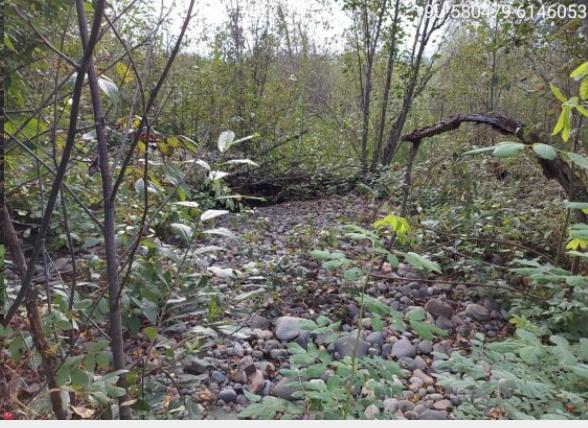
Location and Stream Data	•	Crossing Characteristics	-
Comments: Dewatered stream. 14:46			
Photos: PSCIS ID 198199. From top left clockwise: Road/Site Card, Barrel, Outlet, Downstream, Upstream, Inlet.

Location and Stream Data		Crossing Characteristics	
Date	2022-09-08	Crossing Sub Type	Round Culvert
PSCIS ID	198199	Diameter (m)	0.6
External ID	8300103	Length (m)	13
Crew	MW	Embedded	No
UTM Zone	9	Depth Embedded (m)	–
Easting	580494.9	Resemble Channel	No
Northing	6146061	Backwatered	No
Stream	Tributary to Kispiox River	Percent Backwatered	–
Road	Kispiox Valley Rd	Fill Depth (m)	2
Road Tenure	MoTi Local	Outlet Drop (m)	0
Channel Width (m)	1.4	Outlet Pool Depth (m)	0
Stream Slope (%)	2	Inlet Drop	No
Beaver Activity	No	Slope (%)	1
Habitat Value	Low	Valley Fill	Deep Fill
Final score	21	Barrier Result	Barrier
Fix type	Replace Structure with Streambed Simulation CBS	Fix Span / Diameter	3

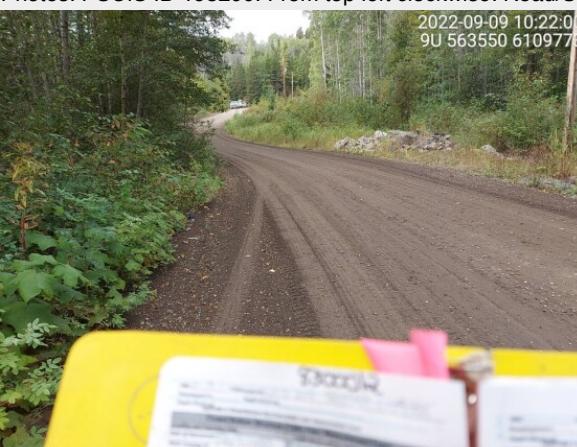
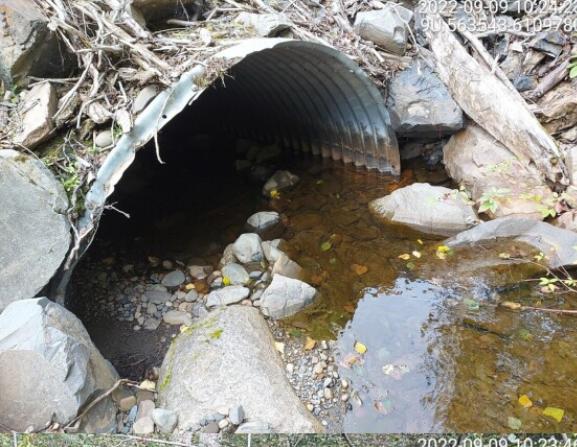
Location and Stream Data	•	Crossing Characteristics	-
Comments: Embedded with no outlet drop. Very wide channel with gravels and cobbles. 10:18			
Photos: PSCIS ID 198200. From top left clockwise: Road/Site Card, Barrel, Outlet, Downstream, Upstream, Inlet.

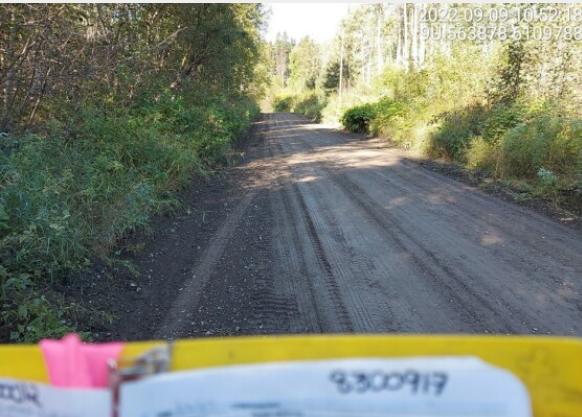
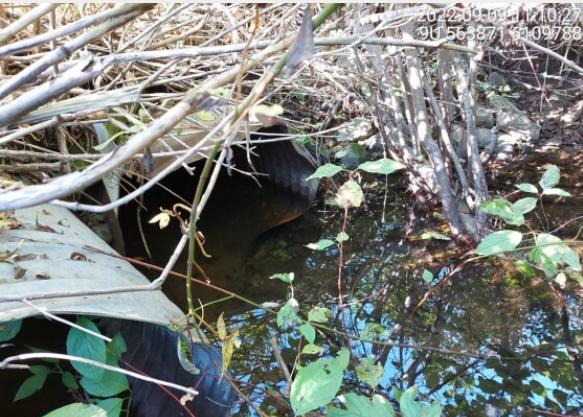
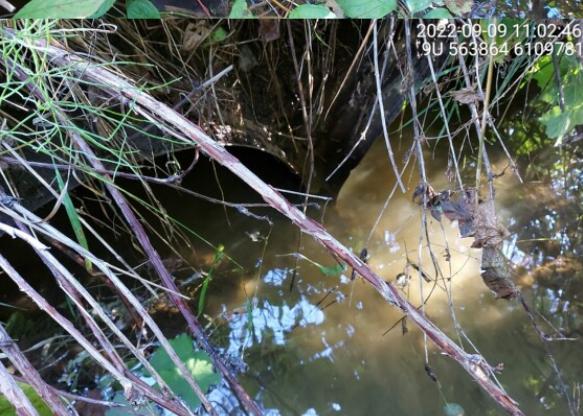
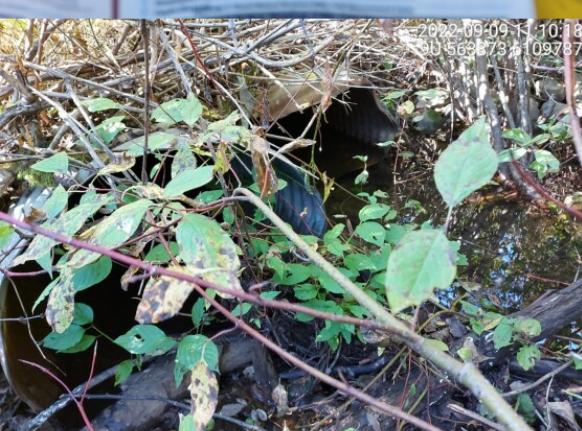
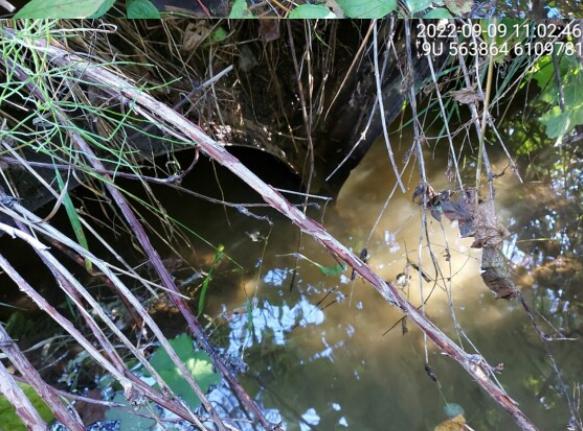
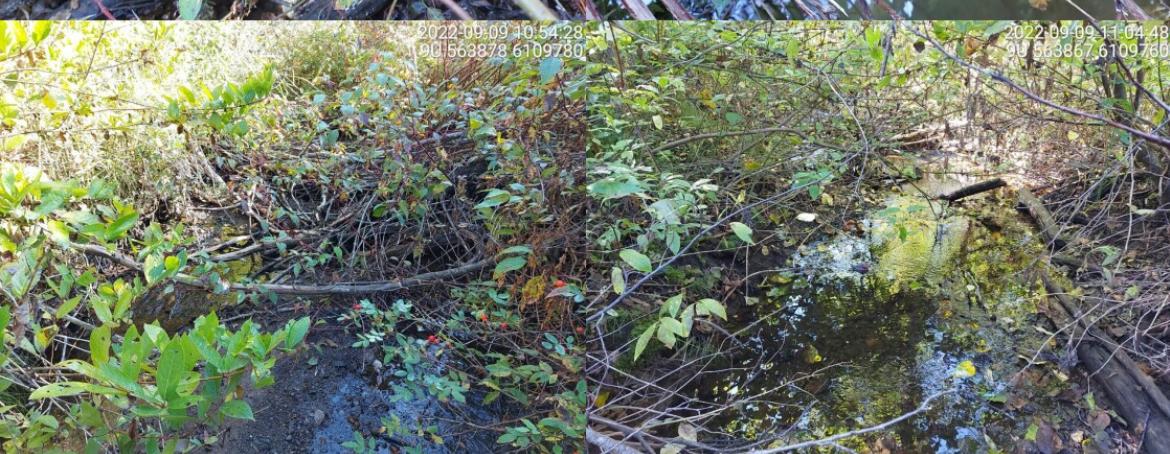
Location and Stream Data	•	Crossing Characteristics	-
Comments: Two culverts, both embedded with no drop. Fish spotted in culvert(up to 20 cm in length) and downstream. Erosion near culvert. 10:50			
Photos: PSCIS ID 198201. From top left clockwise: Road/Site Card, Barrel, Outlet, Downstream, Upstream, Inlet.

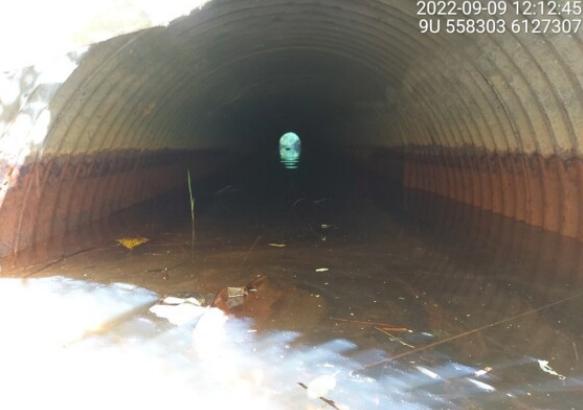
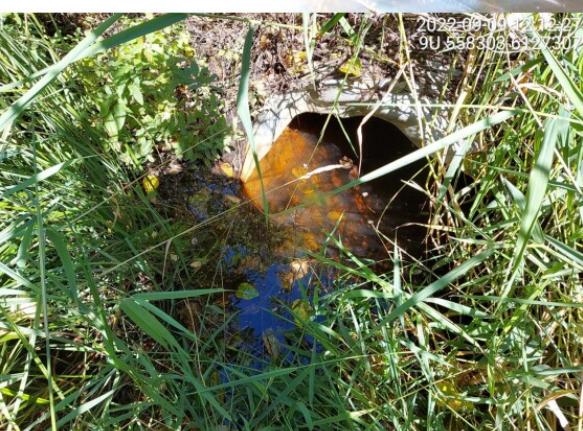
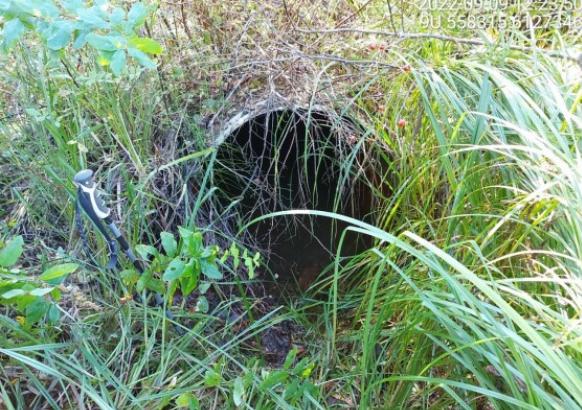
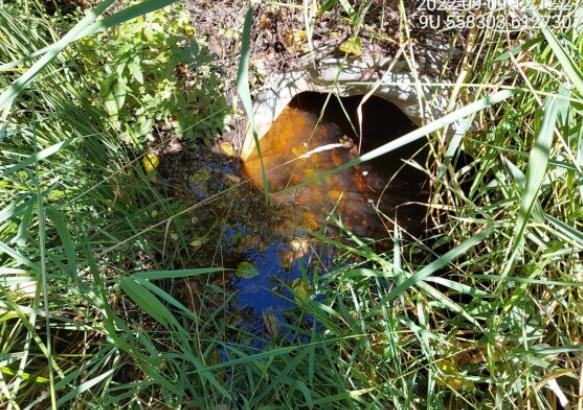
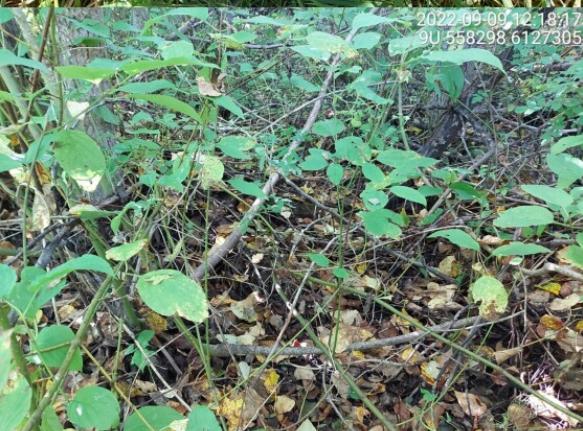
Location and Stream Data	•	Crossing Characteristics	-
Comments: Dewatered downstream, but there's water in the culvert. Water upstream, opens up to big wetland and floodplain. 12:03			
Photos: PSCIS ID 198202. From top left clockwise: Road/Site Card, Barrel, Outlet, Downstream, Upstream, Inlet.

Location and Stream Data		Crossing Characteristics	
Date	2022-09-09	Crossing Sub Type	Round Culvert
PSCIS ID	198202	Diameter (m)	1.2
External ID	8300188	Length (m)	14
Crew	MW	Embedded	Yes
UTM Zone	9	Depth Embedded (m)	0.25
Easting	558317	Resemble Channel	Yes
Northing	6127316	Backwatered	Yes
Stream	Tributary to Kitwanga River	Percent Backwatered	100
Road	Hwy 37	Fill Depth (m)	1.5
Road Tenure	MoTi Highway	Outlet Drop (m)	0.1
Channel Width (m)	1.8	Outlet Pool Depth (m)	0.15
Stream Slope (%)	2	Inlet Drop	No
Beaver Activity	No	Slope (%)	1
Habitat Value	Low	Valley Fill	Deep Fill
Final score	16	Barrier Result	Potential
Fix type	Replace Structure with Streambed Simulation CBS	Fix Span / Diameter	3

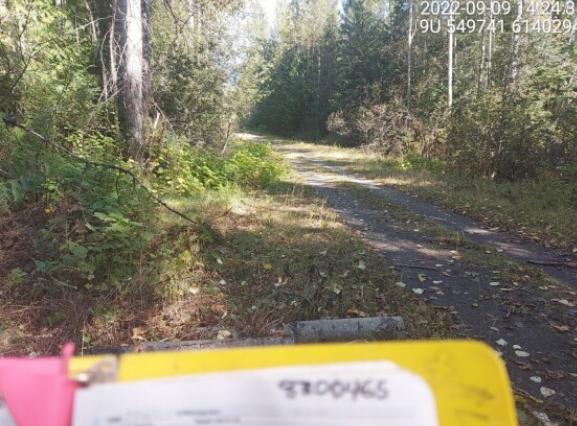
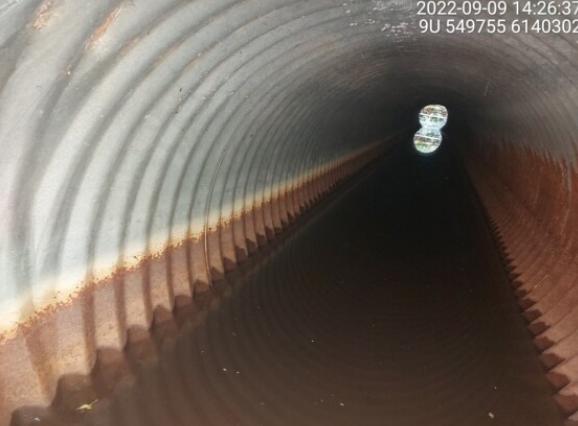
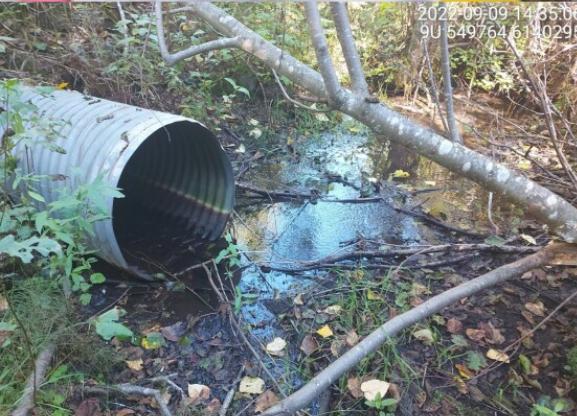
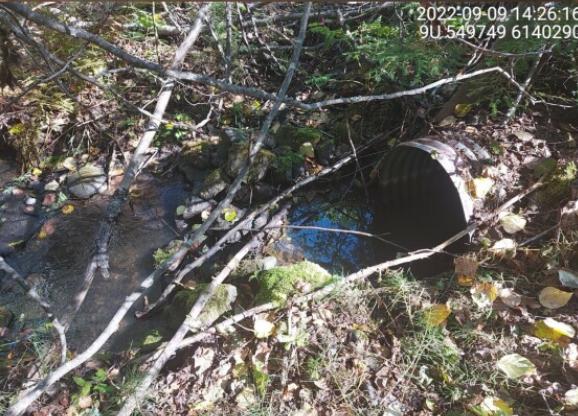
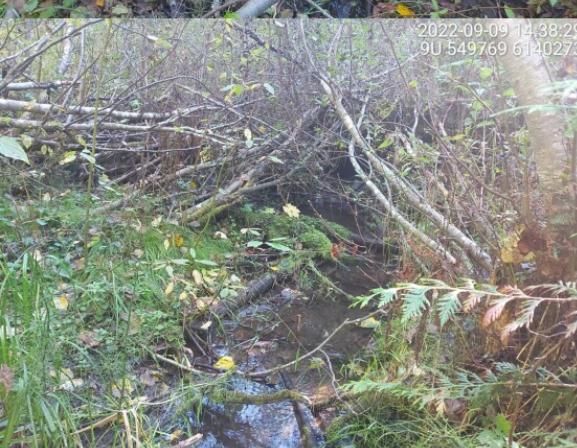
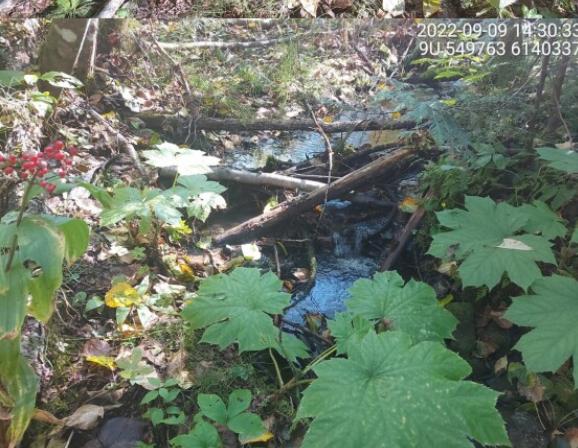
Location and Stream Data	•	Crossing Characteristics	-
Comments: Cascade downstream of culvert that may block smaller fish. Approx 1m in height. No outlet drop. Good habitat upstream with lots of veg cover and LWD, no gravels or cobbles. Mostly fines and instream vegetation. 14:21			
Photos: PSCIS ID 198203. From top left clockwise: Road/Site Card, Barrel, Outlet, Downstream, Upstream, Inlet.

Location and Stream Data		Crossing Characteristics	
Date	2022-09-09	Crossing Sub Type	Round Culvert
PSCIS ID	198203	Diameter (m)	0.8
External ID	2022090901	Length (m)	11
Crew	MW	Embedded	No
UTM Zone	9	Depth Embedded (m)	–
Easting	549761.1	Resemble Channel	No
Northing	6140313	Backwatered	No
Stream	Tributary to Kitwanga River	Percent Backwatered	–
Road	Kitwancool Branch 2 FSR	Fill Depth (m)	1.2
Road Tenure	MoF 8687	Outlet Drop (m)	0
Channel Width (m)	1.7	Outlet Pool Depth (m)	0.2
Stream Slope (%)	3.5	Inlet Drop	No
Beaver Activity	No	Slope (%)	0.5
Habitat Value	Medium	Valley Fill	Deep Fill
Final score	16	Barrier Result	Potential
Fix type	Replace Structure with Streambed Simulation CBS	Fix Span / Diameter	3

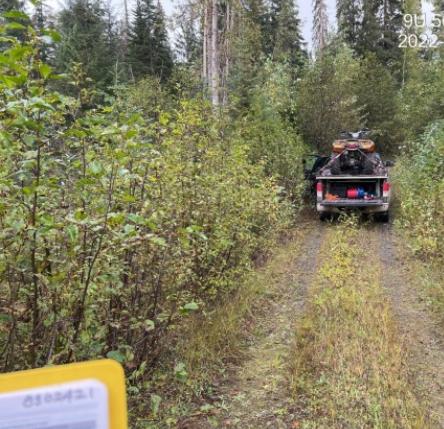
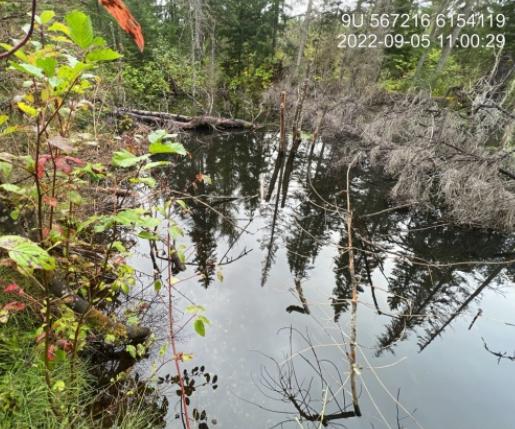
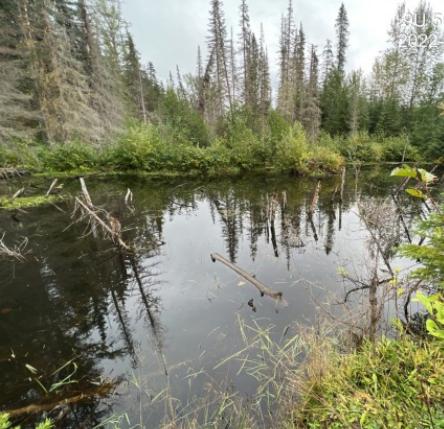
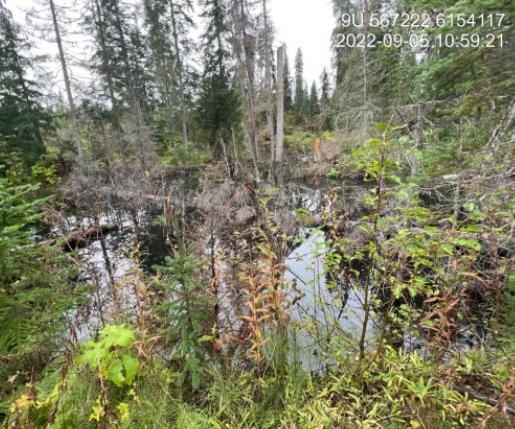
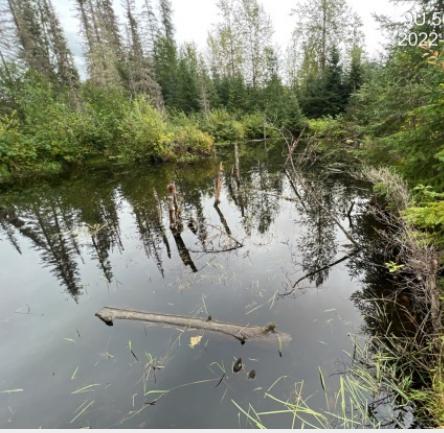
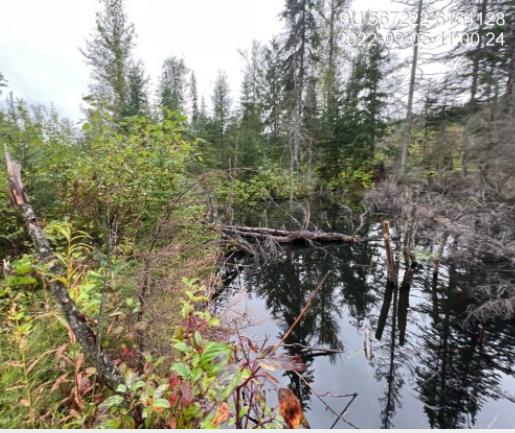
Location and Stream Data	•	Crossing Characteristics	-
Comments: No structure visible. Beaver ponds on both sides of the road. Diameter estimated. Large mature beaver dam located approximately 10 m downstream of road. 10:56			
Photos: PSCIS ID 198204. From top left clockwise: Road/Site Card, Barrel, Outlet, Downstream, Upstream, Inlet.

Location and Stream Data		Crossing Characteristics –	
Date	2022-09-05	Crossing Sub Type	Round Culvert
PSCIS ID	198204	Diameter (m)	1
External ID	8302421	Length (m)	10
Crew	AI	Embedded	No
UTM Zone	9	Depth Embedded (m)	–
Easting	567222.2	Resemble Channel	No
Northing	6154120	Backwatered	Yes
Stream	Tributary to Kispiox River	Percent Backwatered	100
Road	Helen 9000	Fill Depth (m)	0.5
Road Tenure	BCTS 8243	Outlet Drop (m)	0
Channel Width (m)	15	Outlet Pool Depth (m)	1
Stream Slope (%)	0	Inlet Drop	No
Beaver Activity	Yes	Slope (%)	0
Habitat Value	Low	Valley Fill	Deep Fill
Final score	16	Barrier Result	Potential
Fix type	Replace with New Open Bottom Structure	Fix Span / Diameter	20

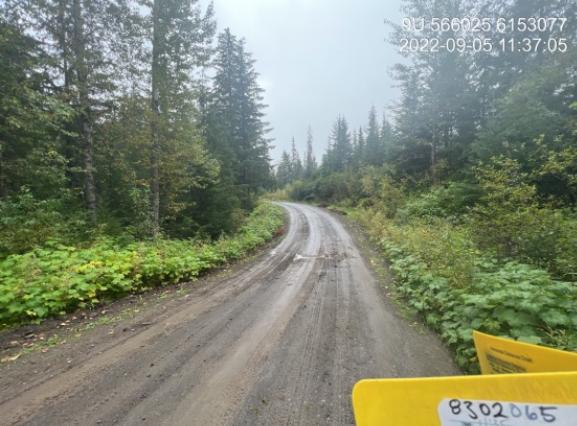
Location and Stream Data	•	Crossing Characteristics	-
Comments: Natural bed rock cascade of greater than 20% immediately downstream of culvert outlet for a distance of approximately 20 m. 11:35			
Photos: PSCIS ID 198205. From top left clockwise: Road/Site Card, Barrel, Outlet, Downstream, Upstream, Inlet.

Location and Stream Data		Crossing Characteristics –	
Date	2022-09-05	Crossing Sub Type	Round Culvert
PSCIS ID	198205	Diameter (m)	0.8
External ID	8302065	Length (m)	10
Crew	AI	Embedded	No
UTM Zone	9	Depth Embedded (m)	–
Easting	566030.3	Resemble Channel	No
Northing	6153077	Backwatered	No
Stream	Tributary to Kispiox River	Percent Backwatered	–
Road	Helen Lake Rd	Fill Depth (m)	1.5
Road Tenure	BCTS 8243	Outlet Drop (m)	0
Channel Width (m)	2.2	Outlet Pool Depth (m)	0.1
Stream Slope (%)	15	Inlet Drop	No
Beaver Activity	Yes	Slope (%)	3
Habitat Value	Low	Valley Fill	Bedrock
Final score	26	Barrier Result	Barrier
Fix type	Replace with New Open Bottom Structure	Fix Span / Diameter	10

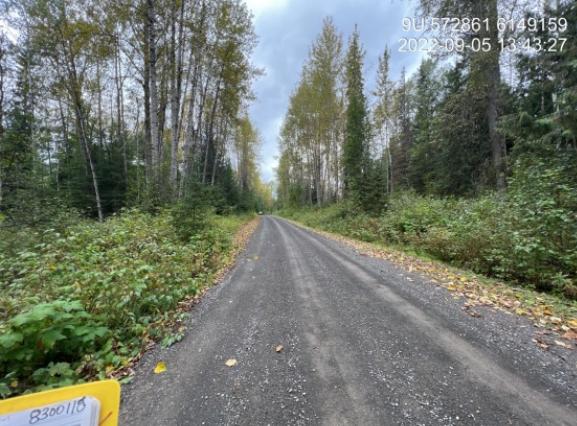
Location and Stream Data	•	Crossing Characteristics	-
Comments: Dry draw with all organic substrate and moss throughout channel. Culvert outlet is severely rusted with the bottom completely corroded for the last approximately 1 m. Unlikely a fish bearing stream. 13:39			
Photos: PSCIS ID 198206. From top left clockwise: Road/Site Card, Barrel, Outlet, Downstream, Upstream, Inlet.

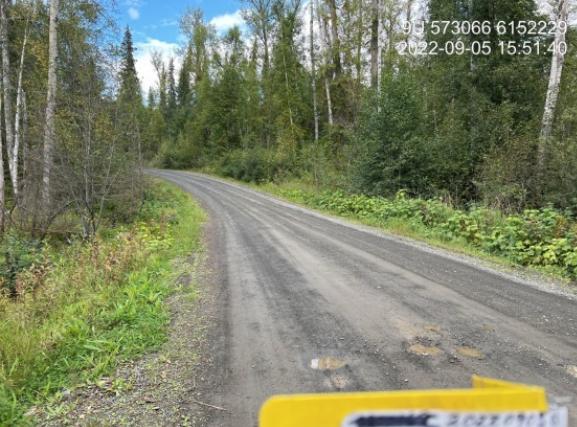
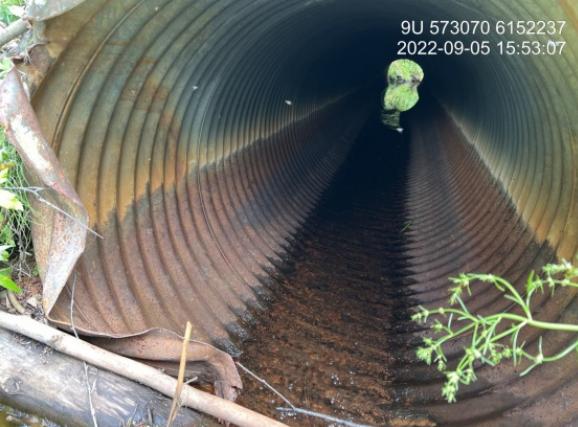
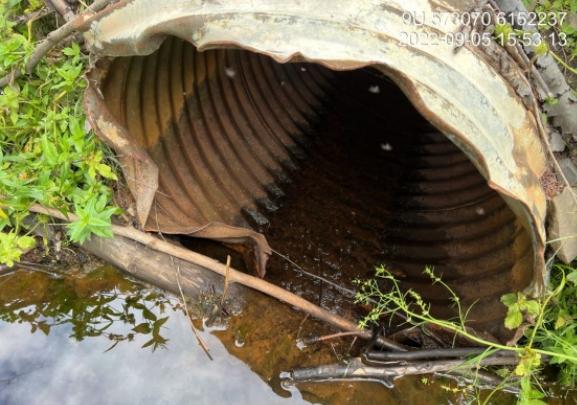
Location and Stream Data	•	Crossing Characteristics	-
Comments: Pentz Lake is located approximately 50 m upstream. Inlet of culvert is significantly damaged with metal that in words. Culvert is separating approximately halfway through the pipe. Pipe is quite corroded. Pentz Lake rec site is located approximately 2 to 300 m up the road. 15:30			
Photos: PSCIS ID 198207. From top left clockwise: Road/Site Card, Barrel, Outlet, Downstream, Upstream, Inlet.

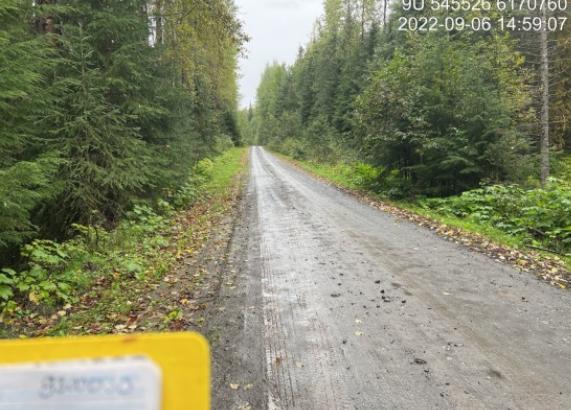
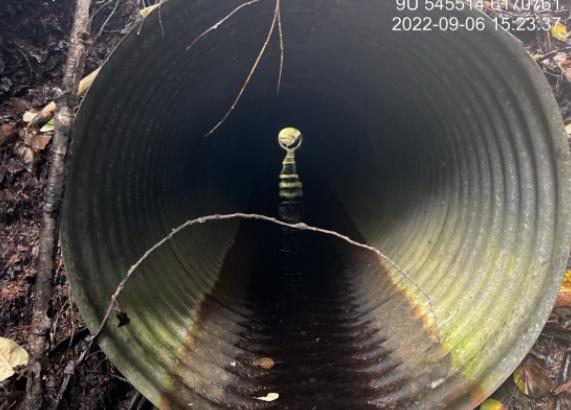
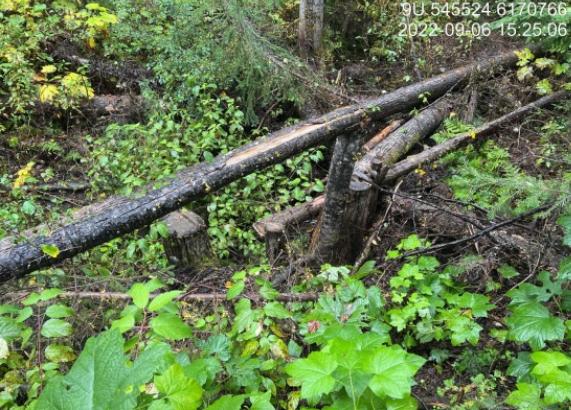
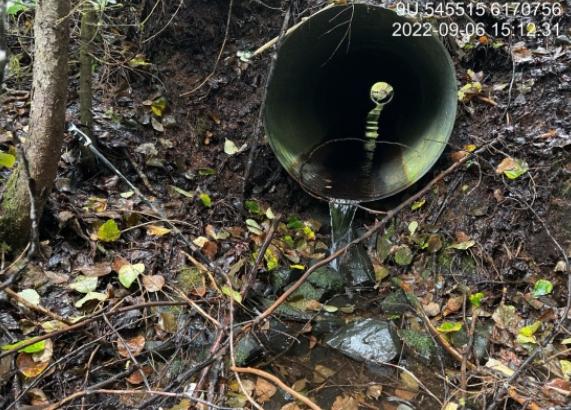
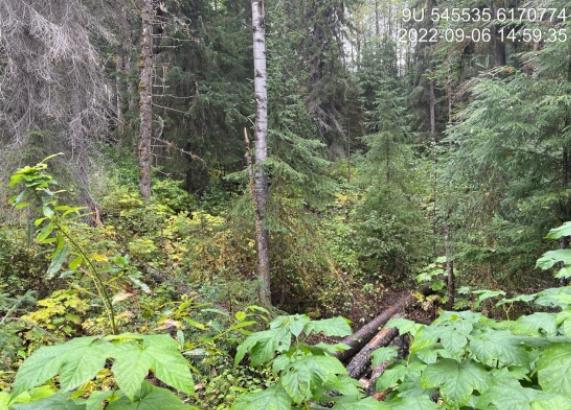
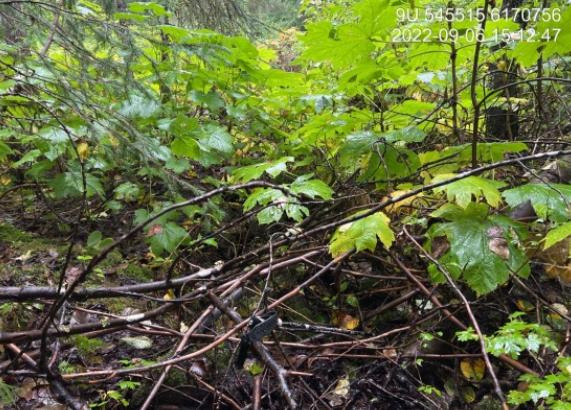
Location and Stream Data	•	Crossing Characteristics	-
Comments: Mossy draw. Channel is very small and poorly defined. Very unlikely that this is fish habitat. Inlet covered with significant amounts of debris. 14:54			
Photos: PSCIS ID 198208. From top left clockwise: Road/Site Card, Barrel, Outlet, Downstream, Upstream, Inlet.

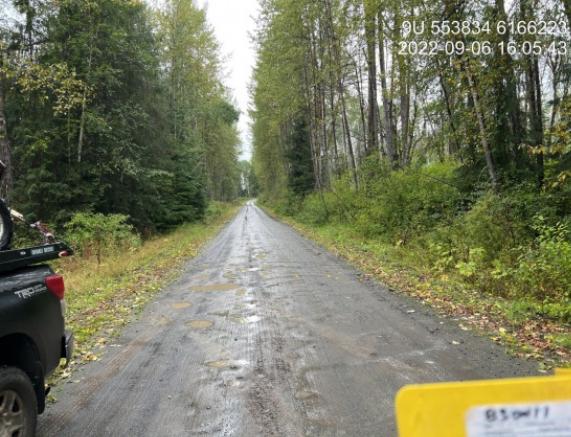
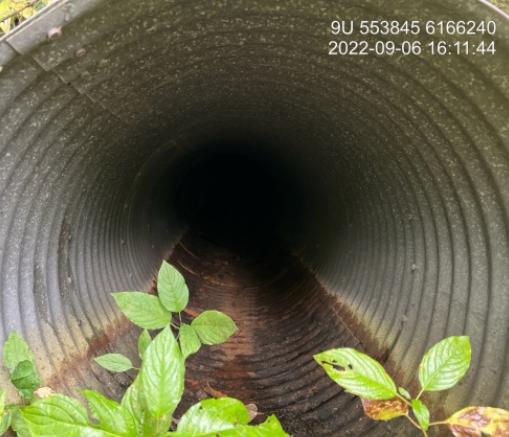
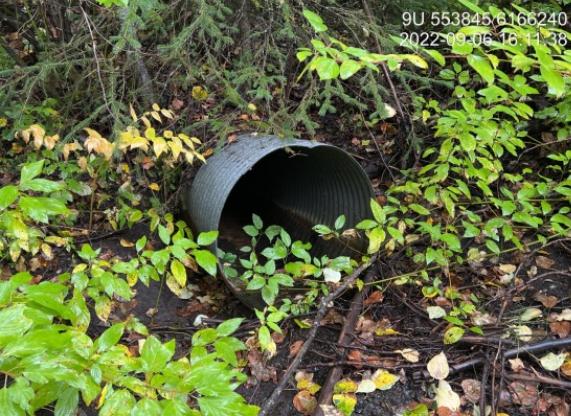
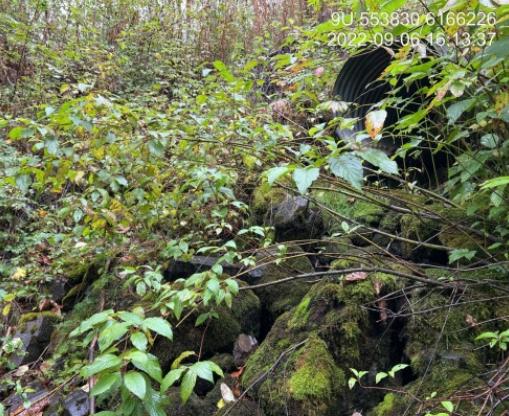
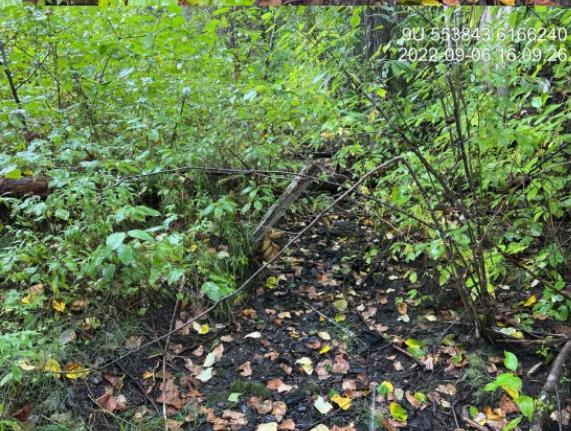
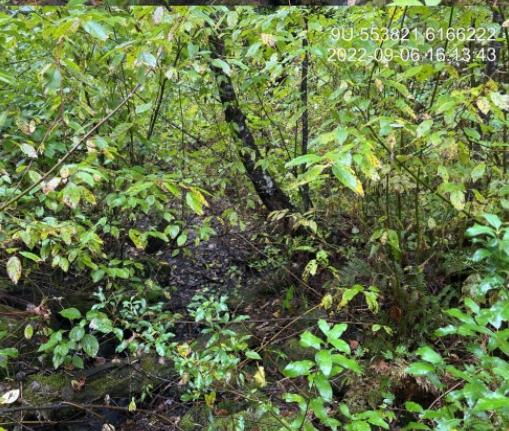
Location and Stream Data	•	Crossing Characteristics	-
Comments: Dry at time of survey. Significant moss on rocks throughout channel indicates dry for a good portion of the year. Culvert is perched 3 m from stream channel with outlet emptying onto riprap. Culvert is bent severely in middle. 16:03			
Photos: PSCIS ID 198209. From top left clockwise: Road/Site Card, Barrel, Outlet, Downstream, Upstream, Inlet.

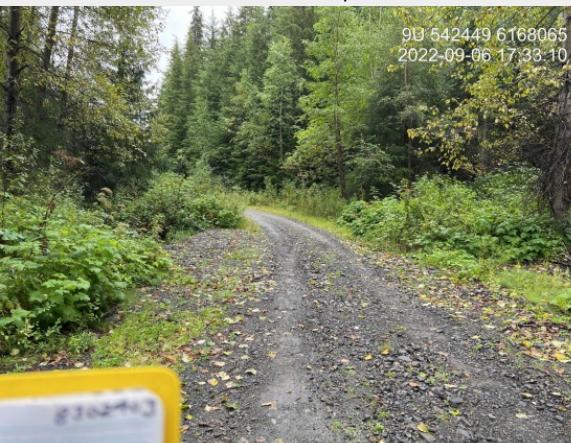
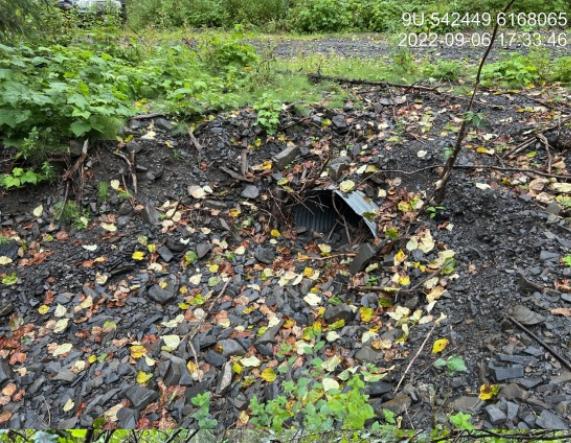
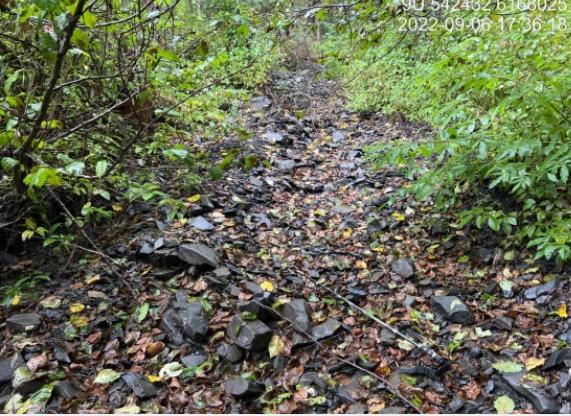
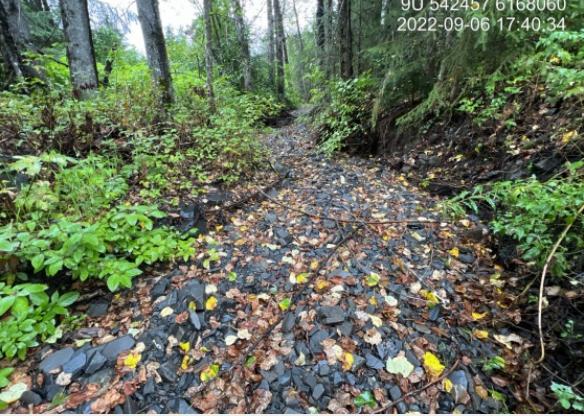
Location and Stream Data	•	Crossing Characteristics	-
Comments: Stream dry at time of assessment. Significant accumulation of debris just upstream of the inlet. 17:30			
Photos: PSCIS ID 198210. From top left clockwise: Road/Site Card, Barrel, Outlet, Downstream, Upstream, Inlet.

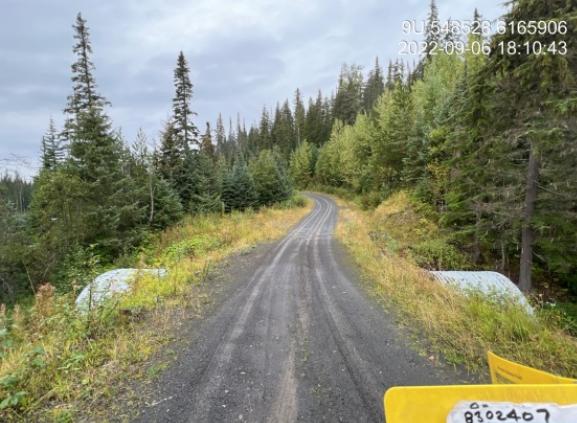
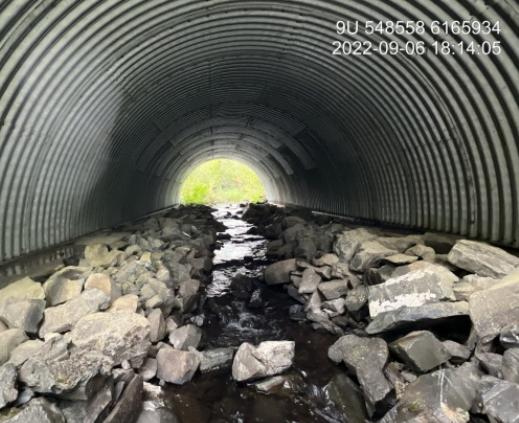
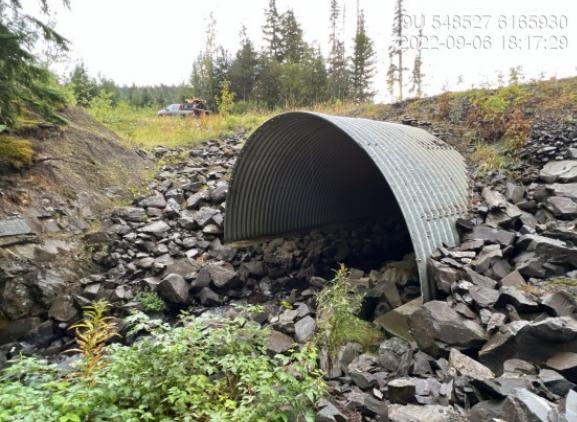
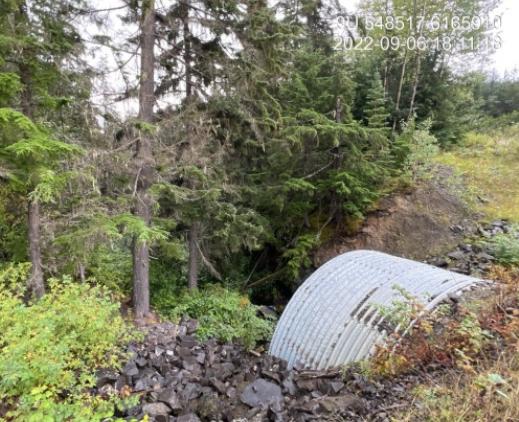
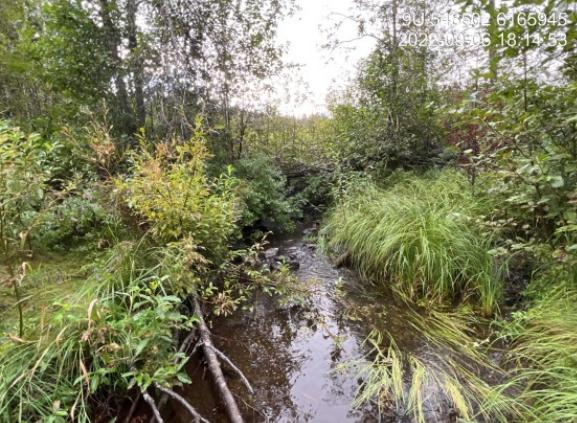
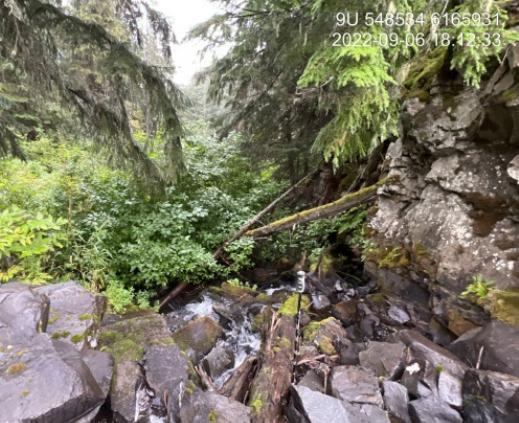
Location and Stream Data	•	Crossing Characteristics	-
Comments: Extremely steep rock steps immediately downstream of outlet. Downstream is 20% gradient with >1m steps. FISS point from Triton indicates there is a 2 m barrier downstream that is a barrier to anadromous species. Additionally, there is a 5 m rock documented near the confluence with the Kispiox. 18:09			
Photos: PSCIS ID 198211. From top left clockwise: Road/Site Card, Barrel, Outlet, Downstream, Upstream, Inlet.

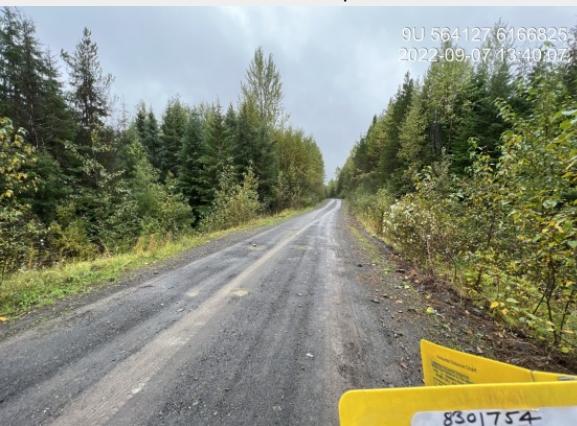
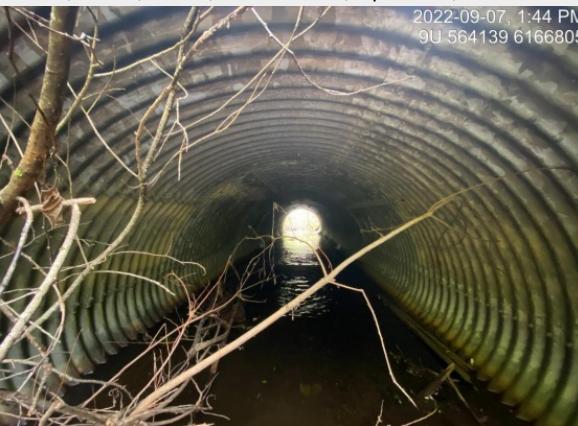
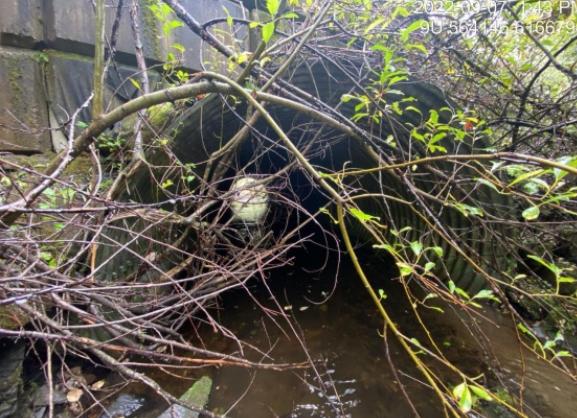
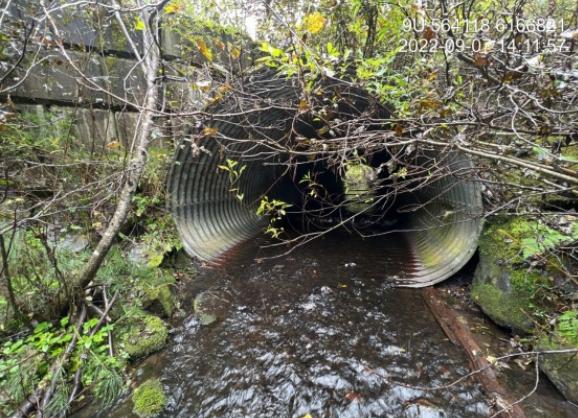
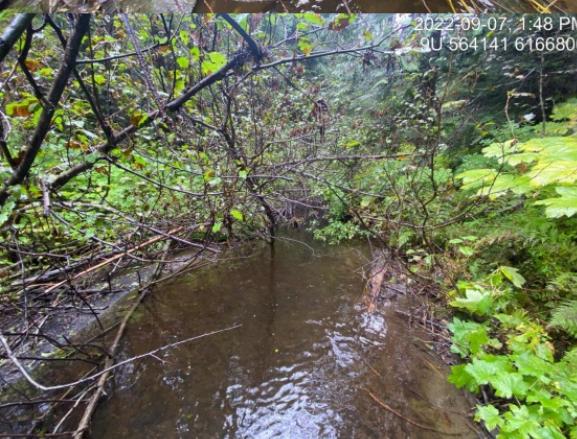
Location and Stream Data	•	Crossing Characteristics
Comments: Baffles installed. 13:32		
Photos: PSCIS ID 198212. From top left clockwise: Road/Site Card, Barrel, Outlet, Downstream, Upstream, Inlet.

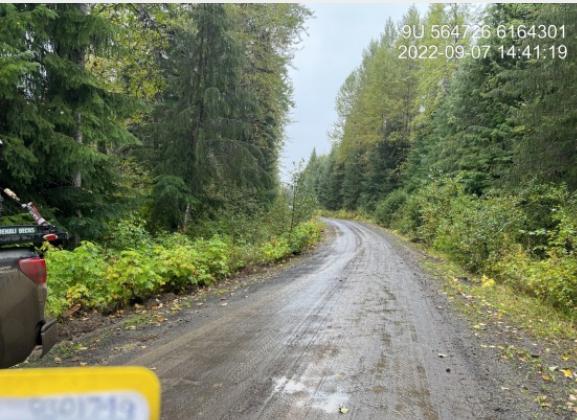
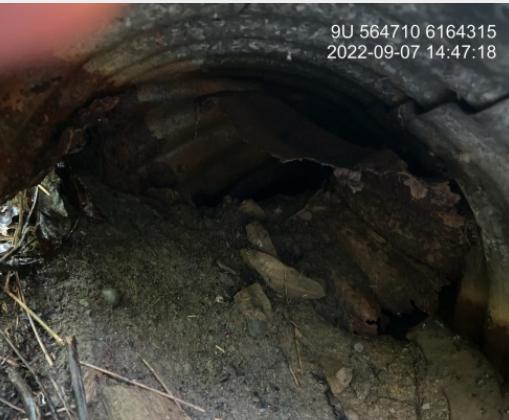
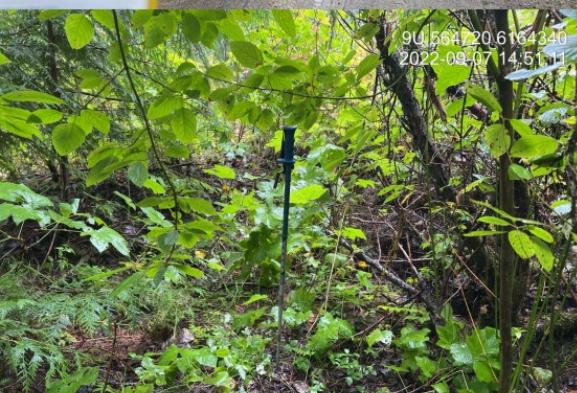
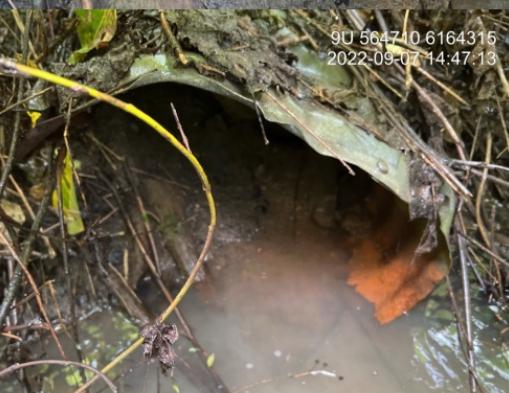
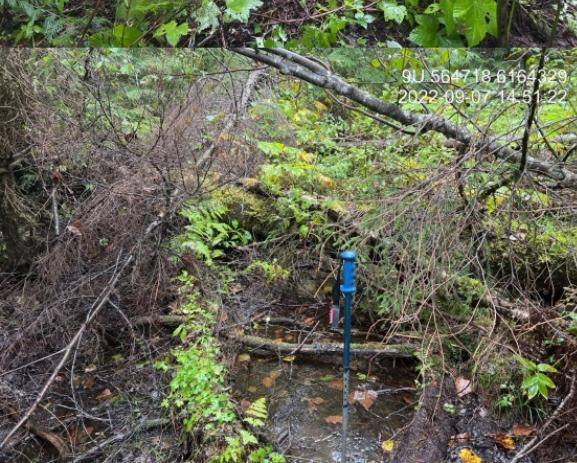
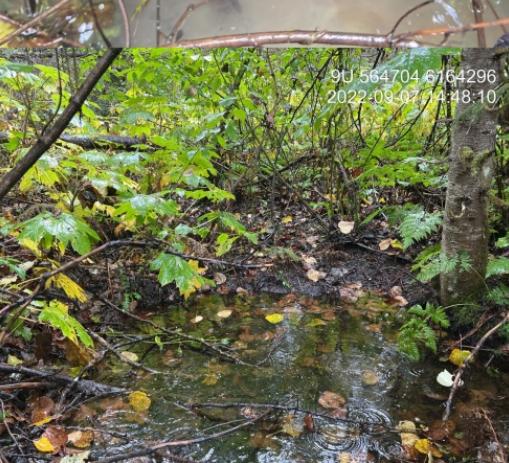
Location and Stream Data	•	Crossing Characteristics
Comments: This is a small non-classified drainage. Culvert is completely plugged and inlet could not be located. Outlet of culvert is severely corroded. Very unlikely that this is a fish bearing system. Culvert slope, channel with, ingredient estimated. 14:39		
Photos: PSCIS ID 198213. From top left clockwise: Road/Site Card, Barrel, Outlet, Downstream, Upstream, Inlet.
