Appendix - Phase 1 Fish Passage Assessment Data and Photos

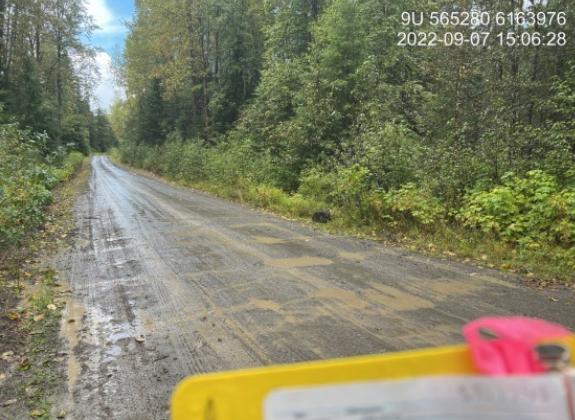
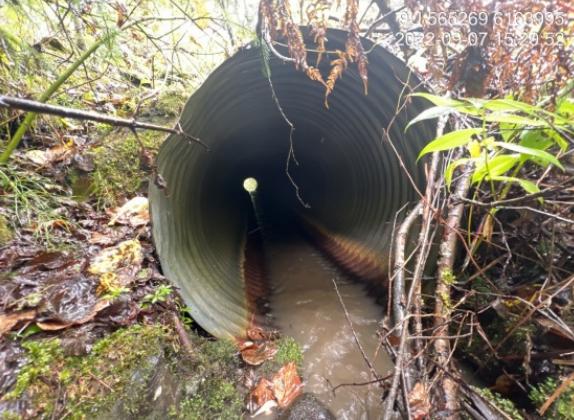
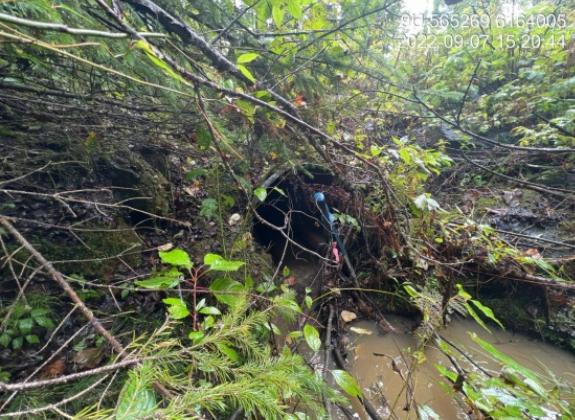
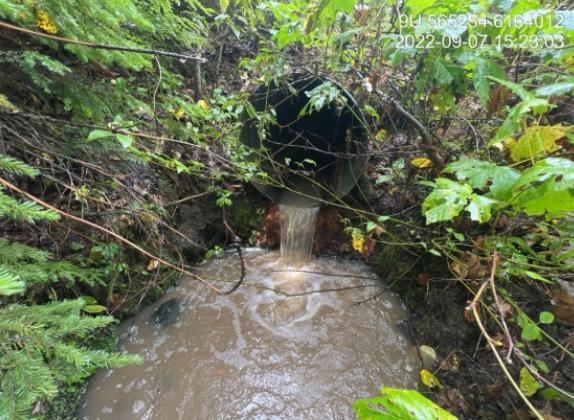
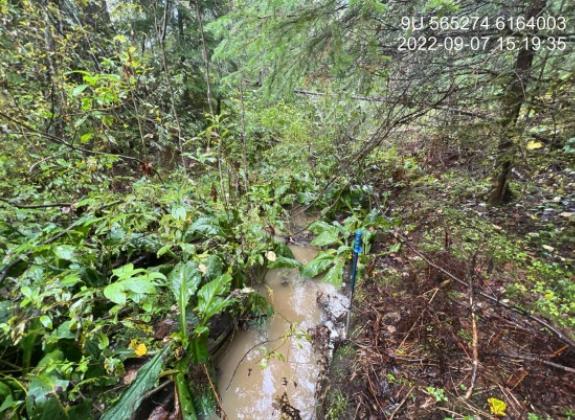
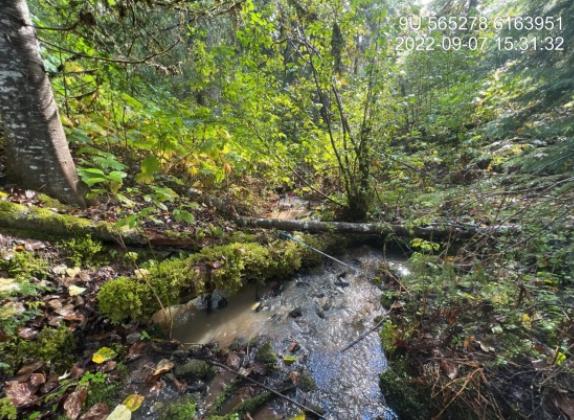
Location and Stream Data	•	Crossing Characteristics	-
<p>Comments: Approximately 15 m down stream of culvert outlet is a natural rock drop of 0.65 cm on bedrock. Downstream of the culvert the gradient was measured at 17% over a distance of approximately 25 m. Seems very unlikely that a stream this small and steep would have fish presence upstream even if the culvert was fixed. This is unconfirmed. 15:06</p>			
<p>Photos: PSCIS ID 198214. From top left clockwise: Road/Site Card, Barrel, Outlet, Downstream, Upstream, Inlet.</p>

Location and Stream Data		Crossing Characteristics	
Date	2022-09-07	Crossing Sub Type	Round Culvert
PSCIS ID	198214	Diameter (m)	0.95
External ID	8301748	Length (m)	20
Crew	AI	Embedded	No
UTM Zone	9	Depth Embedded (m)	–
Easting	565280.8	Resemble Channel	No
Northing	6163976	Backwatered	No
Stream	Tributary to Cullon Creek	Percent Backwatered	–
Road	Kuldo FSR	Fill Depth (m)	2
Road Tenure	MoF 7871	Outlet Drop (m)	0.49
Channel Width (m)	1.6	Outlet Pool Depth (m)	0.28
Stream Slope (%)	2	Inlet Drop	No
Beaver Activity	No	Slope (%)	2.5
Habitat Value	Low	Valley Fill	Deep Fill
Final score	34	Barrier Result	Barrier
Fix type	Replace Structure with Streambed Simulation CBS	Fix Span / Diameter	3

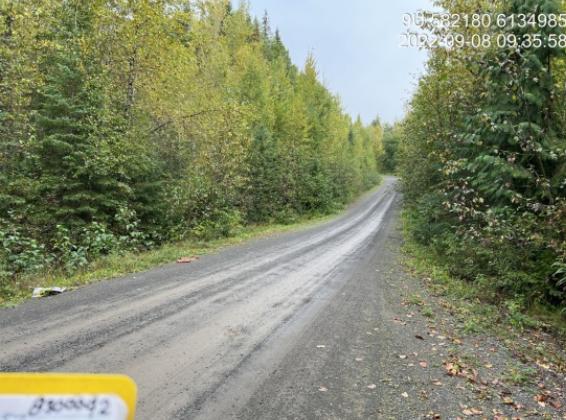
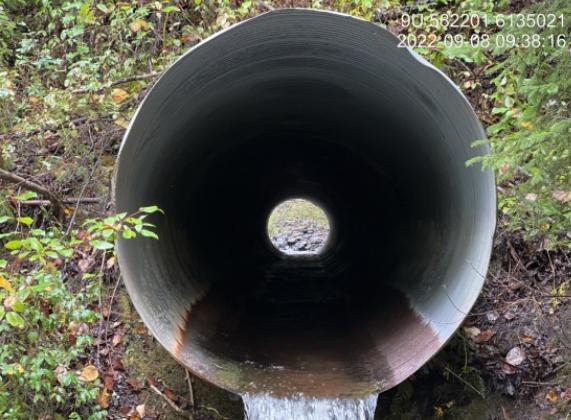
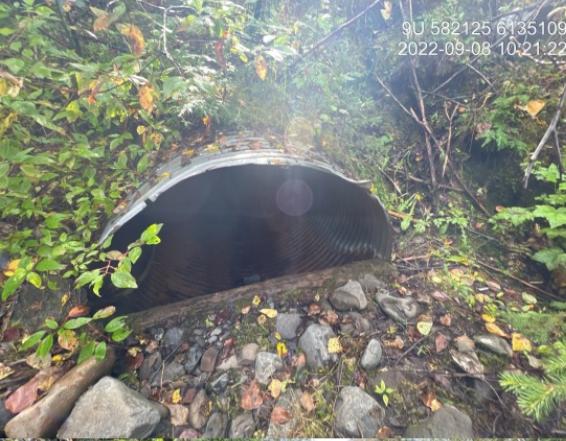
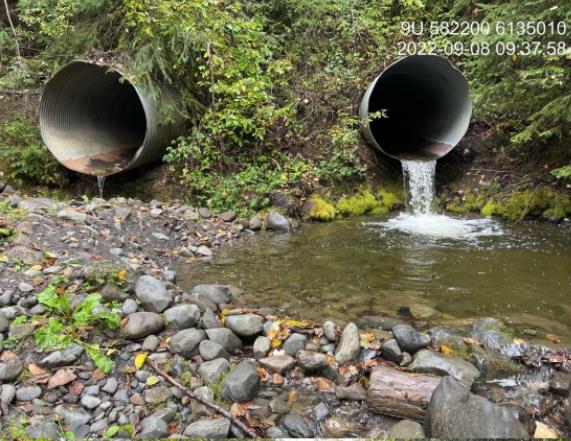
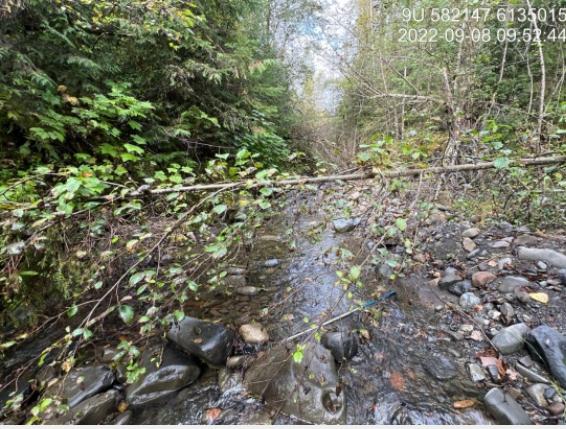
Location and Stream Data	•	Crossing Characteristics	-
Comments: .75-.90 m lock block step approximately 30 m down stream of culvert. Double pipe however river right pipe is not functioning and has 50% blocked outlet. 9:32			
Photos: PSCIS ID 198215. From top left clockwise: Road/Site Card, Barrel, Outlet, Downstream, Upstream, Inlet.

Location and Stream Data		Crossing Characteristics –	
Date	2022-09-09	Crossing Sub Type	Round Culvert
PSCIS ID	198215	Diameter (m)	3.7
External ID	8300042	Length (m)	32
Crew	AI JO	Embedded	No
UTM Zone	9	Depth Embedded (m)	–
Easting	582153.7	Resemble Channel	No
Northing	6135026	Backwatered	No
Stream	Tributary to Kispiox River	Percent Backwatered	–
Road	Kispiox Westside Rd	Fill Depth (m)	5.5
Road Tenure	MoTi Local	Outlet Drop (m)	1.1
Channel Width (m)	5.3	Outlet Pool Depth (m)	0.85
Stream Slope (%)	5.5	Inlet Drop	No
Beaver Activity	No	Slope (%)	4
Habitat Value	High	Valley Fill	Deep Fill
Final score	42	Barrier Result	Barrier
Fix type	Replace with New Open Bottom Structure	Fix Span / Diameter	17.5

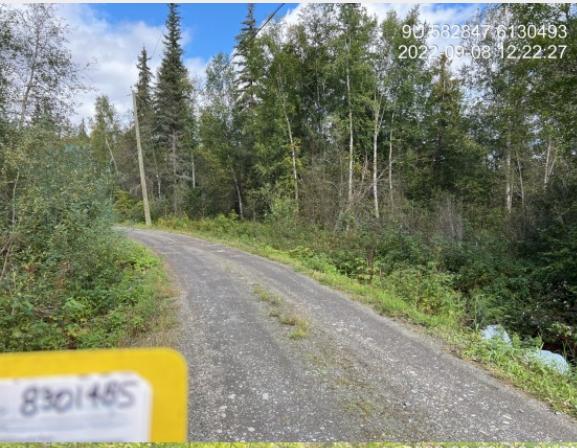
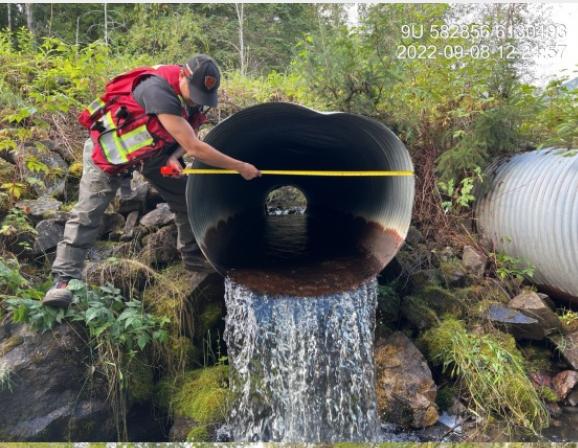
Location and Stream Data	•	Crossing Characteristics	-
Comments: Francis(chief) indicated this is historic coho harvest and spawning stream. 2 active culverts side by side. Trash rack has been removed from inlet. Inlet has significant amount of debris. Extensive gravels present suitable for coho spawning. Good flow and large stream. On road to water treatment plant within reserve boundaries. 12:20			
Photos: PSCIS ID 198217. From top left clockwise: Road/Site Card, Barrel, Outlet, Downstream, Upstream, Inlet.

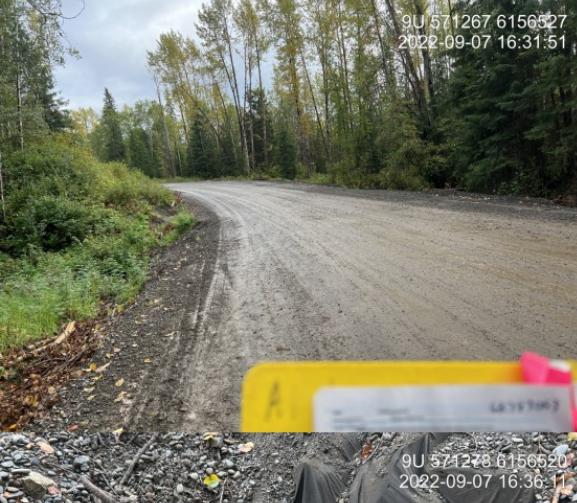
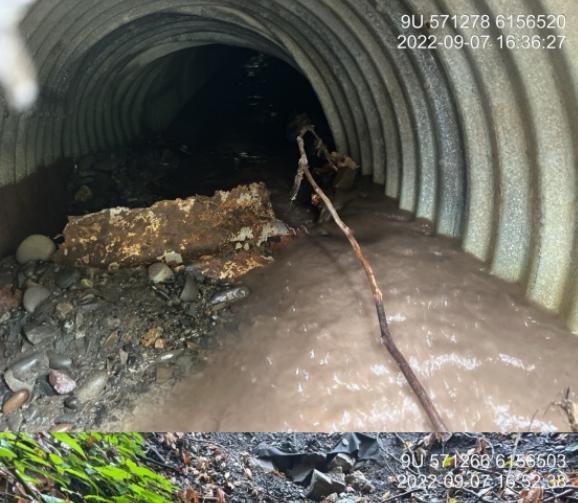
Location and Stream Data	•	Crossing Characteristics
<p>Comments: Culvert has had recent roadwork with significant amounts of fill added. Stream is running clear upstream of the culvert and is extremely turbid downstream due to erosion and runoff related to the construction to fix the road. Inlet of culvert is bent and damaged with a lot of debris at the top end of the pipe blocking significant portions of the flow. Not a modelled crossing location in bcfishpass but is a documented Moti culvert. 16:33</p>		
<p>Photos: PSCIS ID 198218. From top left clockwise: Road/Site Card, Barrel, Outlet, Downstream, Upstream, Inlet.</p>

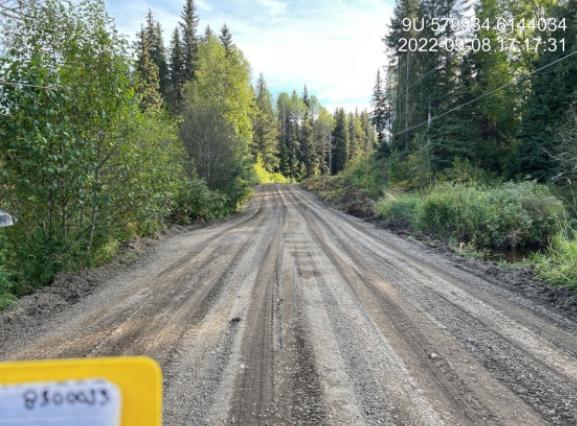
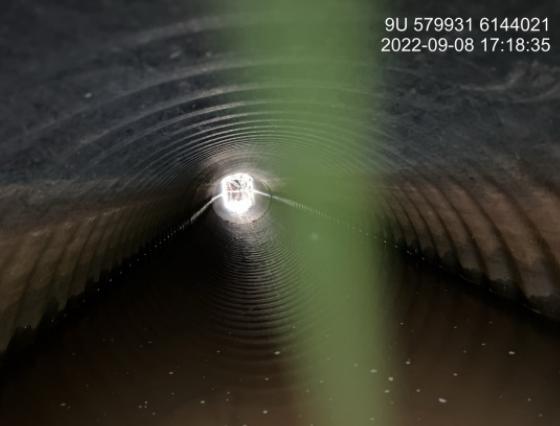
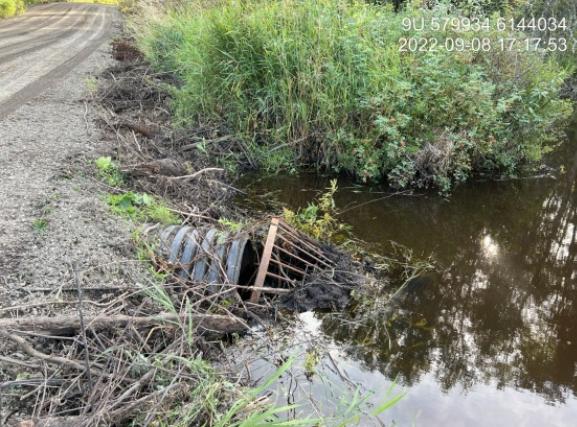
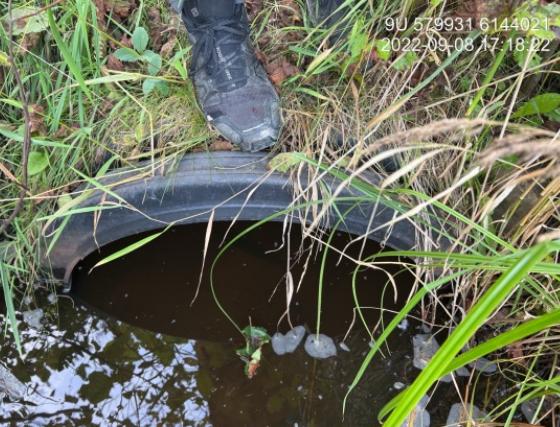
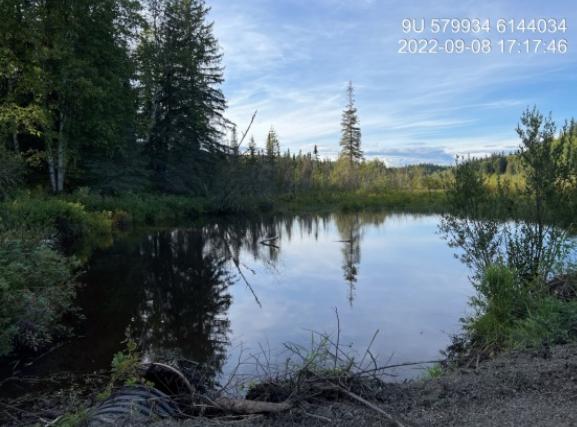
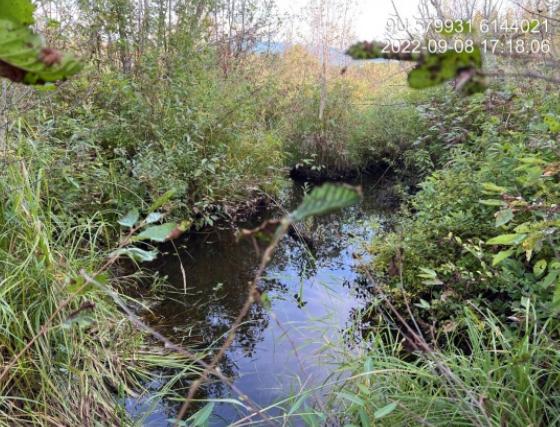
Location and Stream Data	•	Crossing Characteristics	-
Comments: Wetland upstream. Debris cone on inlet has separated from the culvert. Large inlet drop due to the debris caught in the inlet. 17:14			
Photos: PSCIS ID 198219. From top left clockwise: Road/Site Card, Barrel, Outlet, Downstream, Upstream, Inlet.

Location and Stream Data		Crossing Characteristics –	
Date	2022-09-09	Crossing Sub Type	Round Culvert
PSCIS ID	198219	Diameter (m)	0.8
External ID	8300033	Length (m)	13
Crew	AI	Embedded	No
UTM Zone	9	Depth Embedded (m)	–
Easting	579936.8	Resemble Channel	No
Northing	6144037	Backwatered	Yes
Stream	Tributary to Kispiox River	Percent Backwatered	100
Road	Seventeen Mile Rd	Fill Depth (m)	0.3
Road Tenure	MoTi Local	Outlet Drop (m)	0
Channel Width (m)	2.5	Outlet Pool Depth (m)	1
Stream Slope (%)	0	Inlet Drop	Yes
Beaver Activity	Yes	Slope (%)	0.5
Habitat Value	Medium	Valley Fill	Deep Fill
Final score	16	Barrier Result	Potential
Fix type	Replace with New Open Bottom Structure	Fix Span / Diameter	10

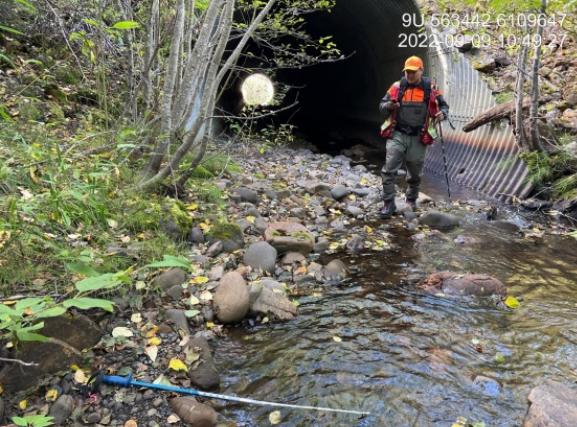
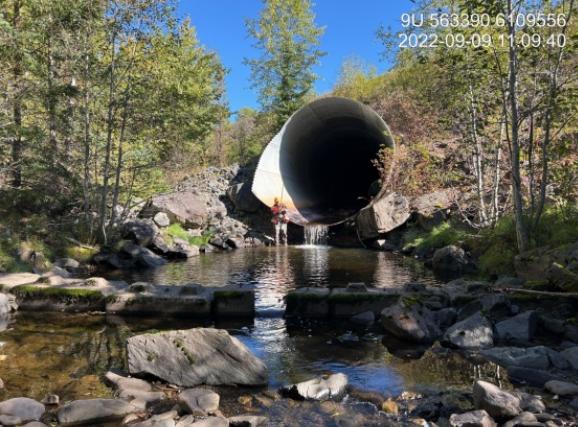
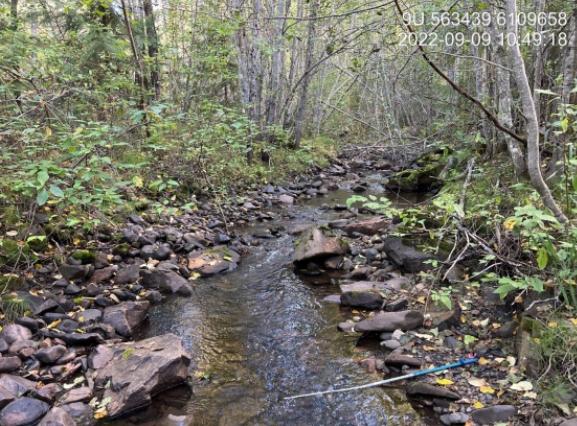
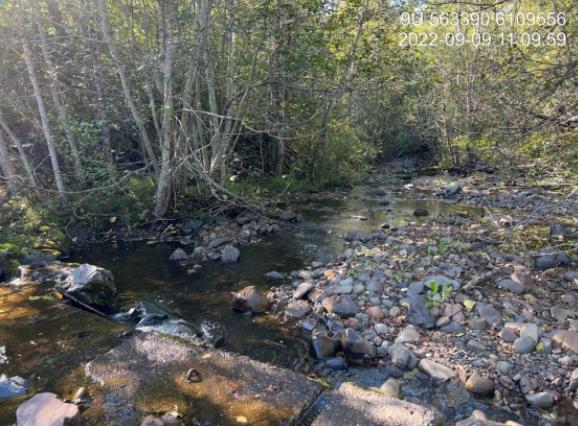
Location and Stream Data	•	Crossing Characteristics	-
Comments: Historic backwatering with 6 downstream lock block weirs. Skeena Fisheries Commission has assessed site in past. Very large system, pipe embedded until last 10m. Large outlet drop. Lots of algae. 10:46			
Photos: PSCIS ID 198220. From top left clockwise: Road/Site Card, Barrel, Outlet, Downstream, Upstream, Inlet.

Location and Stream Data		Crossing Characteristics –	
Date	2022-09-10	Crossing Sub Type	Round Culvert
PSCIS ID	198220	Diameter (m)	4.8
External ID	8300095	Length (m)	75
Crew	AI	Embedded	No
UTM Zone	9	Depth Embedded (m)	–
Easting	563431	Resemble Channel	No
Northing	6109637	Backwatered	No
Stream	Tributary to Kitwanga River	Percent Backwatered	–
Road	Hwy 37	Fill Depth (m)	9.9
Road Tenure	MoTi Highway	Outlet Drop (m)	0.72
Channel Width (m)	5	Outlet Pool Depth (m)	0.75
Stream Slope (%)	2	Inlet Drop	No
Beaver Activity	No	Slope (%)	1.5
Habitat Value	High	Valley Fill	Deep Fill
Final score	34	Barrier Result	Barrier
Fix type	Replace with New Open Bottom Structure	Fix Span / Diameter	30.5

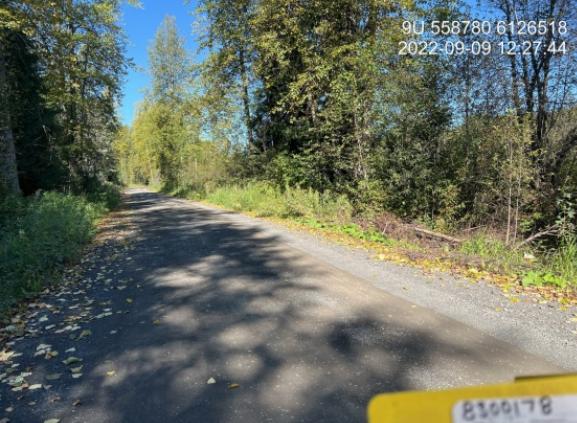
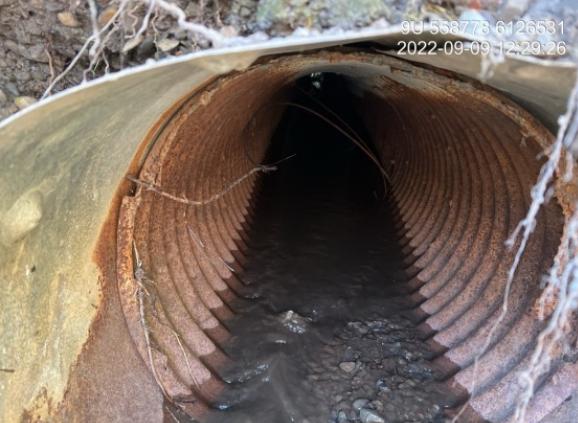
Location and Stream Data	•	Crossing Characteristics	-
Comments: There are actually two pipes that are 0.65 cm. One pipe has an extension into the beaver dam located immediately upstream of the inlet. This stream is not at the map location as it is located upstream via the Kitwanga River approximately 250 m. 12:14			
Photos: PSCIS ID 198221. From top left clockwise: Road/Site Card, Barrel, Outlet, Downstream, Upstream, Inlet.

Location and Stream Data		Crossing Characteristics –	
Date	2022-09-10	Crossing Sub Type	Round Culvert
PSCIS ID	198221	Diameter (m)	1.3
External ID	8300178	Length (m)	9
Crew	AI	Embedded	No
UTM Zone	9	Depth Embedded (m)	–
Easting	558773.2	Resemble Channel	No
Northing	6126523	Backwatered	No
Stream	Tributary to Kitwanga River	Percent Backwatered	–
Road	11A Ave	Fill Depth (m)	1
Road Tenure	MoTi Local	Outlet Drop (m)	0
Channel Width (m)	4	Outlet Pool Depth (m)	0.2
Stream Slope (%)	0	Inlet Drop	No
Beaver Activity	Yes	Slope (%)	1
Habitat Value	Medium	Valley Fill	Deep Fill
Final score	21	Barrier Result	Barrier
Fix type	Replace with New Open Bottom Structure	Fix Span / Diameter	10

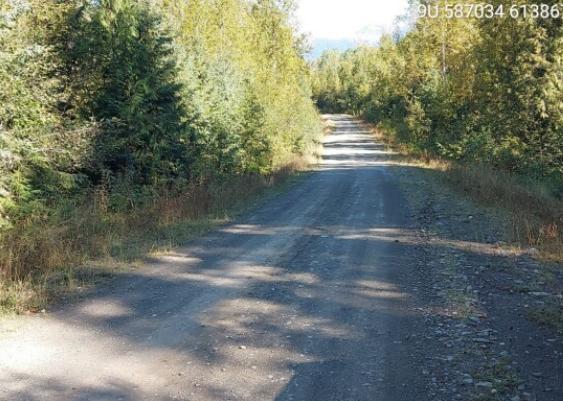
Location and Stream Data	•	Crossing Characteristics	-
Comments: Structure was replaced in 1985. Concrete wing walls on inlet. Structure in decent shape. 13:39			
Photos: PSCIS ID 198222. From top left clockwise: Road/Site Card, Barrel, Outlet, Downstream, Upstream, Inlet.

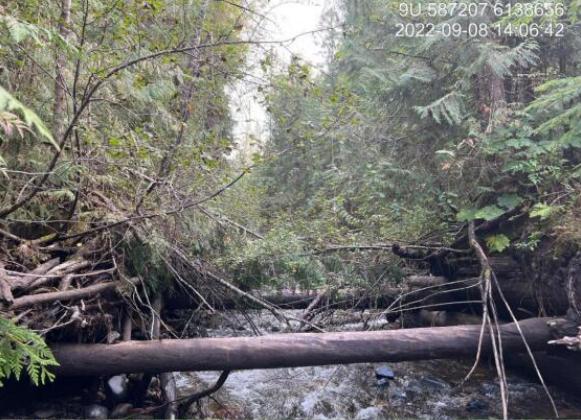
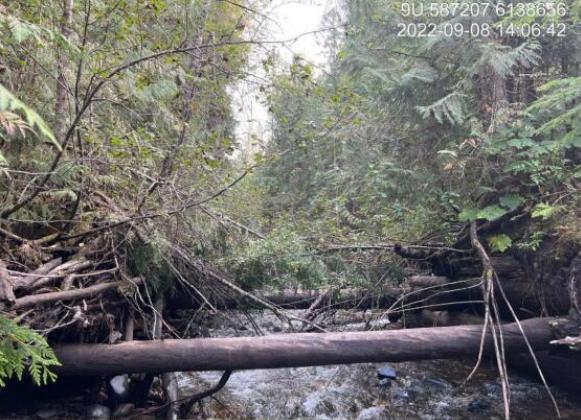
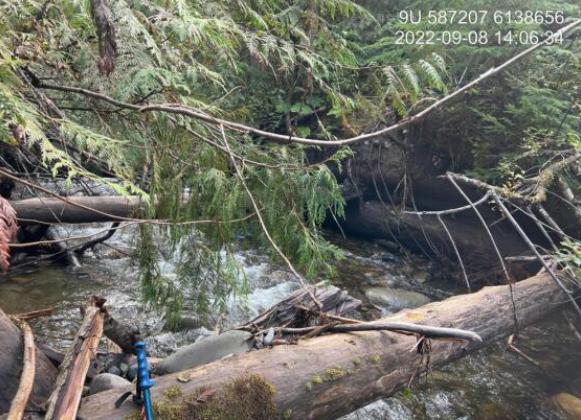
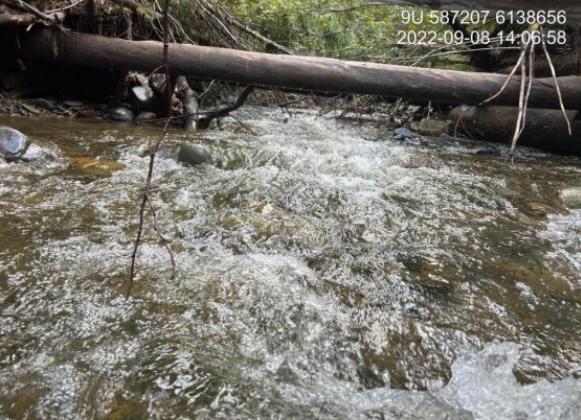
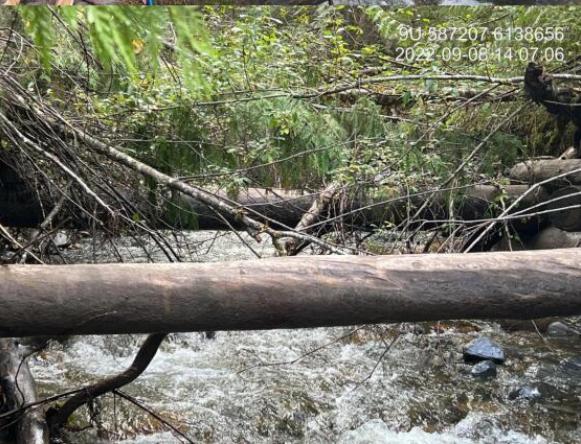
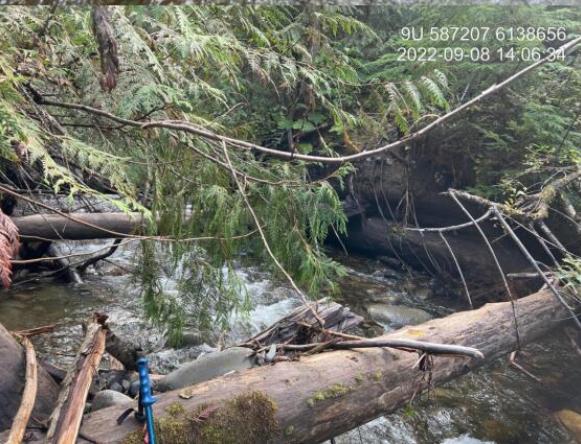
Location and Stream Data	•	Crossing Characteristics	-
Comments: Collapsed bridge. Some erosion along side but not fish passage issue. 14:04			
Photos: PSCIS ID 198223. From top left clockwise: Road/Site Card, Barrel, Outlet, Downstream, Upstream, Inlet.

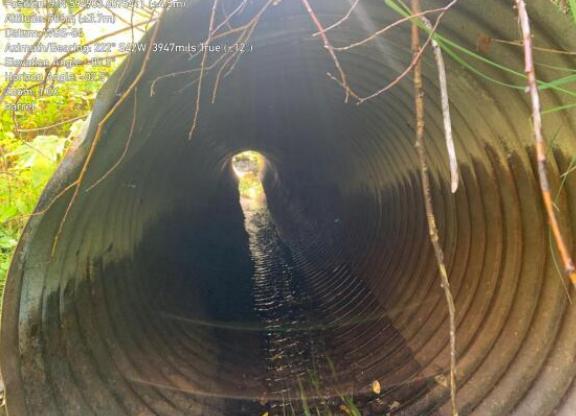
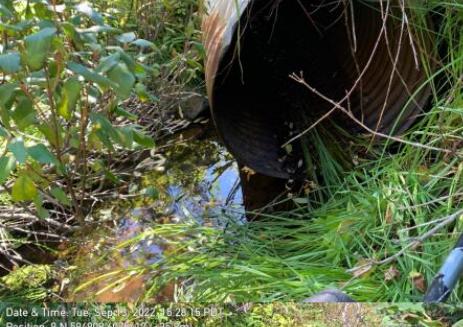
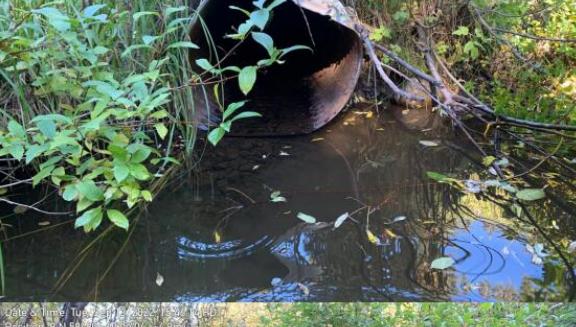
Location and Stream Data	•	Crossing Characteristics	-
Comments: Round culvert. 15:23:00			
Photos: PSCIS ID 198224. From top left clockwise: Road/Site Card, Barrel, Outlet, Downstream, Upstream, Inlet.			
Date & Time: Tue, Sep 13, 2022, 15:23:00 PDT Position: 9°N 59'49.10" W 60°50'41.0" (+4.7m) Altitude: 907m (+3.4m) Datum: WGS-84 Azimuth/Bearing: 309° N51W 5493mils True (+12°) Elevation Angle: -20.3° Horizon Angle: -02.2° Zoom: 1.0X		Date & Time: Tue, Sep 13, 2022, 15:23:00 PDT Position: 9°N 59'49.10" W 60°50'41.0" (+4.7m) Altitude: 907m (+3.4m) Datum: WGS-84 Azimuth/Bearing: 221° S52W 3947mils True (-12°) Elevation Angle: +01.1° Horizon Angle: +00.0° Zoom: 1.0X

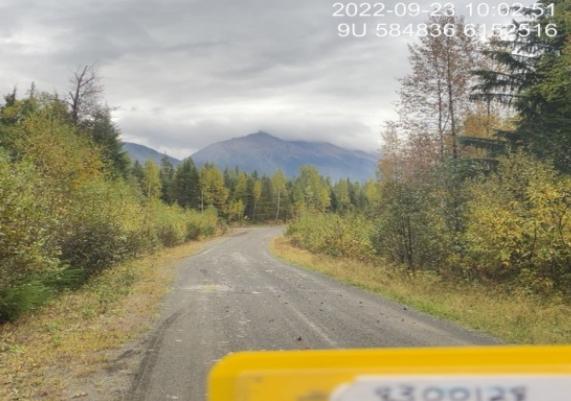
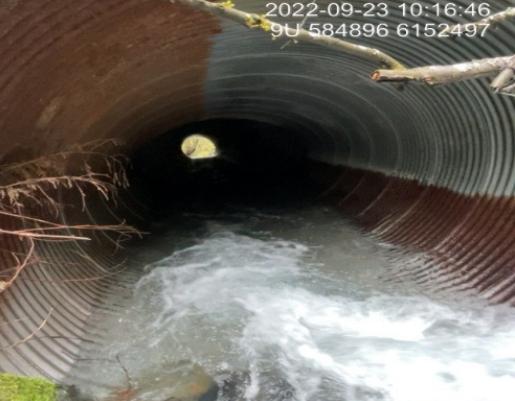
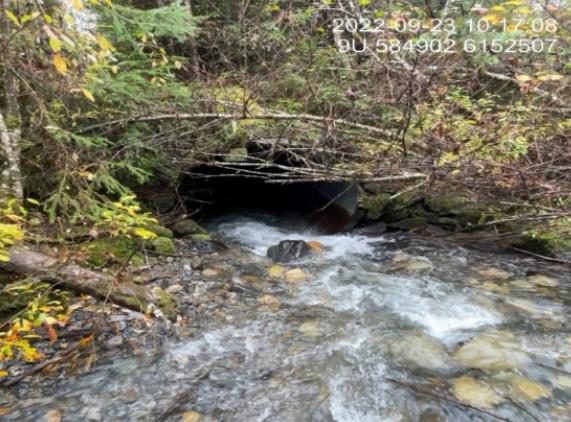
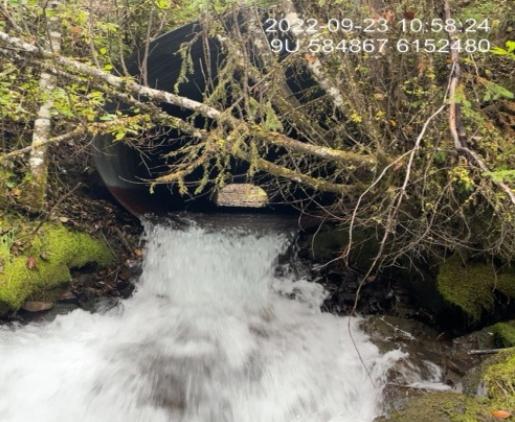
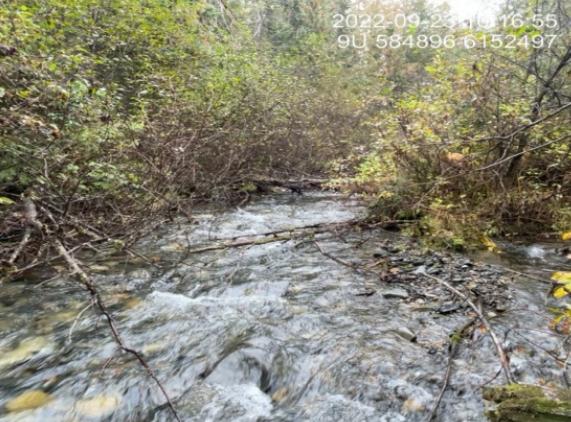
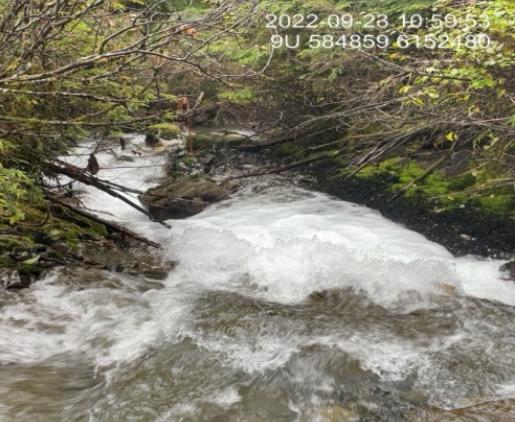
Location and Stream Data	•	Crossing Characteristics	-
Comments: Culvert is separating 10 meters in from upstream, top of culvert slumping in. 10:06			
Photos: PSCIS ID 198225. From top left clockwise: Road/Site Card, Barrel, Outlet, Downstream, Upstream, Inlet.

Location and Stream Data		Crossing Characteristics –	
Date	2022-09-23	Crossing Sub Type	Round Culvert
PSCIS ID	198225	Diameter (m)	2.4
External ID	8300128	Length (m)	30
Crew	JO	Embedded	No
UTM Zone	9	Depth Embedded (m)	–
Easting	584898.7	Resemble Channel	No
Northing	6152502	Backwatered	No
Stream	Sterritt creek	Percent Backwatered	–
Road	Babine Slide FSR	Fill Depth (m)	4
Road Tenure	MoF 4841	Outlet Drop (m)	2
Channel Width (m)	3.7	Outlet Pool Depth (m)	2
Stream Slope (%)	4.5	Inlet Drop	Yes
Beaver Activity	No	Slope (%)	3.5
Habitat Value	Low	Valley Fill	Deep Fill
Final score	42	Barrier Result	Barrier
Fix type	Replace with New Open Bottom Structure	Fix Span / Diameter	13

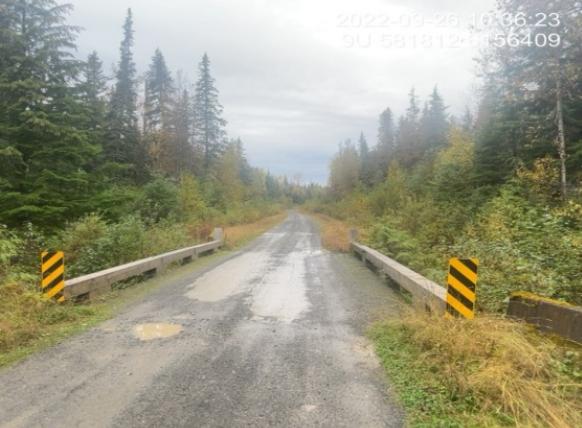
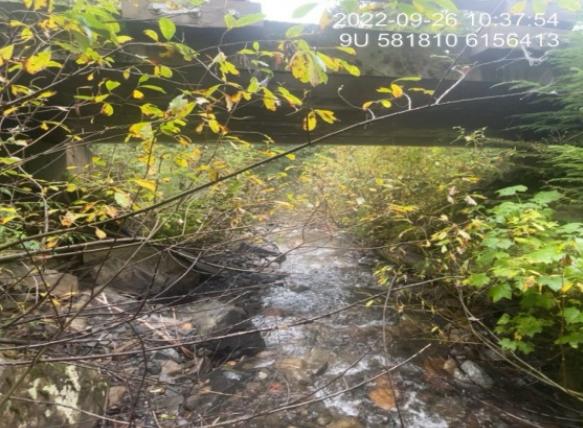
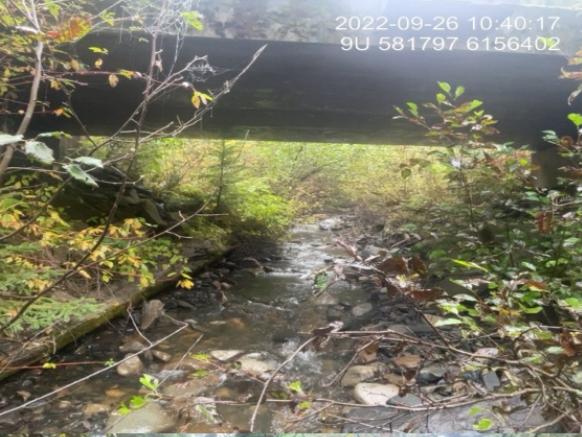
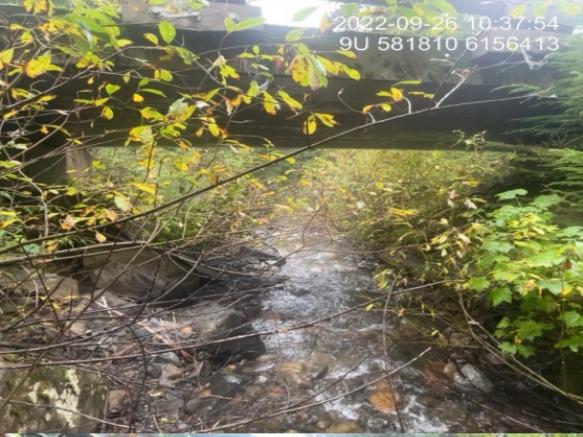
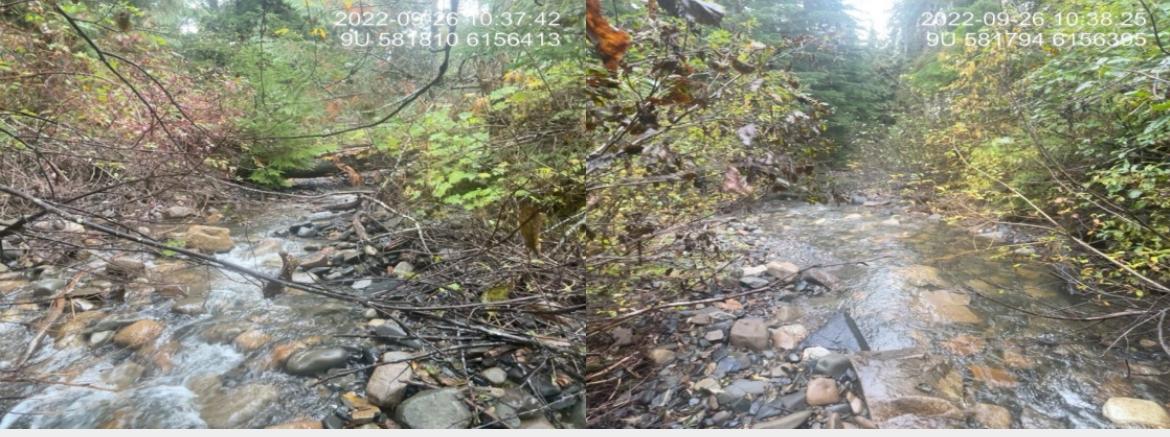
Location and Stream Data	•	Crossing Characteristics	-
Comments: New structure and old structure was on the side of the road near bridge. 10:35			
Photos: PSCIS ID 198226. From top left clockwise: Road/Site Card, Barrel, Outlet, Downstream, Upstream, Inlet.

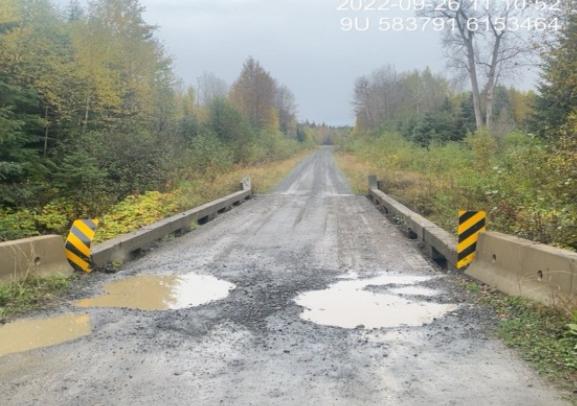
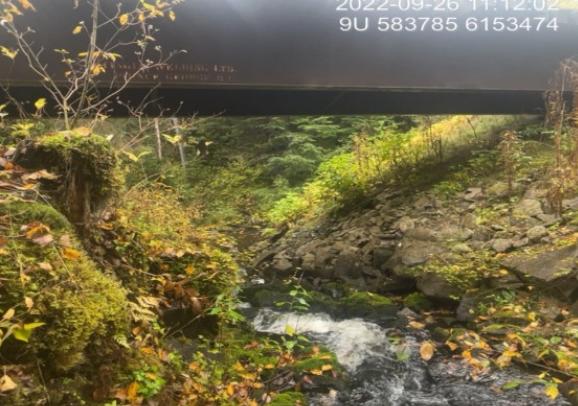
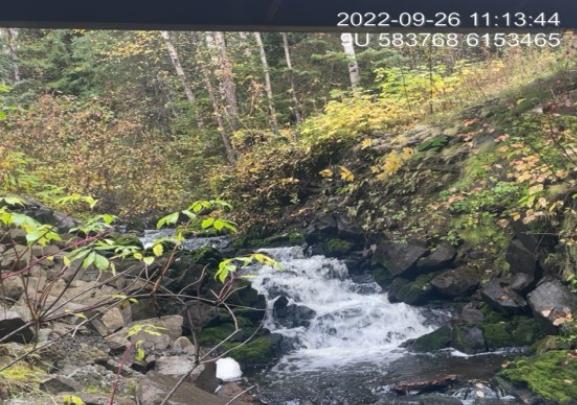
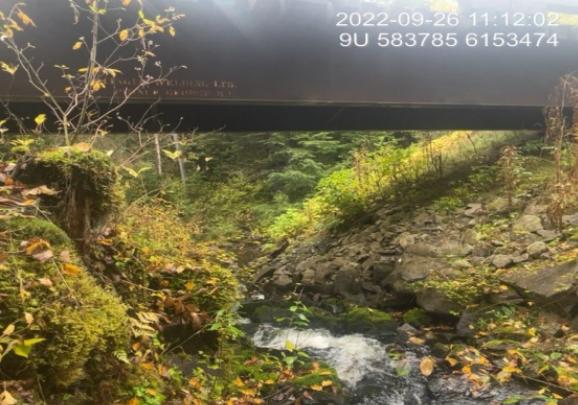
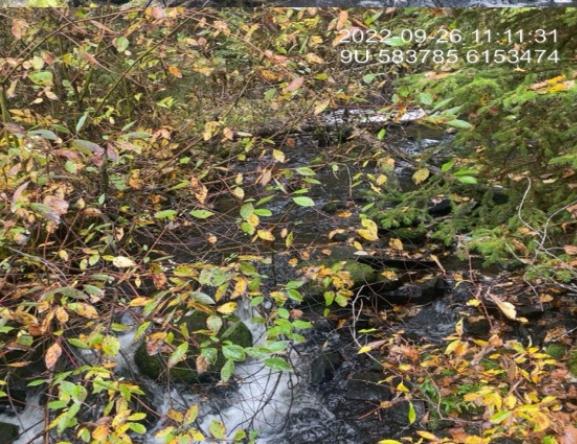
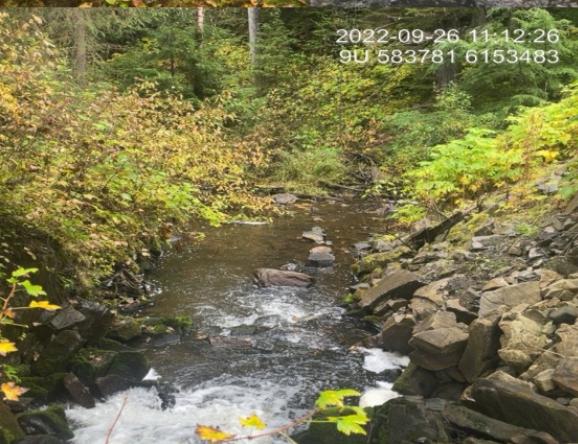
Location and Stream Data	•	Crossing Characteristics	-
Comments: Bridge. 11:14:00	•		-
Photos: PSCIS ID 198227. From top left clockwise: Road/Site Card, Barrel, Outlet, Downstream, Upstream, Inlet.

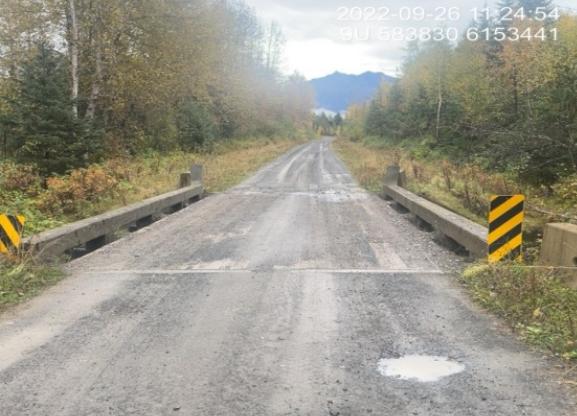
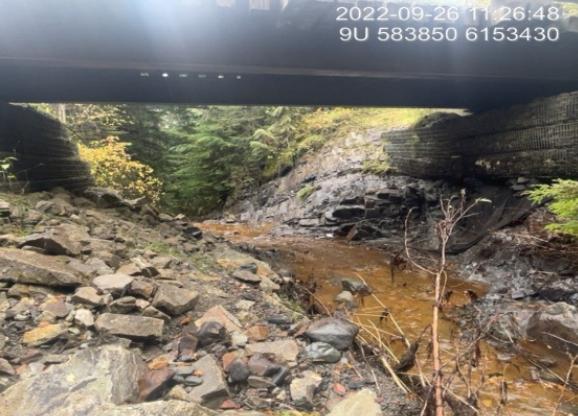
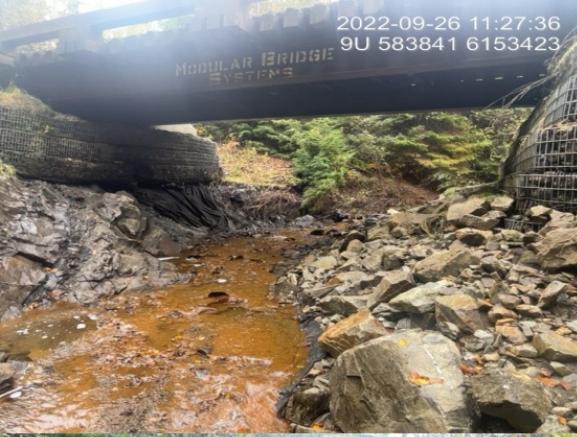
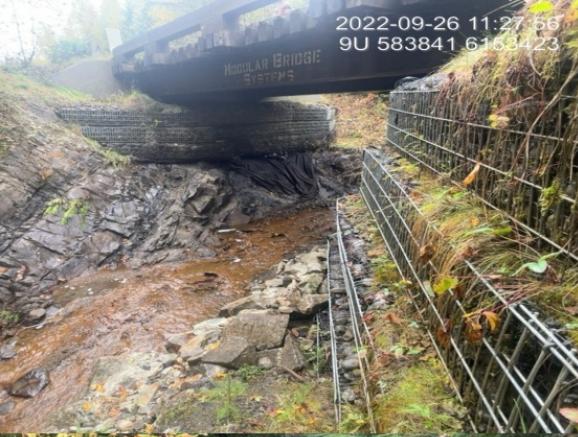
Location and Stream Data	•	Crossing Characteristics	-
Comments: Retaining fencing installed on both side of streams. Black sediment fencing also installed. 11:28			
Photos: PSCIS ID 198228. From top left clockwise: Road/Site Card, Barrel, Outlet, Downstream, Upstream, Inlet.

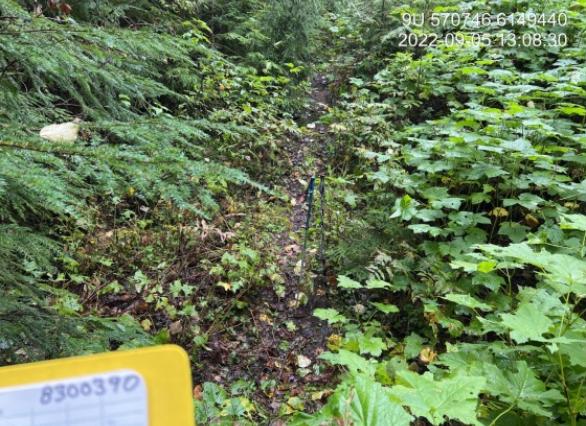
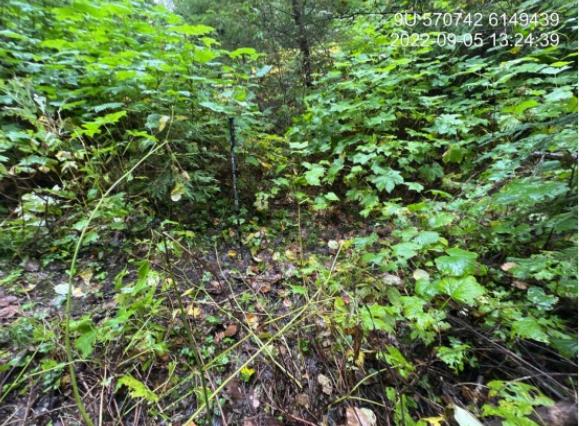
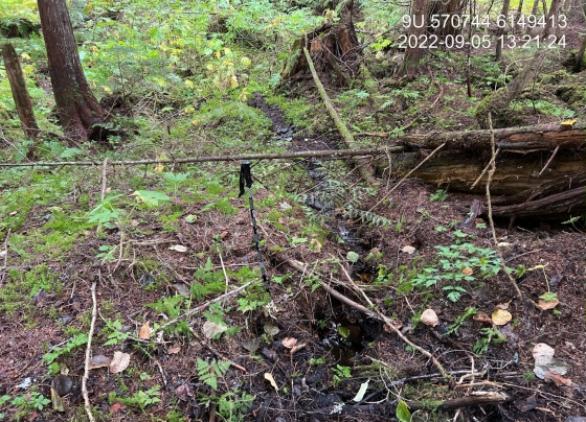
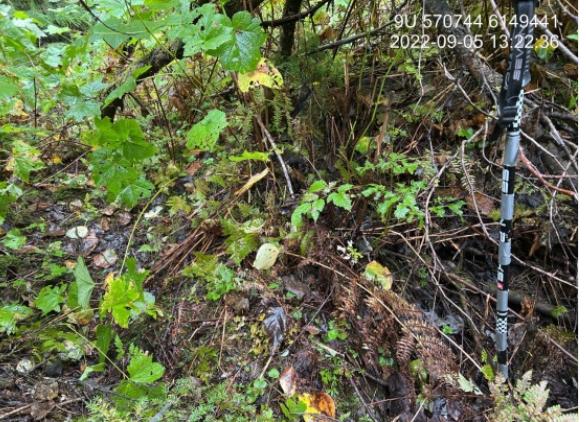
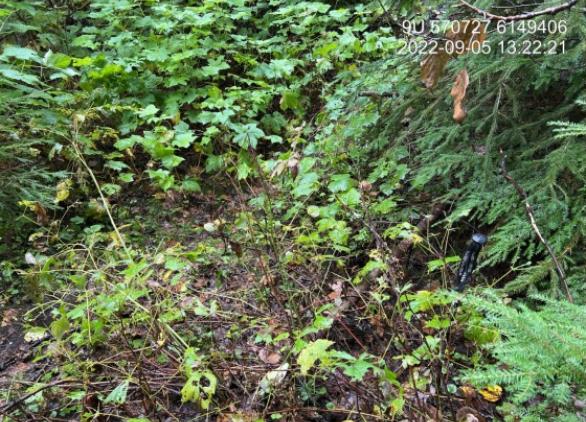
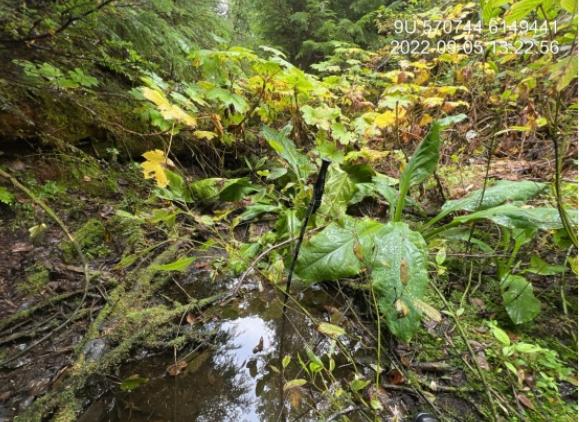
Location and Stream Data	•	Crossing Characteristics	-
Comments: Deactivated spur road. Ford is not in the same position as shown on the map. 13:08			
Photos: PSCIS ID 198229. From top left clockwise: Road/Site Card, Barrel, Outlet, Downstream, Upstream, Inlet.

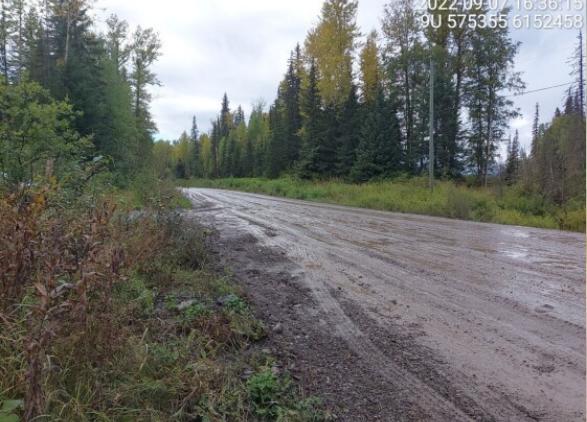
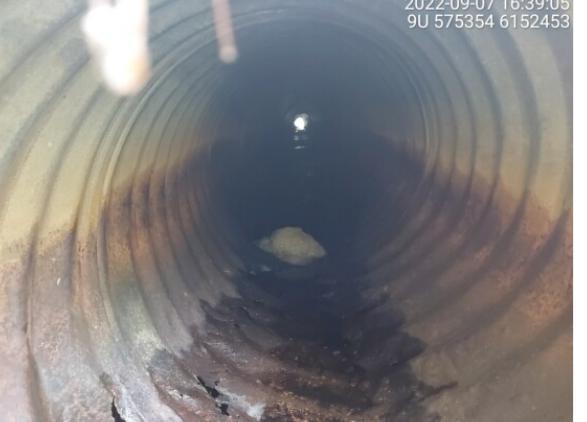
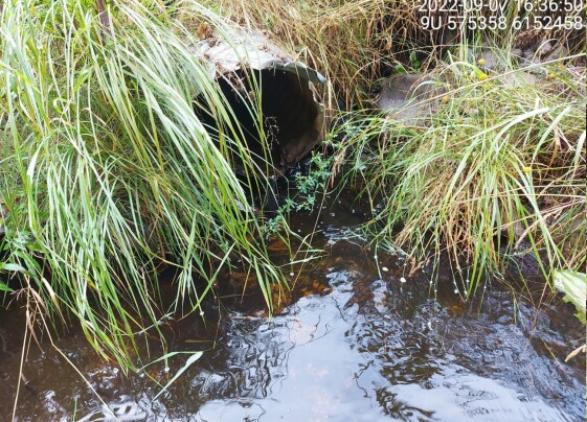
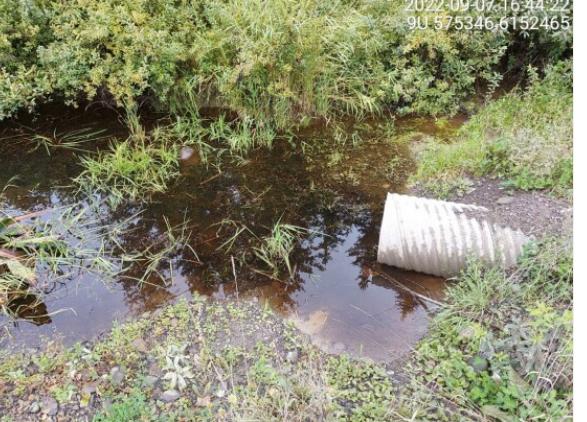
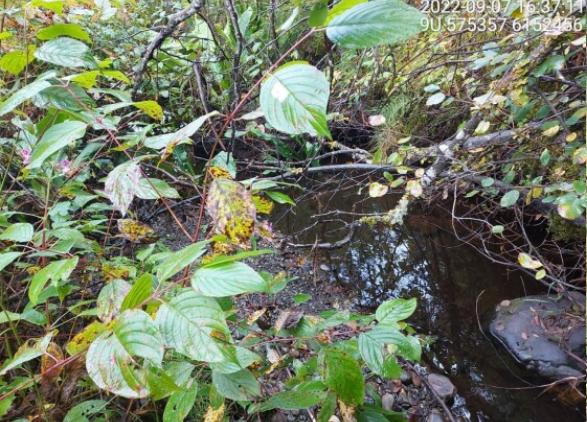
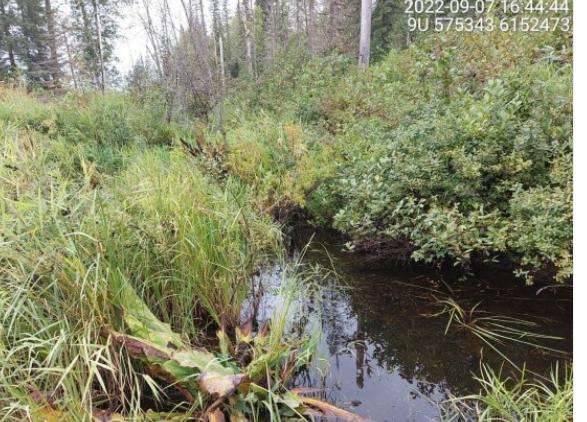
Location and Stream Data		Crossing Characteristics	
Date	2022-09-07	Crossing Sub Type	Round Culvert
PSCIS ID	198230	Diameter (m)	0.5
External ID	8300108	Length (m)	14
Crew	MW	Embedded	No
UTM Zone	9	Depth Embedded (m)	–
Easting	575356.8	Resemble Channel	No
Northing	6152462	Backwatered	No
Stream	Trib to Sammon Lake	Percent Backwatered	–
Road	Kispiox Valley Rd	Fill Depth (m)	1
Road Tenure	MoTi Local	Outlet Drop (m)	0.1
Channel Width (m)	1.9	Outlet Pool Depth (m)	0.3
Stream Slope (%)	2.5	Inlet Drop	No
Beaver Activity	No	Slope (%)	3
Habitat Value	Medium	Valley Fill	Deep Fill
Final score	26	Barrier Result	Barrier
Fix type	Replace Structure with Streambed Simulation CBS	Fix Span / Diameter	3

Location and Stream Data	•	Crossing Characteristics	-
Comments: Fish spotted downstream of culvert. 16:38			
Photos: PSCIS ID 198230. From top left clockwise: Road/Site Card, Barrel, Outlet, Downstream, Upstream, Inlet.

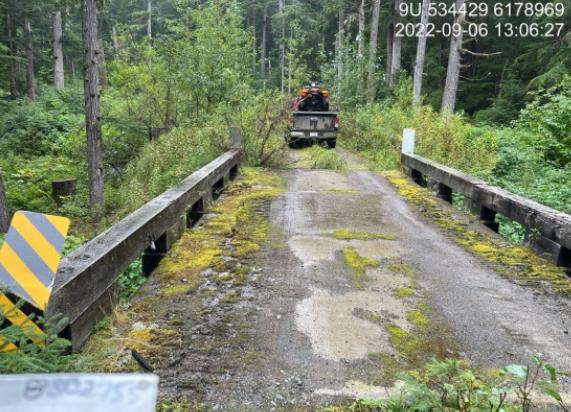
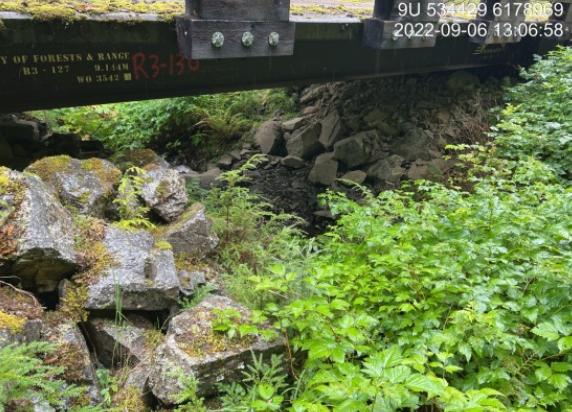
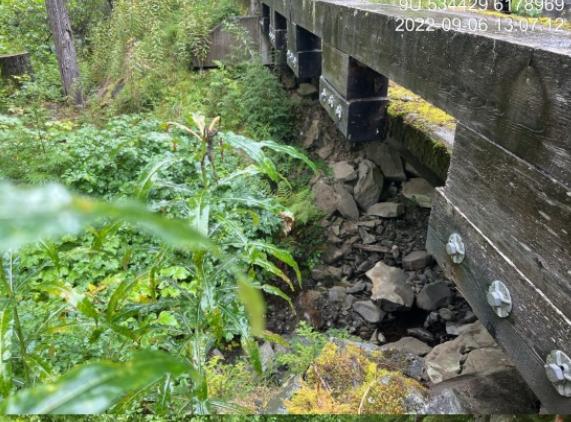
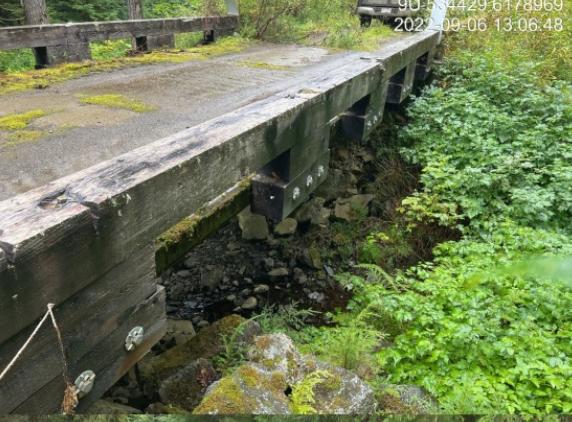
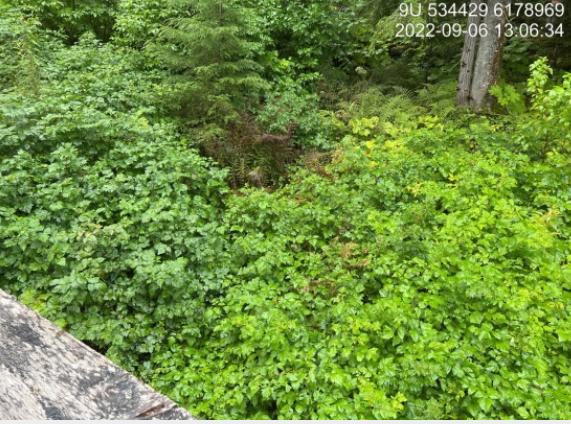
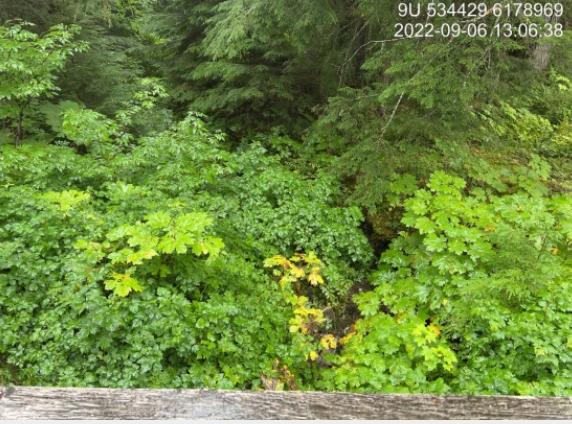
Location and Stream Data	•	Crossing Characteristics	-
Comments: Bridge. Road fairly brushed in. 13:03			
Photos: PSCIS ID 198231. From top left clockwise: Road/Site Card, Barrel, Outlet, Downstream, Upstream, Inlet.

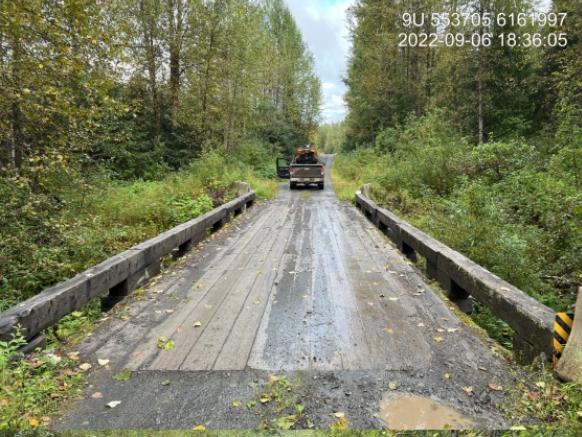
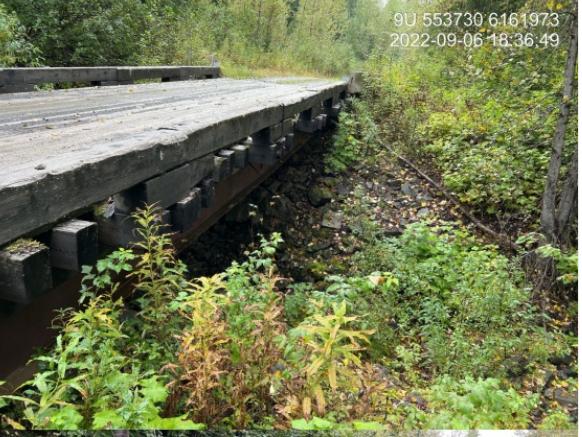
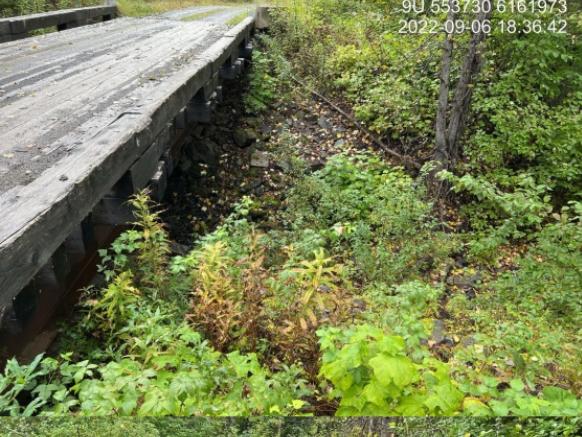
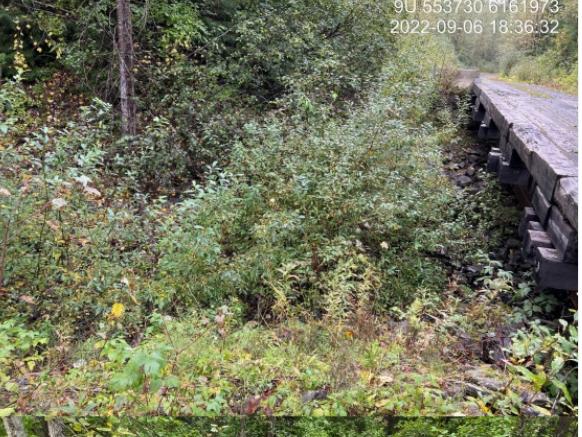
Location and Stream Data	•	Crossing Characteristics	-
Comments: Bridge. Stream bed is dry at time of assessment. 18:33			
Photos: PSCIS ID 198232. From top left clockwise: Road/Site Card, Barrel, Outlet, Downstream, Upstream, Inlet.
