Appendix - Phase 1 Fish Passage Assessment Data and Photos

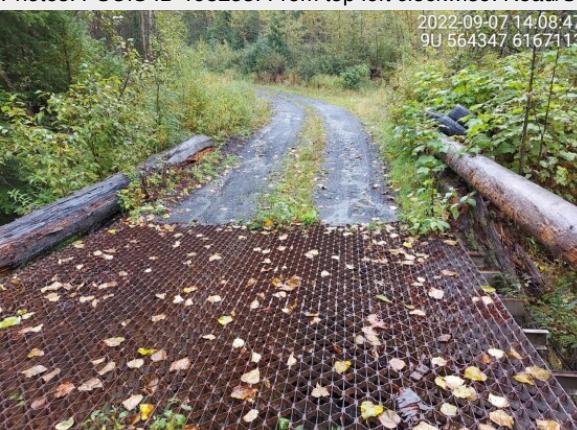
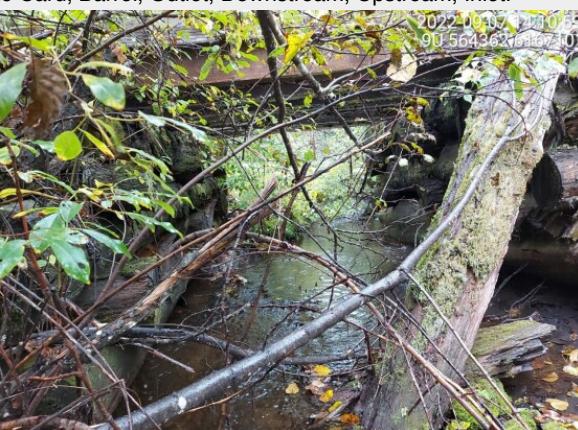
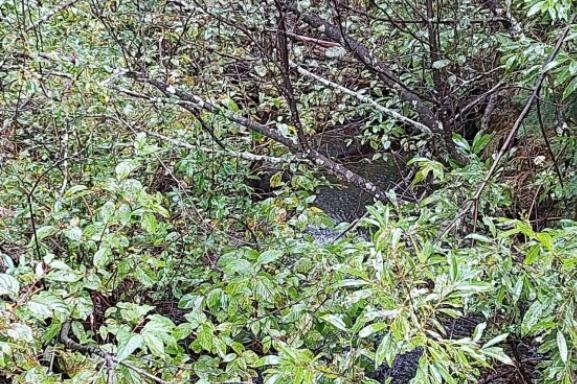
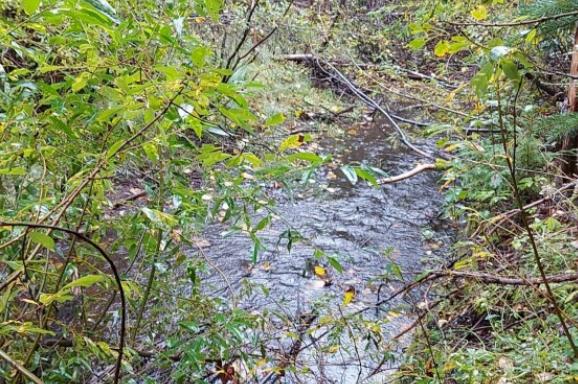
Location and Stream Data	•	Crossing Characteristics	-
Comments: Bridge is a little rotten but in ok shape. 14:11			
Photos: PSCIS ID 198233. From top left clockwise: Road/Site Card, Barrel, Outlet, Downstream, Upstream, Inlet.

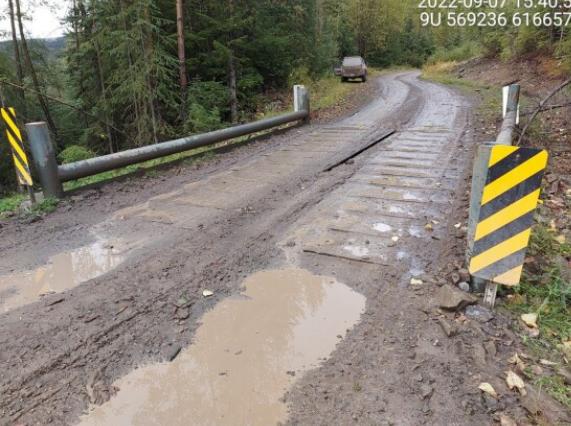
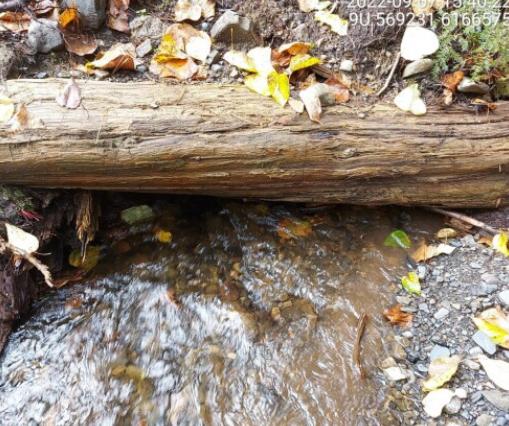
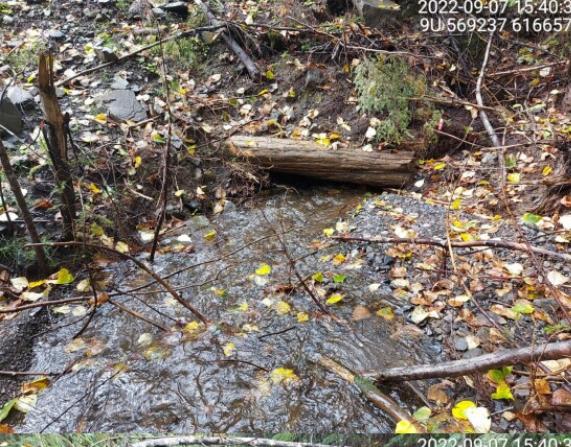
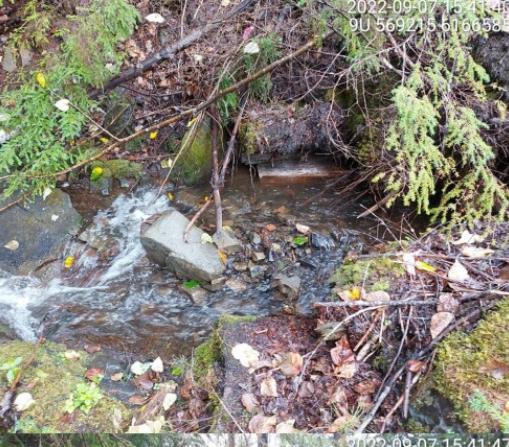
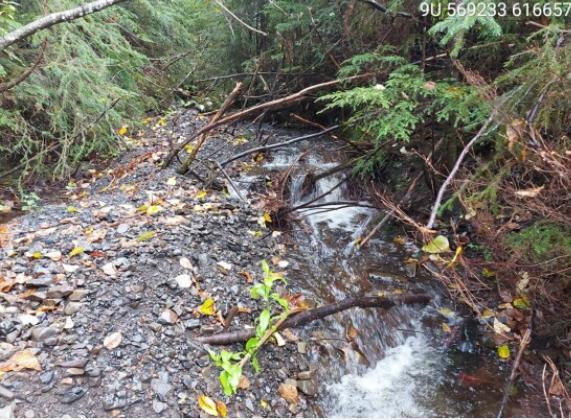
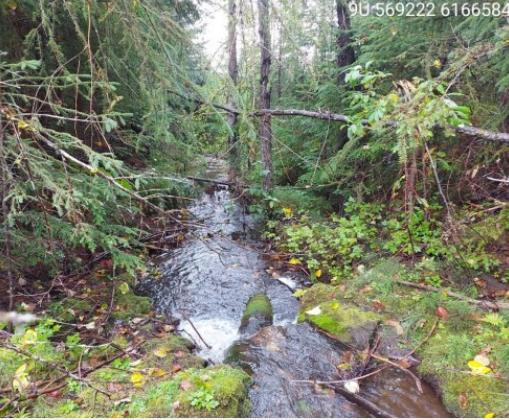
Location and Stream Data	•	Crossing Characteristics
Comments: Bridge with very deep fill. Approx. 10cm between water and bottom of bridge. 15:38		
Photos: PSCIS ID 198234. From top left clockwise: Road/Site Card, Barrel, Outlet, Downstream, Upstream, Inlet.

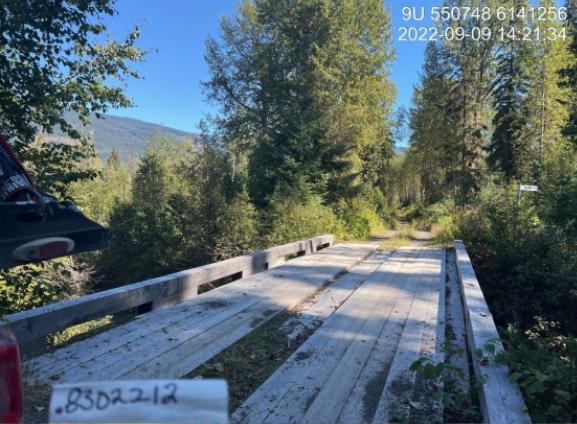
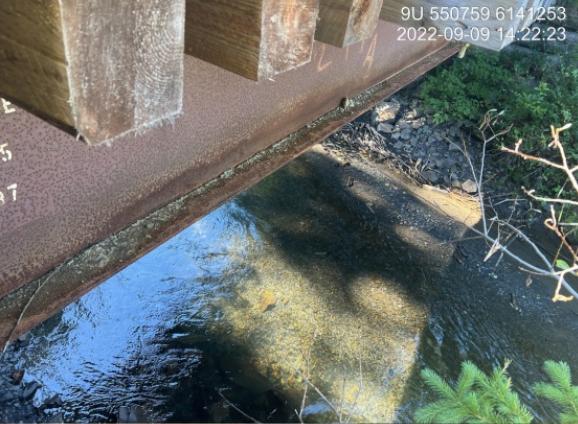
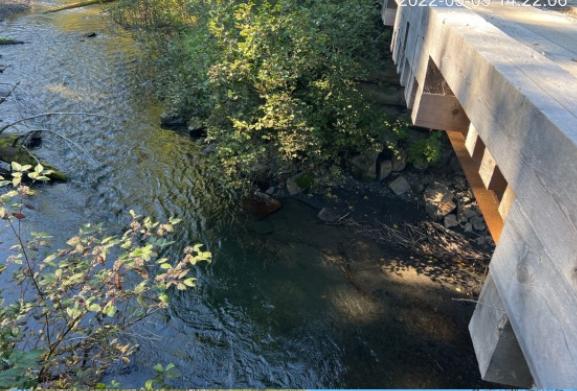
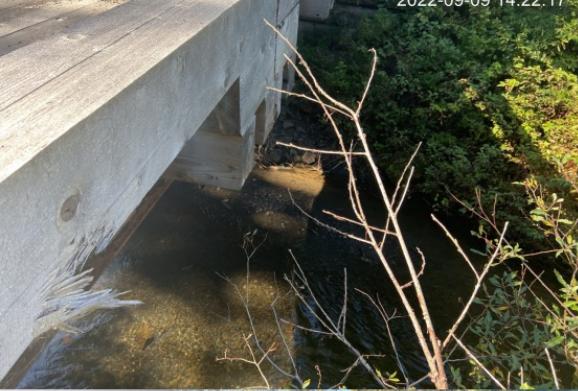
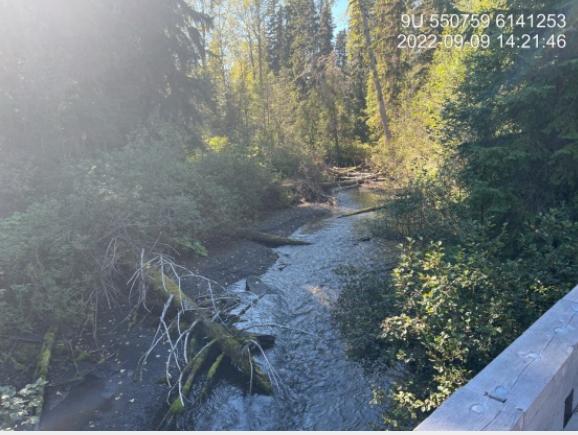
Location and Stream Data	•	Crossing Characteristics
Comments: Bridge, beautiful river. 14:18		
Photos: PSCIS ID 198235. From top left clockwise: Road/Site Card, Barrel, Outlet, Downstream, Upstream, Inlet.

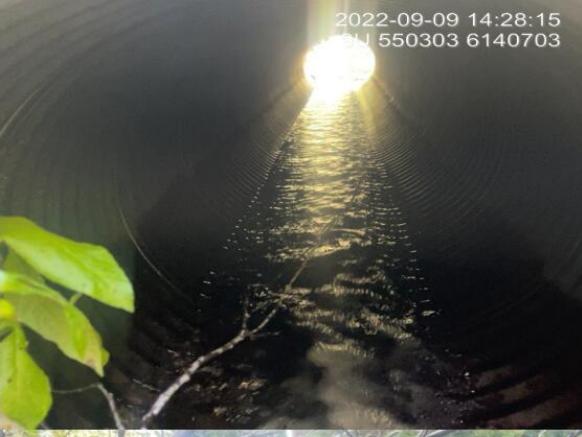
Location and Stream Data	•	Crossing Characteristics	-
Comments: 2 culverts side by side, lots of beaver activity in the area. 14:23:18			
Photos: PSCIS ID 198236. From top left clockwise: Road/Site Card, Barrel, Outlet, Downstream, Upstream, Inlet.

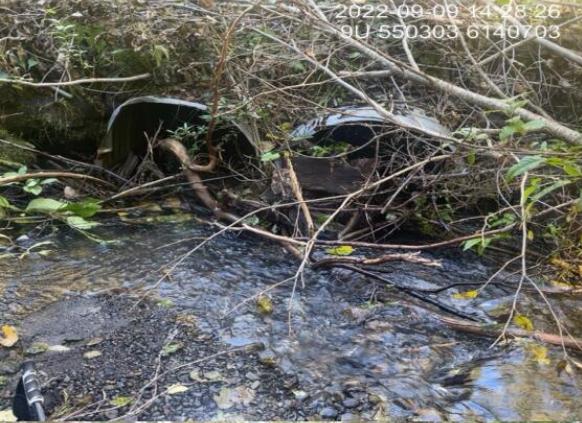
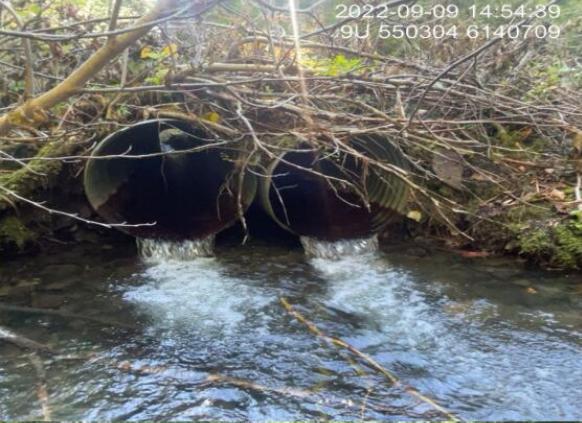
Location and Stream Data		Crossing Characteristics –	
Date	2022-09-09	Crossing Sub Type	Round Culvert
PSCIS ID	198236	Diameter (m)	0.85
External ID	8301994	Length (m)	10
Crew	AI JO	Embedded	No
UTM Zone	9	Depth Embedded (m)	–
Easting	550300	Resemble Channel	No
Northing	6140708	Backwatered	No
Stream	Tributary to Kitwanga River	Percent Backwatered	–
Road	Kitwancool Branch 2 FSR	Fill Depth (m)	0.45
Road Tenure	MoF 8687	Outlet Drop (m)	0.24
Channel Width (m)	2.3	Outlet Pool Depth (m)	0.22
Stream Slope (%)	1	Inlet Drop	No
Beaver Activity	No	Slope (%)	3.5
Habitat Value	High	Valley Fill	Deep Fill
Final score	31	Barrier Result	Barrier
Fix type	Replace with New Open Bottom Structure	Fix Span / Diameter	10
