Skeena Watershed Fish Passage Restoration Planning 2022

Prepared for
Habitat Conservation Trust Foundation - CAT23-6-288
BC Fish Passage Remediation Program
Ministry of Transportation and Infrastructure

Prepared by
Al Irvine, B.Sc., R.P.Bio. and Mateo Wintersheidt, B.Sc.
New Graph Environment Ltd.
on behalf of
Society for Ecosystem Restoration in Northern British Columbia

Version 0.1.0 2023-07-19

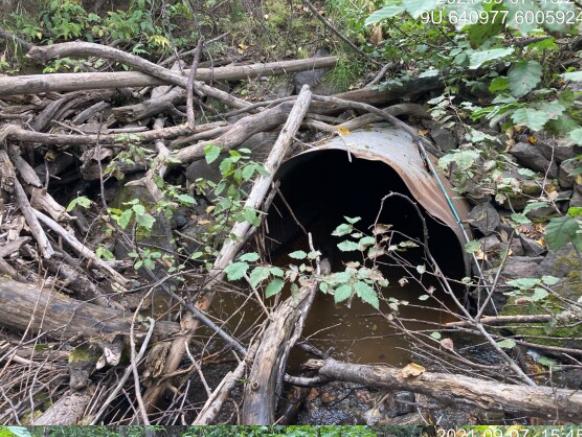
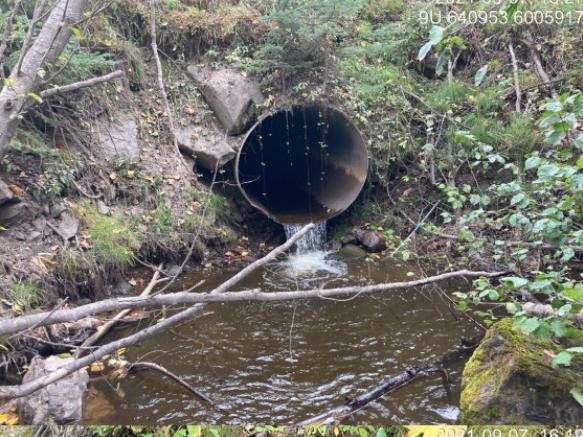
Location and Stream Data	•	Crossing Characteristics	-
Comments: Two thirds of culvert on upstream side has baffles. Fish sampling and PIT tagging conducted. Design underway by MoF. 13:18			
Photos: From top left clockwise: Road/Site Card, Barrel, Outlet, Downstream, Upstream, Inlet.

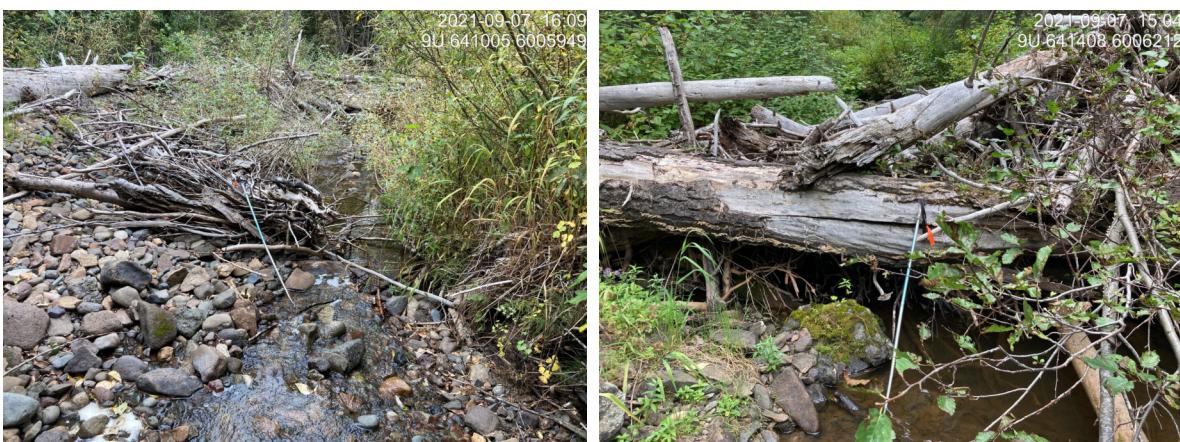
Figure 5.3: Left: Typical habitat upstream of PSCIS crossing 197379. Right: Large woody debris jam upstream of PSCIS crossing 197379.

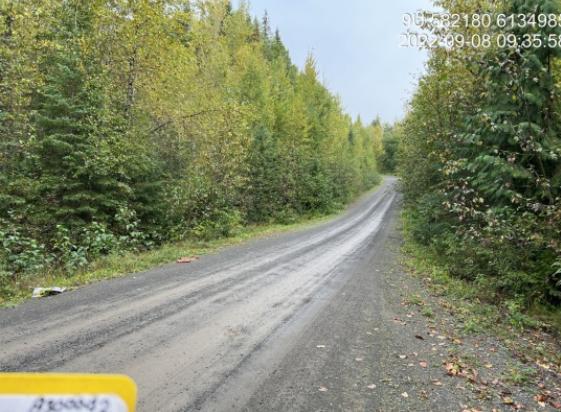
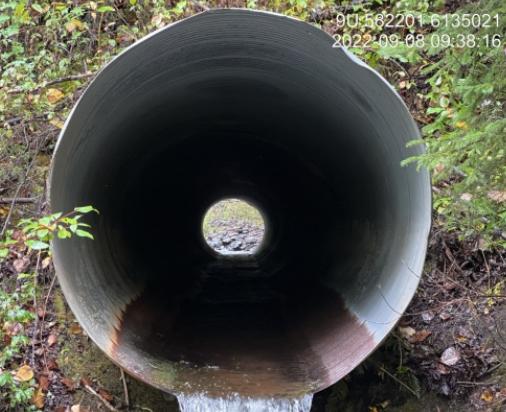
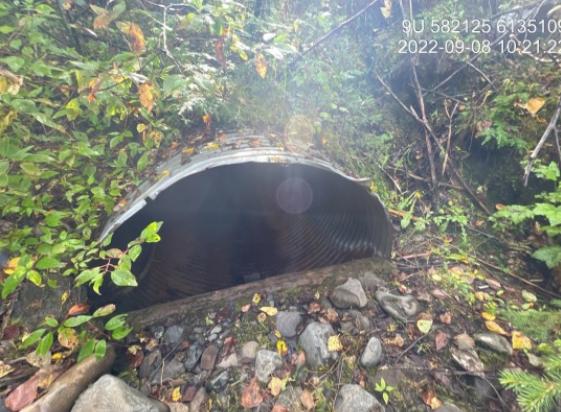
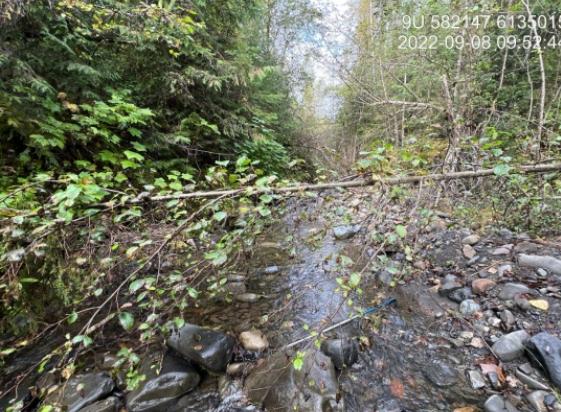
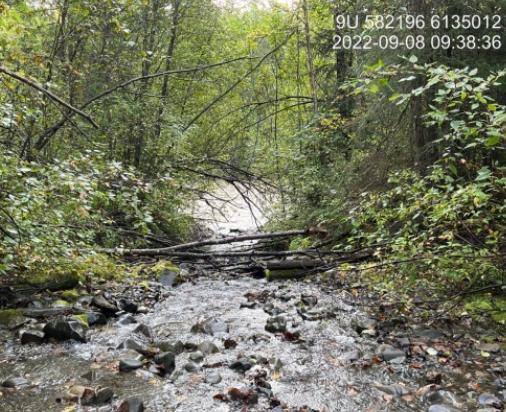
Location and Stream Data	•	Crossing Characteristics
Comments: .75-.90 m lock block step located approximately 30 m down stream of culvert. Double pipe however right pipe is not functioning and is 50% blocked at the outlet. Both pipes are of same diameter (1.85m). 9:32		
Photos: From top left clockwise: Road/Site Card, Barrel, Outlet, Downstream, Upstream, Inlet.

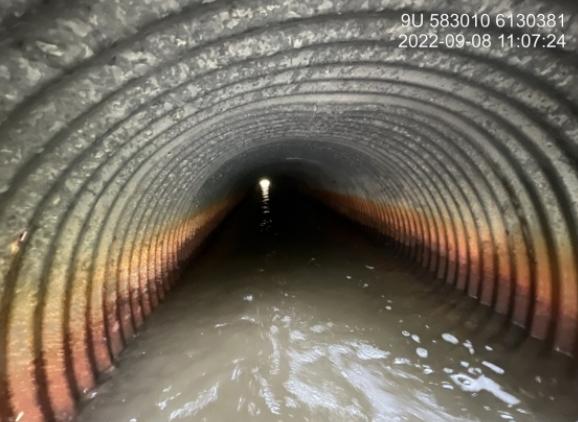
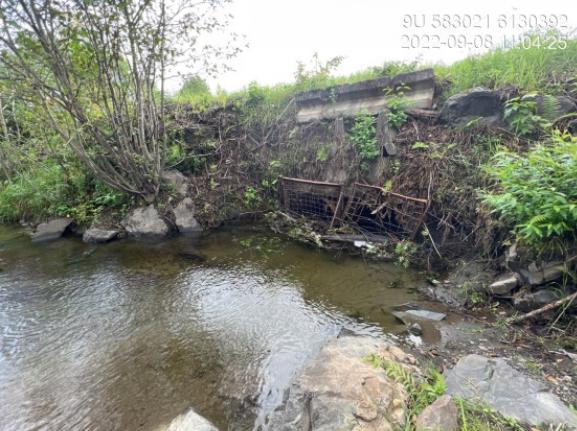
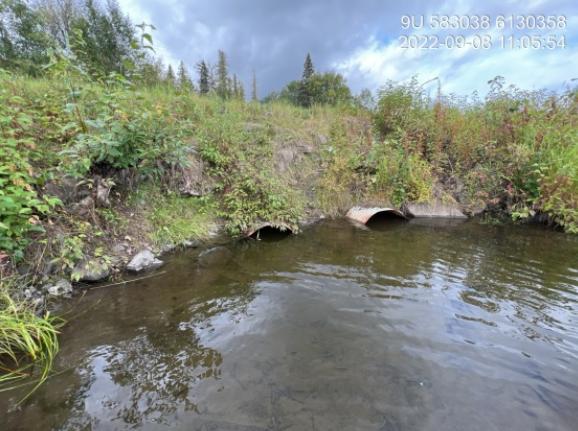
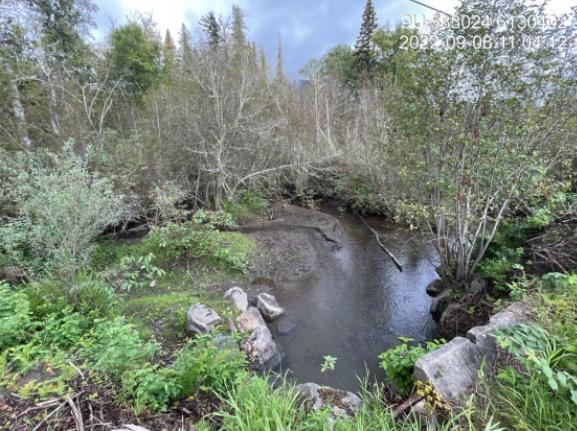
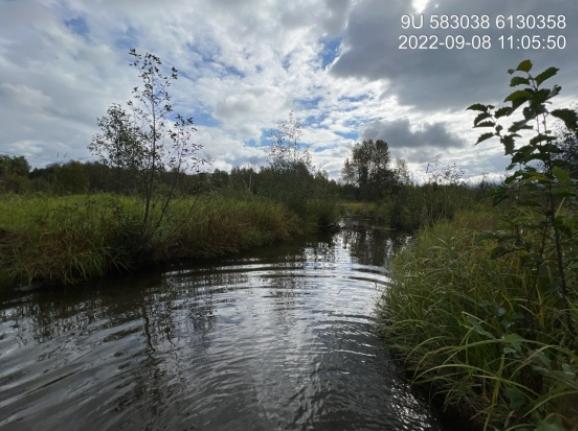
Location and Stream Data	•	Crossing Characteristics	-
Comments: Culvert appears very old and near end of life. Nice gravels upstream. Flow is moving between the two 1 m pipes. Trash rack on inlet could be barrier to adult coho migrating upstream. 10:57			
Photos: From top left clockwise: Road/Site Card, Barrel, Outlet, Downstream, Upstream, Inlet.

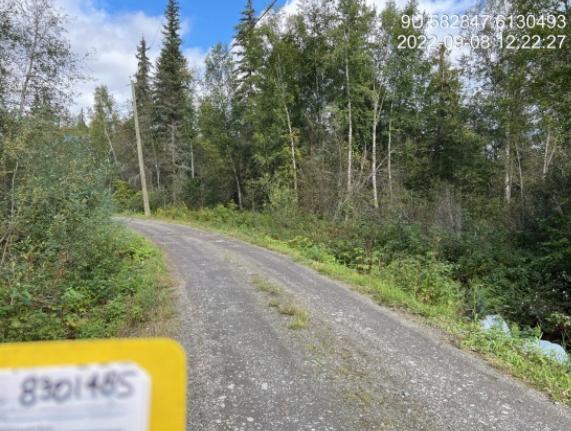
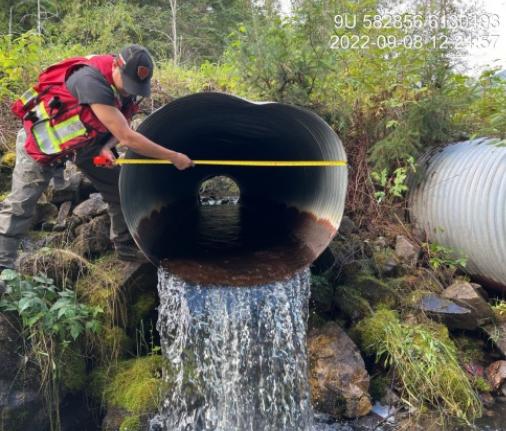
Location and Stream Data	•	Crossing Characteristics	-
<p>Comments: Francis (chief) indicated this is historic coho harvest site for Glen Vowell community and historic coho spawning stream. 2 1.25m culverts side by side. Trash rack has been removed from inlet. Inlet has significant amount of debris. Extensive gravels present suitable for CO spawning upstream and downstream. Good flow and large stream. On road to water treatment plant. 12:20</p>			
<p>Photos: From top left clockwise: Road/Site Card, Barrel, Outlet, Downstream, Upstream, Inlet.</p>

Location and Stream Data		Crossing Characteristics –	
		Crossing Characteristics –	
Date	2022-09-09	Crossing Sub Type	Round Culvert
PSCIS ID	198217	Diameter (m)	2.5
External ID	–	Length (m)	10
Crew	AI	Embedded	No
UTM Zone	9	Depth Embedded (m)	–
Easting	582851.3	Resemble Channel	No
Northing	6130491	Backwatered	No
Stream	Tributary to Skeena River	Percent Backwatered	–
Road	Sik-e-dakh Water Tower Rd	Fill Depth (m)	1
Road Tenure	Resource	Outlet Drop (m)	0.6
Channel Width (m)	5.6	Outlet Pool Depth (m)	0.7
Stream Slope (%)	1.5	Inlet Drop	Yes
Beaver Activity	Yes	Slope (%)	3.5
Habitat Value	High	Valley Fill	Deep Fill
Final score	36	Barrier Result	Barrier
Fix type	Replace with New Open Bottom Structure	Fix Span / Diameter	15

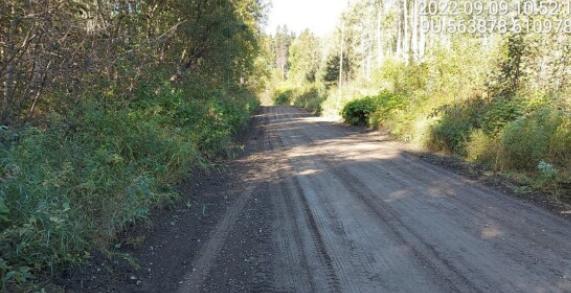
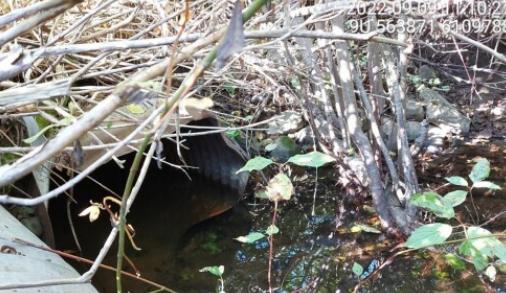
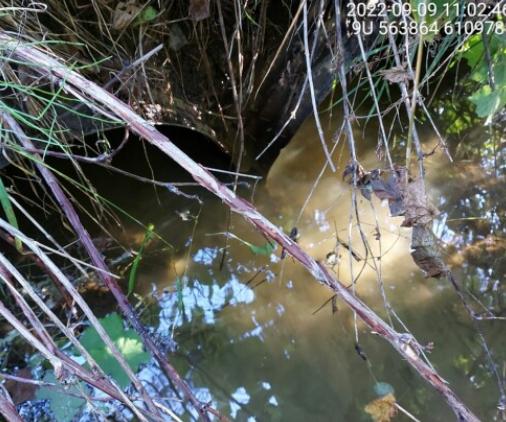
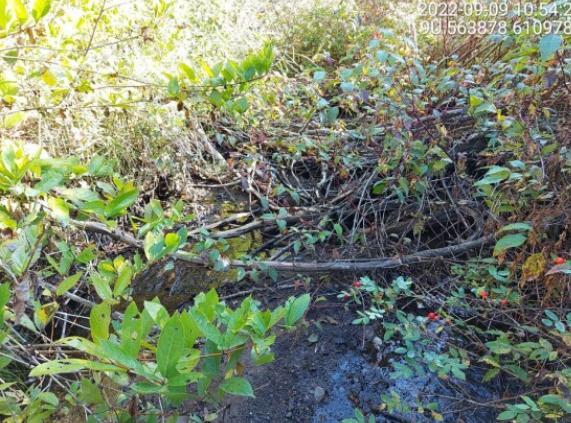
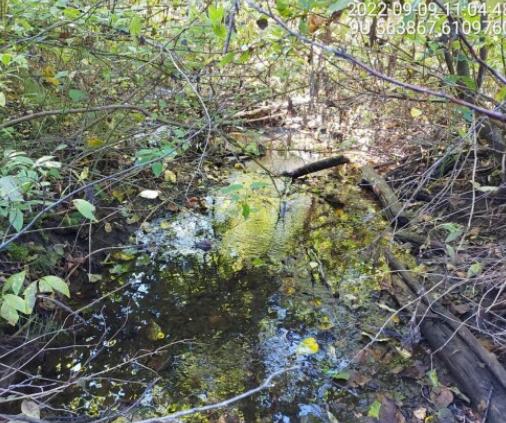
Location and Stream Data	•	Crossing Characteristics	-
Comments: Two culverts, both embedded with no drop. Fish spotted in culvert(up to 20 cm in length) and downstream. Erosion near culvert. 10:50			
Photos: From top left clockwise: Road/Site Card, Barrel, Outlet, Downstream, Upstream, Inlet.

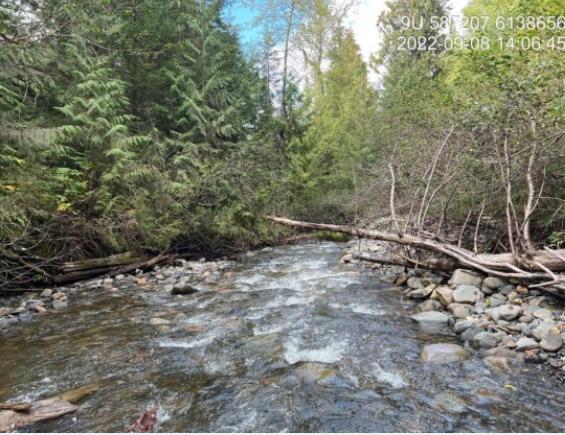
At the time of the survey, PSCIS crossing 198222 was un-embedded, non-backwatered and ranked as a barrier to upstream fish passage according to the provincial protocol (MoE 2011b) (Table 5.30). This crossing was replaced in 1985. Water temperature was 9.7°C, pH was 8.2 and conductivity was 75uS/cm.

Location and Stream Data	•	Crossing Characteristics	-
Comments: Structure was replaced in 1985. Concrete wing walls on inlet. Structure is in decent shape. 13:39			
Photos: From top left clockwise: Road/Site Card, Barrel, Outlet, Downstream, Upstream, Inlet.

Should restoration/maintenance activities proceed, replacement of PSCIS crossing 198222 with a bridge (15m span) is recommended. The cost of the work is estimated at \$375,000 for a cost benefit of 10453.3 linear m/\$1000 and 42858.7 m²/\$1000.

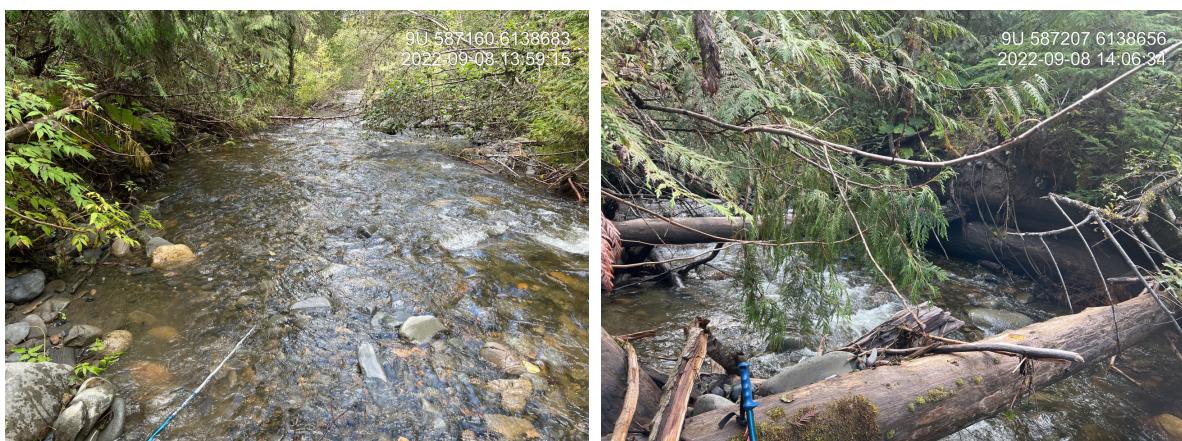
Figure 5.18: Left: Typical habitat upstream of PSCIS crossing 198222. Right: Collapsed bridge upstream of PSCIS crossing 198222.

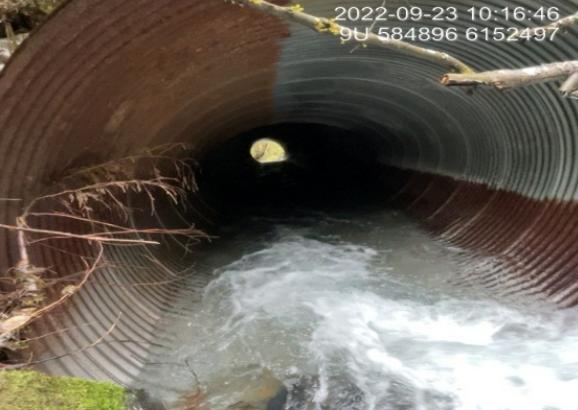
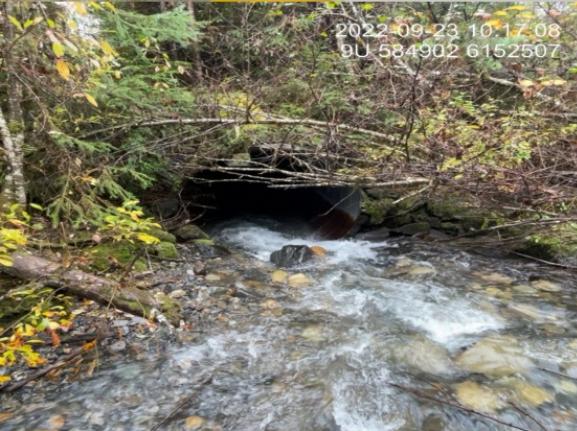
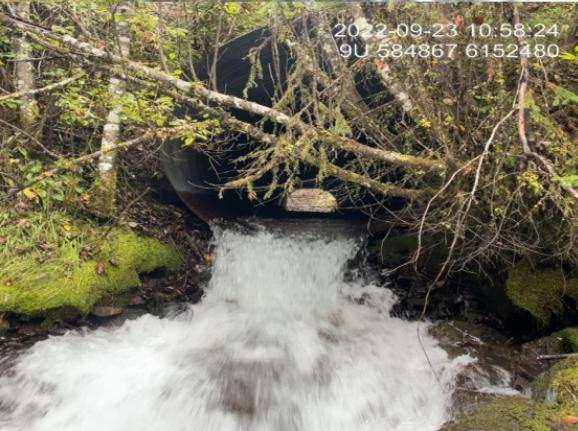
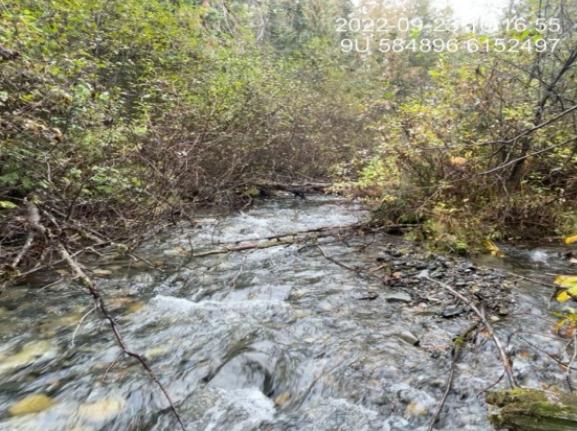
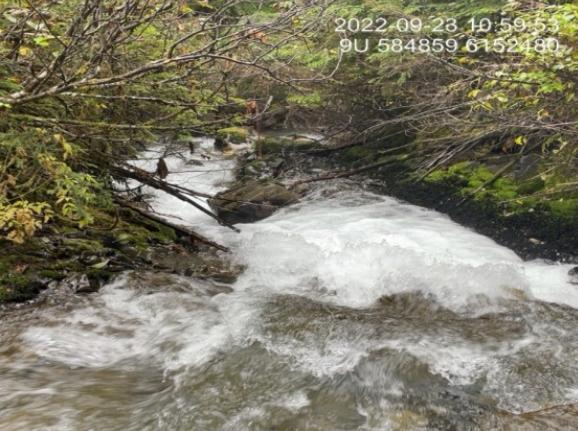
Location and Stream Data	•	Crossing Characteristics	-
Comments: Culvert is separating 10 meters in from upstream, top of culvert slumping in. 10:06			
Photos: From top left clockwise: Road/Site Card, Barrel, Outlet, Downstream, Upstream, Inlet.

Should restoration/maintenance activities proceed, replacement of PSCIS crossing 198225 with a bridge (15m span) is recommended. The cost of the work is estimated at \$375,000 for a cost benefit of 3440 linear m/\$1000 and 6364 m²/\$1000.

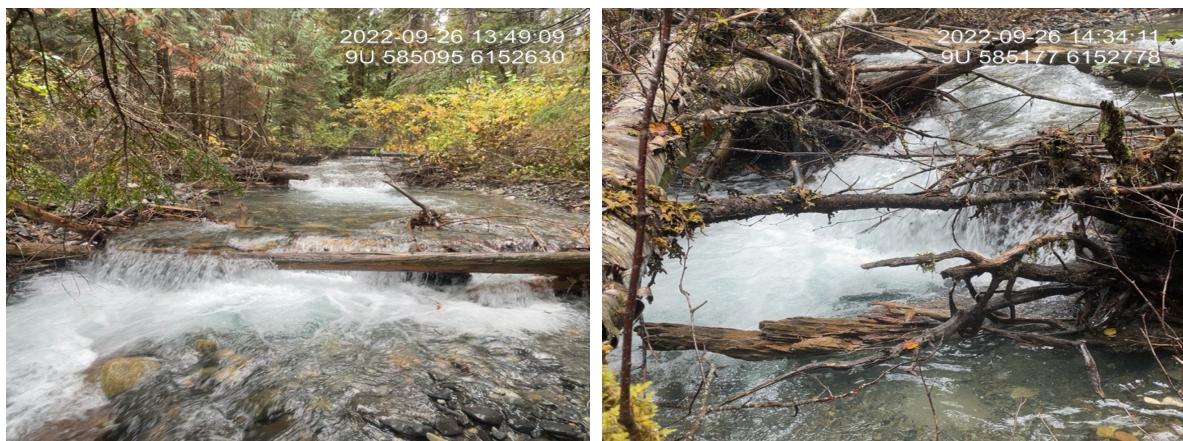
Figure 5.22: Left: Typical habitat upstream of PSCIS crossing 198225. Right: Typical habitat upstream of PSCIS crossing 198225.

The stream was surveyed upstream from crossing 198225 for 500m (Figure 5.22). The dominant substrate was cobbles with gravels sub-dominant. Total cover amount was rated as abundant with large woody debris dominant. Cover was also present as small woody debris. The average channel width was 12.2m, the average wetted width was 5.5m, and the average gradient was 4.4%. This stream has the potential to be fish bearing but the gradient is steep. The bank full depth is very high, with a measured average of 0.8m. There was an abundance of large woody debris that provided functionality to the stream habitat by diverting flow and providing cover. The habitat was rated as medium value as an important migration corridor containing suitable rearing habitat.

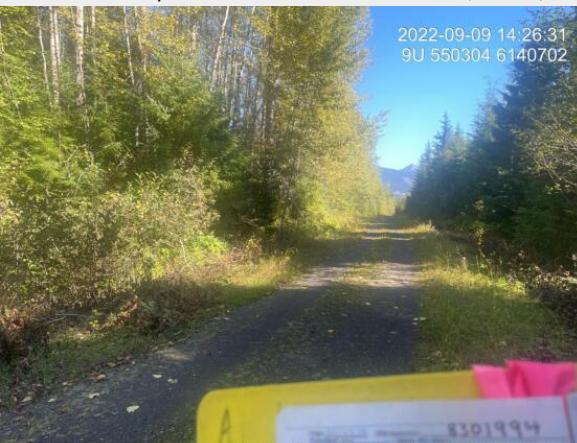
Location and Stream Data	•	Crossing Characteristics	-
Comments: Two culverts side by side (0.85m each). 14:23			
Photos: From top left clockwise: Road/Site Card, Barrel, Outlet, Downstream, Upstream, Inlet.

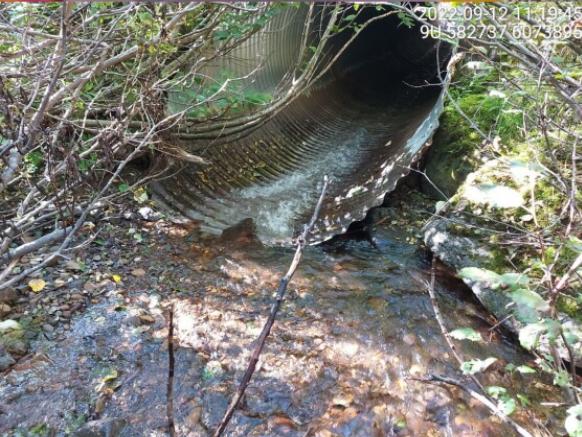
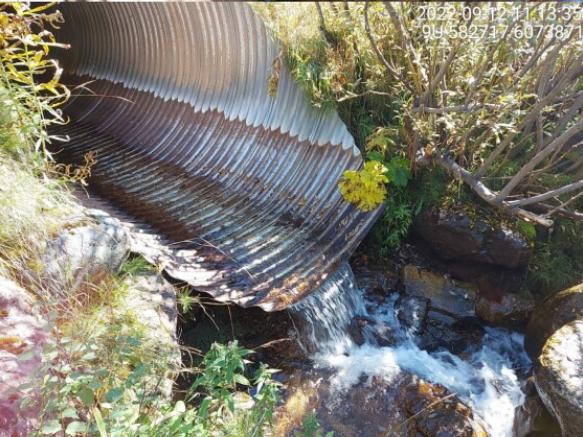
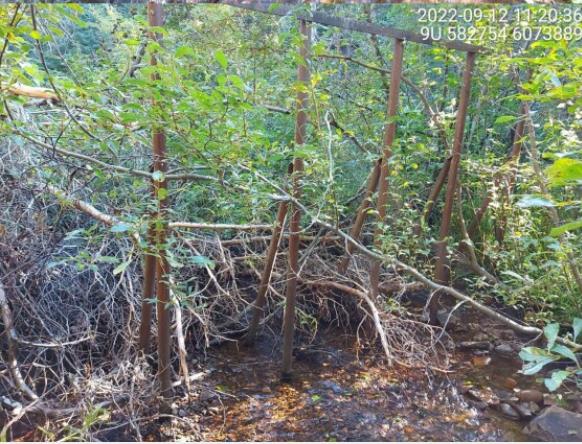
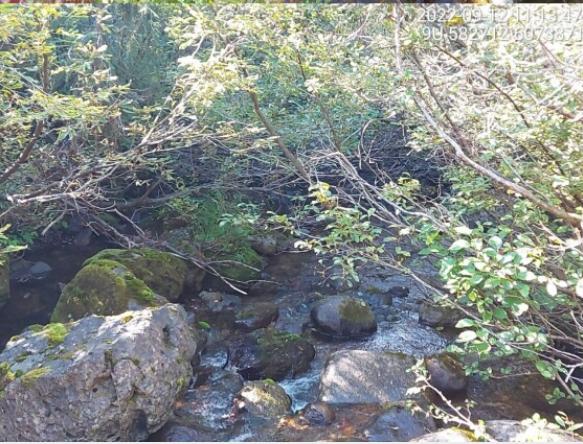
Location and Stream Data		Crossing Characteristics –	
Stream	Sandstone Creek	Percent Backwatered	–
Road	Mcdonell FSR	Fill Depth (m)	3
Road Tenure	MoF 7552	Outlet Drop (m)	0.3
Channel Width (m)	3.4	Outlet Pool Depth (m)	0.2
Stream Slope (%)	3	Inlet Drop	No
Beaver Activity	No	Slope (%)	3
Habitat Value	Medium	Valley Fill	Deep Fill
Final score	39	Barrier Result	Barrier
Fix type	Replace with New Open Bottom Structure	Fix Span / Diameter	15

Location and Stream Data	•	Crossing Characteristics	-
Comments: Channel is steeper downstream of culvert. Very deep fill with a small outlet drop. 10:59			
Photos: From top left clockwise: Road/Site Card, Barrel, Outlet, Downstream, Upstream, Inlet.

Should restoration/maintenance activities proceed, replacement of PSCIS crossing 8530 with a bridge (15m span) is recommended. The cost of the work is estimated at \$375,000 for a cost benefit of 15200 linear m/\$1000 and 25840 m²/\$1000.
