## **Skeena Watershed Fish Passage Restoration Planning 2023**

Prepared for  
**Habitat Conservation Trust Foundation - CAT23-6-288**  
**BC Fish Passage Remediation Program**  
**Ministry of Transportation and Infrastructure**

Prepared by  
**Al Irvine, B.Sc., R.P.Bio and Lucy Schick, B.Sc.**  
**New Graph Environment Ltd.**  
on behalf of  
**Society for Ecosystem Restoration in Northern British Columbia**

Version 0.0.2 2024-06-17

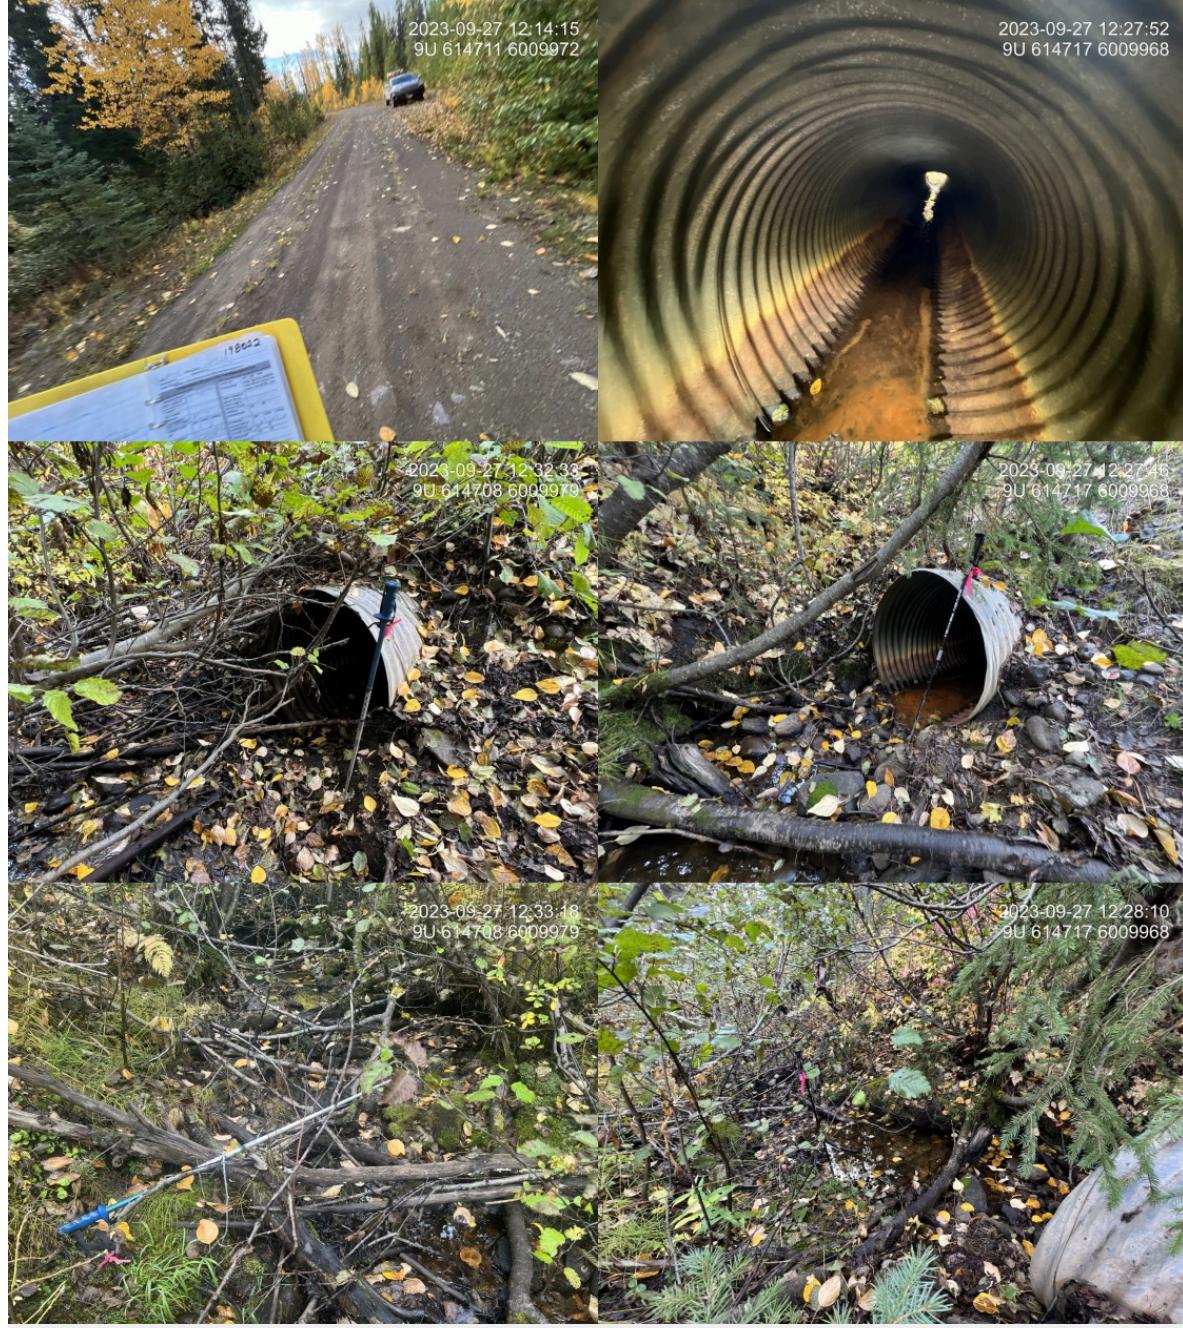
Location and Stream Data	Crossing Characteristics
<p>Comments: Moderate value habitat. Habitat confirmation conducted on stream, walked from upstream crossing down through wetland type area to culvert. Mostly dewatered besides small section above this crossing and below the upper crossing. Surveyed from upstream to down and ended up on road approximately 40 m to the north. Stream seems to merge with wetland type area just upstream of the road. Fish sampling conducted with dolly varden captured in small (2.5m<sup>2</sup>) outlet pool. Cutthroat are known to be upstream of crossing.. 12:12:45</p> <p>Photos: From top left clockwise: Road/Site Card, Barrel, Outlet, Downstream, Upstream, Inlet.</p>

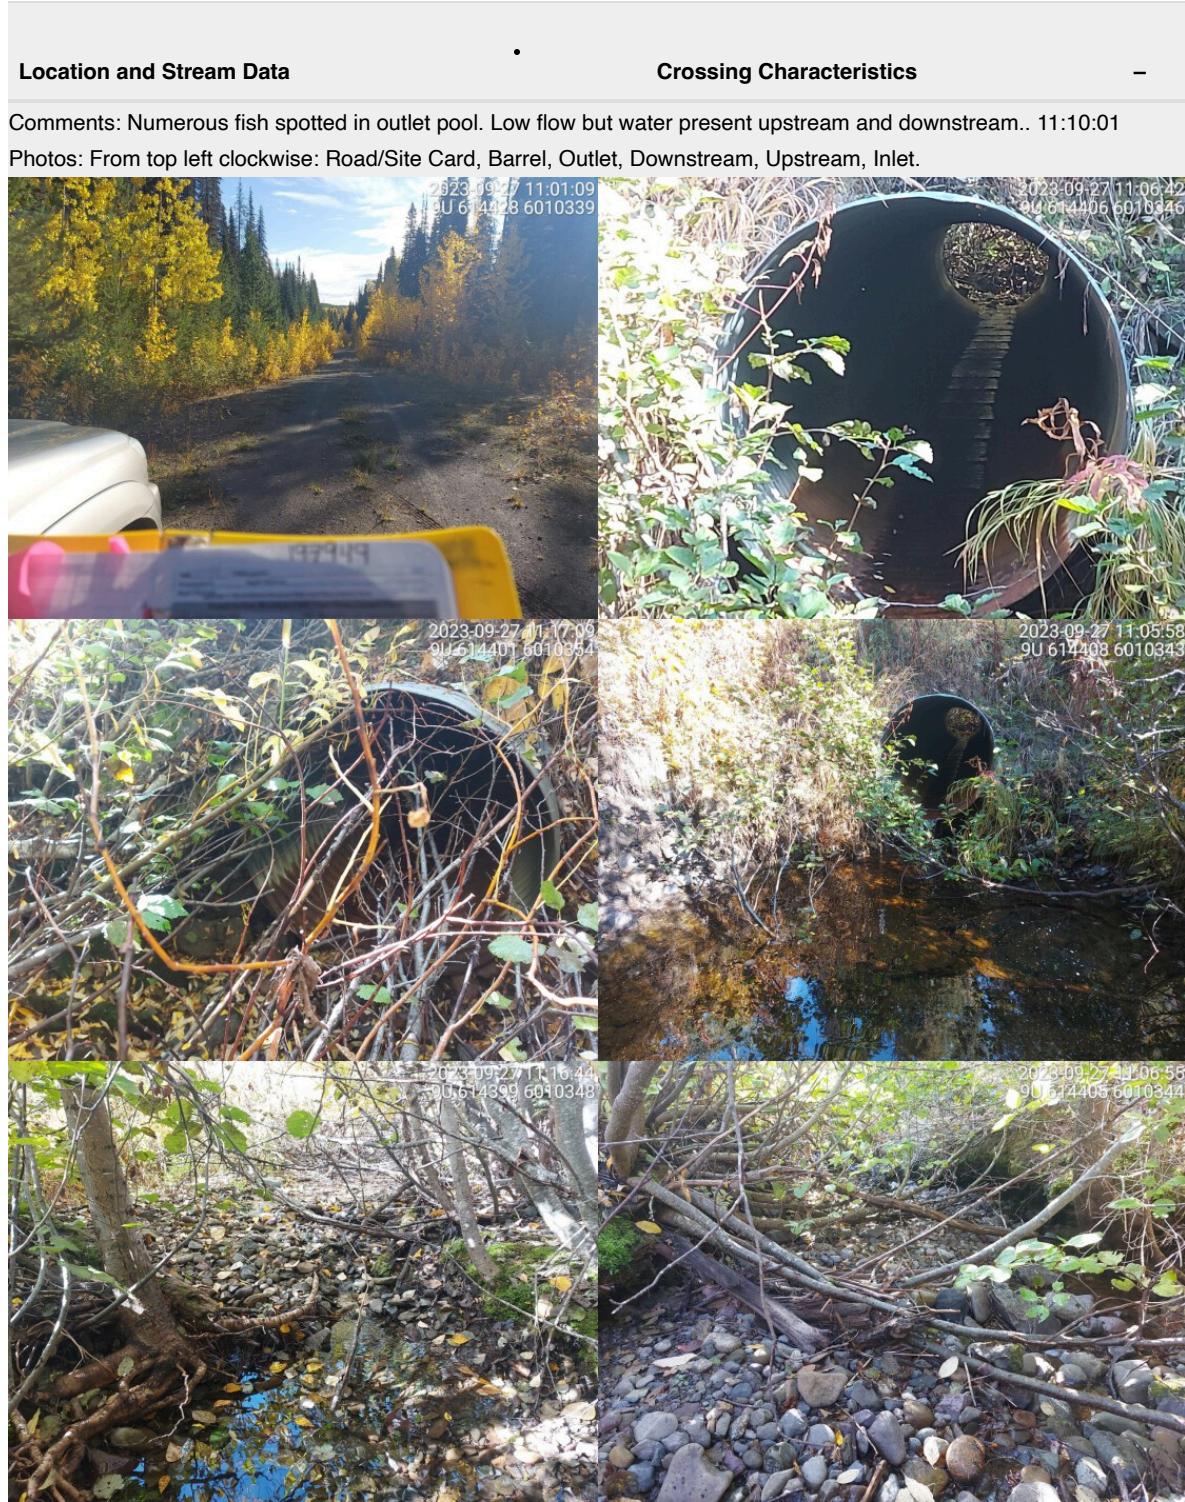
Table 5.4: Summary of fish passage assessment for PSCIS crossing 197949.

Location and Stream Data		Crossing Characteristics	
Date	2023-09-27	Crossing Sub Type	Round Culvert
PSCIS ID	197949	Diameter (m)	1.2
External ID	–	Length (m)	14
Crew	MW	Embedded	No
UTM Zone	9	Depth Embedded (m)	–
Easting	614404	Resemble Channel	No
Northing	6010346	Backwatered	No
Stream	Tributary to Tagit Creek	Percent Backwatered	–
Road	Spur	Fill Depth (m)	1.2
Road Tenure	MOF 9946	Outlet Drop (m)	0.5
Channel Width (m)	2.3	Outlet Pool Depth (m)	0.6
Stream Slope (%)	2	Inlet Drop	No
Beaver Activity	No	Slope (%)	2
Habitat Value	High	Valley Fill	Deep Fill
Final score	31	Barrier Result	Barrier
Fix type	Replace with New Open Bottom Structure	Fix Span / Diameter	15

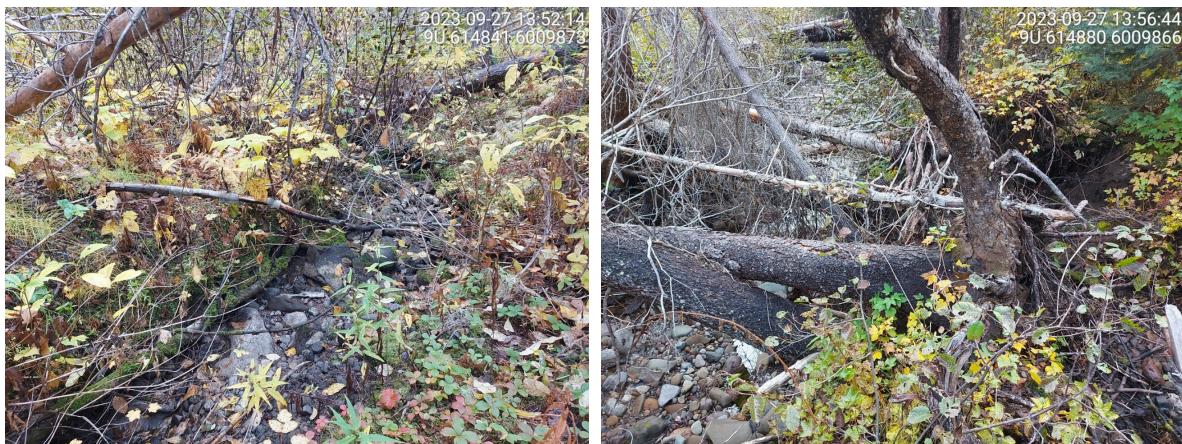
Figure 5.2: Left: Typical habitat downstream of PSCIS crossing 198022. Right: Log jam at the confluence with Tagit Creek.

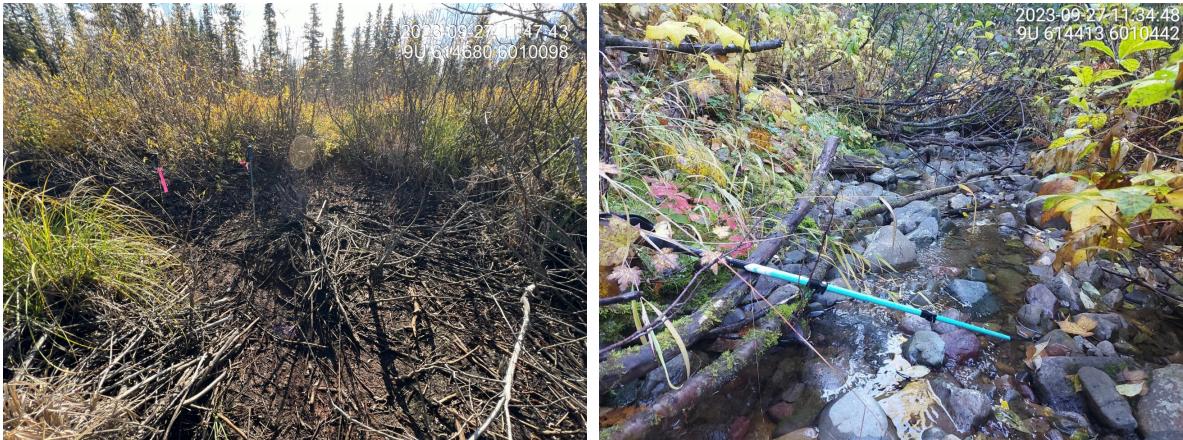
Figure 5.3: Left: Typical habitat upstream of PSCIS crossing 198022 and downstream of crossing 197949. Right: Typical habitat upstream of PSCIS crossing 197949.

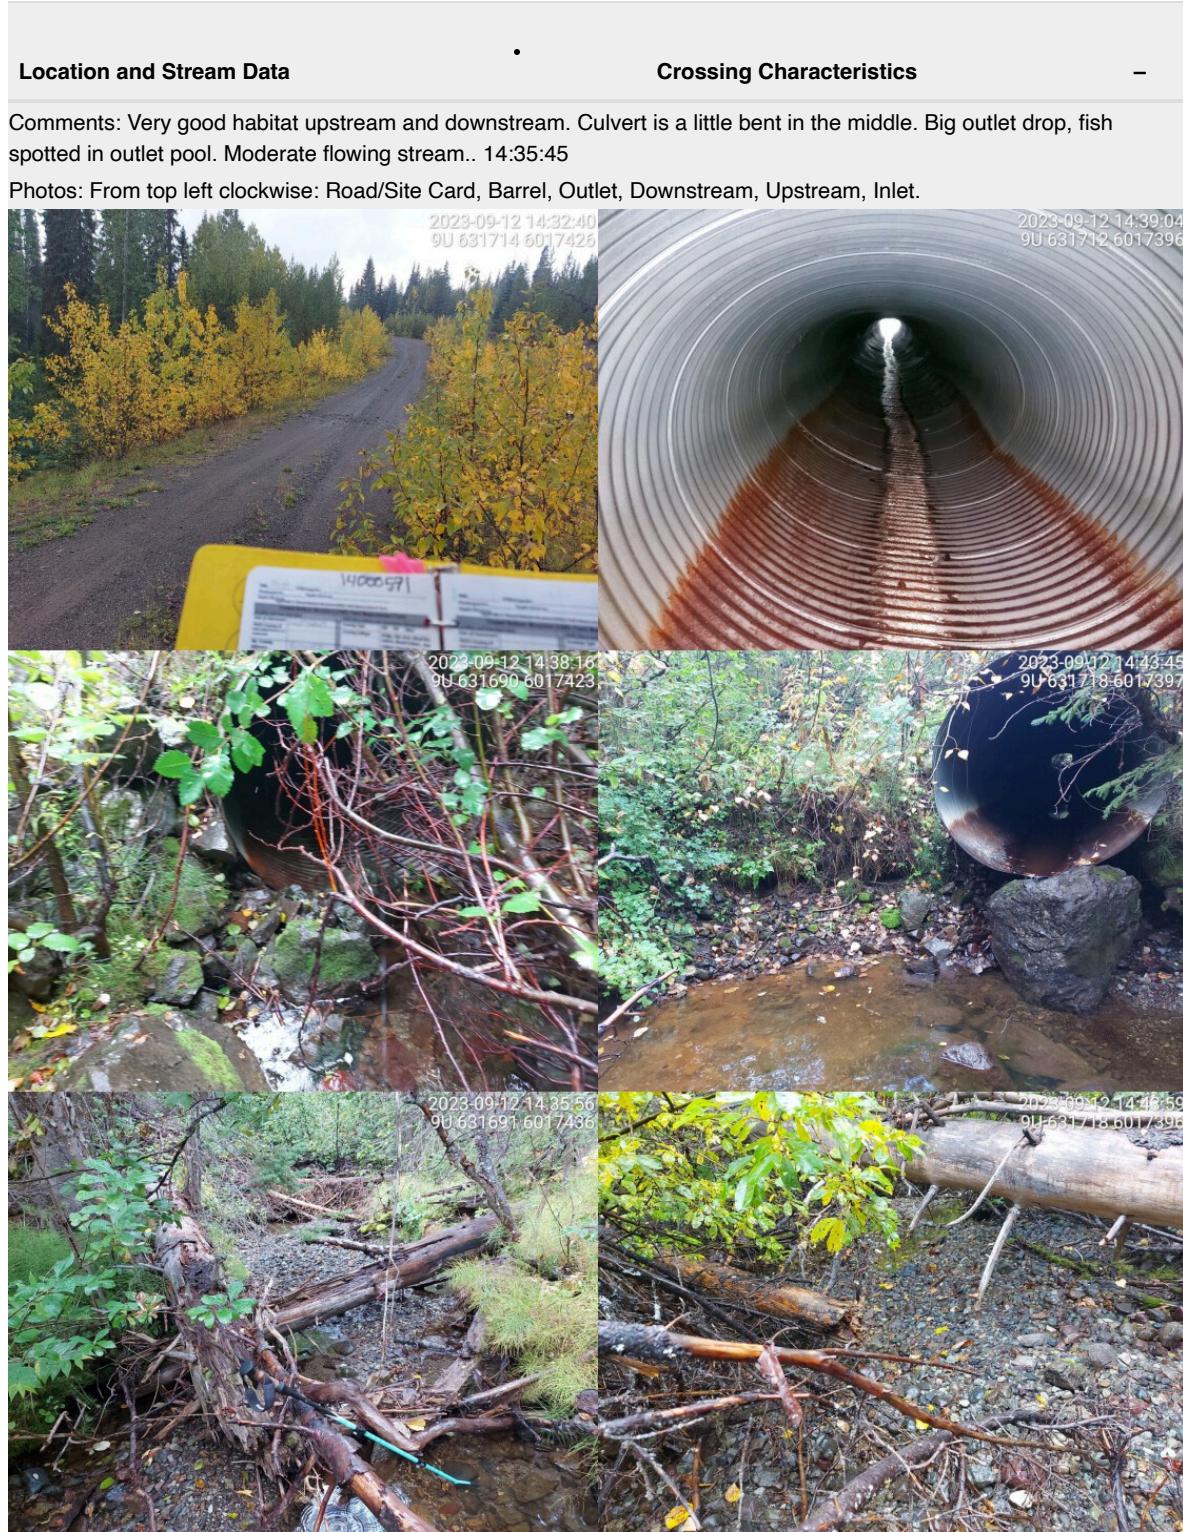
Location and Stream Data		Crossing Characteristics	
Date	2023-09-12	Crossing Sub Type	Round Culvert
PSCIS ID	198934	Diameter (m)	1.6
External ID	–	Length (m)	18
Crew	MW	Embedded	No
UTM Zone	9	Depth Embedded (m)	–
Easting	631703	Resemble Channel	No
Northing	6017418	Backwatered	No
Stream	Tributary to Houston Tommy Creek	Percent Backwatered	–
Road	Spur	Fill Depth (m)	8
Road Tenure	Canfor R07549	Outlet Drop (m)	0.7
Channel Width (m)	3.3	Outlet Pool Depth (m)	0.5
Stream Slope (%)	3	Inlet Drop	No
Beaver Activity	No	Slope (%)	4
Habitat Value	High	Valley Fill	Deep Fill
Final score	39	Barrier Result	Barrier
Fix type	Replace Structure with Streambed Simulation CBS	Fix Span / Diameter	4.5

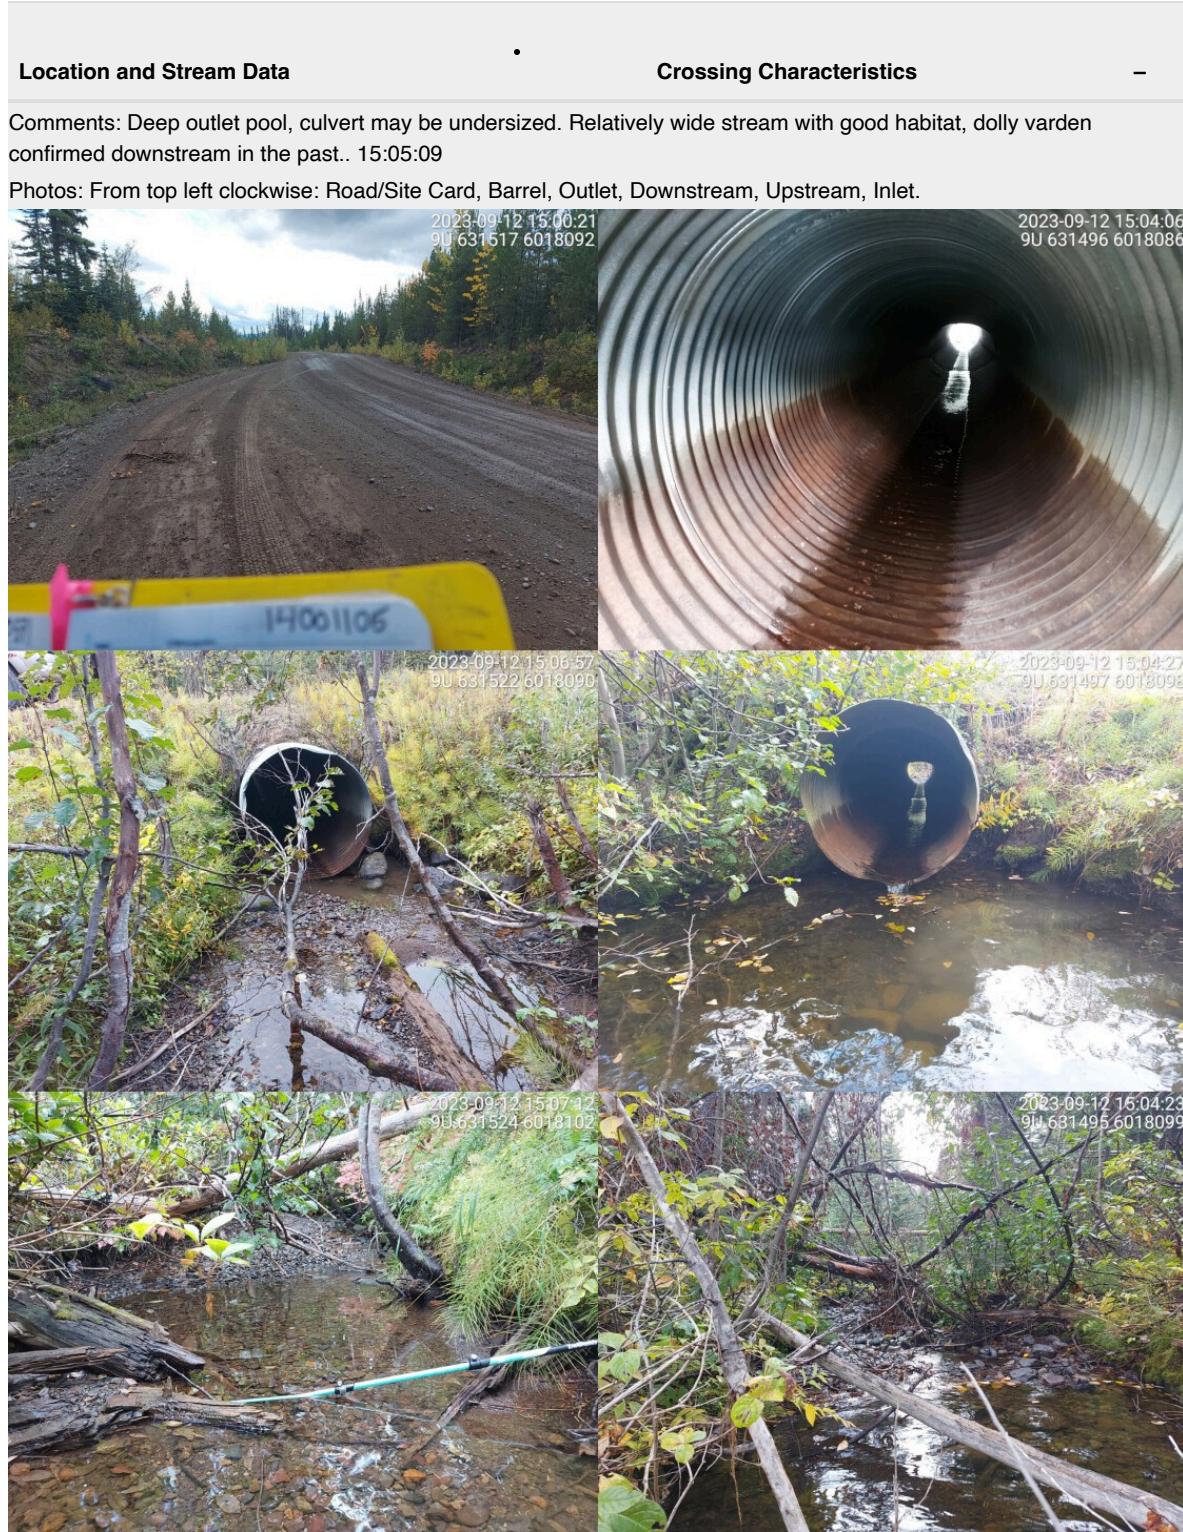
Table 5.11: Summary of fish passage assessment for PSCIS crossing 198942.

Location and Stream Data		Crossing Characteristics	
Date	2023-09-12	Crossing Sub Type	Round Culvert
PSCIS ID	198942	Diameter (m)	1.2
External ID	–	Length (m)	14
Crew	MW	Embedded	No
UTM Zone	9	Depth Embedded (m)	–
Easting	631508	Resemble Channel	No
Northing	6018096	Backwatered	No
Stream	Tributary to Houston Tommy Creek	Percent Backwatered	–
Road	Holland Rd	Fill Depth (m)	0.7
Road Tenure	Canfor R07549	Outlet Drop (m)	0.1
Channel Width (m)	1.9	Outlet Pool Depth (m)	0.7
Stream Slope (%)	2	Inlet Drop	No
Beaver Activity	No	Slope (%)	1
Habitat Value	High	Valley Fill	Deep Fill
Final score	21	Barrier Result	Barrier
Fix type	Replace Structure with Streambed Simulation CBS	Fix Span / Diameter	3

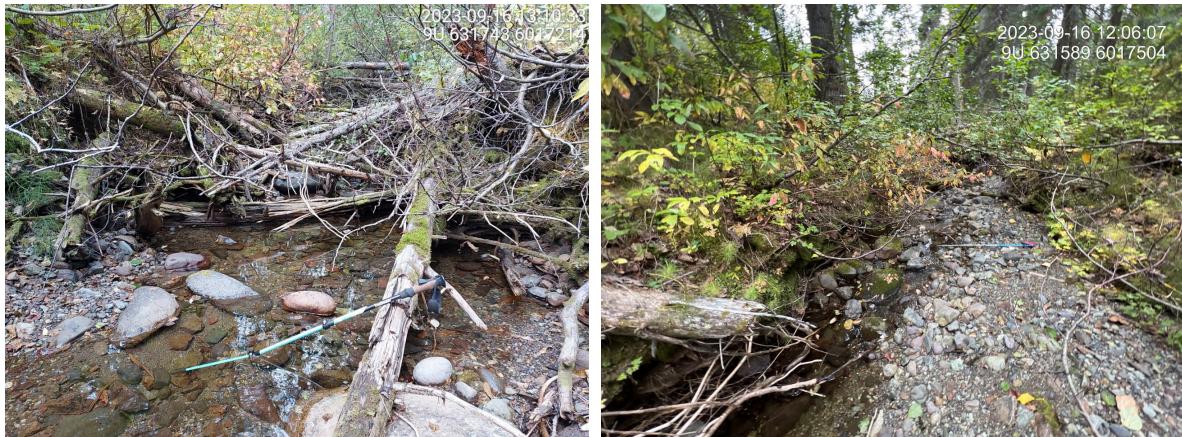
The stream was surveyed downstream from crossing 198934 for 275m (Figure [5.5](#)). The dominant substrate was cobbles with gravels sub-dominant. The average channel width was 3.2m, the average wetted width was 2.1m, and the average gradient was 2.7%. Total cover amount was rated as moderate with large woody debris dominant. Cover was also present as small woody debris, undercut banks, and overhanging vegetation. Surveyor notes indicate pockets of gravel suitable for resident salmonid spawning and occasional deep pools for overwintering. Fish (<150mm - species unconfirmed) were observed in the outlet pool of the culvert. Overall, habitat was rated as medium value for salmonid rearing and spawning.

Figure 5.5: Left: Typical habitat downstream of PSCIS crossing 198934. Right: Typical habitat upstream of PSCIS crossing 198934 and downstream of PSCIS crossing 198942.

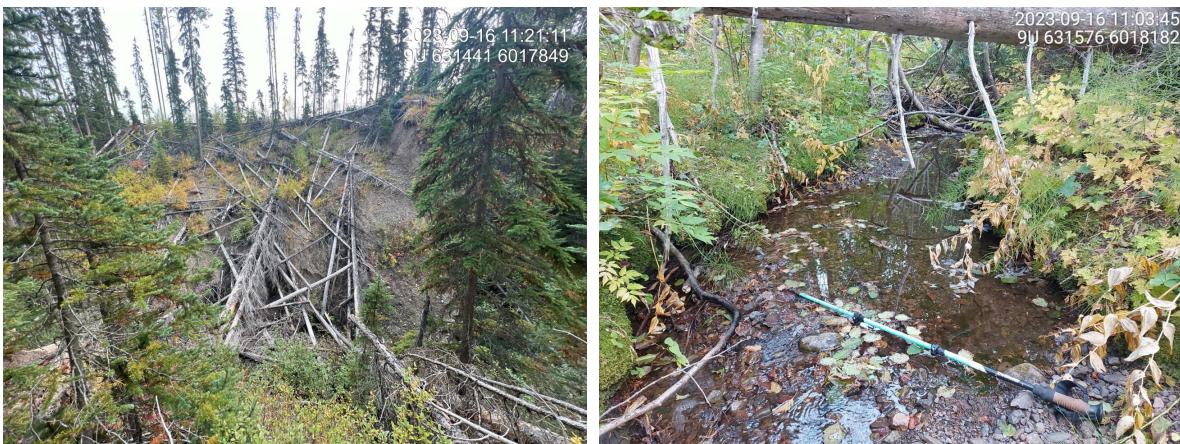
Figure 5.6: Left: Landslide located 300m downstream of crossing 198942. Right: Typical habitat upstream of PSCIS crossing 198942.

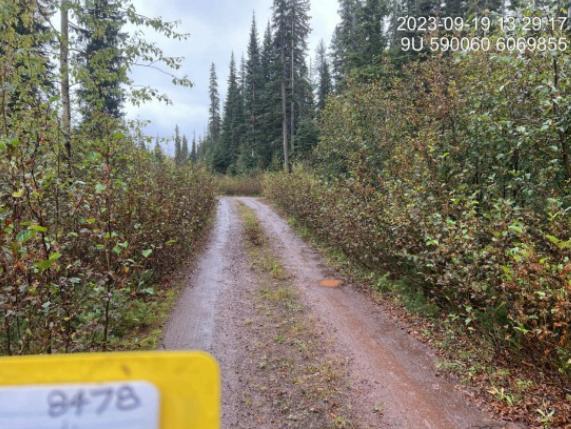
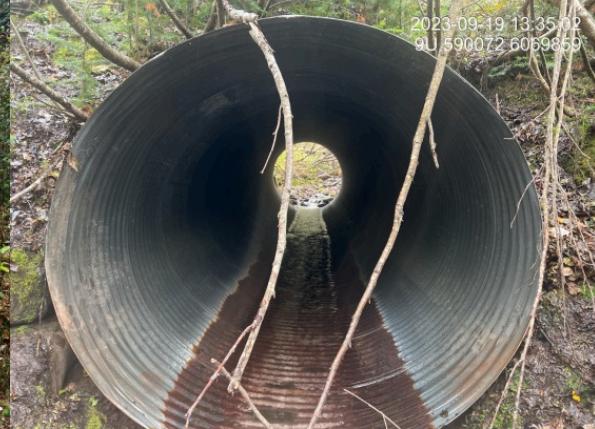
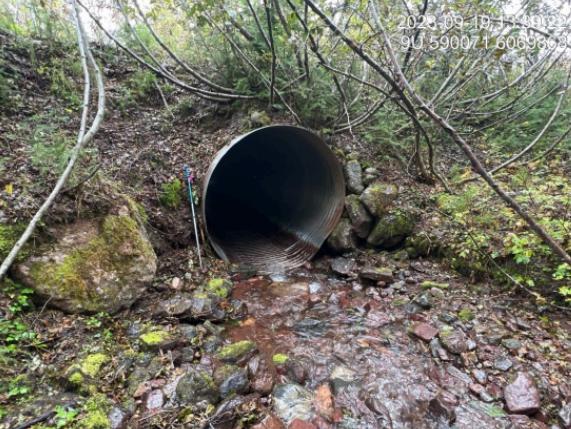
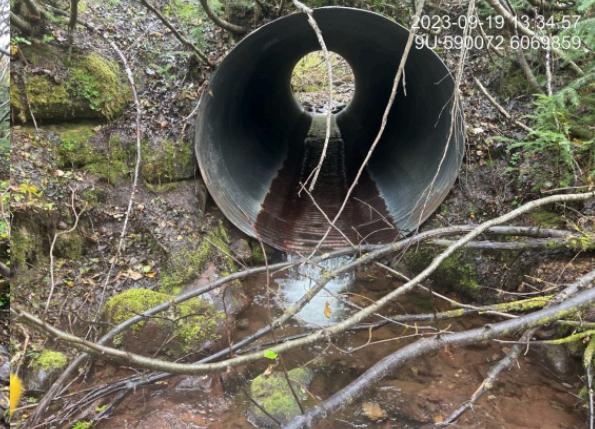
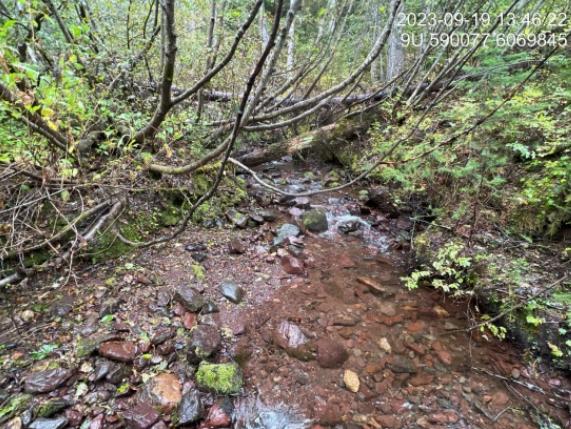
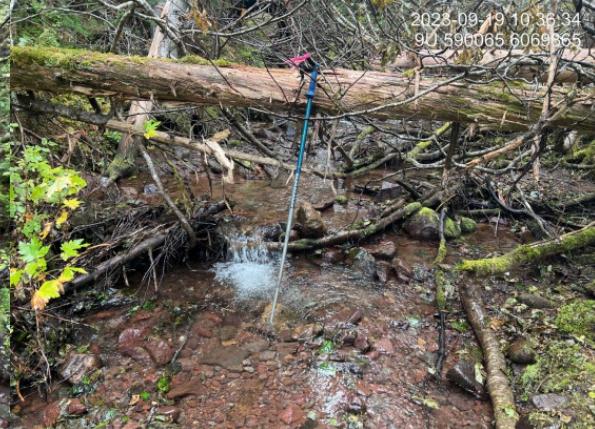
Location and Stream Data	Crossing Characteristics
Comments: Pipe is in good condition. Nice habitat upstream and downstream. Very good flow for time of year. Dolly Varden captured upstream and downstream of crossing.. 13:30:02	
Photos: From top left clockwise: Road/Site Card, Barrel, Outlet, Downstream, Upstream, Inlet.

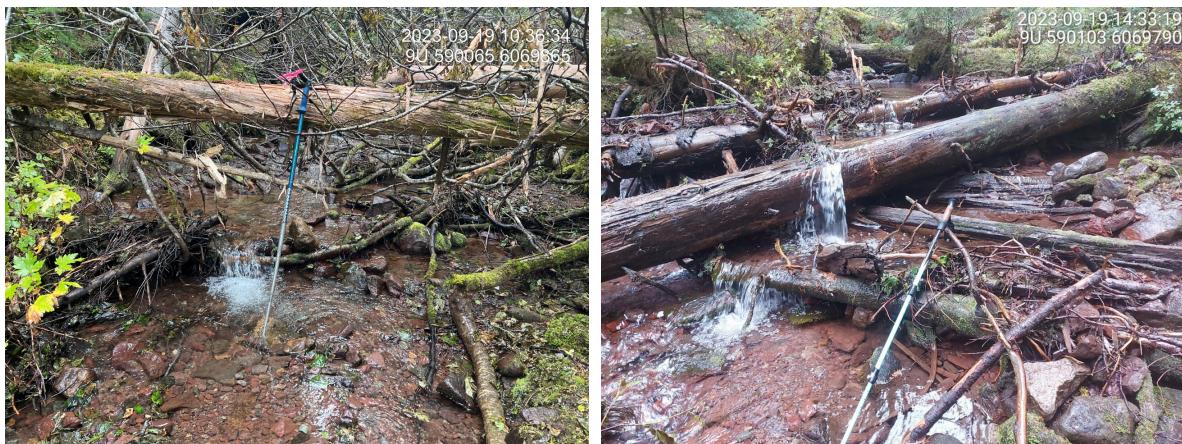
Figure 5.8: Left: Typical habitat downstream of PSCIS crossing 8478. Right: Typical habitat upstream of PSCIS crossing 8478.

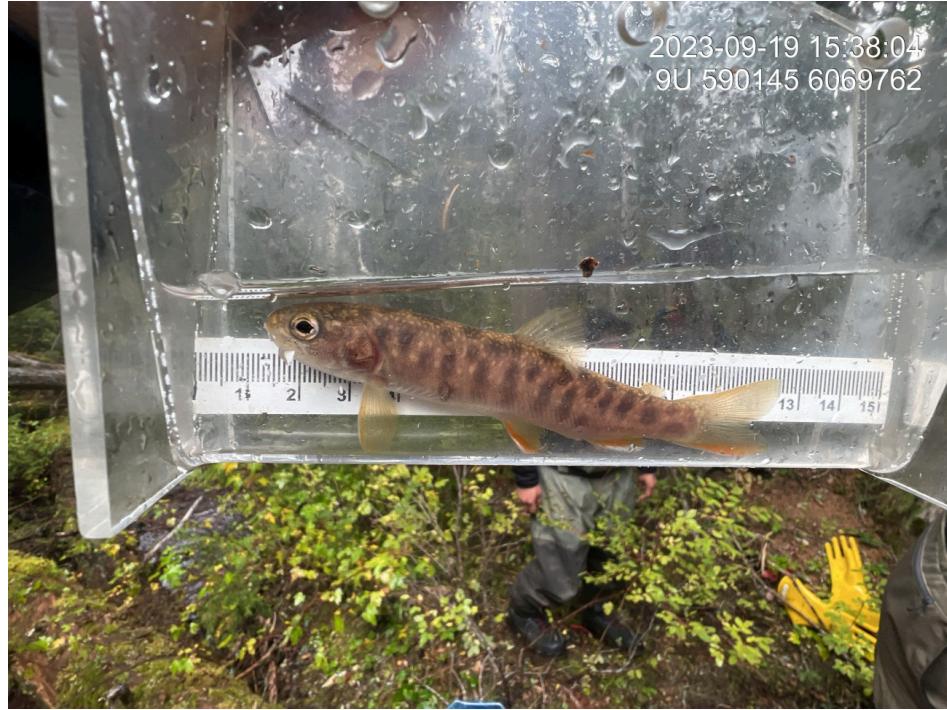
Figure 5.9: Dolly varden with deteriorating purple gill plates and unusual black spots captured upstream of crossing 8478.

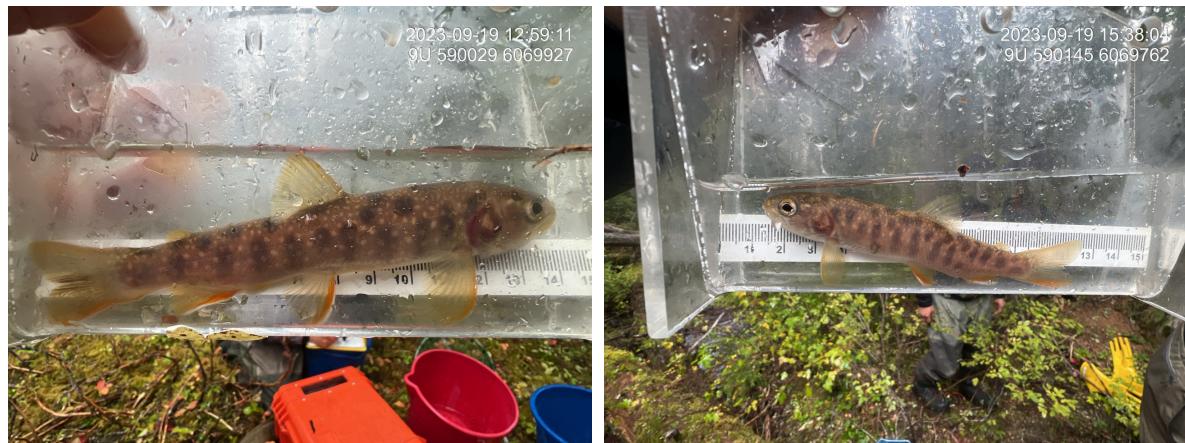
Figure 5.10: Left: Dolly varden with deteriorating purple gill plates and unusual black spots captured downstream of crossing 8478. Right: Dolly varden with deteriorating purple gill plates and unusual black spots captured upstream of crossing 8478.

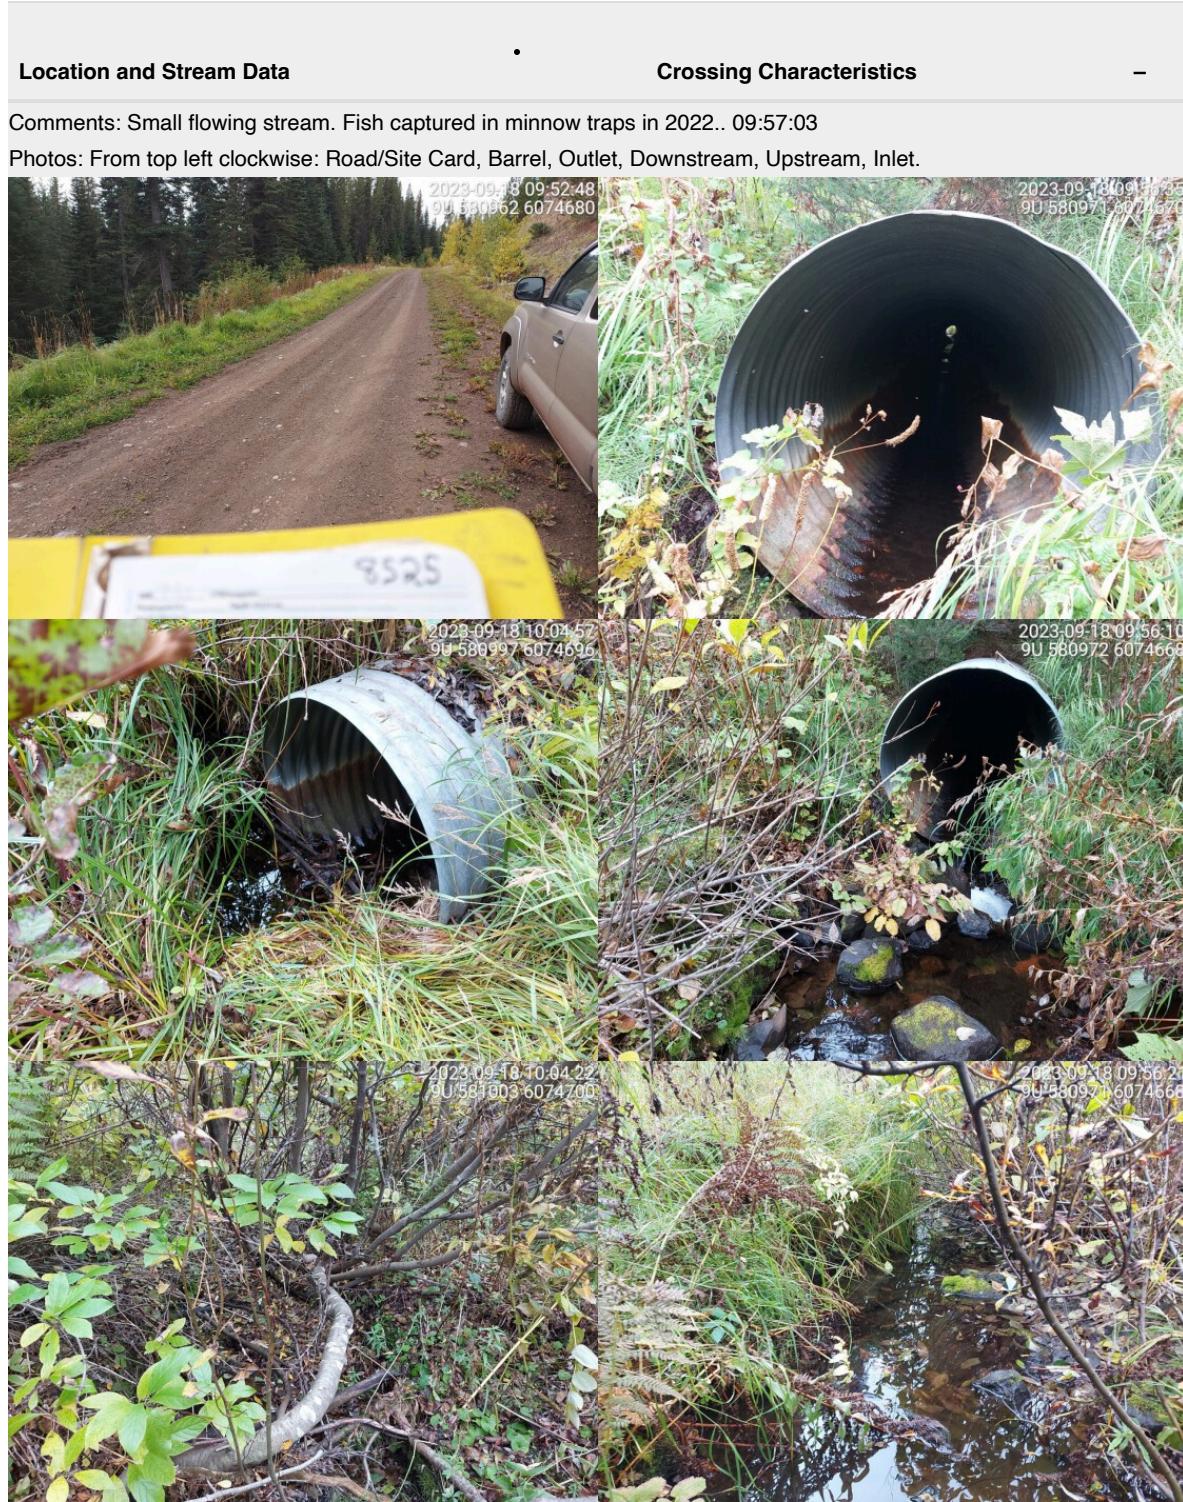
Table 5.21: Summary of fish passage assessment for PSCIS crossing 8525.

Location and Stream Data		Crossing Characteristics	
Date	2023-09-18	Crossing Sub Type	Round Culvert
PSCIS ID	8525	Diameter (m)	0.9
External ID	–	Length (m)	28
Crew	MW TP VJ	Embedded	No
UTM Zone	9	Depth Embedded (m)	–
Easting	580998	Resemble Channel	No
Northing	6074681	Backwatered	No
Stream	Tributary to Coal Creek	Percent Backwatered	–
Road	McDonell FSR	Fill Depth (m)	2
Road Tenure	MOF 7552	Outlet Drop (m)	0.5
Channel Width (m)	1.9	Outlet Pool Depth (m)	0.2
Stream Slope (%)	4	Inlet Drop	No
Beaver Activity	No	Slope (%)	1
Habitat Value	Medium	Valley Fill	Deep Fill
Final score	34	Barrier Result	Barrier
Fix type	Replace Structure with Streambed Simulation CBS	Fix Span / Diameter	3

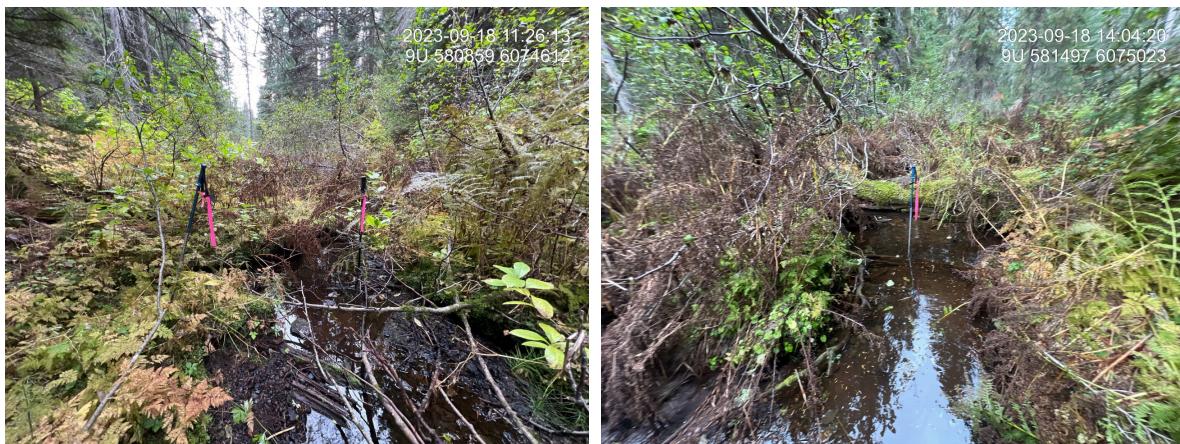
The stream was surveyed upstream from crossing 8525 for 600m (Figure 5.12). The dominant substrate was gravels with fines sub-dominant.The average channel width was 1.9m, the average wetted width was 1.7m, and the average gradient was 1.4%.Total cover amount was rated as moderate with undercut banks dominant. Cover was also present as small woody debris, large woody debris, and overhanging vegetation. There were isolated pools every 30 to 50m that were up to 55cm in depth, and abundant gravel throughout. The habitat was wetland in character dominated by fern, alder and mature spruce. The habitat was rated as medium for salmonid rearing and spawning.

Figure 5.12: Left: Typical habitat downstream of PSCIS crossing 8525. Right: Typical habitat upstream of PSCIS crossing 8525.

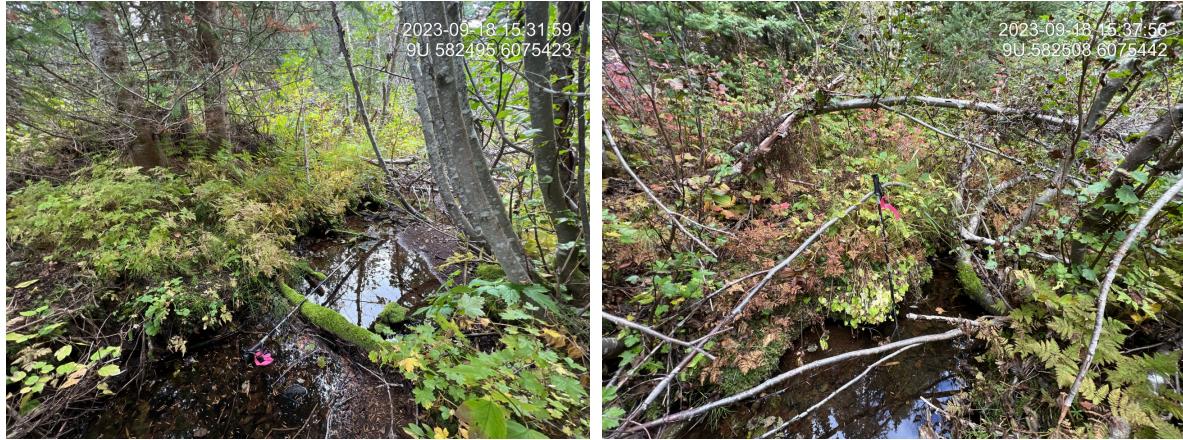
Approximately 1.7km upstream of crossing 8525, PSCIS crossing 8529 was previously documented as a wooden box culvert. This site was reassessed in 2023 and the habitat adjacent to the structure assessed. The wooden box culvert had recently been replaced with a bridge. The stream was surveyed upstream from crossing 8529 for approximately 100m and was noted as having good flow for a small system on a dry year. The dominant substrate was gravels with cobbles sub-dominant.Total cover amount was rated as moderate with undercut banks dominant. Cover was also present as small woody debris and overhanging vegetation.The average channel width was 2m, the average wetted width was 1.5m, and the average gradient was 2.5%. (Figure 5.13). The average channel width was 2m, the average wetted width was 1.5m, and the average gradient was 2.5%.Total cover amount was rated as moderate with undercut banks dominant. Cover was also present as small woody debris and overhanging vegetation.The dominant substrate was gravels with cobbles sub-dominant. The habitat was rated as medium value for salmonid rearing and spawning.

Figure 5.13: Left: Typical habitat upstream of PSCIS crossing 8529. Right: Typical pool habitat at PSCIS crossing 8529.

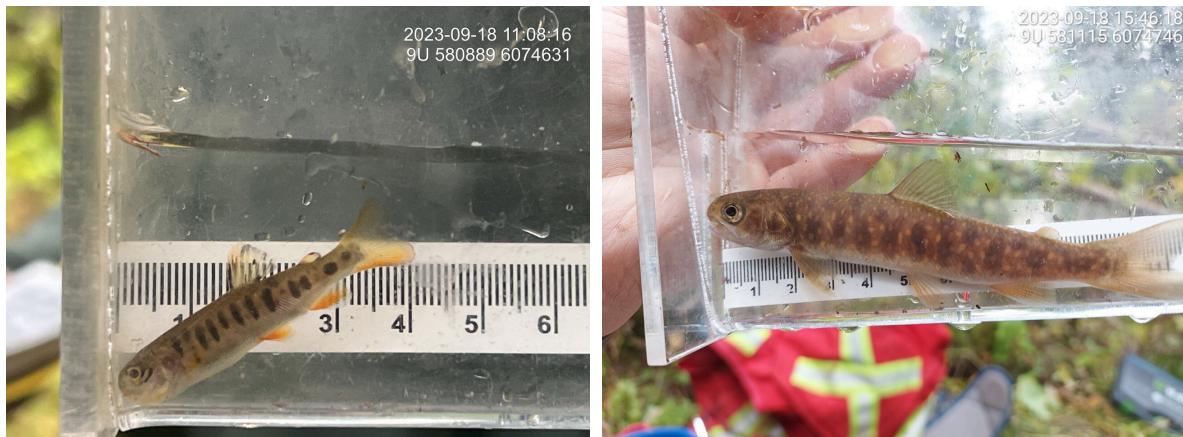
Figure 5.14: Left: Rainbow trout captured downstream of crossing 8525. Right: Dolly varden captured upstream of crossing 8525.

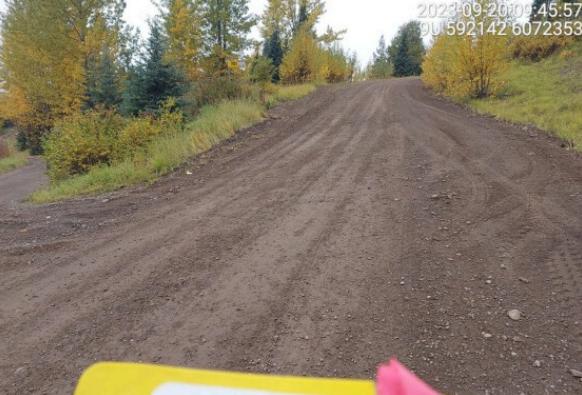
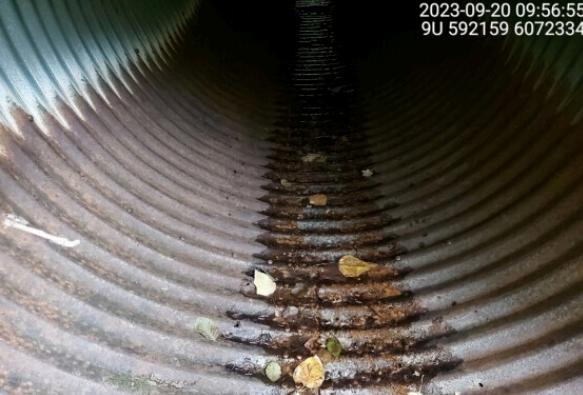
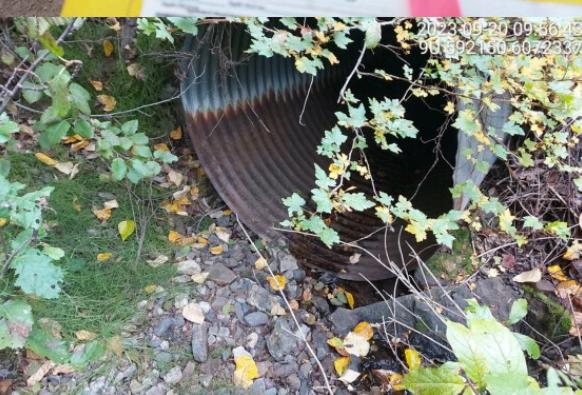
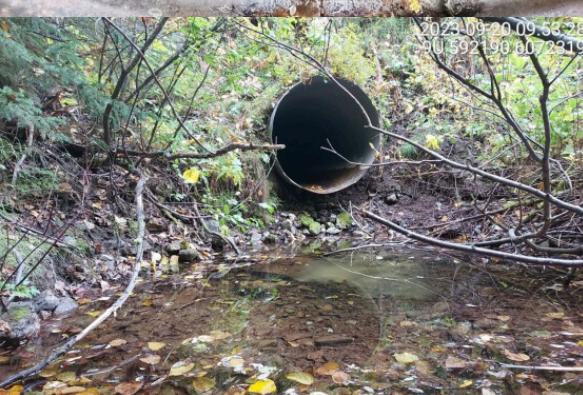
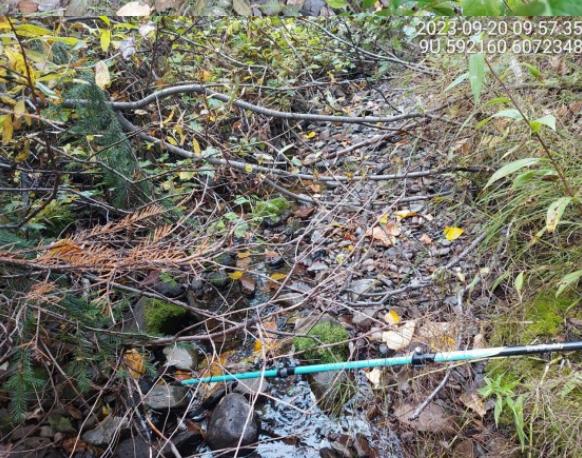
Location and Stream Data	Crossing Characteristics
Comments: Small trickle in stream, very little flowing water. Stream runs halfway down culvert from inlet and then flows through holes underneath culvert. Stream gets wider upstream of crossing. Fish caught in the past above and below culvert. Deep outlet pool.. 09:49:51	
Photos: From top left clockwise: Road/Site Card, Barrel, Outlet, Downstream, Upstream, Inlet.

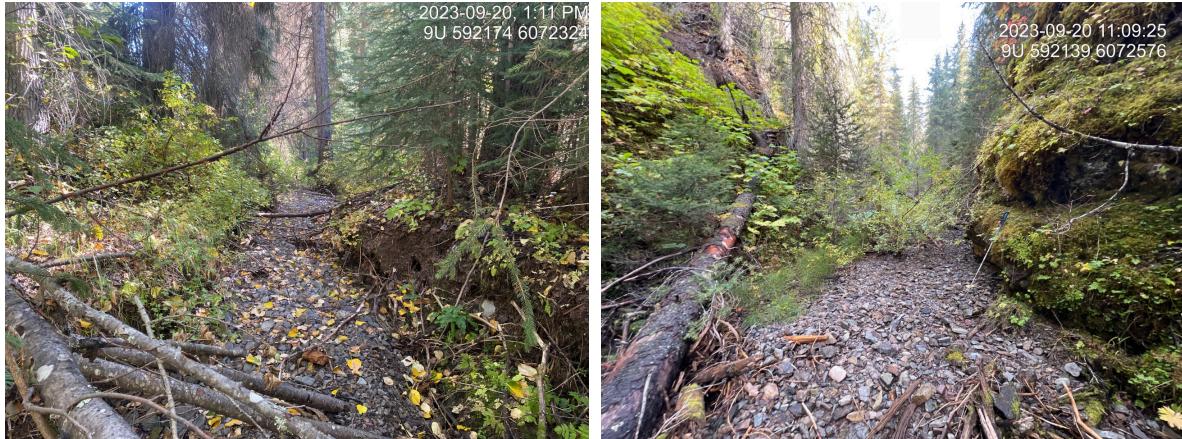
The stream was surveyed downstream from crossing 8543 for 160m (Figure 5.15). The stream was dry at the time of the survey. The dominant substrate was cobbles with gravels sub-dominant. The average channel width was 2.4m, the average wetted width was 0.7m, and the average gradient was 2.8%. Total cover amount was rated as moderate with overhanging vegetation dominant. Cover was also present as small woody debris, large woody debris, undercut banks, and deep pools. There are historic dolly varden and rainbow trout observations just downstream of the crossing in the FISS database. The habitat was rated as low value for salmonid rearing and spawning.

The stream was surveyed upstream from crossing 8543 for 450m (Figure 5.15). The dominant substrate was cobbles with gravels sub-dominant. The average channel width was 3.2m, the average wetted width was 1.2m, and the average gradient was 5.9%. Total cover amount was rated as trace with deep pools dominant. Cover was also present as small woody debris, large woody debris, undercut banks, and overhanging vegetation. The stream had intermittent dewatering with isolated pools to 60 cm deep spaced every 30 to 40 m. The stream channel was entrenched in the valley with large amounts of mobile angular cobbled substrate throughout. Fish were observed in multiple isolated pools up to 300m upstream of the crossing, and there is a historic dolly varden observation just upstream of the crossing in the FISS database. The habitat was rated as low for salmonid rearing and spawning. There is a FISS obstacle noted as a cascade just upstream of crossing 8543 but no permanent natural barriers were observed during the survey.

Figure 5.15: Left: Typical habitat downstream of PSCIS crossing 8543. Right: Typical habitat upstream of PSCIS crossing 8543.

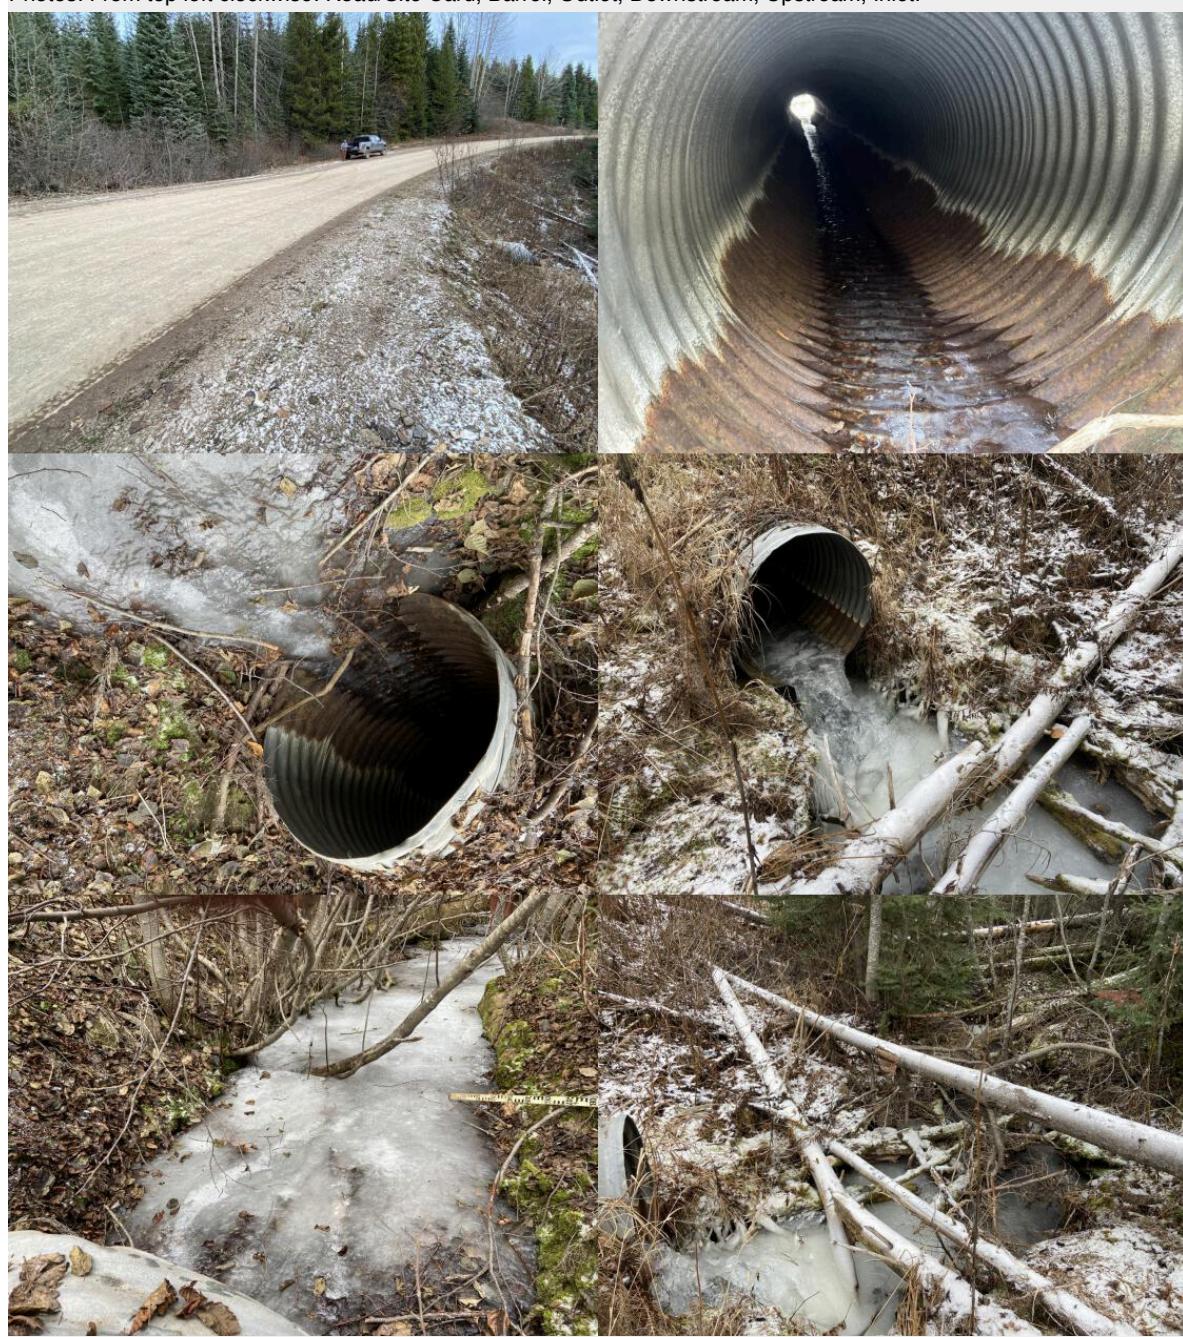
Location and Stream Data	Crossing Characteristics
<p>Comments: 2 round culverts, one is not functional and was installed higher above stream channel. Culvert slope was estimated.CT observed in stream and historic CT FISS downstream.. 13:34:15</p> <p>Photos: From top left clockwise: Road/Site Card, Barrel, Outlet, Downstream, Upstream, Inlet.</p>
