## **Skeena Watershed Fish Passage Restoration Planning 2023**

Prepared for  
**Habitat Conservation Trust Foundation - CAT23-6-288**  
**BC Fish Passage Remediation Program**  
**Ministry of Transportation and Infrastructure**

Prepared by  
**Al Irvine, B.Sc., R.P.Bio and Lucy Schick, B.Sc.**  
**New Graph Environment Ltd.**  
on behalf of  
**Society for Ecosystem Restoration in Northern British Columbia**

Version 0.0.2 2024-06-17

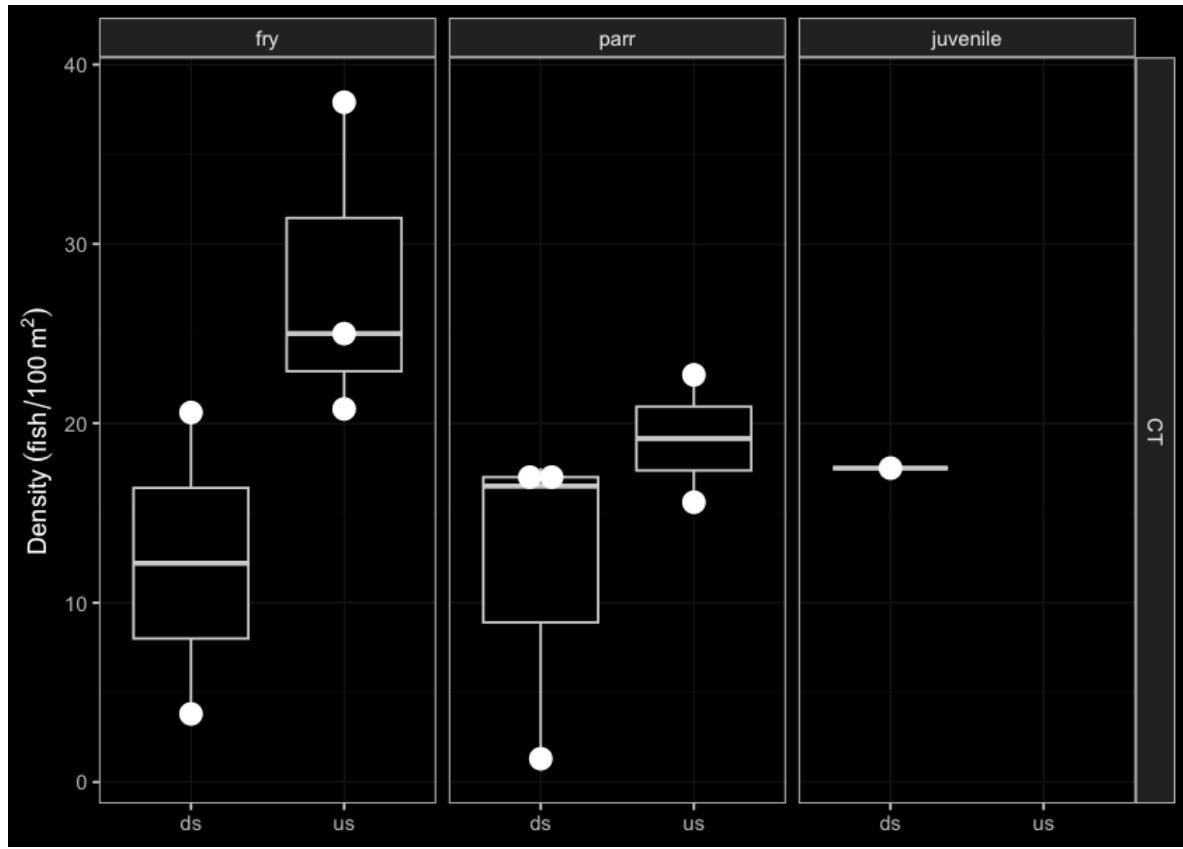
Electrofishing was conducted at three sites above and three sites below the FSR crossing, with results summarised in Tables 5.33 - 5.34 and Figure 5.16. A total of 19 fish were captured upstream and 15 fish were captured downstream, all of which were cutthroat trout (Figures 5.18). All fish captured with a fork length greater than 60mm were tagged with Passive Integrated Transponders (PIT tags) with data stored [here](#).

Figure 5.16: Densities of fish (fish/100m<sup>2</sup>) captured upstream and downstream of PSCIS crossing 8547.

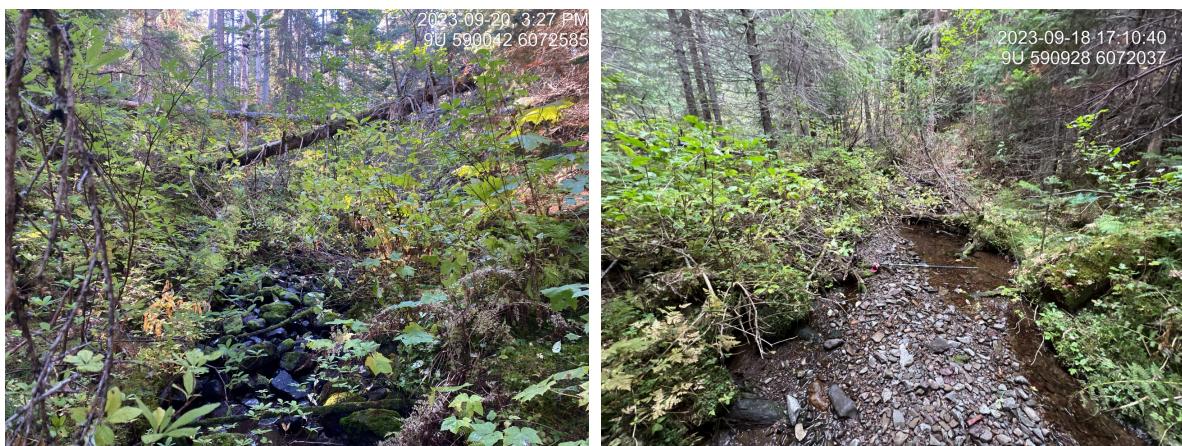
The stream was surveyed downstream from crossing 8547 for 220m . This section of stream was shallow with slow moving water and had some shallow pools with large rocks for fish shelter. (Figure 5.17). Total cover amount was rated as moderate with large woody debris dominant. Cover was also present as small woody debris, boulders, undercut banks, and overhanging vegetation. The average channel width was 2m, the average wetted width was 0.7m, and the average gradient was 11%. The dominant substrate was boulders with cobbles sub-dominant. The habitat was rated as Medium value for salmonid rearing and spawning.

Approximately 1.2km downstream of the FSR, the location of PSCIS crossing 24600461 was also assessed. The crossing had been removed. The stream was surveyed upstream the mapped location of crossing 24600461 for 100m. The average channel width was 2.3m, the average wetted width was 1.3m, and the average gradient was 4.8%. Total cover amount was rated as moderate with large woody debris dominant. Cover was also present as small woody debris, undercut banks, and overhanging vegetation. The dominant substrate was gravels with cobbles sub-dominant. There were abundant gravels, few deep pools, and multiple shallow pools up to 20-25cm deep (Figure 5.17).

Figure 5.17: Left: Typical habitat downstream of PSCIS crossing 8547. Right: Typical habitat downstream of PSCIS crossing 24600461.

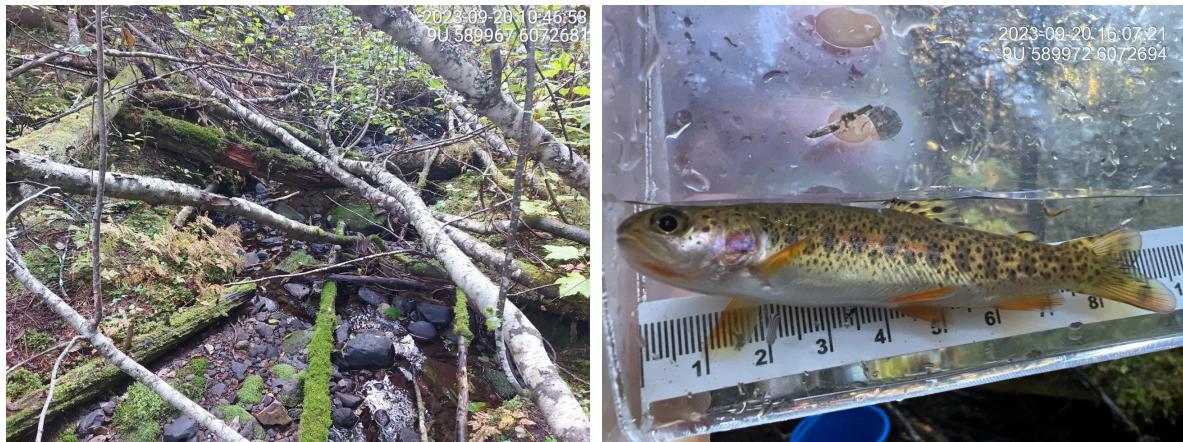
The stream was surveyed upstream from crossing 8547 for 500m (Figure 5.18). The dominant substrate was cobbles with gravels sub-dominant. The average channel width was 1.9m, the average wetted width was 1.2m, and the average gradient was 5.6%. Total cover amount was rated as moderate with small woody debris dominant. Cover was also present as large woody debris, undercut banks, and overhanging vegetation. The stream channel was small and moderately steep, with modest flow. There were very few areas with gravels suitable for spawning and not many deep pools. Other than the culvert no natural or anthropogenic barriers were observed. The habitat was rated as medium for salmonid rearing and spawning.

Figure 5.18: Left: Typical habitat upstream of PSCIS crossing 8547. Right: Cutthroat trout captured upstream of crossing 8547.
