Skeena Watershed Fish Passage Restoration Planning 2023

Prepared for
Habitat Conservation Trust Foundation - CAT23-6-288
BC Fish Passage Remediation Program
Ministry of Transportation and Infrastructure

Prepared by
Al Irvine, B.Sc., R.P.Bio and Lucy Schick, B.Sc.
New Graph Environment Ltd.
on behalf of
Society for Ecosystem Restoration in Northern British Columbia

Version 0.0.2 2024-06-18

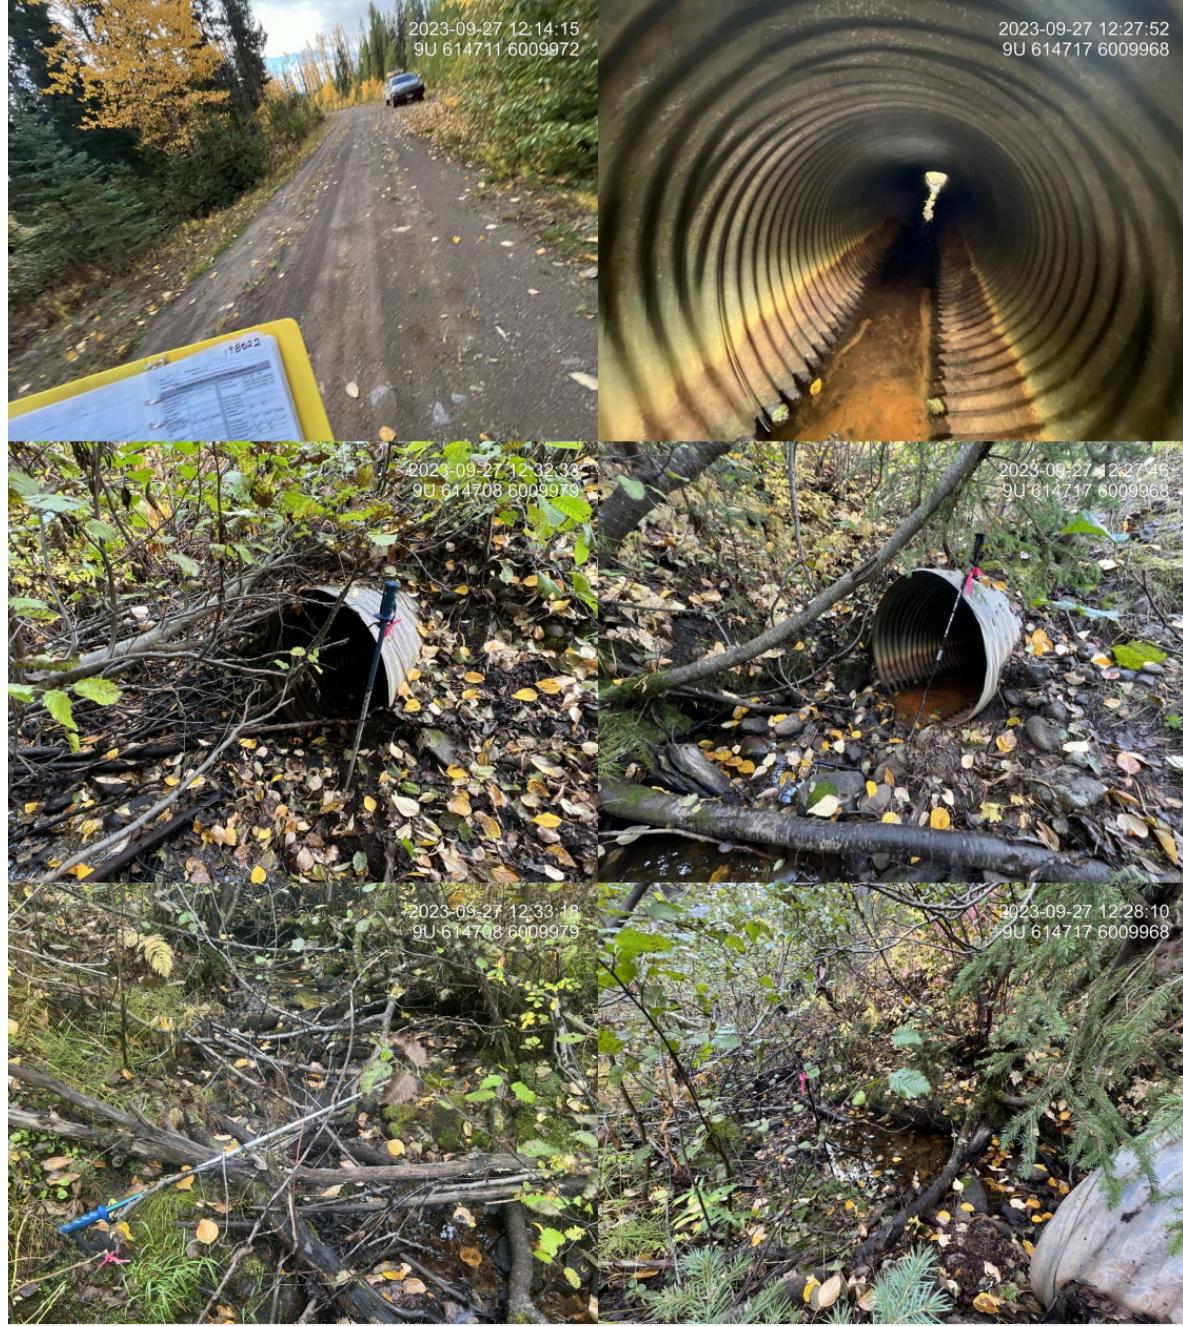
Location and Stream Data	Crossing Characteristics
<p>Comments: Moderate value habitat. Habitat confirmation conducted on stream, walked from upstream crossing down through wetland type area to culvert. Mostly dewatered besides small section above this crossing and below the upper crossing. Surveyed from upstream to down and ended up on road approximately 40 m to the north. Stream seems to merge with wetland type area just upstream of the road. Fish sampling conducted with dolly varden captured in small (2.5m²) outlet pool. Cutthroat are known to be upstream of crossing.. 12:12:45</p> <p>Photos: From top left clockwise: Road/Site Card, Barrel, Outlet, Downstream, Upstream, Inlet.</p>

Location and Stream Data		Crossing Characteristics	
Road Tenure	West Fraser Mills Ltd.	Outlet Drop (m)	0
Channel Width (m)	2.4	Outlet Pool Depth (m)	0
Stream Slope (%)	2	Inlet Drop	No
Beaver Activity	Yes	Slope (%)	2
Habitat Value	Medium	Valley Fill	Deep Fill
Final score	21	Barrier Result	Barrier
Fix type	Replace with New Open Bottom Structure	Fix Span / Diameter	15

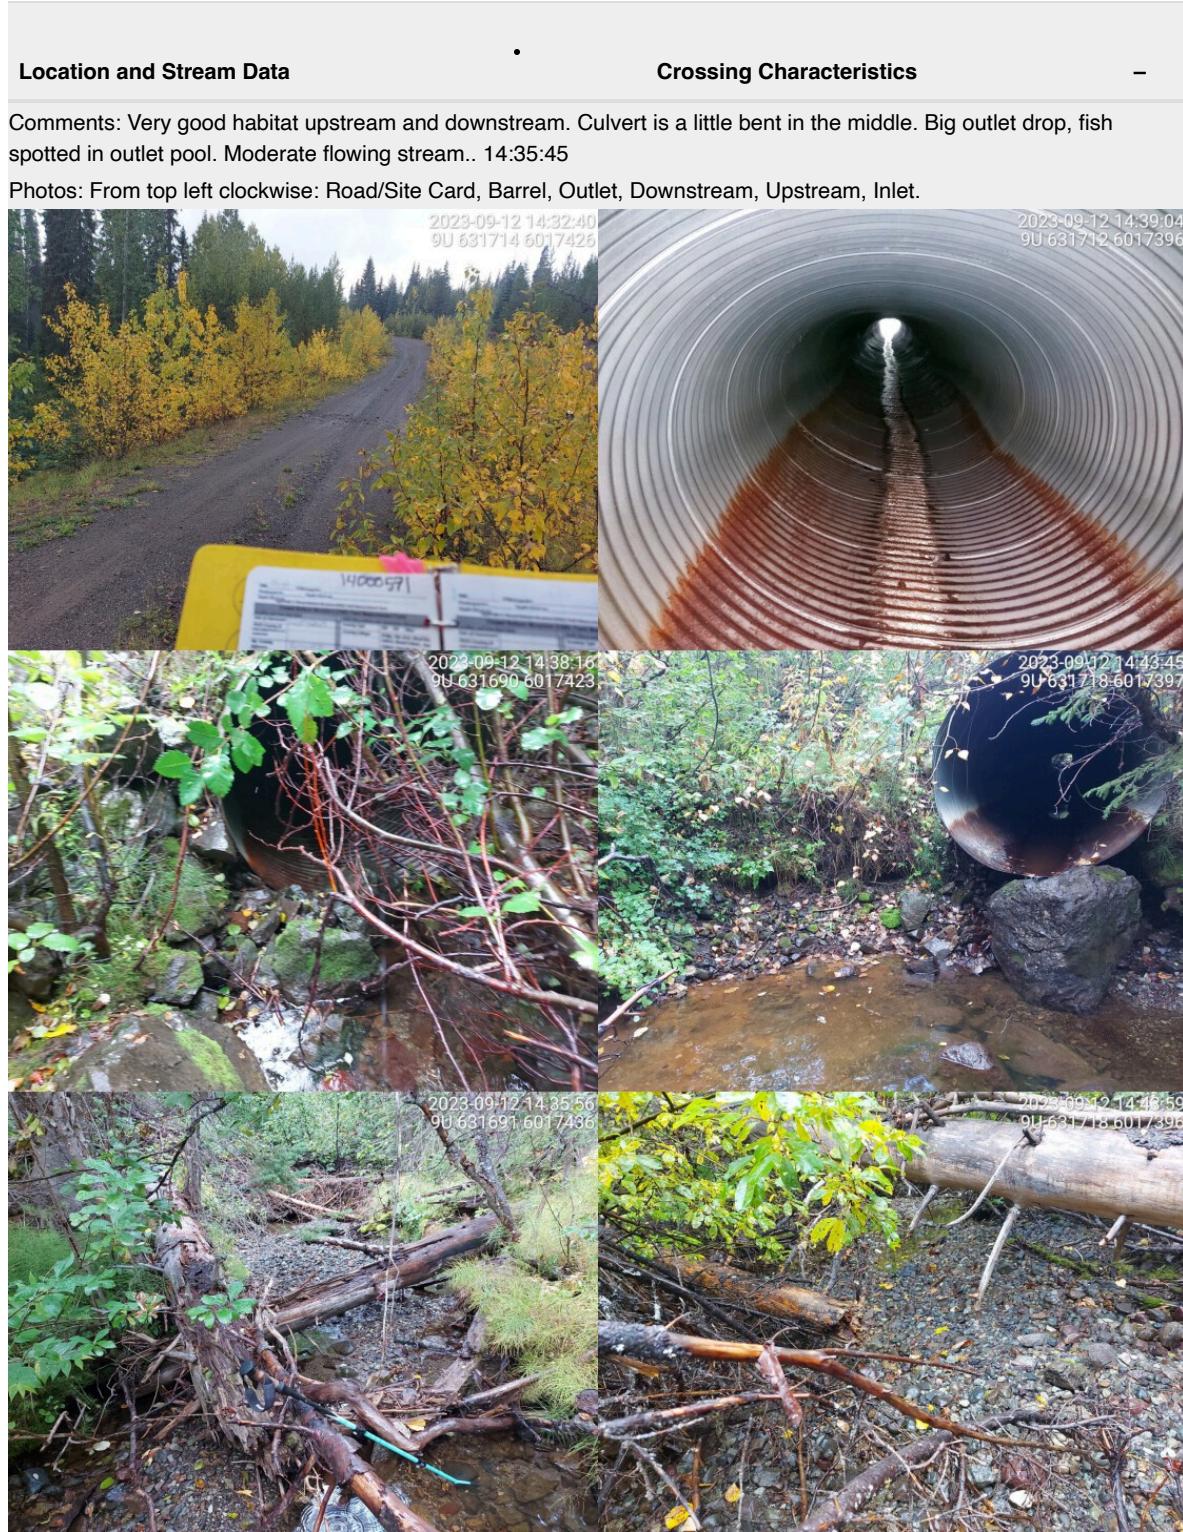
Table 5.11: Summary of fish passage assessment for PSCIS crossing 198942.

Location and Stream Data		Crossing Characteristics	
Date	2023-09-12	Crossing Sub Type	Round Culvert
PSCIS ID	198942	Diameter (m)	1.2
External ID	–	Length (m)	14
Crew	MW	Embedded	No
UTM Zone	9	Depth Embedded (m)	–
Easting	631508	Resemble Channel	No
Northing	6018096	Backwatered	No
Stream	Tributary to Houston Tommy Creek	Percent Backwatered	–
Road	Holland Rd	Fill Depth (m)	0.7
Road Tenure	Canfor R07549	Outlet Drop (m)	0.1
Channel Width (m)	1.9	Outlet Pool Depth (m)	0.7
Stream Slope (%)	2	Inlet Drop	No
Beaver Activity	No	Slope (%)	1
Habitat Value	High	Valley Fill	Deep Fill
Final score	21	Barrier Result	Barrier
Fix type	Replace Structure with Streambed Simulation CBS	Fix Span / Diameter	3

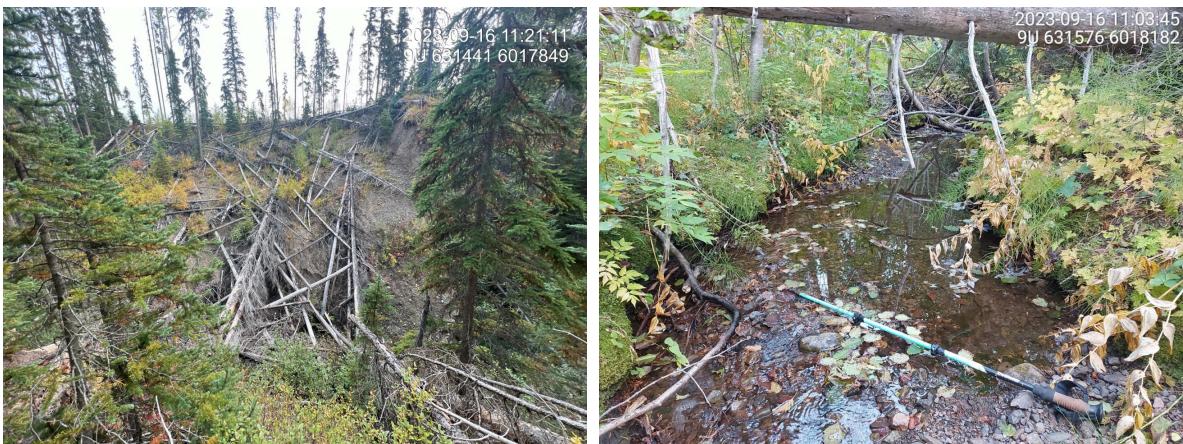
Figure 5.6: Left: Landslide located 300m downstream of crossing 198942. Right: Typical habitat upstream of PSCIS crossing 198942.

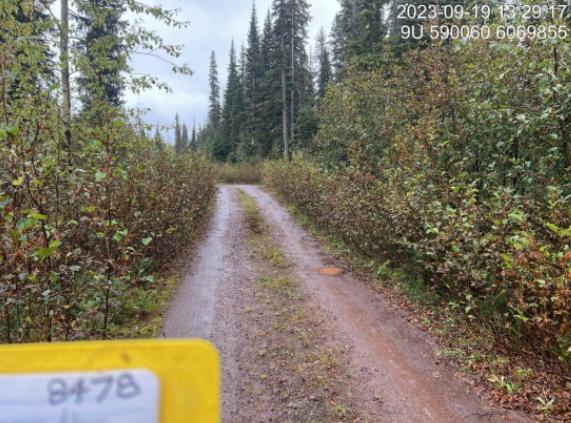
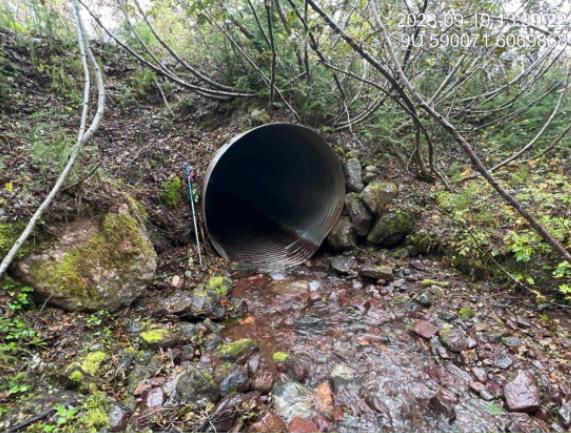
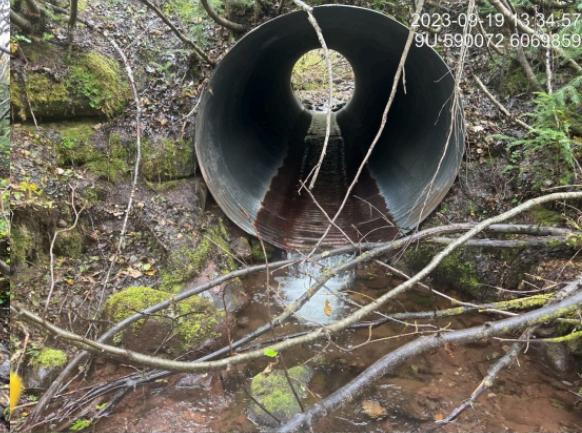
Location and Stream Data	Crossing Characteristics
Comments: Pipe is in good condition. Nice habitat upstream and downstream. Very good flow for time of year. Dolly Varden captured upstream and downstream of crossing.. 13:30:02	-
Photos: From top left clockwise: Road/Site Card, Barrel, Outlet, Downstream, Upstream, Inlet.	-

Location and Stream Data		Crossing Characteristics	
Date	2023-09-19	Crossing Sub Type	Round Culvert
PSCIS ID	8478	Diameter (m)	1.9
External ID	–	Length (m)	12
Crew	AI	Embedded	No
UTM Zone	9	Depth Embedded (m)	–
Easting	590065	Resemble Channel	No
Northing	6069867	Backwatered	No
Stream	Tributary to McDonell Lake	Percent Backwatered	–
Road	Dennis West FSR	Fill Depth (m)	1.5
Road Tenure	BCTS R22433	Outlet Drop (m)	0.2
Channel Width (m)	2.5	Outlet Pool Depth (m)	0.25
Stream Slope (%)	8	Inlet Drop	Yes
Beaver Activity	No	Slope (%)	4
Habitat Value	Medium	Valley Fill	Deep Fill
Final score	31	Barrier Result	Barrier
Fix type	Replace with New Open Bottom Structure	Fix Span / Diameter	15

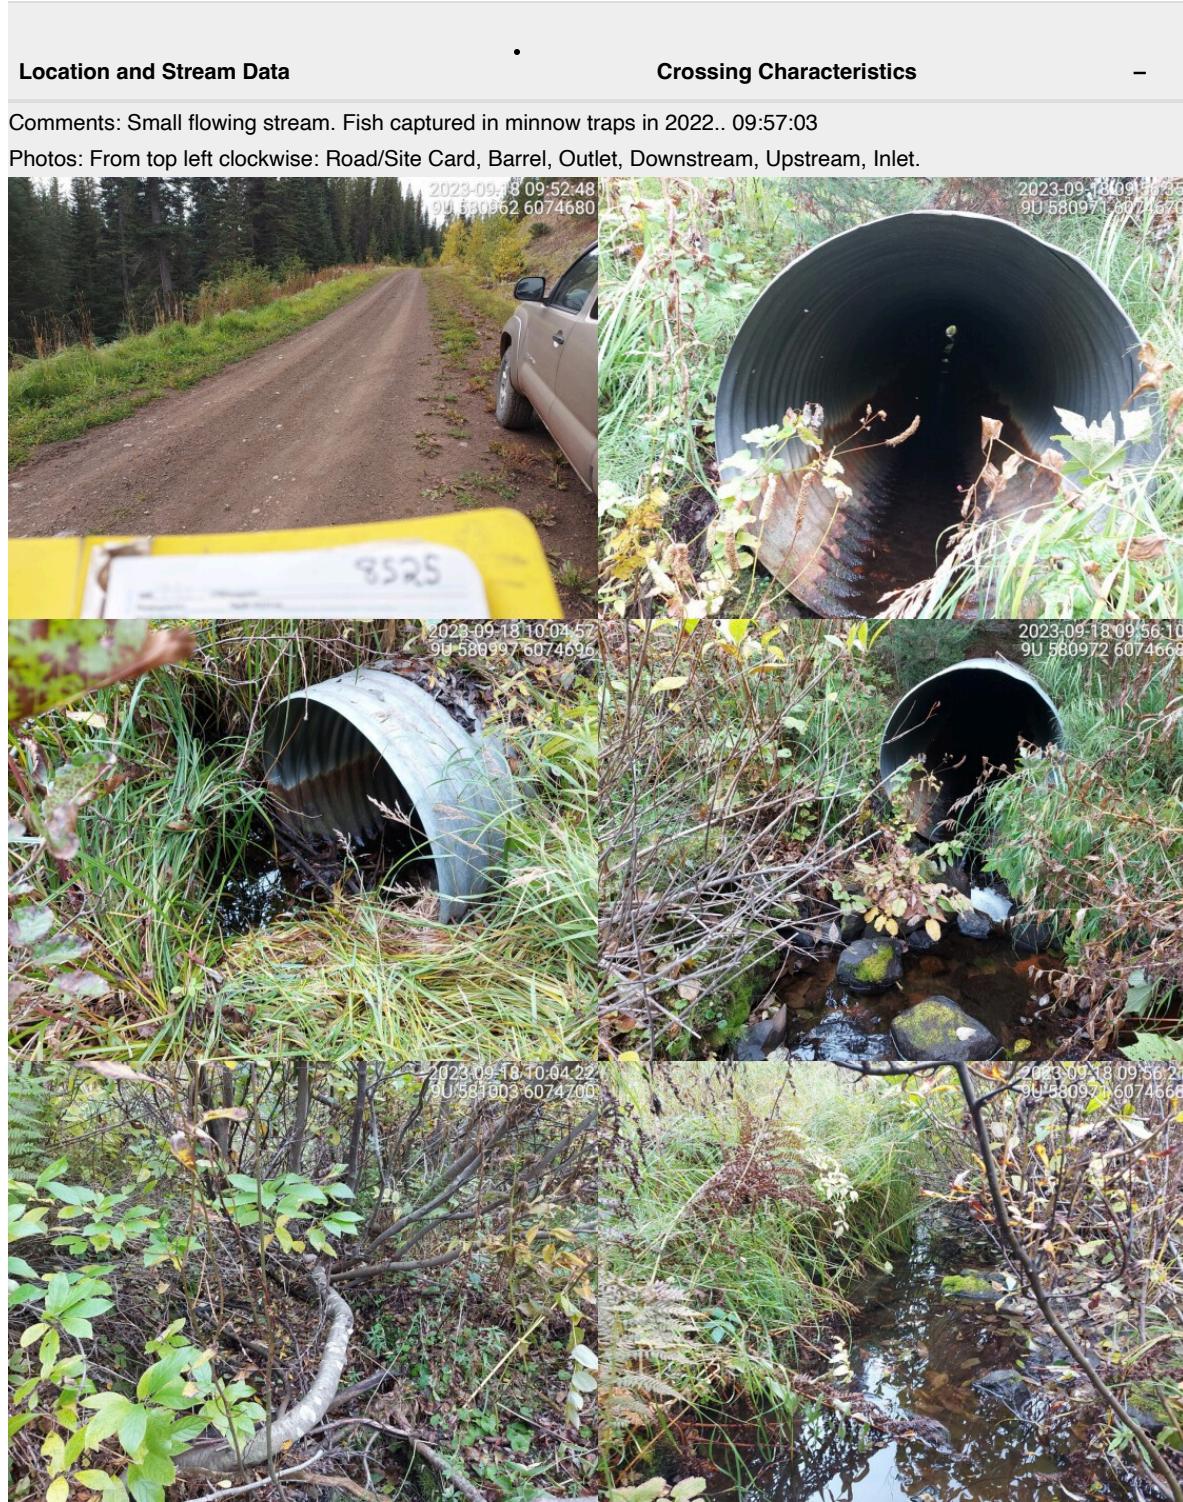
Table 5.21: Summary of fish passage assessment for PSCIS crossing 8525.

Location and Stream Data		Crossing Characteristics	
Date	2023-09-18	Crossing Sub Type	Round Culvert
PSCIS ID	8525	Diameter (m)	0.9
External ID	–	Length (m)	28
Crew	MW TP VJ	Embedded	No
UTM Zone	9	Depth Embedded (m)	–
Easting	580998	Resemble Channel	No
Northing	6074681	Backwatered	No
Stream	Tributary to Coal Creek	Percent Backwatered	–
Road	McDonell FSR	Fill Depth (m)	2
Road Tenure	MOF 7552	Outlet Drop (m)	0.5
Channel Width (m)	1.9	Outlet Pool Depth (m)	0.2
Stream Slope (%)	4	Inlet Drop	No
Beaver Activity	No	Slope (%)	1
Habitat Value	Medium	Valley Fill	Deep Fill
Final score	34	Barrier Result	Barrier
Fix type	Replace Structure with Streambed Simulation CBS	Fix Span / Diameter	3

Should restoration/maintenance activities proceed, replacement of PSCIS crossing 8525 with a streambed simulation (embedded culvert) recommended (3m span). Although preliminary - a rough cost of the work is estimated at \$100,000.

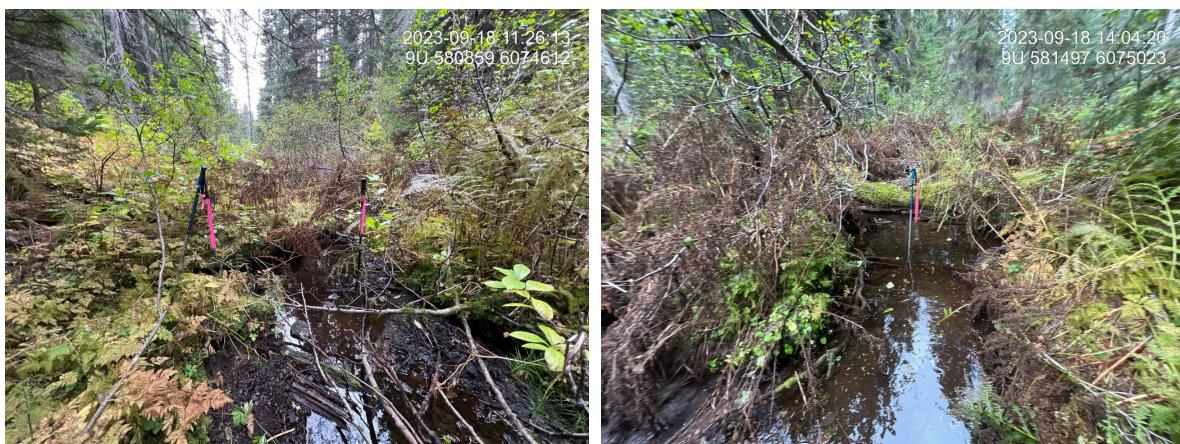
Figure 5.12: Left: Typical habitat downstream of PSCIS crossing 8525. Right: Typical habitat upstream of PSCIS crossing 8525.

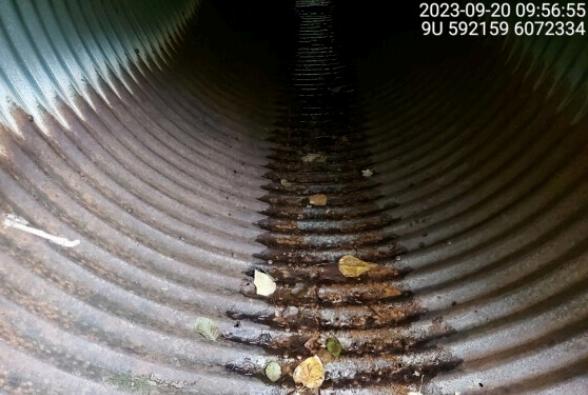
A close-up photograph of the inlet end of a corrugated metal culvert. The culvert has several small holes through which water is leaking. The date and time "2023-09-20 09:56:55" and coordinates "9U 592159 6072334" are visible in the top right corner.

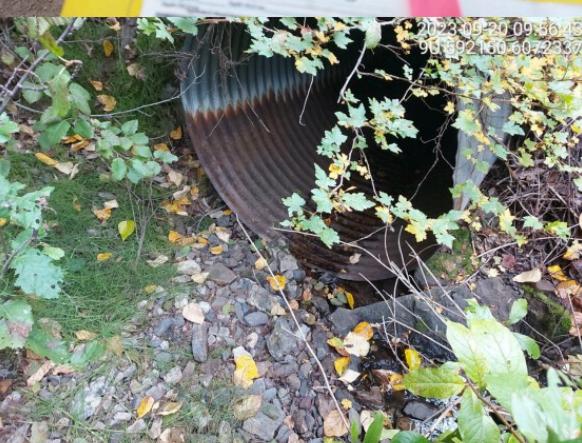
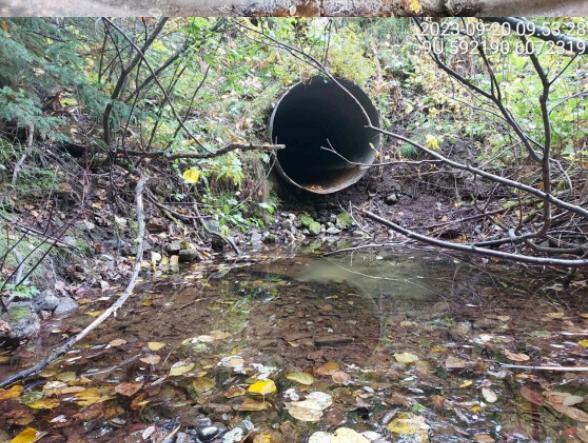
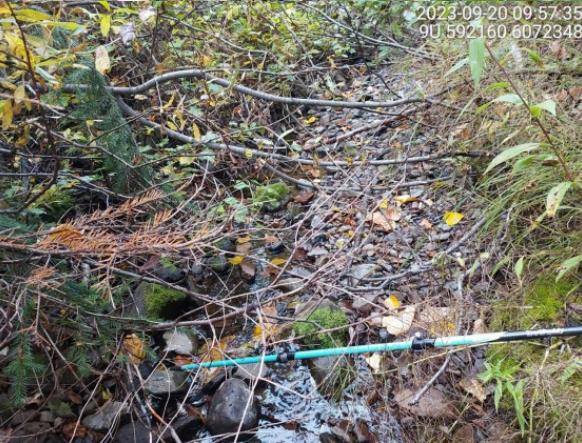
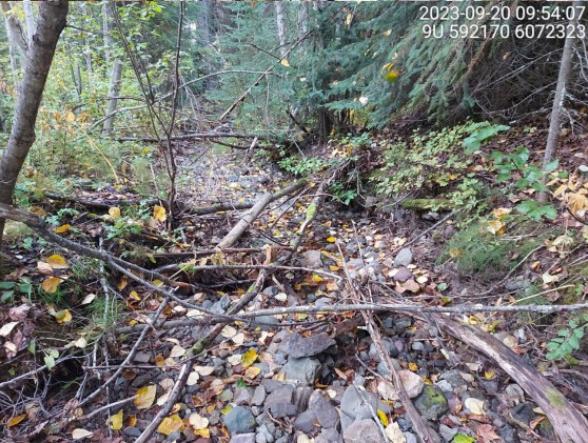
At the time of the survey in 2023, PSCIS crossing 8543 was un-embedded, non-backwatered and ranked as a barrier to upstream fish passage according to the provincial protocol (MoE 2011) (Table [5.27](#)). The culvert was in poor condition with holes in the bottom and had a 0.5m outlet drop.

Location and Stream Data	Crossing Characteristics
Comments: Small trickle in stream, very little flowing water. Stream runs halfway down culvert from inlet and then flows through holes underneath culvert. Stream gets wider upstream of crossing. Fish caught in the past above and below culvert. Deep outlet pool.. 09:49:51	
Photos: From top left clockwise: Road/Site Card, Barrel, Outlet, Downstream, Upstream, Inlet.

The culvert at crossing 8543 was in bad condition with holes in the bottom and had a significant 0.5m outlet drop. The crossing ranked as a barrier to fish passage. There are historic fish observations both upstream and downstream of the crossing in the FISS database and surveyors observed fish upstream of the crossing during the assessment, suggesting this stream provides habitat suitable for rearing and spawning. Therefore, we recommendation electrofishing above and below the crossing to provide insight into fish community composition and density to help further inform prioritization.

Should restoration/maintenance activities proceed, replacement of PSCIS crossing 8543 with an embedded culvert (streambed simulation) (3m span) is recommended. Although preliminary - a rough cost of the work is estimated at \$100,000.

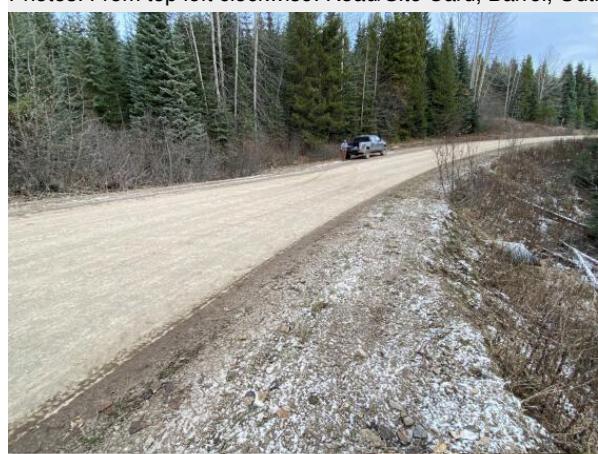
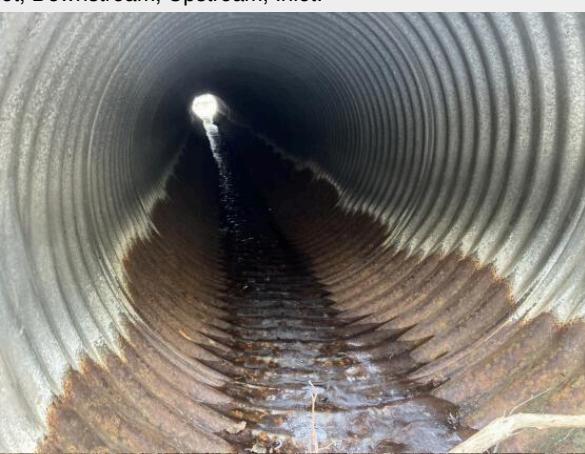
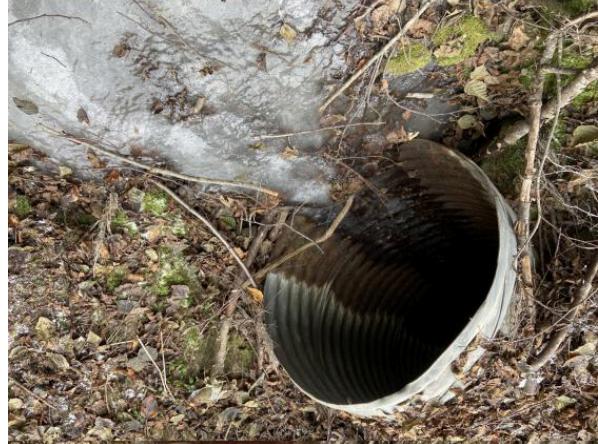
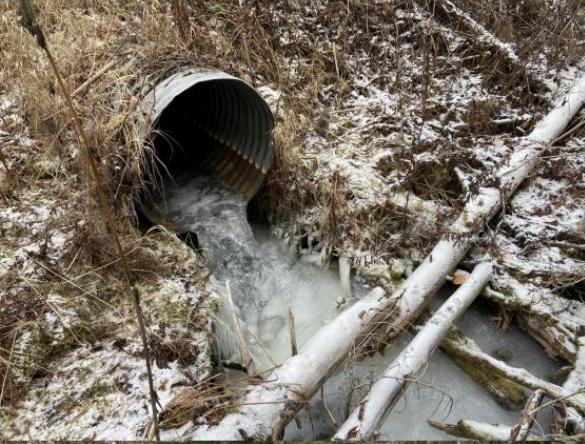
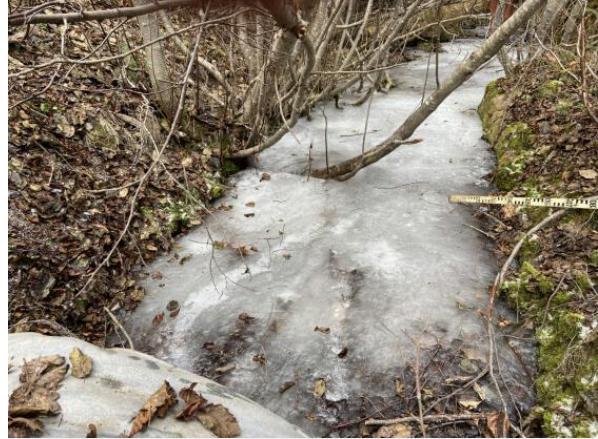
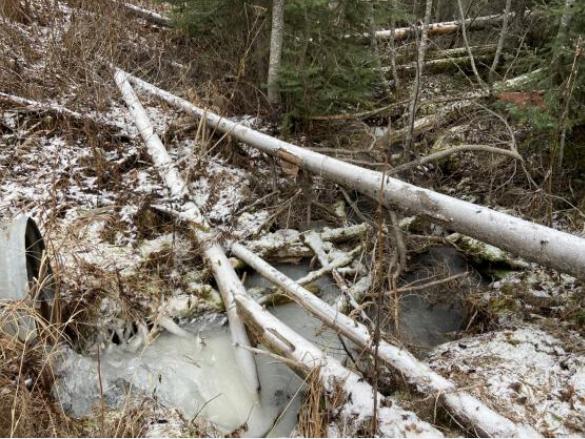
Location and Stream Data	Crossing Characteristics
<p>Comments: 2 round culverts, one is not functional and was installed higher above stream channel. Culvert slope was estimated.CT observed in stream and historic CT FISS downstream.. 13:34:15</p> <p>Photos: From top left clockwise: Road/Site Card, Barrel, Outlet, Downstream, Upstream, Inlet.</p>

Should restoration/maintenance activities proceed, replacement of PSCIS crossing 8547 with an embedded culvert (streambed simulation) (3m span) is recommended. A preliminary cost of the work is estimated at \$100,000.

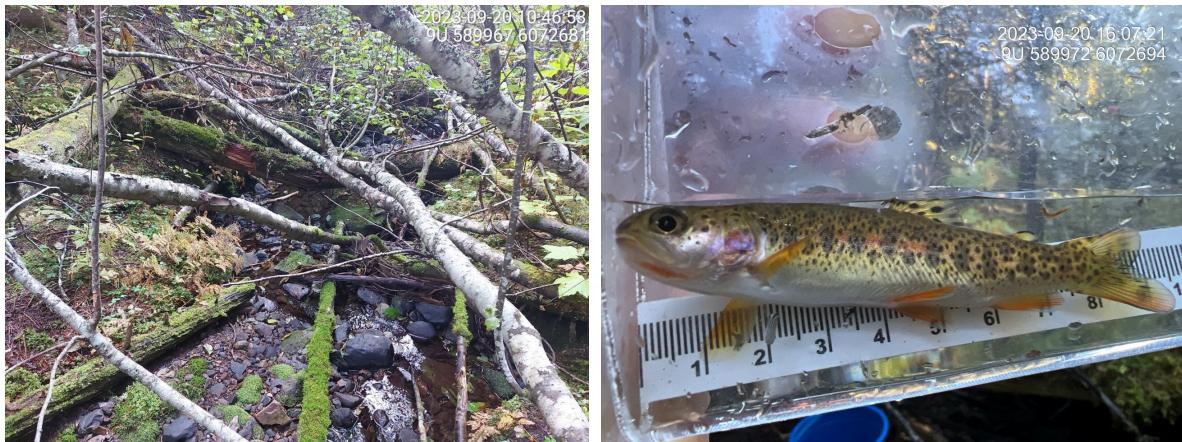
Figure 5.18: Left: Typical habitat upstream of PSCIS crossing 8547. Right: Cutthroat trout captured upstream of crossing 8547.
