## **Skeena Watershed Fish Passage Restoration Planning 2024**

Prepared for  
Habitat Conservation Trust Foundation - CAT23-6-288  
BC Fish Passage Remediation Program  
Ministry of Transportation and Infrastructure

Prepared by  
Al Irvine, B.Sc., R.P.Bio and Lucy Schick, B.Sc.  
New Graph Environment Ltd.  
on behalf of  
Society for Ecosystem Restoration in Northern British Columbia

DRAFT Version 0.1.1 2025-04-16

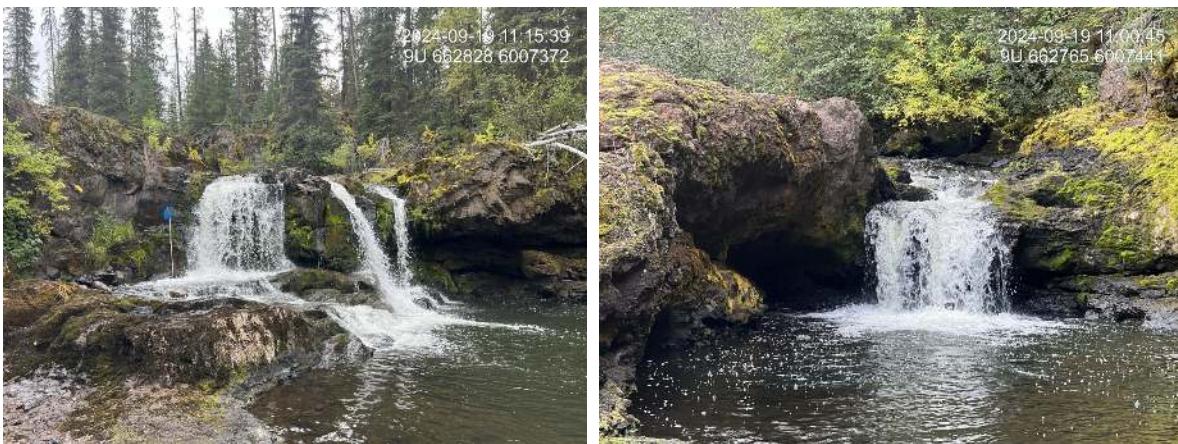
Figure 5.1: Left: Buck Falls – The downstream most feature is a ~2m high drop with a ~30% gradient extending over a 5 m length. A 2m tall net is included for scale. Right: Buck Falls – The second step consisted of a ~1.5 m vertical drop with an overlying cascade, exhibiting a ~15% gradient over a 1.0m height.

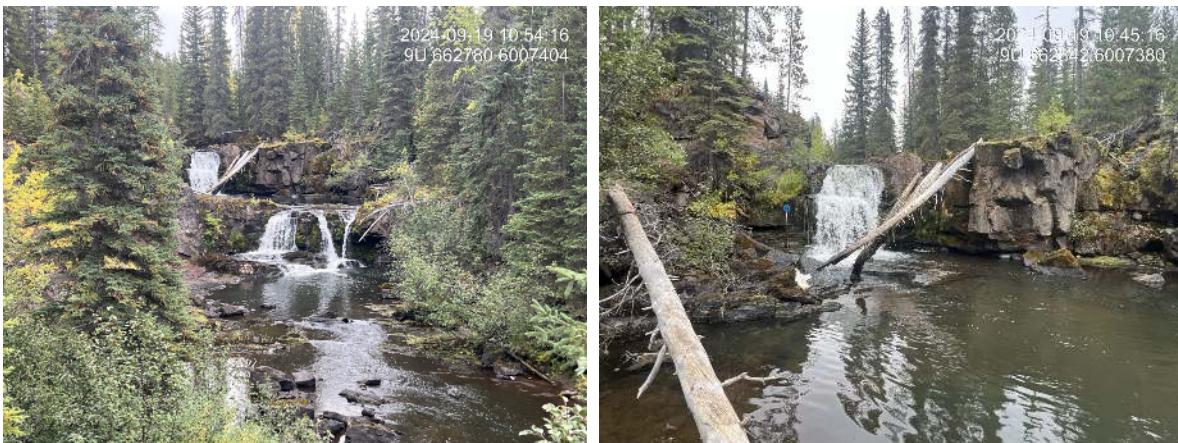
Figure 5.2: Left: Buck Falls – The third falls consisted of a ~3.5m high sheer drop to bedrock. Right: Buck Falls – The upper falls featured a ~4m high vertical drop. A 2m tall net is included for scale.

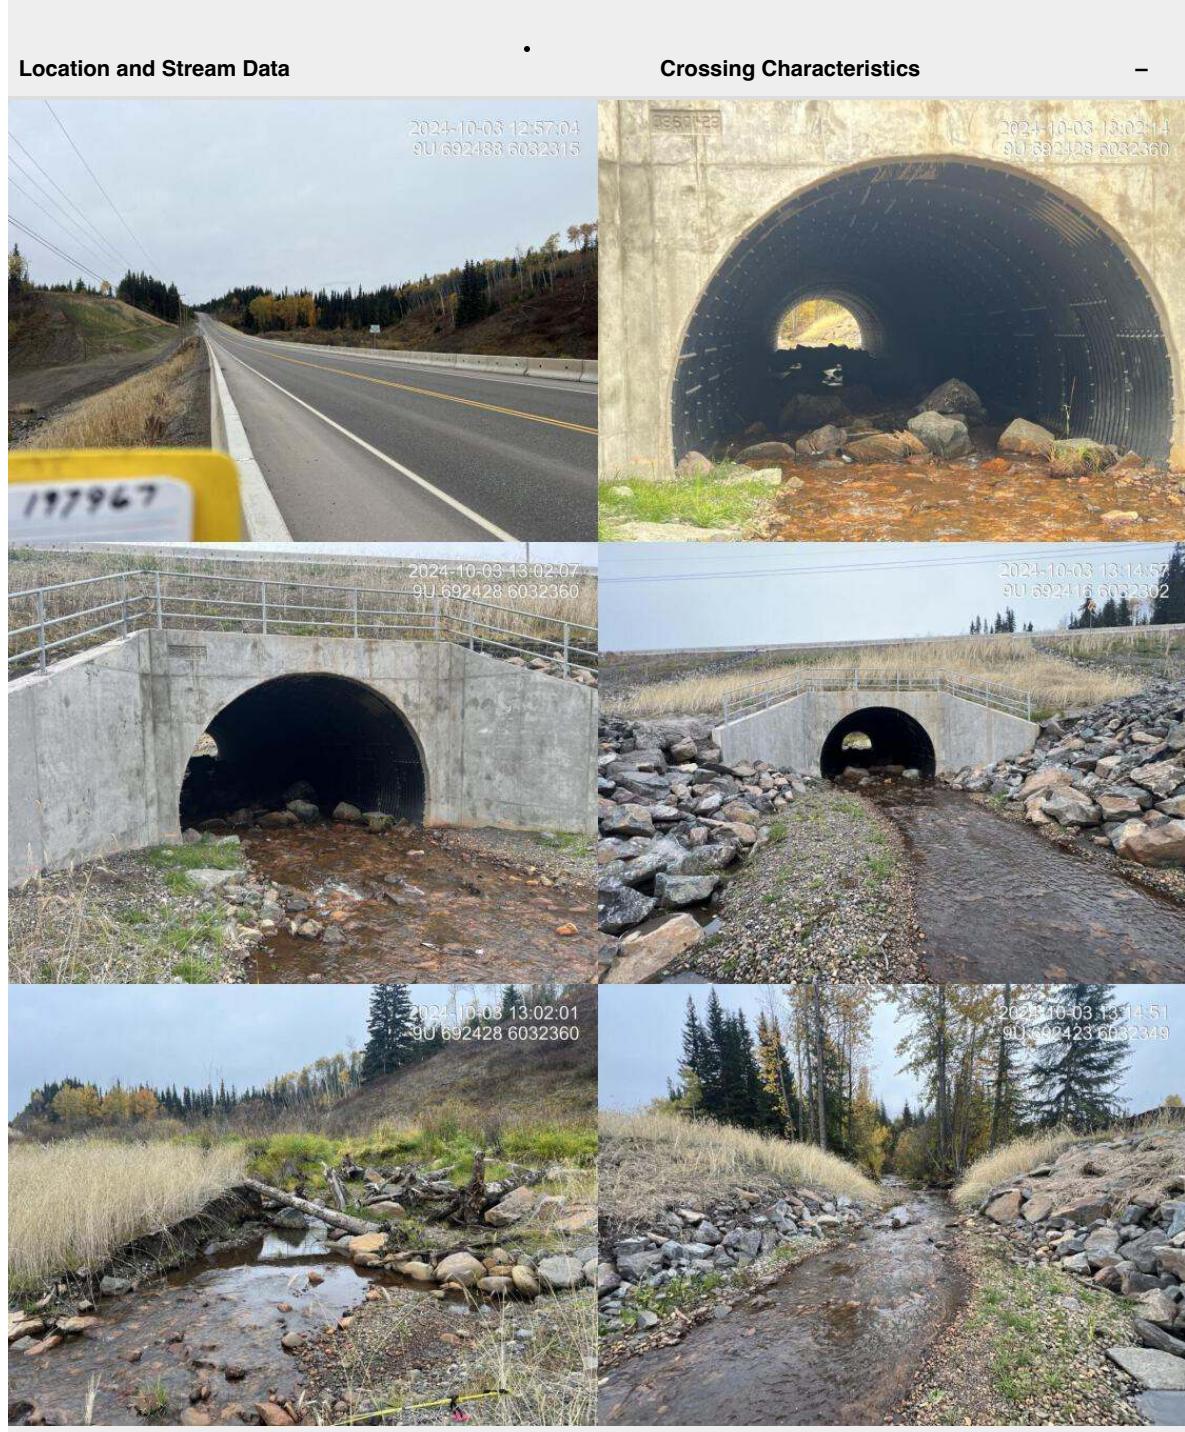
Photos: From top left clockwise: Road/Site Card, Barrel, Outlet, Downstream, Upstream, Inlet.

Location and Stream Data		Crossing Characteristics	
Date	2024-10-03	Crossing Sub Type	Round Culvert
PSCIS ID	197967	Diameter (m)	5.6
External ID	–	Length (m)	40
Crew	AI	Embedded	Yes
UTM Zone	9	Depth Embedded (m)	2
Easting	692426	Resemble Channel	Yes
Northing	6032341	Backwatered	No
Stream	Taman Creek	Percent Backwatered	–
Road	Highway 16	Fill Depth (m)	7
Road Tenure	MoTi	Outlet Drop (m)	0
Channel Width (m)	5.5	Outlet Pool Depth (m)	0
Stream Slope (%)	2	Inlet Drop	No
Beaver Activity	Yes	Slope (%)	3
Habitat Value	Medium	Valley Fill	Deep Fill
Final score	16	Barrier Result	Potential
Fix type	Replace with New Open Bottom Structure	Fix Span / Diameter	27
Comments:			
This is a brand-new replacement structure, extremely well built with extensive embedment that includes numerous large boulders, cobbles, and gravel. The multiplate round structure is embedded nearly 2 m. Upstream, woody debris and boulder structures are cabled together for added stability. This massive construction project involved a substantial amount of fill extending 60 m downstream and over 200 m upstream. The site now offers migration conditions for fish that are equal to or better than previous conditions. MoTi chris_culvert_id: 2076452

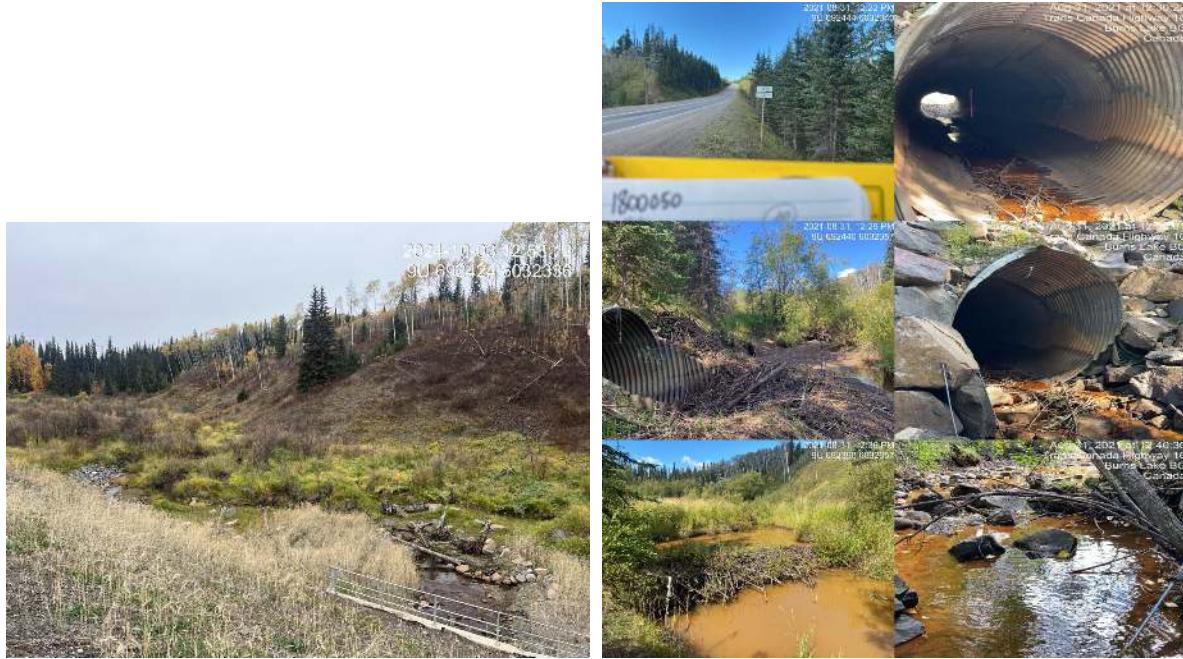
In 2024, conditions for upstream fish passage through the highway crossing at Taman Creek was greatly improved through installation of a streambed simulation structure featuring a large culvert width, embedded natural streambed substrates, and the addition of well designed habitat features within the reconstructed channel. Future monitoring of the site could repeat monitoring metrics conducted in 2024, track morphological changes to the channel in the years following construction (via drone generated elevation models or lidar) and include fish sampling and/or eDNA presence surveys to understand fish use upstream and downstream of the crossing.

Figure 5.3: Left: Woody debris and boulder structures located upstream of 197967 in 2024. Right: Photos of crossing 197967 in 2021.

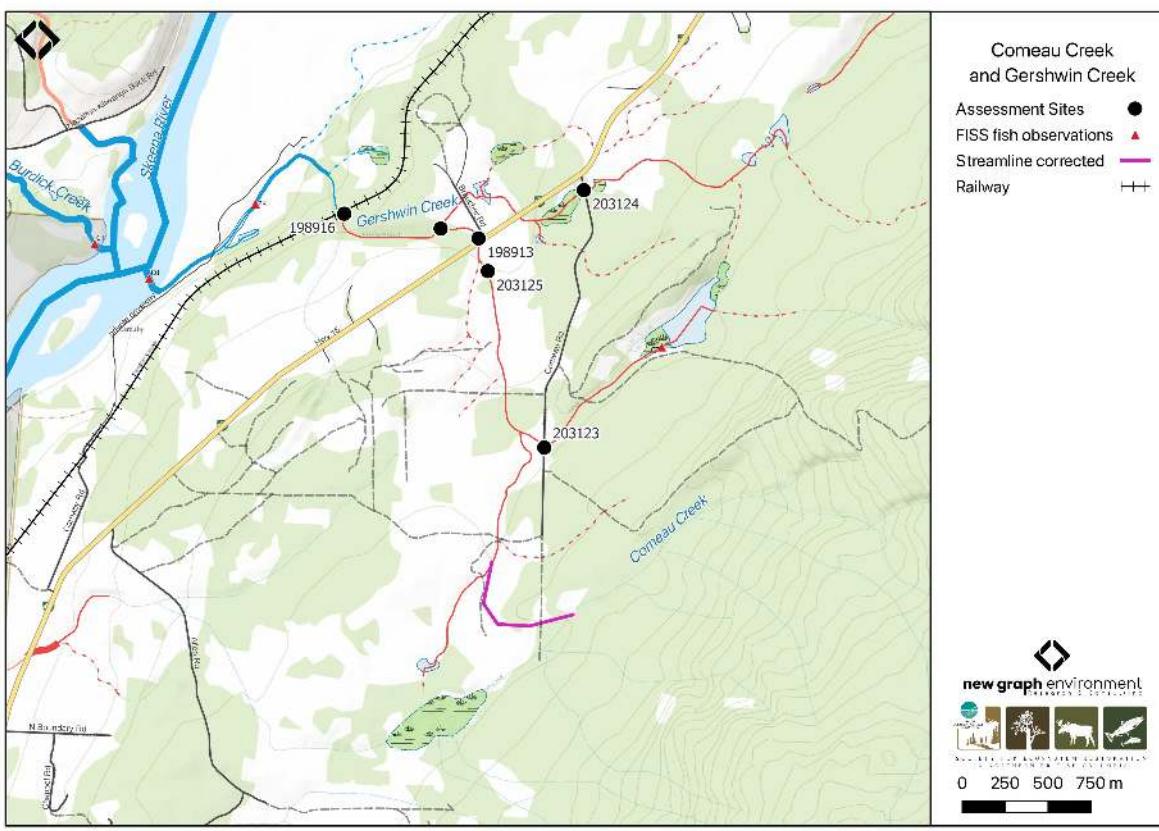
BC Freshwater atlas mapping of this watershed is incorrect as the main stream at the confluence with the Skeena River is actually Comeau Creek vs Gershwin Creek - as it is labelled in provincial mapping (Figure 5.4). Gershwin Creek is a much smaller tributary that flows into Comeau Creek approximately 270m downstream of Highway 16 at a location 2.5km upstream from the Comeau Creek/Skeena River confluence. As noted in M. McCarthy (2000) - the mainstem of Comeau Creek deviates from the mapped Comeau Creek stream line approximately 5.3km upstream of the incorrectly mapped confluence of Comeau Creek and the Skeena River and enters the drainage labelled as Gershwin Creek at a location 4.8km upstream of the true Comeau Creek confluence with the Skeena River (see corrected streamline in Figure 5.4).

Figure 5.4: Comeau Creek and Gershwin Creek

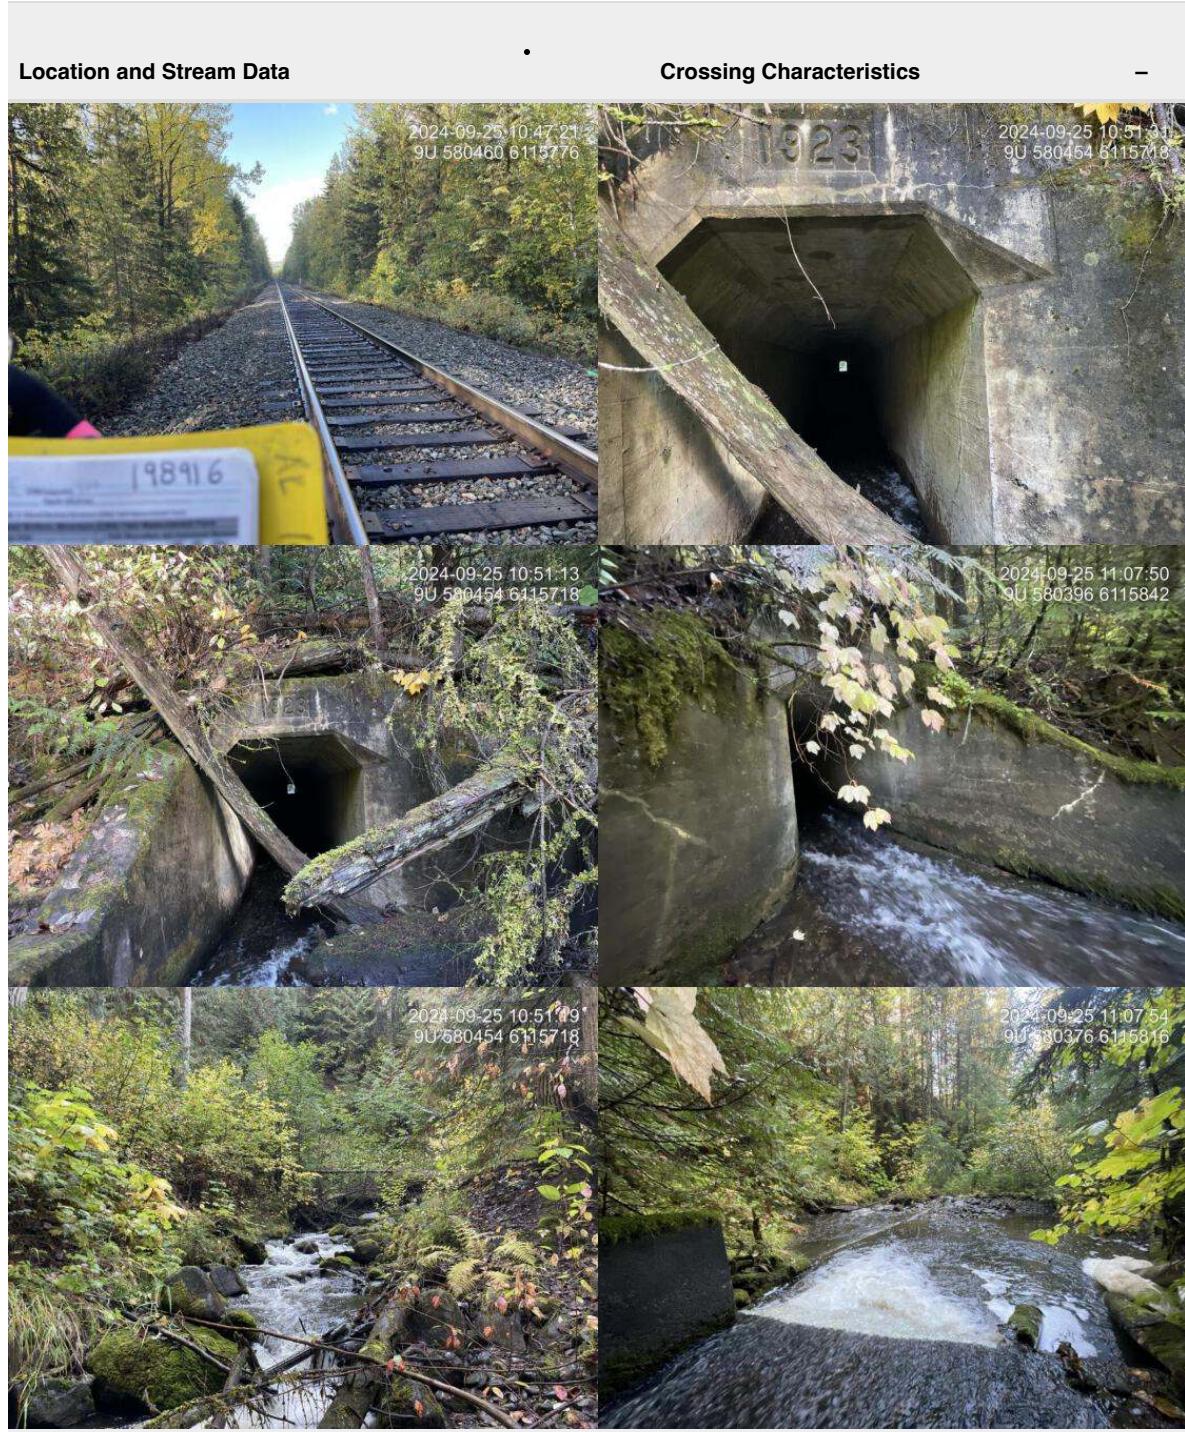
Location and Stream Data		Crossing Characteristics	
Date	2024-09-25	Crossing Sub Type	Round Culvert
PSCIS ID	198913	Diameter (m)	1.5
External ID	–	Length (m)	40
Crew	AI JO	Embedded	No
UTM Zone	9	Depth Embedded (m)	–
Easting	581250	Resemble Channel	–
Northing	6115660	Backwatered	No
Stream	Comeau Creek	Percent Backwatered	–
Road	Highway 16	Fill Depth (m)	2.5
Road Tenure	MOTi	Outlet Drop (m)	0.35
Channel Width (m)	5	Outlet Pool Depth (m)	0.85
Stream Slope (%)	3	Inlet Drop	No
Beaver Activity	No	Slope (%)	3
Habitat Value	Medium	Valley Fill	Deep Fill
Final score	42	Barrier Result	Barrier
Fix type	Replace with New Open Bottom Structure	Fix Span / Diameter	15

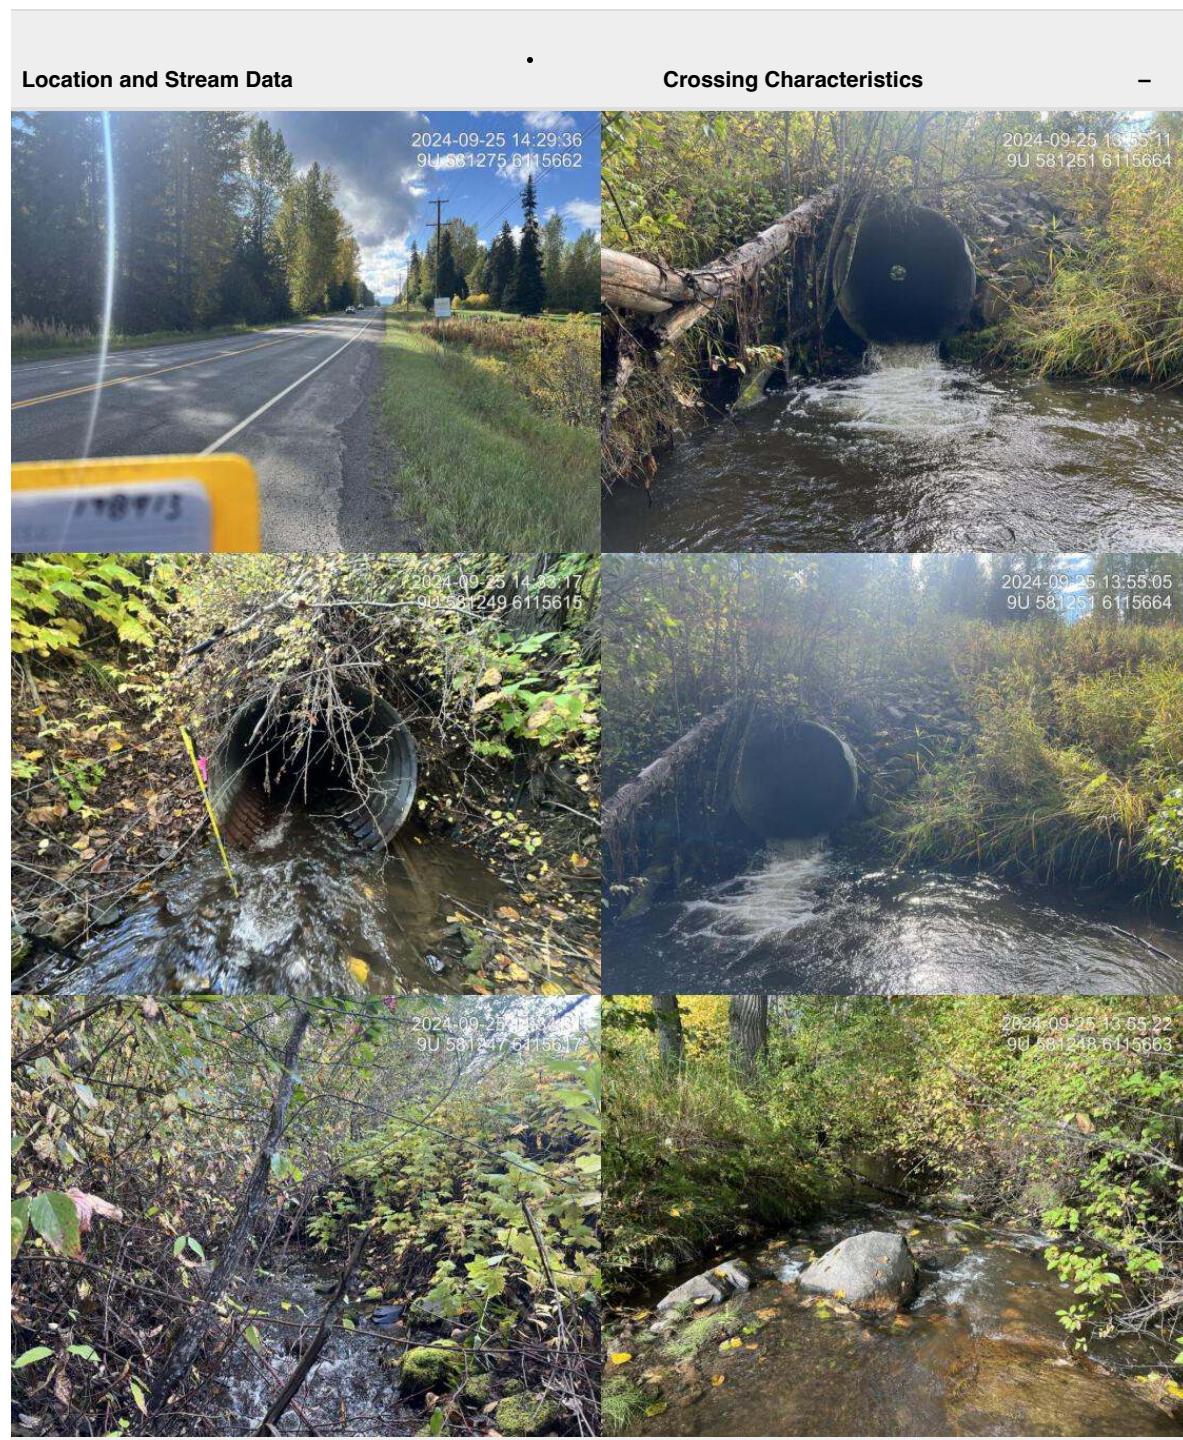
Photos: From top left clockwise: Road/Site Card, Barrel, Outlet, Downstream, Upstream, Inlet.

There is a deep outlet pool, suggesting the culvert is undersized for the stream. High-quality gravels were present at the pool's outlet, and upstream of the crossing, there was high-value habitat with frequent overwintering pools, spawning gravels, and adequate riparian cover with large cottonwoods throughout. This site was part of a habitat confirmation assessment, with the stream surveyed from the downstream railway crossing up to this location and an additional 600 m upstream. Downstream, crossing 198916 consists of a large, long box culvert beneath the railway with minimal flow depth and a swift current, making it unlikely that fish from the mainstem of the Skeena River can access this site until the railway barrier is addressed. Fish sampling at this site captured cutthroat trout and Dolly Varden. MoTi chris\_culvert\_id: 8300872

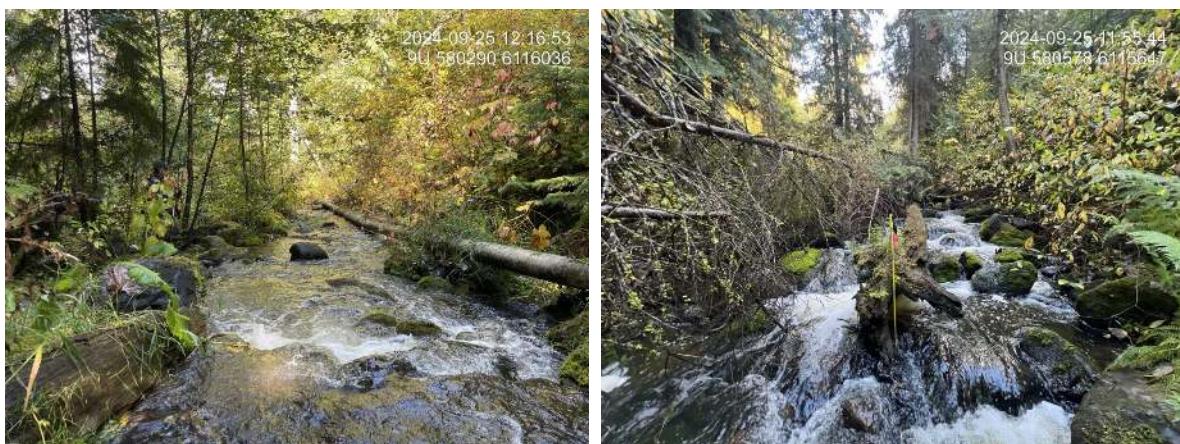
The stream was surveyed downstream from crossing 198916 for 300m . The stream contained numerous boulders forming step pools; however, moderate flows at the time of assessment limited the availability of pools suitable for fish. The first pool suitable for overwintering fish, with adequately reduced flow, was located approximately 250m downstream of the culvert. There were occasional gravels suitable for spawning and frequent large woody debris, which contributed to the formation of additional steps. (Figure [5.7](#)). The average channel width was 5.9m, the average wetted width was 3.7m, and the average gradient was 5.1%.The dominant substrate was cobbles with gravels sub-dominant.Total cover amount was rated as moderate with boulders dominant. Cover was also present as small woody debris, large woody debris, and overhanging vegetation. The habitat was rated as medium value suitable for salmonid rearing and spawning.

Figure 5.7: Left: Typical habitat downstream of PSCIS crossing 198916. Right: Typical habitat upstream of PSCIS crossing 198916.

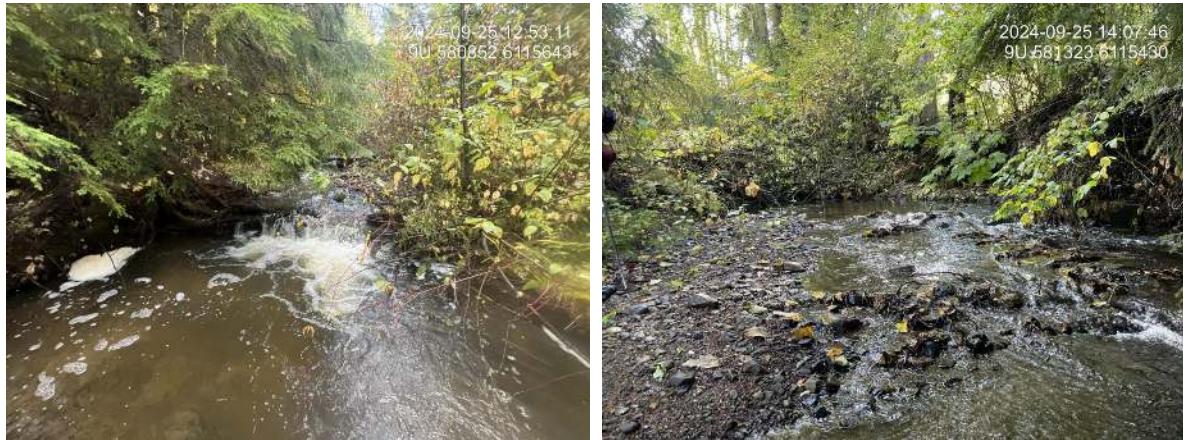
Figure 5.8: Left: Typical habitat downstream of PSCIS crossing 198913. Right: Typical habitat upstream of PSCIS crossing 198913.

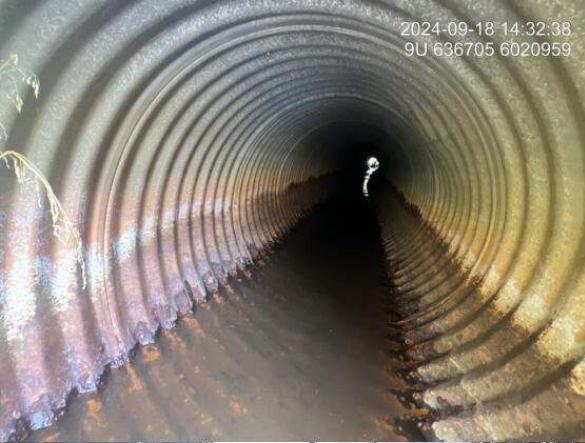
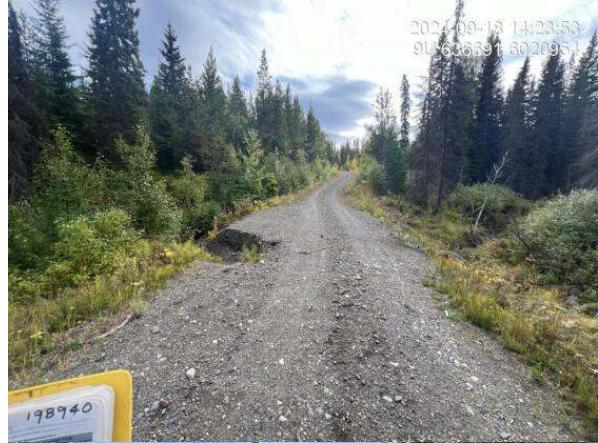
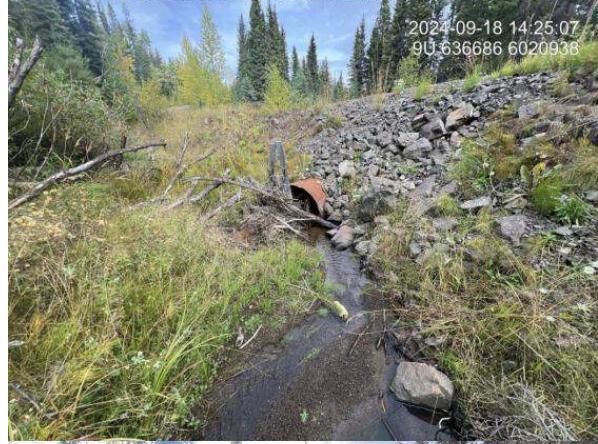
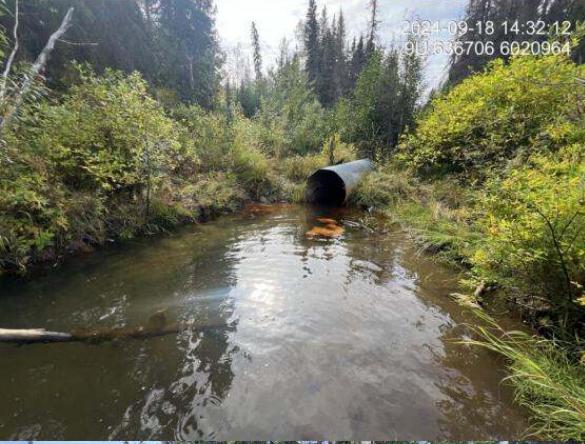
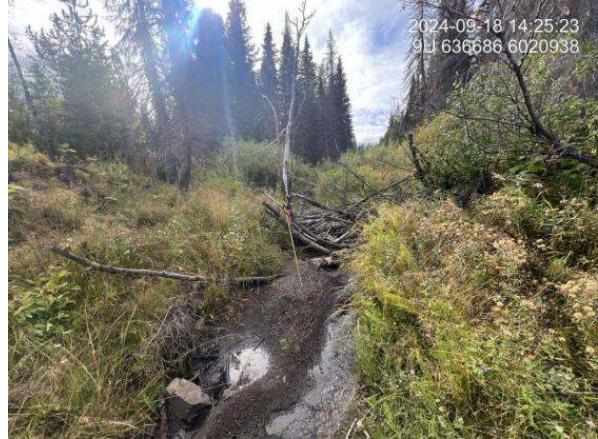
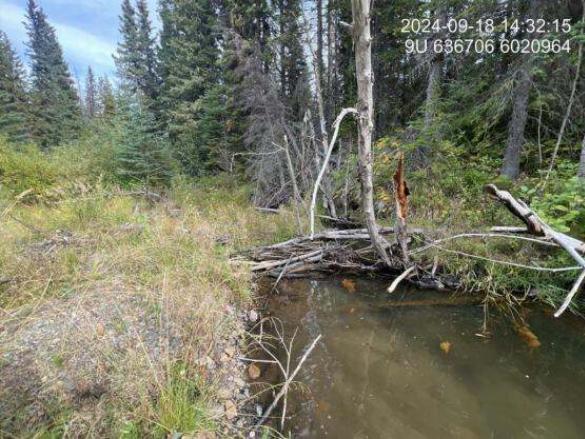
Location and Stream Data	Crossing Characteristics
<p>Comments: Very nice stream with good flow, abundant gravels for spawning, and undercut banks and occasional deep pools for rearing. Confirmed populations of cutthroat trout, rainbow trout, and Dolly Varden. The culvert is significantly undersized for the stream, and the road appears to be failing, likely due to a partially clogged inlet and spring freshet. Habitat confirmations were completed for this crossing and the next upstream crossing (198935) on the Gold FSR.</p>	
<p>Photos: From top left clockwise: Road/Site Card, Barrel, Outlet, Downstream, Upstream, Inlet.</p>

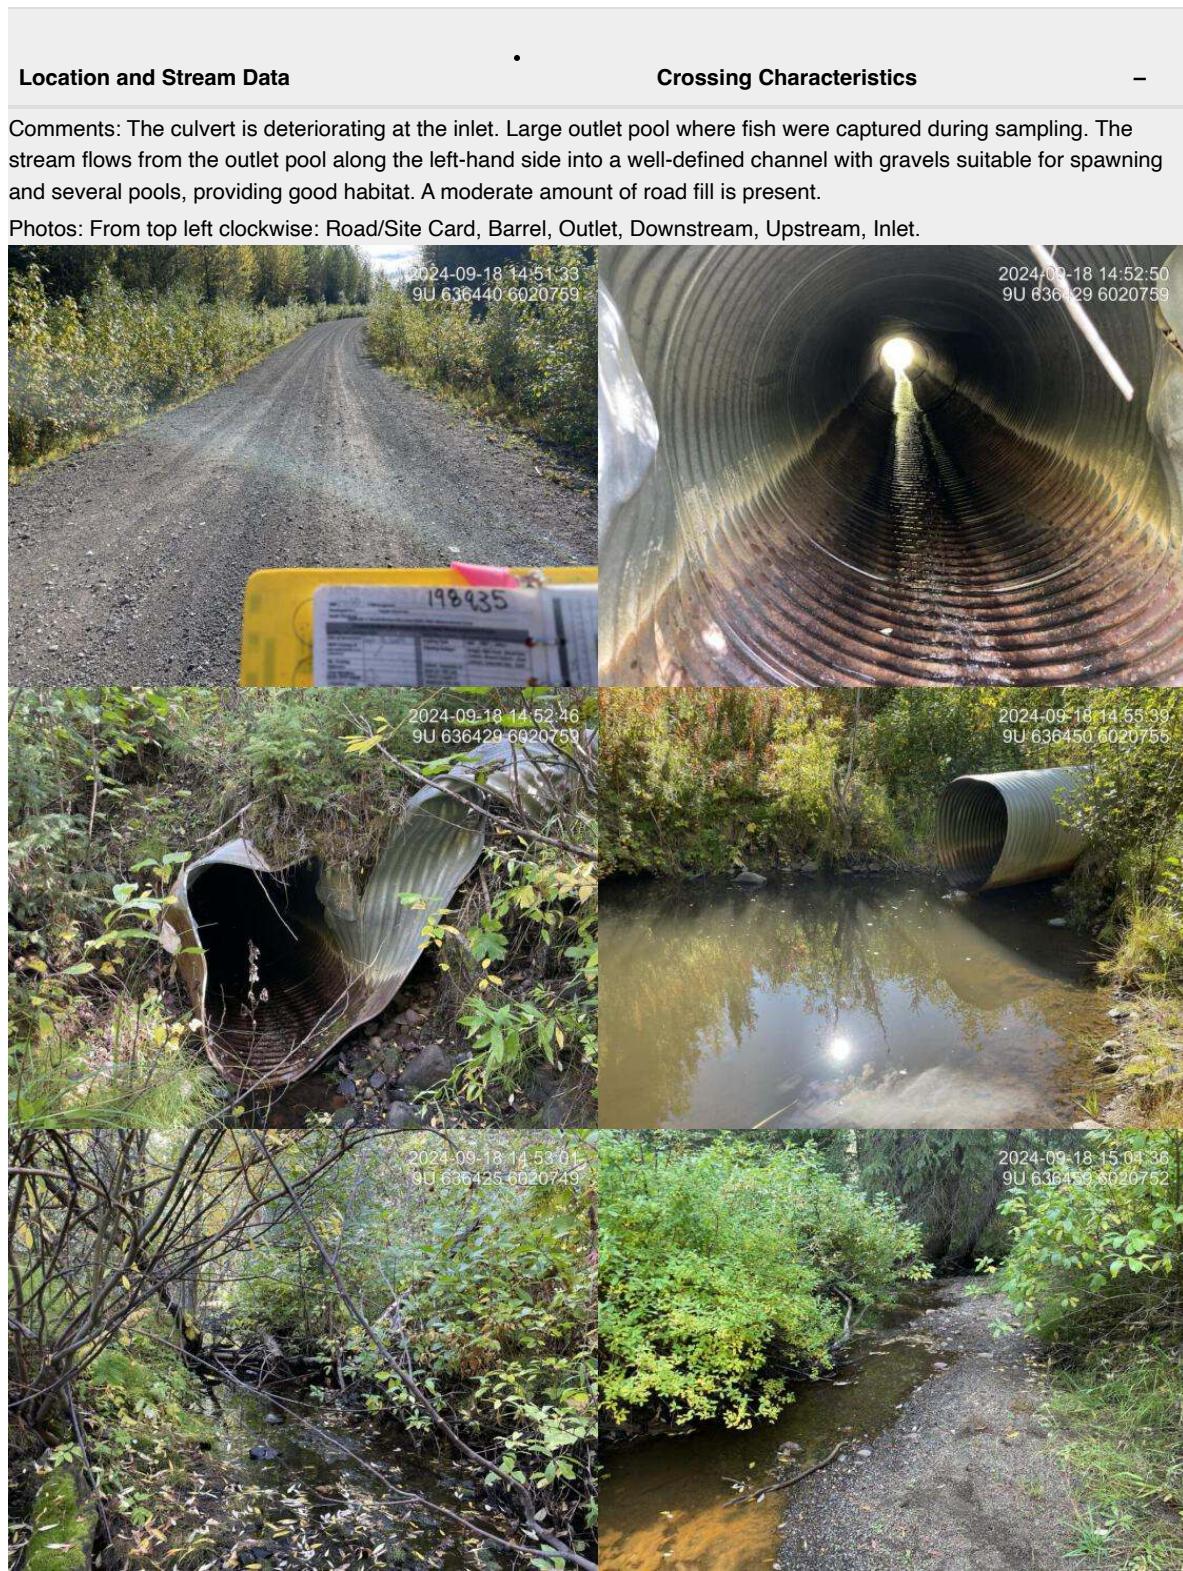
Location and Stream Data		Crossing Characteristics	
Date	2024-09-18	Crossing Sub Type	Round Culvert
PSCIS ID	198935	Diameter (m)	1.2
External ID	–	Length (m)	20
Crew	LS	Embedded	No
UTM Zone	9	Depth Embedded (m)	–
Easting	636440	Resemble Channel	–
Northing	6020756	Backwatered	No
Stream	Tributary to Knapper Creek	Percent Backwatered	–
Road	Gold creek fsr	Fill Depth (m)	4
Road Tenure	Canfor R07549 6	Outlet Drop (m)	0.15
Channel Width (m)	2.7	Outlet Pool Depth (m)	0.8
Stream Slope (%)	2.2	Inlet Drop	No
Beaver Activity	Yes	Slope (%)	1.5
Habitat Value	Medium	Valley Fill	Deep Fill
Final score	29	Barrier Result	Barrier
Fix type	Replace with New Open Bottom Structure	Fix Span / Diameter	18

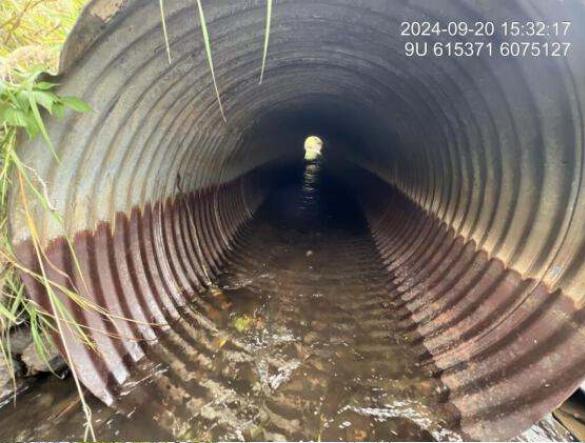
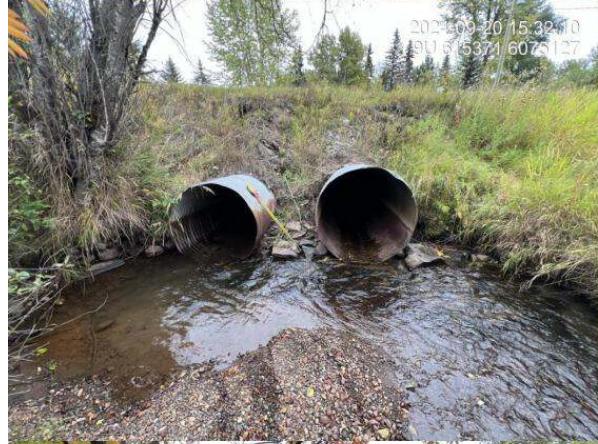
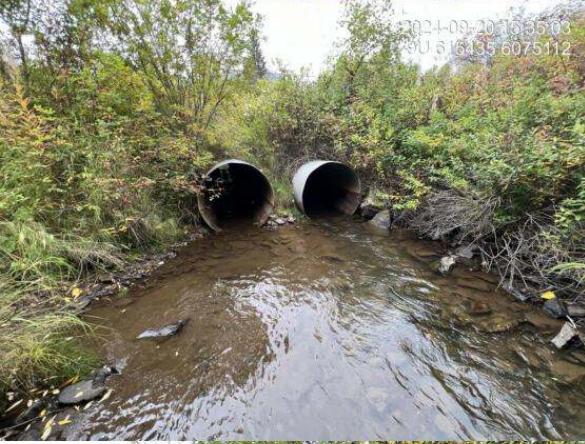
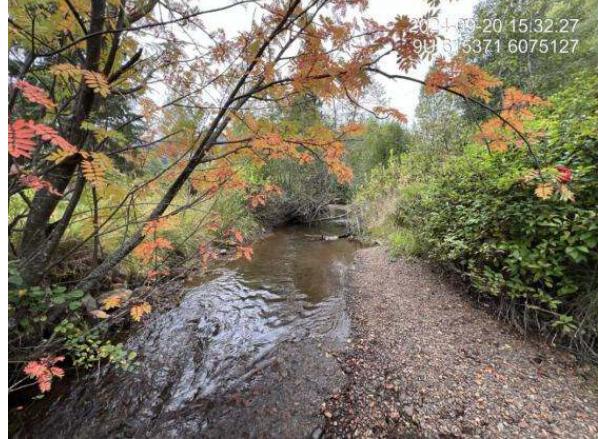
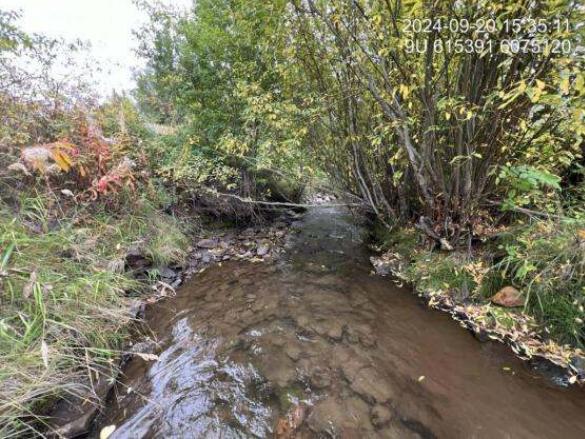
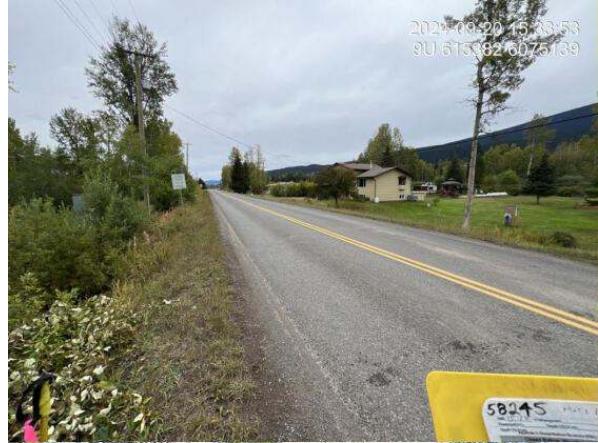
Location and Stream Data	Crossing Characteristics
<p>Comments: Two 1.25 m pipes are present and are heavily corroded. Upstream and downstream, the streambanks are heavily modified adjacent to private land, including riparian vegetation removal, stream channelization, and bank armouring. High-value steelhead, coho, and chinook spawning habitat is documented further upstream above the railway crossing. MoTi chris_culvert_id: 1514706, 1514705</p>	
Photos: From top left clockwise: Road/Site Card, Barrel, Outlet, Downstream, Upstream, Inlet.

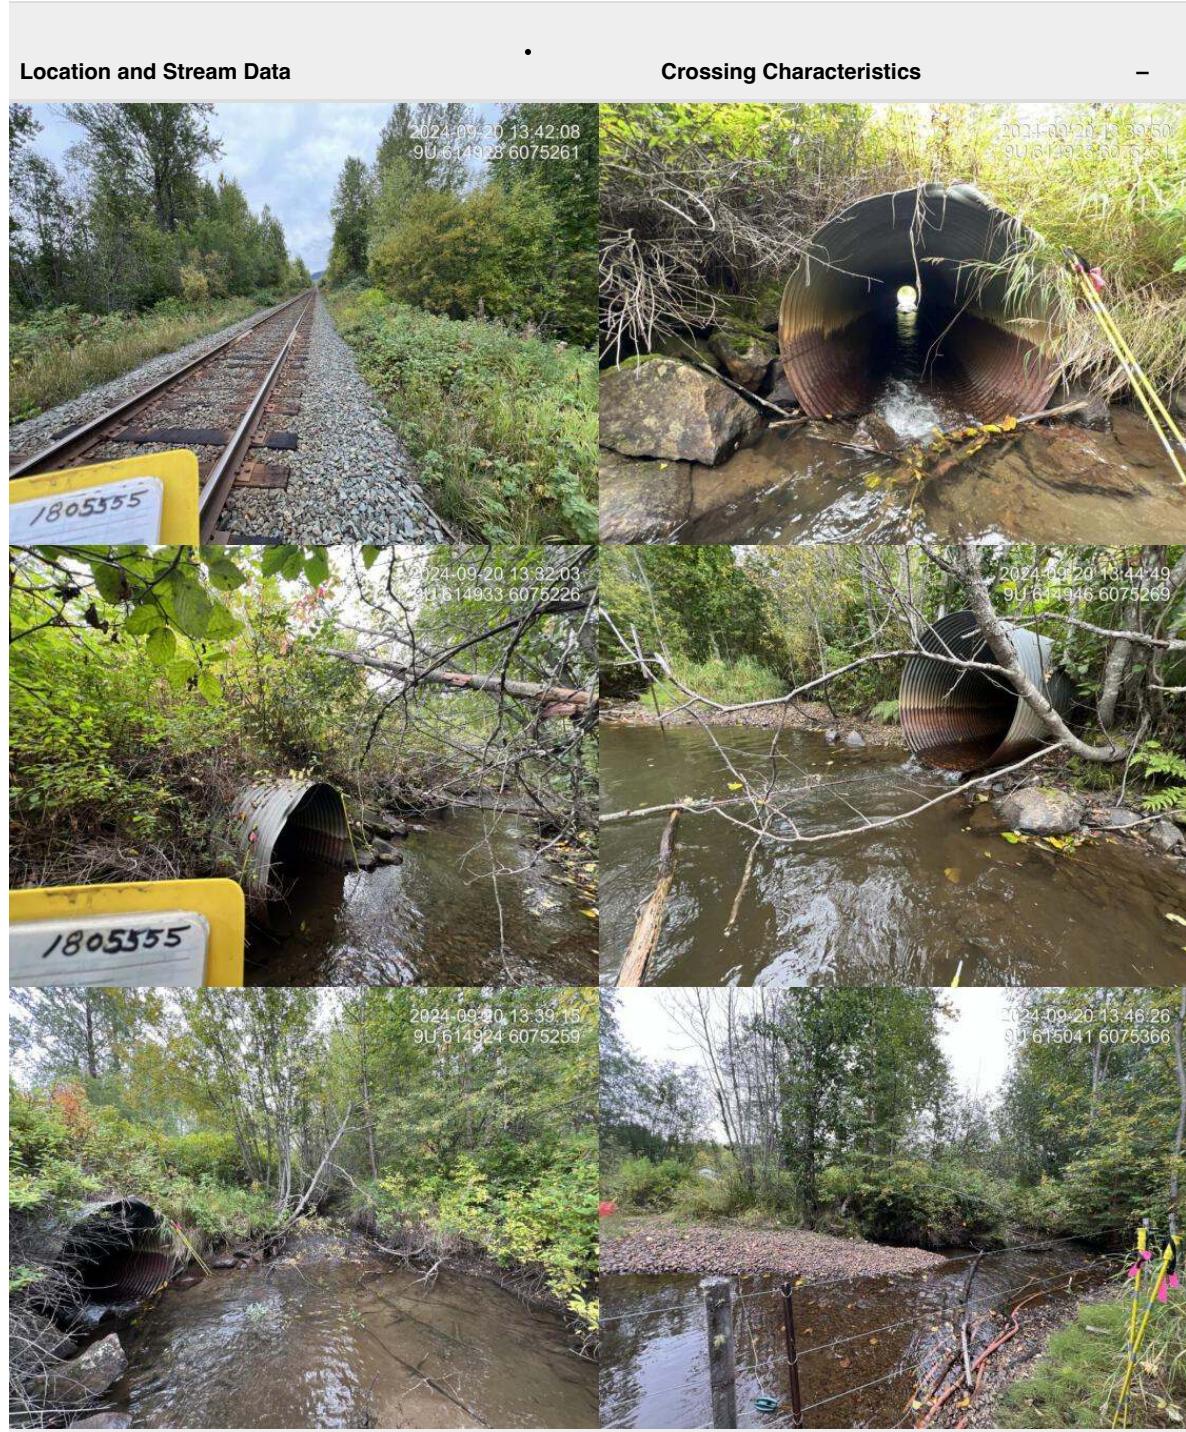
Photos: From top left clockwise: Road/Site Card, Barrel, Outlet, Downstream, Upstream, Inlet.

Location and Stream Data		Crossing Characteristics	
Date	2024-09-20	Crossing Sub Type	Round Culvert
PSCIS ID	203122	Diameter (m)	3
External ID	–	Length (m)	25
Crew	AI	Embedded	No
UTM Zone	9	Depth Embedded (m)	–
Easting	614941	Resemble Channel	Yes
Northing	6075232	Backwatered	No
Stream	Simpson Creek	Percent Backwatered	–
Road	Railway	Fill Depth (m)	1
Road Tenure	CN Rail	Outlet Drop (m)	0.05
Channel Width (m)	5	Outlet Pool Depth (m)	0.9
Stream Slope (%)	1	Inlet Drop	Yes
Beaver Activity	Yes	Slope (%)	2
Habitat Value	High	Valley Fill	Deep Fill
Final score	24	Barrier Result	Barrier
Fix type	Replace with New Open Bottom Structure	Fix Span / Diameter	15
Comments: Although this culvert is on Simpson Creek, it is not currently conveying the main flow and remains mostly dry. Two 1.5 m diameter pipes run under the railway, approximately 30 m apart. The southern pipe is fully embedded with an average embedment depth of 25 cm, while the northern pipe is currently passing all stream flow. This is a high-value stream with extensive gravel areas suitable for steelhead, coho, and chinook salmon spawning upstream. The adjacent landowner has reported recent observations of steelhead spawning and has historical knowledge of chinook spawning approximately 300 m downstream from Nielsen Road.

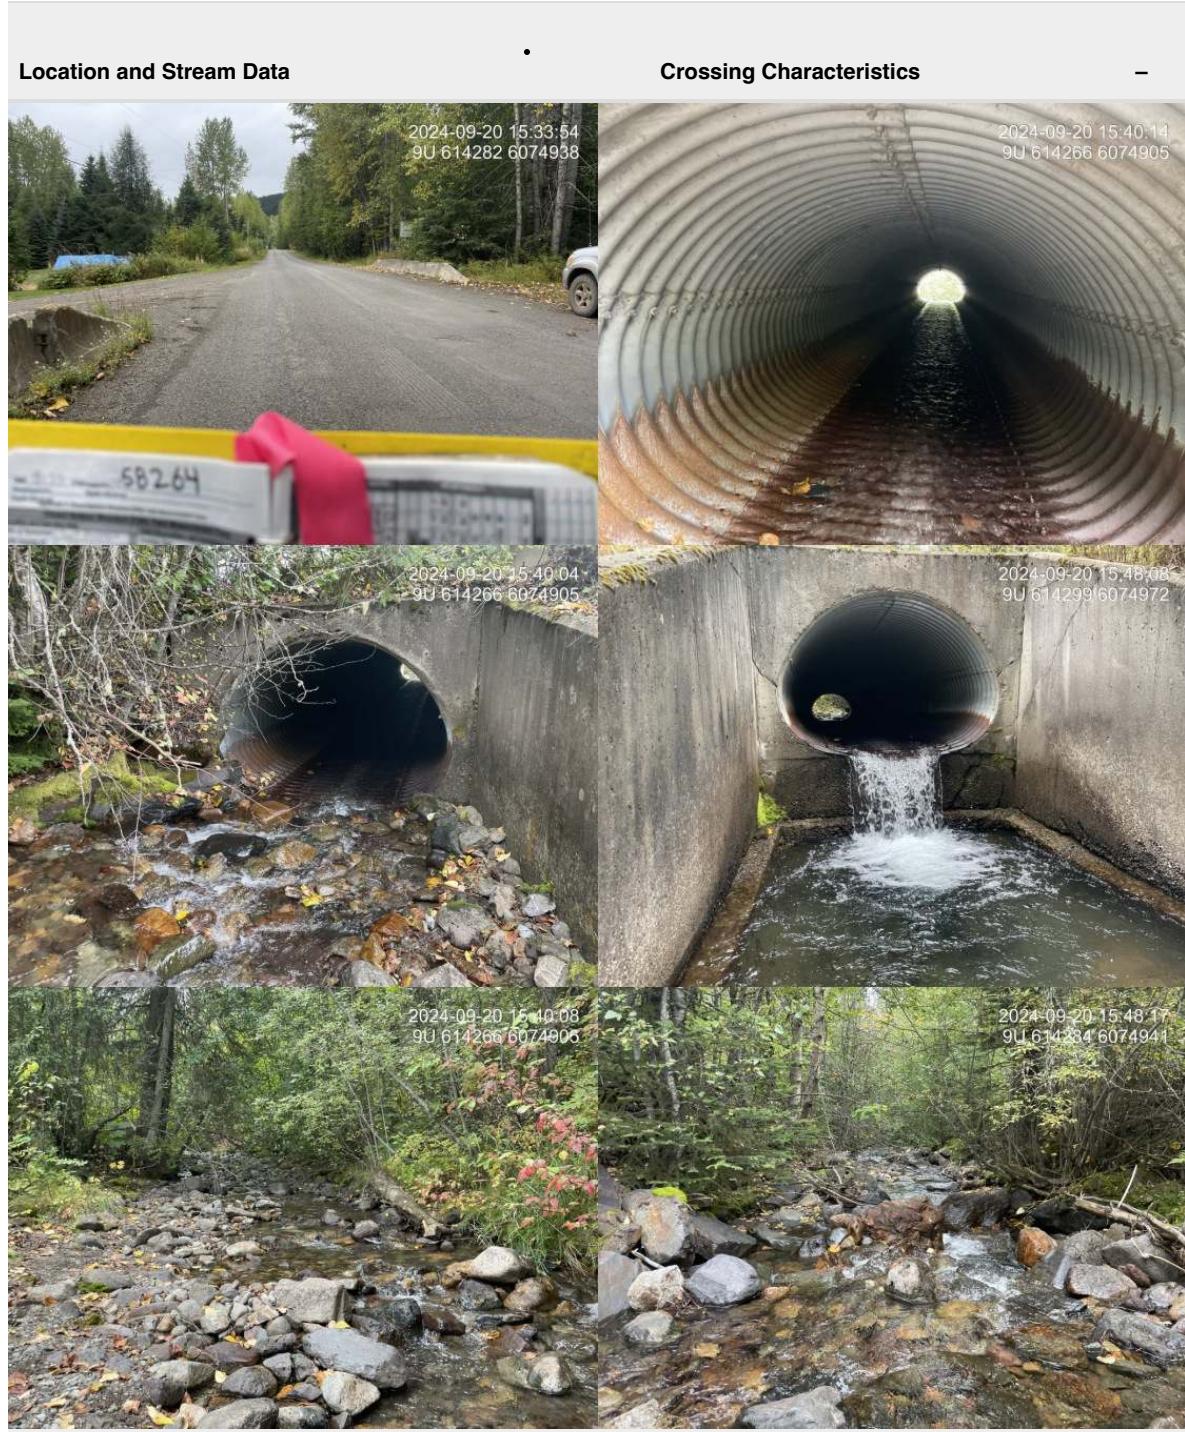
Comments: This concrete oval culvert has a significant 1 m outlet drop, likely inhibiting fish passage. The stream is incorrectly mapped in the Freshwater Atlas, located south of the mapped channel. Upstream habitat includes boulder cover, gravel pockets suitable for coho, steelhead, and Dolly Varden spawning, and a healthy mature mixed forest riparian zone. Downstream habitat transitions to lower-gradient, high-value conditions with extensive gravels, deep pools (up to 90 cm), large woody debris, and abundant cover, supporting recent steelhead and historically chinook spawning, as reported by the adjacent landowner. Habitat confirmations were completed at this site and all downstream crossings to the confluence with Kathlyn Creek. The stream is a major contributor to the greater Kathlyn Creek watershed, with flow volumes during the assessment slightly less than the Kathlyn Creek mainstem. Electrofishing upstream of Nielsen Road captured rainbow trout, while downstream sampling confirmed the presence of Dolly Varden, rainbow trout, cutthroat trout/rainbow trout hybrids, and coho. The coho were captured approximately 350 m downstream of Nielsen Road. According to the landowner, this crossing was originally a bridge but was replaced with the current culvert during an emergency flood event in the 1990s.

Photos: From top left clockwise: Road/Site Card, Barrel, Outlet, Downstream, Upstream, Inlet.

Should restoration/maintenance activities proceed, replacement of the Nielson Road crossing (58264) with a bridge (15 m span) is recommended. The significant 1 m outlet drop at this crossing, combined with the presence of salmonids in the system, makes it a top priority for remediation. At the time of reporting in 2025, the cost of the work is estimated at \$ 3,000,000.

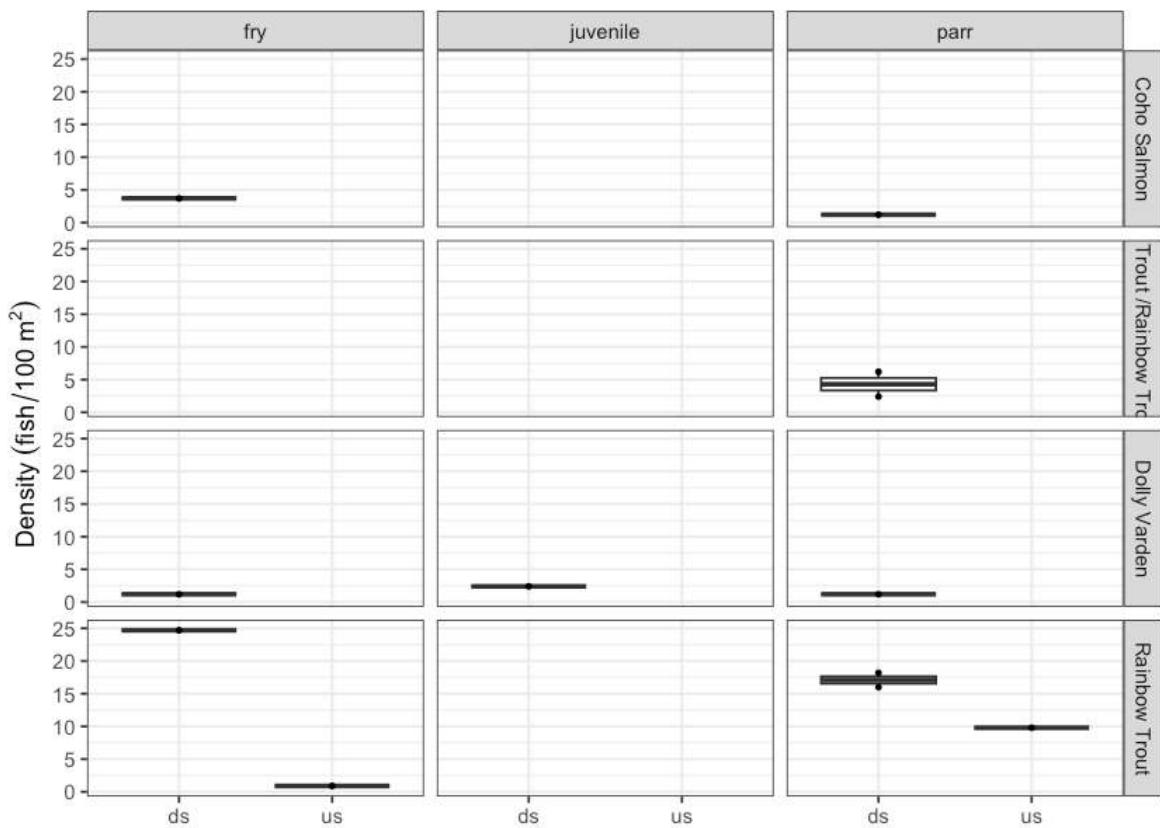
Electrofishing was conducted upstream and downstream of crossing (58264) with results summarised in Tables 5.23 - 5.24 and Figure 5.15. A total of 20 fish were captured downstream including rainbow trout, cutthroat trout/rainbow trout hybrid, and Dolly Varden. Upstream of the crossing 12 rainbow trout were captured (Figure 5.18) .

Figure 5.15: Densities of fish (fish/100m<sup>2</sup>) captured upstream and downstream of PSCIS crossing 58264.

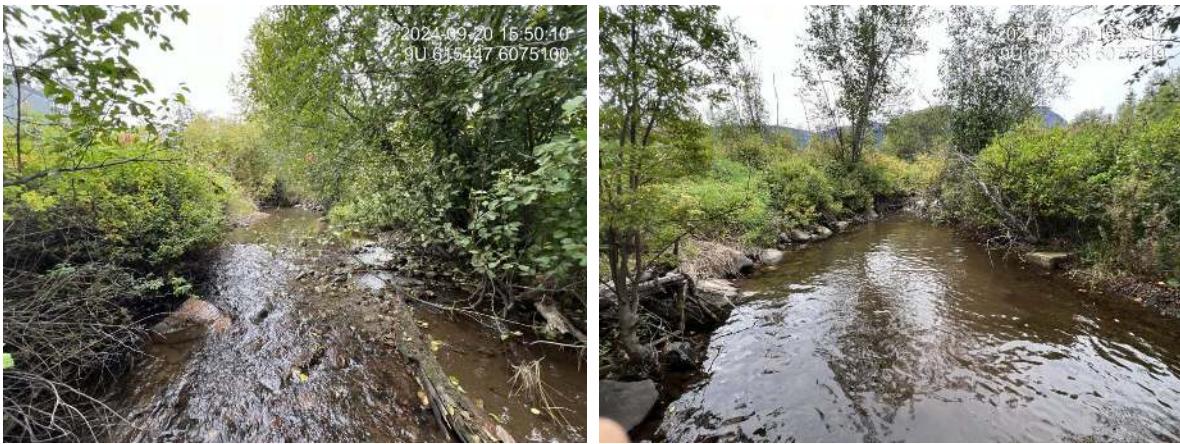
Figure 5.16: Left: Typical habitat downstream of PSCIS crossing 58245. Right: Typical habitat upstream of PSCIS crossing 58245 and downstream of PSCIS crossing 203122, with signs of bank armouring and channelization.
