## **Skeena Watershed Fish Passage Restoration Planning 2024**

Prepared for  
Habitat Conservation Trust Foundation - CAT23-6-288  
BC Fish Passage Remediation Program  
Ministry of Transportation and Infrastructure

Prepared by  
Al Irvine, B.Sc., R.P.Bio and Lucy Schick, B.Sc.  
New Graph Environment Ltd.  
on behalf of  
Society for Ecosystem Restoration in Northern British Columbia

DRAFT Version 0.1.1 2025-04-16

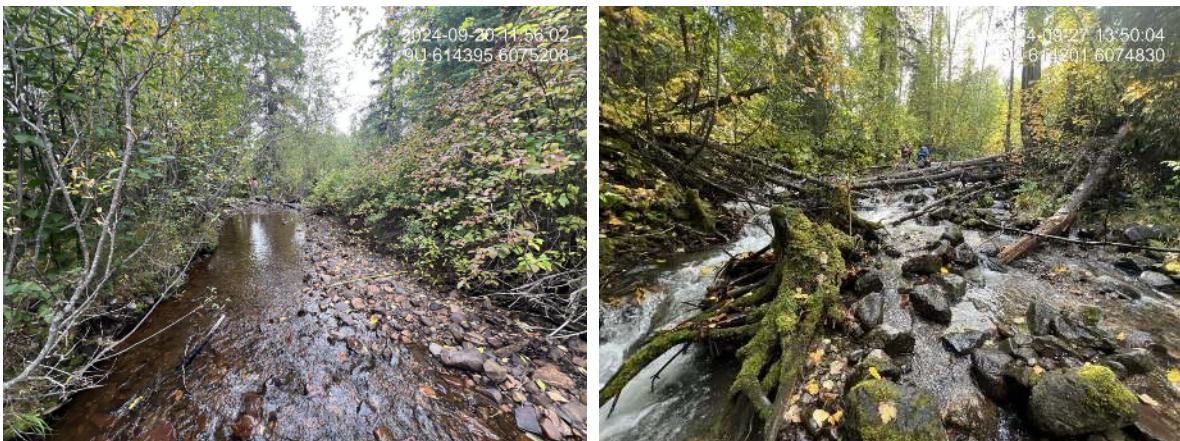
The stream was surveyed upstream from crossing 58264 for 615m . This section of the stream featured a steeper gradient, predominantly characterized by boulder cover with occasional pockets of gravels suitable for coho, steelhead, and Dolly Varden spawning (Figure 5.17). Pools were infrequent throughout. The riparian zone was composed of a healthy, mature mixed forest, providing stability and shading. The upper end of the site was situated just upstream of a short cascade with a 20% gradient. The habitat was rated as medium value for salmonid rearing and spawning. Total cover amount was rated as moderate with boulders dominant. Cover was also present as large woody debris. The dominant substrate was cobbles with boulders sub-dominant. The average channel width was 8.9m, the average wetted width was 4.7m, and the average gradient was 7.3%.

Figure 5.17: Left: Steelhead spawning location upstream of PSCIS crossing 203122 and downstream of PSCIS crossing 58264, as reported by the adjacent landowner. Right: Typical habitat upstream of PSCIS crossing 58264.

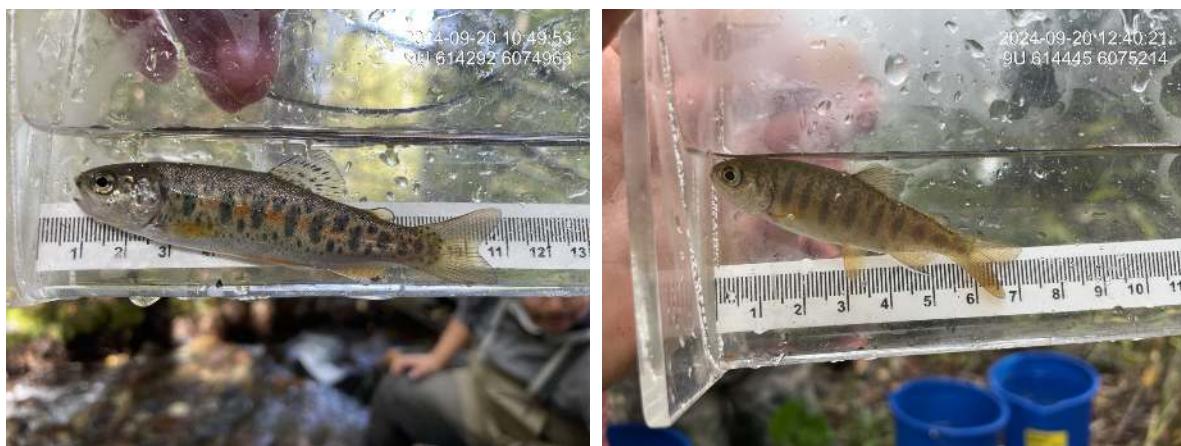
Electrofishing was conducted upstream and downstream of crossing (58264) with results summarised in Tables 5.23 - 5.24 and Figure 5.15. A total of 20 fish were captured downstream including rainbow trout, cutthroat trout/rainbow trout hybrid, and Dolly Varden. Upstream of the crossing 12 rainbow trout were captured (Figure 5.18) .

Electrofishing was conducted at one site approximately 360 m downstream of Nielsen Road, with results summarised in Tables 5.23 - 5.24 and Figure 5.15. At this location, the adjacent landowner had reported recent steelhead and coho spawning and historically Chinook spawning. A total of 43 fish were captured including coho salmon, cutthroat trout/rainbow trout hybrid, and Dolly Varden (Figure 5.18).

Figure 5.18: Left: Rainbow trout captured downstream of crossing 58264. Right: Coho salmon captured approximately 360 m downstream of crossing 58264.
