Skeena Watershed Fish Passage Restoration Planning 2024

Prepared for
Habitat Conservation Trust Foundation - CAT23-6-288
BC Fish Passage Remediation Program
Ministry of Transportation and Infrastructure

DRAFT Version 0.1.0 2025-03-30

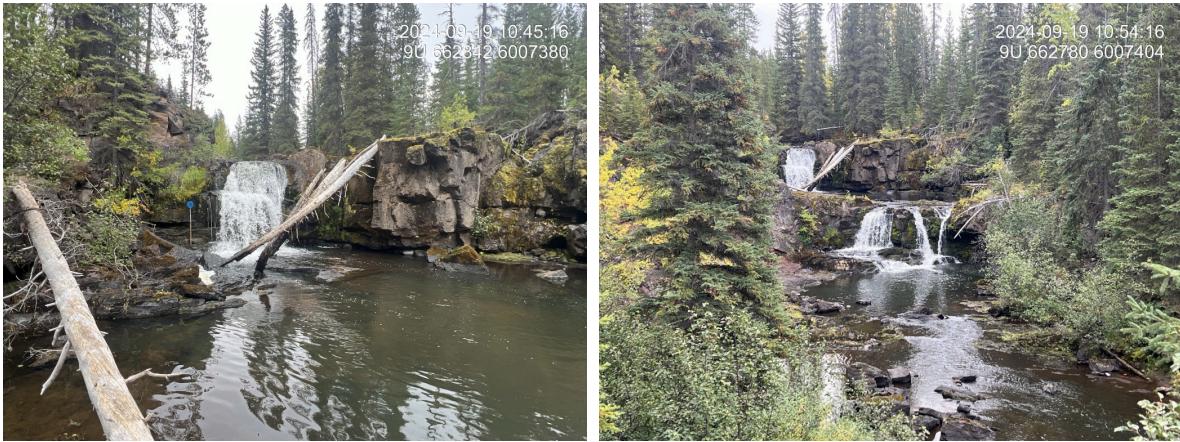
Figure 4.4: Left: Buck Falls – The upper falls featured a ~4m high vertical drop. A 2m tall net is included for scale. Right: Buck Falls – The second falls consisted of a ~3.5m high sheer drop to bedrock.

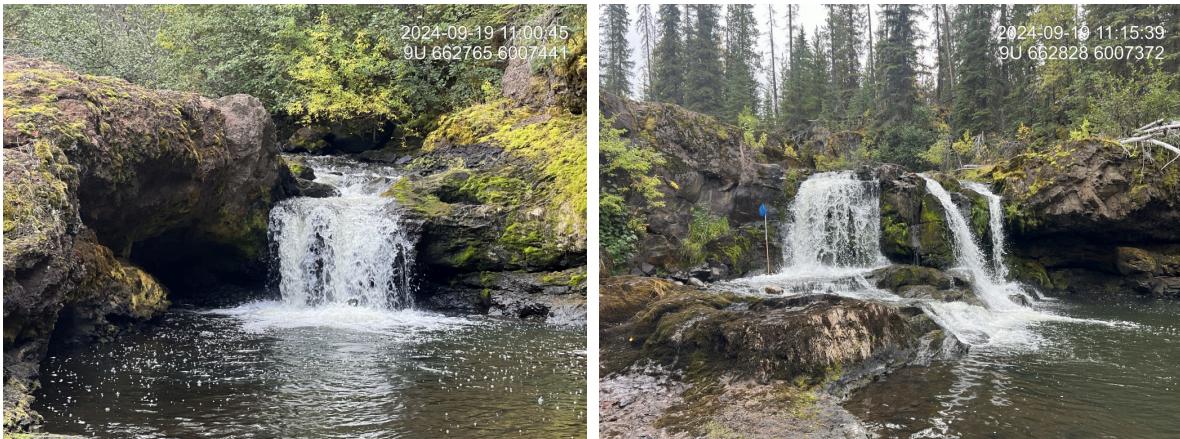
Figure 4.5: Left: Buck Falls – The third step consisted of a ~1.5 m vertical drop with an overlying cascade, exhibiting a ~15% gradient over a 1.0m height. Right: Buck Falls – An additional cascade featured a ~2m high drop with a ~30% gradient extending over a 5 m length. A 2m tall net is included for scale.

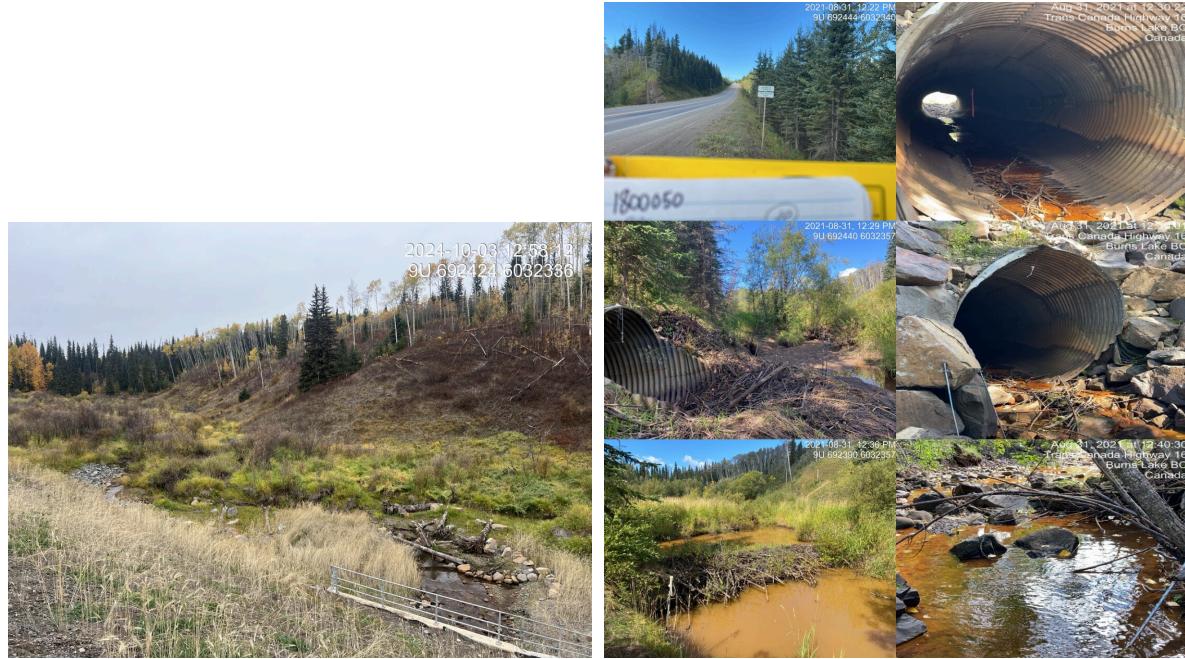
Figure 4.6: Left: Woody debris and boulder structures located upstream of 197967 in 2024. Right: Photos of crossing 197967 in 2021.

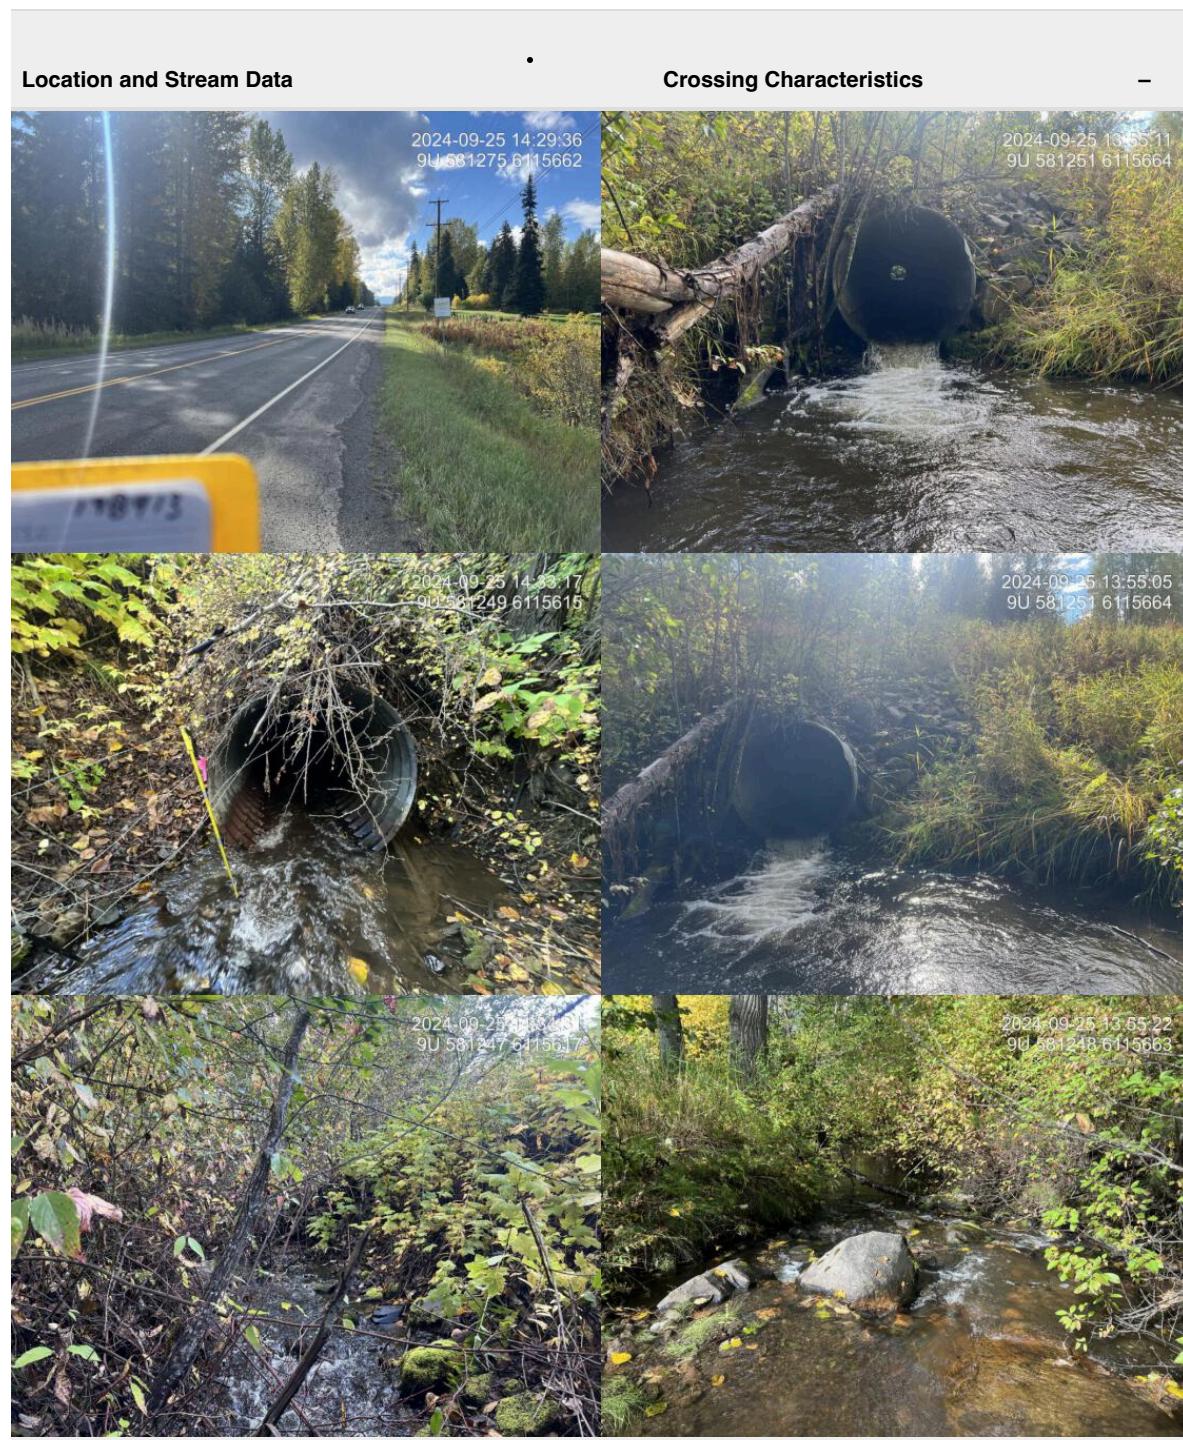
Location and Stream Data		Crossing Characteristics	
Date	2024-09-25	Crossing Sub Type	Round Culvert
PSCIS ID	198913	Diameter (m)	1.5
External ID	-	Length (m)	40
Crew	AI JO	Embedded	No
UTM Zone	9	Depth Embedded (m)	-
Easting	581250	Resemble Channel	-
Northing	6115660	Backwatered	No
Stream	Gershwin Creek	Percent Backwatered	-
Road	Highway 16	Fill Depth (m)	2.5
Road Tenure	MOTi	Outlet Drop (m)	0.35
Channel Width (m)	5	Outlet Pool Depth (m)	0.85
Stream Slope (%)	3	Inlet Drop	No
Beaver Activity	No	Slope (%)	3
Habitat Value	Medium	Valley Fill	Deep Fill
Final score	42	Barrier Result	Barrier
Fix type	Replace with New Open Bottom Structure	Fix Span / Diameter	15

There is a deep outlet pool, suggesting the culvert is undersized for the stream. High-quality gravels were present at the pool's outlet, and upstream of the crossing, there was high-value habitat with frequent overwintering pools, spawning gravels, and adequate riparian cover with large cottonwoods throughout. This site was part of a habitat confirmation assessment, with the stream surveyed from the downstream railway crossing up to this location and an additional 600 m upstream. Downstream, crossing 198916 consists of a large, long box culvert beneath the railway with minimal flow depth and a swift current, making it unlikely that fish from the mainstem of the Skeena River can access this site until the railway barrier is addressed. Fish sampling at this site captured cutthroat trout and Dolly Varden. MoTi chris_culvert_id: 8300872

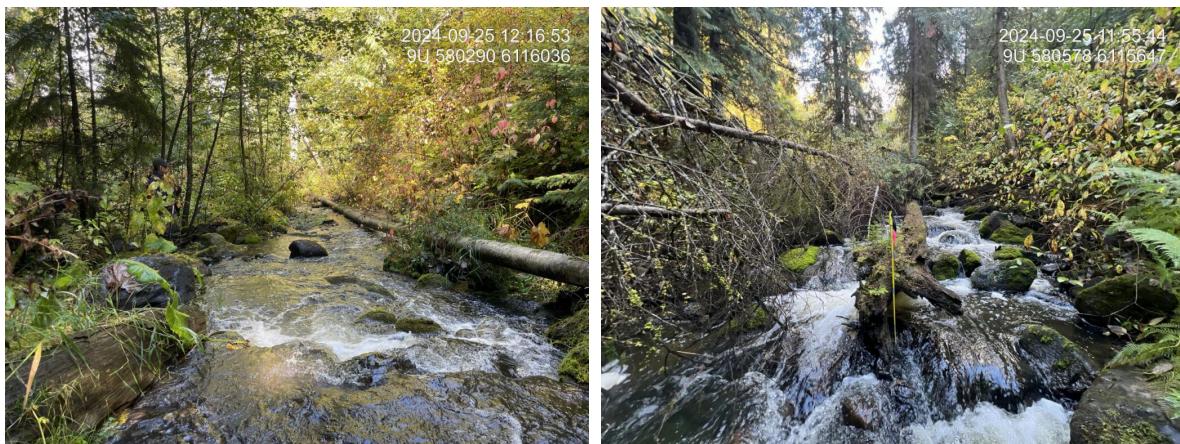
Figure 4.10: Left: Typical habitat downstream of PSCIS crossing 198916. Right: Typical habitat upstream of PSCIS crossing 198916.

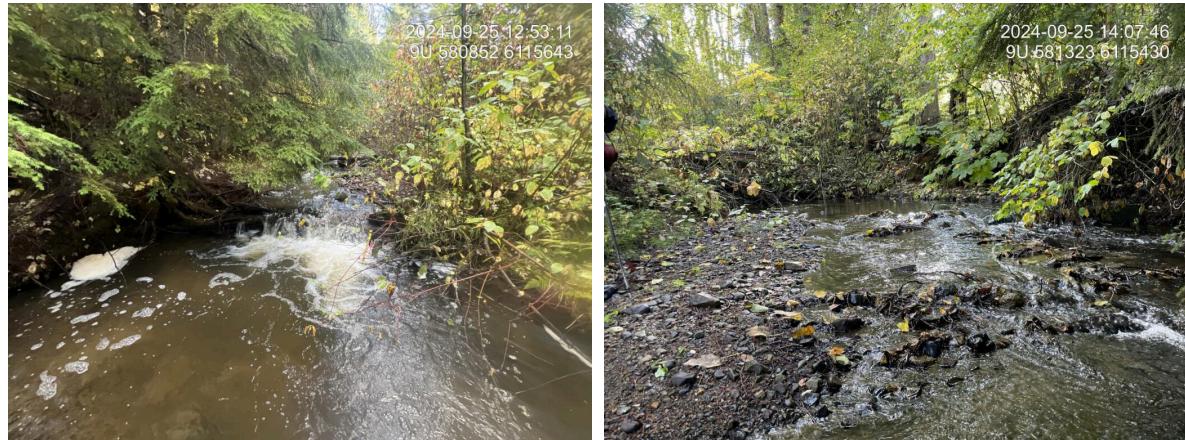
Figure 4.11: Left: Typical habitat downstream of PSCIS crossing 198913. Right: Typical habitat upstream of PSCIS crossing 198913.

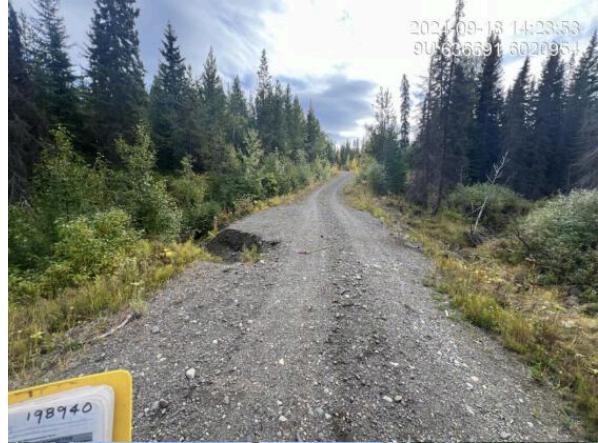
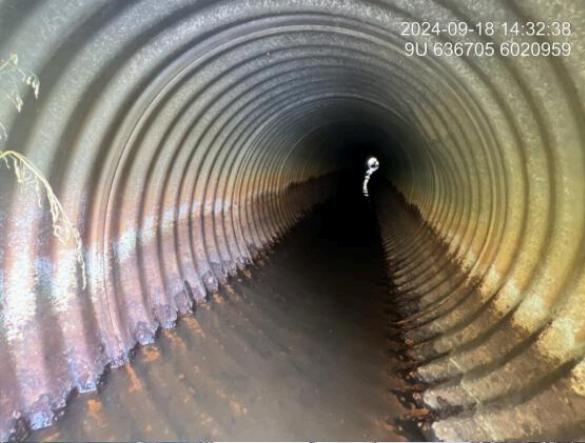
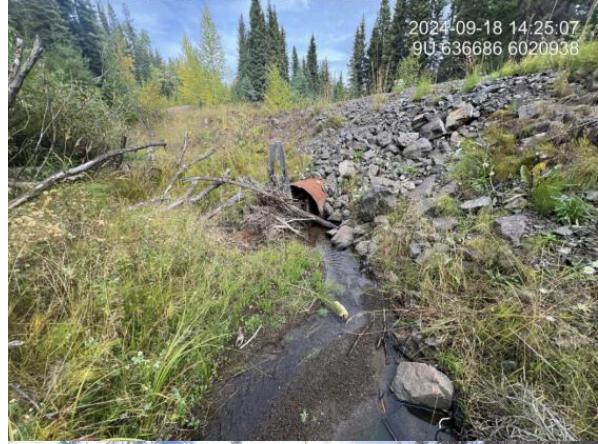
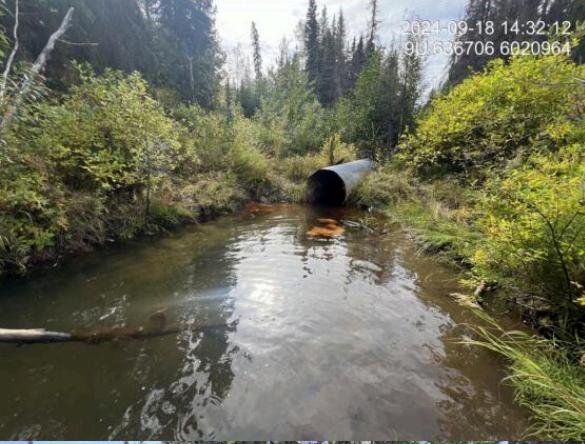
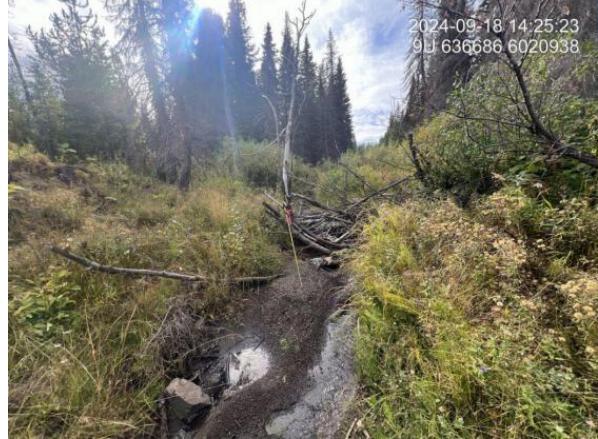
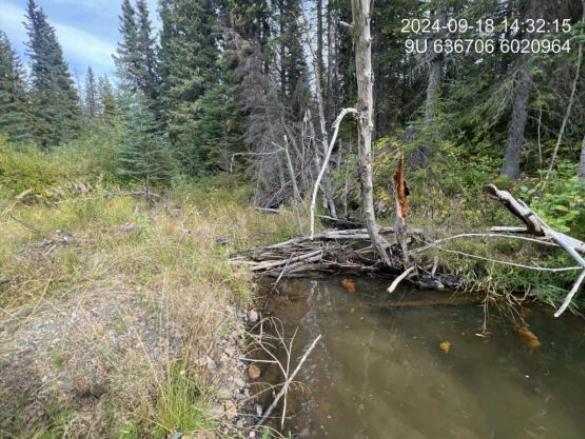
Location and Stream Data		Crossing Characteristics	
Date	2024-09-18	Crossing Sub Type	Round Culvert
PSCIS ID	198940	Diameter (m)	0.95
External ID	–	Length (m)	25
Crew	AI	Embedded	No
UTM Zone	9	Depth Embedded (m)	–
Easting	636706	Resemble Channel	–
Northing	6020960	Backwatered	Yes
Stream	Tributary to Knapper Creek	Percent Backwatered	30
Road	HM7504	Fill Depth (m)	1.75
Road Tenure	Canfor R07549 16	Outlet Drop (m)	0
Channel Width (m)	4.3	Outlet Pool Depth (m)	0.9
Stream Slope (%)	3	Inlet Drop	Yes
Beaver Activity	Yes	Slope (%)	2
Habitat Value	Medium	Valley Fill	Deep Fill
Final score	24	Barrier Result	Barrier
Fix type	Replace with New Open Bottom Structure	Fix Span / Diameter	15

Location and Stream Data	Crossing Characteristics
<p>Comments: Very nice stream with good flow, abundant gravels for spawning, and undercut banks and occasional deep pools for rearing. Confirmed populations of cutthroat trout, rainbow trout, and Dolly Varden. The culvert is significantly undersized for the stream, and the road appears to be failing, likely due to a partially clogged inlet and spring freshet. Habitat confirmations were completed for this crossing and the next upstream crossing (198935) on the Gold FSR.</p>	
<p>Photos: From top left clockwise: Road/Site Card, Barrel, Outlet, Downstream, Upstream, Inlet.</p>

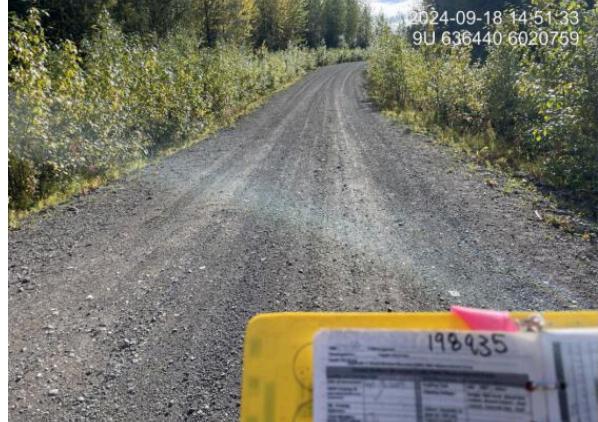
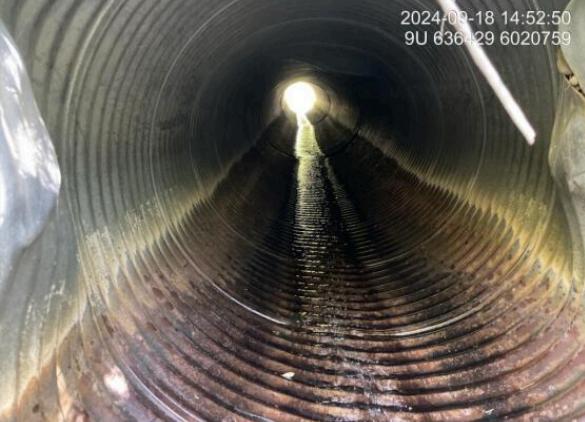
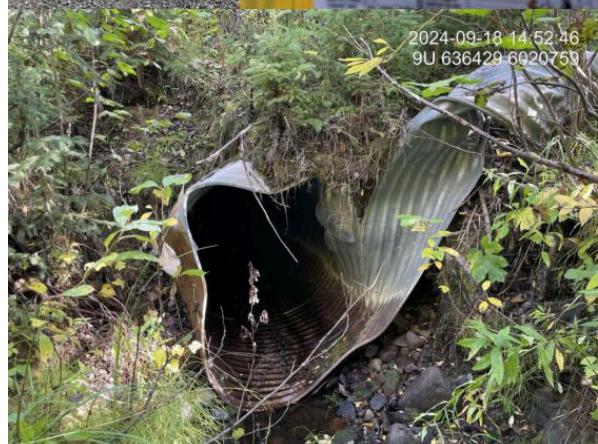
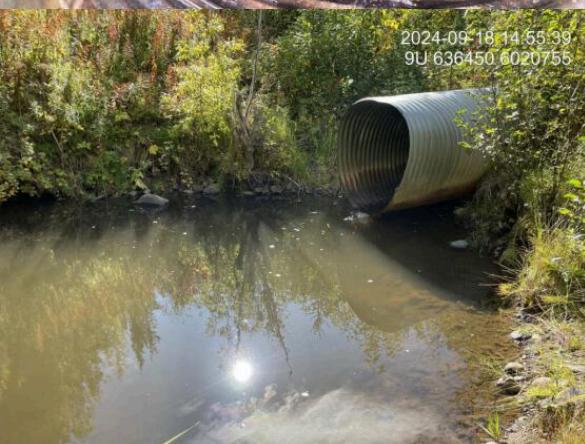
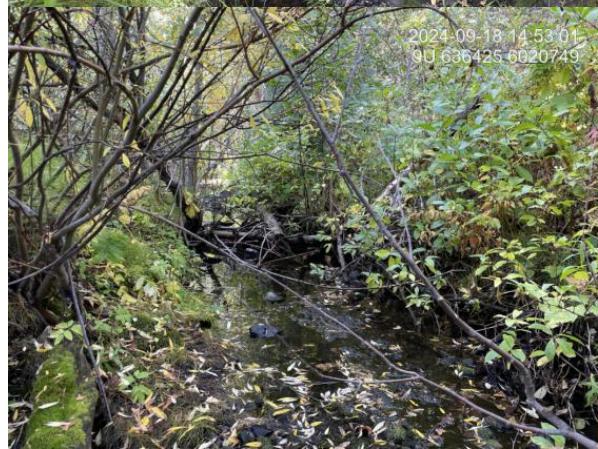
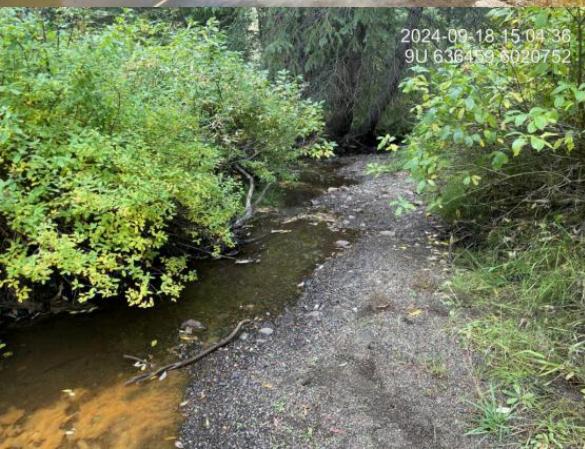
Location and Stream Data	Crossing Characteristics
<p>Comments: The culvert is deteriorating at the inlet. Large outlet pool where fish were captured during sampling. The stream flows from the outlet pool along the left-hand side into a well-defined channel with gravels suitable for spawning and several pools, providing good habitat. A moderate amount of road fill is present.</p>	
<p>Photos: From top left clockwise: Road/Site Card, Barrel, Outlet, Downstream, Upstream, Inlet.</p>

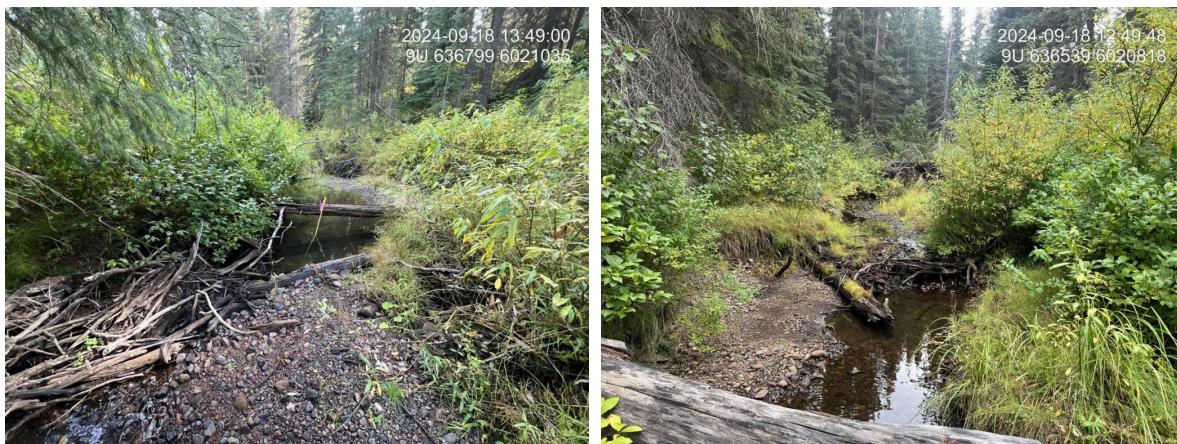
Should restoration activities proceed, efforts should focus on PSCIS crossing [as.character\(my_site2\)](#) on Gold Creek FSR, which had a small outlet drop and a deep outlet pool. PSCIS crossing 198940 on Road/Spur HM7504 was backwatered and not presumed to be a barrier to fish passage. Both crossings were noted as undersized for the stream.

Figure 4.15: Left: Typical habitat downstream of PSCIS crossing 198940. Right: Typical habitat upstream of PSCIS crossing 198940.

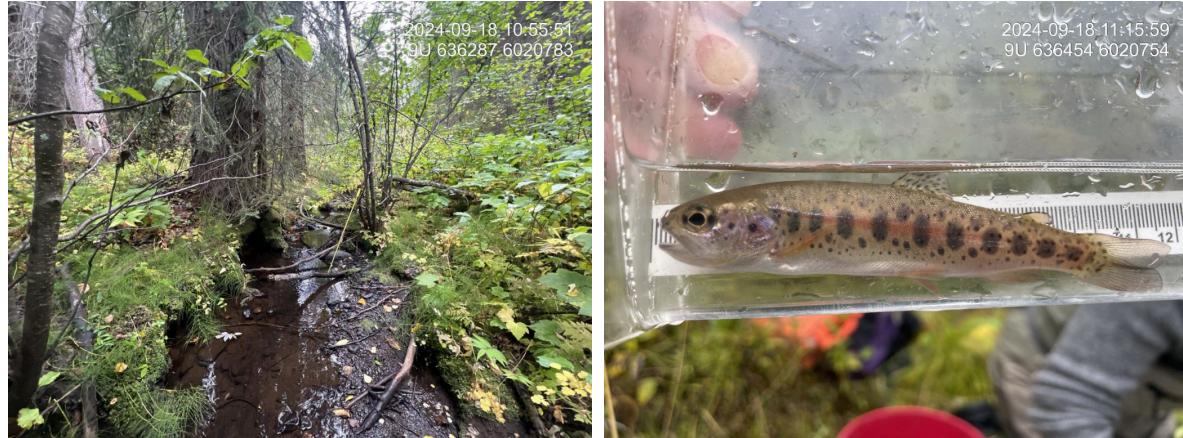
Figure 4.16: Left: Typical habitat upstream of PSCIS crossing 198935. Right: Rainbow trout captured downstream of crossing 198935.

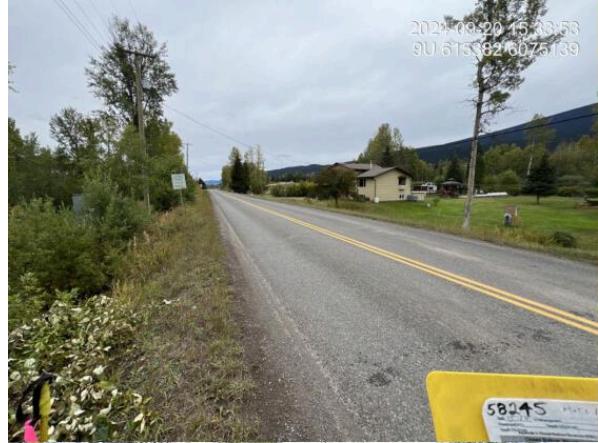
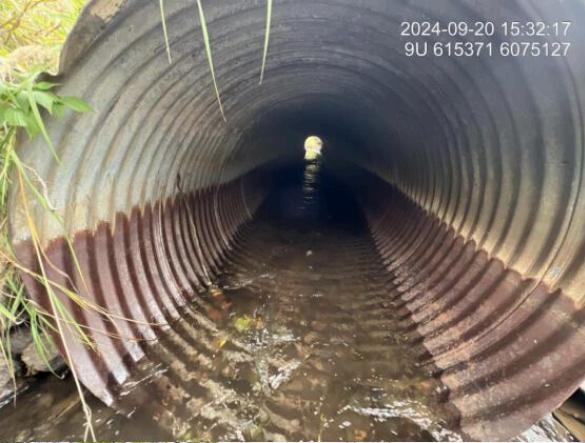
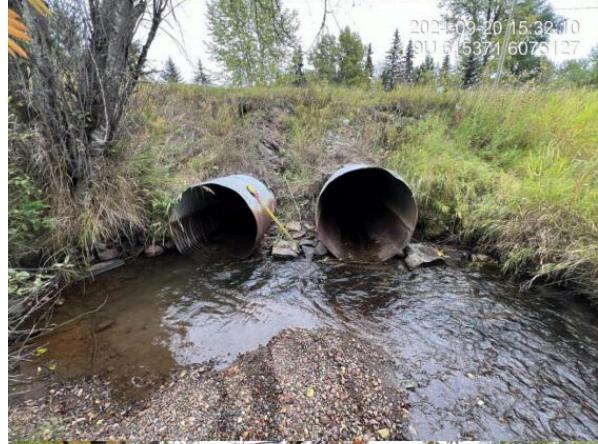
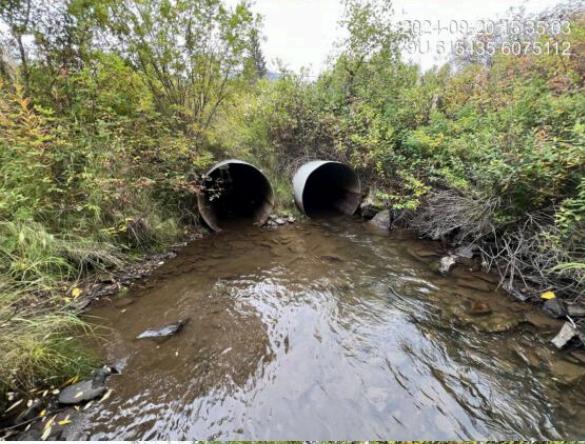
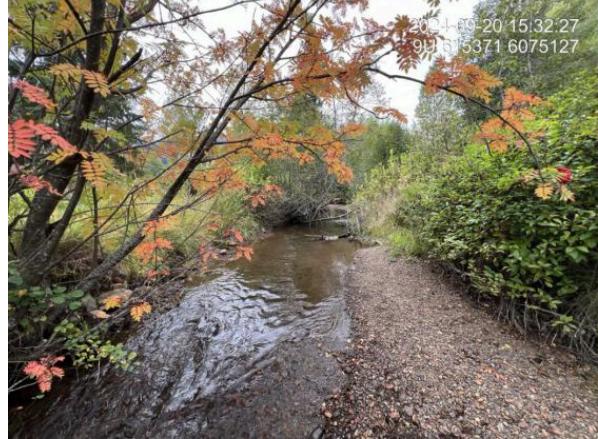
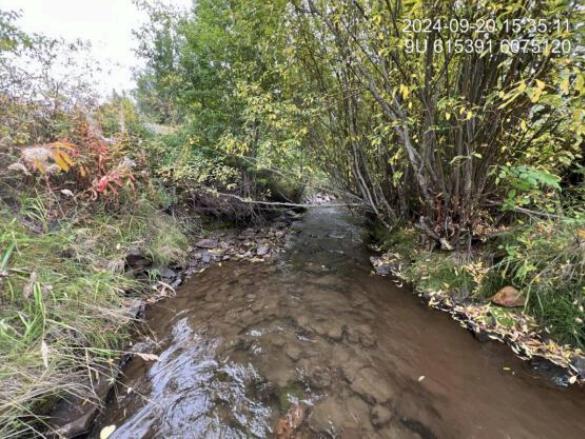
Location and Stream Data	Crossing Characteristics
<p>Comments: Two 1.25 m pipes are present and are heavily corroded. Upstream and downstream, the streambanks are heavily modified adjacent to private land, including riparian vegetation removal, stream channelization, and bank armouring. High-value steelhead, coho, and chinook spawning habitat is documented further upstream above the railway crossing. MoTi chris_culvert_id: 1514706, 1514705</p>	
Photos: From top left clockwise: Road/Site Card, Barrel, Outlet, Downstream, Upstream, Inlet.

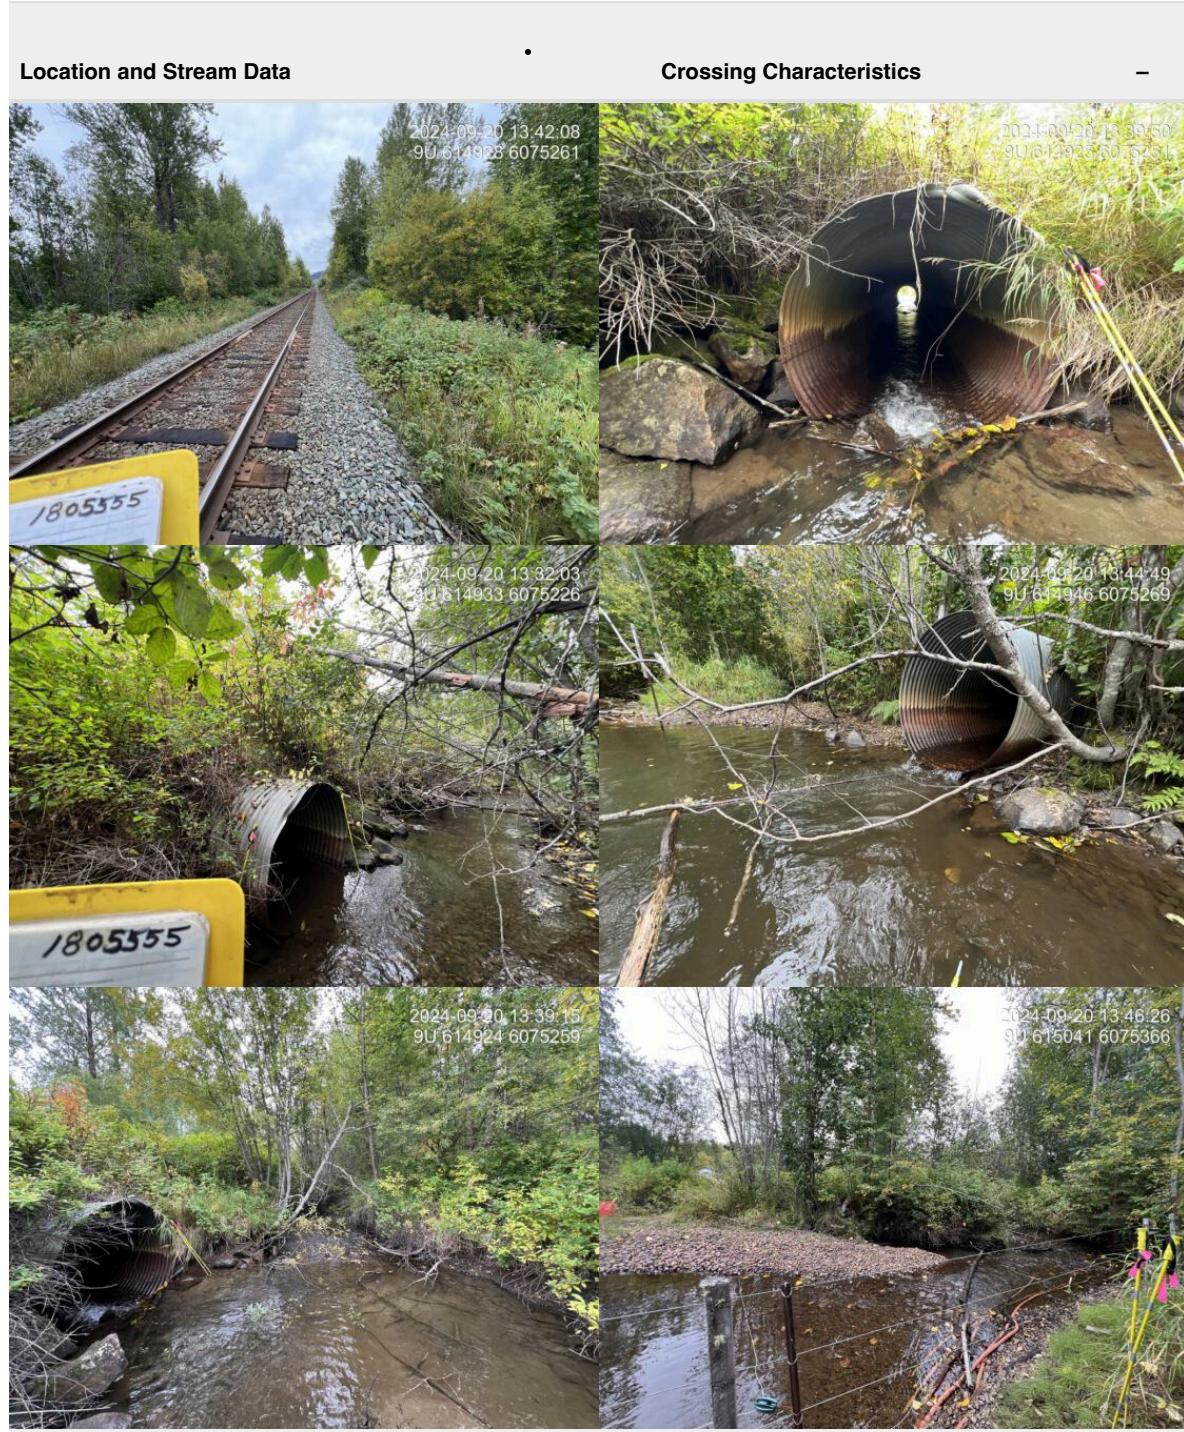
Location and Stream Data		Crossing Characteristics	
Date	2024-09-20	Crossing Sub Type	Round Culvert
PSCIS ID	203122	Diameter (m)	3
External ID	–	Length (m)	25
Crew	AI	Embedded	No
UTM Zone	9	Depth Embedded (m)	–
Easting	614941	Resemble Channel	Yes
Northing	6075232	Backwatered	No
Stream	Simpson Creek	Percent Backwatered	–
Road	Railway	Fill Depth (m)	1
Road Tenure	CN Rail	Outlet Drop (m)	0.05
Channel Width (m)	5	Outlet Pool Depth (m)	0.9
Stream Slope (%)	1	Inlet Drop	Yes
Beaver Activity	Yes	Slope (%)	2
Habitat Value	High	Valley Fill	Deep Fill
Final score	24	Barrier Result	Barrier
Fix type	Replace with New Open Bottom Structure	Fix Span / Diameter	15
Comments: Although this culvert is on Simpson Creek, it is not currently conveying the main flow and remains mostly dry. Two 1.5 m diameter pipes run under the railway, approximately 30 m apart. The southern pipe is fully embedded with an average embedment depth of 25 cm, while the northern pipe is currently passing all stream flow. This is a high-value stream with extensive gravel areas suitable for steelhead, coho, and chinook salmon spawning upstream. The adjacent landowner has reported recent observations of steelhead spawning and has historical knowledge of chinook spawning approximately 300 m downstream from Nielsen Road.

Photos: From top left clockwise: Road/Site Card, Barrel, Outlet, Downstream, Upstream, Inlet.

PSCIS crossing 203122 on the CN Railway presented a minimal barrier to fish passage and is considered a low priority for replacement. However, if restoration activities are undertaken, replacing the existing structure with a bridge spanning 15 m is recommended. As of 2025, the estimated replacement cost is \$ 11,250,000, with the high cost attributed to the complexities of working within a railway corridor.

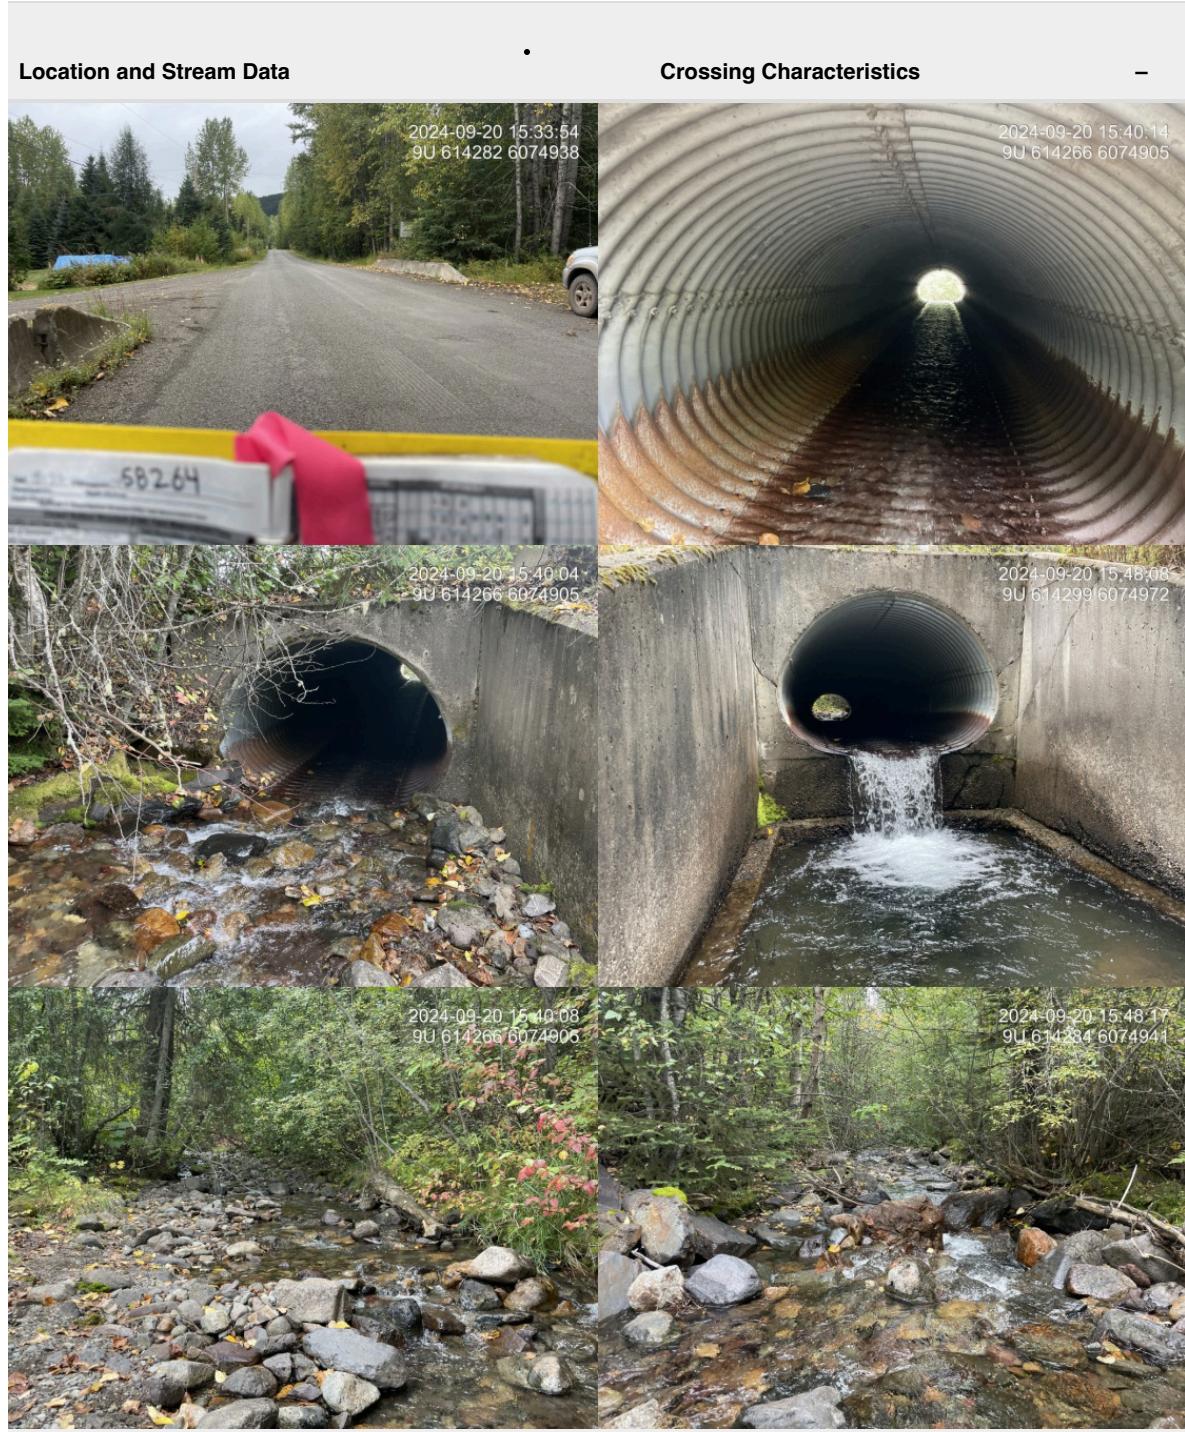
Location and Stream Data		Crossing Characteristics	
Date	2024-09-20	Crossing Sub Type	Oval Culvert
PSCIS ID	58264	Diameter (m)	2.4
External ID	–	Length (m)	23
Crew	LS TP	Embedded	No
UTM Zone	9	Depth Embedded (m)	–
Easting	614280	Resemble Channel	–
Northing	6074951	Backwatered	No
Stream	Simpson Creek	Percent Backwatered	–
Road	Nielson Road	Fill Depth (m)	0.4
Road Tenure	MoTi	Outlet Drop (m)	1
Channel Width (m)	5.6	Outlet Pool Depth (m)	1.2
Stream Slope (%)	13	Inlet Drop	No
Beaver Activity	No	Slope (%)	5
Habitat Value	High	Valley Fill	Deep Fill
Final score	39	Barrier Result	Barrier
Fix type	Replace with New Open Bottom Structure	Fix Span / Diameter	15

Comments: This concrete oval culvert has a significant 1 m outlet drop, likely inhibiting fish passage. The stream is incorrectly mapped in the Freshwater Atlas, located south of the mapped channel. Upstream habitat includes boulder cover, gravel pockets suitable for coho, steelhead, and Dolly Varden spawning, and a healthy mature mixed forest riparian zone. Downstream habitat transitions to lower-gradient, high-value conditions with extensive gravels, deep pools (up to 90 cm), large woody debris, and abundant cover, supporting recent steelhead and historically chinook spawning, as reported by the adjacent landowner. Habitat confirmations were completed at this site and all downstream crossings to the confluence with Kathlyn Creek. The stream is a major contributor to the greater Kathlyn Creek watershed, with flow volumes during the assessment slightly less than the Kathlyn Creek mainstem. Electrofishing upstream of Nielsen Road captured rainbow trout, while downstream sampling confirmed the presence of Dolly Varden, rainbow trout, cutthroat trout/rainbow trout hybrids, and coho. The coho were captured approximately 350 m downstream of Nielsen Road. According to the landowner, this crossing was originally a bridge but was replaced with the current culvert during an emergency flood event in the 1990s.

Photos: From top left clockwise: Road/Site Card, Barrel, Outlet, Downstream, Upstream, Inlet.

Should restoration/maintenance activities proceed, replacement of the Nielson Road crossing (58264) with a bridge (15 m span) is recommended. The significant 1 m outlet drop at this crossing, combined with the presence of salmonids in the system, makes it a top priority for remediation. At the time of reporting in 2025, the cost of the work is estimated at \$ 3,000,000.

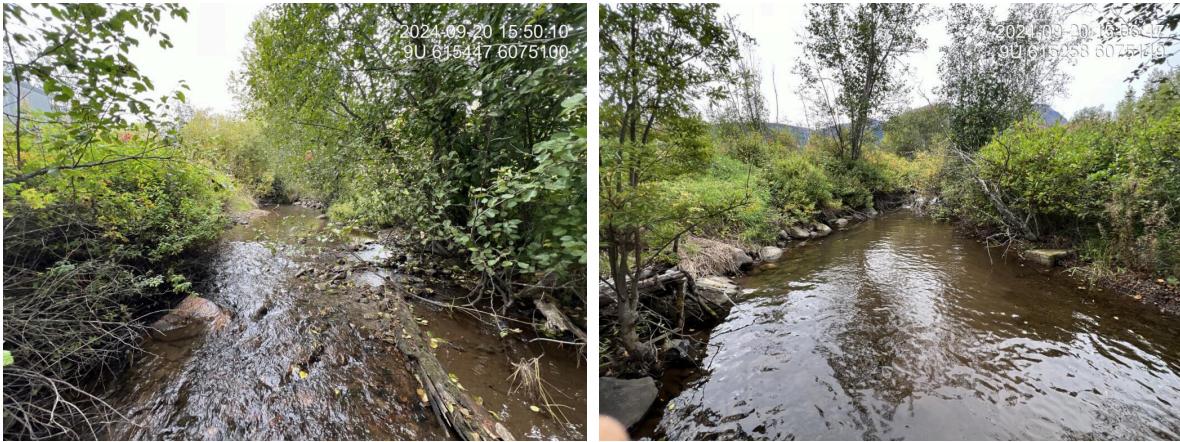
Figure 4.19: Left: Typical habitat downstream of PSCIS crossing 58245. Right: Typical habitat upstream of PSCIS crossing 58245 and downstream of PSCIS crossing 203122, with signs of bank armouring and channelization.

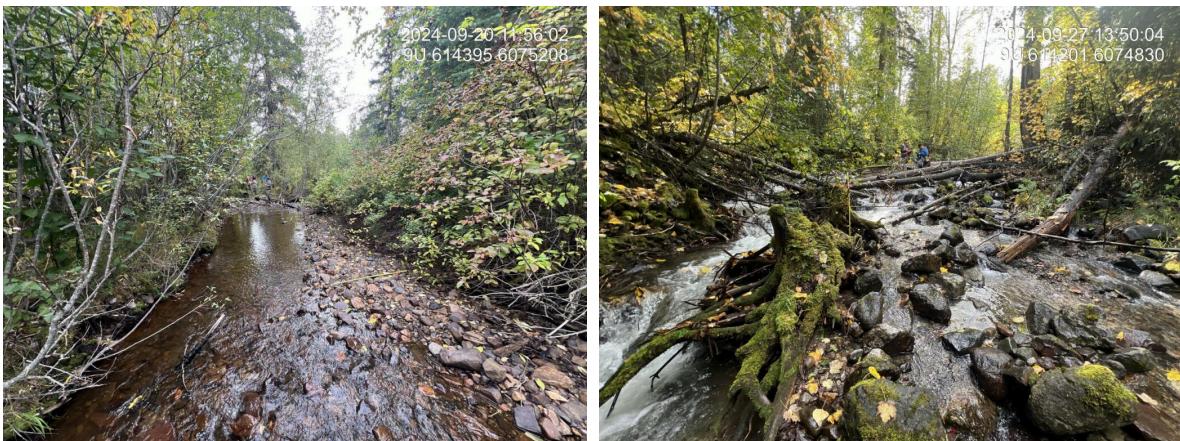
The stream was surveyed upstream from crossing 58264 for 615m . This section of the stream featured a steeper gradient, predominantly characterized by boulder cover with occasional pockets of gravels suitable for coho, steelhead, and Dolly Varden spawning (Figure 4.20). Pools were infrequent throughout. The riparian zone was composed of a healthy, mature mixed forest, providing stability and shading. The upper end of the site was situated just upstream of a short cascade with a 20% gradient. The habitat was rated as medium value for salmonid rearing and spawning. The dominant substrate was cobbles with boulders sub-dominant. Total cover amount was rated as moderate with boulders dominant. Cover was also present as large woody debris. The average channel width was 8.9m, the average wetted width was 4.7m, and the average gradient was 7.3%.

Figure 4.20: Left: Steelhead spawning location upstream of PSCIS crossing 203122 and downstream of PSCIS crossing 58264, as reported by the adjacent landowner. Right: Typical habitat upstream of PSCIS crossing 58264.

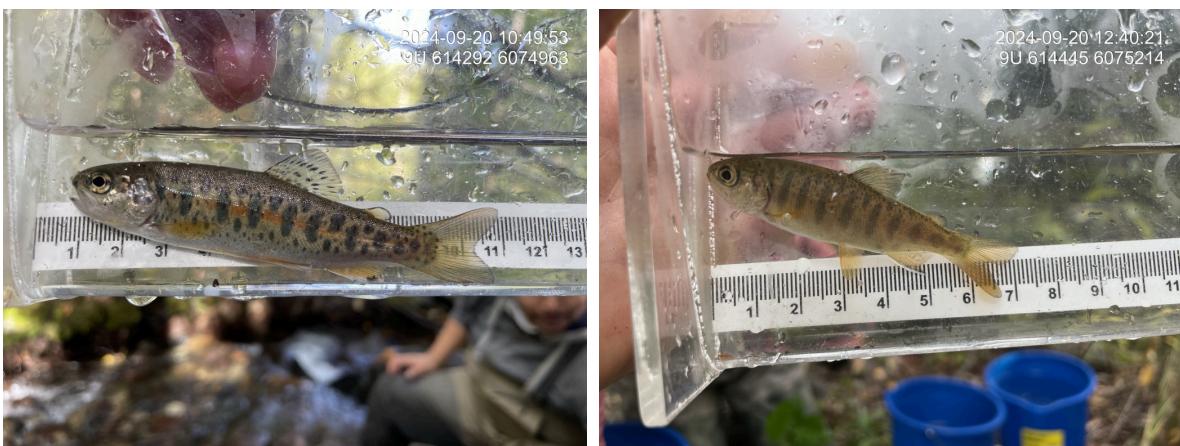
Electrofishing was conducted upstream and downstream of crossing (58264) with results summarised in Tables 4.30 - 4.31 and Figure 4.18. A total of 20 fish were captured downstream including rainbow trout, cutthroat trout/rainbow trout hybrid, and Dolly Varden. Upstream of the crossing 12 rainbow trout were captured (Figure 4.21).

Electrofishing was conducted at one site approximately 360 m downstream of Nielsen Road, with results summarised in Tables 4.30 - 4.31 and Figure 4.18. At this location, the adjacent landowner had reported recent steelhead and coho spawning and historically Chinook spawning. A total of 43 fish were captured including coho salmon, cutthroat trout/rainbow trout hybrid, and Dolly Varden (Figure 4.21).

Figure 4.21: Left: Rainbow trout captured downstream of crossing 58264. Right: Coho salmon captured approximately 360 m downstream of crossing 58264.
