Skeena Watershed Fish Passage Restoration Planning 2024

Prepared for
Habitat Conservation Trust Foundation - CAT23-6-288
BC Fish Passage Remediation Program
Ministry of Transportation and Infrastructure

Prepared by
Al Irvine, B.Sc., R.P.Bio and Lucy Schick, B.Sc.
New Graph Environment Ltd.
on behalf of
Society for Ecosystem Restoration in Northern British Columbia

DRAFT Version 0.1.0 2025-03-30

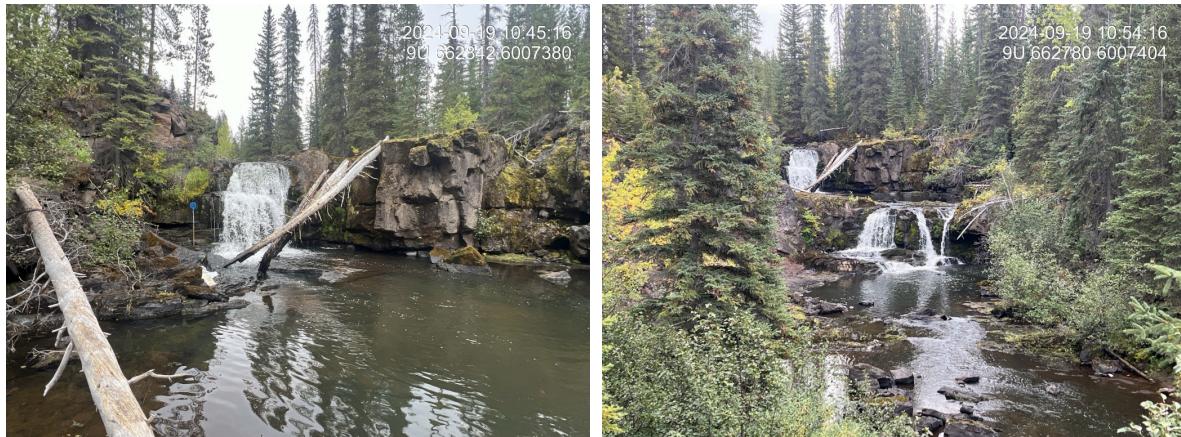
The falls consist of a series of three separate vertical and cascade sections over an approximately 200m section of stream. The upper falls consisted of a ~4 m high vertical drop, presenting a substantial barrier to fish passage (Figure 4.4). Approximately 25 m downstream, the second falls was a ~3.5 m high sheer drop to bedrock, with minimal pool depth available to facilitate fish passage (Figure 4.4). Further downstream ~100 m, the third step comprised a ~1.5 m vertical drop with an overlying cascade, exhibiting a ~15% gradient over a 1.0 m height (Figure 4.5). An additional cascade, located a further ~25 m downstream, featured a ~2 m high drop with a ~30% gradient extending over a 5 m length (Figure 4.5).

Figure 4.4: Left: Buck Falls – The upper falls featured a ~4m high vertical drop. A 2m tall net is included for scale. Right: Buck Falls – The second falls consisted of a ~3.5m high sheer drop to bedrock.

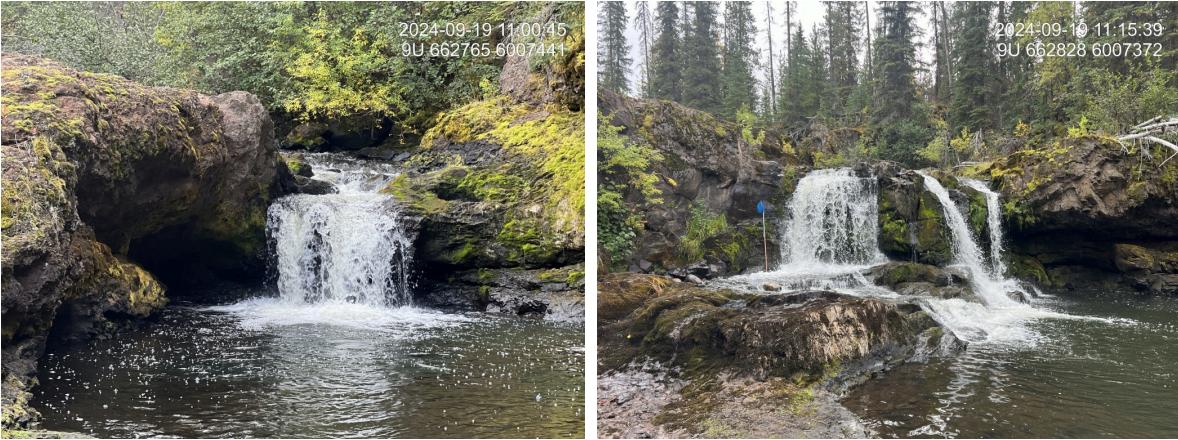
Figure 4.5: Left: Buck Falls – The third step consisted of a ~1.5 m vertical drop with an overlying cascade, exhibiting a ~15% gradient over a 1.0m height. Right: Buck Falls – An additional cascade featured a ~2m high drop with a ~30% gradient extending over a 5 m length. A 2m tall net is included for scale.

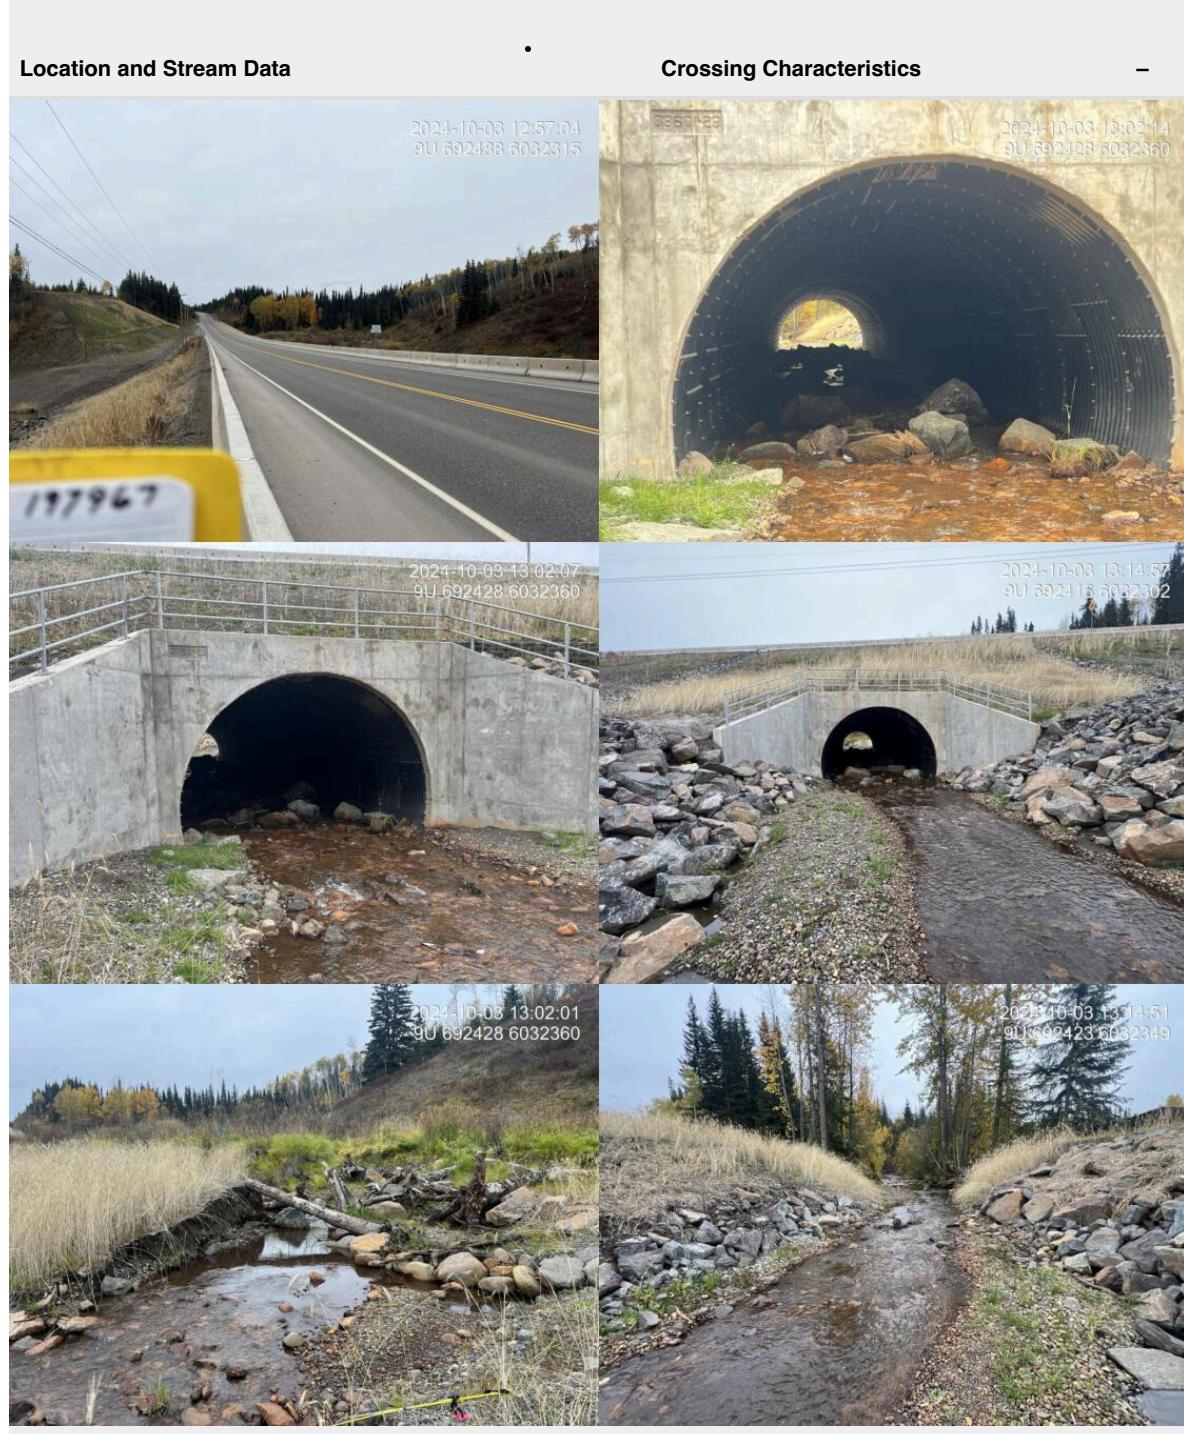
Photos: From top left clockwise: Road/Site Card, Barrel, Outlet, Downstream, Upstream, Inlet.

Location and Stream Data		Crossing Characteristics	
Date	2024-10-03	Crossing Sub Type	Round Culvert
PSCIS ID	197967	Diameter (m)	5.6
External ID	–	Length (m)	40
Crew	AI	Embedded	Yes
UTM Zone	9	Depth Embedded (m)	2
Easting	692426	Resemble Channel	Yes
Northing	6032341	Backwatered	No
Stream	Taman Creek	Percent Backwatered	–
Road	Highway 16	Fill Depth (m)	7
Road Tenure	MoTi	Outlet Drop (m)	0
Channel Width (m)	5.5	Outlet Pool Depth (m)	0
Stream Slope (%)	2	Inlet Drop	No
Beaver Activity	Yes	Slope (%)	3
Habitat Value	Medium	Valley Fill	Deep Fill
Final score	16	Barrier Result	Potential
Fix type	Replace with New Open Bottom Structure	Fix Span / Diameter	27
Comments:			
This is a brand-new replacement structure, extremely well built with extensive embedment that includes numerous large boulders, cobbles, and gravel. The multiplate round structure is embedded nearly 2 m. Upstream, woody debris and boulder structures are cabled together for added stability. This massive construction project involved a substantial amount of fill extending 60 m downstream and over 200 m upstream. The site now offers migration conditions for fish that are equal to or better than previous conditions. MoTi chris_culvert_id: 2076452

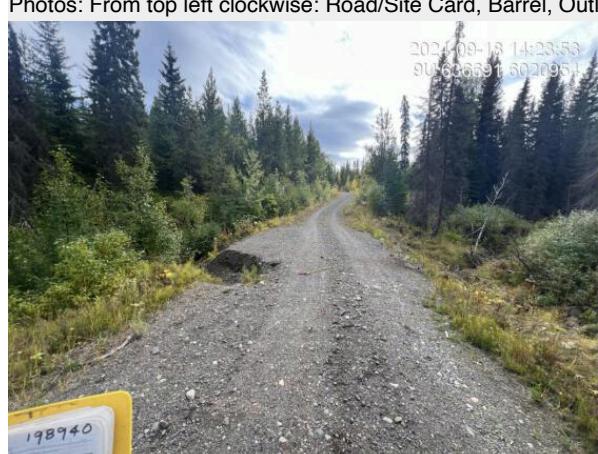
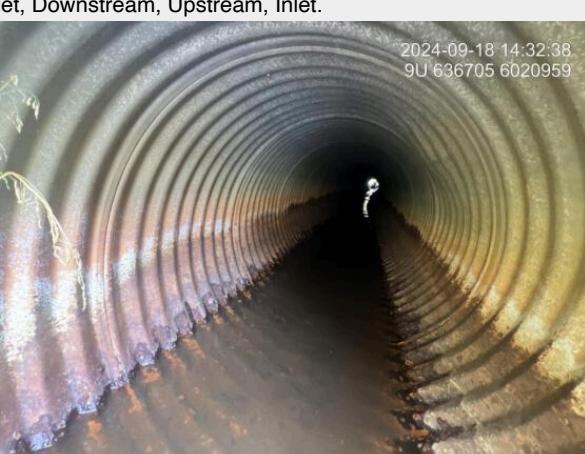
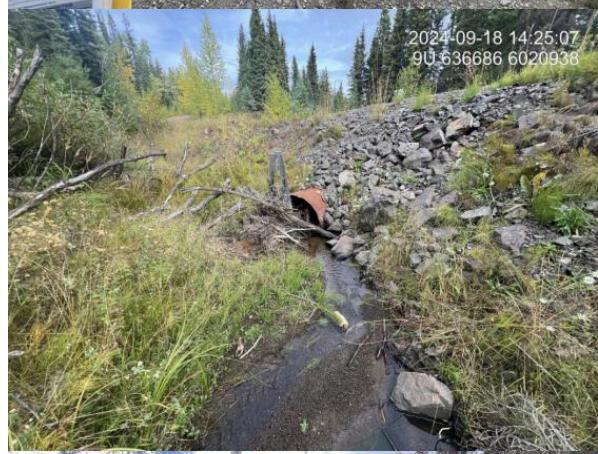
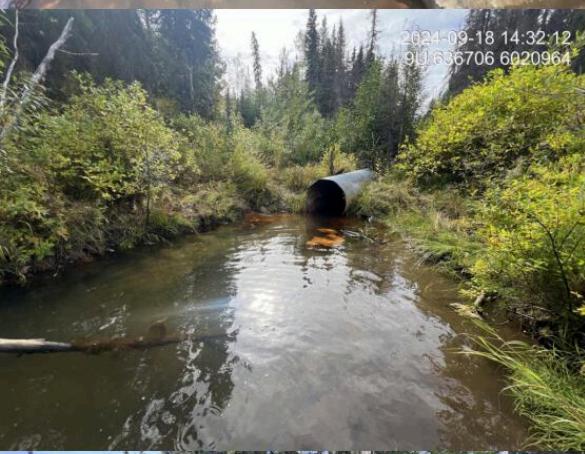
Location and Stream Data	Crossing Characteristics
<p>Comments: Very nice stream with good flow, abundant gravels for spawning, and undercut banks and occasional deep pools for rearing. Confirmed populations of cutthroat trout, rainbow trout, and Dolly Varden. The culvert is significantly undersized for the stream, and the road appears to be failing, likely due to a partially clogged inlet and spring freshet. Habitat confirmations were completed for this crossing and the next upstream crossing (198935) on the Gold FSR.</p> <p>Photos: From top left clockwise: Road/Site Card, Barrel, Outlet, Downstream, Upstream, Inlet.</p>

Location and Stream Data		Crossing Characteristics	
Date	2024-09-18	Crossing Sub Type	Round Culvert
PSCIS ID	198940	Diameter (m)	0.95
External ID	–	Length (m)	25
Crew	AI	Embedded	No
UTM Zone	9	Depth Embedded (m)	–
Easting	636706	Resemble Channel	–
Northing	6020960	Backwatered	Yes
Stream	Tributary to Knapper Creek	Percent Backwatered	30
Road	HM7504	Fill Depth (m)	1.75
Road Tenure	Canfor R07549 16	Outlet Drop (m)	0
Channel Width (m)	4.3	Outlet Pool Depth (m)	0.9
Stream Slope (%)	3	Inlet Drop	Yes
Beaver Activity	Yes	Slope (%)	2
Habitat Value	Medium	Valley Fill	Deep Fill
Final score	24	Barrier Result	Barrier
Fix type	Replace with New Open Bottom Structure	Fix Span / Diameter	15

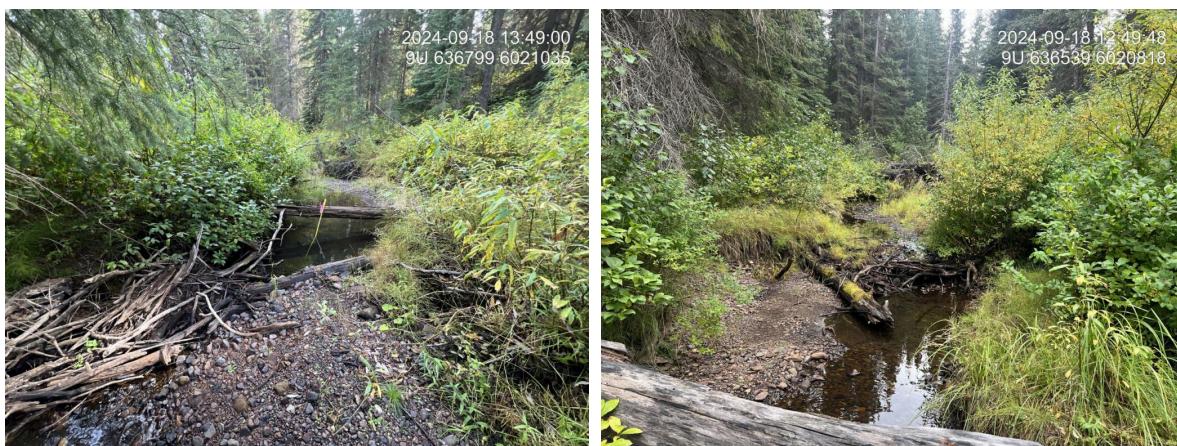
Should restoration activities proceed, efforts should focus on PSCIS crossing [as.character\(my_site2\)](#) on Gold Creek FSR, which had a small outlet drop and a deep outlet pool. PSCIS crossing 198940 on Road/Spur HM7504 was backwatered and not presumed to be a barrier to fish passage. Both crossings were noted as undersized for the stream.

Figure 4.15: Left: Typical habitat downstream of PSCIS crossing 198940. Right: Typical habitat upstream of PSCIS crossing 198940.

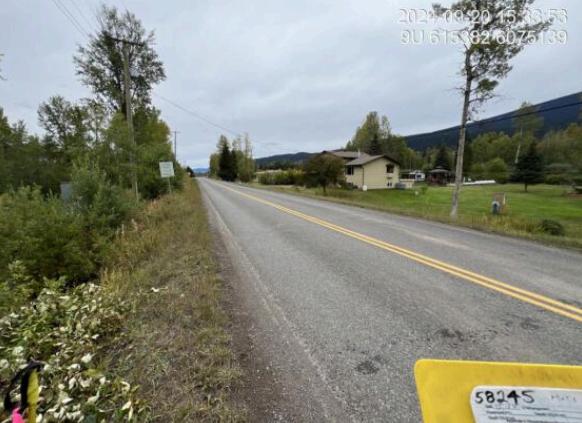
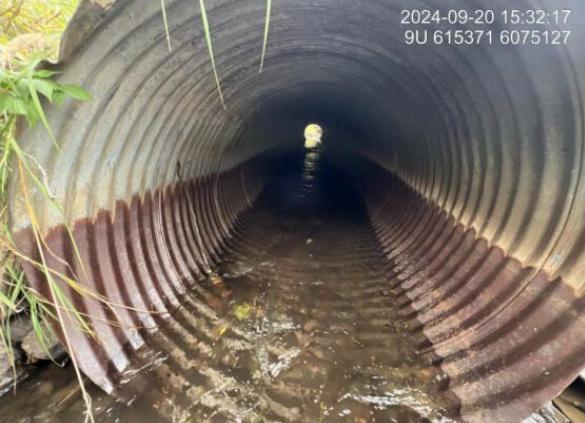
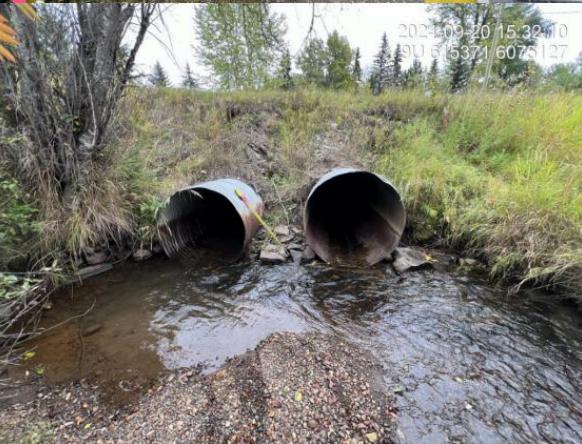
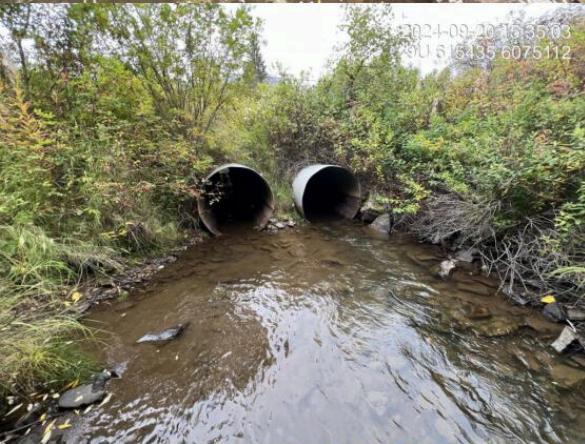
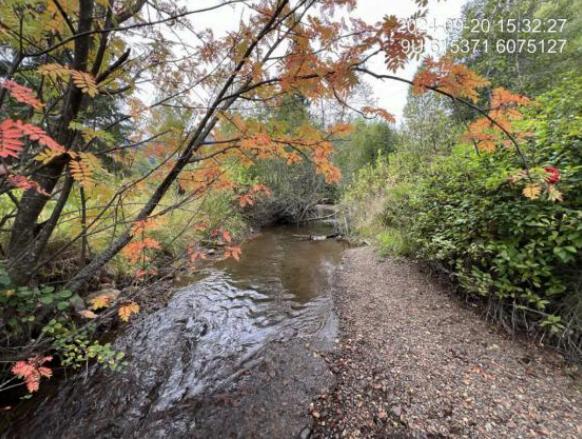
Location and Stream Data	Crossing Characteristics
<p>Comments: Two 1.25 m pipes are present and are heavily corroded. Upstream and downstream, the streambanks are heavily modified adjacent to private land, including riparian vegetation removal, stream channelization, and bank armouring. High-value steelhead, coho, and chinook spawning habitat is documented further upstream above the railway crossing. MoTi chris_culvert_id: 1514706, 1514705</p>	
<p>Photos: From top left clockwise: Road/Site Card, Barrel, Outlet, Downstream, Upstream, Inlet.</p>
