Skeena Watershed Fish Passage Restoration Planning 2024

Prepared for
Habitat Conservation Trust Foundation - CAT23-6-288
BC Fish Passage Remediation Program
Ministry of Transportation and Infrastructure

Prepared by
Al Irvine, B.Sc., R.P.Bio and Lucy Schick, B.Sc.
New Graph Environment Ltd.
on behalf of
Society for Ecosystem Restoration in Northern British Columbia

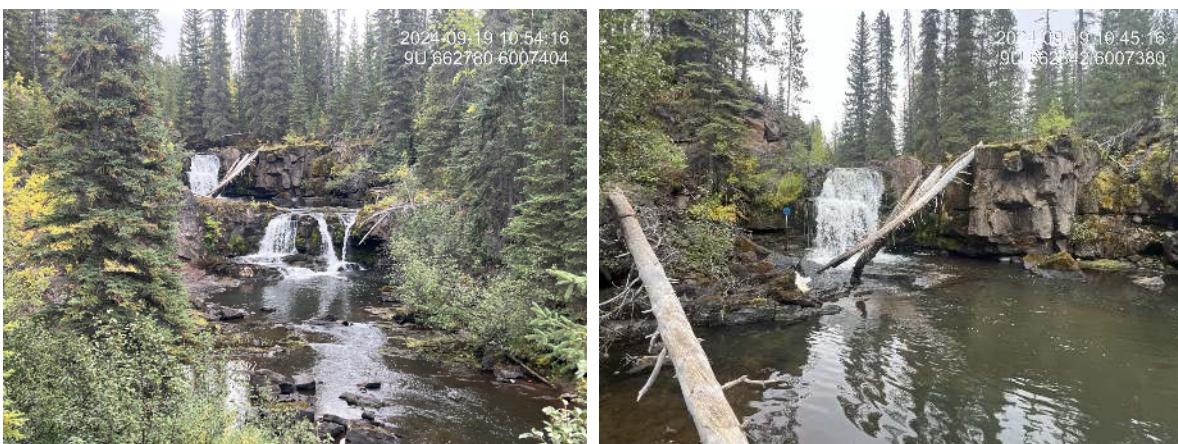
Figure 5.2: Left: Buck Falls – The third falls consisted of a ~3.5m high sheer drop to bedrock. Right: Buck Falls – The upper falls featured a ~4m high vertical drop. A 2m tall net is included for scale.

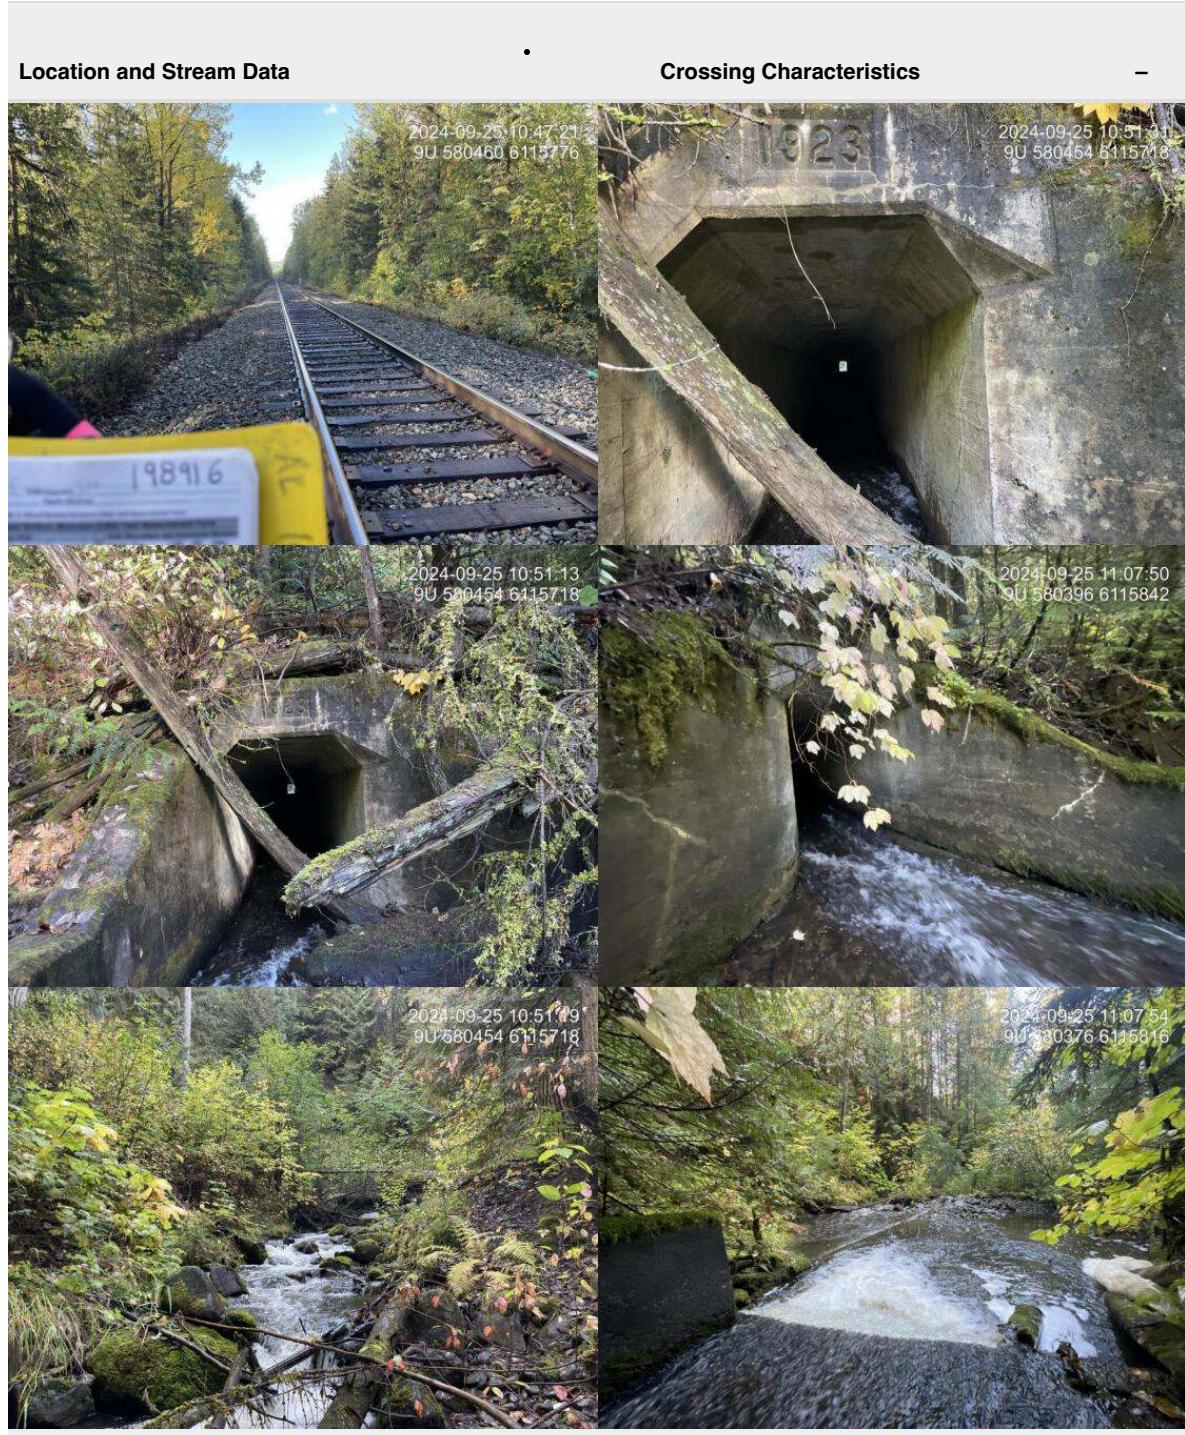
Comments: The concrete box culvert is approximately 100m long beneath a railway crossing, with about 30 - 40m of fill above it. A swift current flows through the culvert, and installing baffles could improve fish passage. Fish sampling captured cutthroat trout and Dolly Varden downstream of the crossing, and Dolly Varden upstream. There is a moderate outlet drop, but adult fish could likely move upstream. The habitat upstream features good flow through a steeper section with a healthy, mature mixed riparian forest, stable banks, and gravel pockets suitable for spawning coho, Dolly Varden, and cutthroat trout. Downstream, abundant boulders create step pools alongside frequent large woody debris, though high flows limited suitable fish habitat during the survey. Although construction would be expensive and challenging, this site is a high priority for restoration follow-up. This crossing is located on Comeau Creek, which is incorrectly mapped in the BC Freshwater Atlas as flowing southwest into the Skeena River. In reality, it flows southwest then turns north, crossing highway 16 and the CN railway (this crossing) before joining the Skeena River. See the 2024 report for a map of the corrected streamline. Culvert length 100 m but changed to 99.0 m to meet submission requirements. Fill depth 30 m but changed to 9.9 m to meet submission requirements.

Photos: From top left clockwise: Road/Site Card, Barrel, Outlet, Downstream, Upstream, Inlet.

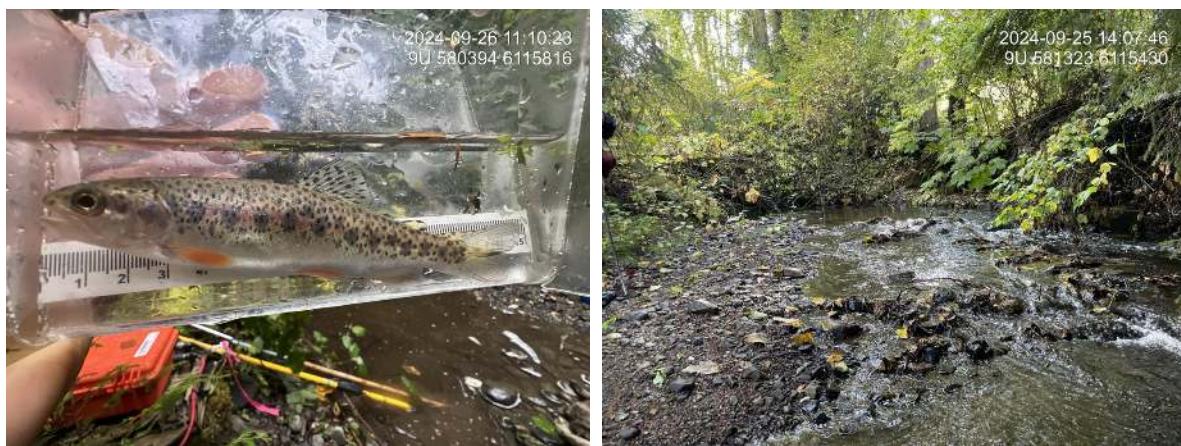
Figure 5.10: Left: Cutthroat trout captured downstream of crossing 198916. Right: Typical habitat upstream of PSCIS crossing 198913.

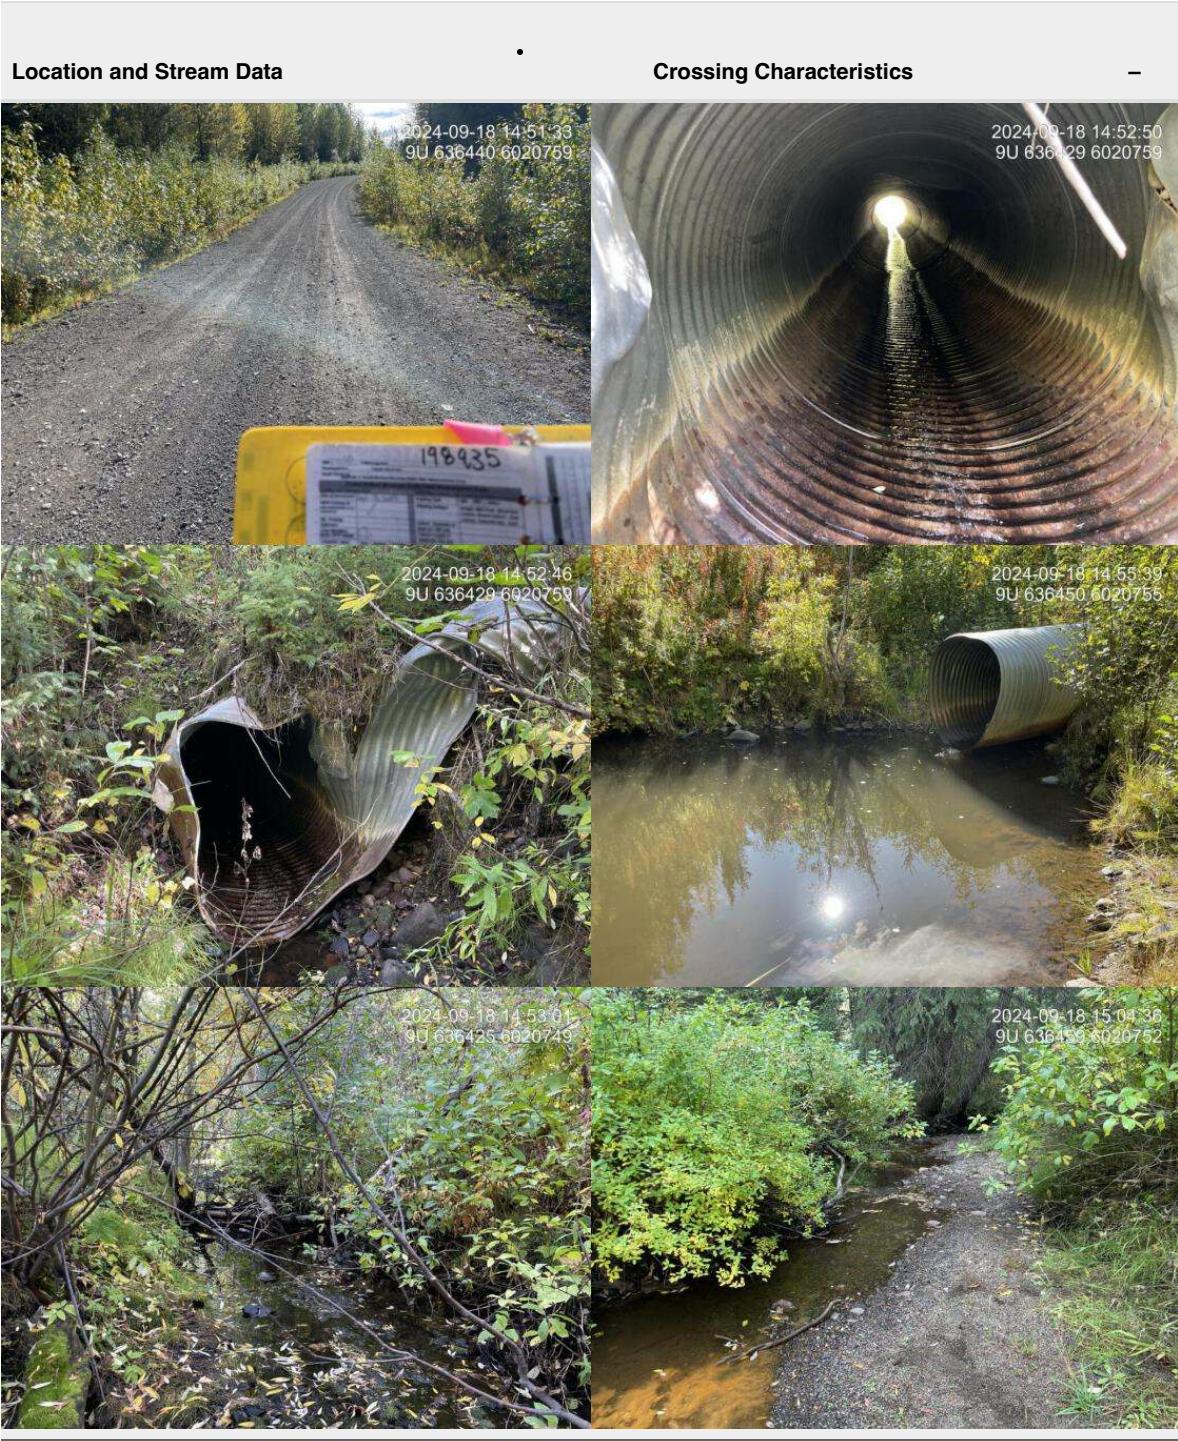
Photos: From top left clockwise: Road/Site Card, Barrel, Outlet, Downstream, Upstream, Inlet.

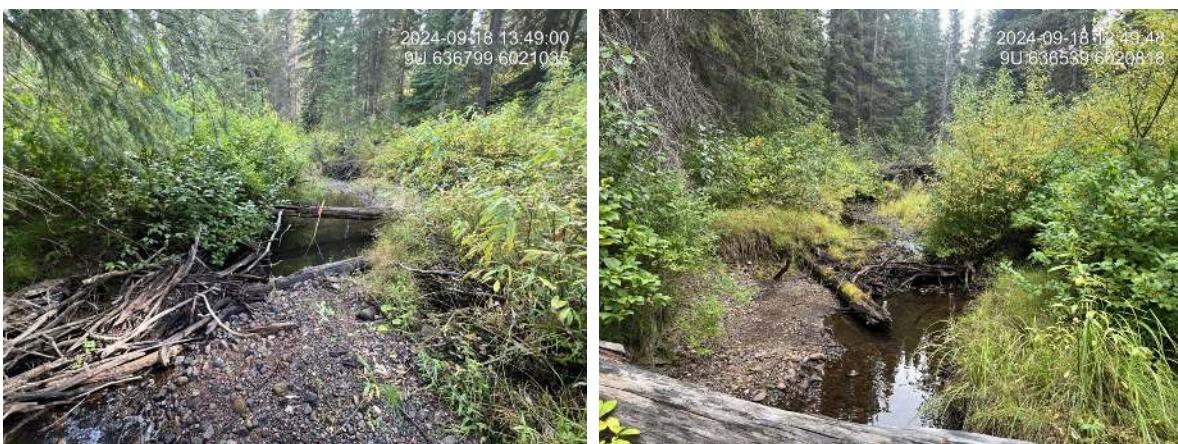
The stream was surveyed downstream from crossing 198940 for 300m (Figure [5.12](#)).. The habitat was rated as medium, with good flow, abundant gravels, overhanging banks, and healthy riparian vegetation, providing good rearing and spawning habitat for coho, rainbow trout, Dolly Varden, and cutthroat trout. Total cover amount was rated as moderate with undercut banks dominant. Cover was also present as small woody debris, large woody debris, and overhanging vegetation. The dominant substrate was gravels with cobbles sub-dominant. The average channel width was 3.3m, the average wetted width was 1.5m, and the average gradient was 3.3%..

Figure 5.12: Left: Typical habitat downstream of PSCIS crossing 198940. Right: Typical habitat upstream of PSCIS crossing 198940.

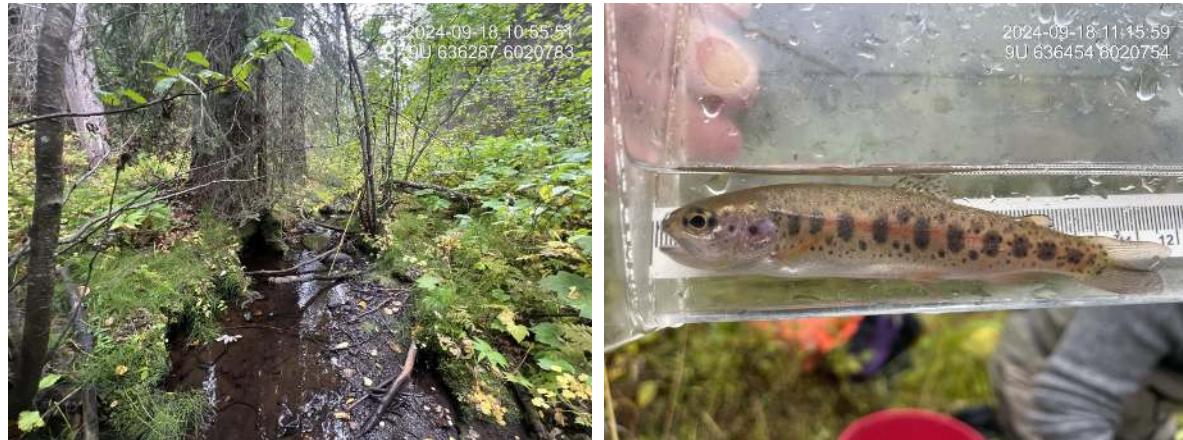
Figure 5.13: Left: Typical habitat upstream of PSCIS crossing 198935. Right: Rainbow trout captured downstream of crossing 198935.

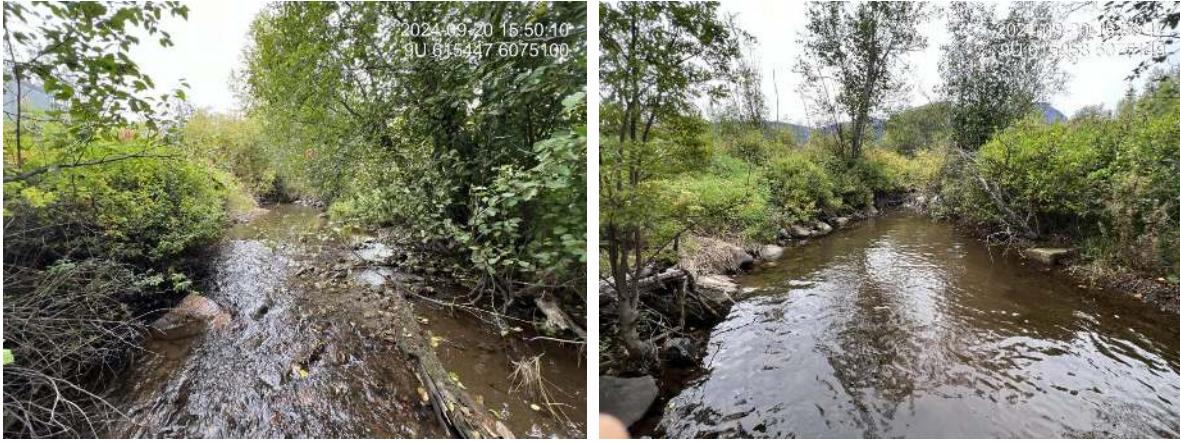
The stream was surveyed downstream from crossing 58245 for 70m , to the confluence with Kathlyn Creek. The stream ran adjacent to the road along one bank, which had limited riparian vegetation consisting primarily of shrubs. The opposite bank, bordered by private property, had minimal vegetation and no significant riparian cover. Multiple sections of bank armouring and channelization were observed near the private property, and only small pockets of gravels suitable for spawning were observed (Figure [5.16](#)). Total cover amount was rated as moderate with undercut banks dominant. Cover was also present as small woody debris, deep pools, and overhanging vegetation. The average channel width was 6.2m, the average wetted width was 3.9m, and the average gradient was 2%. The dominant substrate was fines with cobbles sub-dominant. The habitat was rated as medium value for salmonid rearing and spawning.

Figure 5.16: Left: Typical habitat downstream of PSCIS crossing 58245. Right: Typical habitat upstream of PSCIS crossing 58245 and downstream of PSCIS crossing 203122, with signs of bank armouring and channelization.
