Skeena Watershed Fish Passage Restoration Planning 2024

Prepared for
Habitat Conservation Trust Foundation - CAT23-6-288
BC Fish Passage Remediation Program
Ministry of Transportation and Infrastructure

Prepared by
Al Irvine, B.Sc., R.P.Bio and Lucy Schick, B.Sc.
New Graph Environment Ltd.
on behalf of
Society for Ecosystem Restoration in Northern British Columbia

Version 0.0.1 2025-03-26

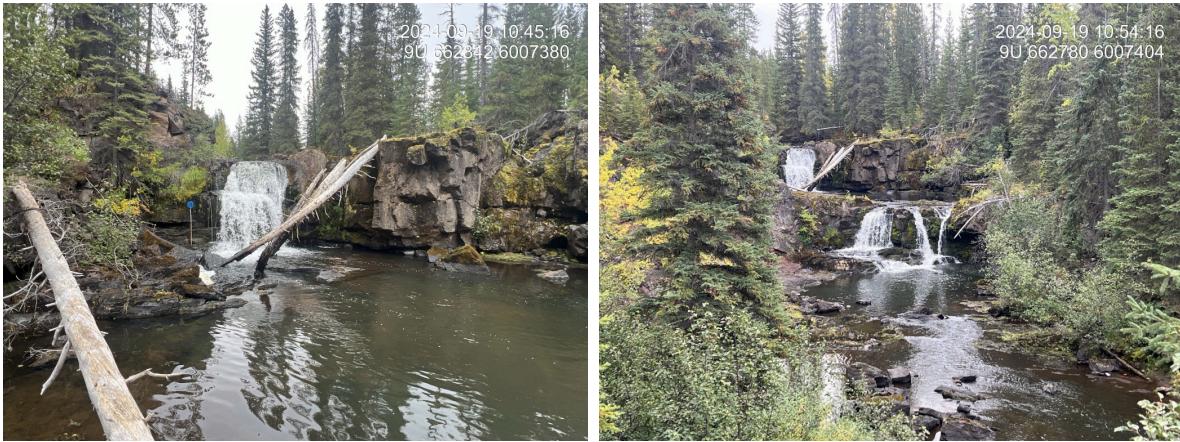
Figure 4.1: Left: Buck Falls – The upper falls featured a ~4m high vertical drop. A 2m tall net is included for scale. Right: Buck Falls – The second falls consisted of a ~3.5m high sheer drop to bedrock.

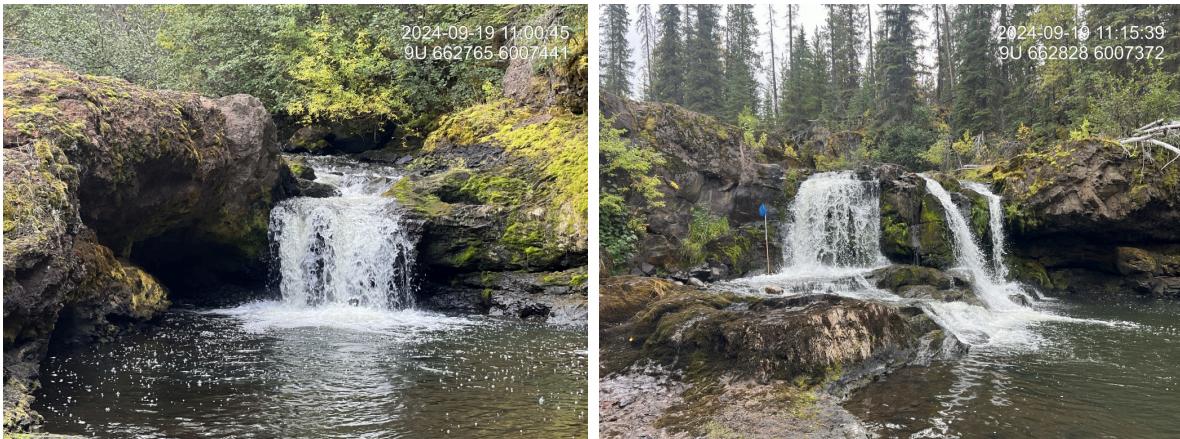
Figure 4.2: Left: Buck Falls – The third step consisted of a ~1.5 m vertical drop with an overlying cascade, exhibiting a ~15% gradient over a 1.0m height. Right: Buck Falls – An additional cascade featured a ~2m high drop with a ~30% gradient extending over a 5 m length. A 2m tall net is included for scale.

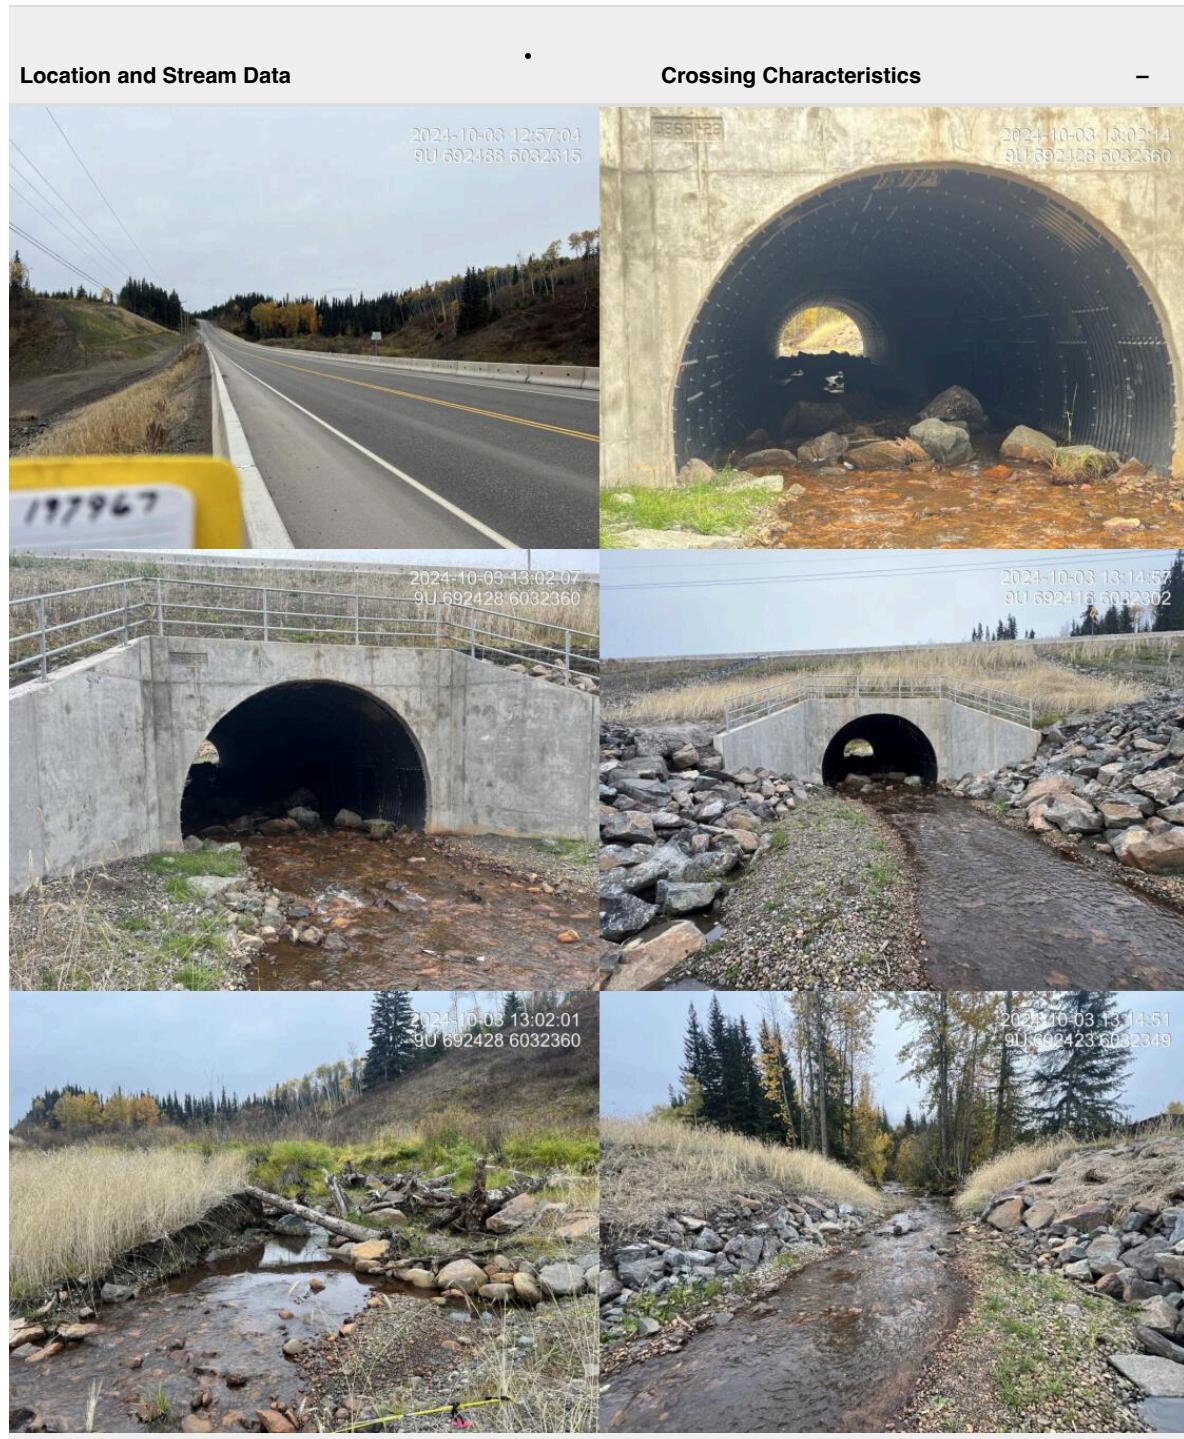
Location and Stream Data		Crossing Characteristics	
External ID	—	Length (m)	40
Crew	AI	Embedded	Yes
UTM Zone	9	Depth Embedded (m)	2
Easting	692426	Resemble Channel	Yes
Northing	6032341	Backwatered	No
Stream	Taman Creek	Percent Backwatered	—
Road	Highway 16	Fill Depth (m)	7
Road Tenure	MoTi	Outlet Drop (m)	0
Channel Width (m)	5.5	Outlet Pool Depth (m)	0
Stream Slope (%)	2	Inlet Drop	No
Beaver Activity	Yes	Slope (%)	3
Habitat Value	Medium	Valley Fill	Deep Fill
Final score	16	Barrier Result	Potential
Fix type	Replace with New Open Bottom Structure	Fix Span / Diameter	27
Comments: This is a brand-new replacement structure, extremely well built with extensive embedment that includes numerous large boulders, cobbles, and gravel. The multiplate round structure is embedded nearly 2 m. Upstream, woody debris and boulder structures are cabled together for added stability. This massive construction project involved a substantial amount of fill extending 60 m downstream and over 200 m upstream. The site now offers migration conditions for fish that are equal to or better than previous conditions. MoTi chris_culvert_id: 2076452

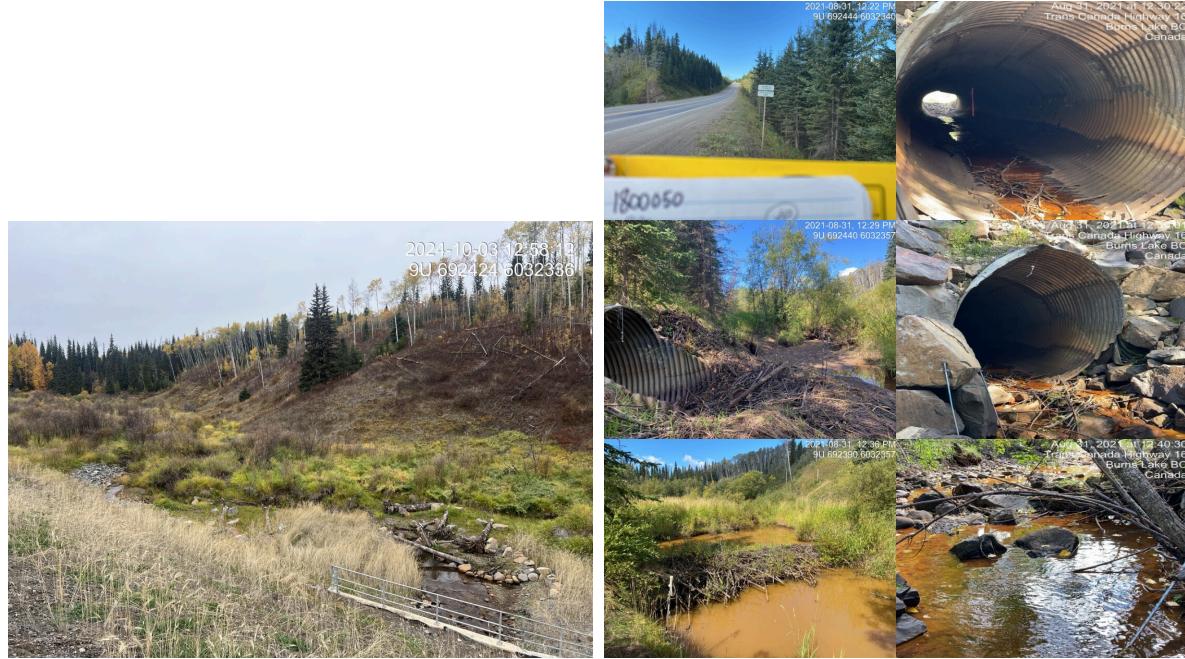
Figure 4.6: Left: Woody debris and boulder structures cabled together for additional reinforcement located upstream of 197967 in 2024. Right: Photos of crossing 197967 in 2021.

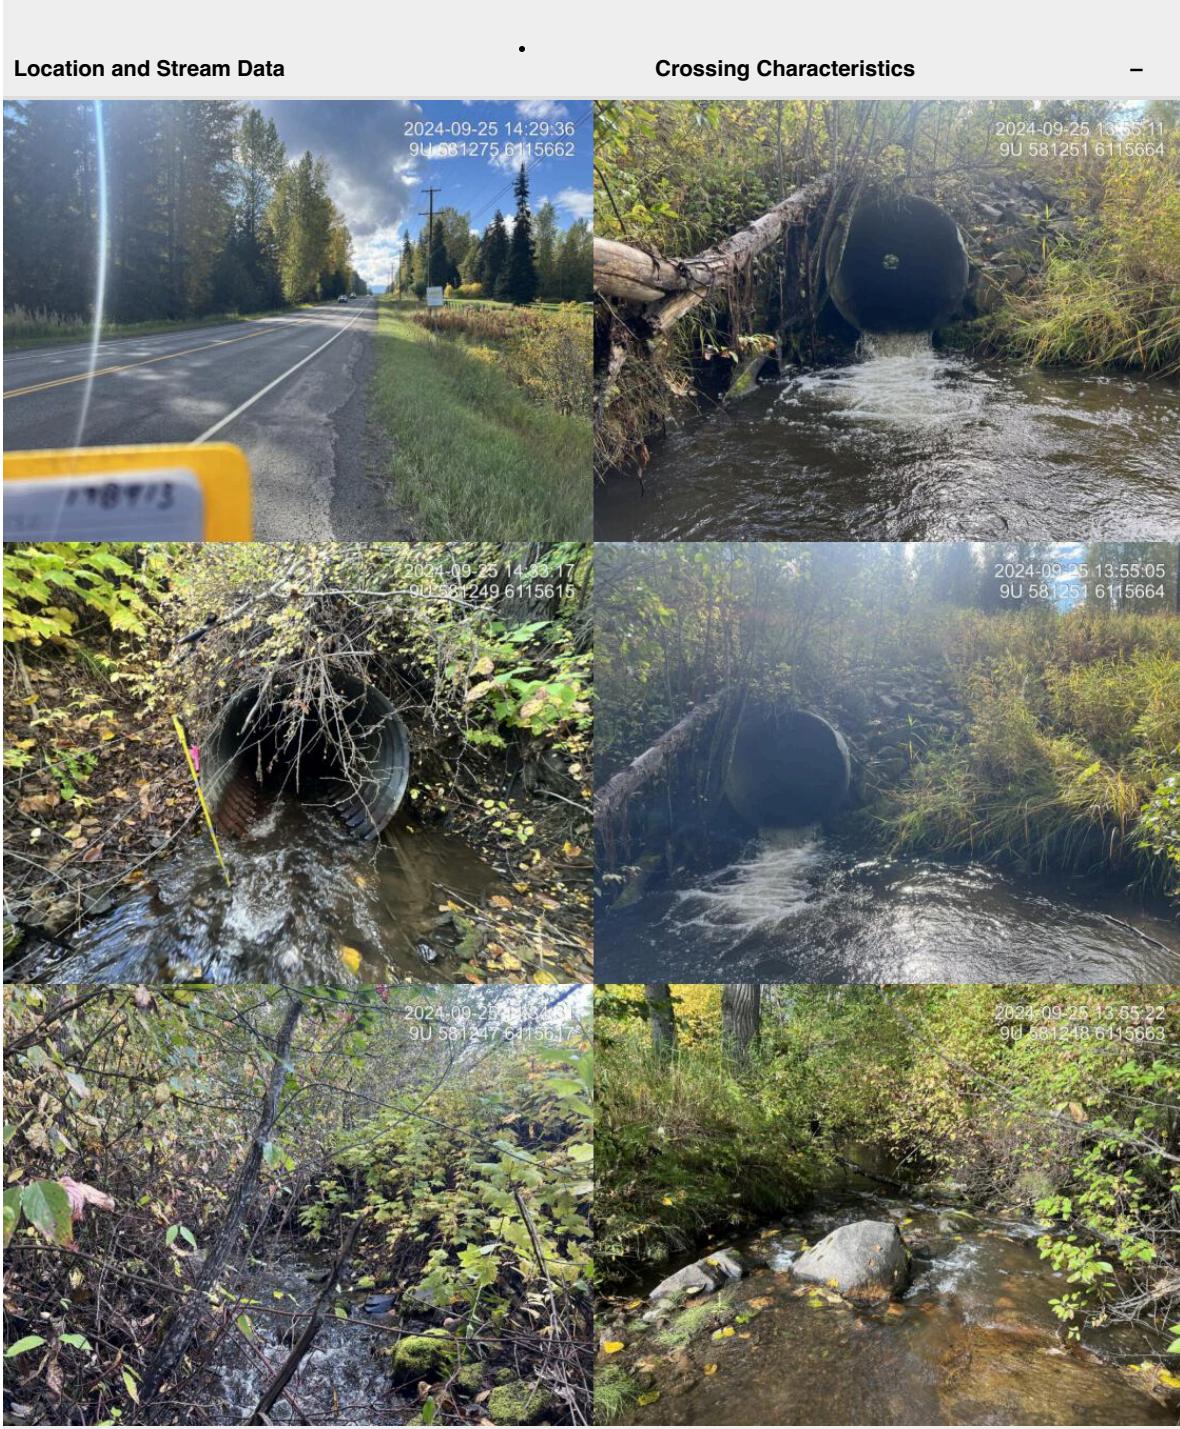
Stream Characteristics Downstream of Crossing 198916

The stream was surveyed downstream from crossing 198916 for 300m . The stream contained numerous boulders forming step pools; however, moderate flows at the time of assessment limited the availability of pools suitable for fish. The first pool suitable for overwintering fish, with adequately reduced flow, was located approximately 250 m downstream of the culvert. There were occasional gravels suitable for spawning and frequent large woody debris, which contributed to the formation of additional steps. (Figure [4.9](#)). Total cover amount was rated as moderate with boulders dominant. Cover was also present as small woody debris, large woody debris, and overhanging vegetation. The dominant substrate was cobbles with gravels sub-dominant. The average channel width was 5.9m, the average wetted width was 3.7m, and the average gradient was 5.1%. The habitat was rated as medium value suitable for salmonid rearing and spawning.

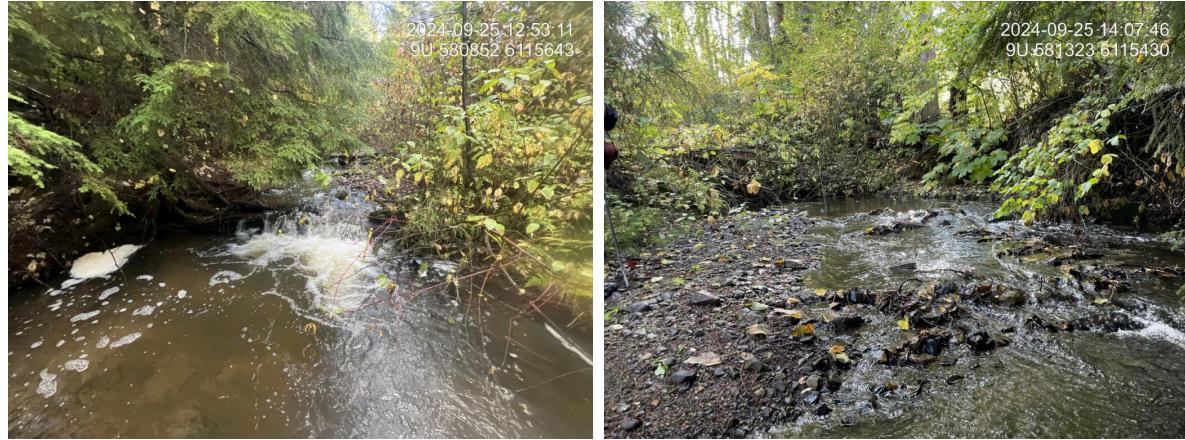
Figure 4.10: Left: Typical habitat downstream of PSCIS crossing 198913. Right: Typical habitat upstream of PSCIS crossing 198913.

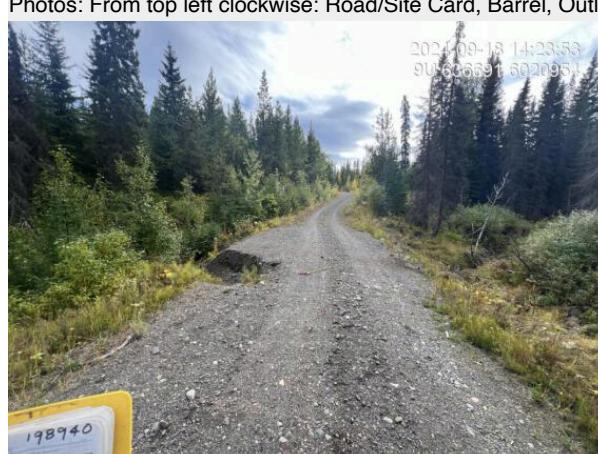
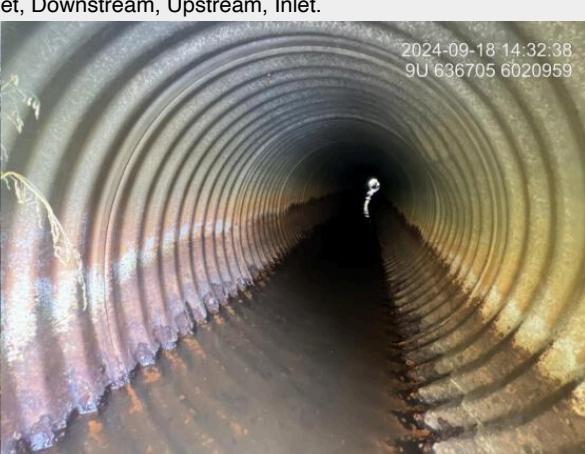
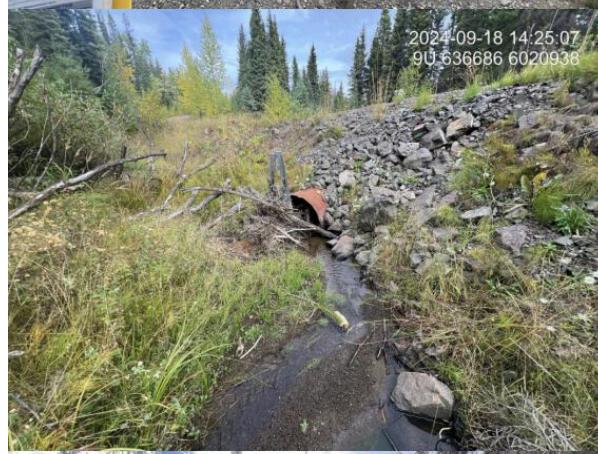
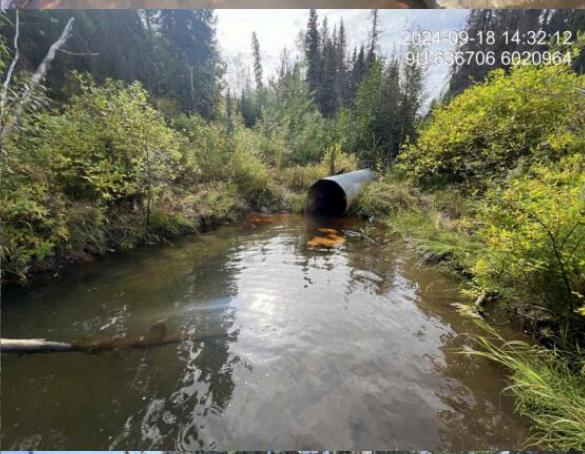
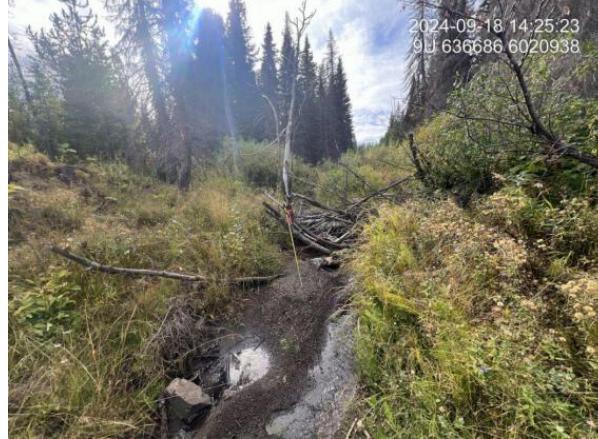
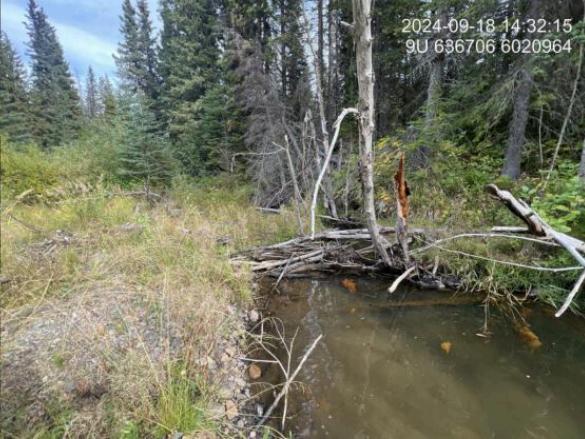
Location and Stream Data	Crossing Characteristics
<p>Comments: Very nice stream with good flow, abundant gravels for spawning, and undercut banks and occasional deep pools for rearing. Confirmed populations of cutthroat trout, rainbow trout, and Dolly Varden. The culvert is significantly undersized for the stream, and the road appears to be failing, likely due to a partially clogged inlet and spring freshet. Habitat confirmations were completed for this crossing and the next upstream crossing (198935) on the Gold FSR.</p> <p>Photos: From top left clockwise: Road/Site Card, Barrel, Outlet, Downstream, Upstream, Inlet.</p>

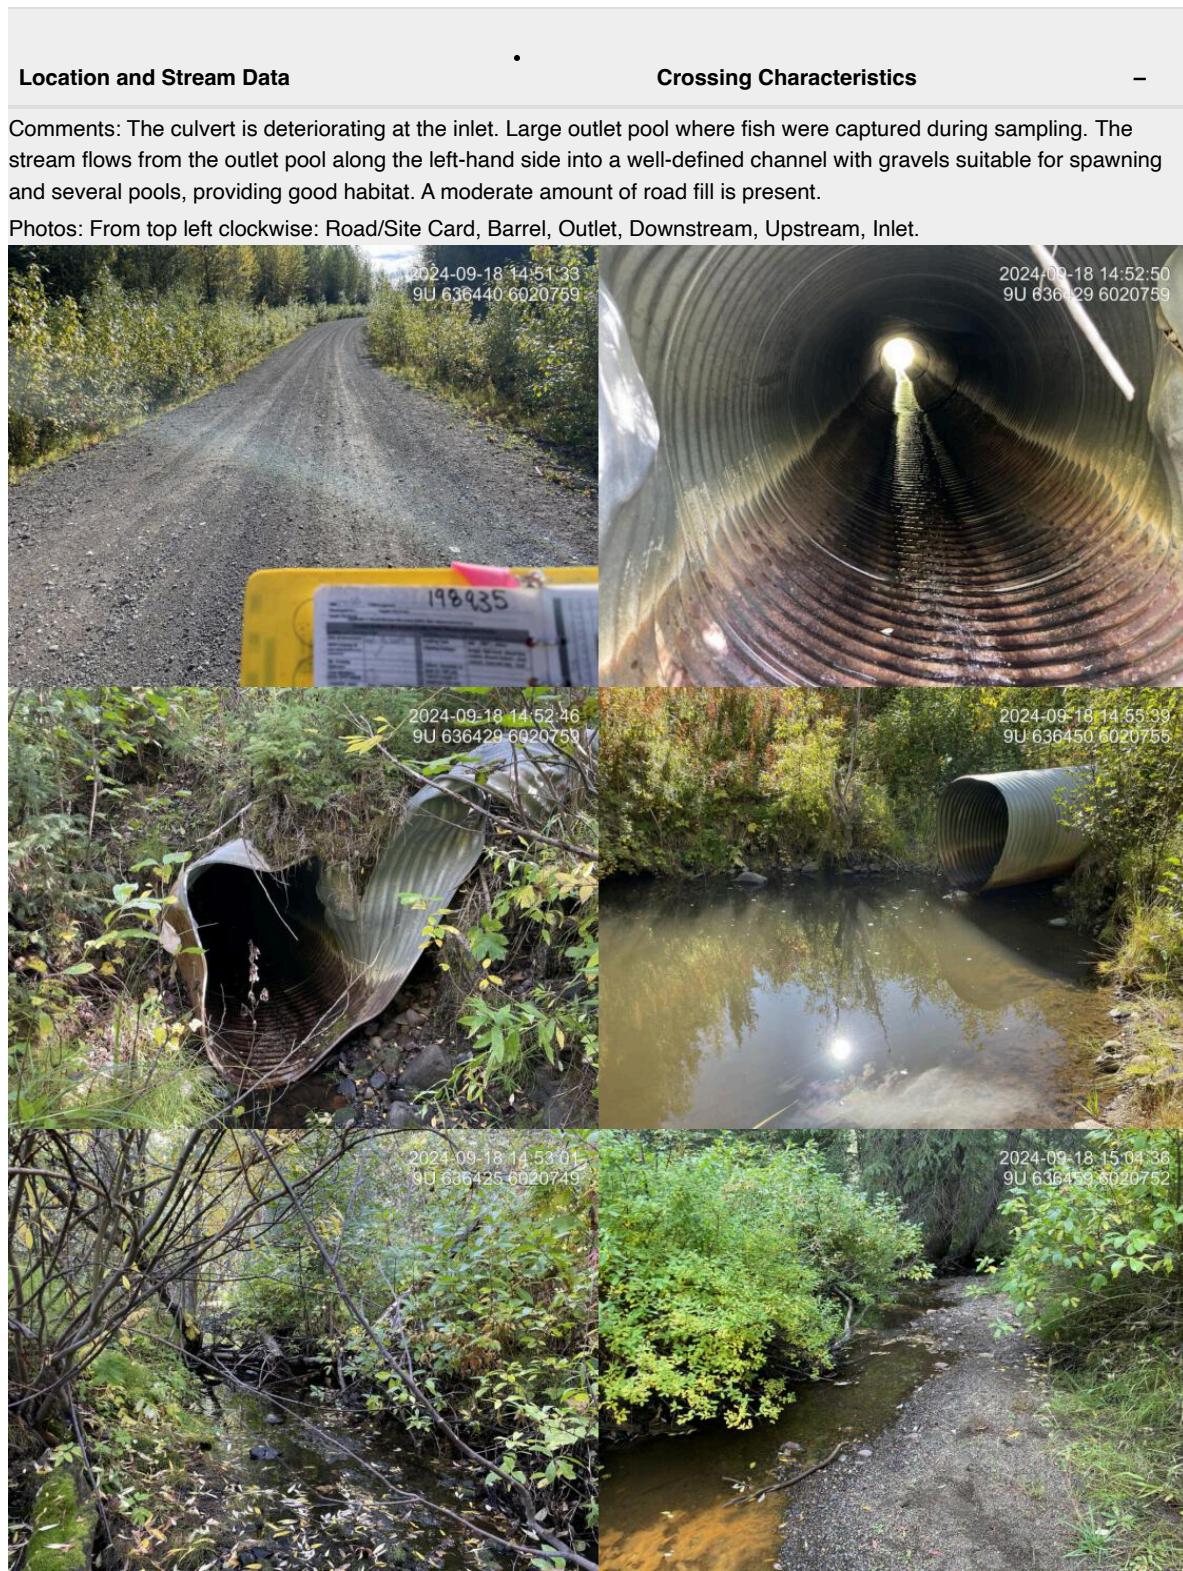
Location and Stream Data		Crossing Characteristics	
Date	2024-09-18	Crossing Sub Type	Round Culvert
PSCIS ID	198935	Diameter (m)	1.2
External ID	–	Length (m)	20
Crew	LS	Embedded	No
UTM Zone	9	Depth Embedded (m)	–
Easting	636440	Resemble Channel	–
Northing	6020756	Backwatered	No
Stream	Tributary to Knapper Creek	Percent Backwatered	–
Road	Gold creek fsr	Fill Depth (m)	4
Road Tenure	Canfor R07549 6	Outlet Drop (m)	0.15
Channel Width (m)	2.7	Outlet Pool Depth (m)	0.8
Stream Slope (%)	2.2	Inlet Drop	No
Beaver Activity	Yes	Slope (%)	1.5
Habitat Value	Medium	Valley Fill	Deep Fill
Final score	29	Barrier Result	Barrier
Fix type	Replace with New Open Bottom Structure	Fix Span / Diameter	18

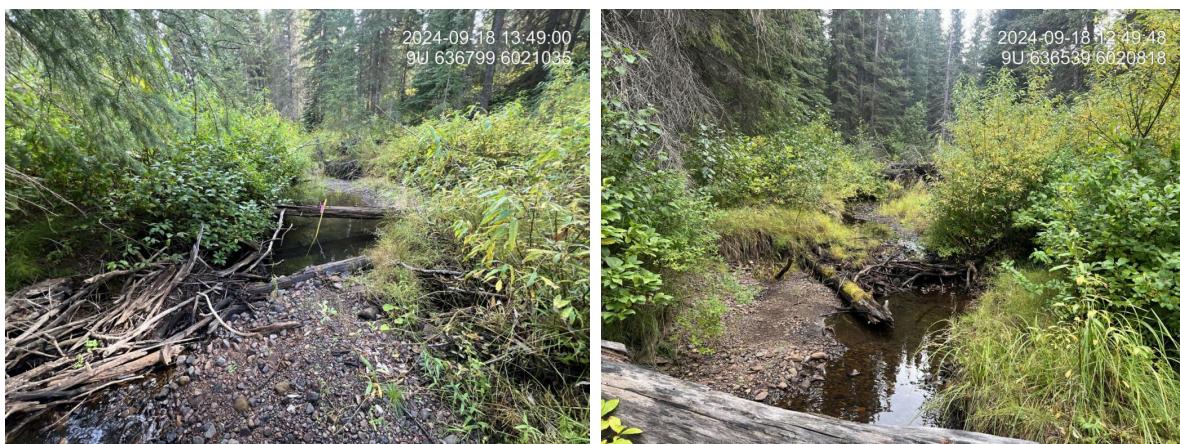
The stream was surveyed downstream from crossing 198940 for 300m (Figure [4.14](#)).. The habitat was rated as medium, with good flow, abundant gravels, overhanging banks, and healthy riparian vegetation, providing good rearing and spawning habitat for coho, rainbow trout, Dolly Varden, and cutthroat trout. The average channel width was 3.3m, the average wetted width was 1.5m, and the average gradient was 3.3%. Total cover amount was rated as moderate with undercut banks dominant. Cover was also present as small woody debris, large woody debris, and overhanging vegetation. The dominant substrate was gravels with cobbles sub-dominant..

Figure 4.14: Left: Typical habitat downstream of PSCIS crossing 198940. Right: Typical habitat upstream of PSCIS crossing 198940.

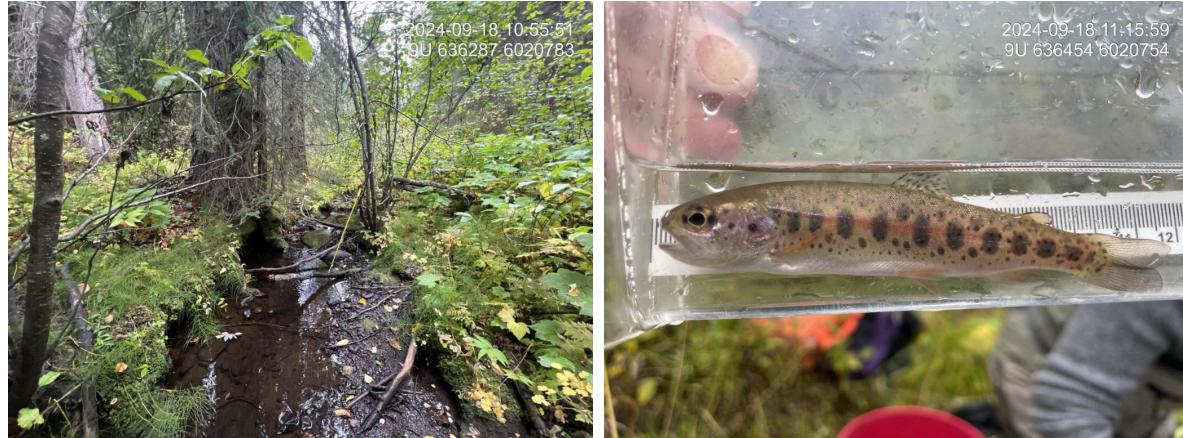
Figure 4.15: Left: Typical habitat upstream of PSCIS crossing 198935. Right: Rainbow trout captured downstream of crossing 198935.

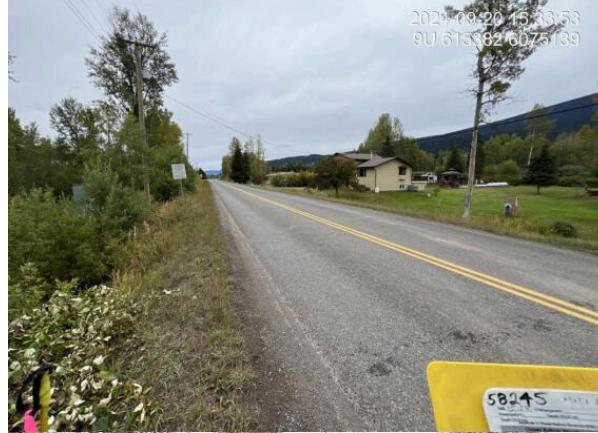
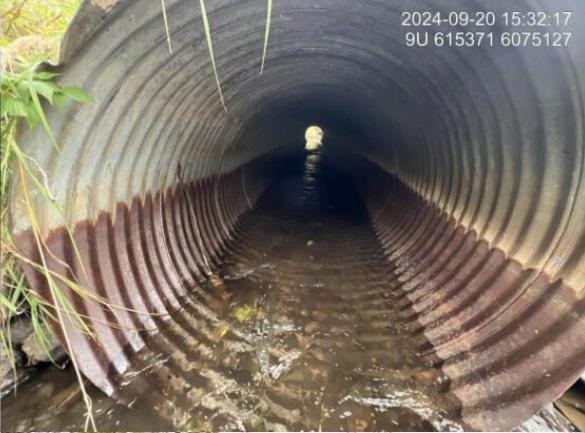
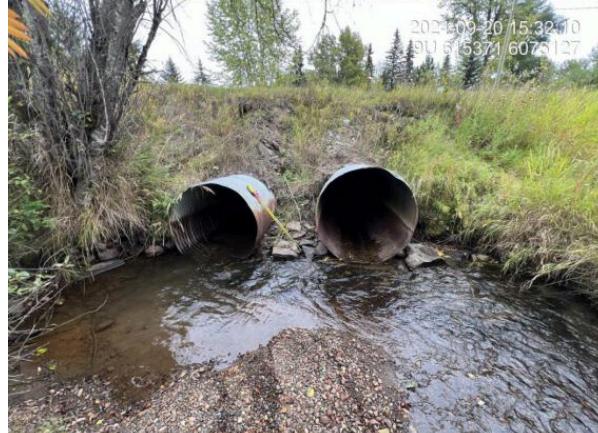
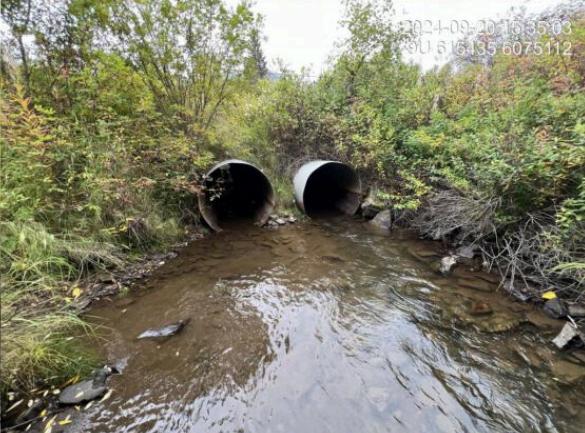
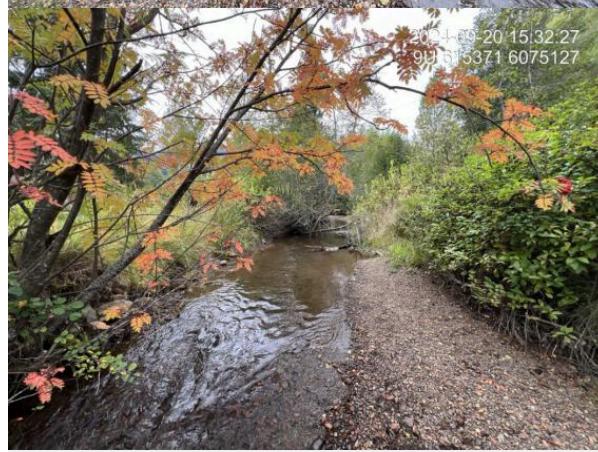
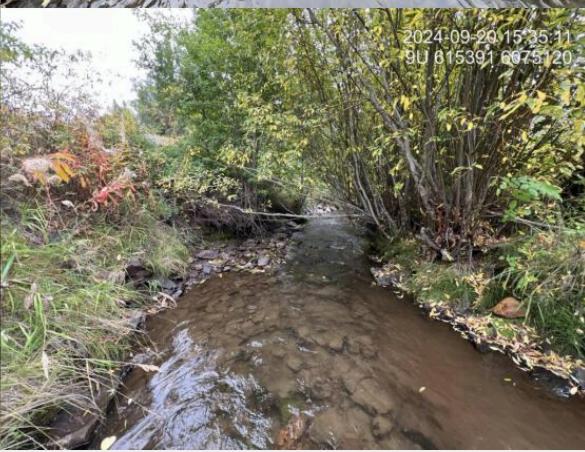
Location and Stream Data	Crossing Characteristics
<p>Comments: Two 1.25 m pipes are present and are heavily corroded. Upstream and downstream, the streambanks are heavily modified adjacent to private land, including riparian vegetation removal, stream channelization, and bank armouring. High-value steelhead, coho, and chinook spawning habitat is documented further upstream above the railway crossing. MoTi chris_culvert_id: 1514706, 1514705</p>	
<p>Photos: From top left clockwise: Road/Site Card, Barrel, Outlet, Downstream, Upstream, Inlet.</p>

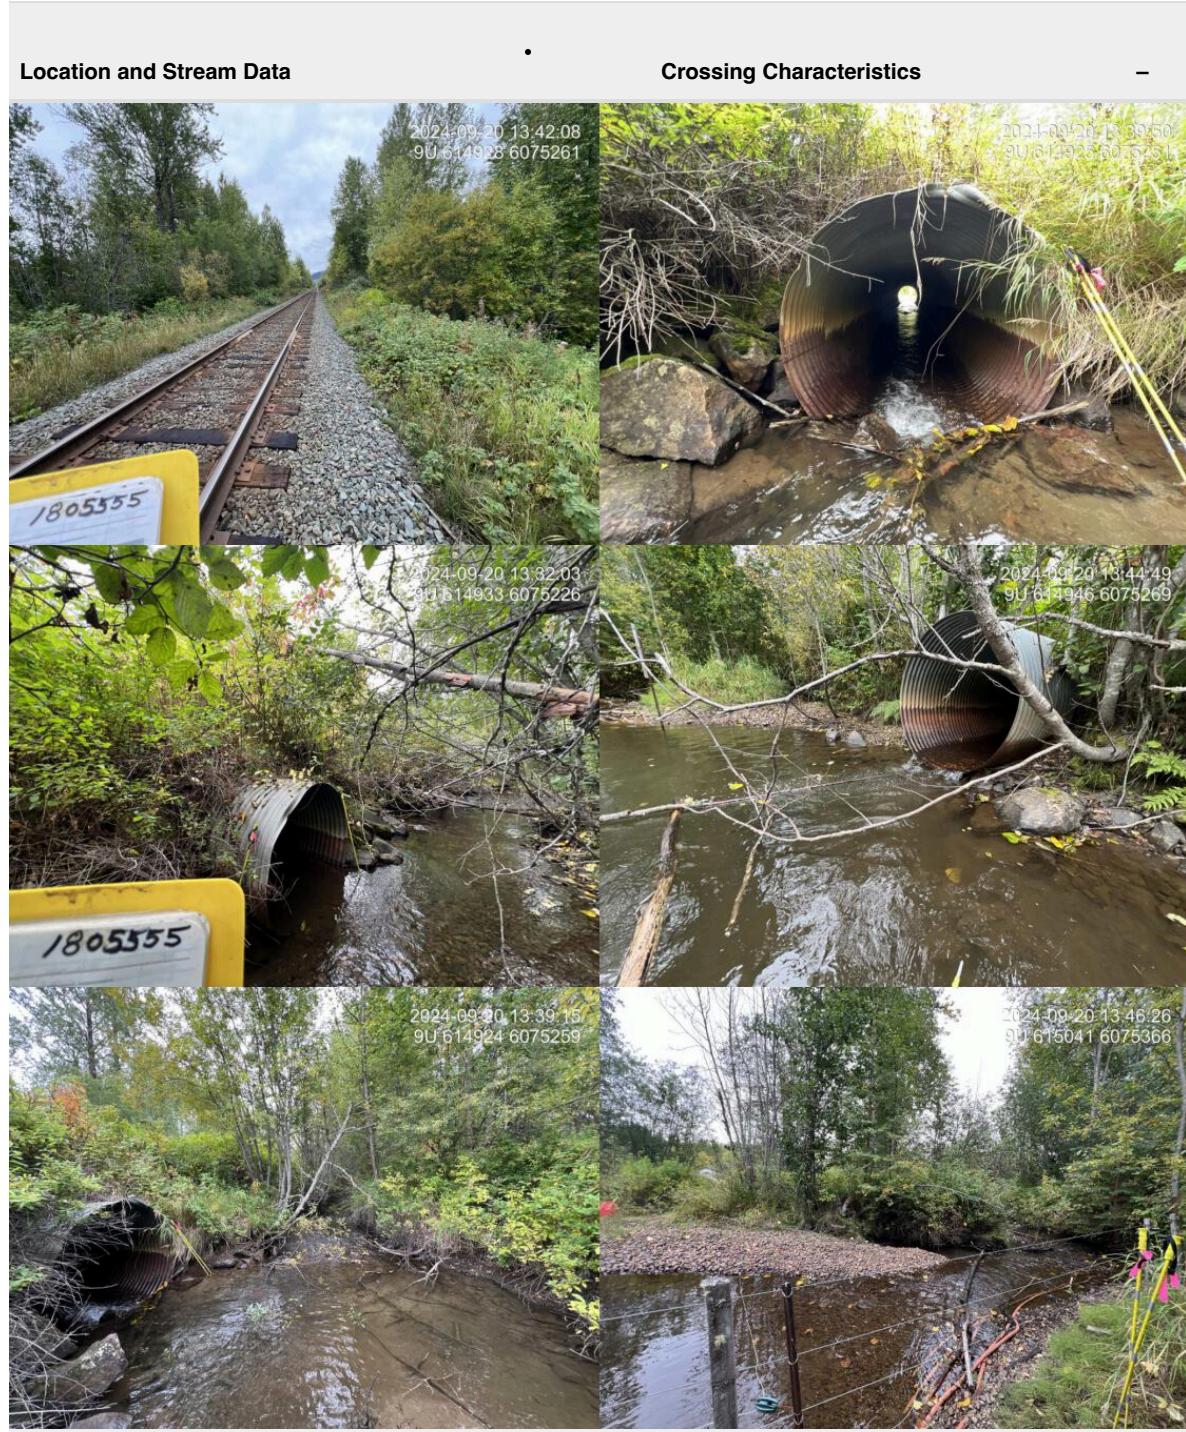
Location and Stream Data		Crossing Characteristics	
Date	2024-09-20	Crossing Sub Type	Oval Culvert
PSCIS ID	58264	Diameter (m)	2.4
External ID	-	Length (m)	23
Crew	LS TP	Embedded	No
UTM Zone	9	Depth Embedded (m)	-
Easting	614280	Resemble Channel	-
Northing	6074951	Backwatered	No
Stream	Simpson Creek	Percent Backwatered	-
Road	Nielson Road	Fill Depth (m)	0.4
Road Tenure	MoTi	Outlet Drop (m)	1
Channel Width (m)	5.6	Outlet Pool Depth (m)	1.2
Stream Slope (%)	13	Inlet Drop	No
Beaver Activity	No	Slope (%)	5
Habitat Value	High	Valley Fill	Deep Fill
Final score	39	Barrier Result	Barrier
Fix type	Replace with New Open Bottom Structure	Fix Span / Diameter	15
Comments: This concrete oval culvert has a significant 1 m outlet drop, likely inhibiting fish passage. The stream is incorrectly mapped in the Freshwater Atlas, located south of the mapped channel. Upstream habitat includes boulder cover, gravel pockets suitable for coho, steelhead, and Dolly Varden spawning, and a healthy mature mixed forest riparian zone. Downstream habitat transitions to lower-gradient, high-value conditions with extensive gravels, deep pools (up to 90 cm), large woody debris, and abundant cover, supporting recent steelhead and historically chinook spawning, as reported by the adjacent landowner. Habitat confirmations were completed at this site and all downstream crossings to the confluence with Kathlyn Creek. The stream is a major contributor to the greater Kathlyn Creek watershed, with flow volumes during the assessment slightly less than the Kathlyn Creek mainstem. Electrofishing upstream of Nielsen Road captured rainbow trout, while downstream sampling confirmed the presence of Dolly Varden, rainbow trout, cutthroat trout/rainbow trout hybrids, and coho. The coho were captured approximately 350 m downstream of Nielsen Road. According to the landowner, this crossing was originally a bridge but was replaced with the current culvert during an emergency flood event in the 1990s.

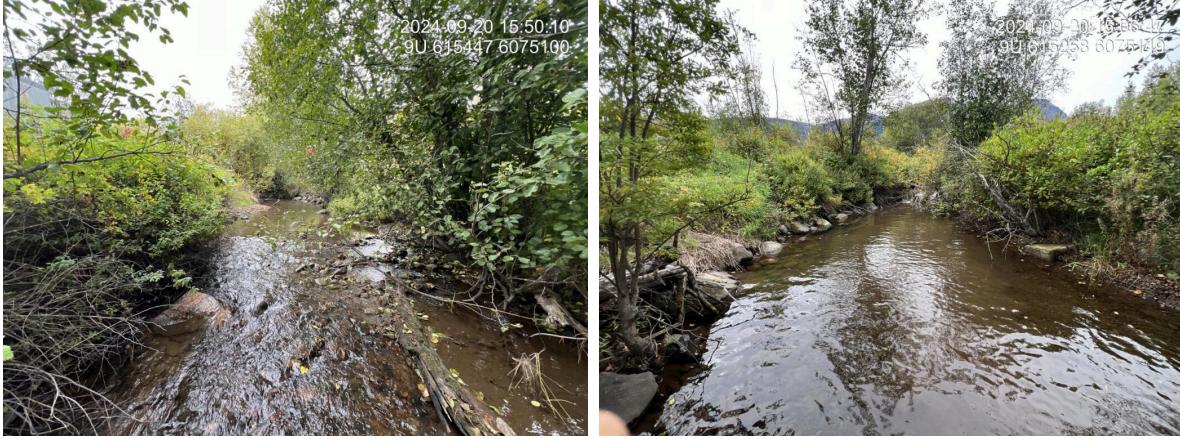
Figure 4.17: Left: Typical habitat downstream of PSCIS crossing 58245. Right: Typical habitat upstream of PSCIS crossing 58245 and downstream of PSCIS crossing 203122, with signs of bank armouring and channelization.

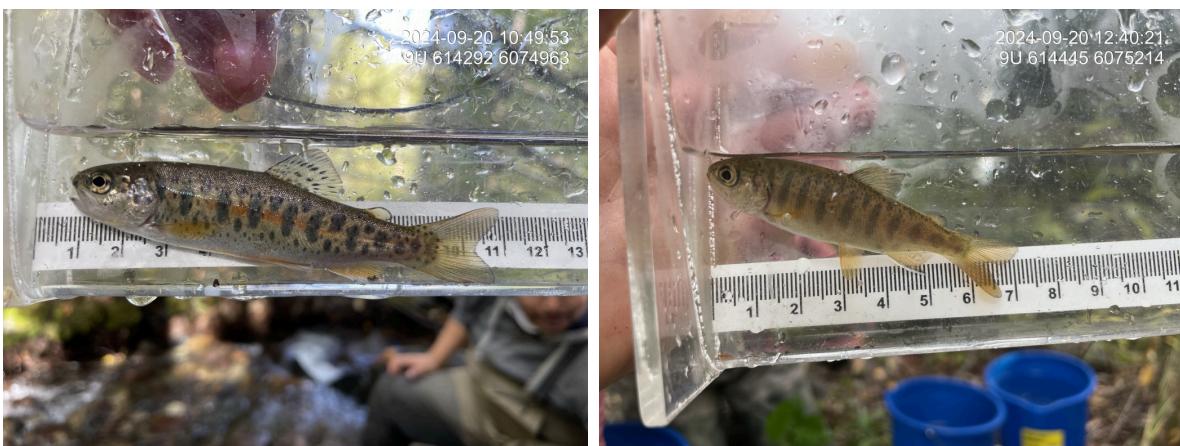
Electrofishing was conducted upstream and downstream of crossing (58264) with results summarised in Tables 4.32 - 4.33 and Figure 4.16. A total of 20 fish were captured downstream including rainbow trout, cutthroat trout/rainbow trout hybrid, and Dolly Varden. Upstream of the crossing 12 rainbow trout were captured (Figure 4.19) .

Electrofishing was conducted at one site approximately 360 m downstream of Nielsen Road, with results summarised in Tables 4.32 - 4.33 and Figure 4.16. At this location, the adjacent landowner had reported recent steelhead and coho spawning and historically Chinook spawning. A total of 43 fish were captured including coho salmon, cutthroat trout/rainbow trout hybrid, and Dolly Varden (Figure 4.19).

Figure 4.19: Left: Rainbow trout captured downstream of crossing 58264. Right: Coho salmon captured approximately 360 m downstream of crossing 58264.
