## **Skeena Watershed Fish Passage Restoration Planning 2024**

**Prepared for**  
**Habitat Conservation Trust Foundation - CAT23-6-288**  
**BC Fish Passage Remediation Program**  
**Ministry of Transportation and Infrastructure**

**Prepared by**  
**Al Irvine, B.Sc., R.P.Bio and Lucy Schick, B.Sc.**  
**New Graph Environment Ltd.**  
**on behalf of**  
**Society for Ecosystem Restoration in Northern British Columbia**

DRAFT Version 0.1.1 2025-03-31

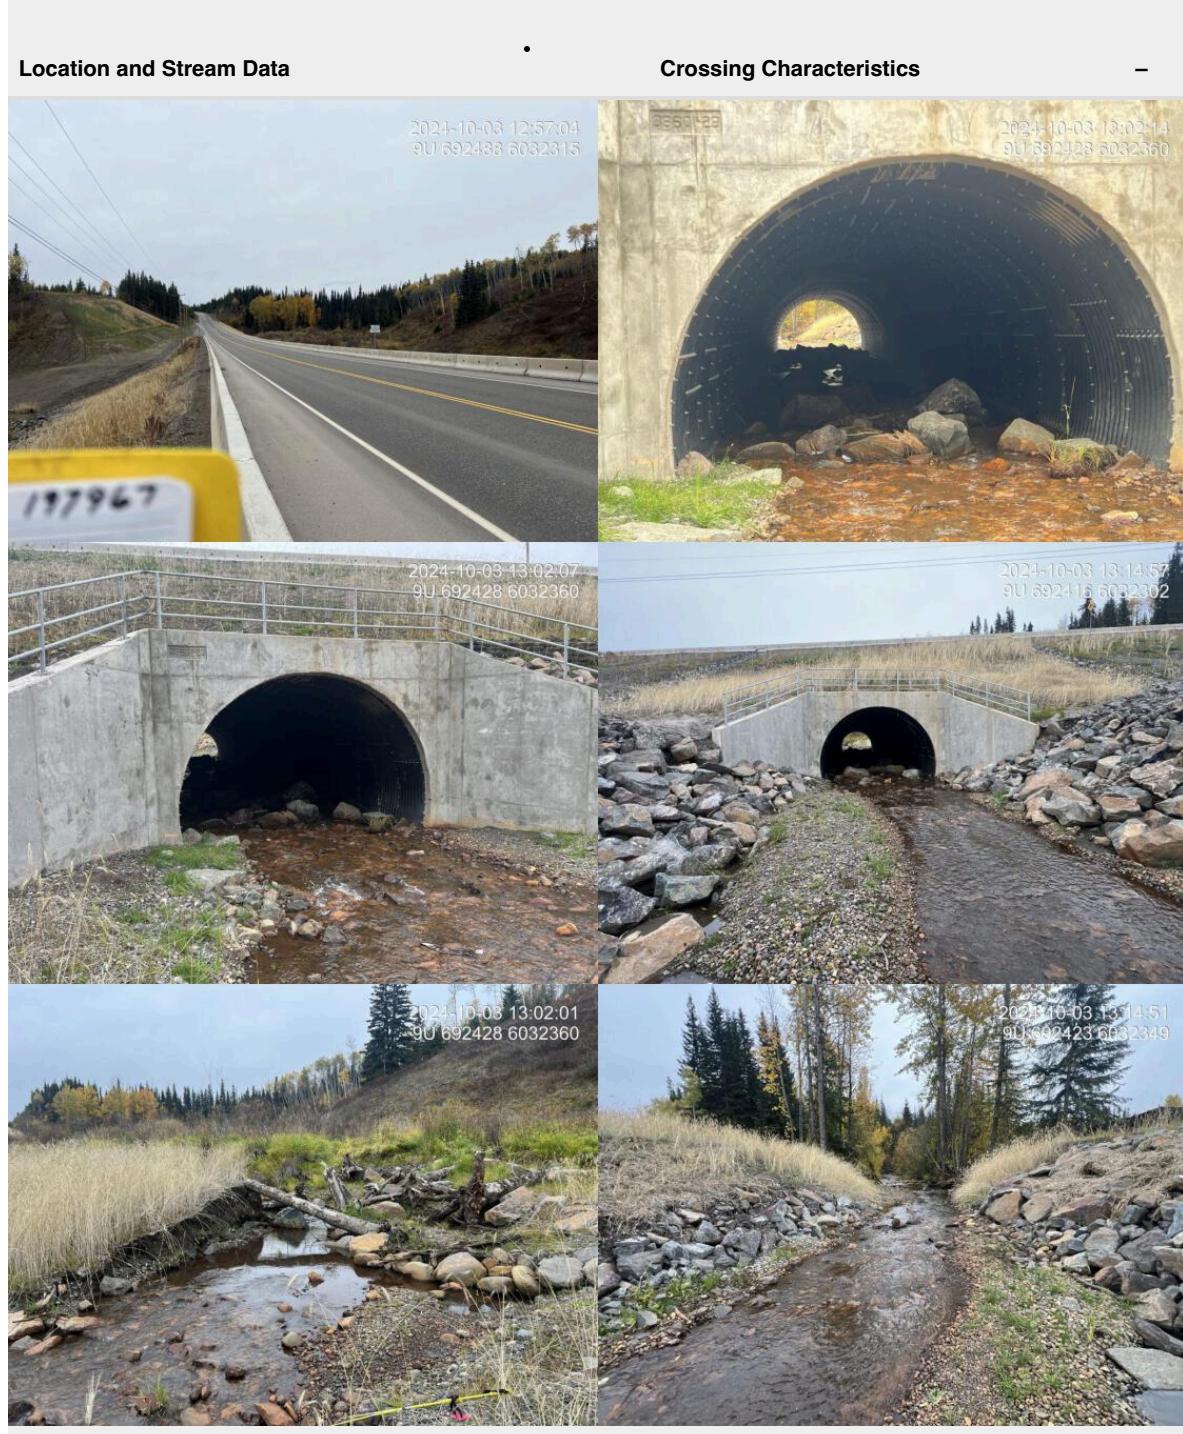
Photos: From top left clockwise: Road/Site Card, Barrel, Outlet, Downstream, Upstream, Inlet.

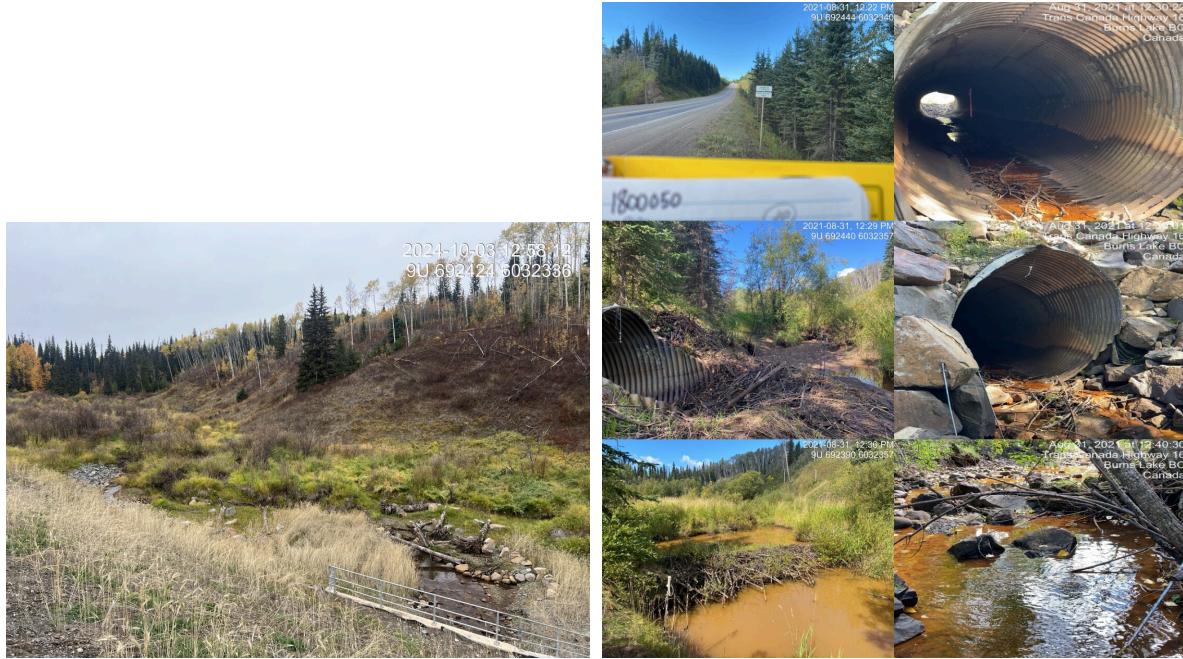
Figure 5.3: Left: Woody debris and boulder structures located upstream of 197967 in 2024. Right: Photos of crossing 197967 in 2021.

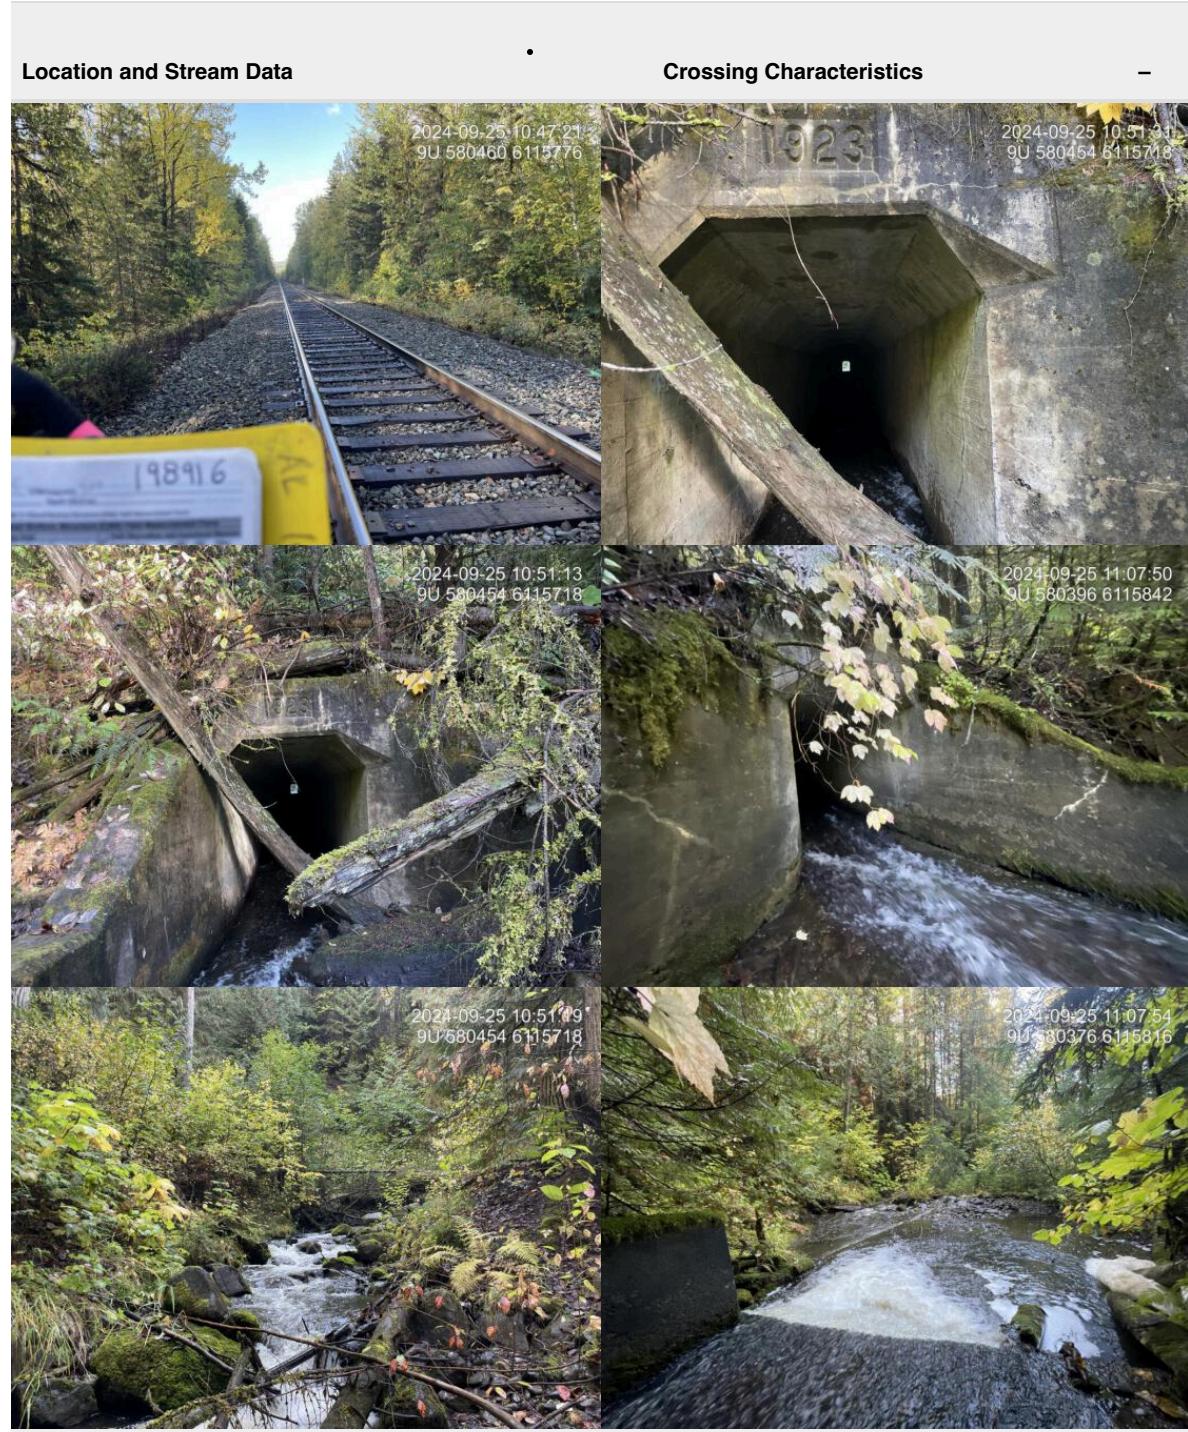
Photos: From top left clockwise: Road/Site Card, Barrel, Outlet, Downstream, Upstream, Inlet.

Location and Stream Data		Crossing Characteristics	
Date	2024-09-25	Crossing Sub Type	Round Culvert
PSCIS ID	198913	Diameter (m)	1.5
External ID	-	Length (m)	40
Crew	AI JO	Embedded	No
UTM Zone	9	Depth Embedded (m)	-
Easting	581250	Resemble Channel	-
Northing	6115660	Backwatered	No
Stream	Gershwin Creek	Percent Backwatered	-
Road	Highway 16	Fill Depth (m)	2.5
Road Tenure	MOTi	Outlet Drop (m)	0.35
Channel Width (m)	5	Outlet Pool Depth (m)	0.85
Stream Slope (%)	3	Inlet Drop	No
Beaver Activity	No	Slope (%)	3
Habitat Value	Medium	Valley Fill	Deep Fill
Final score	42	Barrier Result	Barrier
Fix type	Replace with New Open Bottom Structure	Fix Span / Diameter	15

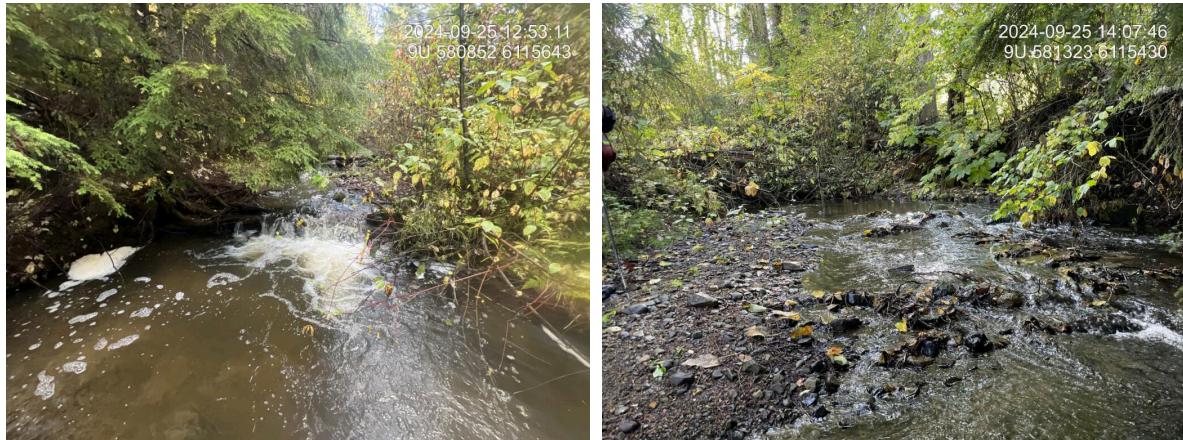
Figure 5.8: Left: Typical habitat downstream of PSCIS crossing 198913. Right: Typical habitat upstream of PSCIS crossing 198913.

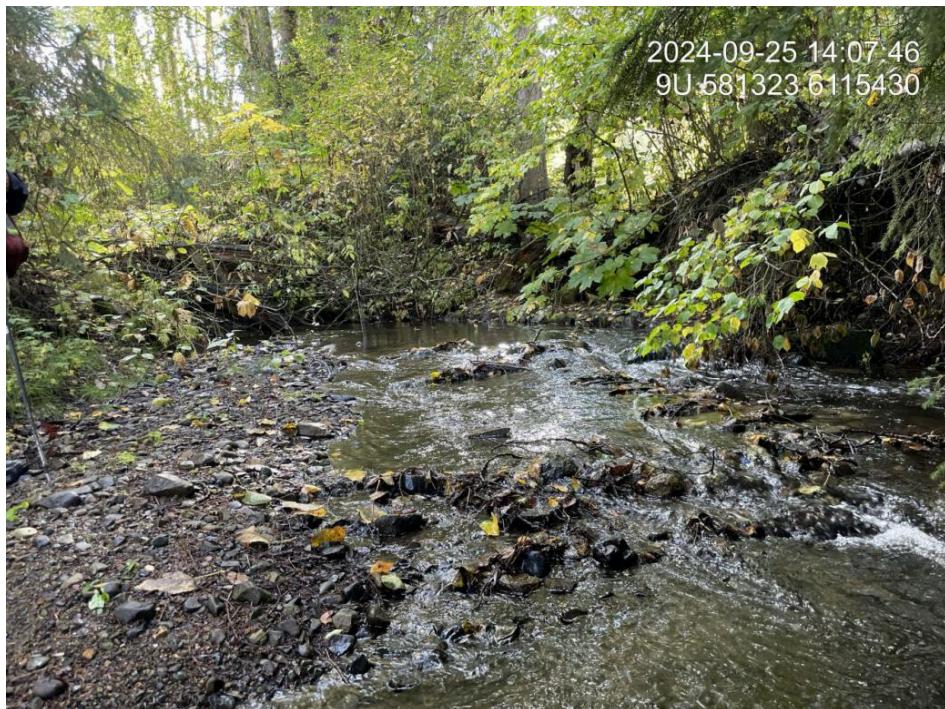
Figure 5.9: Typical habitat upstream of PSCIS crossing 198913.

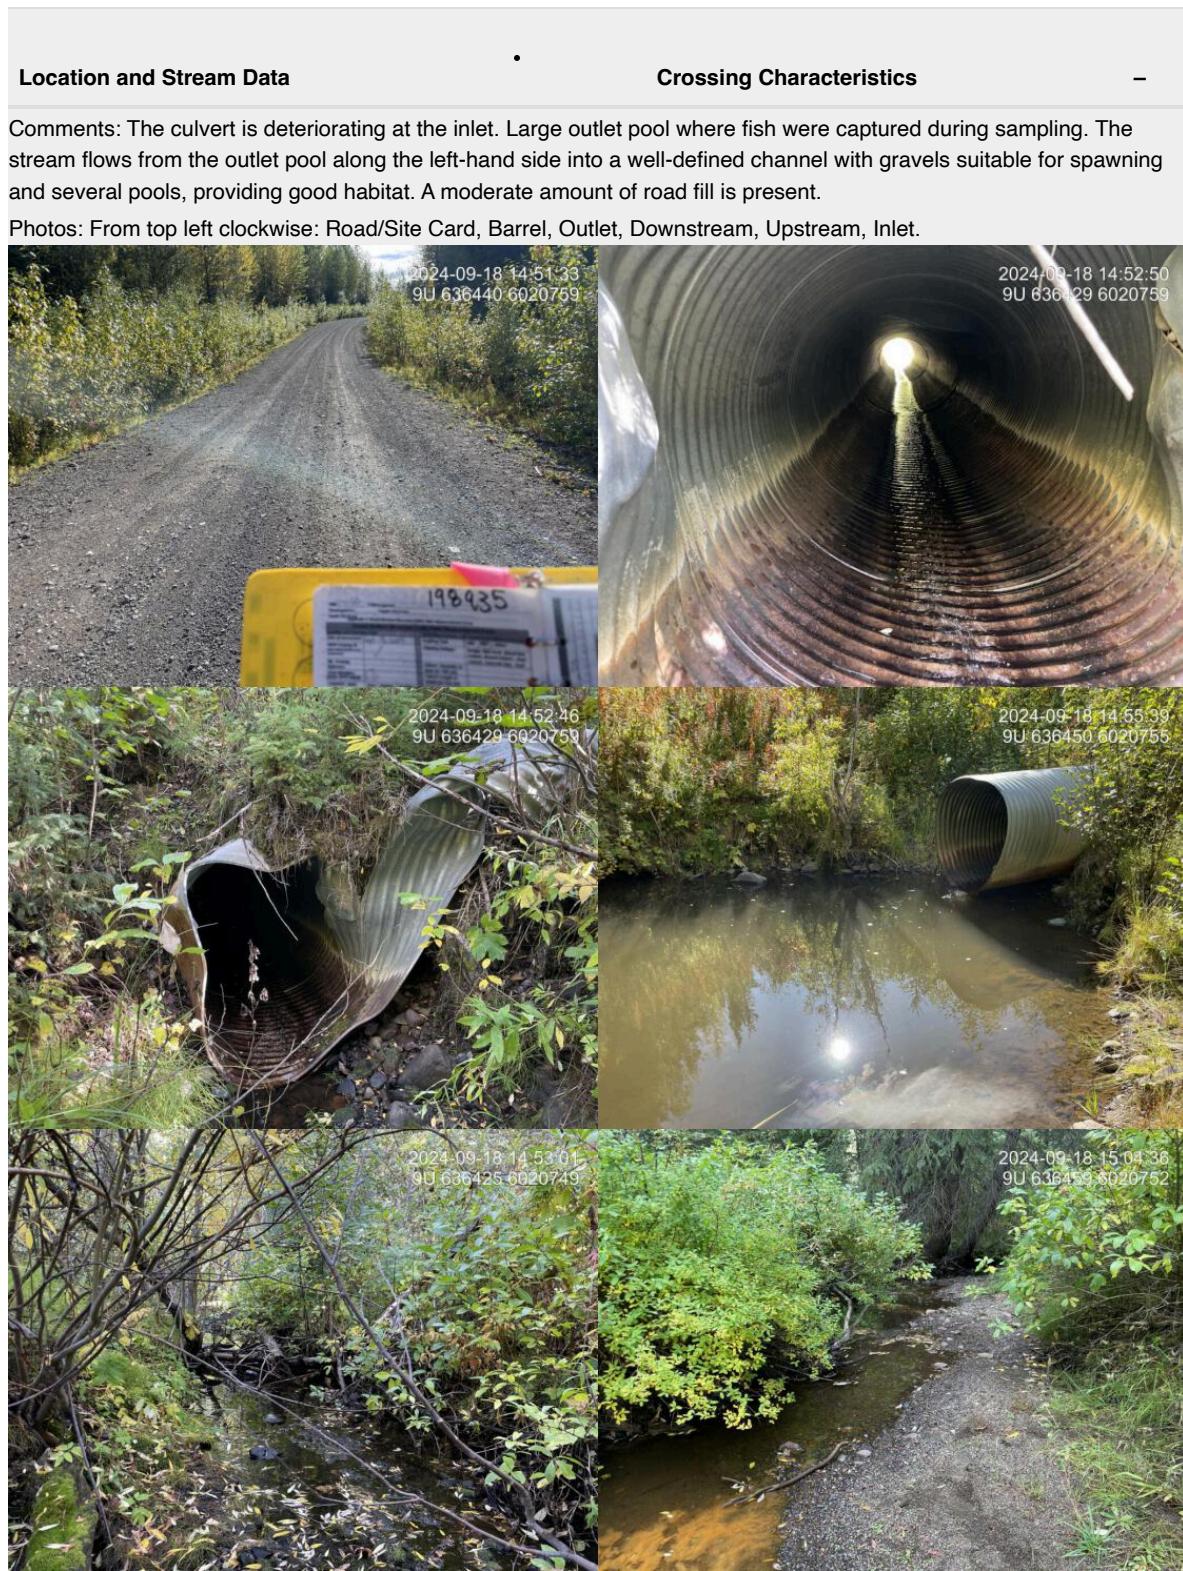
Location and Stream Data		Crossing Characteristics	
Date	2024-09-18	Crossing Sub Type	Round Culvert
PSCIS ID	198935	Diameter (m)	1.2
External ID	–	Length (m)	20
Crew	LS	Embedded	No
UTM Zone	9	Depth Embedded (m)	–
Easting	636440	Resemble Channel	–
Northing	6020756	Backwatered	No
Stream	Tributary to Knapper Creek	Percent Backwatered	–
Road	Gold creek fsr	Fill Depth (m)	4
Road Tenure	Canfor R07549 6	Outlet Drop (m)	0.15
Channel Width (m)	2.7	Outlet Pool Depth (m)	0.8
Stream Slope (%)	2.2	Inlet Drop	No
Beaver Activity	Yes	Slope (%)	1.5
Habitat Value	Medium	Valley Fill	Deep Fill
Final score	29	Barrier Result	Barrier
Fix type	Replace with New Open Bottom Structure	Fix Span / Diameter	18

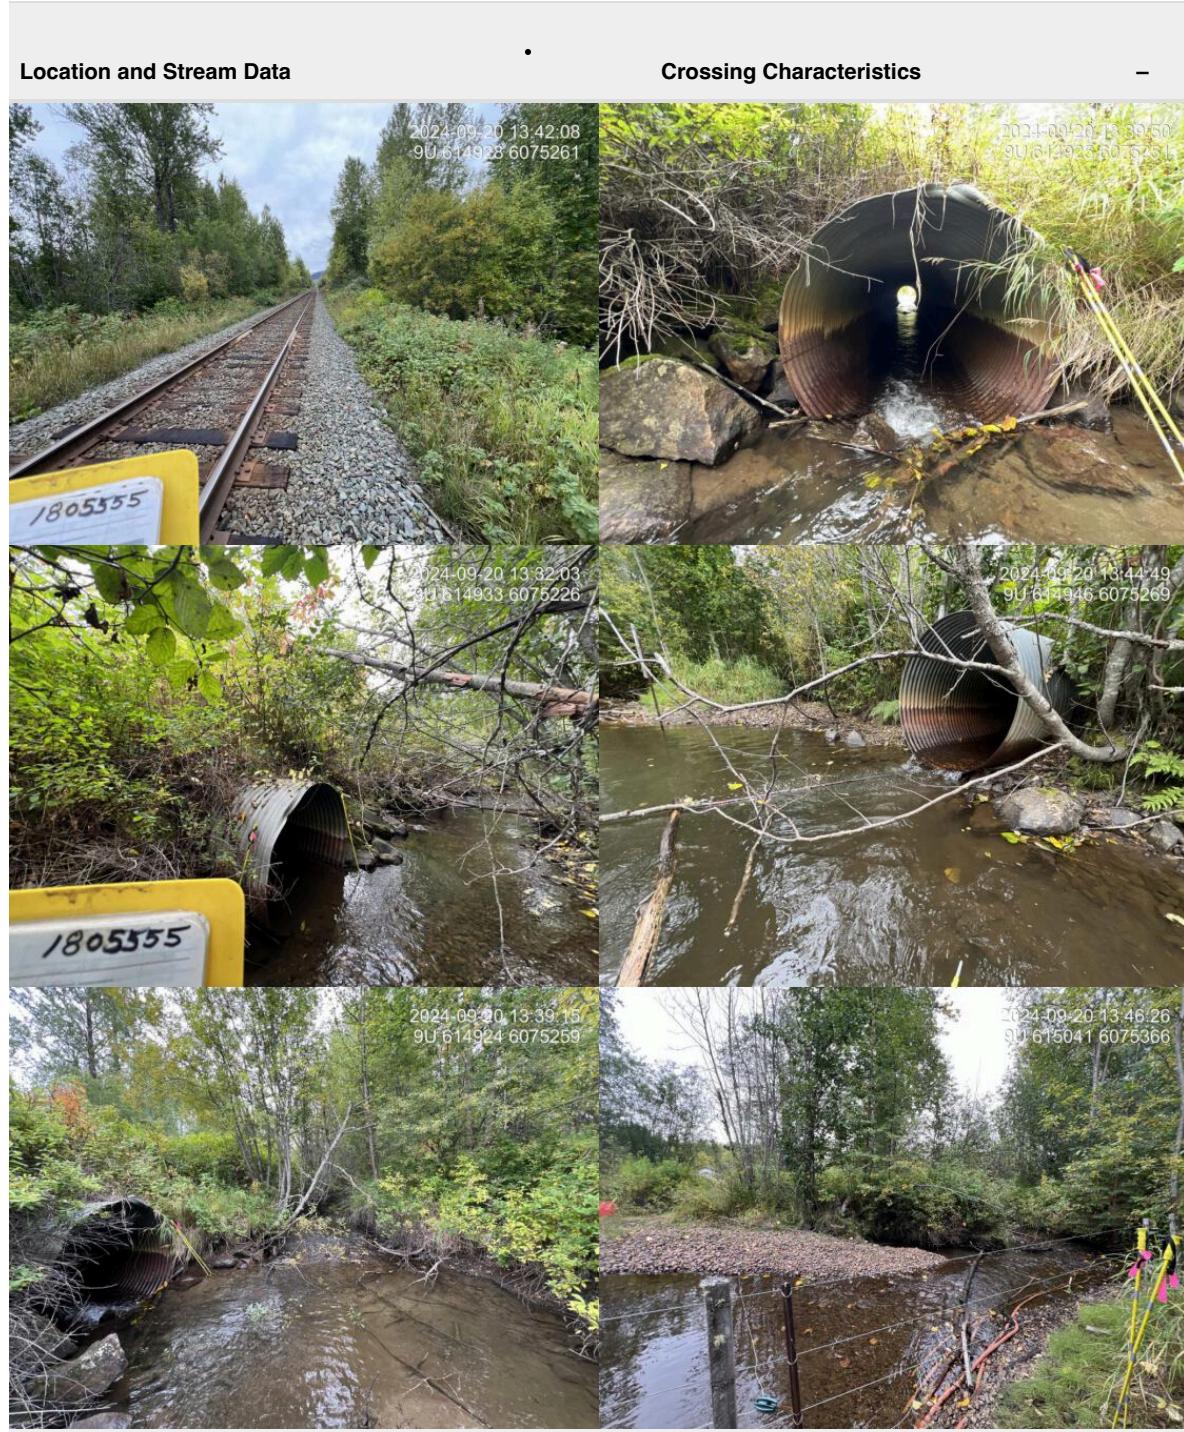
Location and Stream Data		Crossing Characteristics	
Date	2024-09-20	Crossing Sub Type	Round Culvert
PSCIS ID	203122	Diameter (m)	3
External ID	–	Length (m)	25
Crew	AI	Embedded	No
UTM Zone	9	Depth Embedded (m)	–
Easting	614941	Resemble Channel	Yes
Northing	6075232	Backwatered	No
Stream	Simpson Creek	Percent Backwatered	–
Road	Railway	Fill Depth (m)	1
Road Tenure	CN Rail	Outlet Drop (m)	0.05
Channel Width (m)	5	Outlet Pool Depth (m)	0.9
Stream Slope (%)	1	Inlet Drop	Yes
Beaver Activity	Yes	Slope (%)	2
Habitat Value	High	Valley Fill	Deep Fill
Final score	24	Barrier Result	Barrier
Fix type	Replace with New Open Bottom Structure	Fix Span / Diameter	15
Comments: Although this culvert is on Simpson Creek, it is not currently conveying the main flow and remains mostly dry. Two 1.5 m diameter pipes run under the railway, approximately 30 m apart. The southern pipe is fully embedded with an average embedment depth of 25 cm, while the northern pipe is currently passing all stream flow. This is a high-value stream with extensive gravel areas suitable for steelhead, coho, and chinook salmon spawning upstream. The adjacent landowner has reported recent observations of steelhead spawning and has historical knowledge of chinook spawning approximately 300 m downstream from Nielsen Road.

Photos: From top left clockwise: Road/Site Card, Barrel, Outlet, Downstream, Upstream, Inlet.

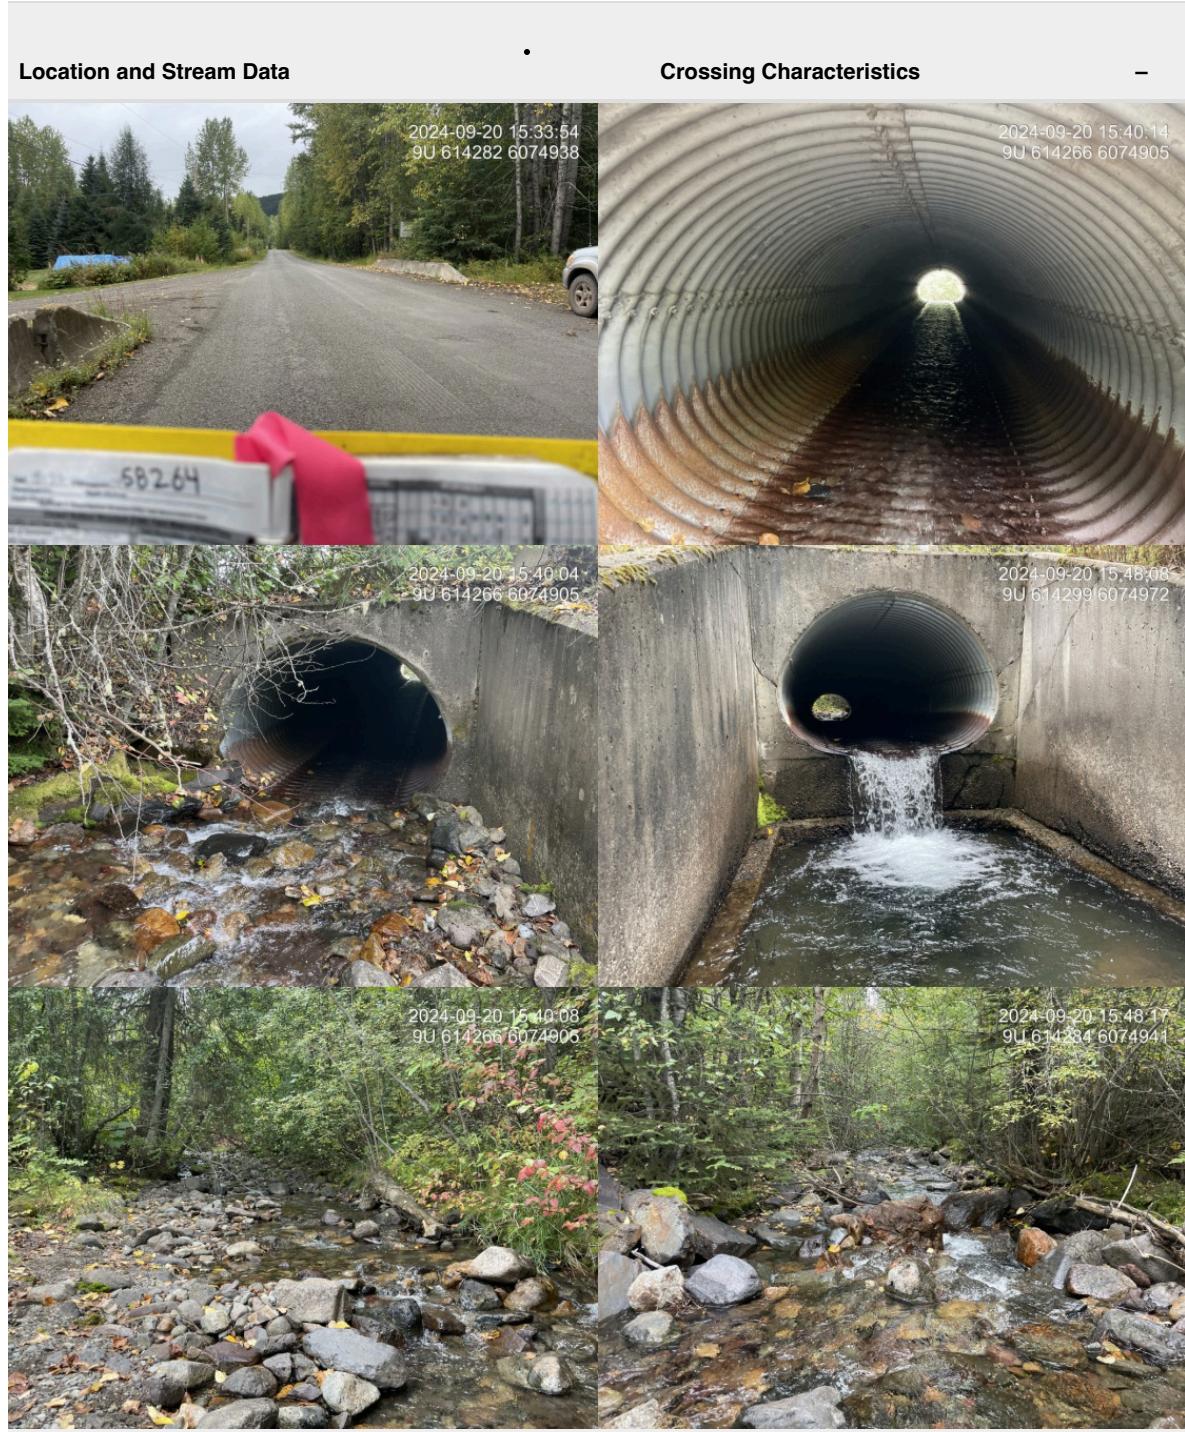
Comments: This concrete oval culvert has a significant 1 m outlet drop, likely inhibiting fish passage. The stream is incorrectly mapped in the Freshwater Atlas, located south of the mapped channel. Upstream habitat includes boulder cover, gravel pockets suitable for coho, steelhead, and Dolly Varden spawning, and a healthy mature mixed forest riparian zone. Downstream habitat transitions to lower-gradient, high-value conditions with extensive gravels, deep pools (up to 90 cm), large woody debris, and abundant cover, supporting recent steelhead and historically chinook spawning, as reported by the adjacent landowner. Habitat confirmations were completed at this site and all downstream crossings to the confluence with Kathlyn Creek. The stream is a major contributor to the greater Kathlyn Creek watershed, with flow volumes during the assessment slightly less than the Kathlyn Creek mainstem. Electrofishing upstream of Nielsen Road captured rainbow trout, while downstream sampling confirmed the presence of Dolly Varden, rainbow trout, cutthroat trout/rainbow trout hybrids, and coho. The coho were captured approximately 350 m downstream of Nielsen Road. According to the landowner, this crossing was originally a bridge but was replaced with the current culvert during an emergency flood event in the 1990s.

Photos: From top left clockwise: Road/Site Card, Barrel, Outlet, Downstream, Upstream, Inlet.

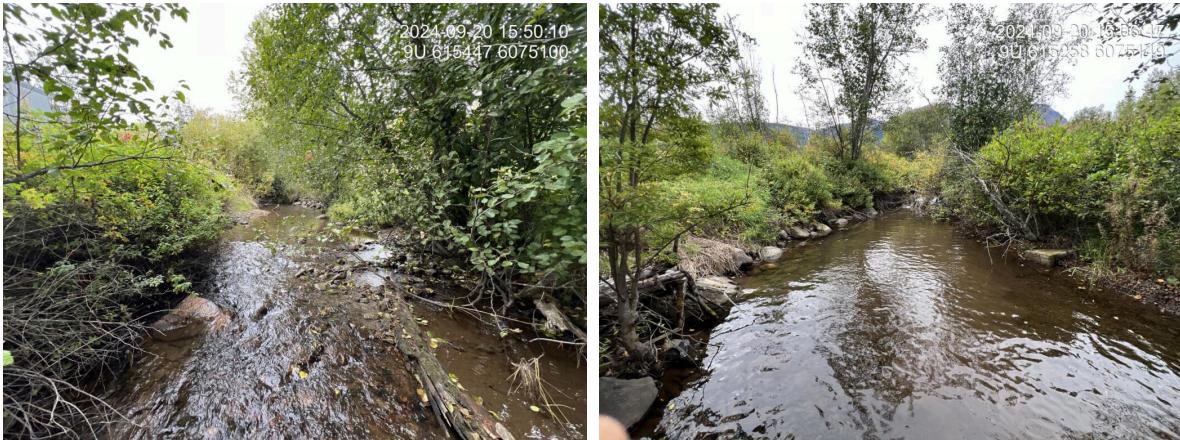
Figure 5.16: Left: Typical habitat downstream of PSCIS crossing 58245. Right: Typical habitat upstream of PSCIS crossing 58245 and downstream of PSCIS crossing 203122, with signs of bank armouring and channelization.

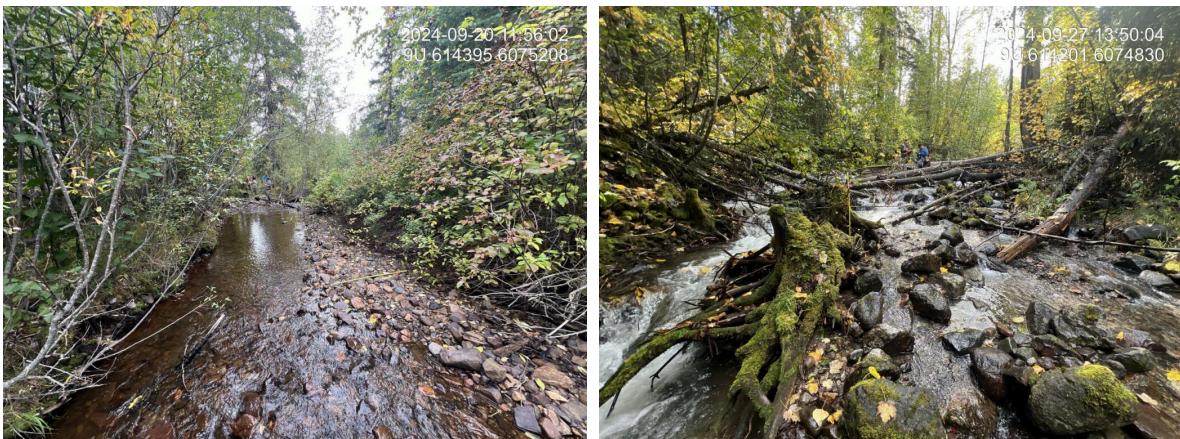
Figure 5.17: Left: Steelhead spawning location upstream of PSCIS crossing 203122 and downstream of PSCIS crossing 58264, as reported by the adjacent landowner. Right: Typical habitat upstream of PSCIS crossing 58264.

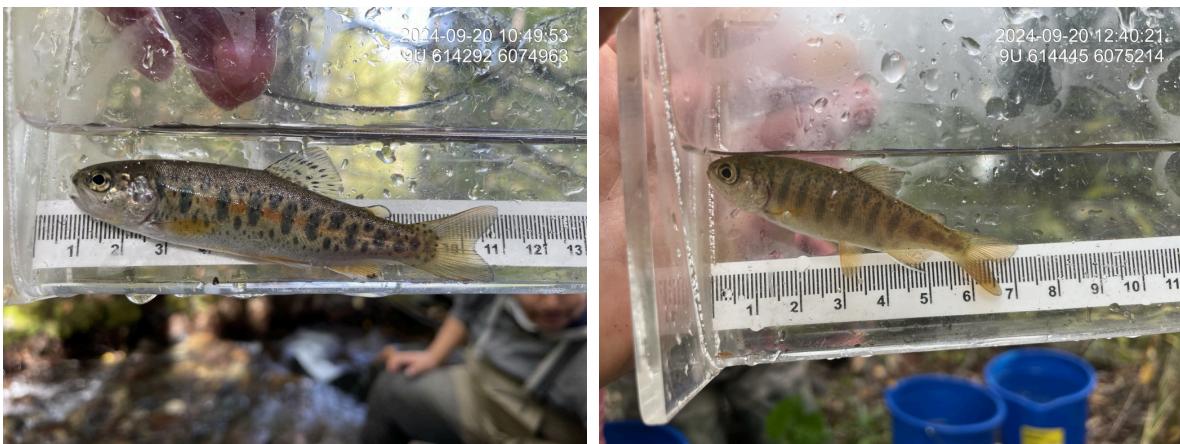
Electrofishing was conducted upstream and downstream of crossing (58264) with results summarised in Tables 5.23 - 5.24 and Figure 5.15. A total of 20 fish were captured downstream including rainbow trout, cutthroat trout/rainbow trout hybrid, and Dolly Varden. Upstream of the crossing 12 rainbow trout were captured (Figure 5.18) .

Electrofishing was conducted at one site approximately 360 m downstream of Nielsen Road, with results summarised in Tables 5.23 - 5.24 and Figure 5.15. At this location, the adjacent landowner had reported recent steelhead and coho spawning and historically Chinook spawning. A total of 43 fish were captured including coho salmon, cutthroat trout/rainbow trout hybrid, and Dolly Varden (Figure 5.18).

Figure 5.18: Left: Rainbow trout captured downstream of crossing 58264. Right: Coho salmon captured approximately 360 m downstream of crossing 58264.
