Skeena Watershed Fish Passage Restoration Planning 2024

Prepared for
Habitat Conservation Trust Foundation - CAT23-6-288
BC Fish Passage Remediation Program
Ministry of Transportation and Infrastructure

Prepared by
Al Irvine, B.Sc., R.P.Bio and Lucy Schick, B.Sc.
New Graph Environment Ltd.
on behalf of
Society for Ecosystem Restoration in Northern British Columbia

DRAFT Version 0.1.0 2025-03-31

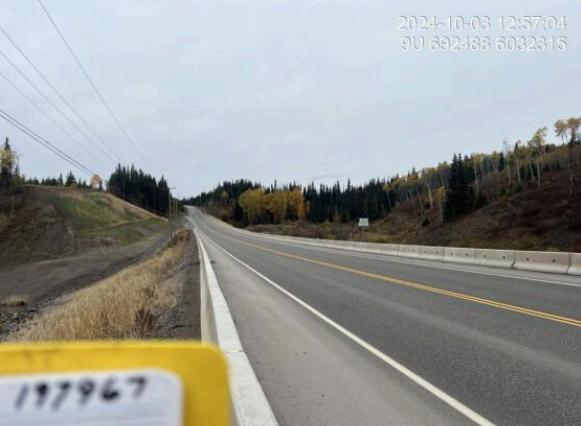
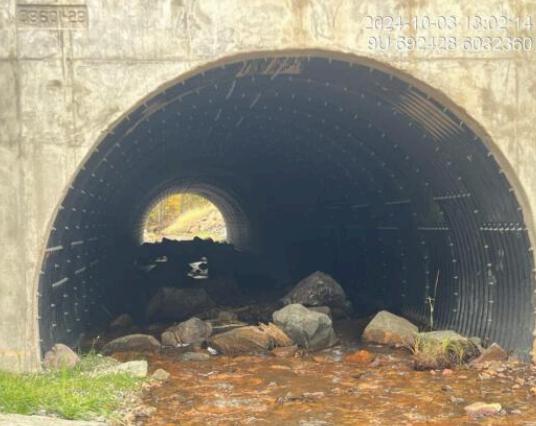
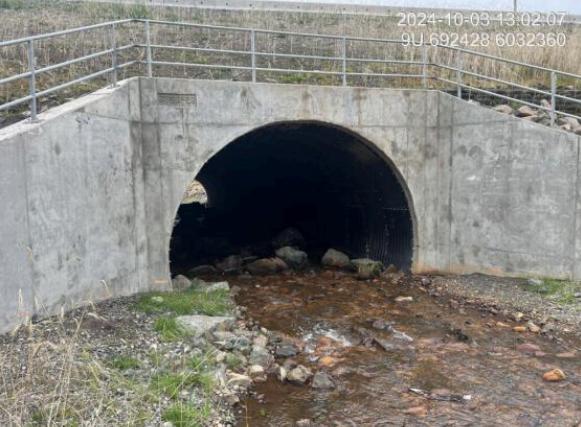
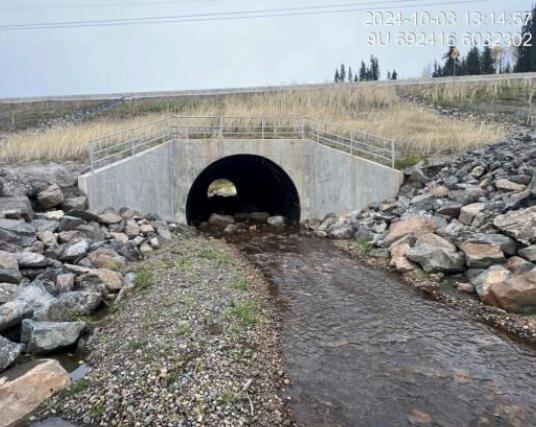
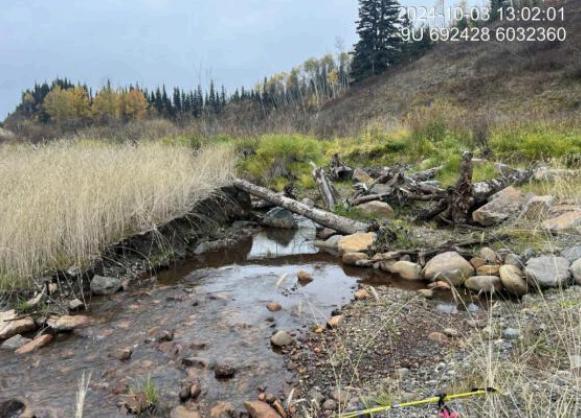
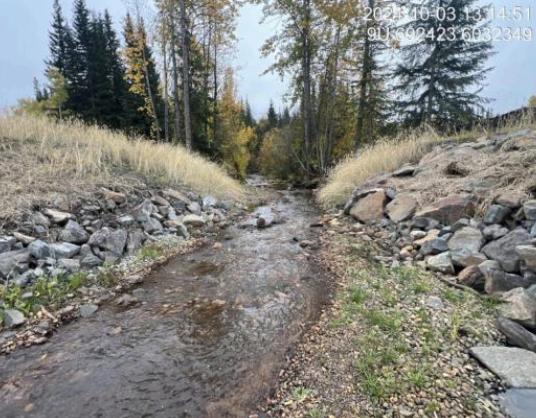
Photos: From top left clockwise: Road/Site Card, Barrel, Outlet, Downstream, Upstream, Inlet.

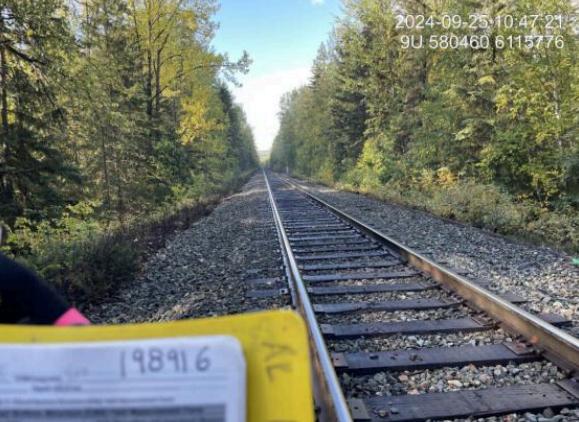
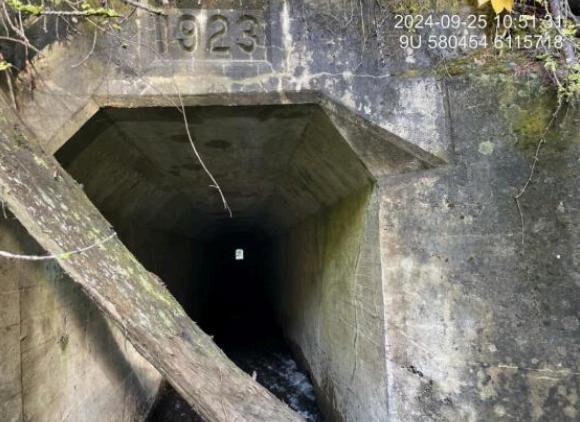
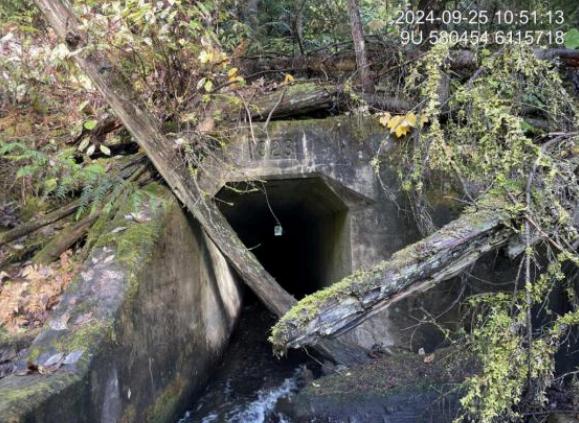
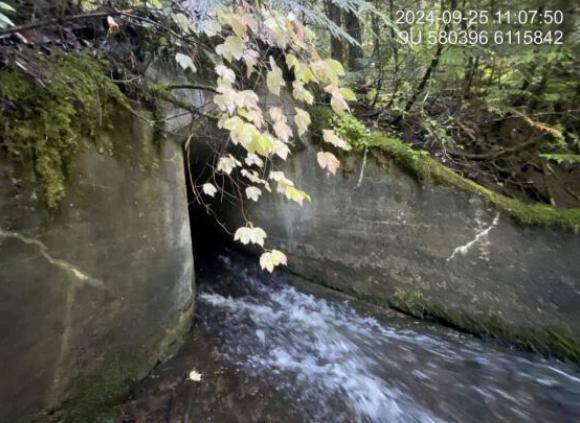
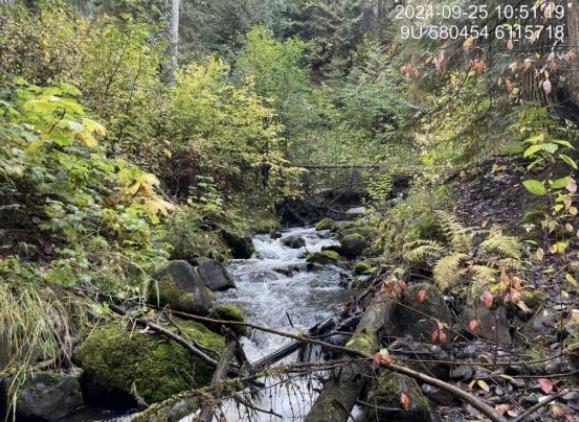
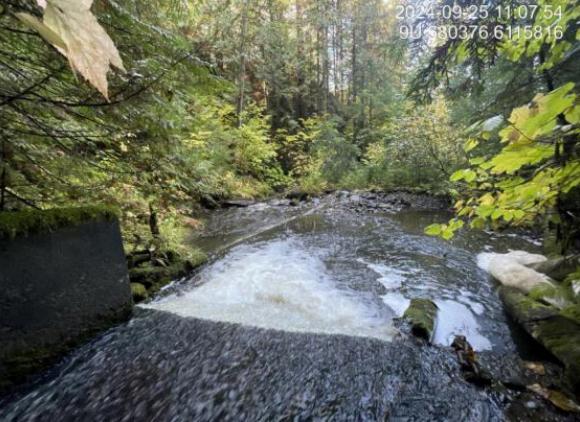
Photos: From top left clockwise: Road/Site Card, Barrel, Outlet, Downstream, Upstream, Inlet.

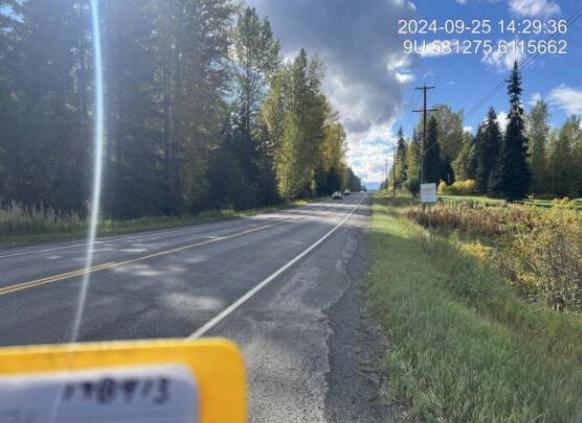
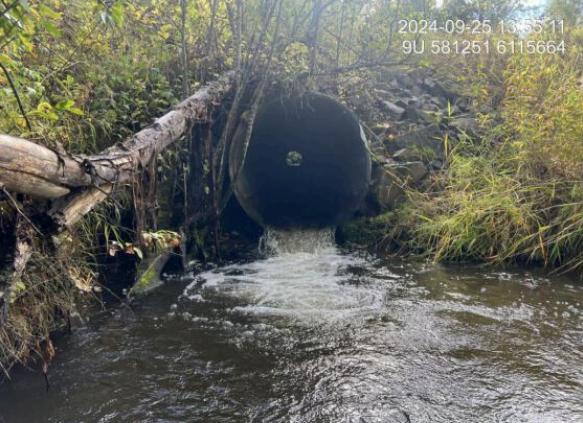
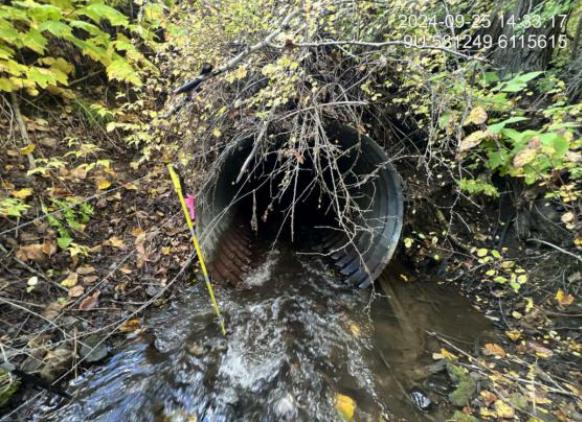
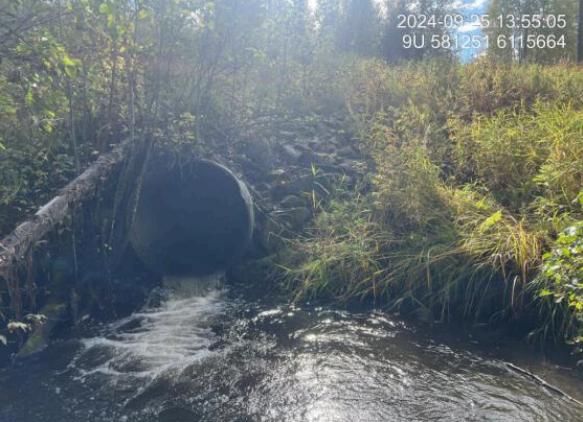
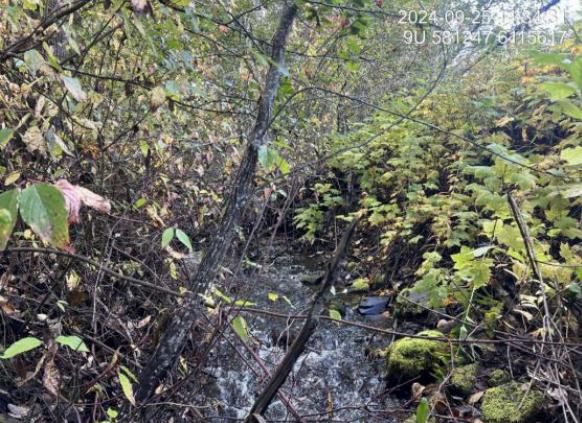
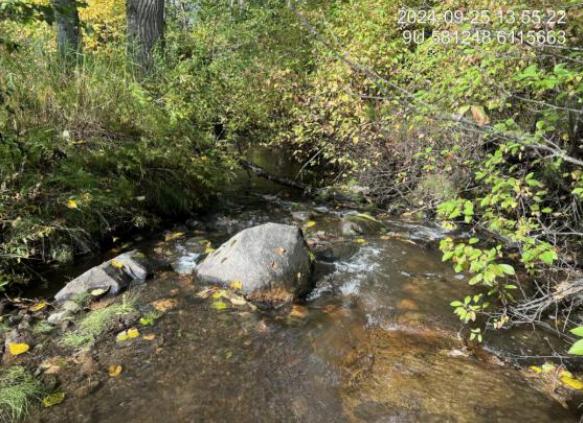
Photos: From top left clockwise: Road/Site Card, Barrel, Outlet, Downstream, Upstream, Inlet.

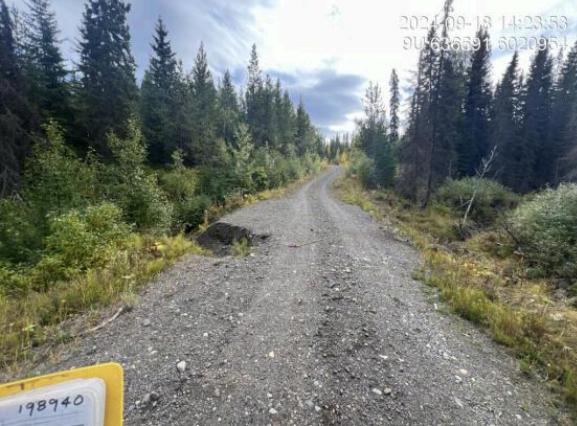
2024-09-18 14:23:53 9U 636691 6020951

Location and Stream Data	•	Crossing Characteristics			
<p>Comments: Very nice stream with good flow, abundant gravels for spawning, and undercut banks and occasional deep pools for rearing. Confirmed populations of cutthroat trout, rainbow trout, and Dolly Varden. The culvert is significantly undersized for the stream, and the road appears to be failing, likely due to a partially clogged inlet and spring freshet. Habitat confirmations were completed for this crossing and the next upstream crossing (198935) on the Gold FSR.</p>					
<p>Photos: From top left clockwise: Road/Site Card, Barrel, Outlet, Downstream, Upstream, Inlet.</p>

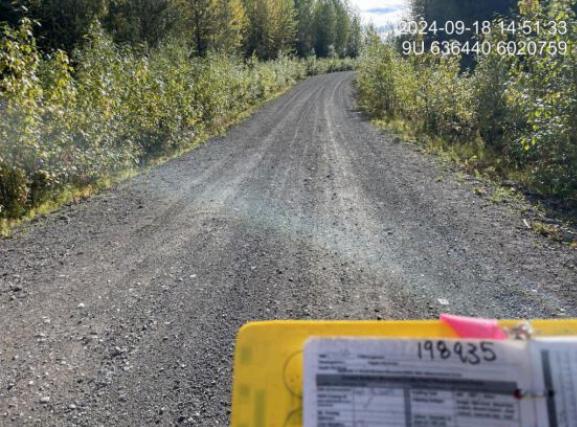
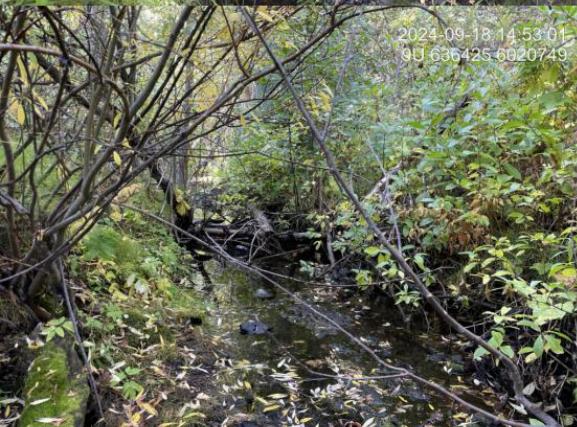
Location and Stream Data	•	Crossing Characteristics	-
<p>Comments: The culvert is deteriorating at the inlet. Large outlet pool where fish were captured during sampling. The stream flows from the outlet pool along the left-hand side into a well-defined channel with gravels suitable for spawning and several pools, providing good habitat. A moderate amount of road fill is present.</p>			
<p>Photos: From top left clockwise: Road/Site Card, Barrel, Outlet, Downstream, Upstream, Inlet.</p>

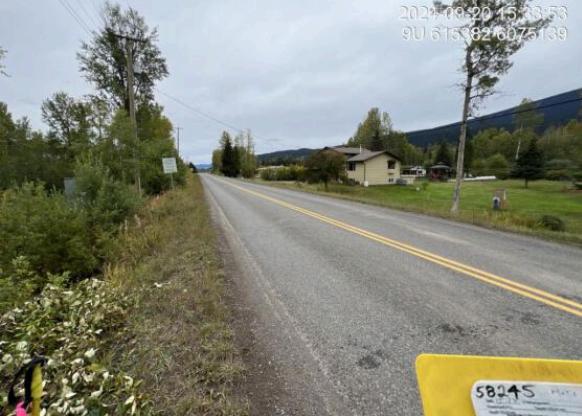
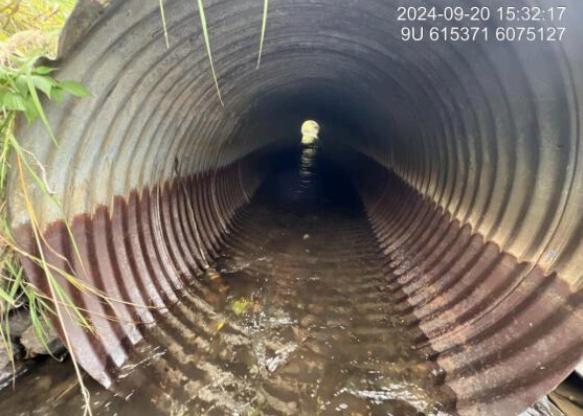
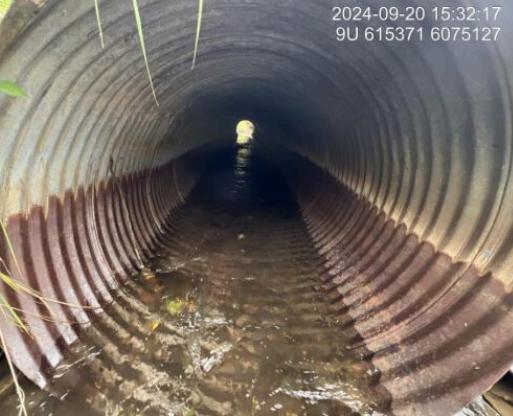
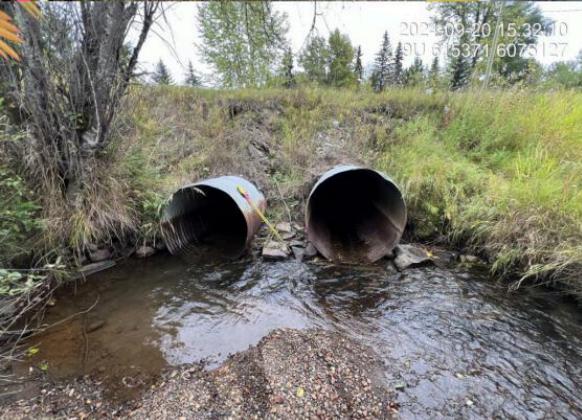
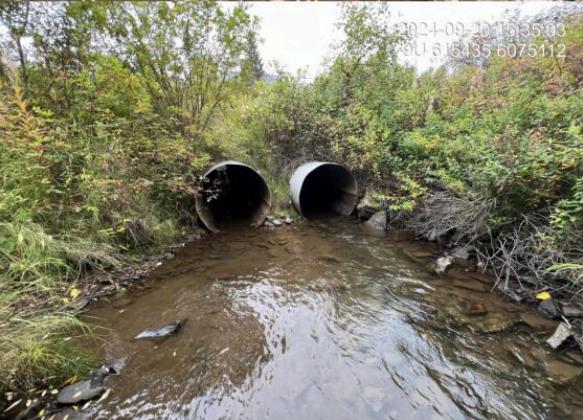
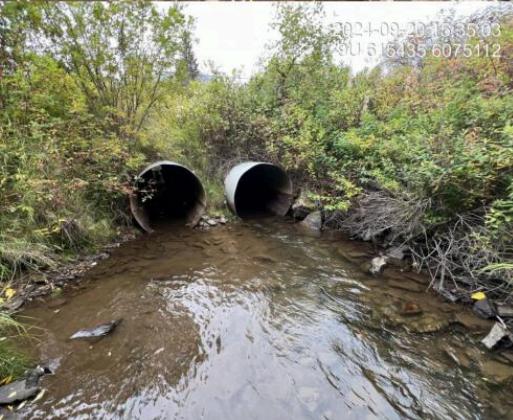
Location and Stream Data	•	Crossing Characteristics
<p>Comments: Two 1.25 m pipes are present and are heavily corroded. Upstream and downstream, the streambanks are heavily modified adjacent to private land, including riparian vegetation removal, stream channelization, and bank armouring. High-value steelhead, coho, and chinook spawning habitat is documented further upstream above the railway crossing. MoTi chris_culvert_id: 1514706, 1514705</p>		
Photos: From top left clockwise: Road/Site Card, Barrel, Outlet, Downstream, Upstream, Inlet.

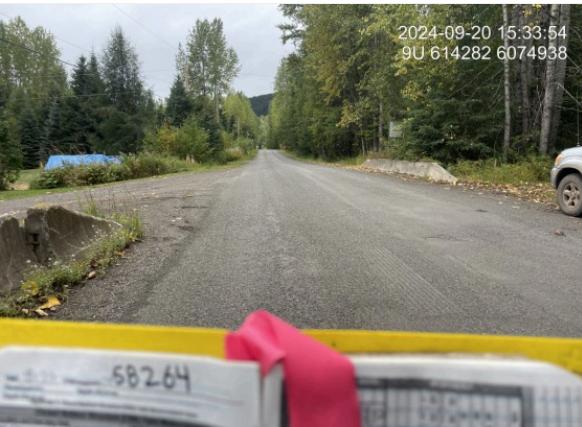
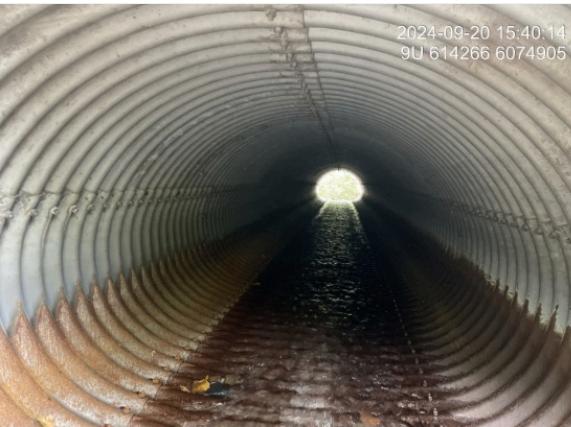
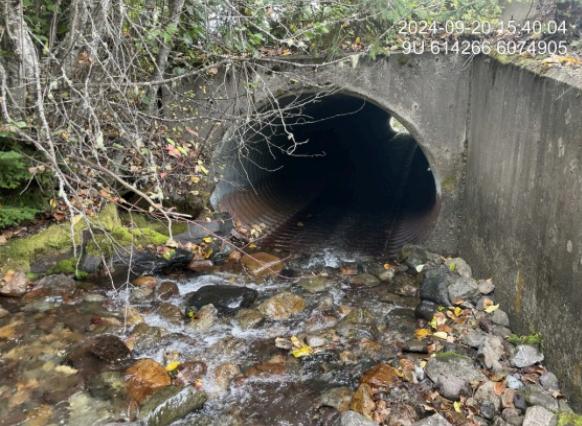
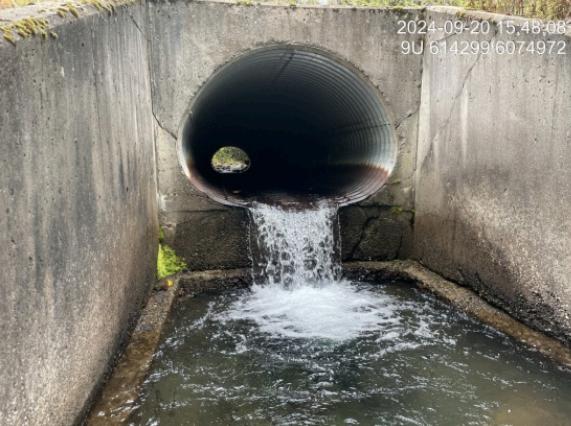
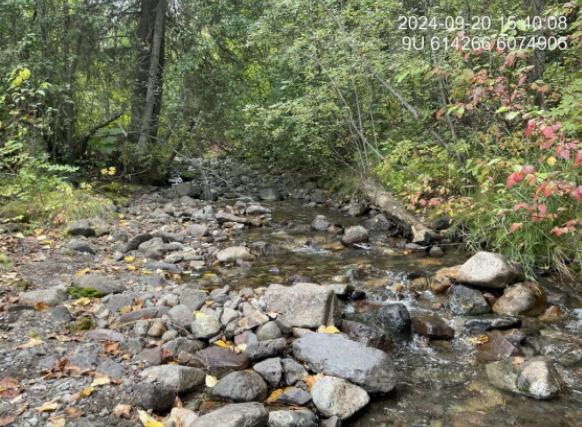
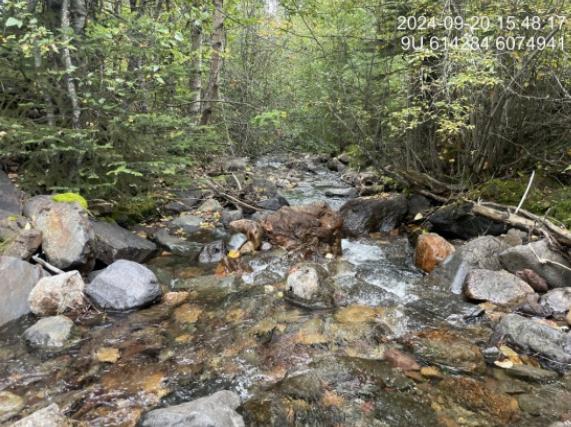
Comments: This concrete oval culvert has a significant 1 m outlet drop, likely inhibiting fish passage. The stream is incorrectly mapped in the Freshwater Atlas, located south of the mapped channel. Upstream habitat includes boulder cover, gravel pockets suitable for coho, steelhead, and Dolly Varden spawning, and a healthy mature mixed forest riparian zone. Downstream habitat transitions to lower-gradient, high-value conditions with extensive gravels, deep pools (up to 90 cm), large woody debris, and abundant cover, supporting recent steelhead and historically chinook spawning, as reported by the adjacent landowner. Habitat confirmations were completed at this site and all downstream crossings to the confluence with Kathlyn Creek. The stream is a major contributor to the greater Kathlyn Creek watershed, with flow volumes during the assessment slightly less than the Kathlyn Creek mainstem. Electrofishing upstream of Nielsen Road captured rainbow trout, while downstream sampling confirmed the presence of Dolly Varden, rainbow trout, cutthroat trout/rainbow trout hybrids, and coho. The coho were captured approximately 350 m downstream of Nielsen Road. According to the landowner, this crossing was originally a bridge but was replaced with the current culvert during an emergency flood event in the 1990s.

Should restoration/maintenance activities proceed, replacement of the Nielson Road crossing (58264) with a bridge (15 m span) is recommended. The significant 1 m outlet drop at this crossing, combined with the presence of salmonids in the system, makes it a top priority for remediation. At the time of reporting in 2025, the cost of the work is estimated at \$ 3,000,000.
