## **Skeena Watershed Fish Passage Restoration Planning 2024**

**Prepared for**  
**Habitat Conservation Trust Foundation - CAT23-6-288**  
**BC Fish Passage Remediation Program**  
**Ministry of Transportation and Infrastructure**

**Prepared by**  
**Al Irvine, B.Sc., R.P.Bio and Lucy Schick, B.Sc.**  
**New Graph Environment Ltd.**  
**on behalf of**  
**Society for Ecosystem Restoration in Northern British Columbia**

DRAFT Version 0.1.1 2025-04-16

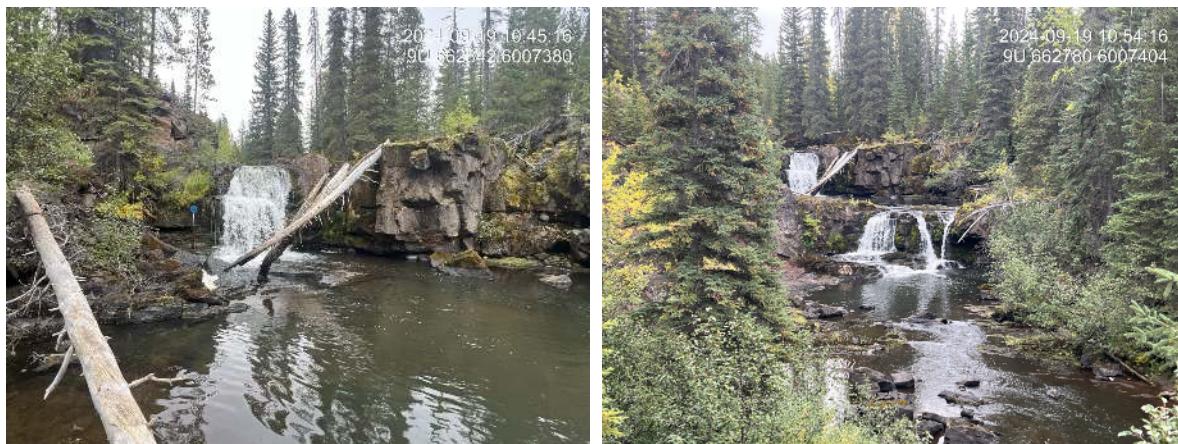
Figure 5.1: Left: Buck Falls – The upper falls featured a ~4m high vertical drop. A 2m tall net is included for scale. Right: Buck Falls – The second falls consisted of a ~3.5m high sheer drop to bedrock.

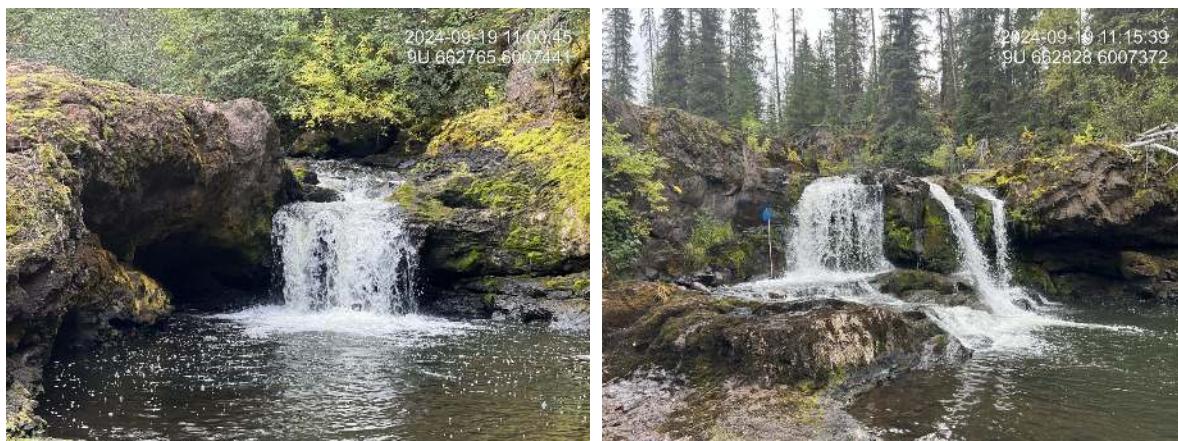
Figure 5.2: Left: Buck Falls – The third step consisted of a ~1.5 m vertical drop with an overlying cascade, exhibiting a ~15% gradient over a 1.0m height. Right: Buck Falls – An additional cascade featured a ~2m high drop with a ~30% gradient extending over a 5 m length. A 2m tall net is included for scale.

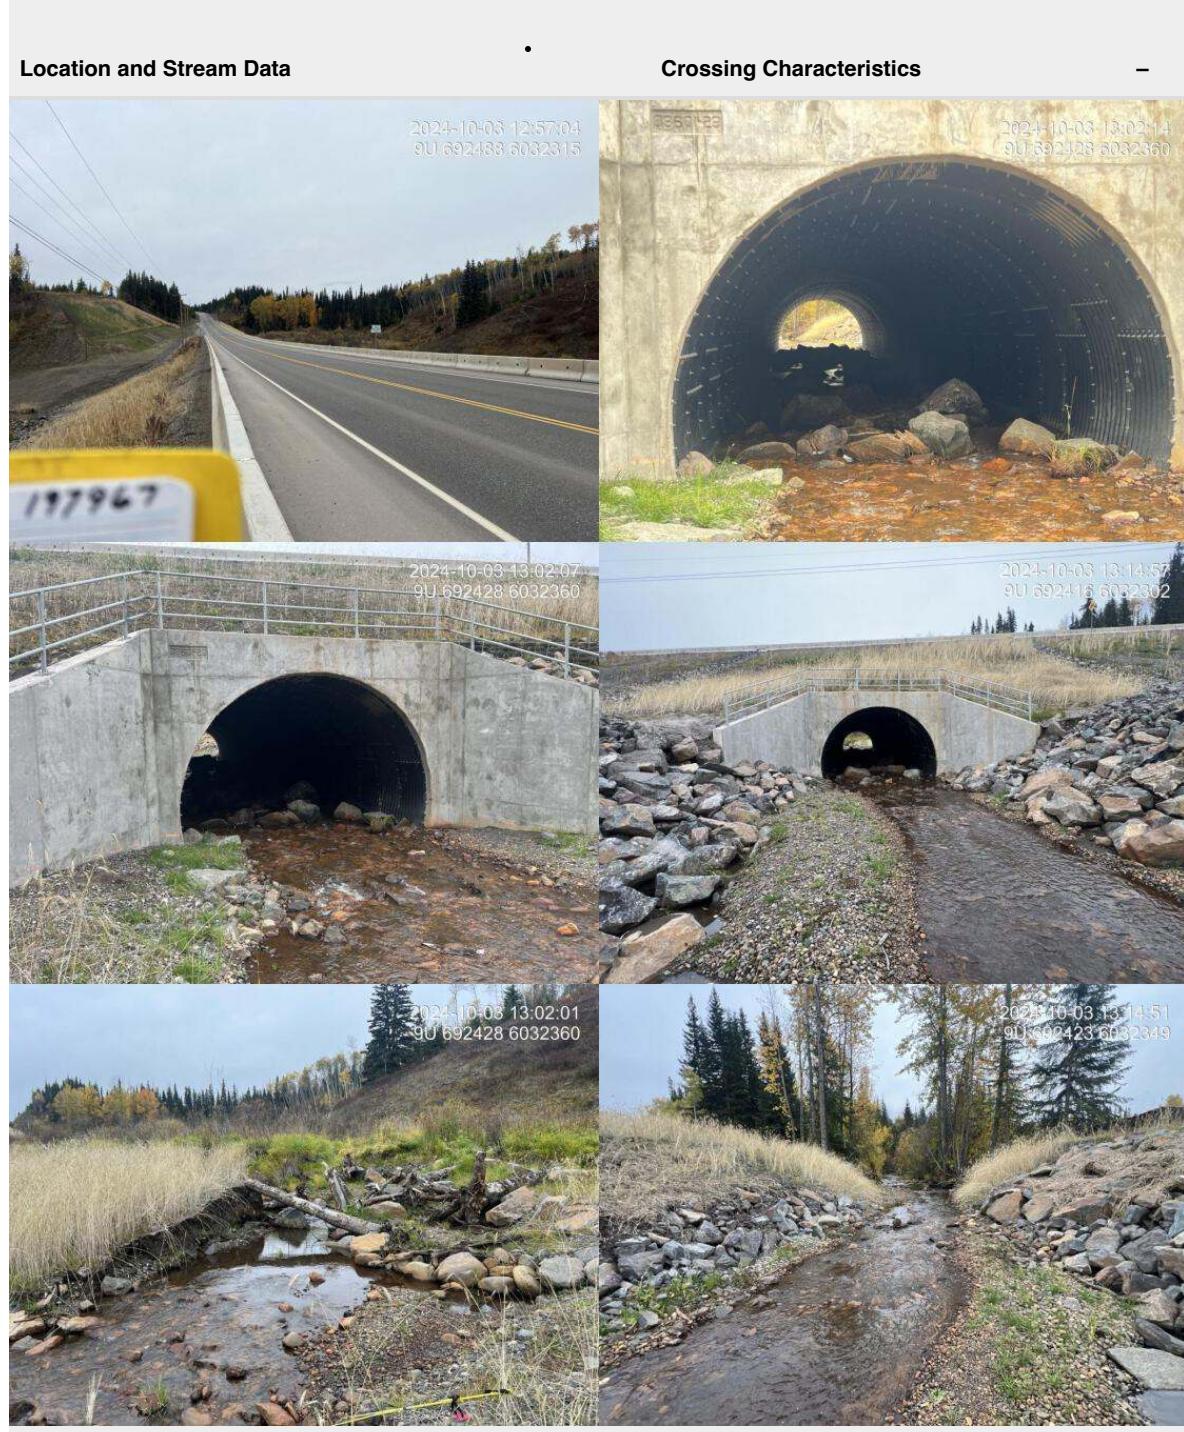
Photos: From top left clockwise: Road/Site Card, Barrel, Outlet, Downstream, Upstream, Inlet.

Location and Stream Data		Crossing Characteristics	
Date	2024-10-03	Crossing Sub Type	Round Culvert
PSCIS ID	197967	Diameter (m)	5.6
External ID	–	Length (m)	40
Crew	AI	Embedded	Yes
UTM Zone	9	Depth Embedded (m)	2
Easting	692426	Resemble Channel	Yes
Northing	6032341	Backwatered	No
Stream	Taman Creek	Percent Backwatered	–
Road	Highway 16	Fill Depth (m)	7
Road Tenure	MoTi	Outlet Drop (m)	0
Channel Width (m)	5.5	Outlet Pool Depth (m)	0
Stream Slope (%)	2	Inlet Drop	No
Beaver Activity	Yes	Slope (%)	3
Habitat Value	Medium	Valley Fill	Deep Fill
Final score	16	Barrier Result	Potential
Fix type	Replace with New Open Bottom Structure	Fix Span / Diameter	27
Comments:			
This is a brand-new replacement structure, extremely well built with extensive embedment that includes numerous large boulders, cobbles, and gravel. The multiplate round structure is embedded nearly 2 m. Upstream, woody debris and boulder structures are cabled together for added stability. This massive construction project involved a substantial amount of fill extending 60 m downstream and over 200 m upstream. The site now offers migration conditions for fish that are equal to or better than previous conditions. MoTi chris_culvert_id: 2076452

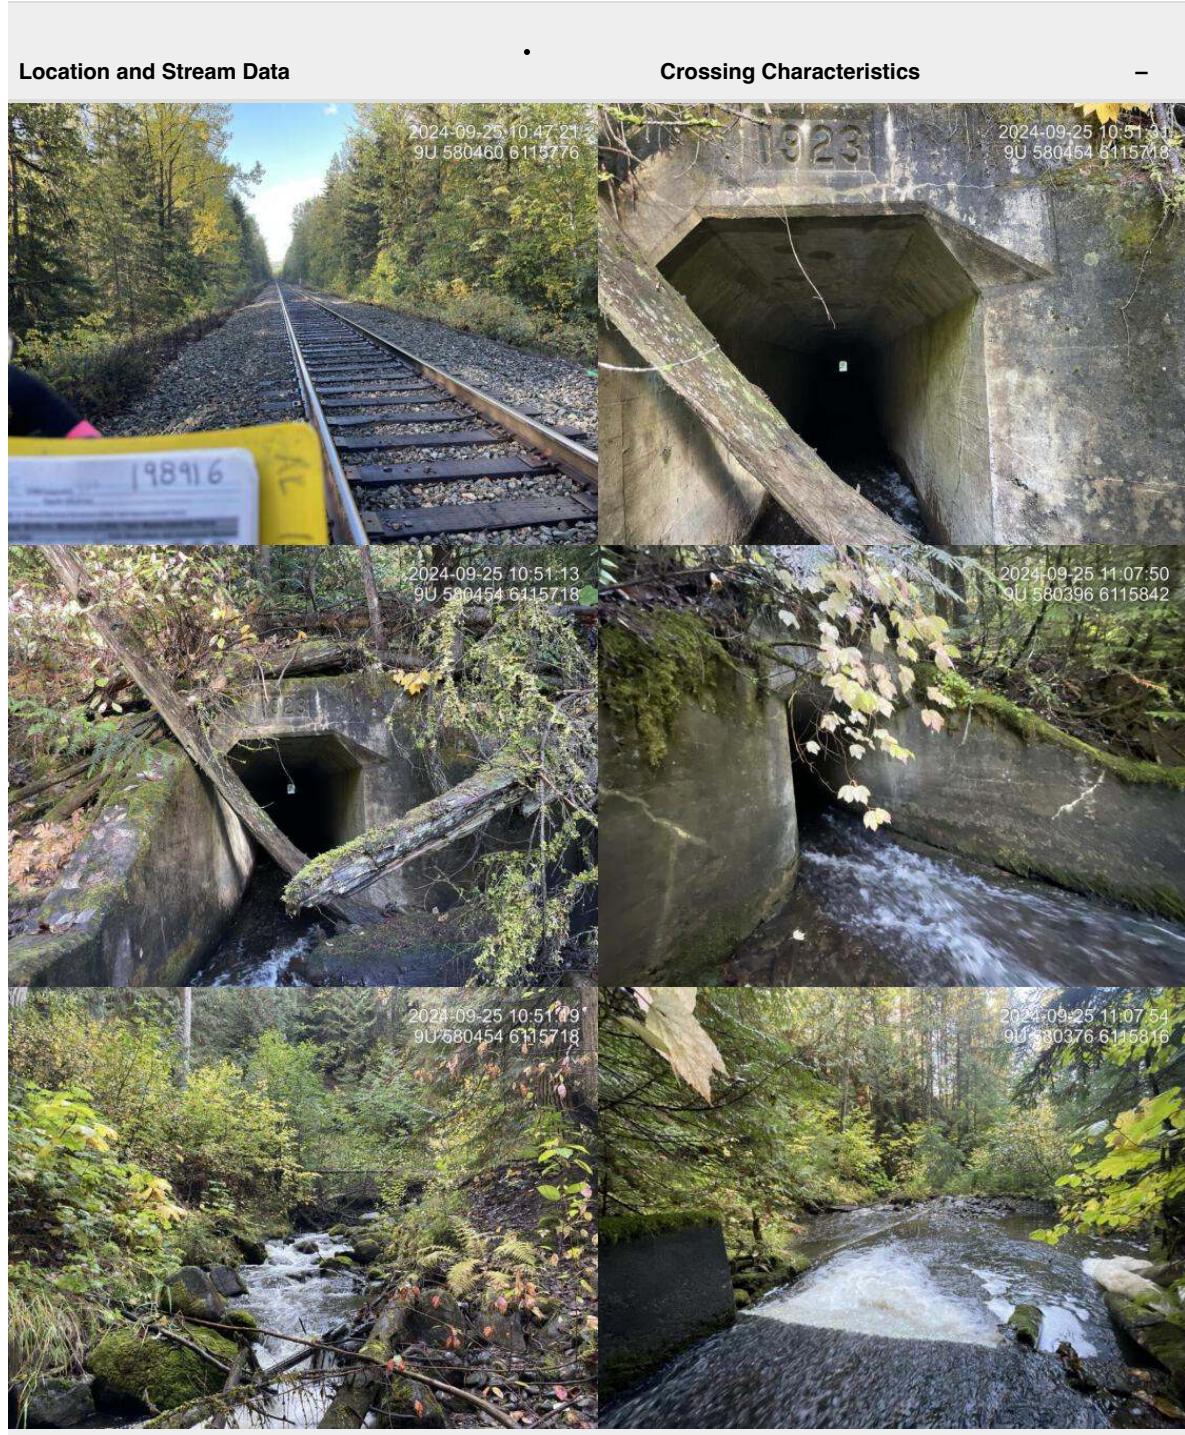
Photos: From top left clockwise: Road/Site Card, Barrel, Outlet, Downstream, Upstream, Inlet.

Although construction would be expensive and challenging, this site is a high priority for restoration follow-up. Culvert length 100 m but changed to 99.9 m to meet submission requirements. Fill depth 30 m but changed to 9.9 m to meet submission requirements.

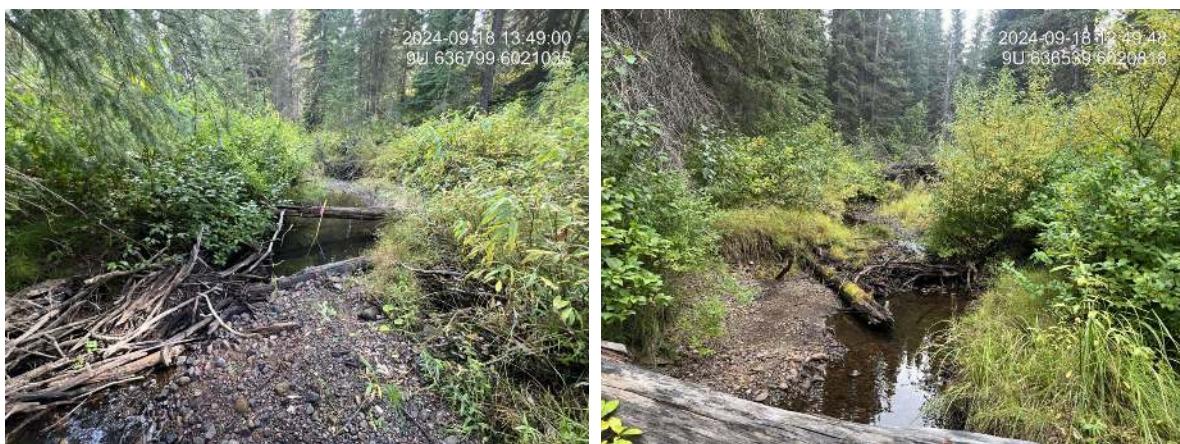
Figure 5.12: Left: Typical habitat downstream of PSCIS crossing 198940. Right: Typical habitat upstream of PSCIS crossing 198940.

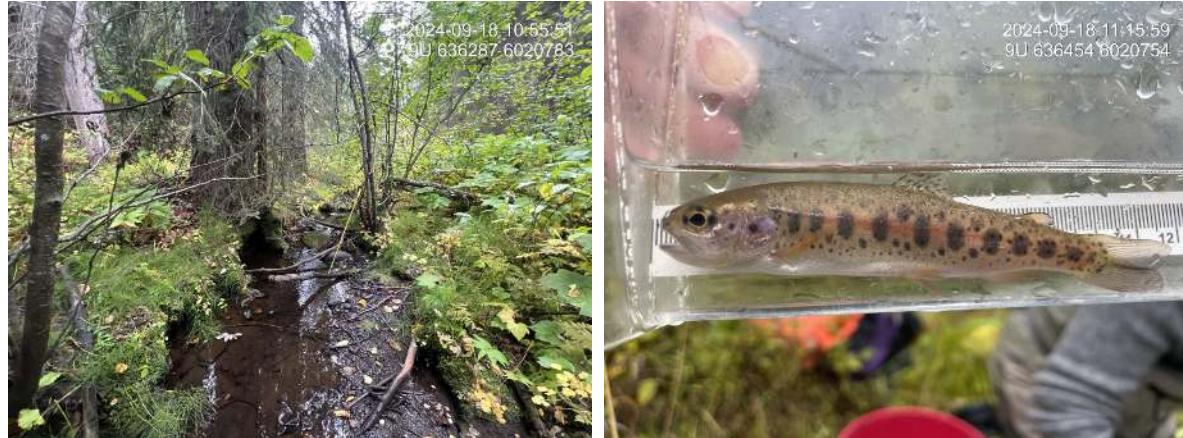
Figure 5.13: Left: Typical habitat upstream of PSCIS crossing 198935. Right: Rainbow trout captured downstream of crossing 198935.
