Skeena Watershed Fish Passage Restoration Planning 2024

Prepared for
Habitat Conservation Trust Foundation - CAT23-6-288
BC Fish Passage Remediation Program
Ministry of Transportation and Infrastructure

Prepared by
Al Irvine, B.Sc., R.P.Bio and Lucy Schick, B.Sc.
New Graph Environment Ltd.
on behalf of
Society for Ecosystem Restoration in Northern British Columbia

DRAFT Version 0.1.0 2025-03-30

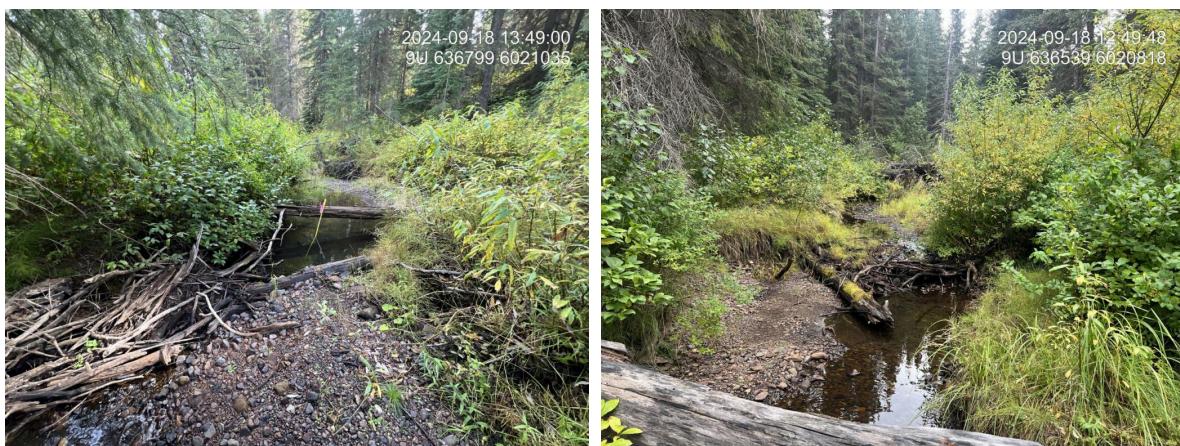
Figure 4.15: Left: Typical habitat downstream of PSCIS crossing 198940. Right: Typical habitat upstream of PSCIS crossing 198940.

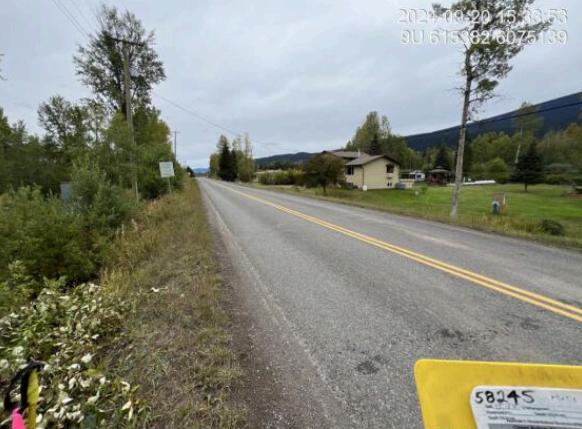
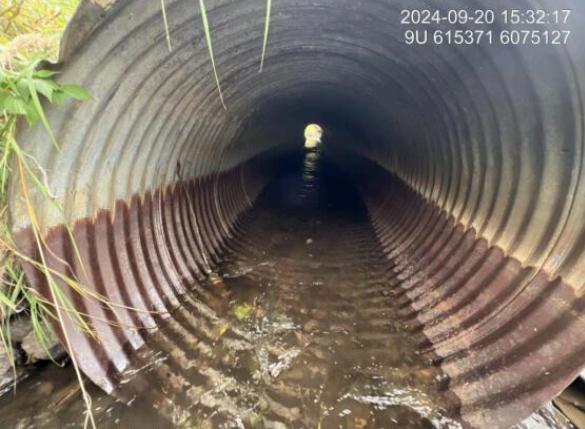
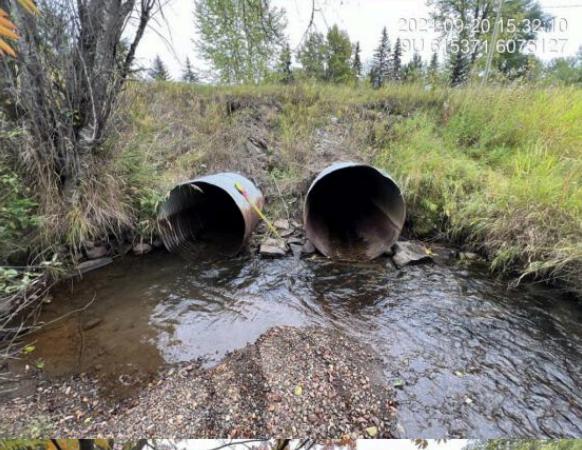
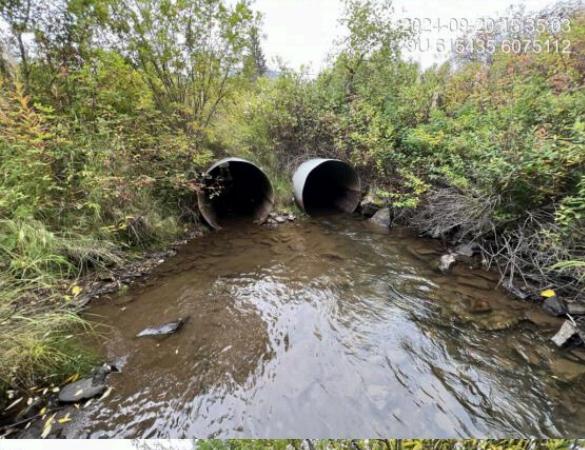
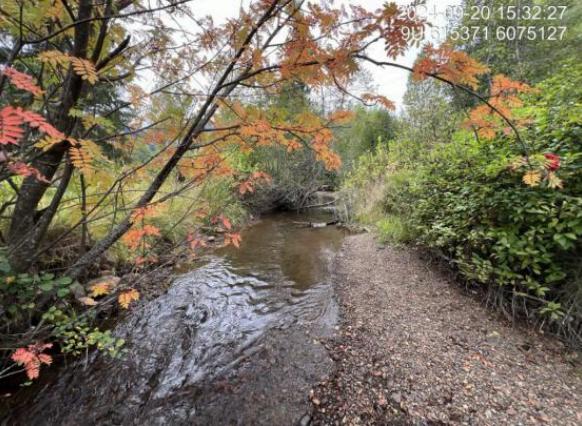
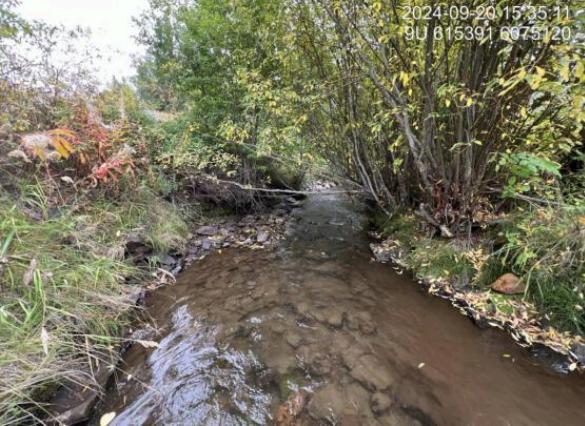
Location and Stream Data	Crossing Characteristics
<p>Comments: Two 1.25 m pipes are present and are heavily corroded. Upstream and downstream, the streambanks are heavily modified adjacent to private land, including riparian vegetation removal, stream channelization, and bank armouring. High-value steelhead, coho, and chinook spawning habitat is documented further upstream above the railway crossing. MoTi chris_culvert_id: 1514706, 1514705</p>	
<p>Photos: From top left clockwise: Road/Site Card, Barrel, Outlet, Downstream, Upstream, Inlet.</p>
