Appendix - Phase 1 Fish Passage Assessment Data and Photos

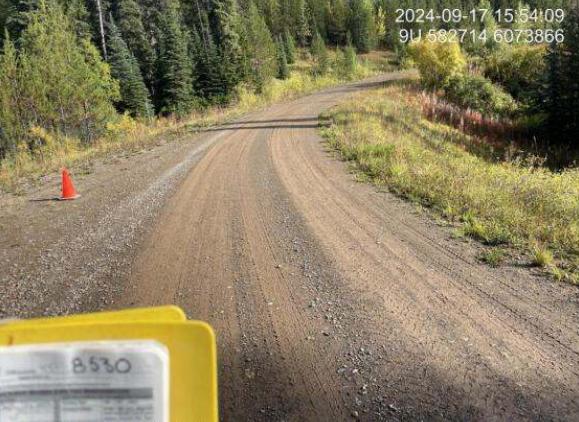
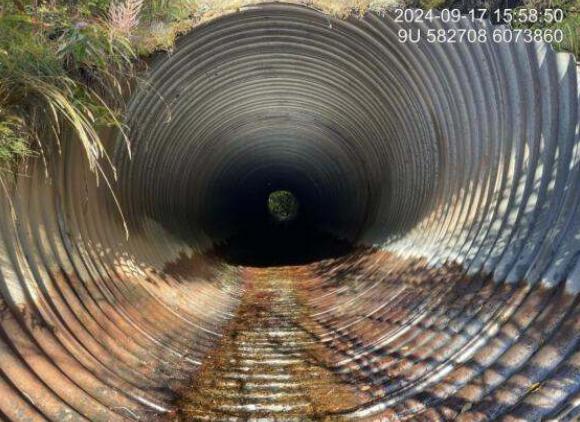
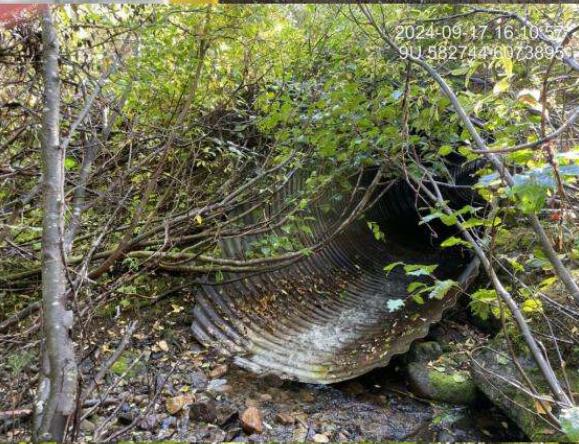
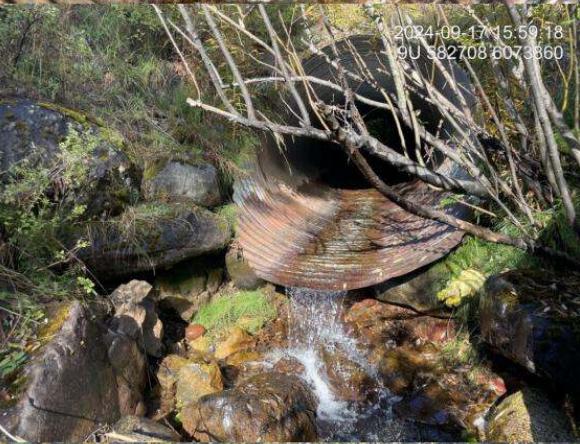
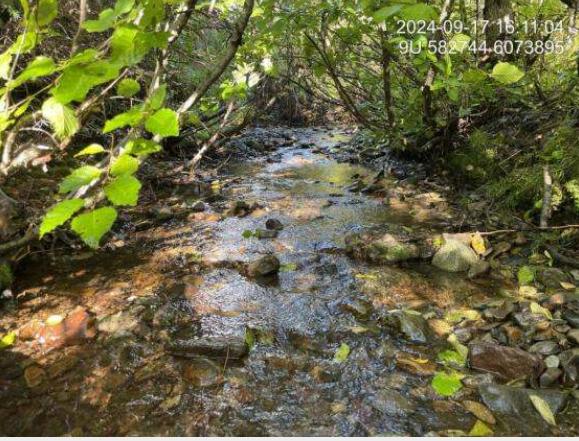
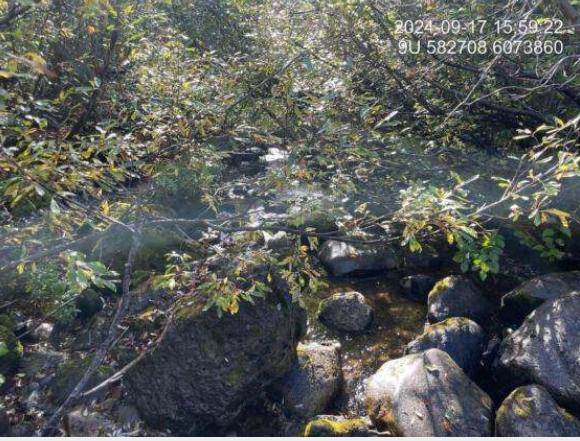
Photos: PSCIS ID 8530. From top left clockwise: Road/Site Card, Barrel, Outlet, Downstream, Upstream, Inlet.

Location and Stream Data	.	Crossing Characteristics	-
Date	2024-09-17	Crossing Sub Type	Round Culvert
PSCIS ID	8530	Diameter (m)	2.4
External ID	-	Length (m)	38
Crew	LS AI TP VJ	Embedded	No
UTM Zone	9	Depth Embedded (m)	-
Easting	582719	Resemble Channel	-
Northing	6073883	Backwatered	No
Stream	Sandstone Creek	Percent Backwatered	-
Road	McDonnell fsr	Fill Depth (m)	9
Road Tenure	MoF	Outlet Drop (m)	0.5
Channel Width (m)	3.9	Outlet Pool Depth (m)	0.4
Stream Slope (%)	2	Inlet Drop	No
Beaver Activity	No	Slope (%)	5
Habitat Value	High	Valley Fill	Deep Fill
Final score	42	Barrier Result	Barrier
Fix type	Replace with New Open Bottom Structure	Fix Span / Diameter	33

Comments: The stream has good quality habitat with abundant overhanging vegetation and boulders providing cover, pools for overwintering fish, and gravel suitable for spawning. Rainbow trout, cutthroat trout, and Dolly Varden were captured during sampling. Very large culvert with a significant amount of road fill (9m). There was an engineering site survey conducted in 2024 but the design plans were put on hold due to high replacement costs and uncertainty around if salmon could access the crossing due to potential barriers downstream. DFO was involved and reported that coho were spawning downstream of the crossing in October 2024.

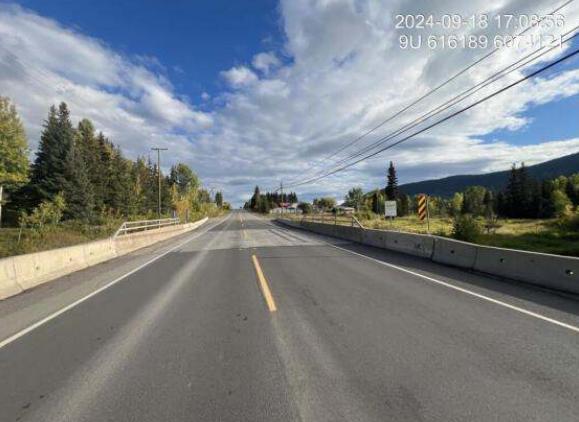
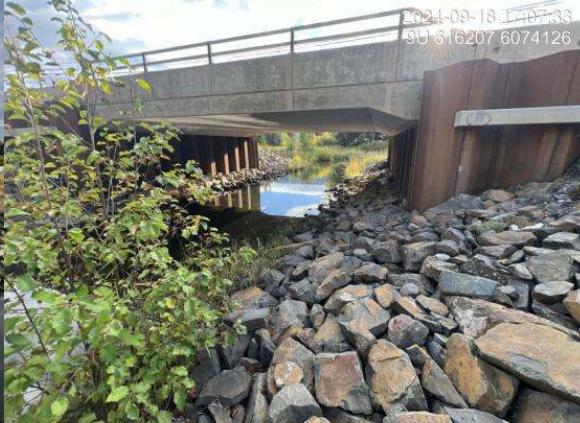
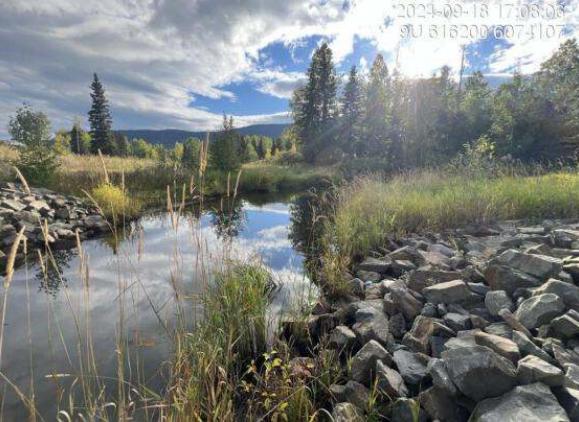
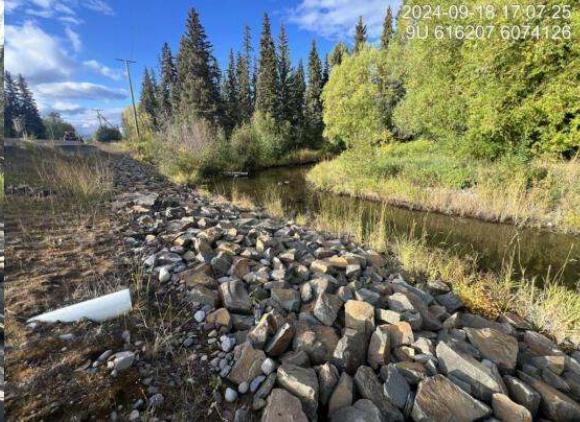
Location and Stream Data		.	Crossing Characteristics	-
Date	2024-09-18	Crossing Sub Type	Bridge	
PSCIS ID	58235	Diameter (m)	12	
External ID	-	Length (m)	10	
Crew	AI	Embedded	-	
UTM Zone	9	Depth Embedded (m)	-	
Easting	616177	Resemble Channel	-	
Northing	6074155	Backwatered	-	
Stream	Kathlyn Creek	Percent Backwatered	-	
Road	Highway 16	Fill Depth (m)	-	
Road Tenure	MoTi	Outlet Drop (m)	-	
Channel Width (m)	-	Outlet Pool Depth (m)	-	
Stream Slope (%)	-	Inlet Drop	-	
Beaver Activity	No	Slope (%)	-	
Habitat Value	-	Valley Fill	-	
Final score	0	Barrier Result	Passable	
Fix type	-	Fix Span / Diameter	-	
Comments: New, well built, bridge.				
Photos: PSCIS ID 58235. From top left clockwise: Road/Site Card, Barrel, Outlet, Downstream, Upstream, Inlet.

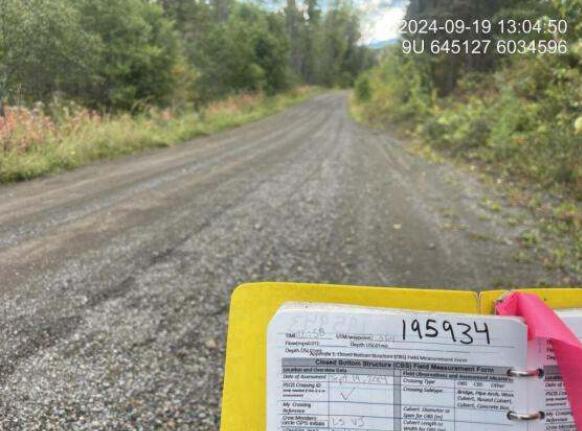
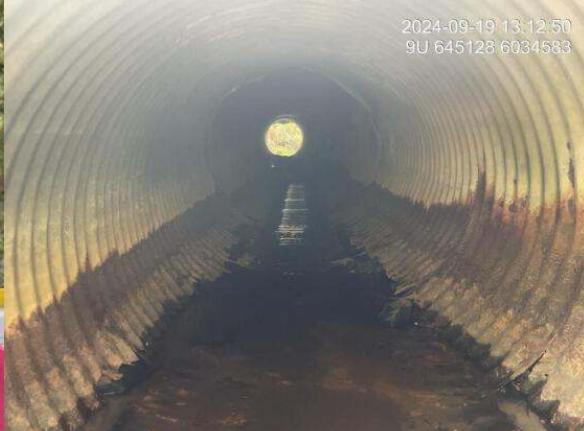
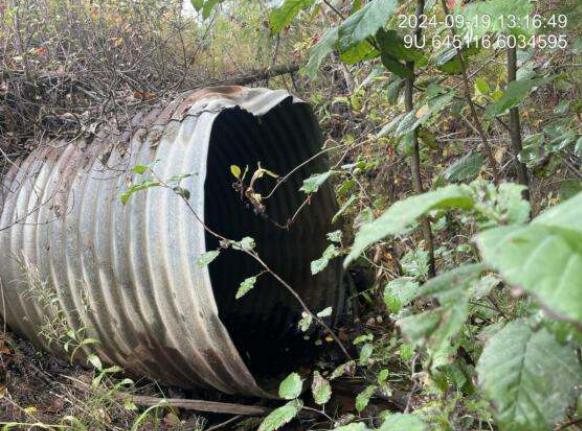
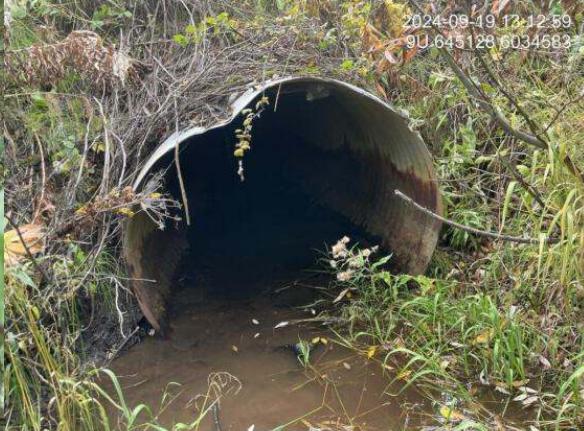
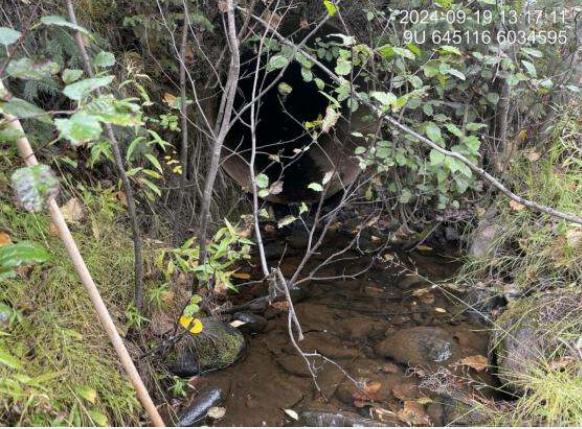
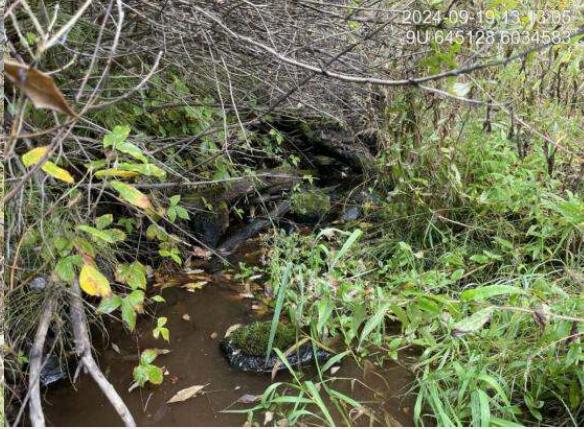
Photos: PSCIS ID 195934. From top left clockwise: Road/Site Card, Barrel, Outlet, Downstream, Upstream, Inlet.

Location and Stream Data	.	Crossing Characteristics	-
Date	2024-09-19	Crossing Sub Type	Round Culvert
PSCIS ID	195934	Diameter (m)	1.2
External ID	-	Length (m)	16
Crew	LS VJ	Embedded	No
UTM Zone	9	Depth Embedded (m)	-
Easting	645128	Resemble Channel	-
Northing	6034597	Backwatered	Yes
Stream	Dunalter Creek	Percent Backwatered	15
Road	Barret station rd	Fill Depth (m)	2
Road Tenure	MoTi	Outlet Drop (m)	0
Channel Width (m)	1.6	Outlet Pool Depth (m)	0.15
Stream Slope (%)	1	Inlet Drop	No
Beaver Activity	No	Slope (%)	4
Habitat Value	Medium	Valley Fill	Deep Fill
Final score	29	Barrier Result	Barrier
Fix type	Replace Structure with Streambed Simulation CBS	Fix Span / Diameter	3

Comments: The inlet of the culvert is approximately 3 m downstream of the outlet of culvert 195935, which crosses under the Houston Airport Rd. The stream has an estimated slope of 1%. Downstream of the culvert, the stream is heavily overgrown. The culvert has holes in the bottom about 2 m from the outlet and is backwatered up to that point.
MoTi chris_culvert_id: 1755233

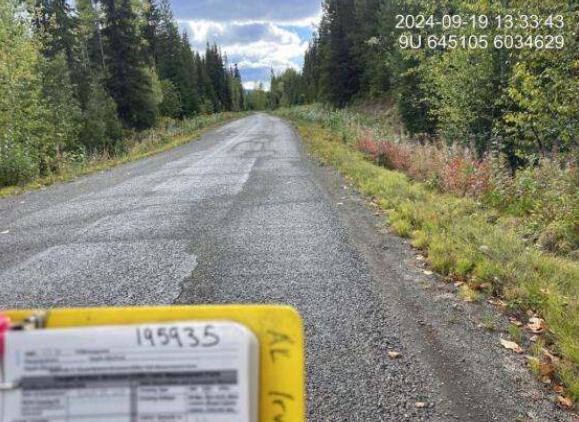
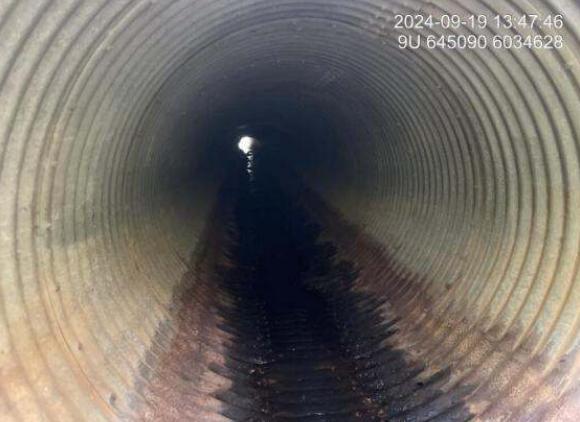
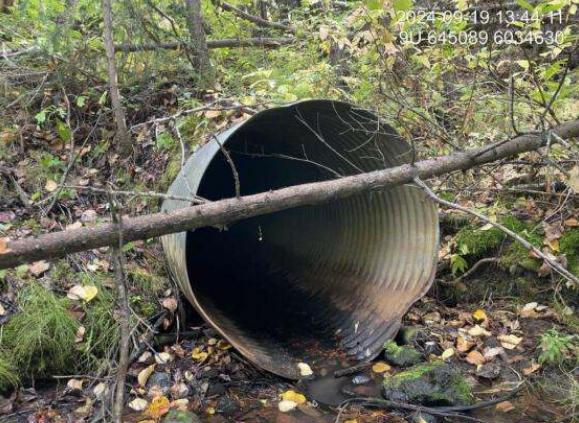
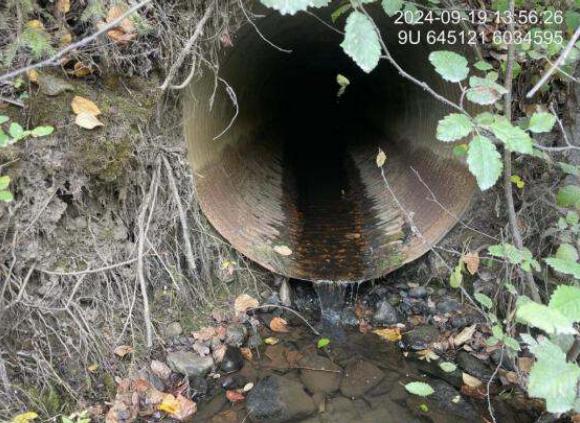
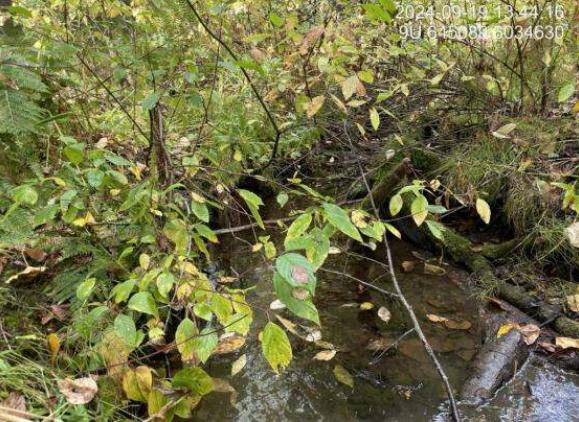
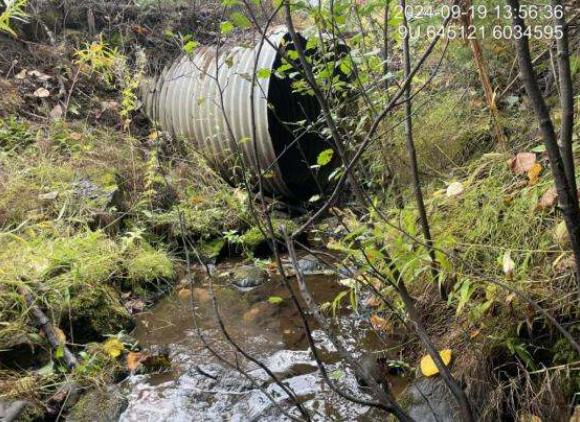
Photos: PSCIS ID 195935. From top left clockwise: Road/Site Card, Barrel, Outlet, Downstream, Upstream, Inlet.

Location and Stream Data	.	Crossing Characteristics	–
Date	2024-09-19	Crossing Sub Type	Round Culvert
PSCIS ID	195935	Diameter (m)	1.2
External ID	–	Length (m)	38
Crew	LS VJ	Embedded	No
UTM Zone	9	Depth Embedded (m)	–
Easting	645104	Resemble Channel	–
Northing	6034615	Backwatered	No
Stream	Dunalter Creek	Percent Backwatered	–
Road	Houston Airport rd	Fill Depth (m)	9.9
Road Tenure	MoTi	Outlet Drop (m)	0.2
Channel Width (m)	1.7	Outlet Pool Depth (m)	0.15
Stream Slope (%)	2	Inlet Drop	No
Beaver Activity	No	Slope (%)	1
Habitat Value	Medium	Valley Fill	Deep Fill
Final score	32	Barrier Result	Barrier
Fix type	Replace Structure with Streambed Simulation CBS	Fix Span / Diameter	35.5

Comments: Upstream of the crossing, there is good habitat for fish, including undercut banks, functional large woody debris, healthy riparian vegetation, and several pools suitable for overwintering fish. A fish ~100 mm in length was observed in one of the pools upstream. A barbed wire fence is present when accessing the inlet. The culvert is extremely long (38 m), with its outlet located approximately 3 m upstream of the inlet of crossing 195934. Downstream of crossing 195934 the stream is heavily overgrown. Fill depth 11 m but changed to 9.9 m to meet submission requirements. MoTi chris_culvert_id: 2078335

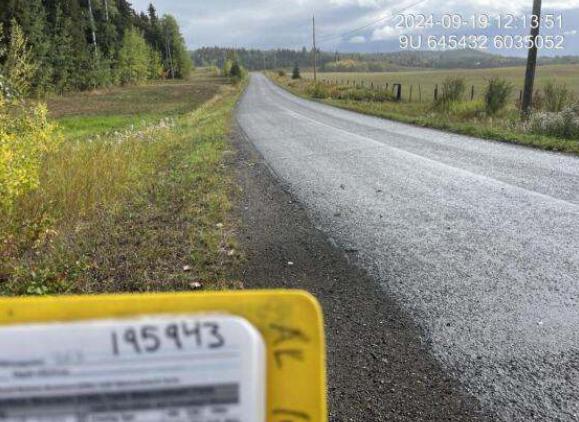
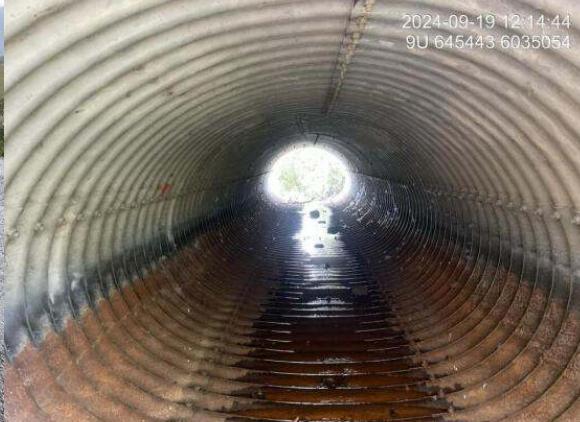
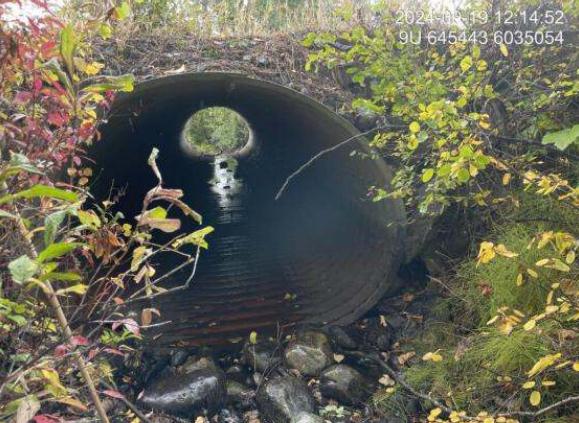
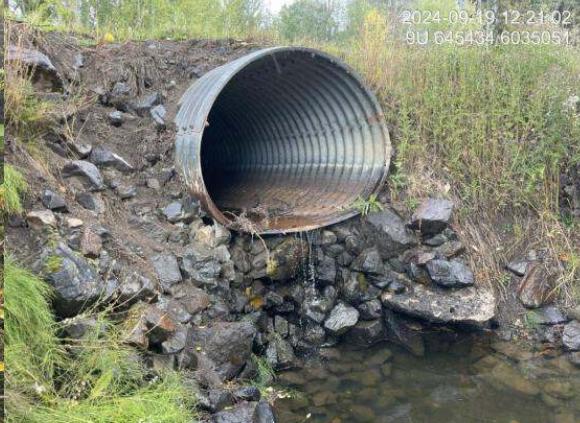
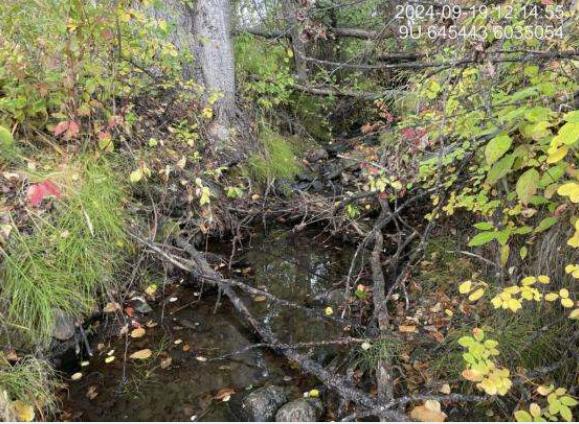
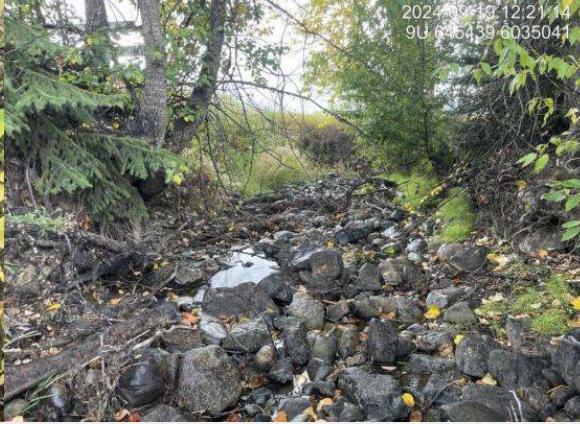
Photos: PSCIS ID 195943. From top left clockwise: Road/Site Card, Barrel, Outlet, Downstream, Upstream, Inlet.

Location and Stream Data		Crossing Characteristics	
Date	2024-09-19	Crossing Sub Type	Oval Culvert
PSCIS ID	195943	Diameter (m)	2.2
External ID	–	Length (m)	14
Crew	LS	Embedded	No
UTM Zone	9	Depth Embedded (m)	–
Easting	645439	Resemble Channel	–
Northing	6035050	Backwatered	No
Stream	Stock Creek	Percent Backwatered	–
Road	Barrett station rd	Fill Depth (m)	0.4
Road Tenure	MoTi	Outlet Drop (m)	1.05
Channel Width (m)	2.6	Outlet Pool Depth (m)	0.6
Stream Slope (%)	2	Inlet Drop	No
Beaver Activity	No	Slope (%)	1.5
Habitat Value	Medium	Valley Fill	Deep Fill
Final score	28	Barrier Result	Barrier
Fix type	Replace with New Open Bottom Structure	Fix Span / Diameter	15

Comments: The culvert has a substantial outlet drop of 1.05 m, with signs of high flows at the outlet. The stream likely contains numerous pools during higher flows but had very low flows at the time of assessment. Flowing through agricultural land on both sides, the stream is heavily eroded downstream, making it a strong candidate for fencing and riparian management. Upstream habitat was less eroded and consisted of mature riparian vegetation providing good habitat for fish. Only two fish were captured during sampling (both in the deep outlet pool), which was unexpected given the good habitat. Conductivity was extremely high, possibly due to upstream cattle activity and surrounding land use.

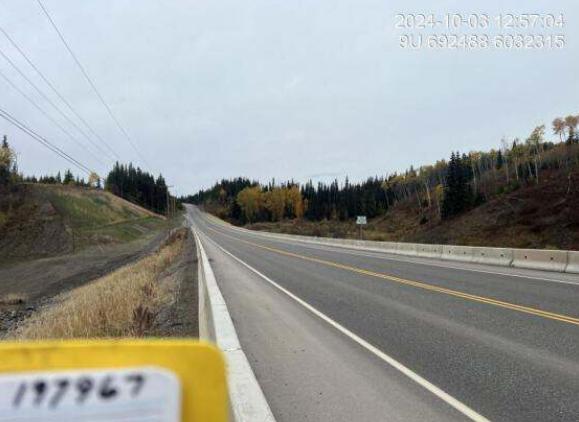
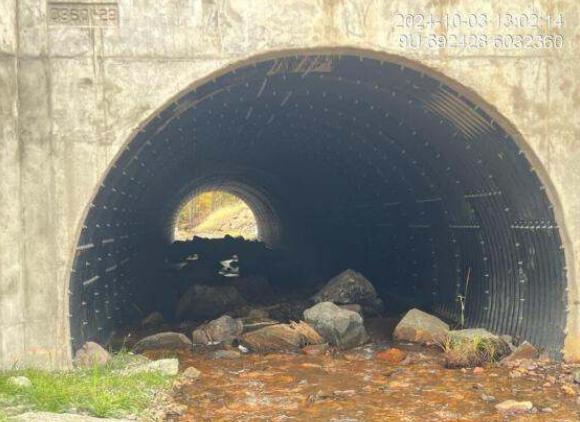
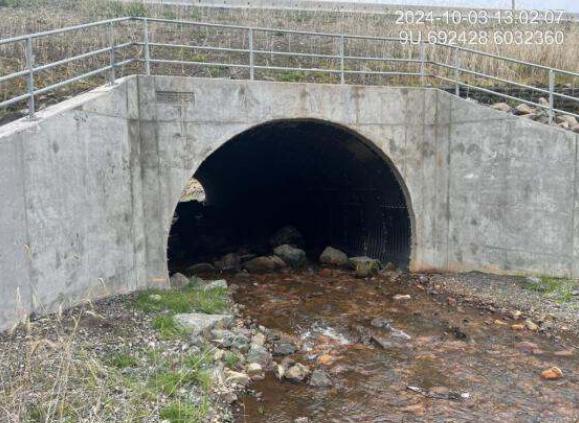
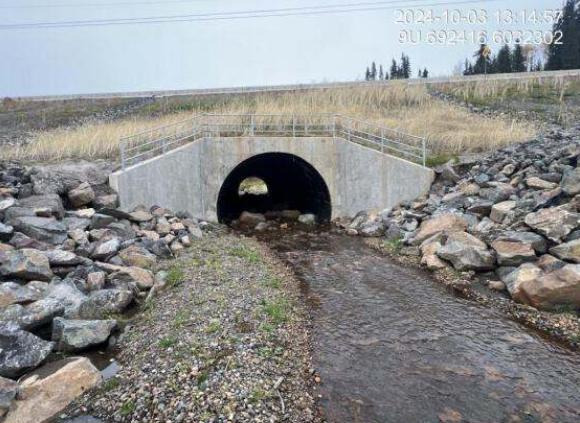
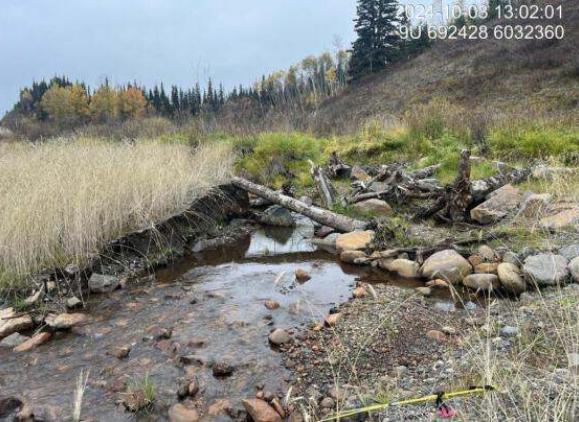
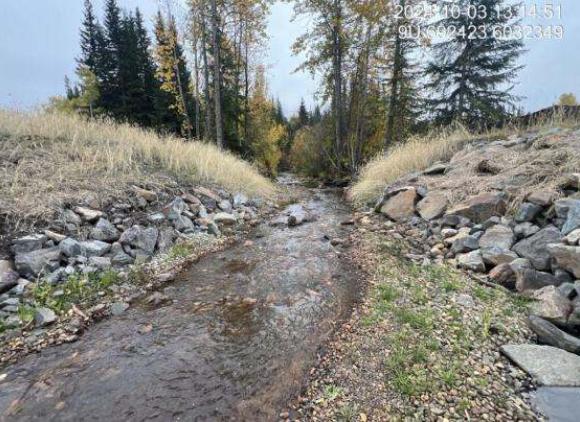
Photos: PSCIS ID 197967. From top left clockwise: Road/Site Card, Barrel, Outlet, Downstream, Upstream, Inlet.

This is a brand-new replacement structure, extremely well built with extensive embedment that includes numerous large boulders, cobbles, and gravel. The multiplate round structure is embedded nearly 2 m. Upstream, woody debris and boulder structures are cabled together for added stability. This massive construction project involved a substantial amount of fill extending 60 m downstream and over 200 m upstream. The site now offers migration conditions for fish that are equal to or better than previous conditions. MoTi chris_culvert_id: 2076452

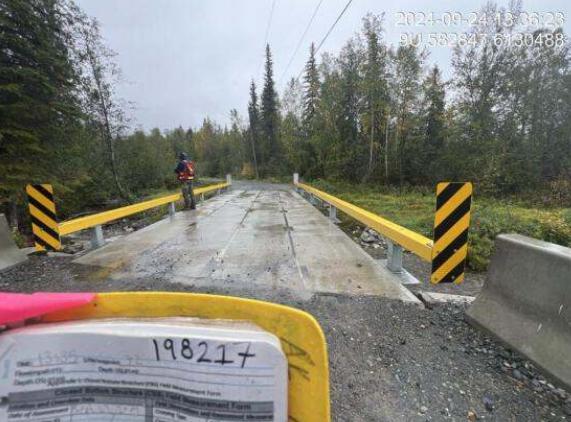
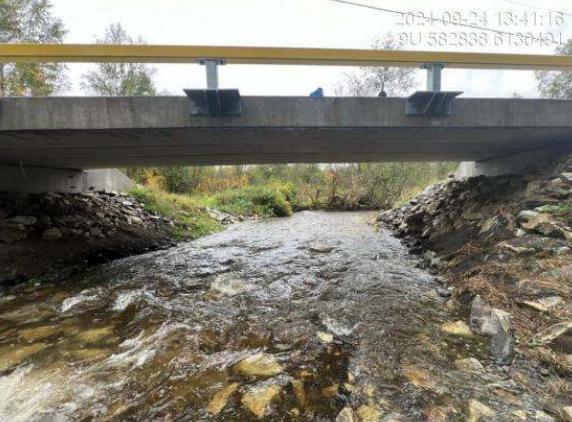
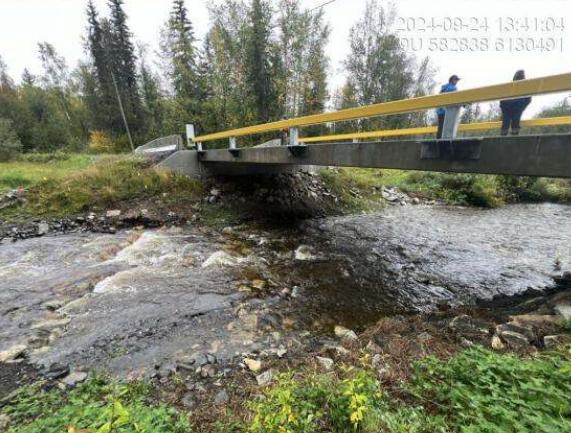
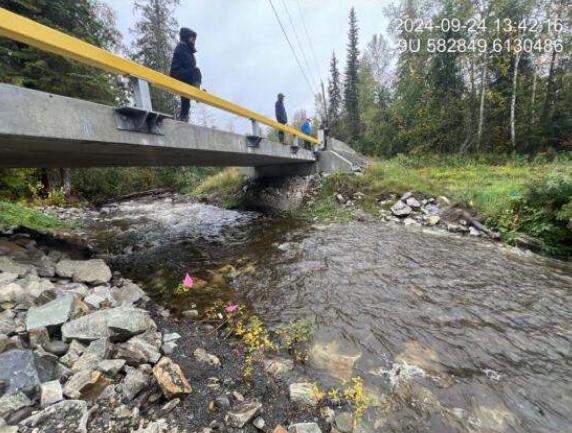
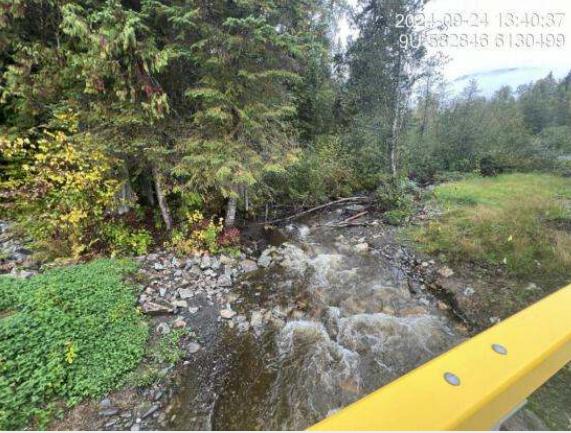
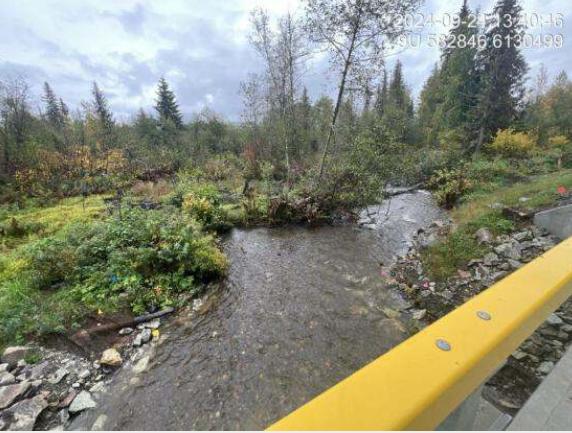
Location and Stream Data		•	Crossing Characteristics	-
Date	2024-09-24		Crossing Sub Type	Bridge
PSCIS ID	198217		Diameter (m)	14
External ID	-		Length (m)	4
Crew	LS AI		Embedded	-
UTM Zone	9		Depth Embedded (m)	-
Easting	582850		Resemble Channel	-
Northing	6130490		Backwatered	-
Stream	Sik-e-dakh		Percent Backwatered	-
Road	Sik-e-dakh Water Tower Rd		Fill Depth (m)	-
Road Tenure	MoTi		Outlet Drop (m)	-
Channel Width (m)	-		Outlet Pool Depth (m)	-
Stream Slope (%)	-		Inlet Drop	-
Beaver Activity	No		Slope (%)	-
Habitat Value	-		Valley Fill	-
Final score	0		Barrier Result	Passable
Fix type	-		Fix Span / Diameter	-
Comments: The culvert was replaced with a bridge, featuring excellent construction with a wide channel beneath the structure. Riprap has been covered with soil to promote vegetation growth, and significant riparian restoration is underway with trees and shrubs being planted. Overall, this is a well-executed replacement project.

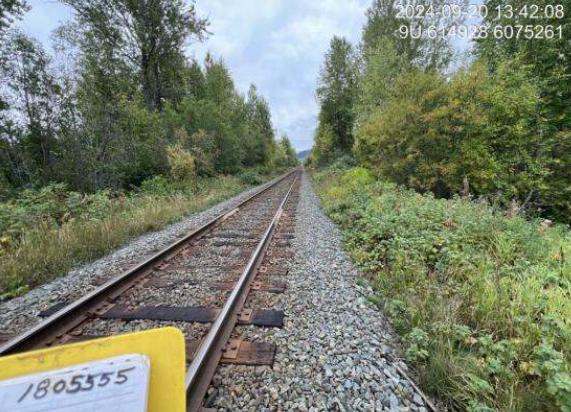
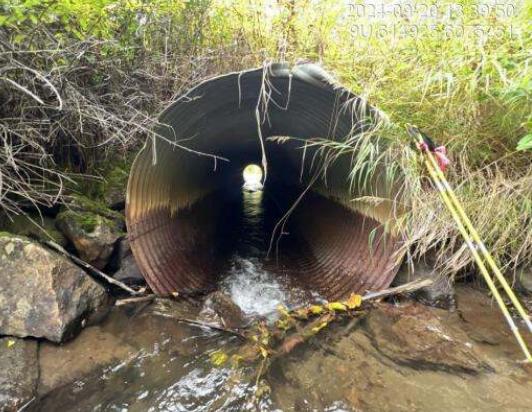
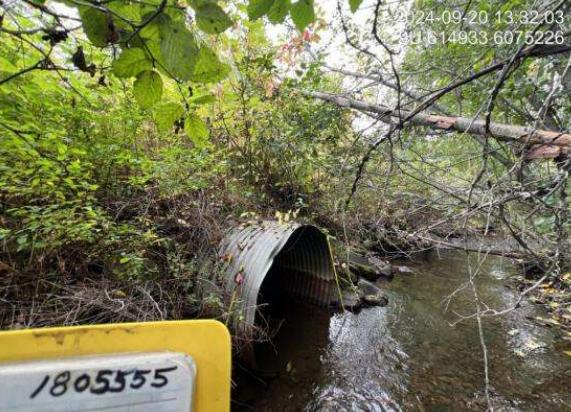
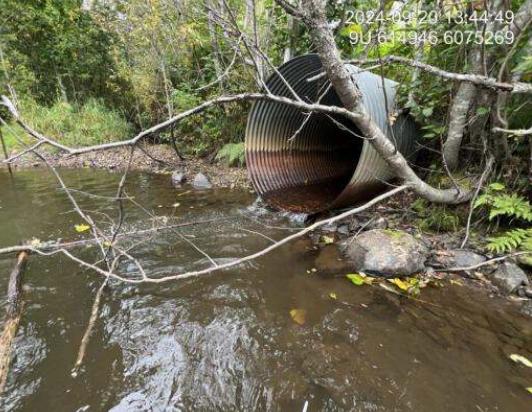
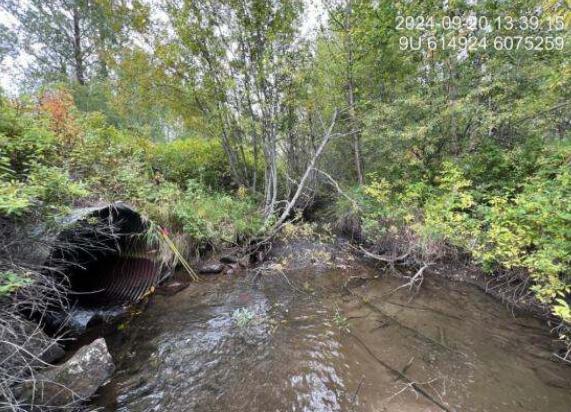
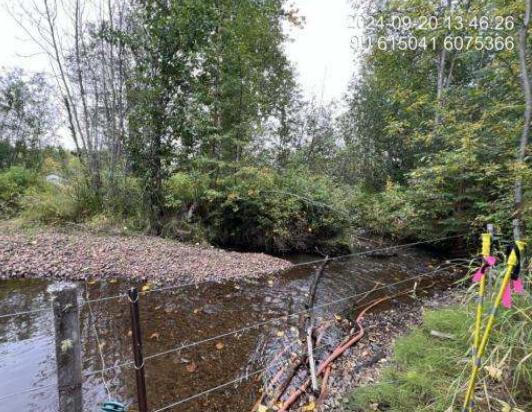
Comments: Although this culvert is on Simpson Creek, it is not currently conveying the main flow and remains mostly dry. Two 1.5 m diameter pipes run under the railway, approximately 30 m apart. The southern pipe is fully embedded with an average embedment depth of 25 cm, while the northern pipe is currently passing all stream flow. This is a high-value stream with extensive gravel areas suitable for steelhead, coho, and chinook salmon spawning upstream. The adjacent landowner has reported recent observations of steelhead spawning and has historical knowledge of chinook spawning approximately 300 m downstream from Nielsen Road.

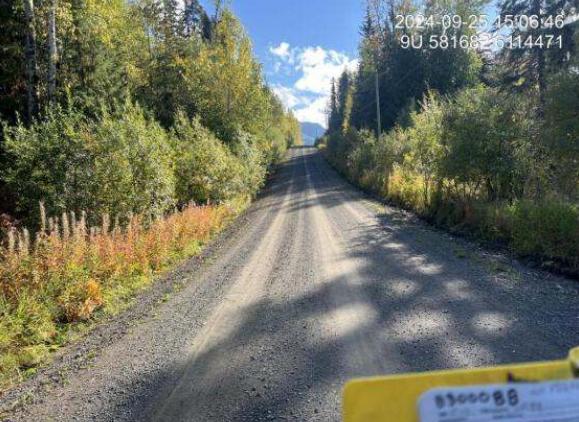
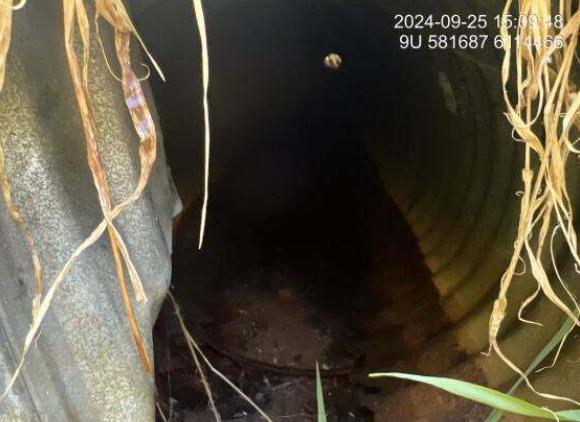
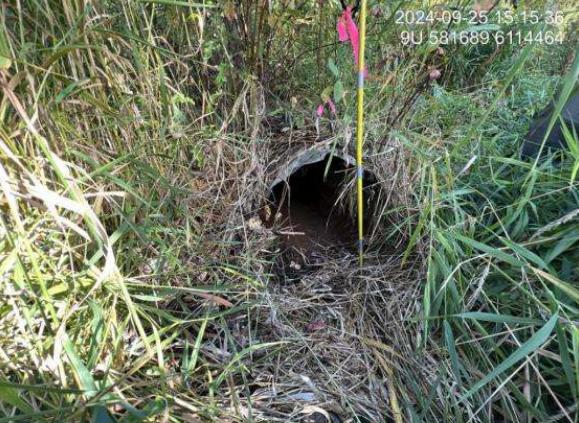
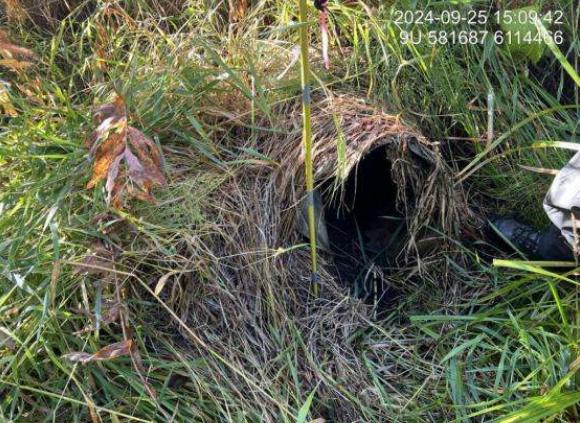
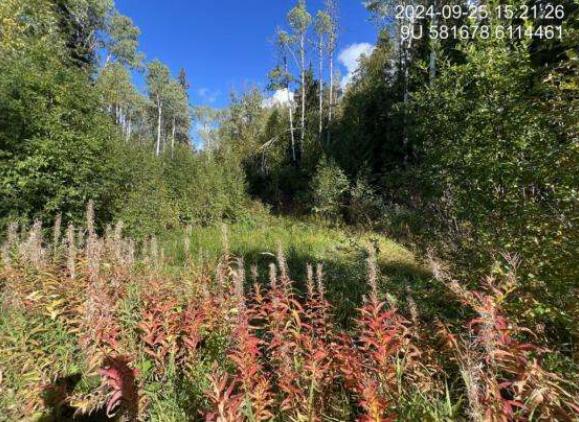
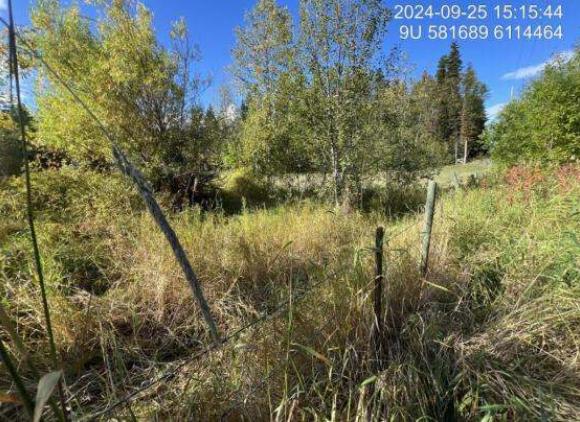
Photos: PSCIS ID 8300088. From top left clockwise: Road/Site Card, Barrel, Outlet, Downstream, Upstream, Inlet.

Comments: No visible channel was observed; the area appeared to be a wet draw during the survey, with some sedges present upstream. It is unlikely to provide fish habitat. BC Freshwater atlas mapping of this watershed is incorrect as the main stream at the confluence with the Skeena River is actually Comeau Creek vs Gershwin Creek. Therefore, this crossing is actually on a tributary to Comeau Creek. MoTi chris_culvert_id: 1524657

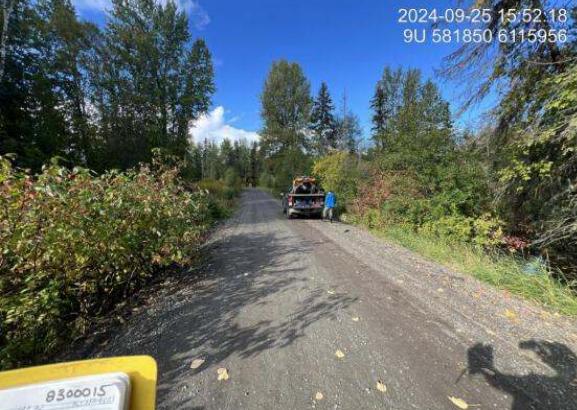
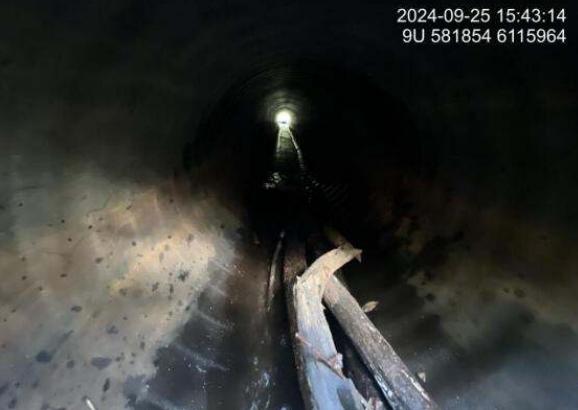
Comments: This is a newer PVC pipe with a beaver grate on the inlet. Debris clogging about 20 cm of the inlet has caused water to back up upstream of the crossing. Downstream, the drainage is very small, with a fence located approximately 10 m away. BC Freshwater atlas mapping of this watershed is incorrect as the main stream at the confluence with the Skeena River is actually Comeau Creek vs Gershwin Creek. This crossing is actually on Gershwin Creek, which is a tributary to Comeau Creek. MoTi chris_culvert_id: 1524661

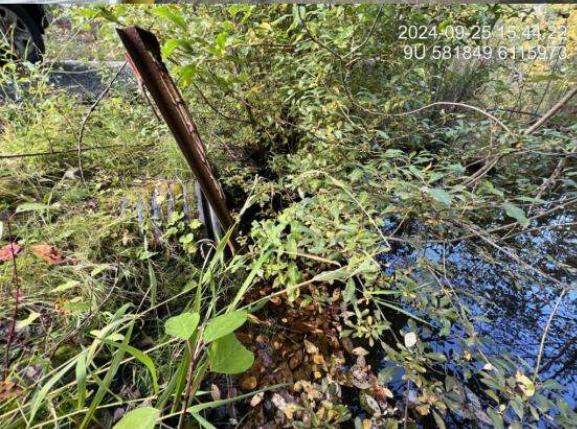
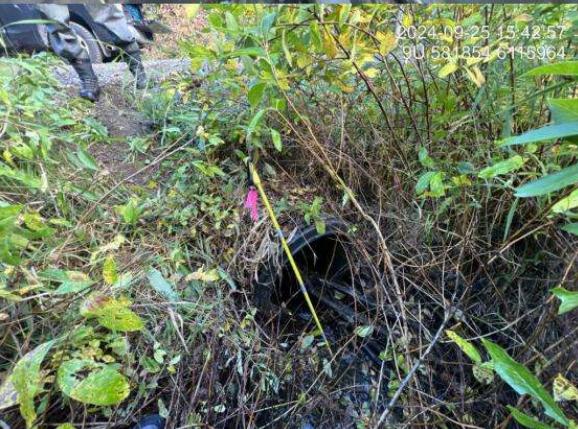
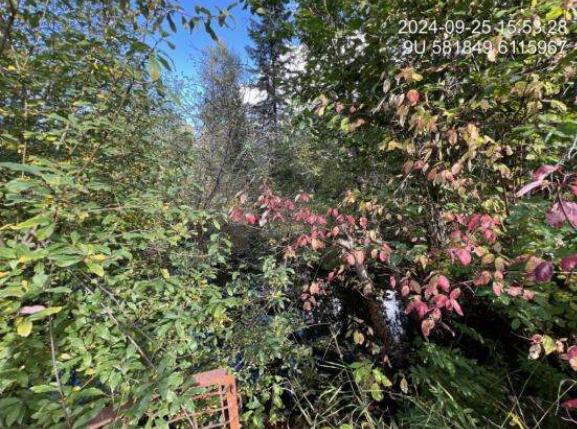
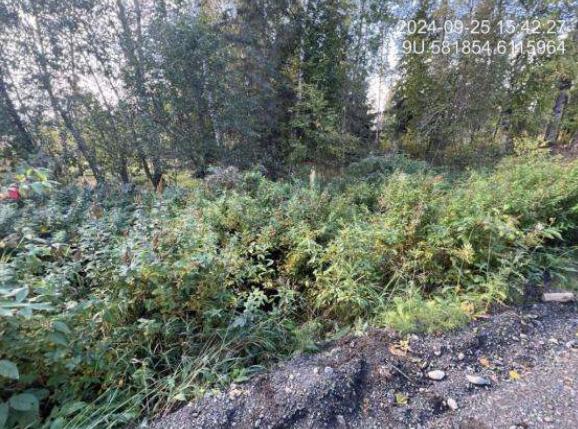
Photos: PSCIS ID 8300015. From top left clockwise: Road/Site Card, Barrel, Outlet, Downstream, Upstream, Inlet.

Location and Stream Data	.	Crossing Characteristics	–
Date	2024-09-25	Crossing Sub Type	Round Culvert
PSCIS ID	203124	Diameter (m)	0.6
External ID	8300015	Length (m)	14
Crew	AI JO	Embedded	No
UTM Zone	9	Depth Embedded (m)	–
Easting	581852	Resemble Channel	–
Northing	6115965	Backwatered	No
Stream	Gershwin Creek	Percent Backwatered	–
Road	Comeau Road	Fill Depth (m)	0.5
Road Tenure	MoTi	Outlet Drop (m)	0
Channel Width (m)	0.95	Outlet Pool Depth (m)	0
Stream Slope (%)	1	Inlet Drop	Yes
Beaver Activity	No	Slope (%)	3
Habitat Value	Medium	Valley Fill	Deep Fill
Final score	26	Barrier Result	Barrier
Fix type	Replace Structure with Streambed Simulation CBS	Fix Span / Diameter	3

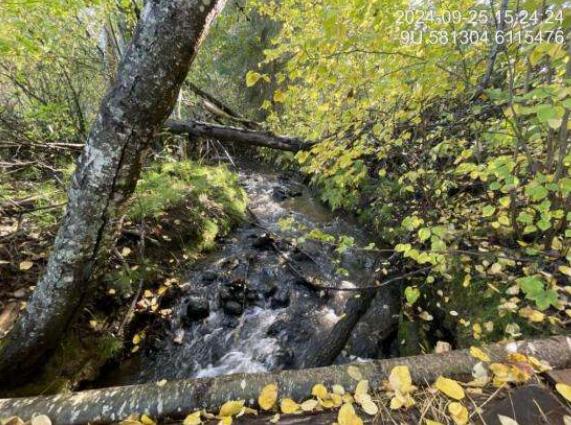
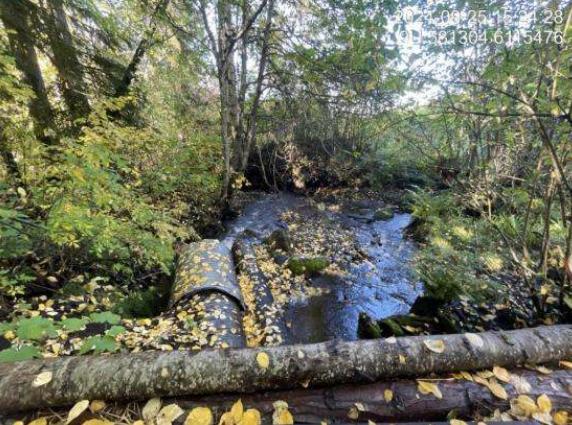
Photos: PSCIS ID 2024092550. From top left clockwise: Road/Site Card, Barrel, Outlet, Downstream, Upstream, Inlet.

Comments: The landowner has constructed a bridge over the stream with two culverts, measuring 0.47 m and 0.9 m in diameter. Some flow passes through the culverts while some bypasses them, though it is unclear if fish can navigate the bypassing flow. The bridge appears to provide access to adjacent agricultural fields. High-quality habitat with numerous pools and abundant gravel is present, but strong currents in the culverts due to significant flow likely inhibit fish passage. BC Freshwater atlas mapping of this watershed is incorrect as the main stream at the confluence with the Skeena River is actually Comeau Creek vs Gershwin Creek. Therefore, this crossing is actually on Comeau Creek.

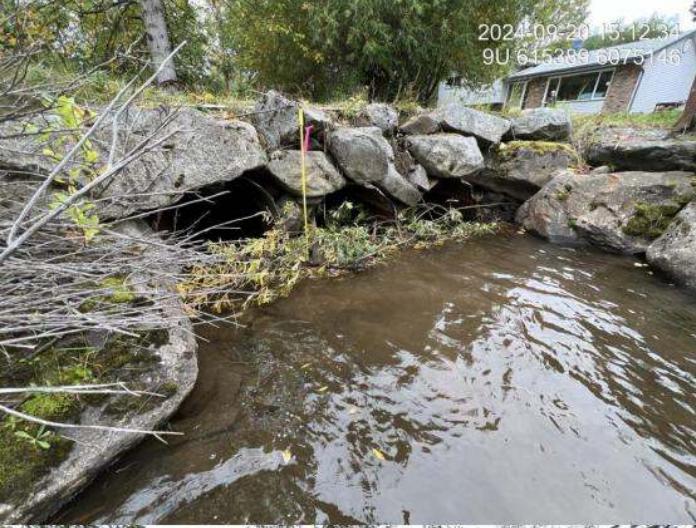
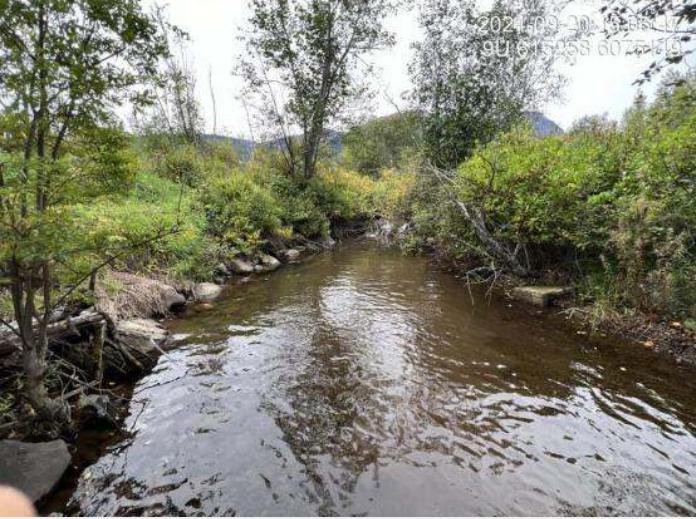
Photos: PSCIS ID 2024092003. From top left clockwise: Road/Site Card, Barrel, Outlet, Downstream, Upstream, Inlet.

Comments: Three 0.95 m pipes run under a private driveway. The pipe lengths and gradients are estimated, with two pipes appearing fully embedded and one slightly elevated by approximately 30 cm. The stream is channelized with large boulders throughout the property. Beaver activity is evident, with debris at the inlet and three dams ranging from 0.4 to 1 m high within 150 m upstream. The landowner reported previous blockages caused by beavers, requiring the inlet to be cleared and significant amounts of accumulated material to be dredged out.

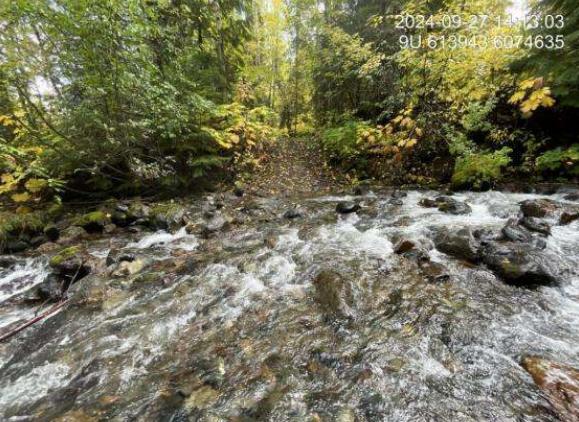
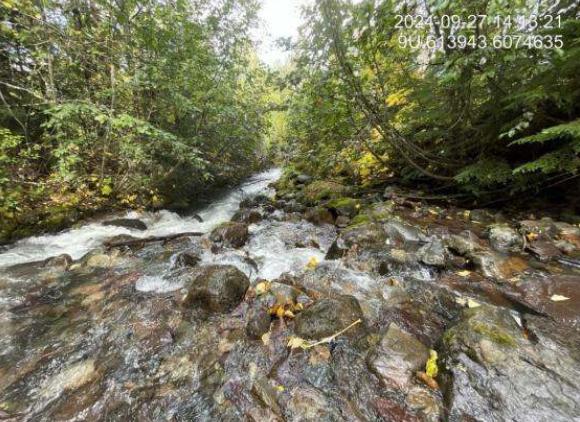
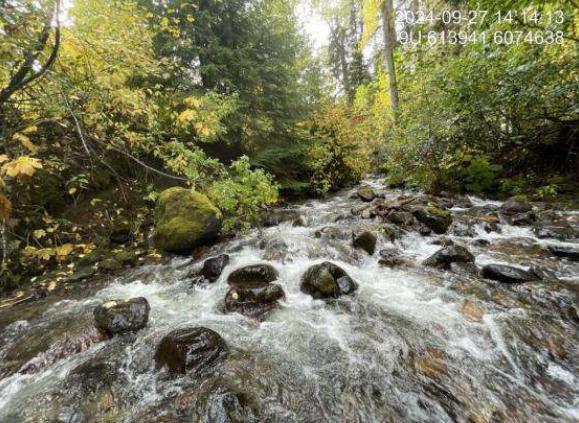
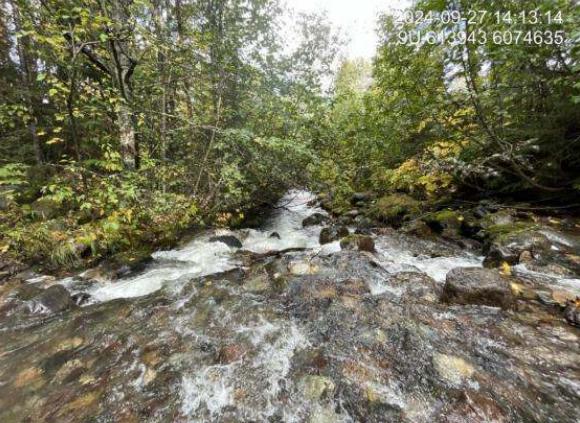
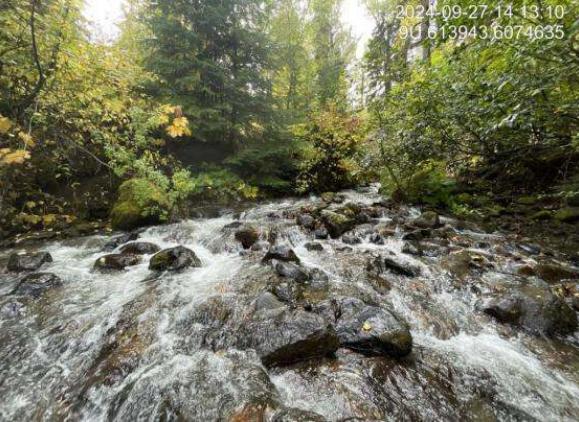
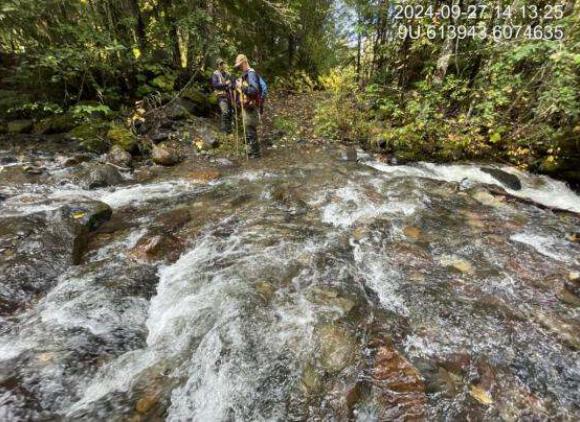
Location and Stream Data		•	Crossing Characteristics	–
Date	2024-09-27	Crossing Sub Type	Ford	
PSCIS ID	203130	Diameter (m)	9	
External ID	2024092751	Length (m)	3	
Crew	LS AI	Embedded	–	
UTM Zone	9	Depth Embedded (m)	–	
Easting	613951	Resemble Channel	–	
Northing	6074629	Backwatered	–	
Stream	Simpson Creek	Percent Backwatered	–	
Road	Transmission line road	Fill Depth (m)	–	
Road Tenure	–	Outlet Drop (m)	–	
Channel Width (m)	–	Outlet Pool Depth (m)	–	
Stream Slope (%)	–	Inlet Drop	–	
Beaver Activity	No	Slope (%)	–	
Habitat Value	–	Valley Fill	–	
Final score	0	Barrier Result	Passable	
Fix type	–	Fix Span / Diameter	–	
Comments: Ford across transmission line road which parallels the transmission lines. Fully passable.				
Photos: PSCIS ID 2024092751. From top left clockwise: Road/Site Card, Barrel, Outlet, Downstream, Upstream, Inlet.
