Skeena Watershed Fish Passage Restoration Planning 2024

Prepared for
Habitat Conservation Trust Foundation - CAT23-6-288
BC Fish Passage Remediation Program
Ministry of Transportation and Infrastructure

Prepared by
Al Irvine, B.Sc., R.P.Bio and Lucy Schick, B.Sc.
New Graph Environment Ltd.
on behalf of
Society for Ecosystem Restoration in Northern British Columbia

DRAFT Version 0.1.1 2025-04-16

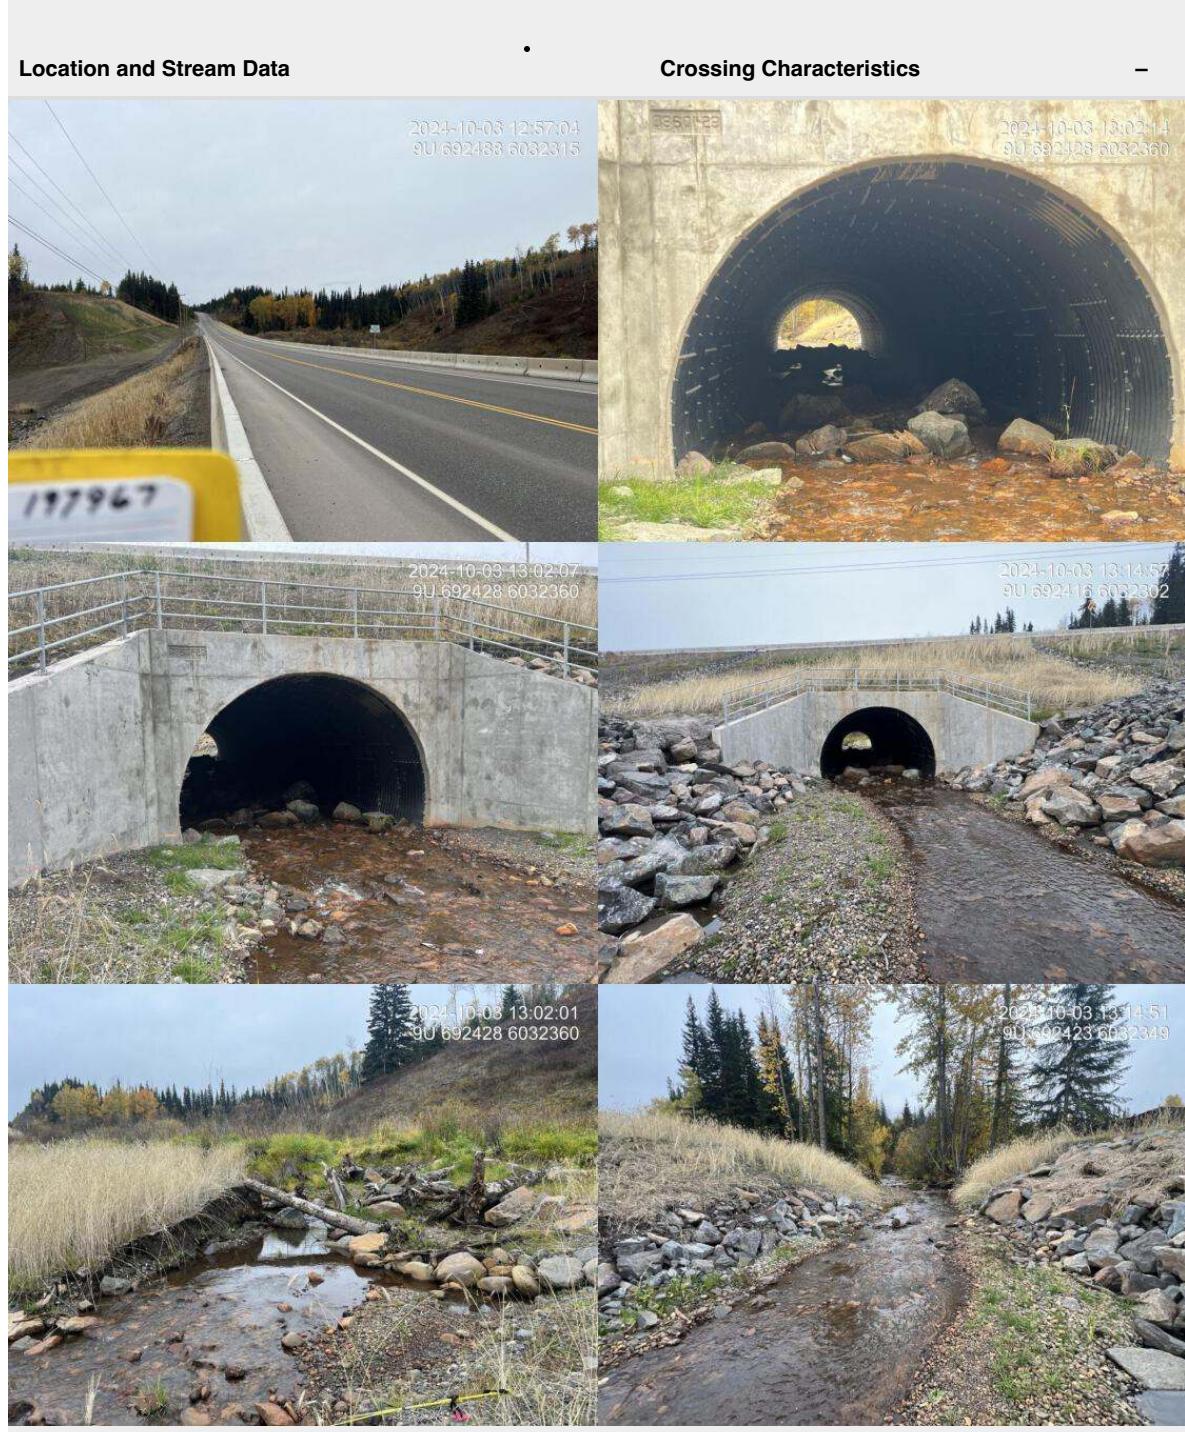
Photos: From top left clockwise: Road/Site Card, Barrel, Outlet, Downstream, Upstream, Inlet.

In 2024, conditions for upstream fish passage through the highway crossing at Taman Creek was greatly improved through installation of a streambed simulation structure featuring a large culvert width, embedded natural streambed substrates, and the addition of well designed habitat features within the reconstructed channel. Future monitoring of the site could repeat monitoring metrics conducted in 2024, track morphological changes to the channel in the years following construction (via drone generated elevation models or lidar) and include fish sampling and/or eDNA presence surveys to understand fish use upstream and downstream of the crossing.

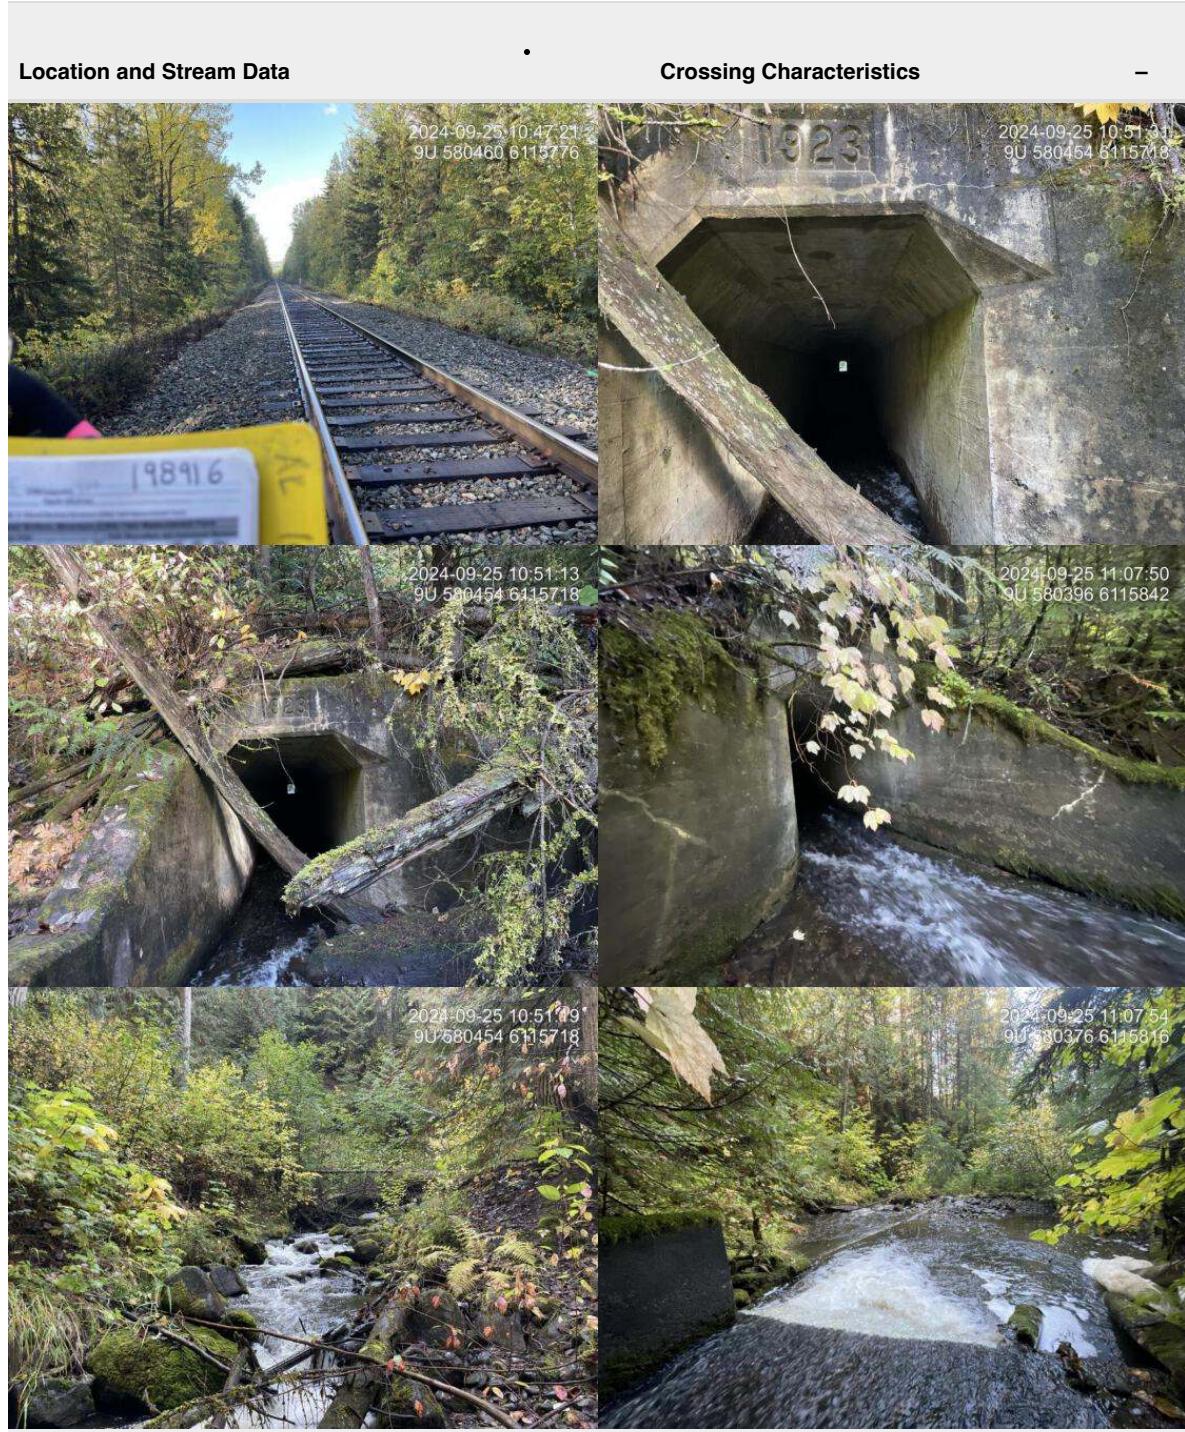
Stream Characteristics at Crossings 1...

Location and Stream Data		Crossing Characteristics	
Date	2024-09-25	Crossing Sub Type	Round Culvert
PSCIS ID	198913	Diameter (m)	1.5
External ID	-	Length (m)	40
Crew	AI JO	Embedded	No
UTM Zone	9	Depth Embedded (m)	-
Easting	581250	Resemble Channel	-
Northing	6115660	Backwatered	No
Stream	Comeau Creek	Percent Backwatered	-
Road	Highway 16	Fill Depth (m)	2.5
Road Tenure	MOTi	Outlet Drop (m)	0.35
Channel Width (m)	5	Outlet Pool Depth (m)	0.85
Stream Slope (%)	3	Inlet Drop	No
Beaver Activity	No	Slope (%)	3
Habitat Value	Medium	Valley Fill	Deep Fill
Final score	42	Barrier Result	Barrier
Fix type	Replace with New Open Bottom Structure	Fix Span / Diameter	15

Comments: There is a deep outlet pool, suggesting the culvert is undersized for the stream. High-quality gravels were present at the pool, outlet, and upstream of the crossing, there was high-value habitat with frequent overwintering pools, spawning gravels, and adequate riparian cover with large cottonwoods throughout. This site was part of a habitat confirmation assessment, with the stream surveyed from the downstream railway crossing up to this location and an additional 600 m upstream. Downstream, crossing 198916 consists of a large, long box culvert beneath the railway with minimal flow depth and a swift current, making it unlikely that fish from the mainstem of the Skeena River can access this site until the railway barrier is addressed. Fish sampling at this site captured cutthroat trout and Dolly Varden.BC Freshwater atlas mapping of this watershed is incorrect as the main stream at the confluence with the Skeena River is actually Comeau Creek vs Gershwin Creek. Therefore, this crossing is actually on Comeau Creek. MoTi chris_culvert_id: 8300872

Although construction would be expensive and challenging, this site is a high priority for restoration follow-up. BC Freshwater atlas mapping of this watershed is incorrect as the main stream at the confluence with the Skeena River is actually Comeau Creek vs Gershwin Creek. Therefore, this crossing is actually on Comeau Creek. Culvert length 100 m but changed to 99.9 m to meet submission requirements. Fill depth 30 m but changed to 9.9 m to meet submission requirements.

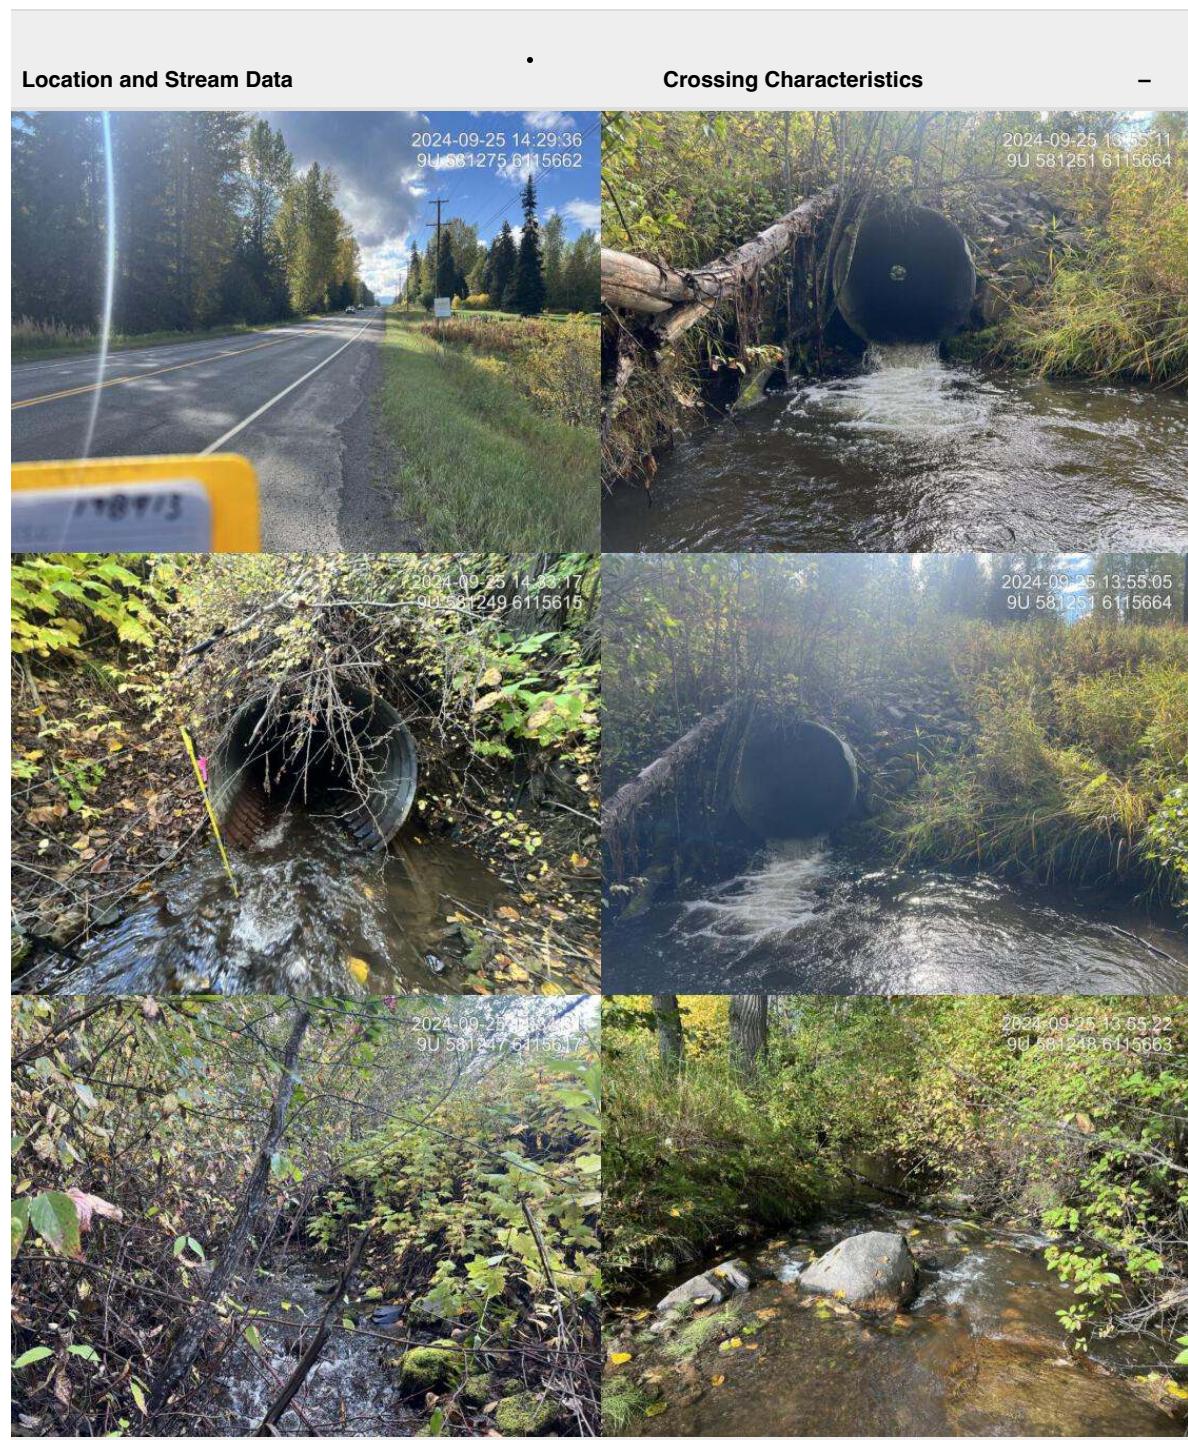
Stream Characteristics Downstream of Crossing 198916

The stream was surveyed downstream from crossing 198916 for 300m . The stream contained numerous boulders forming step pools; however, moderate flows at the time of assessment limited the availability of pools suitable for fish. The first pool suitable for overwintering fish, with adequately reduced flow, was located approximately 250m downstream of the culvert. There were occasional gravels suitable for spawning and frequent large woody debris, which contributed to the formation of additional steps. (Figure [5.7](#)). Total cover amount was rated as moderate with boulders dominant. Cover was also present as small woody debris, large woody debris, and overhanging vegetation. The dominant substrate was cobbles with gravels sub-dominant. The average channel width was 5.9m, the average wetted width was 3.7m, and the average gradient was 5.1%. The habitat was rated as medium value suitable for salmonid rearing and spawning.

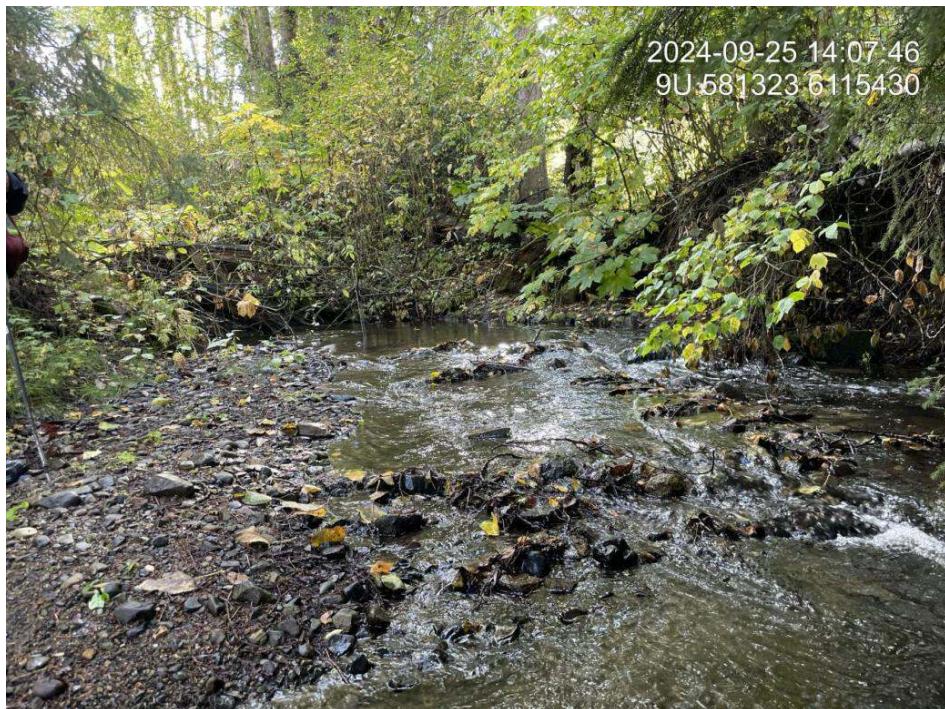
Figure 5.9: Typical habitat upstream of PSCIS crossing 198913.

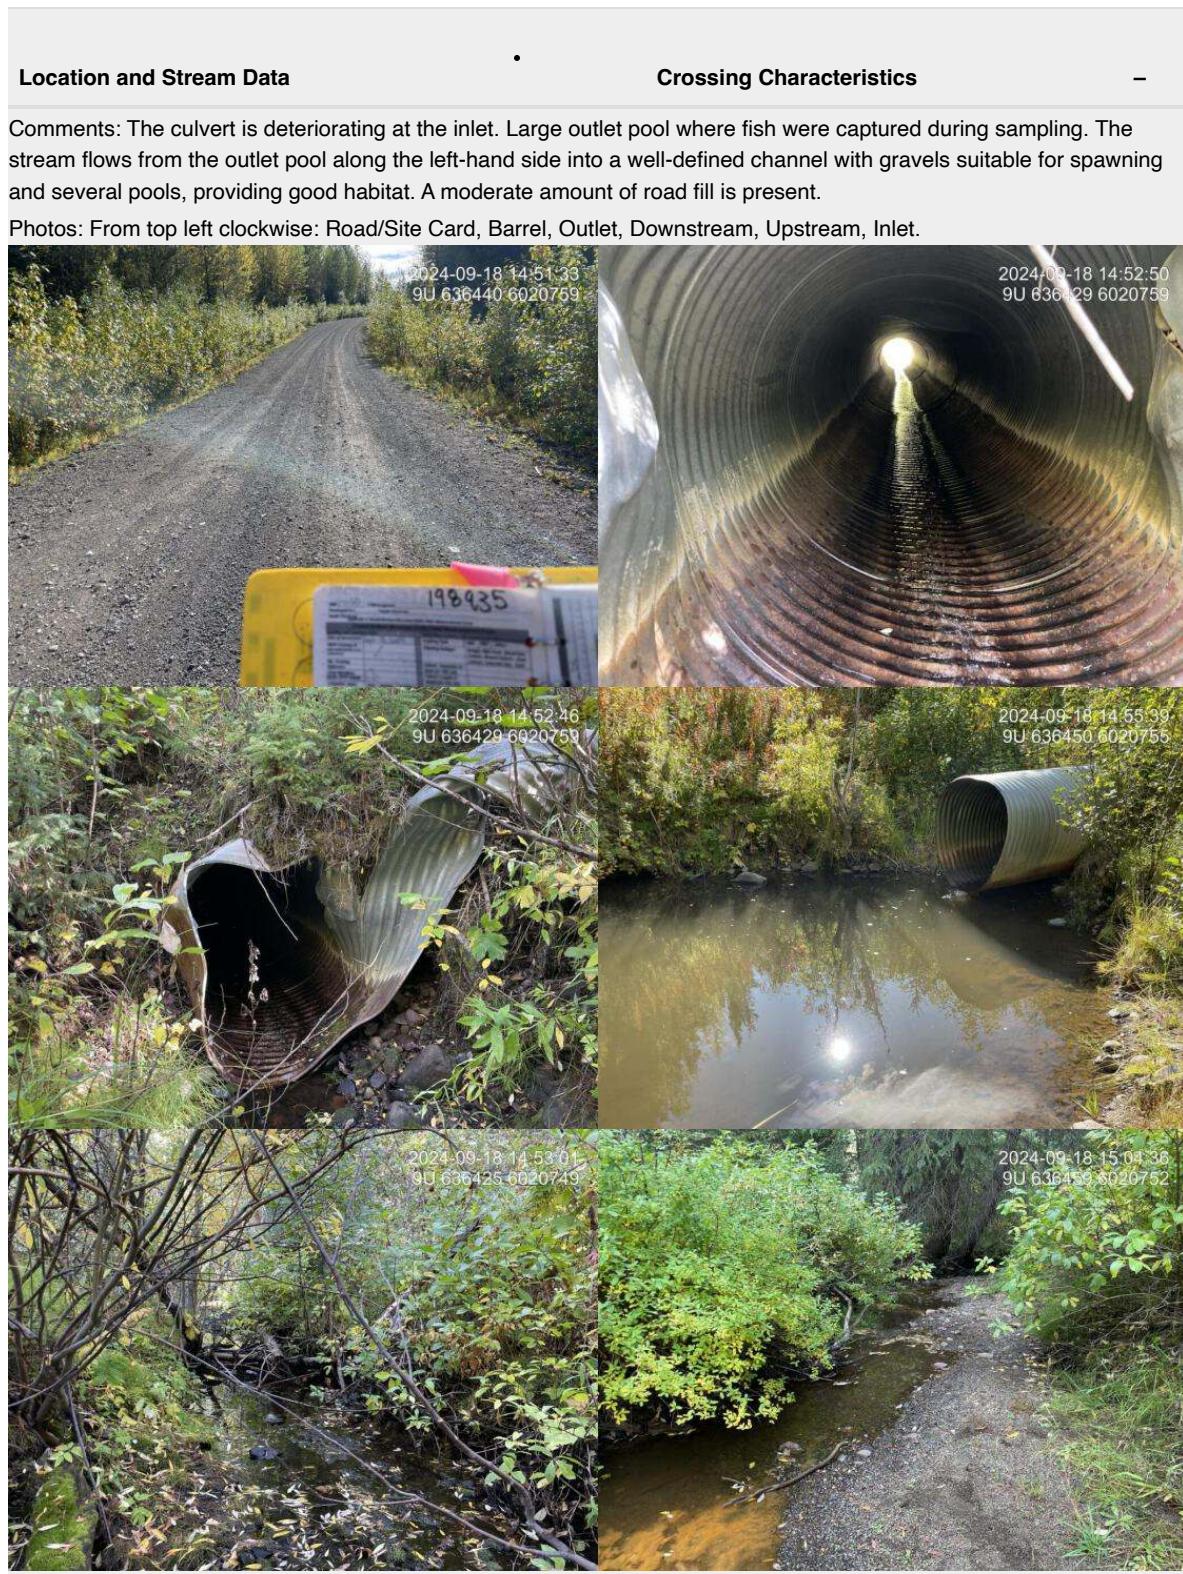
Table 5.13: Summary of fish passage assessment for PSCIS crossing 198935.

Location and Stream Data		Crossing Characteristics	
Date	2024-09-18	Crossing Sub Type	Round Culvert
PSCIS ID	198935	Diameter (m)	1.2
External ID	–	Length (m)	20
Crew	LS	Embedded	No
UTM Zone	9	Depth Embedded (m)	–
Easting	636440	Resemble Channel	–
Northing	6020756	Backwatered	No
Stream	Tributary to Knapper Creek	Percent Backwatered	–
Road	Gold creek fsr	Fill Depth (m)	4
Road Tenure	Canfor R07549 6	Outlet Drop (m)	0.15
Channel Width (m)	2.7	Outlet Pool Depth (m)	0.8
Stream Slope (%)	2.2	Inlet Drop	No
Beaver Activity	Yes	Slope (%)	1.5
Habitat Value	Medium	Valley Fill	Deep Fill
Final score	29	Barrier Result	Barrier
Fix type	Replace with New Open Bottom Structure	Fix Span / Diameter	18

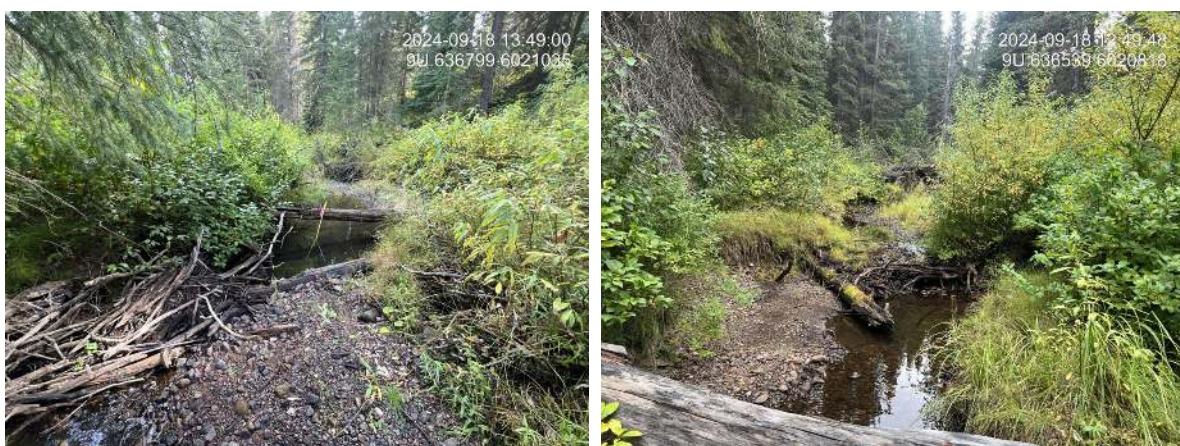
The stream was surveyed downstream from crossing 198940 for 300m (Figure [5.12](#)).. The habitat was rated as medium, with good flow, abundant gravels, overhanging banks, and healthy riparian vegetation, providing good rearing and spawning habitat for coho, rainbow trout, Dolly Varden, and cutthroat trout. Total cover amount was rated as moderate with undercut banks dominant. Cover was also present as small woody debris, large woody debris, and overhanging vegetation. The average channel width was 3.3m, the average wetted width was 1.5m, and the average gradient was 3.3%. The dominant substrate was gravels with cobbles sub-dominant..

Figure 5.12: Left: Typical habitat downstream of PSCIS crossing 198940. Right: Typical habitat upstream of PSCIS crossing 198940.

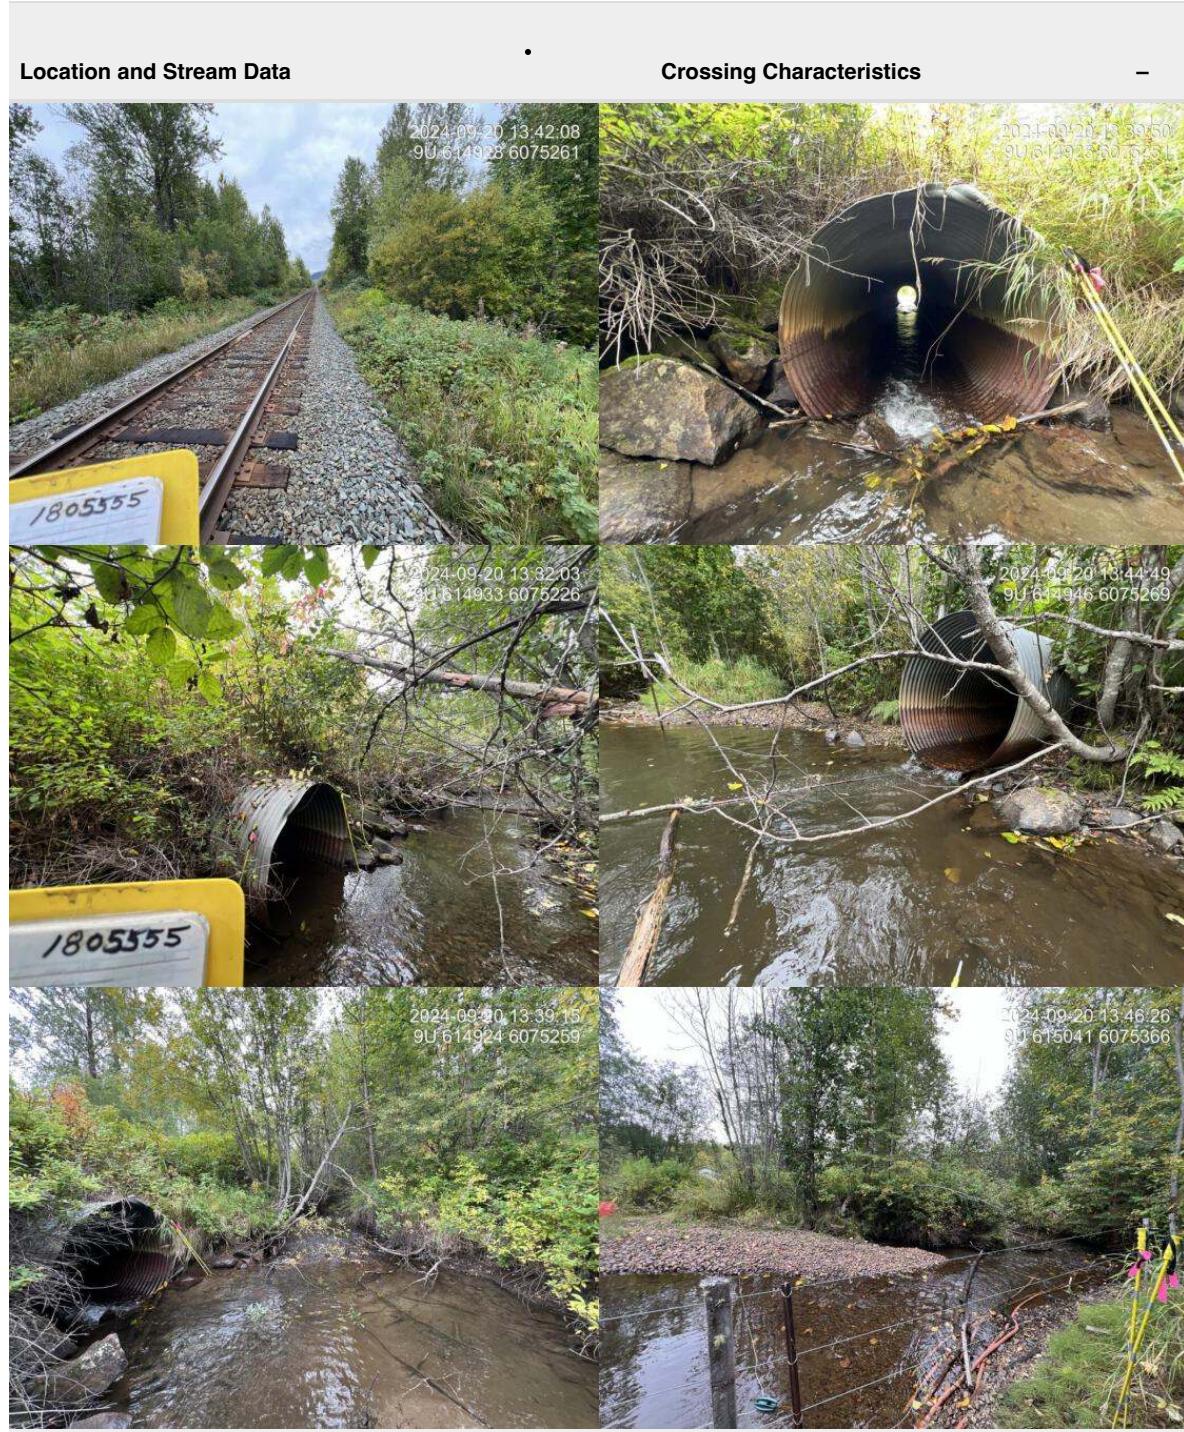
Photos: From top left clockwise: Road/Site Card, Barrel, Outlet, Downstream, Upstream, Inlet.

Location and Stream Data		Crossing Characteristics	
Date	2024-09-20	Crossing Sub Type	Round Culvert
PSCIS ID	203122	Diameter (m)	3
External ID	–	Length (m)	25
Crew	AI	Embedded	No
UTM Zone	9	Depth Embedded (m)	–
Easting	614941	Resemble Channel	Yes
Northing	6075232	Backwatered	No
Stream	Simpson Creek	Percent Backwatered	–
Road	Railway	Fill Depth (m)	1
Road Tenure	CN Rail	Outlet Drop (m)	0.05
Channel Width (m)	5	Outlet Pool Depth (m)	0.9
Stream Slope (%)	1	Inlet Drop	Yes
Beaver Activity	Yes	Slope (%)	2
Habitat Value	High	Valley Fill	Deep Fill
Final score	24	Barrier Result	Barrier
Fix type	Replace with New Open Bottom Structure	Fix Span / Diameter	15
Comments: Although this culvert is on Simpson Creek, it is not currently conveying the main flow and remains mostly dry. Two 1.5 m diameter pipes run under the railway, approximately 30 m apart. The southern pipe is fully embedded with an average embedment depth of 25 cm, while the northern pipe is currently passing all stream flow. This is a high-value stream with extensive gravel areas suitable for steelhead, coho, and chinook salmon spawning upstream. The adjacent landowner has reported recent observations of steelhead spawning and has historical knowledge of chinook spawning approximately 300 m downstream from Nielsen Road.

PSCIS crossing 203122 on the CN Railway presented a minimal barrier to fish passage and is considered a low priority for replacement. However, if restoration activities are undertaken, replacing the existing structure with a bridge spanning 15 m is recommended. As of 2025, the estimated replacement cost is \$ 11,250,000, with the high cost attributed to the complexities of working within a railway corridor.

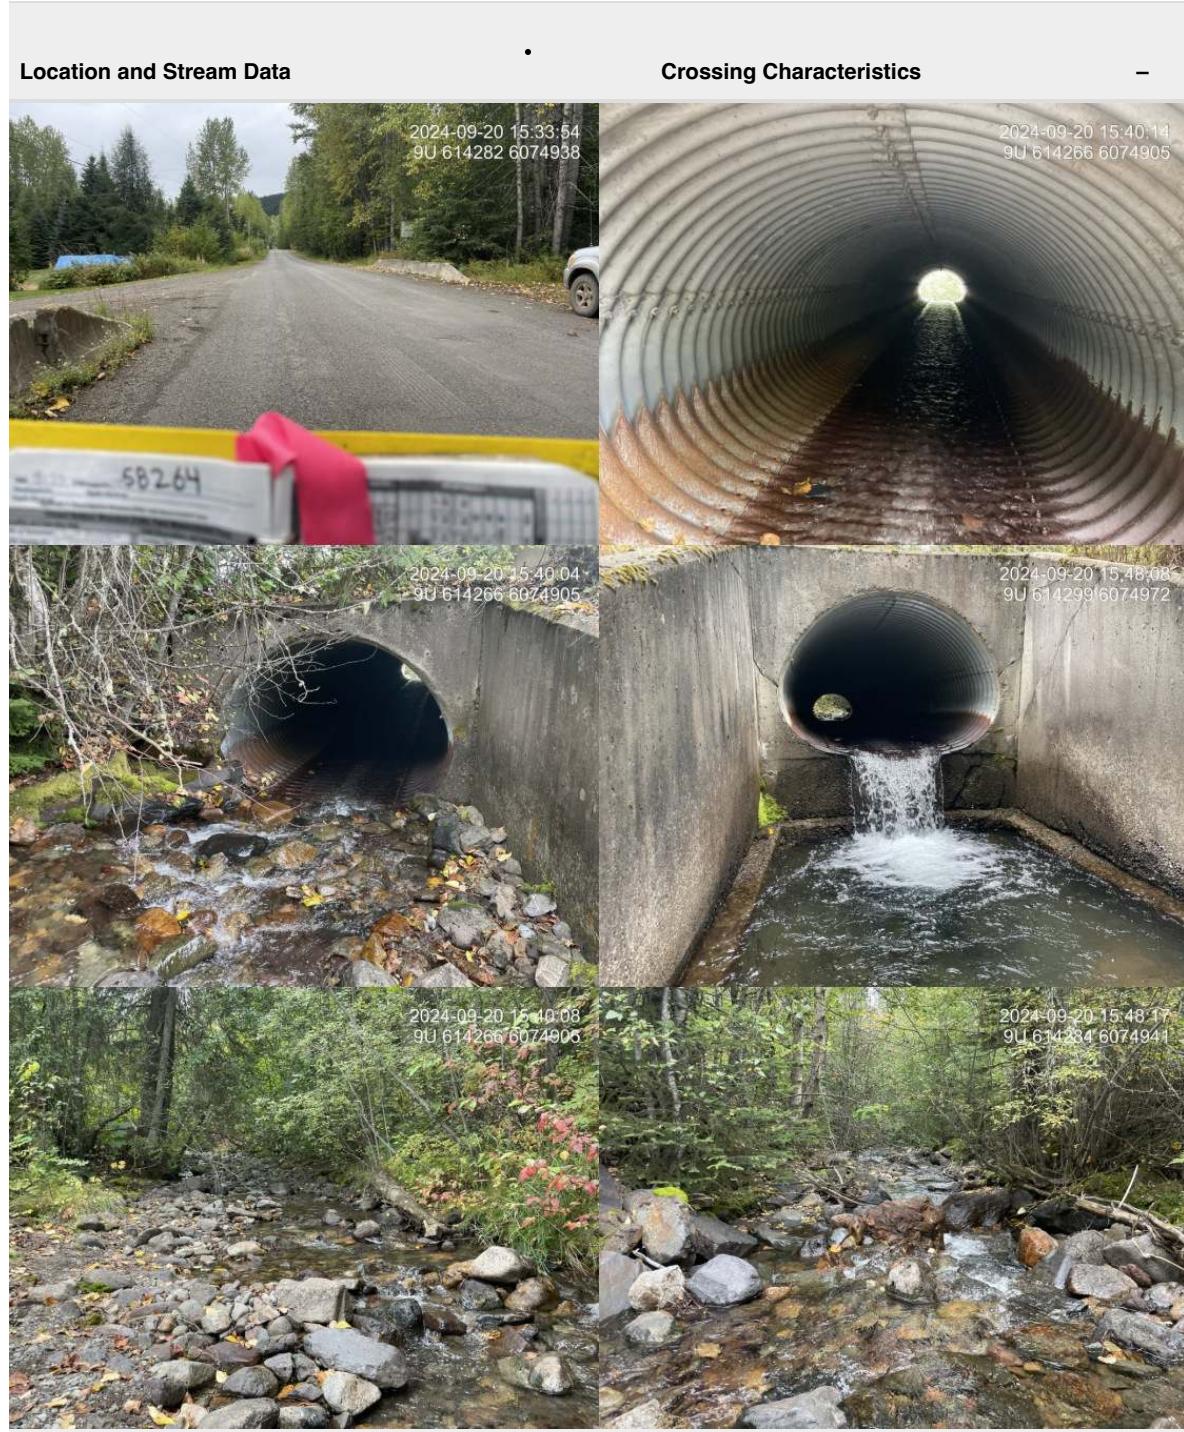
Photos: From top left clockwise: Road/Site Card, Barrel, Outlet, Downstream, Upstream, Inlet.

According to a nearby landowner, the crossing on Nielson Road (58264) was originally a bridge but was replaced with the current culvert during an emergency flood event in the 1990s. Materials from the flood were used to construct dikes upstream and downstream of the crossing, which remained in place at the time of the 2024 assessment. Upstream of the Nielson Road crossing, a trail runs parallel to the stream for 400m up to the power line, offering an excellent opportunity for community engagement. By connecting people to the land, the trail can foster stewardship and advocacy for the stream, potentially leading to future restoration efforts.

Location and Stream Data		Crossing Characteristics	
Date	2024-09-20	Crossing Sub Type	Oval Culvert
PSCIS ID	58264	Diameter (m)	2.4
External ID	–	Length (m)	23
Crew	LS TP	Embedded	No
UTM Zone	9	Depth Embedded (m)	–
Easting	614280	Resemble Channel	–
Northing	6074951	Backwatered	No
Stream	Simpson Creek	Percent Backwatered	–
Road	Nielson Road	Fill Depth (m)	0.4
Road Tenure	MoTi	Outlet Drop (m)	1
Channel Width (m)	5.6	Outlet Pool Depth (m)	1.2
Stream Slope (%)	13	Inlet Drop	No
Beaver Activity	No	Slope (%)	5
Habitat Value	High	Valley Fill	Deep Fill
Final score	39	Barrier Result	Barrier
Fix type	Replace with New Open Bottom Structure	Fix Span / Diameter	15

Comments: This concrete oval culvert has a significant 1 m outlet drop, likely inhibiting fish passage. The stream is incorrectly mapped in the Freshwater Atlas, located south of the mapped channel. Upstream habitat includes boulder cover, gravel pockets suitable for coho, steelhead, and Dolly Varden spawning, and a healthy mature mixed forest riparian zone. Downstream habitat transitions to lower-gradient, high-value conditions with extensive gravels, deep pools (up to 90 cm), large woody debris, and abundant cover, supporting recent steelhead and historically chinook spawning, as reported by the adjacent landowner. Habitat confirmations were completed at this site and all downstream crossings to the confluence with Kathlyn Creek. The stream is a major contributor to the greater Kathlyn Creek watershed, with flow volumes during the assessment slightly less than the Kathlyn Creek mainstem. Electrofishing upstream of Nielsen Road captured rainbow trout, while downstream sampling confirmed the presence of Dolly Varden, rainbow trout, cutthroat trout/rainbow trout hybrids, and coho. The coho were captured approximately 350 m downstream of Nielsen Road. According to the landowner, this crossing was originally a bridge but was replaced with the current culvert during an emergency flood event in the 1990s.

Should restoration/maintenance activities proceed, replacement of the Nielson Road crossing (58264) with a bridge (15 m span) is recommended. The significant 1 m outlet drop at this crossing, combined with the presence of salmonids in the system, makes it a top priority for remediation. At the time of reporting in 2025, the cost of the work is estimated at \$ 3,000,000.

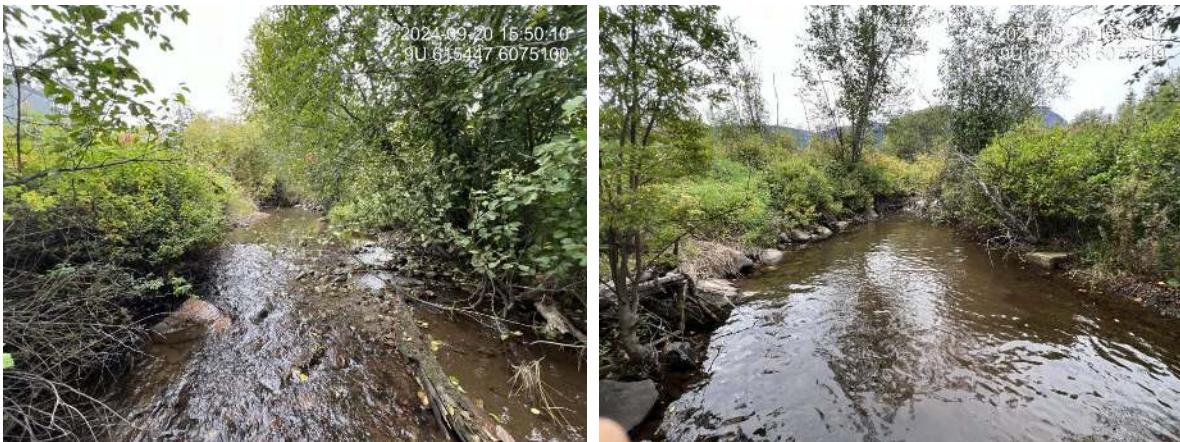
Figure 5.16: Left: Typical habitat downstream of PSCIS crossing 58245. Right: Typical habitat upstream of PSCIS crossing 58245 and downstream of PSCIS crossing 203122, with signs of bank armouring and channelization.
