Appendix - Phase 1 Fish Passage Assessment Data and Photos

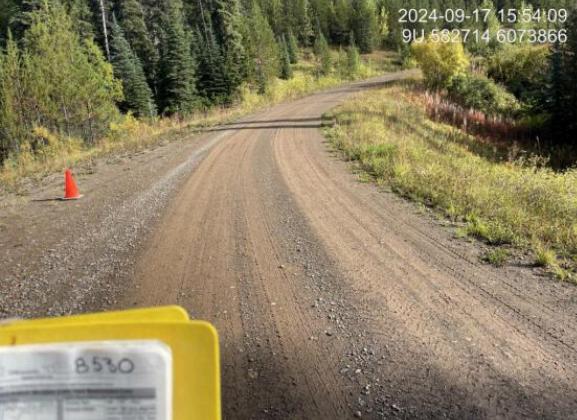
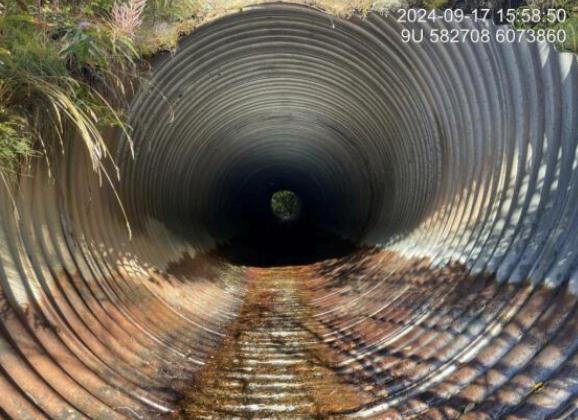
Photos: PSCIS ID 8530. From top left clockwise: Road/Site Card, Barrel, Outlet, Downstream, Upstream, Inlet.

Location and Stream Data		Crossing Characteristics	
Date	2024-09-17	Crossing Sub Type	Round Culvert
PSCIS ID	8530	Diameter (m)	2.4
External ID	—	Length (m)	38
Crew	LS AI TP VJ	Embedded	No
UTM Zone	9	Depth Embedded (m)	—
Easting	582719	Resemble Channel	—
Northing	6073883	Backwatered	No
Stream	Sandstone Creek	Percent Backwatered	—
Road	McDonnell fsr	Fill Depth (m)	9
Road Tenure	MoF	Outlet Drop (m)	0.5
Channel Width (m)	3.9	Outlet Pool Depth (m)	0.4
Stream Slope (%)	2	Inlet Drop	No
Beaver Activity	No	Slope (%)	5
Habitat Value	High	Valley Fill	Deep Fill
Final score	42	Barrier Result	Barrier
Fix type	Replace with New Open Bottom Structure	Fix Span / Diameter	33
Comments: The stream has good quality habitat with abundant overhanging vegetation and boulders providing cover, pools for overwintering fish, and gravel suitable for spawning. Rainbow trout, cutthroat trout, and Dolly Varden were captured during sampling. Very large culvert with a significant amount of road fill (9m). There was an engineering site survey conducted in 2024 but the design plans were put on hold due to high replacement costs and uncertainty around if salmon could access the crossing due to potential barriers downstream. DFO was involved and reported that coho were spawning downstream of the crossing in October 2024.

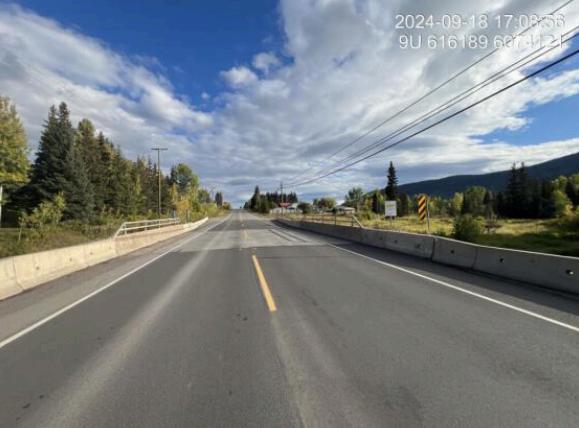
Photos: PSCIS ID 58235. From top left clockwise: Road/Site Card, Barrel, Outlet, Downstream, Upstream, Inlet.

Comments: New, well built, bridge.

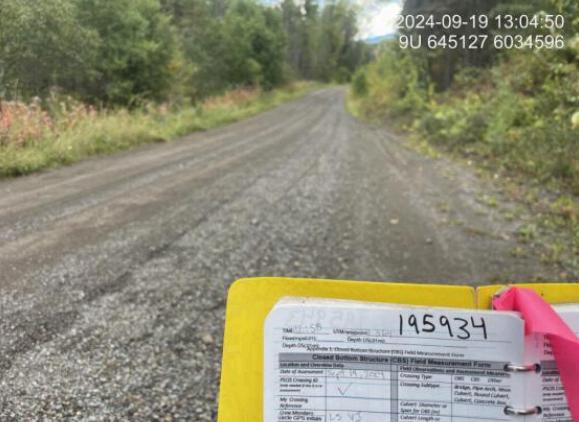
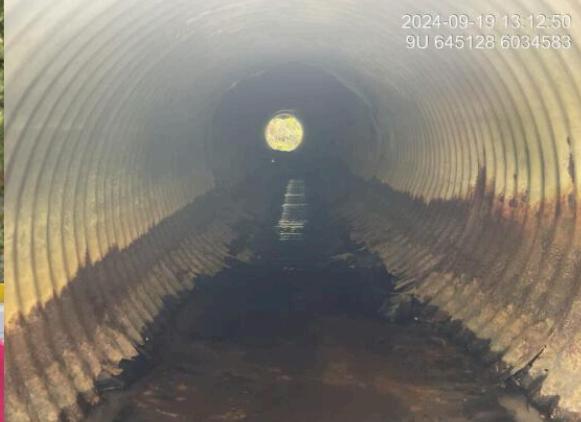
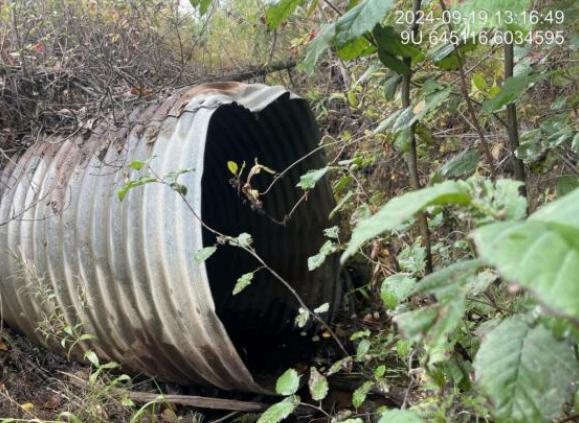
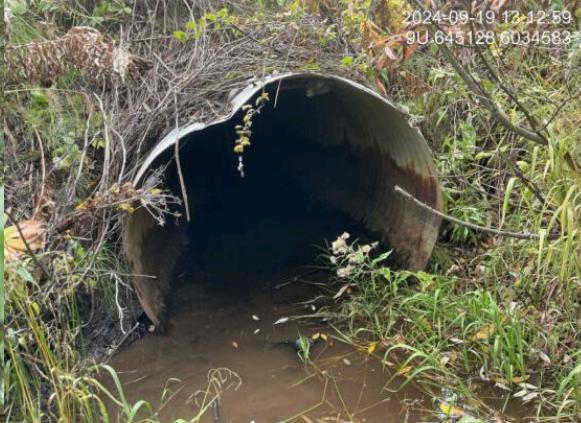
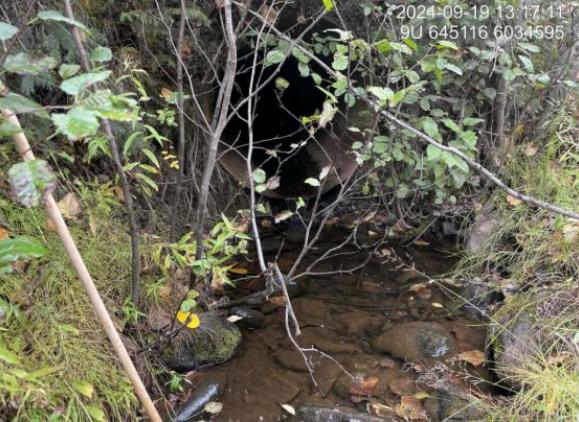
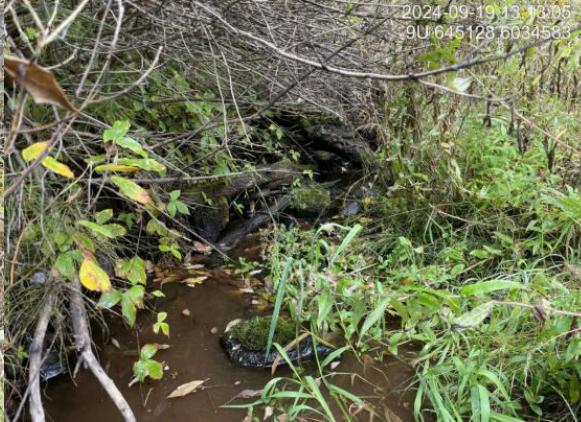
Photos: PSCIS ID 195934. From top left clockwise: Road/Site Card, Barrel, Outlet, Downstream, Upstream, Inlet.

Comments: The inlet of the culvert is approximately 3 m downstream of the outlet of culvert 195935, which crosses under the Houston Airport Rd. The stream has an estimated slope of 1%. Downstream of the culvert, the stream is heavily overgrown. The culvert has holes in the bottom about 2 m from the outlet and is backwatered up to that point.
MoTi chris_culvert_id: 1755233

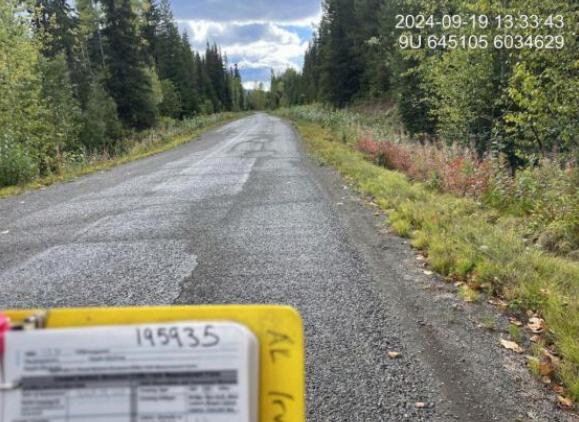
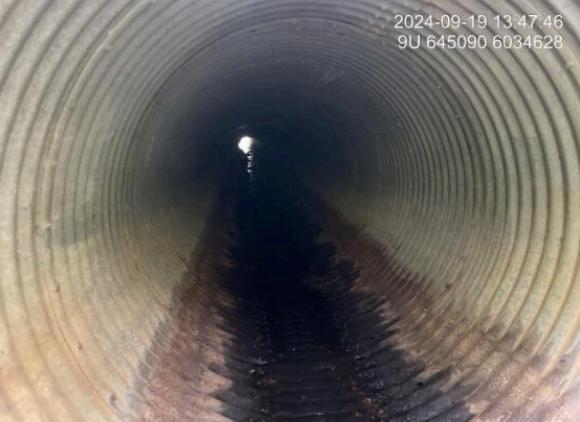
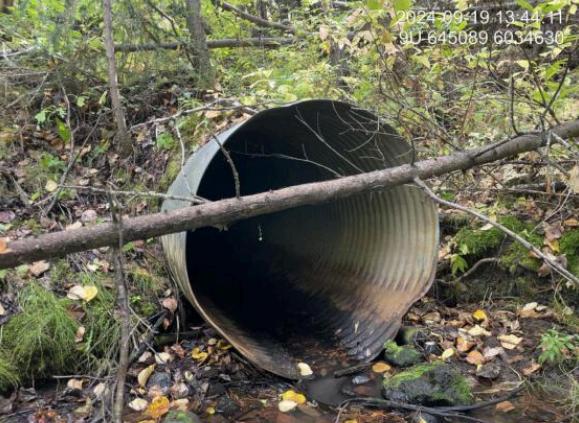
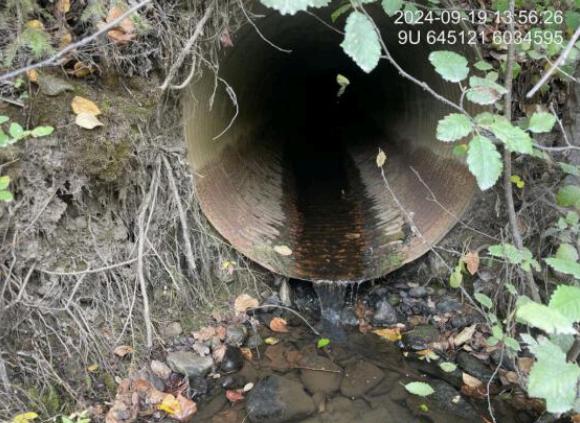
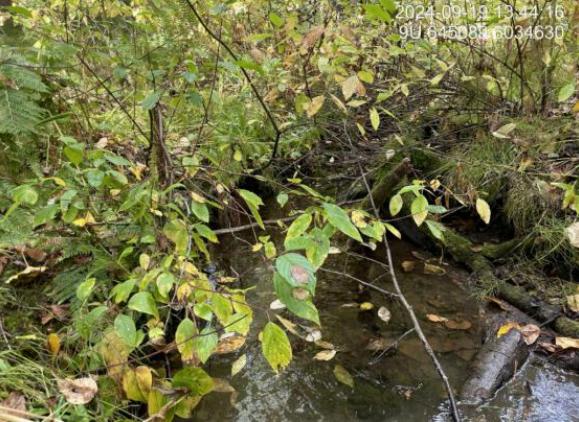
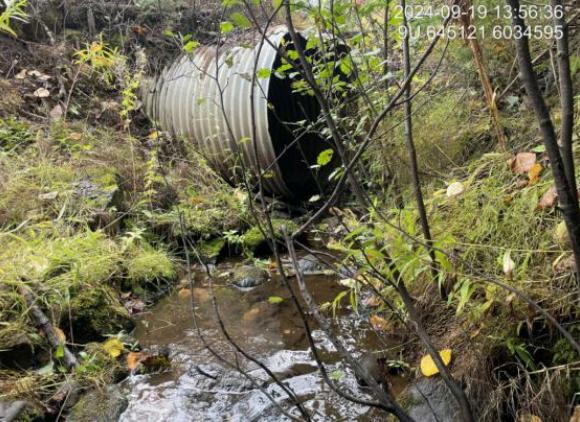
Photos: PSCIS ID 195935. From top left clockwise: Road/Site Card, Barrel, Outlet, Downstream, Upstream, Inlet.

Comments: Upstream of the crossing, there is good habitat for fish, including undercut banks, functional large woody debris, healthy riparian vegetation, and several pools suitable for overwintering fish. A fish ~100 mm in length was observed in one of the pools upstream. A barbed wire fence is present when accessing the inlet. The culvert is extremely long (38 m), with its outlet located approximately 3 m upstream of the inlet of crossing 195934. Downstream of crossing 195934 the stream is heavily overgrown. Fill depth 11 m but changed to 9.9 m to meet submission requirements. MoTi chris_culvert_id: 2078335

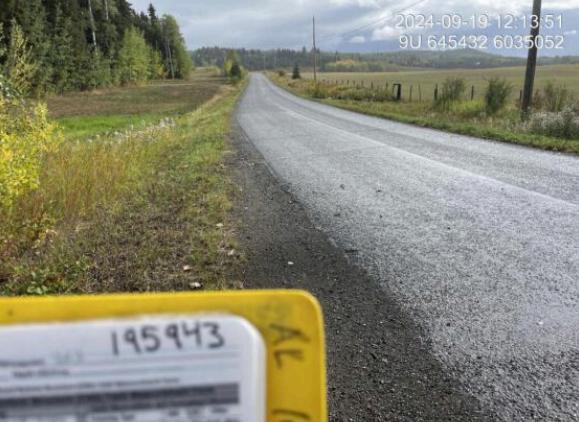
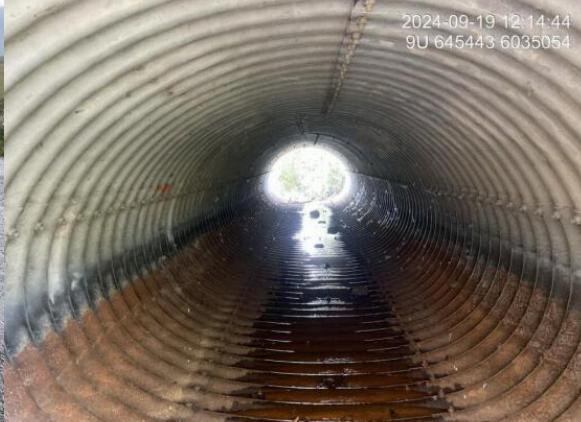
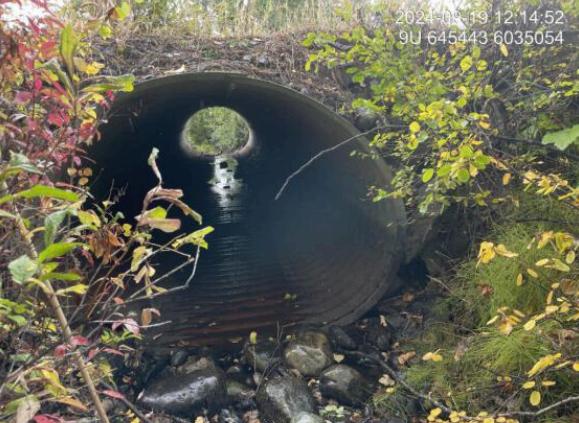
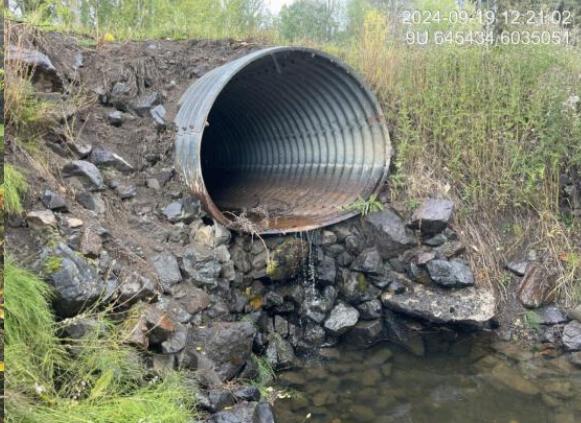
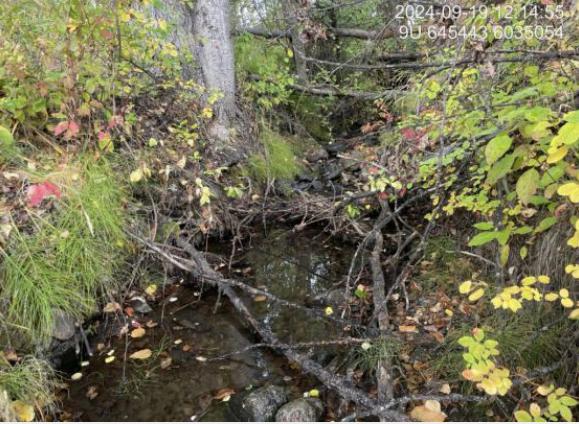
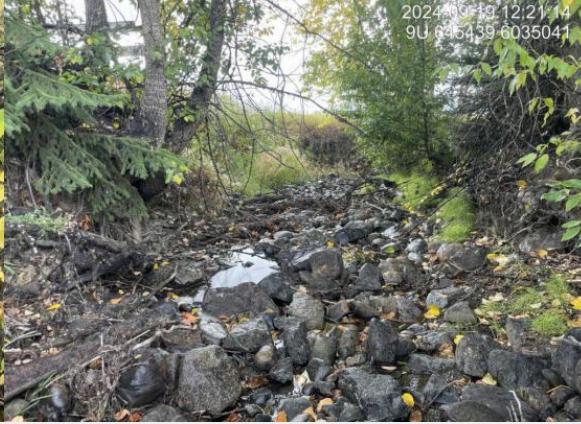
Photos: PSCIS ID 195943. From top left clockwise: Road/Site Card, Barrel, Outlet, Downstream, Upstream, Inlet.

Comments: The culvert has a substantial outlet drop of 1.05 m, with signs of high flows at the outlet. The stream likely contains numerous pools during higher flows but had very low flows at the time of assessment. Flowing through agricultural land on both sides, the stream is heavily eroded downstream, making it a strong candidate for fencing and riparian management. Upstream habitat was less eroded and consisted of mature riparian vegetation providing good habitat for fish. Only two fish were captured during sampling (both in the deep outlet pool), which was unexpected given the good habitat. Conductivity was extremely high, possibly due to upstream cattle activity and surrounding land use.

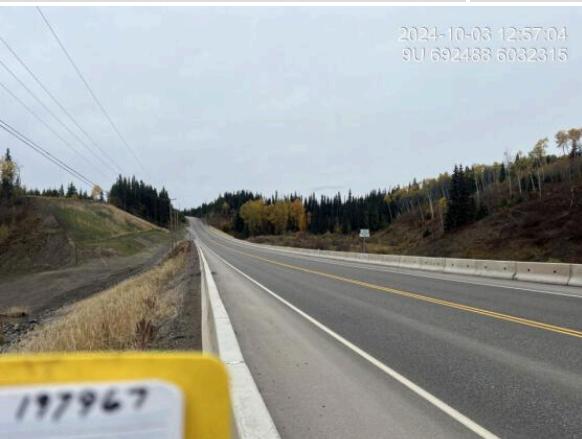
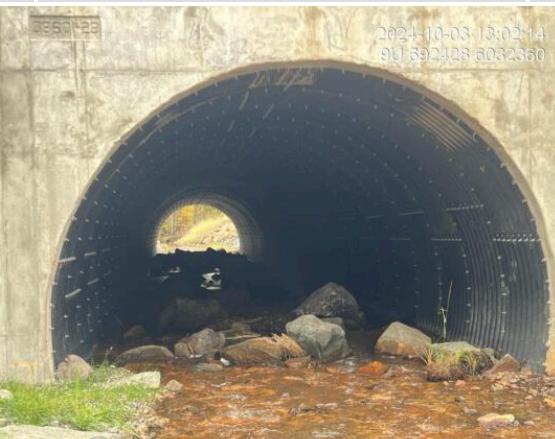
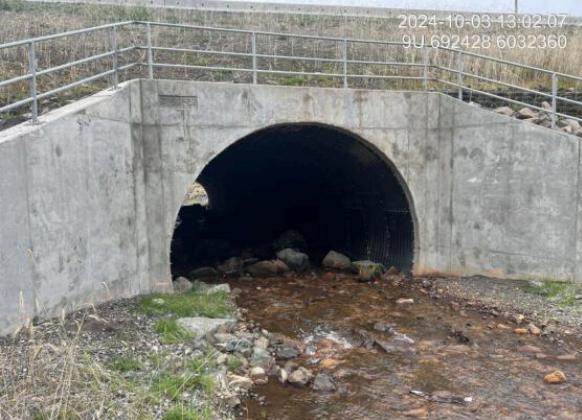
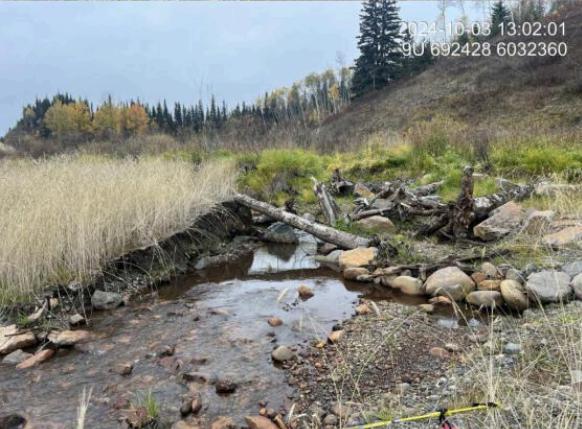
Photos: PSCIS ID 197967. From top left clockwise: Road/Site Card, Barrel, Outlet, Downstream, Upstream, Inlet.

This is a brand-new replacement structure, extremely well built with extensive embedment that includes numerous large boulders, cobbles, and gravel. The multiplate round structure is embedded nearly 2 m. Upstream, woody debris and boulder structures are cabled together for added stability. This massive construction project involved a substantial amount of fill extending 60 m downstream and over 200 m upstream. The site now offers migration conditions for fish that are equal to or better than previous conditions. MoTi chris_culvert_id: 2076452

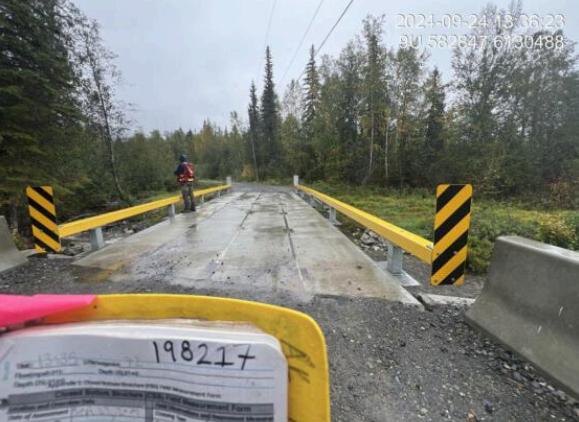
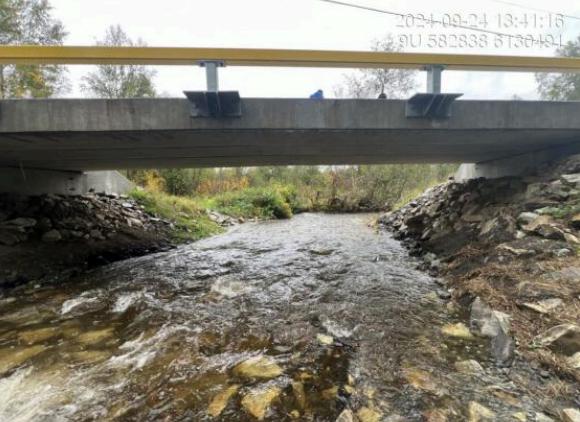
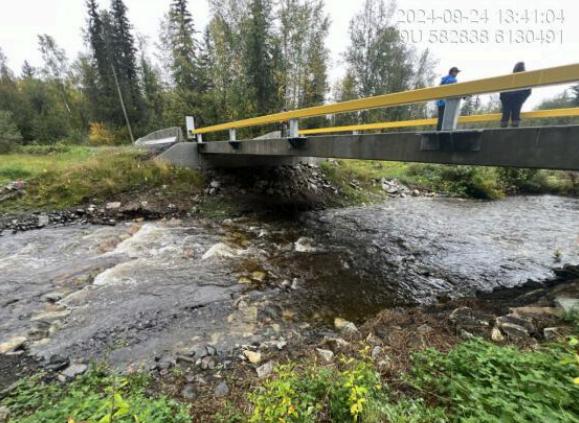
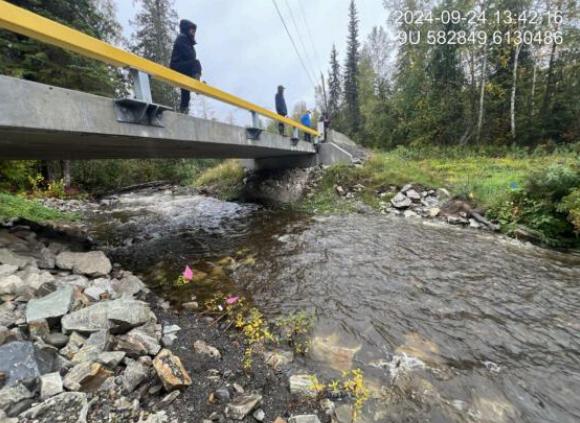
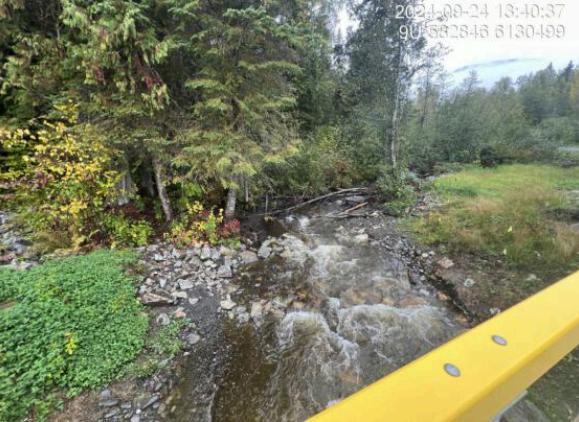
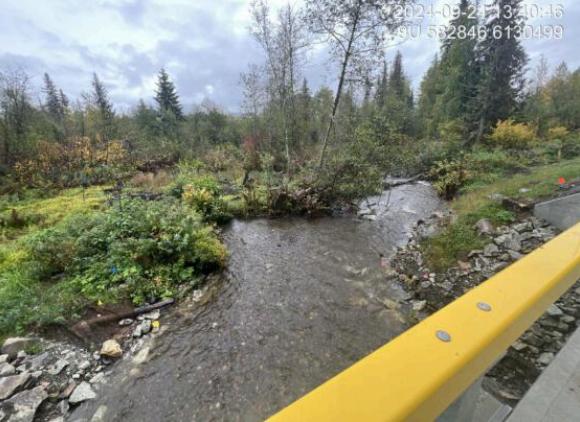
Photos: PSCIS ID 198217. From top left clockwise: Road/Site Card, Barrel, Outlet, Downstream, Upstream, Inlet.

Location and Stream Data		•	Crossing Characteristics	-
Date	2024-09-24		Crossing Sub Type	Bridge
PSCIS ID	198217		Diameter (m)	14
External ID	-		Length (m)	4
Crew	LS AI		Embedded	-
UTM Zone	9		Depth Embedded (m)	-
Easting	582850		Resemble Channel	-
Northing	6130490		Backwatered	-
Stream	Sik-e-dakh		Percent Backwatered	-
Road	Sik-e-dakh Water Tower Rd		Fill Depth (m)	-
Road Tenure	MoTi		Outlet Drop (m)	-
Channel Width (m)	-		Outlet Pool Depth (m)	-
Stream Slope (%)	-		Inlet Drop	-
Beaver Activity	No		Slope (%)	-
Habitat Value	-		Valley Fill	-
Final score	0		Barrier Result	Passable
Fix type	-		Fix Span / Diameter	-
Comments: The culvert was replaced with a bridge, featuring excellent construction with a wide channel beneath the structure. Riprap has been covered with soil to promote vegetation growth, and significant riparian restoration is underway with trees and shrubs being planted. Overall, this is a well-executed replacement project.

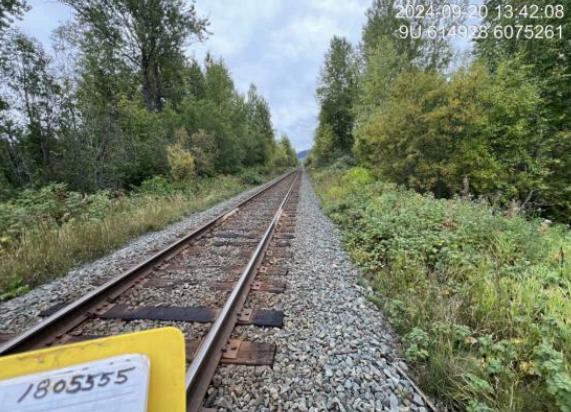
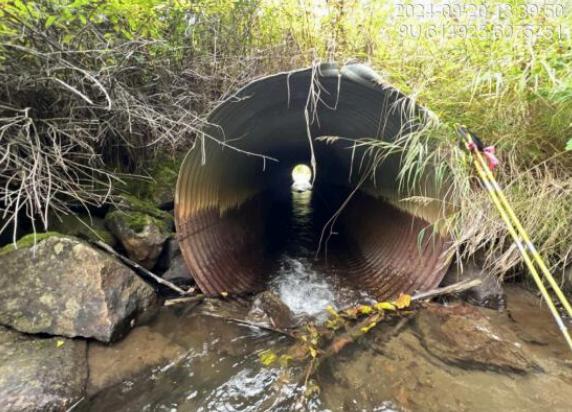
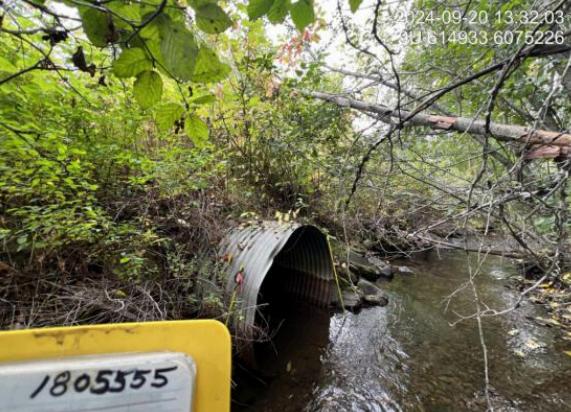
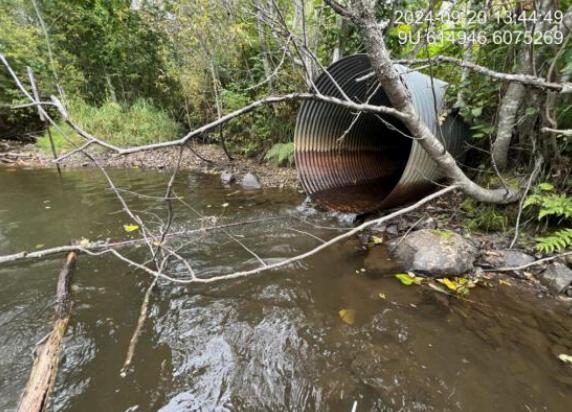
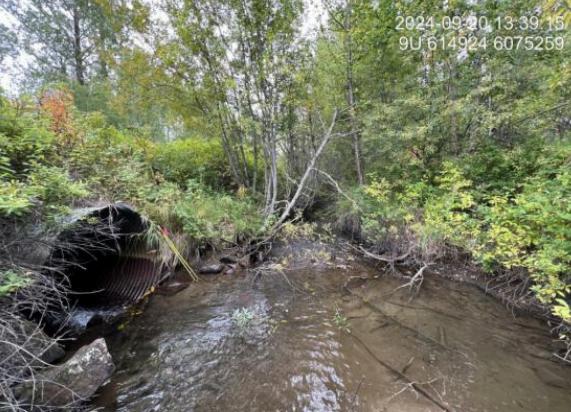
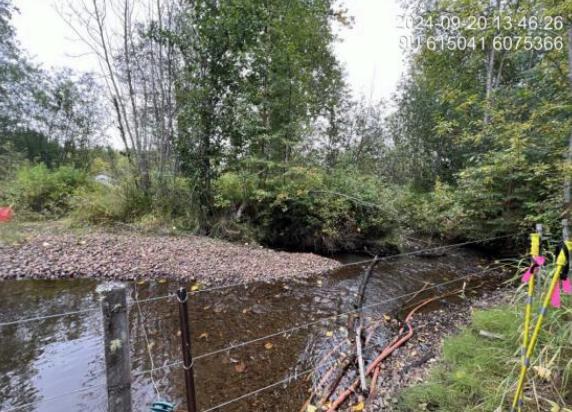
Photos: PSCIS ID 1805555. From top left clockwise: Road/Site Card, Barrel, Outlet, Downstream, Upstream, Inlet.

Comments: Although this culvert is on Simpson Creek, it is not currently conveying the main flow and remains mostly dry. Two 1.5 m diameter pipes run under the railway, approximately 30 m apart. The southern pipe is fully embedded with an average embedment depth of 25 cm, while the northern pipe is currently passing all stream flow. This is a high-value stream with extensive gravel areas suitable for steelhead, coho, and chinook salmon spawning upstream. The adjacent landowner has reported recent observations of steelhead spawning and has historical knowledge of chinook spawning approximately 300 m downstream from Nielsen Road.

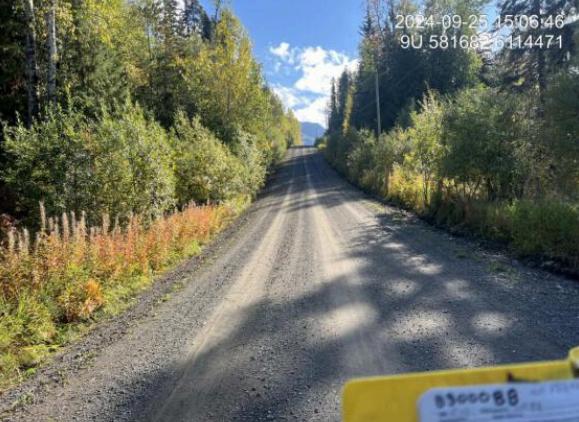
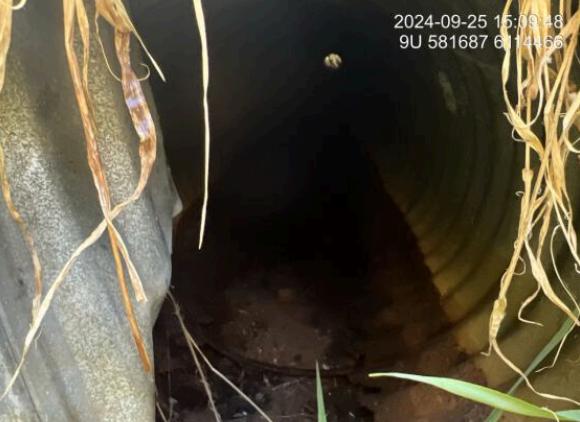
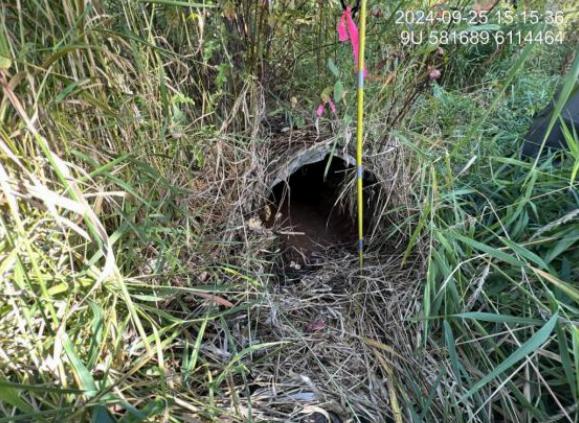
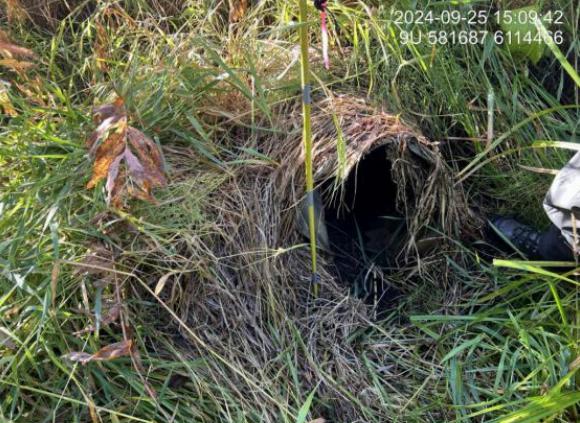
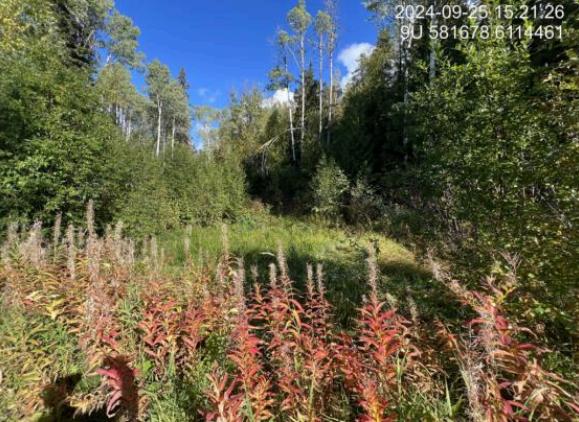
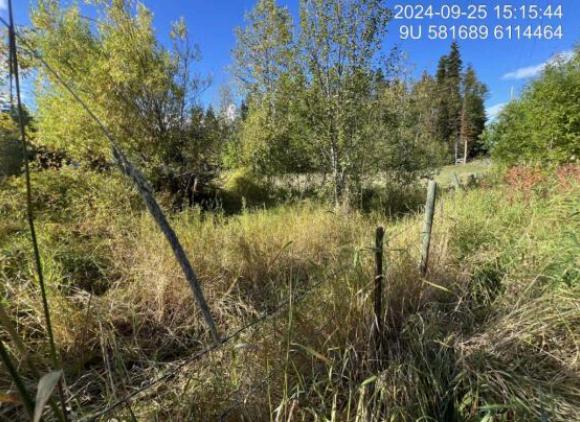
Location and Stream Data		Crossing Characteristics	
Date	2024-09-25	Crossing Sub Type	Round Culvert
PSCIS ID	203123	Diameter (m)	0.6
External ID	8300088	Length (m)	16
Crew	AI JO	Embedded	No
UTM Zone	9	Depth Embedded (m)	–
Easting	581685	Resemble Channel	–
Northing	6114465	Backwatered	No
Stream	Tributary to Gershwin Creek	Percent Backwatered	–
Road	Cormeau Road	Fill Depth (m)	0.4
Road Tenure	MoTi	Outlet Drop (m)	0
Channel Width (m)	0.5	Outlet Pool Depth (m)	0
Stream Slope (%)	1.5	Inlet Drop	No
Beaver Activity	No	Slope (%)	1
Habitat Value	Low	Valley Fill	Deep Fill
Final score	18	Barrier Result	Potential
Fix type	Replace Structure with Streambed Simulation CBS	Fix Span / Diameter	3
Comments: No visible channel was observed; the area appeared to be a wet draw during the survey, with some sedges present upstream. It is unlikely to provide fish habitat. MoTi chris_culvert_id: 1524657			
Photos: PSCIS ID 8300088. From top left clockwise: Road/Site Card, Barrel, Outlet, Downstream, Upstream, Inlet.

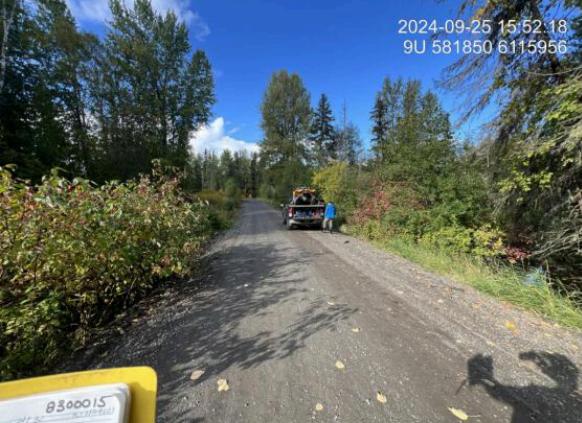
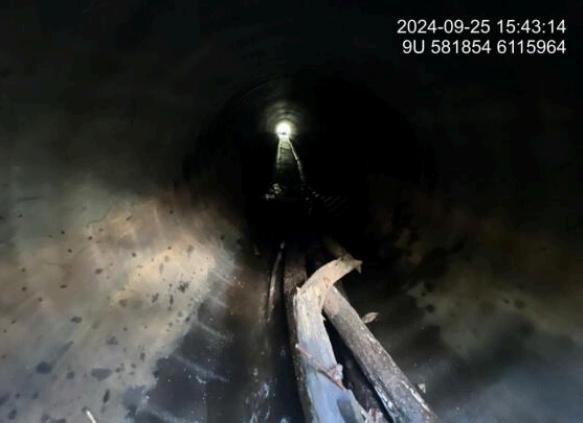
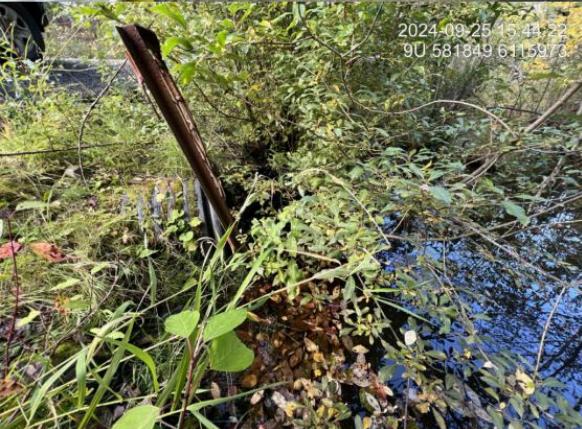
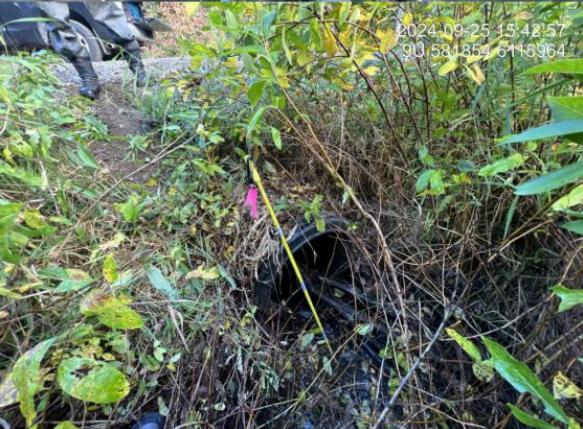
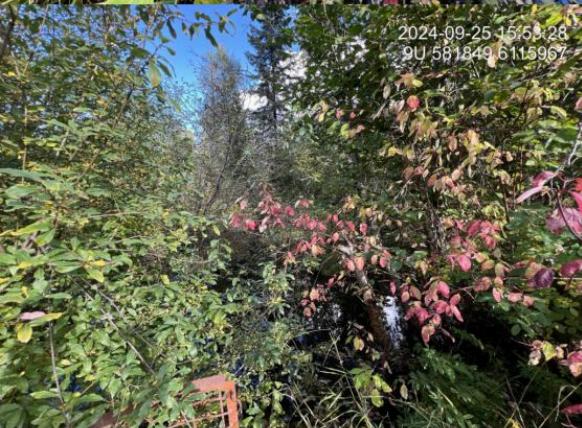
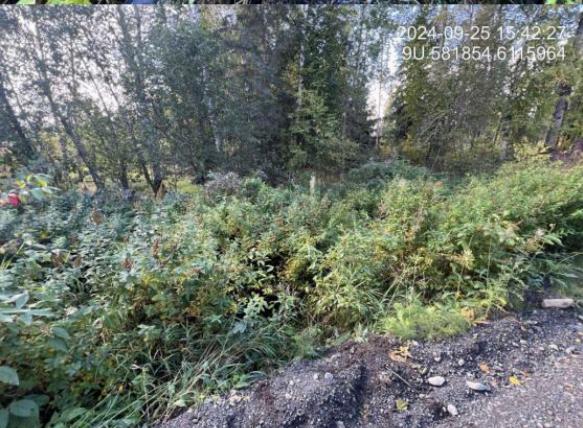
Photos: PSCIS ID 8300015. From top left clockwise: Road/Site Card, Barrel, Outlet, Downstream, Upstream, Inlet.

This is a newer PVC pipe with a beaver grate on the inlet. Debris clogging about 20 cm of the inlet has caused water to back up upstream of the crossing. Downstream, the drainage is very small, with a fence located approximately 10 m away. Cutthroat trout and Dolly Varden are known to inhabit the lake upstream. MoTi chris_culvert_id: 1524661

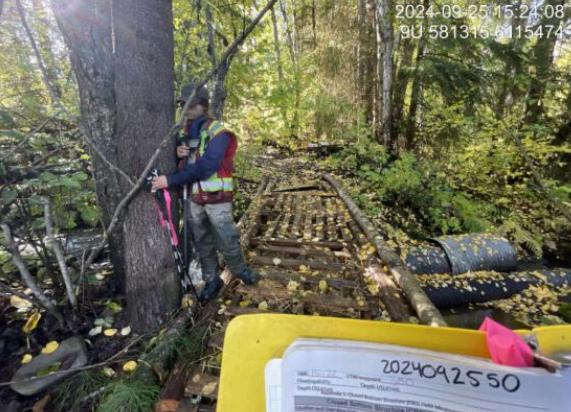
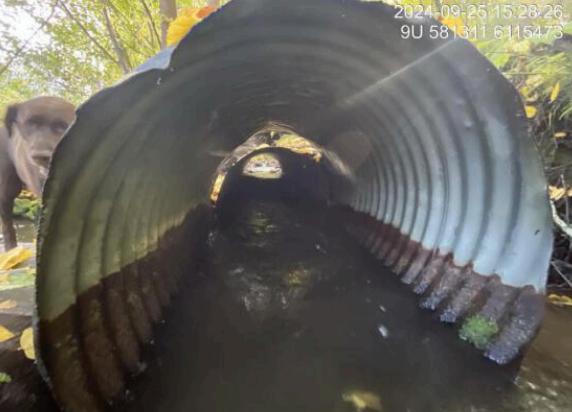
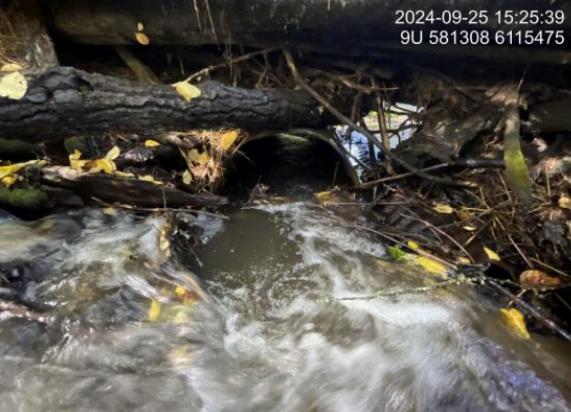
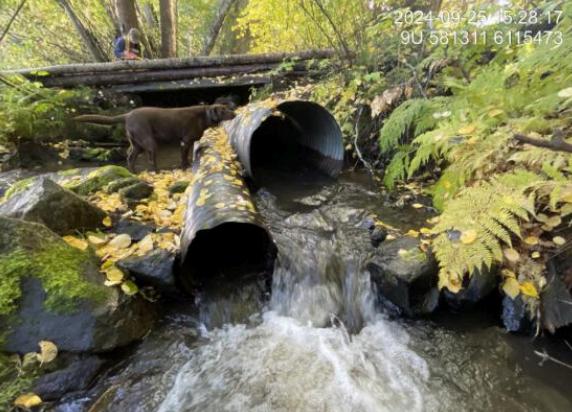
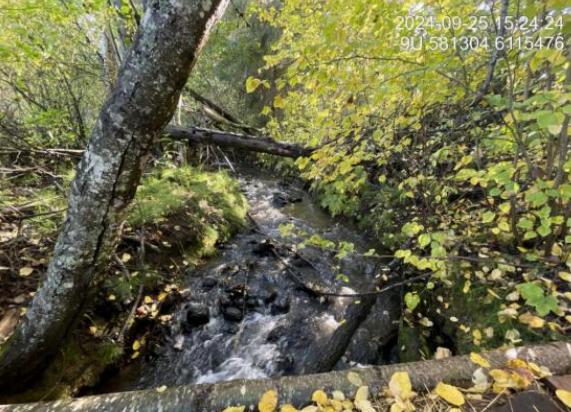
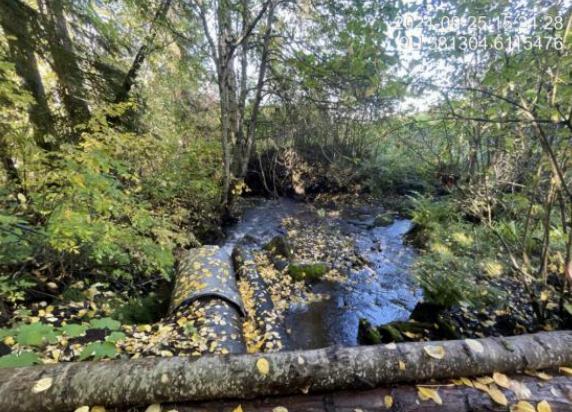
Photos: PSCIS ID 2024092550. From top left clockwise: Road/Site Card, Barrel, Outlet, Downstream, Upstream, Inlet.

Comments: The landowner has constructed a bridge over the stream with two culverts, measuring 0.47 m and 0.9 m in diameter. Some flow passes through the culverts while some bypasses them, though it is unclear if fish can navigate the bypassing flow. The bridge appears to provide access to adjacent agricultural fields. High-quality habitat with numerous pools and abundant gravel is present, but strong currents in the culverts due to significant flow likely inhibit fish passage.

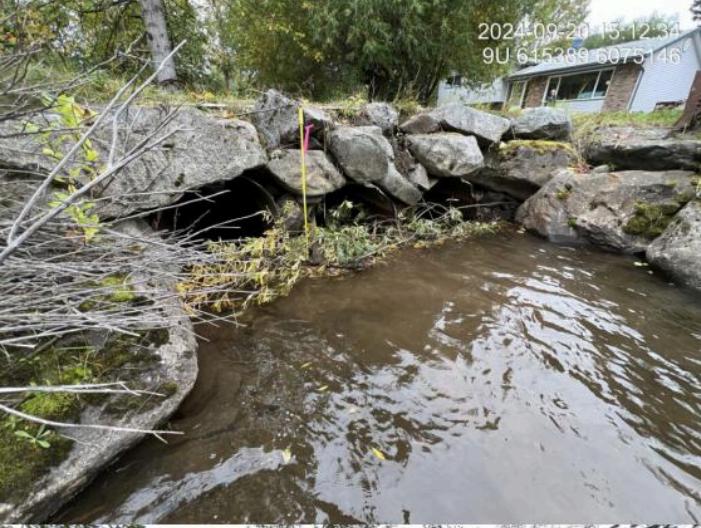
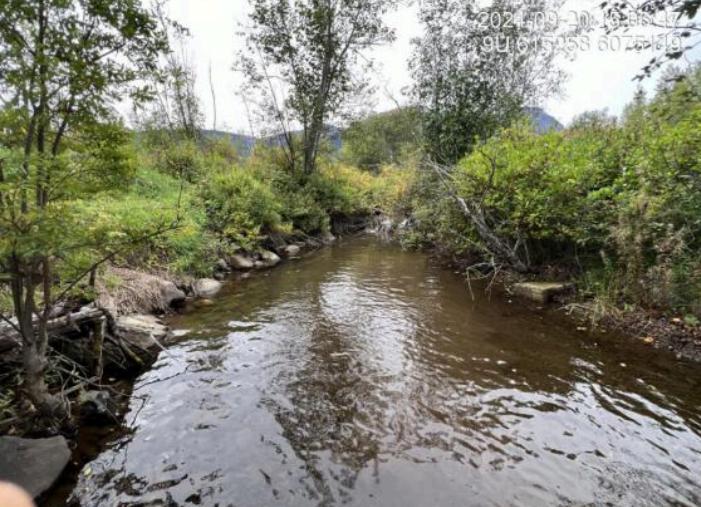
Photos: PSCIS ID 2024092003. From top left clockwise: Road/Site Card, Barrel, Outlet, Downstream, Upstream, Inlet.

Three 0.95 m pipes run under a private driveway. The pipe lengths and gradients are estimated, with two pipes appearing fully embedded and one slightly elevated by approximately 30 cm. The stream is channelized with large boulders throughout the property. Beaver activity is evident, with debris at the inlet and three dams ranging from 0.4 to 1 m high within 150 m upstream. The landowner reported previous blockages caused by beavers, requiring the inlet to be cleared and significant amounts of accumulated material to be dredged out.

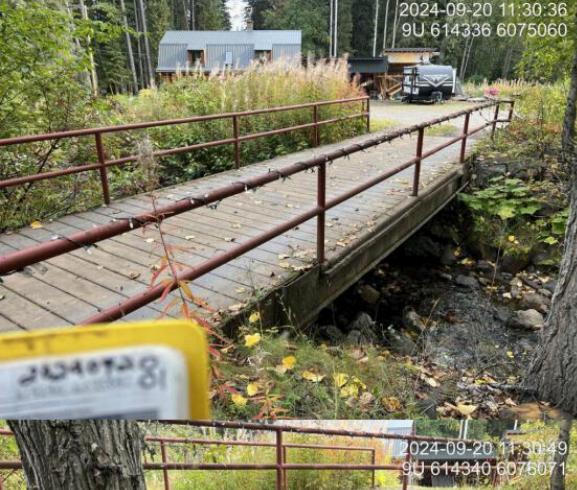
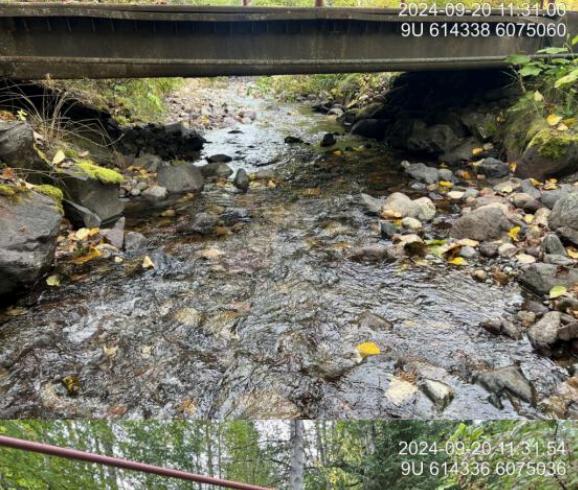
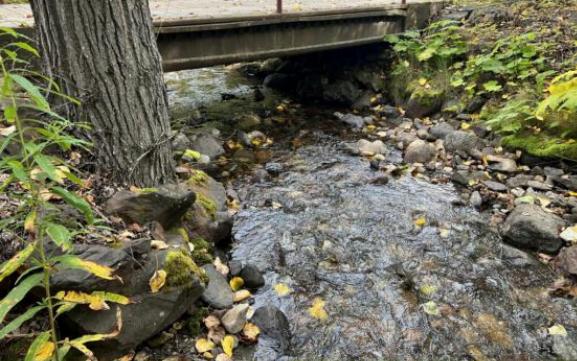
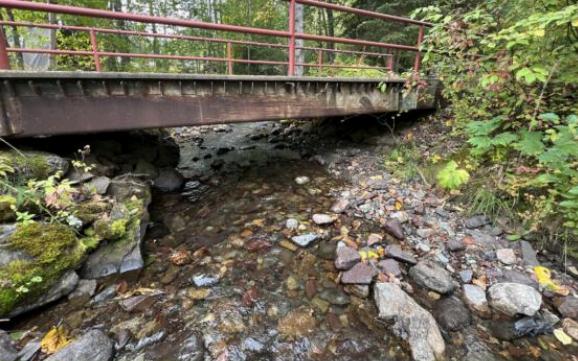
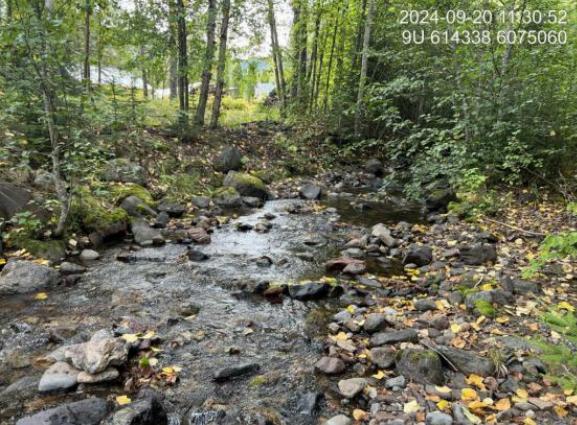
Location and Stream Data	•	Crossing Characteristics	–
Stream	Simpson Creek	Percent Backwatered	–
Road	Private driveway	Fill Depth (m)	–
Road Tenure	Private	Outlet Drop (m)	–
Channel Width (m)	–	Outlet Pool Depth (m)	–
Stream Slope (%)	–	Inlet Drop	–
Beaver Activity	No	Slope (%)	–
Habitat Value	–	Valley Fill	–
Final score	0	Barrier Result	Passable
Fix type	–	Fix Span / Diameter	–
Comments: Steel bridge, potentially for pedestrian or ATV use only, located on a private road on private land.			
Photos: PSCIS ID 2024092001. From top left clockwise: Road/Site Card, Barrel, Outlet, Downstream, Upstream, Inlet.

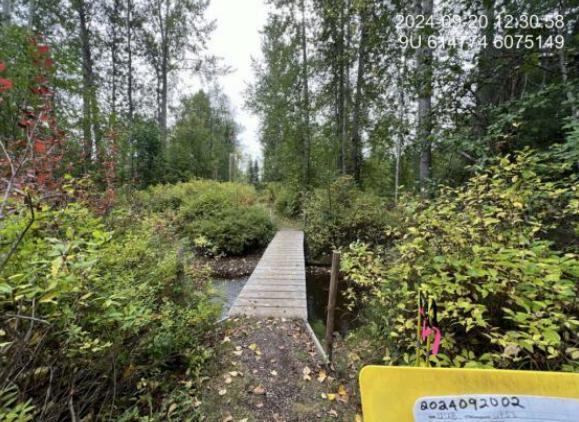
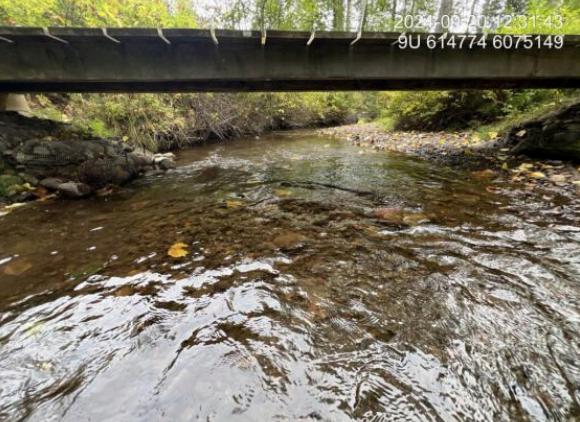
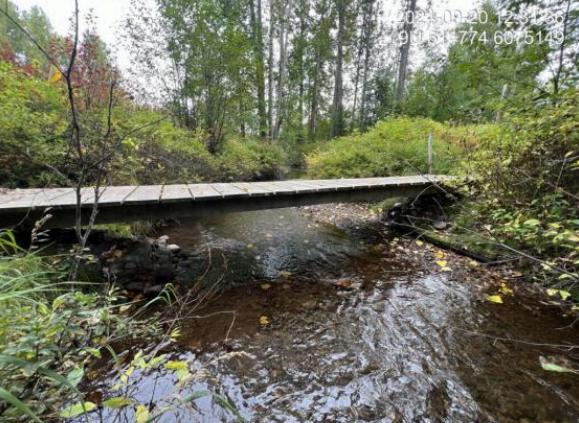
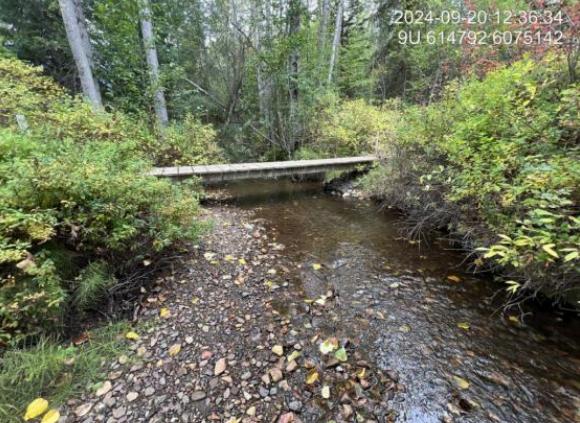
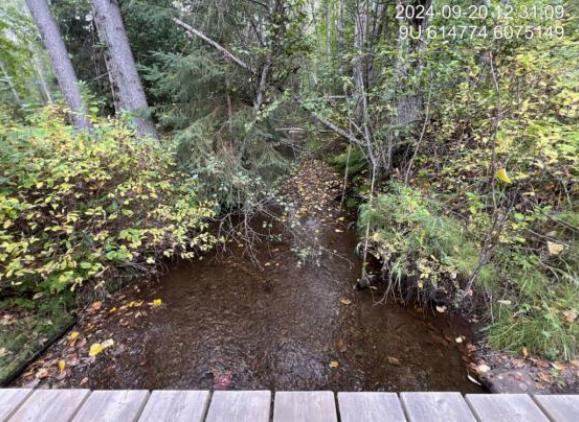
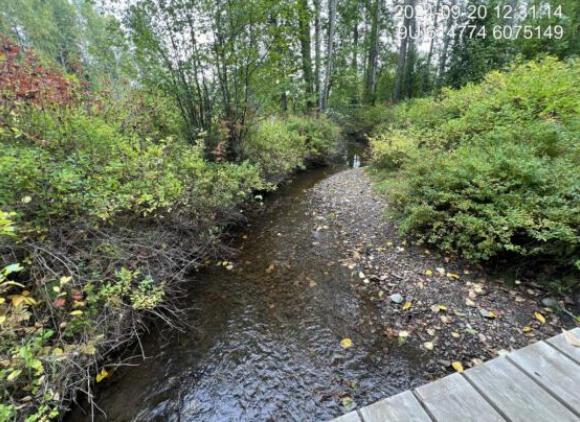
Location and Stream Data		•	Crossing Characteristics	–
Date	2024-09-20	Crossing Sub Type	Bridge	
PSCIS ID	203128	Diameter (m)	7.4	
External ID	2024092002	Length (m)	1	
Crew	AI	Embedded	–	
UTM Zone	9	Depth Embedded (m)	–	
Easting	614775	Resemble Channel	–	
Northing	6075153	Backwatered	–	
Stream	Simpson Creek	Percent Backwatered	–	
Road	Whalen Road	Fill Depth (m)	–	
Road Tenure	MoTi	Outlet Drop (m)	–	
Channel Width (m)	–	Outlet Pool Depth (m)	–	
Stream Slope (%)	–	Inlet Drop	–	
Beaver Activity	No	Slope (%)	–	
Habitat Value	–	Valley Fill	–	
Final score	0	Barrier Result	Passable	
Fix type	–	Fix Span / Diameter	–	
Comments: Small wooden foot bridge linking private property on Whalen Road right of way.				
Photos: PSCIS ID 2024092002. From top left clockwise: Road/Site Card, Barrel, Outlet, Downstream, Upstream, Inlet.

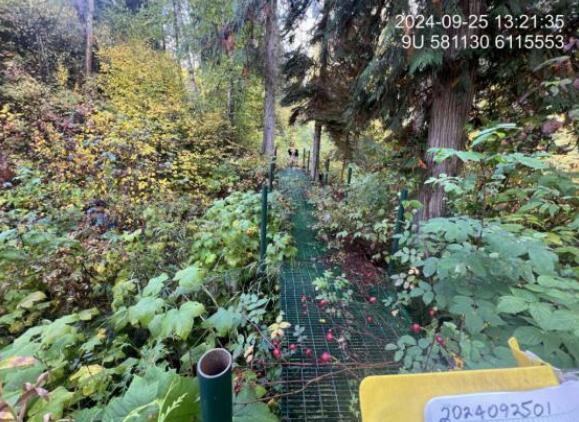
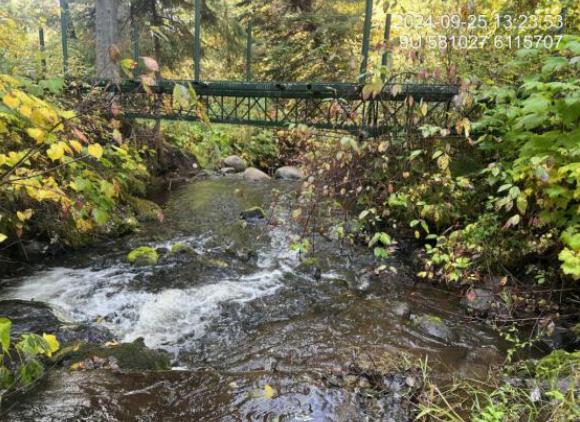
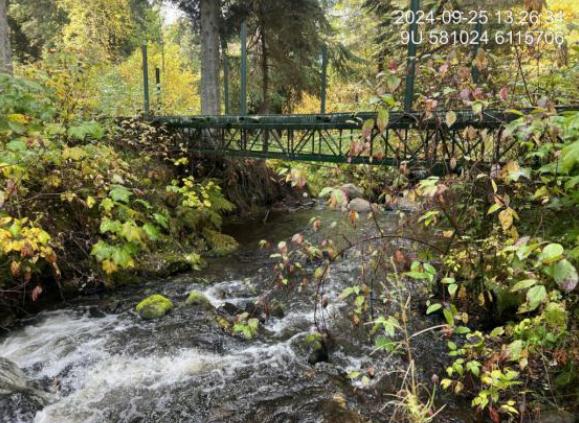
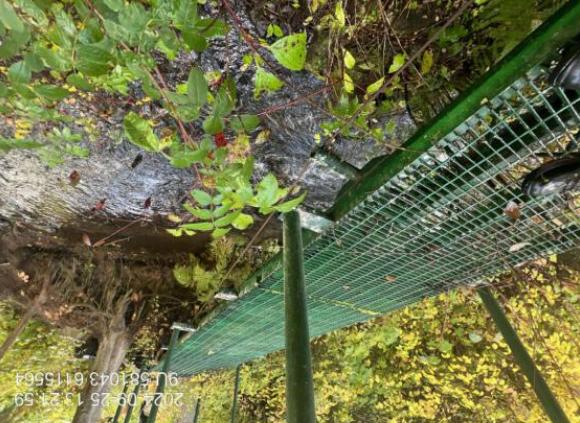
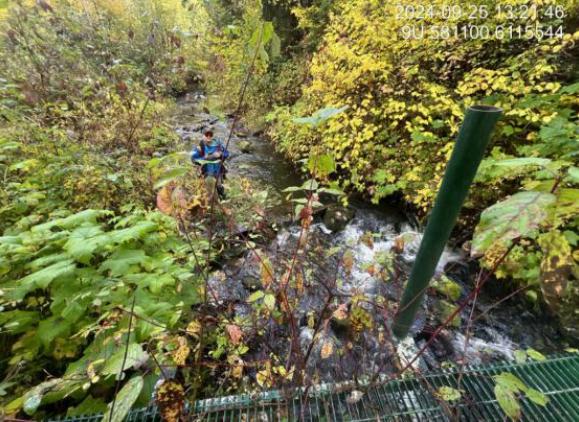
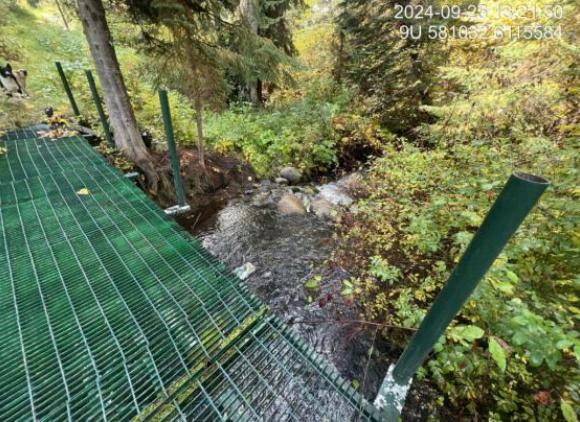
Location and Stream Data		•	Crossing Characteristics	–
Date	2024-09-25	Crossing Sub Type	Bridge	
PSCIS ID	203129	Diameter (m)	13	
External ID	2024092501	Length (m)	2	
Crew	AI JO	Embedded	–	
UTM Zone	9	Depth Embedded (m)	–	
Easting	581028	Resemble Channel	–	
Northing	6115707	Backwatered	–	
Stream	Gershwin Creek	Percent Backwatered	–	
Road	Private	Fill Depth (m)	–	
Road Tenure	Private	Outlet Drop (m)	–	
Channel Width (m)	–	Outlet Pool Depth (m)	–	
Stream Slope (%)	–	Inlet Drop	–	
Beaver Activity	No	Slope (%)	–	
Habitat Value	–	Valley Fill	–	
Final score	0	Barrier Result	Passable	
Fix type	–	Fix Span / Diameter	–	
Comments:				
Steel structure suitable for foot traffic or ATV use, located on private land.				
Photos: PSCIS ID 2024092501. From top left clockwise: Road/Site Card, Barrel, Outlet, Downstream, Upstream, Inlet.
