Appendix - Phase 1 Fish Passage Assessment Data and Photos

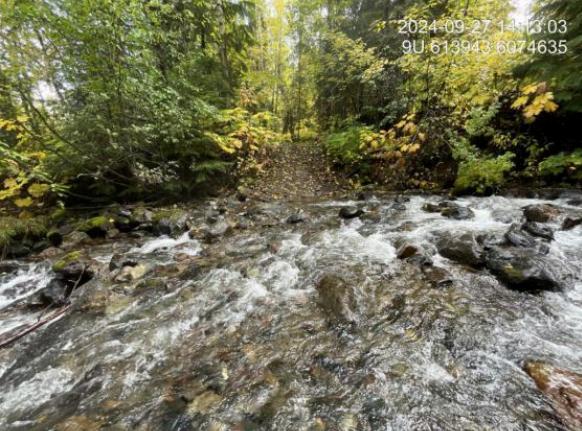
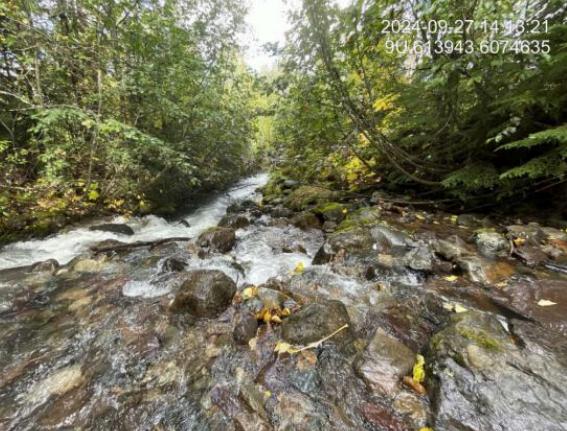
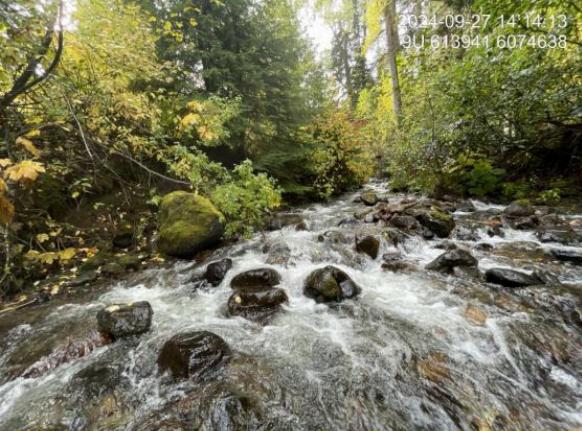
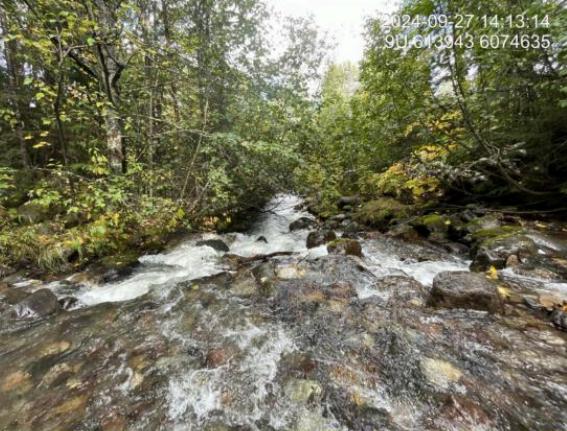
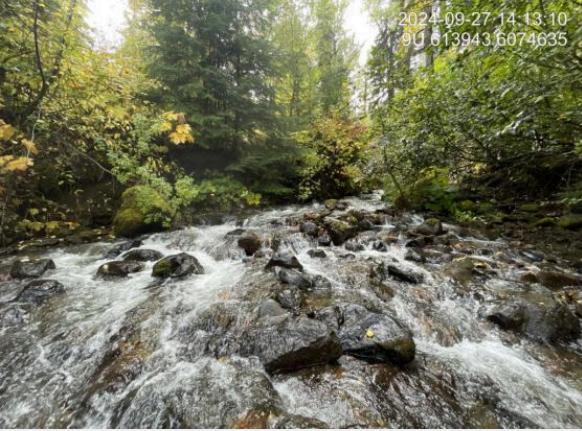
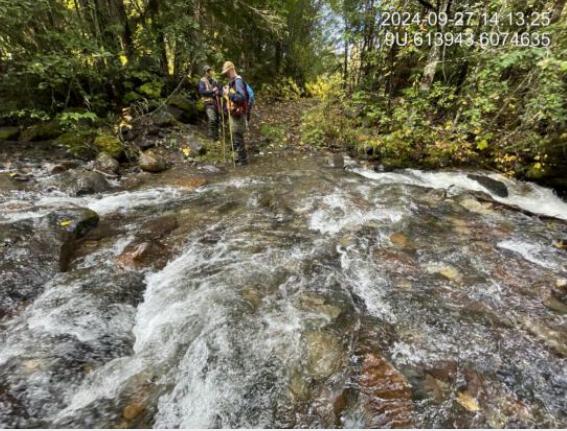
Location and Stream Data		•	Crossing Characteristics	–
Date	2024-09-27	Crossing Sub Type	Ford	
PSCIS ID	203130	Diameter (m)	9	
External ID	2024092751	Length (m)	3	
Crew	LS AI	Embedded	–	
UTM Zone	9	Depth Embedded (m)	–	
Easting	613951	Resemble Channel	–	
Northing	6074629	Backwatered	–	
Stream	Simpson Creek	Percent Backwatered	–	
Road	Transmission line road	Fill Depth (m)	–	
Road Tenure	–	Outlet Drop (m)	–	
Channel Width (m)	–	Outlet Pool Depth (m)	–	
Stream Slope (%)	–	Inlet Drop	–	
Beaver Activity	No	Slope (%)	–	
Habitat Value	–	Valley Fill	–	
Final score	0	Barrier Result	Passable	
Fix type	–	Fix Span / Diameter	–	
Comments: Ford across transmission line road which parallels the transmission lines. Fully passable.				
Photos: PSCIS ID 2024092751. From top left clockwise: Road/Site Card, Barrel, Outlet, Downstream, Upstream, Inlet.
