Skeena Watershed Fish Passage Restoration Planning 2024

Prepared for
Habitat Conservation Trust Foundation - CAT23-6-288
BC Fish Passage Remediation Program
Ministry of Transportation and Infrastructure

Prepared by
Al Irvine, B.Sc., R.P.Bio and Lucy Schick, B.Sc.
New Graph Environment Ltd.
on behalf of
Society for Ecosystem Restoration in Northern British Columbia

Version 0.0.1 2025-03-28

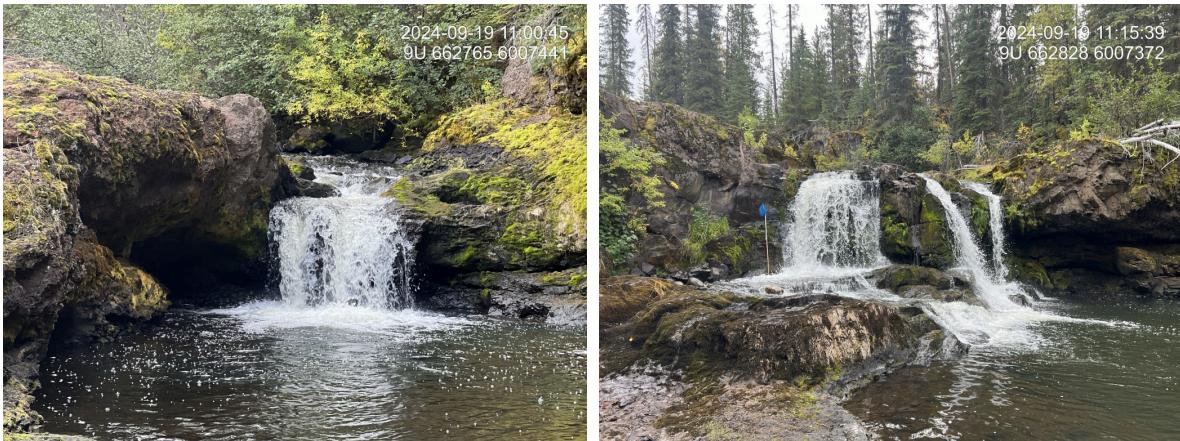
Figure 4.2: Left: Buck Falls – The third step consisted of a ~1.5 m vertical drop with an overlying cascade, exhibiting a ~15% gradient over a 1.0m height. Right: Buck Falls – An additional cascade featured a ~2m high drop with a ~30% gradient extending over a 5 m length. A 2m tall net is included for scale.

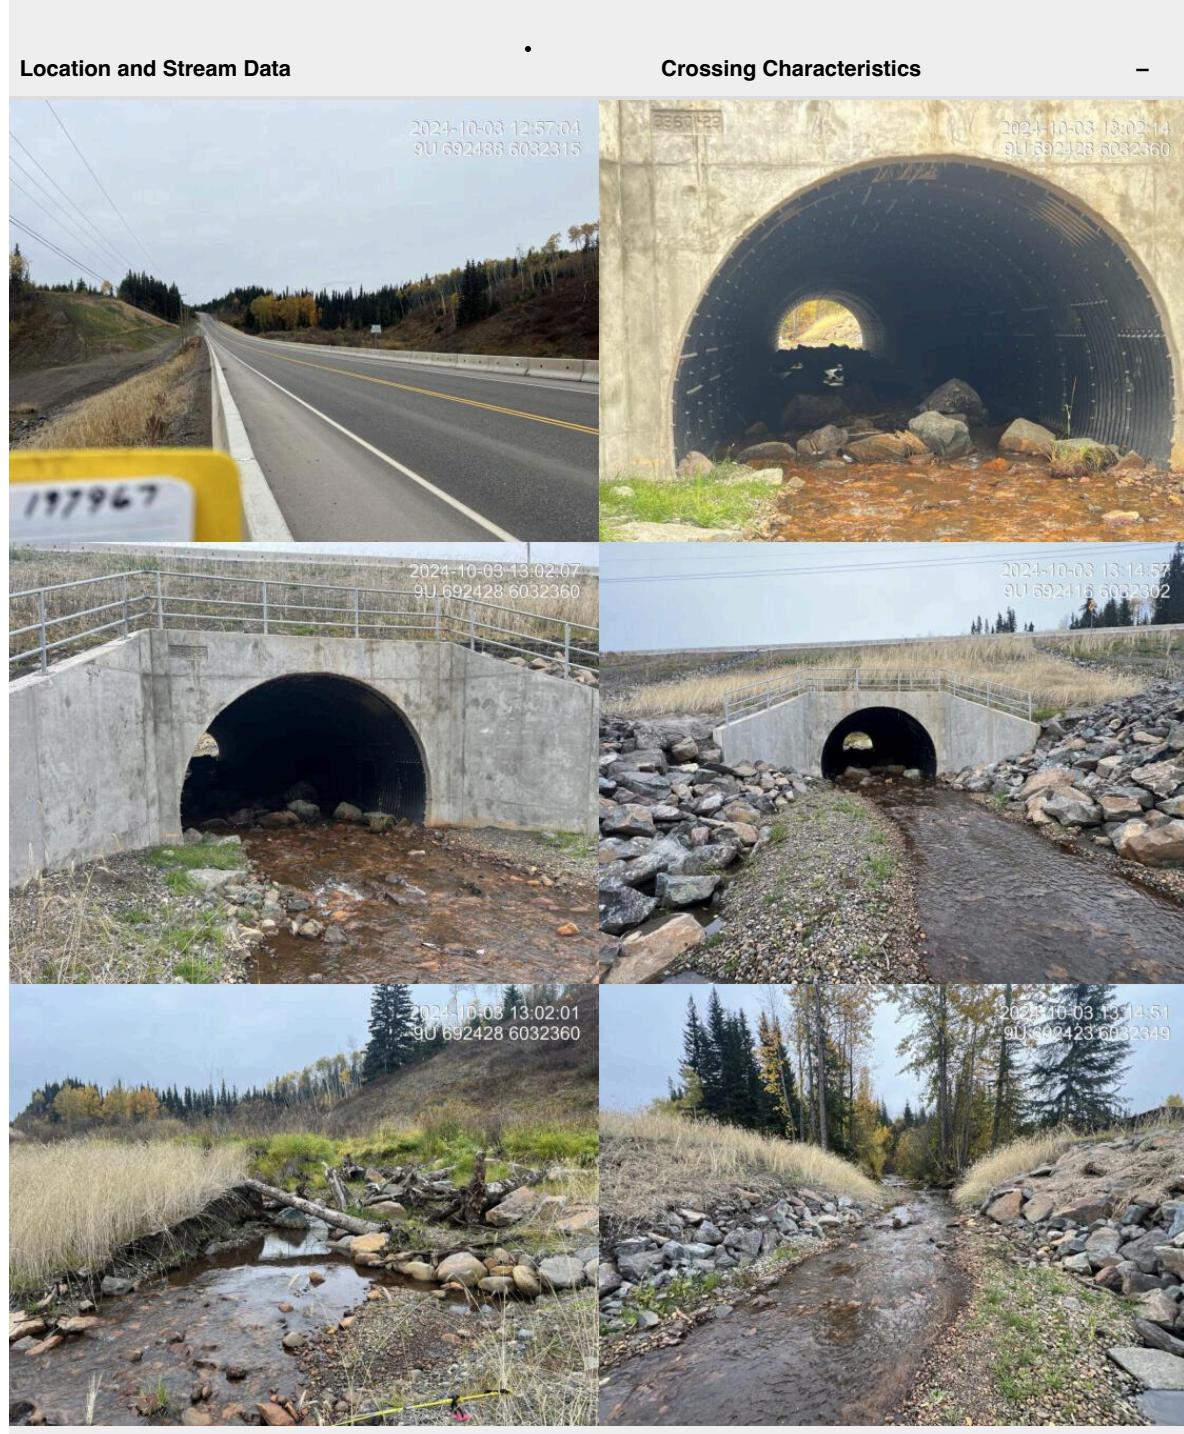
Location and Stream Data		Crossing Characteristics	
Date	2024-10-03	Crossing Sub Type	Round Culvert
PSCIS ID	197967	Diameter (m)	5.6
External ID	–	Length (m)	40
Crew	AI	Embedded	Yes
UTM Zone	9	Depth Embedded (m)	2
Easting	692426	Resemble Channel	Yes
Northing	6032341	Backwatered	No
Stream	Taman Creek	Percent Backwatered	–
Road	Highway 16	Fill Depth (m)	7
Road Tenure	MoTi	Outlet Drop (m)	0
Channel Width (m)	5.5	Outlet Pool Depth (m)	0
Stream Slope (%)	2	Inlet Drop	No
Beaver Activity	Yes	Slope (%)	3
Habitat Value	Medium	Valley Fill	Deep Fill
Final score	16	Barrier Result	Potential
Fix type	Replace with New Open Bottom Structure	Fix Span / Diameter	27
Comments:			
This is a brand-new replacement structure, extremely well built with extensive embedment that includes numerous large boulders, cobbles, and gravel. The multiplate round structure is embedded nearly 2 m. Upstream, woody debris and boulder structures are cabled together for added stability. This massive construction project involved a substantial amount of fill extending 60 m downstream and over 200 m upstream. The site now offers migration conditions for fish that are equal to or better than previous conditions. MoTi chris_culvert_id: 2076452

Photos: From top left clockwise: Road/Site Card, Barrel, Outlet, Downstream, Upstream, Inlet.

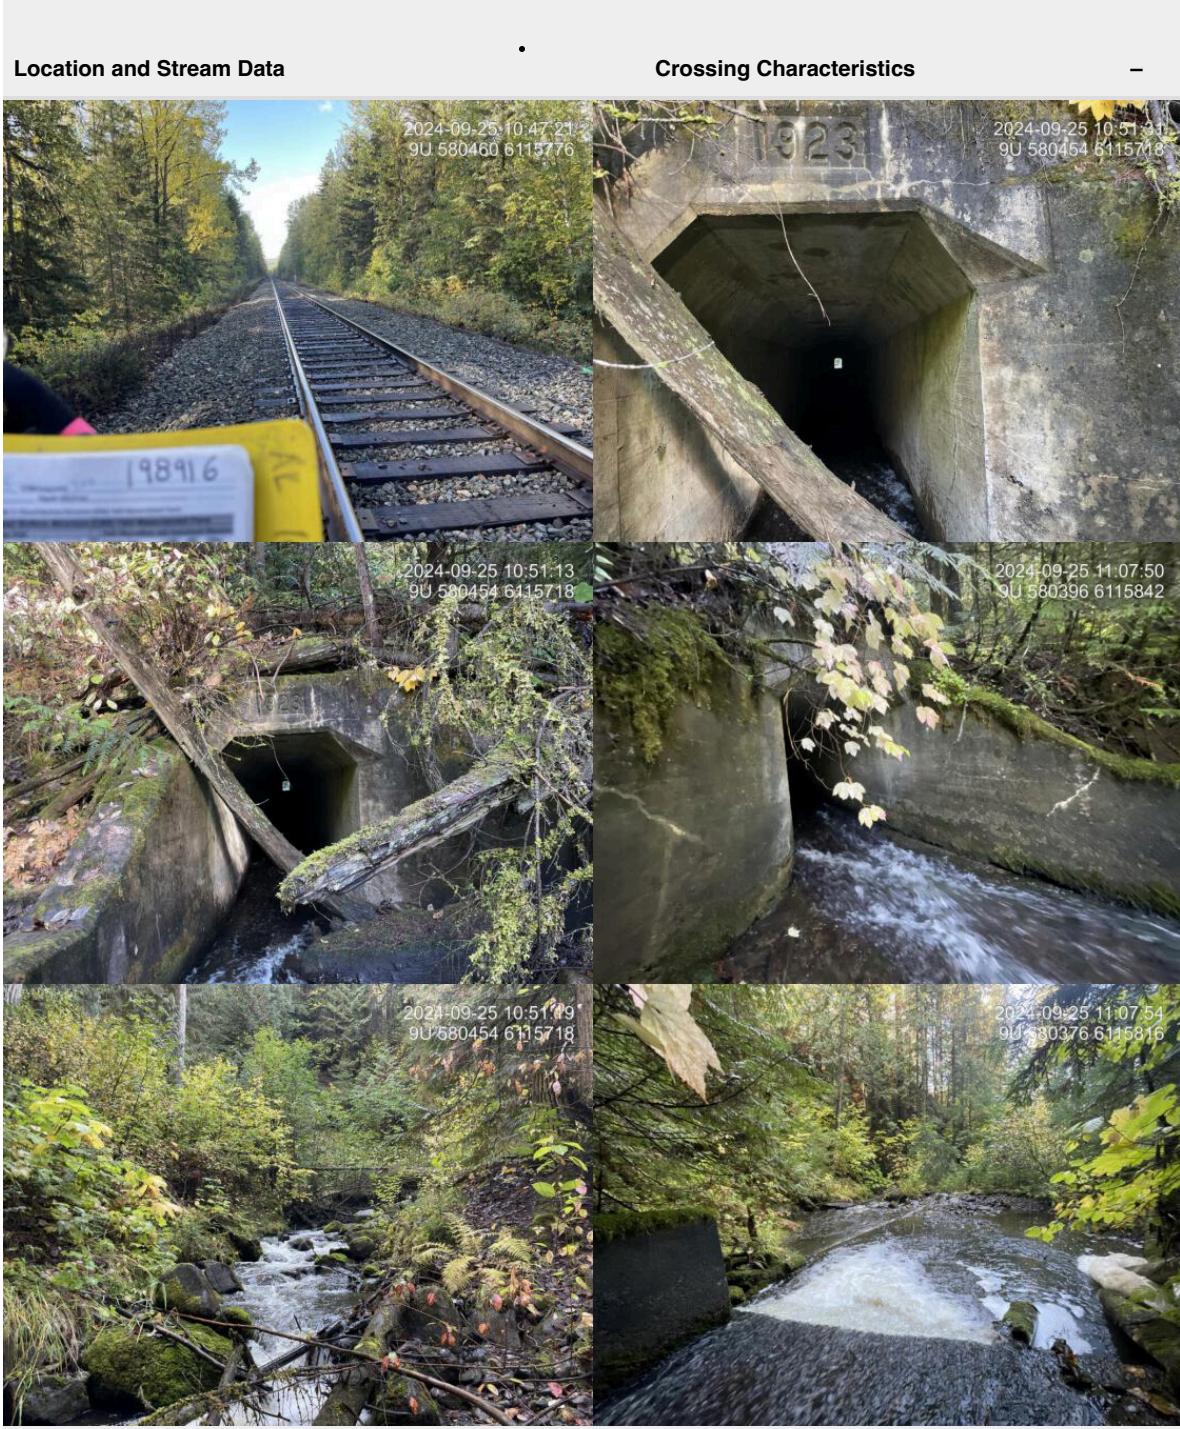
Location and Stream Data		Crossing Characteristics	
Date	2024-09-25	Crossing Sub Type	Round Culvert
PSCIS ID	198913	Diameter (m)	1.5
External ID	-	Length (m)	40
Crew	AI JO	Embedded	No
UTM Zone	9	Depth Embedded (m)	-
Easting	581250	Resemble Channel	-
Northing	6115660	Backwatered	No
Stream	Gershwin Creek	Percent Backwatered	-
Road	Highway 16	Fill Depth (m)	2.5
Road Tenure	MOTi	Outlet Drop (m)	0.35
Channel Width (m)	5	Outlet Pool Depth (m)	0.85
Stream Slope (%)	3	Inlet Drop	No
Beaver Activity	No	Slope (%)	3
Habitat Value	Medium	Valley Fill	Deep Fill
Final score	42	Barrier Result	Barrier
Fix type	Replace with New Open Bottom Structure	Fix Span / Diameter	15

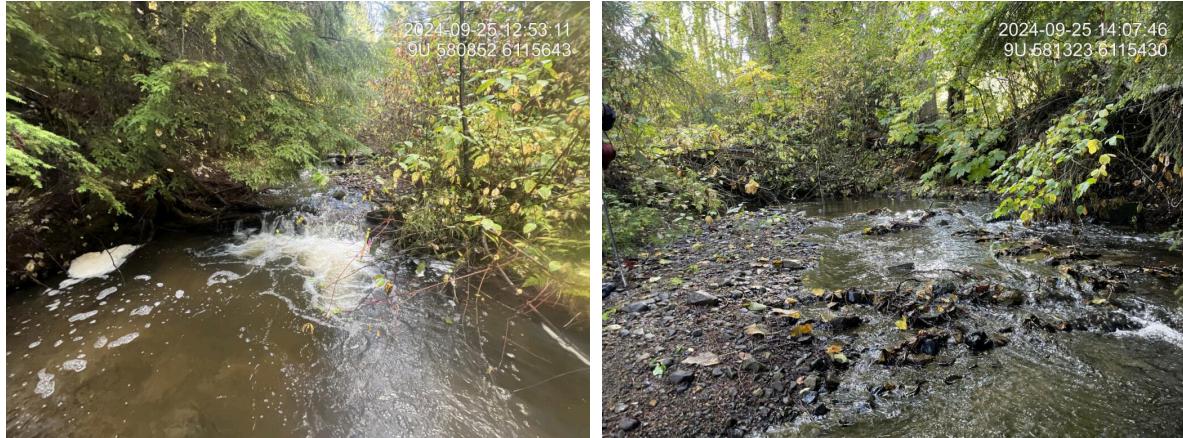
Figure 4.10: Left: Typical habitat downstream of PSCIS crossing 198913. Right: Typical habitat upstream of PSCIS crossing 198913.

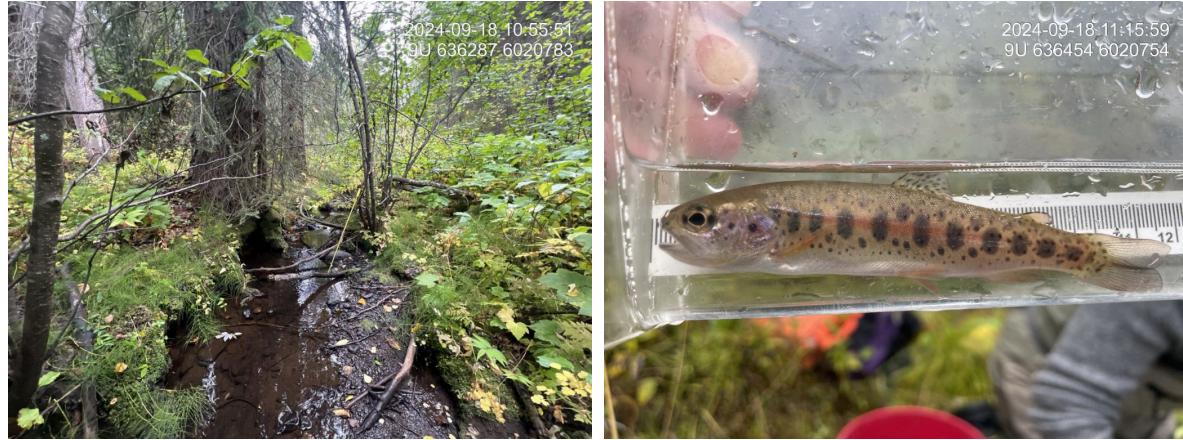
Figure 4.15: Left: Typical habitat upstream of PSCIS crossing 198935. Right: Rainbow trout captured downstream of crossing 198935.

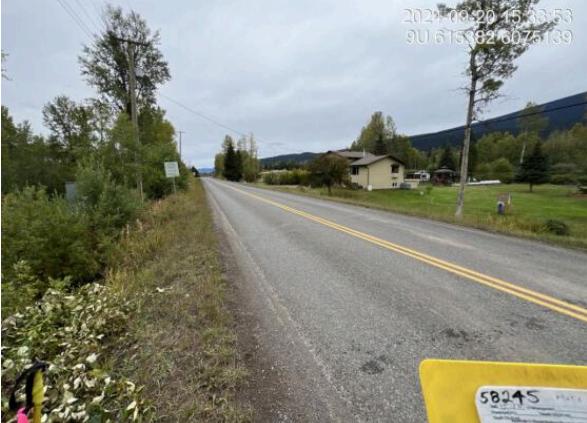
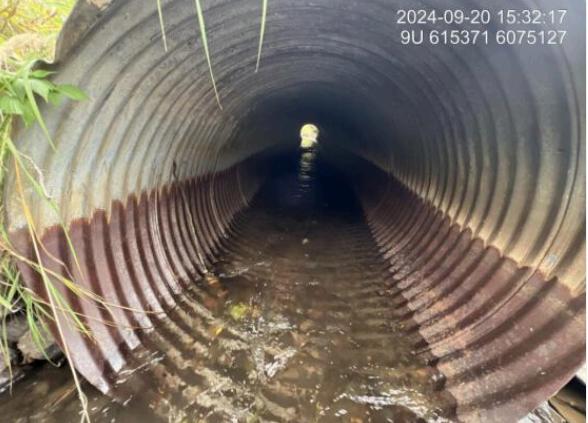
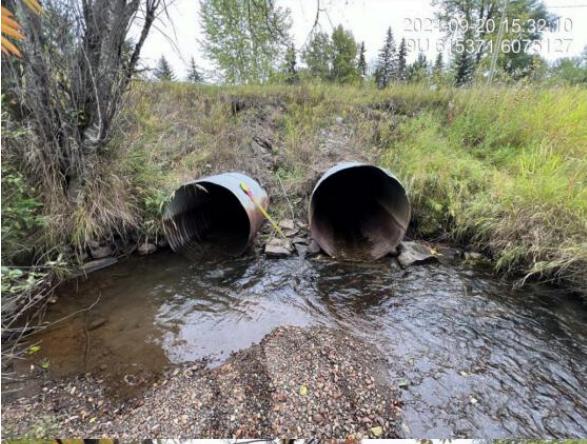
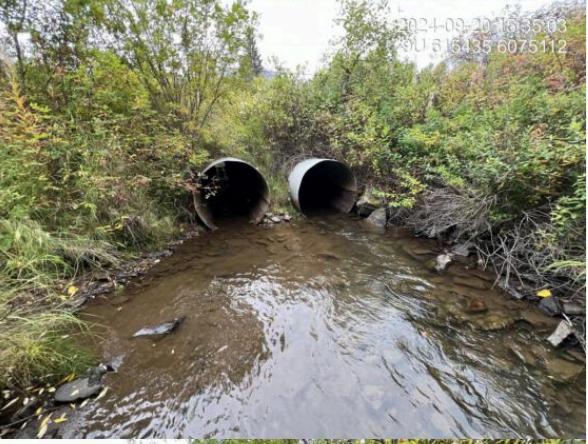
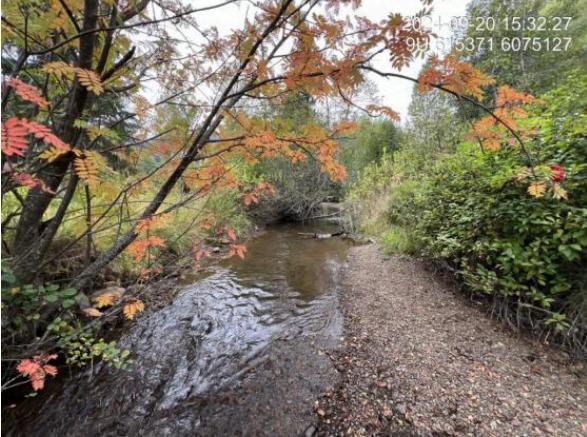
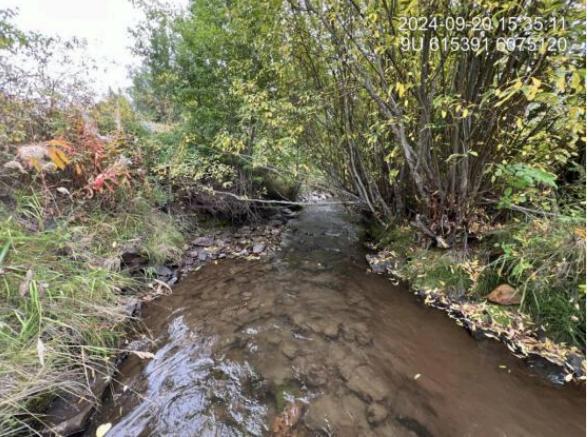
Location and Stream Data	Crossing Characteristics
Comments: Two 1.25 m pipes are present and are heavily corroded. Upstream and downstream, the streambanks are heavily modified adjacent to private land, including riparian vegetation removal, stream channelization, and bank armouring. High-value steelhead, coho, and chinook spawning habitat is documented further upstream above the railway crossing. MoTi chris_culvert_id: 1514706, 1514705	-
Photos: From top left clockwise: Road/Site Card, Barrel, Outlet, Downstream, Upstream, Inlet.	-

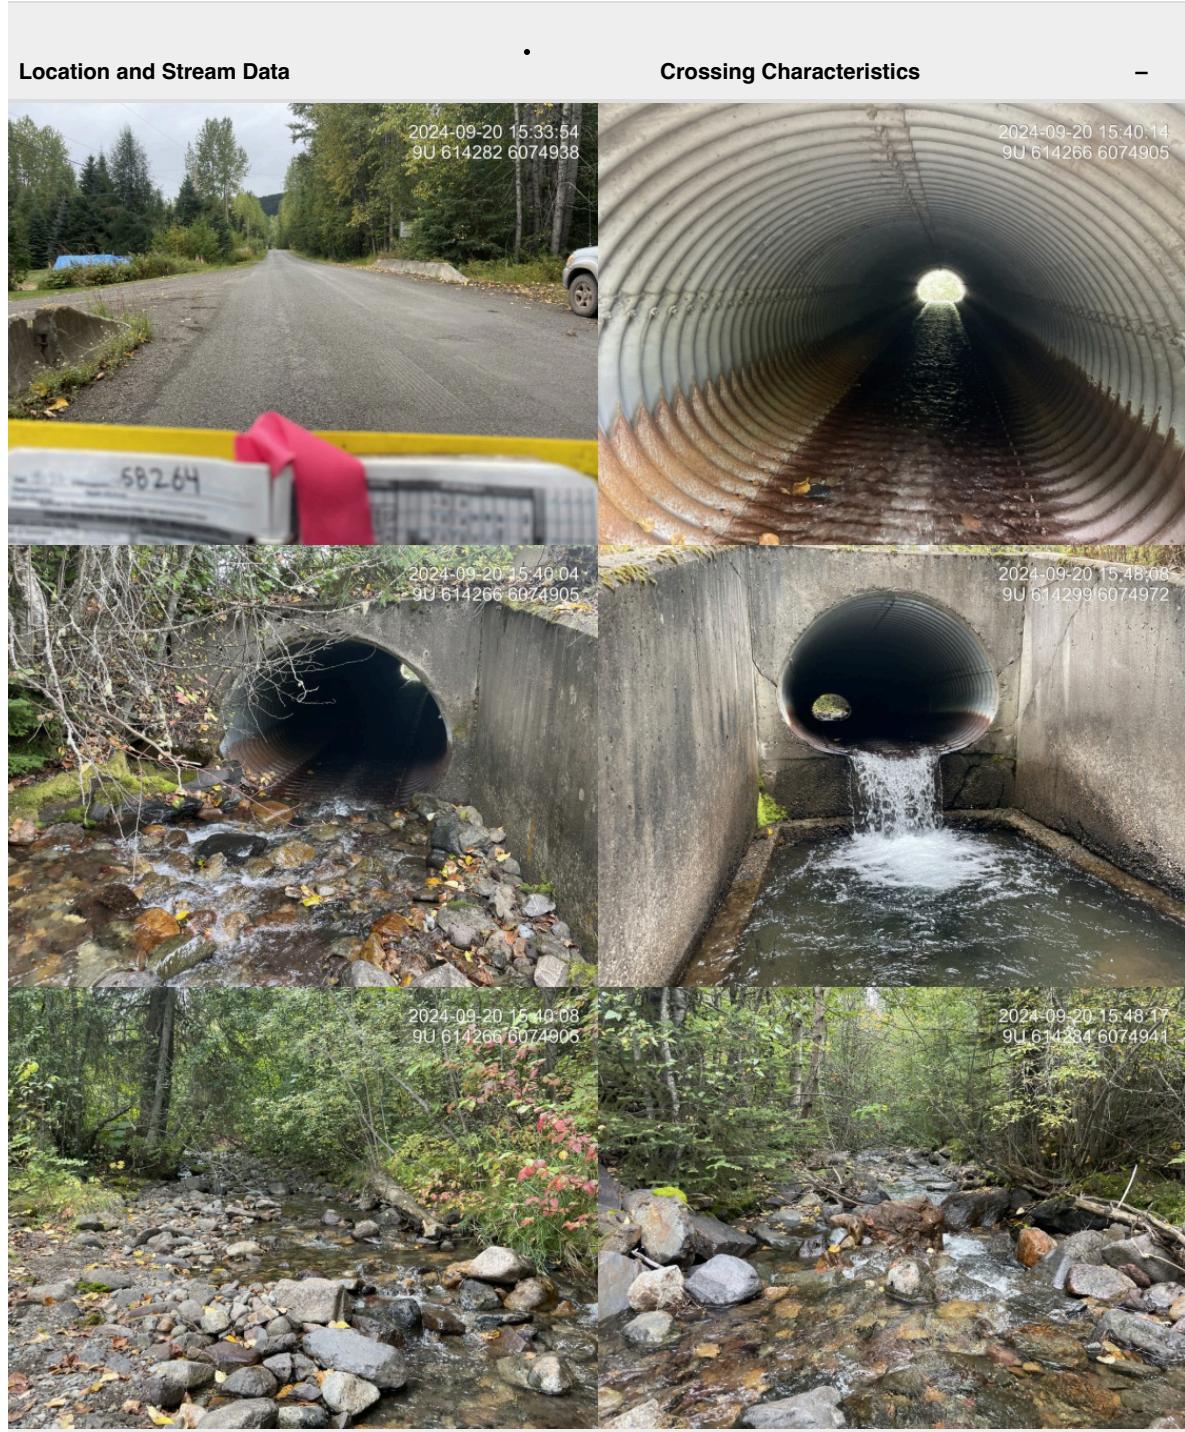
Photos: From top left clockwise: Road/Site Card, Barrel, Outlet, Downstream, Upstream, Inlet.

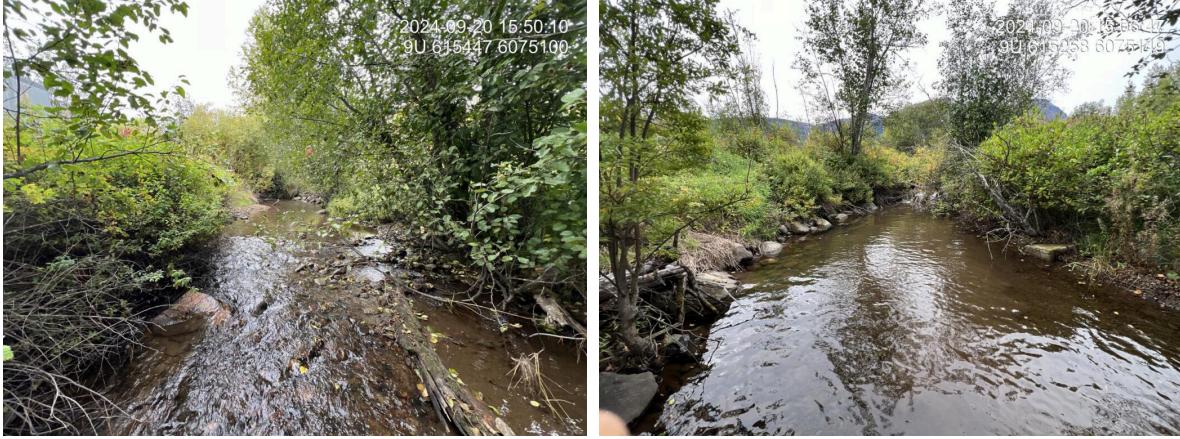
Figure 4.17: Left: Typical habitat downstream of PSCIS crossing 58245. Right: Typical habitat upstream of PSCIS crossing 58245 and downstream of PSCIS crossing 203122, with signs of bank armouring and channelization.

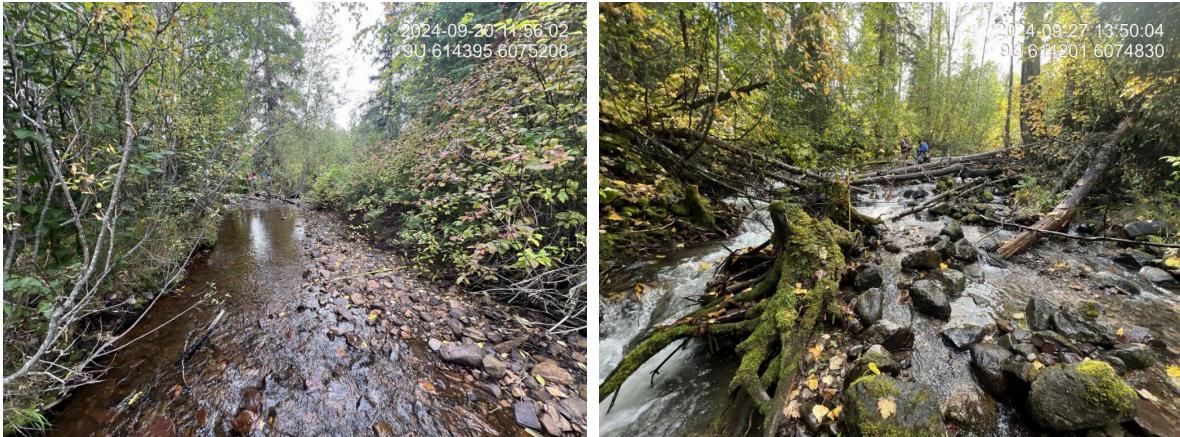
The stream was surveyed upstream from crossing 58264 for 615m . This section of the stream featured a steeper gradient, predominantly characterized by boulder cover with occasional pockets of gravels suitable for coho, steelhead, and Dolly Varden spawning (Figure 4.18). Pools were infrequent throughout. The riparian zone was composed of a healthy, mature mixed forest, providing stability and shading. The upper end of the site was situated just upstream of a short cascade with a 20% gradient. The habitat was rated as medium value for salmonid rearing and spawning. The average channel width was 8.9m, the average wetted width was 4.7m, and the average gradient was 7.3%. The dominant substrate was cobbles with boulders sub-dominant. Total cover amount was rated as moderate with boulders dominant. Cover was also present as large woody debris.

Figure 4.18: Left: Steelhead spawning location upstream of PSCIS crossing 203122 and downstream of PSCIS crossing 58264, as reported by the adjacent landowner. Right: Typical habitat upstream of PSCIS crossing 58264.
