## **Skeena Watershed Fish Passage Restoration Planning 2024**

**Prepared for**  
**Habitat Conservation Trust Foundation - CAT23-6-288**  
**BC Fish Passage Remediation Program**  
**Ministry of Transportation and Infrastructure**

**Prepared by**  
**Al Irvine, B.Sc., R.P.Bio and Lucy Schick, B.Sc.**  
**New Graph Environment Ltd.**  
**on behalf of**  
**Society for Ecosystem Restoration in Northern British Columbia**

DRAFT Version 0.1.1 2025-04-14

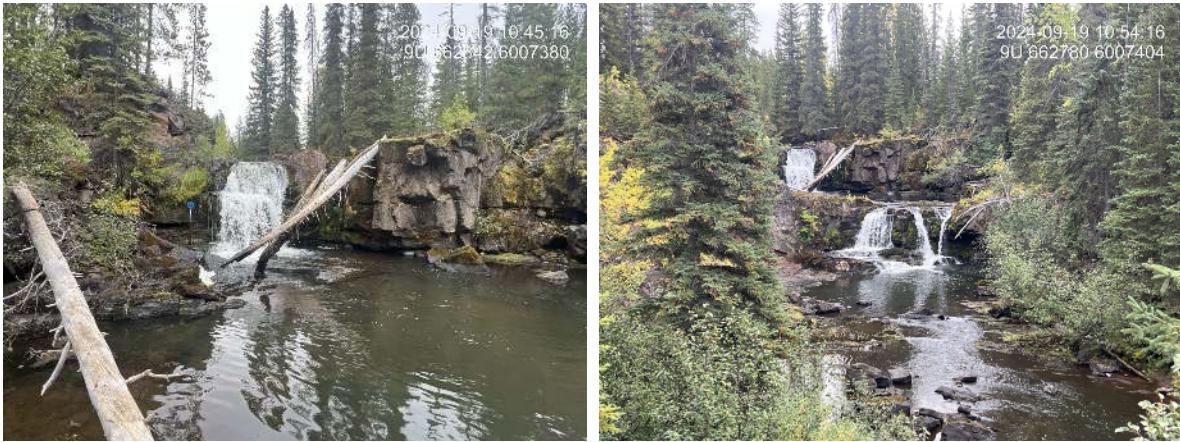
Figure 5.1: Left: Buck Falls – The upper falls featured a ~4m high vertical drop. A 2m tall net is included for scale. Right: Buck Falls – The second falls consisted of a ~3.5m high sheer drop to bedrock.

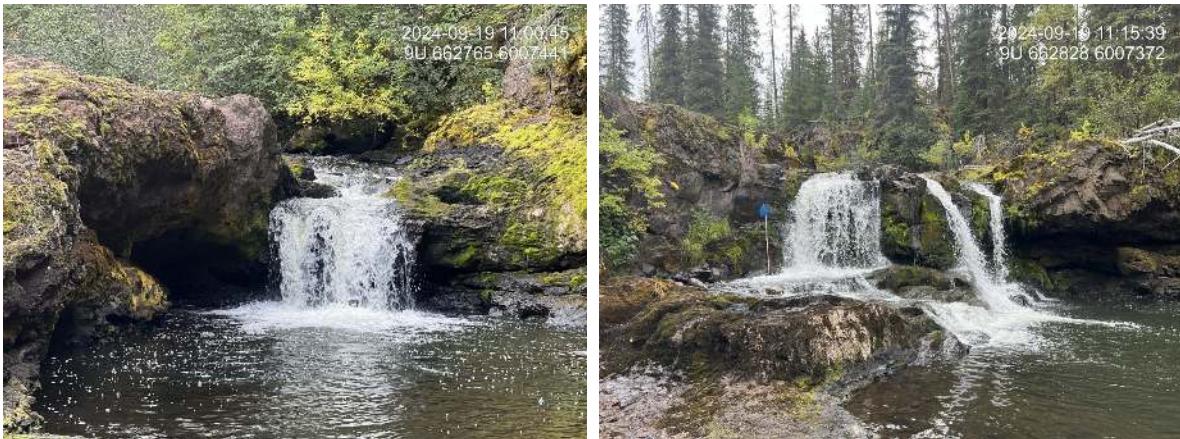
Figure 5.2: Left: Buck Falls – The third step consisted of a ~1.5 m vertical drop with an overlying cascade, exhibiting a ~15% gradient over a 1.0m height. Right: Buck Falls – An additional cascade featured a ~2m high drop with a ~30% gradient extending over a 5 m length. A 2m tall net is included for scale.

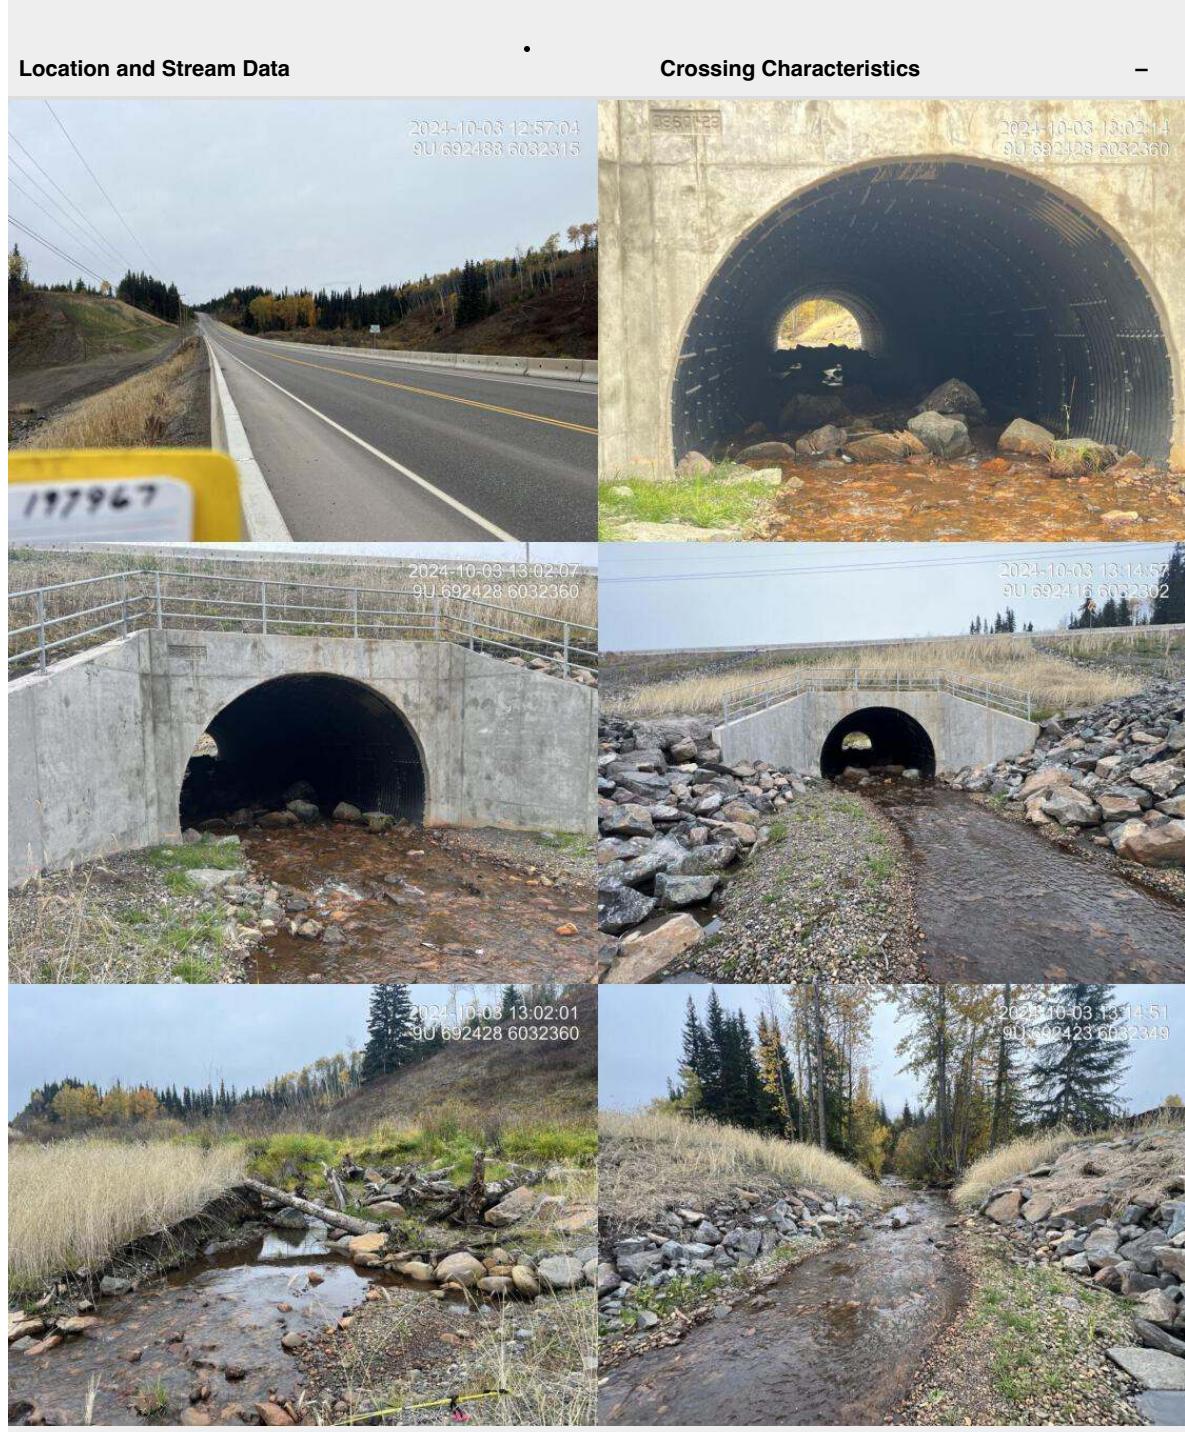
Photos: From top left clockwise: Road/Site Card, Barrel, Outlet, Downstream, Upstream, Inlet.

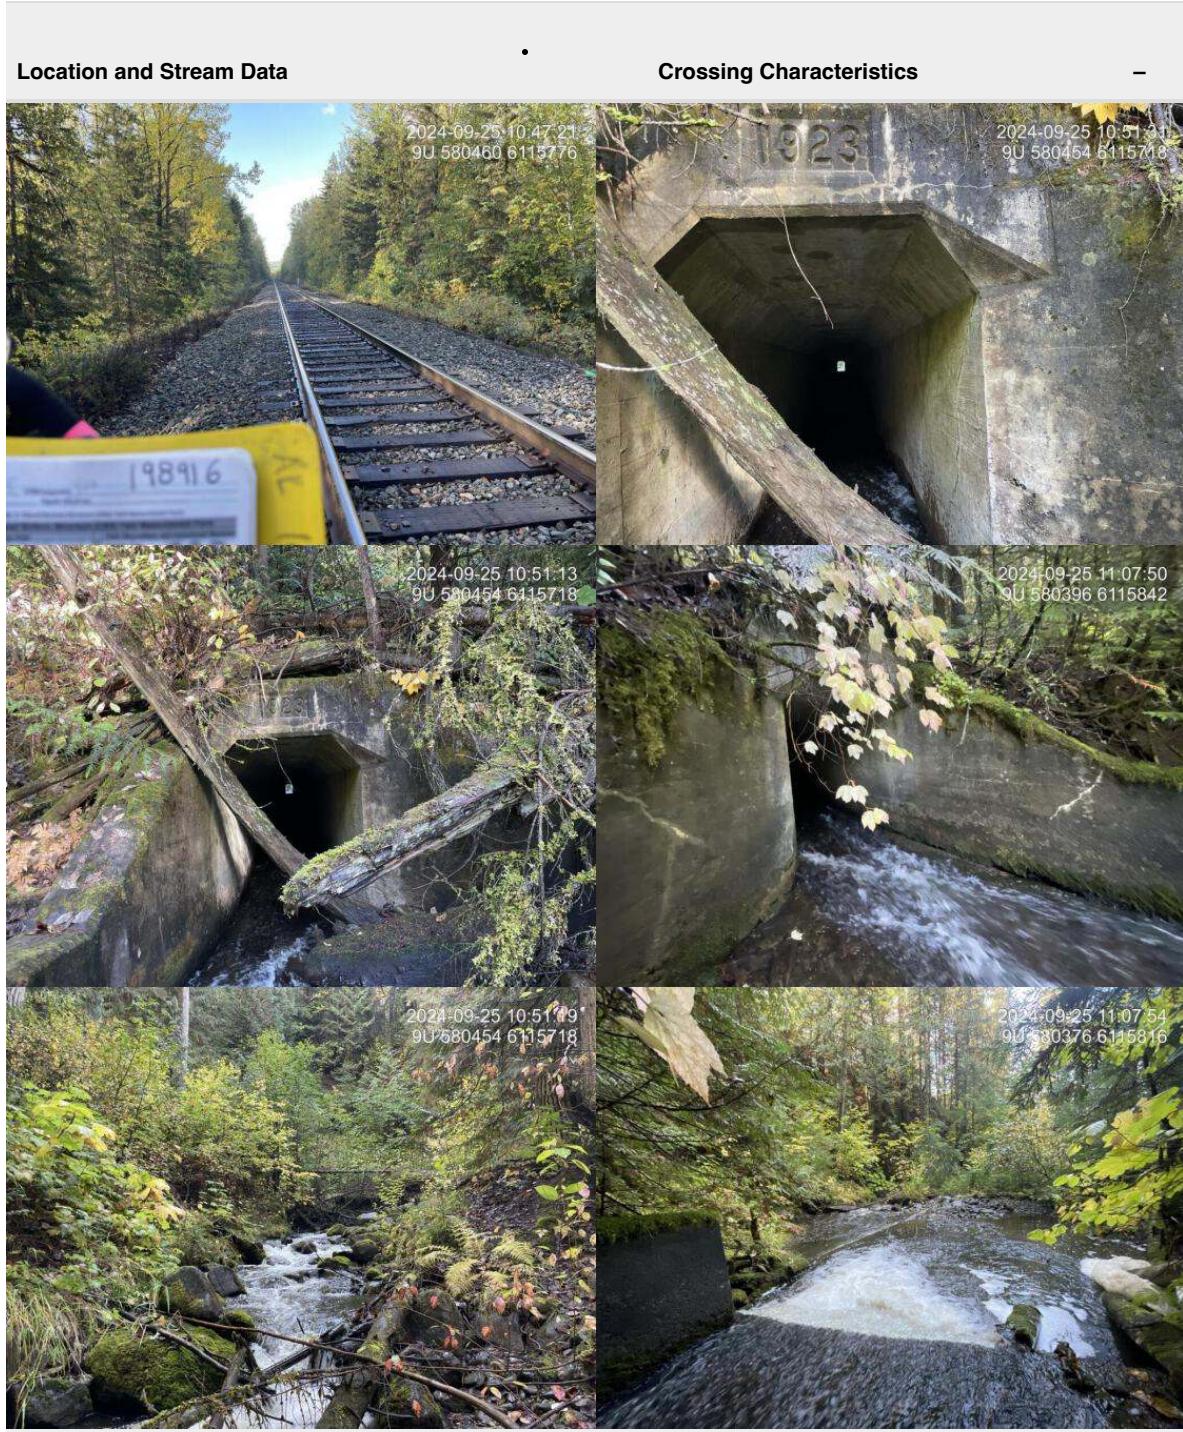
Location and Stream Data		Crossing Characteristics	
Date	2024-09-25	Crossing Sub Type	Round Culvert
PSCIS ID	198913	Diameter (m)	1.5
External ID	-	Length (m)	40
Crew	AI JO	Embedded	No
UTM Zone	9	Depth Embedded (m)	-
Easting	581250	Resemble Channel	-
Northing	6115660	Backwatered	No
Stream	Gershwin Creek	Percent Backwatered	-
Road	Highway 16	Fill Depth (m)	2.5
Road Tenure	MOTi	Outlet Drop (m)	0.35
Channel Width (m)	5	Outlet Pool Depth (m)	0.85
Stream Slope (%)	3	Inlet Drop	No
Beaver Activity	No	Slope (%)	3
Habitat Value	Medium	Valley Fill	Deep Fill
Final score	42	Barrier Result	Barrier
Fix type	Replace with New Open Bottom Structure	Fix Span / Diameter	15

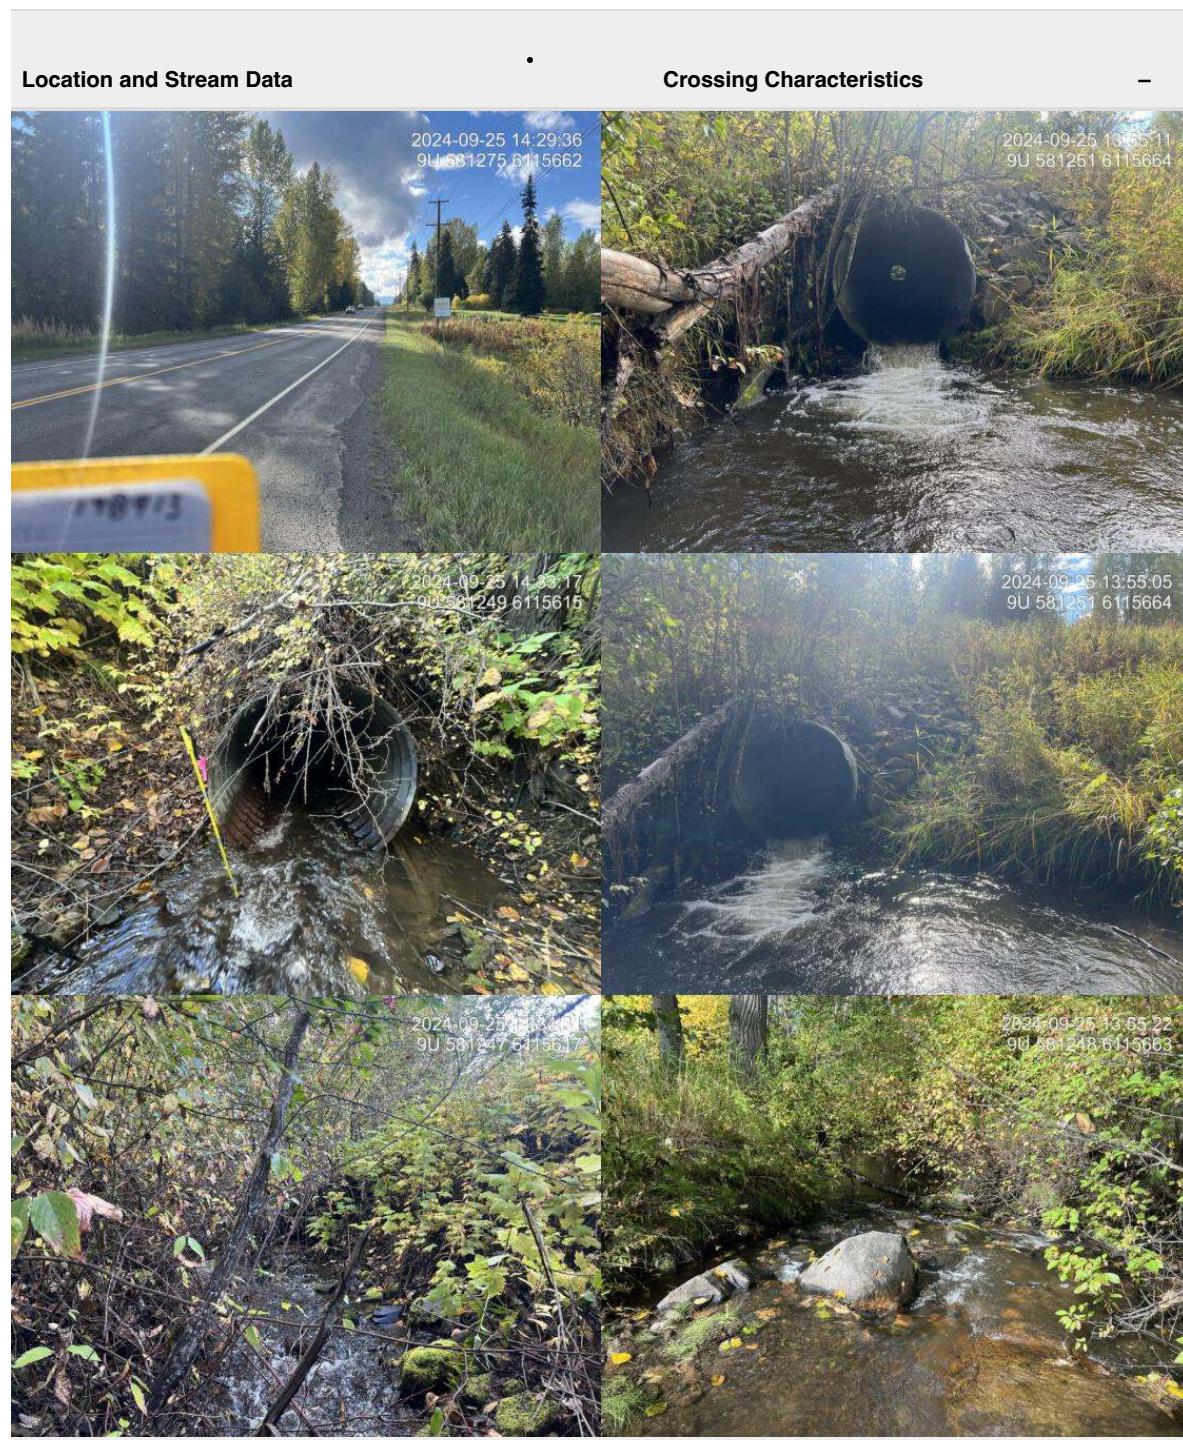
There is a deep outlet pool, suggesting the culvert is undersized for the stream. High-quality gravels were present at the pool's outlet, and upstream of the crossing, there was high-value habitat with frequent overwintering pools, spawning gravels, and adequate riparian cover with large cottonwoods throughout. This site was part of a habitat confirmation assessment, with the stream surveyed from the downstream railway crossing up to this location and an additional 600 m upstream. Downstream, crossing 198916 consists of a large, long box culvert beneath the railway with minimal flow depth and a swift current, making it unlikely that fish from the mainstem of the Skeena River can access this site until the railway barrier is addressed. Fish sampling at this site captured cutthroat trout and Dolly Varden. MoTi chris\_culvert\_id: 8300872

Photos: From top left clockwise: Road/Site Card, Barrel, Outlet, Downstream, Upstream, Inlet.

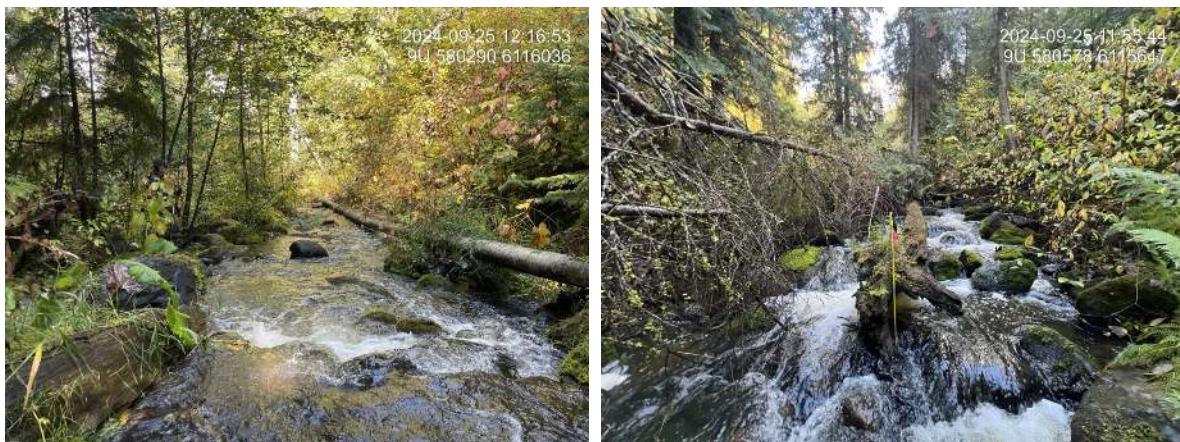
Figure 5.7: Left: Typical habitat downstream of PSCIS crossing 198916. Right: Typical habitat upstream of PSCIS crossing 198916.

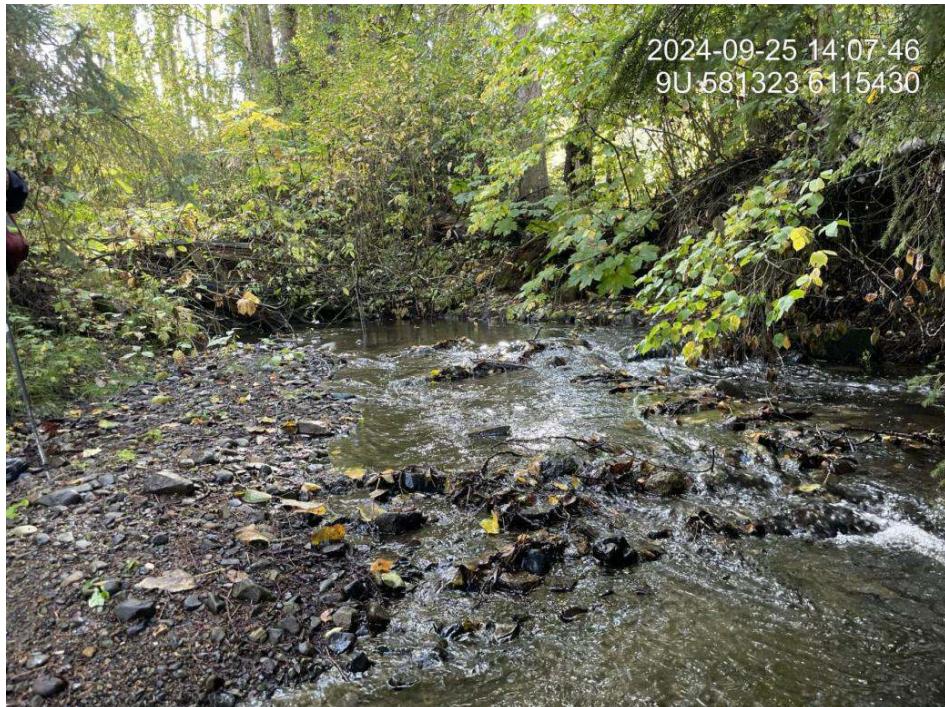
Figure 5.9: Typical habitat upstream of PSCIS crossing 198913.

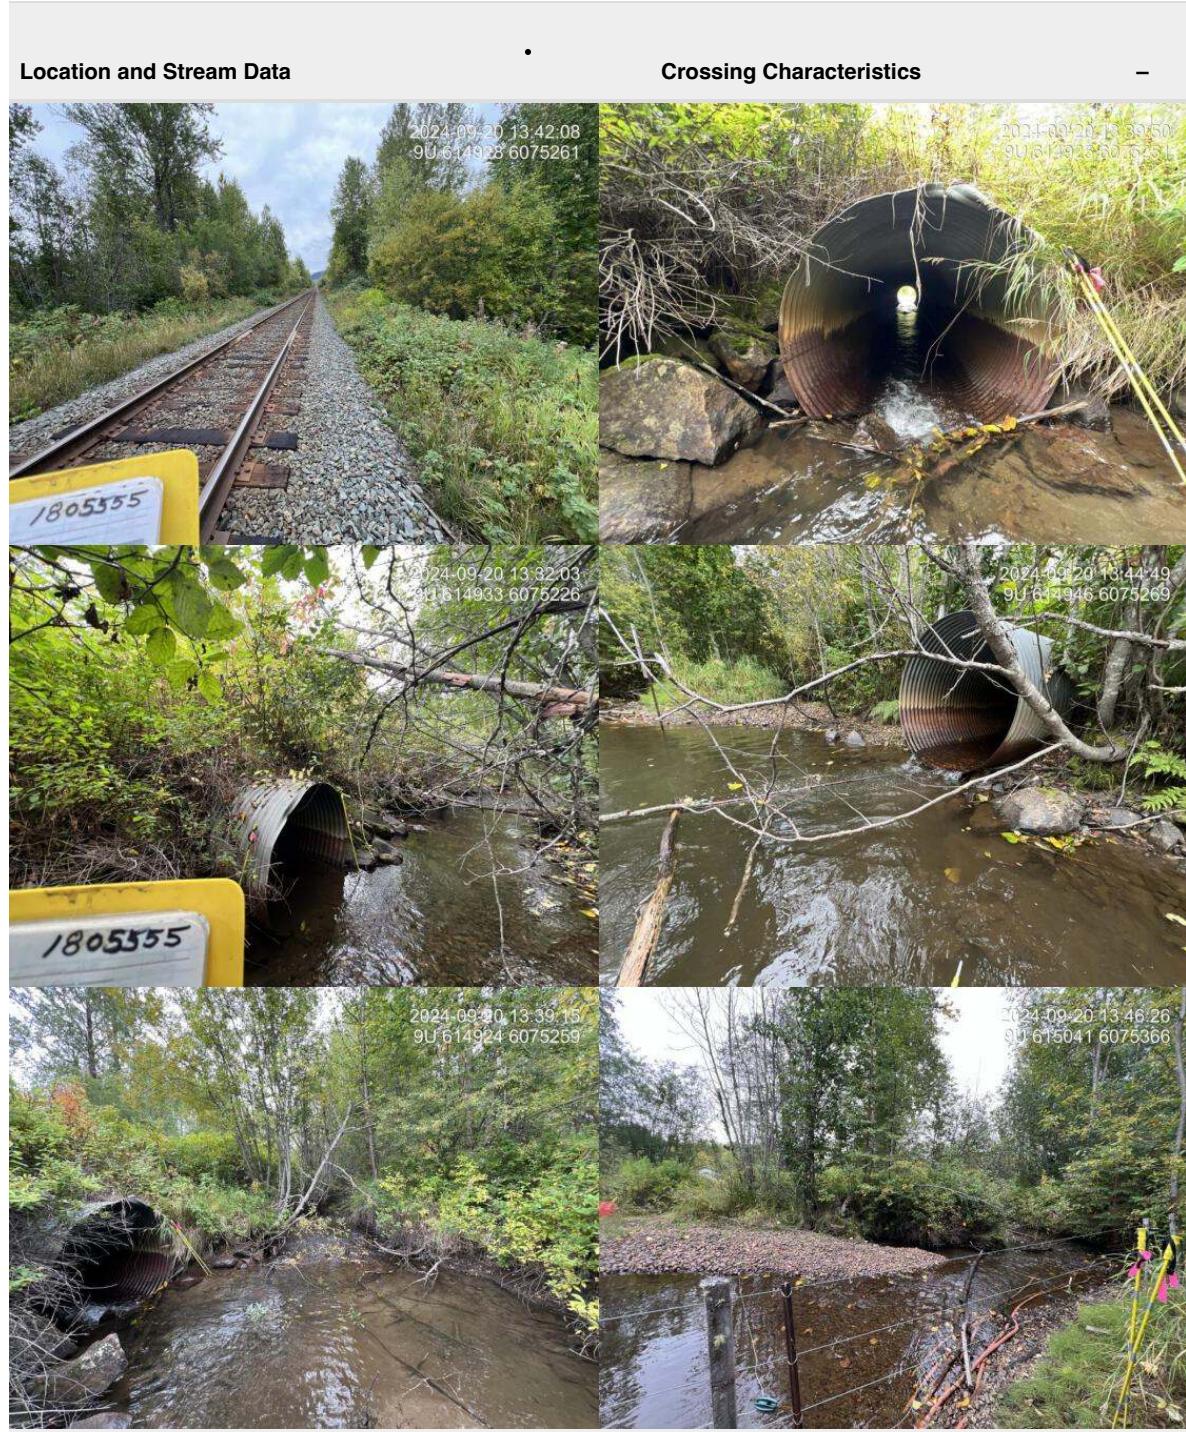
Location and Stream Data		Crossing Characteristics	
Date	2024-09-20	Crossing Sub Type	Round Culvert
PSCIS ID	203122	Diameter (m)	3
External ID	–	Length (m)	25
Crew	AI	Embedded	No
UTM Zone	9	Depth Embedded (m)	–
Easting	614941	Resemble Channel	Yes
Northing	6075232	Backwatered	No
Stream	Simpson Creek	Percent Backwatered	–
Road	Railway	Fill Depth (m)	1
Road Tenure	CN Rail	Outlet Drop (m)	0.05
Channel Width (m)	5	Outlet Pool Depth (m)	0.9
Stream Slope (%)	1	Inlet Drop	Yes
Beaver Activity	Yes	Slope (%)	2
Habitat Value	High	Valley Fill	Deep Fill
Final score	24	Barrier Result	Barrier
Fix type	Replace with New Open Bottom Structure	Fix Span / Diameter	15
Comments: Although this culvert is on Simpson Creek, it is not currently conveying the main flow and remains mostly dry. Two 1.5 m diameter pipes run under the railway, approximately 30 m apart. The southern pipe is fully embedded with an average embedment depth of 25 cm, while the northern pipe is currently passing all stream flow. This is a high-value stream with extensive gravel areas suitable for steelhead, coho, and chinook salmon spawning upstream. The adjacent landowner has reported recent observations of steelhead spawning and has historical knowledge of chinook spawning approximately 300 m downstream from Nielsen Road.

Photos: From top left clockwise: Road/Site Card, Barrel, Outlet, Downstream, Upstream, Inlet.

PSCIS crossing 203122 on the CN Railway presented a minimal barrier to fish passage and is considered a low priority for replacement. However, if restoration activities are undertaken, replacing the existing structure with a bridge spanning 15 m is recommended. As of 2025, the estimated replacement cost is \$ 11,250,000, with the high cost attributed to the complexities of working within a railway corridor.

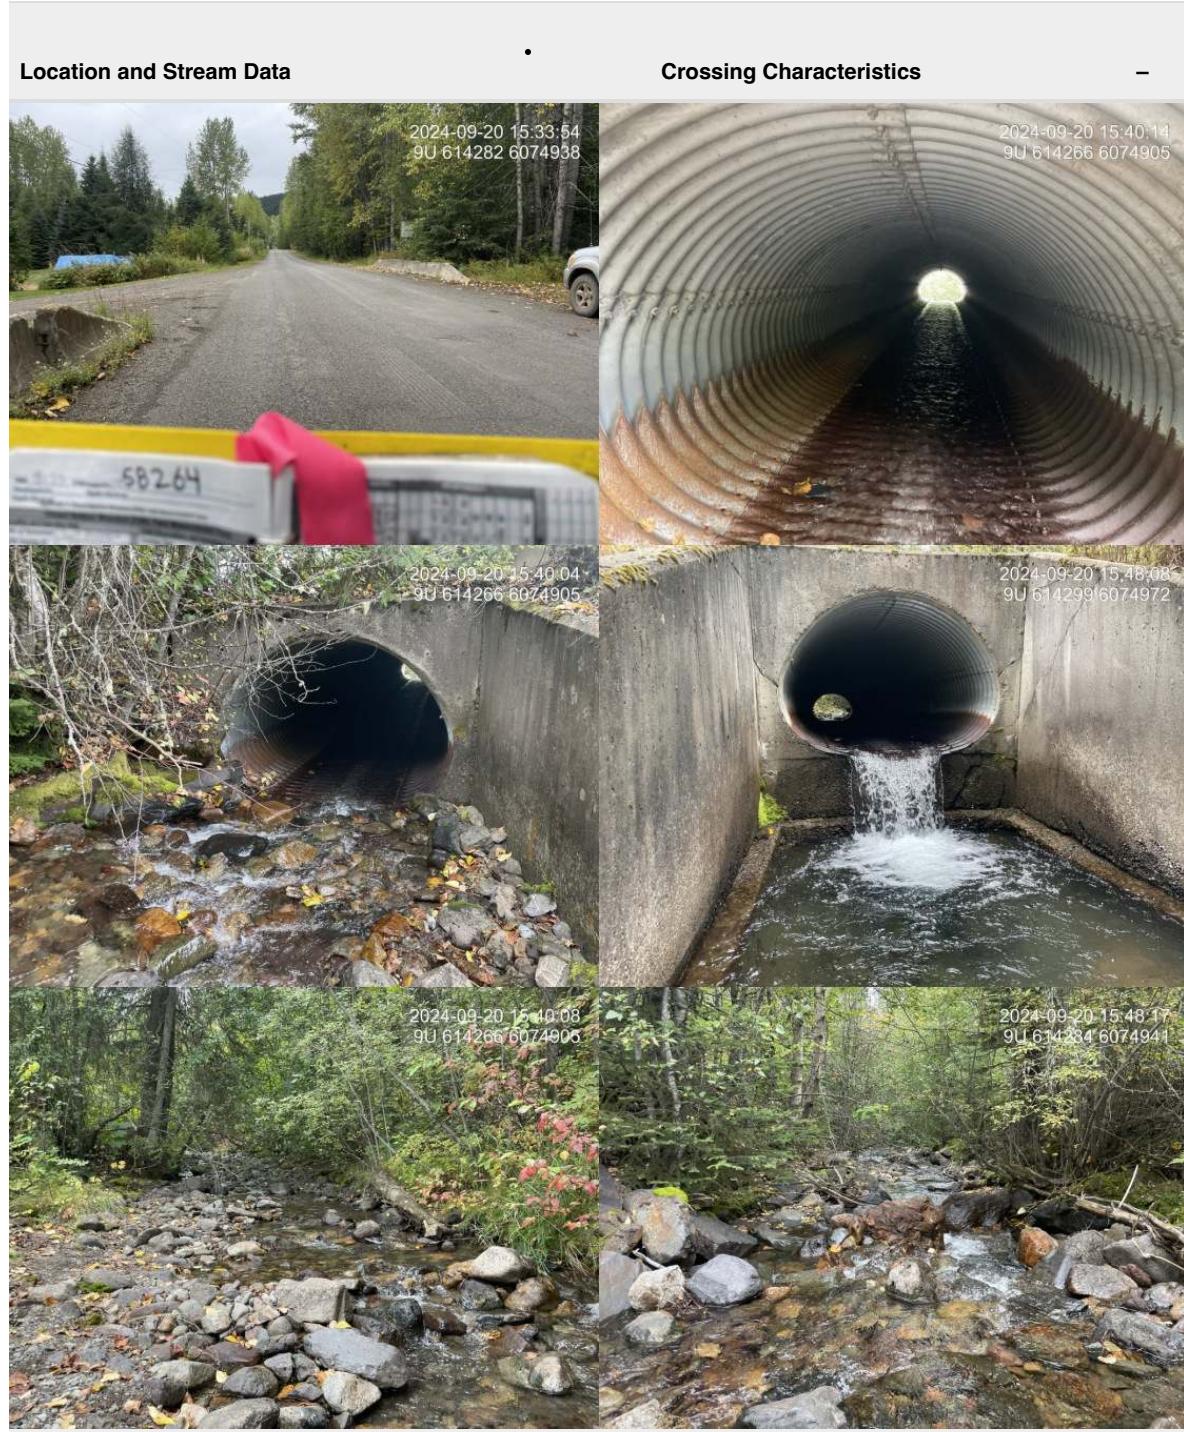
Location and Stream Data		Crossing Characteristics	
Date	2024-09-20	Crossing Sub Type	Oval Culvert
PSCIS ID	58264	Diameter (m)	2.4
External ID	–	Length (m)	23
Crew	LS TP	Embedded	No
UTM Zone	9	Depth Embedded (m)	–
Easting	614280	Resemble Channel	–
Northing	6074951	Backwatered	No
Stream	Simpson Creek	Percent Backwatered	–
Road	Nielson Road	Fill Depth (m)	0.4
Road Tenure	MoTi	Outlet Drop (m)	1
Channel Width (m)	5.6	Outlet Pool Depth (m)	1.2
Stream Slope (%)	13	Inlet Drop	No
Beaver Activity	No	Slope (%)	5
Habitat Value	High	Valley Fill	Deep Fill
Final score	39	Barrier Result	Barrier
Fix type	Replace with New Open Bottom Structure	Fix Span / Diameter	15

Comments: This concrete oval culvert has a significant 1 m outlet drop, likely inhibiting fish passage. The stream is incorrectly mapped in the Freshwater Atlas, located south of the mapped channel. Upstream habitat includes boulder cover, gravel pockets suitable for coho, steelhead, and Dolly Varden spawning, and a healthy mature mixed forest riparian zone. Downstream habitat transitions to lower-gradient, high-value conditions with extensive gravels, deep pools (up to 90 cm), large woody debris, and abundant cover, supporting recent steelhead and historically chinook spawning, as reported by the adjacent landowner. Habitat confirmations were completed at this site and all downstream crossings to the confluence with Kathlyn Creek. The stream is a major contributor to the greater Kathlyn Creek watershed, with flow volumes during the assessment slightly less than the Kathlyn Creek mainstem. Electrofishing upstream of Nielsen Road captured rainbow trout, while downstream sampling confirmed the presence of Dolly Varden, rainbow trout, cutthroat trout/rainbow trout hybrids, and coho. The coho were captured approximately 350 m downstream of Nielsen Road. According to the landowner, this crossing was originally a bridge but was replaced with the current culvert during an emergency flood event in the 1990s.

Photos: From top left clockwise: Road/Site Card, Barrel, Outlet, Downstream, Upstream, Inlet.

Should restoration/maintenance activities proceed, replacement of the Nielson Road crossing (58264) with a bridge (15 m span) is recommended. The significant 1 m outlet drop at this crossing, combined with the presence of salmonids in the system, makes it a top priority for remediation. At the time of reporting in 2025, the cost of the work is estimated at \$ 3,000,000.
