## **Skeena Watershed Fish Passage Restoration Planning 2024**

**Prepared for**  
**Habitat Conservation Trust Foundation - CAT23-6-288**  
**BC Fish Passage Remediation Program**  
**Ministry of Transportation and Infrastructure**

Version 0.1.3 2025-06-13

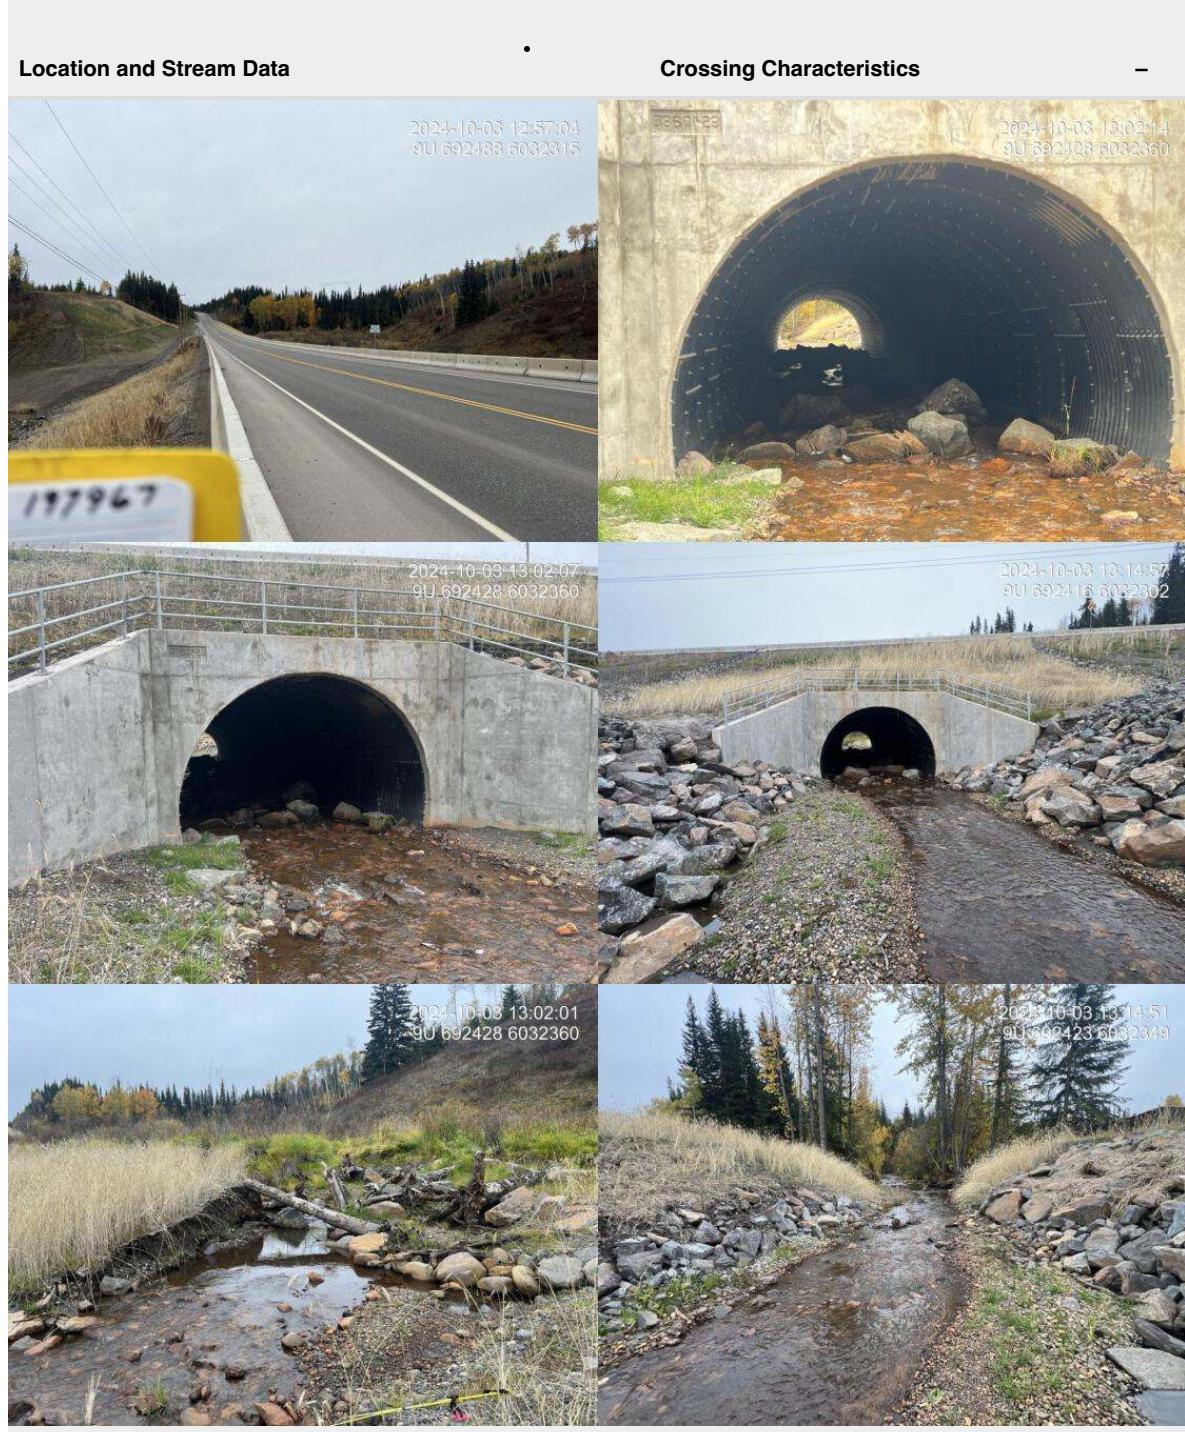
Photos: From top left clockwise: Road/Site Card, Barrel, Outlet, Downstream, Upstream, Inlet.

Location and Stream Data		Crossing Characteristics	
Date	2024-10-03	Crossing Sub Type	Round Culvert
PSCIS ID	197967	Diameter (m)	5.6
External ID	–	Length (m)	40
Crew	AI	Embedded	Yes
UTM Zone	9	Depth Embedded (m)	2
Easting	692426	Resemble Channel	Yes
Northing	6032341	Backwatered	No
Stream	Taman Creek	Percent Backwatered	–
Road	Highway 16	Fill Depth (m)	7
Road Tenure	MoTi	Outlet Drop (m)	0
Channel Width (m)	5.5	Outlet Pool Depth (m)	0
Stream Slope (%)	2	Inlet Drop	No
Beaver Activity	Yes	Slope (%)	3
Habitat Value	Medium	Valley Fill	Deep Fill
Final score	16	Barrier Result	Potential
Fix type	Replace with New Open Bottom Structure	Fix Span / Diameter	27
Comments: This is a brand-new replacement structure, extremely well built with extensive embedment that includes numerous large boulders, cobbles, and gravel. The multiplate round structure is embedded nearly 2m. Upstream, woody debris and boulder structures are cabled together for added stability. This massive construction project involved a substantial amount of fill extending 60m downstream and over 200m upstream. MoTi chris_culvert_id: 2076452

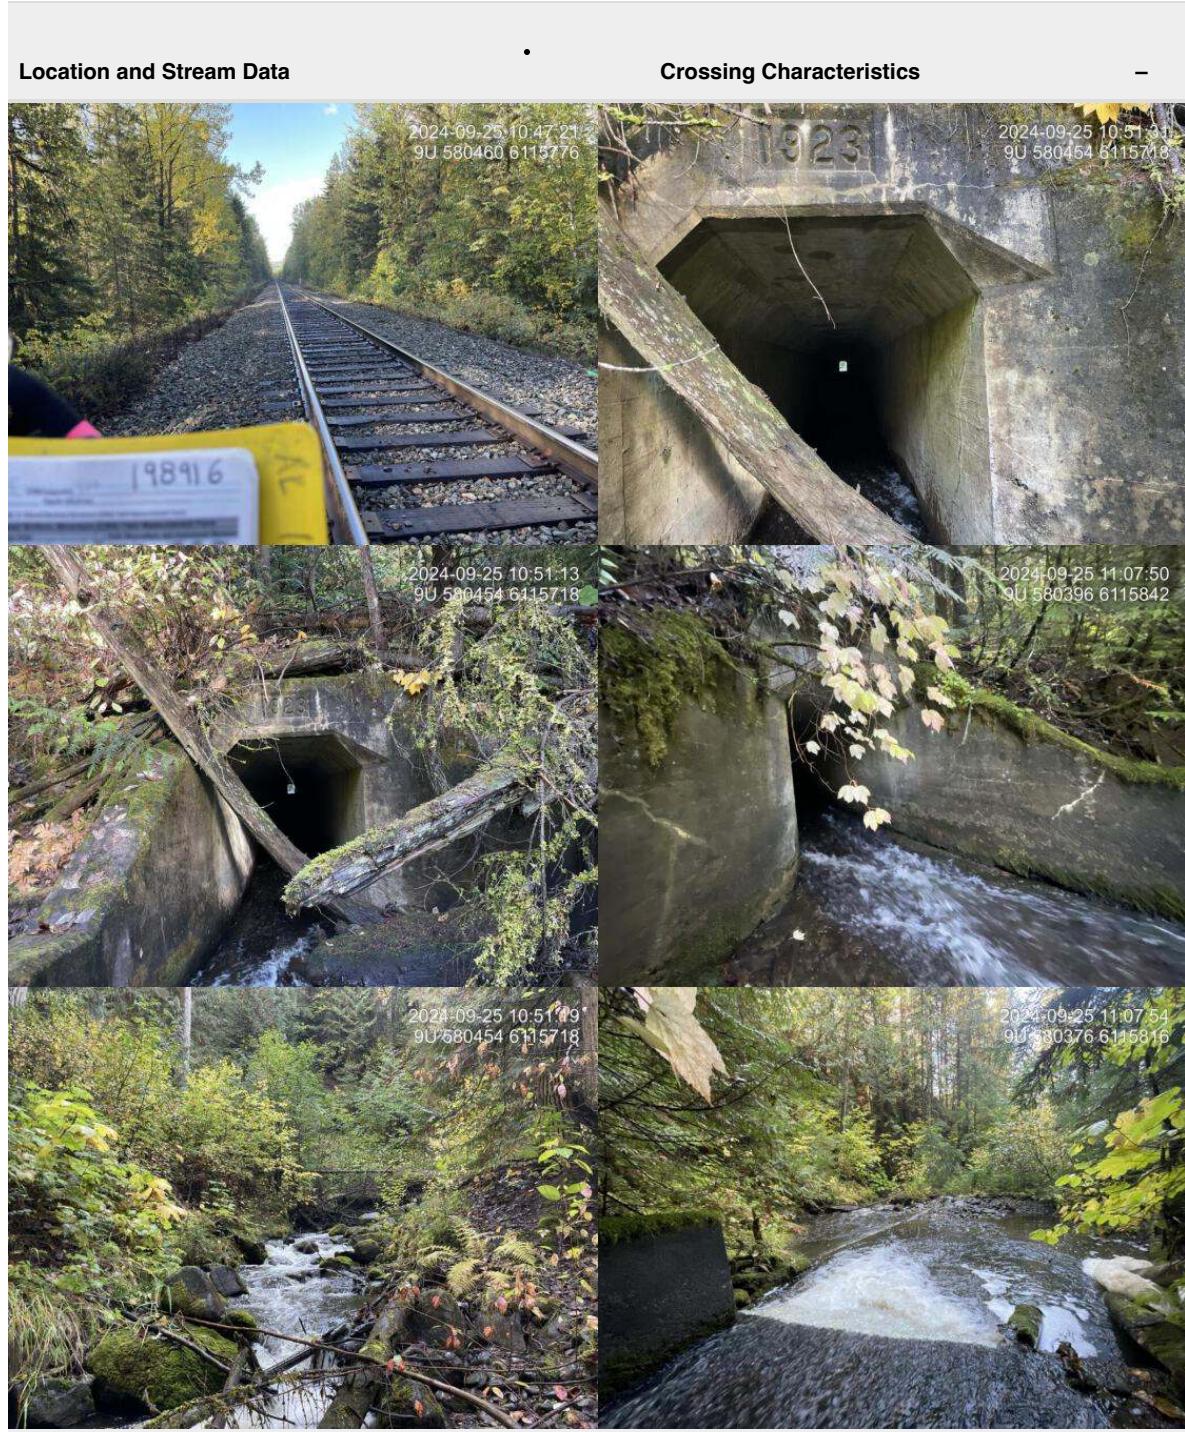
Photos: From top left clockwise: Road/Site Card, Barrel, Outlet, Downstream, Upstream, Inlet.

Comments: The concrete box culvert is approximately 100m long beneath a railway crossing, with about 30–40m of fill above it. A swift current flows through the culvert, and installing baffles could improve fish passage. Fish sampling captured cutthroat trout and Dolly Varden downstream of the crossing, and Dolly Varden upstream. There is a moderate outlet drop, but adult fish could likely move upstream. The habitat upstream features good flow through a steeper section with a healthy, mature mixed riparian forest, stable banks, and gravel pockets suitable for spawning coho, Dolly Varden, and cutthroat trout. Downstream, abundant boulders create step pools alongside frequent large woody debris, though high flows limited suitable fish habitat during the survey. Although construction would be expensive and challenging, this site is a high priority for restoration follow-up. BC Freshwater atlas mapping of this watershed is incorrect as the main stream at the confluence with the Skeena River is actually Comeau Creek vs Gershwin Creek. Therefore, this crossing is actually on Comeau Creek. Culvert length 100 m but changed to 99.9 m to meet submission requirements. Fill depth 30 m but changed to 9.9 m to meet submission requirements.

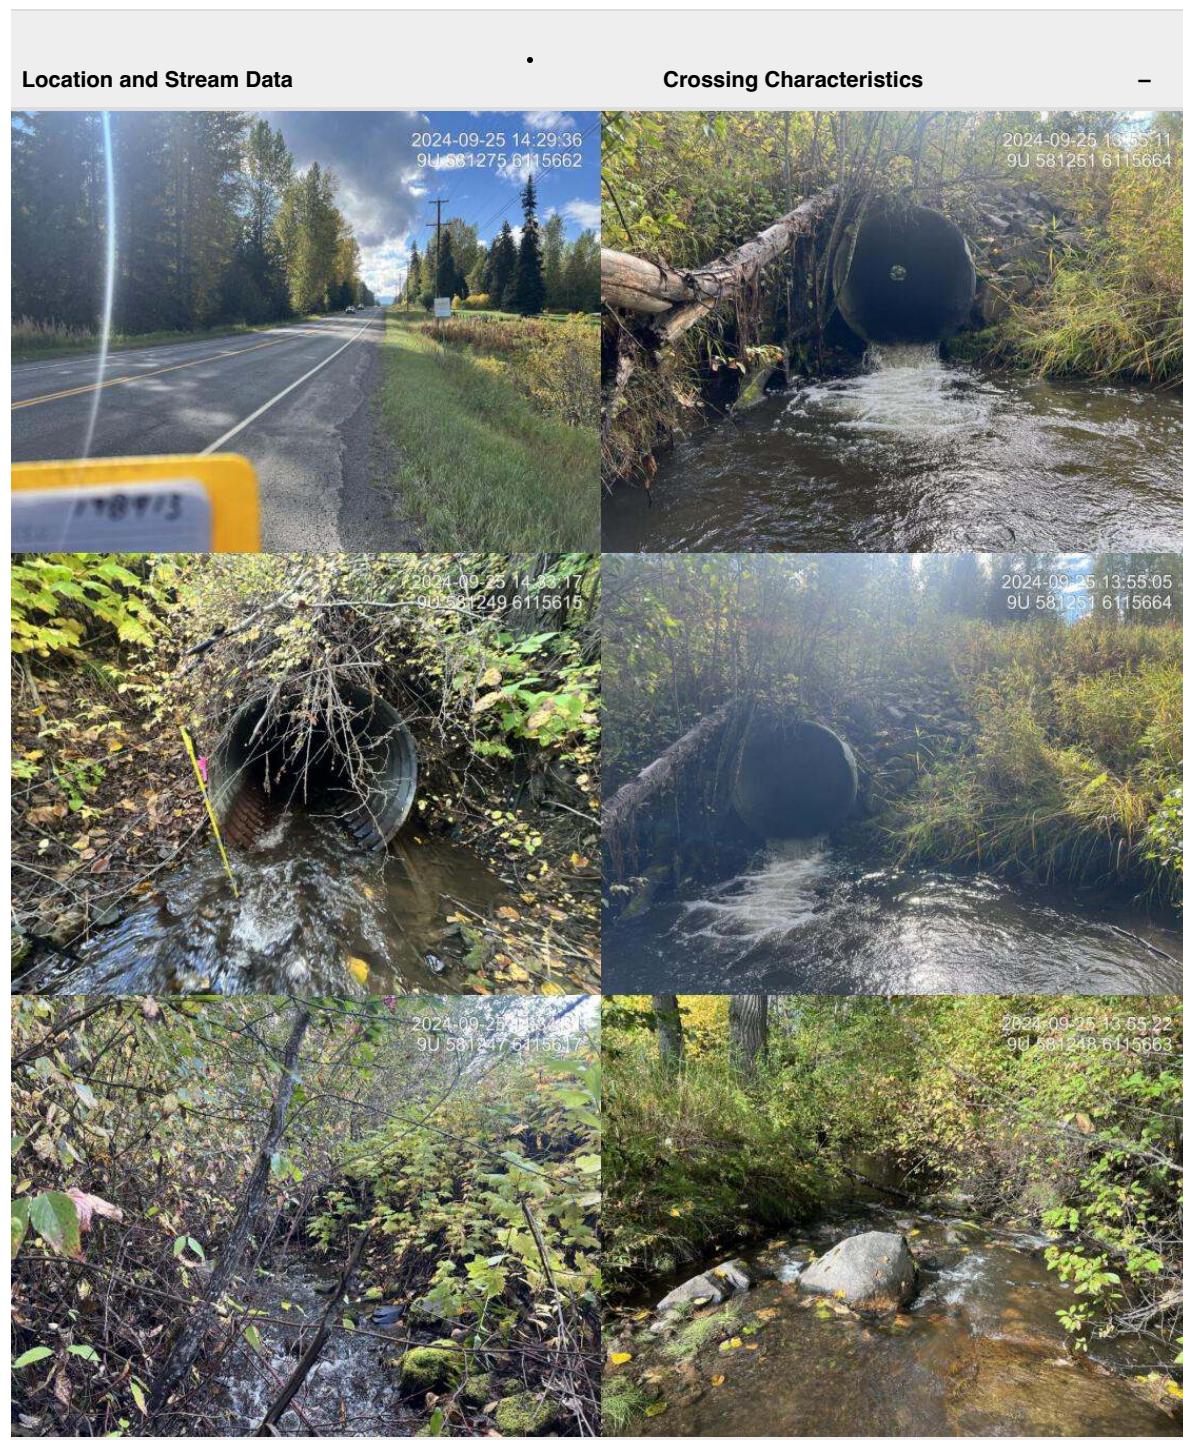
Photos: From top left clockwise: Road/Site Card, Barrel, Outlet, Downstream, Upstream, Inlet.

Comments: There is a deep outlet pool, suggesting the culvert is undersized for the stream. High-quality gravels were present at the pool, outlet, and upstream of the crossing, there was high-value habitat with frequent overwintering pools, spawning gravels, and adequate riparian cover with large cottonwoods throughout. This site was part of a habitat confirmation assessment, with the stream surveyed from the downstream railway crossing up to this location and an additional 600m upstream. Downstream, crossing 198916 consists of a large, long box culvert beneath the railway with minimal flow depth and a swift current, making it unlikely that fish from the mainstem of the Skeena River can access this site until the railway barrier is addressed. Fish sampling upstream of the highway captured Dolly Varden. BC Freshwater atlas mapping of this watershed is incorrect as the main stream at the confluence with the Skeena River is actually Comeau Creek vs Gershwin Creek. Therefore, this crossing is actually on Comeau Creek. MoTi chris\_culvert\_id: 8300872

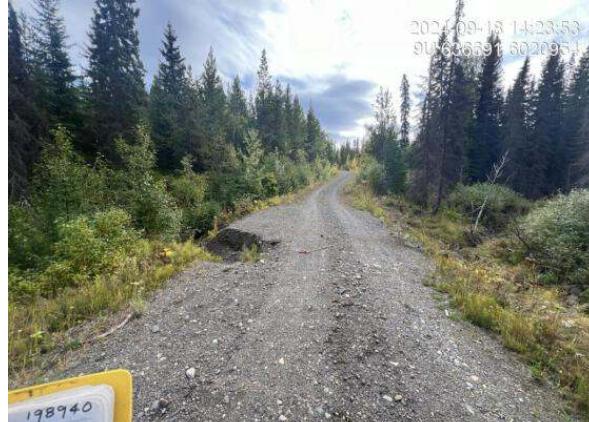
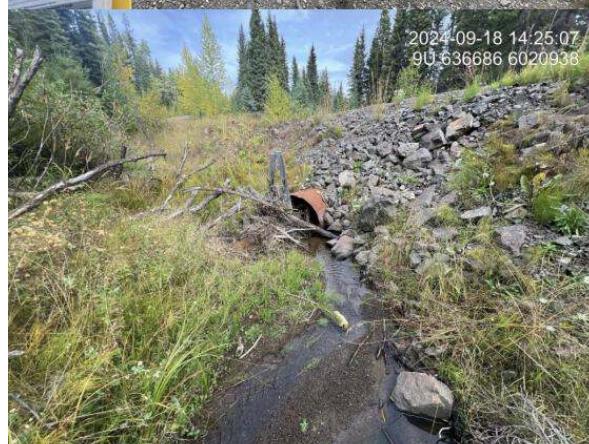
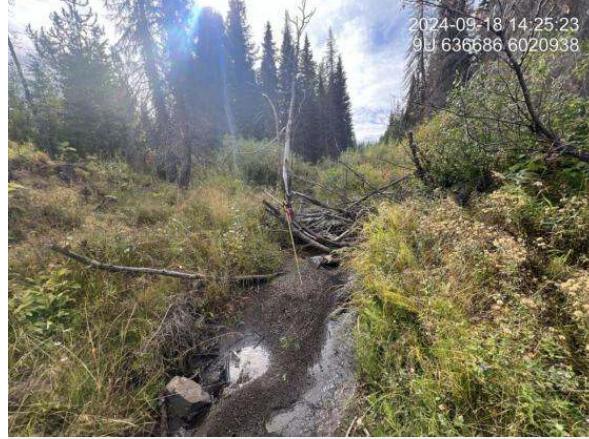
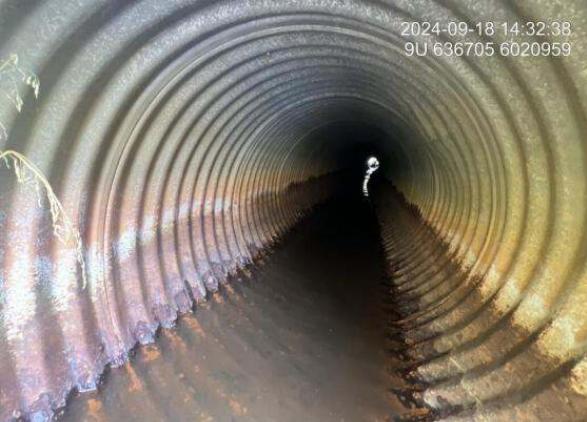
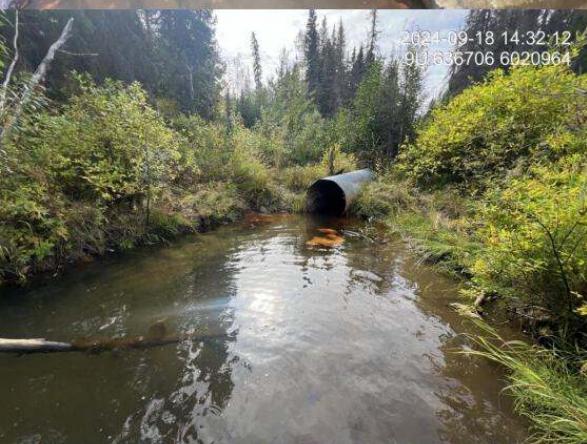
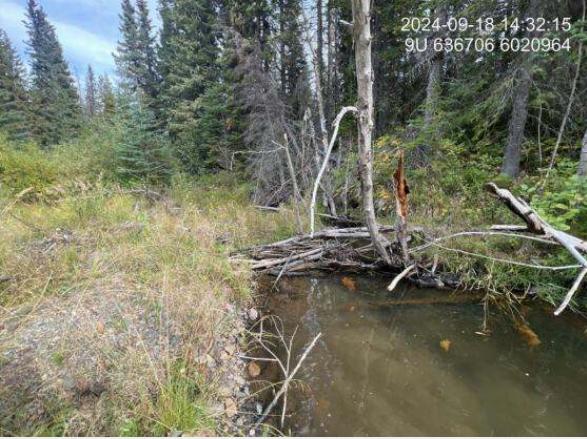
Location and Stream Data	Crossing Characteristics
<p>Comments: Very nice stream with good flow, abundant gravels for spawning, and undercut banks and occasional deep pools for rearing. The culvert is significantly undersized for the stream, and the road appears to be failing, likely due to a partially clogged inlet and spring freshet. Habitat confirmations were completed for this crossing and the next upstream crossing (198935) on the Gold FSR. Electrofishing above Gold FSR captured rainbow trout, cutthroat trout, and cutthroat trout/rainbow trout hybrids.</p> <p>Photos: From top left clockwise: Road/Site Card, Barrel, Outlet, Downstream, Upstream, Inlet.</p>

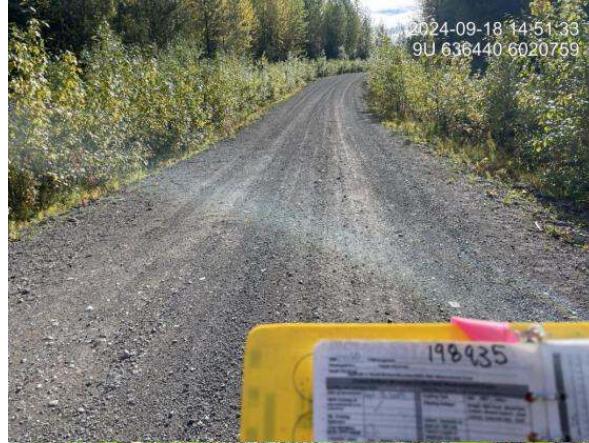
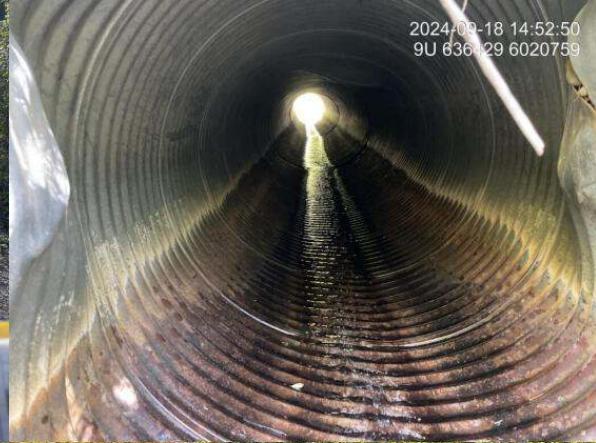
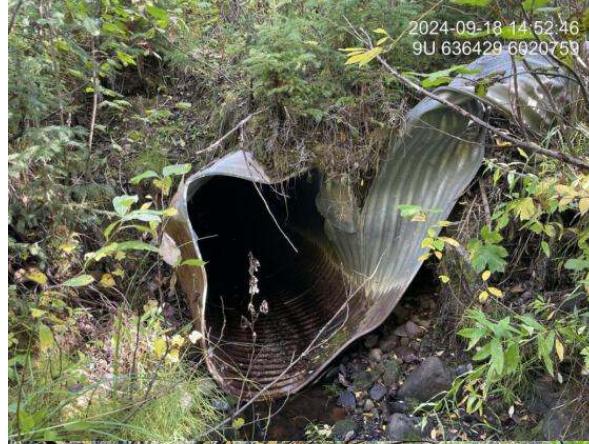
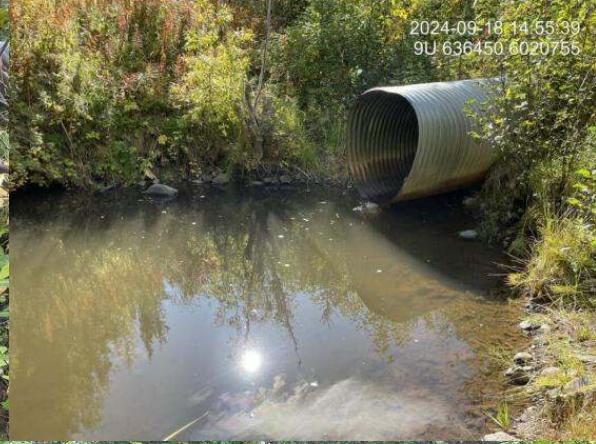
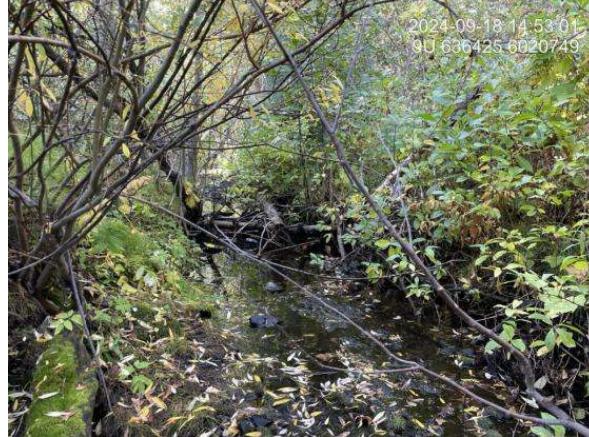
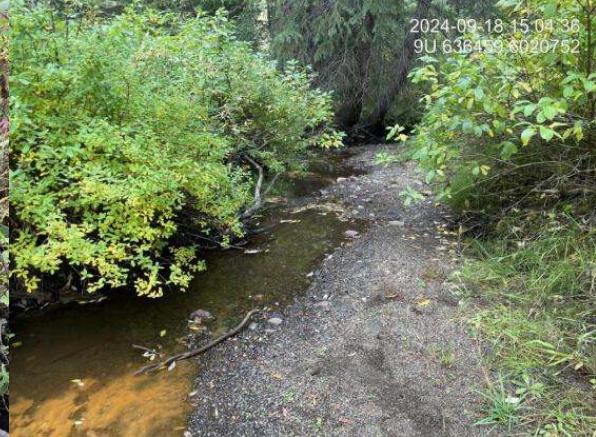
Location and Stream Data	Crossing Characteristics
<p>Comments: The culvert is deteriorating at the inlet. Large outlet pool where fish were captured during sampling. The stream flows from the outlet pool along the left-hand side into a well-defined channel with gravels suitable for spawning and several pools, providing good habitat. A moderate amount of road fill is present. Electrofishing above Gold FSR captured rainbow trout, cutthroat trout, and cutthroat trout/rainbow trout hybrids.</p>	
<p>Photos: From top left clockwise: Road/Site Card, Barrel, Outlet, Downstream, Upstream, Inlet.</p>

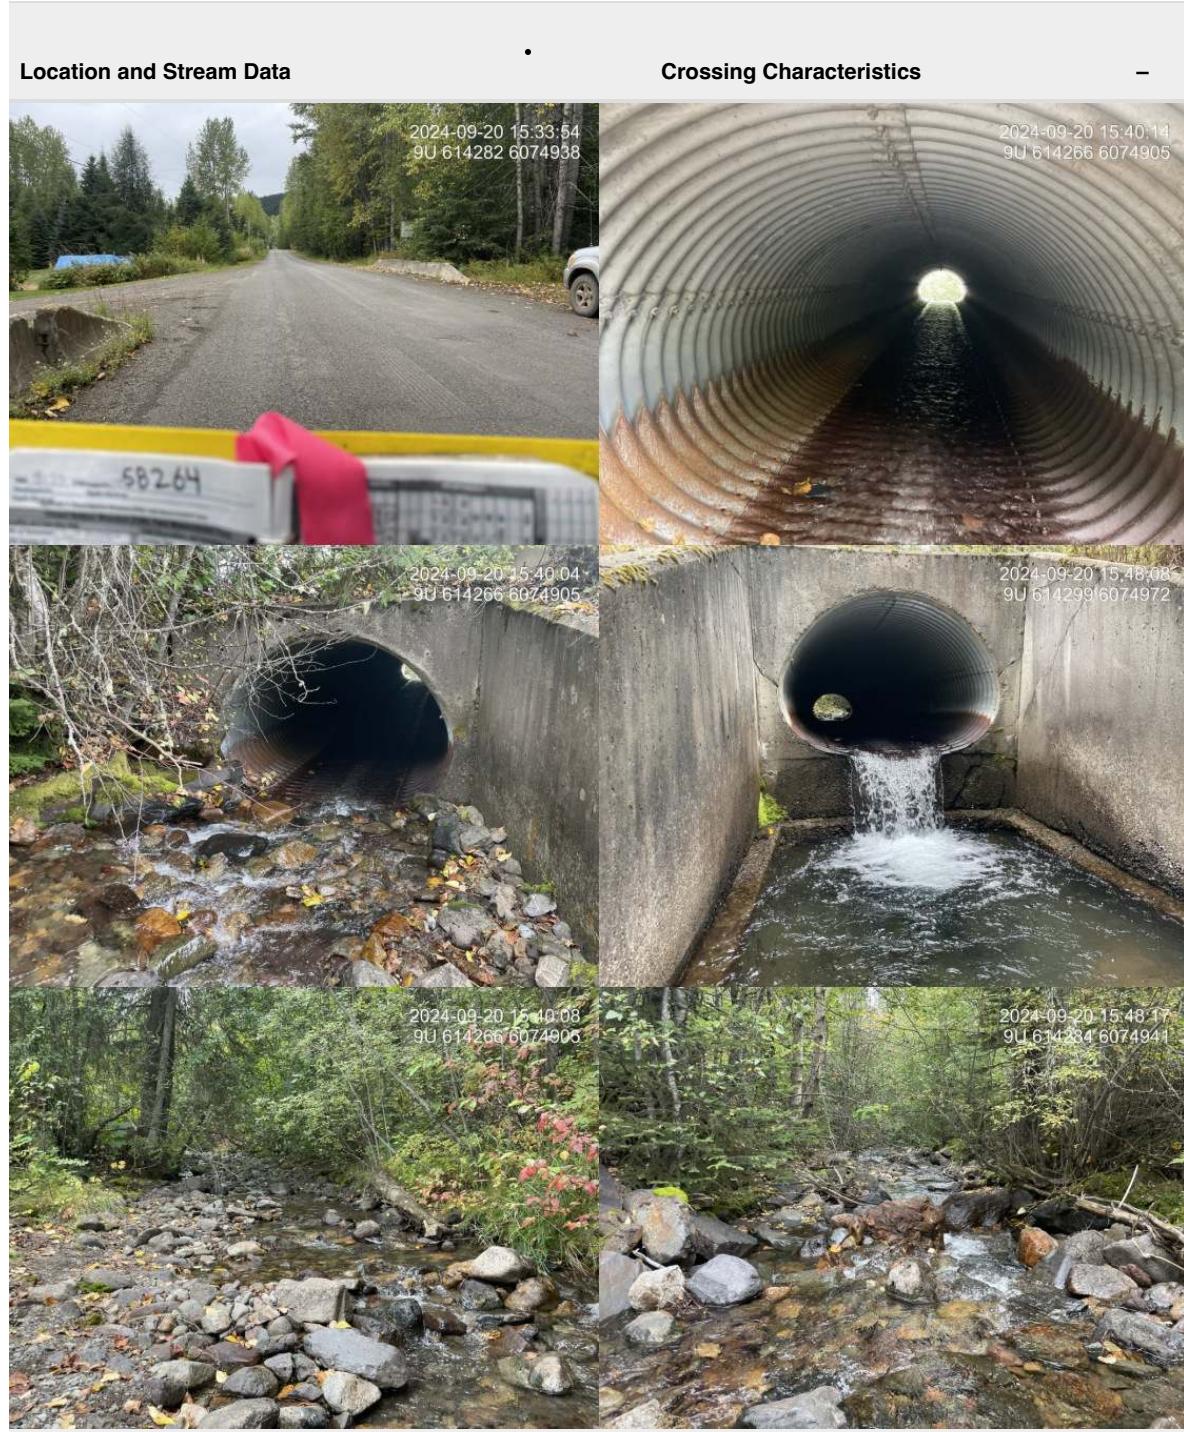
Location and Stream Data		Crossing Characteristics	
Date	2024-09-20	Crossing Sub Type	Oval Culvert
PSCIS ID	58264	Diameter (m)	2.4
External ID	–	Length (m)	23
Crew	LS TP	Embedded	No
UTM Zone	9	Depth Embedded (m)	–
Easting	614280	Resemble Channel	No
Northing	6074951	Backwatered	No
Stream	Simpson Creek	Percent Backwatered	–
Road	Nielson Road	Fill Depth (m)	0.4
Road Tenure	MoTi	Outlet Drop (m)	1
Channel Width (m)	5.6	Outlet Pool Depth (m)	1.2
Stream Slope (%)	13	Inlet Drop	No
Beaver Activity	No	Slope (%)	5
Habitat Value	High	Valley Fill	Deep Fill
Final score	39	Barrier Result	Barrier
Fix type	Replace with New Open Bottom Structure	Fix Span / Diameter	15

Comments: This concrete oval culvert has a significant 1m outlet drop, likely inhibiting fish passage. The stream is incorrectly mapped in the Freshwater Atlas, located south of the mapped channel. Upstream habitat includes boulder cover, gravel pockets suitable for coho, steelhead, and Dolly Varden spawning, and a healthy mature mixed forest riparian zone. Downstream habitat transitions to lower-gradient, high-value habitat with extensive gravels, deep pools (up to 90cm), large woody debris, and abundant cover, supporting recent steelhead and historically chinook spawning, as reported by the adjacent landowner. Habitat confirmations were completed at this site and all downstream crossings to the confluence with Kathlyn Creek. Electrofishing upstream of Nielsen Road captured rainbow trout, while downstream sampling confirmed the presence of coho, Dolly Varden, rainbow trout, and cutthroat trout/rainbow trout hybrids. According to the landowner, this crossing was originally a bridge but was replaced with the current culvert during an emergency flood event in the 1990s.

Should restoration/maintenance activities proceed, replacement of the Nielson Road crossing (58264) with a bridge (15m span) is recommended. The significant outlet drop at this crossing, combined with the presence of salmonids in the system, makes it a top priority for remediation. At the time of reporting in 2025, the cost of the work is estimated at \$ 3,000,000.

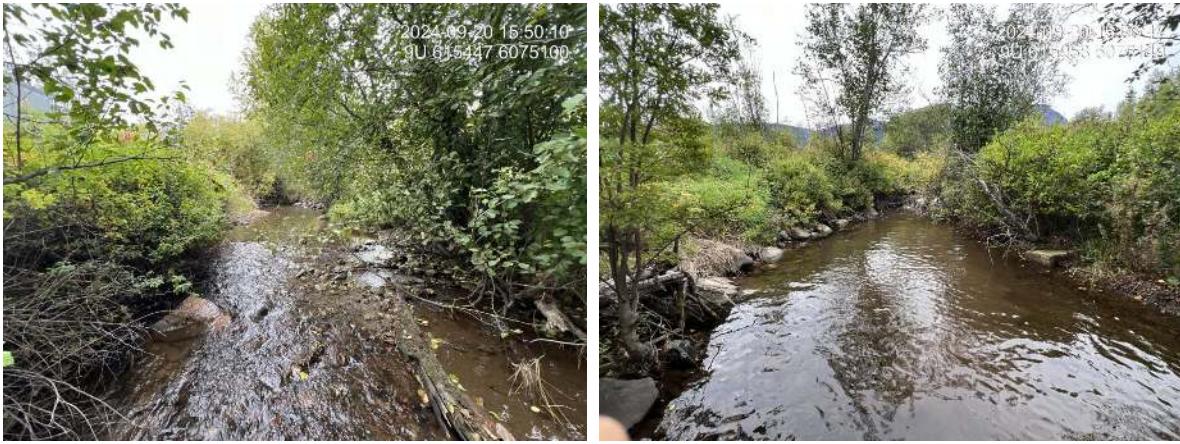
Figure 5.16: Left: Typical habitat downstream of PSCIS crossing 58245. Right: Typical habitat upstream of PSCIS crossing 58245 and downstream of PSCIS crossing 203122, with signs of bank armouring and channelization.

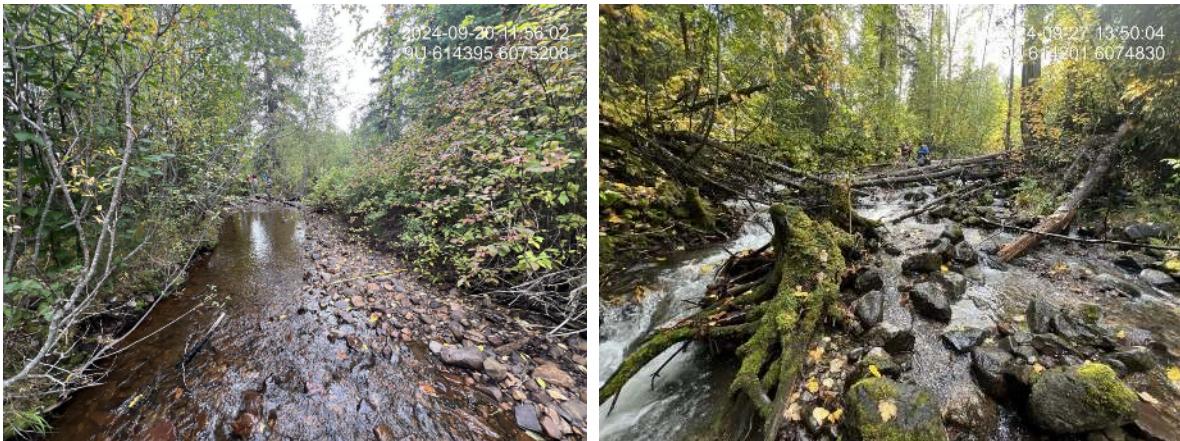
The stream was surveyed upstream from crossing 58264 for 615m . This section of the stream featured a steeper gradient, predominantly characterized by boulder cover with occasional pockets of gravels suitable for coho, steelhead, and Dolly Varden spawning (Figure 5.17). Pools were infrequent throughout. The riparian zone was composed of a healthy, mature mixed forest, providing stability and shading. The upper end of the site was situated just upstream of a short cascade with a 20% gradient. The habitat was rated as medium value for salmonid rearing and spawning. The dominant substrate was cobbles with boulders sub-dominant. The average channel width was 8.9m, the average wetted width was 4.7m, and the average gradient was 7.3%. Total cover amount was rated as moderate with boulders dominant. Cover was also present as large woody debris.

Figure 5.17: Left: Steelhead spawning location upstream of PSCIS crossing 203122 and downstream of PSCIS crossing 58264, as reported by the adjacent landowner. Right: Typical habitat upstream of PSCIS crossing 58264.
