Skeena Watershed Fish Passage Restoration Planning 2024

Prepared for
Habitat Conservation Trust Foundation - CAT23-6-288
BC Fish Passage Remediation Program
Ministry of Transportation and Infrastructure

Prepared by
Al Irvine, B.Sc., R.P.Bio and Lucy Schick, B.Sc.
New Graph Environment Ltd.
on behalf of
Society for Ecosystem Restoration in Northern British Columbia

DRAFT Version 0.1.1 2025-03-31

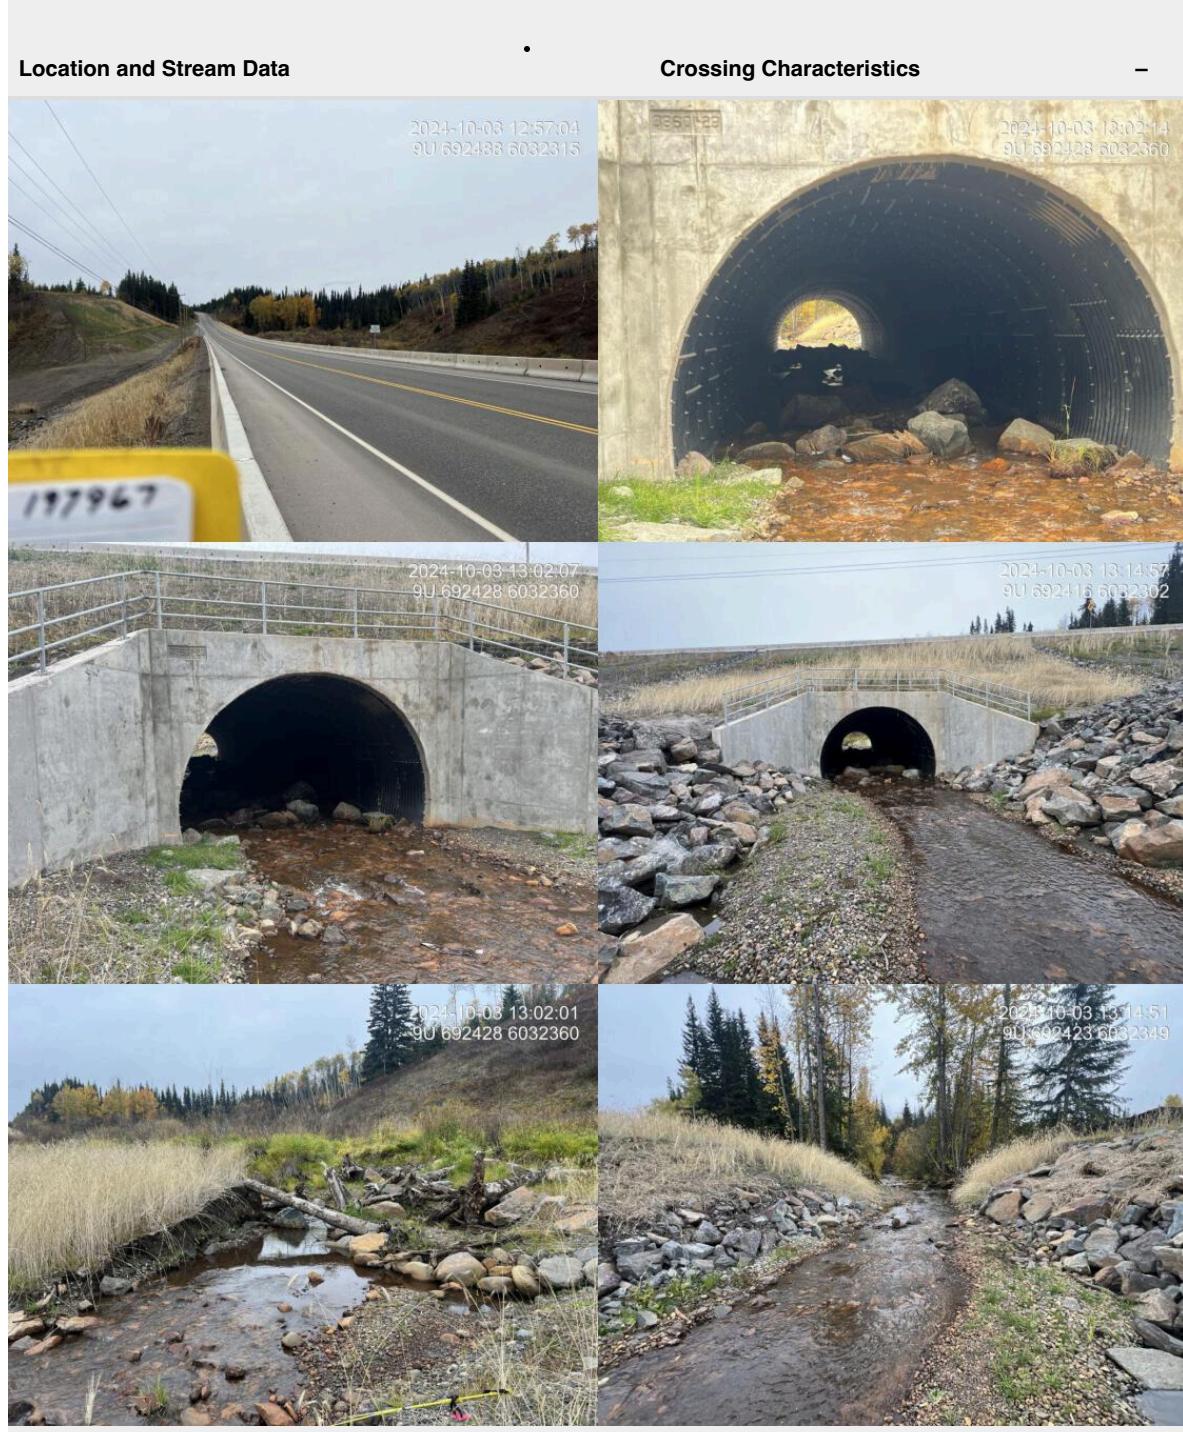
Photos: From top left clockwise: Road/Site Card, Barrel, Outlet, Downstream, Upstream, Inlet.

Location and Stream Data		Crossing Characteristics	
Date	2024-10-03	Crossing Sub Type	Round Culvert
PSCIS ID	197967	Diameter (m)	5.6
External ID	–	Length (m)	40
Crew	AI	Embedded	Yes
UTM Zone	9	Depth Embedded (m)	2
Easting	692426	Resemble Channel	Yes
Northing	6032341	Backwatered	No
Stream	Taman Creek	Percent Backwatered	–
Road	Highway 16	Fill Depth (m)	7
Road Tenure	MoTi	Outlet Drop (m)	0
Channel Width (m)	5.5	Outlet Pool Depth (m)	0
Stream Slope (%)	2	Inlet Drop	No
Beaver Activity	Yes	Slope (%)	3
Habitat Value	Medium	Valley Fill	Deep Fill
Final score	16	Barrier Result	Potential
Fix type	Replace with New Open Bottom Structure	Fix Span / Diameter	27
Comments:			
This is a brand-new replacement structure, extremely well built with extensive embedment that includes numerous large boulders, cobbles, and gravel. The multiplate round structure is embedded nearly 2 m. Upstream, woody debris and boulder structures are cabled together for added stability. This massive construction project involved a substantial amount of fill extending 60 m downstream and over 200 m upstream. The site now offers migration conditions for fish that are equal to or better than previous conditions. MoTi chris_culvert_id: 2076452

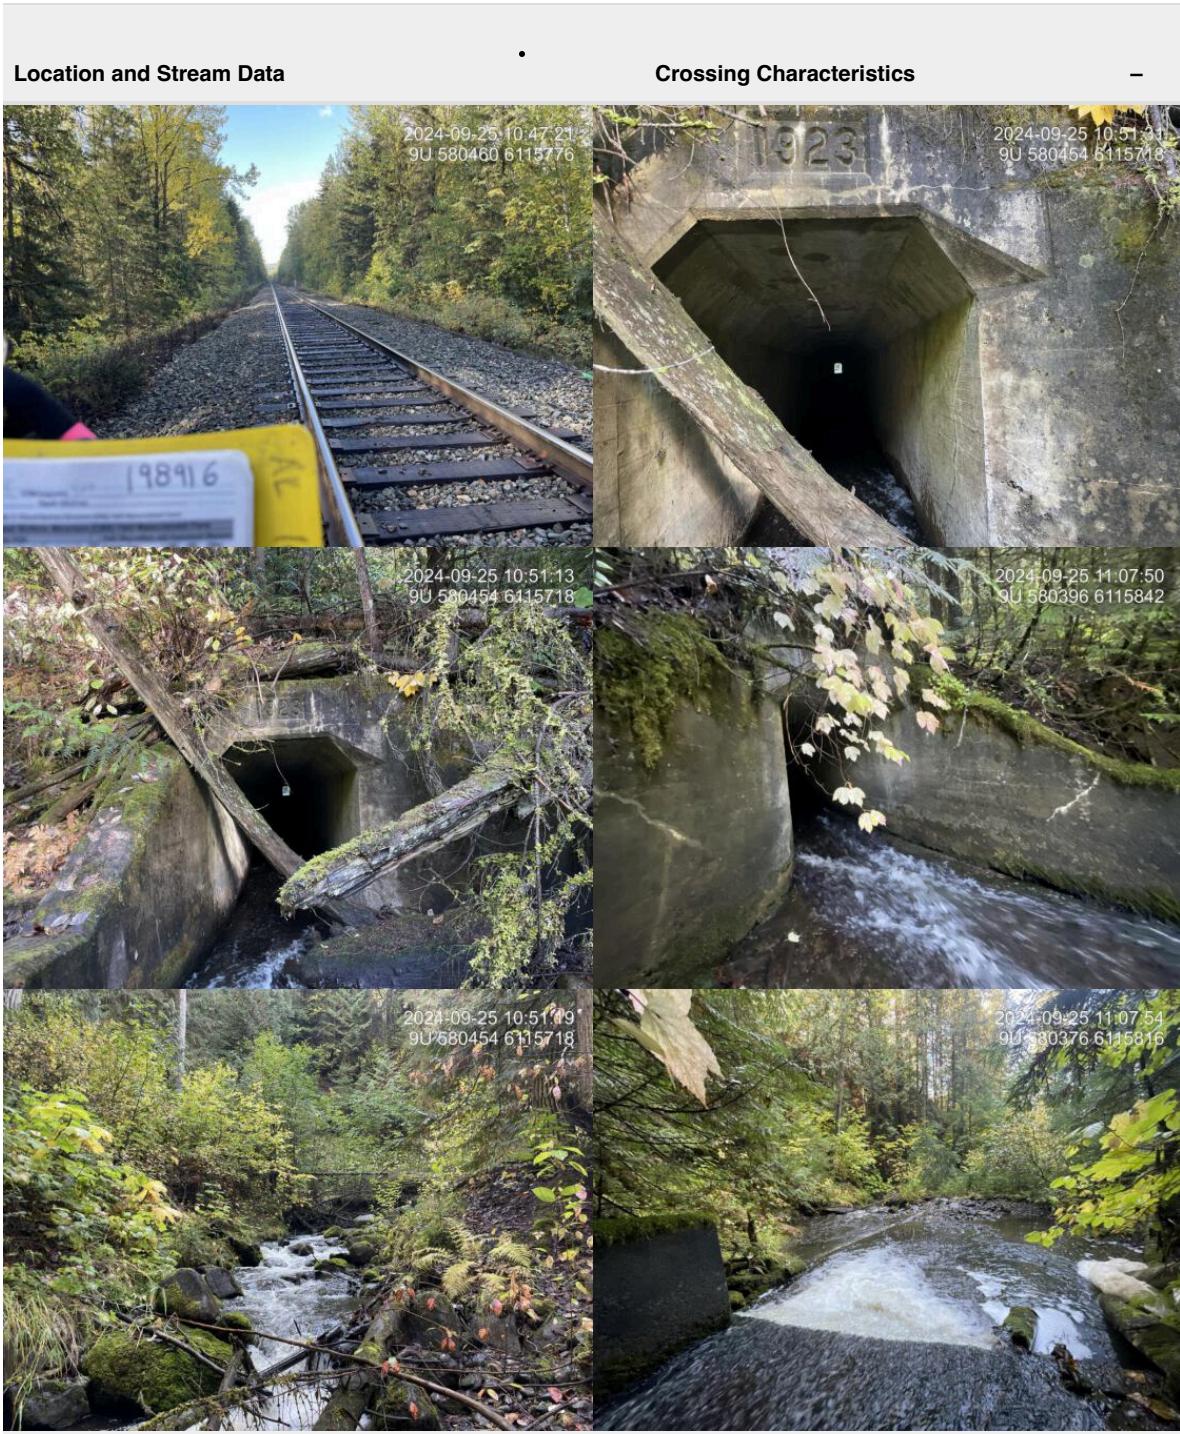
Location and Stream Data		Crossing Characteristics	
Date	2024-09-25	Crossing Sub Type	Round Culvert
PSCIS ID	198913	Diameter (m)	1.5
External ID	-	Length (m)	40
Crew	AI JO	Embedded	No
UTM Zone	9	Depth Embedded (m)	-
Easting	581250	Resemble Channel	-
Northing	6115660	Backwatered	No
Stream	Gershwin Creek	Percent Backwatered	-
Road	Highway 16	Fill Depth (m)	2.5
Road Tenure	MOTi	Outlet Drop (m)	0.35
Channel Width (m)	5	Outlet Pool Depth (m)	0.85
Stream Slope (%)	3	Inlet Drop	No
Beaver Activity	No	Slope (%)	3
Habitat Value	Medium	Valley Fill	Deep Fill
Final score	42	Barrier Result	Barrier
Fix type	Replace with New Open Bottom Structure	Fix Span / Diameter	15

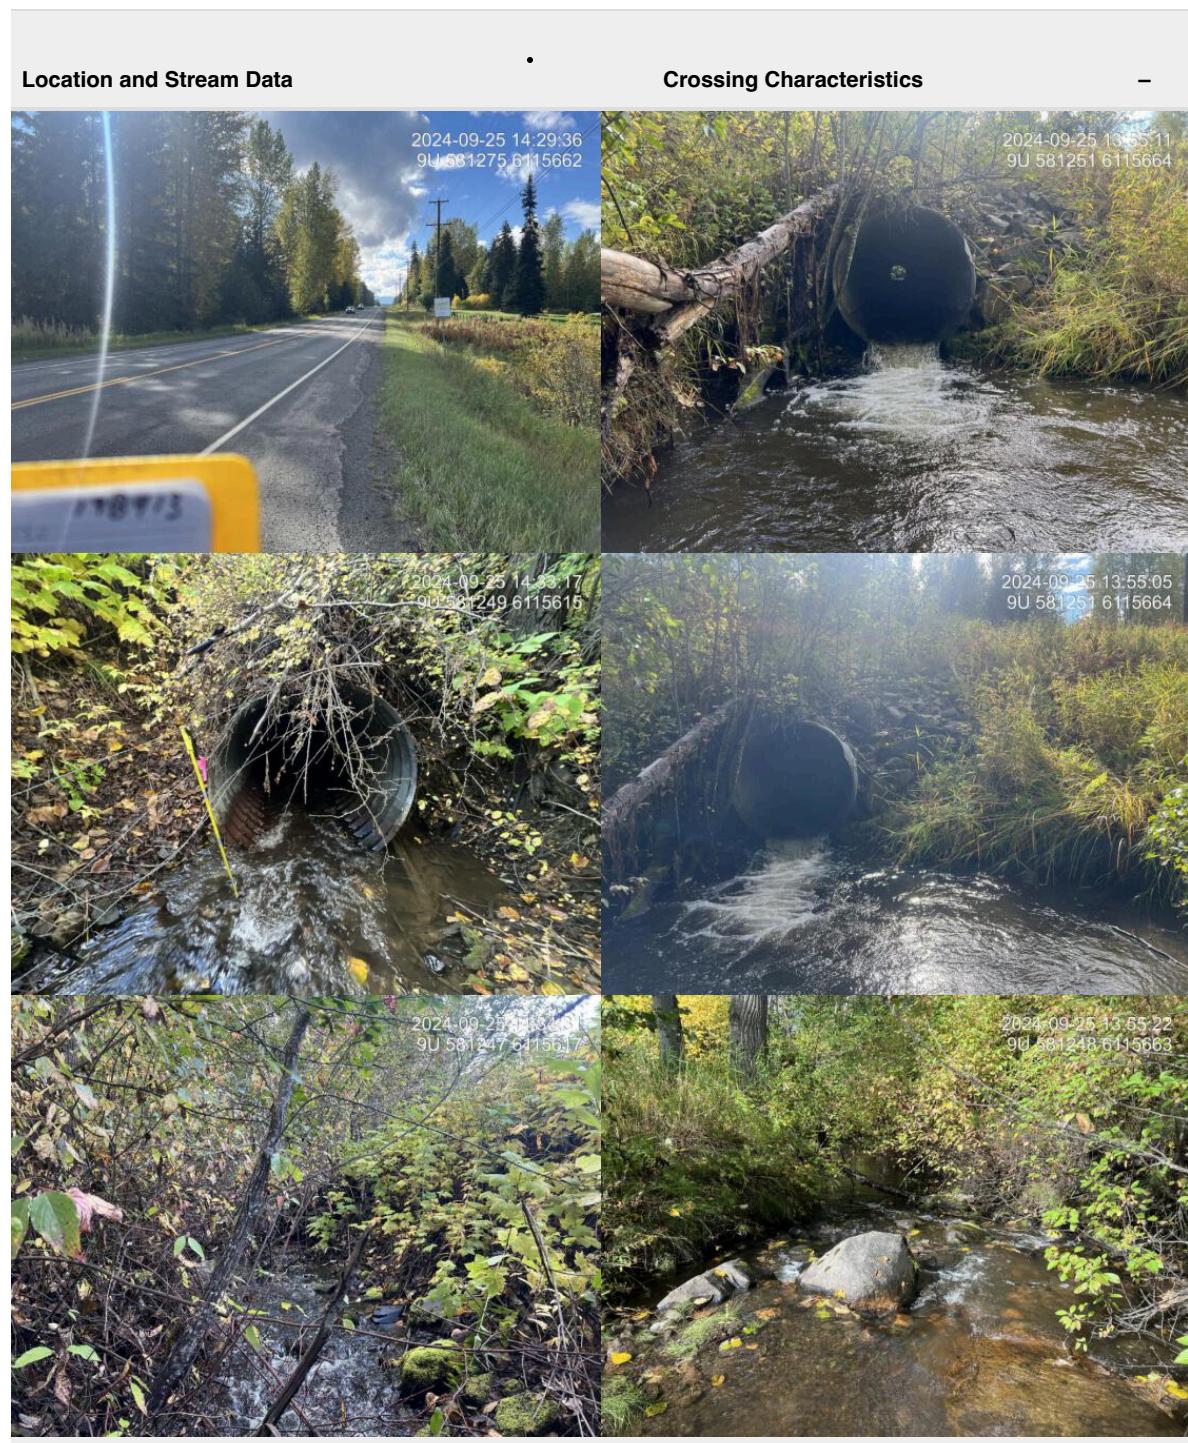
Photos: From top left clockwise: Road/Site Card, Barrel, Outlet, Downstream, Upstream, Inlet.

There is a deep outlet pool, suggesting the culvert is undersized for the stream. High-quality gravels were present at the pool's outlet, and upstream of the crossing, there was high-value habitat with frequent overwintering pools, spawning gravels, and adequate riparian cover with large cottonwoods throughout. This site was part of a habitat confirmation assessment, with the stream surveyed from the downstream railway crossing up to this location and an additional 600 m upstream. Downstream, crossing 198916 consists of a large, long box culvert beneath the railway with minimal flow depth and a swift current, making it unlikely that fish from the mainstem of the Skeena River can access this site until the railway barrier is addressed. Fish sampling at this site captured cutthroat trout and Dolly Varden. MoTi chris_culvert_id: 8300872

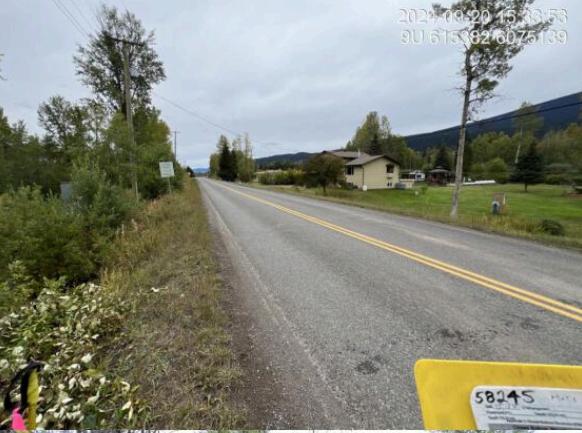
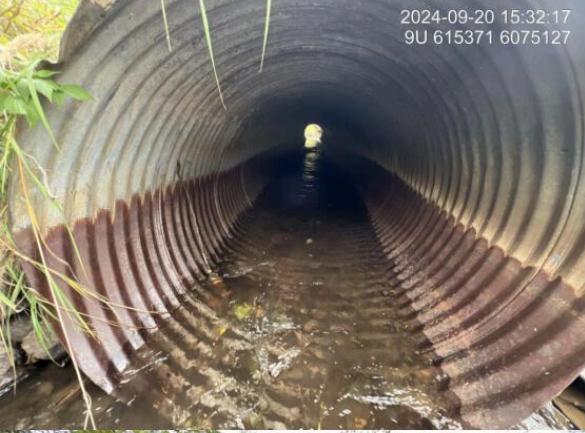
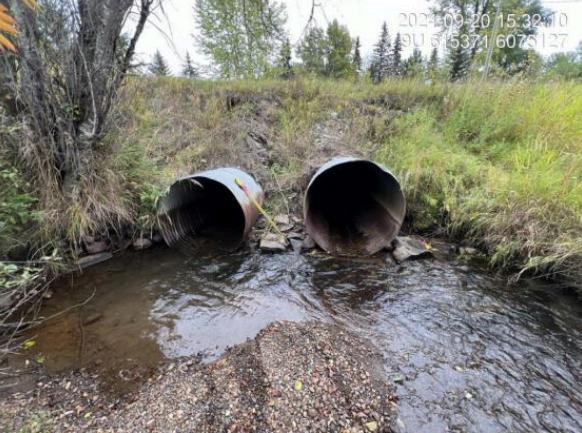
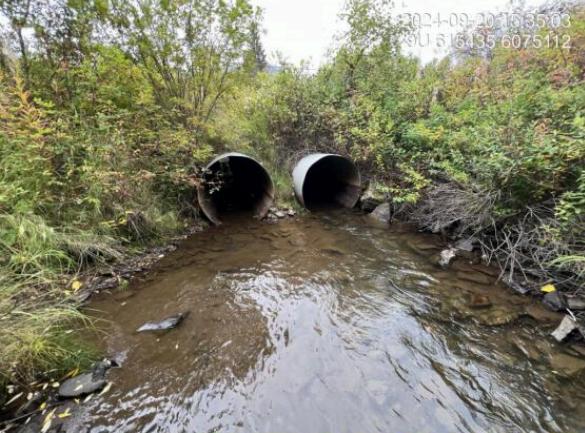
Location and Stream Data	Crossing Characteristics
<p>Comments: Two 1.25 m pipes are present and are heavily corroded. Upstream and downstream, the streambanks are heavily modified adjacent to private land, including riparian vegetation removal, stream channelization, and bank armouring. High-value steelhead, coho, and chinook spawning habitat is documented further upstream above the railway crossing. MoTi chris_culvert_id: 1514706, 1514705</p>	
<p>Photos: From top left clockwise: Road/Site Card, Barrel, Outlet, Downstream, Upstream, Inlet.</p>

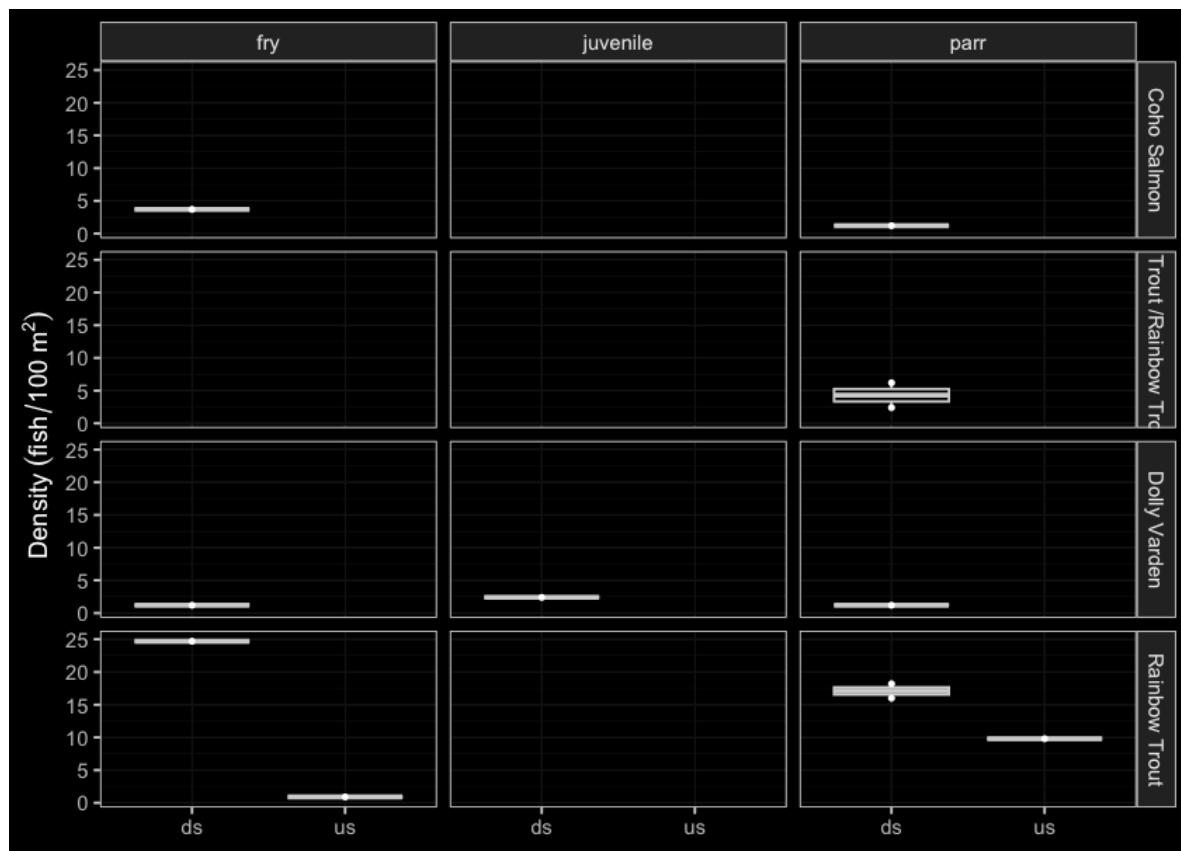
Electrofishing was conducted upstream and downstream of crossing (58264) with results summarised in Tables 5.23 - 5.24 and Figure 5.15. A total of 20 fish were captured downstream including rainbow trout, cutthroat trout/rainbow trout hybrid, and Dolly Varden. Upstream of the crossing 12 rainbow trout were captured (Figure 5.18) .

Electrofishing was conducted at one site approximately 360 m downstream of Nielsen Road, with results summarised in Tables 5.23 - 5.24 and Figure 5.15. At this location, the adjacent landowner had reported recent steelhead and coho spawning and historically Chinook spawning. A total of 43 fish were captured including coho salmon, cutthroat trout/rainbow trout hybrid, and Dolly Varden (Figure 5.18).

Figure 5.15: Densites of fish (fish/100m²) captured upstream and downstream of PSCIS crossing 58264.
