Skeena Watershed Fish Passage Restoration Planning 2024

Prepared for
Habitat Conservation Trust Foundation - CAT23-6-288
BC Fish Passage Remediation Program
Ministry of Transportation and Infrastructure

Prepared by
Al Irvine, B.Sc., R.P.Bio and Lucy Schick, B.Sc.
New Graph Environment Ltd.
on behalf of
Society for Ecosystem Restoration in Northern British Columbia

Version 0.0.1 2025-03-26

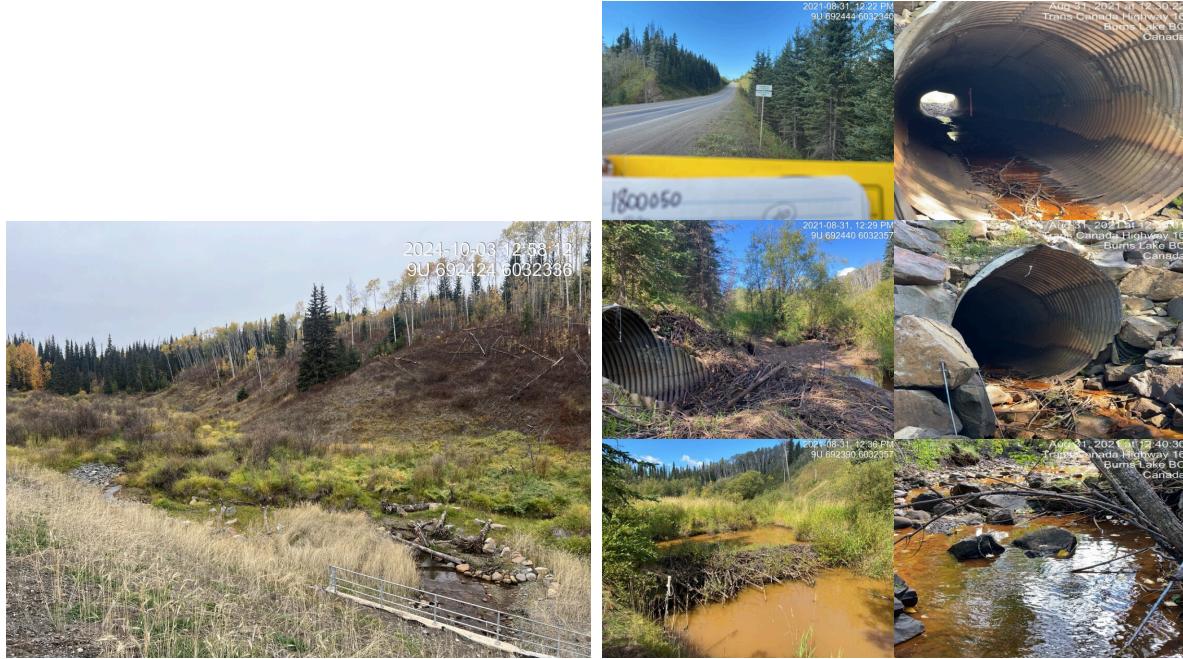
Figure 4.6: Left: Woody debris and boulder structures cabled together for additional reinforcement located upstream of 197967 in 2024. Right: Photos of crossing 197967 in 2021.

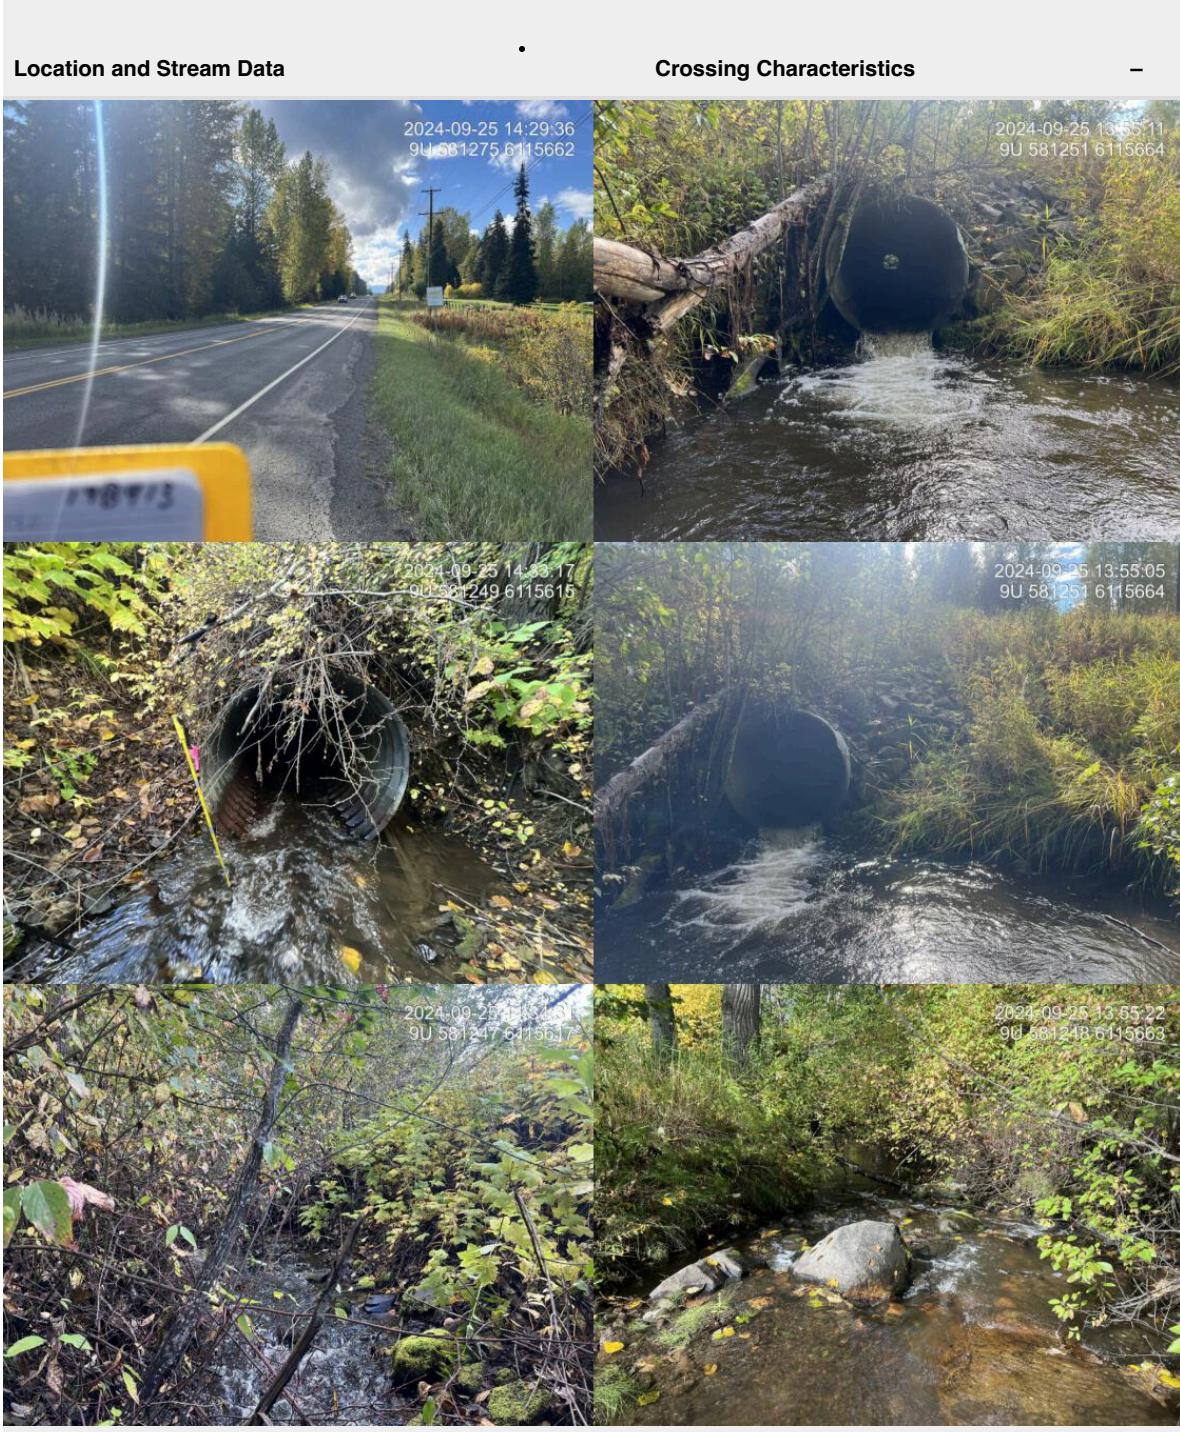
Photos: From top left clockwise: Road/Site Card, Barrel, Outlet, Downstream, Upstream, Inlet.

Location and Stream Data		Crossing Characteristics	
Date	2024-09-25	Crossing Sub Type	Round Culvert
PSCIS ID	198913	Diameter (m)	1.5
External ID	-	Length (m)	40
Crew	AI JO	Embedded	No
UTM Zone	9	Depth Embedded (m)	-
Easting	581250	Resemble Channel	-
Northing	6115660	Backwatered	No
Stream	Gershwin Creek	Percent Backwatered	-
Road	Highway 16	Fill Depth (m)	2.5
Road Tenure	MOTi	Outlet Drop (m)	0.35
Channel Width (m)	5	Outlet Pool Depth (m)	0.85
Stream Slope (%)	3	Inlet Drop	No
Beaver Activity	No	Slope (%)	3
Habitat Value	Medium	Valley Fill	Deep Fill
Final score	42	Barrier Result	Barrier
Fix type	Replace with New Open Bottom Structure	Fix Span / Diameter	15
Comments:			
There is a deep outlet pool, suggesting the culvert is undersized for the stream. High-quality gravels were present at the pool's outlet, and upstream of the crossing, there was high-value habitat with frequent overwintering pools, spawning gravels, and adequate riparian cover with large cottonwoods throughout. This site was part of a habitat confirmation assessment, with the stream surveyed from the downstream railway crossing up to this location and an additional 600 m upstream. Downstream, crossing 198916 consists of a large, long box culvert beneath the railway with minimal flow depth and a swift current, making it unlikely that fish from the mainstem of the Skeena River can access this site until the railway barrier is addressed. Fish sampling at this site captured cutthroat trout and Dolly Varden. MoTi chris_culvert_id: 8300872

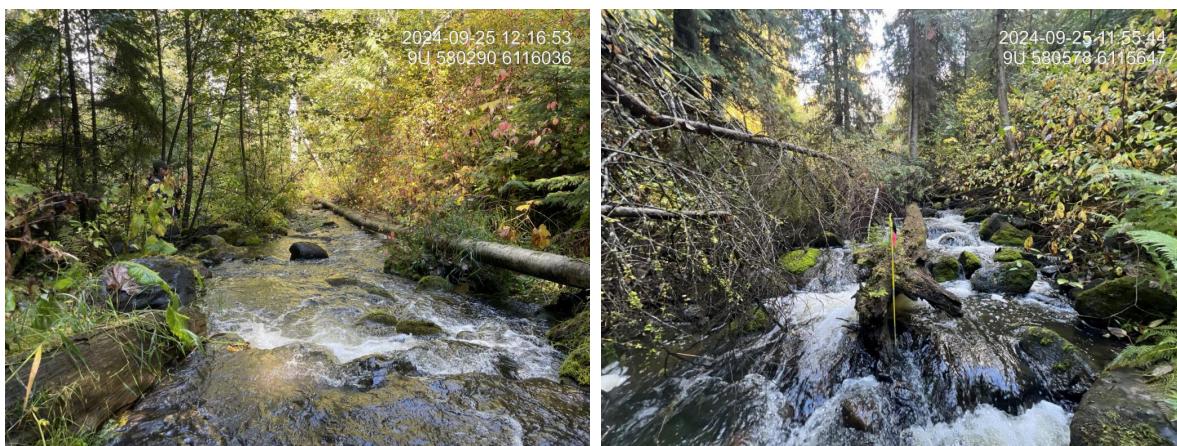
Figure 4.9: Left: Typical habitat downstream of PSCIS crossing 198916. Right: Typical habitat upstream of PSCIS crossing 198916.

The stream was surveyed downstream from crossing 198916 for 300m . The stream contained numerous boulders forming step pools; however, moderate flows at the time of assessment limited the availability of pools suitable for fish. The first pool suitable for overwintering fish, with adequately reduced flow, was located approximately 250 m downstream of the culvert. There were occasional gravels suitable for spawning and frequent large woody debris, which contributed to the formation of additional steps. (Figure [4.9](#)). The dominant substrate was cobbles with gravels sub-dominant. The average channel width was 5.9m, the average wetted width was 3.7m, and the average gradient was 5.1%. Total cover amount was rated as moderate with boulders dominant. Cover was also present as small woody debris, large woody debris, and overhanging vegetation. The habitat was rated as medium value suitable for salmonid rearing and spawning.

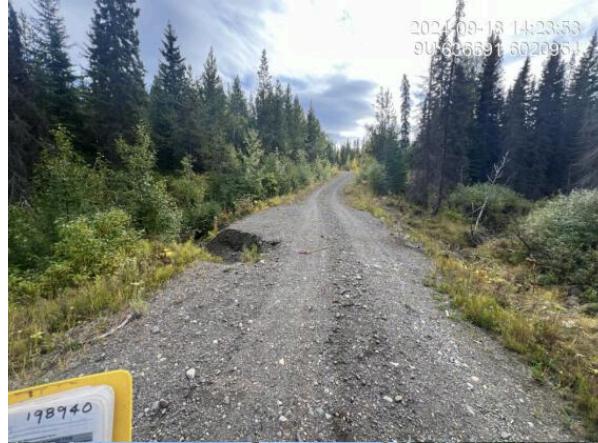
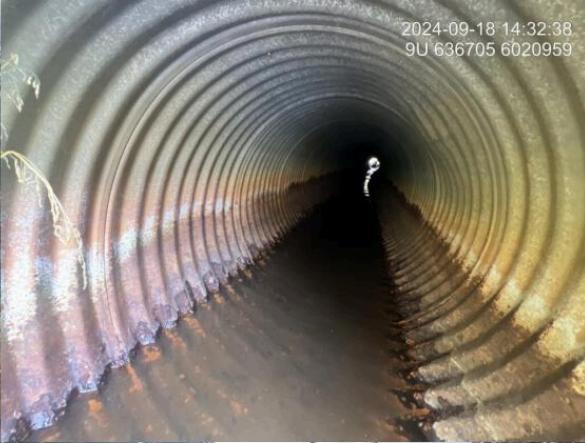
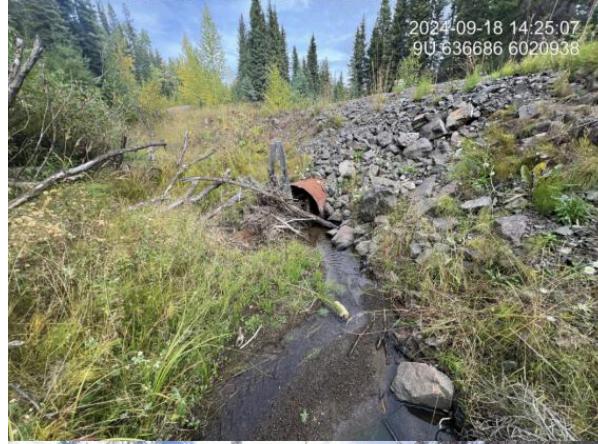
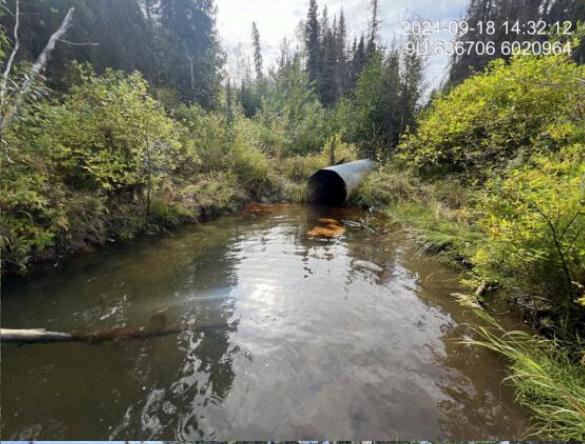
Location and Stream Data	Crossing Characteristics
<p>Comments: Very nice stream with good flow, abundant gravels for spawning, and undercut banks and occasional deep pools for rearing. Confirmed populations of cutthroat trout, rainbow trout, and Dolly Varden. The culvert is significantly undersized for the stream, and the road appears to be failing, likely due to a partially clogged inlet and spring freshet. Habitat confirmations were completed for this crossing and the next upstream crossing (198935) on the Gold FSR.</p>	
<p>Photos: From top left clockwise: Road/Site Card, Barrel, Outlet, Downstream, Upstream, Inlet.</p>

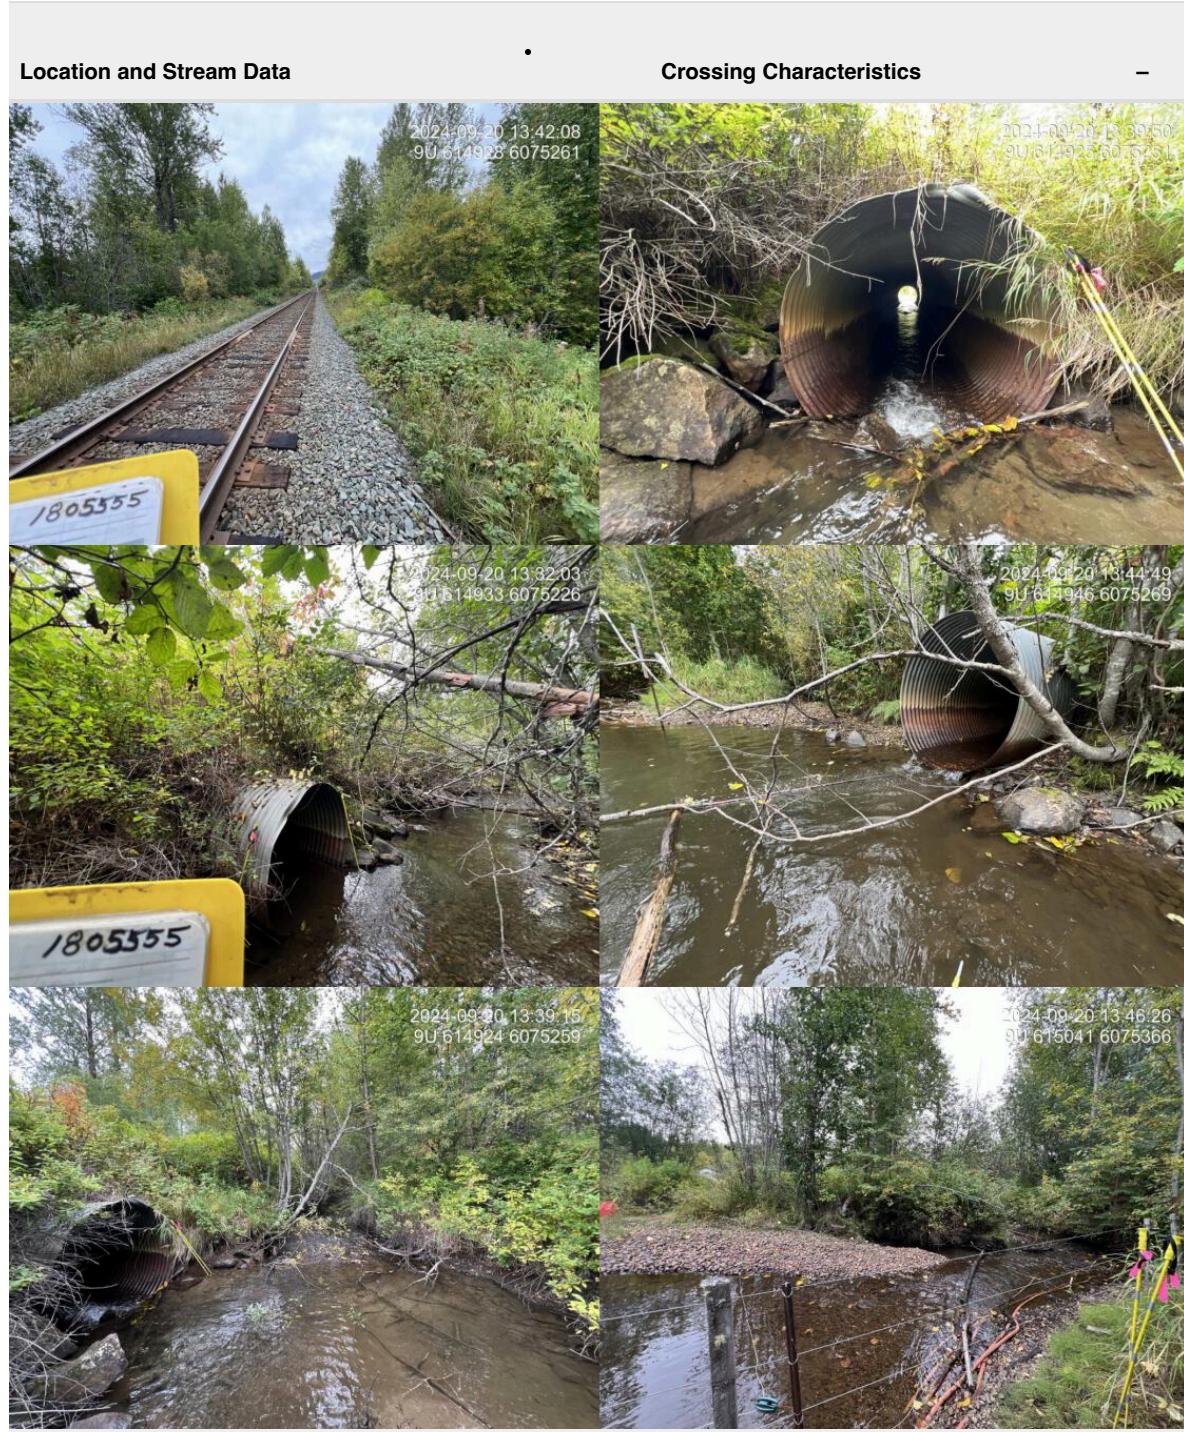
Location and Stream Data		Crossing Characteristics	
Date	2024-09-20	Crossing Sub Type	Round Culvert
PSCIS ID	203122	Diameter (m)	3
External ID	–	Length (m)	25
Crew	AI	Embedded	No
UTM Zone	9	Depth Embedded (m)	–
Easting	614941	Resemble Channel	Yes
Northing	6075232	Backwatered	No
Stream	Simpson Creek	Percent Backwatered	–
Road	Railway	Fill Depth (m)	1
Road Tenure	CN Rail	Outlet Drop (m)	0.05
Channel Width (m)	5	Outlet Pool Depth (m)	0.9
Stream Slope (%)	1	Inlet Drop	Yes
Beaver Activity	Yes	Slope (%)	2
Habitat Value	High	Valley Fill	Deep Fill
Final score	24	Barrier Result	Barrier
Fix type	Replace with New Open Bottom Structure	Fix Span / Diameter	15
Comments: Although this culvert is on Simpson Creek, it is not currently conveying the main flow and remains mostly dry. Two 1.5 m diameter pipes run under the railway, approximately 30 m apart. The southern pipe is fully embedded with an average embedment depth of 25 cm, while the northern pipe is currently passing all stream flow. This is a high-value stream with extensive gravel areas suitable for steelhead, coho, and chinook salmon spawning upstream. The adjacent landowner has reported recent observations of steelhead spawning and has historical knowledge of chinook spawning approximately 300 m downstream from Nielsen Road.

Photos: From top left clockwise: Road/Site Card, Barrel, Outlet, Downstream, Upstream, Inlet.

PSCIS crossing 203122 on the CN Railway presented a minimal barrier to fish passage and is considered a low priority for replacement. However, if restoration activities are undertaken, replacing the existing structure with a bridge spanning 15 m is recommended. As of 2025, the estimated replacement cost is \$ 11,250,000, with the high cost attributed to the complexities of working within a railway corridor.

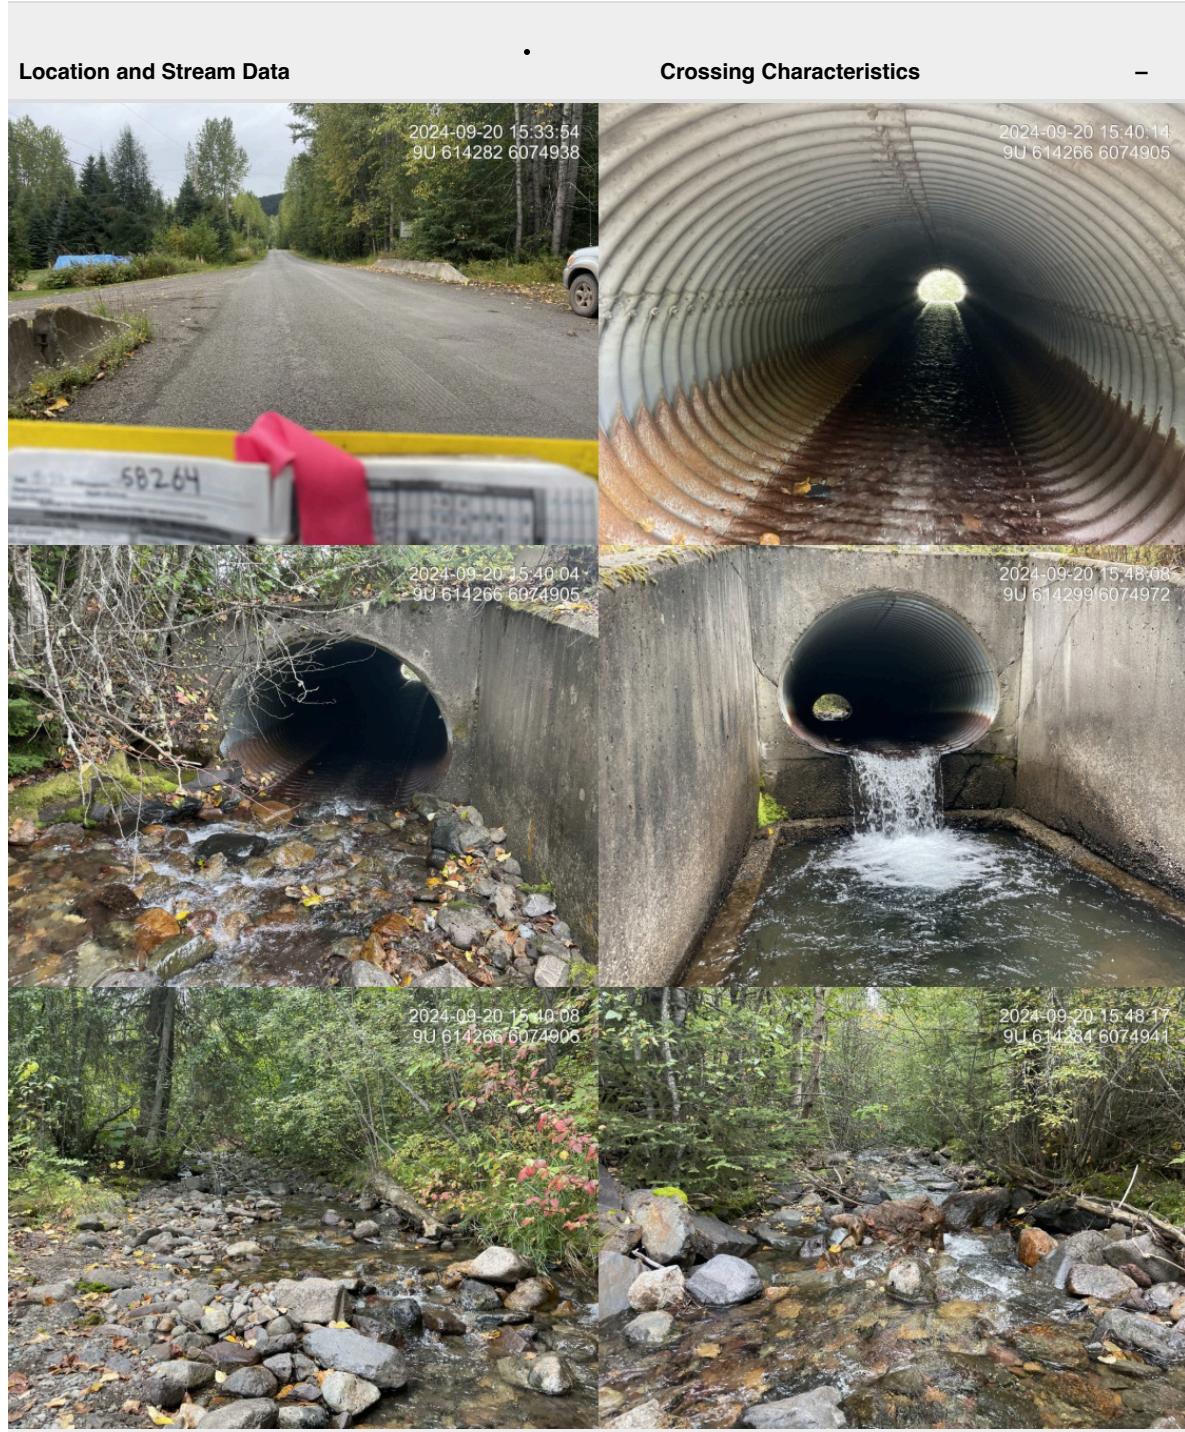
Location and Stream Data		Crossing Characteristics	
Date	2024-09-20	Crossing Sub Type	Oval Culvert
PSCIS ID	58264	Diameter (m)	2.4
External ID	-	Length (m)	23
Crew	LS TP	Embedded	No
UTM Zone	9	Depth Embedded (m)	-
Easting	614280	Resemble Channel	-
Northing	6074951	Backwatered	No
Stream	Simpson Creek	Percent Backwatered	-
Road	Nielson Road	Fill Depth (m)	0.4
Road Tenure	MoTi	Outlet Drop (m)	1
Channel Width (m)	5.6	Outlet Pool Depth (m)	1.2
Stream Slope (%)	13	Inlet Drop	No
Beaver Activity	No	Slope (%)	5
Habitat Value	High	Valley Fill	Deep Fill
Final score	39	Barrier Result	Barrier
Fix type	Replace with New Open Bottom Structure	Fix Span / Diameter	15
Comments: This concrete oval culvert has a significant 1 m outlet drop, likely inhibiting fish passage. The stream is incorrectly mapped in the Freshwater Atlas, located south of the mapped channel. Upstream habitat includes boulder cover, gravel pockets suitable for coho, steelhead, and Dolly Varden spawning, and a healthy mature mixed forest riparian zone. Downstream habitat transitions to lower-gradient, high-value conditions with extensive gravels, deep pools (up to 90 cm), large woody debris, and abundant cover, supporting recent steelhead and historically chinook spawning, as reported by the adjacent landowner. Habitat confirmations were completed at this site and all downstream crossings to the confluence with Kathlyn Creek. The stream is a major contributor to the greater Kathlyn Creek watershed, with flow volumes during the assessment slightly less than the Kathlyn Creek mainstem. Electrofishing upstream of Nielsen Road captured rainbow trout, while downstream sampling confirmed the presence of Dolly Varden, rainbow trout, cutthroat trout/rainbow trout hybrids, and coho. The coho were captured approximately 350 m downstream of Nielsen Road. According to the landowner, this crossing was originally a bridge but was replaced with the current culvert during an emergency flood event in the 1990s.

Photos: From top left clockwise: Road/Site Card, Barrel, Outlet, Downstream, Upstream, Inlet.

Should restoration/maintenance activities proceed, replacement of the Nielson Road crossing (58264) with a bridge (15 m span) is recommended. The significant 1 m outlet drop at this crossing, combined with the presence of salmonids in the system, makes it a top priority for remediation. At the time of reporting in 2025, the cost of the work is estimated at \$ 3,000,000.

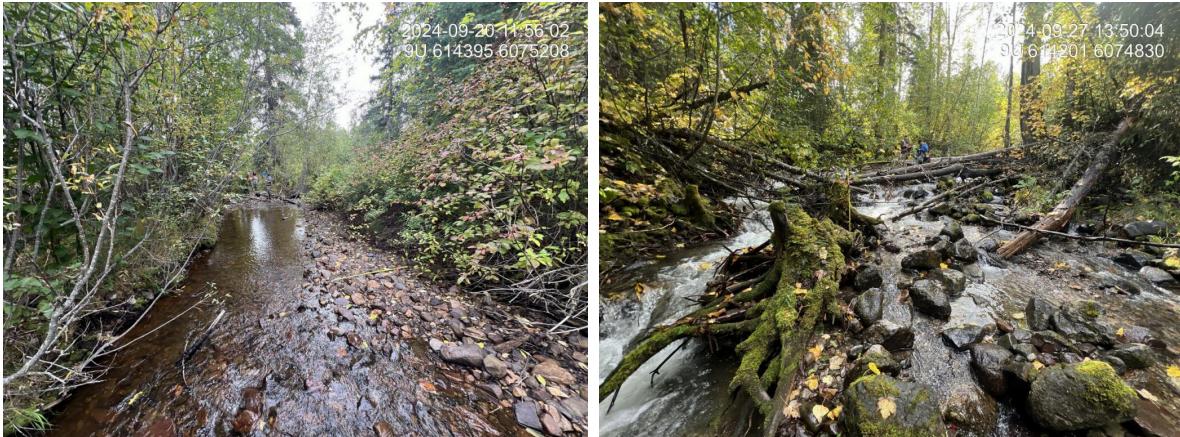
Figure 4.18: Left: Steelhead spawning location upstream of PSCIS crossing 203122 and downstream of PSCIS crossing 58264, as reported by the adjacent landowner. Right: Typical habitat upstream of PSCIS crossing 58264.

The stream was surveyed upstream from crossing 58264 for 615m . This section of the stream featured a steeper gradient, predominantly characterized by boulder cover with occasional pockets of gravels suitable for coho, steelhead, and Dolly Varden spawning (Figure 4.18). Pools were infrequent throughout. The riparian zone was composed of a healthy, mature mixed forest, providing stability and shading. The upper end of the site was situated just upstream of a short cascade with a 20% gradient. The habitat was rated as medium value for salmonid rearing and spawning. The dominant substrate was cobbles with boulders sub-dominant. The average channel width was 8.9m, the average wetted width was 4.7m, and the average gradient was 7.3%. Total cover amount was rated as moderate with boulders dominant. Cover was also present as large woody debris.
