SOCIETY FOR ECOSYSTEM RESTORATION  
IN NORTHERN BRITISH COLUMBIA

## Restoring Fish Passage in the Skeena Region - 2025

Prepared for  
Habitat Conservation Trust Foundation - CAT26-0-636  
Ministry of Transportation and Infrastructure

Version 0.1.0 DRAFT 2026-08-04

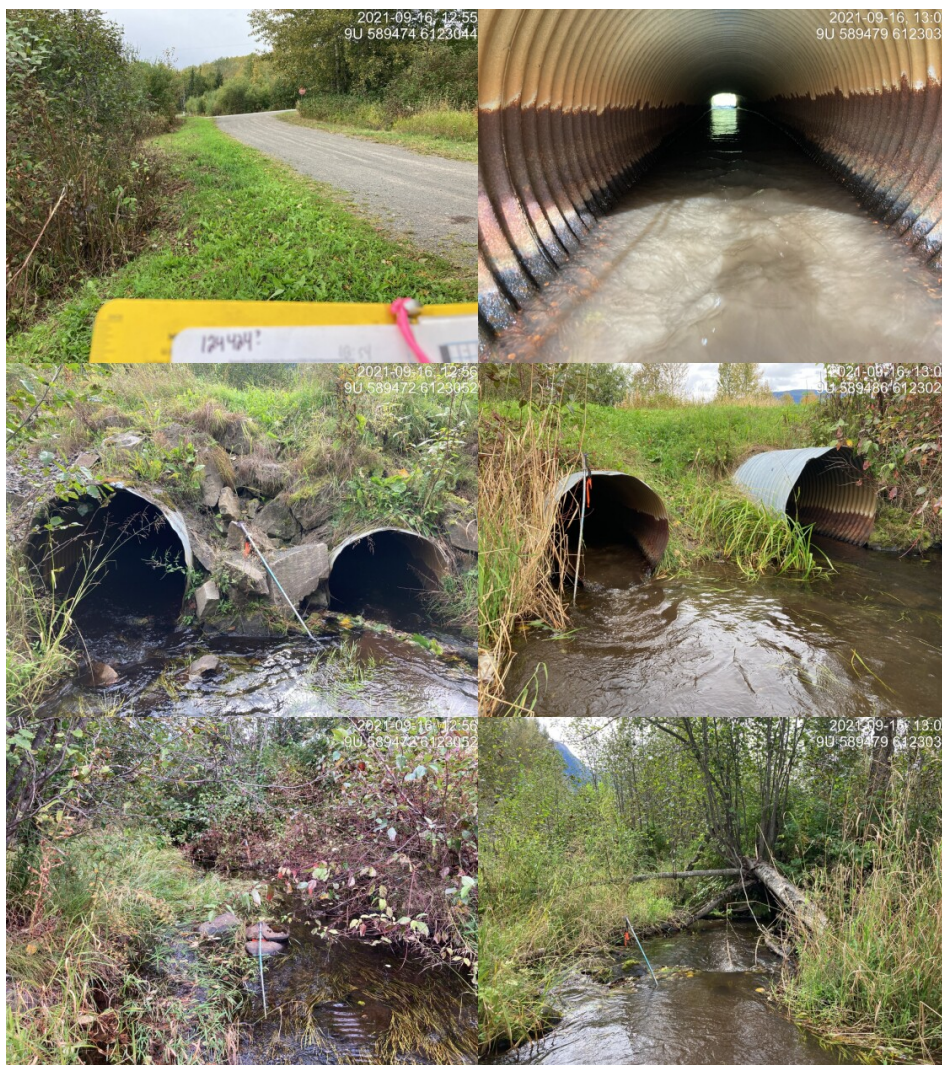
Before removal, the structure was a round culvert ranked a barrier to upstream migration under the provincial protocol (MoE 2011). The September 2021 assessment recorded the pipes bent in the middle from road weight and an inlet drop of 0.10 m on both, in a reach described as slow, steady flow through almost wetland habitat above and below the crossing (Figure [5.1](#)).

Figure 5.1: Culvert on Waterfall Creek at PSCIS crossing 124421 on 11th Avenue, photographed in September 2021 before removal.

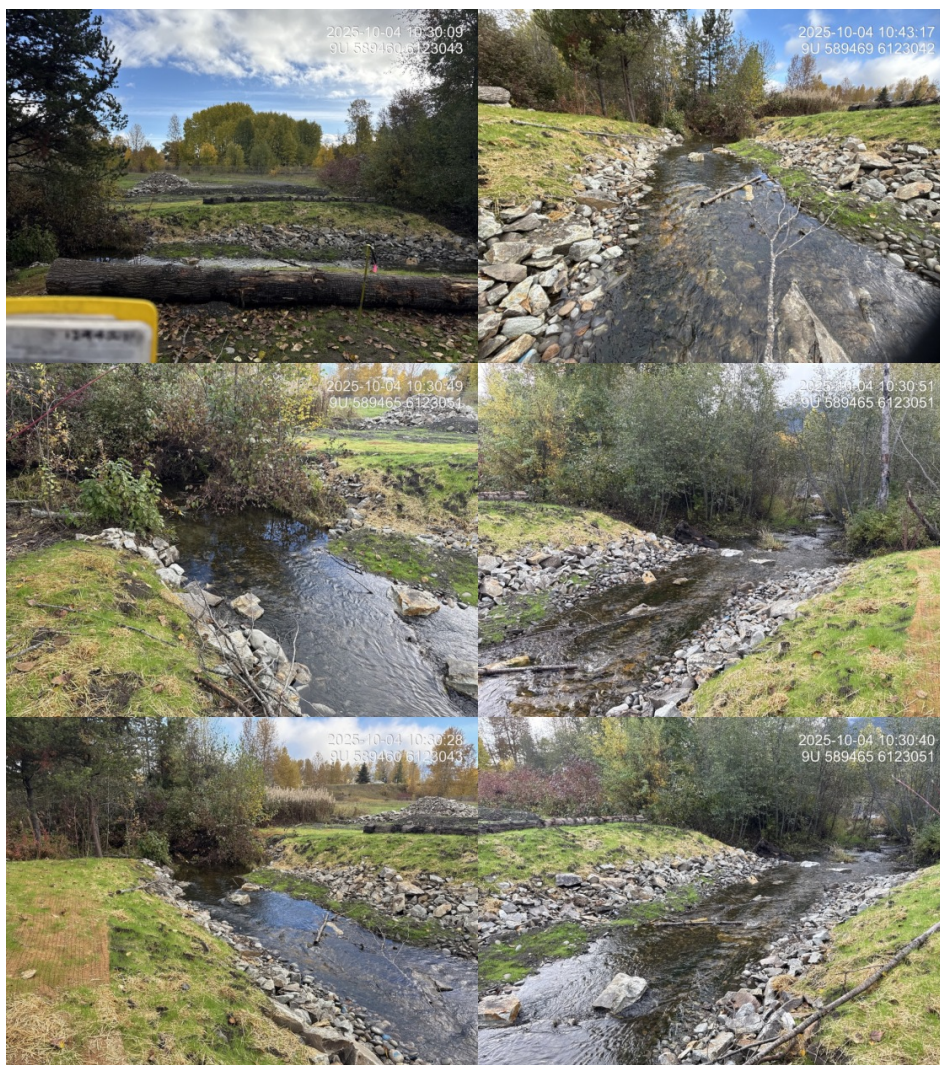
The culvert has since been removed. At the 2025 visit the riprap at the site had been buried with soil and seeded, with good regrowth of grasses established, and shrub planting was planned for the fall (Figure [5.2](#)).

Figure 5.2: Waterfall Creek at PSCIS crossing 124421 on 11th Avenue, photographed on 2025-10-04 following removal of the culvert.

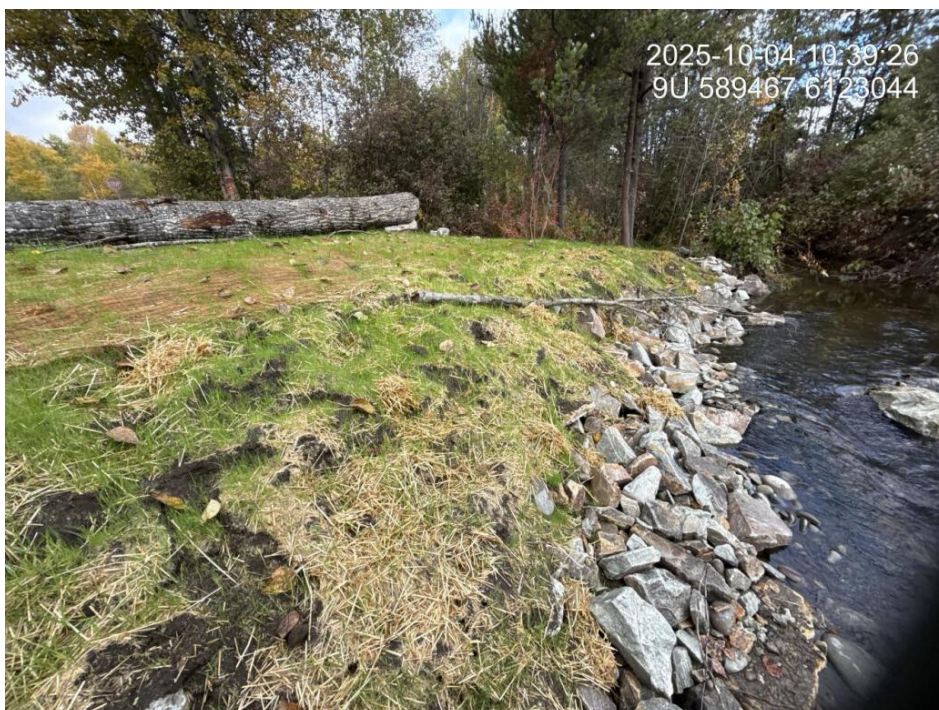
Figure 5.3: Revegetation of the buried riprap at PSCIS crossing 124421, recorded during the 2025 effectiveness monitoring visit.

Removing a crossing outright, rather than replacing it, is the most complete form of remediation available and it is uncommon in this program. The 2025 visit found the site stabilising as intended — riprap buried and seeded, grasses established, shrub planting to follow.

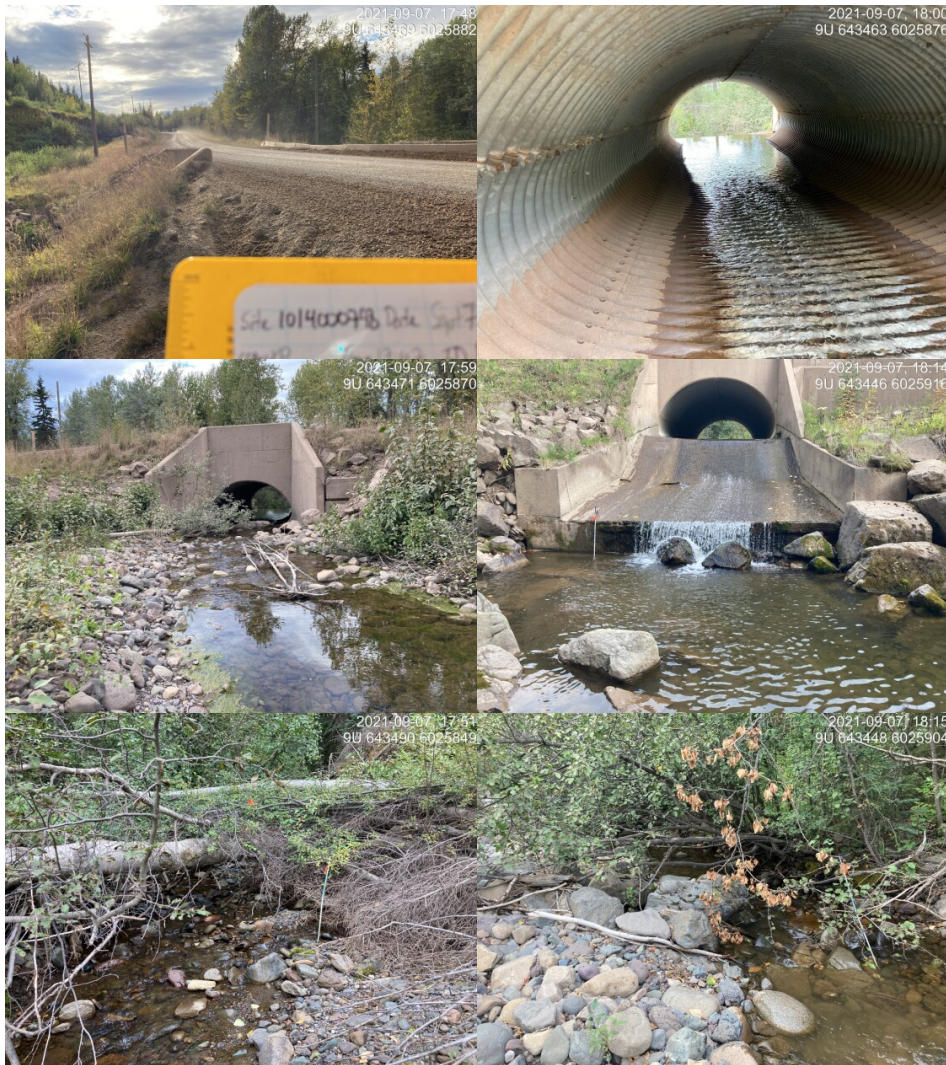
Before replacement, the structure was a corrugated metal culvert with a concrete headwall, ranked a barrier to upstream migration under the provincial protocol (MoE 2011). The assessment recorded a partial inlet drop of varying height caused by large woody debris and boulders. Photographs taken during the September 2021 assessment show the outlet perched above a plunge pool, with the drop and the pool visible below the headwall (Figure [5.4](#)).

Figure 5.4: Culvert on Peacock Creek at PSCIS crossing 197962 on the Morice FSR, photographed on 2021-09-07 before replacement. The outlet is perched above a plunge pool.

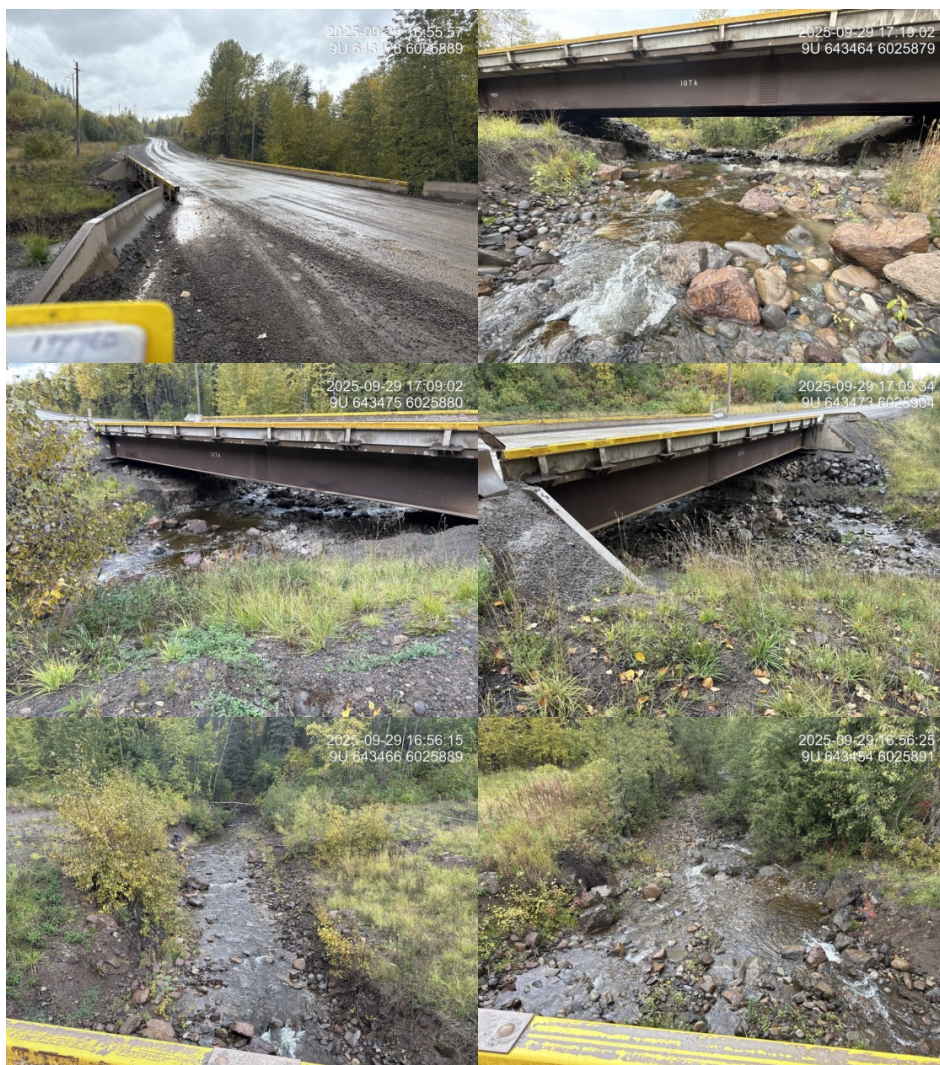
The replacement structure is an open-span bridge. Photographs from the 2025 monitoring visit show an unconstricted channel through the crossing, with the bed continuous through the opening and no residual outlet drop (Figure [5.5](#)).

Figure 5.5: Bridge on Peacock Creek at PSCIS crossing 197962 on the Morice FSR, photographed on 2025-09-29 following replacement.

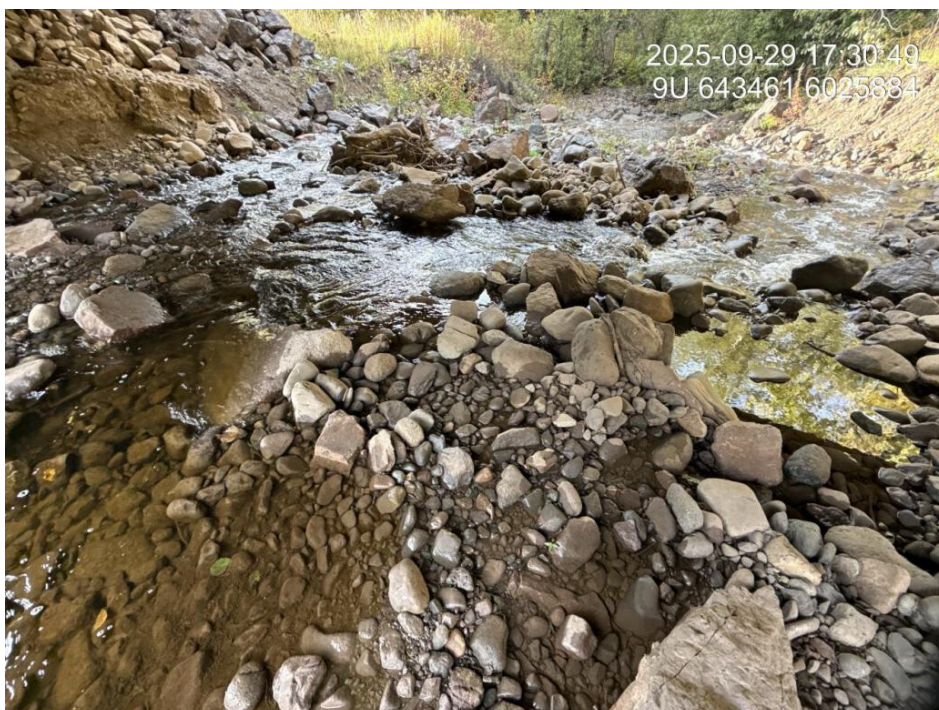
Figure 5.6: Substrate condition through the crossing at PSCIS crossing 197962, recorded during the 2025 effectiveness monitoring visit.
