Fast Dynamic Control of Damaged Historical Buildings: A New Useful Approach for Structural Health Monitoring after an Earthquake

Sergio Vincenzo Calcina, Luca Piroddi, and Gaetano Ranieri

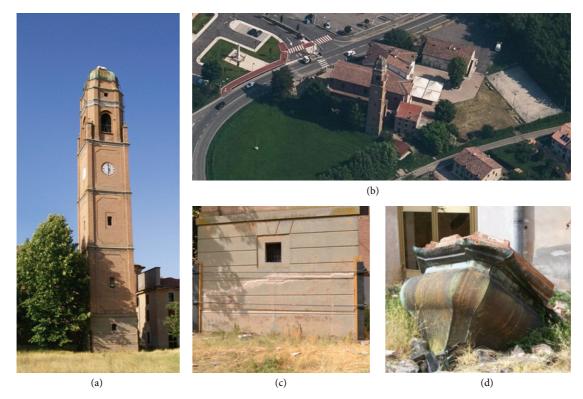
FIGURE 1: Some images of the damaged bell tower. (a) Southwest side of the building. (b) Panoramic view. (c) Cracks at the base of the tower. (d) Collapsed top.

in case of earthquakes. In this work, we present the study performed for the bell tower of San Giacomo Roncole. The actual structure was built from 1771 to 1774 with the same materials of the previous Carmelite Convent of Santa Maria delle Grazie della Galeazza [14]. The building is located few metres away from the singular nave of the church. The structure replaced an earlier tower, adjacent to the body of the church, and demolished by the damage caused by the vibrations of the bells. The new tower is a masonry structure located at southwest of the church. The tower reaches a height of about 36 metres with a square base (5 metres per side). After the earthquakes of the 20th and 29th May, 2012, (magnitude $M_l = 5.9$ and $M_l = 5.8$, resp.) the building sustained serious damage to the base, highlighted by displacements of about 2 cm toward the southwest side and of 1 cm on the southeast side. In other words, after the earthquake, the structure was shifted at the base, assuming an eccentric position. Also there are various fractures on the first section of the tower horizontally and diagonally crossing its perimeter walls, where a rigid motion on the order of

centimetres was measured. The top of the structure collapsed at about 9 metres from the base toward the southwest side (see Figure 1).

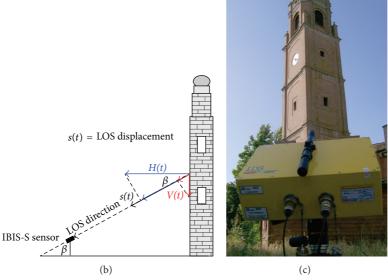
FIGURE 2: (a) Installation of the IBIS-S system in several acquisition stations placed at 25 m (St 01) and 23 m (St 02) from the base of the tower with LOS angle of 30° (central beam) and at 8 m (St 03) with LOS angle of 70° (central beam). (b) Radar line of sight displacement and true displacement vector. (c) Image of the IBIS-S system used during the experiments.

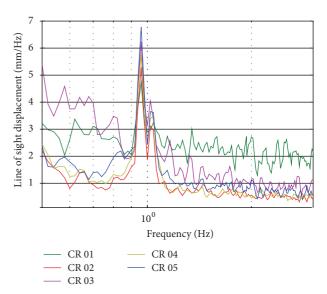
FIGURE 4: Displacement spectra calculated by using the entire 10-minute record, for five different radar-bins with variable SNR achieved from data acquisition with configuration 1.

The calculated displacement spectra, obtained over the whole recorded ten minutes signal, are shown in Figure 4. A band-pass filter (0.3 Hz–10 Hz) was applied to reduce the presence of disturbances linked to atmospheric effects and to vibration of the sensor itself. The influence of the first effect is prevalent on the measured phases and, as a consequence, on the estimated displacements with long period (0.1–0.2 Hz). Another effect is caused by the vibration of the measurement tool. Luzi et al. [16] observe that the measured resonant frequency of the system ranges within $10 \, \text{Hz} \pm 2 \, \text{Hz}$ for typical working conditions. Then a low-pass filtering may
