Cement Bond Log Report for 33847-CBL.las

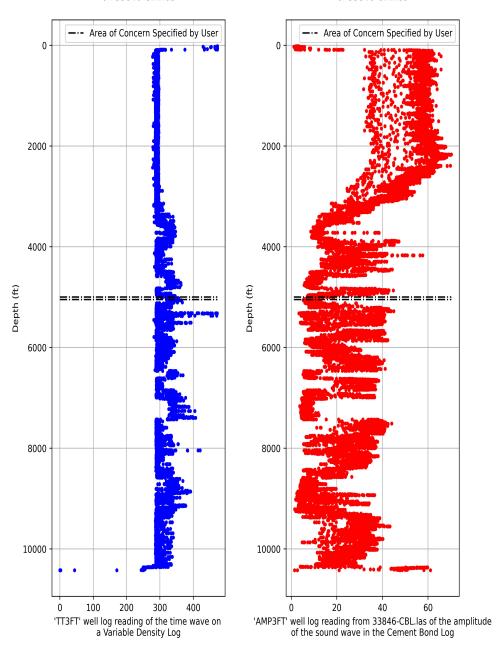
This is the time of return for the transmission on 33846-CBL.las

This is the sound wave amplitude of 33846-CBL.las

oad cement

The area of concern for casing inspection ranges from 5000 - 5050 feet.

For the area of concern specified, the average time in usec is 391.0 with a standard deviation of 55.0.

In contrast, the average time of return for the entire length of the well log is 331.0.

For the area of concern specified, the average amplitude in mV is 7.0 with a standard deviation of 1.0.

In contrast, the average amplitude for the entire well log is 22.0.
