# "Spinning Wheel" Troubleshooting

## Display-to-Expansion-Module Communication Failure

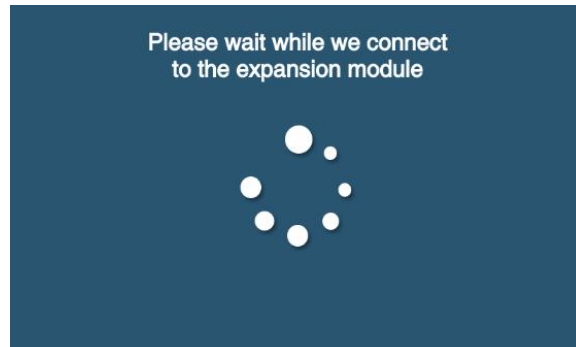
This issue occurs when the display becomes stuck on the following start-up screen:

*"Please wait while we connect to the expansion module"*

It is caused by a physical problem in the unit — typically damaged wiring, a wire that has worked loose from a connector, a burnt/damaged Expansion Module (EM), or one of the 4 connectors in the communication path not seated firmly.

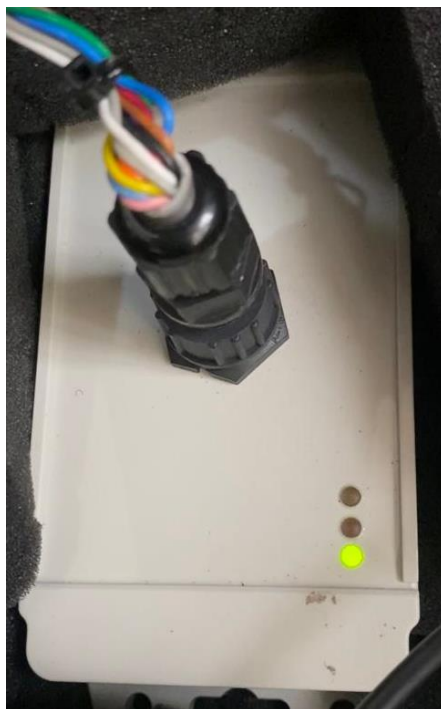
- **No light at all** — the EM is not receiving power. Check the power wiring and connections feeding the module.
- **Green LED flashing slowly** — normal operation. Power is good; continue to Step 2.
- **Green LED on steady (not flashing)** — the EM is likely burnt out or damaged and will need to be replaced.

*Expansion Module LED indicator*

***Before replacing an EM that may be damaged, make sure there are no shorts in the connections and that everything is within electrical specifications — otherwise the replacement module could be damaged as well.***

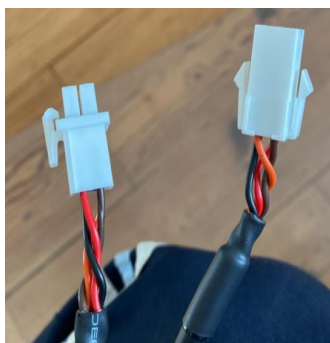
Inspect the two 4-pin connectors in the display-to-EM communication path: the 4-pin connector in the middle of the harness (joining the display harness to the EM harness), and the 4-pin connector at the EM itself.

*Disconnected*

*Properly seated (notch engaged)*

*Secured with tape*

Disconnect and reconnect each one, making sure it seats firmly and the notch/locking clip engages so the connectors cannot separate.

Optional: wrap the connection with electrical tape to secure it — being careful not to press the disconnect clip while doing so.

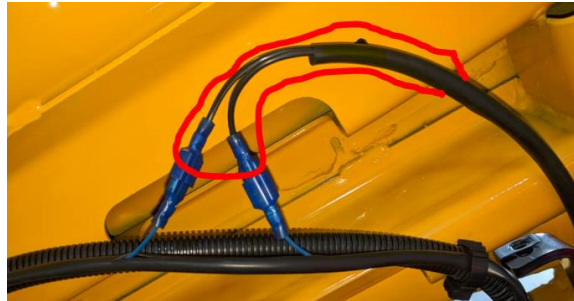
*Disconnect the twin wiring from the Fleet iQ360 system (red)*

Once the connectors for bypassing the system have been identified, disconnect the twin wiring (black and black/white) from the Fleet iQ360 system.

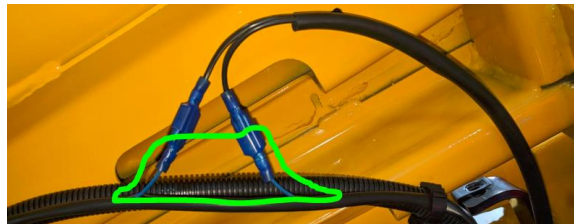
*Connect the forklift harness connectors to each other (green)*

Then connect the other two connectors from the other end — the ones coming from the forklift harness — to each other.
